Flood of April 2–3, 2005, Esopus Creek Basin, New York

By Thomas P. Suro and Gary D. Firda

Open-File Report 2007–1036

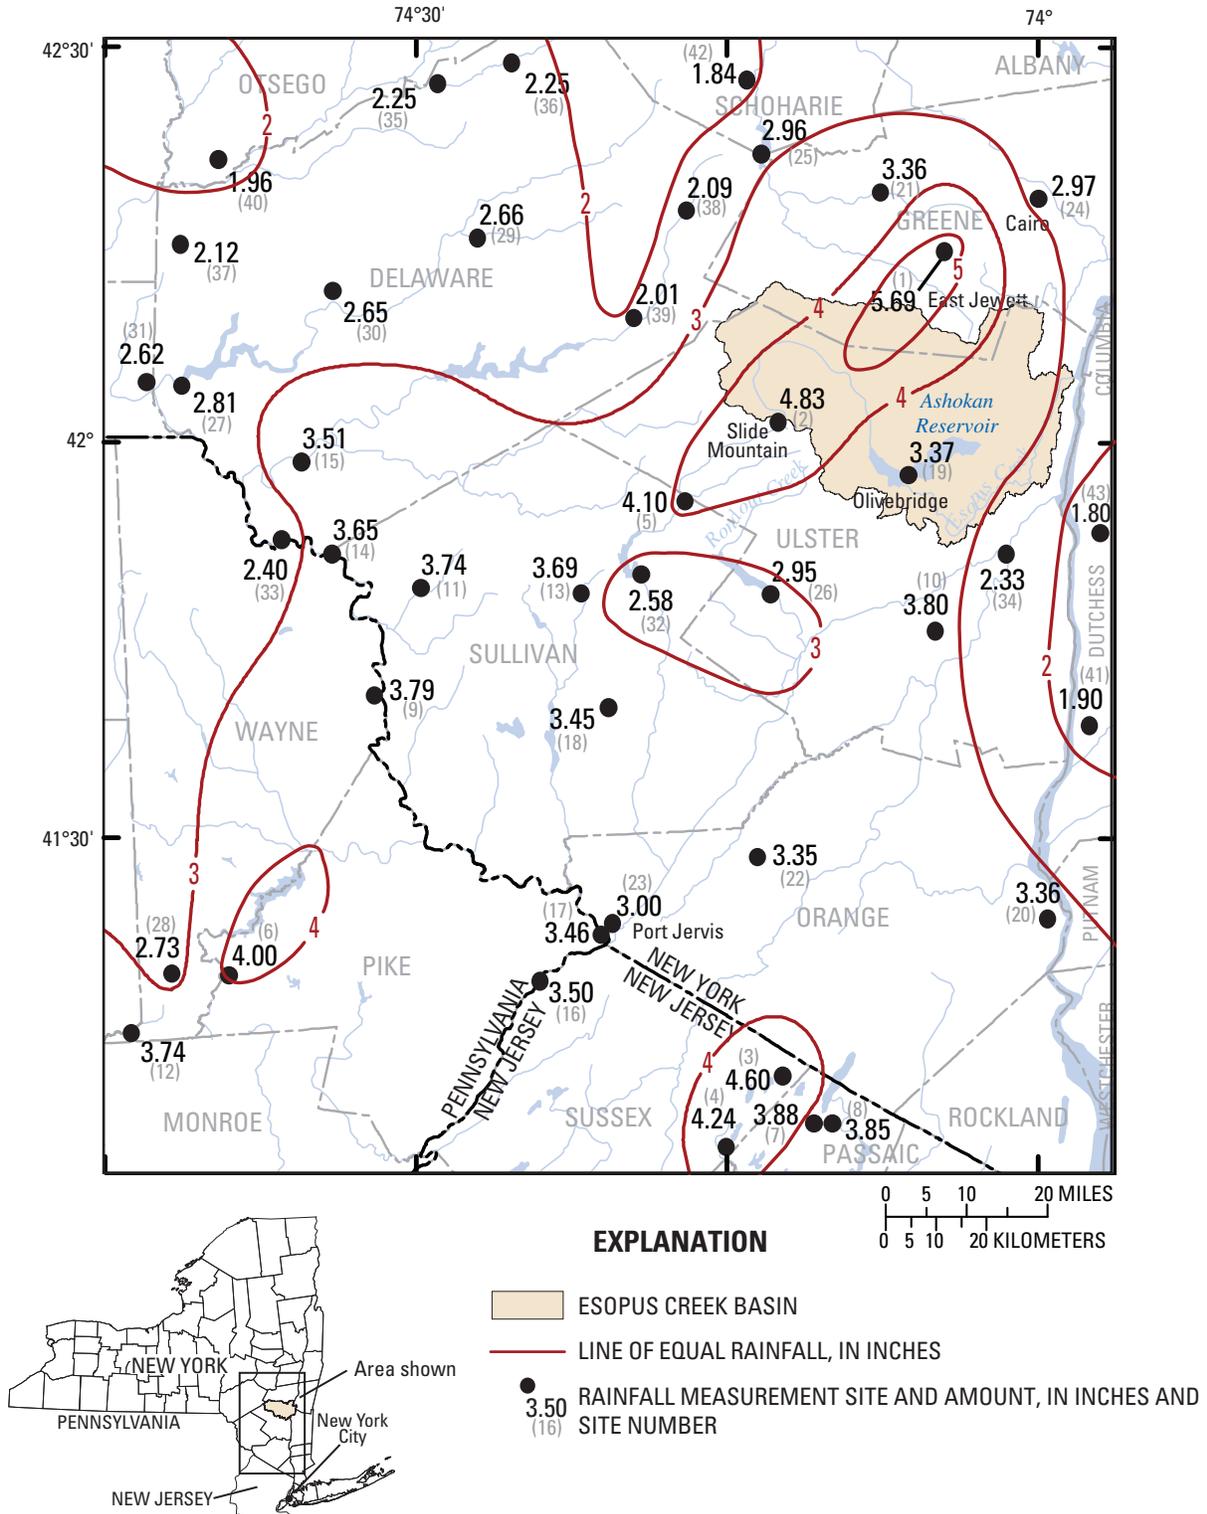
Figure 1. Pertinent geographic features of southeastern New York and rainfall amounts from the storm of April 2–3, 2005 (National Oceanic and Atmospheric Administration (2005b) and New York City Department of Environmental Protection (written commun., 2005)).

flowing at an above normal level. On April 1 the daily mean flow at the USGS stream-gaging station Esopus Creek at Allaben, N.Y. was at a level that is exceeded less than 10 percent of the time. The flow level on April 1 at the USGS stream-gaging station Esopus Creek at Coldbrook, N.Y., was at a level that is exceeded less than 15 percent of the time. The maximum recorded rainfalls for the period of April 2–3, 2005, near the headwaters of the Esopus Creek at Slide Mountain, N.Y., and at Ashokan Reservoir (fig. 1), located midway along the Esopus Creek, were 4.83 and 3.37 inches, respectively. Rainfall amounts recorded at 43 selected sites in New York, New Jersey, and Pennsylvania are listed in table 1. Selected rainfall amounts with respect to frequency and duration at Ashokan Reservoir, N.Y., which is centrally located along the Esopus Creek (fig. 1), are listed in table 2.

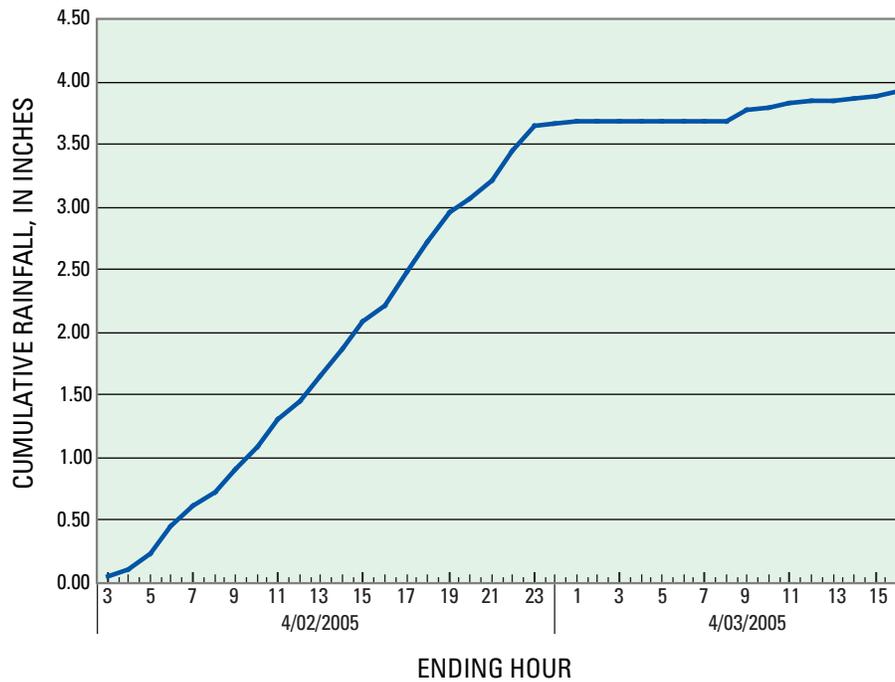
Figure 2. Cumulative rainfall during April 2-3, 2005, recorded at New York City Department of Environmental Protection station at Ashokan Reservoir, N.Y.

The rainfall intensity was not very high in the Esopus Creek Basin, with only a 2-year recurrence interval for a 24-hour storm at Ashokan Reservoir. Generally, the rainfall frequency associated with this storm across the Esopus Creek Basin was less than a 5-year recurrence interval. Most of the rainfall at Ashokan Reservoir fell at a fairly constant rate from the early morning hours on Saturday, April 2, 2005, until about midnight. Rainfall continued at a lower intensity until late afternoon on Sunday, April 3 (New York City Department of Environmental Protection, written commun. 2005). A plot of cumulative rainfall at the NYCDEP station at Ashokan Reservoir, N.Y. (fig. 2) illustrates this rainfall pattern from the early morning of Saturday, April 2, until late afternoon on Sunday, April 3, 2005.

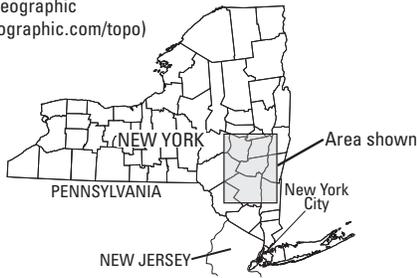
Figure 3. Locations of selected U.S. Geological Survey stream-gaging stations in the Hudson River Basin, N.Y. (See table 3 for station names and flood-related data.)

The locations of 19 USGS stream-gaging stations in the Hudson River Basin cited in this report are presented in figure 3. Historical flood peak discharges and peak discharges for the flood of April 2–3, 2005, at these stations are presented in table 3.

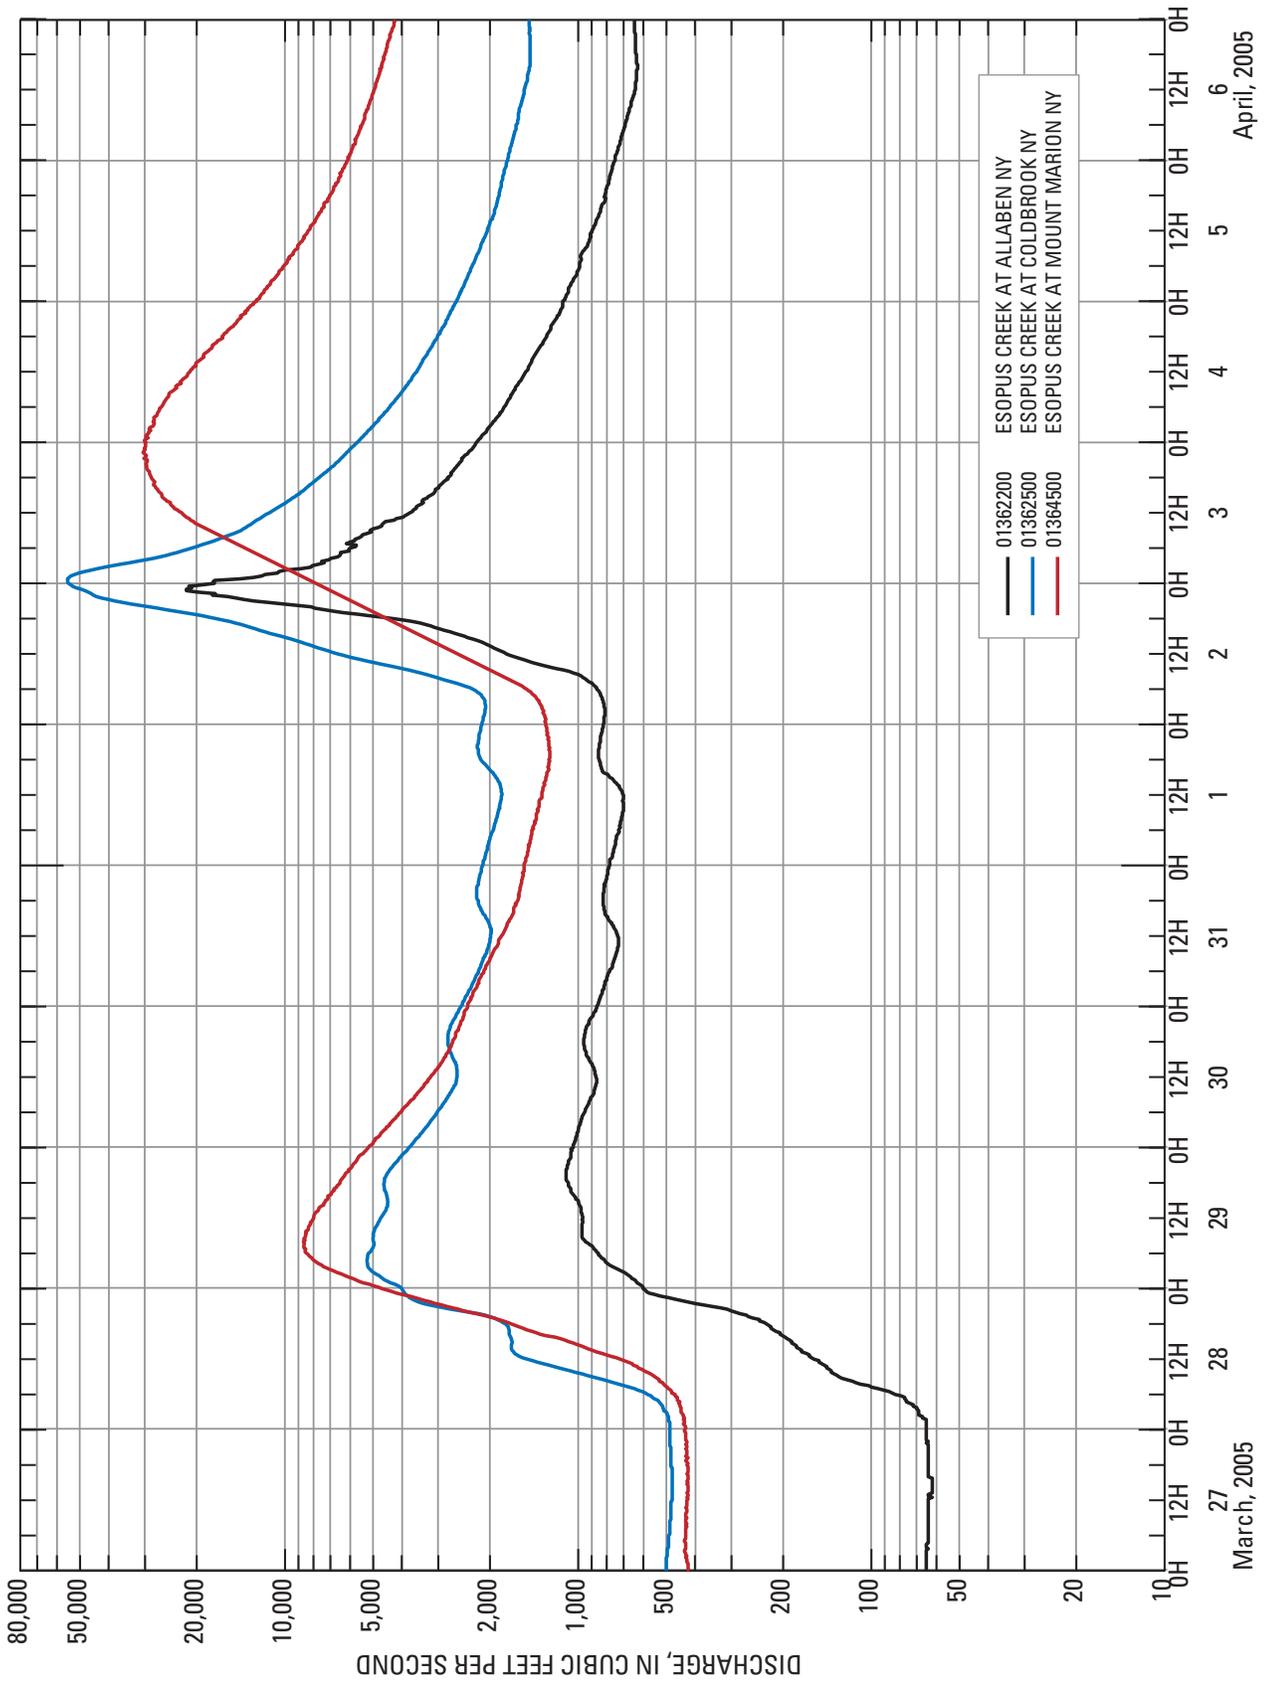
Figure 4. Discharge hydrographs for selected stream-gaging stations in the Esopus Creek Basin, N.Y., March 27 to April 6, 2005. (Locations shown in fig. 3).

Recurrence intervals for Esopus Creek at Allaben and Esopus Creek at Coldbrook, N.Y. (stations located upstream from Ashokan Reservoir) were 60 and 30 years, respectively, whereas the recurrence interval for Esopus Creek at Mount Marion, N.Y. (located downstream of Ashokan Reservoir) was 80 years. The stream-gaging stations Esopus Creek at Allaben, in operation since 1963, and Esopus Creek at Mount Marion, in continuous operation since 1970, recorded new period-of-record maximums of 21,700 ft³/s and 30,500 ft³/s, respectively. The peak discharge of 55,200 ft³/s at Esopus Creek at Coldbrook, N.Y. stream-gaging station was about 15 percent less than the period-of-record maximum of 65,300 ft³/s set in March 1980. Discharge hydrographs for these three USGS stream-gaging stations (two stations are upstream from the Ashokan Reservoir and one is downstream) in the Esopus Creek Basin for the period March 27 to April 6, 2005, are presented in figure 4.

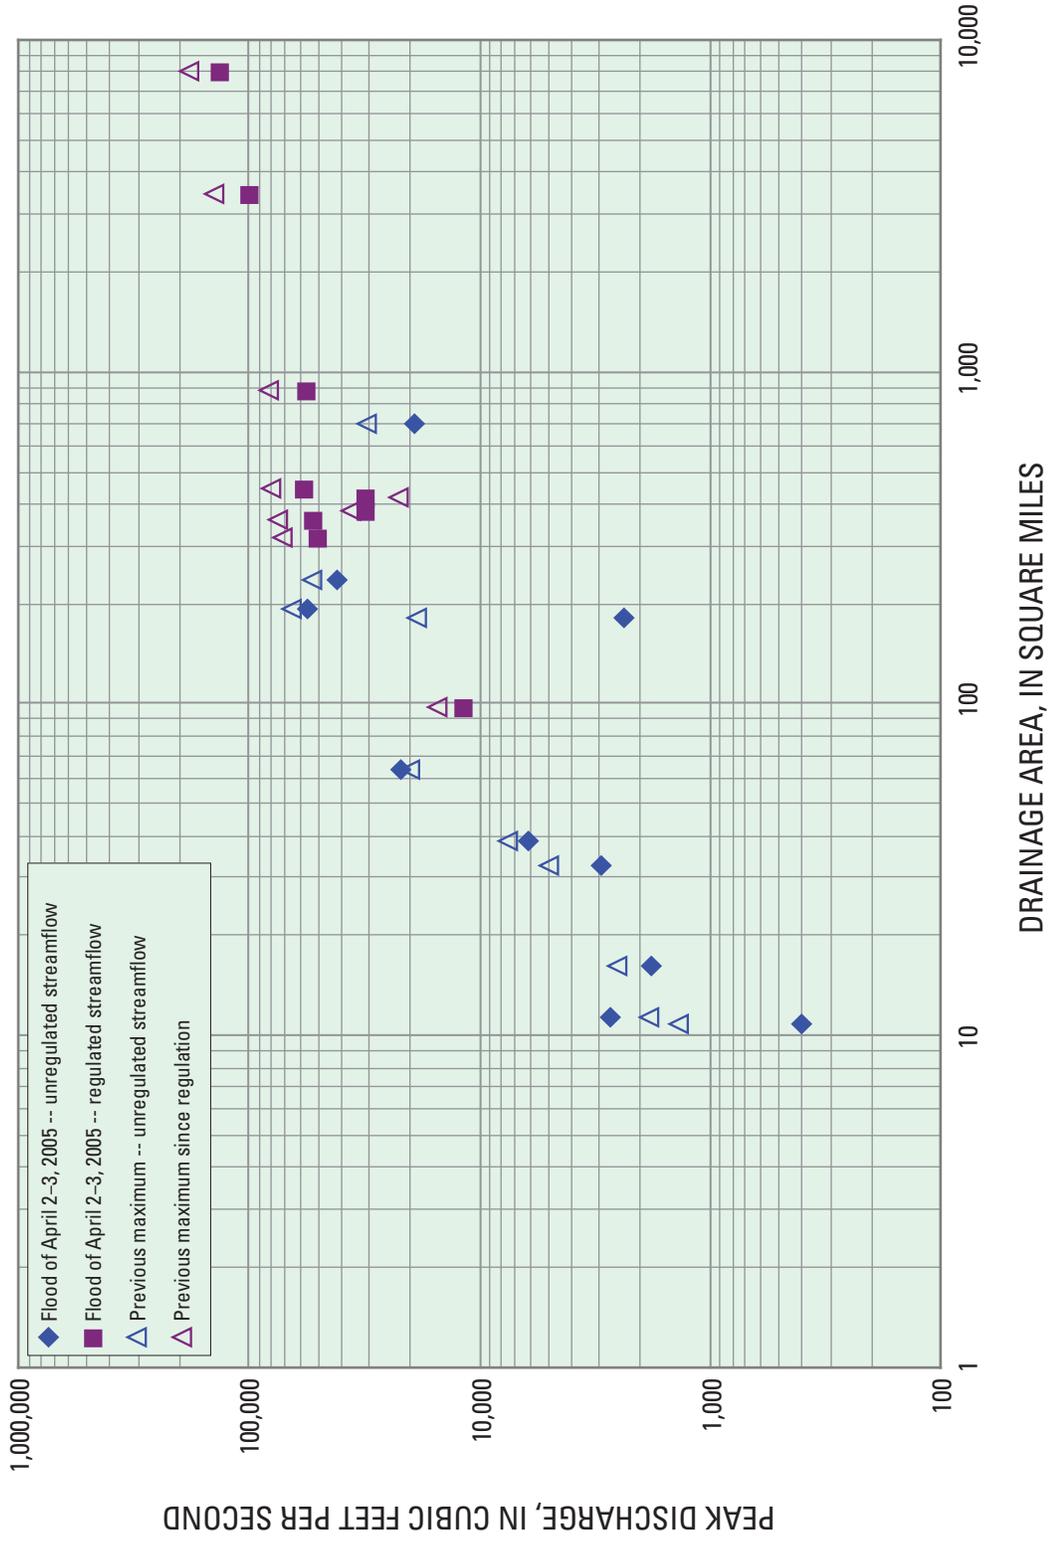
Figure 5. Peak discharges at selected stream-gaging stations in the Hudson River Basin, N.Y., as a function of drainage area during the flood of April 2-3, 2005, and previous maximum known discharges.

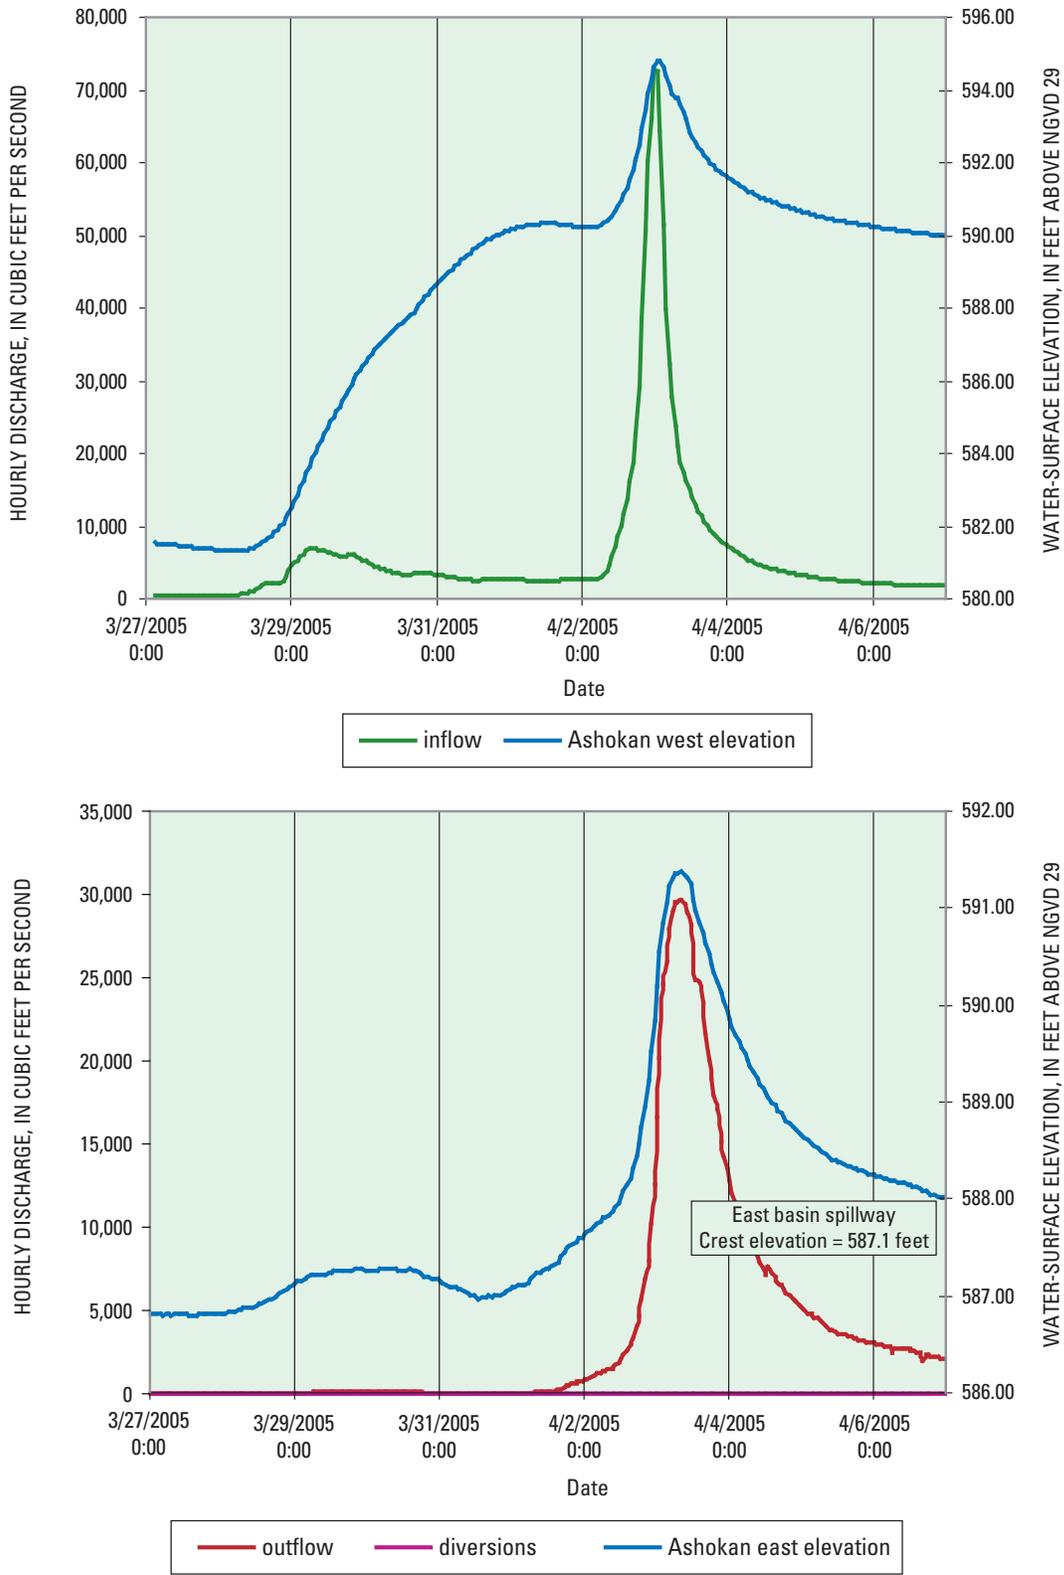
Figure 6. Hourly inflow, outflow, diversion, and water-surface elevation at the Ashokan Reservoir, N.Y., for March 27 to April 6, 2005.

The reservoir water-surface elevation was 590.3 ft above NGVD 29 in the west basin and 587.2 ft above NGVD 29 in the east basin on April 1 (fig. 6), and the reservoir was spilling before the storm. Maximum contents observed for the west and east basins of the Ashokan Reservoir prior to this storm occurred on March 31, 1951, at elevations of 594.33 and 592.23 ft above NGVD 29, respectively. The maximum observed water-surface elevation of the reservoir for the period of March 27 to April 6, 2005, occurred on April 3. The west basin of the reservoir reached a new period-of-record maximum elevation of 594.86 ft above NGVD 29, while the east basin reached a maximum elevation of 591.38 ft above NGVD 29.

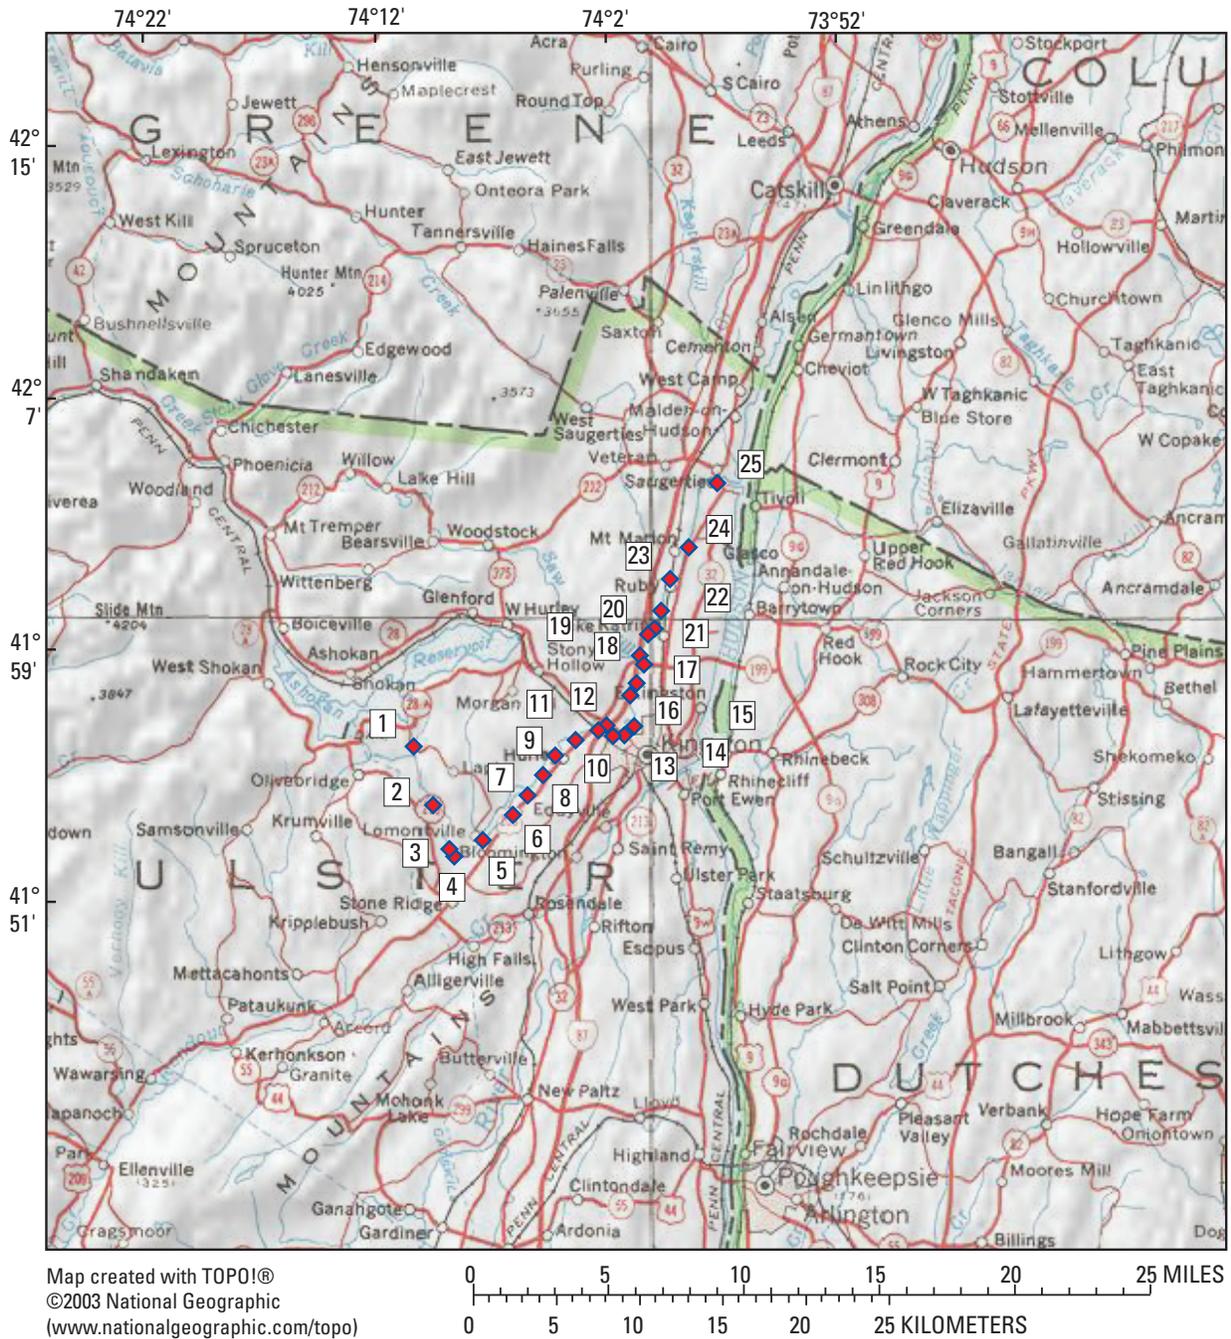
Figure 7. Locations of high-water-mark sites chosen for study in the Esopus Creek Basin, N.Y. during the flood of April 2-3, 2005.

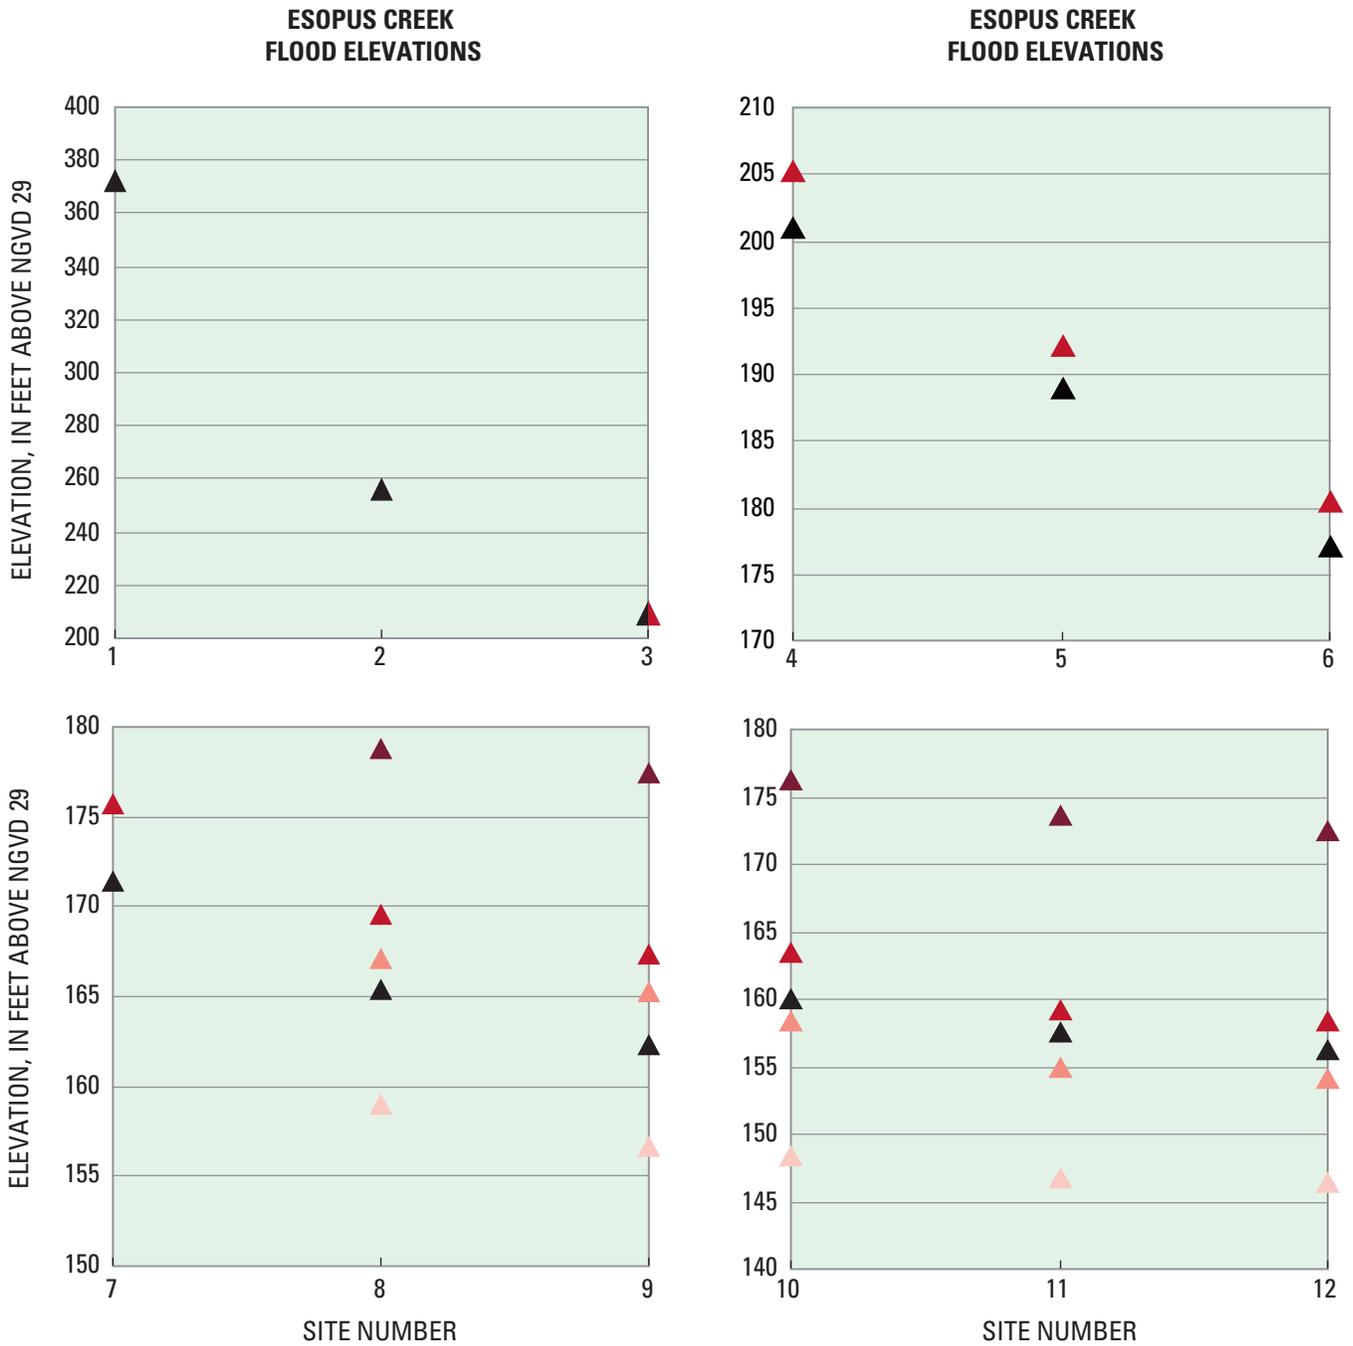
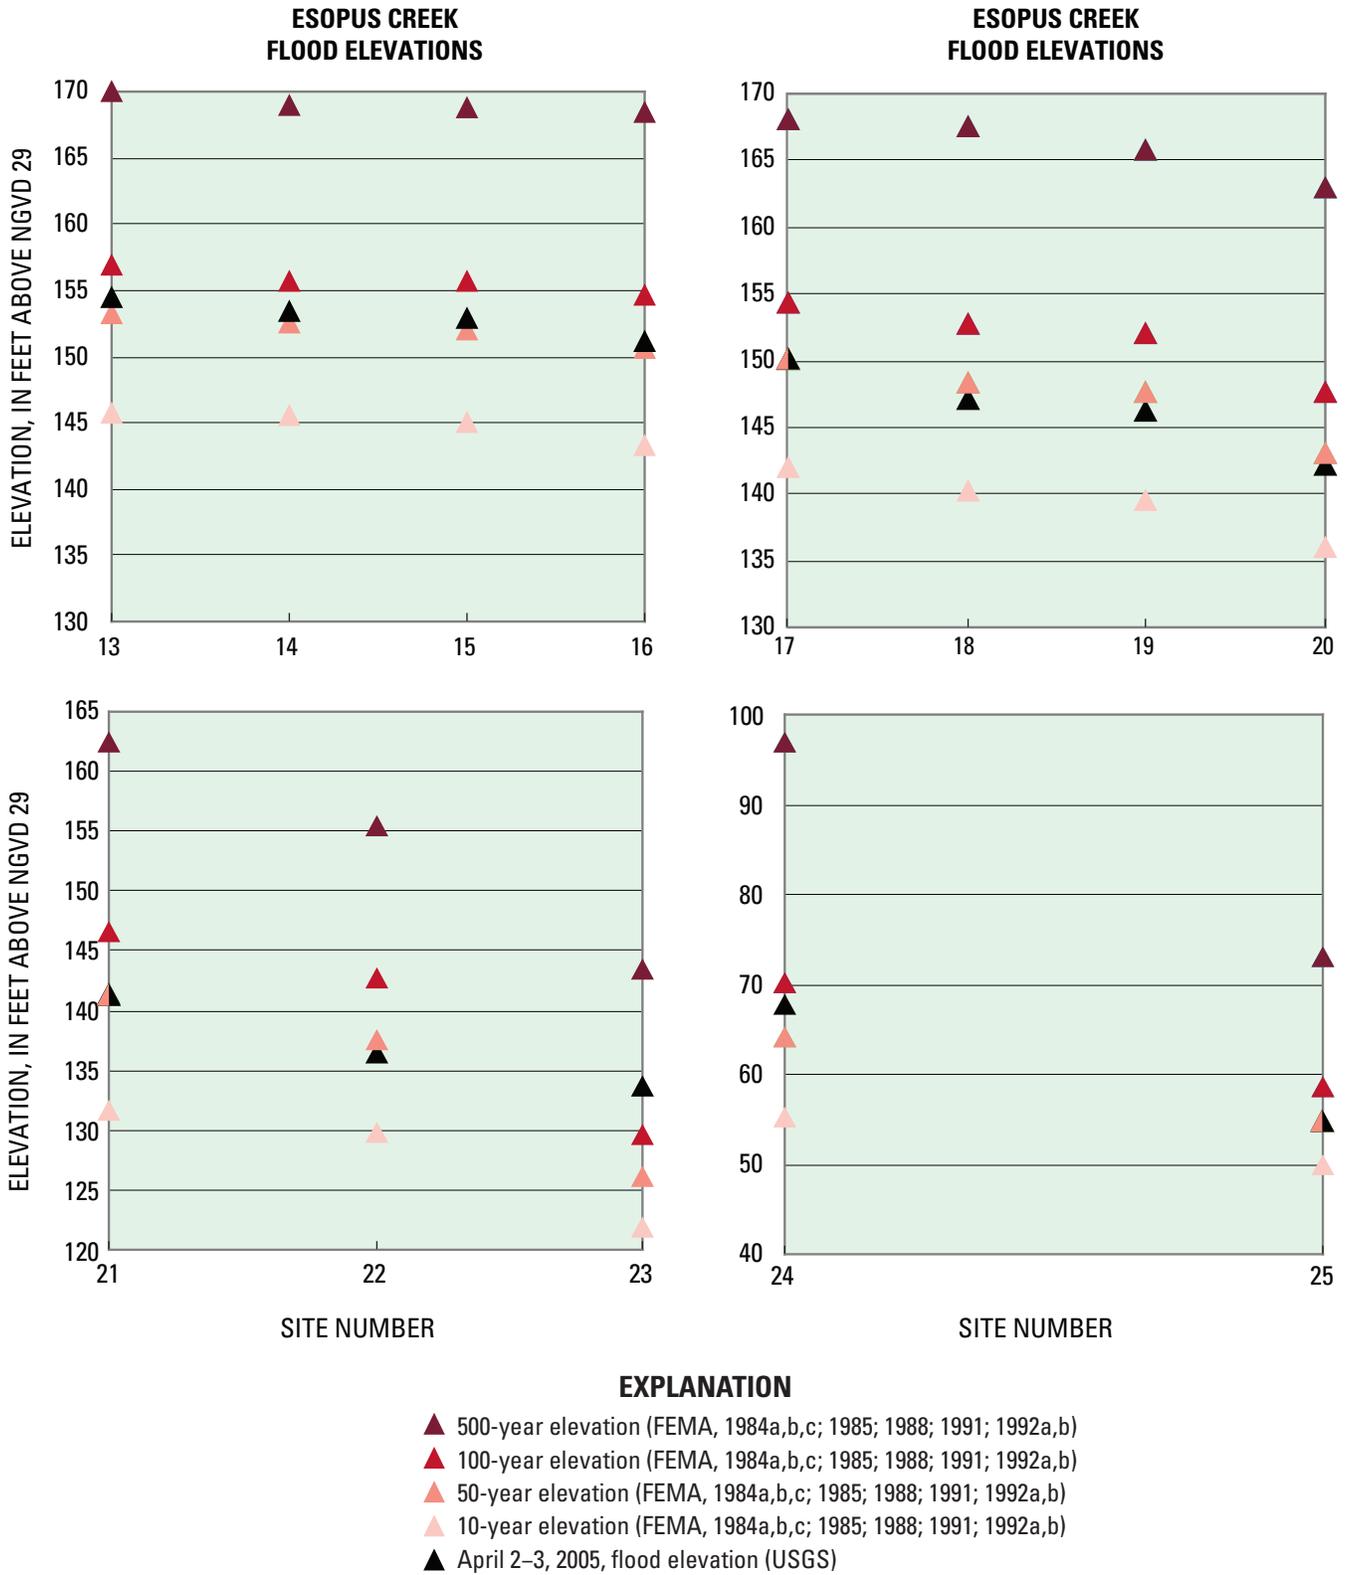
Figure 8. Peak water-surface elevations at selected sites in the Esopus Creek Basin, N.Y., during flood of April 2-3, 2005, and flood-recurrence values from Federal Emergency Management Agency flood-insurance studies. Site names and locations are listed in table 5.

Figure 8. Peak water-surface elevations at selected sites in the Esopus Creek Basin, N.Y., during flood of April 2-3, 2005, and flood-recurrence values from Federal Emergency Management Agency flood-insurance studies. Site names and locations are listed in table 5.—Continued

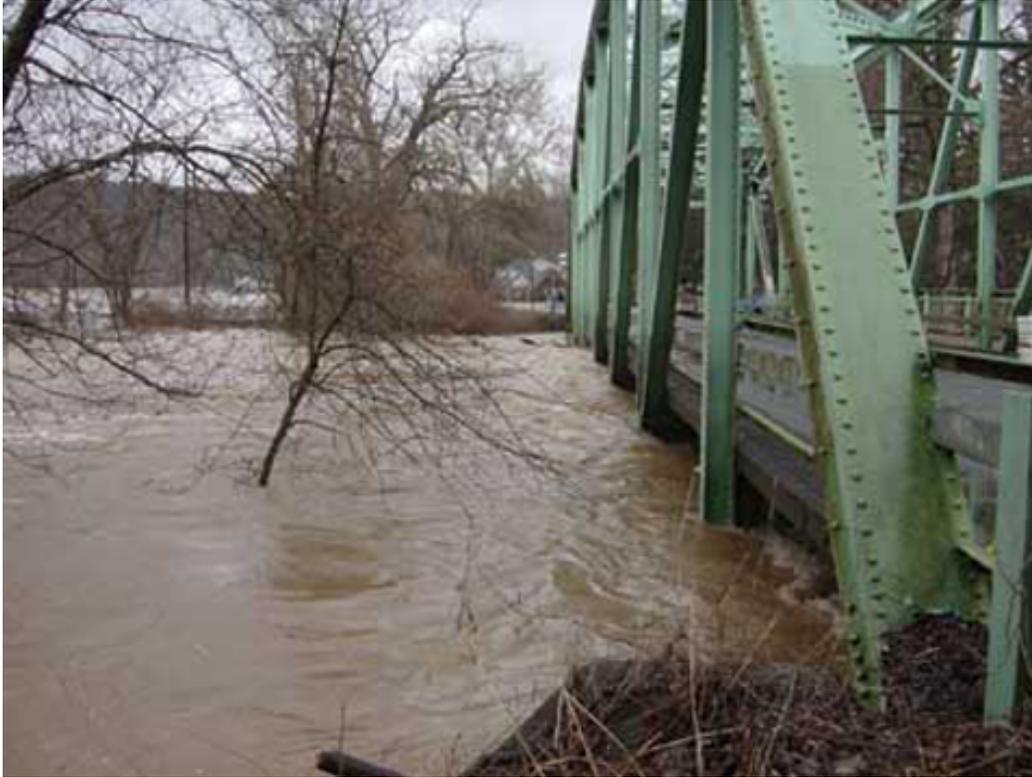
Figure 9a. Study site no. 9, County Route 29A (Wynkoop Road) bridge over the Esopus Creek at Hurley, N.Y on April 3 at about 2:30 p.m. (Photo courtesy of Times Herald-Record, Middletown, N.Y.)

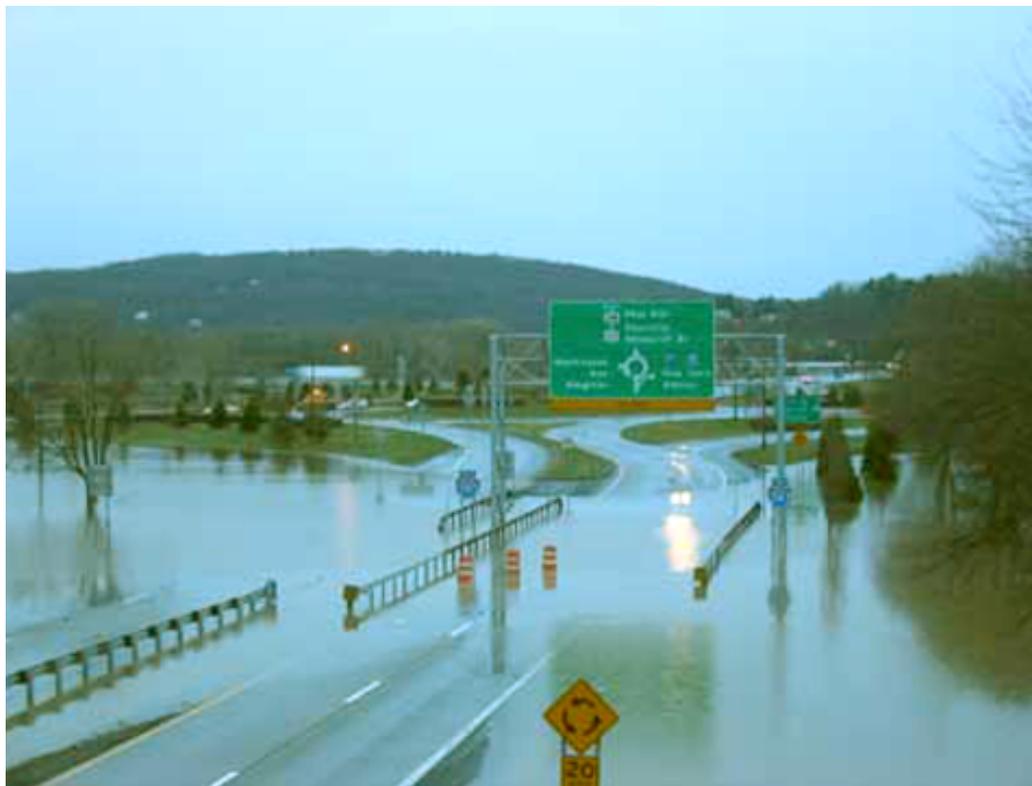
Figure 9b. Area between study sites 12 and 13 at the Kingston Circle, junction of Interstate Route 587, Route 28 and Washington Ave. Kingston, N.Y. (Photo courtesy of Times Herald-Record, Middletown, N.Y.)

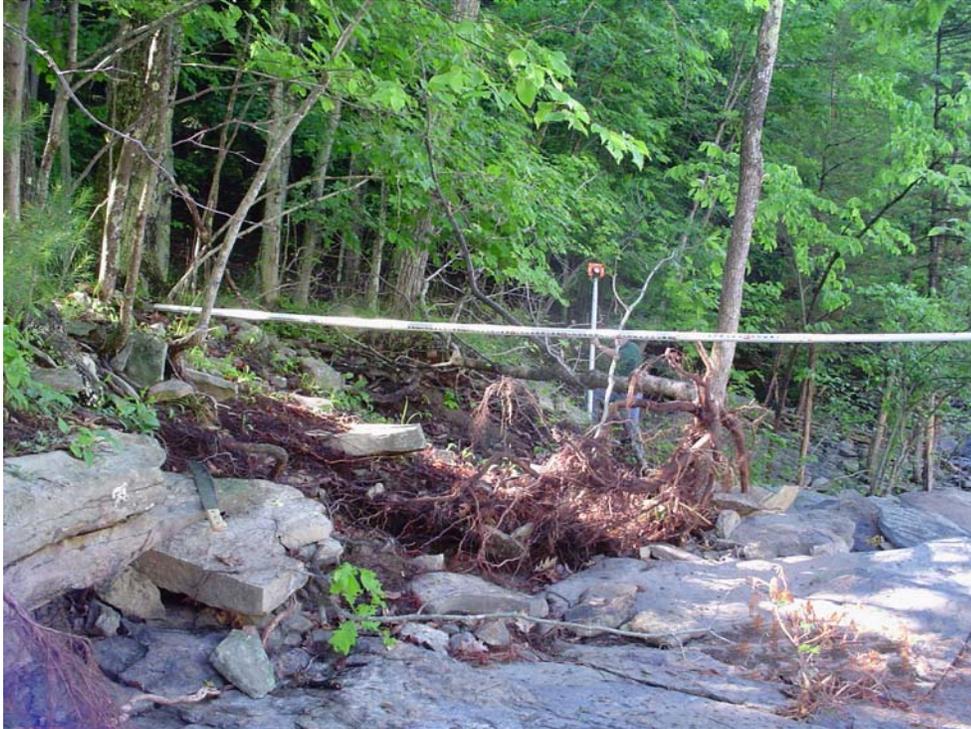
High-water mark 1.2 is a poor wash line on the ground, on the left bank, 100 feet downstream from the Spillway Road bridge, at elevation 371.97 feet above NGVD 29 (lat 41° 55' 56.7", long 74° 10' 10.8").

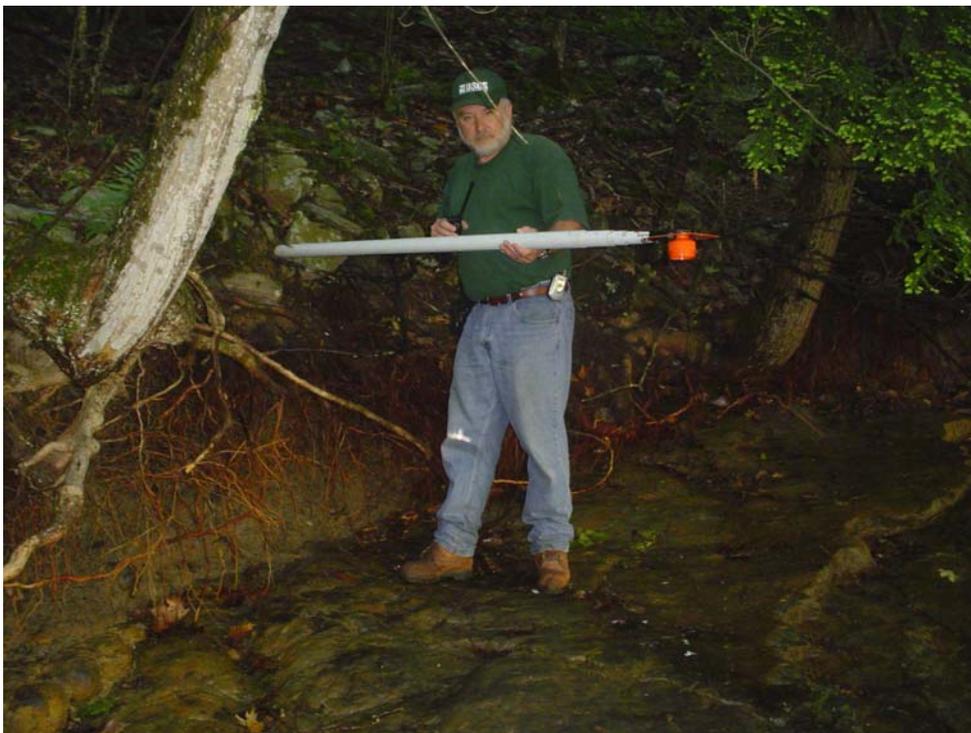
High-water mark 1.5 is a poor debris line on the ground, on the left bank, 200 feet downstream from the Spillway Road bridge, at elevation 369.37 feet above NGVD 29 (lat 41° 55' 55.9", long 74° 10' 10.7").

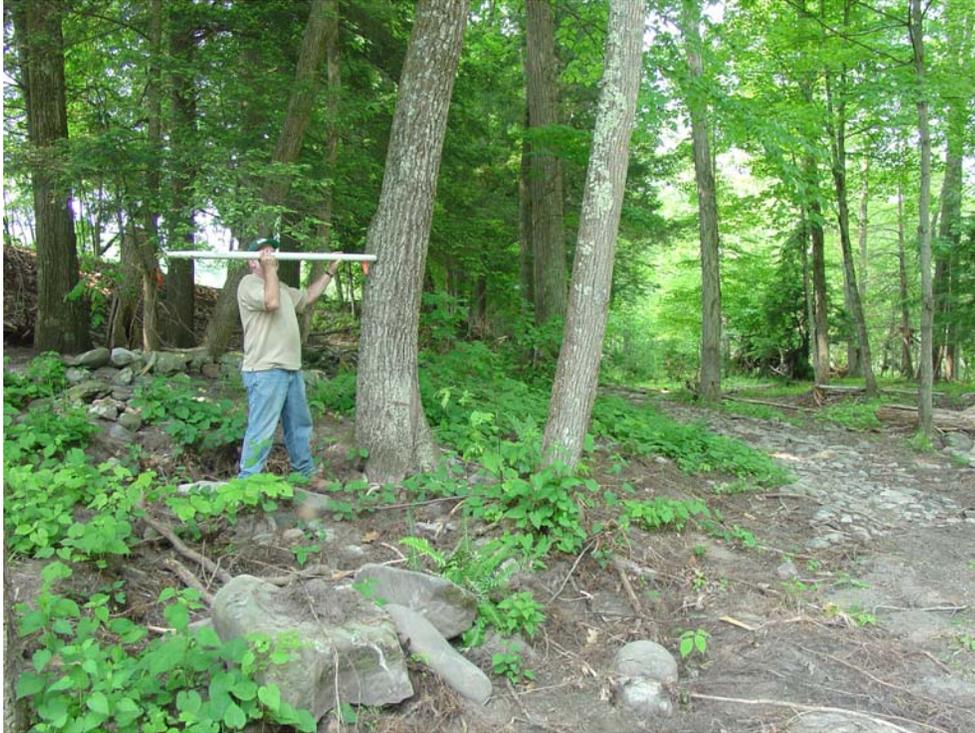
High-water mark 2.1 is a good seed line about 5.5 feet above the ground, on a tree on the right bank, at elevation 255.77 feet above NGVD 29 (lat 41° 54' 06.8", long 74° 09' 21.8").

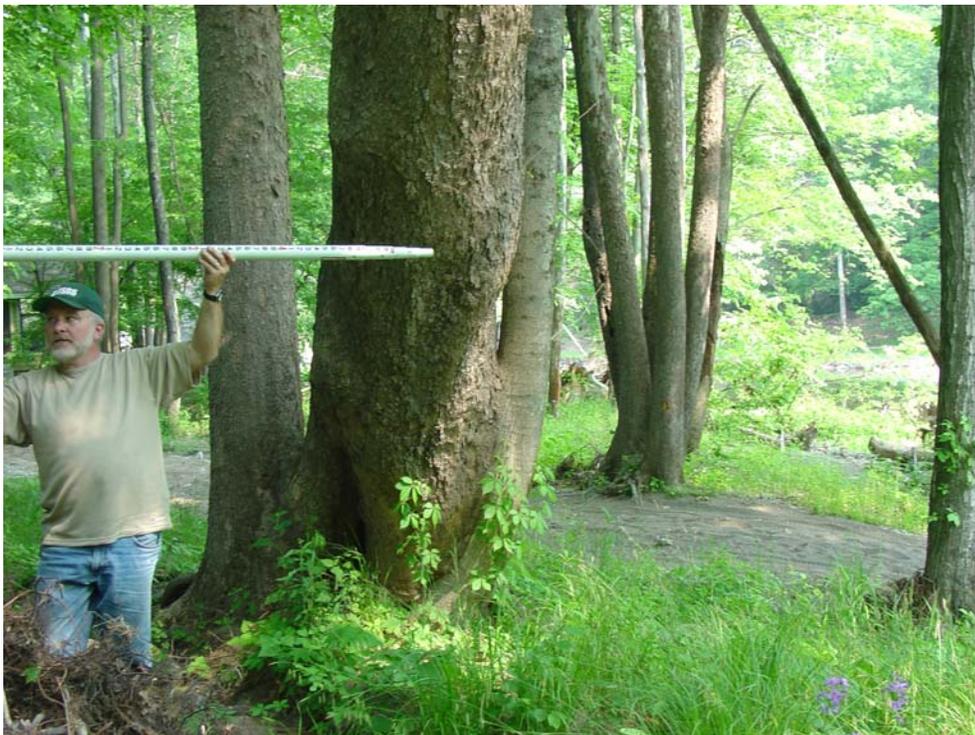
High-water mark 2.8 is a fair debris line about 6 feet above the ground, on a tree on the right bank, at elevation 254.30 feet above NGVD 29 (lat 41° 54' 04.8", long 74° 09' 17.8").

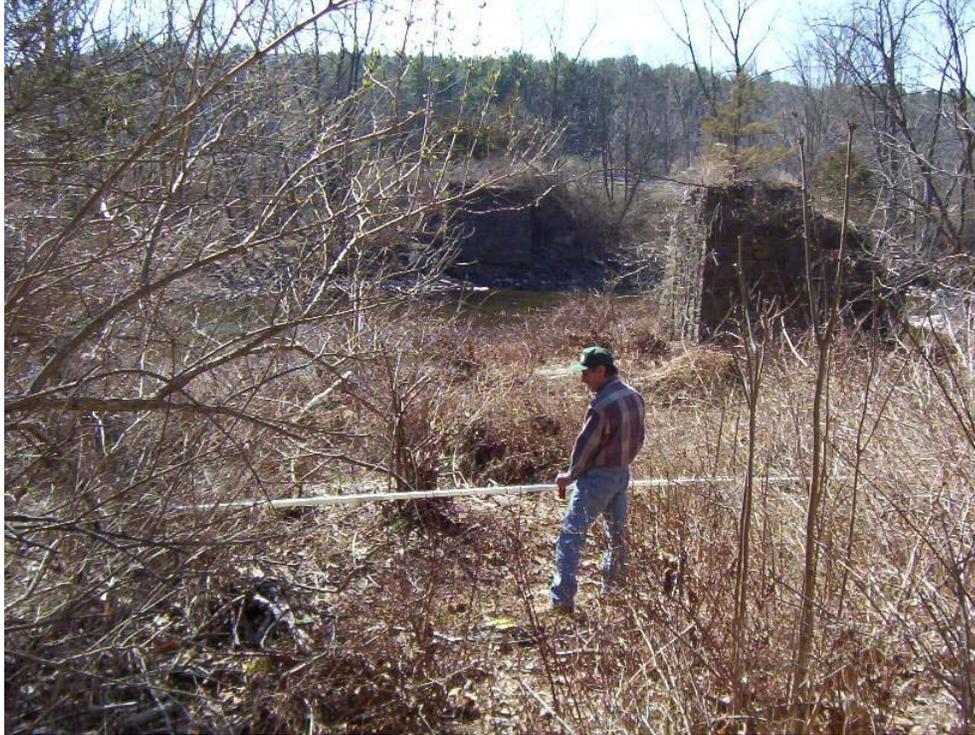
High-water mark 3.12 is a fair debris line about 2 feet above the ground, on a tree on the left bank, 80 feet upstream from the County Route 5 bridge, at elevation 208.61 feet above NGVD 29 (lat 41° 52' 45.9", long 74° 08' 40.2").

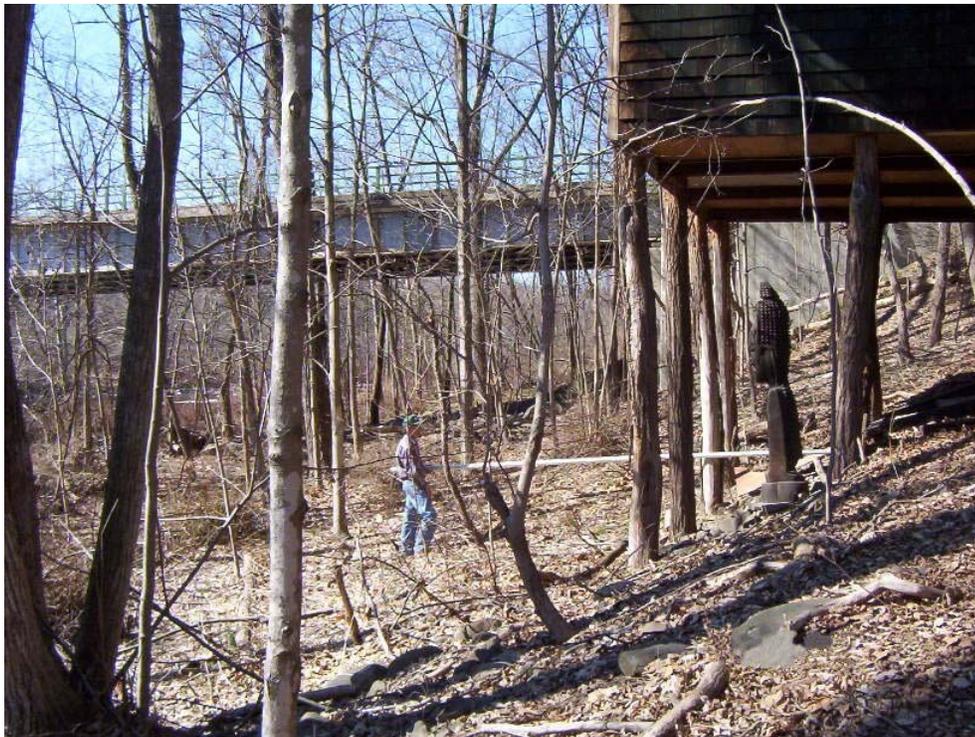
High-water mark 3.14 is a good seed line about 2 feet above the ground, on a support post of guest house upstream from house 2671 on County Route 5, on the left bank, 70 feet downstream from the County Route 5 bridge, at elevation 208.19 feet above NGVD 29 (lat 41° 52' 44.6", long 74° 08' 39.8").

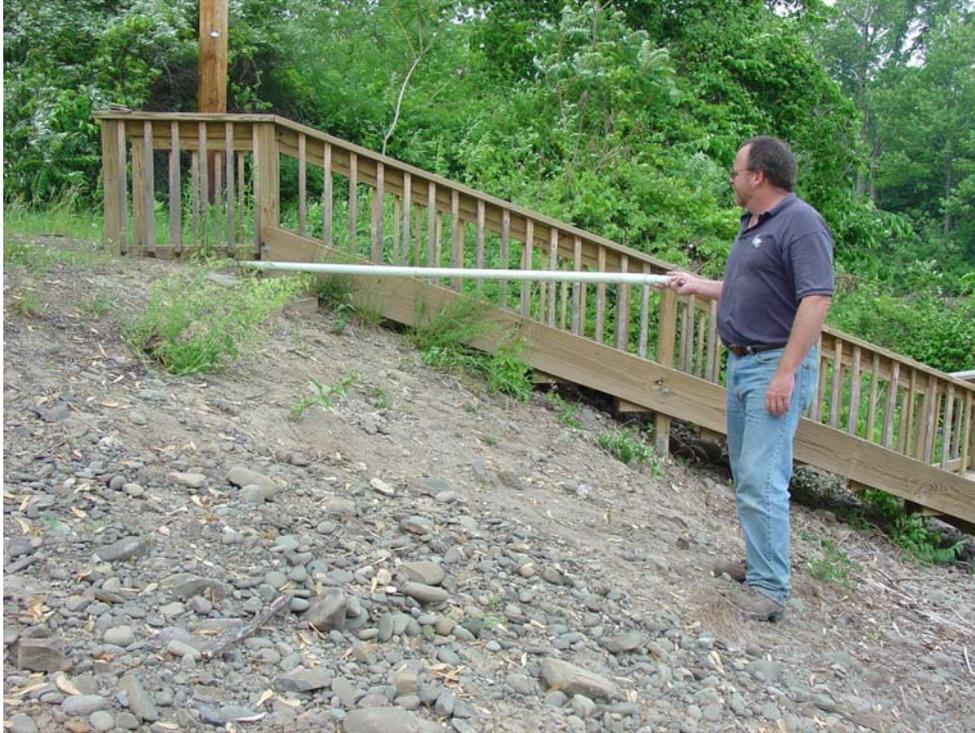
High-water mark 4.1 is a good mud line at ground level, on the downstream side of the Town of Marbletown Recreation Park beach access stairs, on the right bank, at elevation 201.81 feet above NGVD 29 (lat 41° 52' 27.4", long 74° 08' 27.5").

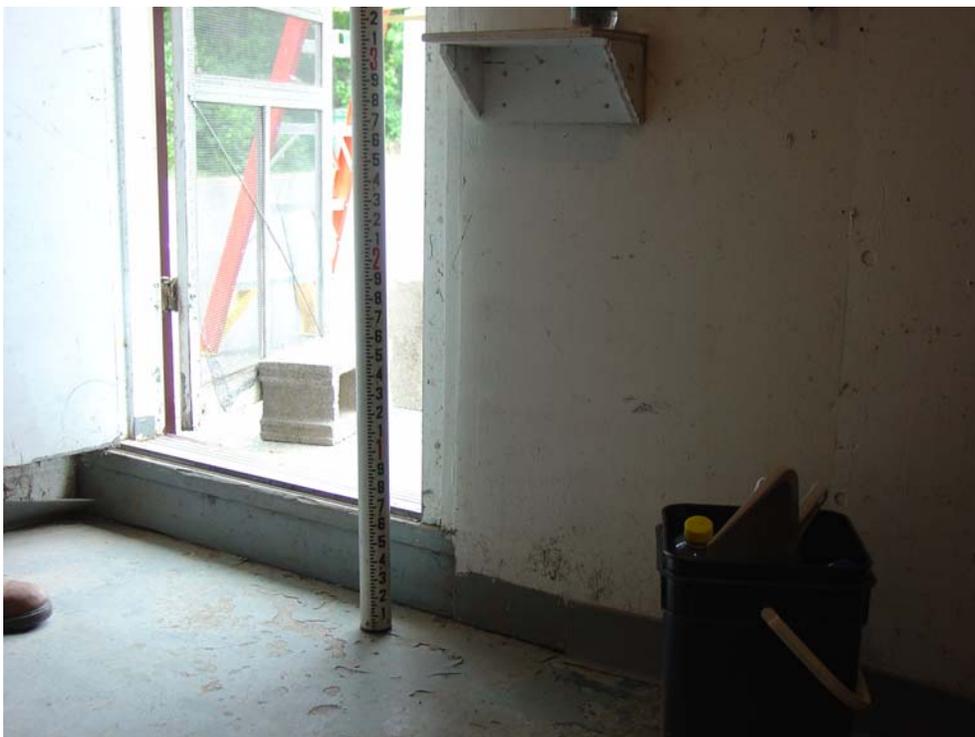
High-water mark 4.3 is an excellent mud line 0.5 foot above the floor, inside of the Town of Marbletown Recreation Park concession building, on the right bank, at elevation 200.95 feet above NGVD 29 (lat 41° 52' 26.3", long 74° 08' 29.5").
