Flood of April 2–3, 2005, Esopus Creek Basin, New York

By Thomas P. Suro and Gary D. Firda

Open-File Report 2007–1036

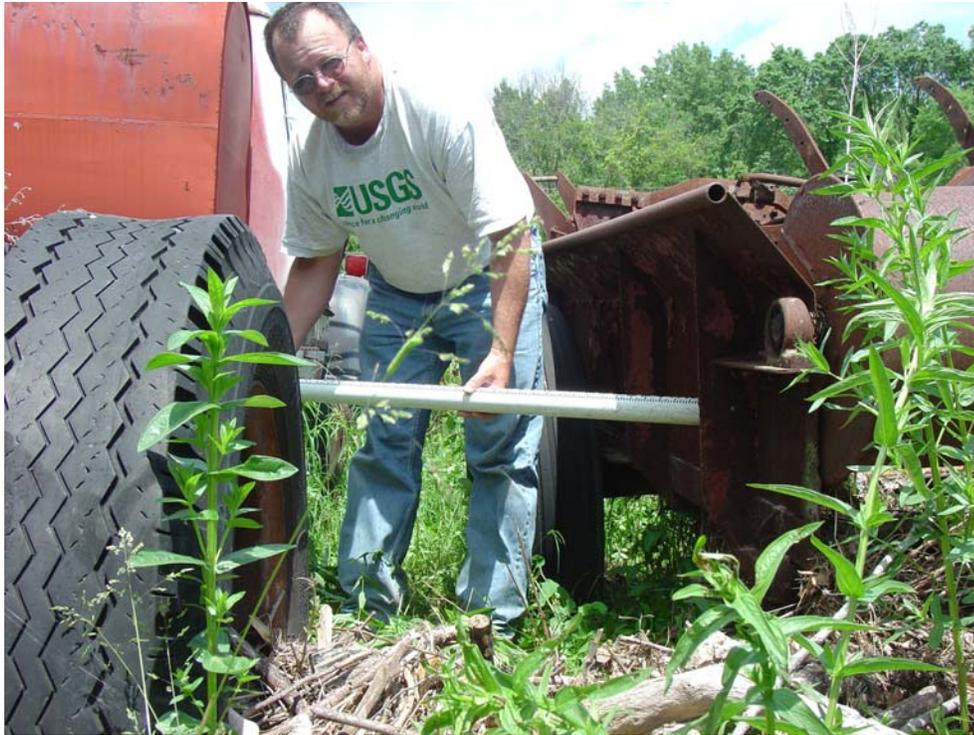
High-water mark 5.1 is a good mud line about 2 feet above the ground, on farm equipment 150 feet upstream from scale house on Fording Place Road, on the left bank, 200 feet upstream from Fording Place Road, at elevation 188.93 feet above NGVD 29 (lat 41° 53' 02.9", long 74° 07' 10.9").

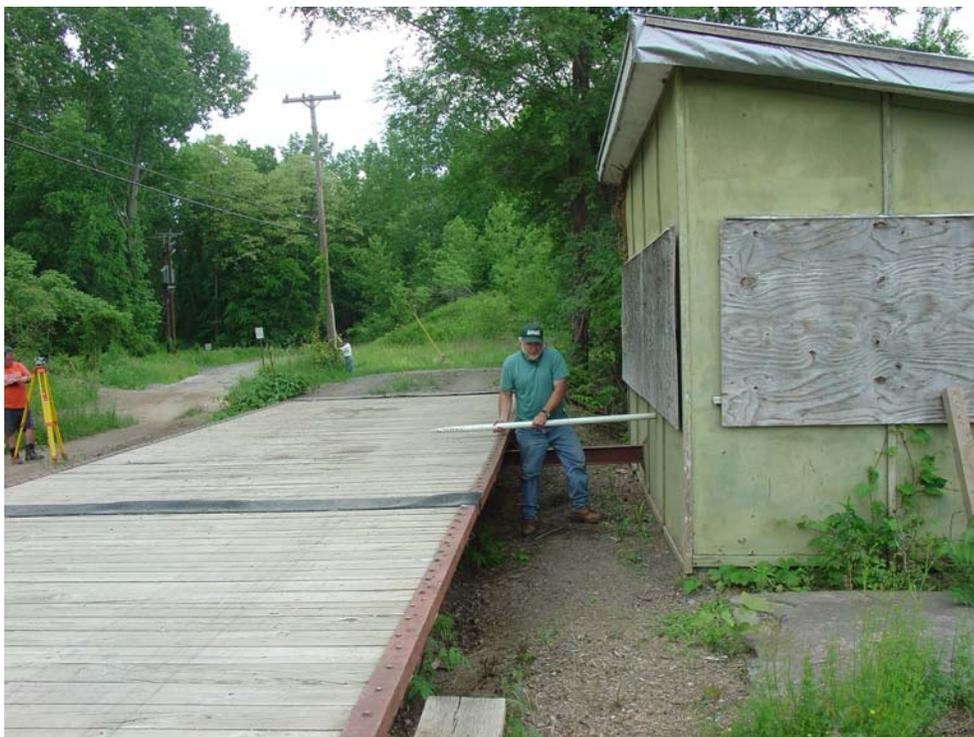
High-water mark 5.2 is a good mud line about 3 feet above the ground, on the downstream side of scale house on Fording Place Road, on the left bank, 30 feet upstream from Fording Place Road, at elevation 188.98 feet above NGVD 29 (lat 41° 53' 03.8", long 74° 07' 09.2").

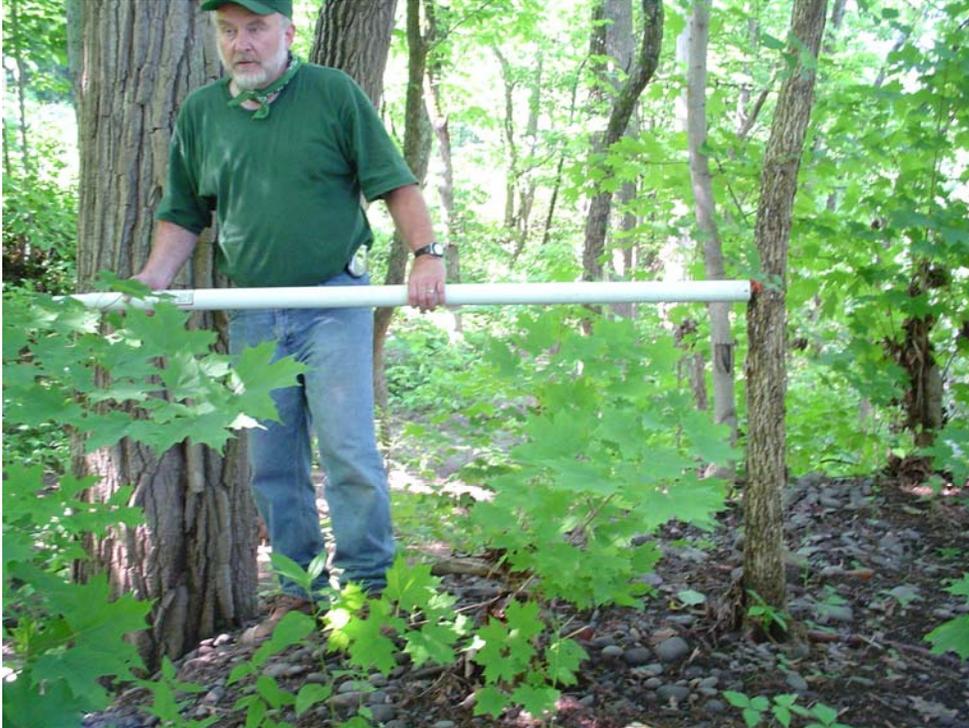
High-water mark 6.2 is a good debris line about 2.5 feet above the ground, on a tree on the right bank, at elevation 176.87 feet above NGVD 29 (lat 41° 53' 48.4", long 74° 05' 54.5").

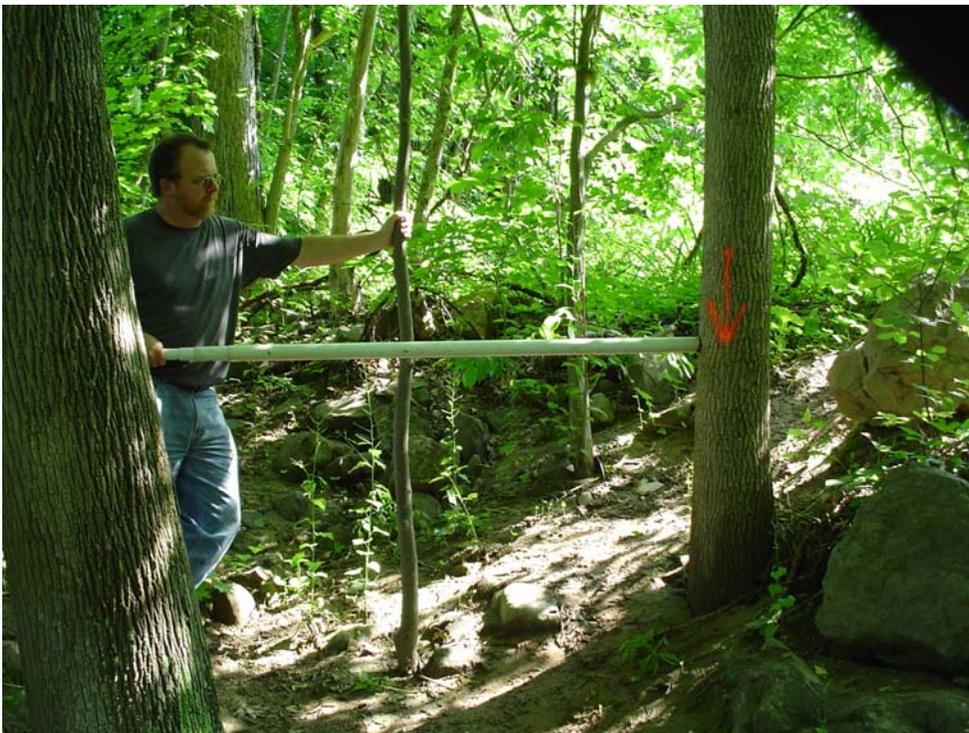
High-water mark 6.3 is a good seed line about 2.5 feet above the ground, on a tree on the right bank, at elevation 177.11 feet above NGVD 29 (lat 41° 53' 47.8", long 74° 05' 54.5").

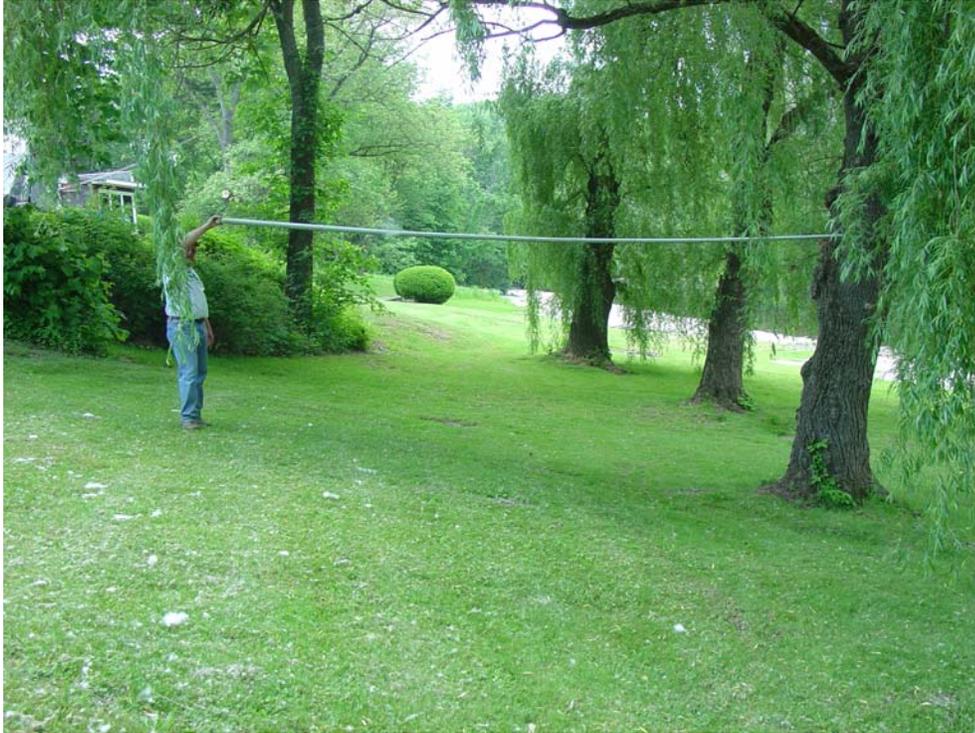
High-water mark 7.1 is a fair debris line about 8 feet above the ground, on a tree on the right bank, 40 feet upstream and 110 feet streamward from house 606 on Creekside Road, at elevation 171.37 feet above NGVD 29 (lat 41° 54' 22.9", long 74° 05' 23.2").

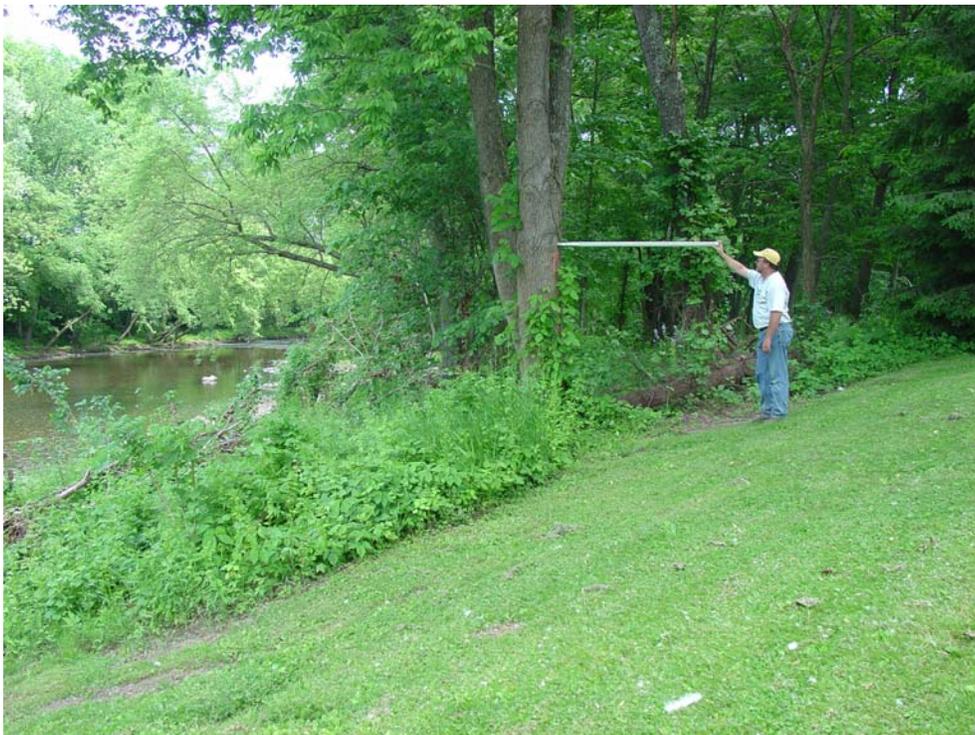
High-water mark 7.3 is a fair debris line about 7 feet above the ground, on a tree on the right bank, 60 feet downstream and 130 feet streamward from house 606 on Creekside Road, at elevation 171.45 feet above NGVD 29 (lat 41° 54' 23.8", long 74° 05' 21.9").

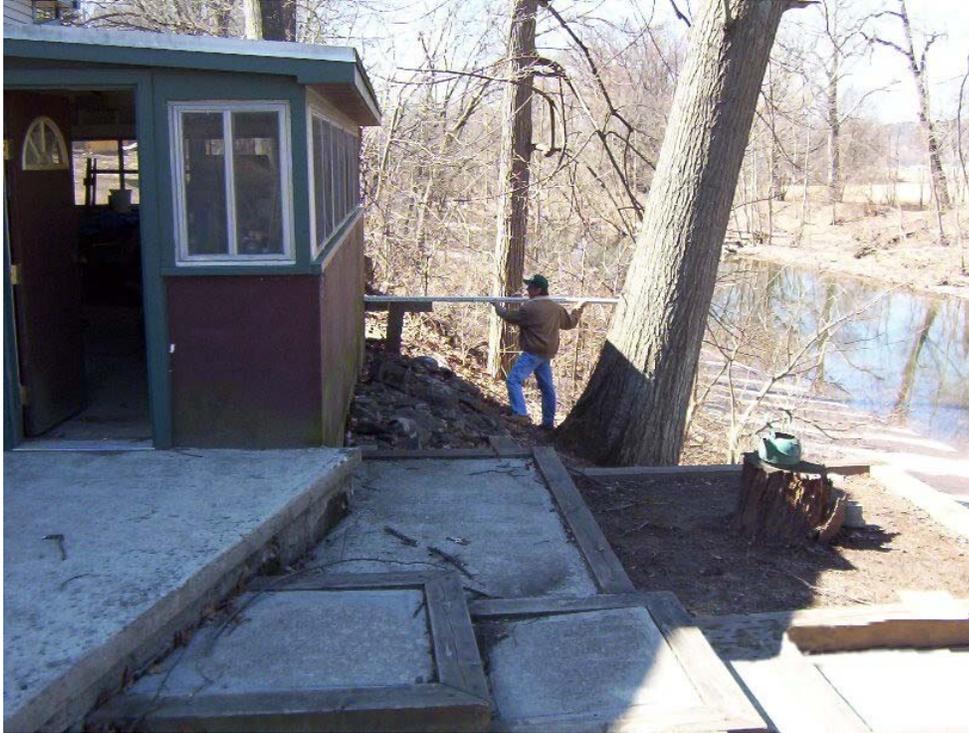
High-water mark 8.1 is a good mud line about 2 feet above the ground, on the streamward side of house 103 on Riverside Avenue, on the right bank, at elevation 165.34 feet above NGVD 29 (lat 41° 55' 01.4", long 74° 04' 35.9").

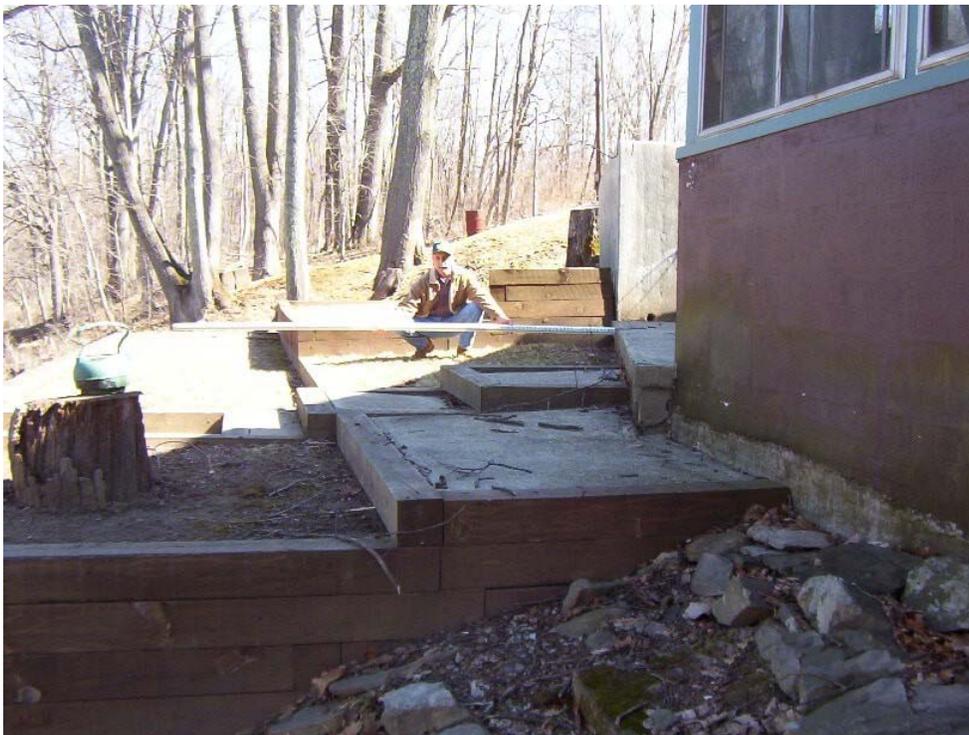
High-water mark 8.3 is a fair mud line about 1 foot above the ground, on the streamward side of house 103 on Riverside Avenue, on the right bank, at elevation 165.07 feet above NGVD 29 (lat 41° 55' 01.9", long 74° 04' 35.6").

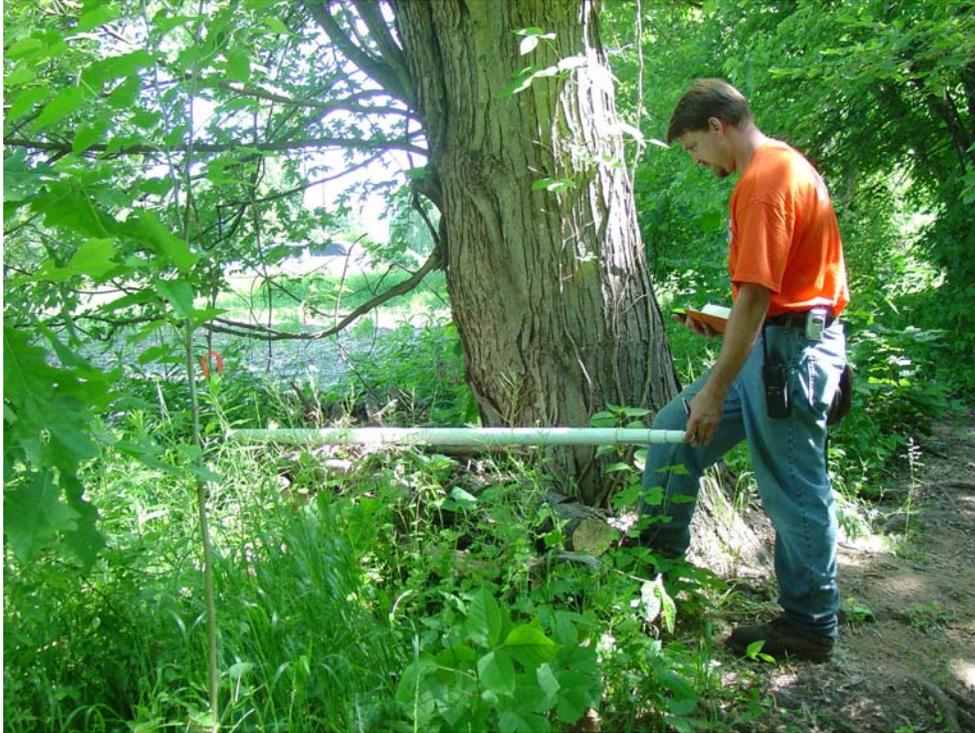
High-water mark 9.5 is a fair debris line about 2.5 feet above the ground, on a tree on the left bank, 100 feet upstream from the County Route 29A bridge, at elevation 162.32 feet above NGVD 29 (lat 41° 55' 37.7", long 74° 04' 07.8").

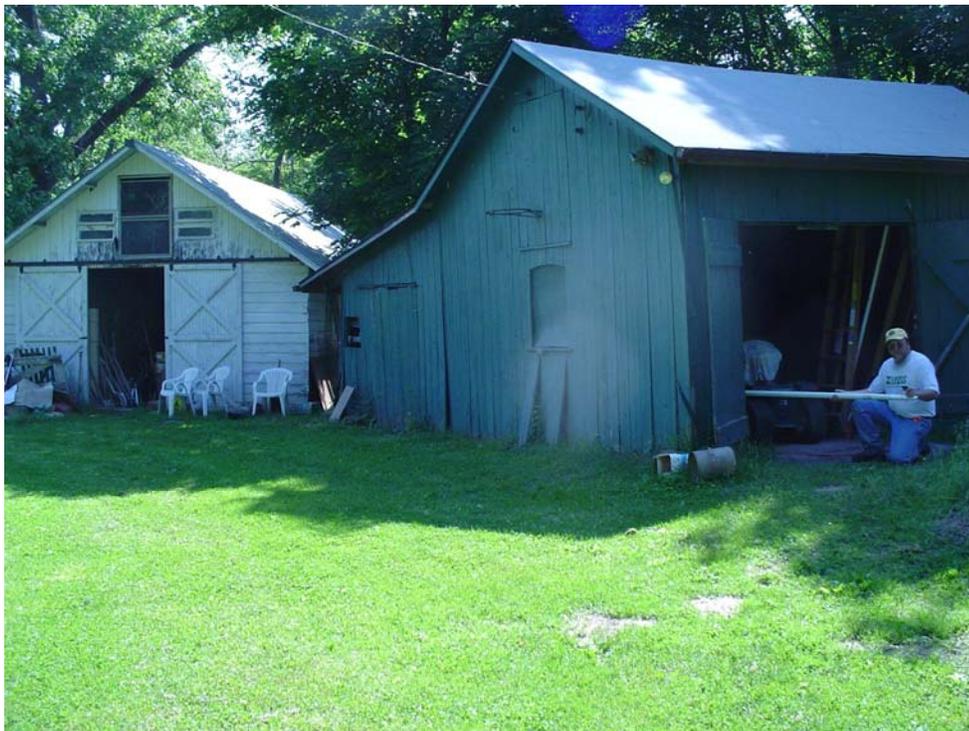
High-water mark 9.9 is a good mud line about 2 feet above the ground, on the upstream side of a detached garage downstream of house 322 on County Route 29A, on the left bank, 150 feet downstream from the County Route 29A bridge, at elevation 161.59 feet above NGVD 29 (lat 41° 55' 38.8", long 74° 04' 04.0").

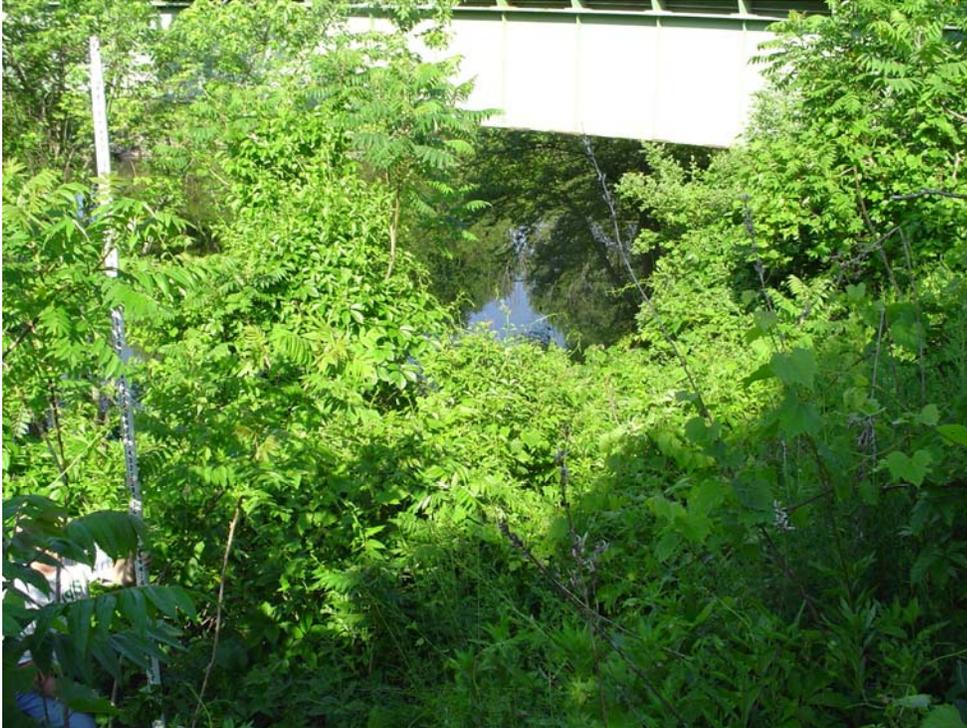
High-water mark 10.2 is a poor debris line on the ground, on the left bank, 50 feet downstream from the U.S. Route 209 bridge, at elevation 158.32 feet above NGVD 29 (lat 41° 56' 09.3", long 74° 03' 11.0").

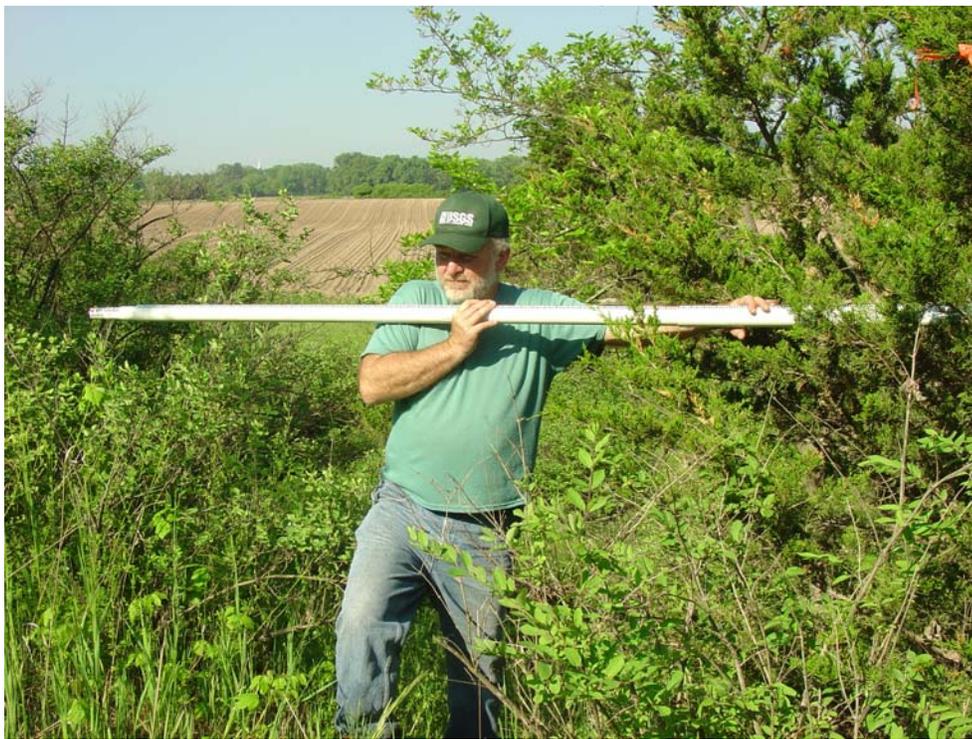
High-water mark 10.5 is a poor seed line about 5 feet above the ground, on a tree on the right bank, 10 feet upstream from the U.S. Route 209 bridge, at elevation 159.93 feet above NGVD 29 (lat 41° 56' 05.9", long 74° 03' 14.5").

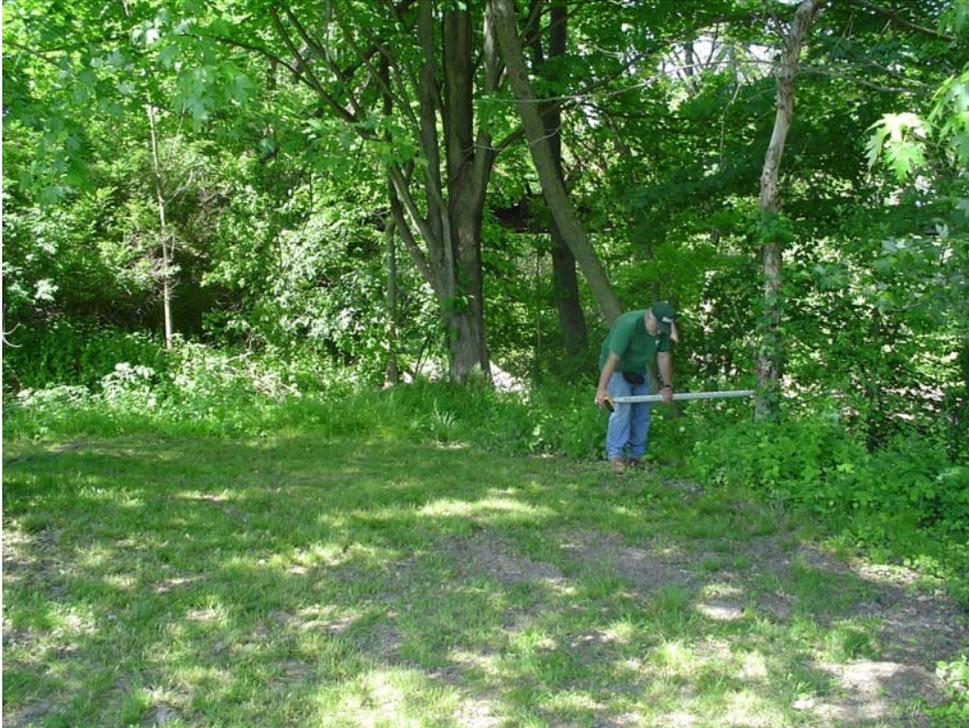
High-water mark 11.4 is a poor debris line about 2 feet above the ground, on a tree on the right bank, 150 feet downstream from the Conrail Railroad bridge, at elevation 157.54 feet above NGVD 29 (lat 41° 56' 29.6", long 74° 02' 14.7").

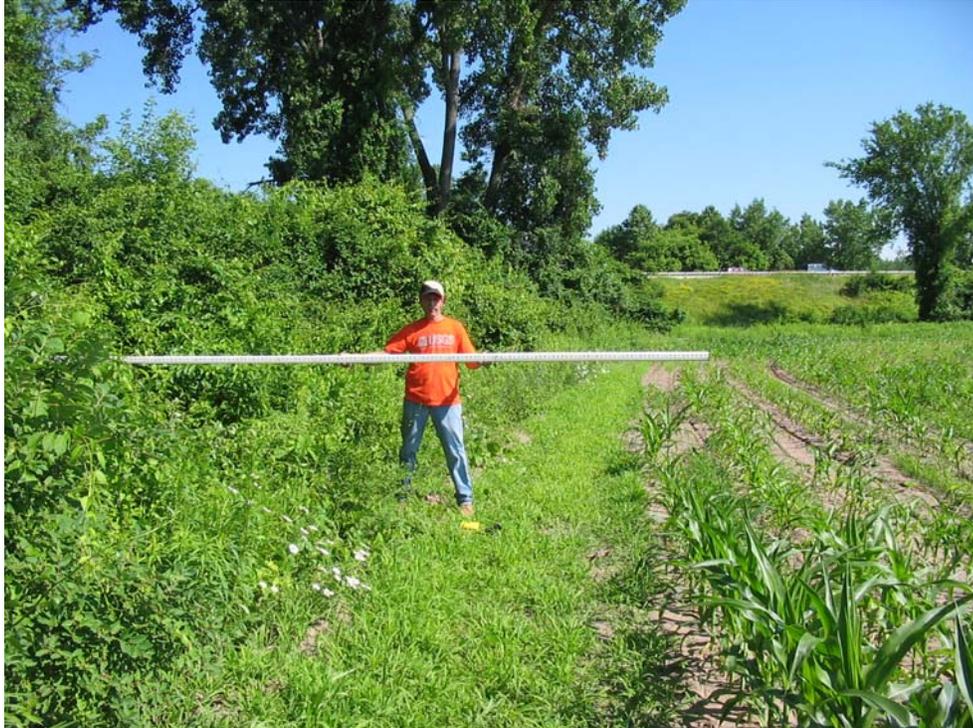
High-water mark 12.5 is a fair debris line about 4 feet above the ground, on a tree on the right bank, 130 feet upstream from the Interstate Route 87 bridge, at elevation 155.00 feet above NGVD 29 (lat 41° 56' 38.1", long 74° 01' 58.3").

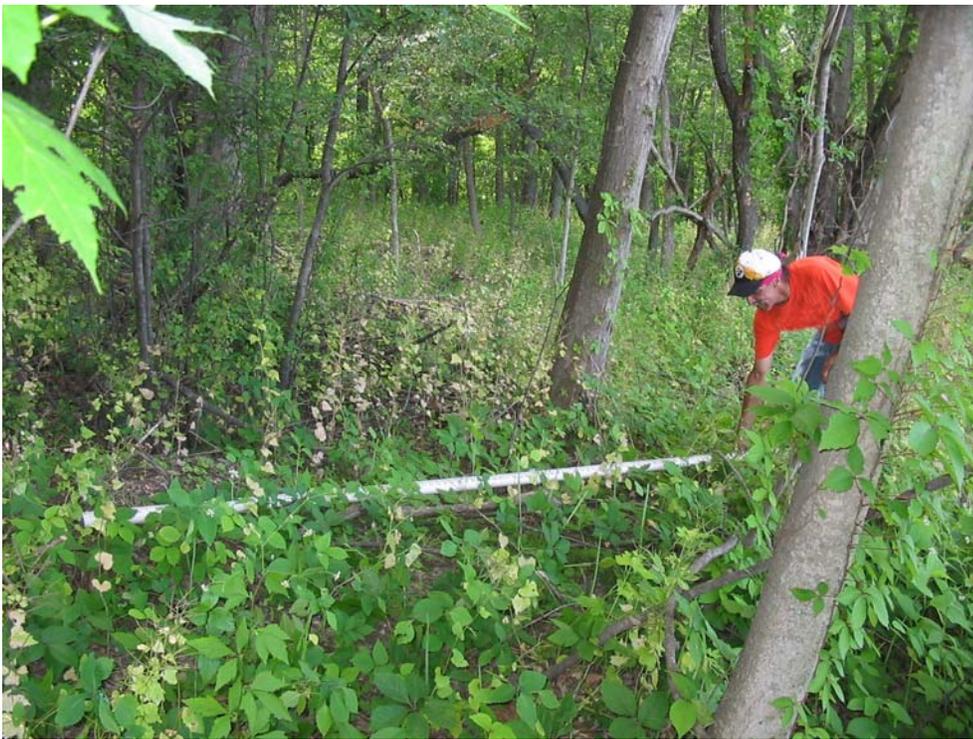
High-water mark 12.8 is a poor debris line on the ground, on the right bank, 1,015 feet upstream from the Interstate Route 87 bridge, at elevation 156.19 feet above NGVD 29 (lat 41° 56' 34.1", long 74° 02' 13.5").

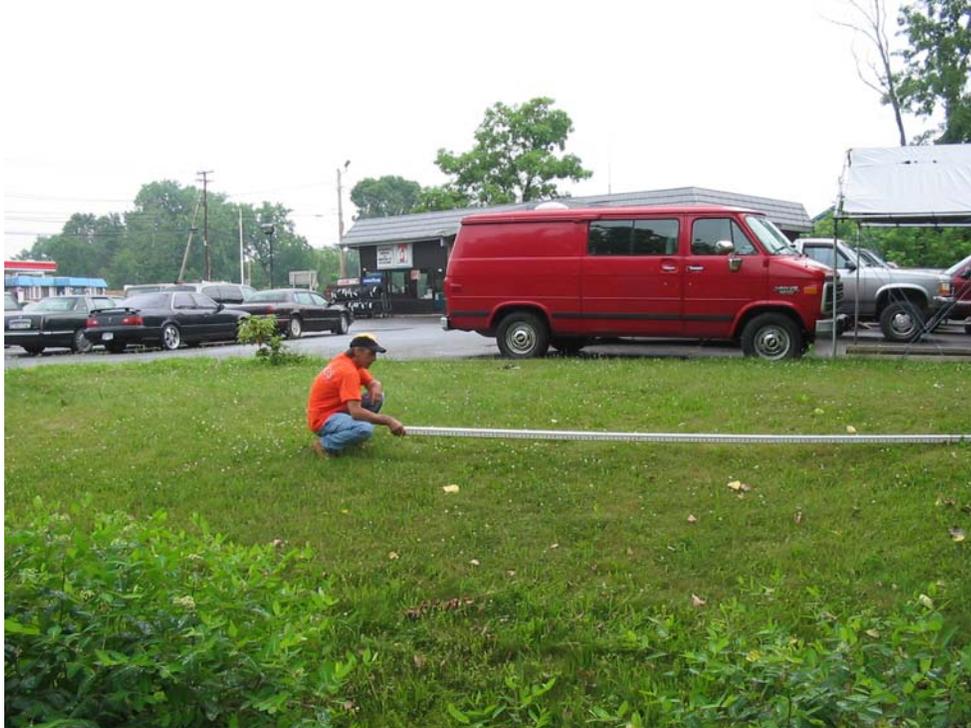
High-water mark 13.12 is a fair debris line on the ground, on the left bank, 15 feet landward from the Szymkowicz Service Inc. parking lot, and 180 feet upstream from the Washington Avenue bridge, at elevation 154.51 feet above NGVD 29 (lat 41° 56' 26.9", long 74° 01' 40.8").

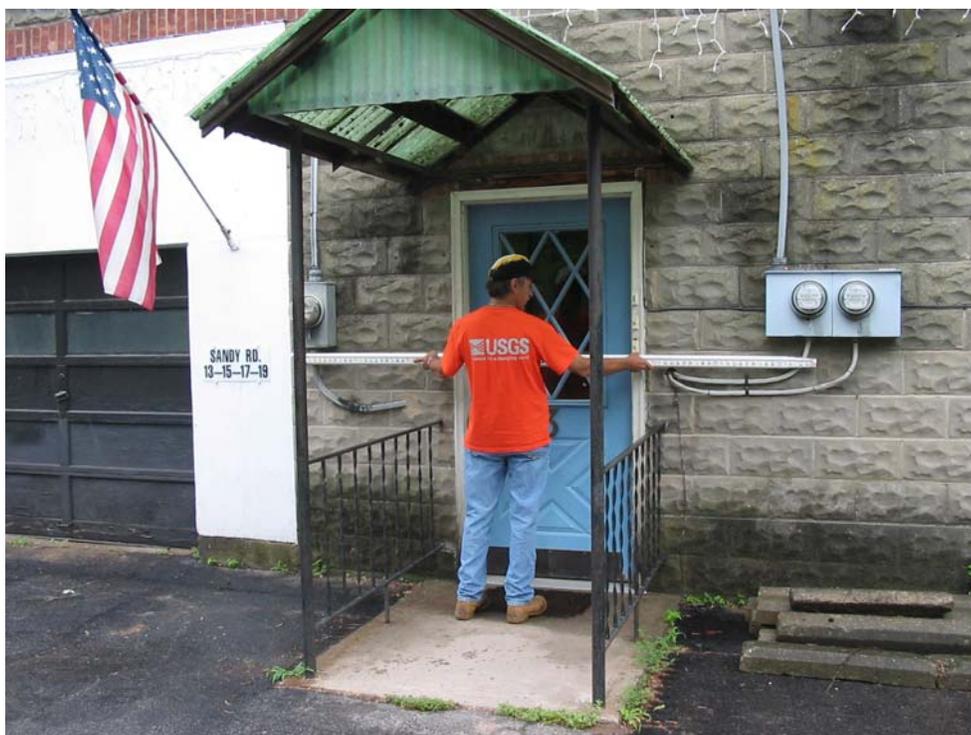
High-water mark 13.14 is an excellent mud line about 4 feet above the ground, on the streamward side of building 15 on Sandy Road, on the left bank, 415 feet downstream from the Washington Avenue bridge, at elevation 154.16 feet above NGVD 29 (lat 41° 56' 24.0", long 74° 01' 31.1").

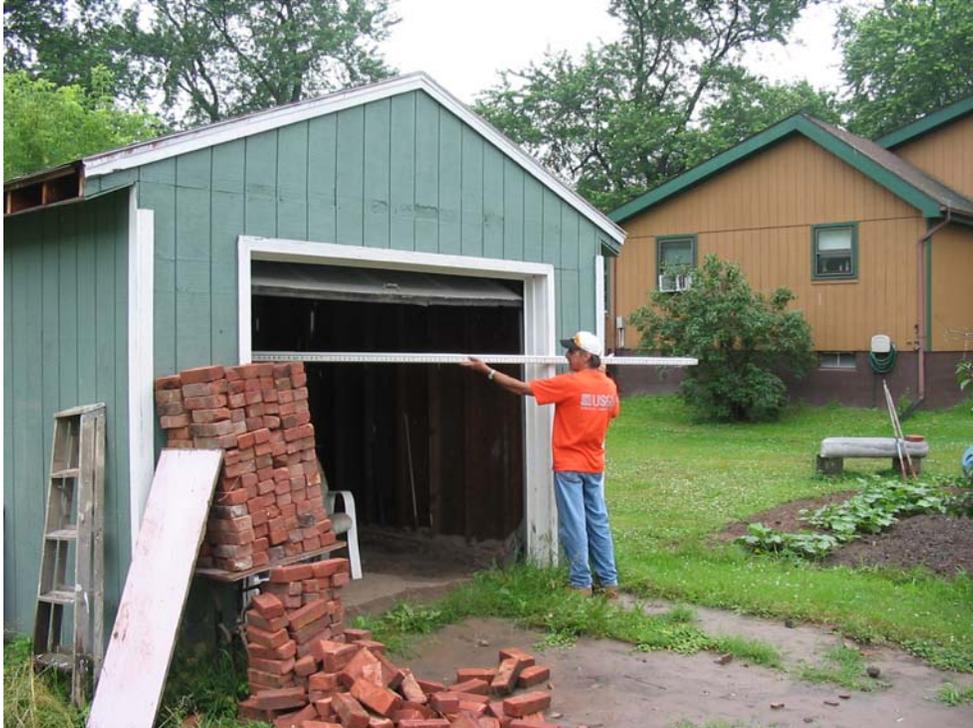
High-water mark 13.15 is an excellent seed line about 5 feet above the ground, on the landward side of a detached garage upstream from house 32 on Sandy Road, on the left bank, 715 feet downstream from the Washington Avenue bridge, at elevation 154.10 feet above NGVD 29 (lat 41° 56' 23.4", long 74° 01' 27.1").

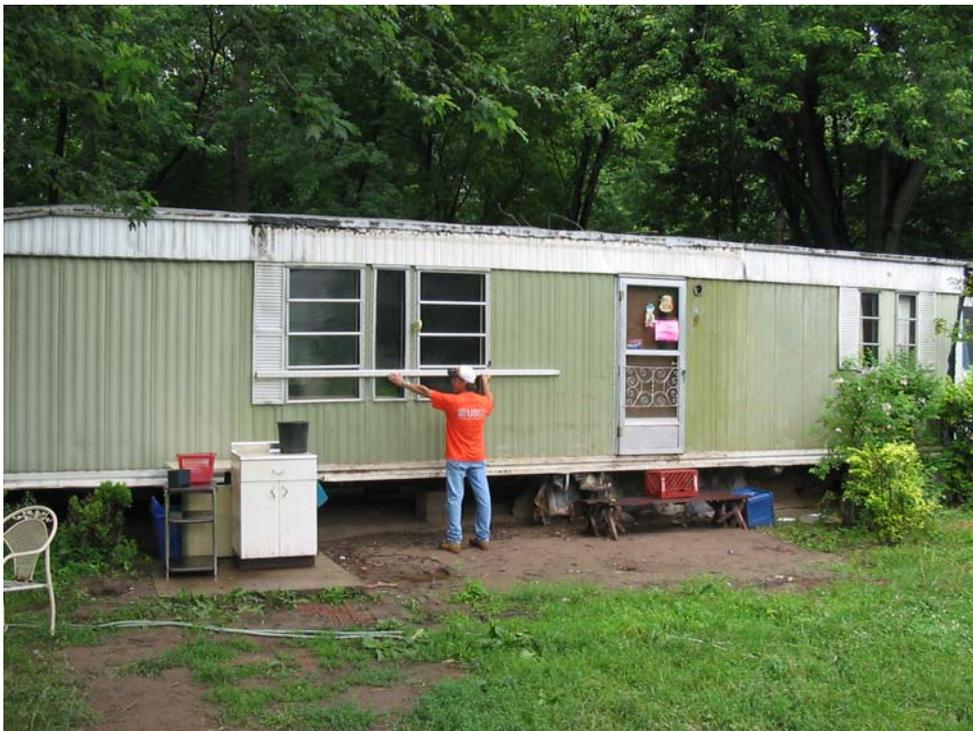
High-water mark 13.16 is an excellent seed line about 5.5 feet above the ground, on the upstream side of house 42 on Sandy Road, on the left bank, 830 feet downstream from the Washington Avenue bridge, at elevation 154.04 feet above NGVD 29 (lat 41° 56' 24.1", long 74° 01' 25.6").

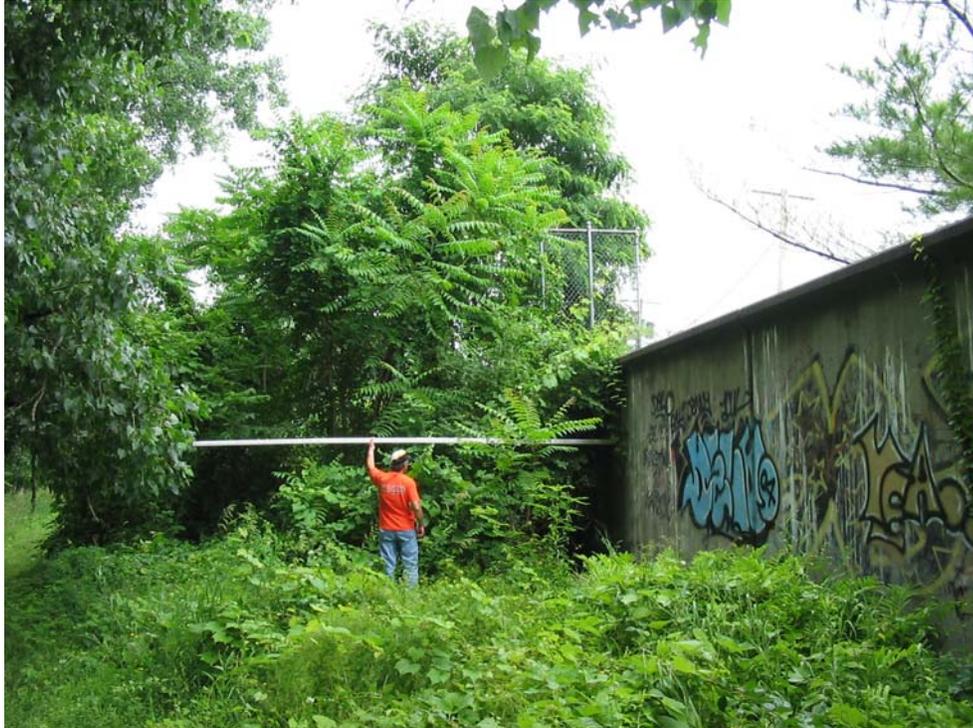
High-water mark 14.2 is an excellent mud line about 6.5 feet above the ground, on the streamward side of flood wall (3.5 feet below top), on the right bank, 160 feet upstream from the Interstate Route 587 and State Route 28 bridge, at elevation 153.46 feet above NGVD 29 (lat 41° 56' 18.4", long 74° 01' 07.7").

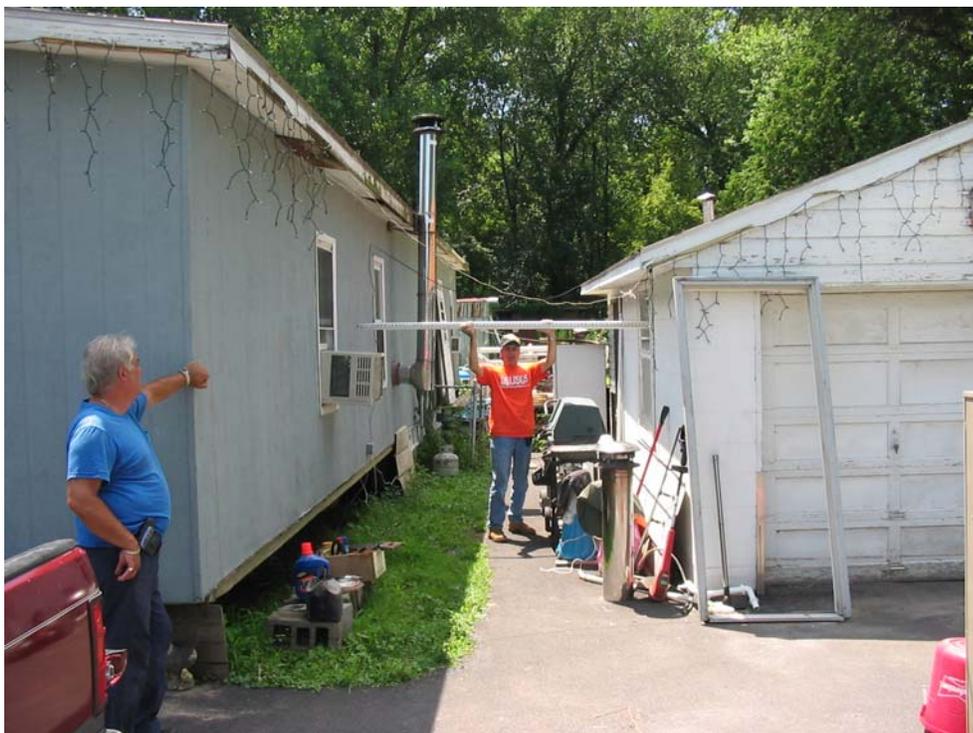
High-water mark 14.10 is a good mud line about 6.5 feet above the ground, on the streamward side of a detached garage landward from house 8 on Weidy Road, on the left bank, 450 feet downstream from the Interstate Route 587 and State Route 28 bridge, at elevation 152.68 feet above NGVD 29 (lat 41° 56' 28.4", long 74° 01' 13.0").

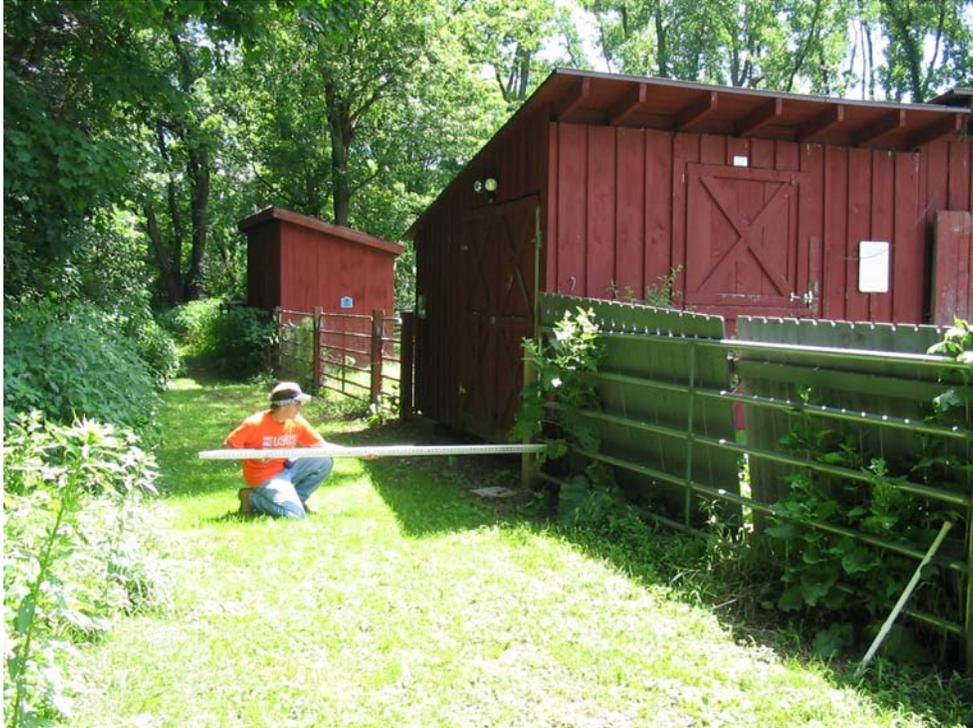
High-water mark 14.12 is an excellent seed line about 1.5 feet above the ground, on the downstream side of the Ulster County Society for the Prevention of Cruelty to Animals downstream barnyard fence, on the left bank, 260 feet downstream from the Interstate Route 587 and State Route 28 bridge, at elevation 152.65 feet above NGVD 29 (lat 41° 56' 25.1", long 74° 01' 10.3").

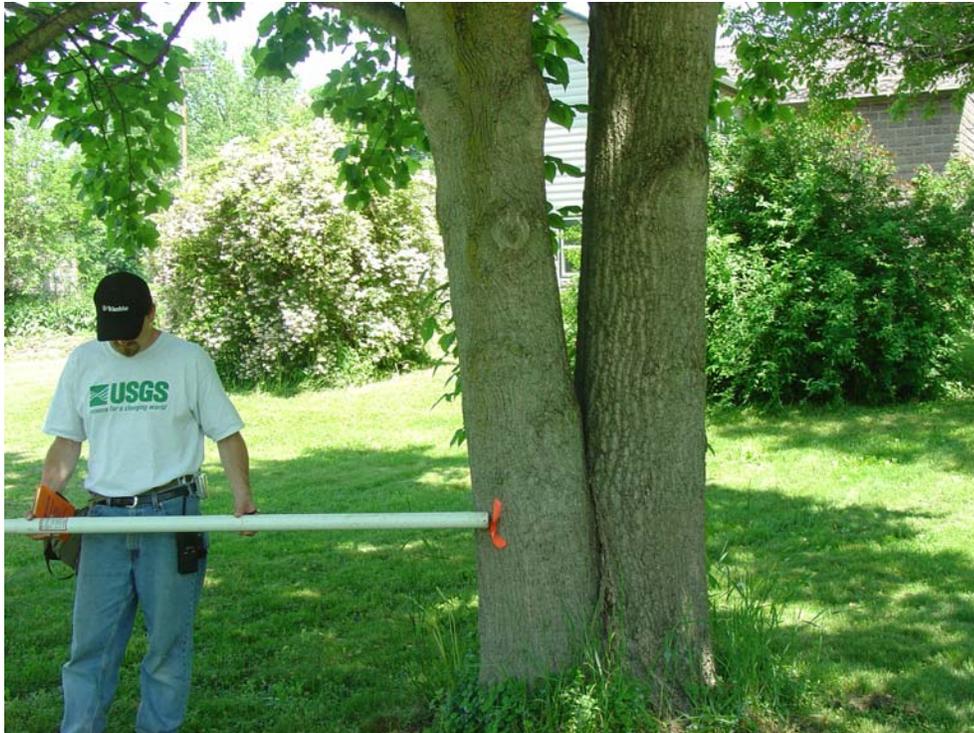
High-water mark 15.1 is a fair debris line about 3 feet above the ground, on a tree on the right bank, streamward of house 406 on Manor Lake, 20 feet downstream from Manor Lake, at elevation 152.76 feet above NGVD 29 (lat 41° 56' 34.5", long 74° 00' 38.9").

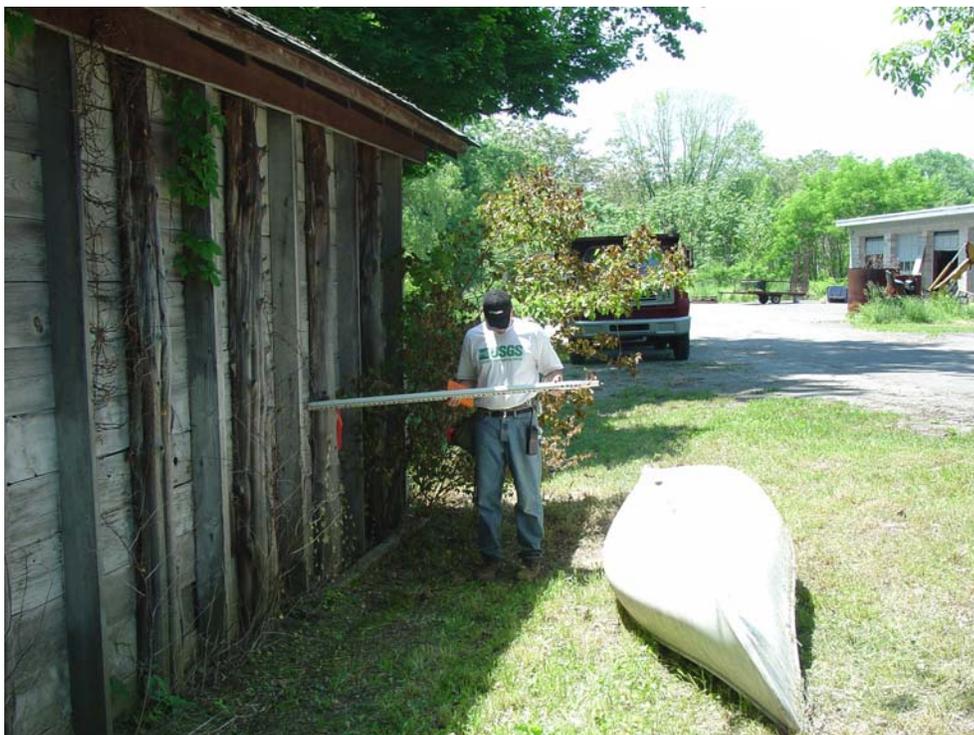
High-water mark 15.4 is a good mud line about 4 feet above the ground, on the downstream side of a storage shed streamward of house 406 on Manor Lake, on the right bank, 20 feet upstream from Manor Lake, at elevation 152.87 feet above NGVD 29 (lat 41° 56' 34.0", long 74° 00' 38.0").

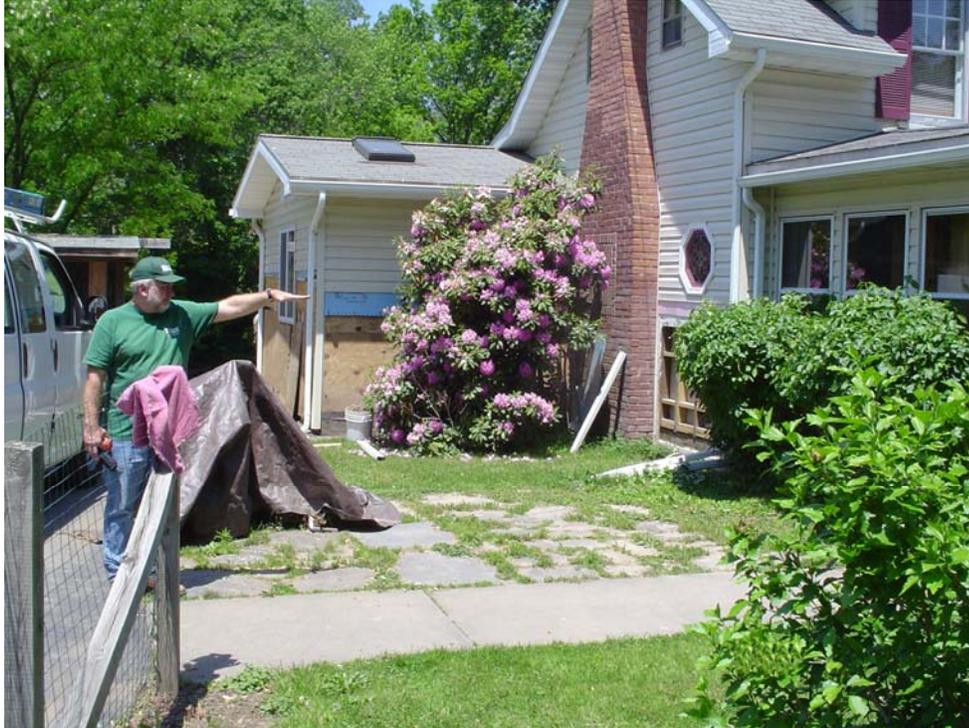
High-water mark 16.2 is an excellent mud line about 5 feet above the ground, on the landward side of house 48 on Buckley Street, on the right bank, at elevation 151.16 feet above NGVD 29 (lat 41° 57' 36.2", long 74° 00' 48.8").

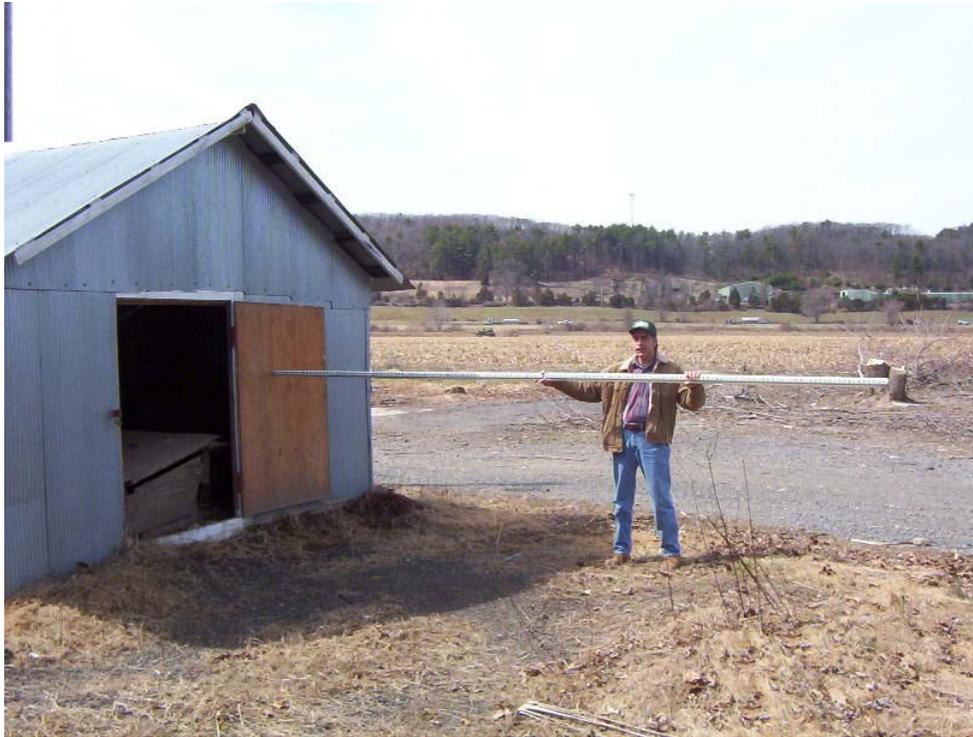
High-water mark 17.1 is an excellent mud line about 5 feet above the ground, on the streamward side of house 58 on Farm To Market Road, on the left bank, at elevation 150.02 feet above NGVD 29 (lat 41° 57' 56.7", long 74° 00' 35.5"). No photos were taken of high-water mark 17.1. Photo of excellent seed line about 4.5 feet above the ground on upstream side of nearby well house.

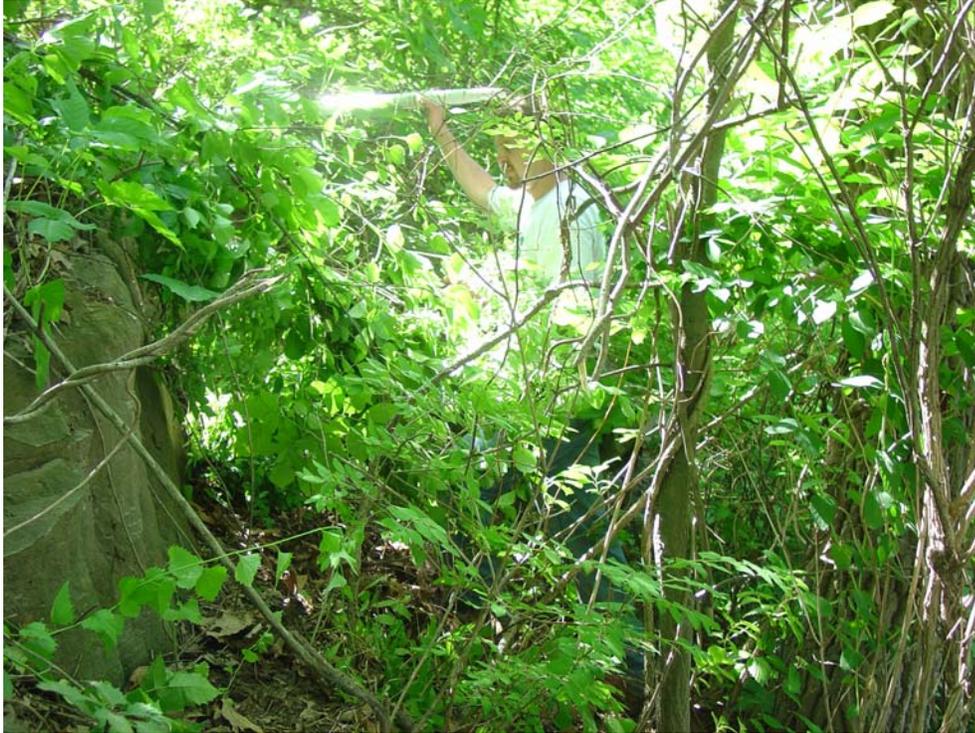
High-water mark 18.1 is a fair debris line on the ground, on the right bank, 150 feet upstream from the U.S. Route 209 bridge, at elevation 147.11 feet above NGVD 29 (lat 41° 58' 31.6", long 74° 00' 11.1").

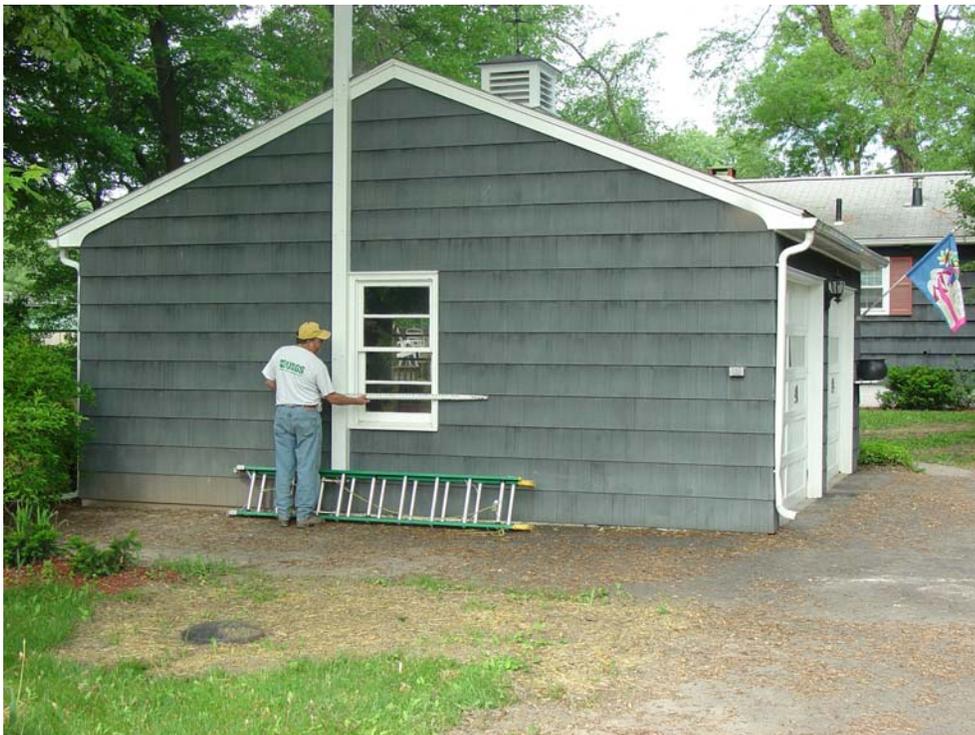
High-water mark 18.4 is an excellent mud line about 3.5 feet above the ground, on the landward side of a detached garage landward from house 18 on Mulvin Drive, on the right bank, 250 feet downstream from the U.S. Route 209 bridge, at elevation 146.76 feet above NGVD 29 (lat 41° 58' 36.3", long 74° 00' 12.3").

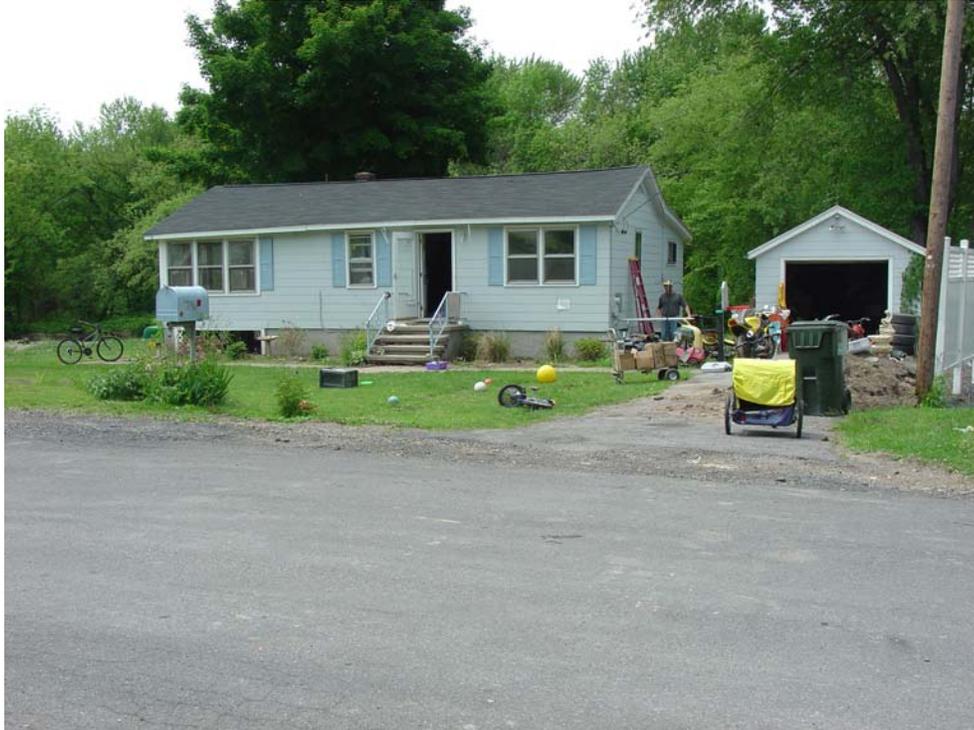
High-water mark 19.1 is an excellent mud line about 3 feet above the ground, on the downstream side of house 132 on Parish Lane, on the right bank, at elevation 146.28 feet above NGVD 29 (lat 41° 58' 49.1", long 74° 00' 25.9").
