Flood of April 2–3, 2005, Esopus Creek Basin, New York

By Thomas P. Suro and Gary D. Firda

Open-File Report 2007–1036

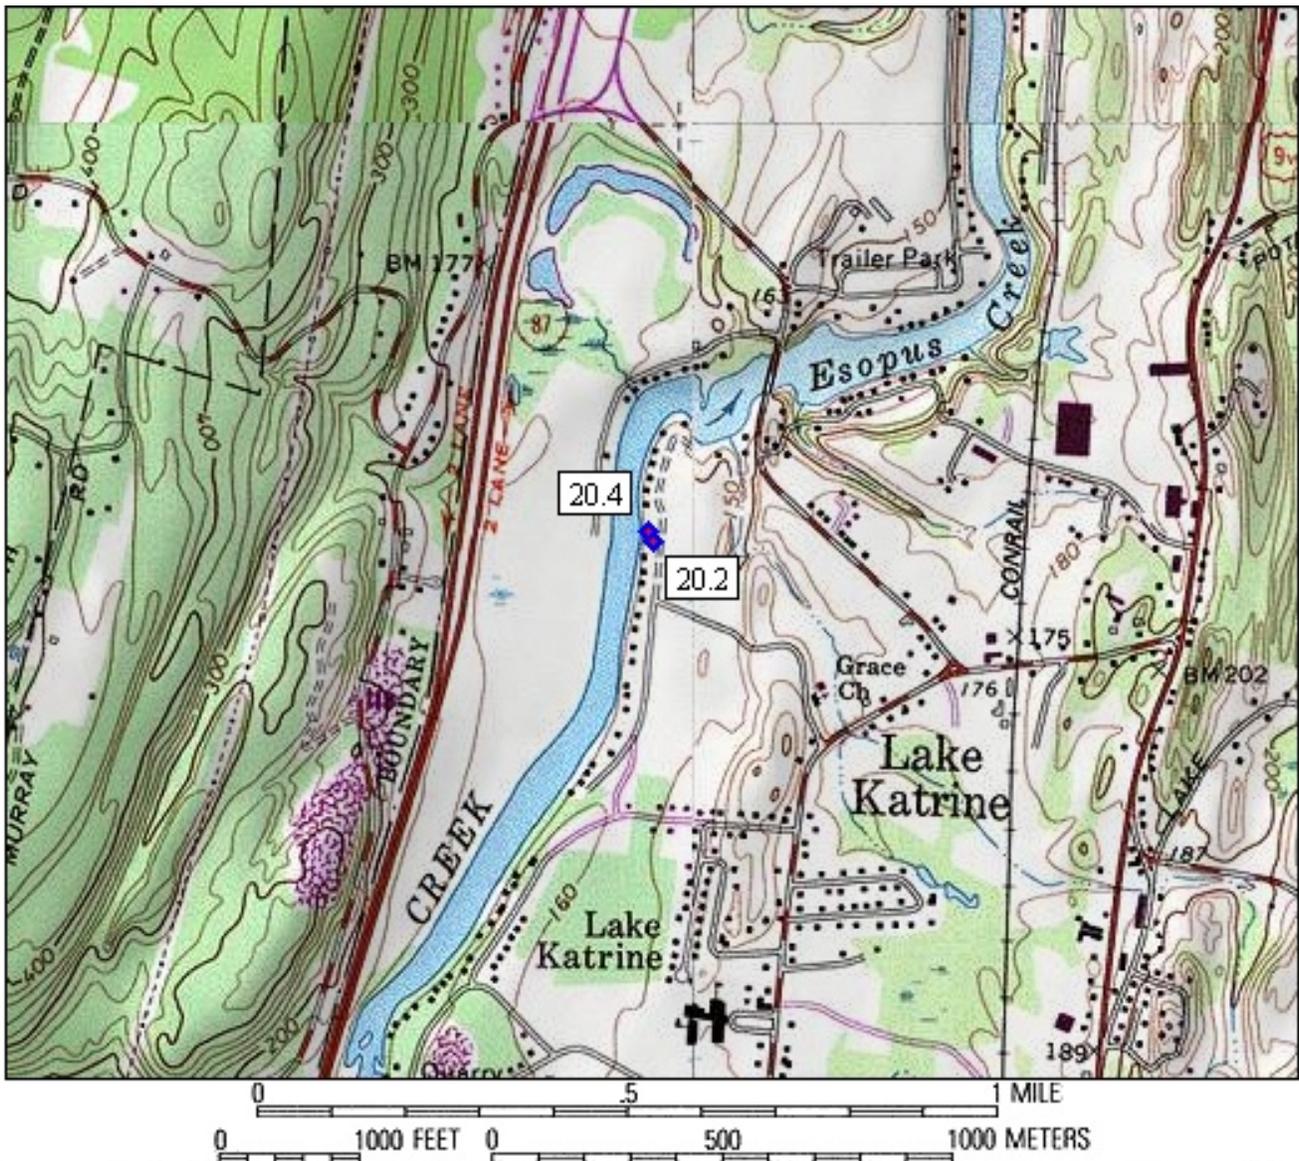
Kingston West quad map with location of site 20, Esopus Creek at Sawmill Road at Lake Katrine, N.Y.

SITE DESCRIPTION
Site 20: Esopus Creek at Sawmill Road at Lake Katrine, N.Y.
Site Location: Sawmill Road, lat 41° 59' 30.5", long 74° 00' 03.5", NAD 83
Town of Ulster, Ulster County, N.Y.
Kingston West USGS 7.5' Topographic Quadrangle
High-Water Marks: Four high-water marks were surveyed: three debris lines and one wash line.
Photos and GPS readings were taken at each high-water mark. Field notes are filed at the USGS office in Troy, N.Y.
Marks were surveyed and photos taken by C. J. Ostheimer and S.A. Vivian on June 3, 2005.
High-water-mark elevations were surveyed from a reference mark that is a chiseled square on the southwest corner of the northwest wingwall of the Leggs Mills Road bridge over Esopus Creek. This is RM 4 in the Town of Ulster FEMA flood-insurance study. Elevation is 157.07 feet above NGVD 29. To convert to NAVD 88, subtract 0.79 feet from all elevations at this site.

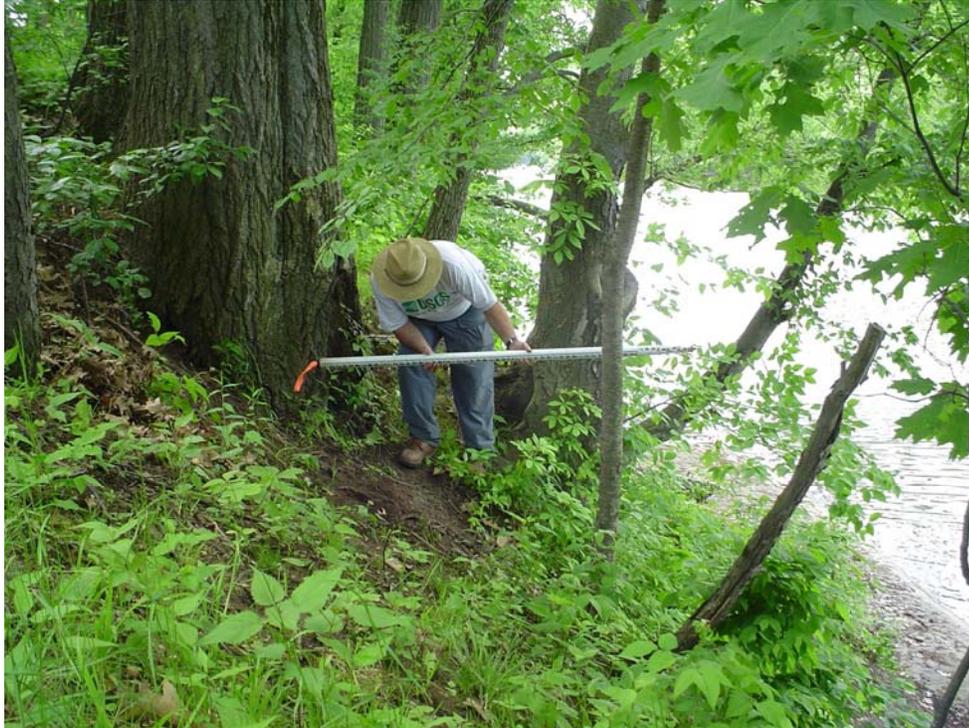
High-water mark 20.2 is a fair debris line about 1 foot above the ground, on a tree on the right bank, streamward from house 182 on Sawmill Road, at elevation 142.17 feet above NGVD 29 (lat 41° 59' 30.5", long 74° 00' 03.5").

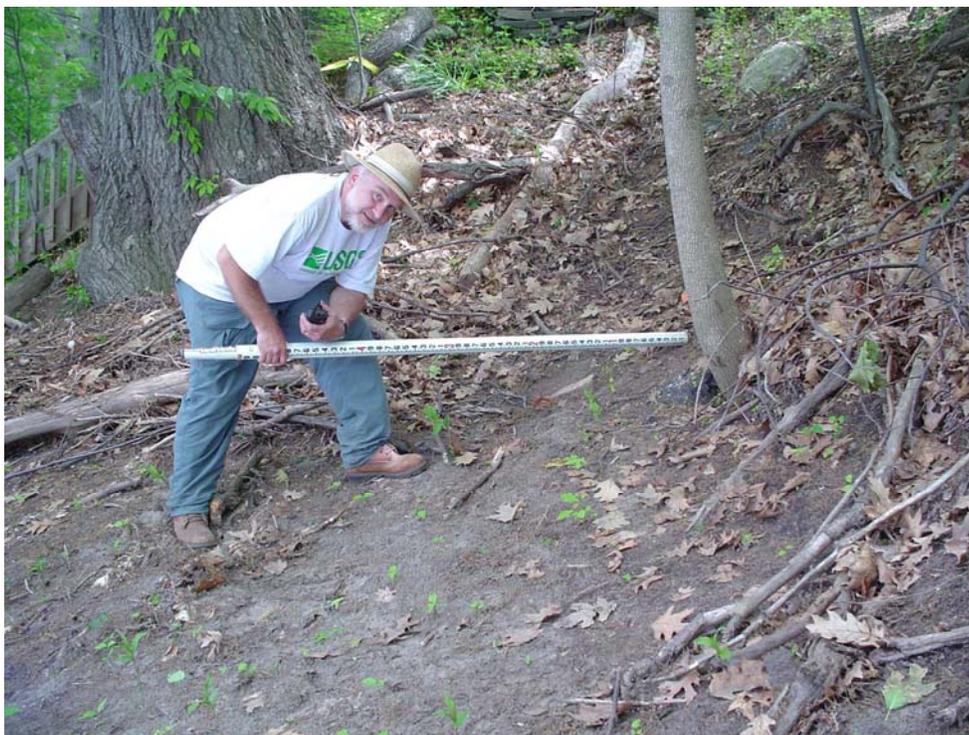
High-water mark 20.4 is a fair debris line on the ground, on the right bank, streamward from house 174 on Sawmill Road, at elevation 141.85 feet above NGVD 29 (lat 41° 59' 31.2", long 74° 00' 04.1").

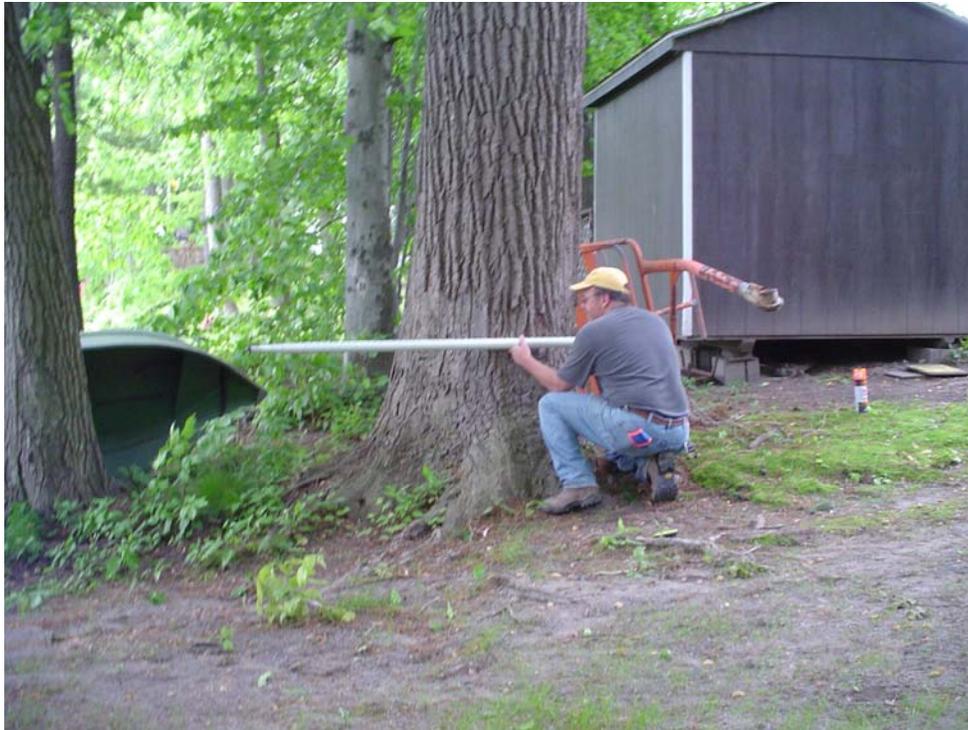
High-water mark 21.2 is a good debris line about 2 feet above the ground, on a tree on the left bank, 370 feet upstream from the Leggs Mills Road bridge, at elevation 141.46 feet above NGVD 29 (lat 41° 59' 42.4", long 73° 59' 56.5").

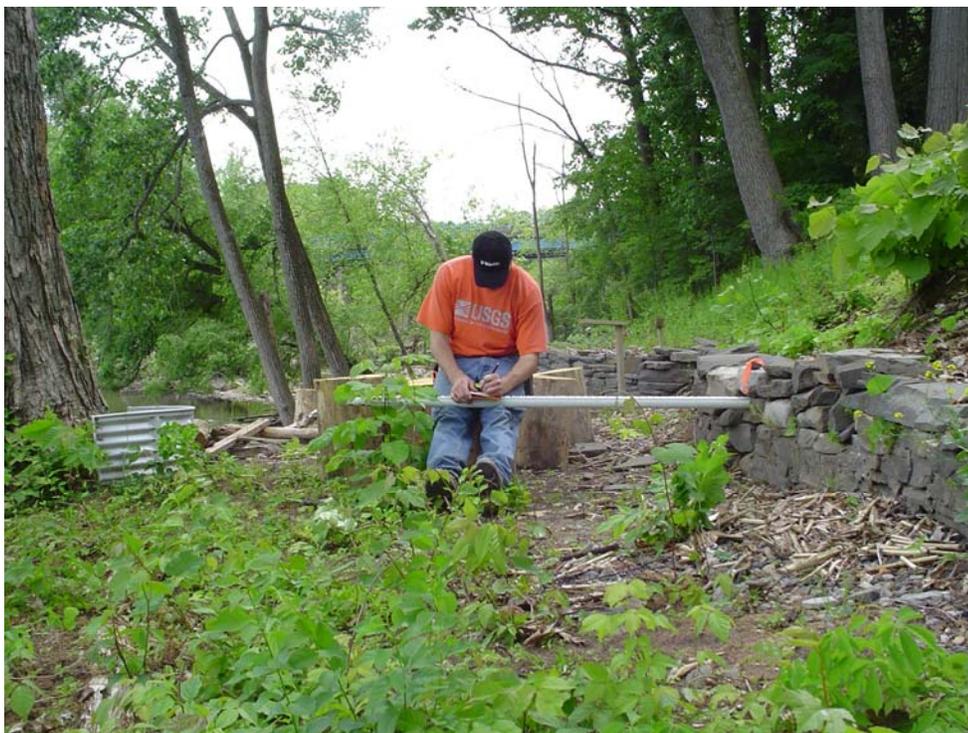
High-water mark 21.8 is a fair debris line about 1.5 feet above the ground, on the streamward side of a stone wall, on the left bank, 270 feet downstream from the Leggs Mills Road bridge, at elevation 138.80 feet above NGVD 29 (lat 41° 59' 44.8", long 73° 59' 48.8").

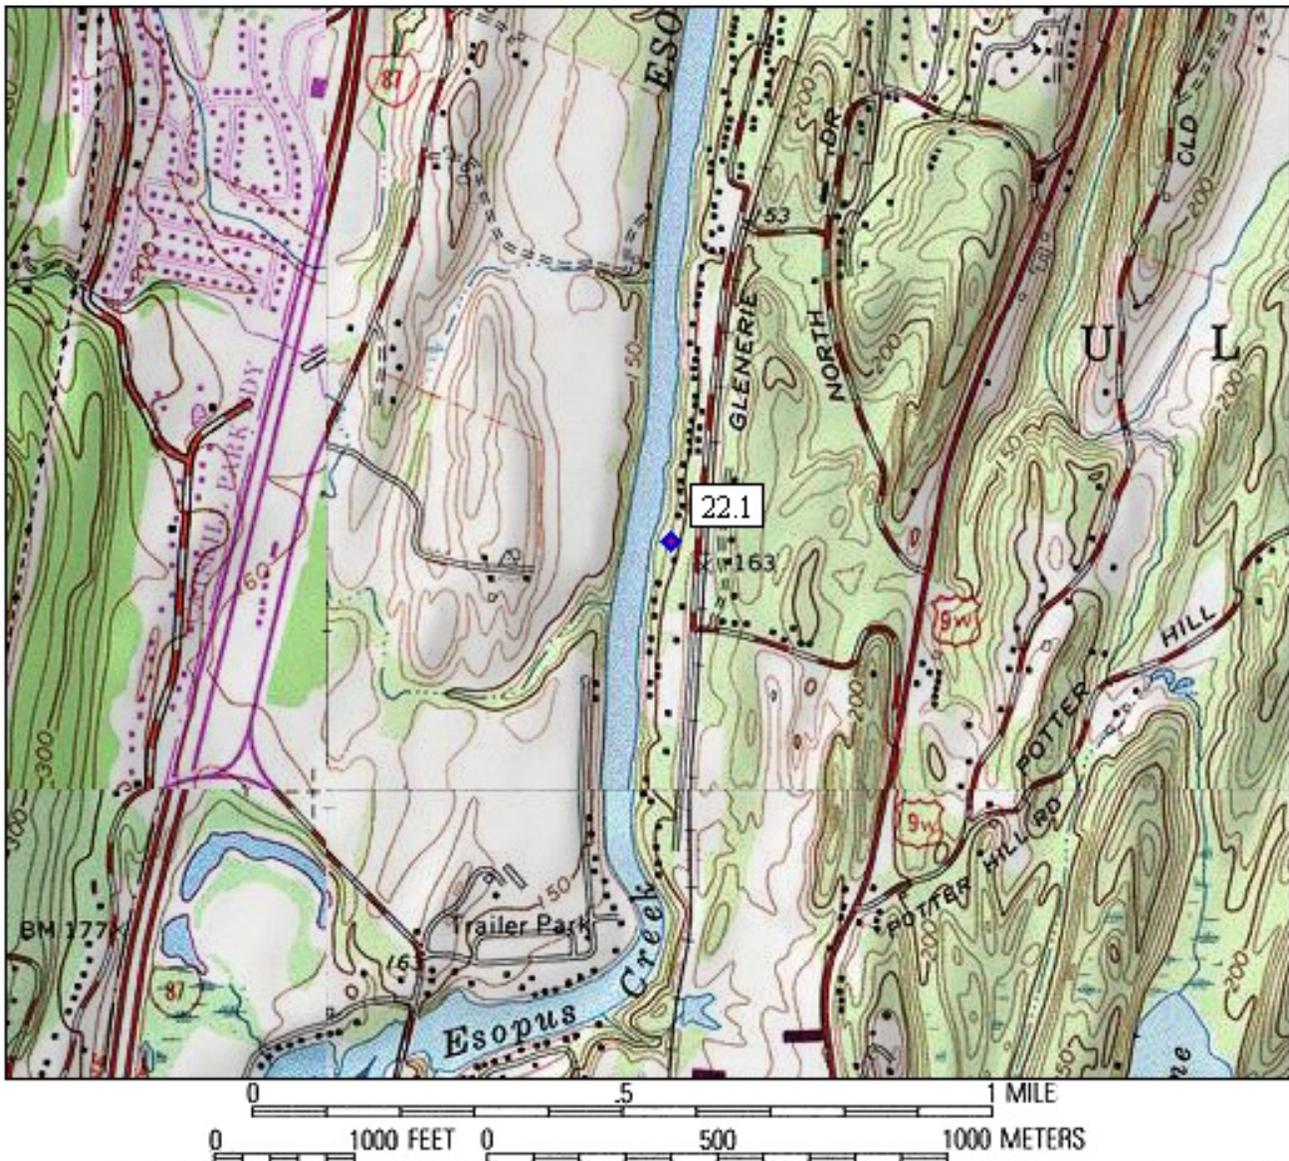
Saugerties quad map with location of site 22, Esopus Creek at Glenerie Boulevard (south) at Glenerie Lake Park, N.Y.

SITE DESCRIPTION
Site 22: Esopus Creek at Glenerie Boulevard (south) at Glenerie Lake Park, N.Y.
Site Location: Glenerie Boulevard, lat 42° 00' 17.6", long 73° 59' 27.2", NAD 83
Town of Ulster, Ulster County, N.Y.
Saugerties USGS 7.5' Topographic Quadrangle
High-Water Marks: Four high-water marks were surveyed: three debris lines and one seed line.
Photos and GPS readings were taken at each high-water mark. Field notes are filed at the USGS office in Troy, N.Y.
Marks were surveyed and photos taken by K.D. Metzker, C. J. Ostheimer, S.A. Vivian, and M.T. Whitehead on June 2, 2005.
High-water-mark elevations were surveyed from a benchmark that is an NGS standard disk stamped H-280 1942, located at the municipal building in Saugerties, set vertically in the south face at the southwest corner, 17.7 feet east of the east curb of Partition Street, 0.6 foot above the building corner stone, NGS PID MZ0780. Elevation is 155.04 feet above NGVD 29. To convert to NAVD 88, subtract 0.79 feet from all elevations at this site.

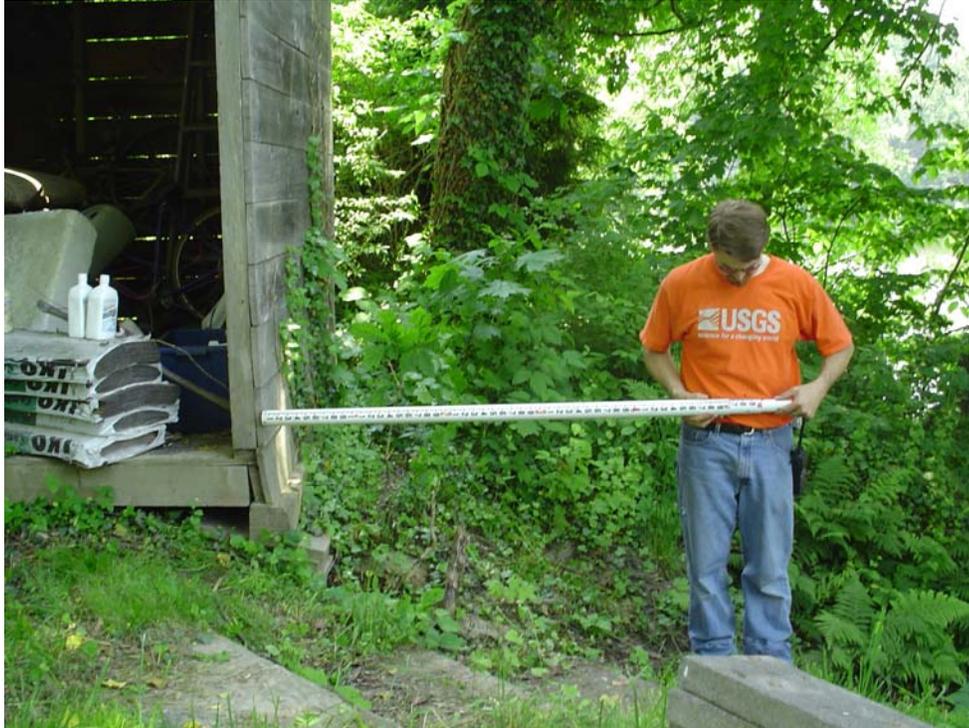
High-water mark 22.1 is a good debris line about 1.5 feet above the ground, on the streamward side of a storage shed streamward from house 370 on Glenerie Boulevard, on the right bank, at elevation 136.33 feet above NGVD 29 (lat 42° 00' 17.6", long 73° 59' 27.2").

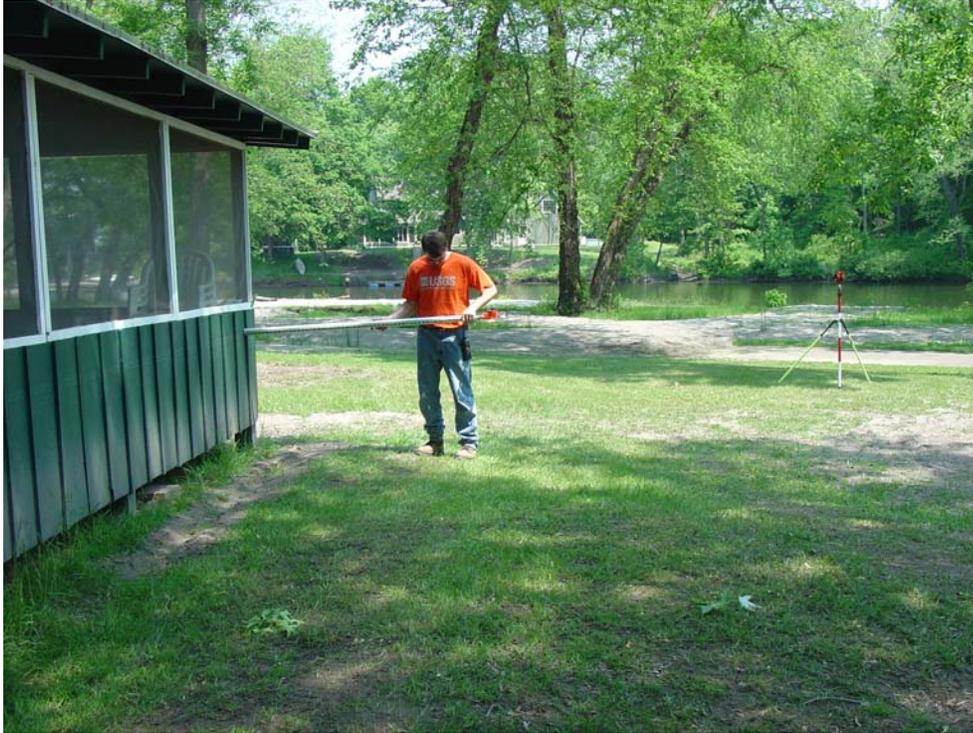
High-water mark 23.1 is an excellent mud line about 3 feet above the ground, on the downstream side of cabin C5 at 127 Glenerie Boulevard, on the right bank, at elevation 133.59 feet above NGVD 29 (lat 42° 01' 15.5", long 73° 59' 08.9").

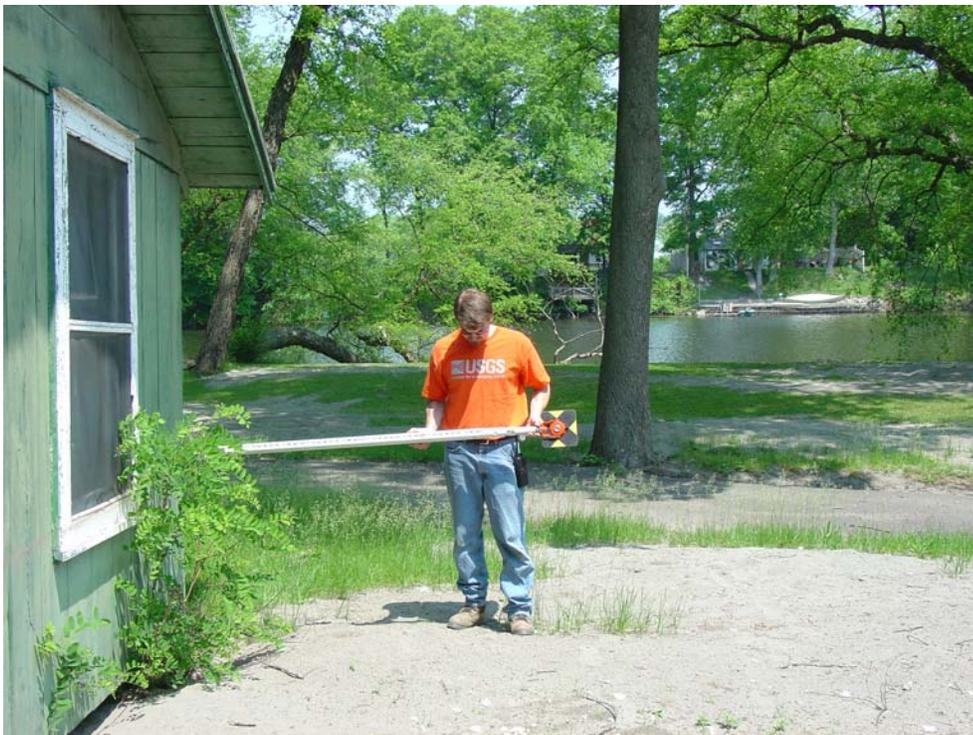
High-water mark 23.2 is an excellent mud line about 3 feet above the ground, on the downstream side of cabin C7 at 127 Glenerie Boulevard, on the right bank, at elevation 133.59 feet above NGVD 29 (lat 42° 01' 16.3", long 73° 59' 09.9").

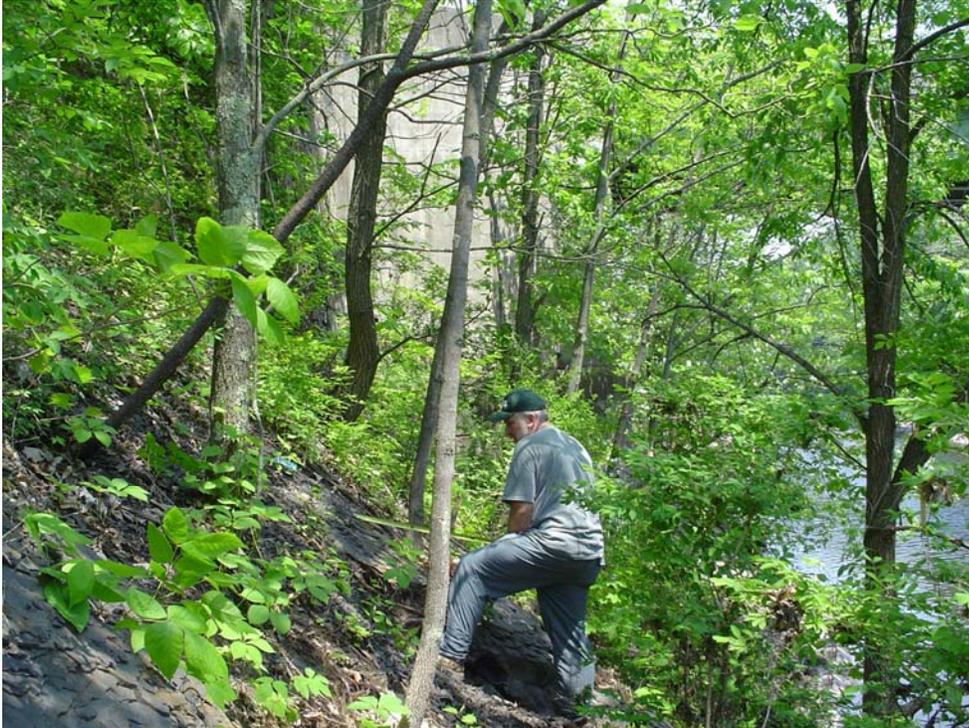
High-water mark 24.2 is a fair wash line on the ground, on the left bank, 150 feet upstream from the Glasco Turnpike bridge, at elevation 67.80 feet above NGVD 29 (lat 42° 02' 15.3", long 73° 58' 19.2").

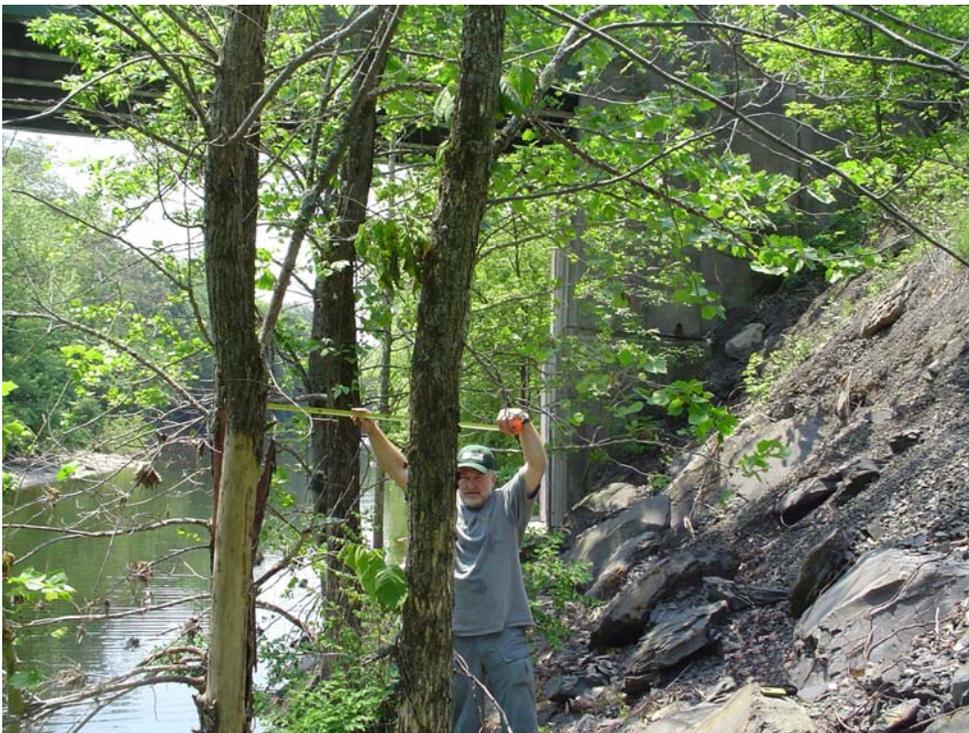
High-water mark 24.4 is a poor debris line about 6 feet above the ground, on a tree on the left bank, 100 feet downstream from the Glasco Turnpike bridge, at elevation 66.19 feet above NGVD 29 (lat 42° 02' 17.5", long 73° 58' 18.7").

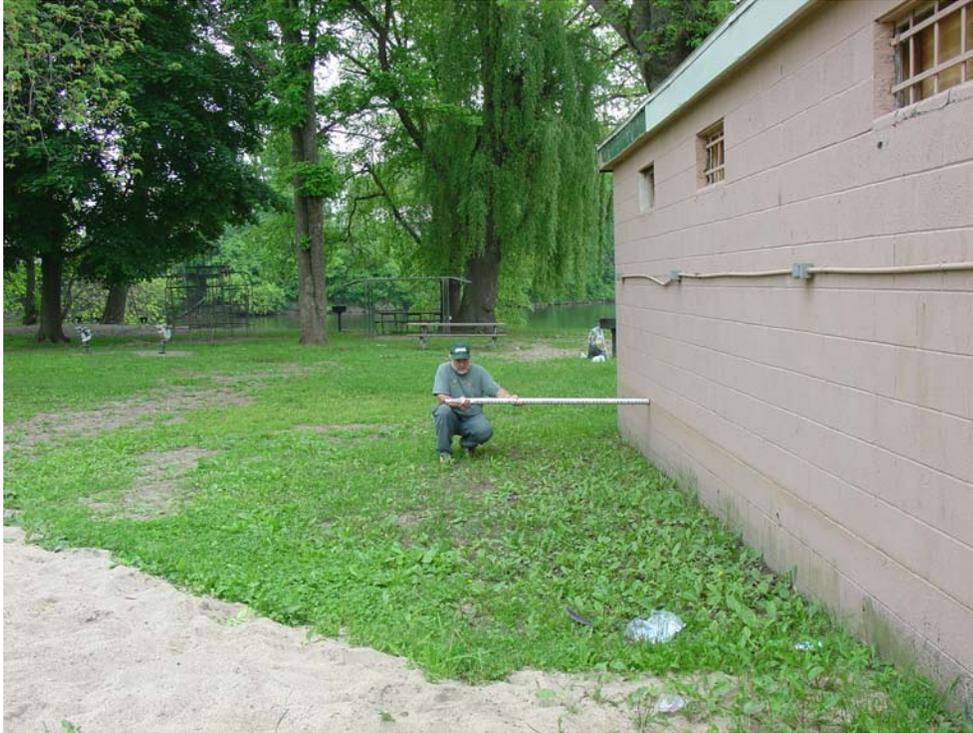
High-water mark 25.1 is an excellent mud line about 2 feet above the ground, on the downstream side of the Village of Saugerties Waterfront Park beach house, on the left bank, 220 feet upstream from the U.S. Route 9W and State Route 32 bridge, at elevation 54.64 feet above NGVD 29 (lat 42° 04' 15.8", long 73° 57' 04.6").

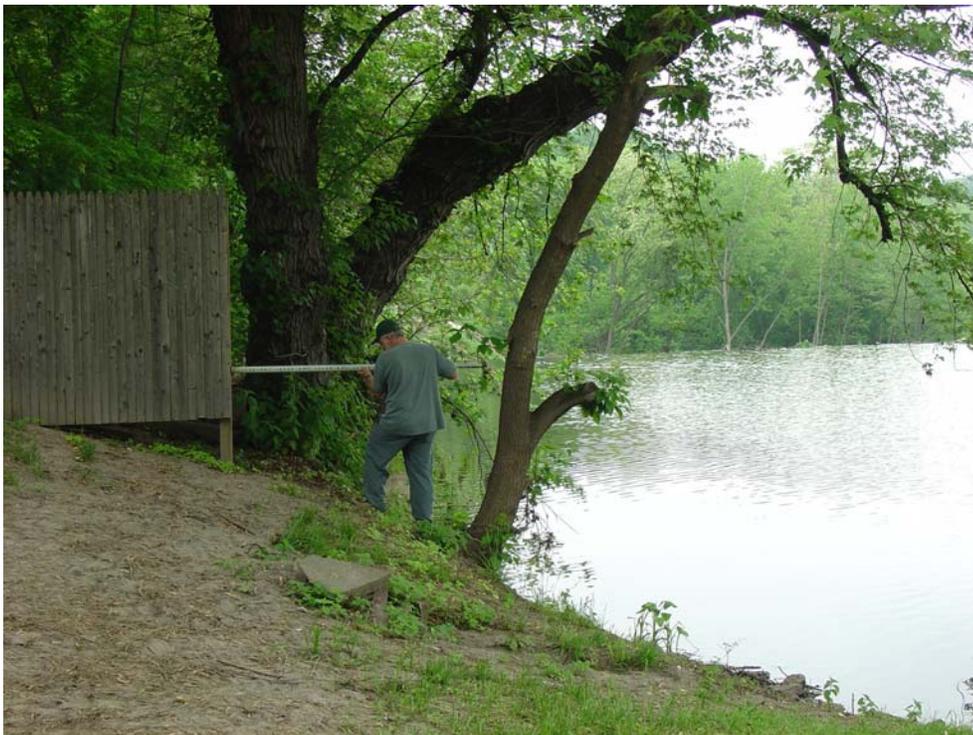
High-water mark 25.4 is a good mud line about 2 feet above the ground, on the upstream side of a fence, on the left bank, 105 feet downstream from the U.S. Route 9W and State Route 32 bridge, at elevation 54.61 feet above NGVD 29 (lat 42° 04' 18.6", long 73° 57' 02.1").

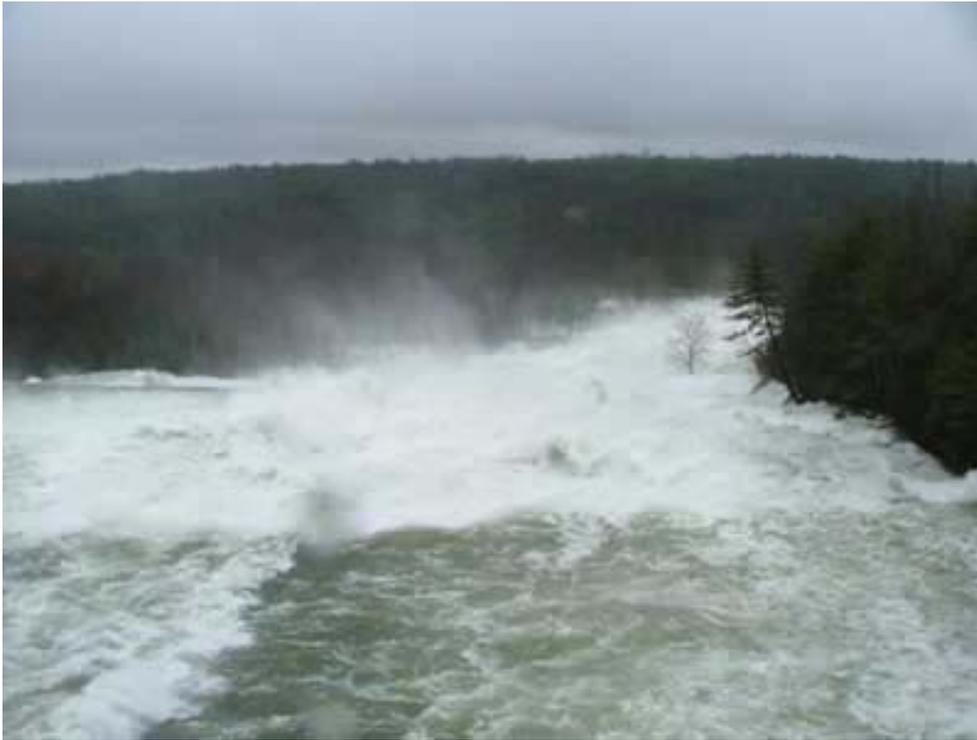
Ashokan Reservoir spill channel to Esopus Creek on April 3, 2005.
Photo courtesy of Times Herald-Record.

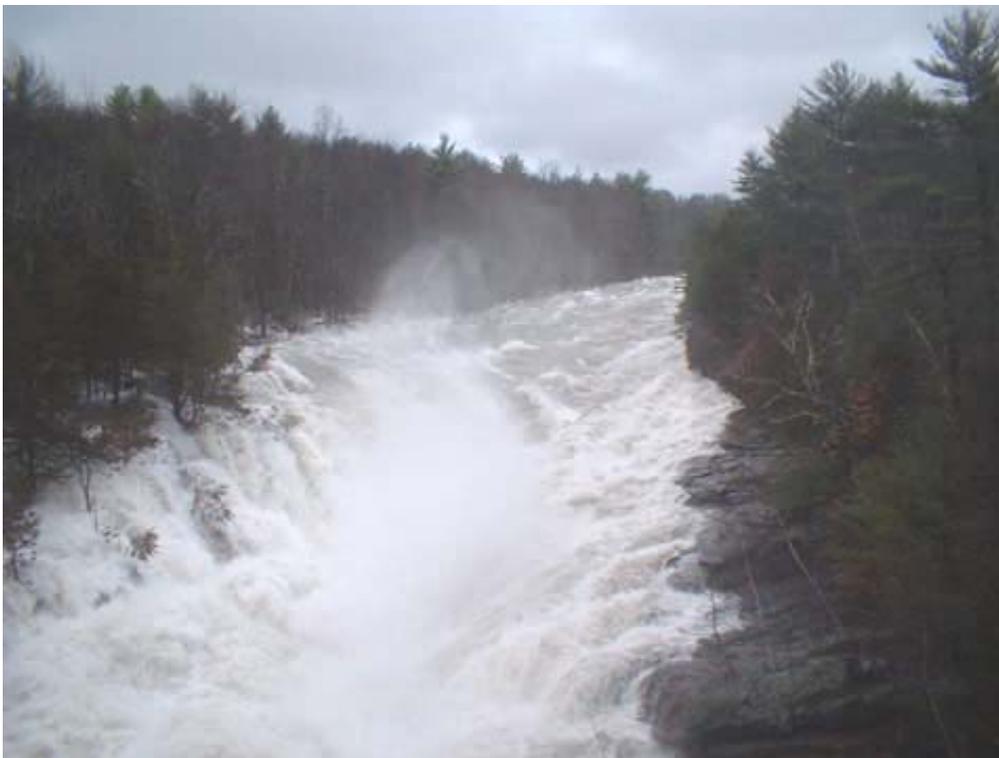
Ashokan Reservoir spillway channel on April 3, 2005. Photo courtesy of James Werner.
