Mass Wasting Following the 2002 Missionary Ridge Fire near Durango, Colorado, a Field Trip Guidebook

Open File Report 2007-1289

Association of Environmental & Engineering Geologists
Special Publication No. 20

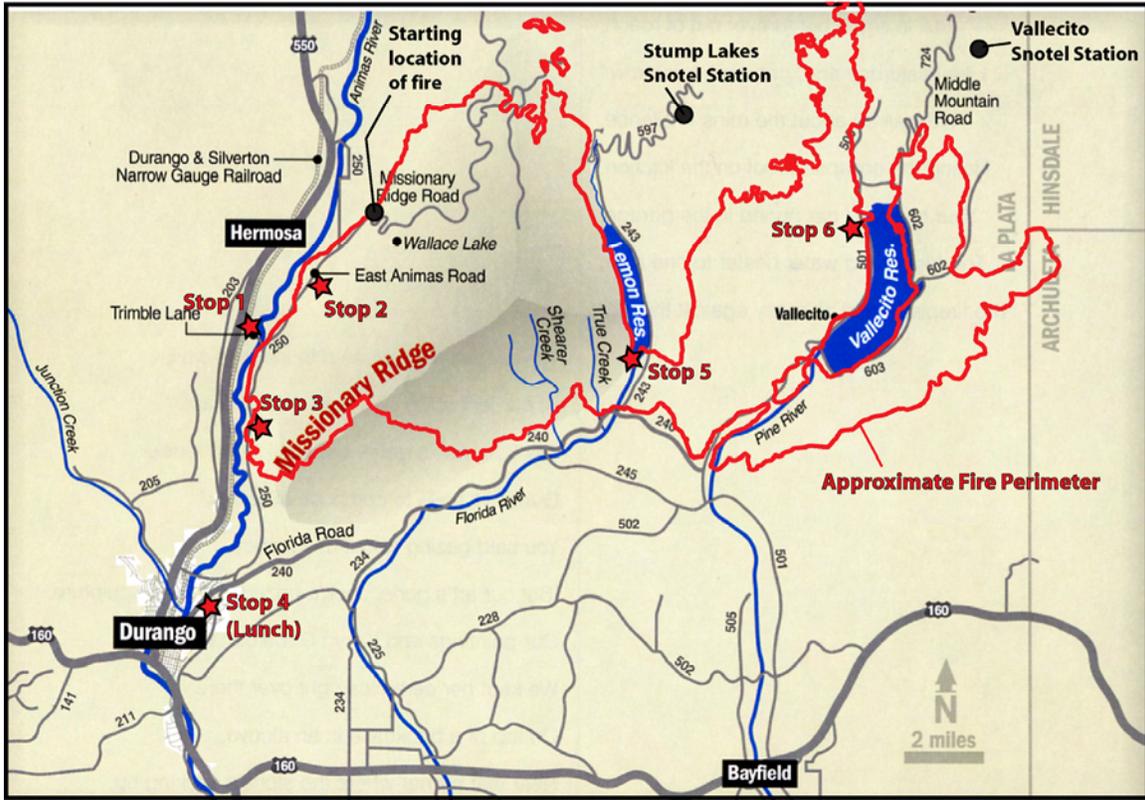
Figure 1. Map showing the Missionary Ridge fire burn area (outlined in red) and field trip stops (indicated by red stars). Base map has been modified from Greenhill (2002).

The one-day field trip begins and ends in Durango. Many of the field trip stops are at debris-flow fans around the periphery of the burn area (fig. 1), but one stop examines landslide activity in the burn area that initiated during spring 2005 snowmelt within a dormant, deep-seated landslide, as well as an erosion/debris-flow mitigation effort in a drainage basin above Lemon Reservoir. Stops on fans will focus on (1) erosion and sediment entrainment that caused debris flows in the summer of 2002; (2) Holocene and 2002 debris-flow deposits; and (3) fire history, debris-flow hazards, hazard assessments, and mitigation schemes. A lunch stop provides a geologic overview of the Durango area.

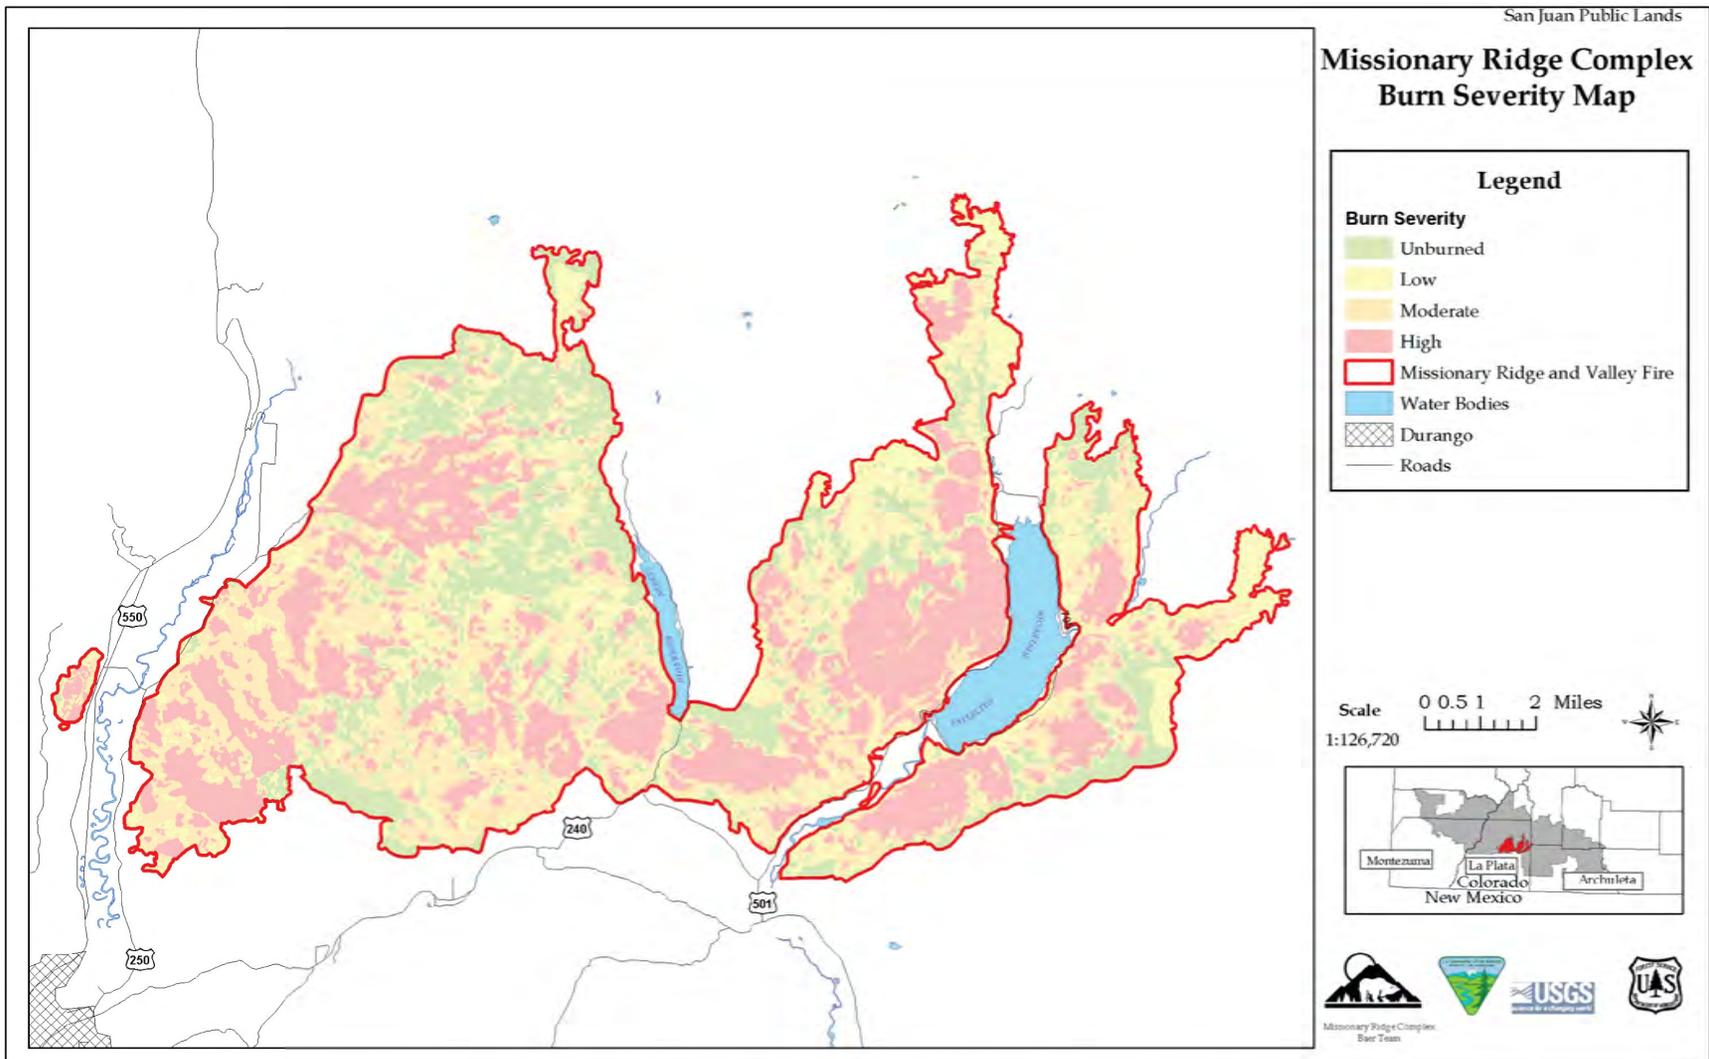
Figure 2. Map showing burn severity of the Missionary Ridge fire. From Burn Area Emergency Rehabilitation Team (2002).

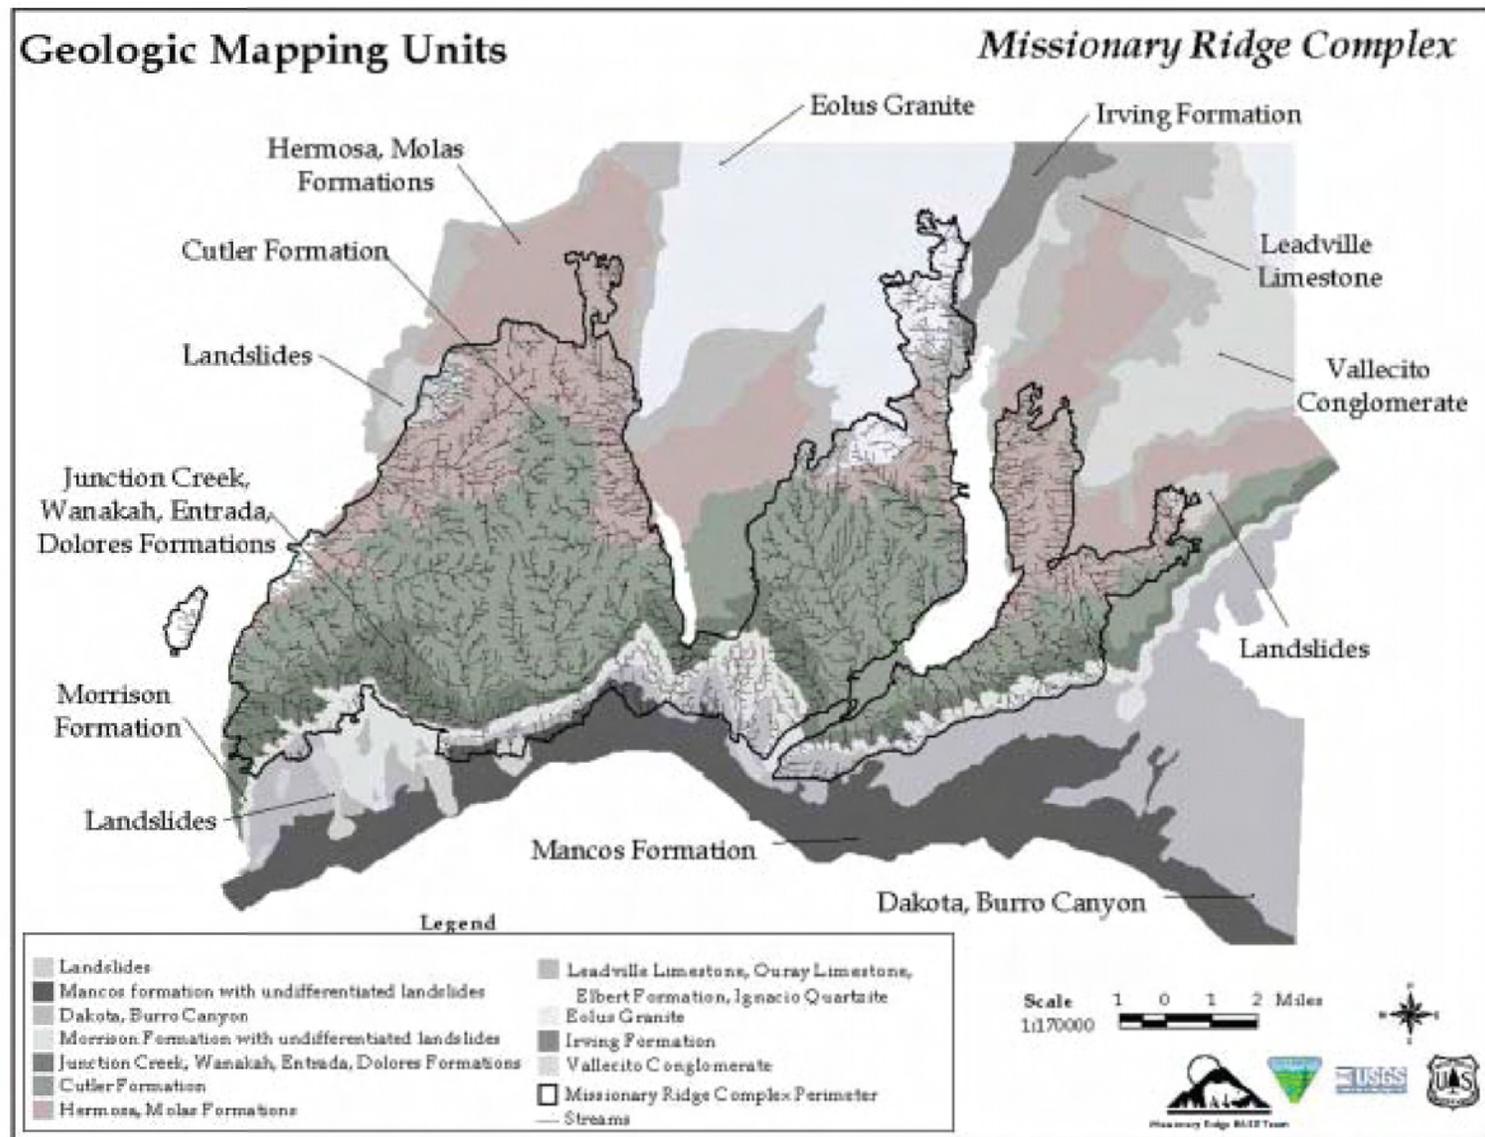
Figure 3. Geologic map of the Missionary Ridge fire burn area. From Burn Area Emergency Rehabilitation Team (2002).

Most of the burned area is underlain by Paleozoic and Mesozoic sedimentary rocks (figs. 3 and 4). About 50 percent of the burn area is underlain by the Permian Cutler Formation, which consists of a sequence of red-colored sandstones, siltstones, and shales deposited by streams flowing from the Ancestral Rocky Mountains (Blair, 1996; Carroll and others, 1997; Carroll and others, 1998; Carroll and others, 1999; Gonzales and others, 2002). Additional sedimentary formations that underlie the burn area include the Hermosa, Molas, Junction Creek, Wanaka, Entrada, Dolores, Dakota, and Morrison Formations (fig. 3). These formations consist of interbedded sandstones, siltstones, shales, limestones, and conglomerates. The Precambrian Eolus Granite also underlies the burn area near the northern boundary. Colluvial and glacial deposits have also been mapped in the burn area.

Mass wasting is common in the area, as evidenced by extensive deep-seated landslide deposits (fig. 3), debris-flow fans (for example, fig. 5), and fresh rock-fall scars and deposits (for example, fig. 6). Deep-seated and shallow landslides are common in the Morrison, Burro Canyon, Dakota, Mancos Shale, and Lewis Shale Formations (for example, Colton and others, 1975; Blair, 1977; Carroll and others, 1997; Carroll and others, 1999; Krochenski and Kenny, 2003; Coe and Burke, 2003). Debris flows are frequently initiated from colluvium derived from the Cutler Formation and Eolus Granite, and less frequently from colluvium derived from the Hermosa and Morrison Formations (Burn Area Emergency Rehabilitation Team, 2002).

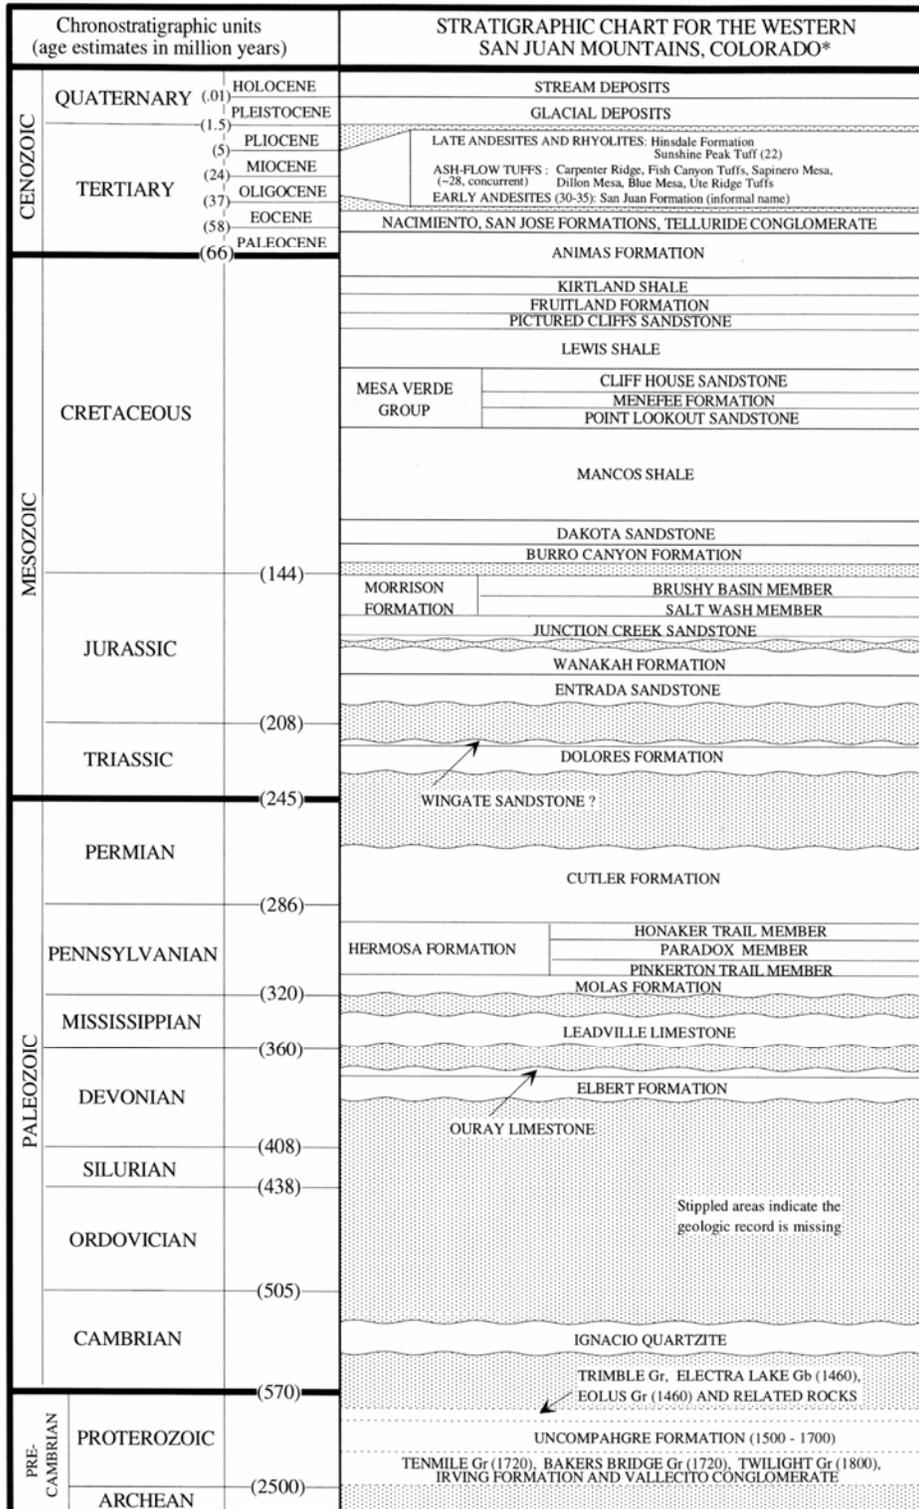
Figure 4. Stratigraphic section of the Missionary Ridge fire burn area. From Blair (1996).

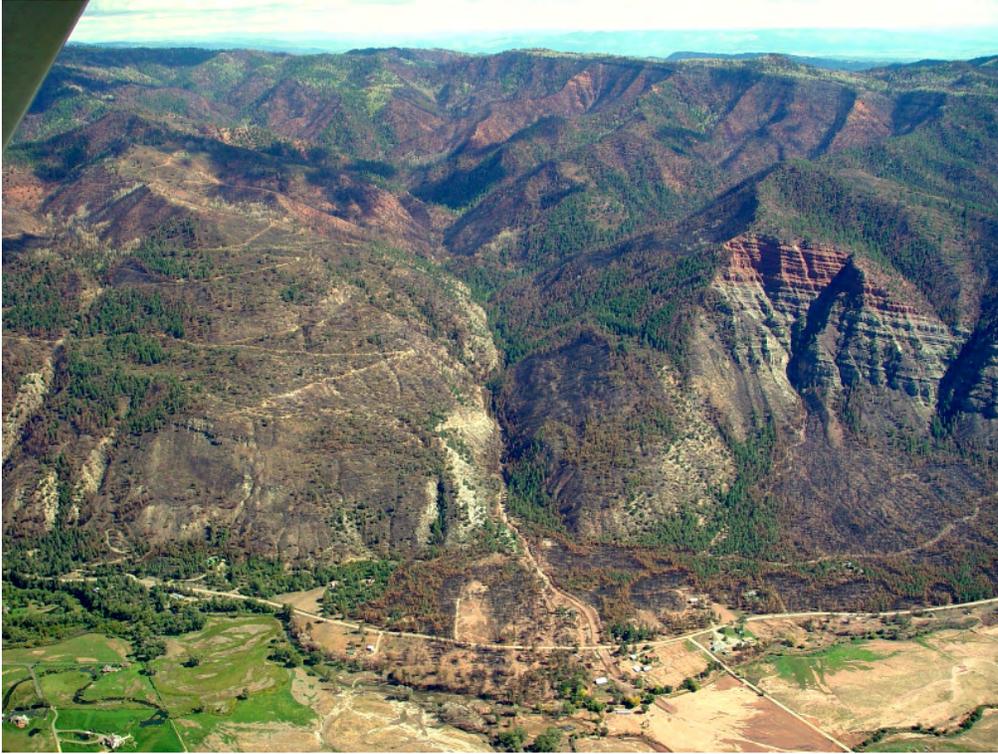
Figure 5. Fan at the mouth of Stevens Creek (Stop 2, fig. 1). Photograph taken after the Missionary Ridge fire. Photograph courtesy of La Plata County.

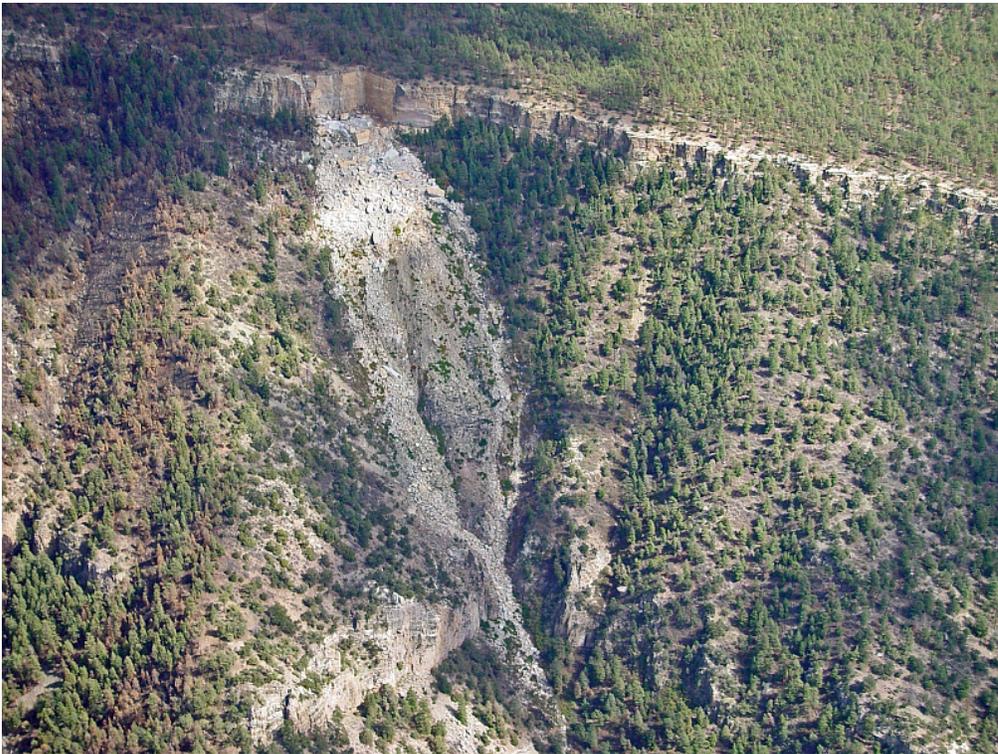
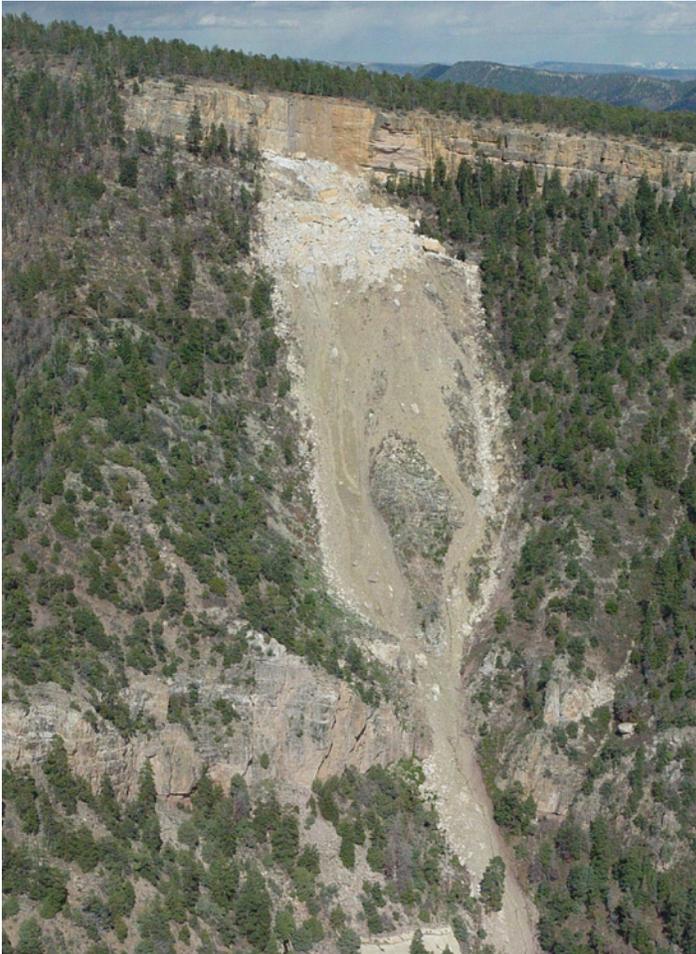
Figure 6. Rock fall/rock slide from the Dakota Sandstone along the east side of the Animas River valley about 4 km north of Durango. A, Photograph taken in the early 2000's; B, Photograph from 2005.

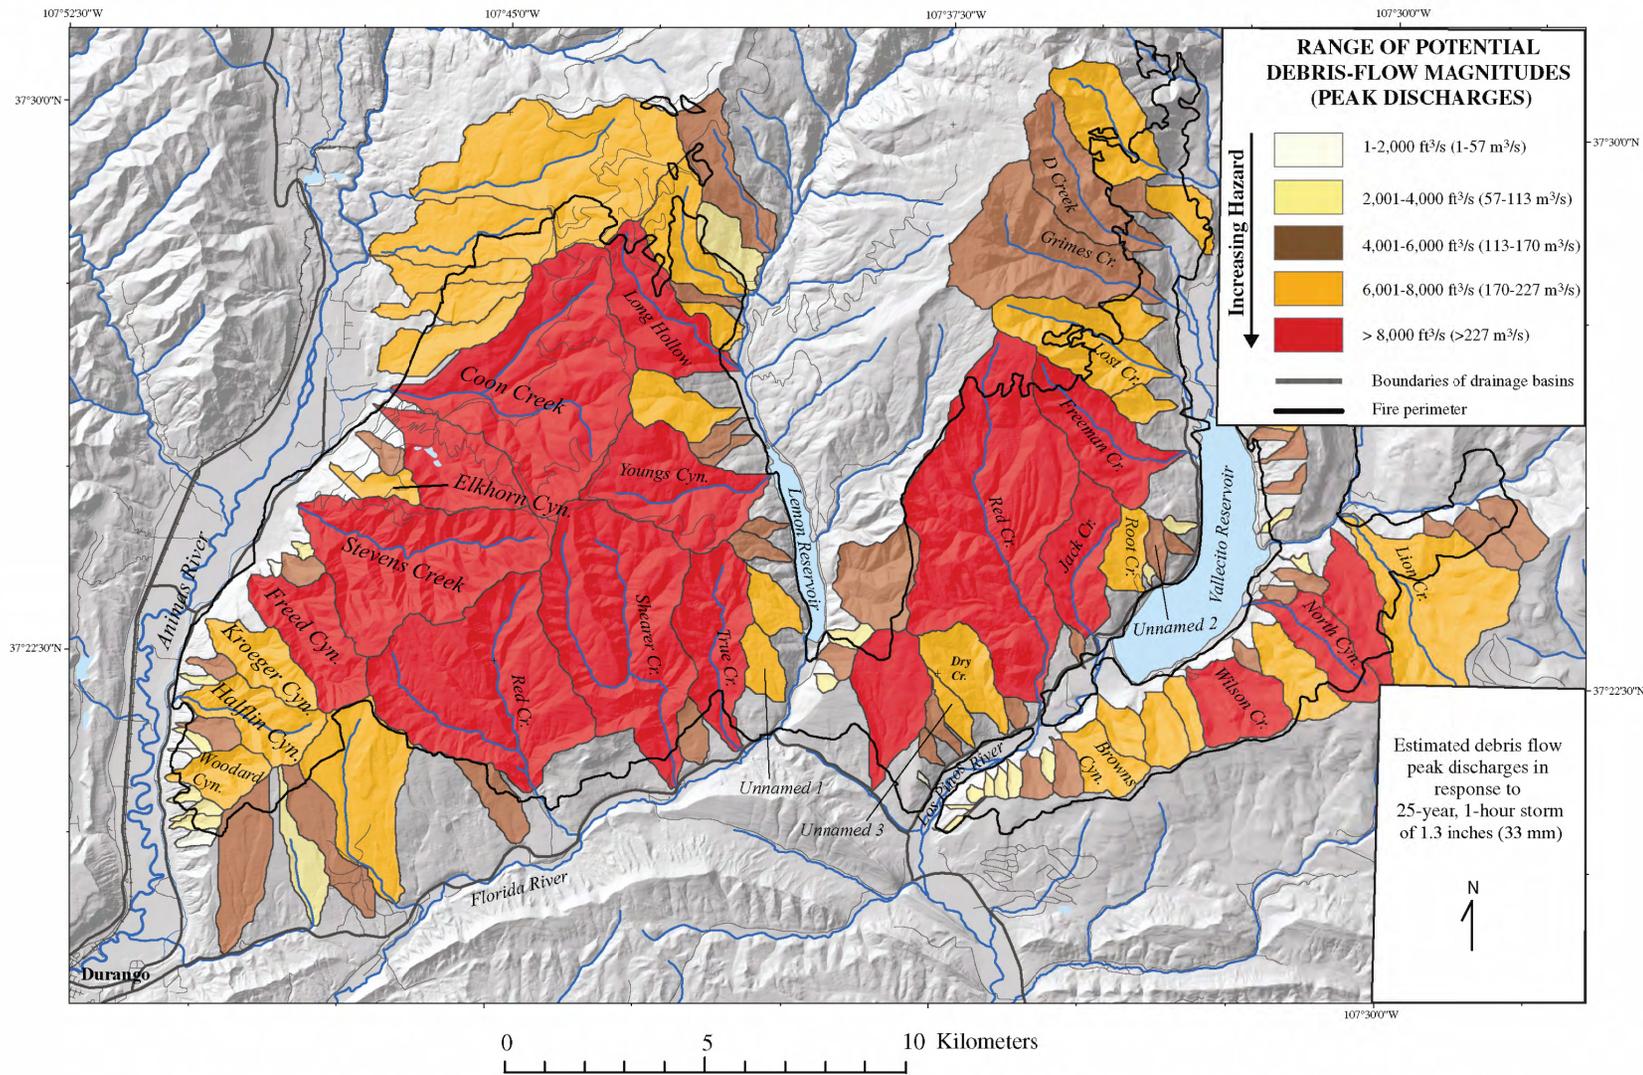
Figure 7. Map showing potential peak discharges of debris flows from basins in the Missionary Ridge fire burn area for a 1-hr duration, 25-yr recurrence storm of 1.3 in (33 mm). From Cannon and others (2003b).

Third, predictive hazard maps for peak debris-flow discharges and debris-flow volumes were produced for the burn area. Peak-discharge maps were generated immediately after the fire, and are based on a preliminary regression model developed using debris-flow and basin characteristic data from 53 recently burned basins throughout the intermountain west (Cannon and others, 2003c). The model used to estimate peak debris-flow discharges (Q_p) for basins in the Missionary Ridge area was:

where I is average storm rainfall intensity (m/s), S_{50} is the percentage of slopes greater than or equal to 50 percent within a basin, and A_b is the area burned within a basin. Slope values were determined from 10-m or 30-m Digital Elevation Models (DEMs) and burned area values were determined by BAER Teams or from Landsat Thematic Mapper data. Results from this model for a 1-hr rainstorm of 1.3 in (33 mm) and a 25-yr return period are shown in figure 7. Assessments for 1-hr duration, 5- and 100-yr recurrence storms were also generated (Cannon and others, 2003a).

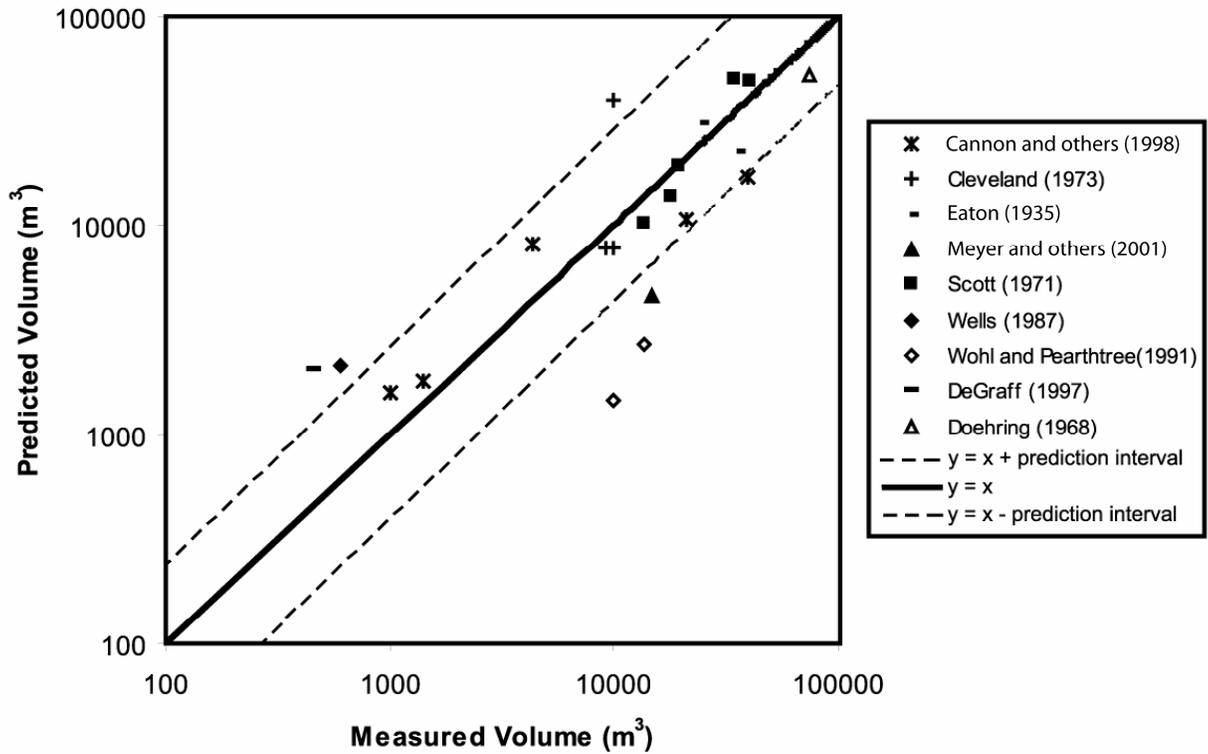
Figure 8. Comparison of debris-flow volume estimates from the literature to predictions of the volume model of Gartner (2005). The solid black line indicates a perfect fit and the dotted lines represent the 68 percent error estimate of the model.

The model for debris-flow volume was validated by comparing predicted debris flow volumes with reported volumes using data from 21 basins not used in the generation of the model (Gartner, 2005). The validation indicated that all but seven, or 67 percent, of the reported volumes were within one standard error of the volumes predicted by the model (fig. 8).

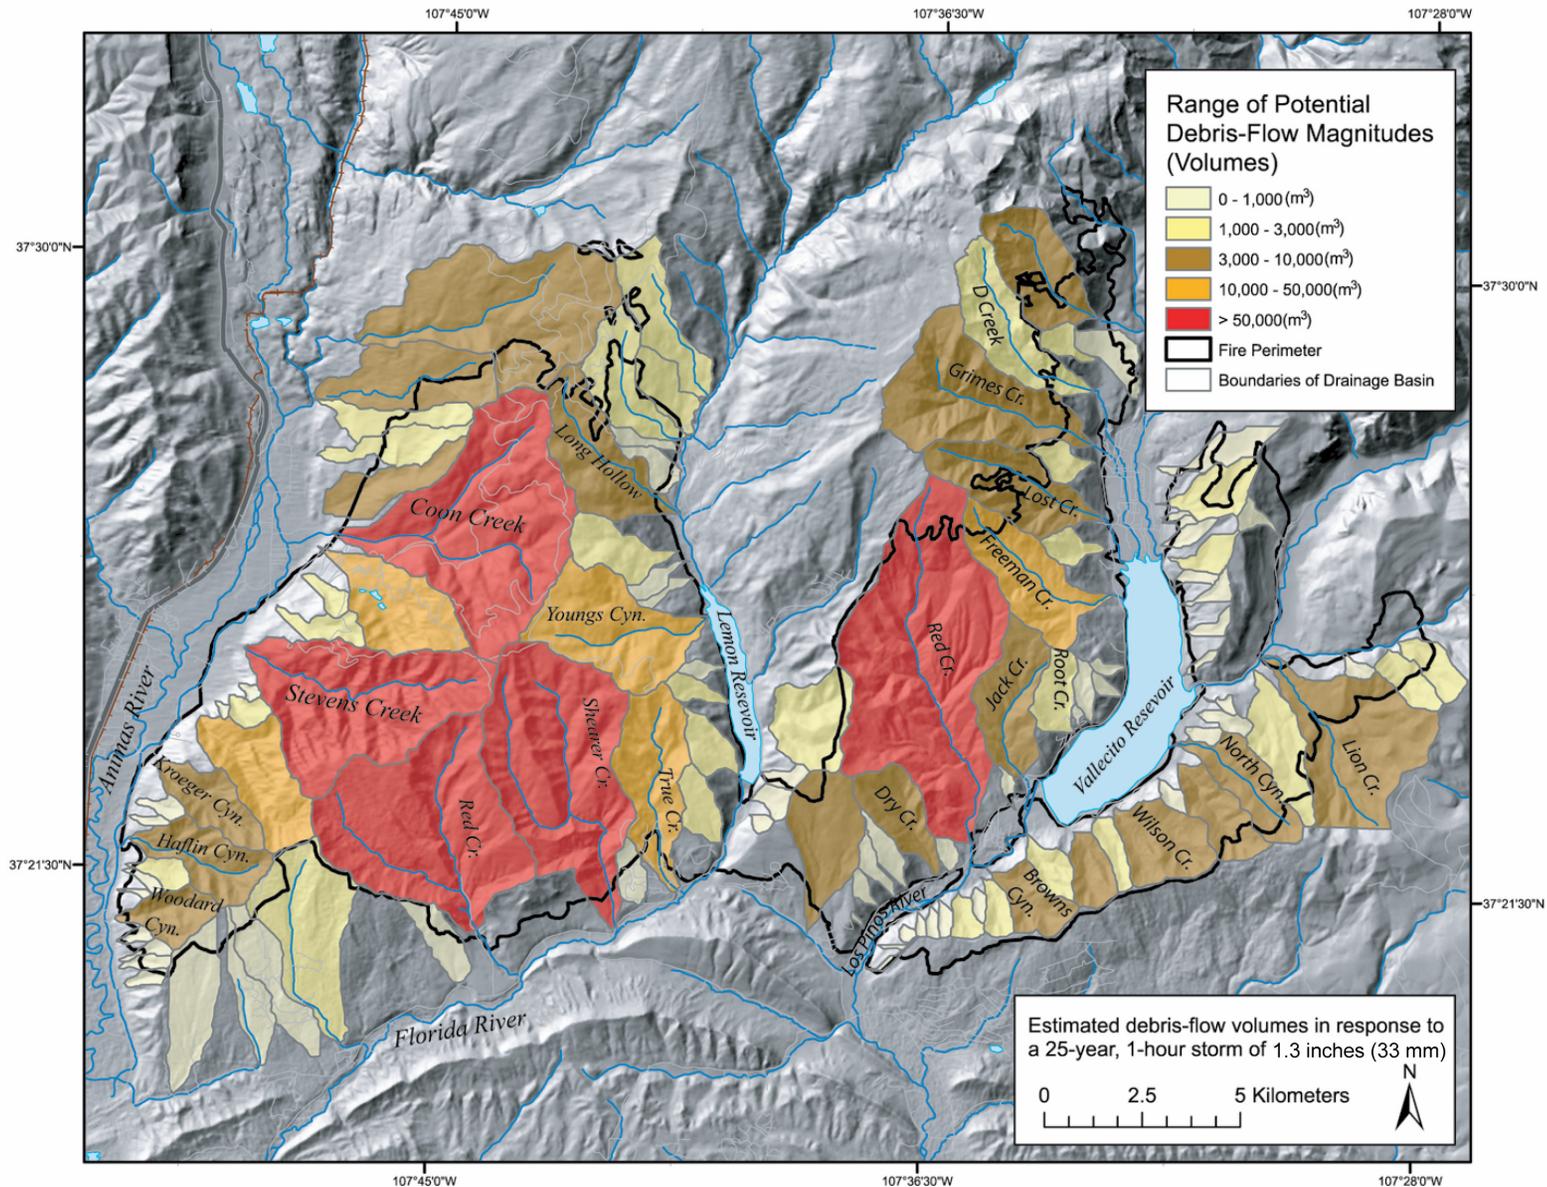
Figure 9. Map showing potential volumes of debris flows from basins in the Missionary Ridge fire burn area for a 1-hr duration, 25 yr recurrence storm of 1.3 in (33 mm). From J.E. Gartner, unpublished data (2006).

Results from the application of this model to basins in the Missionary Ridge burn area using a 1-hr duration, 25-yr recurrence storm of 1.3 in (33 mm) are given in figure 9.

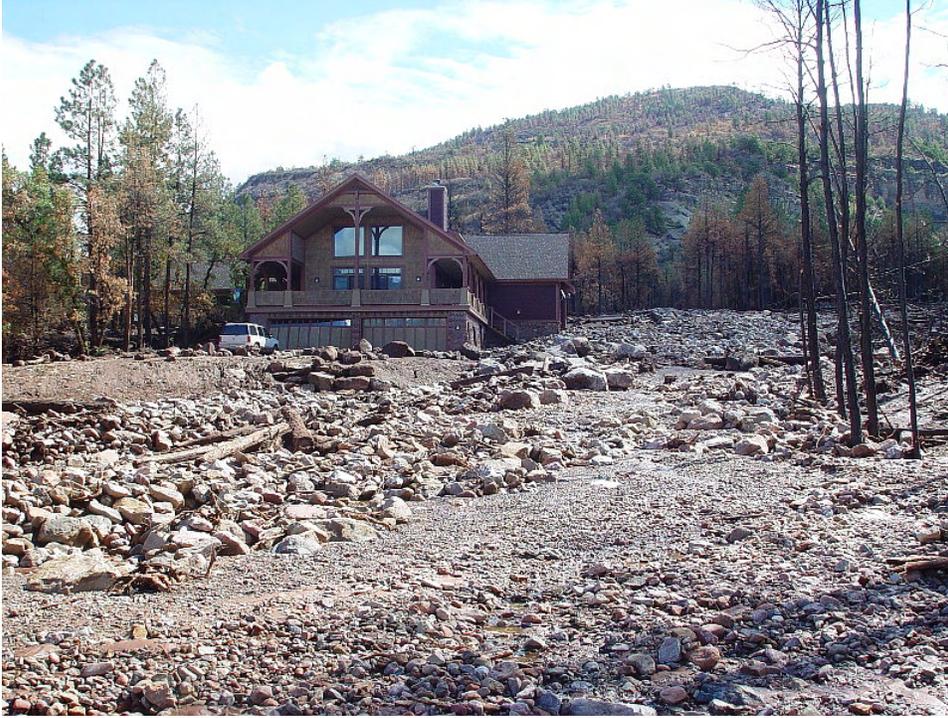
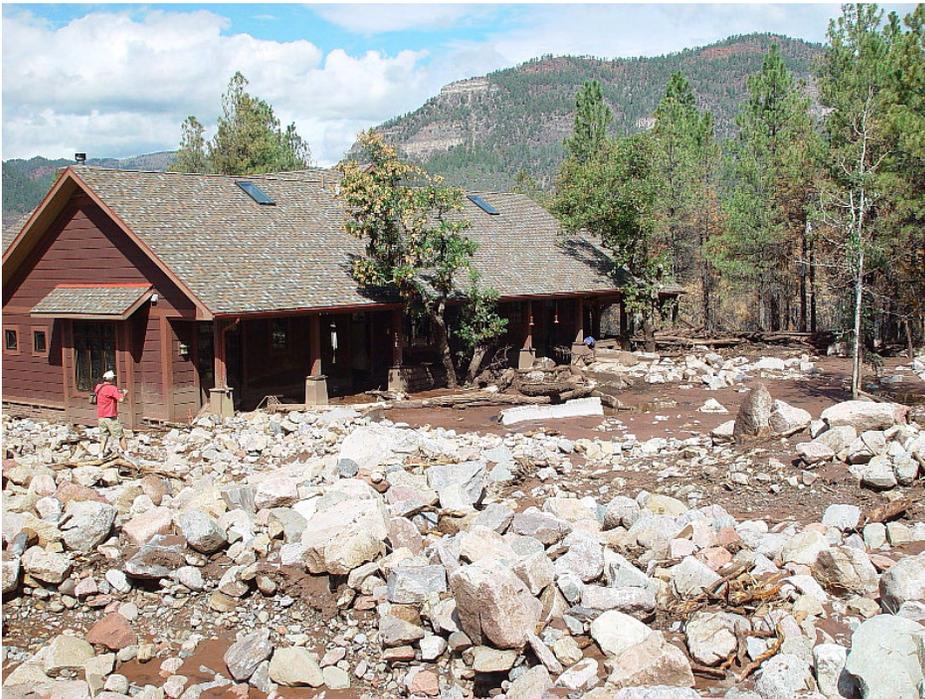
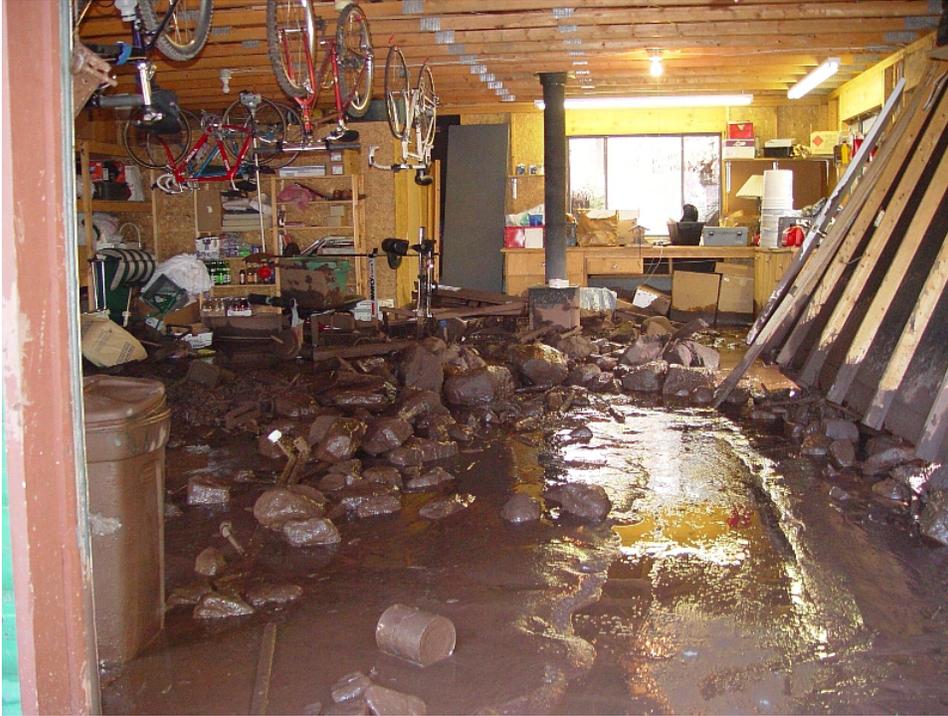
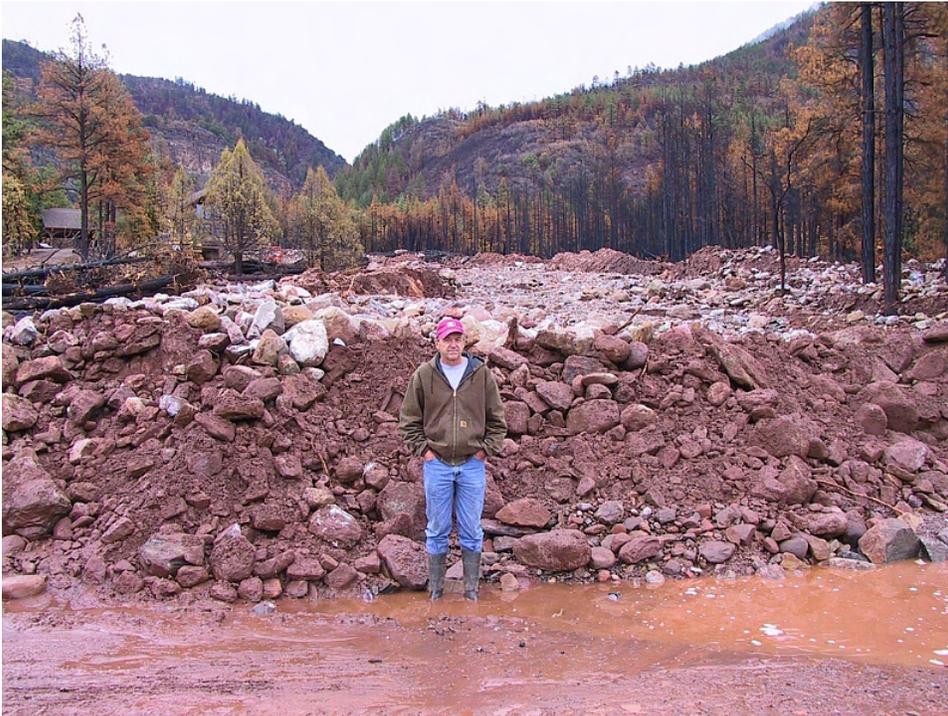
Figure 10. Debris-flow deposits on the Stevens Creek fan caused by the September 7, 2002, rainstorm. *A-C*, Deposits in and near residence on central part of fan; *D*, Deposits in channel near County Road 250. Photographs courtesy of La Plata County.

The Stevens Creek fan was burned by the wildfire and then impacted by debris flows several months later. Debris flowed onto the fan on September 7, September 10–12, and September 20, 2002. The September 7 debris flow covered approximately one-quarter of the fan area with deposits as deep as 5 ft (1.5 m) and filled part of a house with tons of rock and mud (fig. 10). Prior to the debris flow, the house was at least 200 ft (61 m) from the active channel. During the event, the channel moved from a position on the north side of the house to a position on the south side of the house (fig. 11). The event moved material up to 8 ft (2.5 m) in diameter in a muddy matrix. Evidence on the fan surface suggested that channels were blocked by large boulders and diverted many times during the event. The current Stevens Creek channel on the fan has been excavated (by excavating equipment) and made deeper and straighter than the natural channel. This excavation provides an excellent longitudinal exposure of Holocene fan deposits (fig. 12). Upstream from the fan, the channels showed up to 8 ft (2.5 m) of incision into extensive valley-fill deposits.

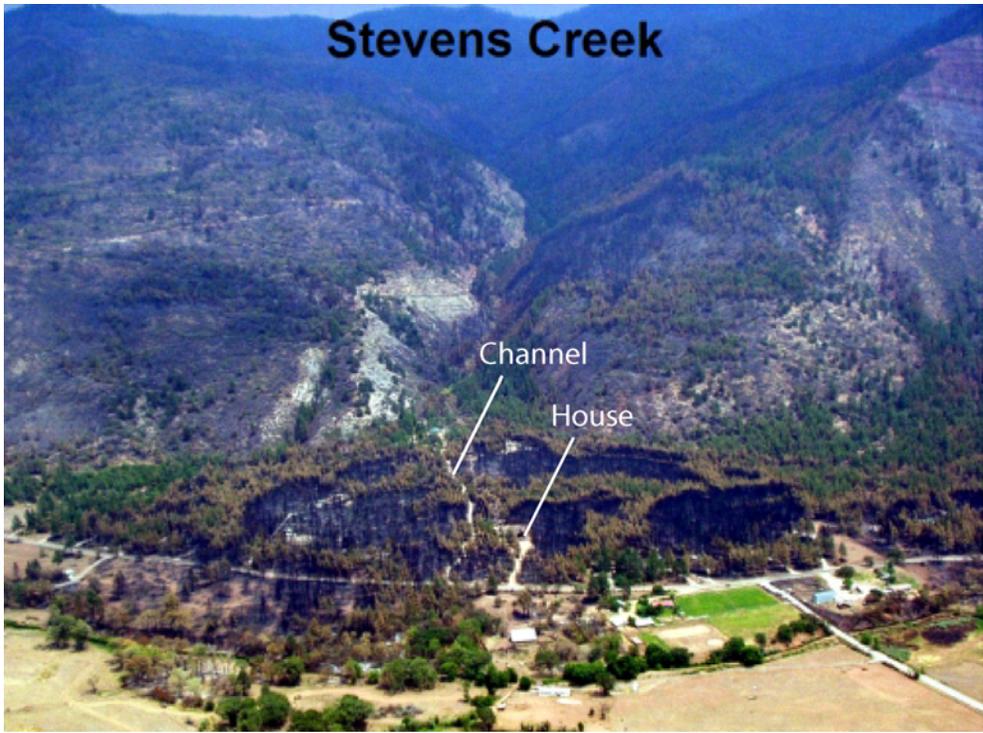
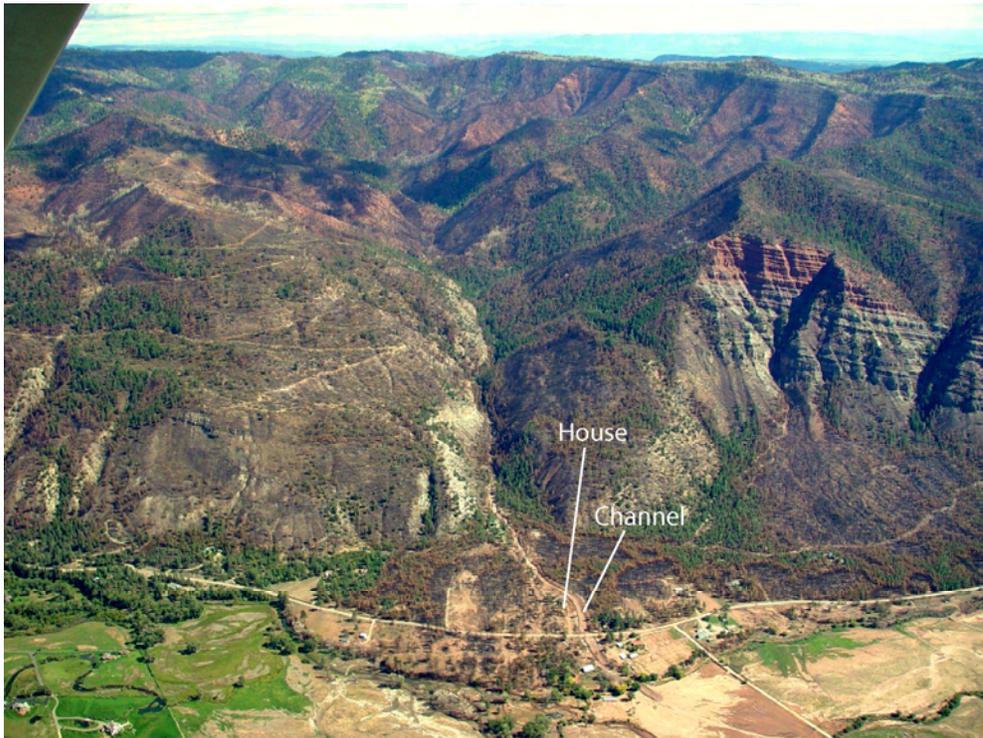
Figure 11. Photographs showing channel migration on the Stevens Creek fan. *A*, Pre-debris flow channel location; *B*, Post-debris flow channel location. Photographs courtesy of La Plata County.

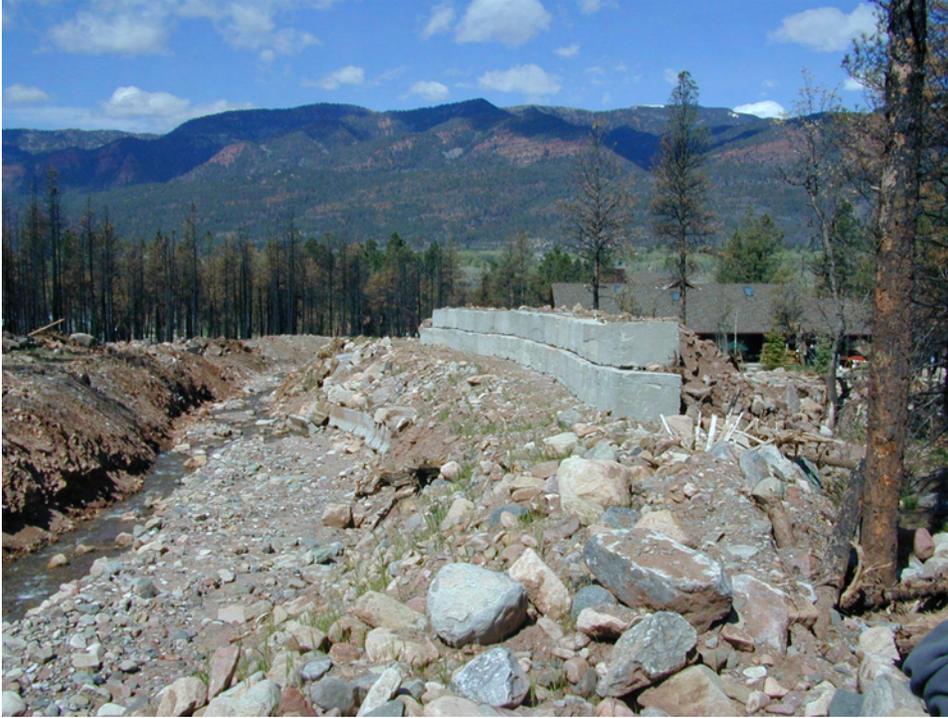
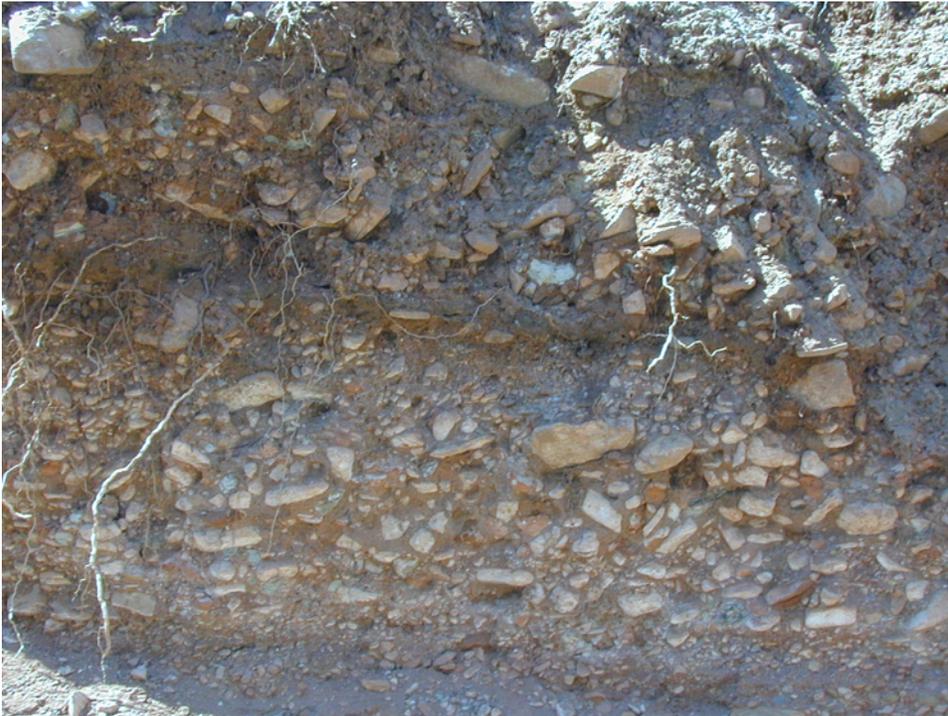
Figure 12. Debris-flow channel on the Stevens Creek fan. *A*, Excavated channel and barrier; *B*, Holocene debris-flow deposits exposed on the south side of the channel.

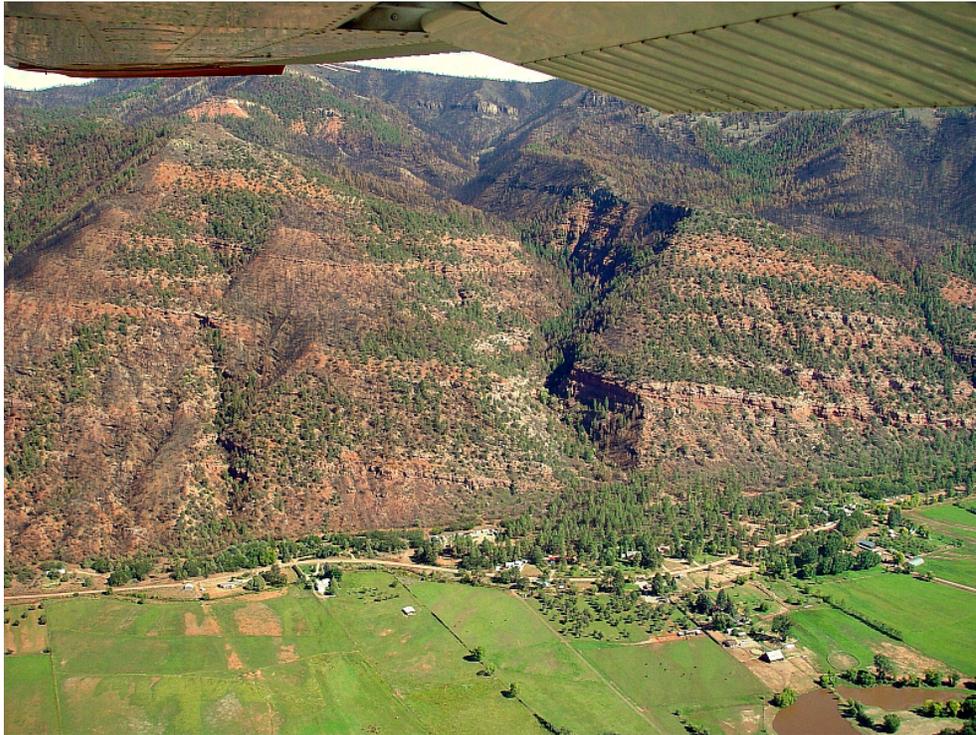
Figure 13. Haflin Creek drainage basin and fan. Photograph courtesy of La Plata County.

The entire Haflin Creek drainage basin was burned by the fire (figs. 13 and 14) and then impacted by debris flows several months later. As described at the last stop, debris flows were generated by rilling and erosion of channel materials (figs. 15–18) and impacted structures and CR 250 on the fan at the mouth of the drainage (fig. 19). Two storms generated the debris flows, one on August 29 and the other on September 20, 2002. The August 29 debris flows carried material no greater than 3 ft (1 m) in diameter in a muddy matrix. The September 20 debris flows carried materials only up to about 1.5 ft (0.5 m) in diameter, a significant decrease in size from the August event.

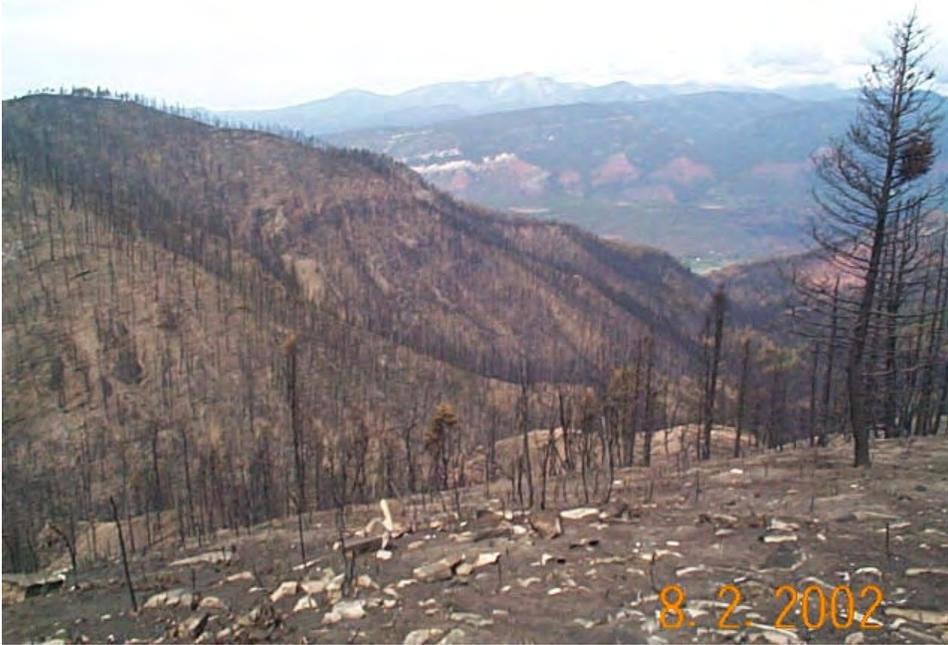
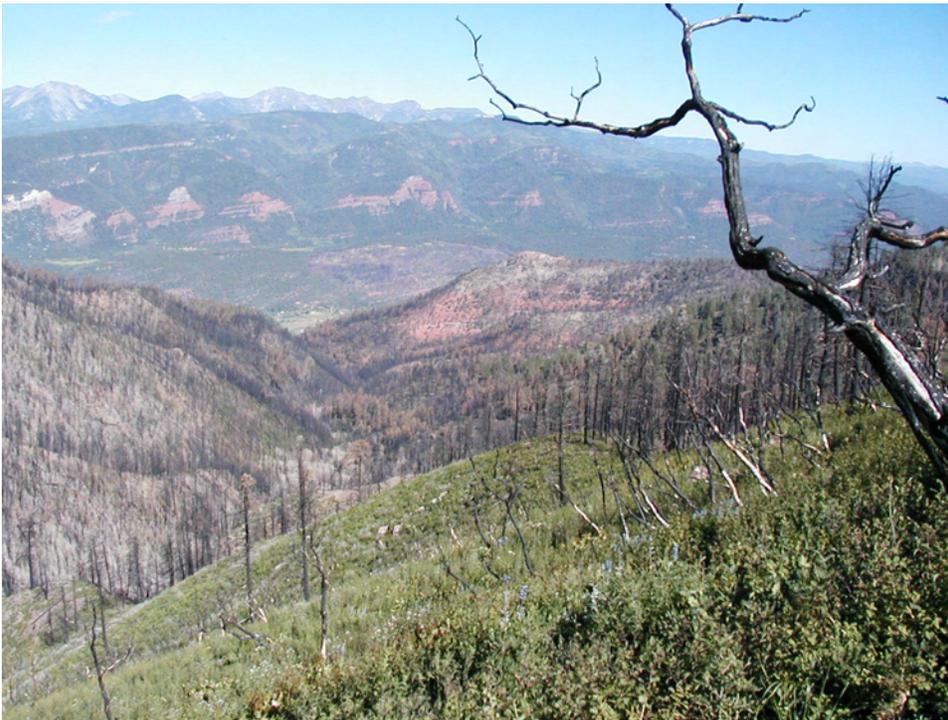
Figure 14. Mountainside near the head of the Haflin Creek drainage basin. *A*, About 1 month after the fire was extinguished; *B*, About 1 yr after the fire. Photographs courtesy of La Plata County.

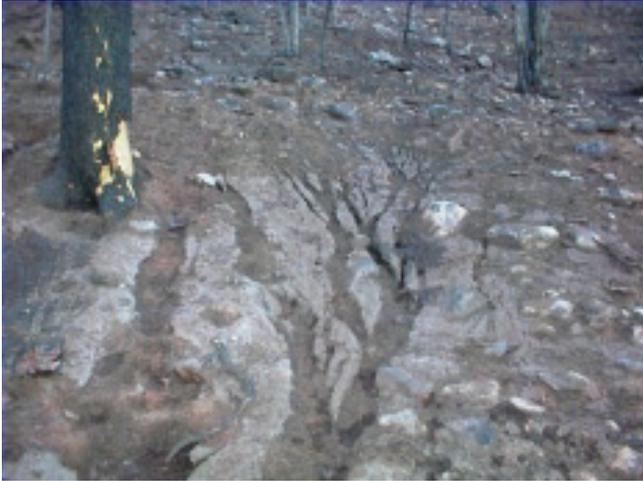
Figure 15. Rills in the Haflin Creek drainage basin. Photograph courtesy of La Plata County.
