Mass Wasting Following the 2002 Missionary Ridge Fire near Durango, Colorado, a Field Trip Guidebook

Open File Report 2007-1289

Association of Environmental & Engineering Geologists
Special Publication No. 20

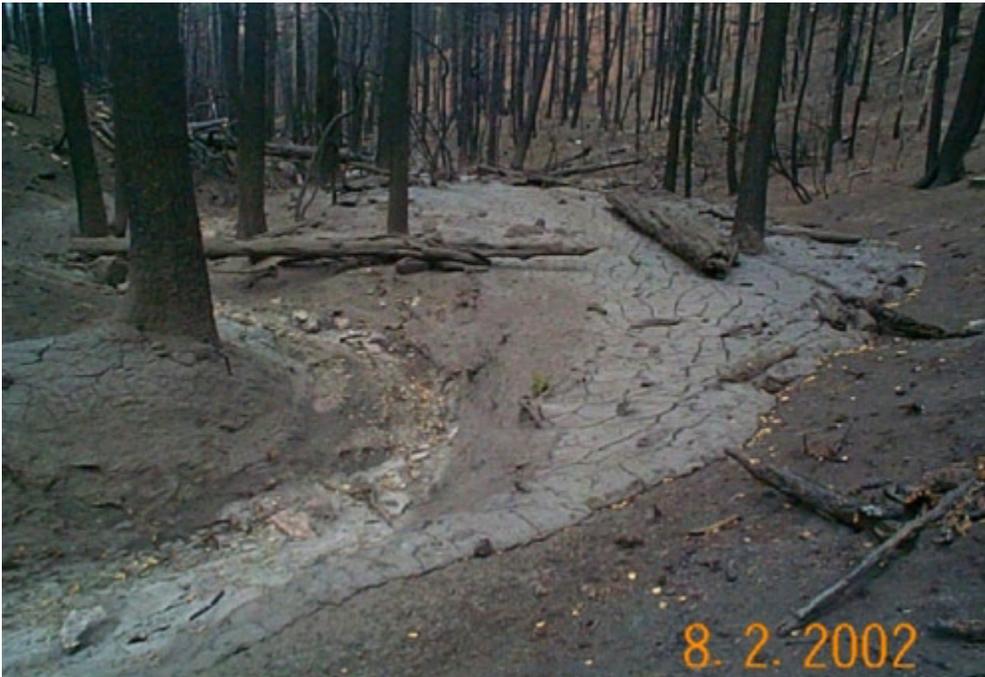
Figure 16. Ash/mud flow deposit in the Haflin Creek drainage basin. Photograph courtesy of La Plata County.

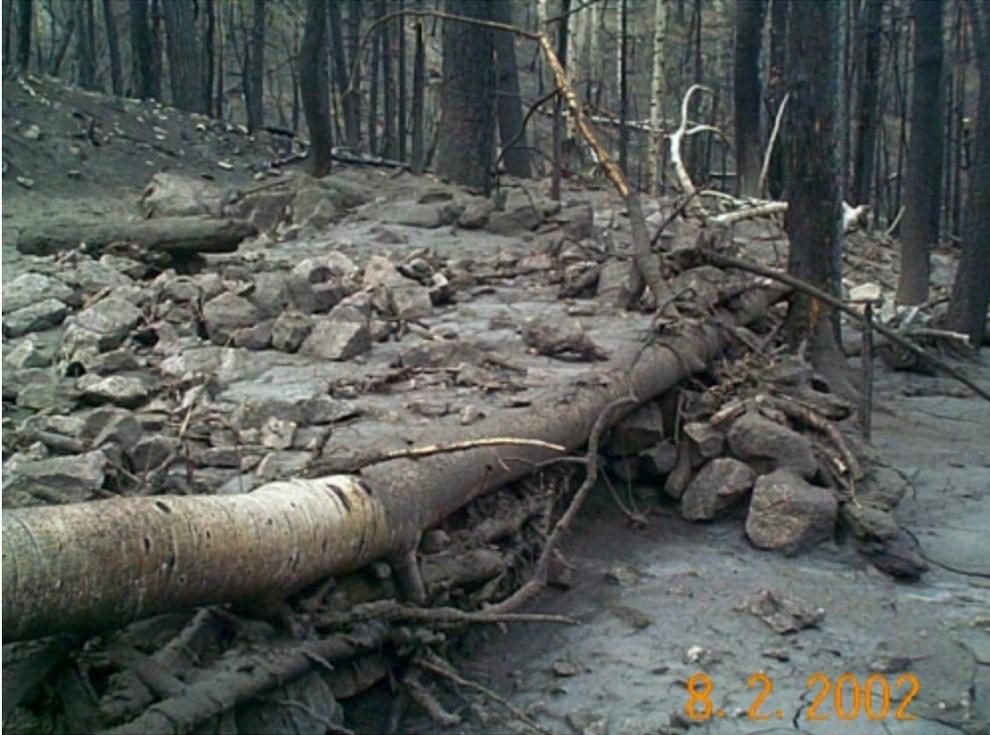
Figure 17. Debris-flow deposits in the Haflin Creek drainage basin. Photograph courtesy of La Plata County.

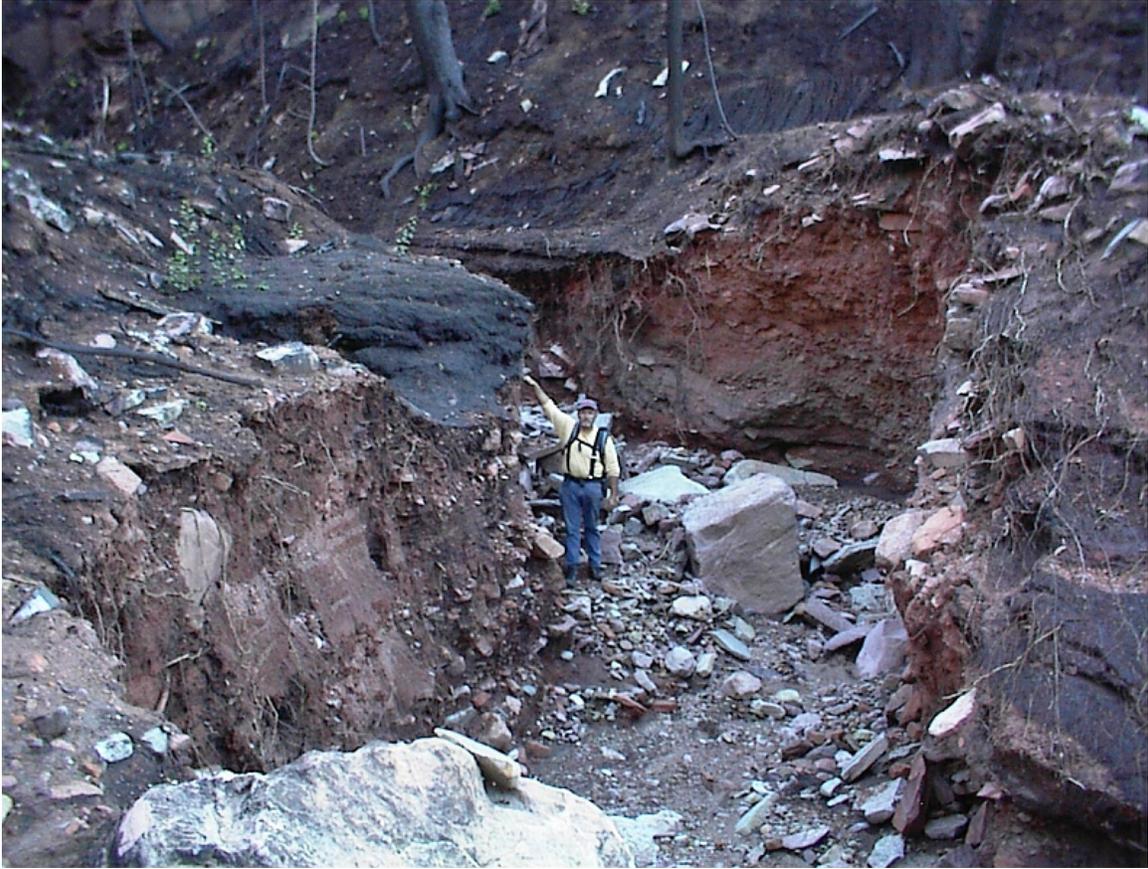
Figure 18. Channel incision in the Haflin Creek drainage basin. Photograph courtesy of La Plata County.

The Haflin Creek channel is also an excellent location to demonstrate the method used by Gartner (2005) to estimate the material eroded from channels by debris flows. Recall that to generate the statistical model used to predict potential debris-flow volumes generated from burned basins, debris-flow volumes from 56 events were estimated by quantifying the amount of material eroded from the main channels of a basin by the passage of a debris flow. Channel cross sections were measured at 50- to 300-ft (15- to 91-m) intervals along the length of the scoured channel using a 1-yd (1-m) length of lumber with legs and an inclinometer attached to measure the slope of the ground surface. The device was used to record angles across the surface of a channel to quickly measure a channel cross section. For each cross section, notes were taken to identify which measurements correspond to incised channel, bedrock, and(or) levees. These notes helped to interpolate the original channel surface and determine the amount of material removed from each cross section. Scoured areas of adjacent cross sections were averaged and multiplied by the distance between them to define a volume of material scoured by the debris flow. The sum of all segments of scoured channel represents the total estimated volume of material eroded from the channel and corresponds to the amount of material deposited at the mouth of the basin.

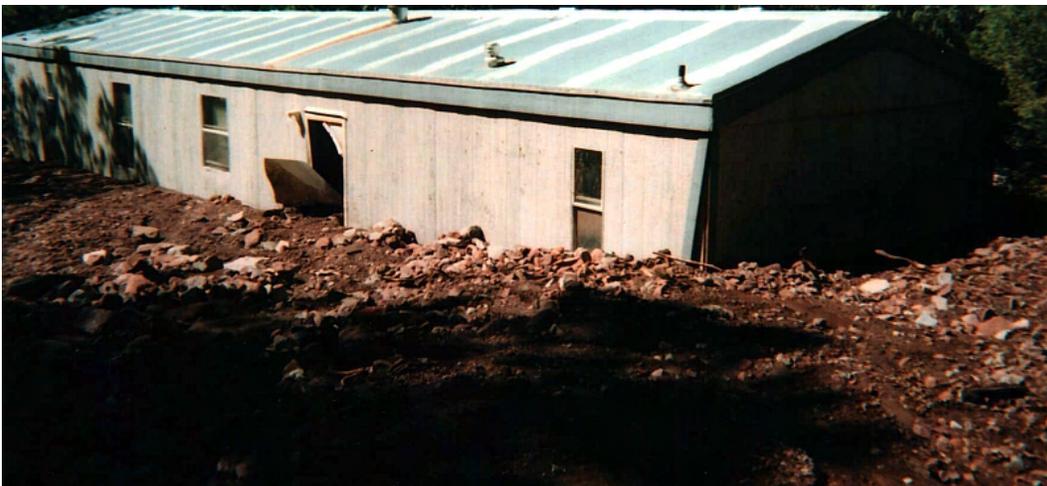
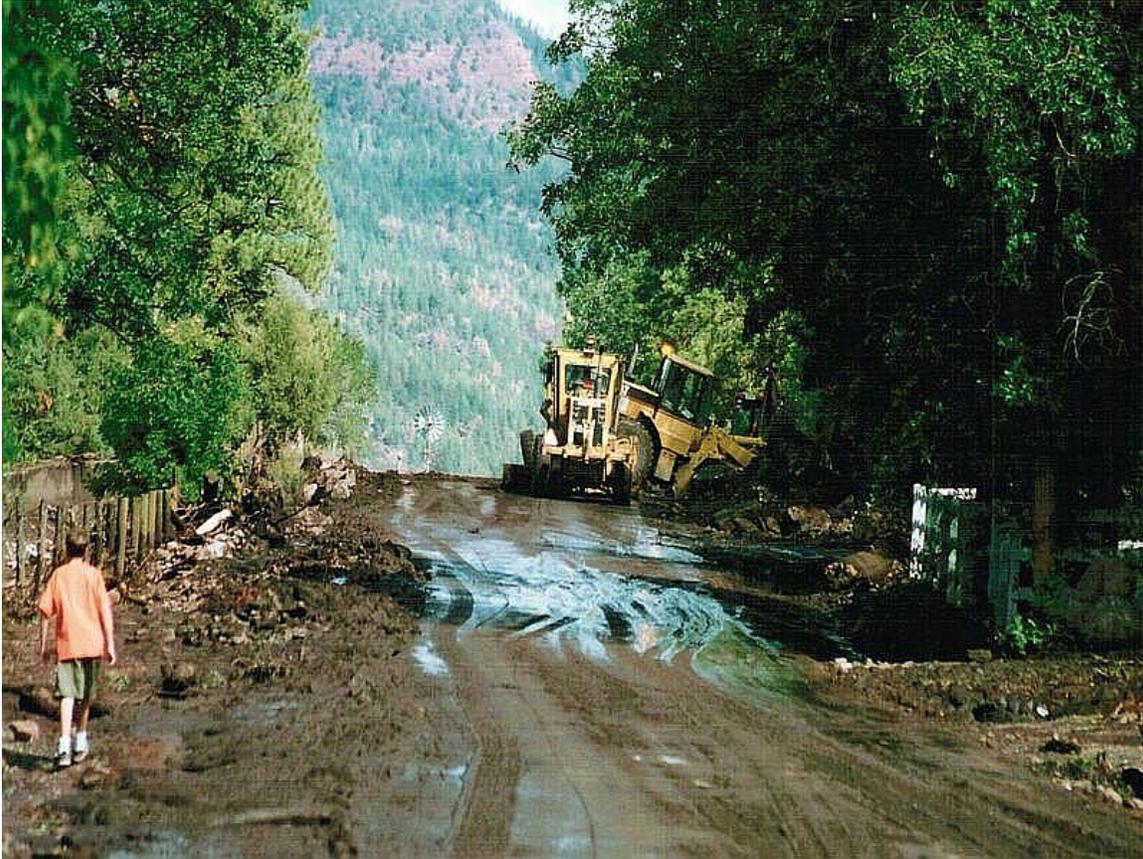
Figure 19. Damage from debris flows on the Haflin Creek fan. A, Structure impacted by debris flow; B, Debris-flow deposits on County Road 250. Photographs courtesy of La Plata County.

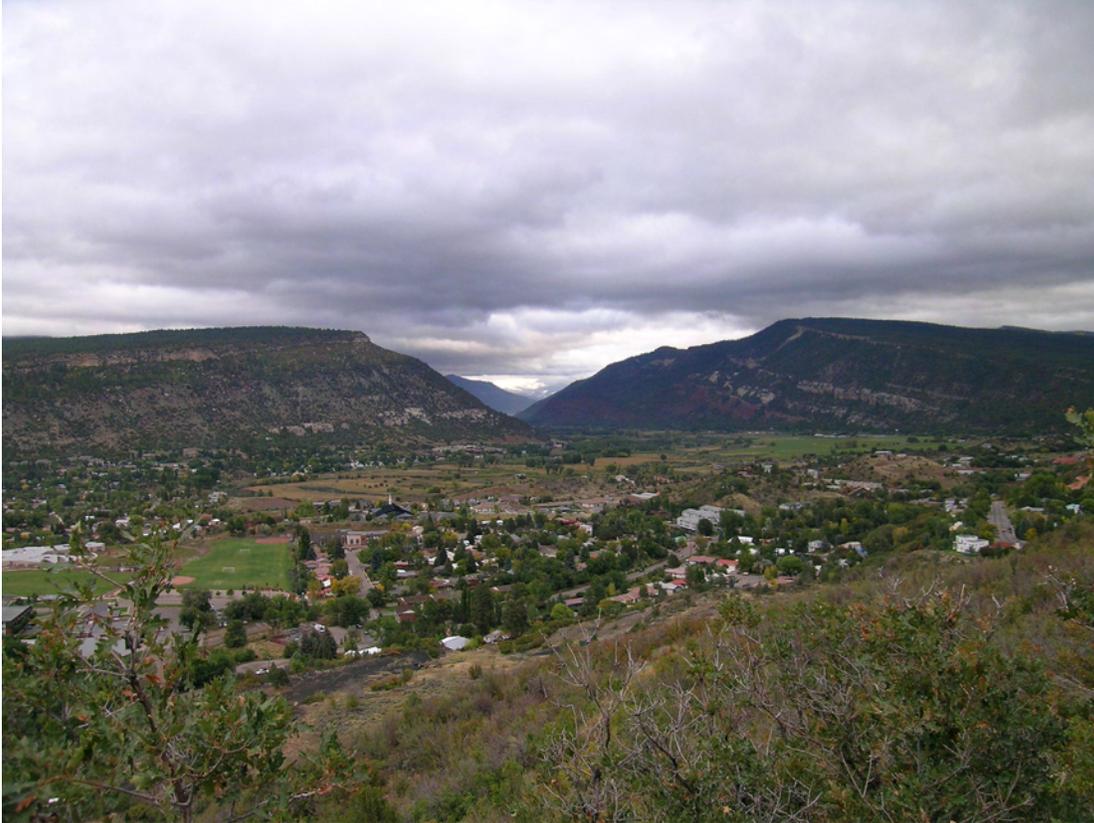
Figure 20. View of the lower Animas Valley to the north, from the Lions Den Picnic Shelter in Durango.

The lower Animas Valley is a glacial valley made flat by stream and lake sediment. The gravel hill upon which the Lyons Shelter is built and the ridges seen between the shelter and the flat floor of the valley are glacial end moraines. At the time of the melting and retreat of Pleistocene glaciers, “Lake Durango” formed. It was, however, quickly filled to capacity with fine sediment and gravel, the height of which was controlled in part by the height of moraines and the base of the Dakota Sandstone. Current age estimates for the moraines are shown in table 1. The outwash terrace (approx. 250 ka) seen to the south of the Lions Den Shelter is now the site of a golf course.

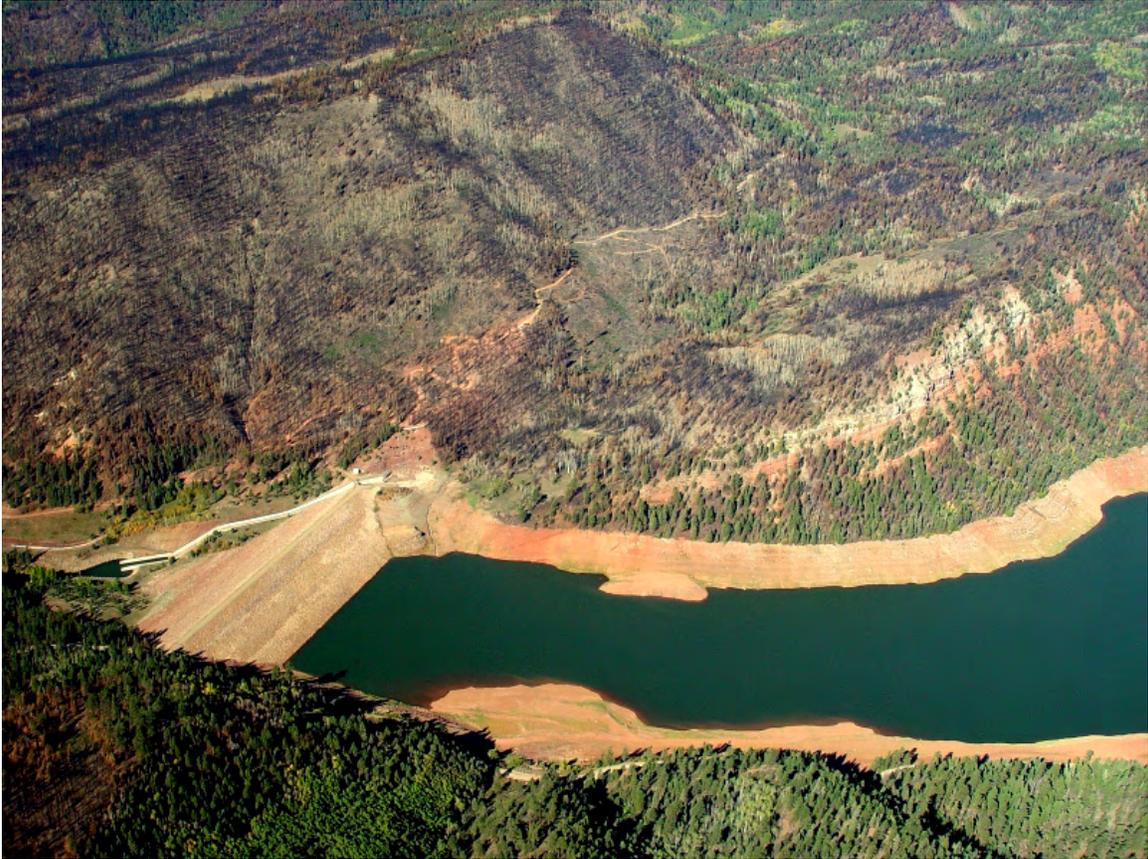
Figure 21. Knight Canyon (upper center/right side of photograph) above the spillway intake at Lemon Dam. Photograph courtesy of La Plata County.

Lemon Dam is a critical part of the water supply system for the City of Durango. Therefore, erosion of sediment and(or) debris flows into the reservoir following the 2002 Missionary Ridge fire could have had severe consequences. The Florida Water Conservancy District (FWCD) was given the resources and the mission to prevent significant sediment movement into critical portions of the reservoir. They concentrated their efforts on the drainage basin known as Knight Canyon, which empties near the intake structure for the water supply system (fig. 21). The mitigation efforts carried out by the FWCD consisted of construction of Log Erosion Barriers (LEBs), mulching, seeding, and construction of check dams and debris racks (deWolfe and others, 2005), as summarized in tables 2 and 3. These methods were effective in virtually eliminating sedimentation into the reservoir. This success can be attributed to a number of factors: the density of application of each mitigation method, the enhancement of methods working in concert, the quality of installation, and the rehabilitation of mitigation features to extend their useful life. The application of each method is summarized below.

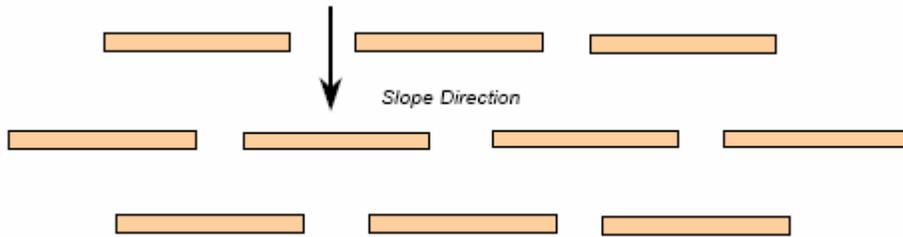
Figure 22. Staggered pattern in which log erosion barriers should be placed on a slope.

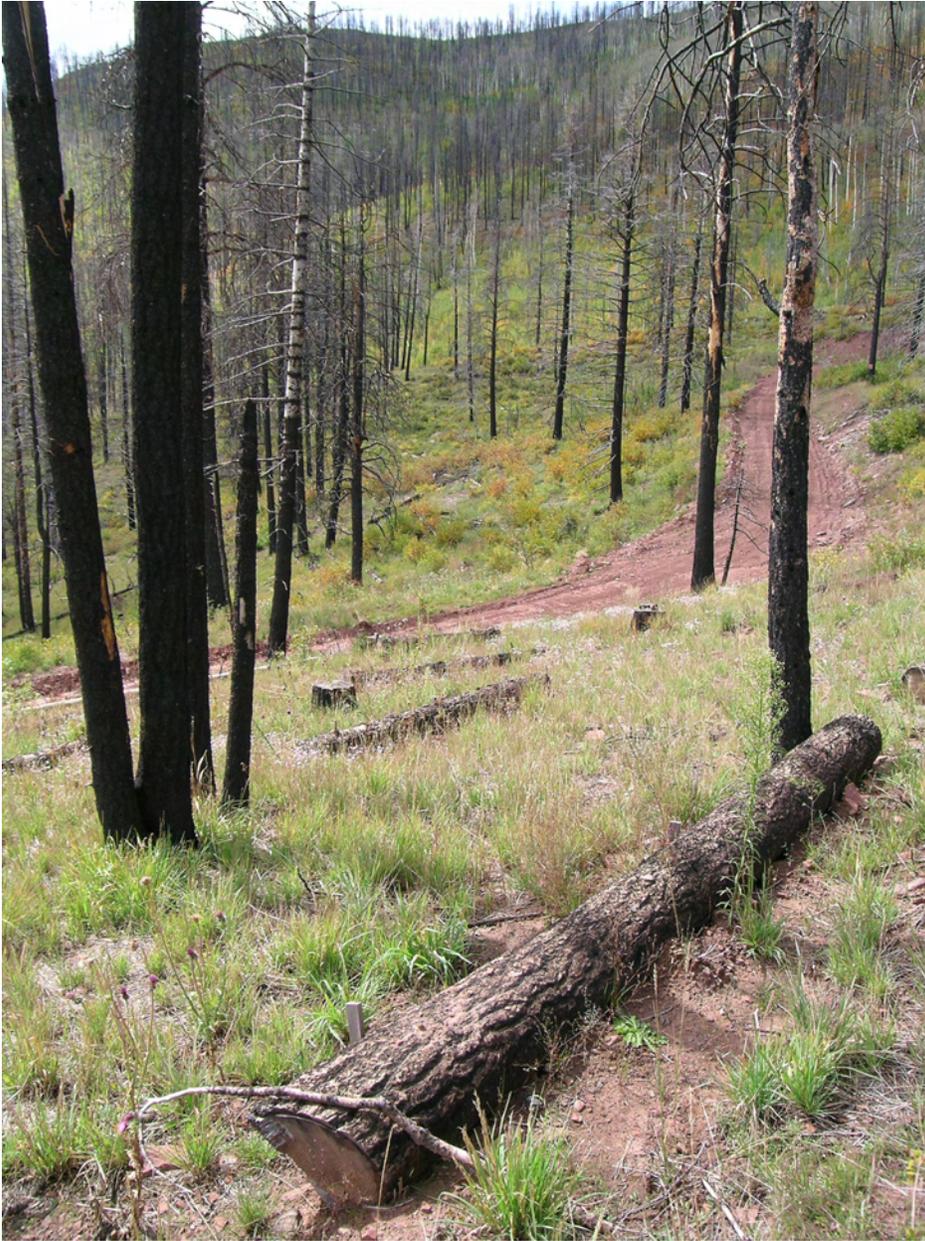
Figure 23. Log erosion barriers near Lemon Dam following the Missionary Ridge fire.

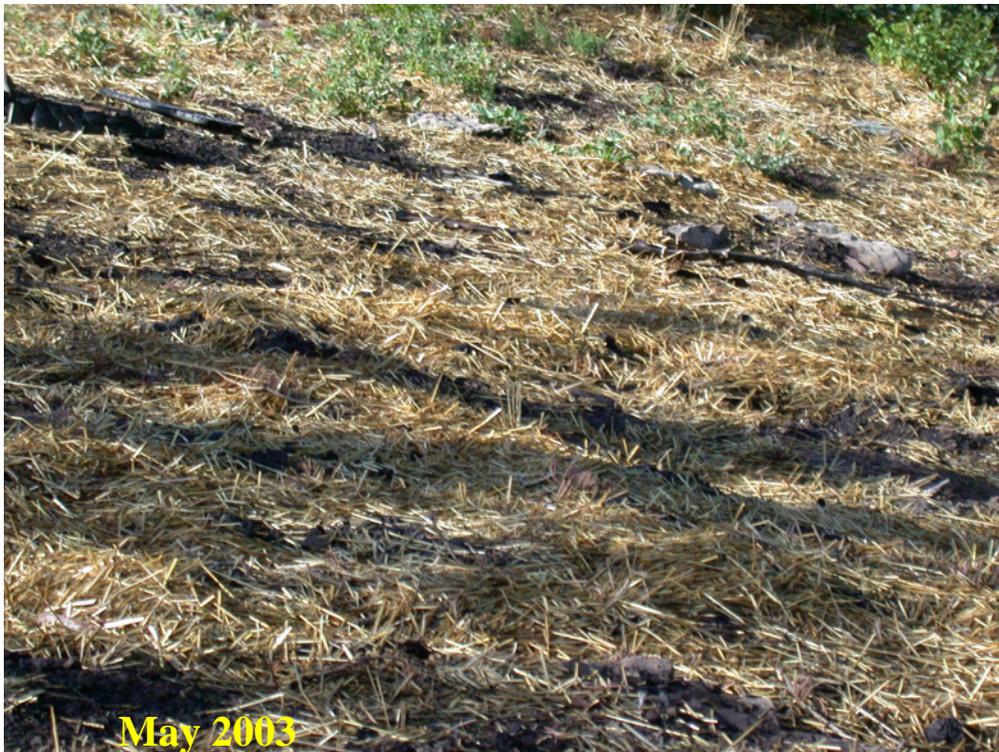
Figure 24. Condition of hand-spread and crimped mulch near Lemon Dam. Notice the vertical straws, products of crimping (photograph from Florida Water Conservancy District, unpub. data, 2003).

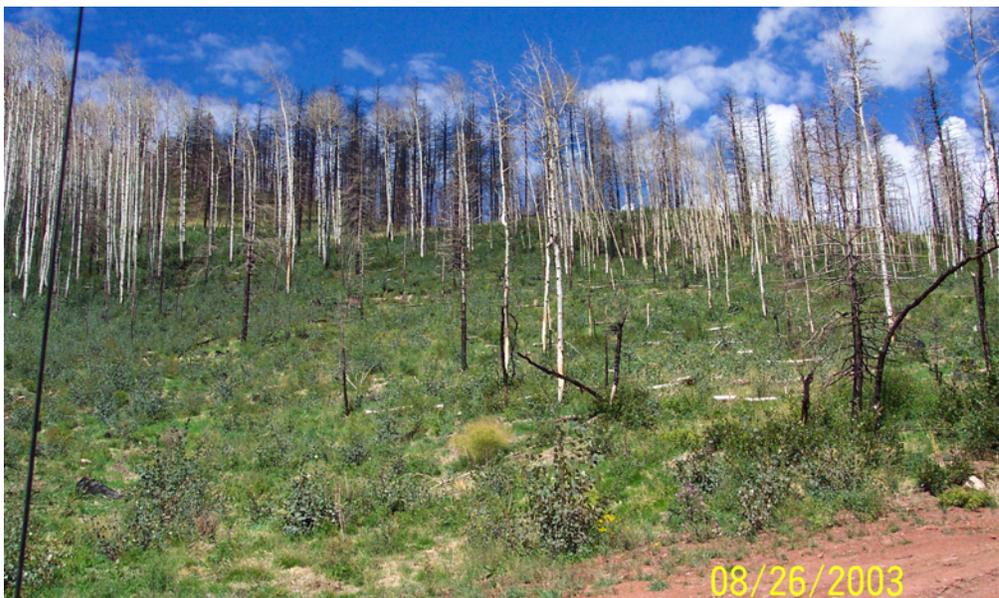
Figure 25. Photograph showing the amount of vegetative cover resulting from hand spread seeding near Lemon Dam in August 2003, approximately 13 mo after the fire. Some of the vegetation is natural growth (photograph from Florida Water Conservancy District, unpub. data, 2003).

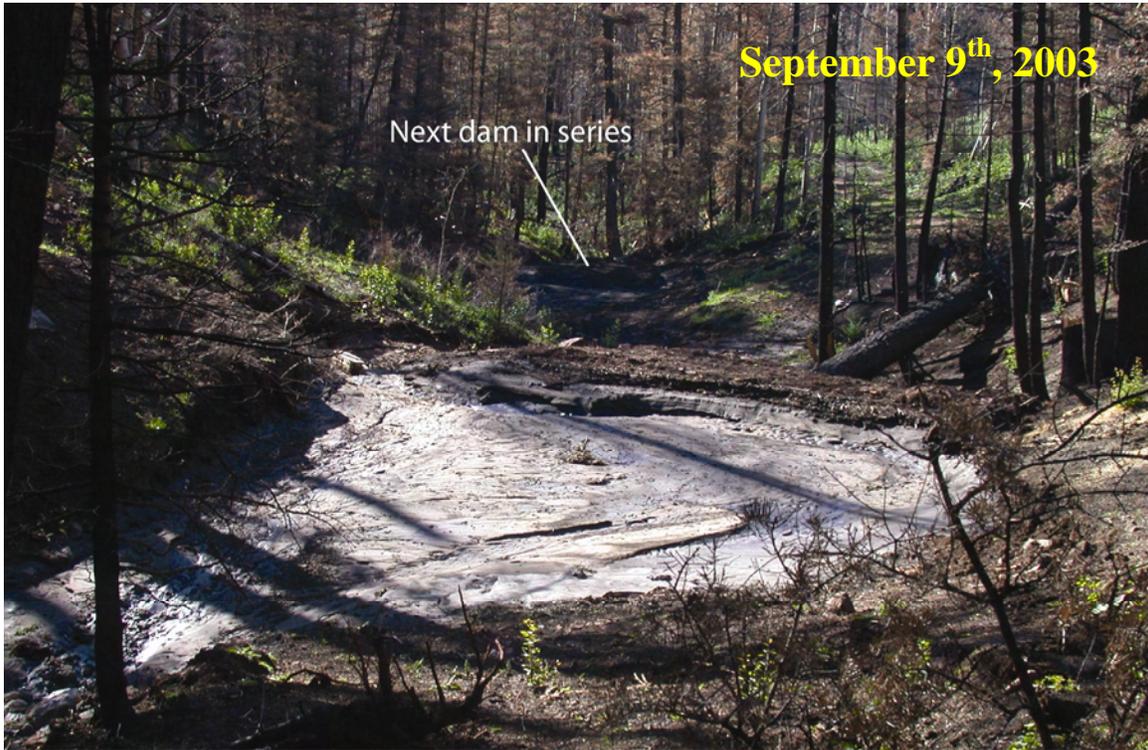
Figure 26. A check dam full of mud and debris in the upper reaches of Knight Canyon above Lemon Dam (photo from Florida Water Conservancy District, unpub. data, 2003).

Thirteen earthen check dams were constructed in the main channel of Knight Canyon above Lemon Dam. Figure 26, a photograph taken on September 9, 2003 (14 mo after the fire), shows a check dam filled with an ash/mud deposit during a heavy rain in the basin. In the background, another check dam can be seen in the series. The dams were monitored by the FWCD and cleaned out after such erosional events. Construction of check dams is expensive, difficult, and labor intensive, especially in steep upper reaches of a channel where access is limited. If debris-flow volume is too large for a check dam, or if the dams are improperly constructed, failure can occur and the debris-flow will incorporate the check-dam materials into the flow, increasing both its volume and erosive potential. This occurred in a basin burned by the Piru fire in southern California (Sue Cannon, oral commun., 2005).

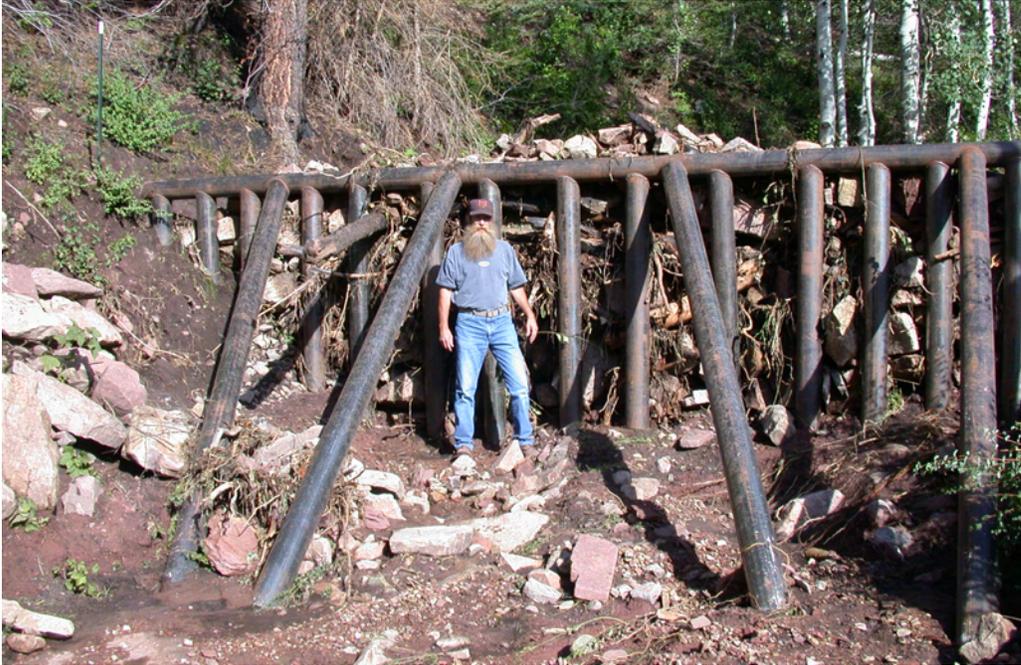
Figure 27. Debris rack holding back a slug of coarse debris and wood above a road and the spillway of Lemon Dam (photo from Florida Water Conservancy District, unpub. data, 2003).

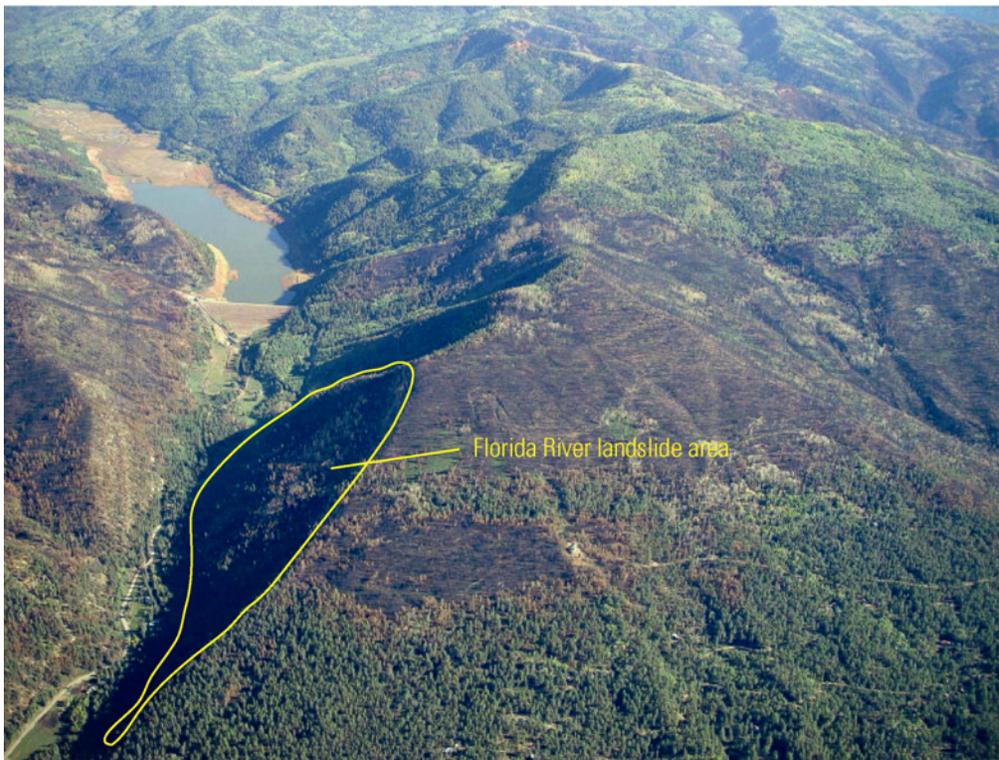
Figure 28. Aerial view of the Florida River landslide area within the Missionary Ridge burn area near Lemon Reservoir. Photograph courtesy of La Plata County.

Landslide activity was observed by residents of the Florida River area during April and May 2005 on a hillslope burned by the 2002 Missionary Ridge fire. This hillslope is located above the Florida River and CR 243 about 1 km downstream from Lemon Dam (fig. 28). Landslide activity on the hillslope poses hazards to area residents and Lemon Dam, should activity be great enough to cause damming of the river. Members of the U.S. Geological Survey Landslide Hazards Project investigated the potential for additional landslide activity on the hillslope and associated hazards (Schulz and others, 2006). The investigation included engineering geologic mapping, subsurface exploration, and monitoring of surface displacement and shallow groundwater conditions.

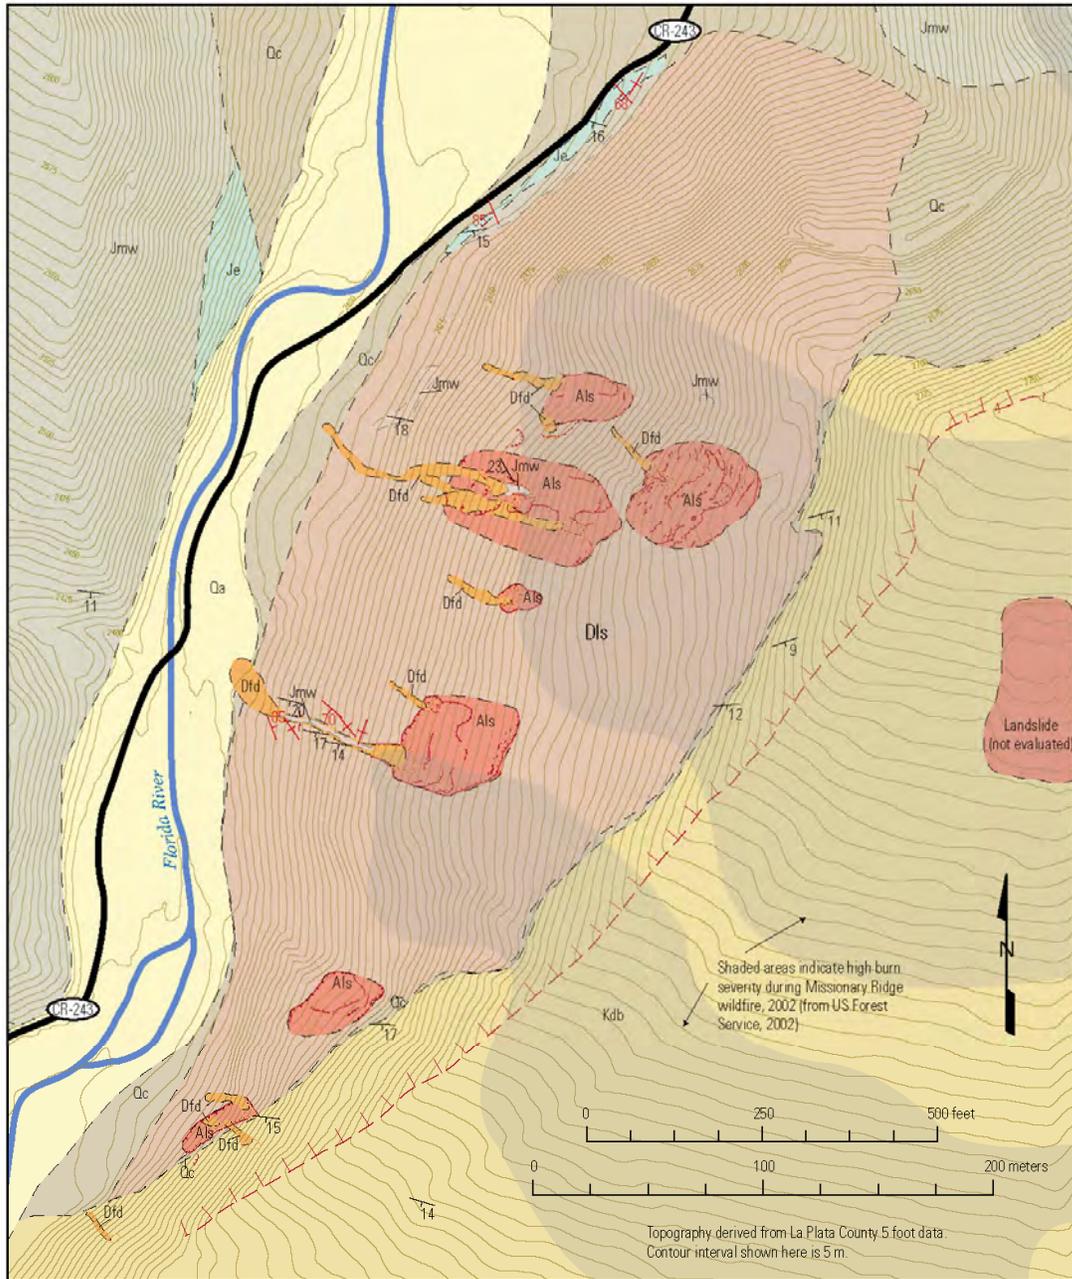
GEOLOGIC UNITS	EXPLANATION	GEOLOGIC AND TOPOGRAPHIC FEATURES		
QUATERNARY	Holocene	Dfd	Debris-flow deposit	— — — — —	Geologic contact (approximate)
	Als	Active landslide	[Red shaded area]	□	Debris-flow source area
	Dls	Dormant landslide (color is semi-transparent)	[Semi-transparent red shaded area]	— — — — —	Fracture
	Qc	Colluvium ^a	[Light brown shaded area]	— — — — —	Headscarp of dormant landslide
	Qa	Alluvium ^a	[Yellow shaded area]	— — — — —	Normal fault, teeth in dip direction
CRETACEOUS	Kdb	Dakota Sandstone and Burro Canyon Formation ^a	— — — — —	Thrust fault, barbs on overriding block	
JURASSIC	Jmw	Morrison Formation, Junction Ck. Sandstone, and Wanakah Formation ^a	— — — — —	Strike and dip of bedding (dip in degrees)	
	Je	Entrada Sandstone ^a	— — — — —	Strike and dip of fracture (dip in degrees)	
				— — — — —	Strike of vertical fracture
				— 250 —	Topographic contour line and elevation (m)

Figure 29. Geologic map of the Florida River landslide area. From Schulz and others (2006).

Landslide activity during the spring of 2005 included the formation of at least nine individual landslides that produced more than a dozen debris flows (fig. 29). Landslide activity was concentrated upon a very large, apparently dormant landslide. Observed activity during 2005 was confined to a shallow (generally about 6 ft (2 m) thick) mantle of colluvium. Landslides within the colluvium were translational debris slides (Cruden and Varnes, 1996) with volumes between 2,600 and 46,000 yd³ (2,000 and 35,000 m³). Debris flows were generally mobilized from dilated, mostly saturated, toe regions of the slides and ranged in volume from 200 to 2,000 yd³ (150 to 1,500 m³) (fig. 30). Although generally quite small, debris flows traveled as far as about 980 ft (300 m) downslope onto the Florida River floodplain. The landslides appeared to have been triggered by rapid melting of deep snow with high water content. Area residents had not observed landsliding on the hillslope previously (during about the past 30 yrs), although similar snowmelt events have occurred historically. It thus appears that landslide initiation was assisted by incineration of vegetation, which resulted in loss of root strength and evapotranspiration.

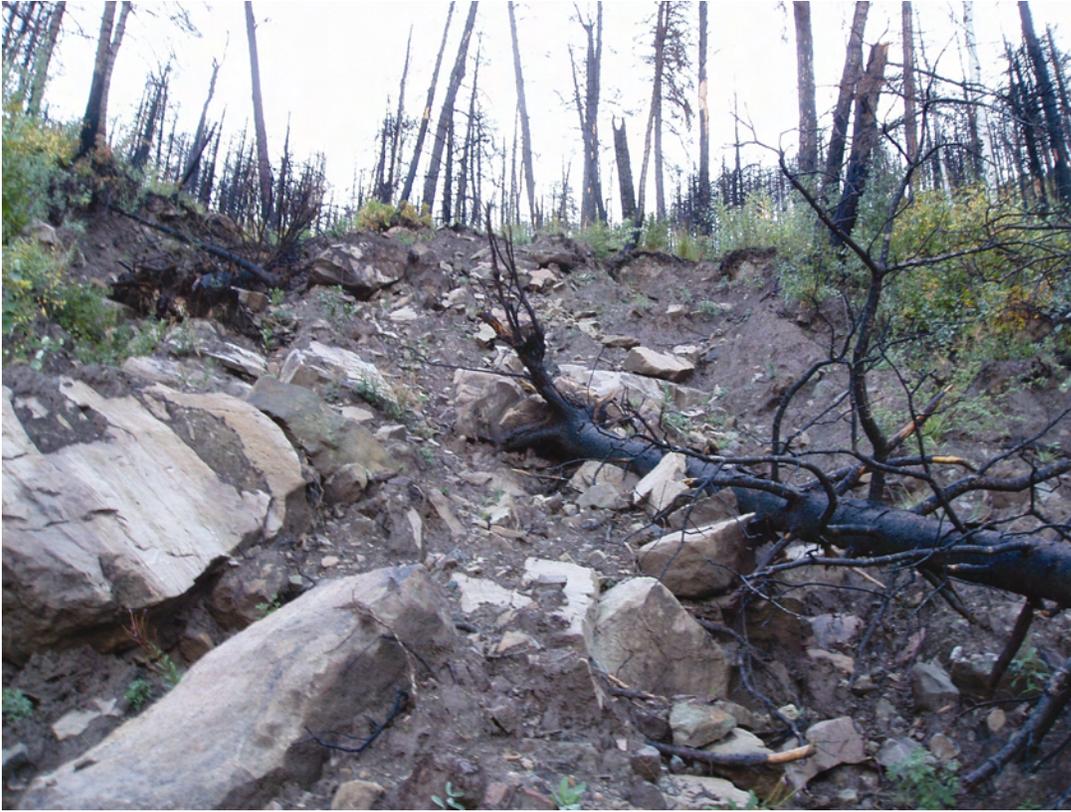
Figure 30. Debris flow source area formed in April 2005 in the Florida River landslide area.

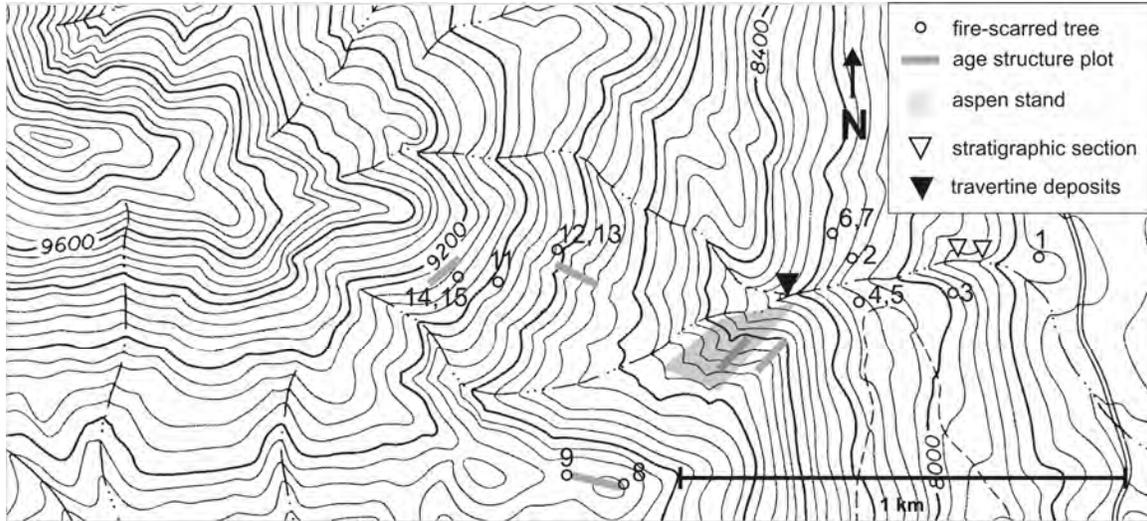
Figure 31. The Stop 6 study basin on the northwest side of Vallecito Reservoir. The basin was burned at approximately 80 percent moderate and high severity. Locations of tree-ring and alluvial sediment samples are noted. The fire-scar sample numbers correspond with the surface fire chronology in figure 34.

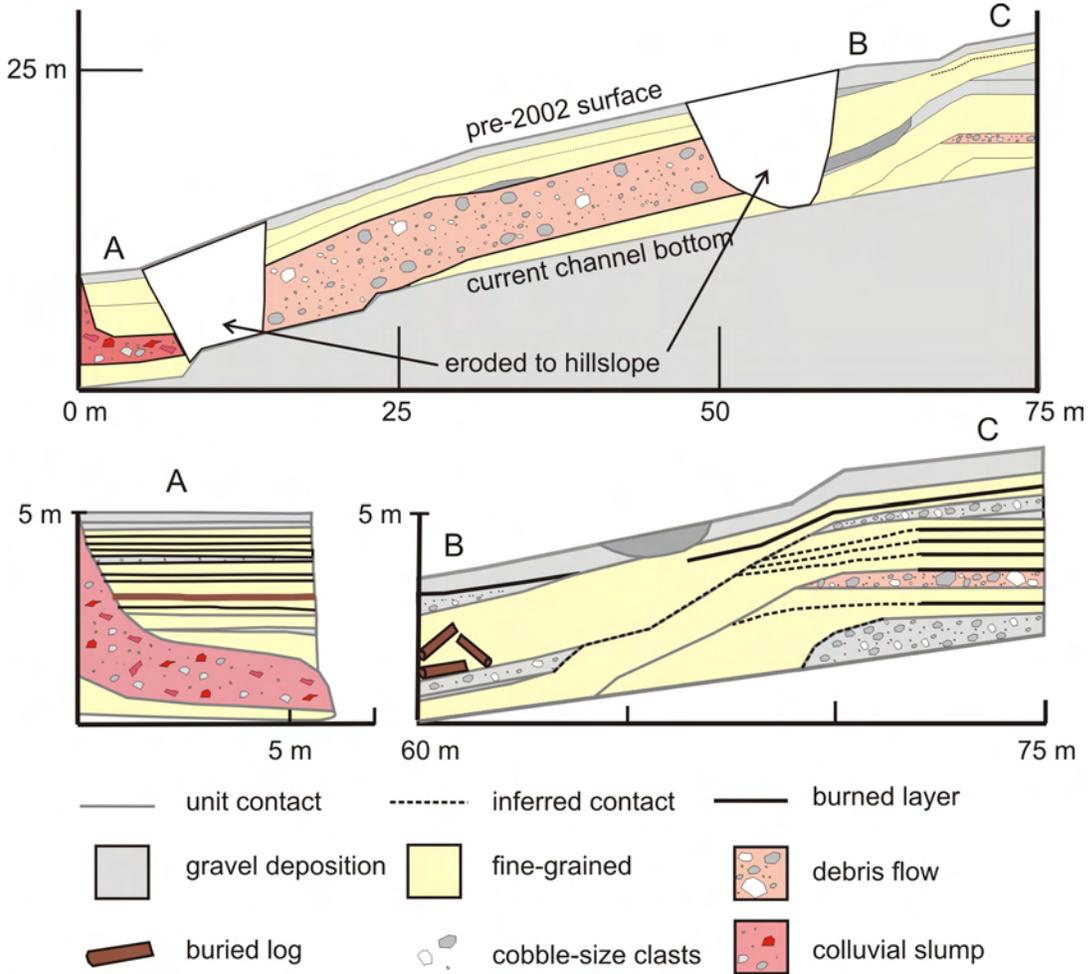
Figure 32. Exposed channel reach within the study basin northwest of Vallecito Reservoir, where three stratigraphic sections (A, B, C) were sampled. The deposit types included a fine-grained, gravel-rich debris flow and a colluvial slump. Several buried logs were exposed in stratigraphic section B.

The alluvial deposits were sampled within a 245-ft (75-m) reach of the exposed channel, feeding into the alluvial fan (fig. 32). Three stratigraphic sections were chosen for their height of natural exposure and the presence of charcoal concentrated in “burned” layers. The sediment characteristics of each stratigraphic unit were used to infer depositional processes, which were then used to infer the relative extent and severity of past fires. Debris-flow deposits with abundant angular charcoal indicate that a significant portion of the contributing basin burned at moderate and high severity (Meyer and others, 1995; Pierce and others, 2004). This inference comes from understanding the conditions that promote debris flow initiation in severely burned basins. For the Missionary Ridge fire, Cannon and others (2003a) found that all debris-flow-producing basins were burned with at least 50 percent moderate and high severities. Alternatively, fine-grained sheetflood and hyperconcentrated-flow deposits may represent a subset of low- and moderate-severity fires in the contributing basin (Pierce, 2004). The timing of past fire events was achieved by radiocarbon dating of charcoal pieces within each stratigraphic unit.

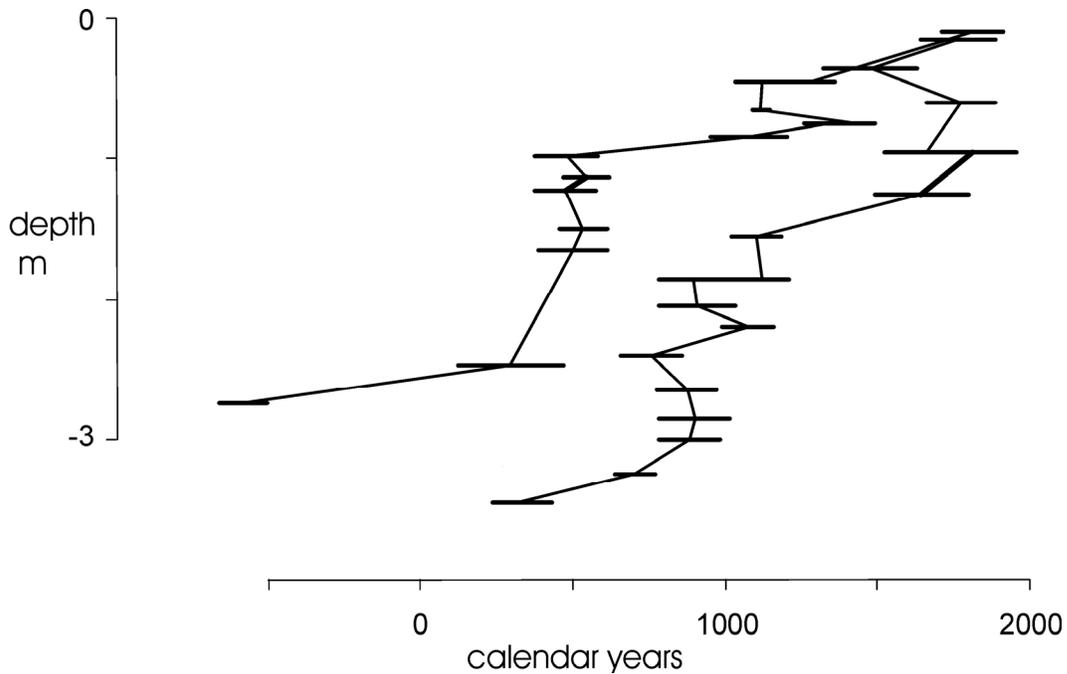
Figure 33. Chronology of fine-grained deposition northwest of Vallecito Reservoir, recorded in two stratigraphic sections. The horizontal bars represent the 2-sigma calendar age ranges of individual charcoal pieces from each sediment layer. The depth of each bar is the median depth of the layer where the sediment was sampled.

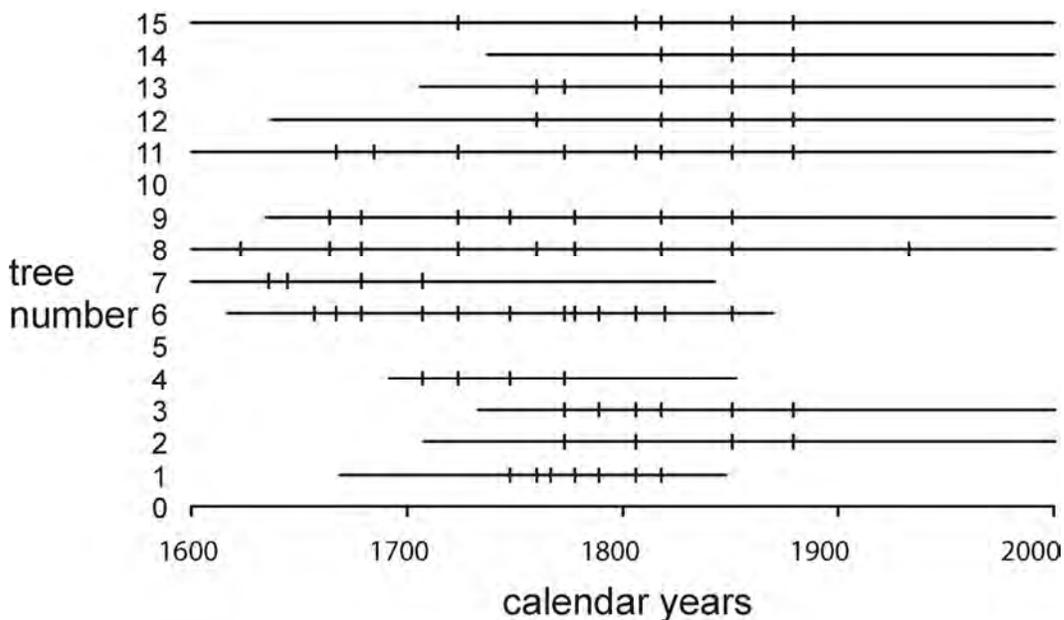
Figure 34. Surface fire chronology northwest of Vallecito Reservoir. The surface fire chronology represents each fire-scarred tree with a horizontal line, organized in order of elevation in the basin. Each tree has multiple fire scars, which are represented by the tick marks along the line.

The evidence from fire-scarred trees shows that low-severity surface fire has been frequent over the past 400 yrs, with a clear cessation following the last widespread surface fire in 1879. The surface-fire chronology (fig. 34) shows that fires were more frequent and patchy during the late 17th and 18th centuries, but became more synchronous and widespread during the 19th century.
