# Effects of a 2006 High-Flow Release from Tiber Dam on Channel Morphology at Selected Sites on the Marias River, Montana

By Gregor T. Auble and Zachary H. Bowen

Open-File Report 2008–1234

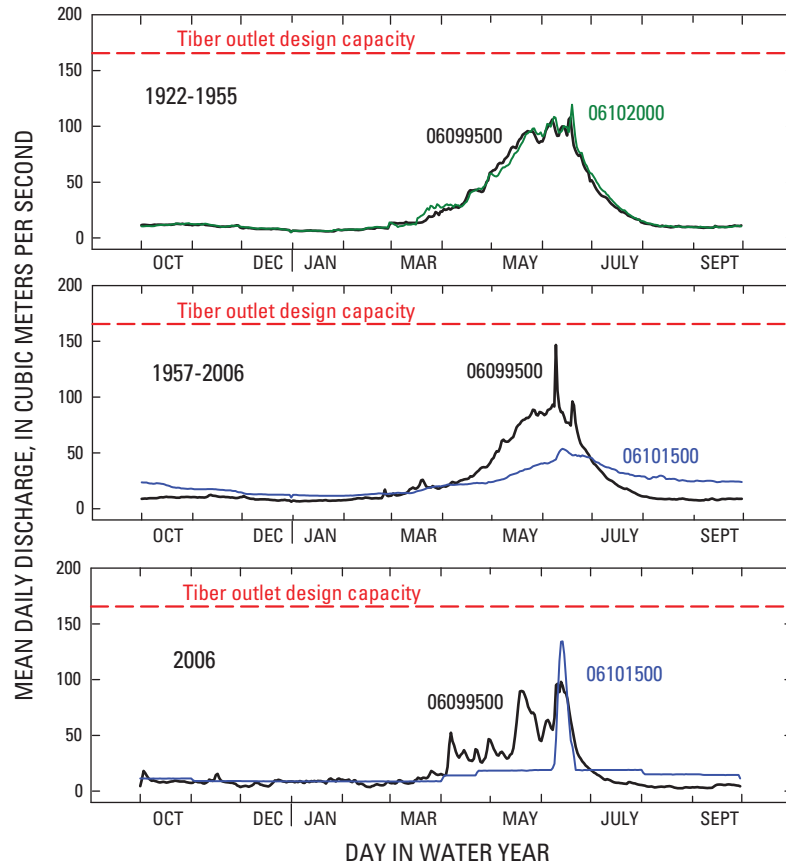
**Figure 2.** Mean daily discharge at selected Marias River gages in 2006 and in periods before (1922–1955) and after (1957–2006) Tiber Dam. Gage 06099500 is upstream from Tiber Dam and gages 06101500 and 06102000 are downstream from the dam (fig. 1).

Tiber Dam was constructed for purposes of water storage and flood control. Those purposes have been achieved as clearly indicated by the contrast between pre-dam mean daily hydrographs from gage 06099500 (upstream from Lake Elwell, fig. 1) and gage 0610200 near Tiber Dam before it was constructed with post-dam mean daily hydrographs from above and below the dam (gages 06099500 and 06101500, respectively) (fig. 2). High flows in April through June have been substantially reduced, and low flows throughout most of the rest of the year have been augmented.

The magnitude of the high-flow release was somewhat higher (maximum daily discharge of  $134 \text{ m}^3/\text{s}$  on June 15 at gage 06101500) than maximum flow upstream from the dam (maximum daily discharge of  $98 \text{ m}^3/\text{s}$  on June 14 at gage 069099500). Although the high flow of 2006 was substantial compared to the annual average of  $71 \text{ m}^3/\text{s}$  for maximum daily discharge downstream from the dam since 1957, it was less than the outlet works design capacity of  $165.5 \text{ m}^3/\text{s}$ . Furthermore, it was a relatively modest high flow compared to unmodified flows as represented either by pre-dam peak flows downstream from the dam or post-dam flows upstream from the dam (figs. 2 and 3).

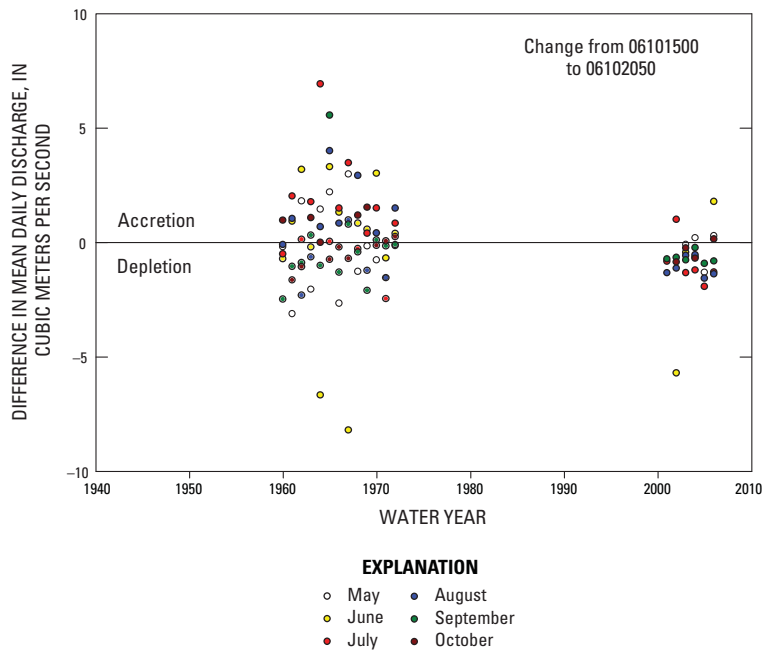
**Figure 4.** Changes in mean daily discharge by month and year from gage 06101500 to gage 06102050. Gage locations are illustrated in figure 1.

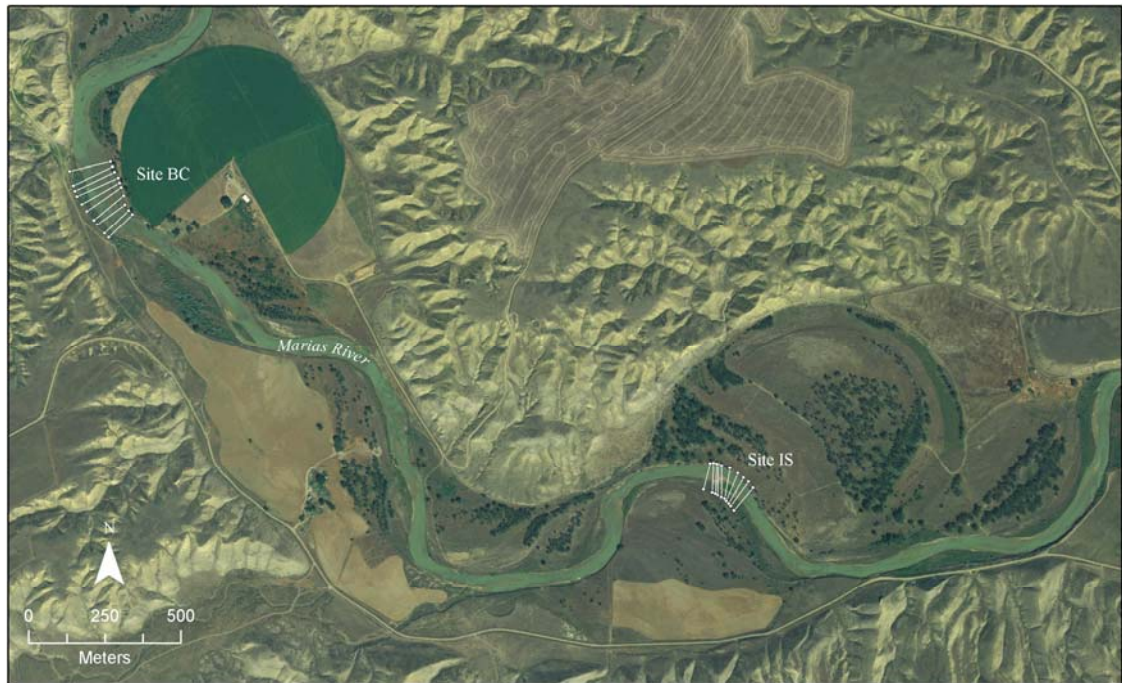
**Figure 5.** Aerial imagery of study region on lower Marias River from 2005. Head pins of cross sections at Sites IS and BC are depicted as solid circles. Grid lines are Universal Transverse Mercator (UTM, Zone 12) projection of latitude and longitude referenced to NAD 83(99) horizontal datum. Note contrast between width of cross sections containing the post-dam flood plain and the width of the zone containing mature cottonwood trees and relict channel locations. Imagery is from National Agriculture Imagery Program (2005).

Whereas reduced disturbance of the bottomland by inundation and channel movement has effects on the natural riverine ecosystem, it was also one of the objectives of Tiber Dam from the perspective of reducing the kind of property damage and loss of life associated with flooding upstream from Tiber Dam in 1964 (Boner and Stermitz, 1967). At our study sites, the zone of disturbance by the high-flow release of 2006 was well within the head-pin to head-pin widths of cross section depicted in figures 7–16 and 23. There were some sections of fencing and some irrigation take-out structures and equipment potentially subject to damage. However, most bottomland infrastructure (buildings, fencing, and roads as well as agricultural fields) was well outside the zone of potential disturbance by flows in the 100- to 160-m<sup>3</sup>/s range (figs. 5 and 6).

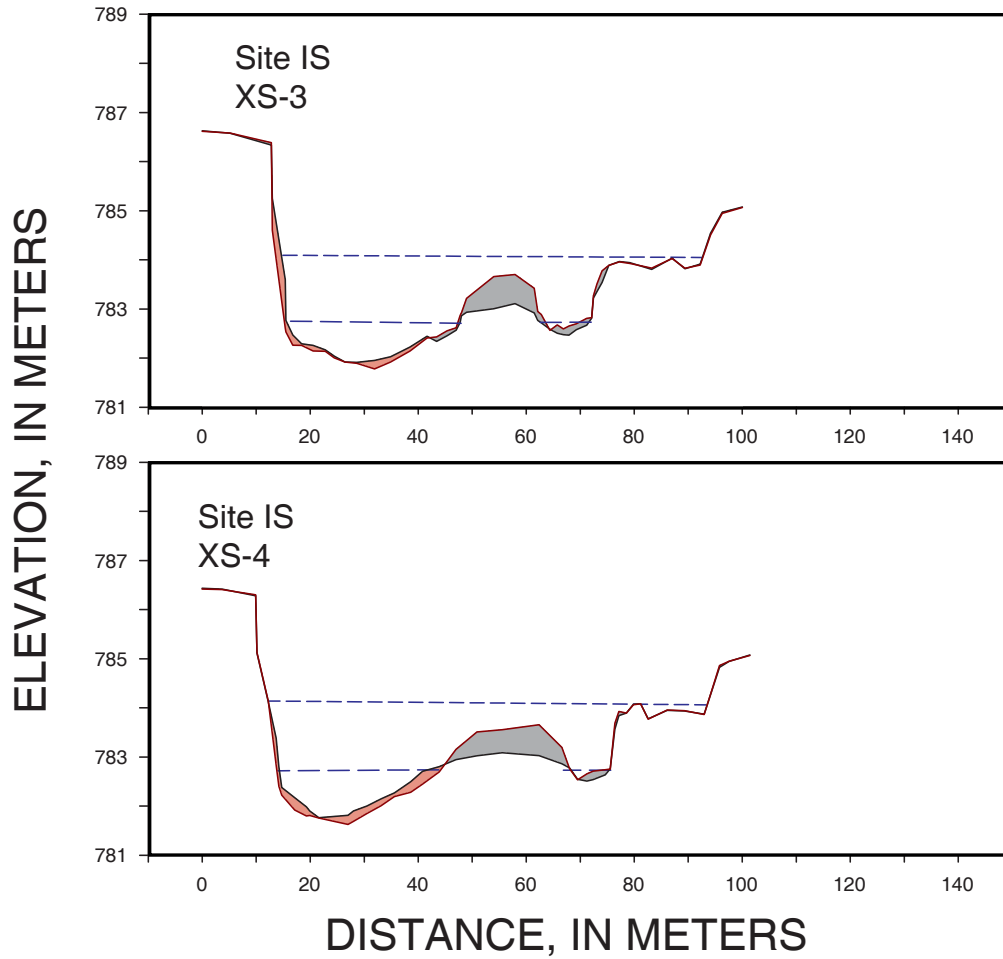
**Figure 8.** Cross sections 3 and 4 at Site IS. Distance along cross section is from left (facing downstream) to right head pins.

Changes in channel morphology for each cross section, along with the observed water-surface elevations, are depicted in figures 7–11 for Site IS and figures 12–16 for Site BC. Discharge values associated with the water surfaces are based on mean daily discharge estimates for gage 06102050 near Loma, Mont., and closest to the study sites. They differ somewhat from the long-term gage 06101500 downstream from the dam in part because of transit time between the gages. Water surfaces for the 19-m<sup>3</sup>/s discharge were measured on June 1, 2006, at edges of all flowing channels, with the exception of one aberrant measurement on a slippery bank on the side channel of cross section 8. Here, the side-channel water surface was assumed to be flat using the single reliable edge measurement. Measurements of water surfaces at the high discharge of 109 m<sup>3</sup>/s were made on June 14, 2006, and are based on edges of only the main channel, with side-channel elevations plotted as equal to the nearest edge of the main channel for each cross section.

The most distinctive response at the IS site was aggradation and vegetation removal and burial on the channel island (figs. 7–11, 17, and 18). Before the high-flow release, this island surface was covered by dense herbaceous vegetation, dominantly *Melilotus* spp., with some cottonwood and willow seedlings. The surface was completely inundated by the high flow, vegetation was almost completely removed or buried, and the top of the island aggraded 20 to 100 cm across most of its surface. Aggradation was partially offset by incision in the deeper part of the channel and some erosion from the steep cut bank on river left, looking downstream (for example, cross sections 3 and 4, figs. 8 and 17). A substantial area of low flood plain on the right side of the river was inundated by the high flow without significant overall aggradation or any substantial reduction in vegetative cover. There was some distinctive, though limited, deposition of sand on the bank edge of the flood-plain surface where water depths, velocities, and transport capacity likely declined most quickly (fig. 19 and cross sections 9 and 10 of fig. 11). The high flow at Site IS also resulted in noticeable movement of large woody debris along the bank and caused the collapse of a large dead cottonwood on the lip of the left cut bank of the river (figs. 17 and 18).

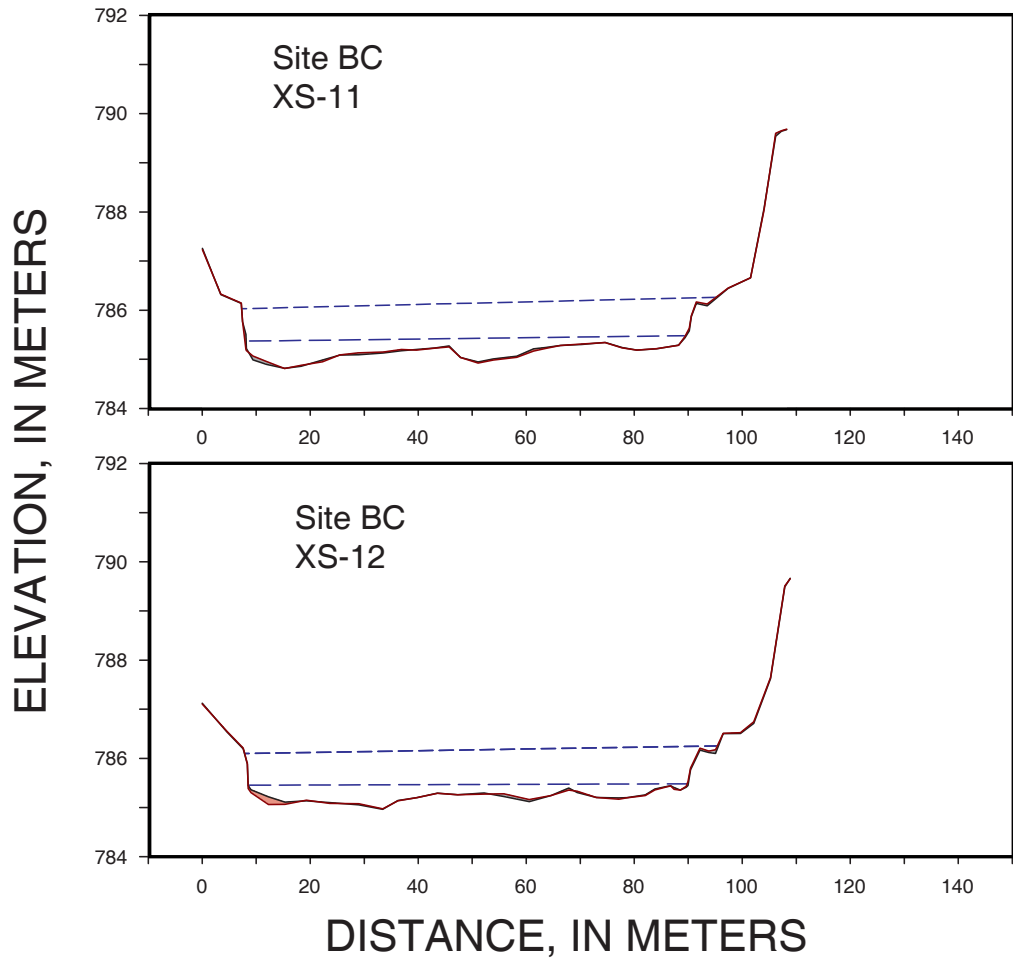
**Figure 12.** Cross sections 11 and 12 at Site BC. Distance along cross section is from left (facing downstream) to right head pins.

The most distinctive response at Site BC was occupation of the back channel on river right at high flow (figs. 12–16 and 20). There was very little channel change at Site BC. There was some aggradation of sediment and movement of large woody debris on the small island on river left and some degradation in the small side channel between this island and the left bank (figs. 12–16 and 21). However, this island was not generally overtopped by the high flow and did not have extensive aggradation or vegetation removal. The back channel on river right (facing downstream) was connected to the main channel at both the upstream and downstream ends (fig. 20) but had very little channel change except for some slight aggradation at the most upstream cross sections (fig. 16).

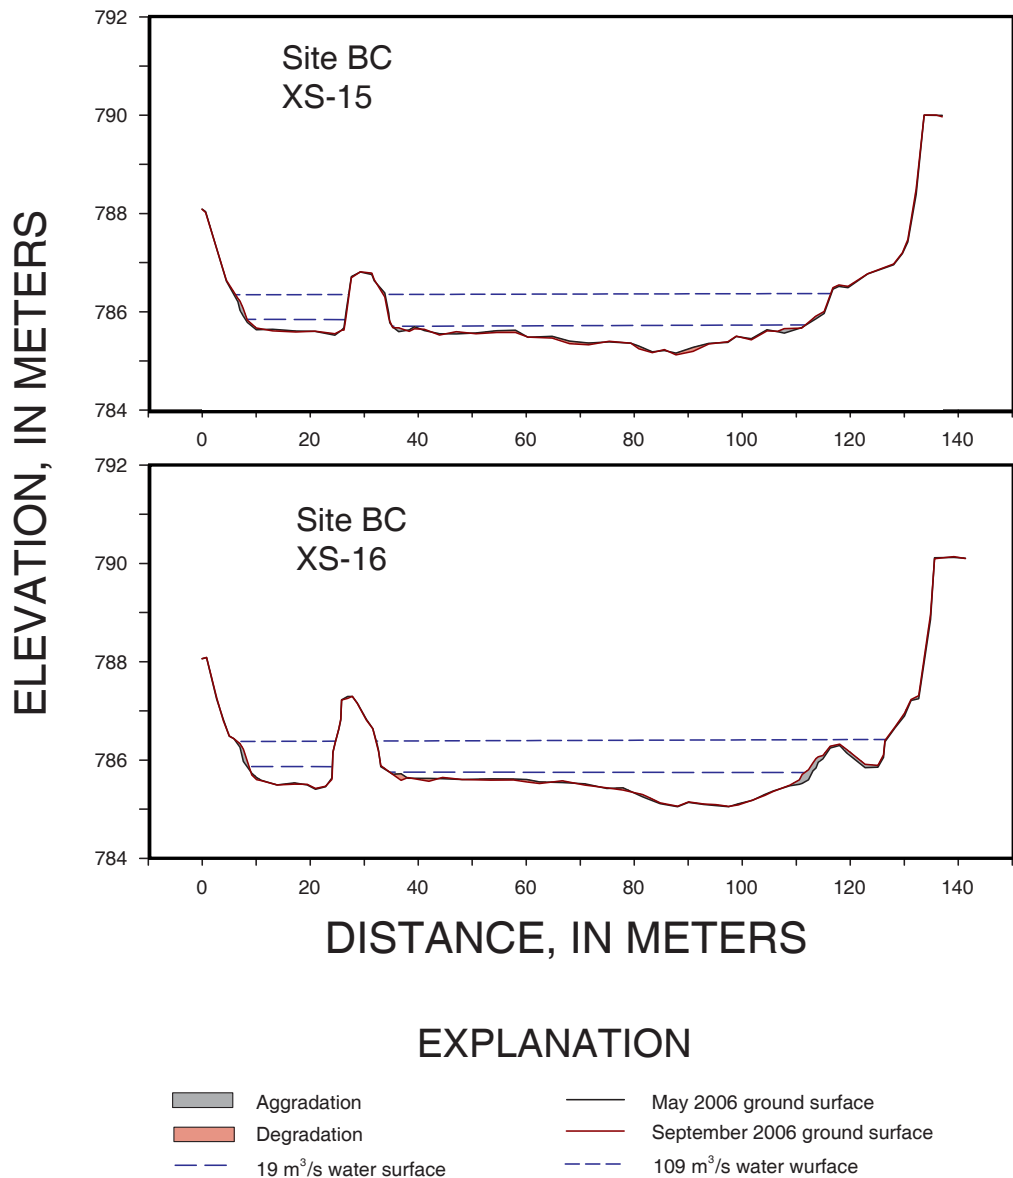
**Figure 14.** Cross sections 15 and 16 at Site BC. Distance along cross section is from left (facing downstream) to right head pins.

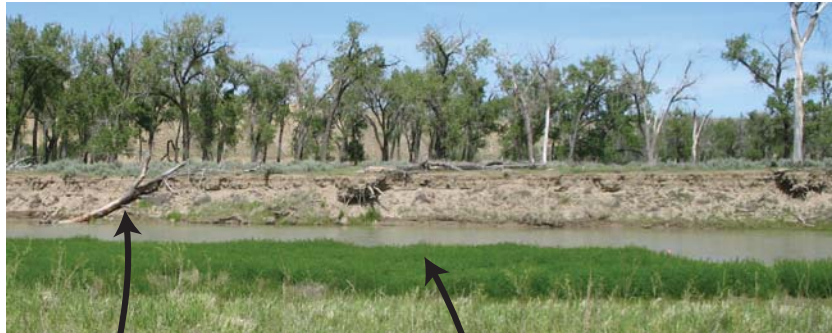
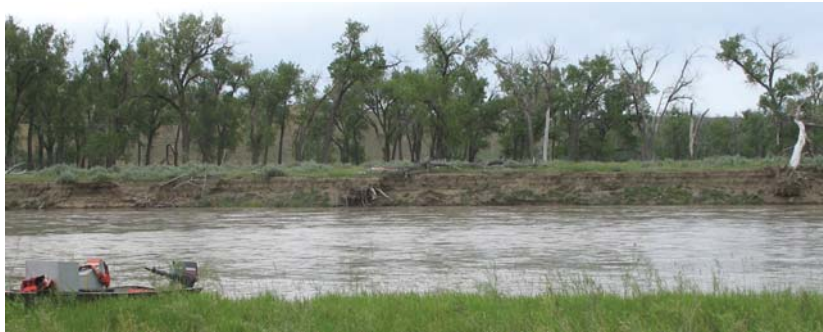
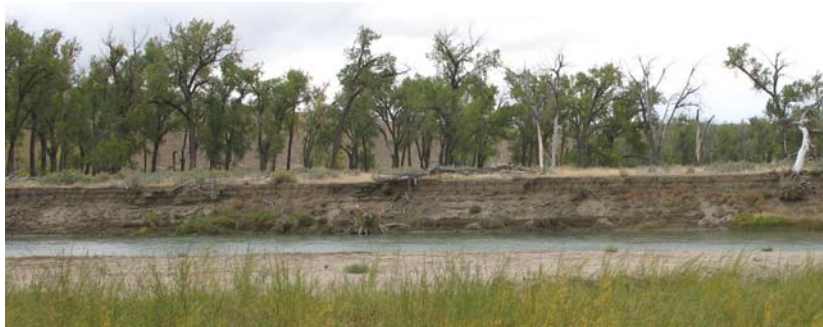
*eroded large  
woody debris*

*inundated island  
with vegetation burial*

**Figure 17.** Cross section 3 at Site IS from right (facing downstream) head pin.

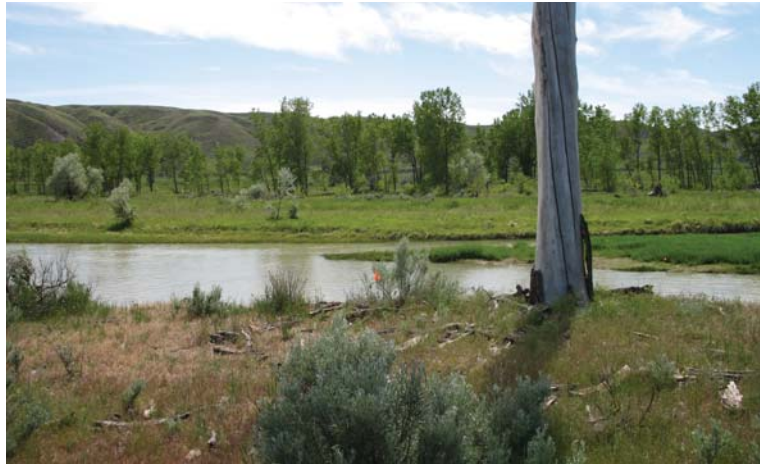
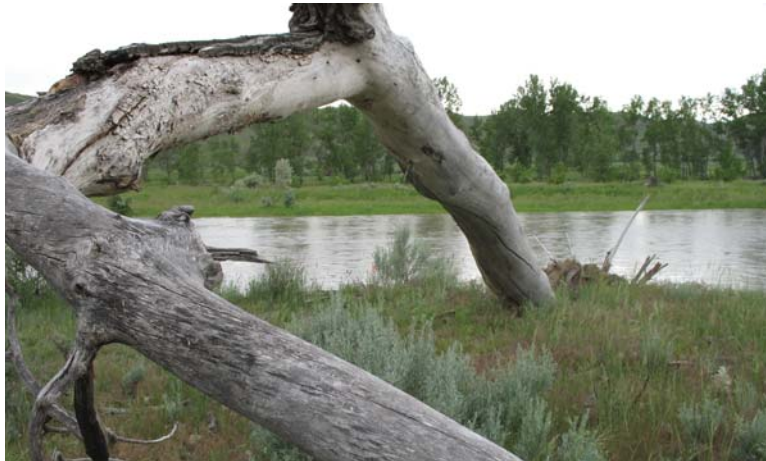
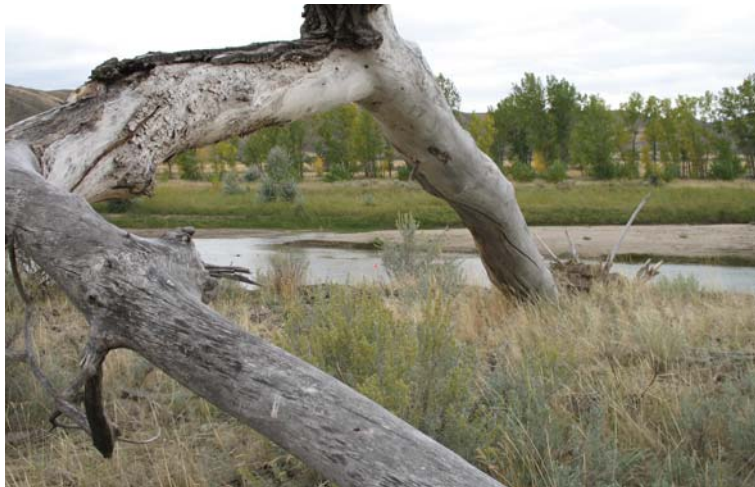
**Figure 18.** Cross section 2 at Site IS from left (facing downstream) head pin.

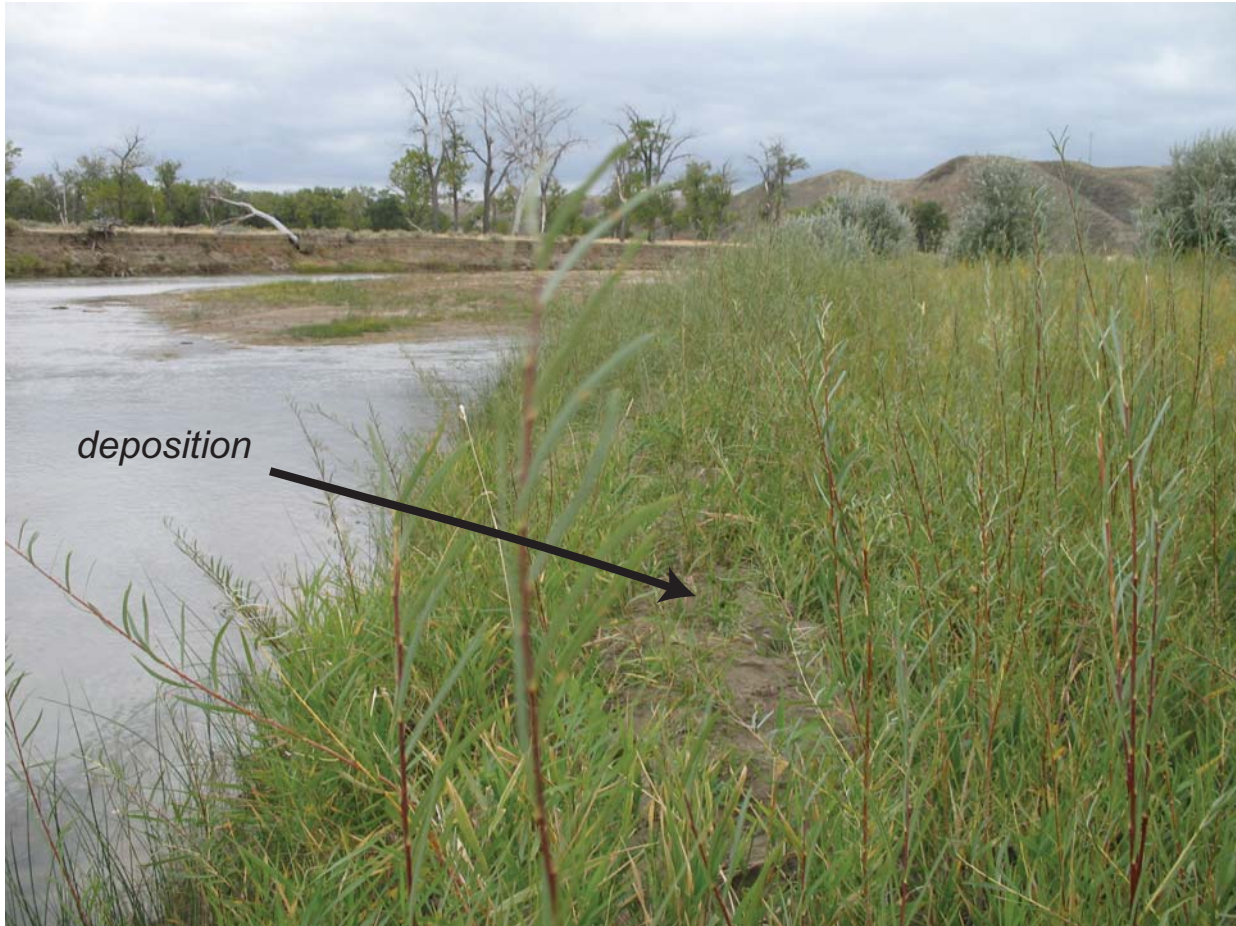
**Figure 19.** Deposition creating primary levee landform on bank lip of right (facing downstream) bank near cross section 10 at Site IS. Dense, 1- to 2-m-tall plants in foreground on bank are willow, *Salix exigua*. Photograph is oriented looking downstream and was taken September 22, 2006.

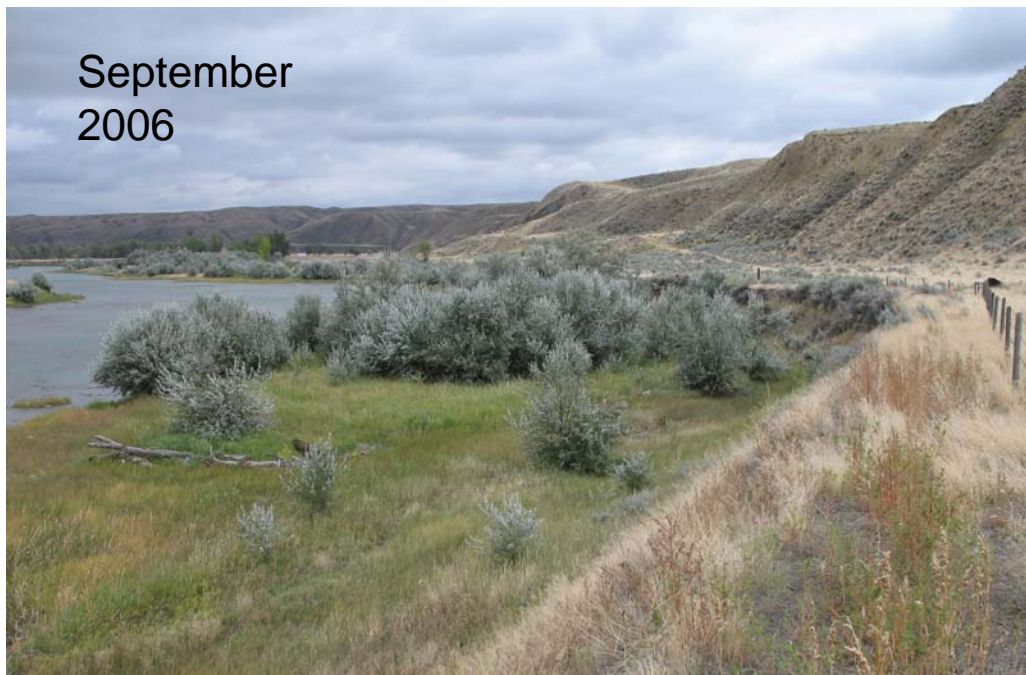
**Figure 20.** Flowing back channel at Site BC. View is looking downstream at site from upstream from cross section 20 on right (facing downstream) bank. Right bank is dominated by Russian-olive, *Elaeagnus angustifolia*.

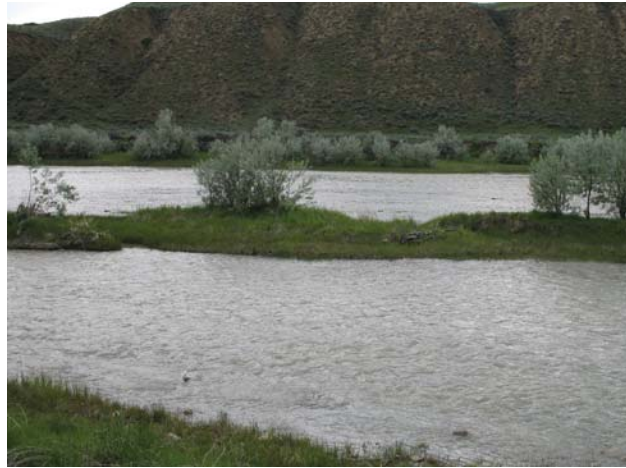
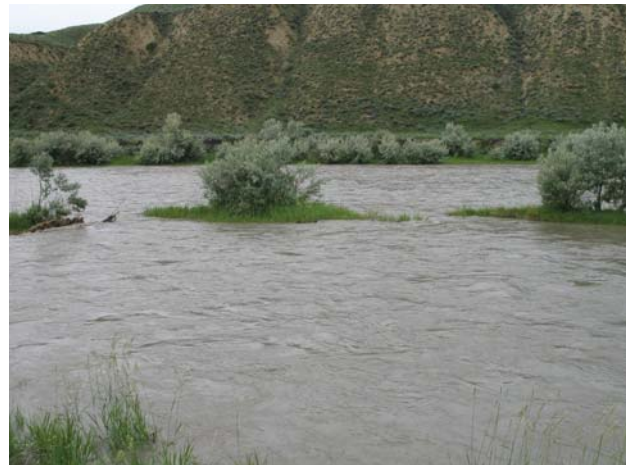
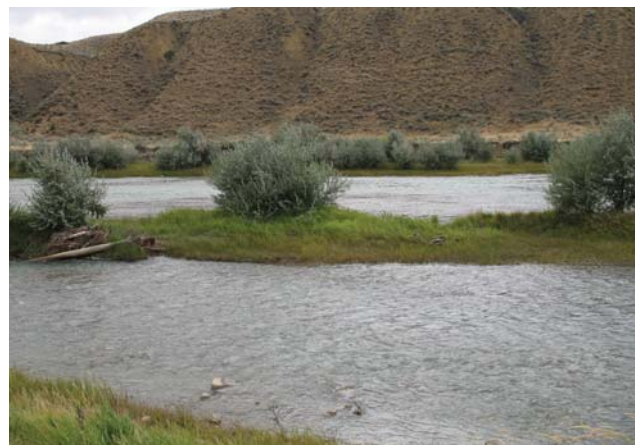
**Figure 21.** Cross section 14 at Site BC from left (facing downstream) head pin. Note tree bole lodged where flow overtops and cuts across small island.

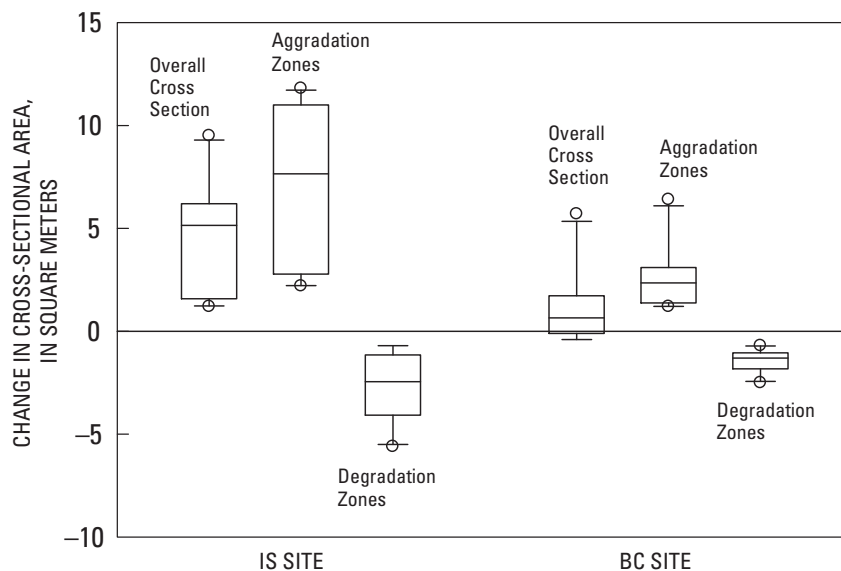
**Figure 22.** Box plots of changes in cross-sectional area. All values represent net change from before to after the 2006 high flow. Cross-sectional values are the total for each cross section of zones of aggradation and degradation within each cross section. The horizontal line within each box is the median of 10 cross sections at each site, tops and bottoms of the box are the 75th and 25th percentile respectively, the vertical whiskers capped with a horizontal line are the 90th and 10th percentiles, and individual observations beyond the 90th and 10th percentiles, are represented by open circles.

Both sites exhibited overall aggradation (fig. 22) during the interval containing the high flow. All individual cross sections at Site IS and almost all cross sections at Site BC had more aggradation than degradation, although both sites had areas of both aggradation and degradation. Site IS was considerably more dynamic than the bedrock-influenced Site BC, with average overall aggradation among cross sections of 4.4 m<sup>2</sup> per cross section, more than 3.5 times the overall average cross-sectional aggradation of 1.2 m<sup>2</sup> per cross section at Site BC. At Site IS, wetted perimeter increased 72 percent, from 50 m at the pre-release discharge of 19 m<sup>3</sup>/s to 86 m at a high-flow discharge of 109 m<sup>3</sup>/s (fig. 23). The BC Site was considerably wider and shallower, with an average wetted perimeter of 91 m at 19 m<sup>3</sup>/s. The higher discharge of 109 m<sup>3</sup>/s resulted in a smaller proportional increase of 18 percent in wetted perimeter at Site BC to 107 m.
