# Hurricane Ike: Observations and Analysis of Coastal Change

## USGS Open-File Report 2009-1061

Open-File Report 2009–1061

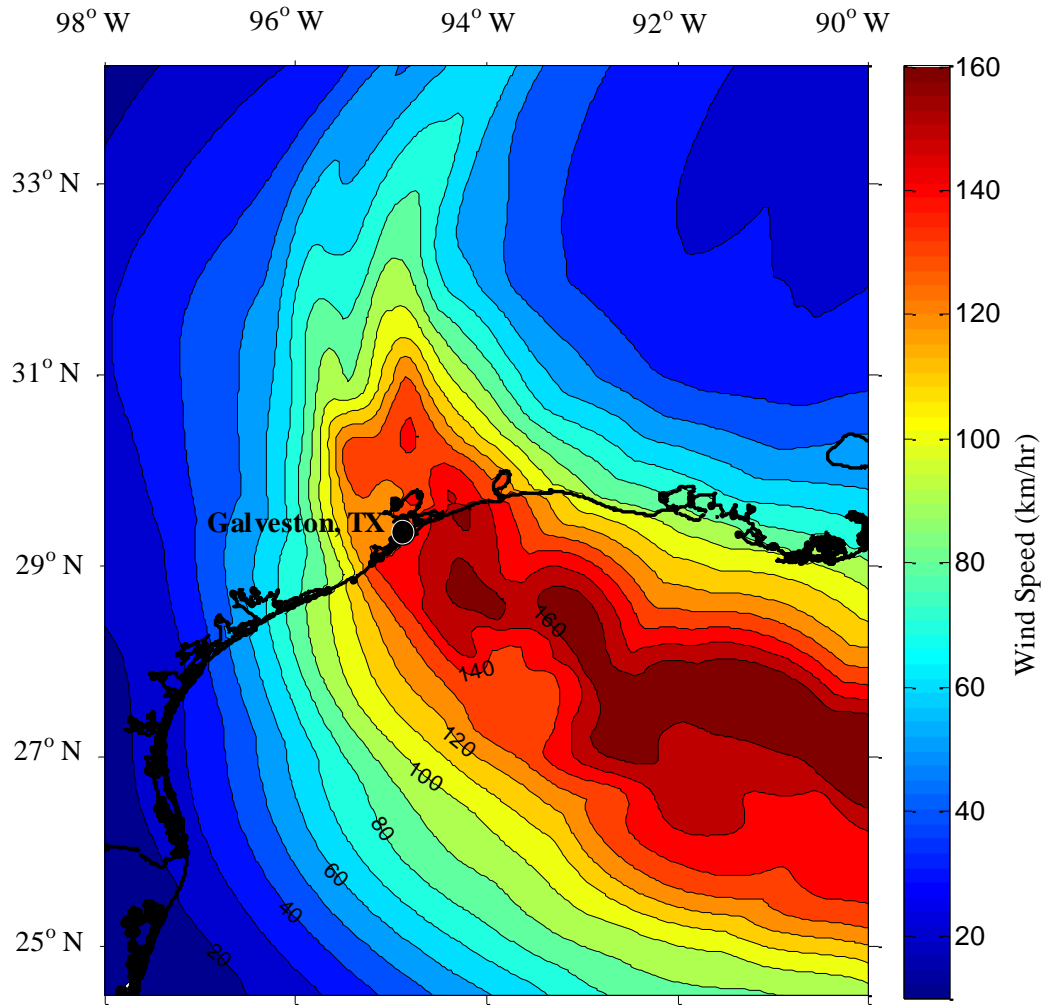
**Figure 2.** Wind speeds in kilometers per hour generated by Hurricane Ike, as calculated by the National Oceanic and Atmospheric Administration Hurricane Research Division. The extent of hurricane-force wind, as defined by a category 1 wind speed of 119 km/hr, is indicated by the orange contour.

Maximum sustained wind swaths estimated by the NOAA Atlantic Oceanographic and Meteorological Laboratory Hurricane Research Division (using methods described by Powell and others, 1998) indicate that hurricane-force winds impacted approximately 180 km of coastline (Fig. 2). The maximum wind-speeds were observed just east of Galveston, Texas. Hurricane-force winds extended across the Texas-Louisiana border and affected much of the Louisiana coast.

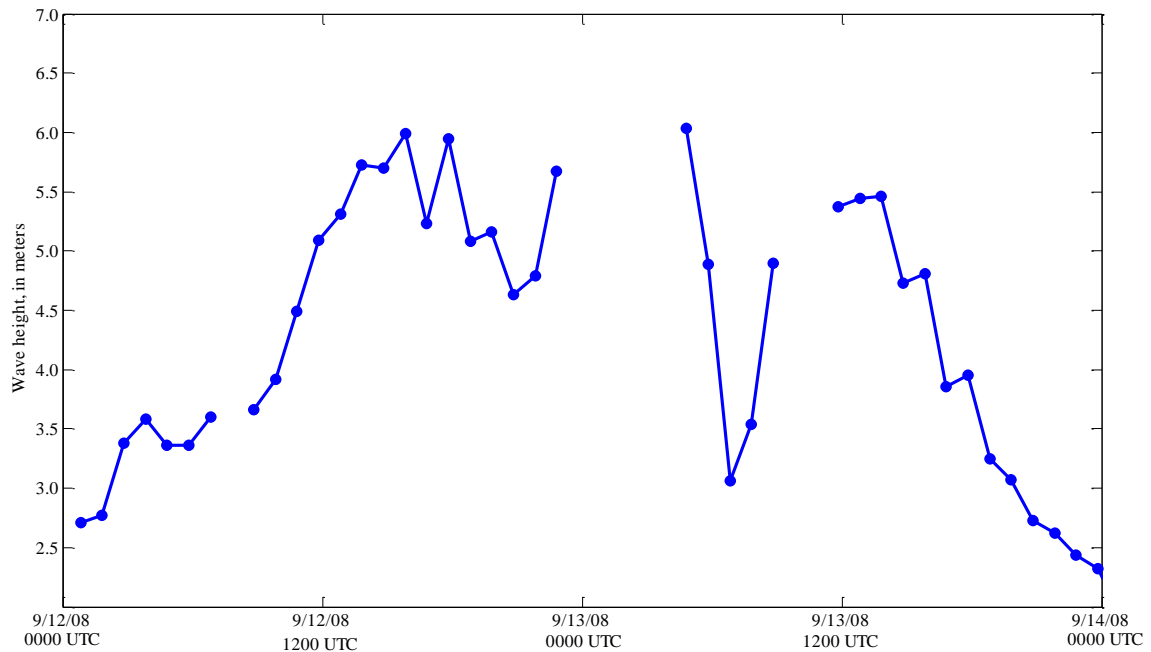
**Figure 3.** Significant wave height during the passage of Hurricane Ike, as measured from National Oceanic and Atmospheric Administration Buoy 42035 located near Galveston, Texas.

Several moored buoys operated by the NOAA National Data Buoy Center recorded heights and periods of waves generated by Hurricane Ike. Approximately 33 hrs prior to landfall, Hurricane Ike passed within 28 km of Buoy 42001 (fig. 1), which is located in the Gulf of Mexico approximately 330 km south of Southwest Pass, Louisiana. The maximum significant wave height recorded at this station was 9.2 m (National Data Buoy Center, 2008). Buoy 42035 (fig. 1), moored east of Galveston, Texas, in 13.7 m of water, went adrift on September 12 and later passed through the eye of Hurricane Ike. The buoy recorded a maximum significant wave height of 6.0 m at 0400 UTC on September 13 (fig. 3), 3 hrs before Hurricane Ike came ashore in Galveston, Texas (National Data Buoy Center, 2008).

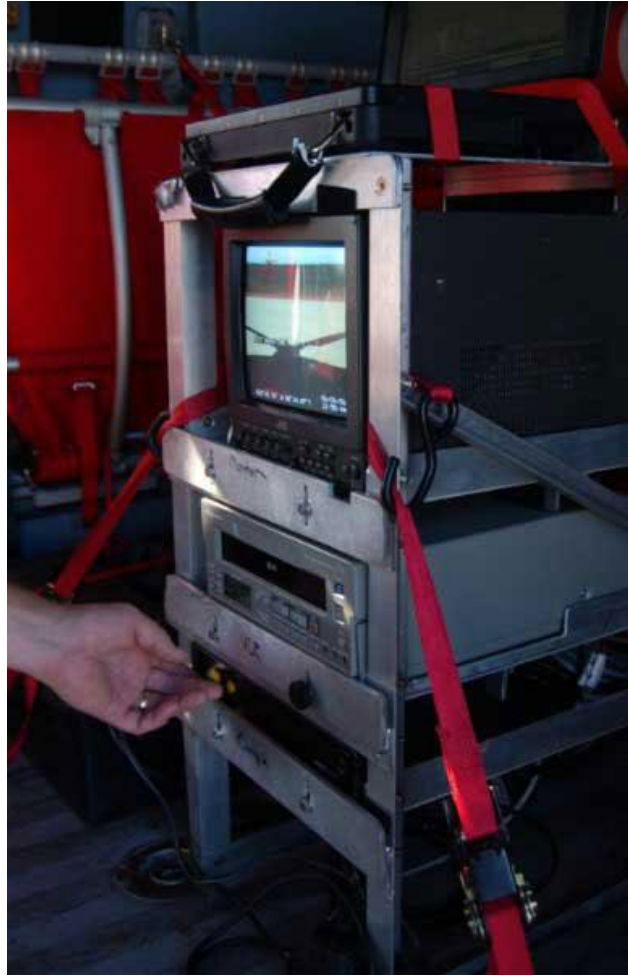
**Figure 4.** Digital-photography and video recording system used aboard aircraft during coastal oblique video and photography missions.

Post-storm oblique aerial photography and video of the region of landfall were collected from a twin engine King Air aircraft on September 14 and 15, 2008, two days after landfall. In total, 2,521 digital photographs and 8 hrs of video were obtained over a 240-km extent from Freeport, Texas, to Cameron, Louisiana. The photography sample rate was 0.5 frames/sec (or approximately 1 photo per 200 m). Examples of both pre- and post-storm photographs obtained during these two flights are shown in Section 4.1.

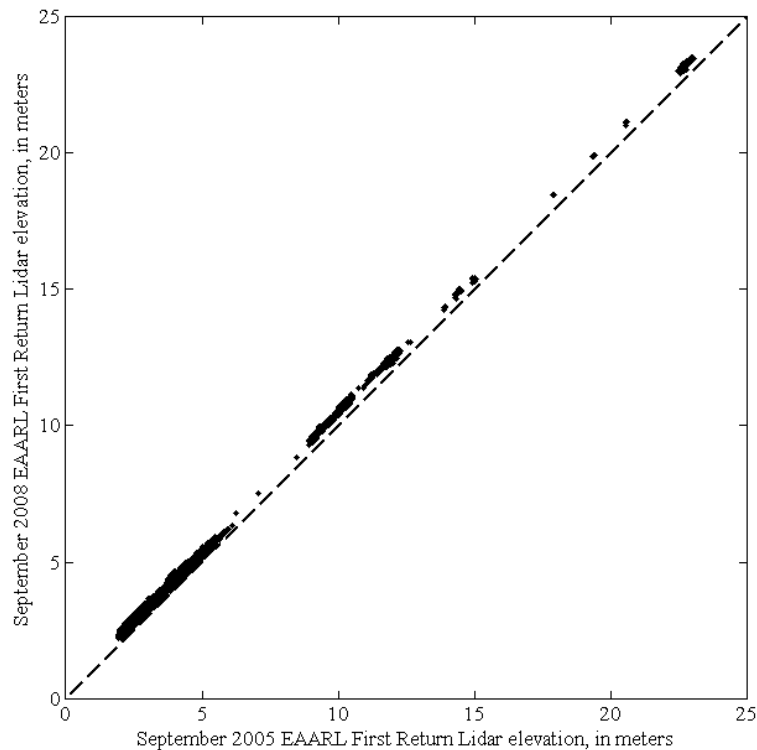
**Figure 7.** Relative offset between 2005 and 2008 Experimental Advanced Airborne Research Lidar first-return lidar.

First-return lidar points were interpolated to a series of regular 5 x 5 m grid domains. The interpolation method applies a smoothing filter that removes short-scale variability and determines the degree to which residual noise has been removed. Elevations at grid points that received too few observations to reduce system noise were removed. Evaluation of the actual vertical accuracy of the

lidar could not be performed against ground-based surveying because the lidar flight path did not overlap the ground base station. Since no ground surveys were conducted concurrent with the September 17, 2008, lidar survey, a relative offset between the 2005 and 2008 data was determined. Lidar data were selected from a number of small areas containing fixed, flat features, such as roads, parking lots, and large buildings (fig. 6). For this intercomparison, a section of the city of Galveston was used. Grid cells were then selected based on their spatial error (normalized sampling error less than 25 percent and residual error less than 20 cm) to eliminate cells with a small number of observations or high noise due to system behavior, or vegetation, or other sources of clutter. The grid cells that were selected were used to determine the relative offset of + 32 (+/- 0.001) cm (fig. 7), indicating that the 2008 survey was biased high compared to the 2005 survey. This bias may be due to navigation errors in either or both of the surveys used in the comparison. Since the bias is within the vertical-error limits of the lidar surveys (+/- 20 cm), the bias has not been removed from either dataset. The presence of a bias is important because it increases the uncertainty of the measures of coastal change presented in Section 4.2.

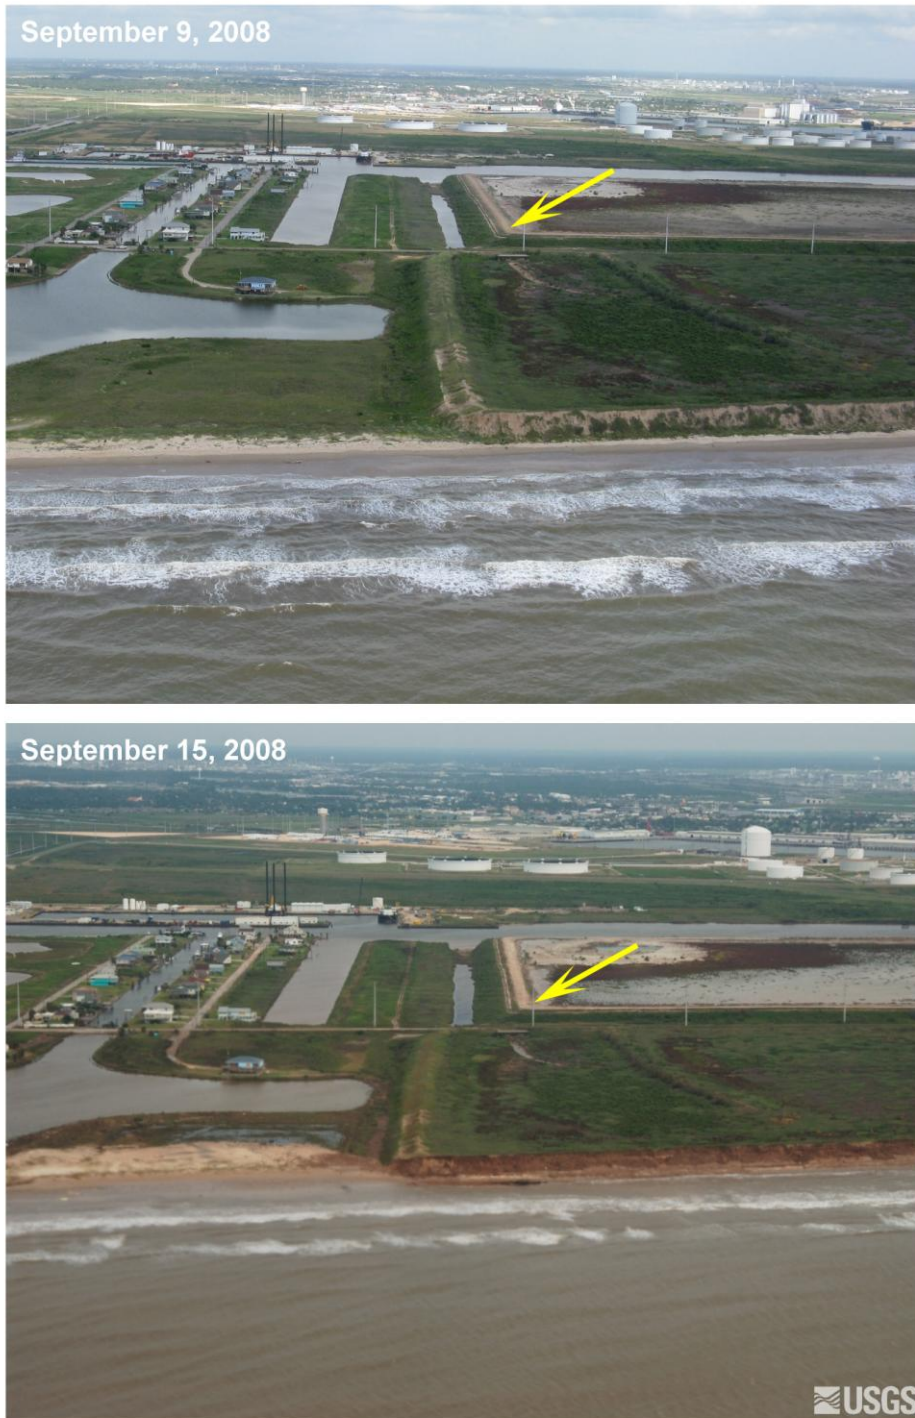
**Figure 9.** Oblique aerial photography from Quintana, Texas (Location 1, Figure 8) on September 9, 2008 (top) and September 15, 2008, two days after landfall of Hurricane Ike (bottom). Yellow arrows mark features visible in each image. At this location well west of Ike's landfall location, there is evidence of erosion of the seaward leg of the rectangular berm. The steep scarp is typical of erosion due to wave collision against the berm slope. Erosion and overwash can be seen on the lower dune to the west (left) of the larger berm.

On the sandy beaches west of Galveston Island (fig. 8, locations 1 and 2), peak dune elevations before the storm ranged from 2 to 4 m. The coastal change along this largely undeveloped stretch of beach was less severe than the change observed on Galveston Island and Bolivar Peninsula. Large waves and surge eroded the beach, causing shoreline retreat and scarping of the dune face (figs. 9 and 10).

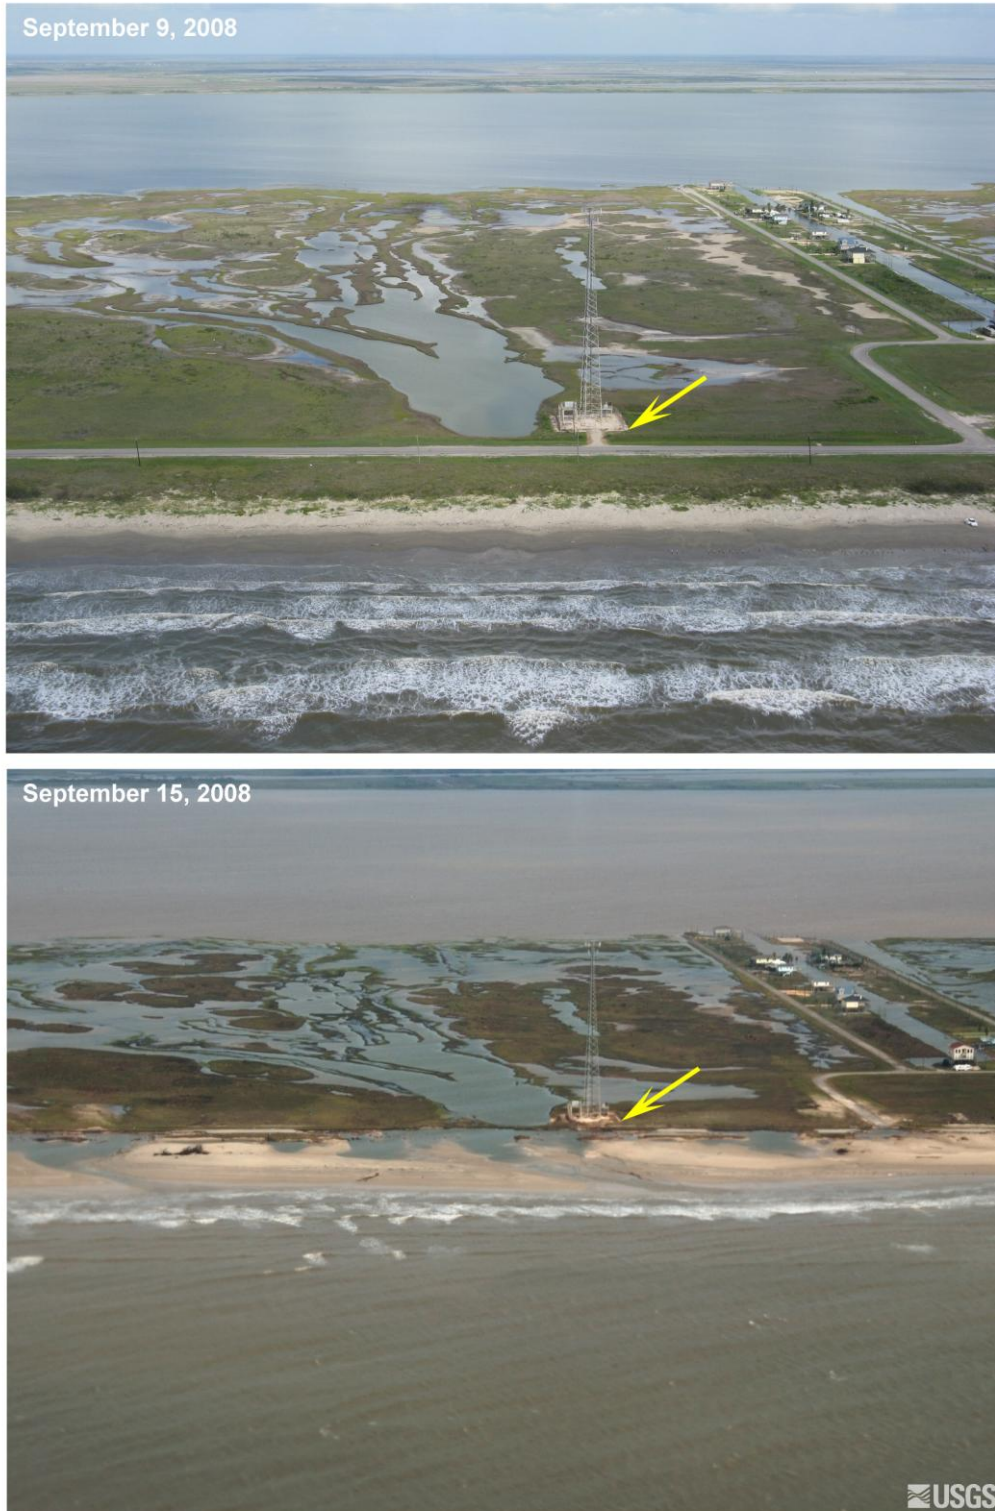
**Figure 10.** Oblique aerial photography from Christmas Bay, Texas (Location 2, Figure 8), on September 9, 2008 (top), and September 15, 2008, two days after landfall of Hurricane Ike (bottom). Yellow arrows mark features visible in each image. Here, severe beach and dune erosion occurred, and overwash or inundation deposited sand behind remnants of the dune and onto the road.

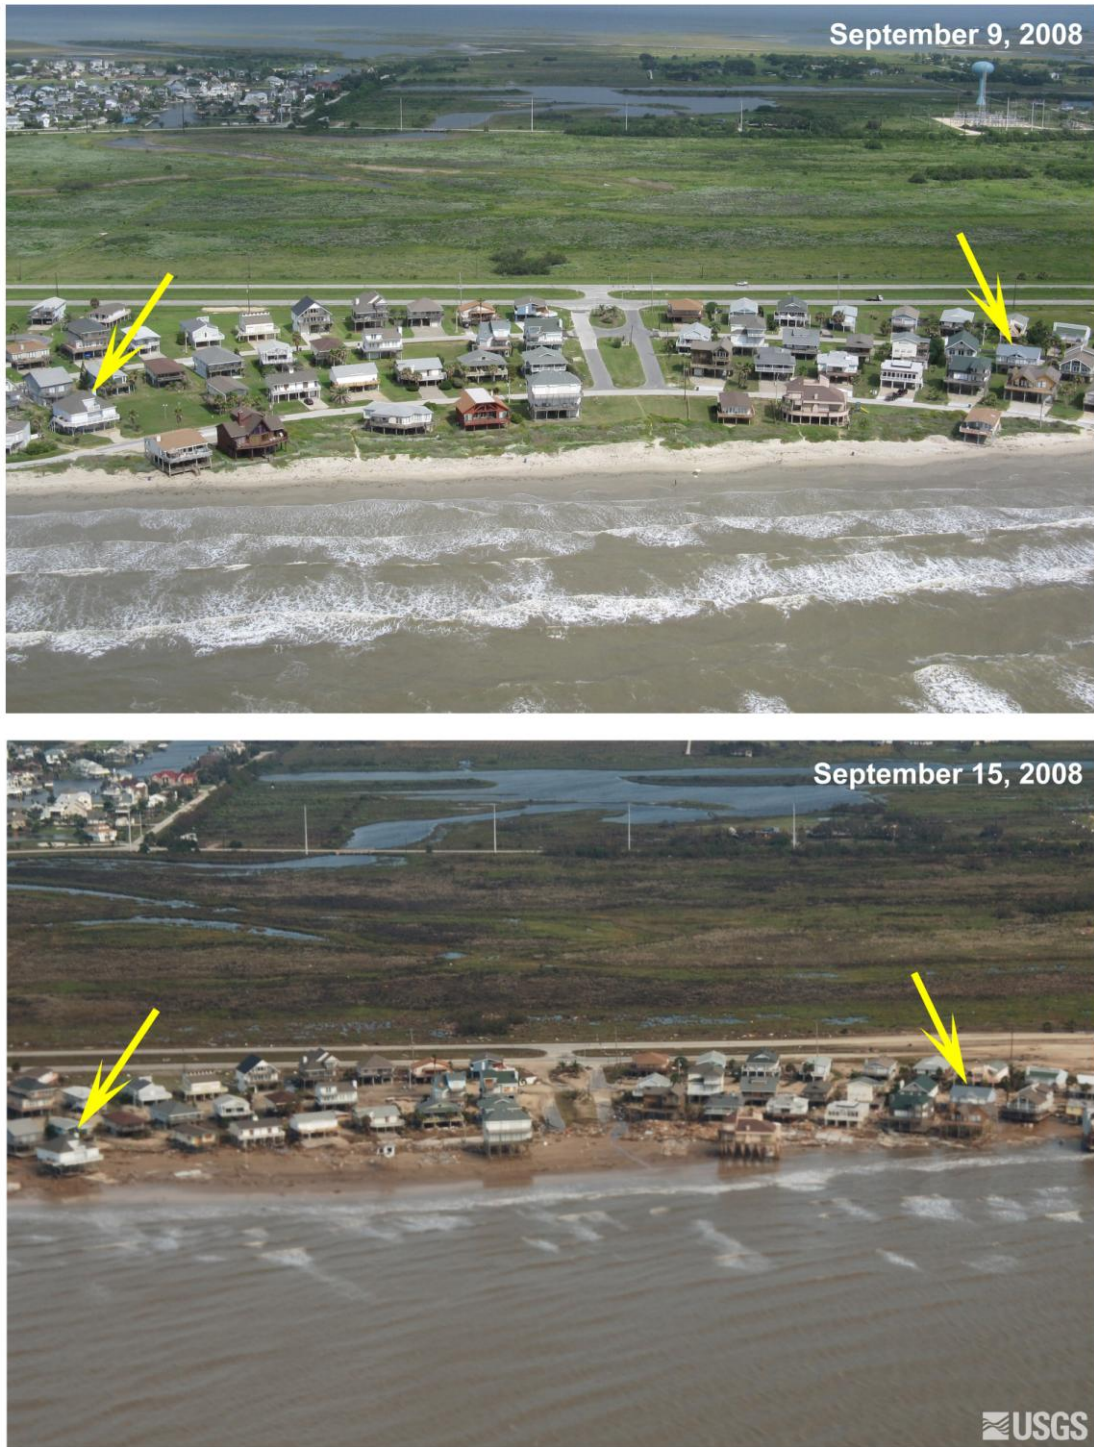
**Figure 11.** Oblique aerial photography of Galveston, Texas (Location 3, Figure 8), on September 9, 2008 (top), and September 15, 2008, two days after landfall of Hurricane Ike (bottom). Yellow arrows mark features visible in each image. Evidence of inundation here includes eroded beach face, sand deposited inland of the shoreline, and distressed vegetation. However, the coastal-change impacts were less severe here than on the Bolivar Peninsula, located northeast of landfall.

Most of Galveston Island was west of Hurricane Ike landfall (fig. 8, locations 3-5) and was not exposed to the extreme winds of the right eyewall that devastated the Bolivar Peninsula. On the sandy beaches west of the Galveston seawall, peak dune elevations before the storm were 2 to 4 m, roughly half of the elevation of the seawall. The coastal change along this stretch of Galveston Island was considerably more than on the seawalled section nearby, but less than the change observed on the Bolivar Peninsula. At landfall, while the Bolivar Peninsula was being pummeled with extreme onshore winds, much of Galveston Island experienced offshore winds, reducing both surge and, to some extent, wave heights. However, impacts were not absent. Waves, aided by high surge, eroded the beach, moving the shoreline landward of some houses west of the seawall (fig. 11).

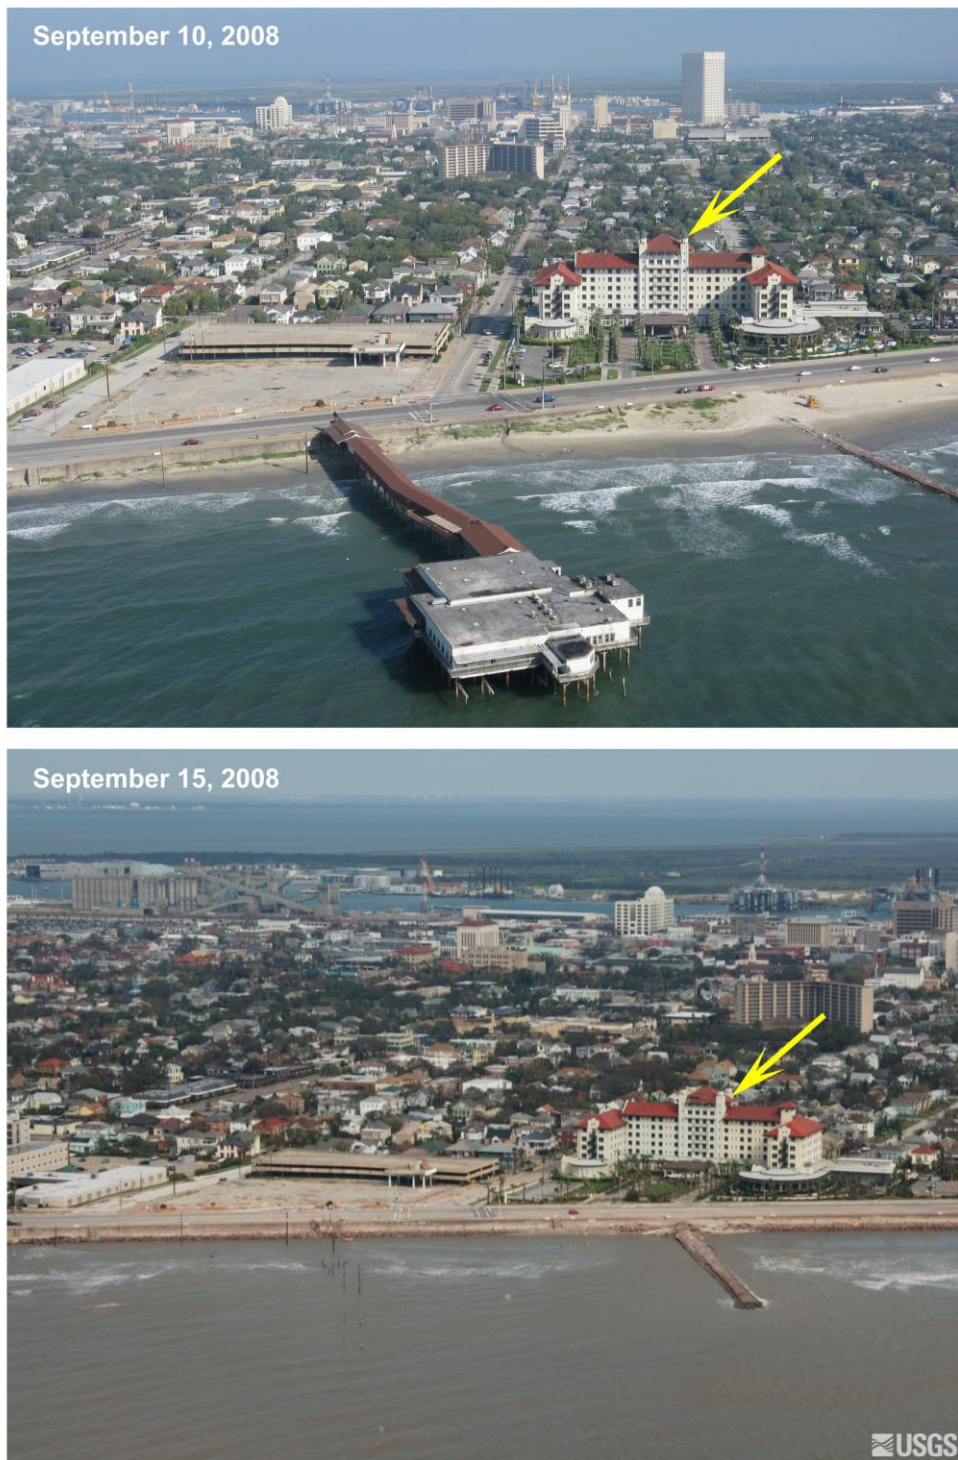
**Figure 12.** Oblique aerial photography of Galveston, Texas (Location 4, Figure 8), on September 9, 2008 (top) and September 15, 2008, two days after landfall of Hurricane Ike (bottom). Yellow arrows mark features visible in each image. Hurricane-induced waves and surge destroyed a pier and eroded adjacent beaches.

The city of Galveston was protected from storm surge and wave attack by a 5- to 6-m high, 16-km-long seawall. Erosion was restricted to the beach in front of the seawall (fig. 12). Here, most of the severe impacts to buildings were confined to those that were built on piers that extended seaward of the seawall. A small section of the eastern end of the island was not protected by the seawall. This area was on the right-hand side of the hurricane track and likely experienced the strongest winds, and the highest surge and waves, leading to beach and dune erosion (fig. 13).

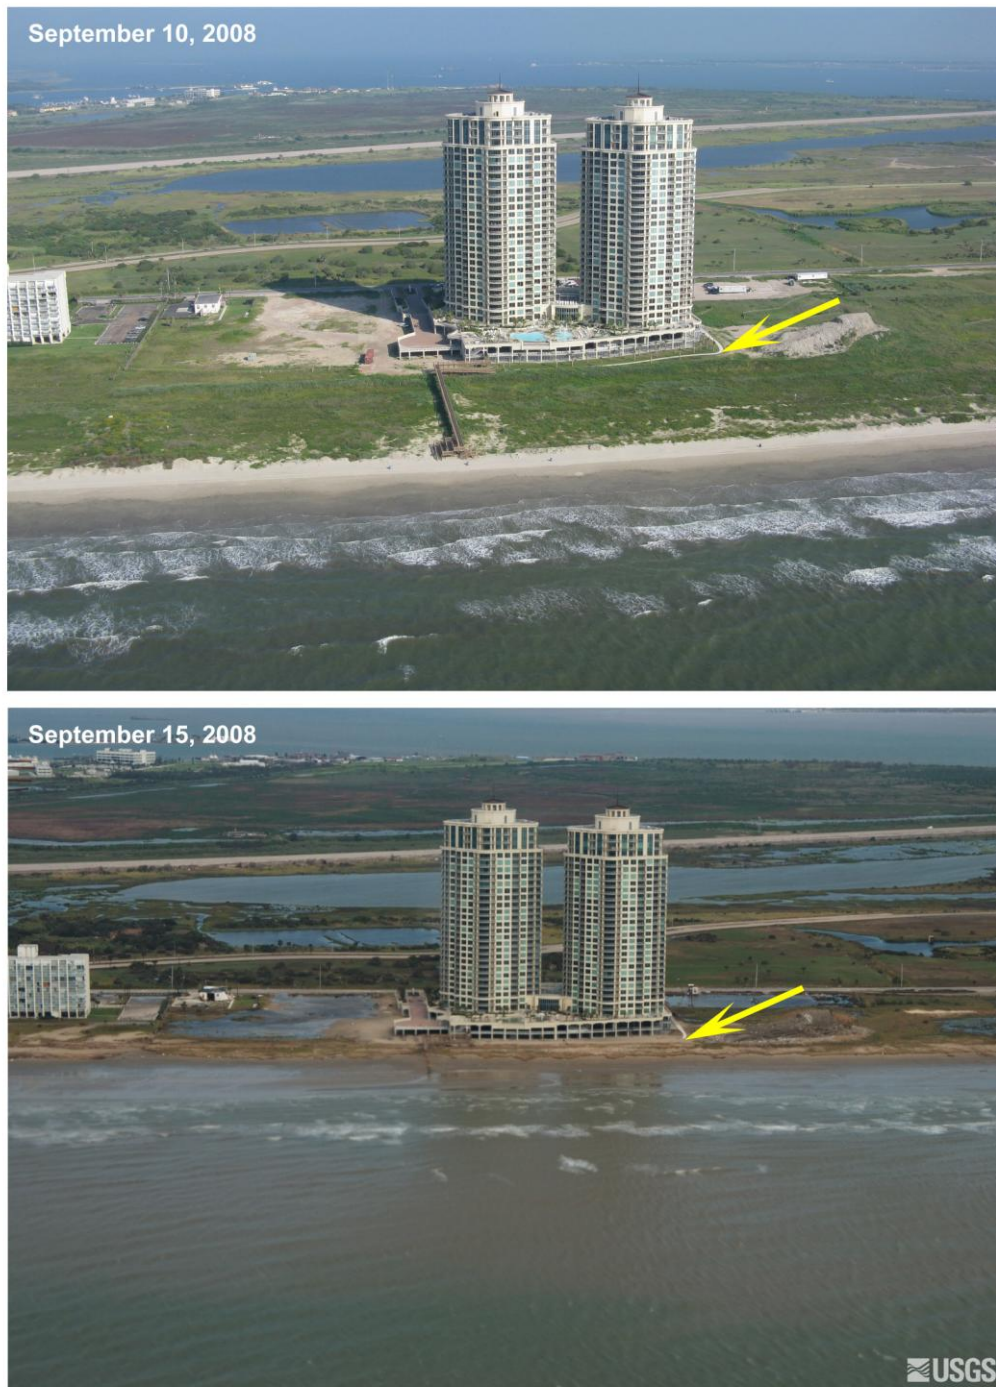
**Figure 13.** Oblique aerial photography of Galveston, Texas (Location 5, Figure 8), on September 9, 2008 (top) and September 15, 2008, two days after landfall of Hurricane Ike (bottom). Yellow arrows mark features visible in each image. Hurricane-induced waves and surge destroyed a small walkway. Coastal-change impacts include beach and dune erosion, and the removal of considerable dune vegetation. This location is on the right-hand side of the hurricane track and likely experienced the strongest winds, highest surge, and waves.

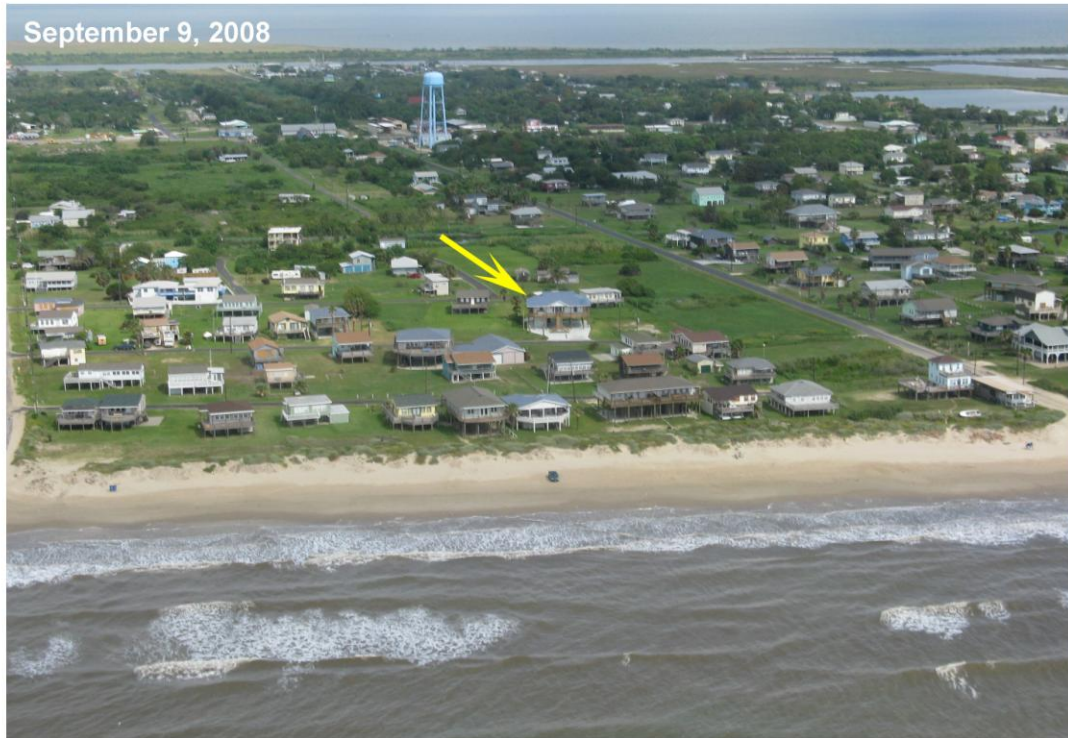
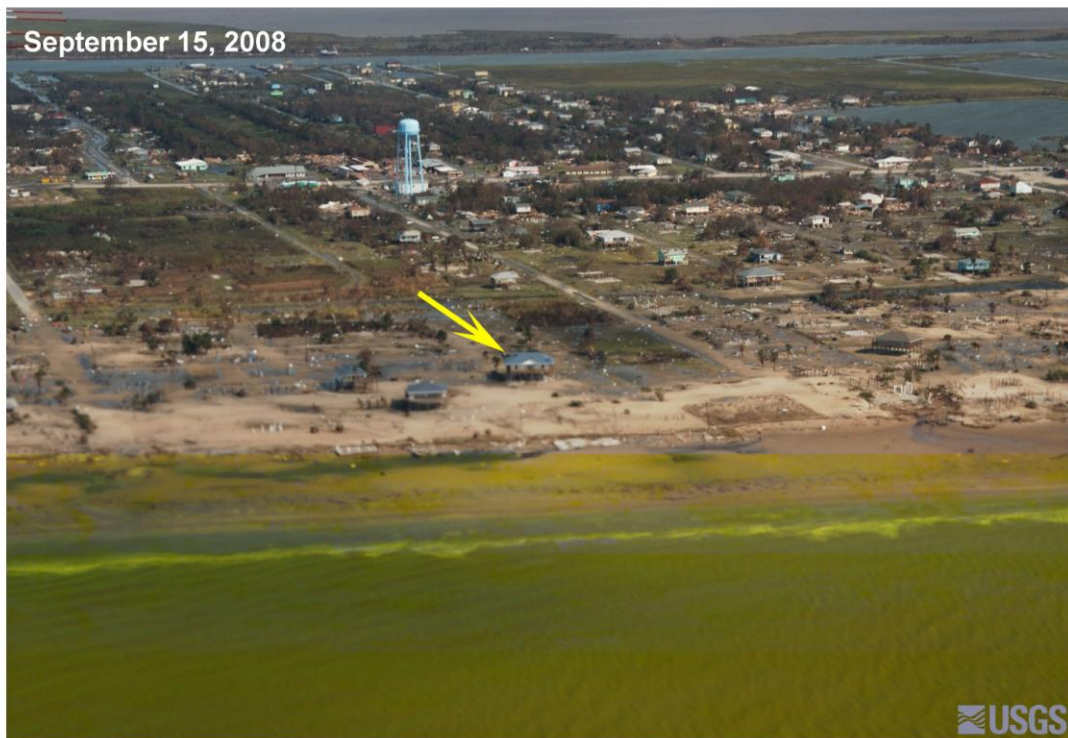
**Figure 14.** Oblique aerial photography of Bolivar Peninsula, Texas (Location 6, Figure 8), on September 9, 2008 (top) and September 15, 2008, two days after landfall of Hurricane Ike (bottom). Yellow arrows mark features visible in each image. In addition to loss of houses, the evidence of inundation here includes eroded dune face and sand deposited well inland of the shoreline.

Hurricane Ike made landfall at the mouth of Galveston Bay, thus exposing the coast lying east of landfall to the right-front quadrant of the storm, the location of the strongest winds. The storm surge, onshore-directed winds, and waves all focused their greatest energy in this area. The combination of low dunes and high-surge levels on the Bolivar Peninsula (fig. 8, locations 6 and 7) made those beaches vulnerable to inundation and large-scale coastal changes during landfall. Entire neighborhoods were destroyed by battering waves riding on top of a 5-m storm surge. Low sand dunes (about 2 m elevation) protecting beach-front neighborhoods were flattened by erosion, and sand from the beach and dunes was transported landward and ultimately deposited across the width of several blocks (figs. 14 and 15). At the narrowest part of the Peninsula near Gilchrist, Texas, the sand and debris were swept into Galveston Bay.

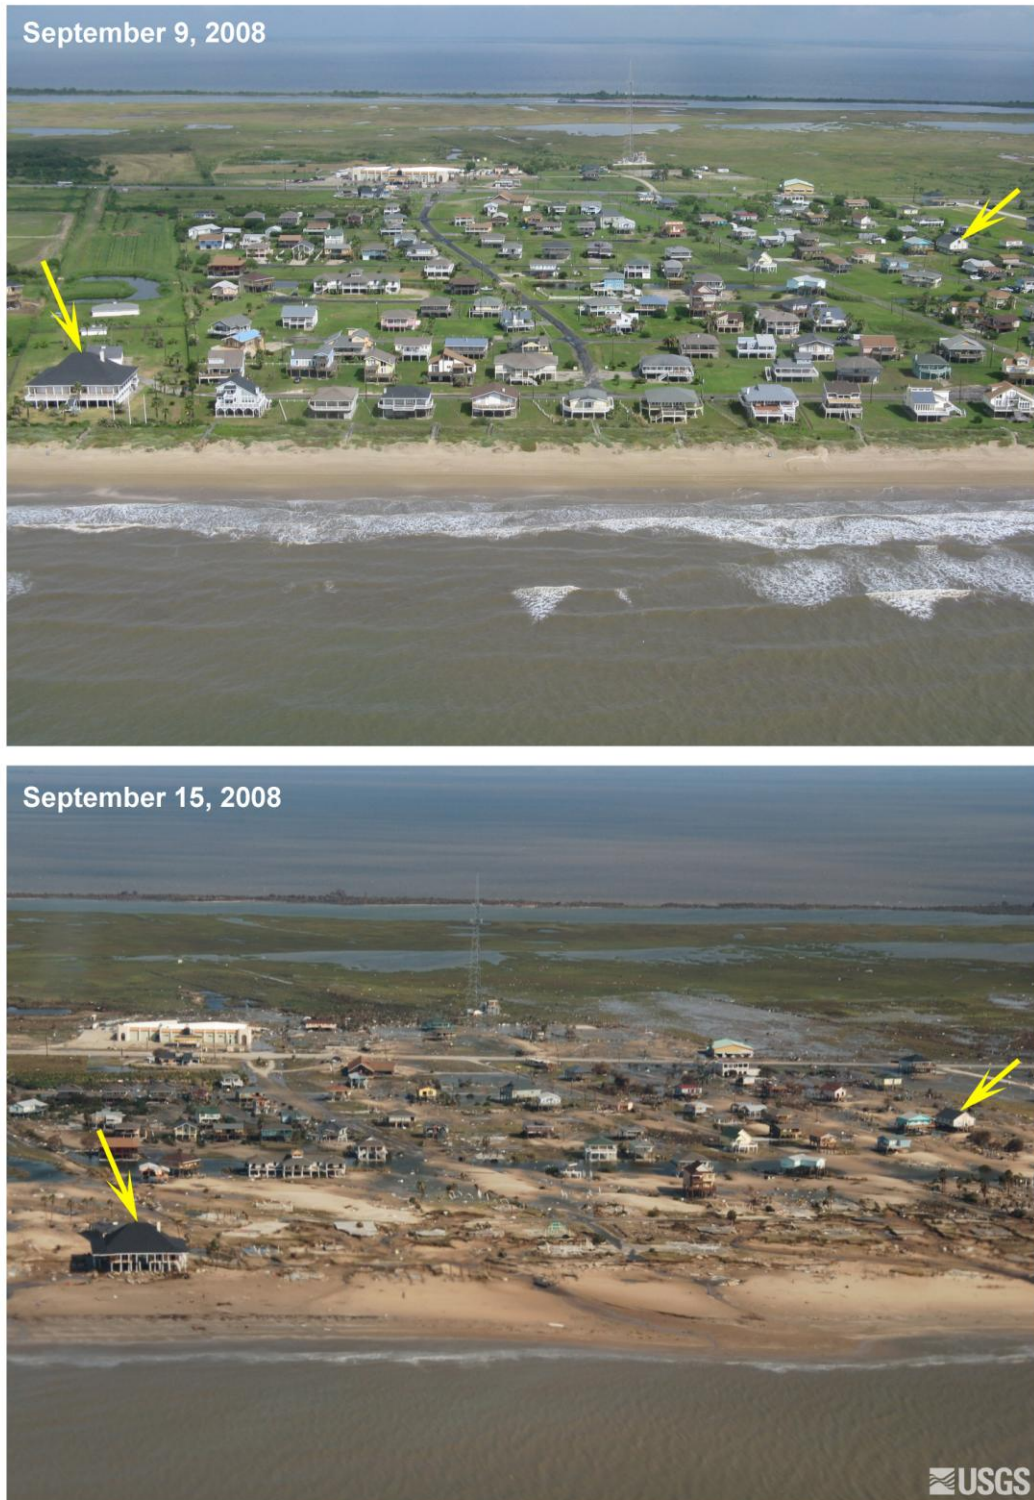
**Figure 15.** Oblique aerial photography of Bolivar Peninsula, Texas (Location 7, Figure 8), on September 9, 2008 (top), and September 15, 2008, two days after landfall of Hurricane Ike (bottom). Yellow arrows mark features visible in each image. In addition to the loss of houses, the evidence of inundation here includes eroded dune face and sand deposited well inland of the shoreline.

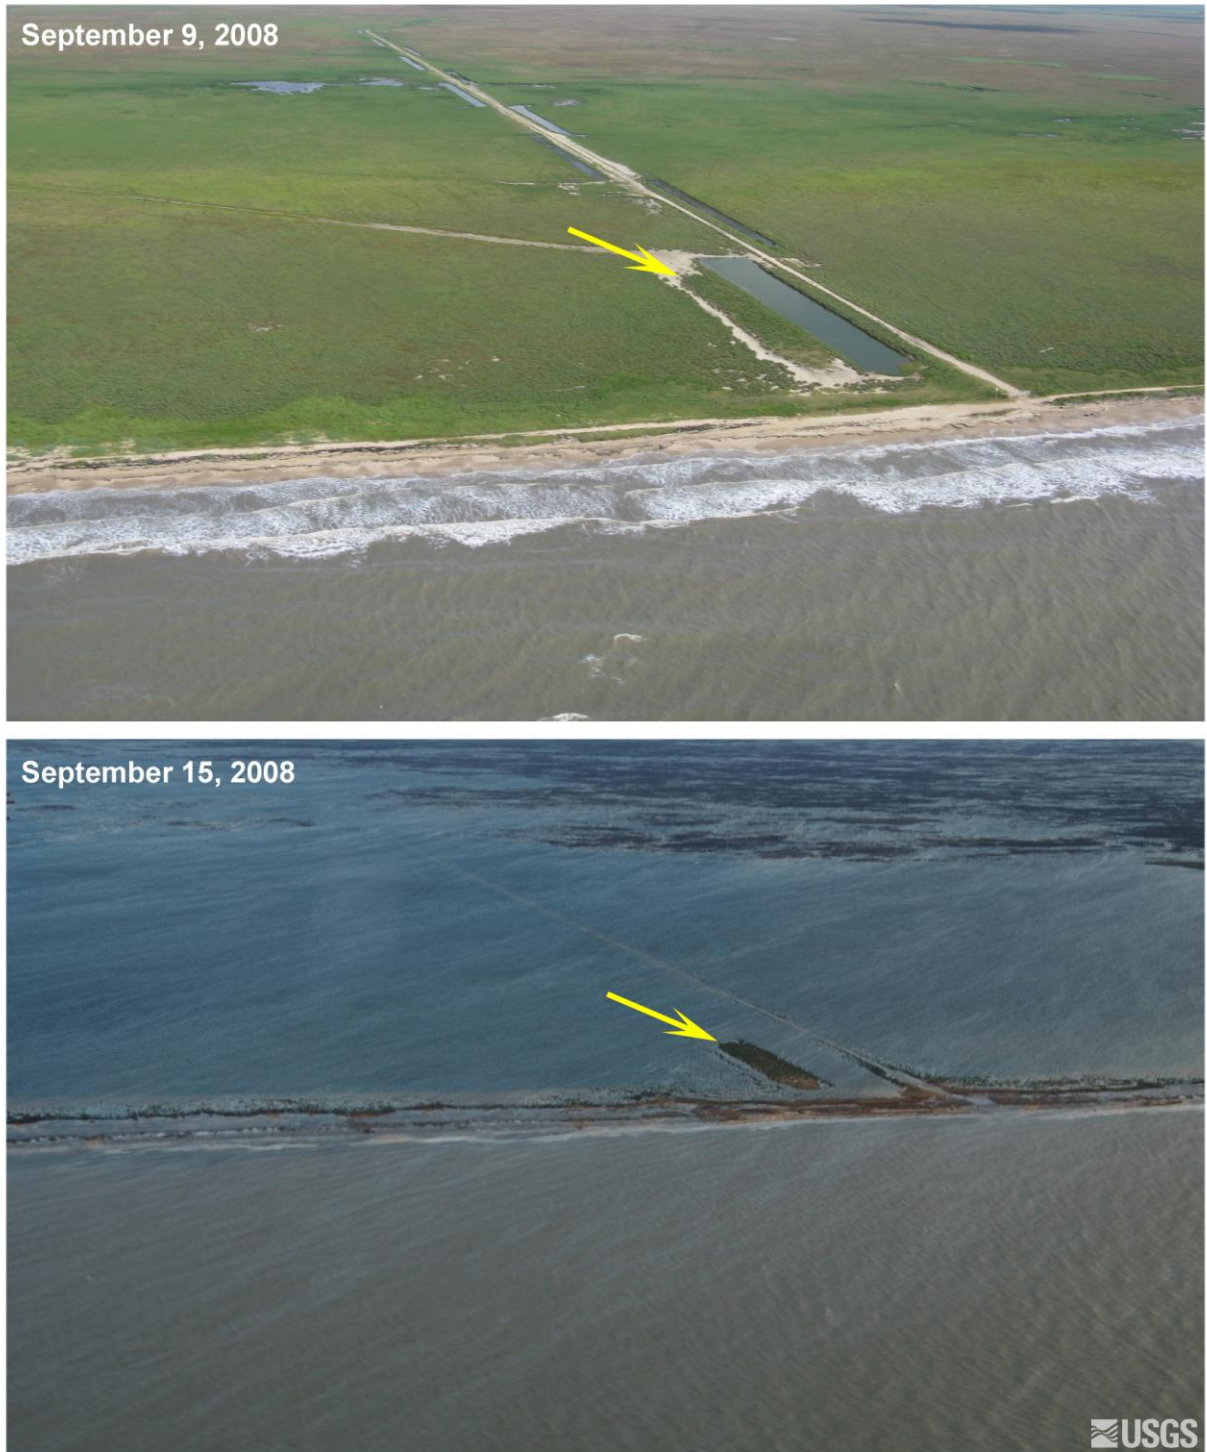
**Figure 16.** Oblique aerial photography near McFaddin Wildlife Refuge, Texas (Location 8, Figure 8), on September 9, 2008 (top) and September 15, 2008, two days after landfall of Hurricane Ike (bottom). Yellow arrows mark features visible in each image. Widespread inundation and persistent flooding are obvious but the extent of coastal change is difficult to assess.

Farther east across the upper Texas coast (fig. 8, locations 8-10), the pre-storm morphology was different and so were the impacts. Before the storm, dune elevations (or berms in the absence of dunes) were extremely low, ranging from only 1 to 2 m high. Landward of mainland beaches were low-lying marshlands. The storm surge of 3 to 4 m overtopped the beach systems and, in places, inundated the marshes tens of kilometers landward from the shoreline. Two days after the storm, floodwaters were still present, held in place by what remained of the beaches that acted like levees containing the water (figs. 16 and 17). The beach crests rose above the water and resembled barrier islands, whereas they were actually mainland beaches. Breaches were cut through these 'barriers' and water flowed seaward, slowly draining the huge, shallow lakes. During this process, eroded sand was transported seaward into the Gulf of Mexico (fig. 18).

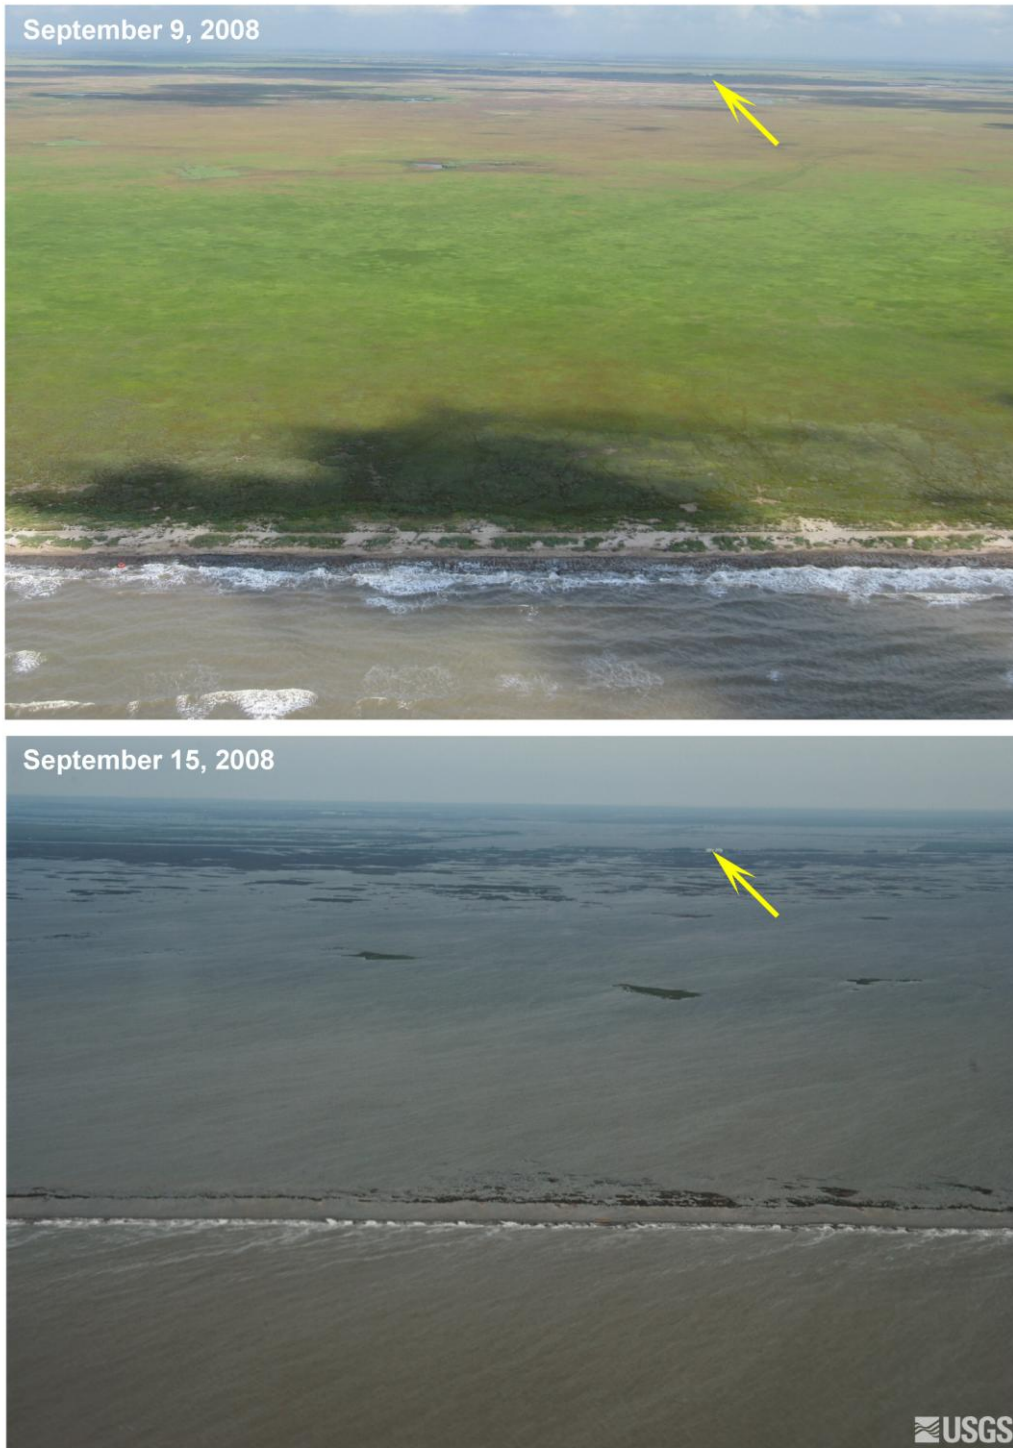
**Figure 17.** Oblique aerial photography near McFaddin Wildlife Refuge, Texas (Location 9, Figure 8), on September 9, 2008 (top) and September 15, 2008, two days after landfall of Hurricane Ike (bottom). Yellow arrows mark features visible in each image. Again, widespread inundation and persistent flooding are obvious. The white foam at the bottom of the post-storm photo is due to the return flow cascading over the berm as the area drains into the Gulf of Mexico.

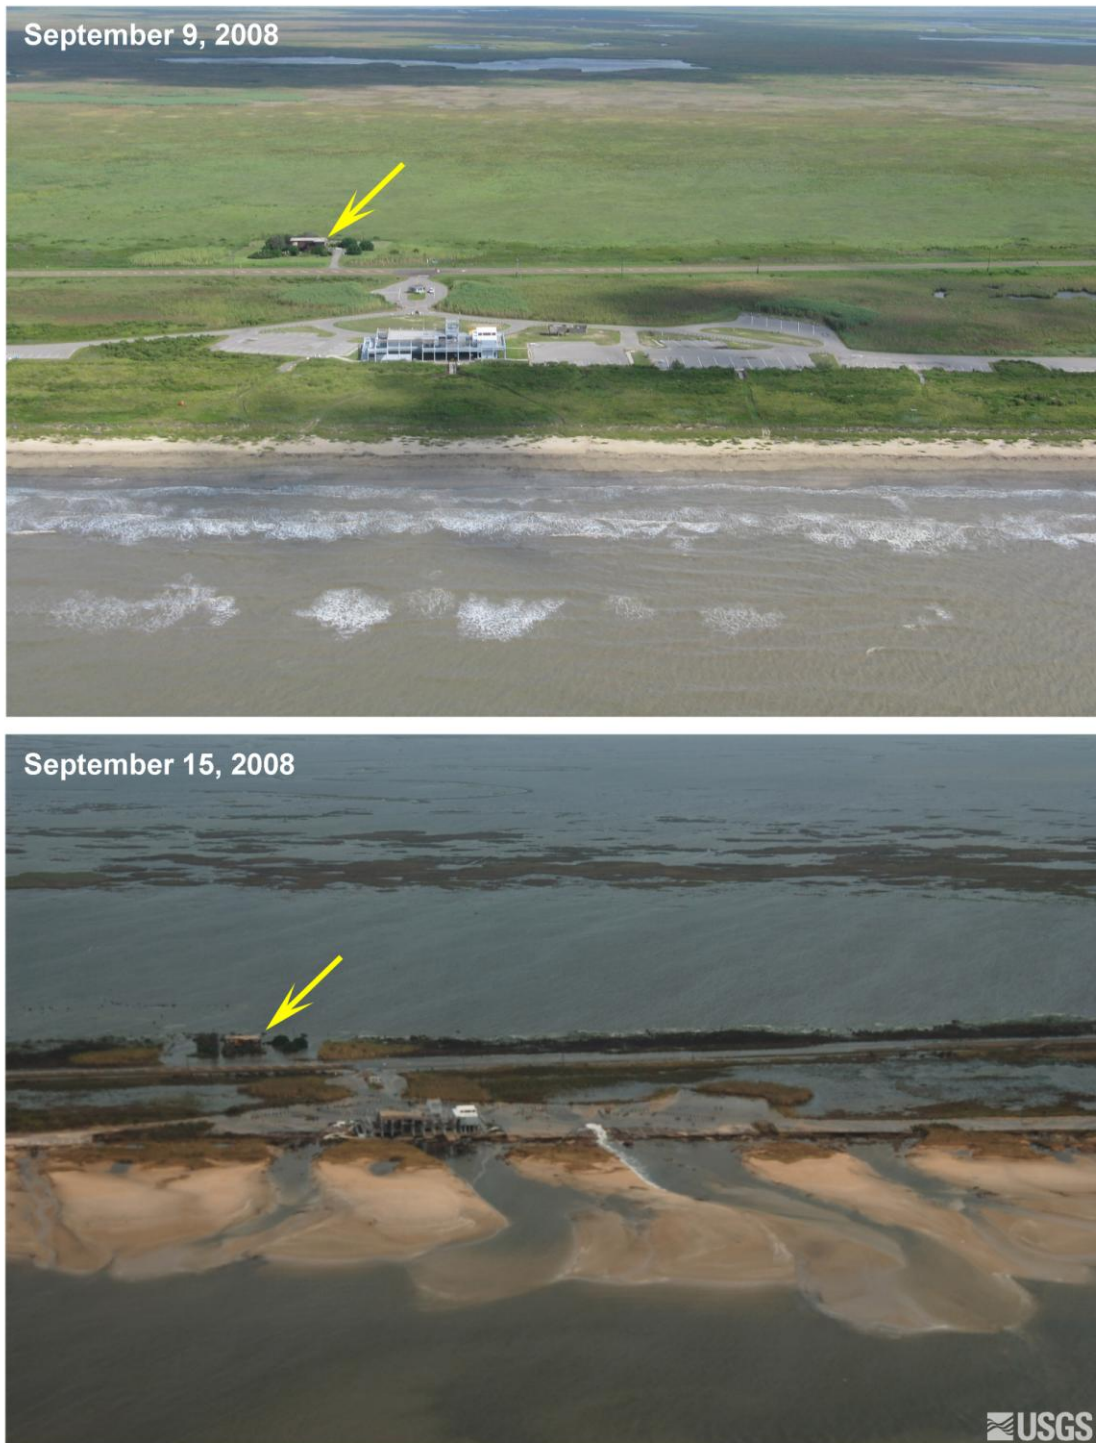
**Figure 18.** Oblique aerial photography near McFaddin Wildlife Refuge, Texas (Location 10, Figure 8), on September 9, 2008 (top) and September 15, 2008, two days after landfall of Hurricane Ike (bottom). Yellow arrows mark features visible in each image. Evidence of widespread inundation is apparent. The flooded area continues to drain through a channel that cuts through the roadway. The dunes have been eroded and dissected. Backflow through this area transported sediment offshore.

Shoreline erosion of 150 m was observed near Gilchrist, Texas. More than 50 m of shoreline erosion was experienced over a wide region from the seawall extending 15 km to the west. The area of positive shoreline change at the south end of Galveston Island is related to spit formation at San Luis Pass and may not be related to Hurricane Ike. The area of positive shoreline change 80 km to the right of landfall is due to the seaward transport of sediment as storm water drained from the marshes (fig. 18).
