# Hurricane Ike: Observations and Analysis of Coastal Change

## USGS Open-File Report 2009-1061

Open-File Report 2009–1061

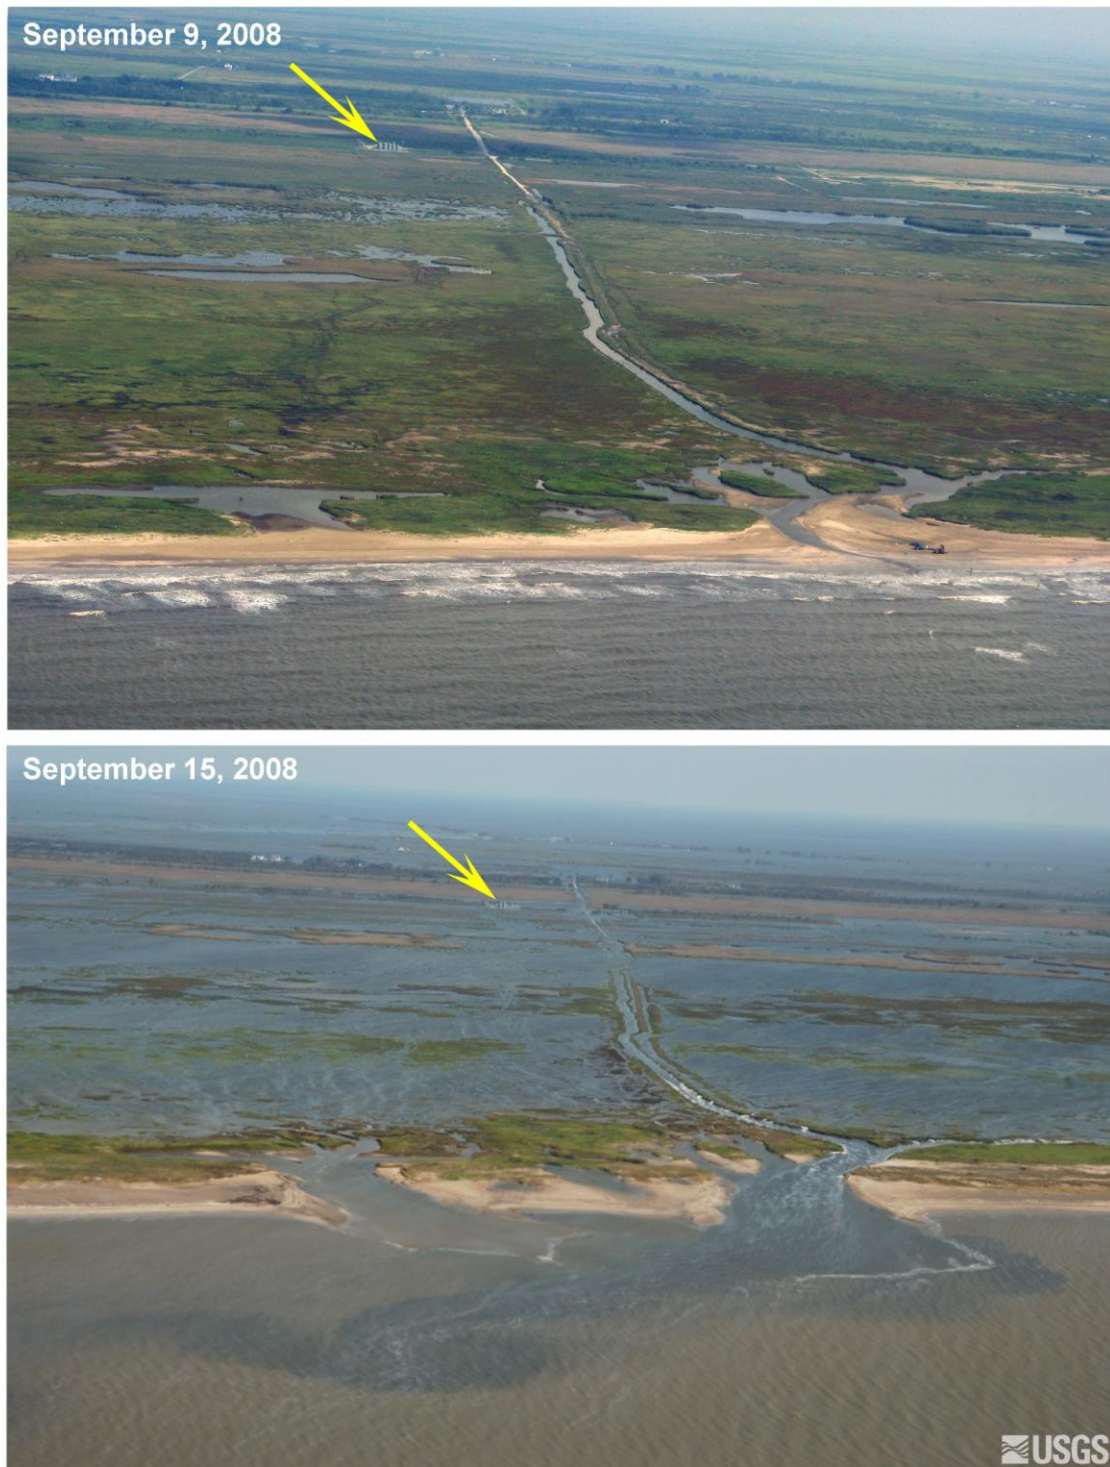
**Figure 19.** Oblique aerial photography from Cameron Parish, Louisiana (Location 11, Figure 8), on September 9, 2008 (top) and September 15, 2008, two days after landfall of Hurricane Ike (bottom). Yellow arrows mark features visible in each image. Widespread inundation and persistent flooding are obvious. Coastal change includes both beach erosion and erosion of channels where water continues to flow seaward to the Gulf of Mexico.

The morphology of the western Louisiana coast (fig. 8, locations 11-13) is similar to that of the Texas coastline north of the Bolivar Peninsula. Before the storm, dune elevations (or berms in the absence of dunes) were low, ranging from only 1 to 2 m high. Landward of the beaches were low-lying marshlands. The storm surge of 1 to 3 m overtopped the beach systems in many areas, and waves (figs. 19 and 20) eroded the shoreline landward. The town of Holly Beach, Louisiana, which was completely destroyed by Hurricane Rita in 2005, was once again flooded by Hurricane Ike (fig. 21).

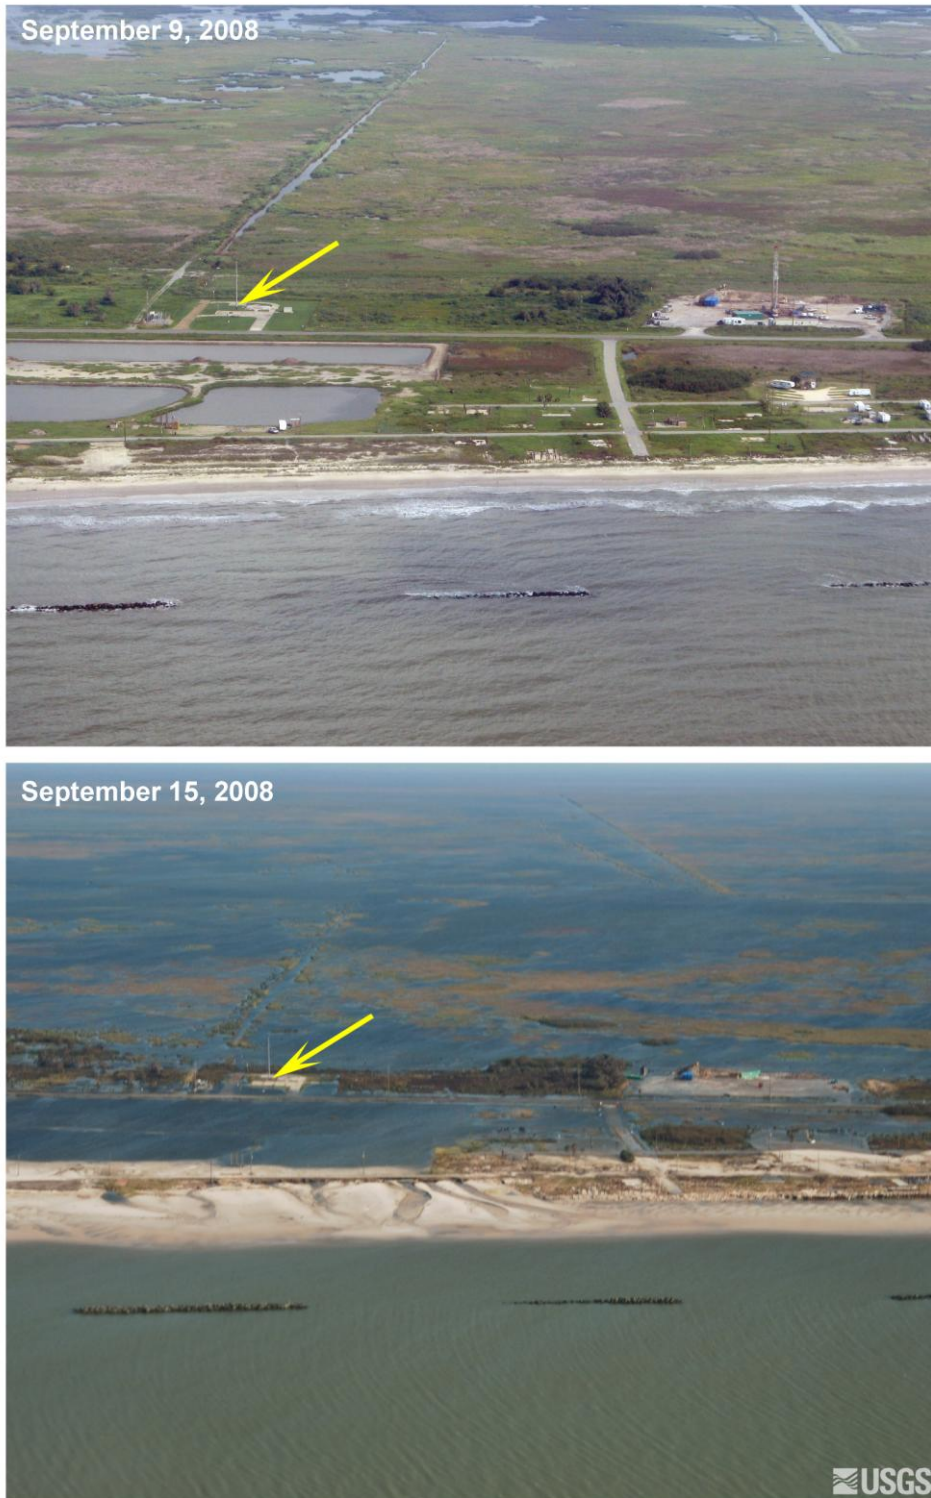
**Figure 20.** Oblique aerial photography from Peveto Beach, Louisiana (Location 12, Figure 8), on September 9, 2008 (top) and September 15, 2008, two days after landfall of Hurricane Ike (bottom). Yellow arrows mark features visible in each image. Evidence of widespread inundation includes erosion of the berm and channels that drained the flooded area.

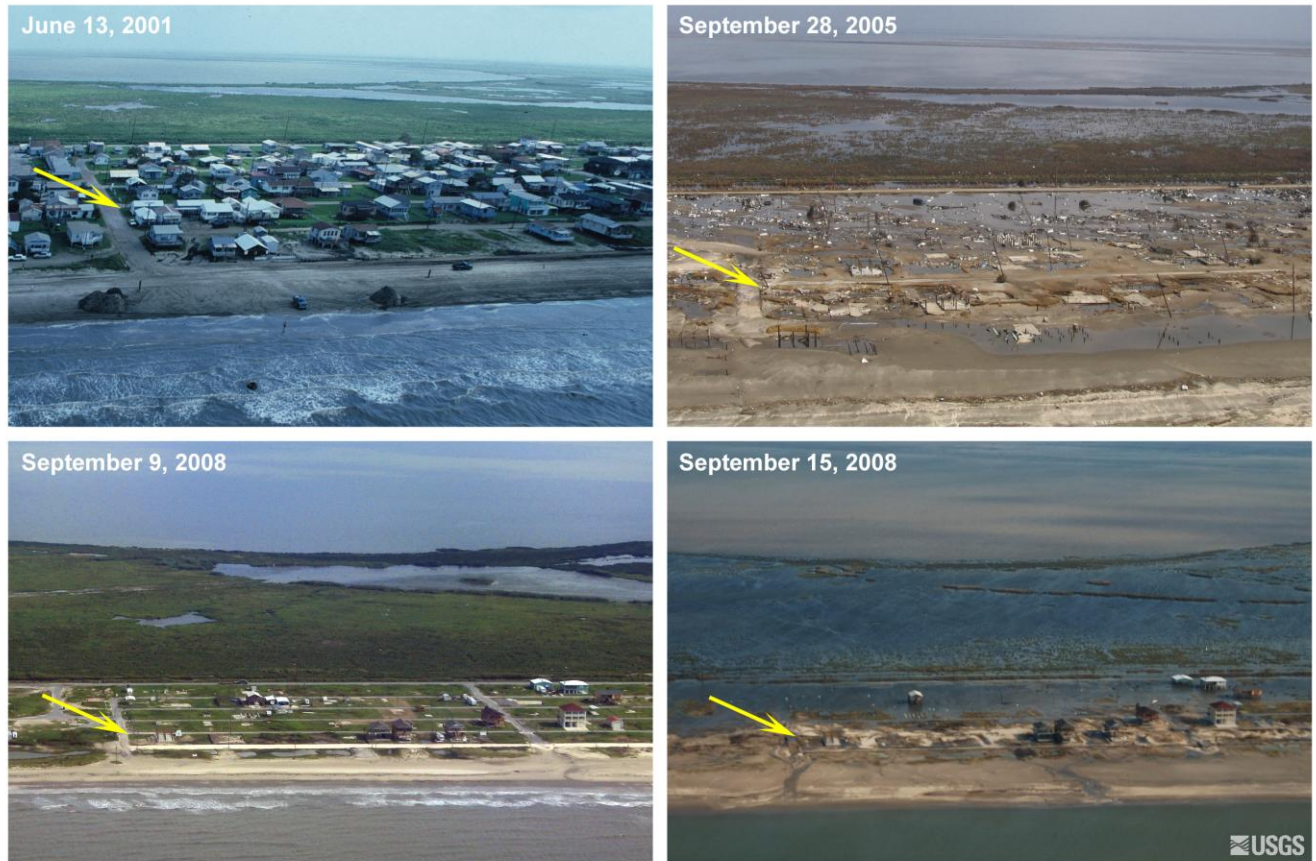
**Figure 21.** Oblique aerial photography from Holly Beach, Louisiana (Location 13, Figure 8), from 2001-2008. Yellow arrows mark features visible in each image. The first photo shows this area prior to landfall of Hurricane Rita on September 24, 2005. Immediately after Rita's landfall, the September 28, 2005, photo shows destruction of houses. Prior to Ike's landfall, on September 9, 2008 there is little evidence of a dune or berm on this beach. Several houses and smaller structures have been rebuilt. On September 15, 2008, two days after landfall of Hurricane Ike, the beach is eroded and there is evidence of overwash and persistent flooding.

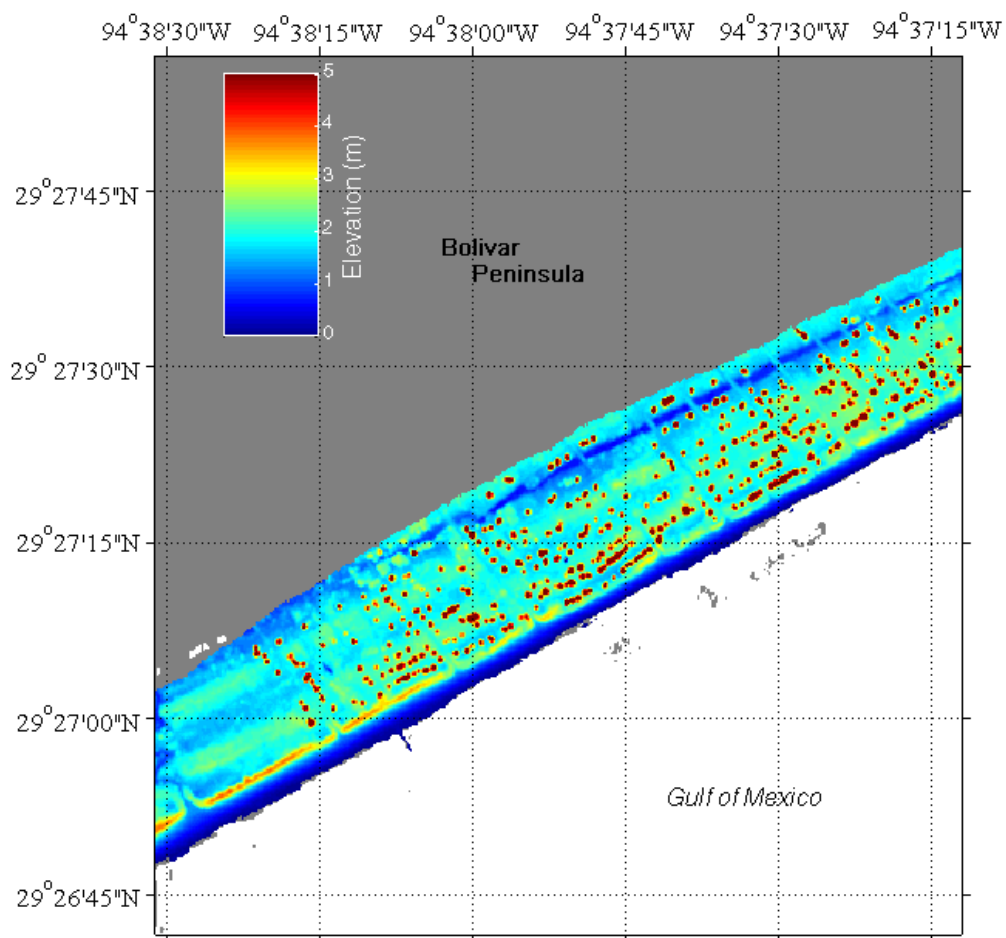
**Figure 22.** September 2005 Experimental Advanced Airborne Research Lidar first-return lidar digital elevation model of Crystal Beach, Texas.

Last-return lidar data were analyzed to compare morphologic changes due to Hurricane Ike. The morphologic analysis was optimized for identifying shorelines and dune height. The analysis required interpolation to a gridded domain that was rotated parallel to the shoreline and had a resolution of 10 m in the longshore direction and 2.5 m in the cross-shore direction. The interpolation method applies spatial filtering with a Hanning window that is twice as wide as the grid resolution (Plant and others, 2002). Grids of pre- and post-storm lidar topography can be differenced over the entire overlapping survey area to compute elevation or volume changes over various distances and to give a quick visual of coastal change. For the town of Crystal Beach, Texas, on the Bolivar Peninsula, difference grids reveal loss of homes, erosion of the shoreline, and reduction of dune elevations (figs. 22-24). Overwash deposits (fig. 24) can be seen several hundred meters from the shoreline.

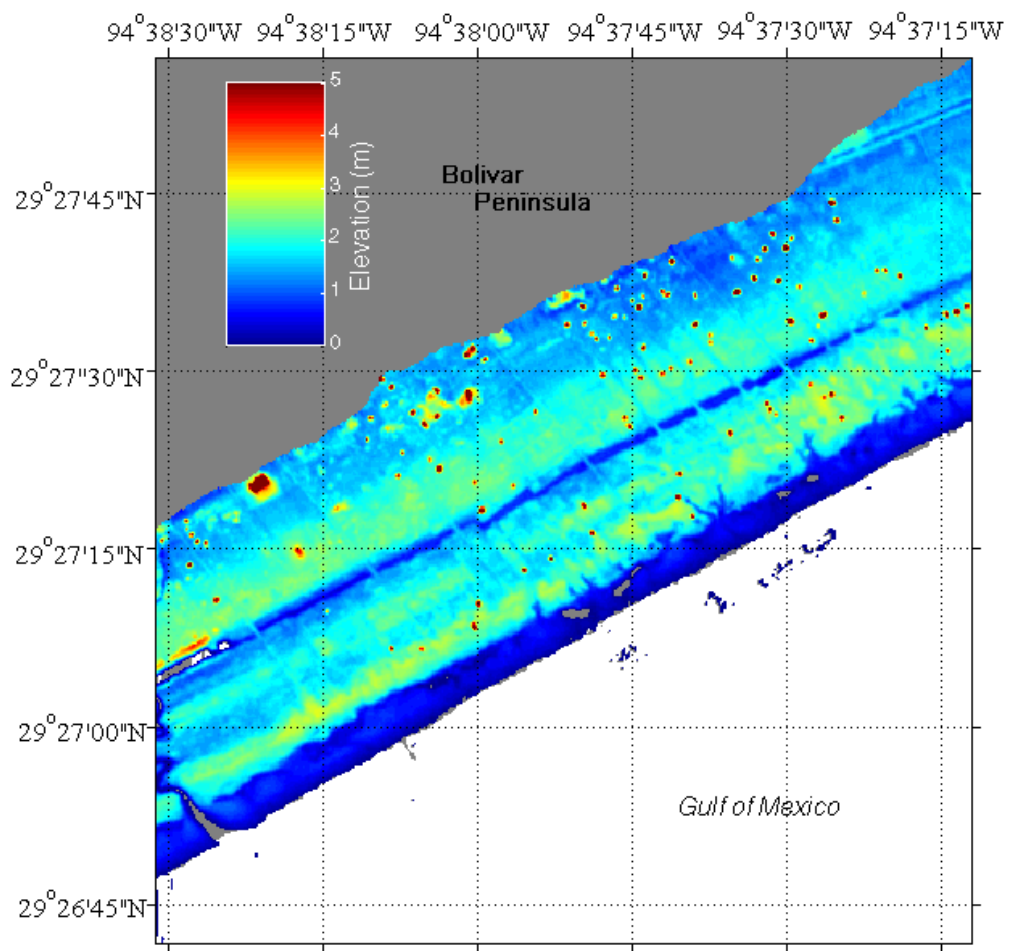
**Figure 23.** September 2008 Experimental Advanced Airborne Research Lidar first-return lidar digital elevation model of Crystal Beach, Texas.

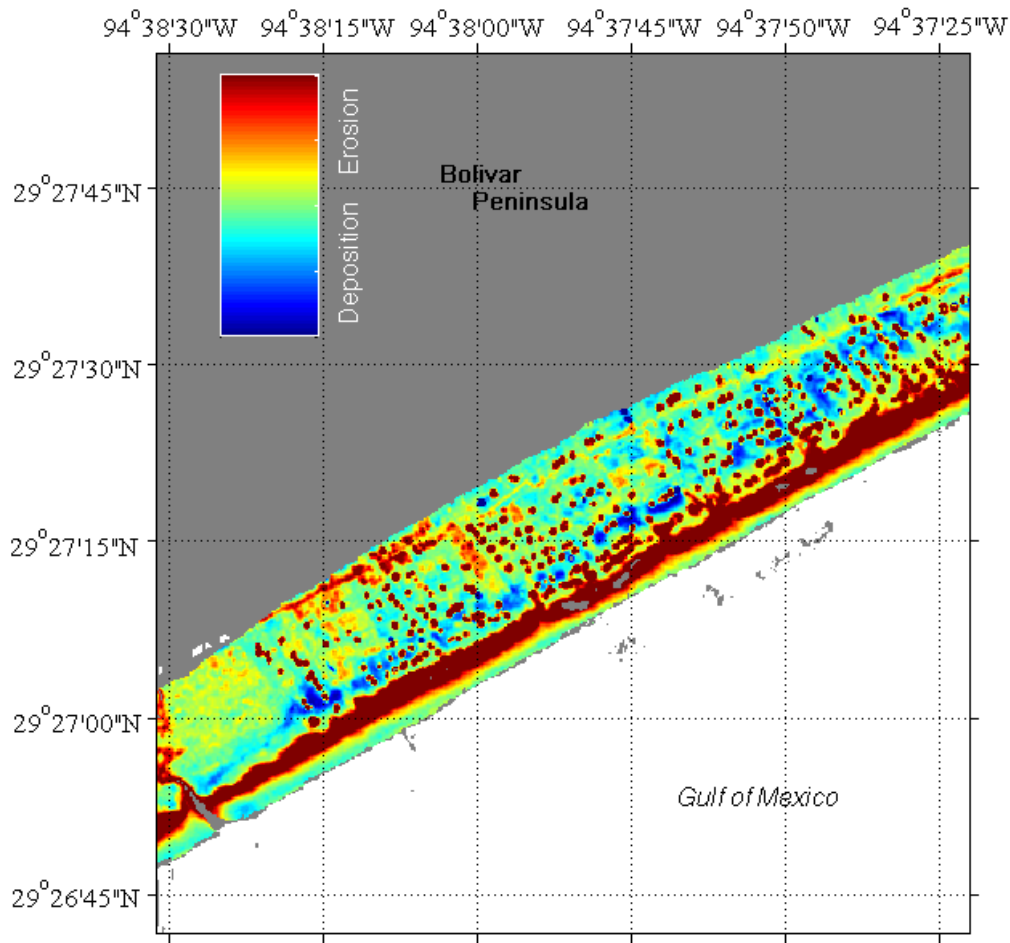
**Figure 24.** Coastal Change at Crystal Beach, Texas, due to Hurricane Ike. The coastal change between the two dates is determined from the difference between the two datasets. For the coastal-change figure, red indicates at least 1 m of erosion and blue indicates at least 1 m of deposition. The spatial coverage of the two data sets differs and the 2008 mission had more extensive coverage than the 2005 mission in this area.

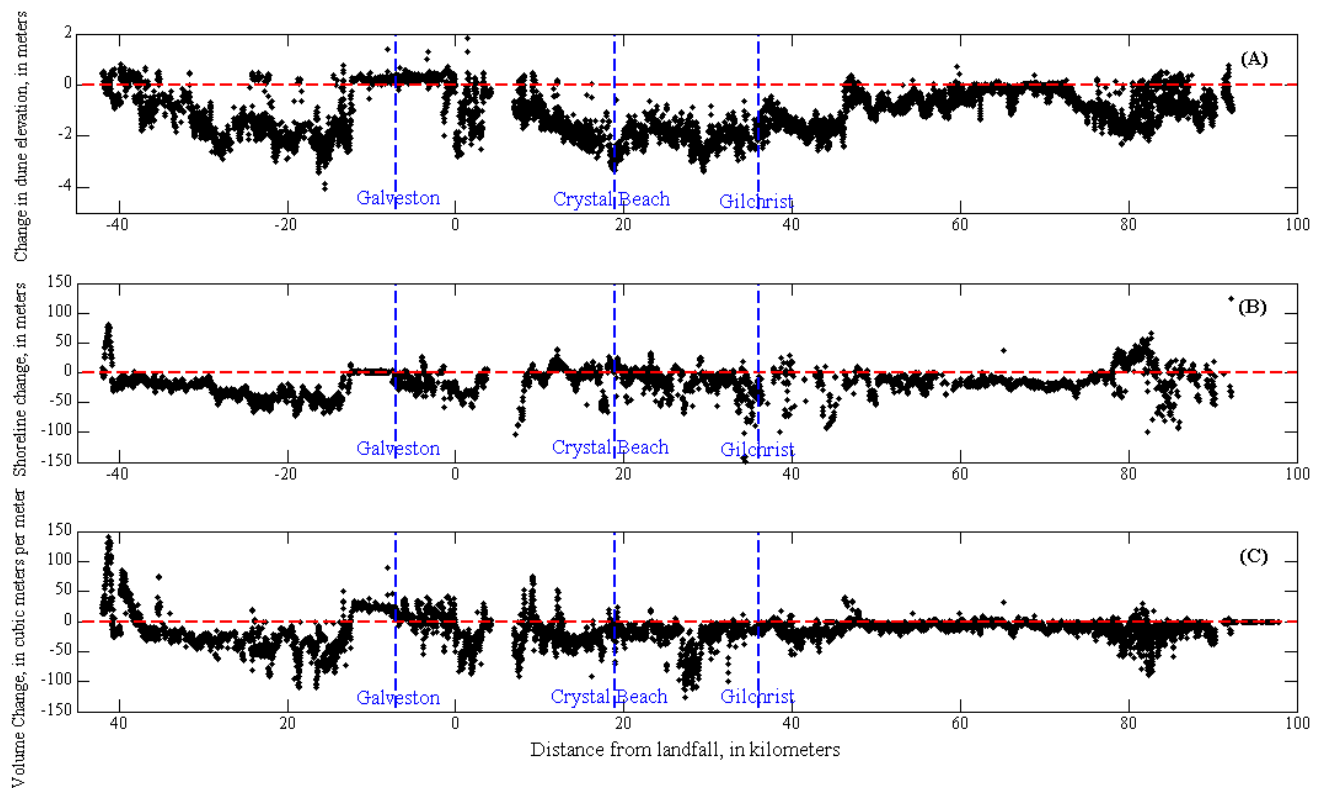
**Figure 25.** Hurricane Ike (A) dune-elevation change (B) shoreline change (C) and beach-volume change. Blue lines indicate the center of the towns of Galveston, Crystal Beach, and Gilchrist, Texas.

Extreme elevation changes of about 3 m were observed near Crystal Beach, Texas, which is located on the Bolivar Peninsula and was in the right-front quadrant of the hurricane impact zone. Dune-height changes exceeding 1 m were observed more than 60 km to the right of the landfall position.

Dune-height changes exceeding 1 m were observed as far as 40 km to the left of landfall. In Galveston, Texas, the seawall is considered to be the dune crest and the elevation change is roughly 30 cm, consistent with the previously determined vertical offset.

Shoreline erosion of 150 m was observed near Gilchrist, Texas. More than 50 m of shoreline erosion was experienced over a wide region from the seawall extending 15 km to the west. The area of positive shoreline change at the south end of Galveston Island is related to spit formation at San Luis Pass and may not be related to Hurricane Ike. The area of positive shoreline change 80 km to the right of landfall is due to the seaward transport of sediment as storm water drained from the marshes (fig. 18).

Volume-change calculations were performed by contouring the topography at a fixed vertical datum, which was set at mean high water from tidal records (Weber and others, 2005). The volume is calculated between the cross-shore location of the pre-storm dune base and the pre-storm shoreline. This eliminates complications from structures and vegetation, which generally are located landward of the dune base. Beach volume change was calculated as the difference between the September 2005 and September 2008 surveys (fig. 25C).

Volume losses typically follow the same pattern as the shoreline changes in the region to the west of Galveston. This implies that sediment lost due to erosion was not deposited farther landward. East of landfall, volume changes were highly variable. Some areas, such as the region between Crystal Beach and Gilchrist, Texas, experienced substantial volume loss. However, the town of Crystal Beach, Texas, experienced little net sediment loss. This is consistent with the appearance of overwash deposits that presumably contain the sediment that was eroded from the shoreline and dunes (fig. 24). The positive volume change near the San Luis Pass at the south end of Galveston Island is likely long-term sediment accumulation at the inlet. Volume change along the seawall of Galveston is positive due to the 30-cm relative offset.
