# **Channel Morphology and Bed Sediment Characteristics Before and After Habitat Enhancement Activities in the Uridil Property, Platte River, Nebraska, Water Years 2005–2008**

Open-File Report 2009-1147

By Paul J. Kinzel

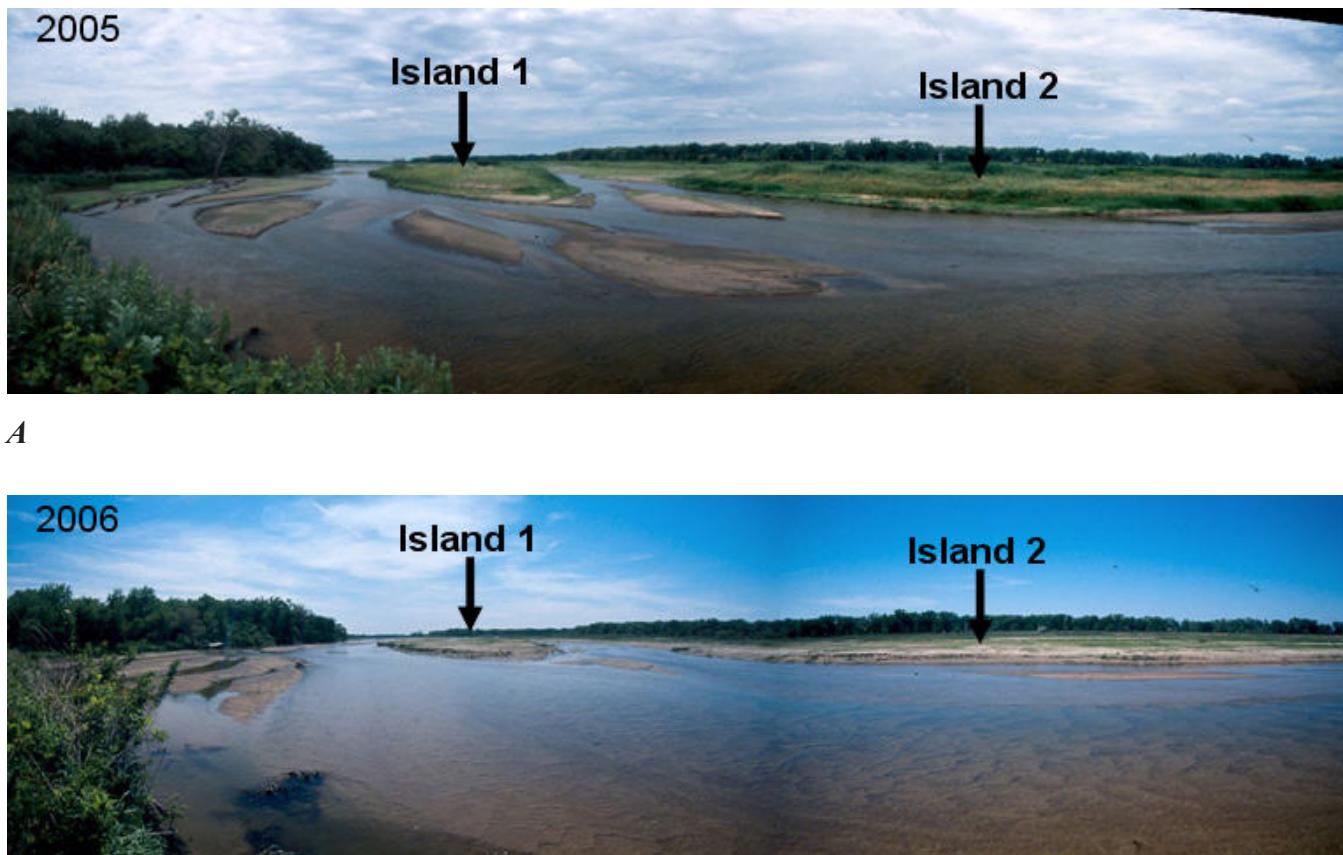
**Figure 6.** Panoramic images created from ground photographs taken from the right bank near transect 13. The photographs were taken looking upstream at islands 1 and 2. (A) Before the management activities on July 26, 2005 and (B) following the management activities on May 20, 2006.

digital images at a resolution of 200 dots per inch. Panorama photographs were taken from the right bank at transect 13 looking upstream at two of the three managed islands in 2005 before the management activities and in 2006 following the management activities (figs. 6A,B). The collection of ground photographs taken during the study period are provided in Appendix 3. The file name of each photograph indicates the year, transect number, and direction the photograph was taken. Photographs taken upstream are identified (us), along transects (xs), and downstream (ds).
