## Land-Surface Subsidence and Open Bedrock Fractures in the Tully Valley, Onondaga County, New York

Open bedrock fractures were mapped in and near two brine field areas in Tully Valley, New York. More than 400 open fractures and closed joints were mapped for dimension, orientation, and distribution along the east and west valley walls adjacent to two former brine fields. The bedrock fractures are as much as 2 feet wide and over 50 feet deep, while linear depressions in the soil, which are 3 to 10 feet wide and 3 to 6 feet deep, indicate the presence of open bedrock fractures below the soil. The fractures are probably the result of solution mining of halite deposits about 1,200 feet below the land surface.

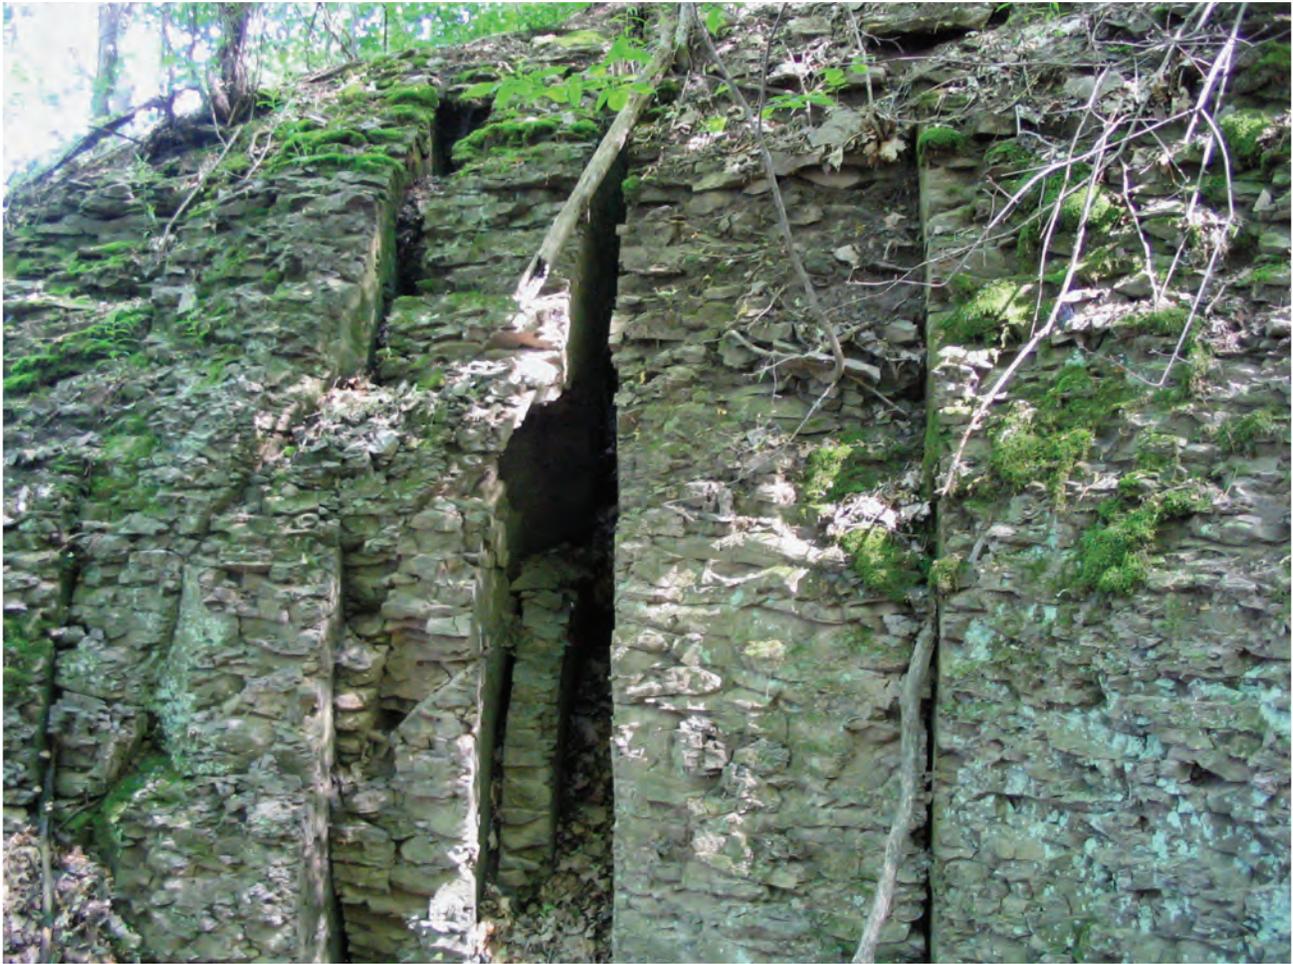
Bedrock fractures have opened in response to subsidence over a former solution-mined area. Subsidence is occurring beyond the left side of the photograph, and has caused these formerly closed bedrock joints to become open bedrock fractures as the rock mass moved to the left.

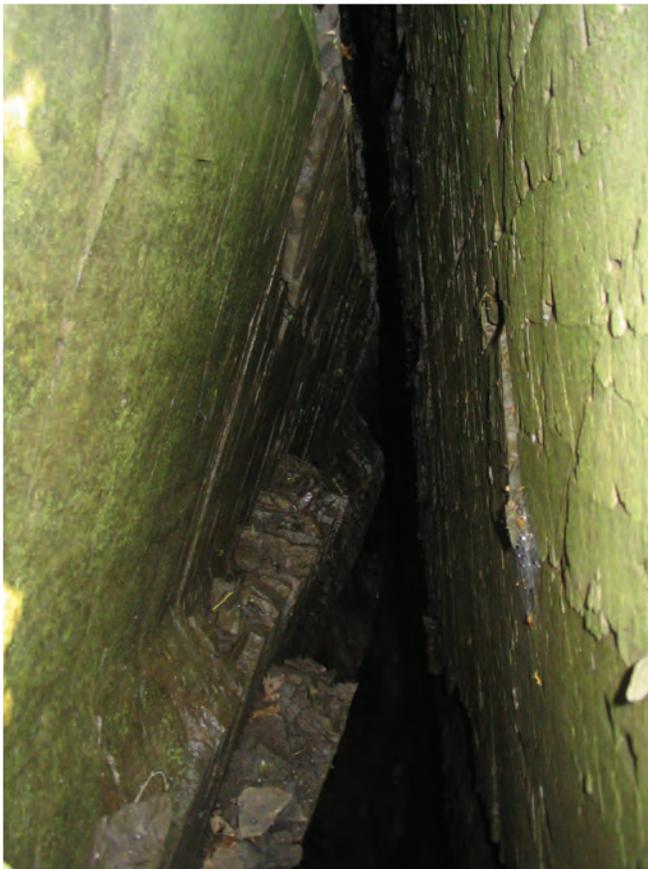
Looking downward into an open bedrock fracture which is about 30 feet deep. The left face has pulled away from the right face of the bedrock fracture in response to land-surface subsidence in the former brine field.

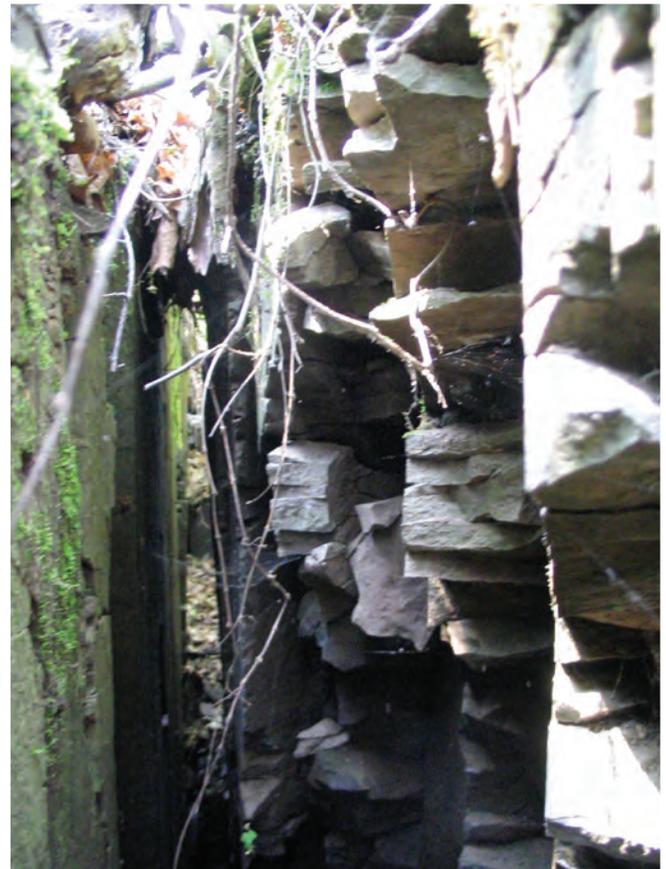
An open fracture showing the uphill face on the left and the downhill face on the right. The saw-tooth pattern of the right face of the fracture shows the close proximity of two intersecting joint sets in the bedrock.

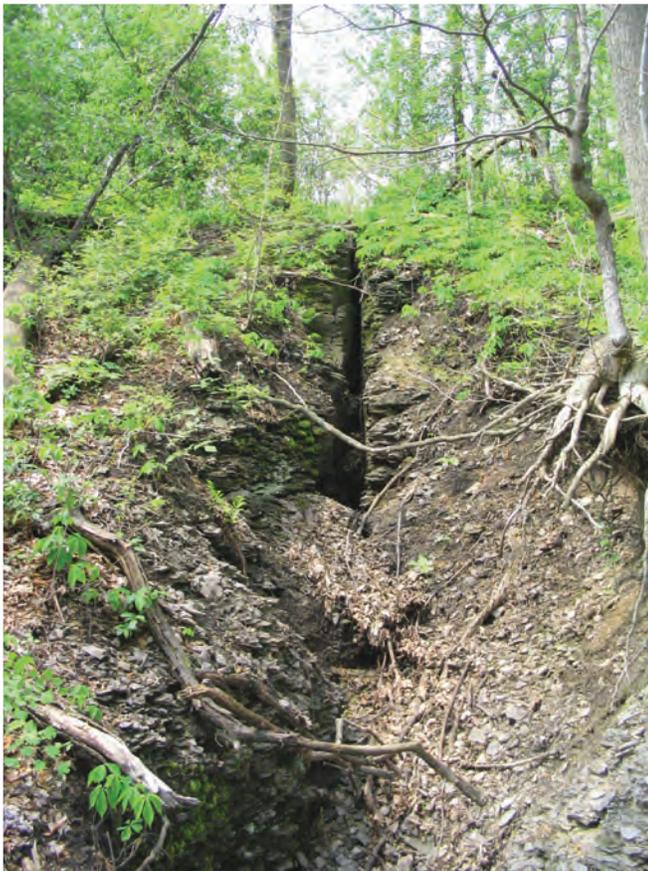
Open bedrock fracture adjacent to the west brine field, showing an open bedrock fracture above, with soil still bridging the open fracture below.

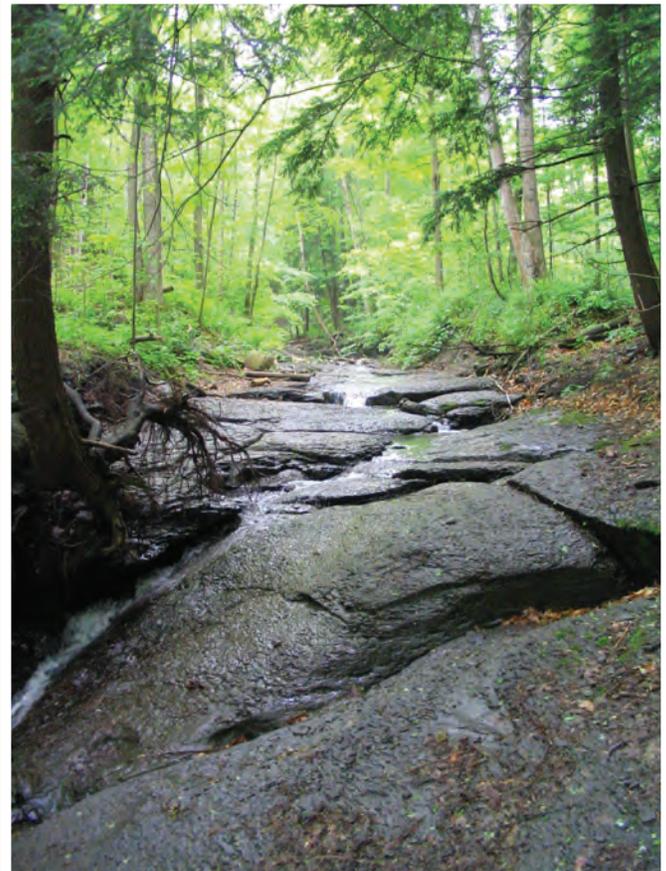
Bedrock floor of Emerson Gulf above the Tully Valley, showing the influence of closed bedrock joints on the erosion of the bedrock surface. This section of stream channel does not lose flow to the closed joints.

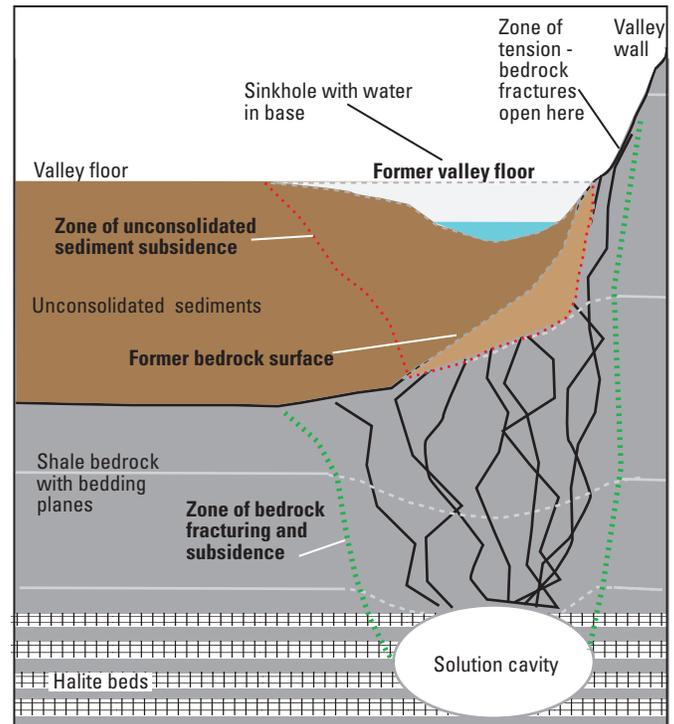
**Figure 3.** Conceptual drawing of subsidence under the floor of the Tully Valley, Onondaga County, N.Y., due to solution mining of deep halite layers, showing sag and subsidence in the bedrock above the solution cavity, the resulting sag at the land surface, and the opening of bedrock fractures along a “zone of tension” along the adjacent valley wall.

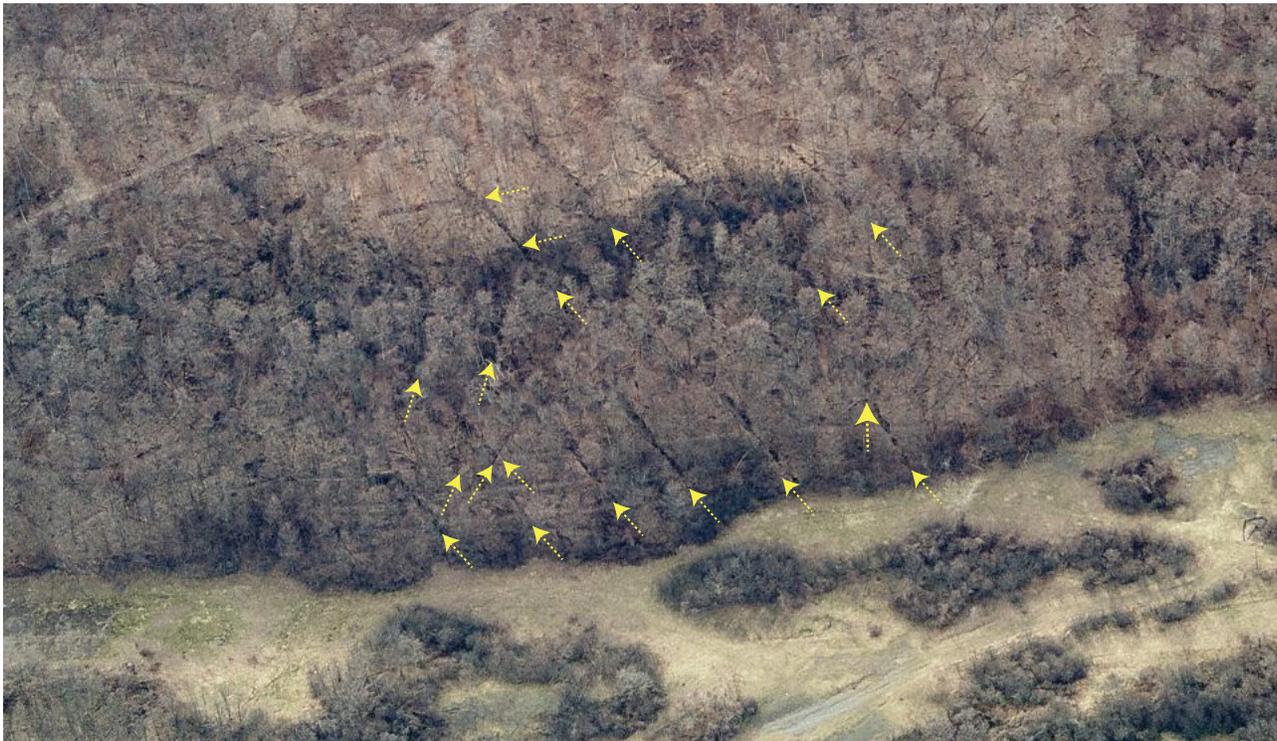
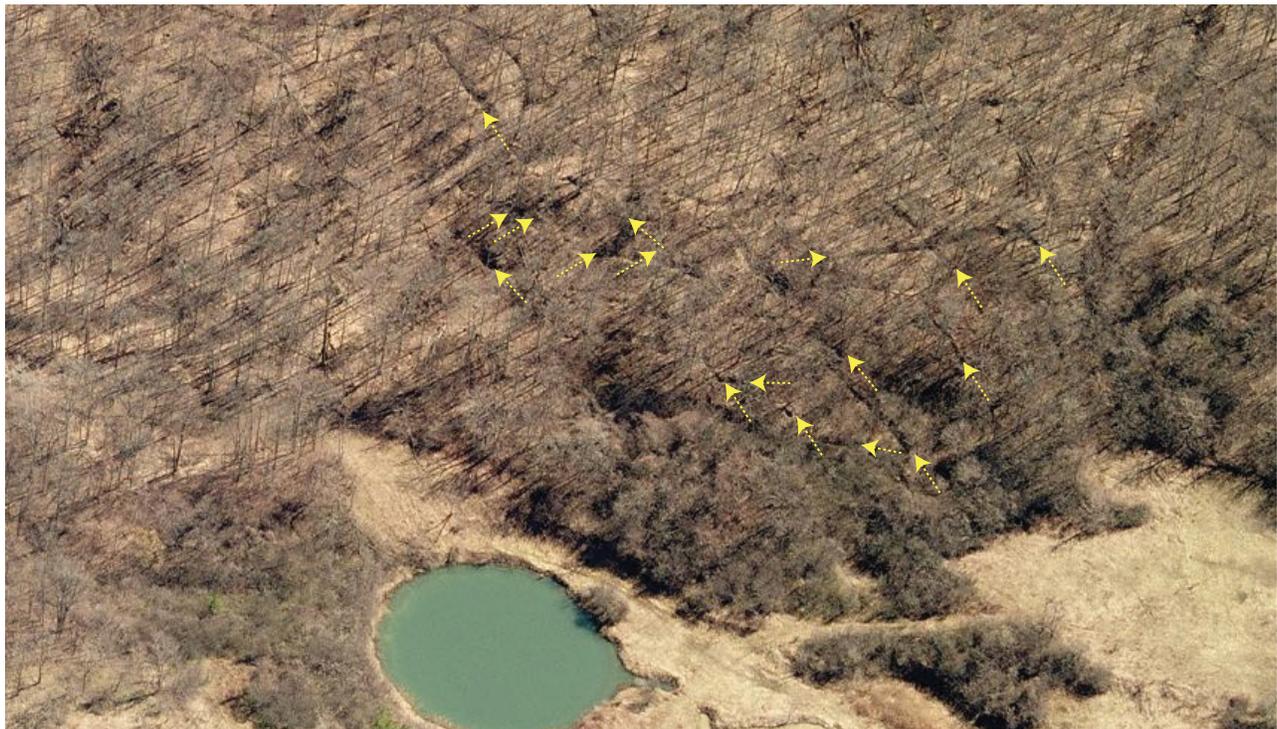
**Figure 4.** Major fractures above the Tully Valley brine fields: (A) near the north end of west brine field and (B) above the central sinkhole in the east brine field, Onondaga County, N.Y. (Arrows indicate location and orientation of large fractures on the lower hillside above each brine field.)

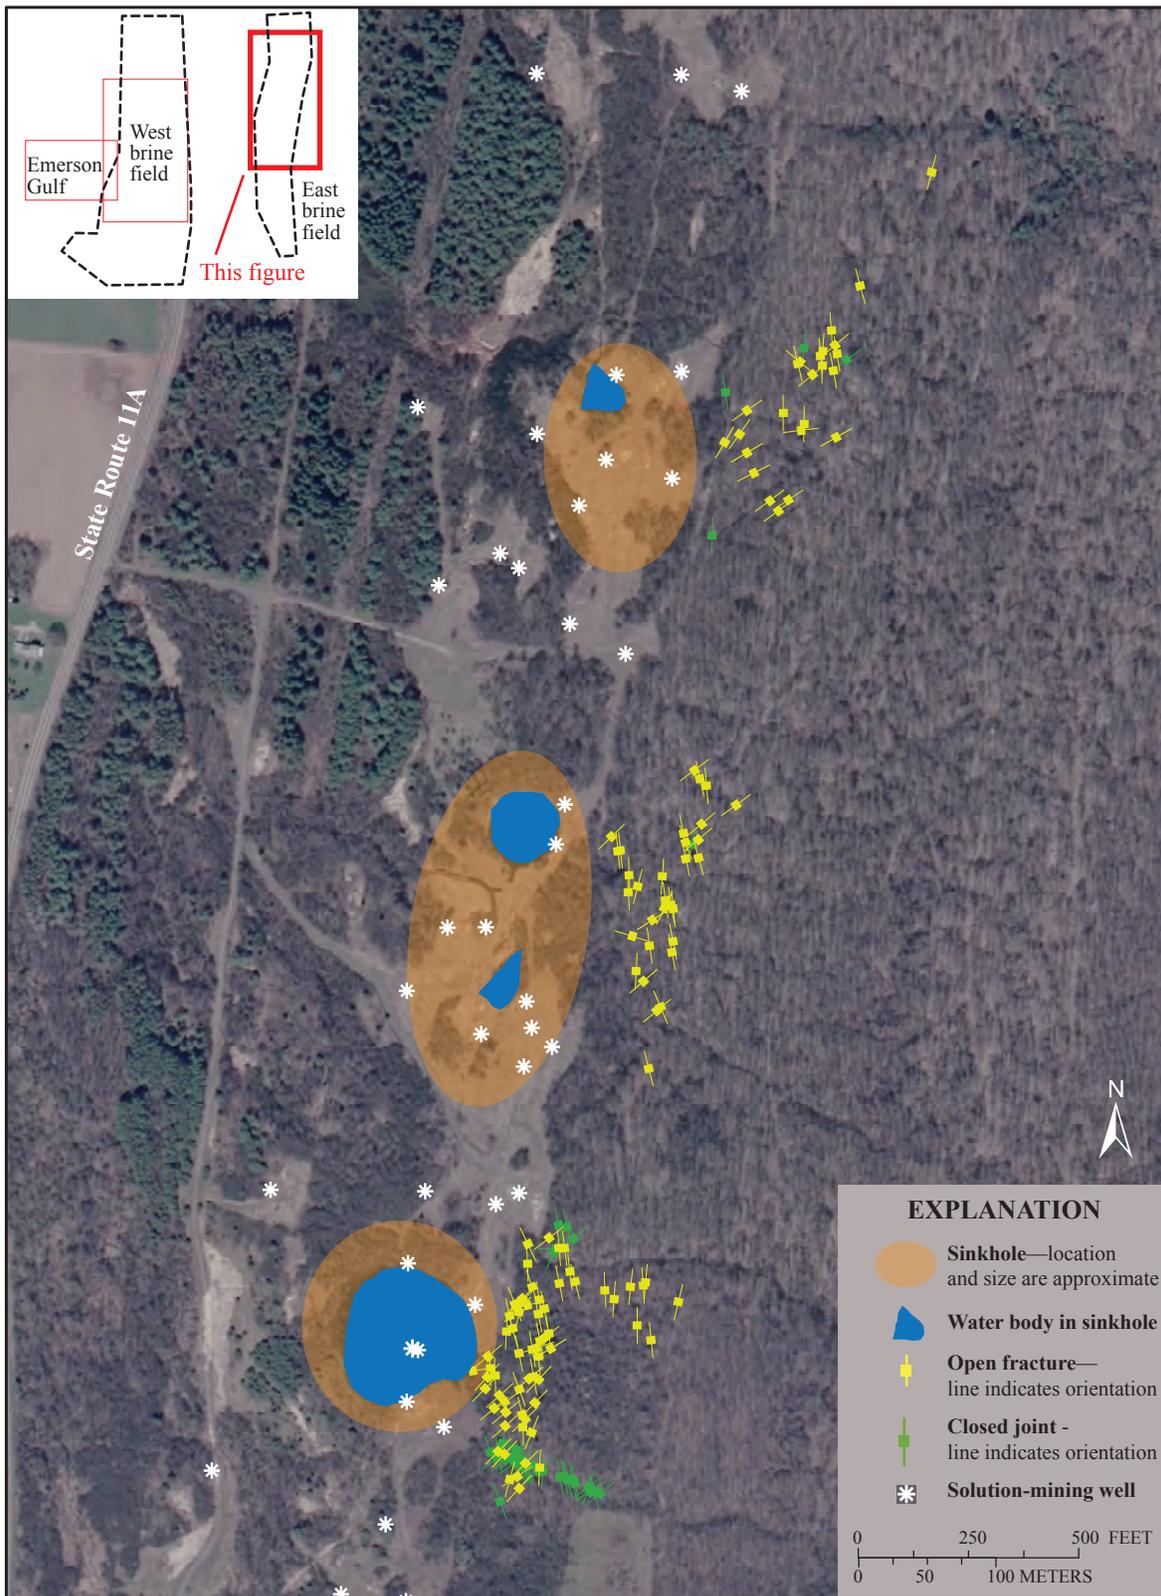
**Figure 5.** Location of open fractures and closed joints upslope from land-surface subsidence and sinkholes in the east brine field of the Tully Valley, Onondaga County, N.Y. (Location shown in figure 2.)

In the east brine field, open fractures are grouped adjacent (just uphill to the east) to three sinkhole areas (fig. 5). In the west brine field, a similar relation between open fractures and sinkhole development is noted where bedrock fractures are grouped adjacent (just uphill to the west) to the three major sinkholes (fig. 6), although along the west valley wall, the open fractures are present in a more consistent pattern near the sinkholes. Neither brine field has substantial open bedrock fractures to the north or south of the current sinkholes despite the presence of many former solution-mining wells north or south of the major sinkhole areas. The location of the sinkholes is north of a reported east-west trending geologic structure within the halite unit; the structure is possibly associated with salt deformation near the northern edge of the halite deposition margin, typically described as a décollement or sliding surface created by the halite (Rickard, 1977). CS Consulting Engineers (1992) reported that the halite beds are thicker to the north of this structure and are thinner to the south as the sliding surface may have “piled up” salt that was south of the structure and pushed it into the salt north of the structure. Therefore, in the area with a thicker sequence of halite, larger halite cavities were formed, which affected the amount and degree of overlying bedrock subsidence, and created the sinkhole areas and subsequent fracturing of adjacent bedrock. CS Consulting Engineers (1992) reported that this structure, a possible reverse fault, is aligned roughly N. 74° W., nearly parallel with and south of Solvay Road (figs. 1 and 2).

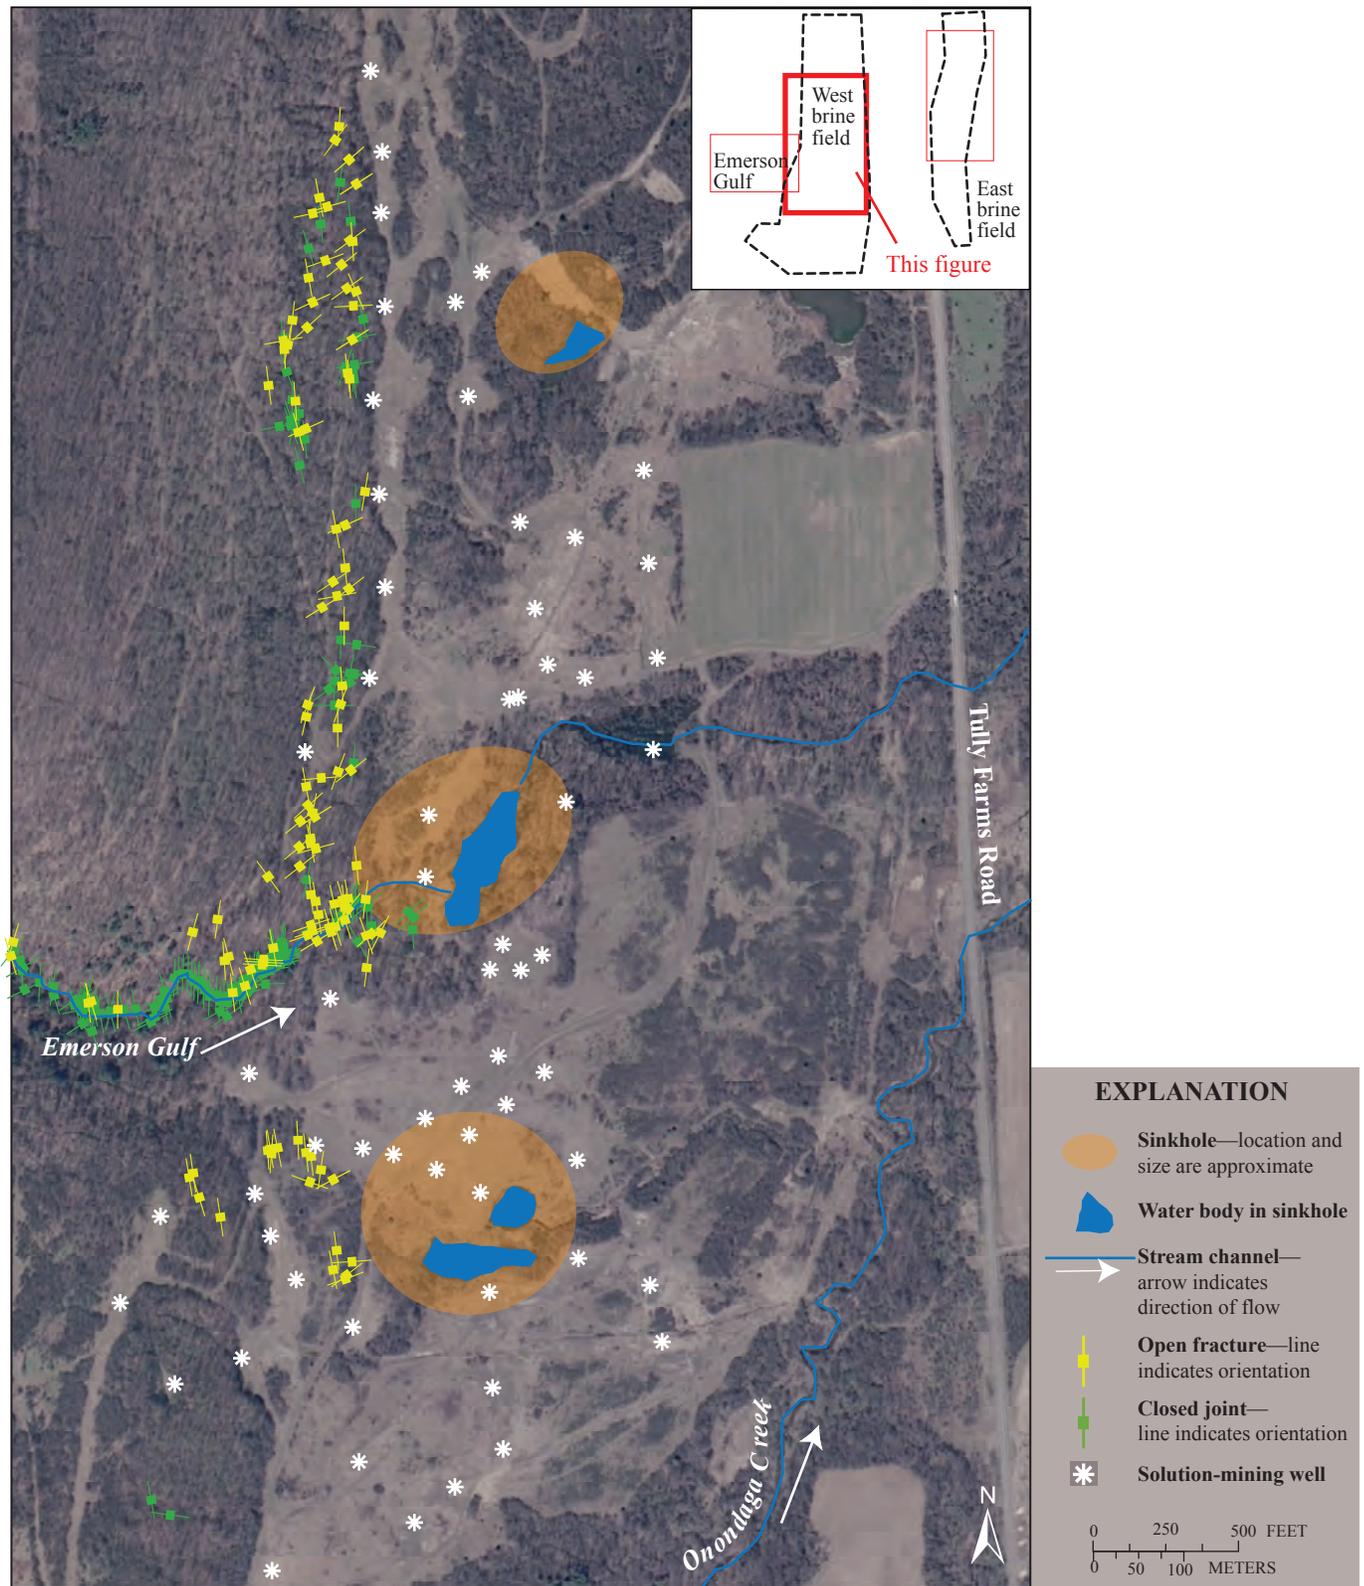
**Figure 6.** Location of open fractures and closed joints upslope of land-surface subsidence and sinkholes in the west brine field of the Tully Valley, Onondaga County, N.Y. (Location shown in figure 2.)

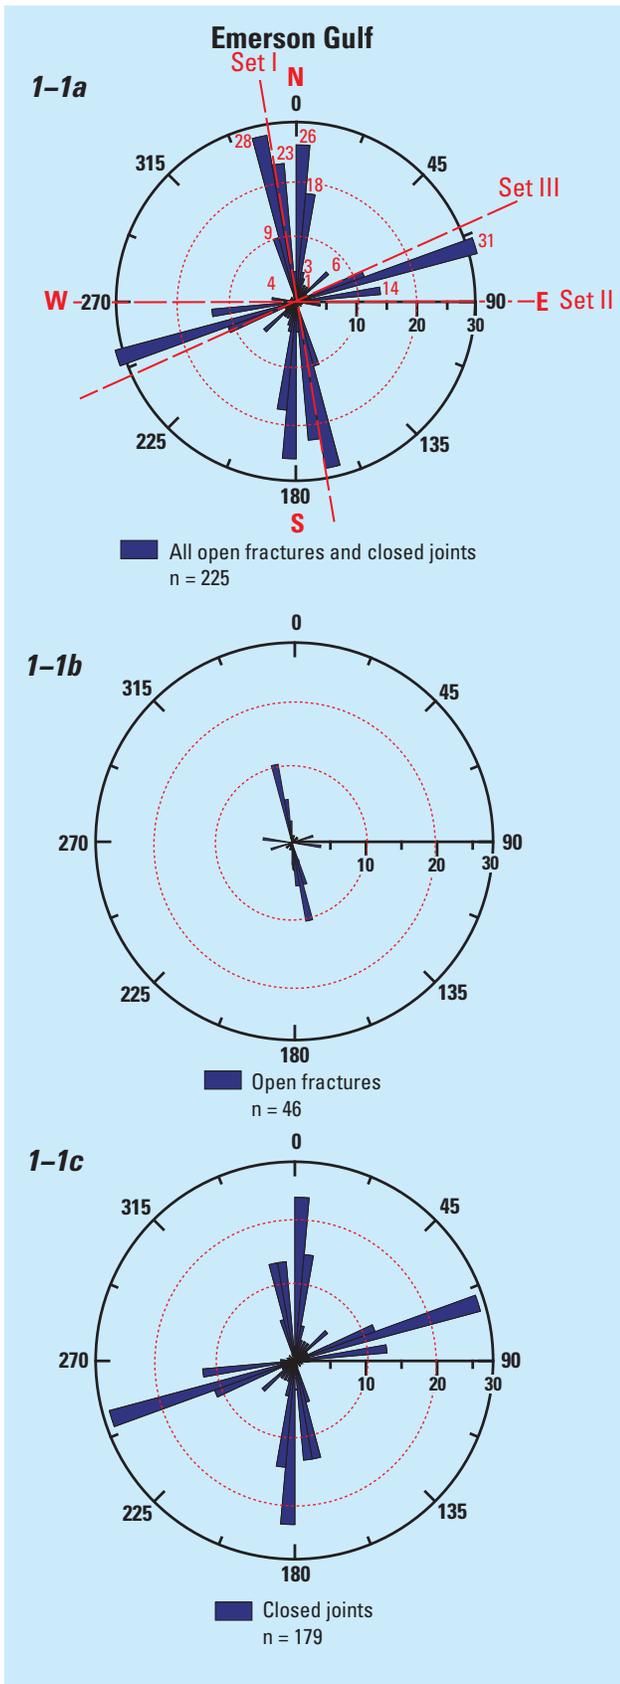
**Figure SB1-1.** Orientation of open fractures and closed joints in the Emerson Gulf stream channel, Tully Valley, Onondaga County, N.Y.

In a fourth stream valley at Emerson Gulf (figs. 1 and 7), mostly closed joints and some open fractures were mapped (SB1–1). Although many of the joints were mapped near the western wall of the Tully Valley opposite one of the large sinkholes in the west brine field (fig. 6), other joints and fractures are present at least 3,000 feet upstream on Emerson Gulf to near the intersection with Woodmancy Road (fig. 7). Nearly 75 percent of the 225 joints and fractures mapped in

the stream channel (fig. SB 1–1) are closed joints, in contrast to the joint/fracture relation in the east and west brine fields where 24 to 33 percent were closed joints (figs. SB1–3 and SB1–4). Reaches of the Emerson Gulf stream also lose water, presumably through open fractures on the floor of the channel (fig. 7—red polygons). Streamflow measurements were made to document losing reaches along Emerson Gulf, although similar measurements along the Onondaga Creek channel to the south indicated no loss of water along its length. No measurements could be made in the east brine field area because of the lack of perennial streams draining the east valley wall near the east brine field. The heavily fractured nature of the Emerson Gulf bedrock channel may be related to the previously noted reverse faulting bedrock structure (CS Consulting Engineers, 1992) whose orientation roughly strikes parallel to the Emerson Gulf tributary valley (fig. 1). A large number of Set III joints (Parker, 1942) are also found in the Emerson Gulf valley.

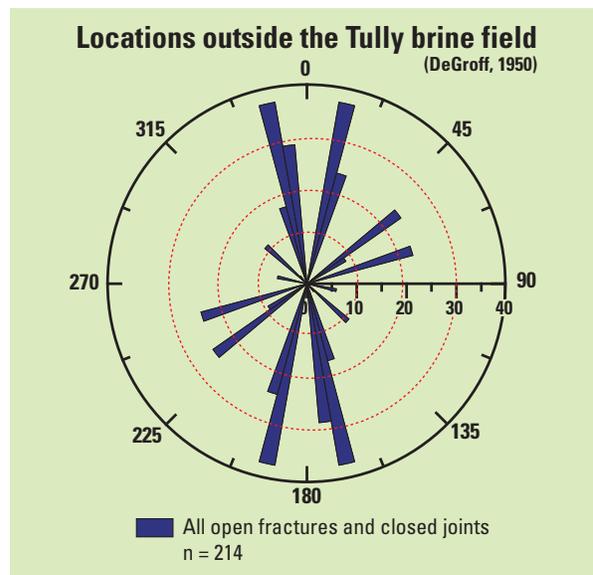
**Figure SB1-2.** Orientation of open fractures and closed joints for locations outside the Tully brine field area, Tully Valley, Onondaga County, N.Y.

Joints and fractures within and adjacent to the Tully Valley were mapped by DeGroof (1950), and their orientations are displayed in the rose diagram (fig. SB1–2). Fracture orientations in three stream valleys (Rattlesnake Gulf, Rainbow Creek, and Onondaga Creek at Fellow Falls) and a bedrock outcrop along U.S. Route 11 just north of New York Route 80 (fig. 1) were compared to the fracture orientations in the two brine fields (figs. SB1–3 and SB1–4). Results of the DeGroof (1950) analysis of all fractures and joints (open and closed) within and adjacent to the Tully Valley (SB1–2), indicate that joint orientations are similar to those mapped in the brine fields (figs. SB1–3 and SB1–4) and to those mapped throughout the Finger Lakes region by Parker (1942).

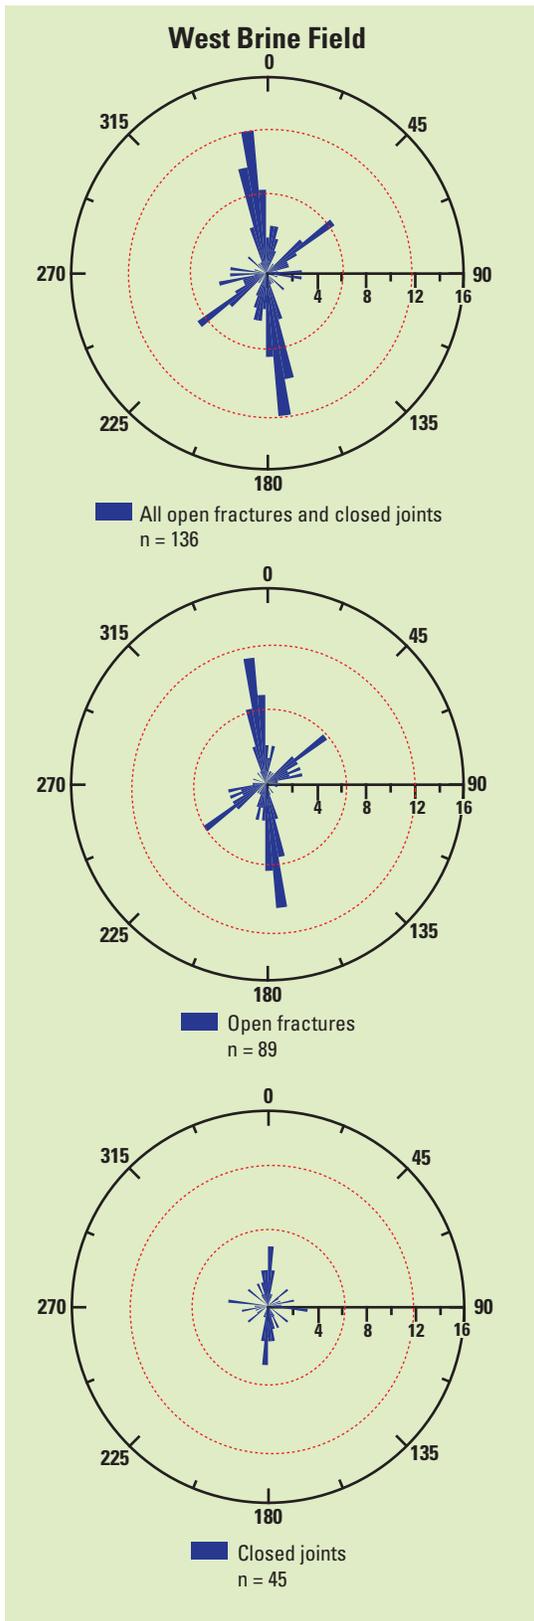
**Figure SB1-3.** Orientation of open fractures and closed joints in the west brine field area, Tully Valley, Onondaga County, N.Y.

Fractures are present along the perimeters of both brine fields—more than 400 open fractures and closed joints were mapped adjacent to the two brine fields (see the Joint Rose sidebar). The dominant set of open fractures strikes just west of north corresponding to Set I of Parker (1942) (see figure SB1–1 in the joint rose sidebar.) A less prevalent set strikes approximately N. 60°–70° E., corresponding to Set III of Parker (1942), and a few east-west striking fractures also were recorded corresponding to Set II of Parker (1942). The orientation of open fractures and closed joints outside the brine field area are shown in figure SB1–2; the orientation of fractures and joints in the west and east brine fields are shown in figures SB1–3 and SB1–4, respectively.

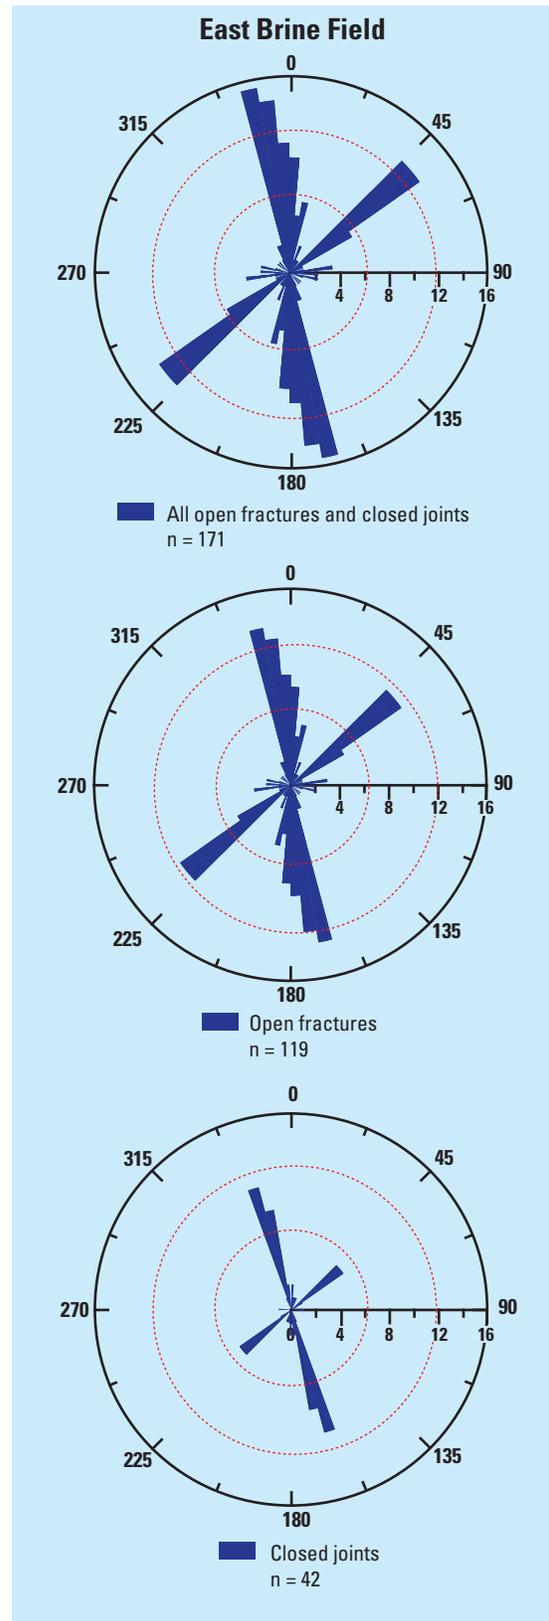
**Figure SB1-4.** Orientation of open fractures and closed joints in the east brine field area, Tully Valley, Onondaga County, N.Y.

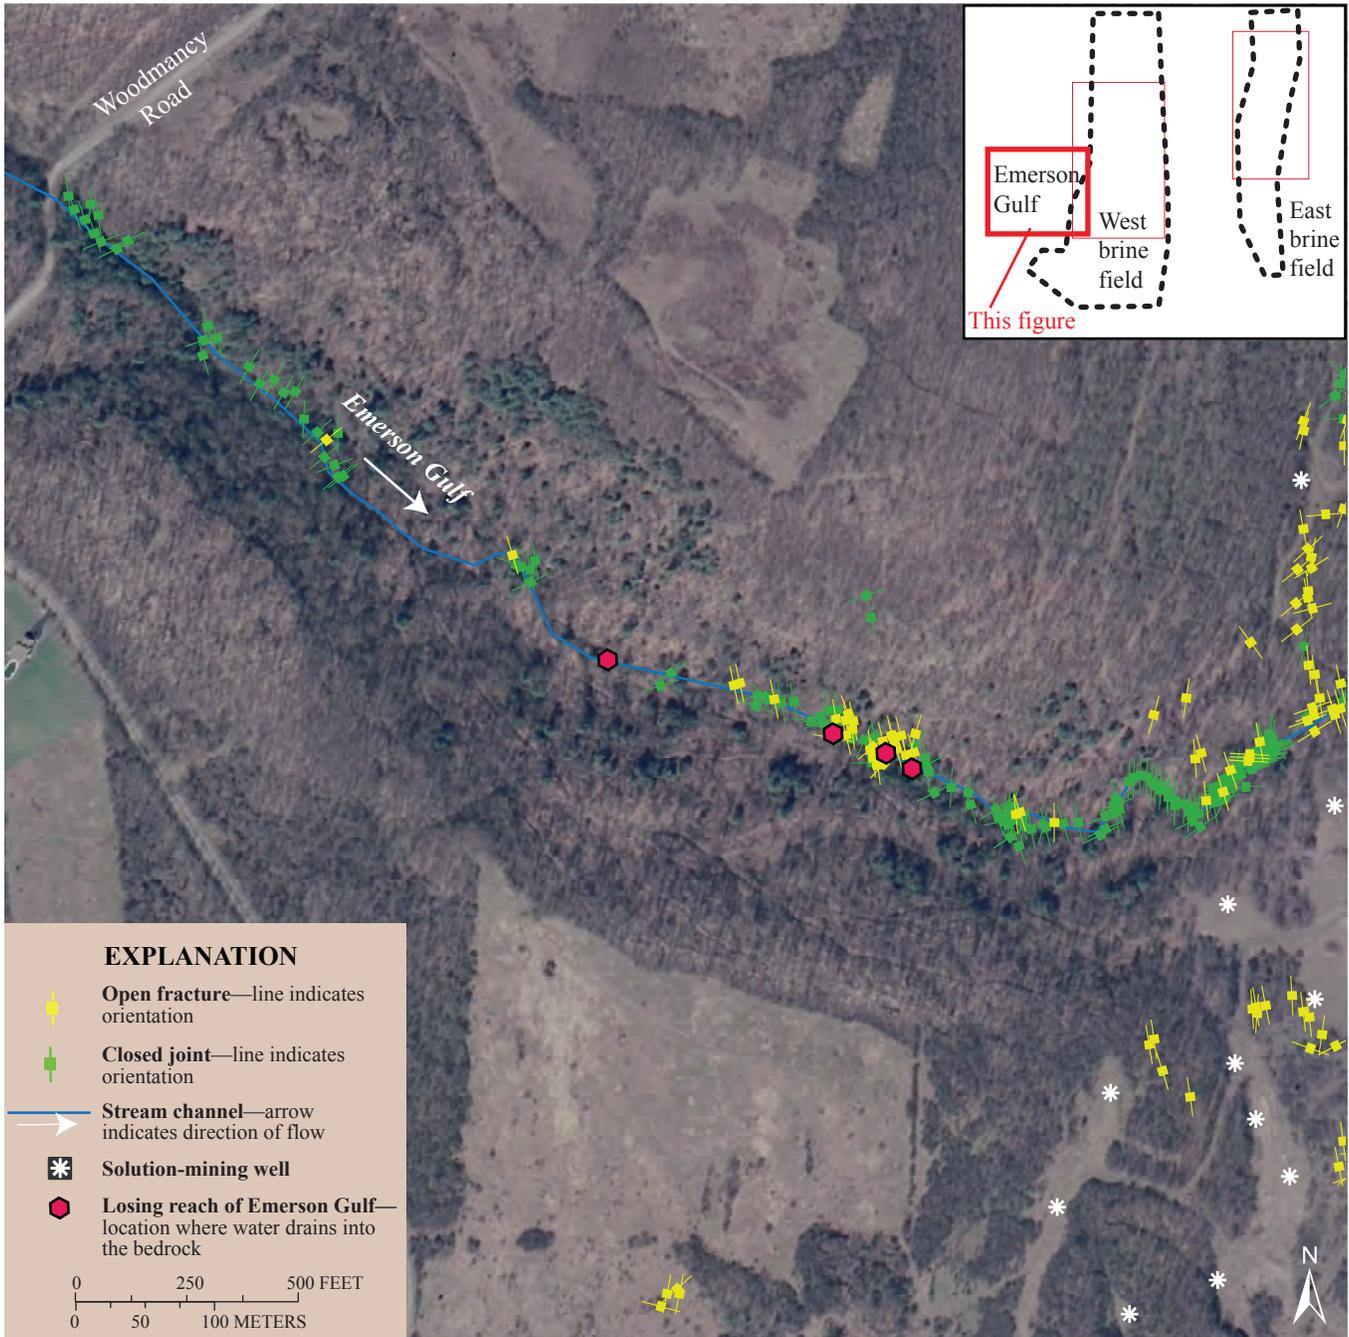
**Figure 7.** Location of open fractures and closed joints within the streambed of Emerson Gulf, west of the west brine field in the Tully Valley, Onondaga County, N.Y. (Location shown in figure 1.)

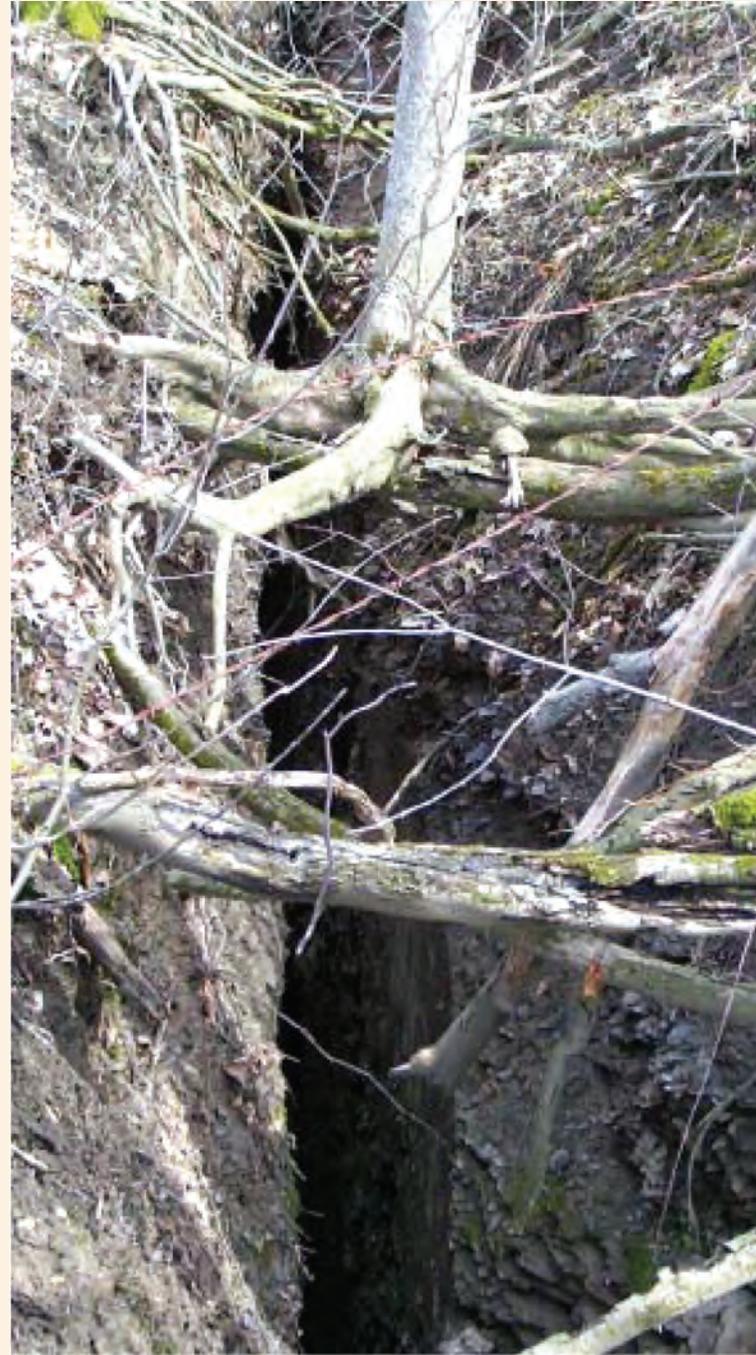
**Figure SB2-1.** Seven-inch diameter maple tree growing over an open bedrock fracture above the east brine field in the Tully Valley, Onondaga County, N.Y., 2006.

The opening of bedrock fractures along the perimeter of each brine field was established in reports of The Solvay Process Company (1950 and 1960), but the rate of fracture opening is not well known. During this study, a maple tree (*Acer* sp.) was found growing over an open fracture above the east brine field (fig. SB2-1). The use of dendrochronology (dating the growth of trees using tree rings) to determine the rate of fracture opening was attempted. Two aspects of the tree were studied: (1) the growth rings in the trunk (which can be used to evaluate changes in the rate of growth), and (2) the growth rings in the tree roots (especially those roots that became exposed to the air as the fracture opened and soil fell away from the roots).

The maple tree was almost 7 inches in diameter and was determined to be 79 years old in 2006, indicating that it began to grow in 1927. An assessment of the tree rings indicated that there was no evidence that growth of the tree had been compromised by the opening of the fracture (Dr. Thomas Yanosky, U.S. Geological Survey—Emeritus, written commun., 2008). In fact, the growth rings from 1985 to 2006 were wider than those of the previous years indicating healthy and vigorous growth despite the tree growing over the open fracture (fig. SB2-1). The outer rings of the exposed roots were branch-like in appearance and did not display any abrupt change in either ring width or ring anatomy that would indicate a rapid excavation of the roots. Rather, the exposure of the root to the air as a result of the widening of the fracture and the erosion of soil around the root seems to have been a gradual process. The outer rings of the roots were wide, similar to those of the main trunk, indicating vigorous recent growth.

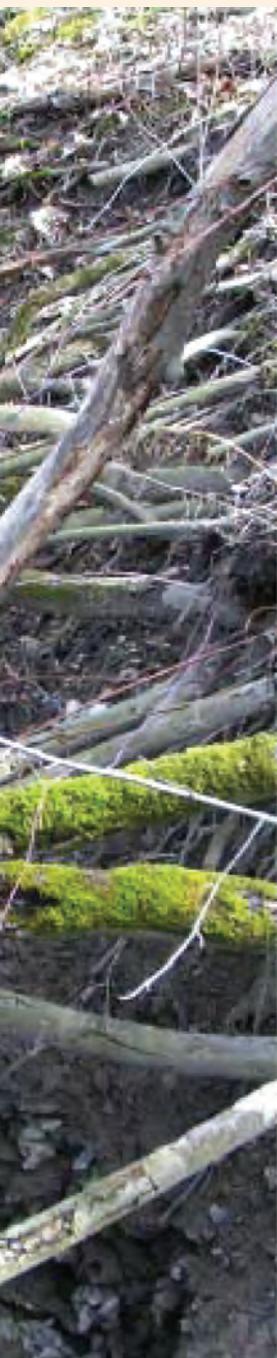
The following timeline of fracture development at this location was derived from the tree-ring information:

- ⊙ 1927—The tree germinates and begins to grow in soil over the bedrock fracture. The width of the fracture in the bedrock is unknown, but it is small enough that it does not affect the initial growth of the tree.

- ⊙ 1947—Twenty years after the tree began to grow, the fracture has opened enough to cause soil to fall into the fracture, allowing the tree roots near the base of the tree to take on a bark-like appearance. Beetles begin to create pith flecks in the outer annual ring of the exposed roots.

- ⊙ 1975—Forty-eight years after the tree began to grow, more soil had fallen away, exposing more of the roots while beetles continue to create pith flecks in the outer annual rings of the exposed roots.

- ⊙ 1986—Improved growth as determined by tree-ring analysis of both the trunk and roots are indicative of a slowing or cessation of fracture widening.

- ⊙ 2006–2008—Tree was removed in 2006 for analysis, and no fracture-width changes were noted at this location through 2008.

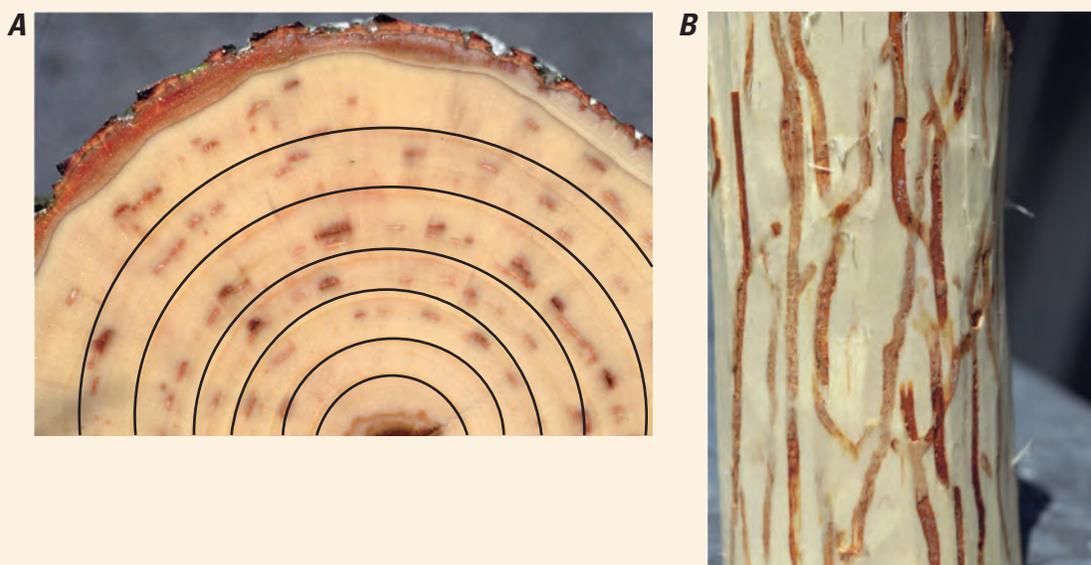
**Figure SB2-2.** Example of pith flecks (brown blotches) in a young willow tree, (A) their arrangement in individual annual rings from a cross-section of the tree trunk (rings enhanced for clarity) and (B) pith channels along the tree trunk with the bark removed.

The wood of maple trees is notorious for the presence of “pith flecks” (small pockets of callous tissue that develop when boring insects inflict minute damage to the cambium where sap flows). Each small fleck is within a single ring, and any one ring may have several flecks when examined along the entire ring circumference (fig. SB2-2A). When the tree is examined by stripping away the bark, one sees a long scar within the outer ring created as the beetle bored its way vertically up the cambium (fig. SB2-2B). Pith flecks were absent from the innermost rings of all the examined roots, but were numerous in the outer growth rings. A possible explanation for this phenomenon is that the beetles can easily access exposed roots but do not burrow into the soil and attack buried roots. Therefore, exposed roots close to the main trunk would contain a greater number of pith flecks in the outside rings; smaller roots more distant from the main trunk would contain fewer pith flecks in the outside rings and no pith flecks in the inside rings. This circumstance indicates that as the fracture opened under the center of the tree, soil fell into the opening fracture and the larger diameter roots close to the trunk of the tree became exposed earlier than the smaller diameter roots more distant from the tree trunk. The larger, more exposed roots were likely attacked periodically by boring beetles, whereas the more distant, still-buried roots were not. As the fracture continued to open, more distant roots became exposed and accessible to pith-boring beetles.
