# **Bank Erosion, Mass Wasting, Water Clarity, Bathymetry and a Sediment Budget Along the Dam-Regulated Lower Roanoke River, North Carolina**

By Edward R. Schenk, Cliff R. Hupp, Jean M. Richter, and Daniel E. Kroes

Open-File Report 2009–1260

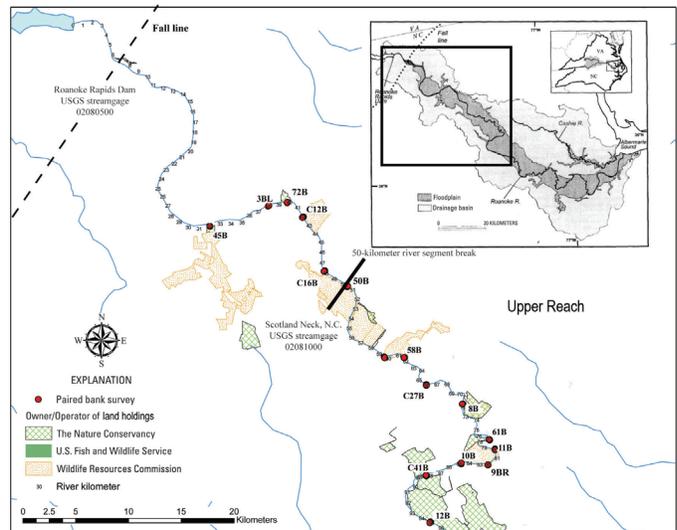
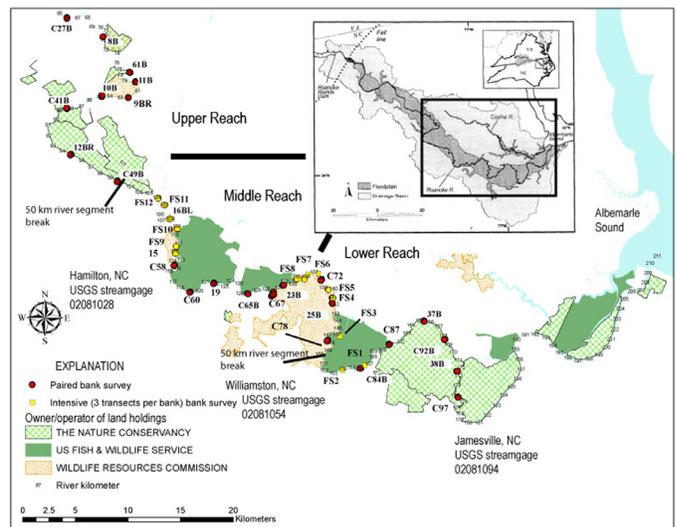
**Figure 1.** Maps of the lower Roanoke River, N.C. Inset maps of the entire lower Roanoke River reaches and the watershed in Virginia/North Carolina indicate the section being detailed. Locations of paired transects, river kilometer below dam, and land holdings are indicated. A. Upstream part of the lower Roanoke River, N.C. B. Downstream part of the lower Roanoke River, N.C. km, kilometers.

Evidence of bank erosion along the lower Roanoke River is common where bank heights (above mean water levels) are substantial [more than 2 meters (m)], particularly along middle reaches between the Fall Line and the Albemarle Sound (fig. 1). Evidence may take the form of particle-by-particle erosion along straight and cut banks with concave upward profiles, often leaving overhanging (undercut root) trees and shrubs on the top of bank, or mass wasting through slab and rotational bank failures that may carry large amounts of soil and vegetation partly or completely down the bank slope (Hupp, 1999).

streamflow gaging station 02080500) below the downstream-most dam; daily mean discharges range from 23 m<sup>3</sup>/s to 1,008 m<sup>3</sup>/s over the period of record (43 years). Prior to dam construction, annual peak flows regularly ranged from 1,400 m<sup>3</sup>/s to 2,800 m<sup>3</sup>/s, with extreme events in excess of 3,400 m<sup>3</sup>/s (fig. 2). Over the course of the postdam streamgaging record (since 1964) the maximum peak flow has been 1,055 m<sup>3</sup>/s, with normal peak-flow maxima about 980 m<sup>3</sup>/s. Conversely, low flows are sustained at higher discharges than before dam construction; annual flows rarely are less than 220 m<sup>3</sup>/s, and most peaks are held around 560 m<sup>3</sup>/s. Water stage information is recorded at seven streamgages along the lower river from Roanoke Rapids (also the discharge measurement station) near the dam and, in downstream order, at Halifax, Scotland Neck, Oak City, Hamilton, Williamston, and Jamesville, N.C., nearest the Albemarle Sound (fig. 1).

The lower Roanoke River flows generally southeasterly from near the Fall Line to the Albemarle Sound as a largely single threaded meandering stream (fig. 1) across Miocene sedimentary material overlain by Quaternary Alluvium (Brown and others, 1972). The material consists largely of unconsolidated fine sands, silt, and clay, although the clayey Miocene deposits may be indurated. Additionally, the floodplain along the lower river trapped a large volume of sediment associated with postcolonial agriculture (Hupp, 1999). This legacy sediment may be between 4 and 6 m in depth along

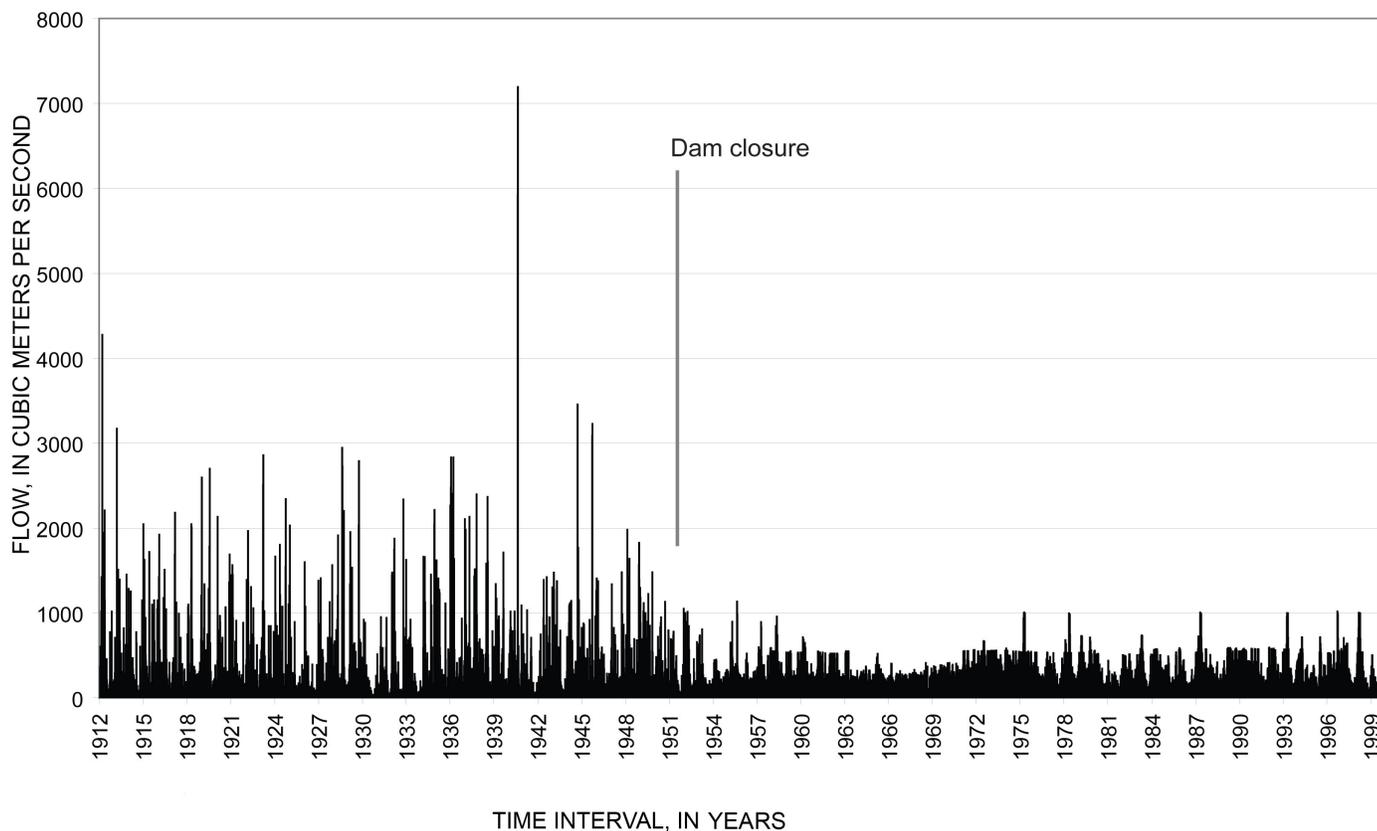
**Figure 2.** Daily flows on the lower Roanoke River from 1912 through 1999, as measured at Roanoke Rapids, N.C., covering both predam and postdam operations. Date and effect of initial dam completion is shown.

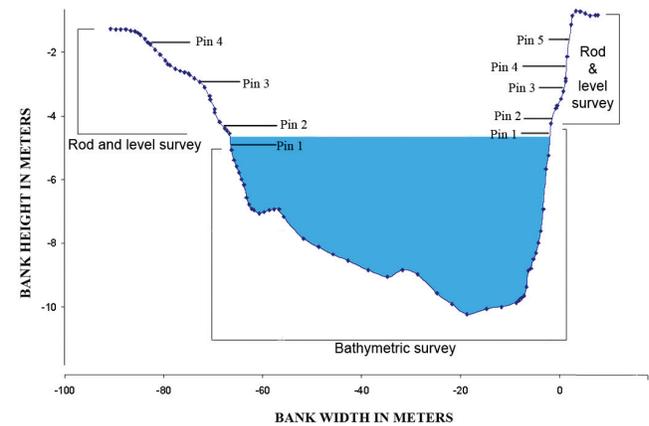
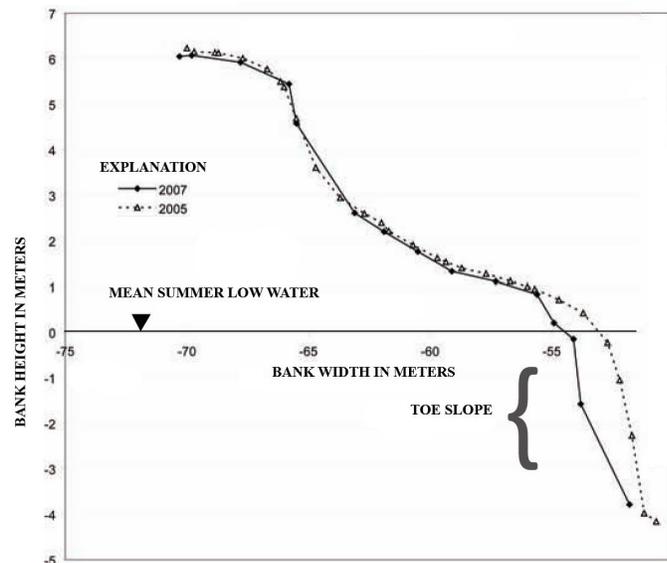
**Figure 3.** Cross sections of banks at transects A, 23 (entire), and B, C60 (left bank). Pin locations and survey methods are shown along transect 23; pins are driven into bank, flush to surface, typically at an oblique angle, normal to bank slope. Shaded part of cross section was surveyed below water surface using bathymetric techniques. Detail of differences in bank profile from 2005 to 2007 on C60 left bank; mean summer low flow elevation is shown. Note the >1 meter difference between surveys is largely on the lowermost part of the bank and toe slope.

During the fall of 2005, approximately 1-m-long erosion pins were placed along transects (fig. 3) beginning at or near the low water surface and ending on the levee adjacent to the top of bank. Pins were spaced to capture prominent breaks in the bank slope and erosion along long straight bank sections. Long transects (larger than 25-m-high banks) typically had 7 to 10 pins established, while short transects (a few meters) had at least three pins. The pins were driven into the soil normal to the local bank slope, flush at the ground surface. In total, 701 pins were established for monitoring. The pins were revisited annually, in the summers of 2006, 2007, and 2008; in selected cases, pins were revisited more frequently. During each visit, the pins were measured for the amount of erosion (pin exposure) or amount of deposition (pin burial); buried pins were located using a metal detector. Measurements were taken along an axis normal to the local bank slope, parallel to the pin.

Paired transects, on opposite sides of the river, were tied to each other using bathymetric surveys (fig. 3). Toe slopes were surveyed (from boat) using a tag line attached to the bank at the water surface for horizontal station. A survey rod was used to determine elevation relative to the water surface (depth). This procedure was used for about 10 m of transect (cross-section) length from the water's edge. The channel bed, along transect, was surveyed to capture the entire channel

of peaking in the middle reaches near Hamilton. Along all reaches, erosion tended to be greatest on the lower bank (table 2). Further, erosion on the upper banks along the upper reaches was nearly an order of magnitude less than that of the lower banks. A subset of transect sites by the FWS (FS transects, n=10, FS 5 and 7 not included) (fig. 1B) comprised three parallel transects spaced by 25 m and located so that the actively eroding middle reaches and part of the adjacent lower reaches were sampled. Along the unstable, actively eroding reach, the lower banks eroded more rapidly than upper banks, while along the lower reaches this trend was reversed, albeit less pronounced (fig. 6). Transect erosion rate variation (at these intensely monitored sites, FS transects) was distinctly higher on the unstable middle reach than at sites located on the lower, more stable reach. Pronounced erosion on the toe of banks occurred along the lower Roanoke River, documented partially in the pin measurements presented above and in rod and level surveys. An example of the predominant lower bank and toe erosion is illustrated in figure 3.

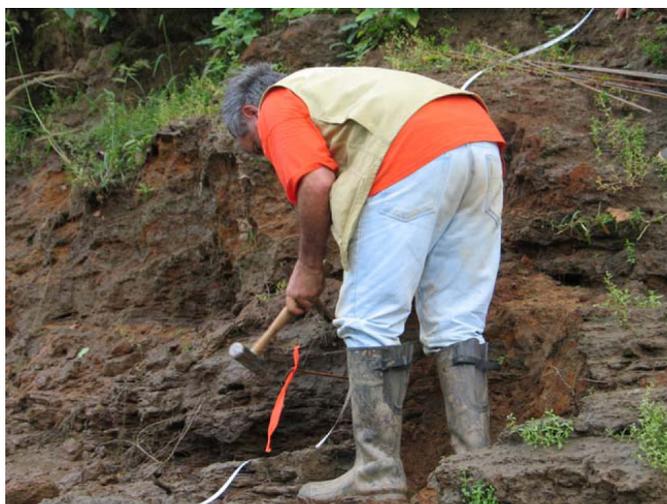
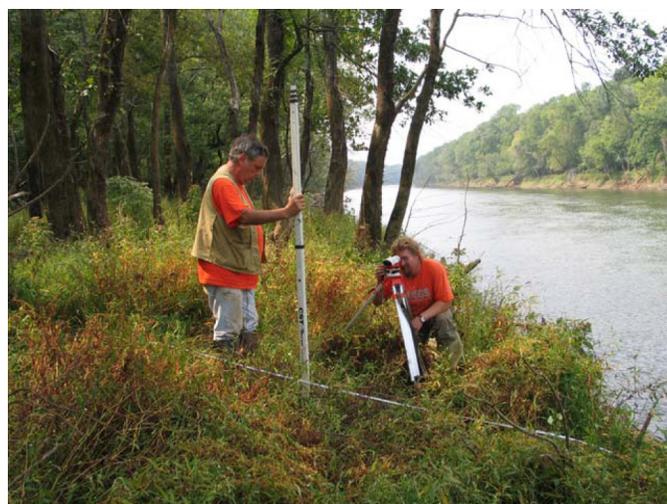
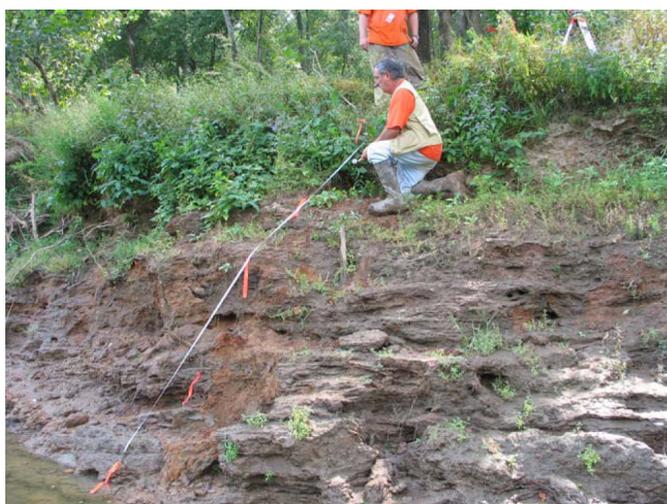
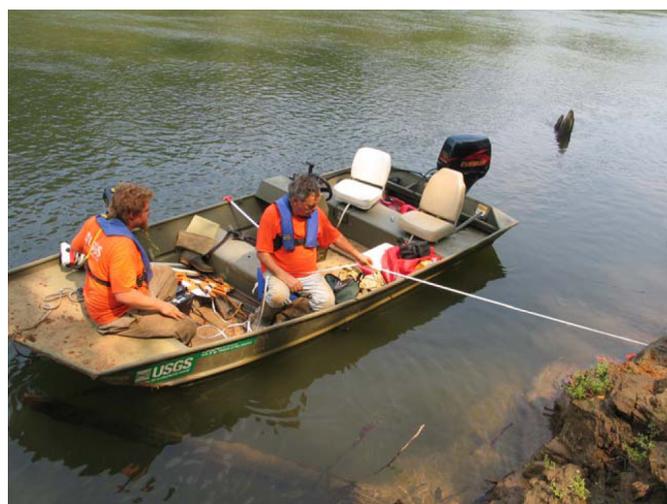
**Figure 4.** Surveying and bathymetric methods used to create cross-sections. *A*, bank pin installation along a transect; *B* and *C*, optical level surveying along the transect; *D*, the beginning of a bathymetric survey from an optically surveyed fixed point.

cross section between paired bank transects using a laser rangefinder for horizontal station and a narrow-beam depth finder [200 kilohertz (kHz)] to determine depth (elevation). Toe-slope and channel cross-section measurements were tied to the monumented bank surveys using a series of duplicate measurements, including rod and level, tag line and rod, and depth finder and rangefinder (fig. 4).

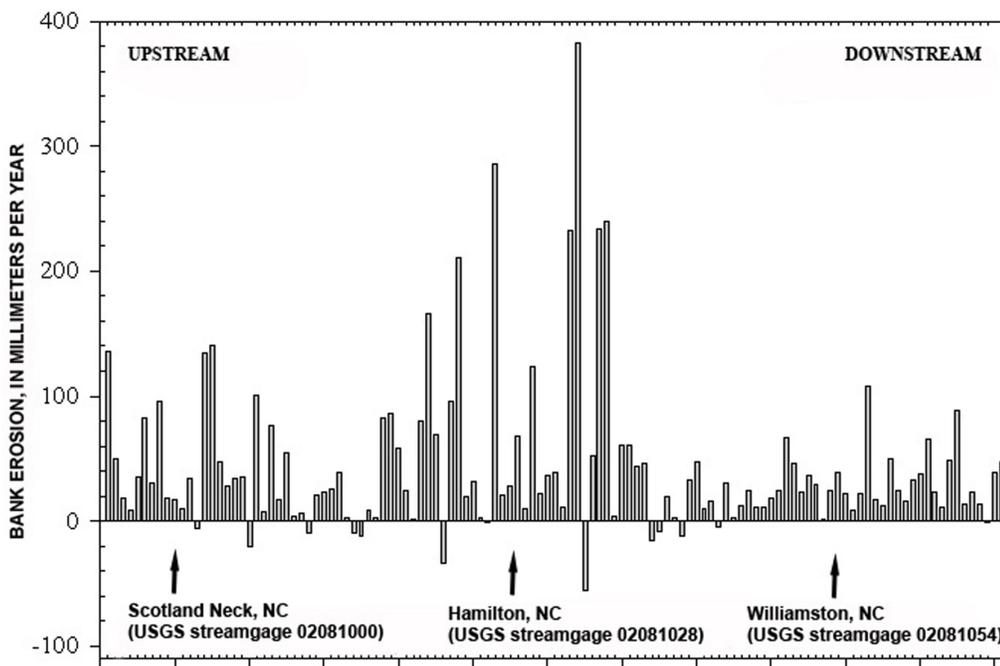
**Figure 5.** Mean bank erosion rate on the lower Roanoke River from erosion pin data from upstream (left) to downstream (right); left and right banks of each transect are shown separately. Observations and transects that are less than zero are net depositional. Approximate locations of stream gages near Scotland Neck, Hamilton, and Williamston, N.C., are shown.

Net bank erosion (channel widening), by transect, was observed on 110 transects, while net deposition occurred on only 14 transects (fig. 5). In general, erosion rates increased from the upstream transects [mean 41 millimeters per year ( $\text{mm}/\text{yr}$ )] to those along the middle study reaches (mean 60  $\text{mm}/\text{yr}$ ), peaking in the vicinity of Hamilton (fig. 1B), and then diminished (mean 27  $\text{mm}/\text{yr}$ ) toward the downstream transects (table 2). Mean erosion by transect ranged from 380  $\text{mm}/\text{yr}$  along a transect near Hamilton (fig. 5) to nearly zero at many transects. To date, only four transects have captured a mass wasting event (15BR, T23BR, and FS8LM and LU at river kilometers 112, 131.5, and 133.5 respectively). Because many more mass wasting events have been observed during the study outside of the bank transects, erosion results are likely quite conservative. Where there was net bank deposition, the transect was typically located on a point bar; the greatest mean deposition amount (55  $\text{mm}/\text{yr}$ ) occurred along the point bar directly opposite the bank with highest erosion (fig. 5) near Hamilton. Total bank erosion tends to be greatest nearest

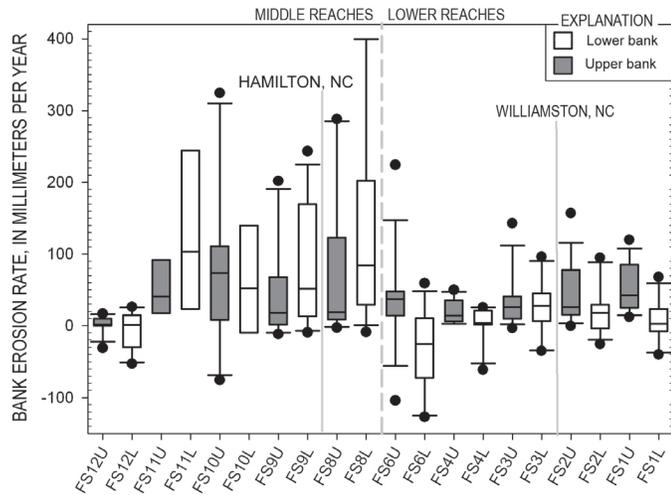
**Figure 6.** Mean bank erosion rate and variation at selected (triplicate) transect locations along middle and lower reaches of the lower Roanoke River. Location of separation between middle and lower reaches is shown in figure 1B.

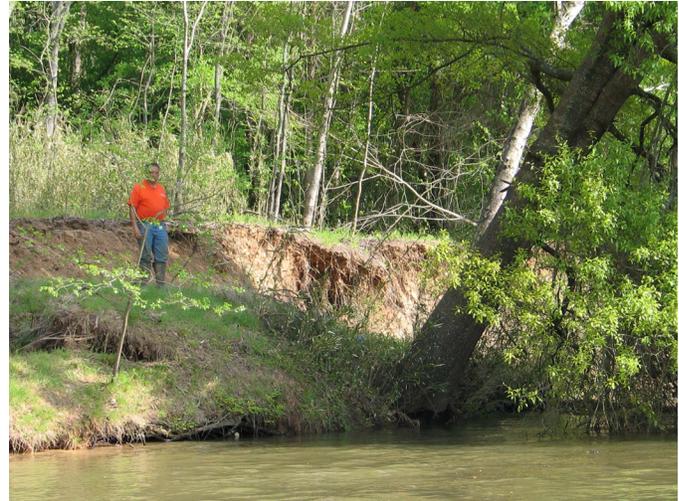
**Figure 7.** A recent (summer 2005) bank failure near Hamilton, N.C.

Mass wasting (fig. 7) as measured by the bank-erosion index (table 1) increased from the upper reaches to the middle reaches where it peaked at 3.5 (table 2) and decreased downstream to the lower reaches. Index values were estimated during the 2007 river survey, and when averaged over about 8 km, river segments from about 30 to 175 km below the dam also showed the distinct trend of peaking along the middle reaches (fig. 8). This trend was generally mirrored by mean transect and pin data plotted at actual transect locations. Mean maximum bank-erosion index values ranged between 4 and 5 (fig. 9), over about a 24-km reach, beginning just below Hamilton (river kilometer 115, fig. 1B). Channel width measurements, taken during river cruises, demonstrated that channel width decreased from upstream (near the dam) to the relatively narrow middle reaches then increased toward the Albemarle Sound (table 2).

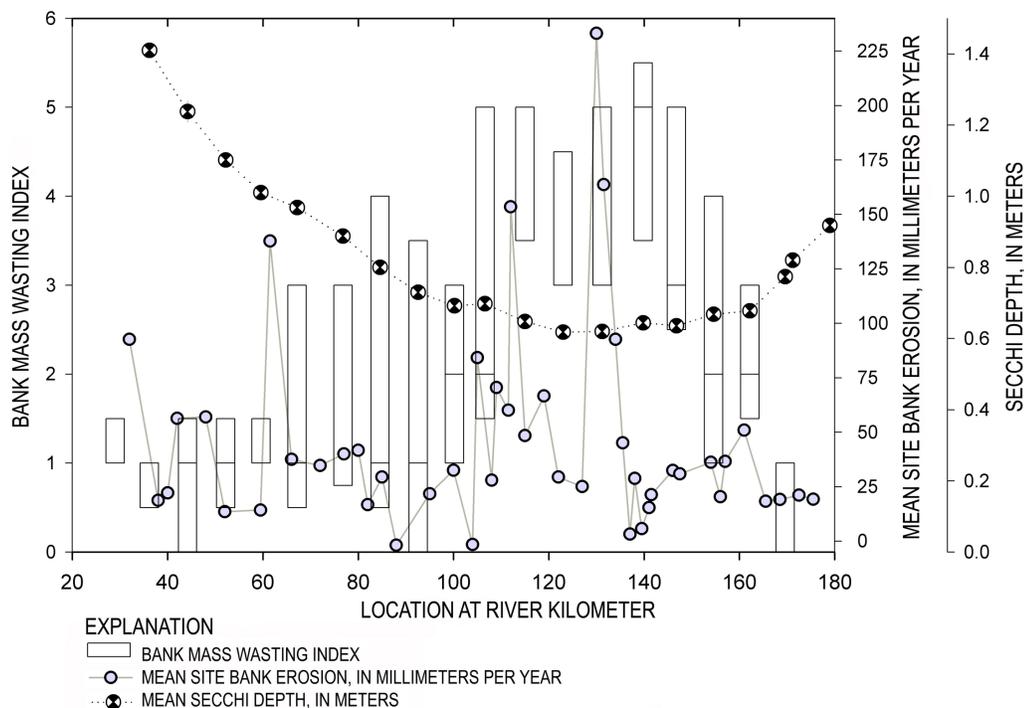
**Figure 8.** Trends in mean bank erosion, bank erosion index, and water clarity (Secchi depth) from upstream to downstream by river kilometer. Mean bank erosion data are from transect pins; bank erosion index and water clarity are averages over sequential river segments, approximately 8 kilometers each.

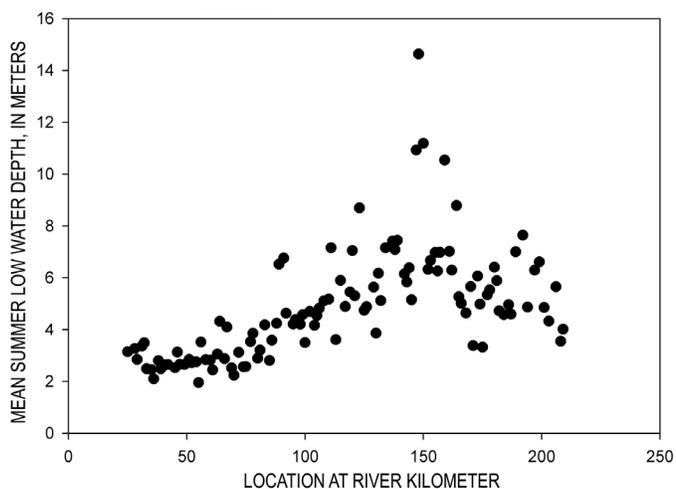
**Figure 9.** Mean summer low water depth; measured in meters. Data were compiled from 1999, 2005, and 2007 bathymetric river surveys.

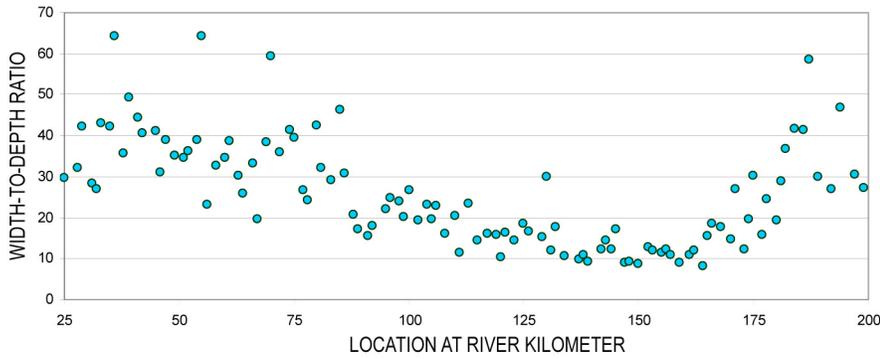
**Figure 10.** Mean width-to-depth ratio by river kilometer. Data were compiled from 1999, 2005, and 2007 bathymetric river surveys.

Between 1998 and 2007, four bathymetric data cruises were completed from near Halifax, NC to the Albemarle Sound. Data from the most recent cruise (2007) are provided in appendix 4. Cruises were completed at or near summer mean low water depth. Data from three of the data cruises were aggregated to provide a longer term analysis of longitudinal trends. Summer mean low water depth was relatively consistent from near the dam to river kilometer 75 and then increased until approximately river kilometer 150 when the water surface approached mean sea level (fig. 9). Water depth decreased from approximately river kilometer 150 to the Albemarle Sound as the river width increased proportionally. Width-to-depth ratios mirror the mean low-water-depth trend, with greater channel incision in the downstream direction from river kilometer 75 to river kilometer 150 (fig. 10).

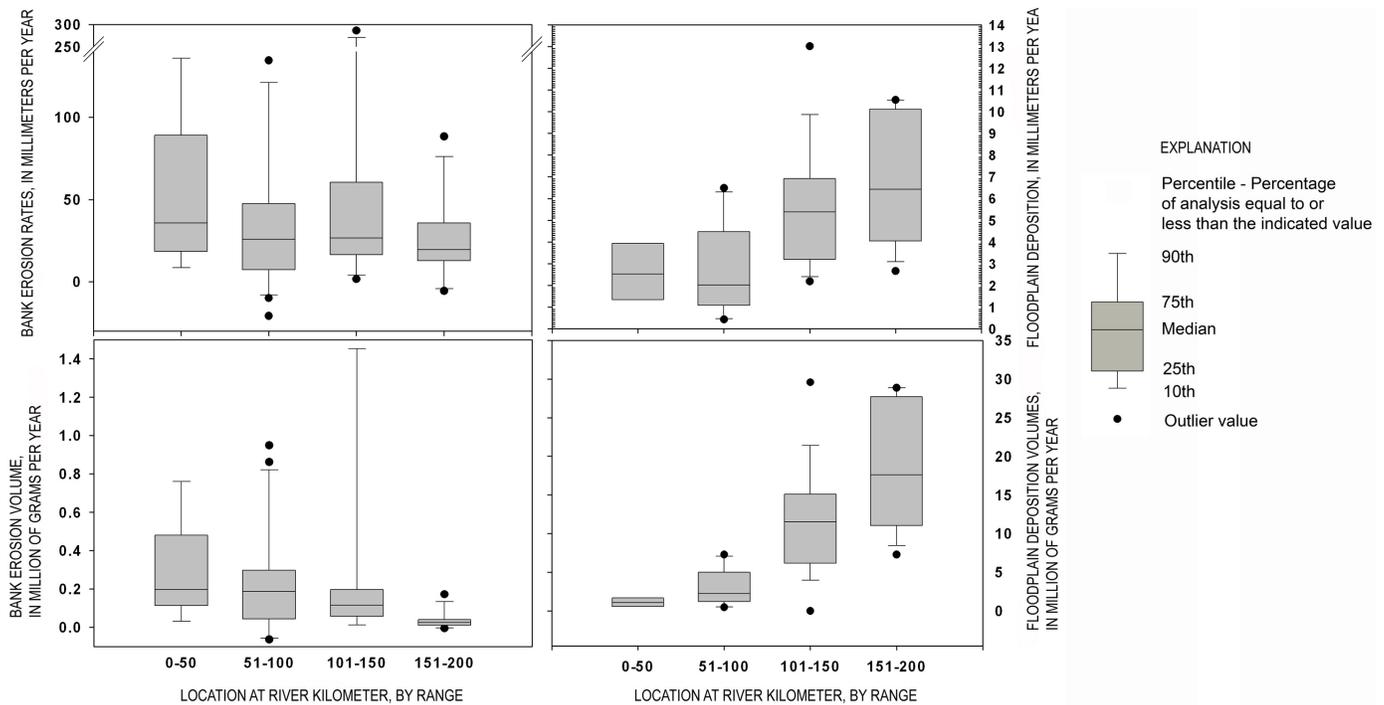
**Figure 11.** Trends in bank erosion and floodplain deposition rates and masses divided into 50-kilometer river reach segments from upstream to downstream. Note the inverse relation between bank erosion and floodplain deposition, particularly as revealed in mass estimates.

A comparison of floodplain deposition and bank erosion rates and loads provides two distinct views of the sediment processes on the lower river (fig. 11). The total observed deposition and erosion showed a several-orders-of-magnitude difference between sediment storage and removal (fig. 12). The total budget, minus suspended sediment loads, also shows the large surplus of sediment that is not accounted by the particle-by-particle erosion measured by the bank erosion pins (fig. 13). Future work on the sediment budget should include measurements of toe slope erosion (below the water line), quantification of sediment mobilized by mass wasting events, and detailed analysis of spatial patterns of floodplain sediment deposition.

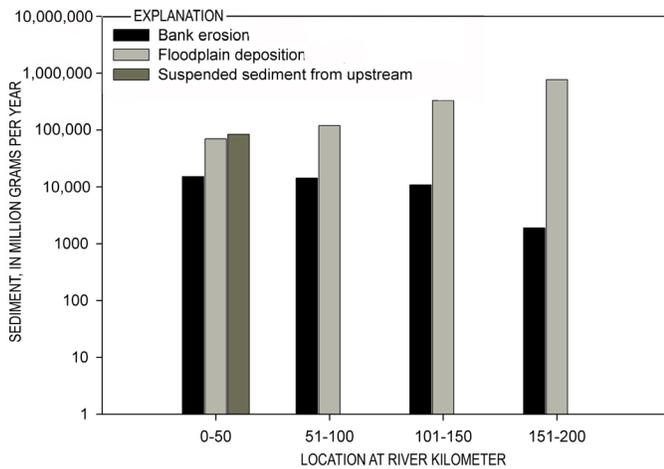
**Figure 12.** Total observed bank erosion and floodplain deposition by 50-kilometer river segment. Included in the figure is an annual suspended sediment yield estimate derived from mean suspended sediment loads measured by the U.S. Geological Survey North Carolina Water Science Center between 1980 and 1995 at the Roanoke Rapids Dam.

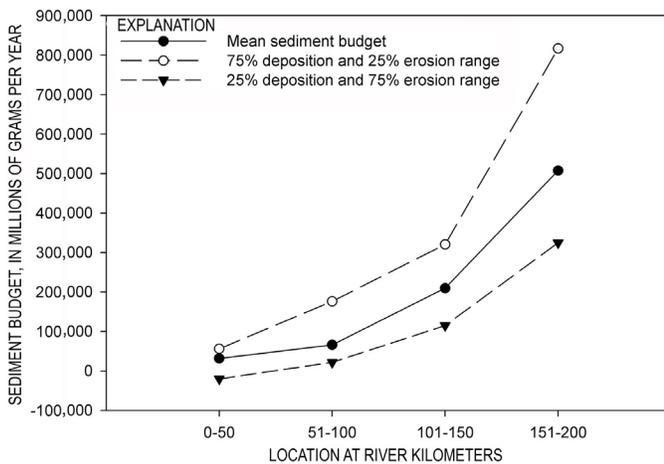
**Figure 13.** Bank erosion and floodplain deposition sediment budget by sequential 50-kilometer river reach segments, upstream to downstream. Where the line plots below zero, more material is eroded from banks than is deposited on floodplains. The 25 and 75 percentile ranges for erosion and deposition are included. Sediment budget does not include toe erosion not documented by bank erosion pins, mass wasting events, or suspended sediment from upstream and other sources.
