Project Management GIS Applications and Tools for Coastal-Erosion Mapping in Ohio

By James McDonald

Ohio Department of Natural Resources
Division of Geological Survey
2045 Morse Road, Bldg. C-1
Columbus, OH 43229-6693
Telephone: (614) 265-6601
Fax: (614) 447-1918
email: jim.mcdonald@dnr.state.oh.us

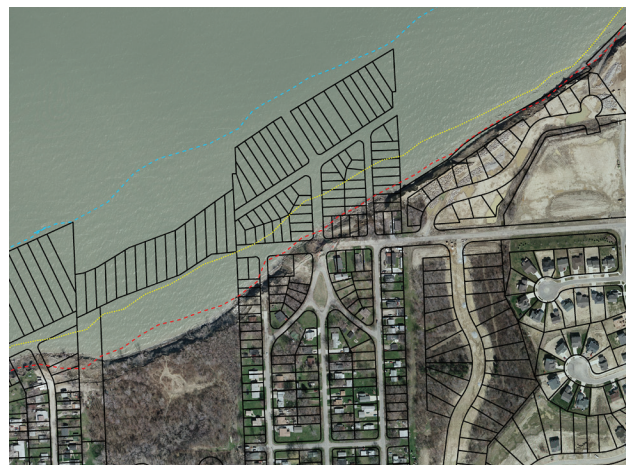
Figure 1. An area of the coast near Painesville, Ohio, that has undergone up to 207 feet of recession from 1973 to 1990. The figure shows the top of the bluff for 1876 (blue dashed line), 1973 (yellow dashed line), and 1990 (red dashed line), and also shows the parcels that have been lost due to coastal erosion since 1945. The black lines are the outlines of the parcels from the Lake County Auditor's Office. The base map image is from 2004.

small-scale changes. Examples of large-scale changes are shown in Figures 1 and 2. Figure 1 shows a coastal area near Painesville, Ohio, that has undergone between 34 and 207 feet of recession from 1973 and 1990. Figure 2 shows the Sheldon Marsh barrier beach, which was blown out during the great November 1972 storm (Carter, 1973), and has undergone between 268 and 953 feet of recession during that 17-year period. While these large-scale changes are very dramatic, more normal erosion rates along the coast are also a hazard,

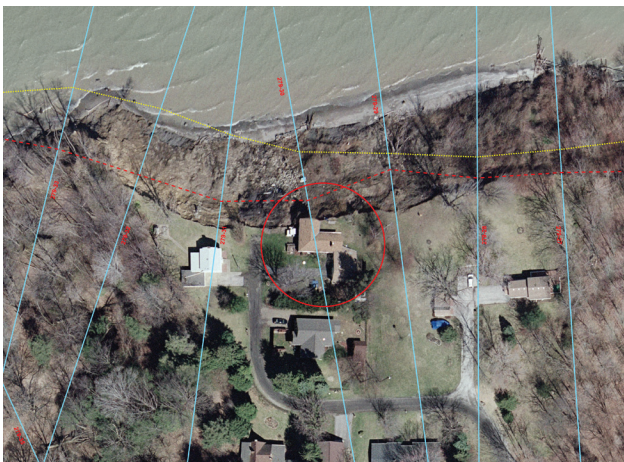
Figure 3. A home, circled in red, that is about to fall off of a bluff because of coastal erosion. Blue lines are shore-normal transects, as described in the text.

eroding bluffs and destroying properties. For example, in Figure 3 a house is in danger of toppling because of erosion at the base of the bluff and rotational landslides that are caused by the unstable bluff slope. As a bluff recedes, buildings can be destroyed from the erosion, torn down before they are destroyed, or moved back from the bluff. Figure 4 shows three examples, including a 3,500 square foot house that was torn down and replaced some distance removed from the bluff.
