The Limit of Inundation of the September 29, 2009, Tsunami on Tutuila, American Samoa

Open-File Report 2010-1018

U.S. Department of the Interior
U.S. Geological Survey

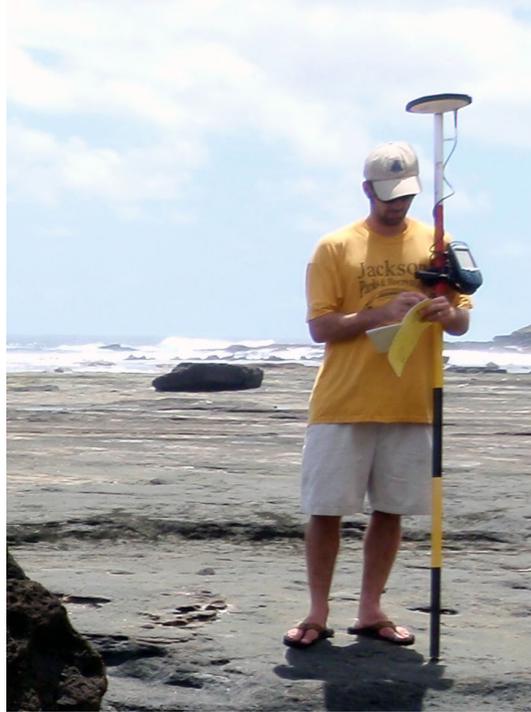
Figure 2. Surveying limit of inundation using antenna fixed to pole that collected data for DGPS positioning.

The inundation limit was mapped using three Differential GPS-enabled (DGPS) Magellan ProMark 3 L1 receivers. The units were mounted to ~ 1.9-m-long survey poles and equipped with NAP 100 antennas fixed to the top of the pole (fig. 2).

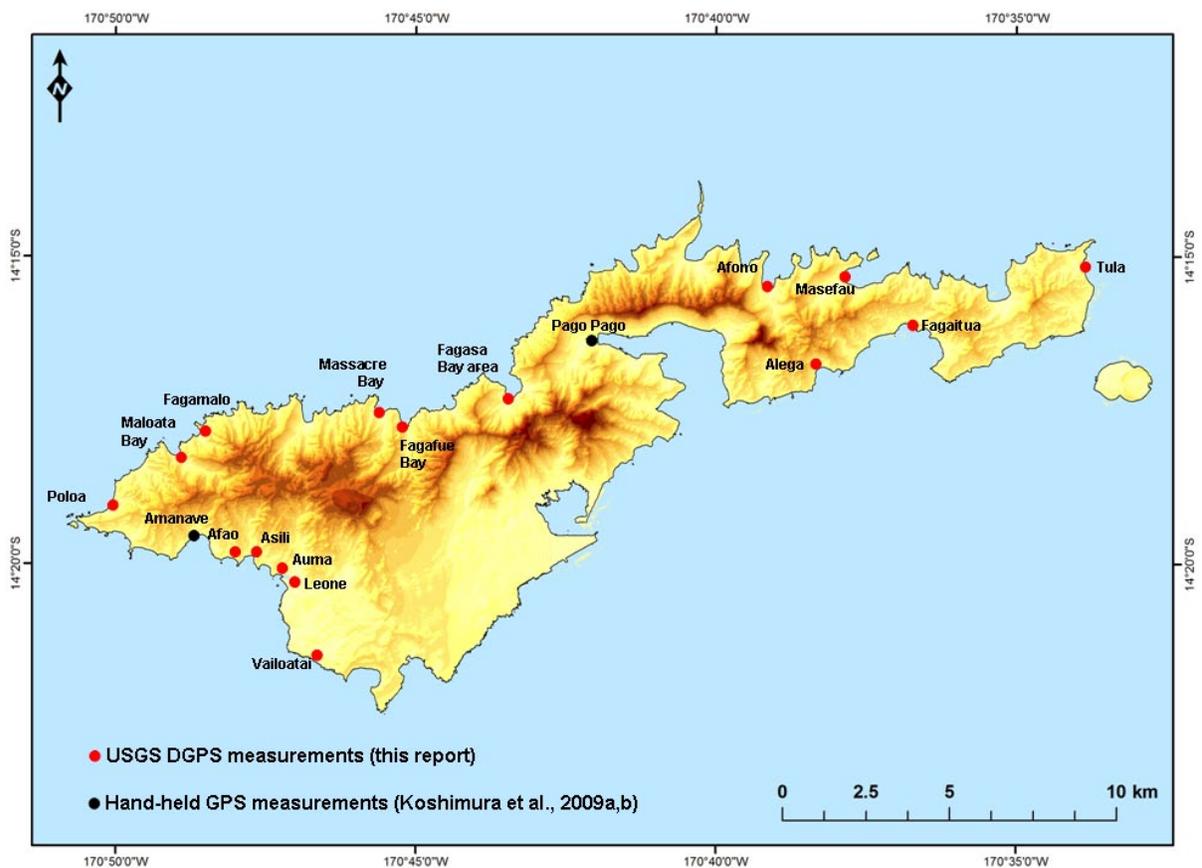
Figure 3. Locations on Tutuila, American Samoa where inundation limits of the September 29, 2009, tsunami were measured. Koshimura and others (2009a,b) measurement locations shown for reference only.

Inundation data were collected at 18 sites around Tutuila (fig. 3, table 1). A total of 15,703 inundation limit points were collected. Estimates of the maximum inundation for each village or embayment from measurements in a GIS are reported in table 1. Only the location of the limit of inundation, not the DGPS error or interpretation uncertainty, are shown in figures A1-A15 in the appendix. The error and location uncertainty for each point are included in the electronic files accompanying this report.

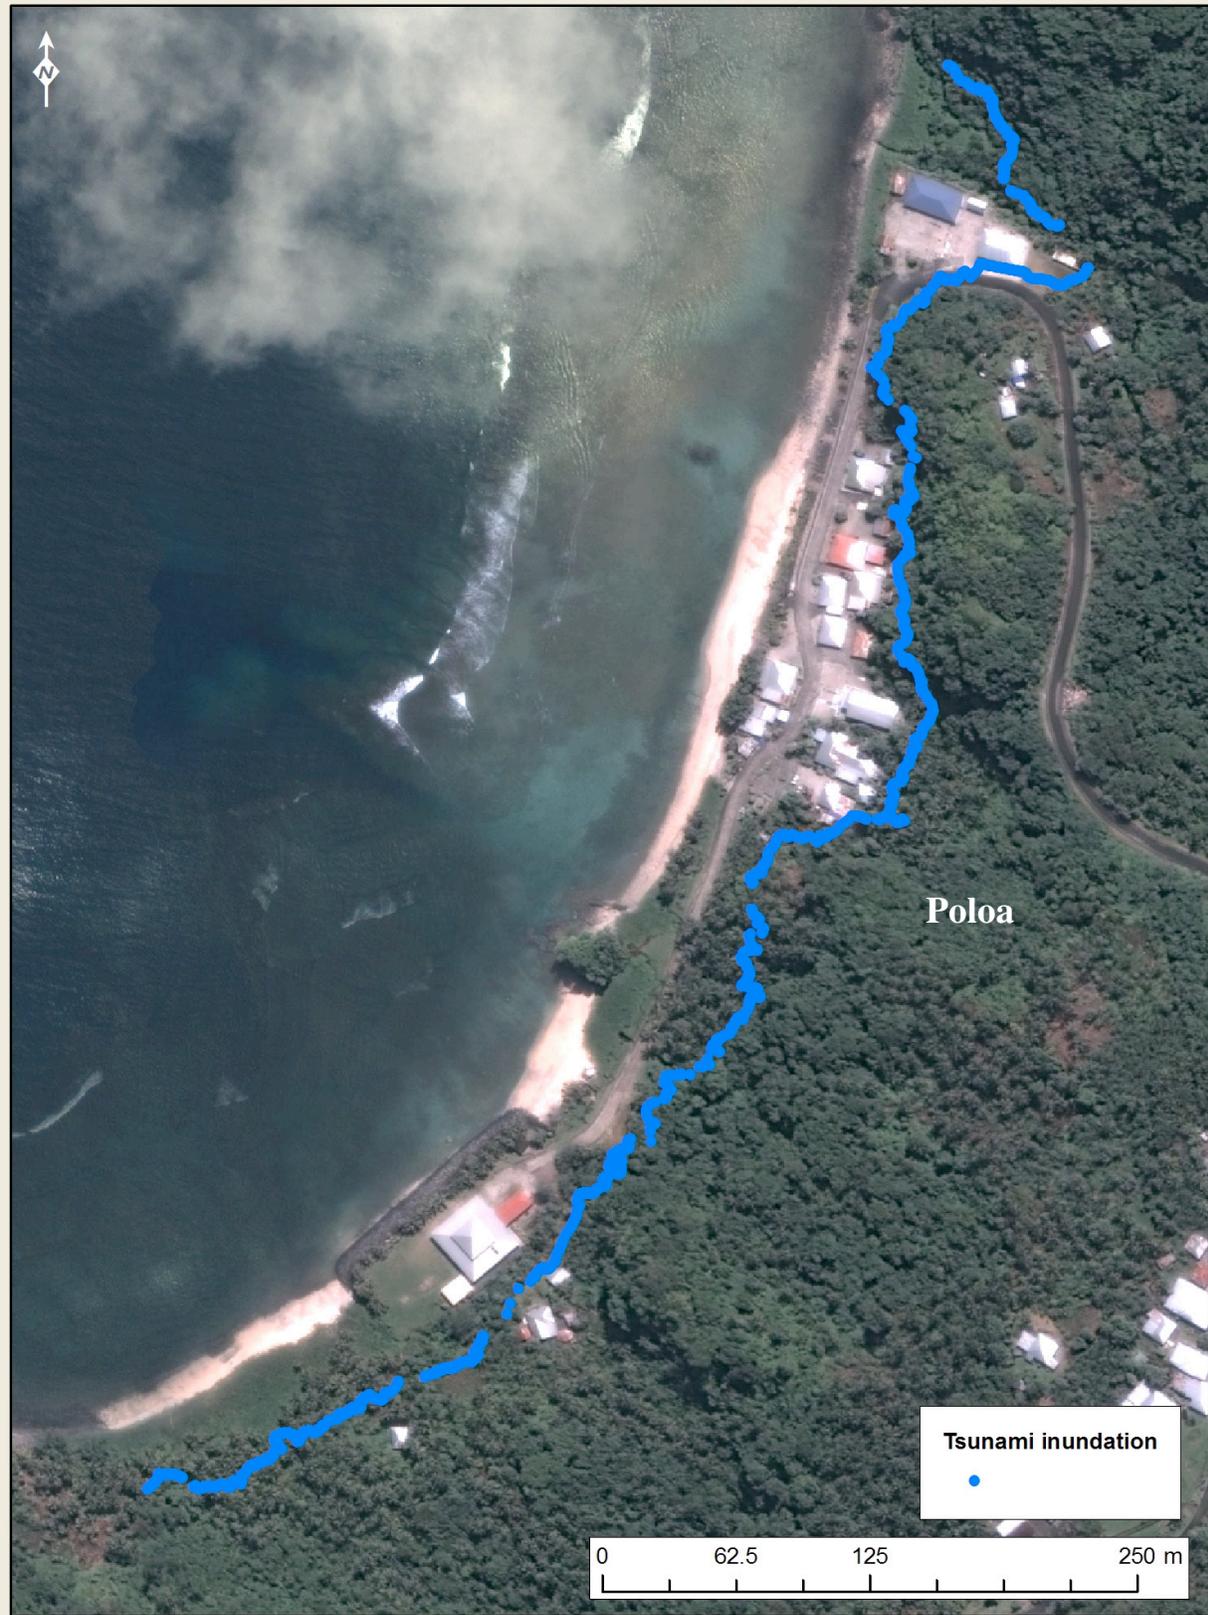
Figure A1. Limit of inundation of the September 29, 2009, tsunami at Poloa, American Samoa. DGPS error and location uncertainty are quantified in the electronic files accompanying this report.

The appendix contains 15 figures with the mapped limit of inundation overlain on 1-m resolution satellite images (U.S. Department of Agriculture, 2010) taken in 2005 before the September 29, 2009, tsunami. The figures are displayed in a clockwise progression starting at Poloa in the northwest of Tutuila, American Samoa. The error and uncertainty for each point are quantified in the electronic files accompanying this report.

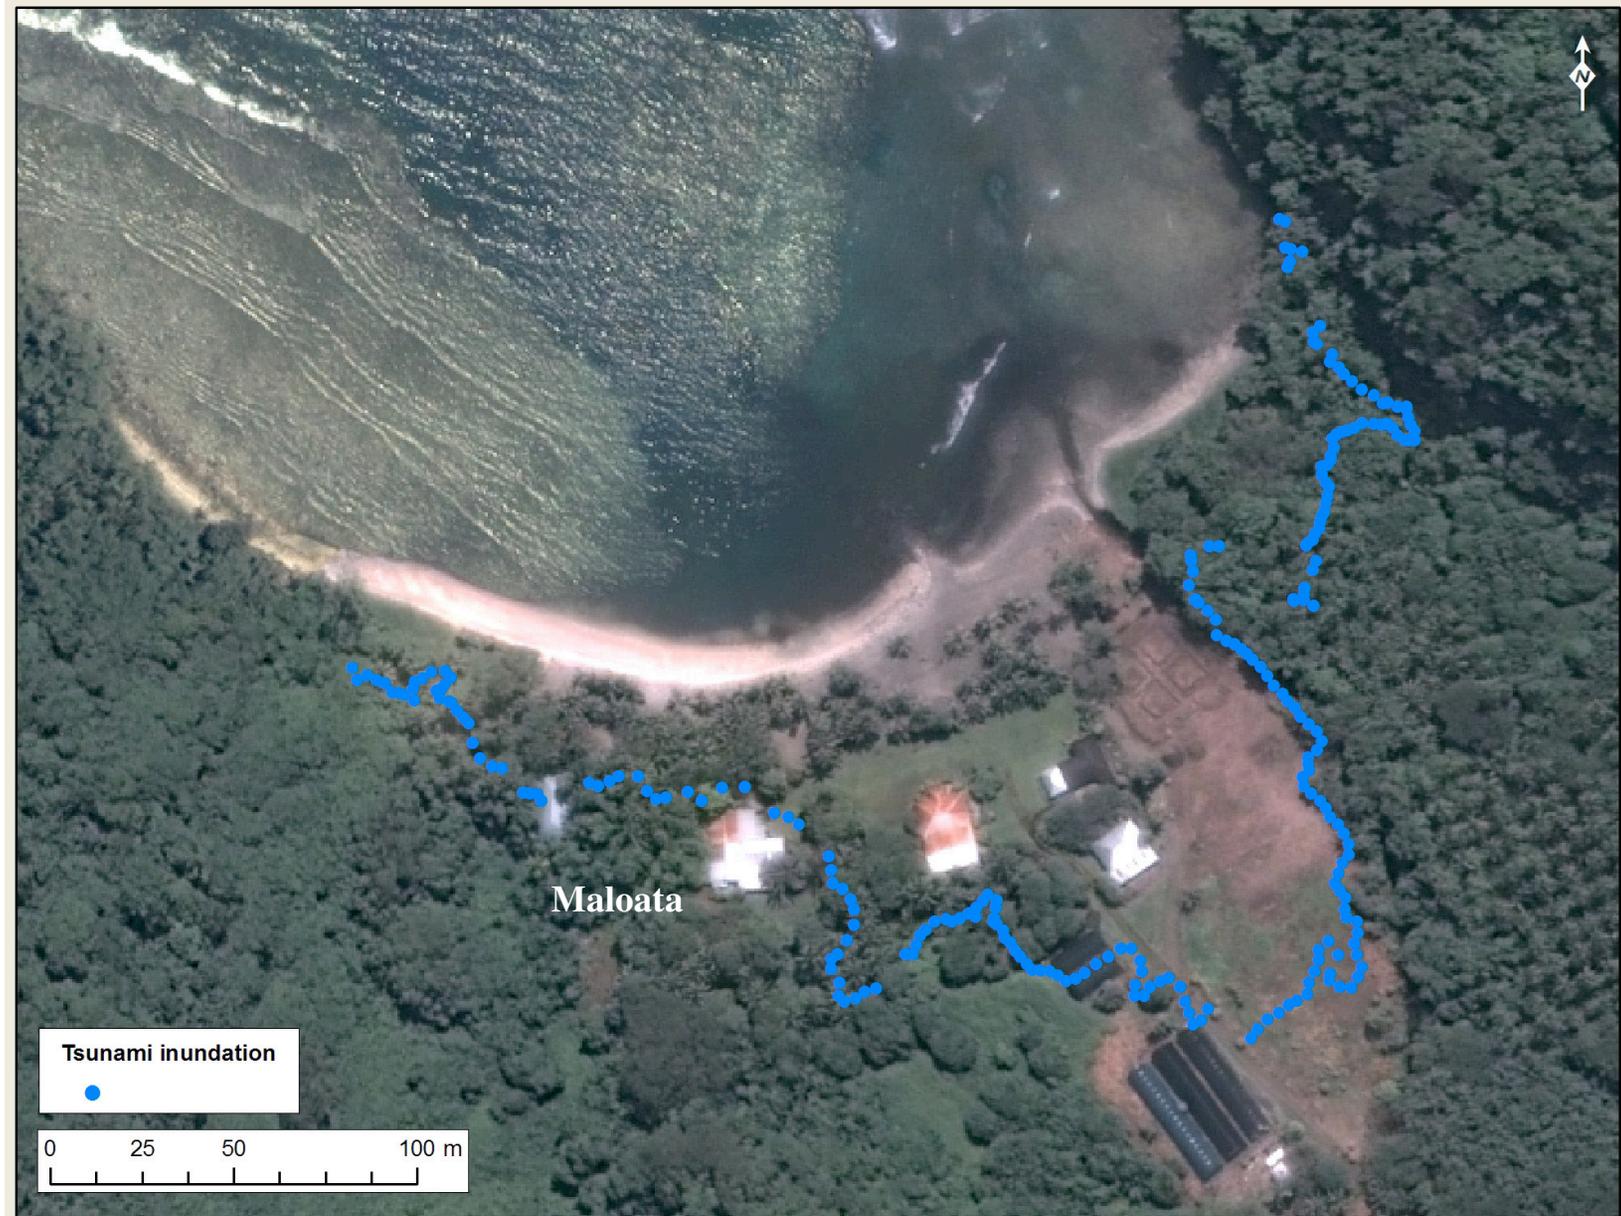
Figure A2. Limit of tsunami inundation of the September 29, 2009, tsunami at Maloata, American Samoa. DGPS error and location uncertainty are quantified in the electronic files accompanying this report.

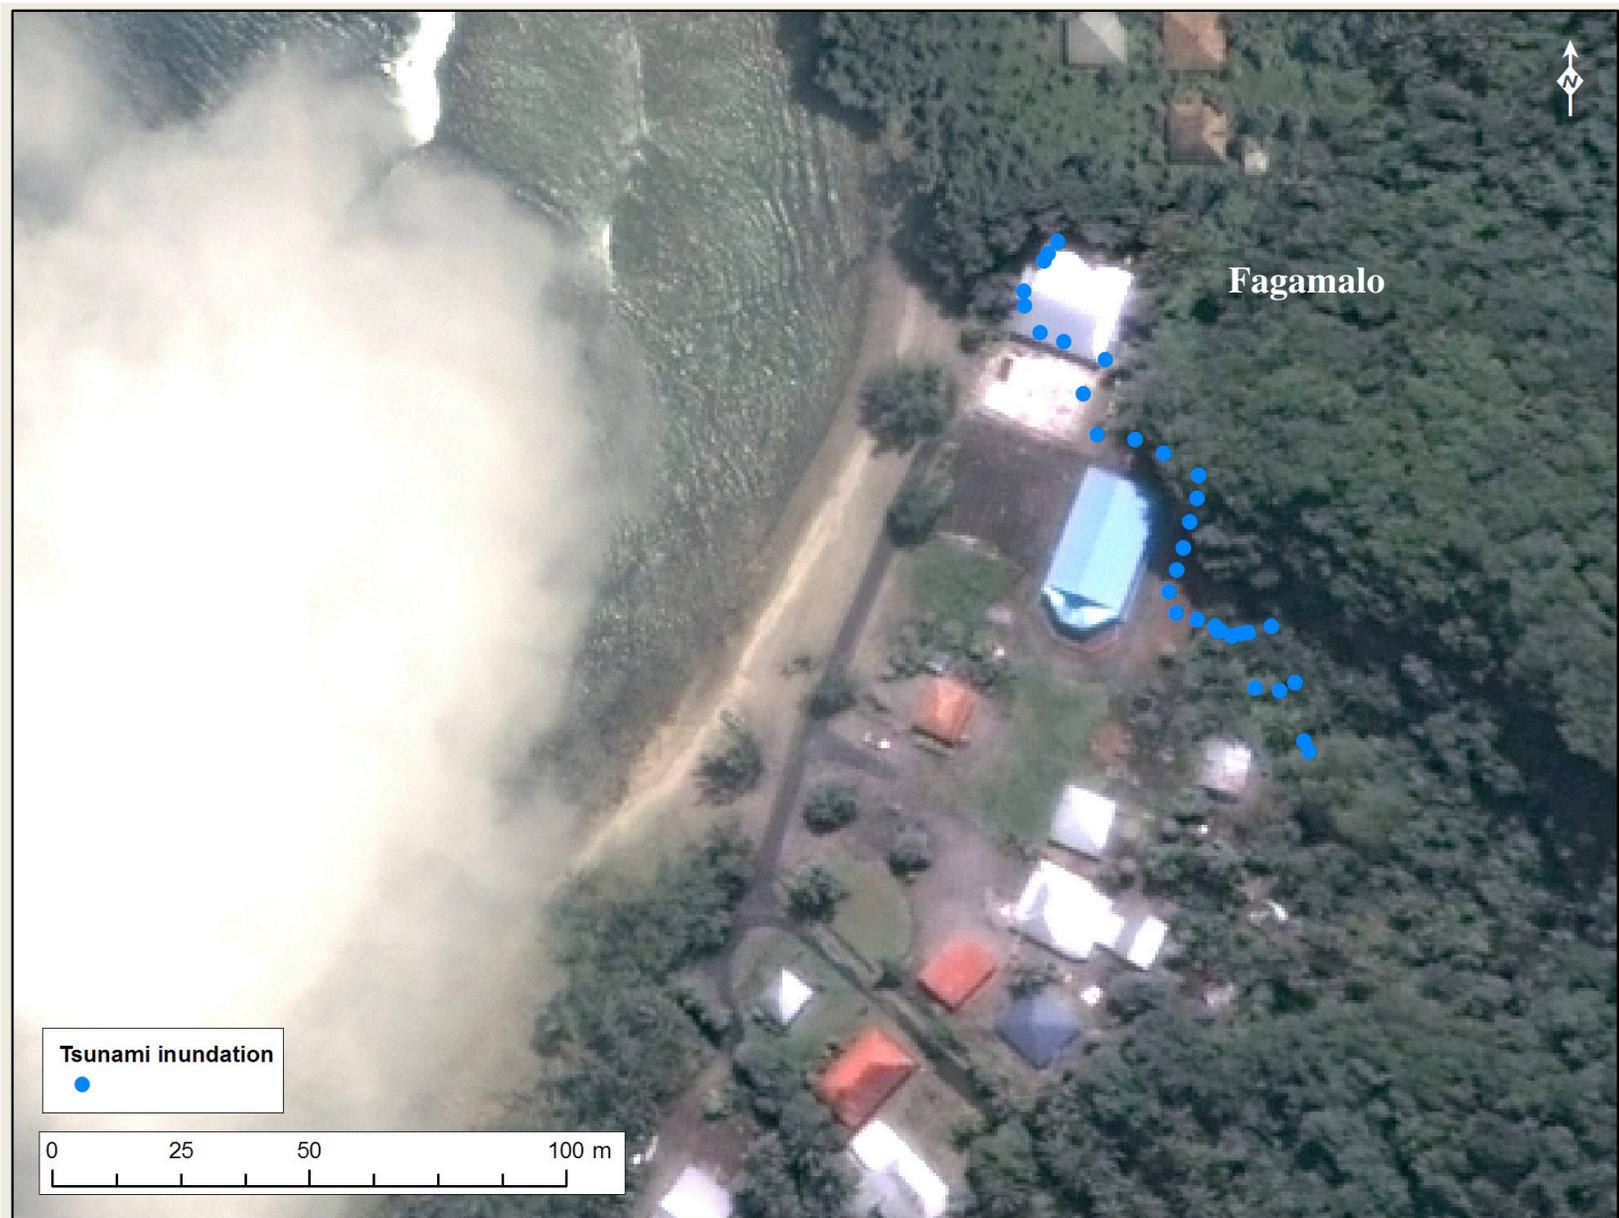
Figure A3. Limit of tsunami inundation of the September 29, 2009, tsunami at Fagamalo, American Samoa. DGPS error and location uncertainty are quantified in the electronic files accompanying this report.

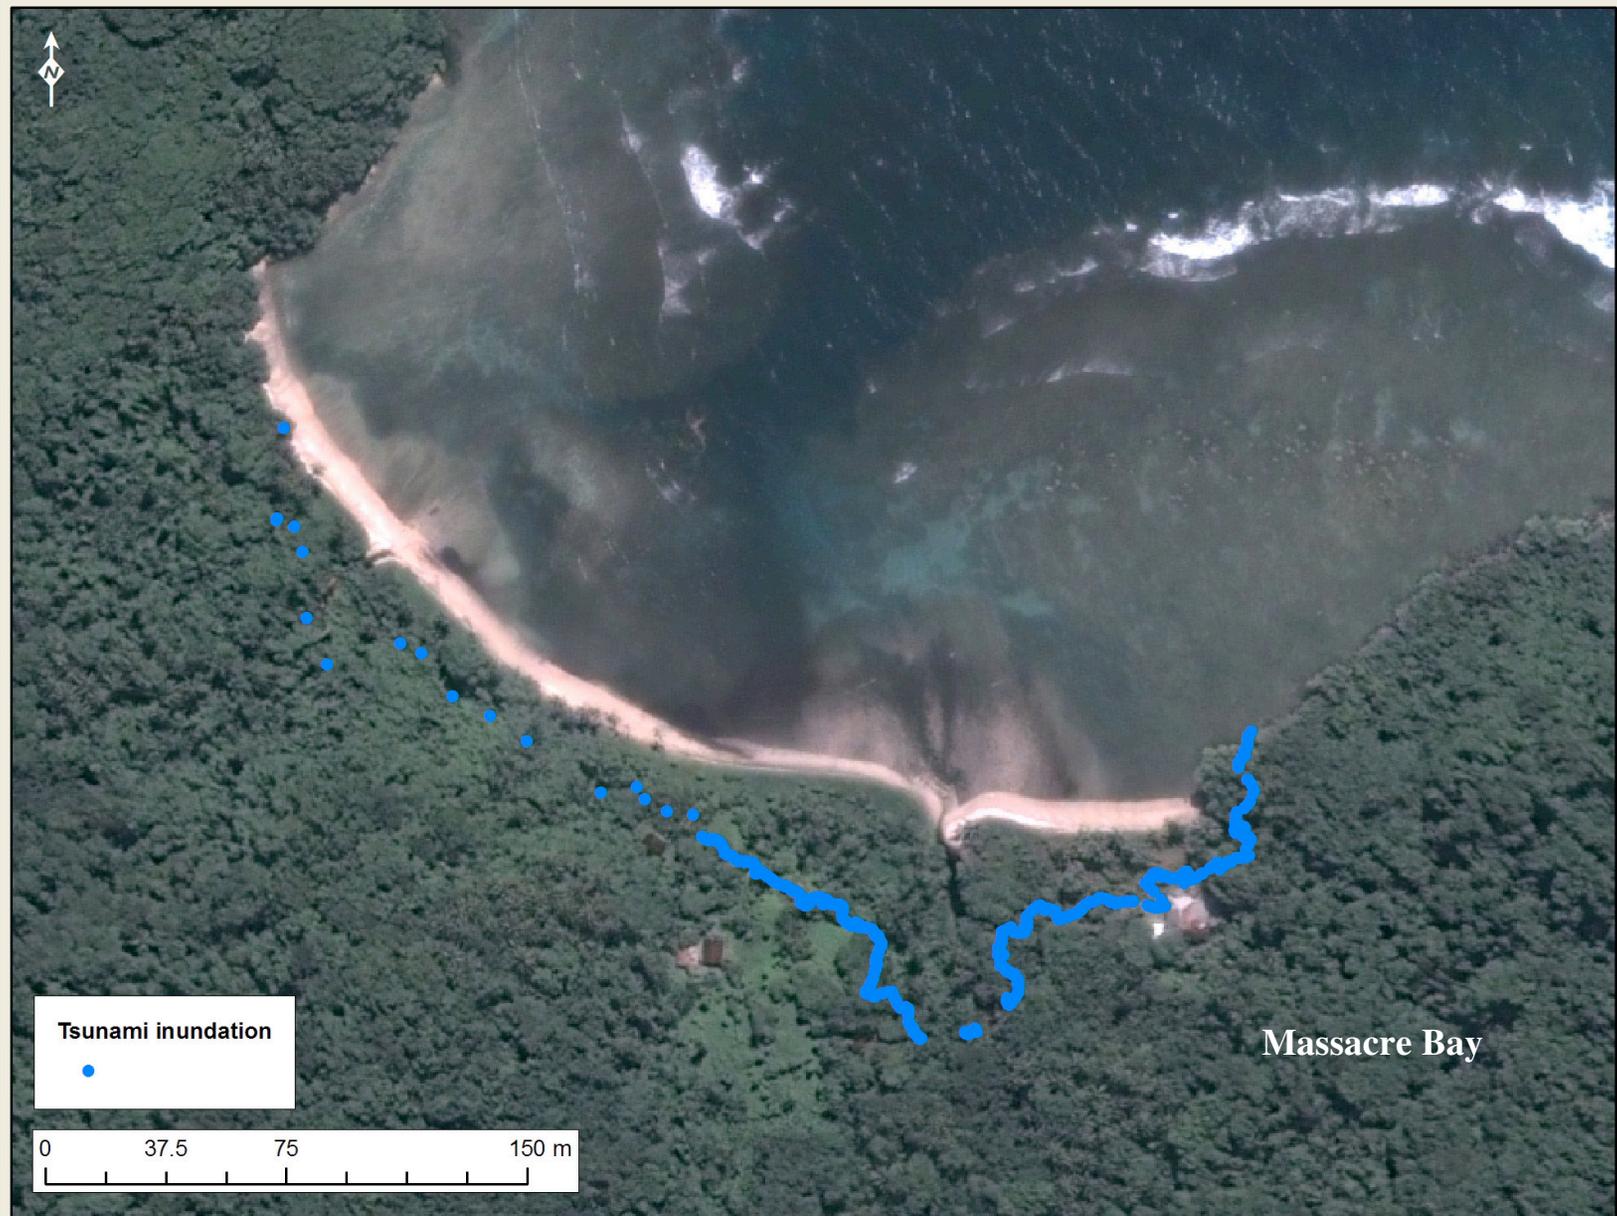
Figure A4. Limit of inundation of the September 29, 2009, tsunami inundation at Massacre Bay, American Samoa. DGPS error and location uncertainty are quantified in the electronic files accompanying this report.

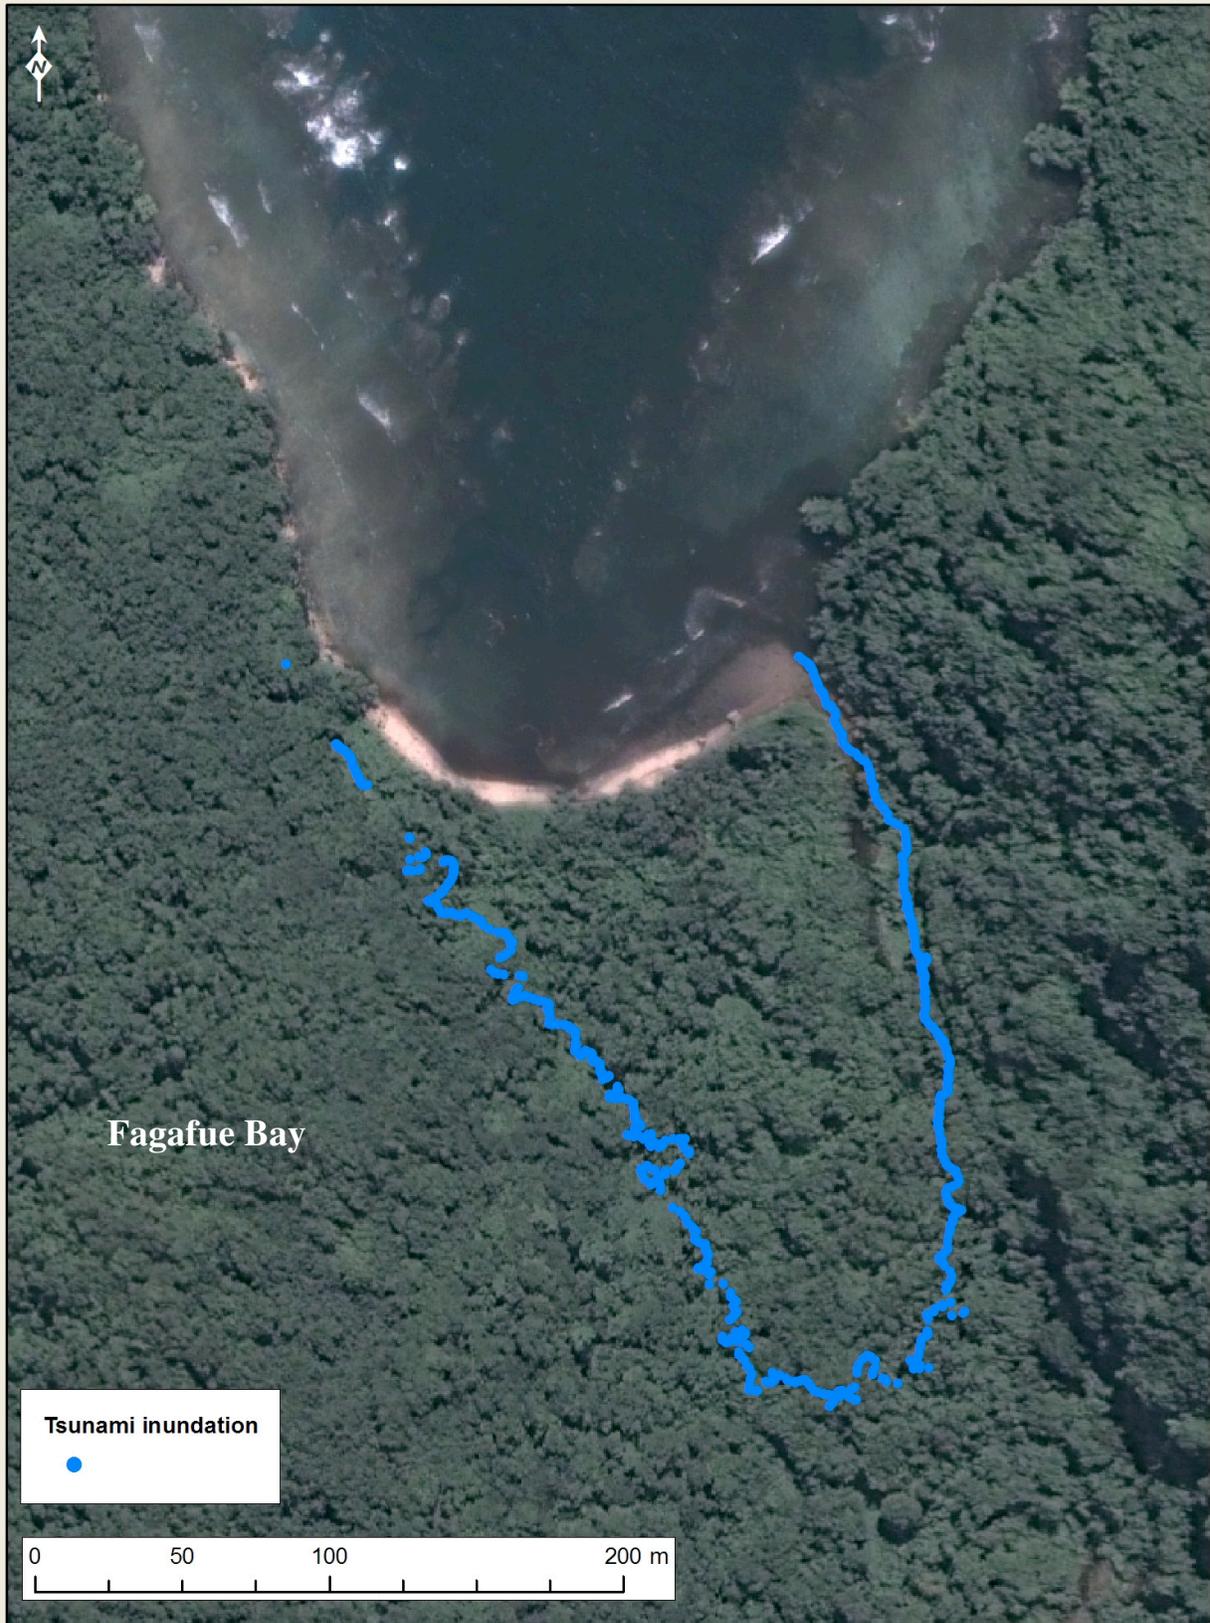
Figure A5. Limit of inundation of the September 29, 2009, tsunami at Fagafue Bay, American Samoa. DGPS error and location uncertainty are quantified in the electronic files accompanying this report.

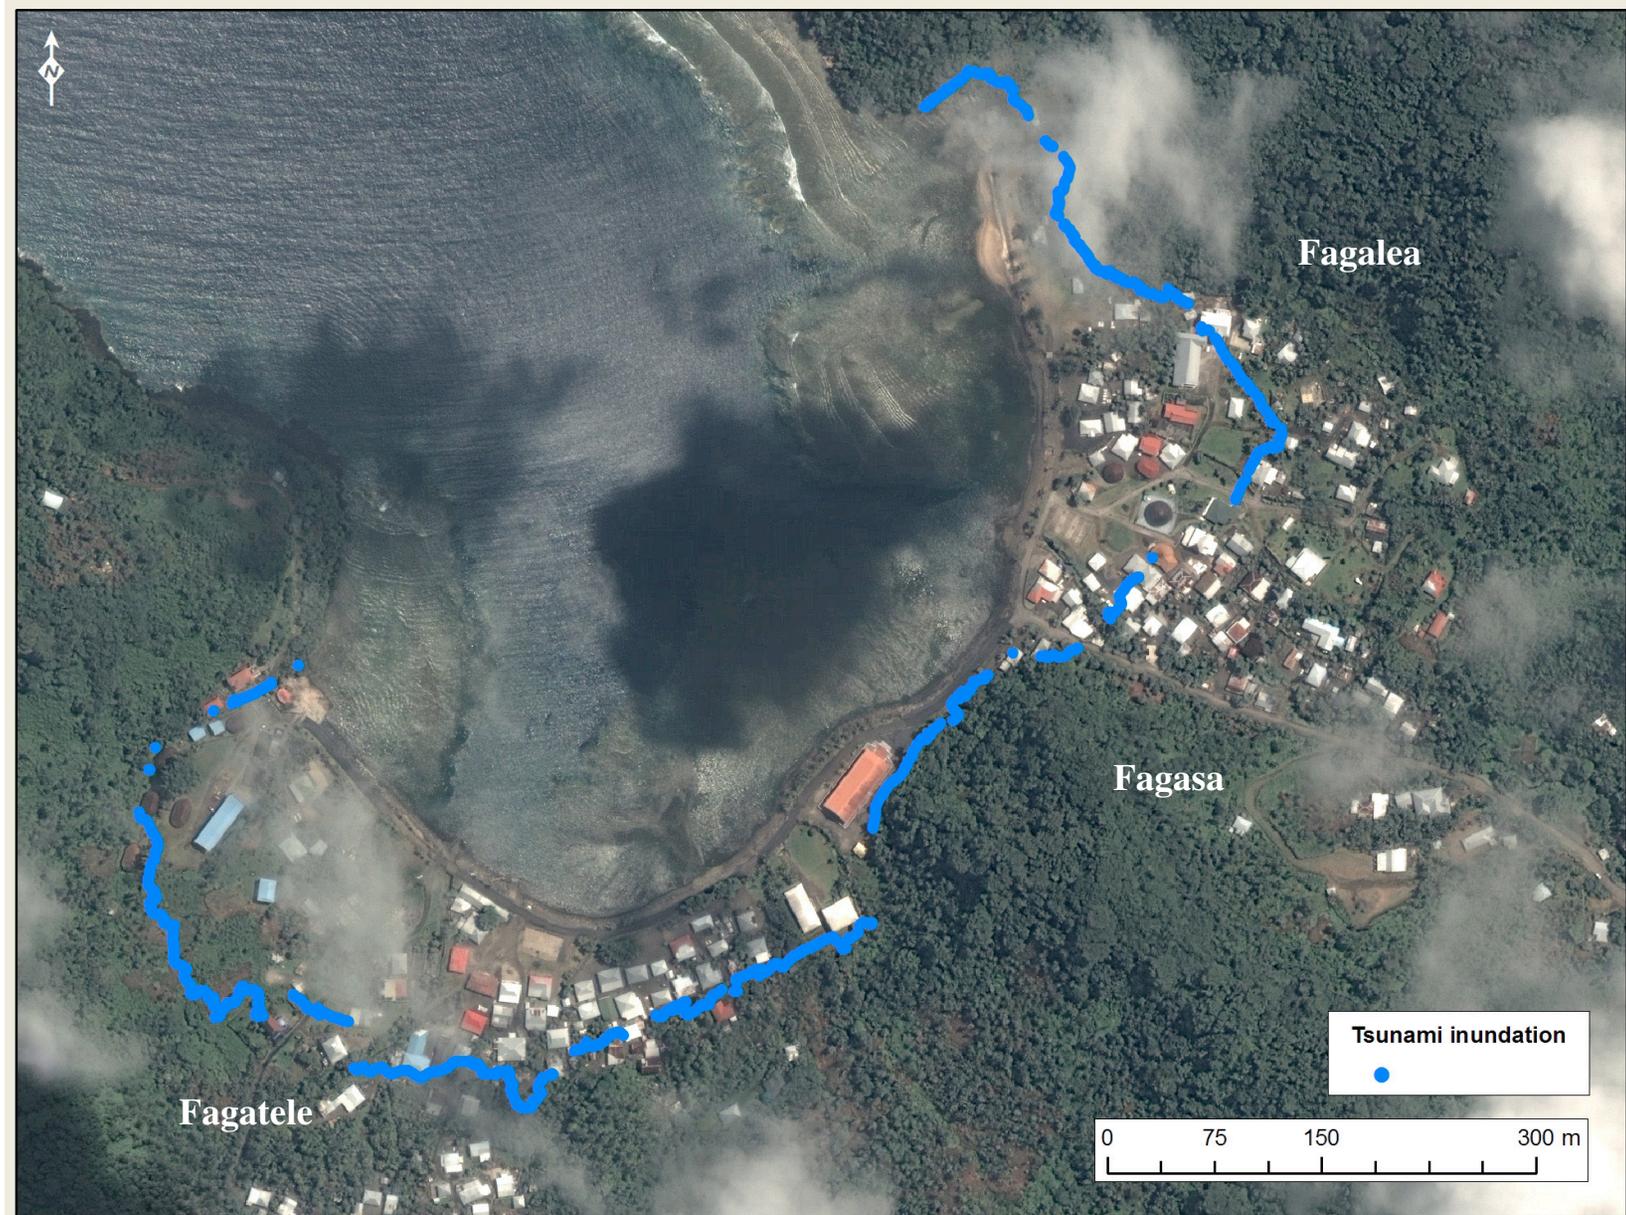
Figure A6. Limit of inundation of the September 29, 2009, tsunami at Fagasa Bay, American Samoa. The villages of Fagalea, Fagasa, and Fagatele are within the Bay. DGPS error and location uncertainty are quantified in the electronic files accompanying this report.

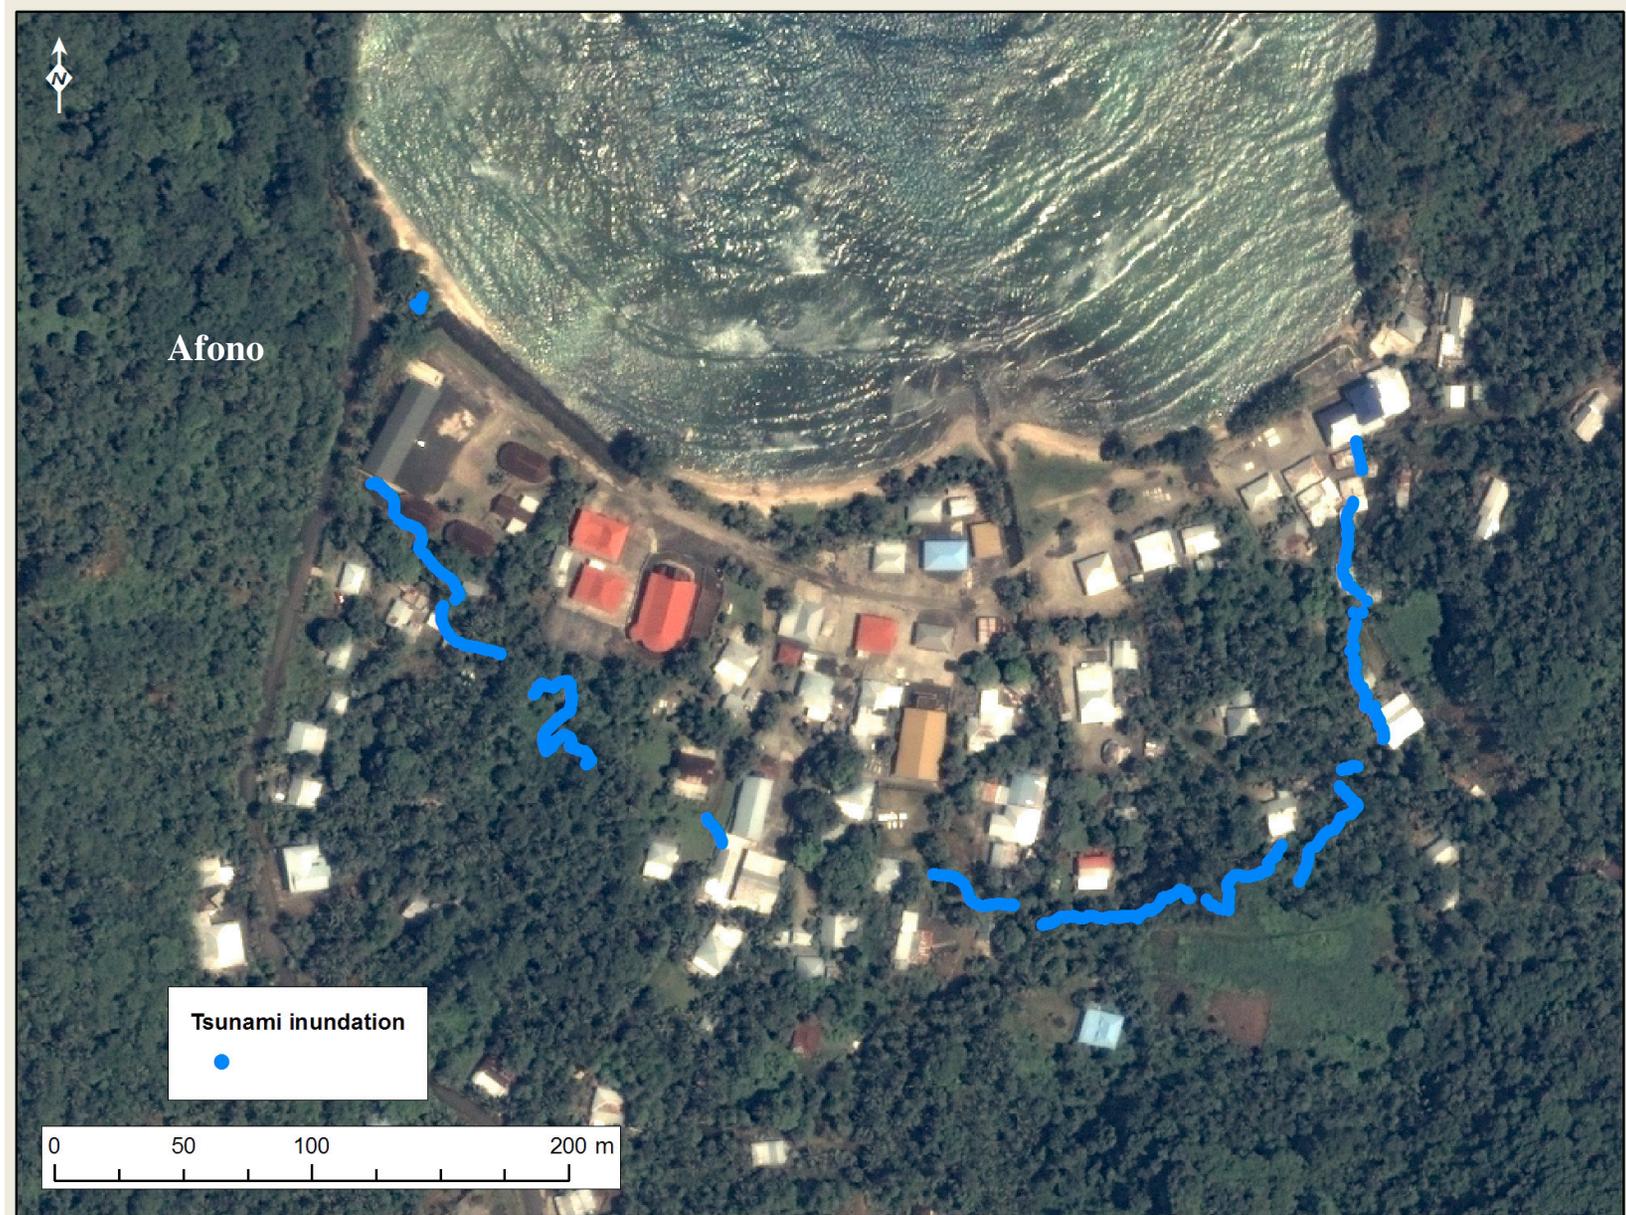
Figure A7. Limit inundation of the September 29, 2009, tsunami at Afono, American Samoa. DGPS error and location uncertainty are quantified in the electronic files accompanying this report.

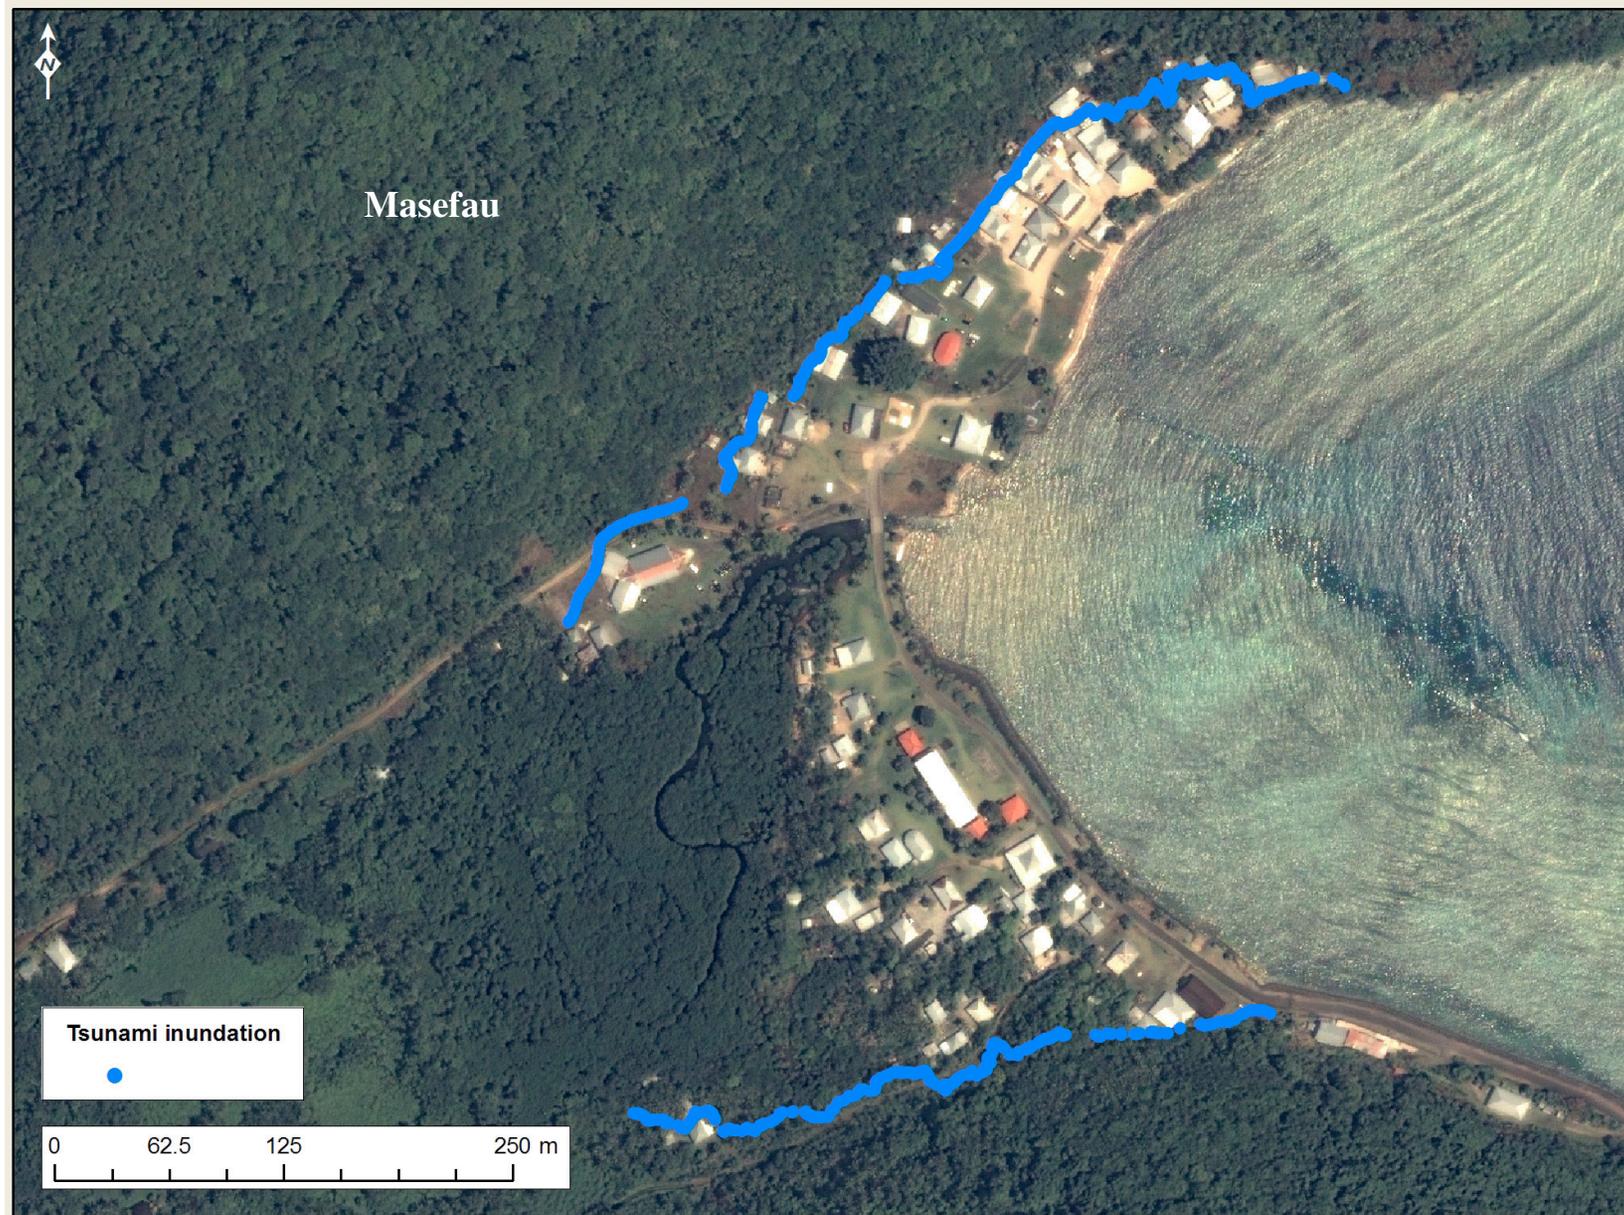
Figure A8. Limit of inundation of the September 29, 2009, tsunami at Masefau, American Samoa. DGPS error and location uncertainty are quantified in the electronic files accompanying this report.

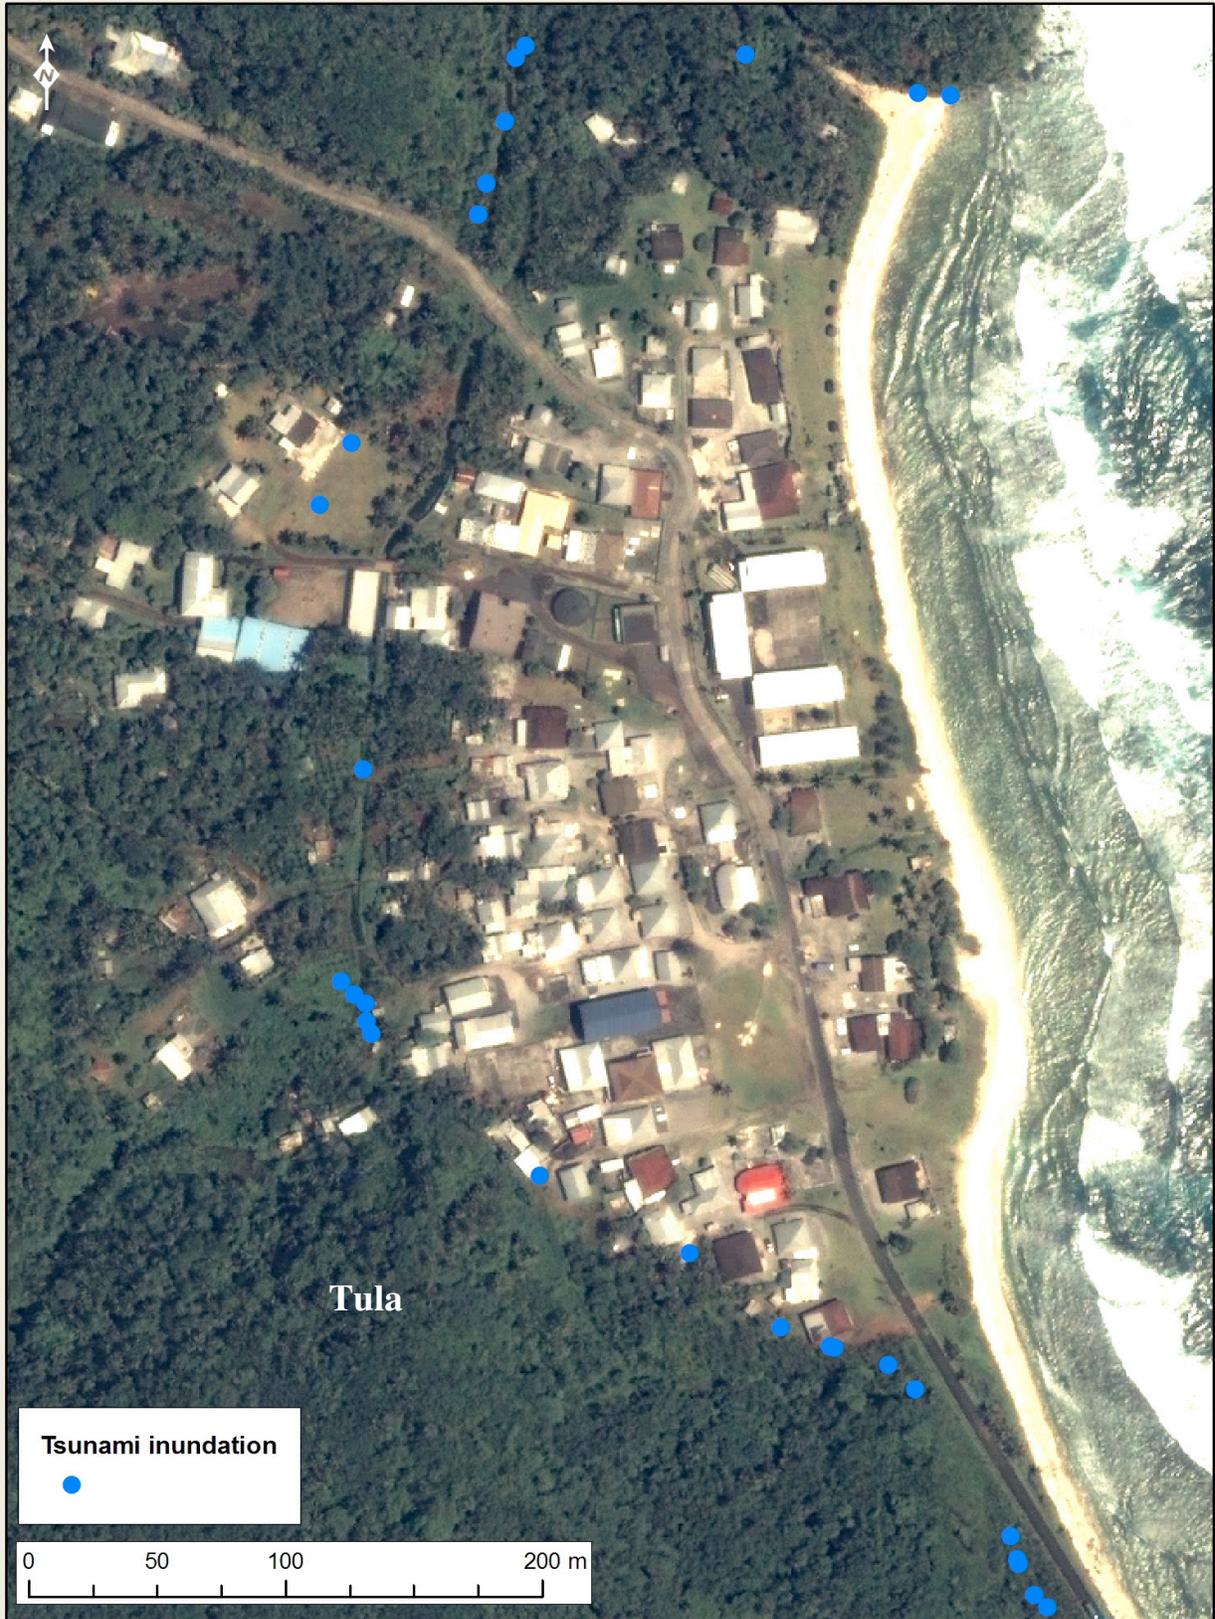
Figure A9. Limit of inundation of the September 29, 2009, tsunami at Tula, American Samoa. DGPS error and location uncertainty are quantified in the electronic files accompanying this report.

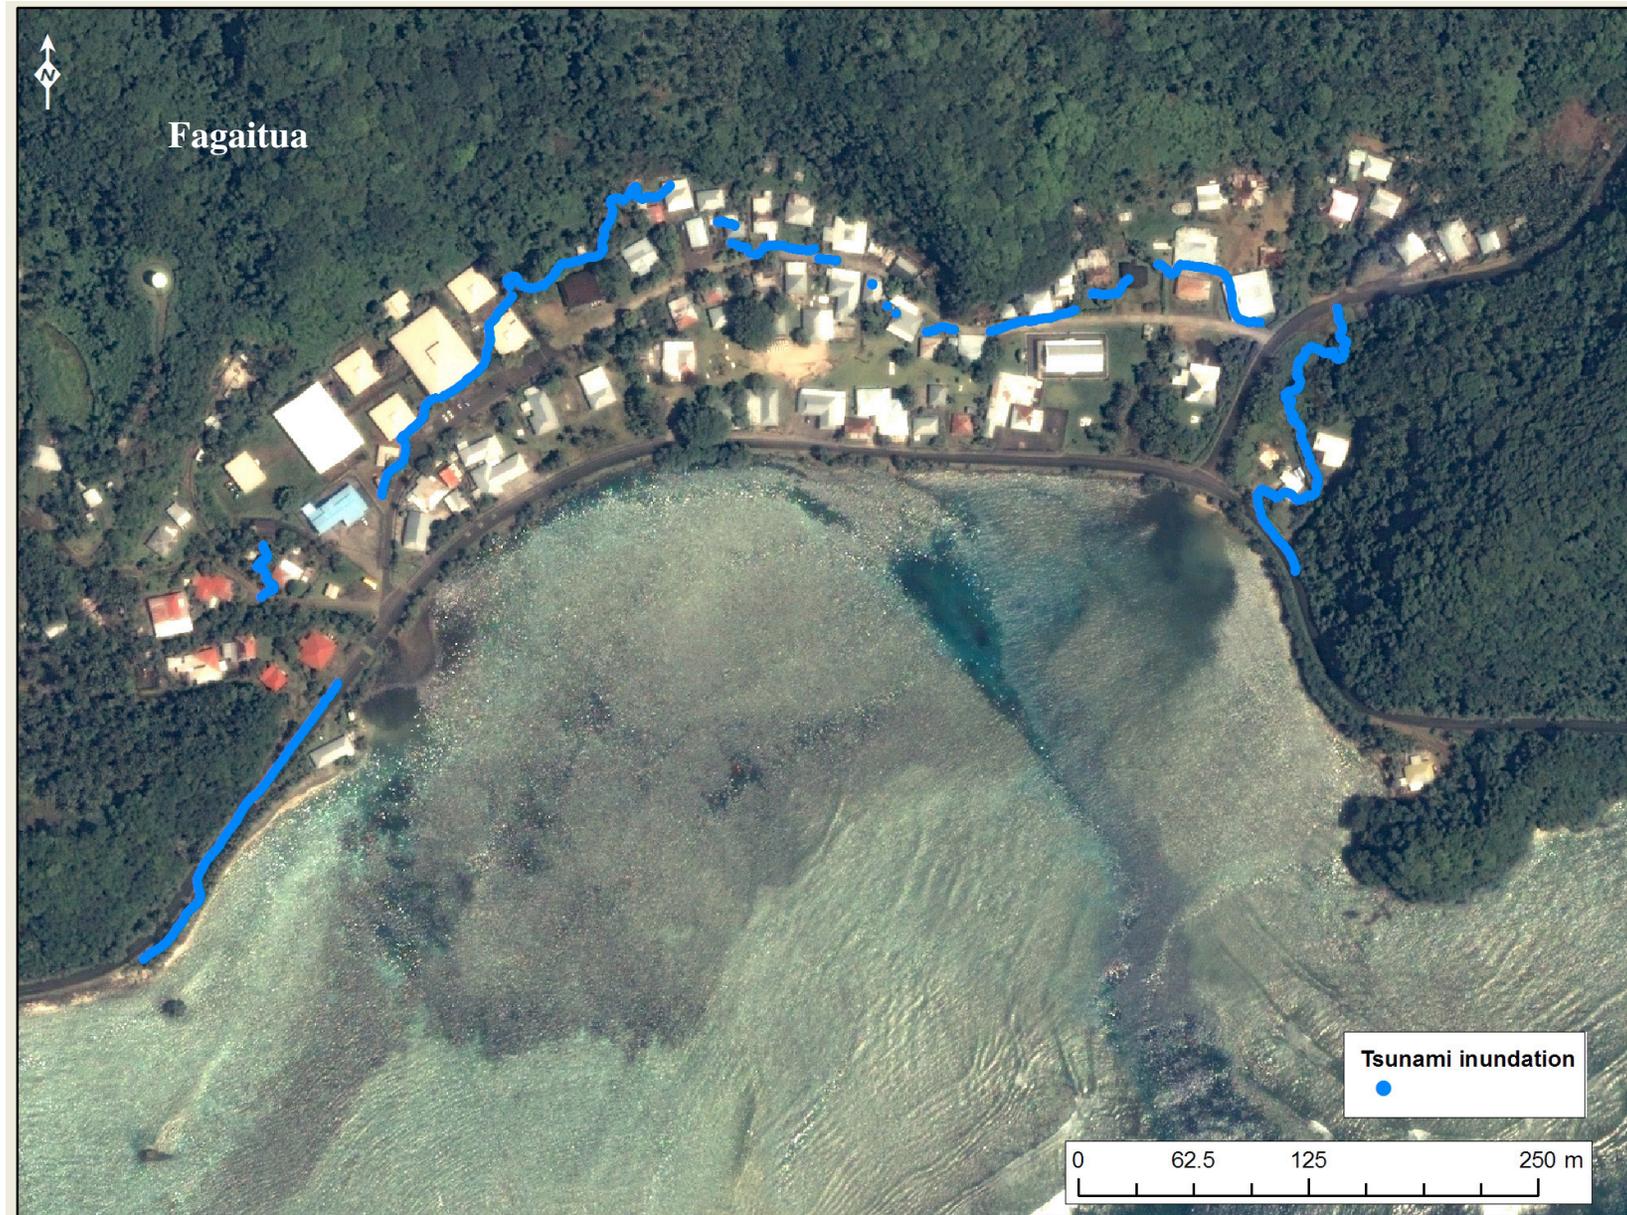
Figure A10. Limit of inundation of the September 29, 2009, tsunami at Fagaitua, American Samoa. DGPS error and location uncertainty are quantified in the electronic files accompanying this report.
