The Limit of Inundation of the September 29, 2009, Tsunami on Tutuila, American Samoa

Open-File Report 2010-1018

U.S. Department of the Interior
U.S. Geological Survey

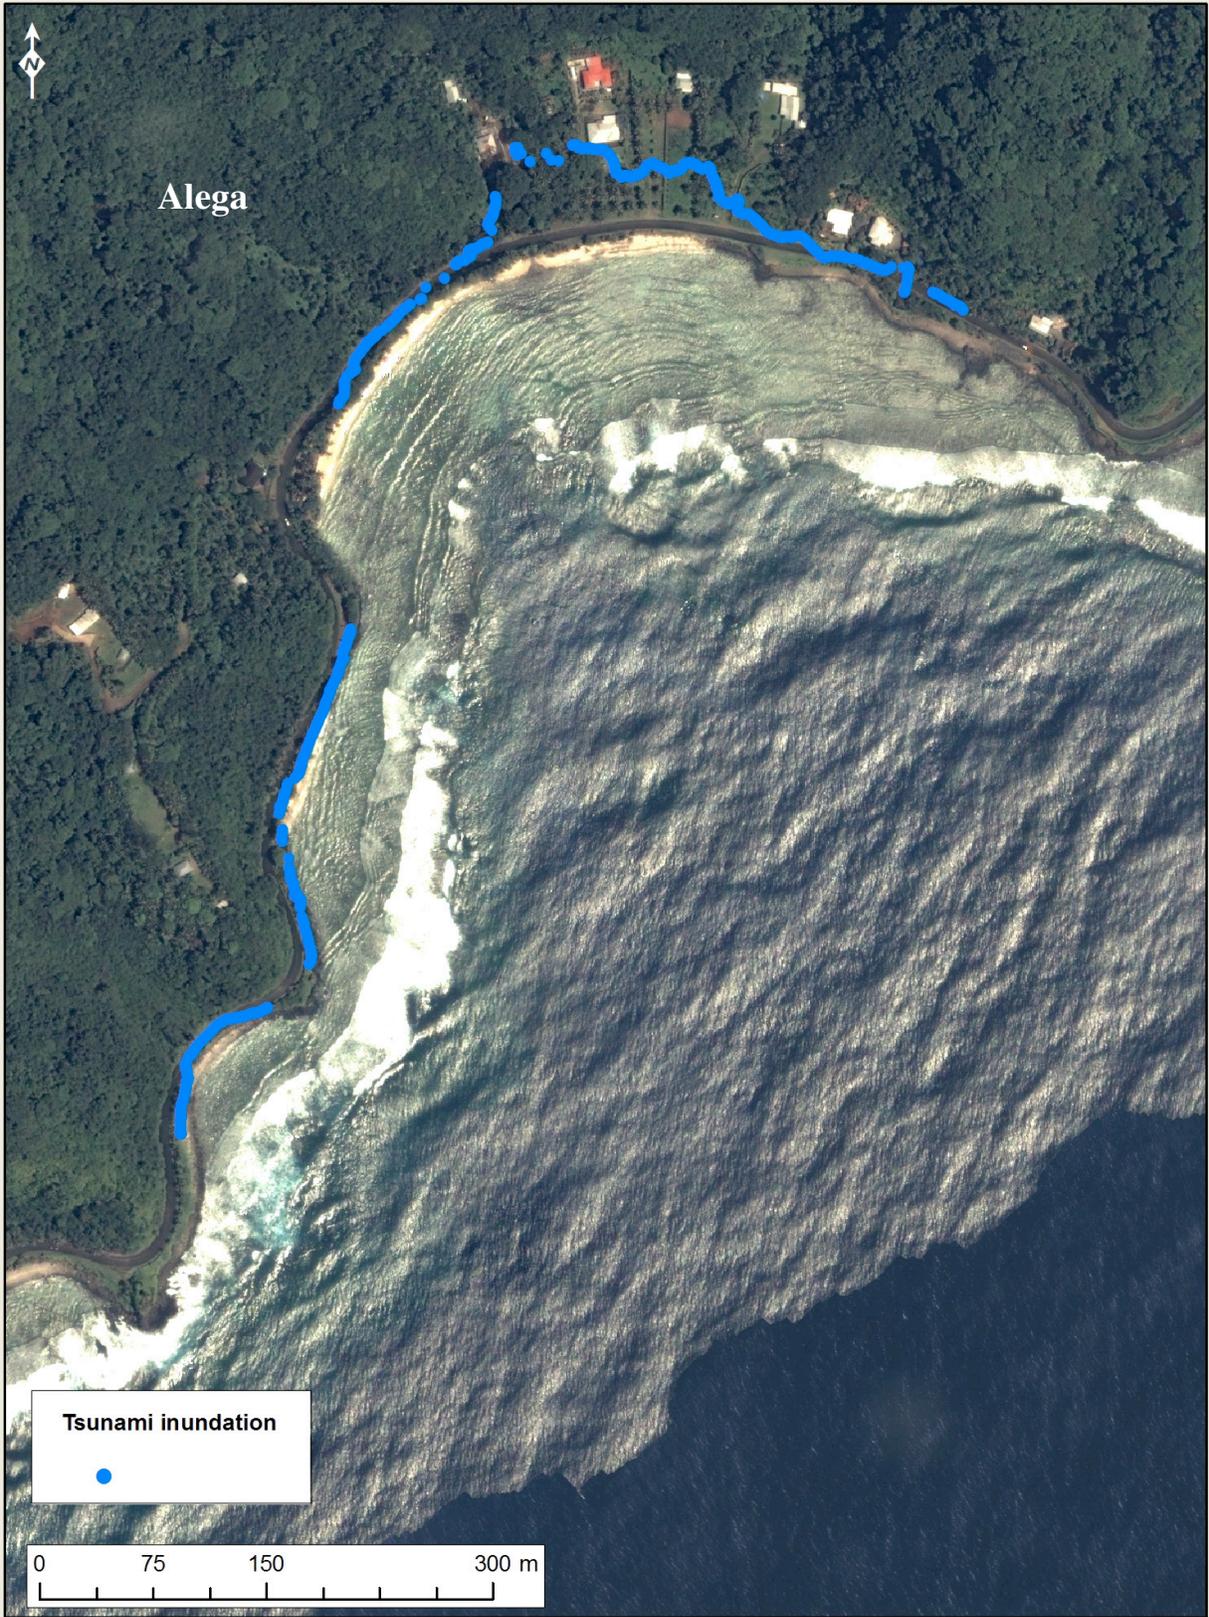
Figure A11. Limit of inundation of the September 29, 2009, tsunami at Alega, American Samoa. DGPS error and location uncertainty are quantified in the electronic files accompanying this report.

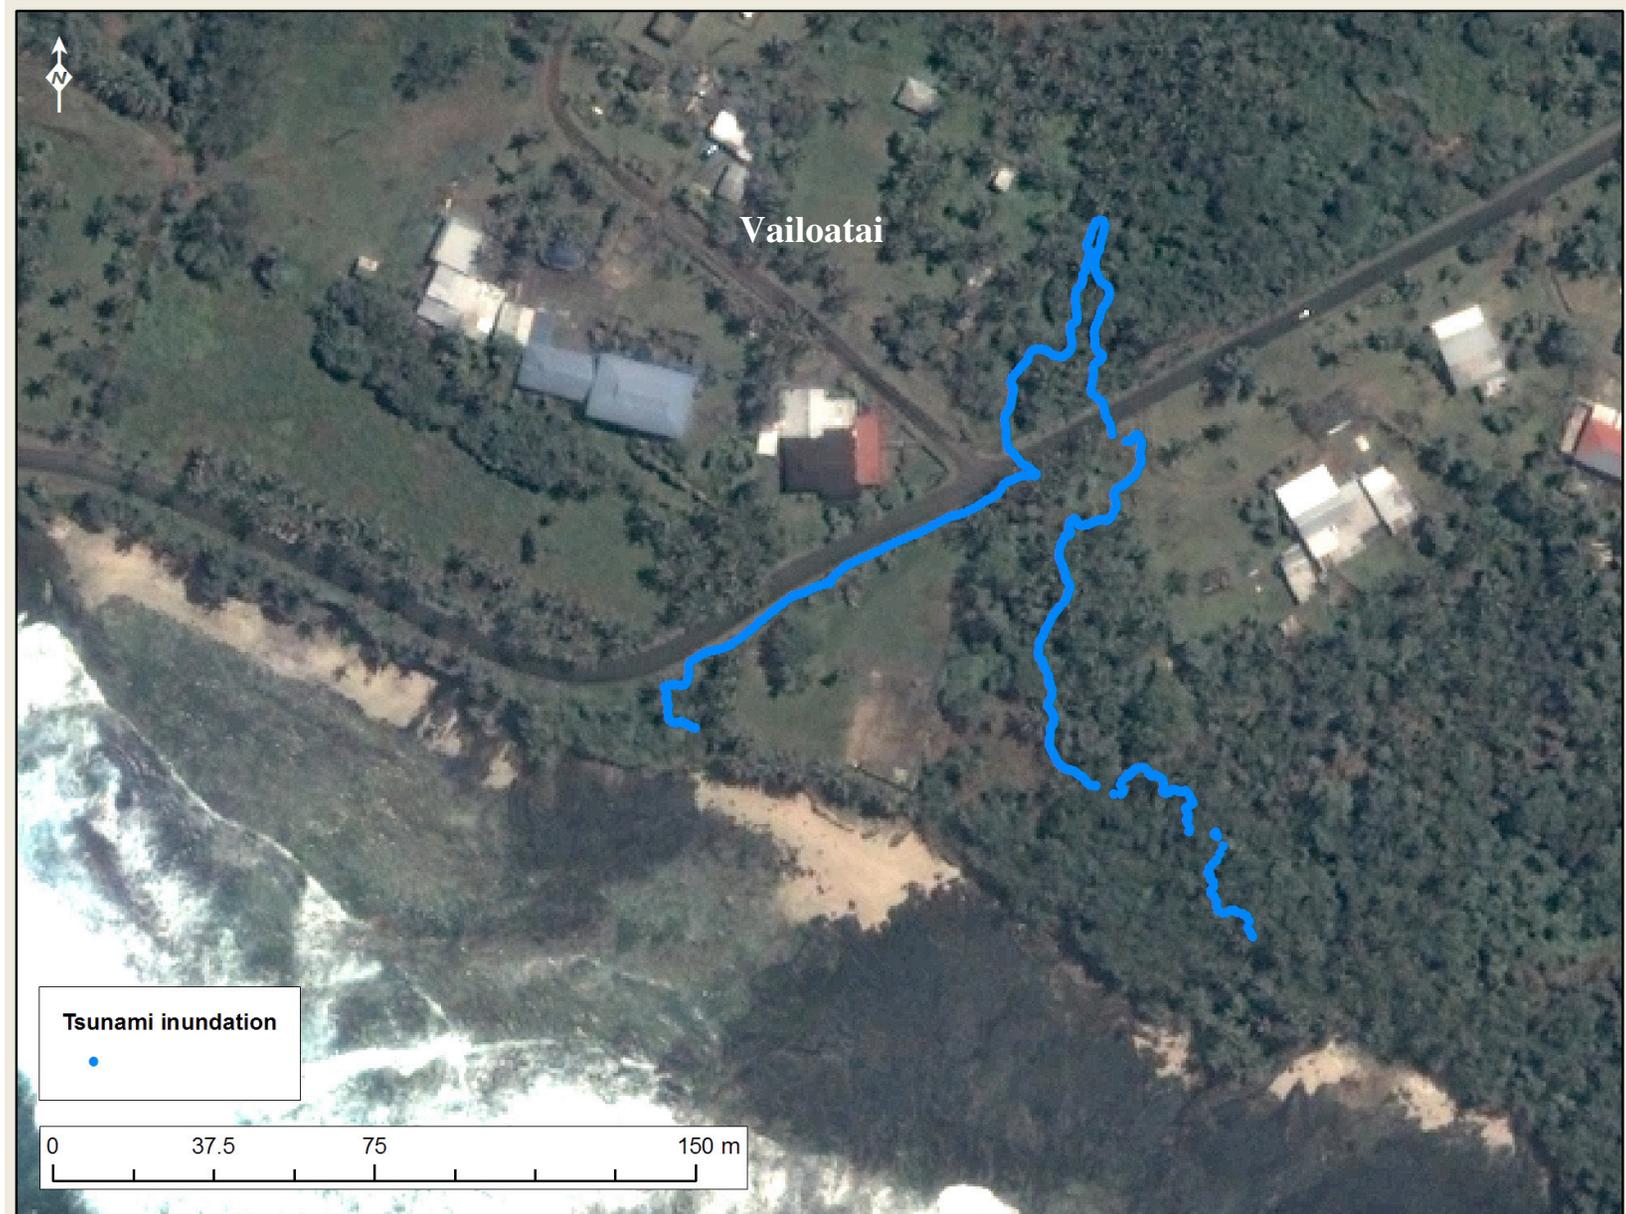
Figure A12. Limit inundation of the September 29, 2009, tsunami at Vailoatai, American Samoa. DGPS error and location uncertainty are quantified in the electronic files accompanying this report.

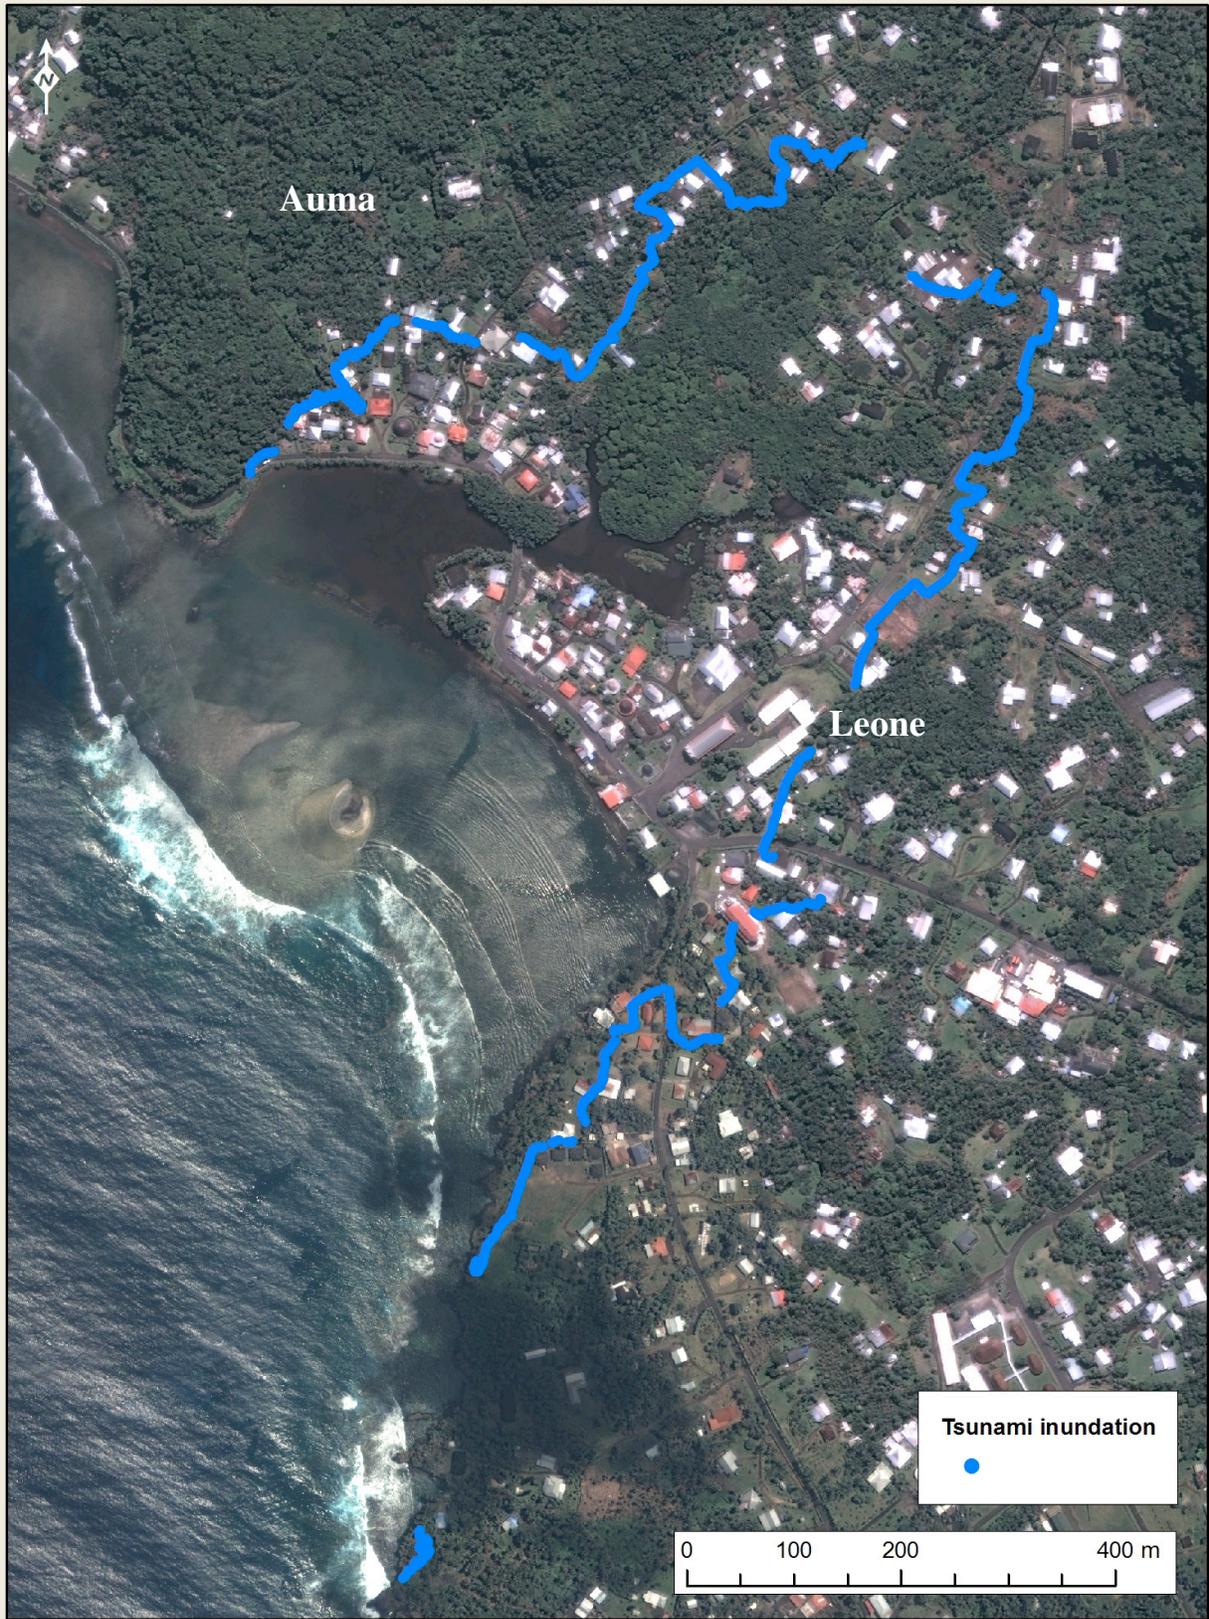
Figure A13. Limit of inundation of the September 29, 2009, tsunami at Auma and Leone, American Samoa. DGPS error and location uncertainty are included in the electronic files accompanying this report.

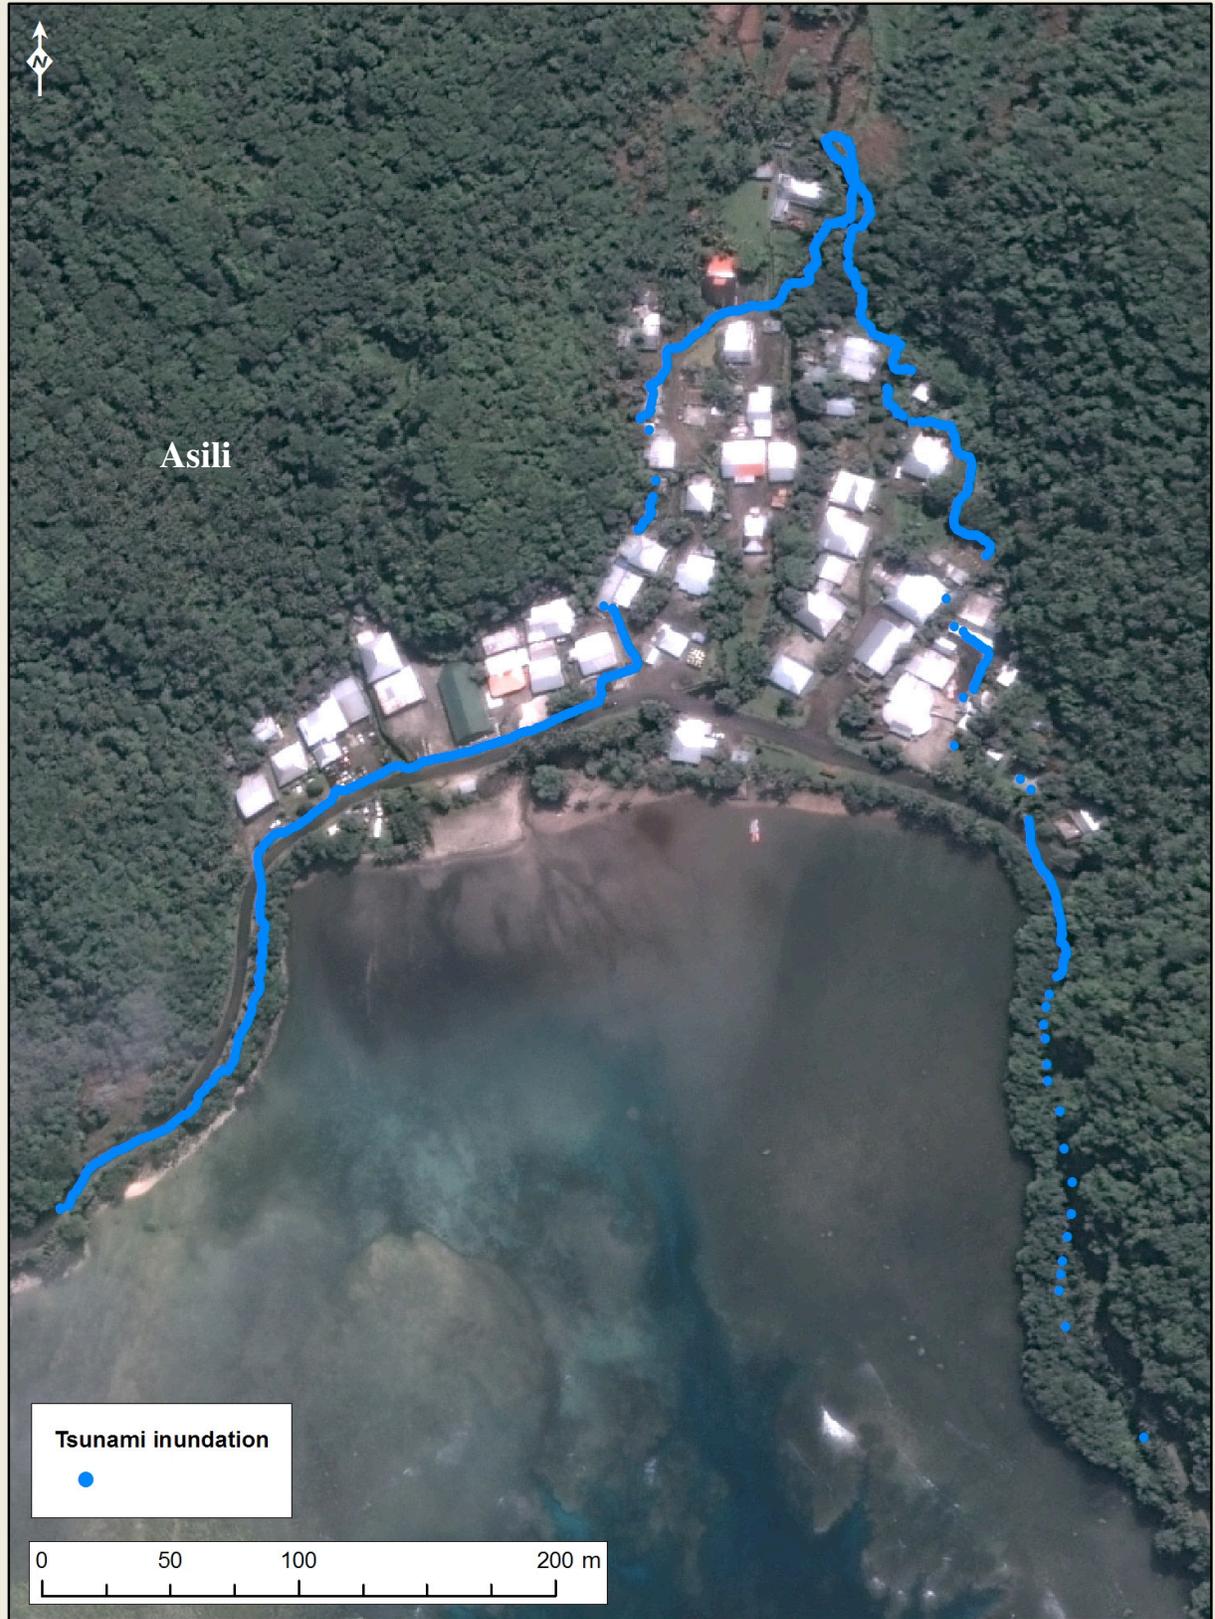
Figure A14. Limit of inundation of the September 29, 2009, tsunami at Asili, American Samoa. DGPS error and location uncertainty are included in the electronic files accompanying this report.

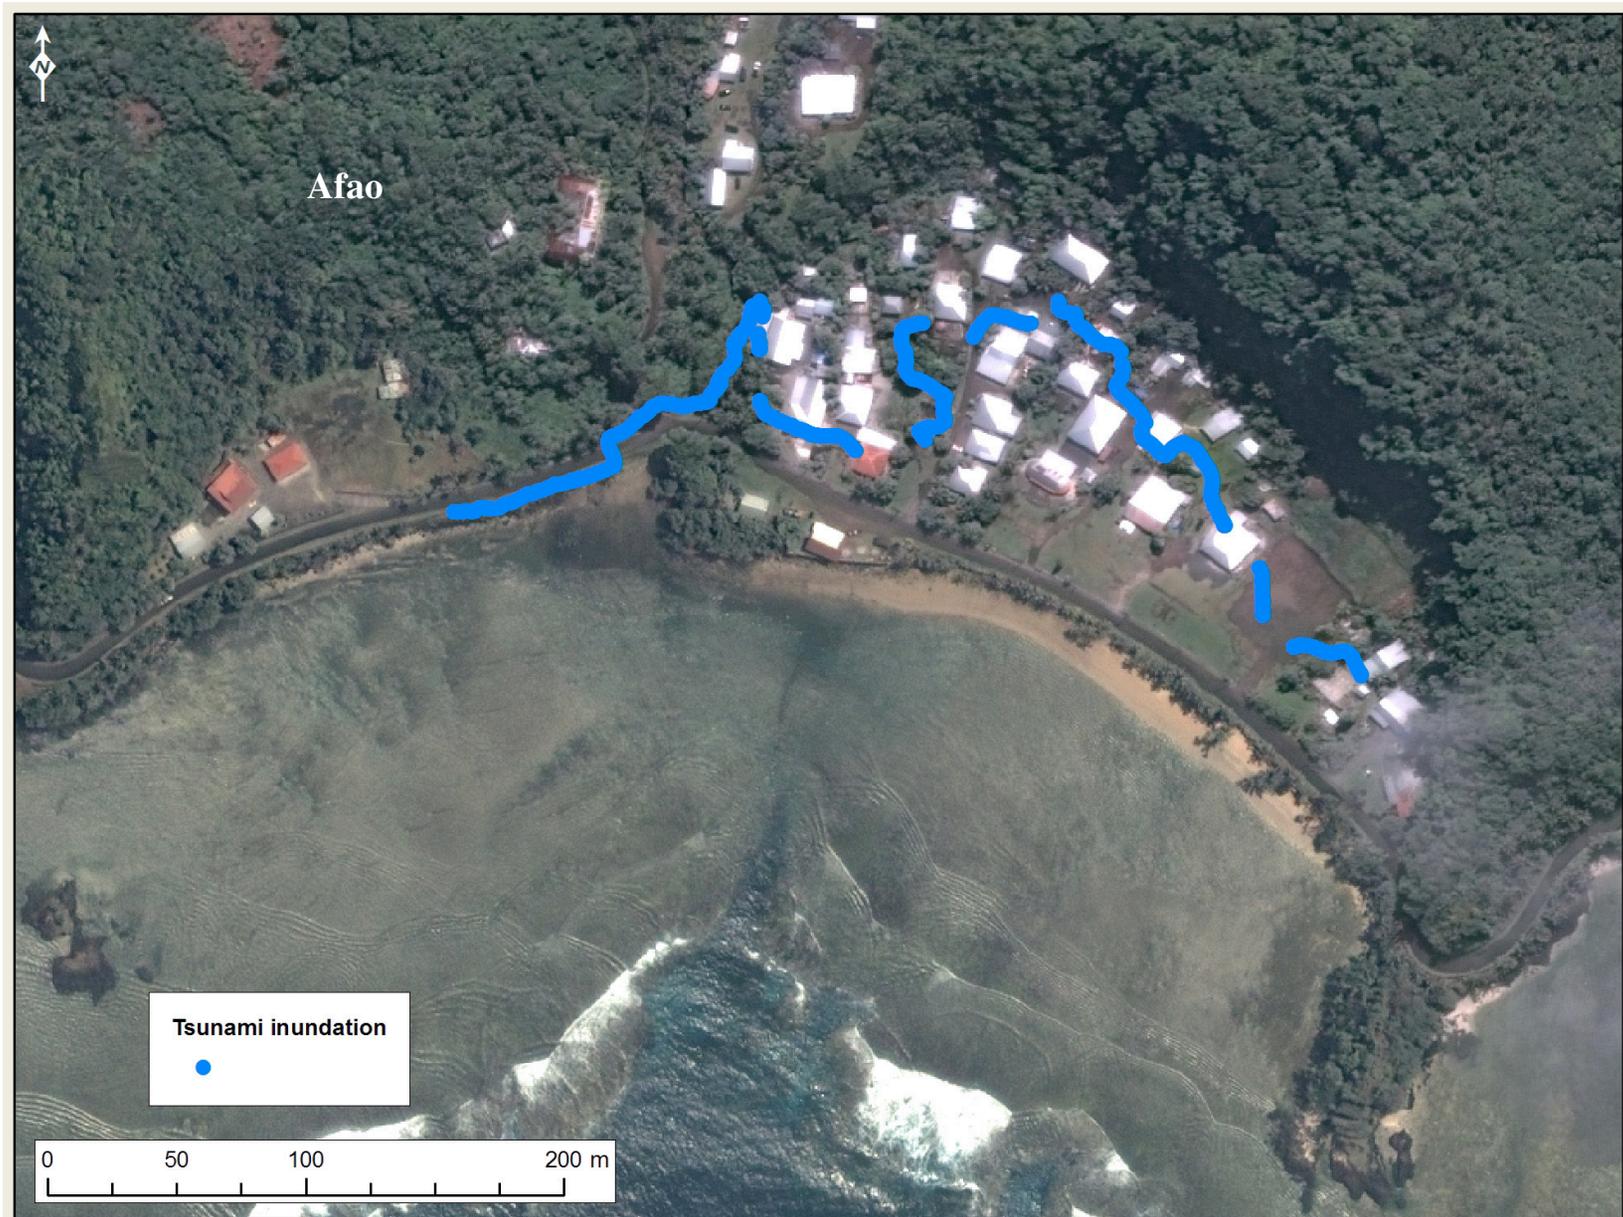
Figure A15. Limit of inundation of the September 29, 2009, tsunami at Afao, American Samoa. DGPS error and location uncertainty are quantified in the electronic files accompanying this report.
