Seismic Performance of the Rural Habitat on the Main Boundary Thrust

Amita Sinvhal¹, Ashok D. Pandey¹, S. M. Pore¹

¹Department of Earthquake Engineering, IIT Roorkee, Roorkee, Uttarakhand, India, amitafeq@iitr.ernet.in

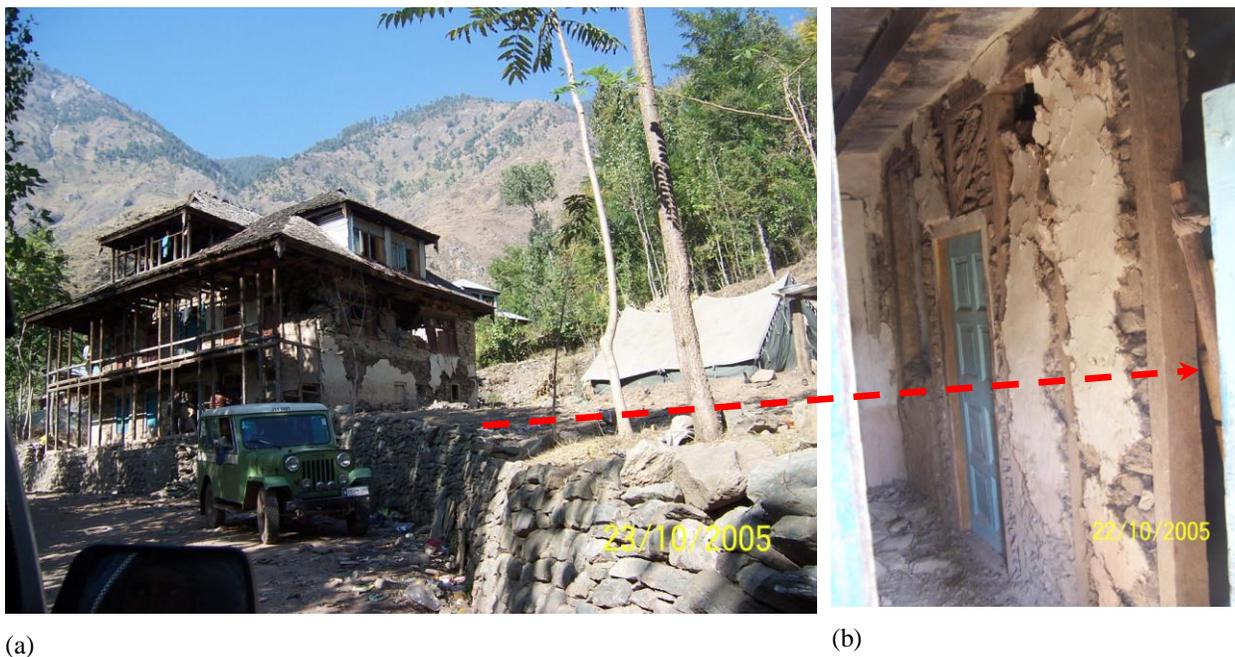
Figure 1. Seismic response of a *dhajji diwari* house in the Kashmir earthquake of October 8, 2006, magnitude, 7.6, epicentral distance 30 km. It survived the most adverse seismic conditions within the western syntaxis: on the MBT, perched on a steep slope near the mountain top, that was covered with weathered, jointed, fractured, sheared and faulted material. (a) The elaborate timber frame around the entire house, and (b) the smaller timber frame in the interior walls of this three-storey stone masonry house received extensive damage but saved all its occupants in the earthquake, unlike other houses in its neighborhood. Location: Sarai Bandi village, District Baramulla.

The *dhajji diwari* style of construction has been observed to exhibit a desirable seismic response, and was ably implemented in the older houses of Kashmir, both in the rural and urban setting. It emerged as a time-tested earthquake resistant technique, indigenously developed through repeated earthquake disasters and several generations, that too in the rural setting. One such example is shown in Figure 1.
