Channel Change and Bed-Material Transport in the Umpqua River Basin, Oregon

Prepared in cooperation with the U.S. Army Corps of Engineers

Open-File Report 2010–1314

U.S. Department of the Interior
U.S. Geological Survey

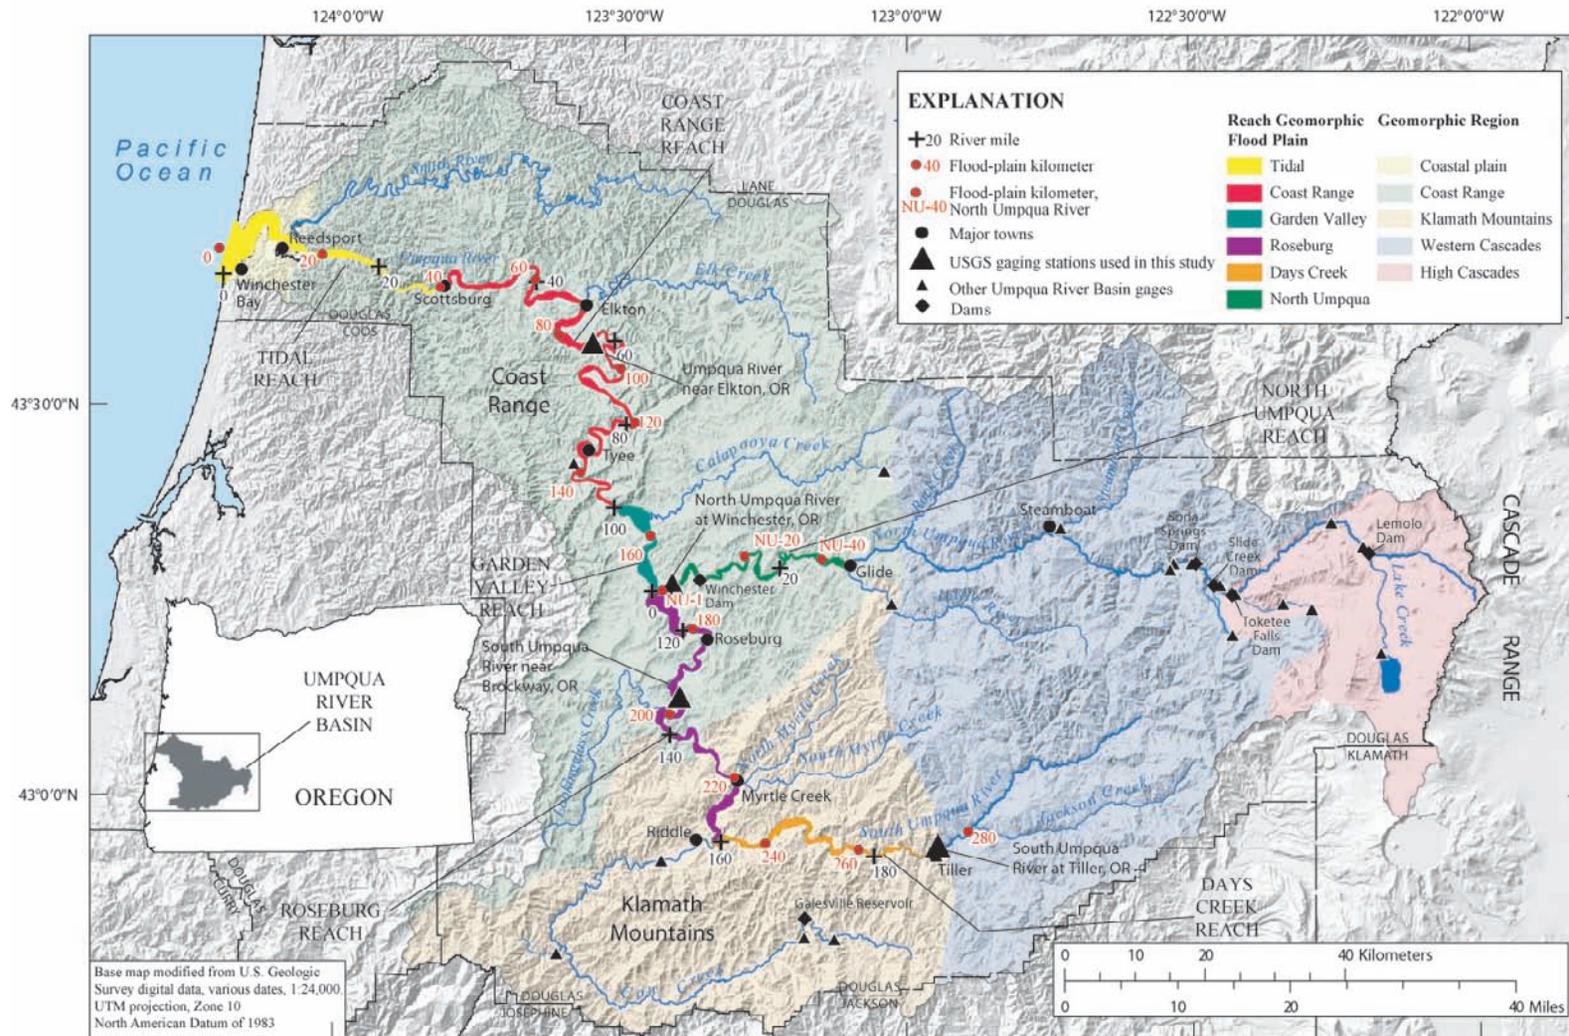
Figure 1. Map showing the Umpqua River, Oregon, drainage basin and study area. Reaches analyzed are defined by valley geomorphology and tributary junctions. Colored reach extents indicate the geomorphic flood plain. Topography based on U.S. Geological Survey 10-m digital elevation.

The Umpqua River drains 12,103 km², heading in the western Cascade Range and Klamath Mountains before traversing the Coast Range and entering the Pacific Ocean through Winchester Bay at Reedsport (fig. 1). The Umpqua River begins 179 km from its mouth at the confluence of the North and South Umpqua Rivers near the city of Roseburg. The main tributaries of the mainstem Umpqua River are the Smith River (961 km²), Elk Creek (756 km²), and the Calapooya River (637 km²) (figs. 1 and 3).

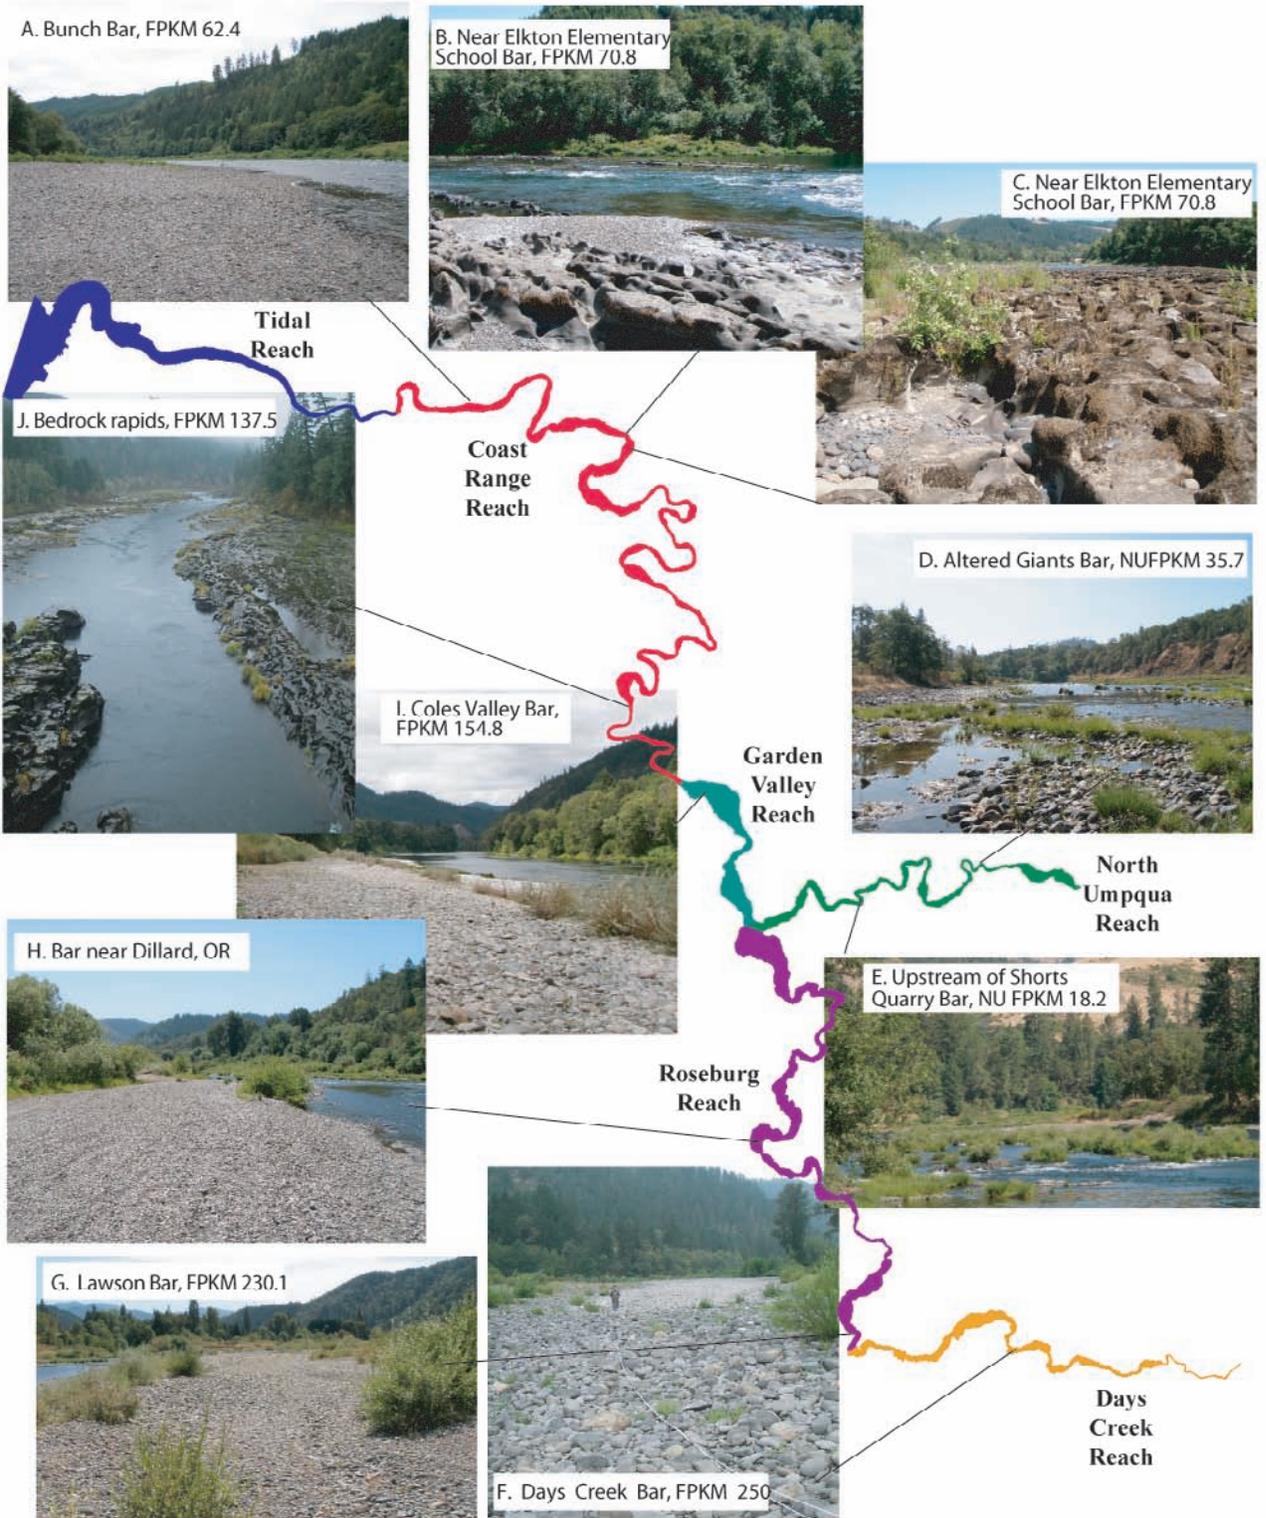
Figure 2. Photographs of gravel bars and bedrock outcrops in the Umpqua River, Oregon.

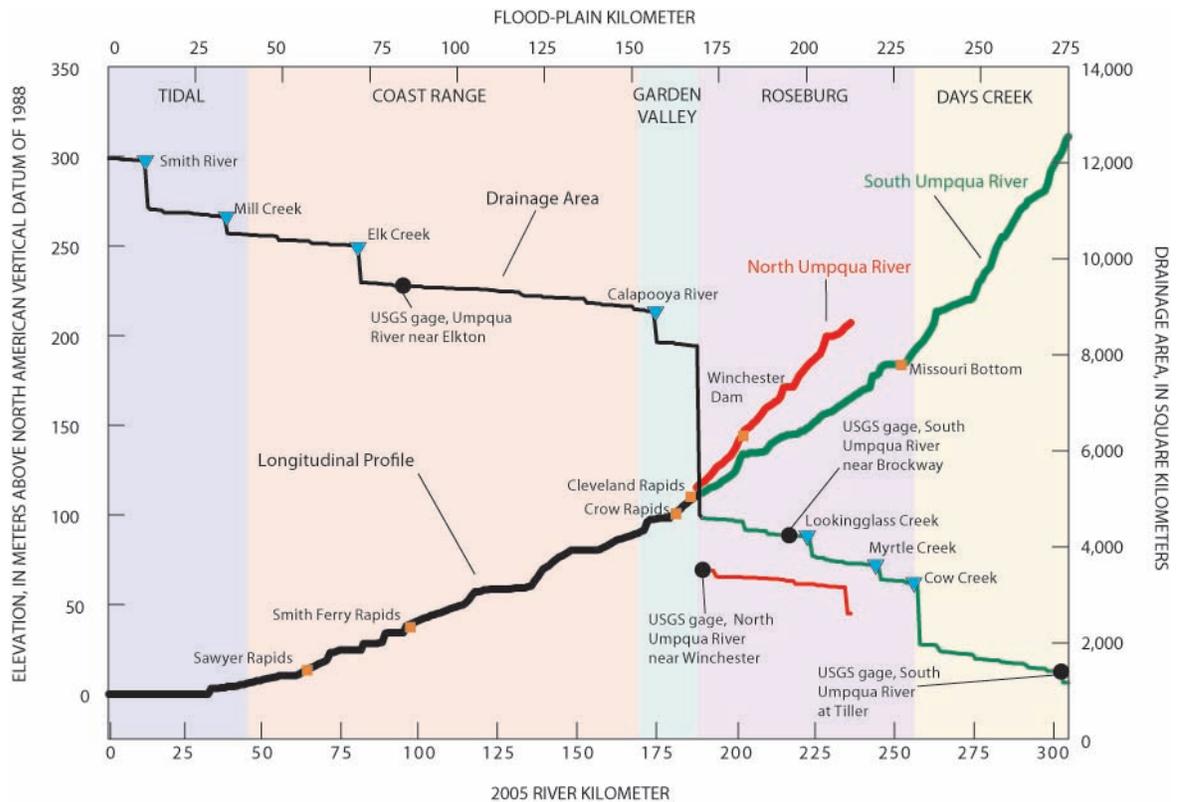
Figure 3. Diagram showing the longitudinal profile and cumulative drainage area of the Umpqua River basin, Oregon.

In the South Umpqua River basin, Galesville Reservoir was constructed in the upper Cow Creek Basin in 1985 to reduce flooding along the lower reaches of Cow Creek. Although Galesville Reservoir almost certainly has a pronounced effect on peak flows on Cow Creek, peak flows farther downstream on the South Umpqua River at Brockway did not show a marked decline following dam construction (fig. 5). It is unlikely that either Galesville Reservoir or the North Umpqua hydroelectric dams strongly influence peak flows as far downstream as the USGS gage at Elkton on the Umpqua River because they control only a small portion of the total drainage-area runoff at this gage (fig. 3).

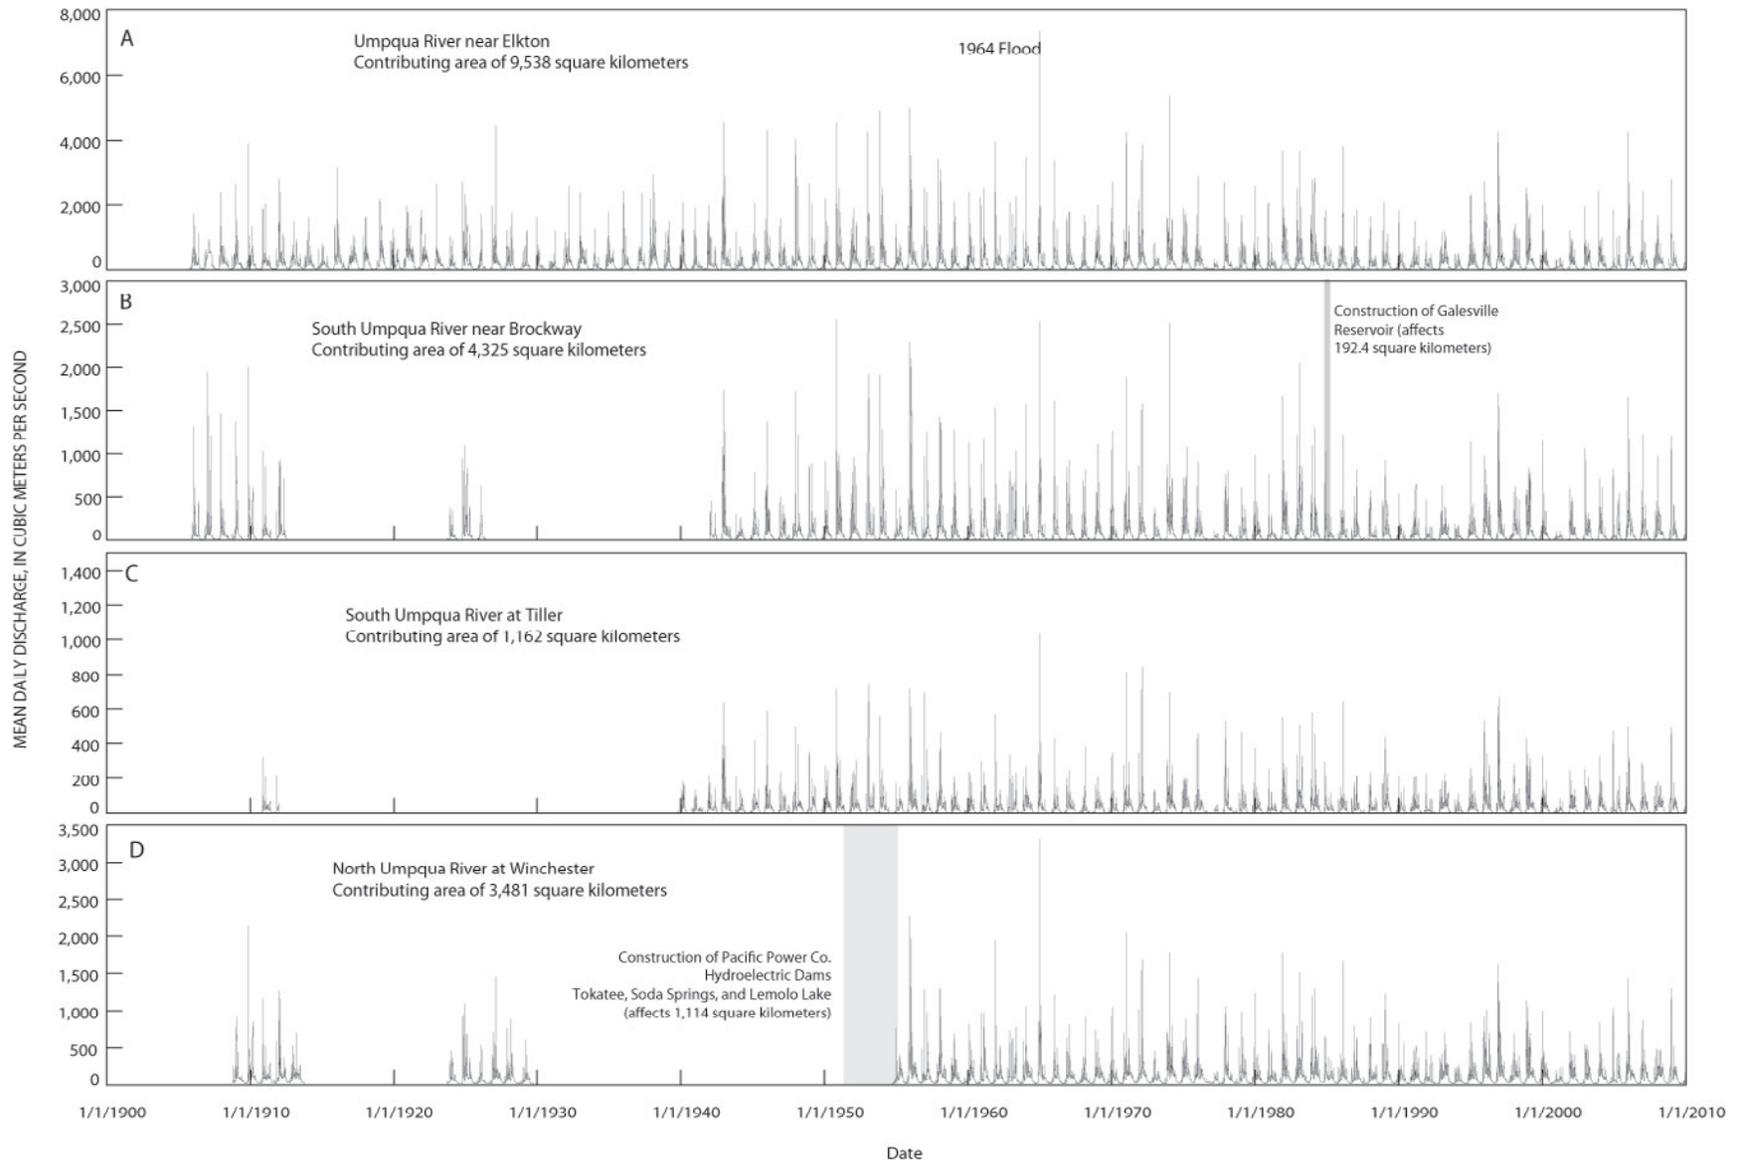
Figure 4. Graph showing daily discharge for selected USGS streamflow-gaging stations in the Umpqua River basin, Oregon.

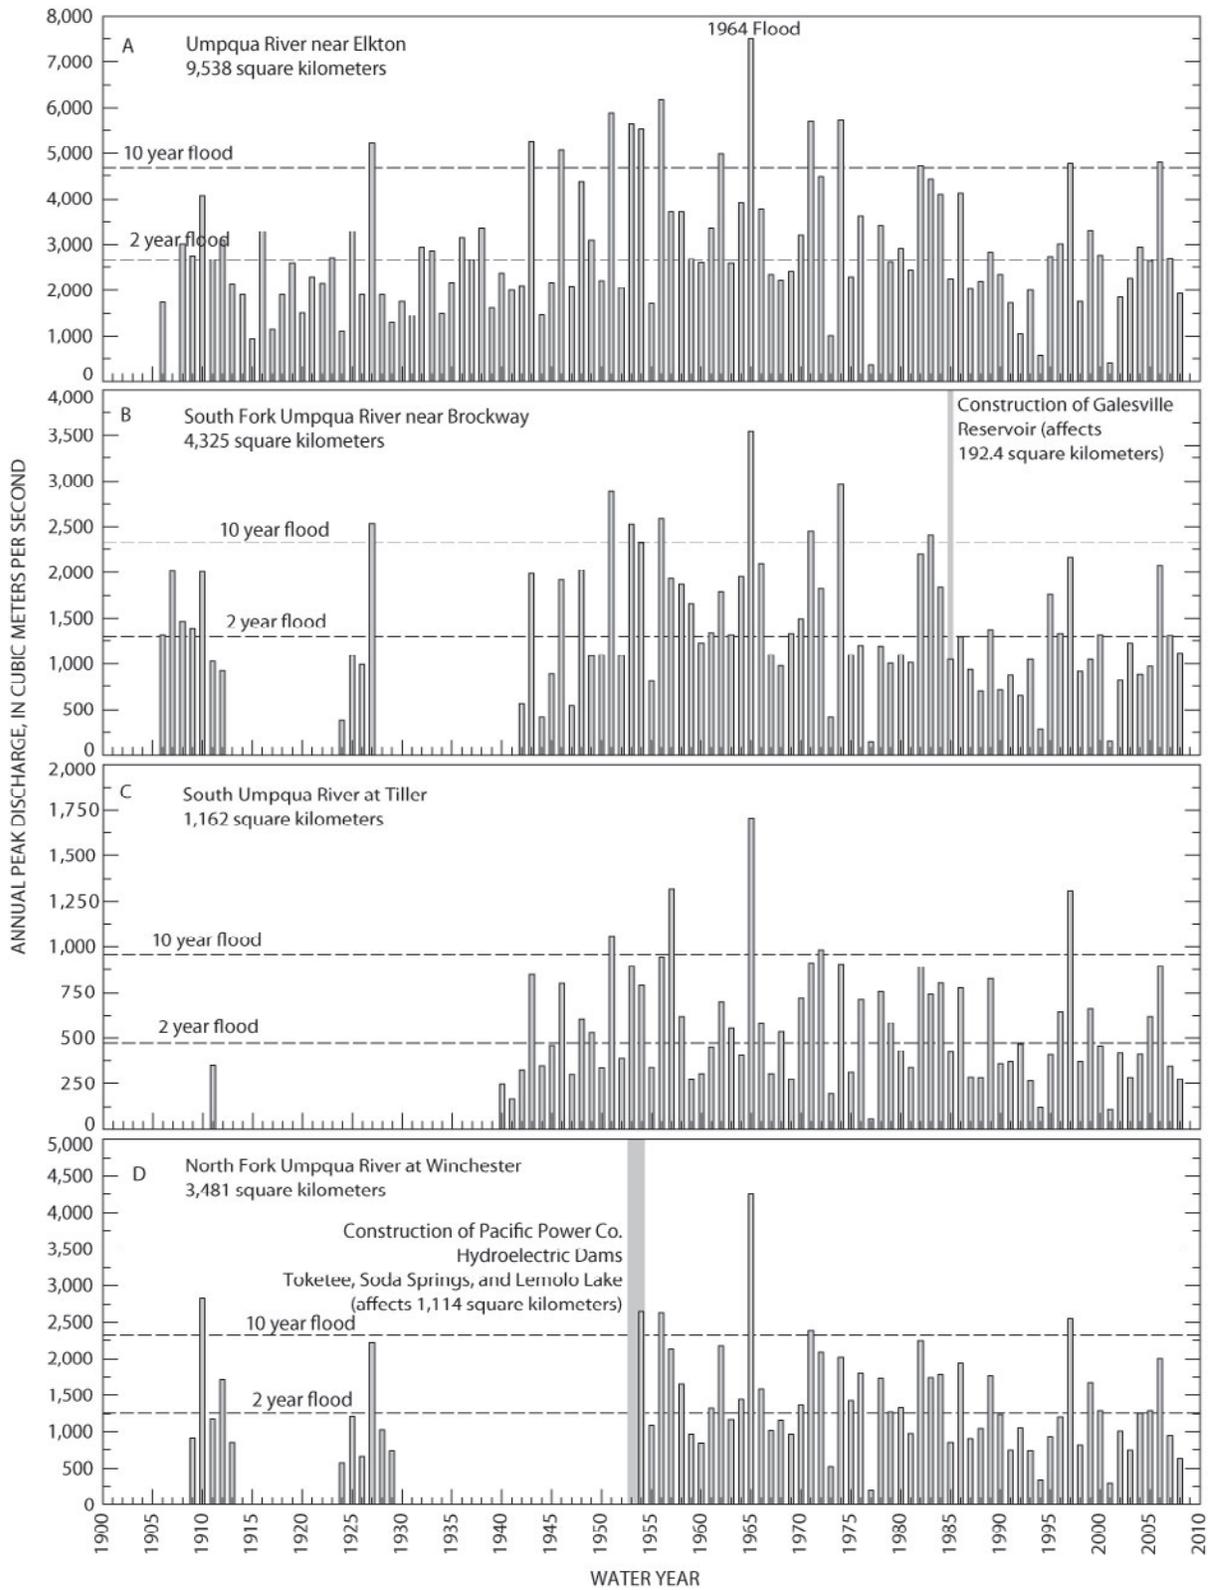
Figure 5. Graph showing annual peak discharge for selected USGS streamflow-gaging stations in the Umpqua River basin, Oregon.

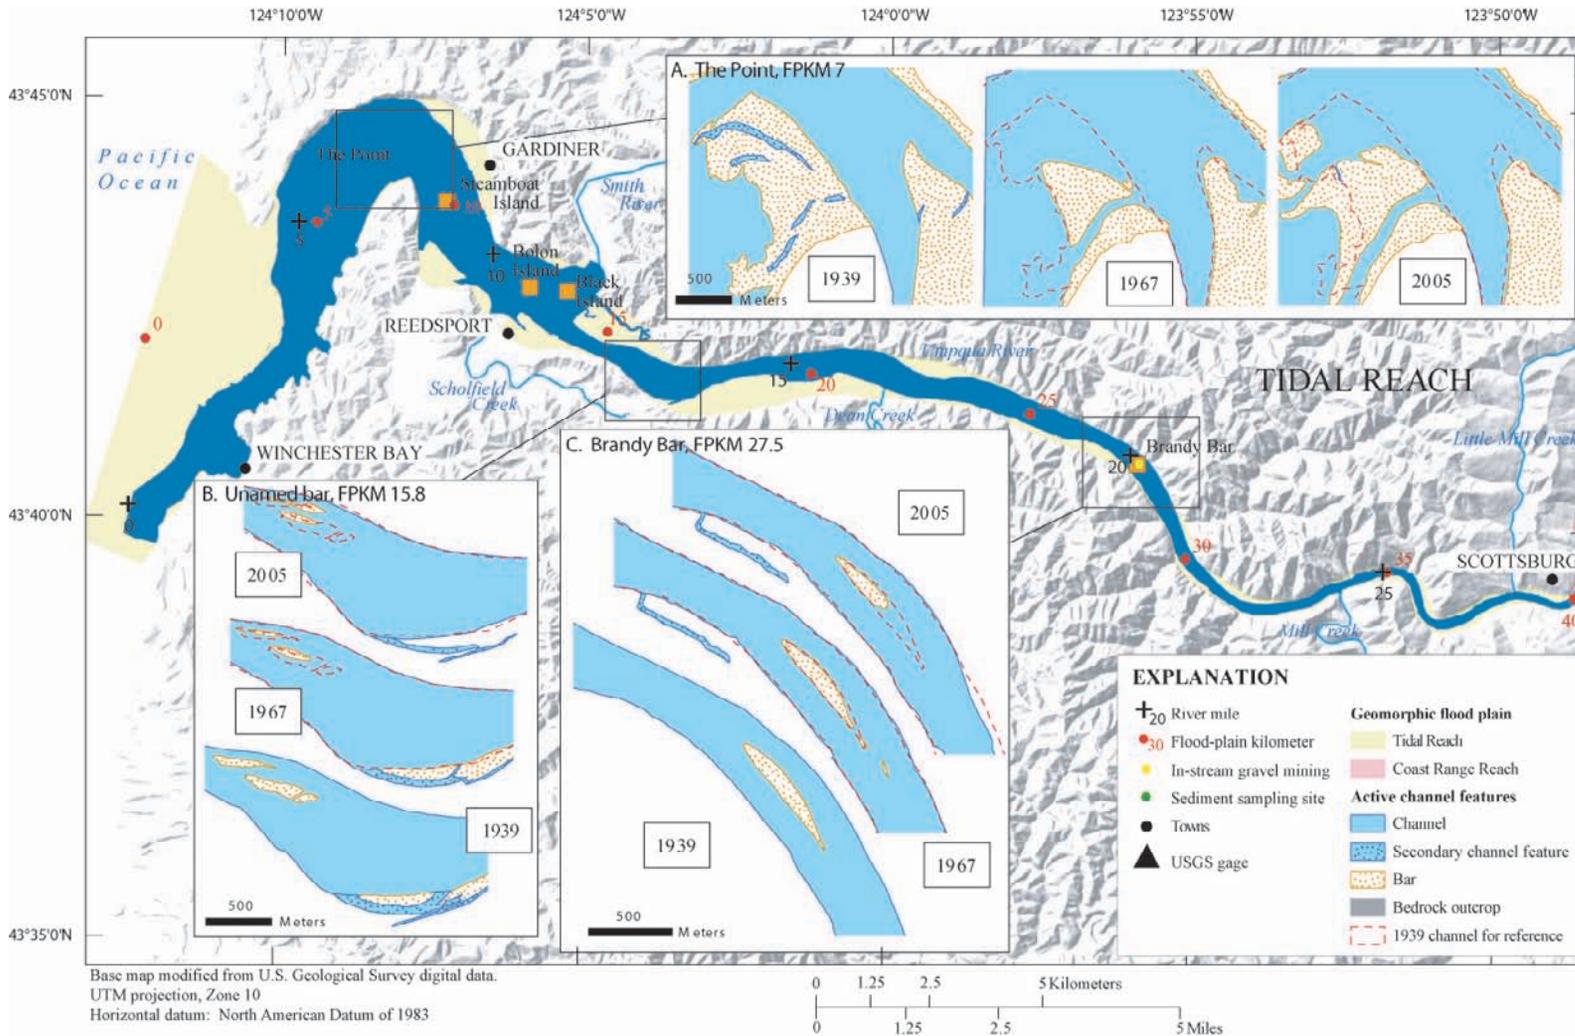
Figure 6. Map showing channel planform in the Tidal reach of the Umpqua River, Oregon. Insets show historical changes to selected bars, as mapped from aerial photographs. Topography based on U.S. Geological Survey 10-m digital elevation data.

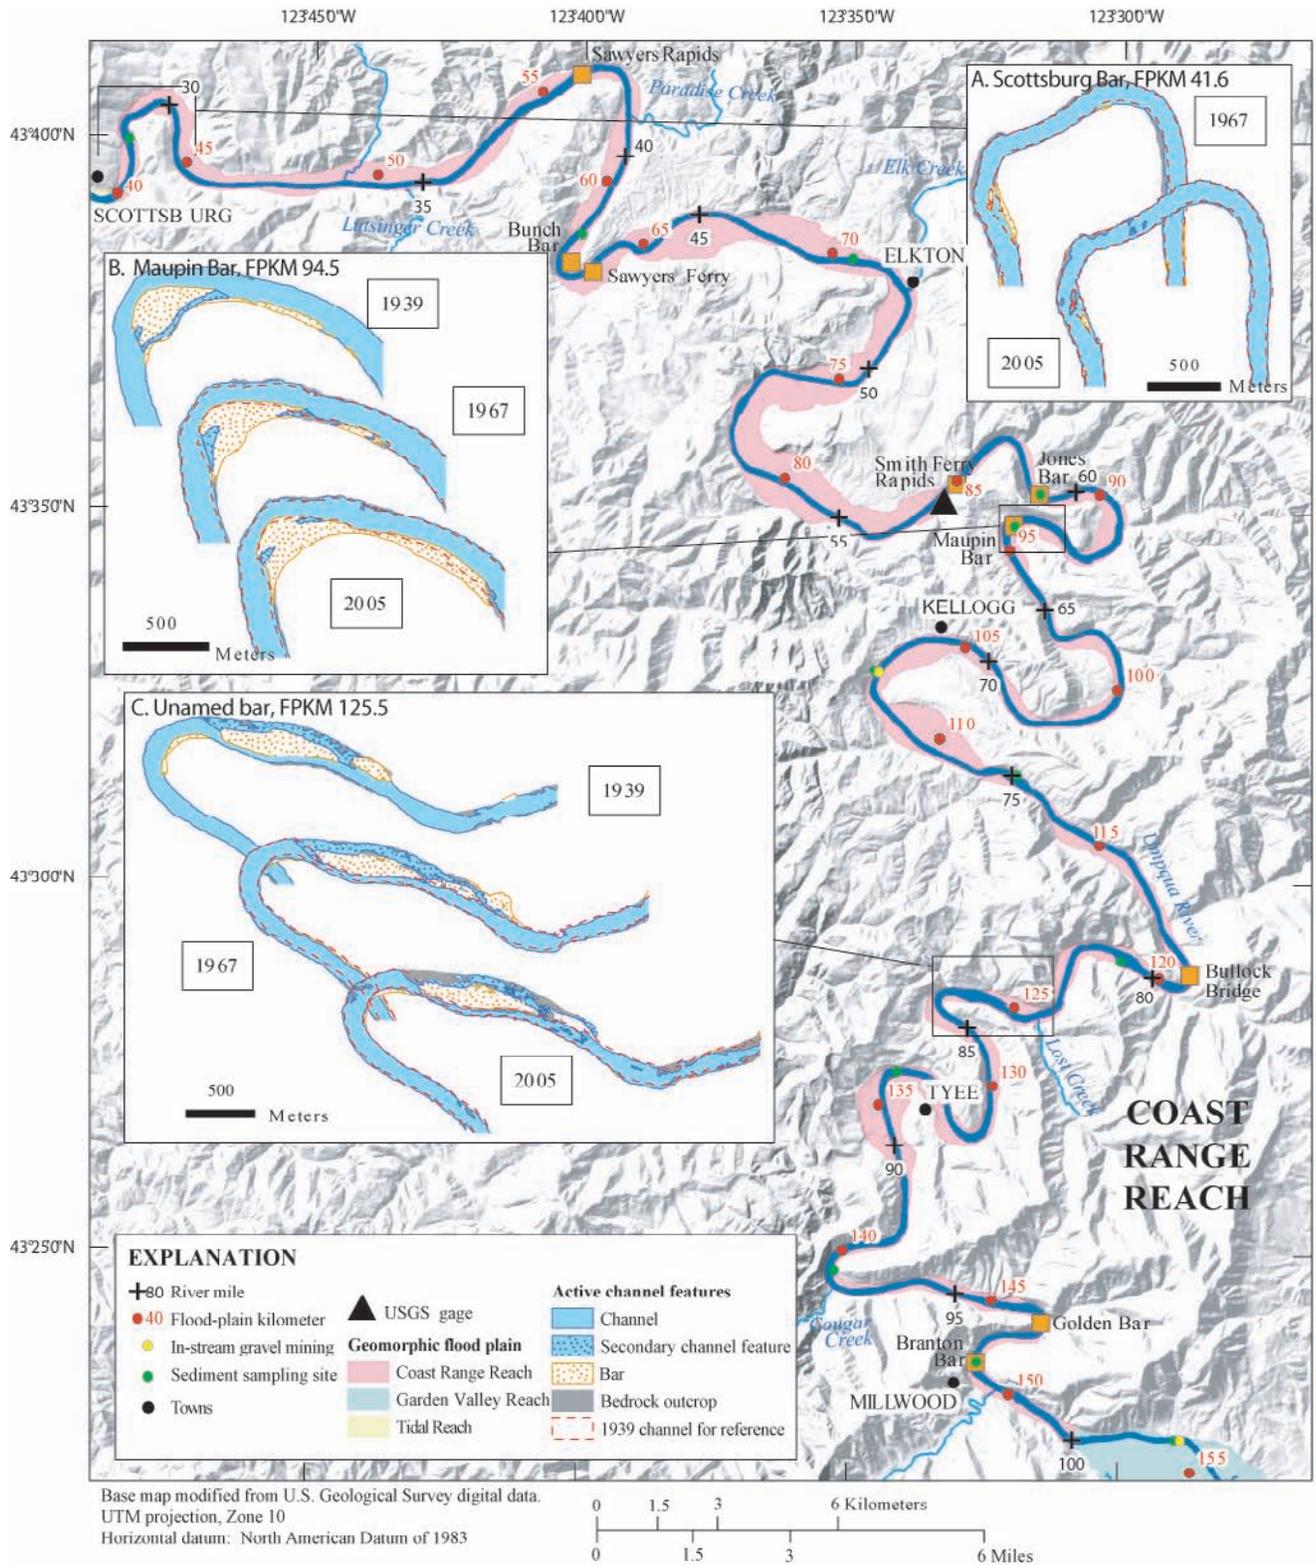
Figure 7. Map showing channel planform in the Coast Range reach of the Umpqua River, Oregon. Insets show historical changes to selected bars, as mapped from aerial photographs. Topography based on U.S. Geological Survey 10-m digital elevation data.

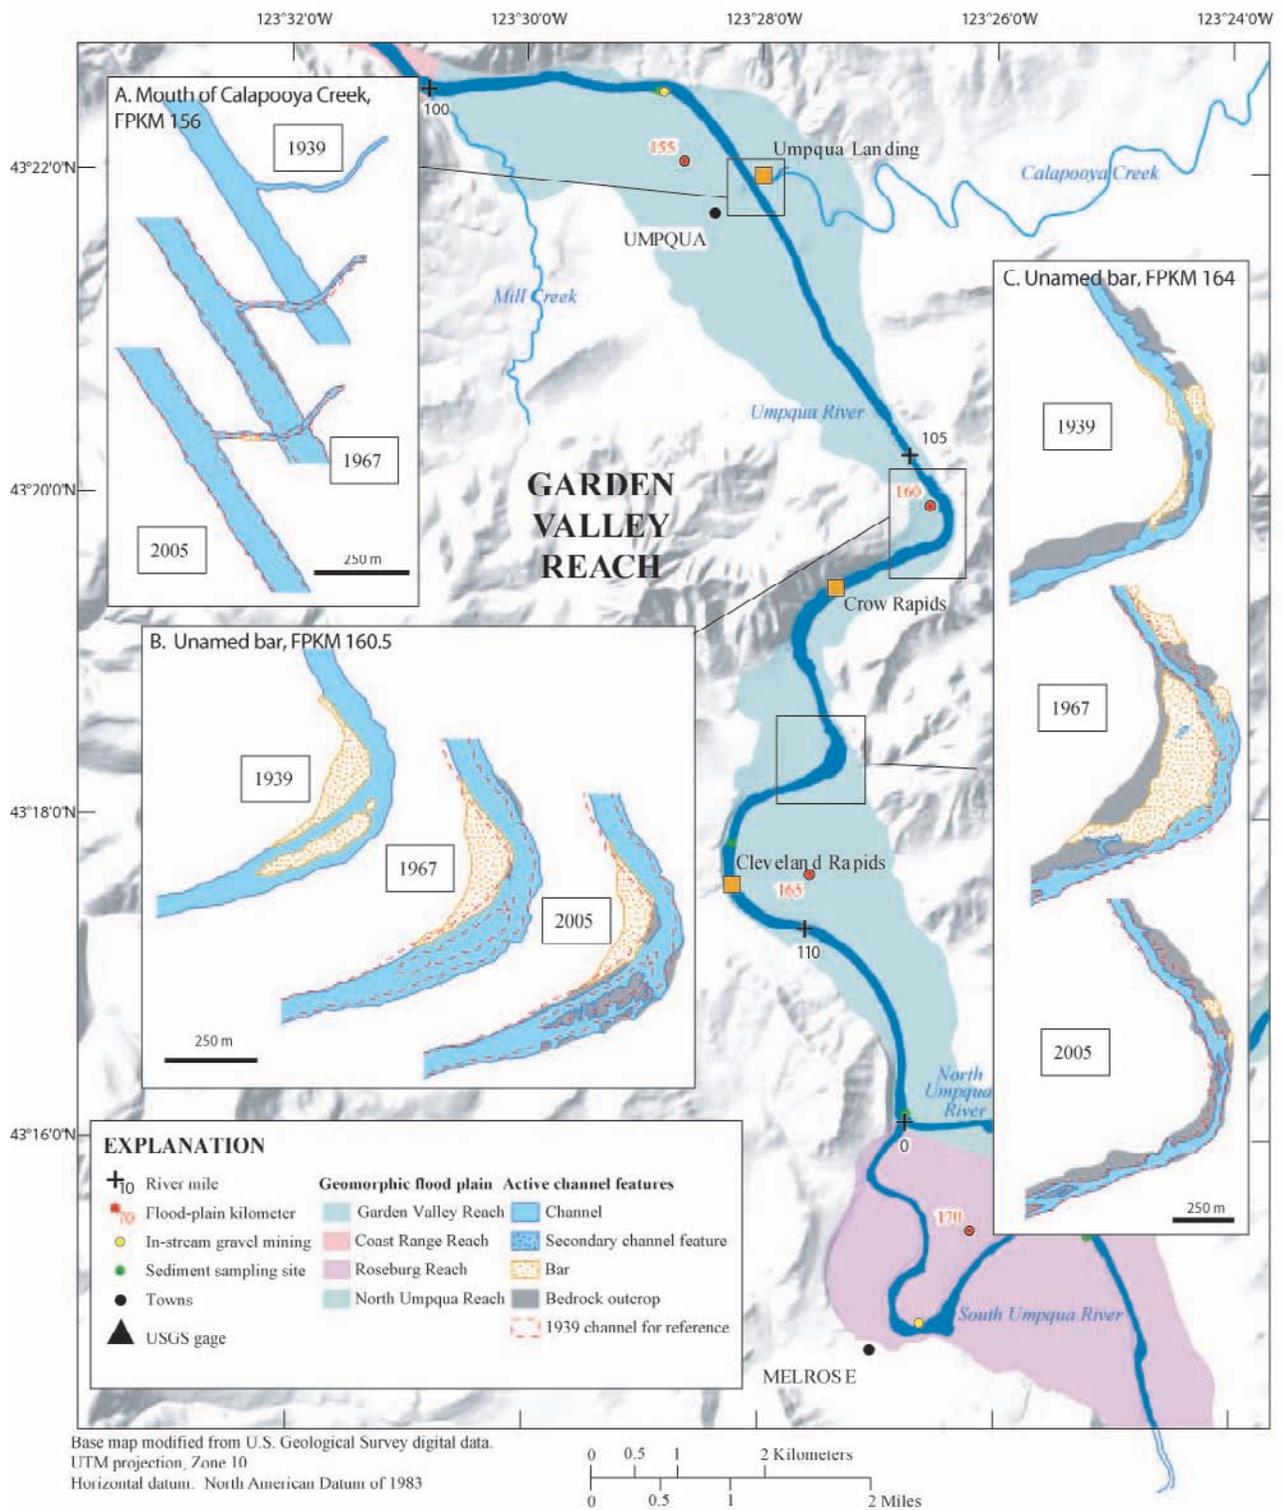
Figure 8. Map showing channel planform of the Garden Valley reach of Umpqua River, Oregon. Insets show historical changes to selected bars, as mapped from aerial photographs. Topography based on U.S. Geological Survey 10-m digital elevation data.

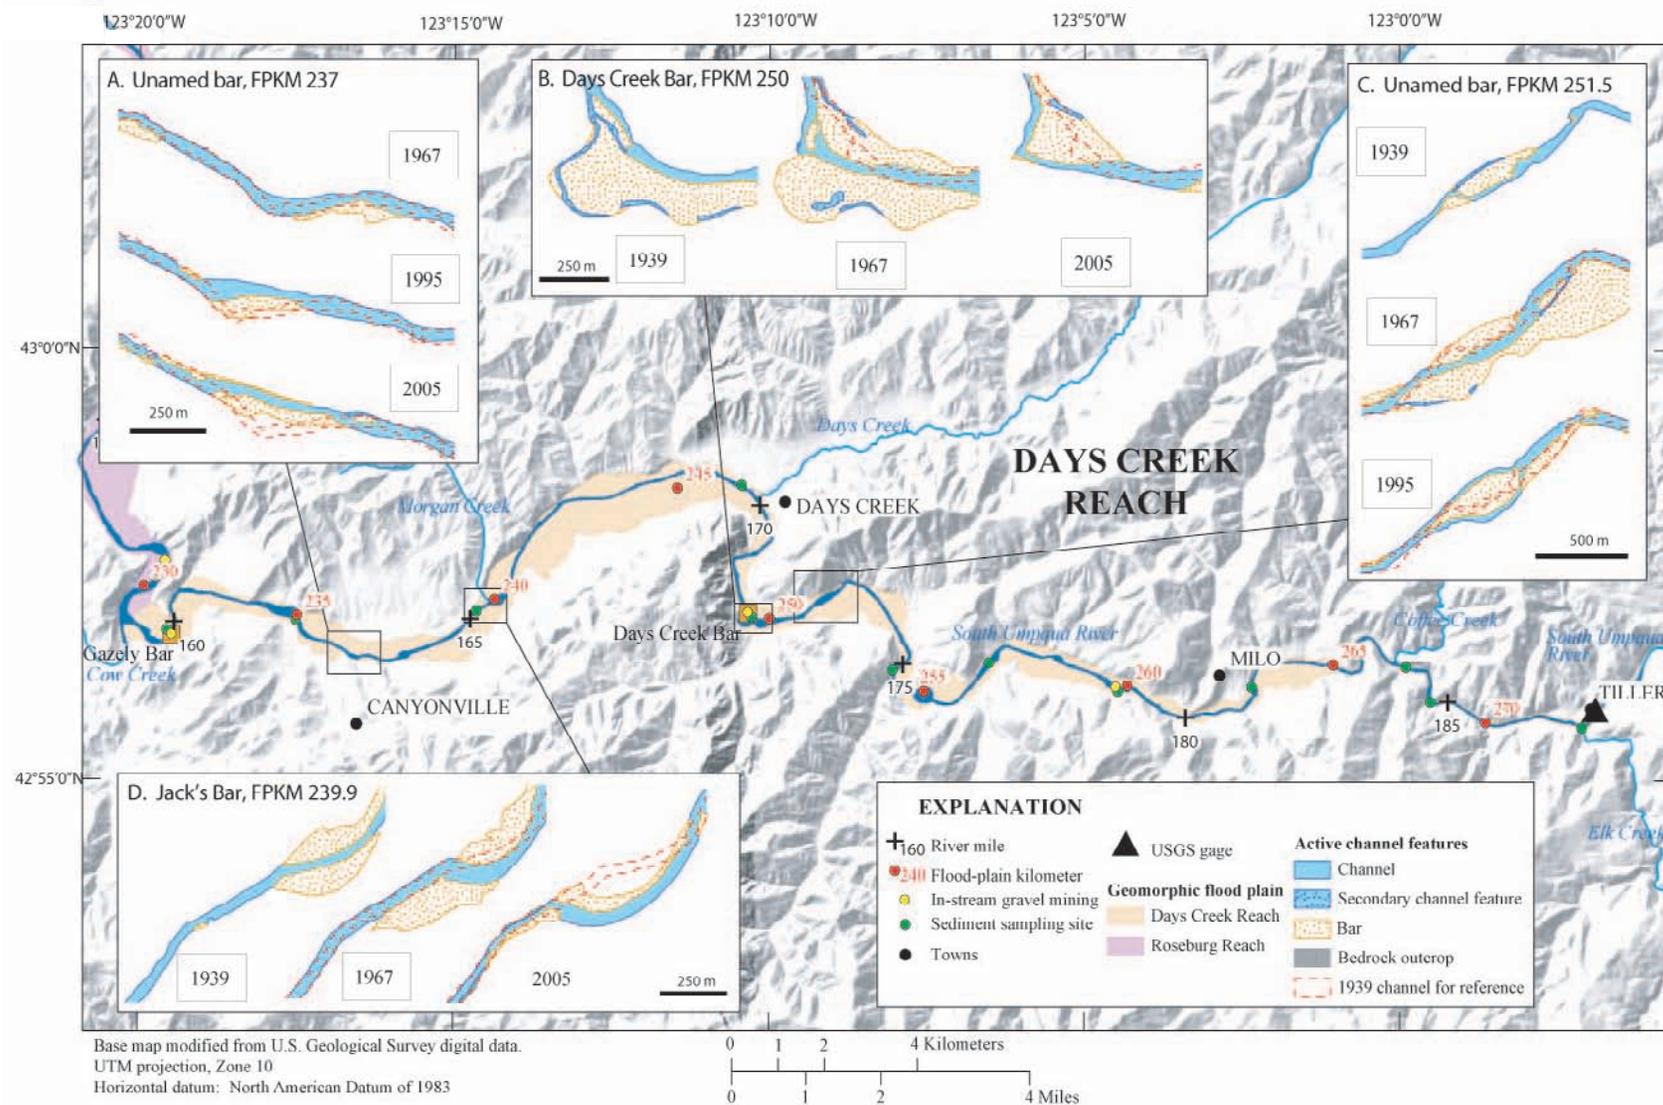
Figure 10. Map showing channel planform of the Days Creek reach of Umpqua River, Oregon. Insets show historical changes to selected bars, as mapped from aerial photographs. Topography based on U.S. Geological Survey 10-m digital elevation data.

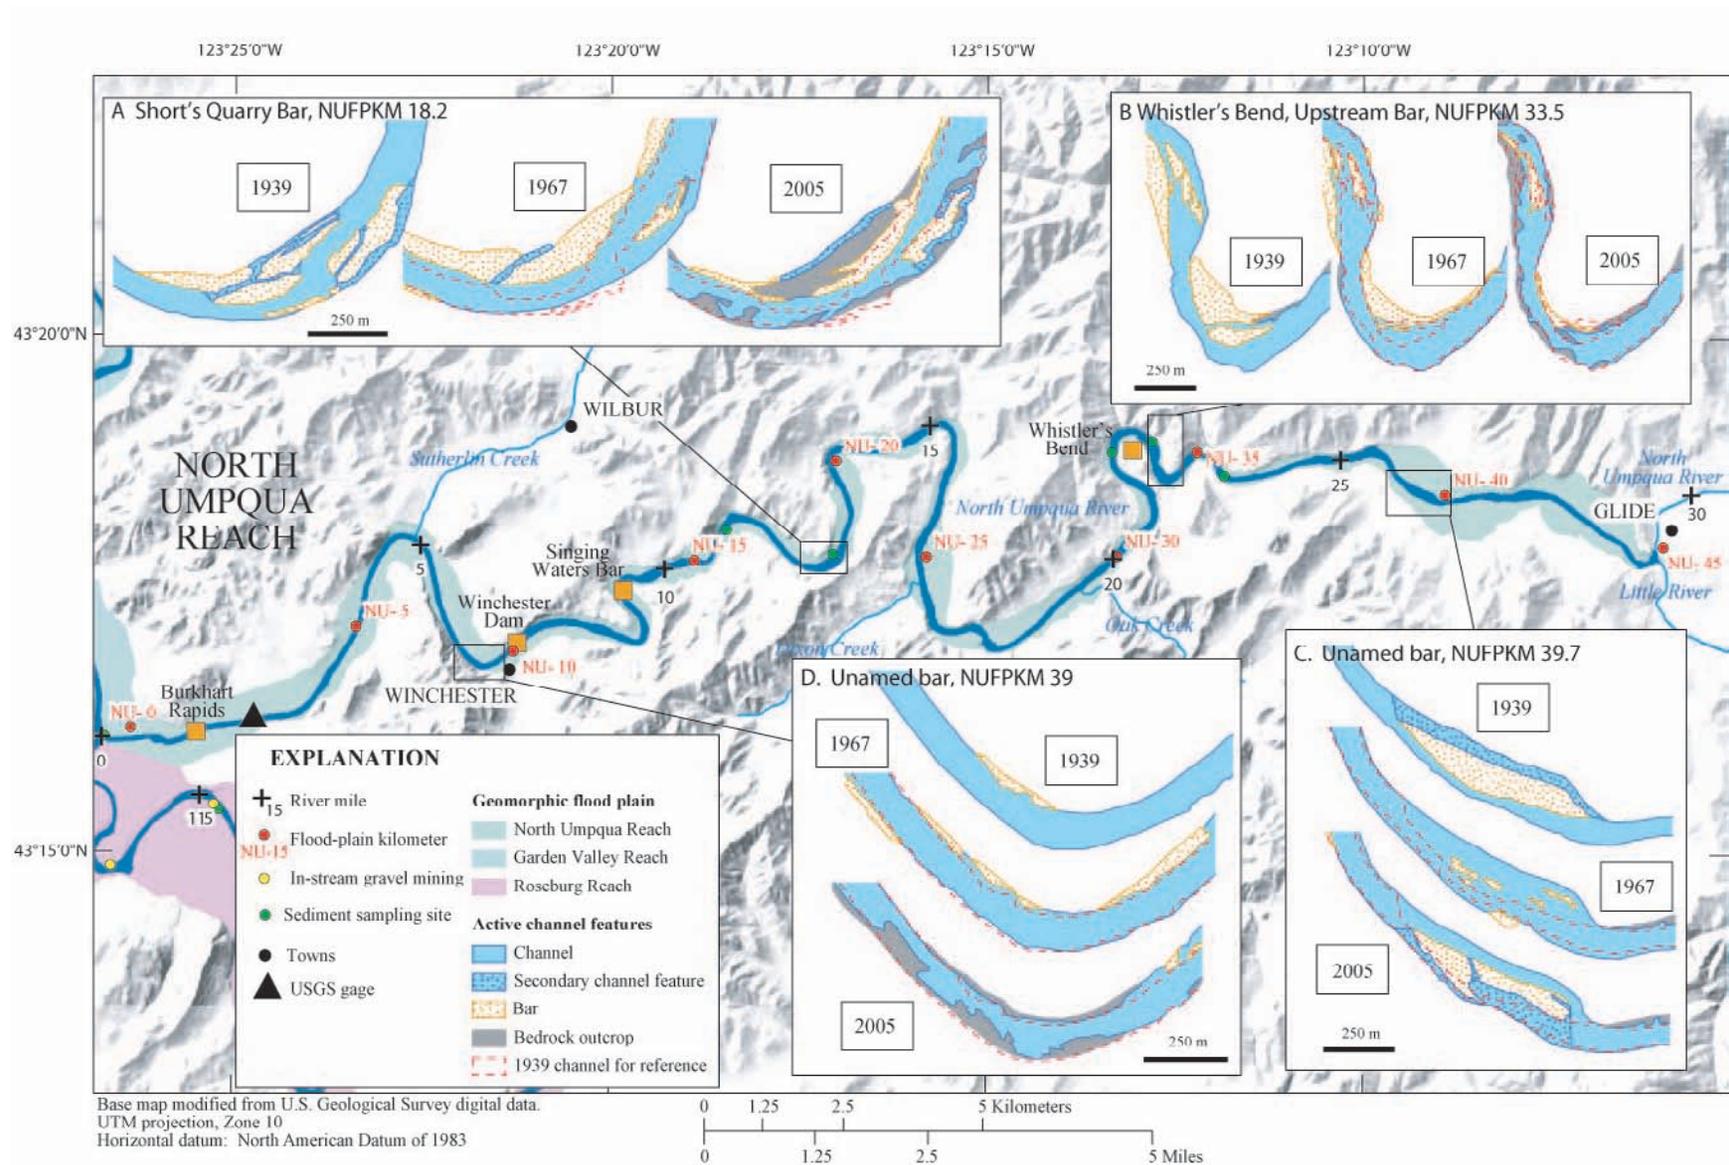
Figure 11. Map showing channel planform of the North Umpqua reach of the North Umpqua River, Oregon. Insets show historical changes to selected bars, as mapped from aerial photographs. Topography based on U.S. Geological Survey 10-m digital elevation data.

(6) North Umpqua reach of the North Umpqua River (fig. 11) between NUFPM 0 and the Little River confluence at NUFPM 45, a reach locally flanked by alluvial deposits but with no recent instream gravel mining.

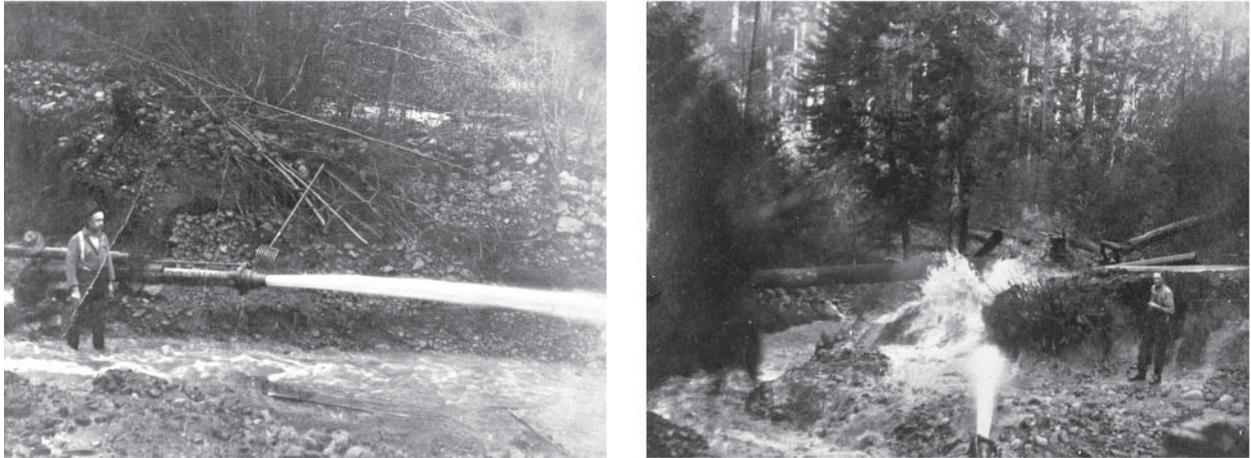
Figure 13. Photographs of hydraulic mining in the Olalla District, Lookingglass Creek drainage, Oregon. Courtesy of Douglas County Museum (Photograph N5155a, and N5155b).

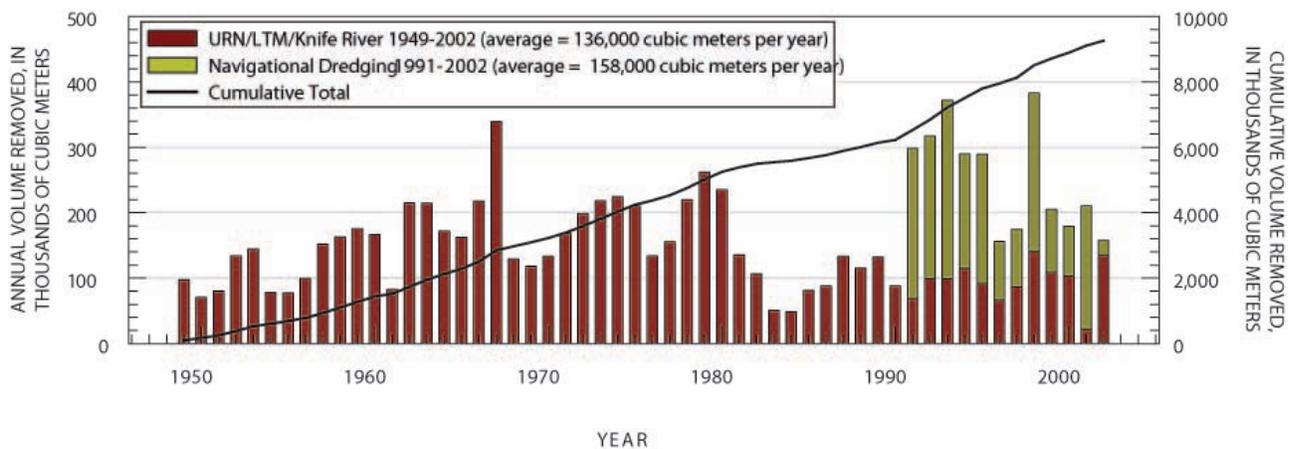
Figure 14. Graph showing annual sediment volume removed between 1949 and 2002, by commercial and navigational dredging in the Umpqua River estuary, Oregon. Commercial dredging focused mainly on lower Umpqua River below FPKM 40, whereas navigational volumes are mainly for Umpqua River entrance, (FPKM 0–3), near Reedsport.

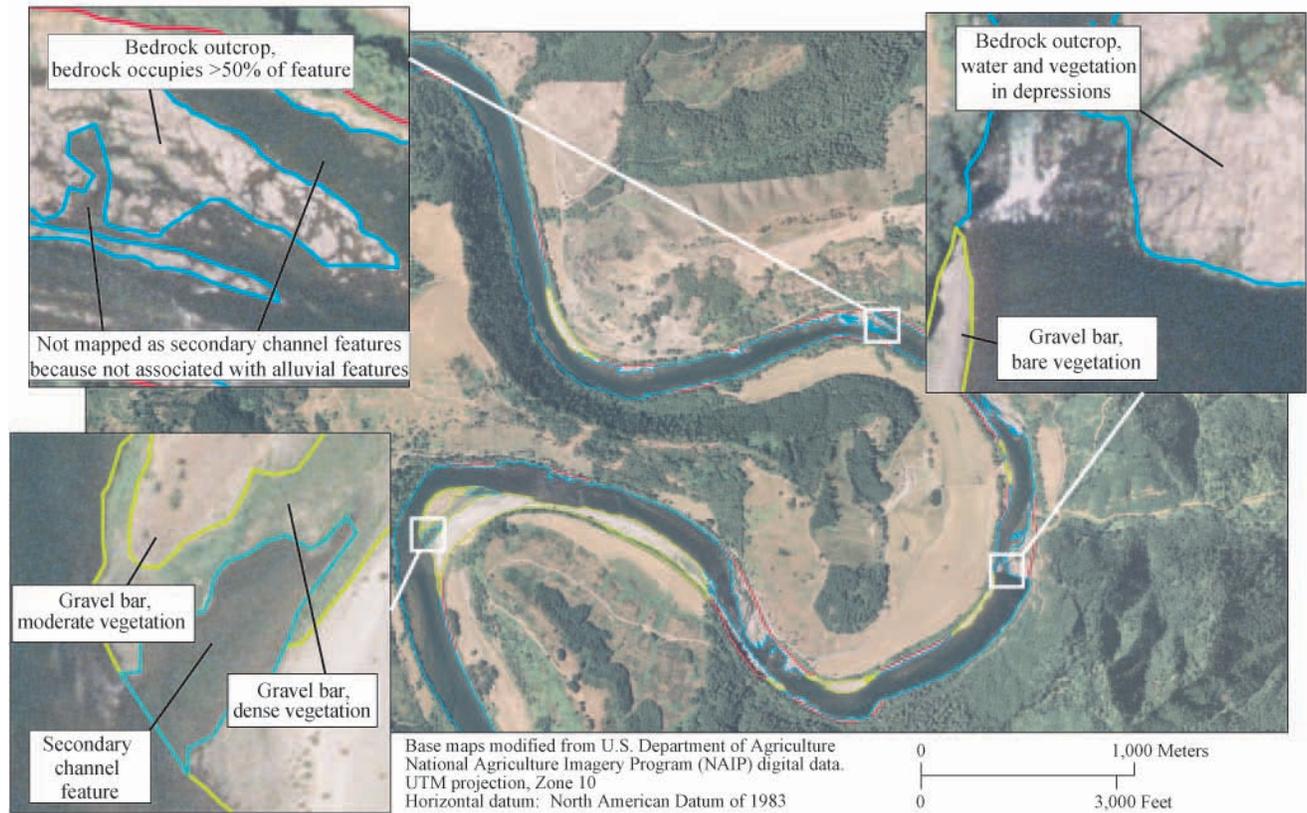
Figure 15. Photographs showing examples of mapping units used when creating historical channel maps of the Umpqua River basin, Oregon, from aerial photographs.

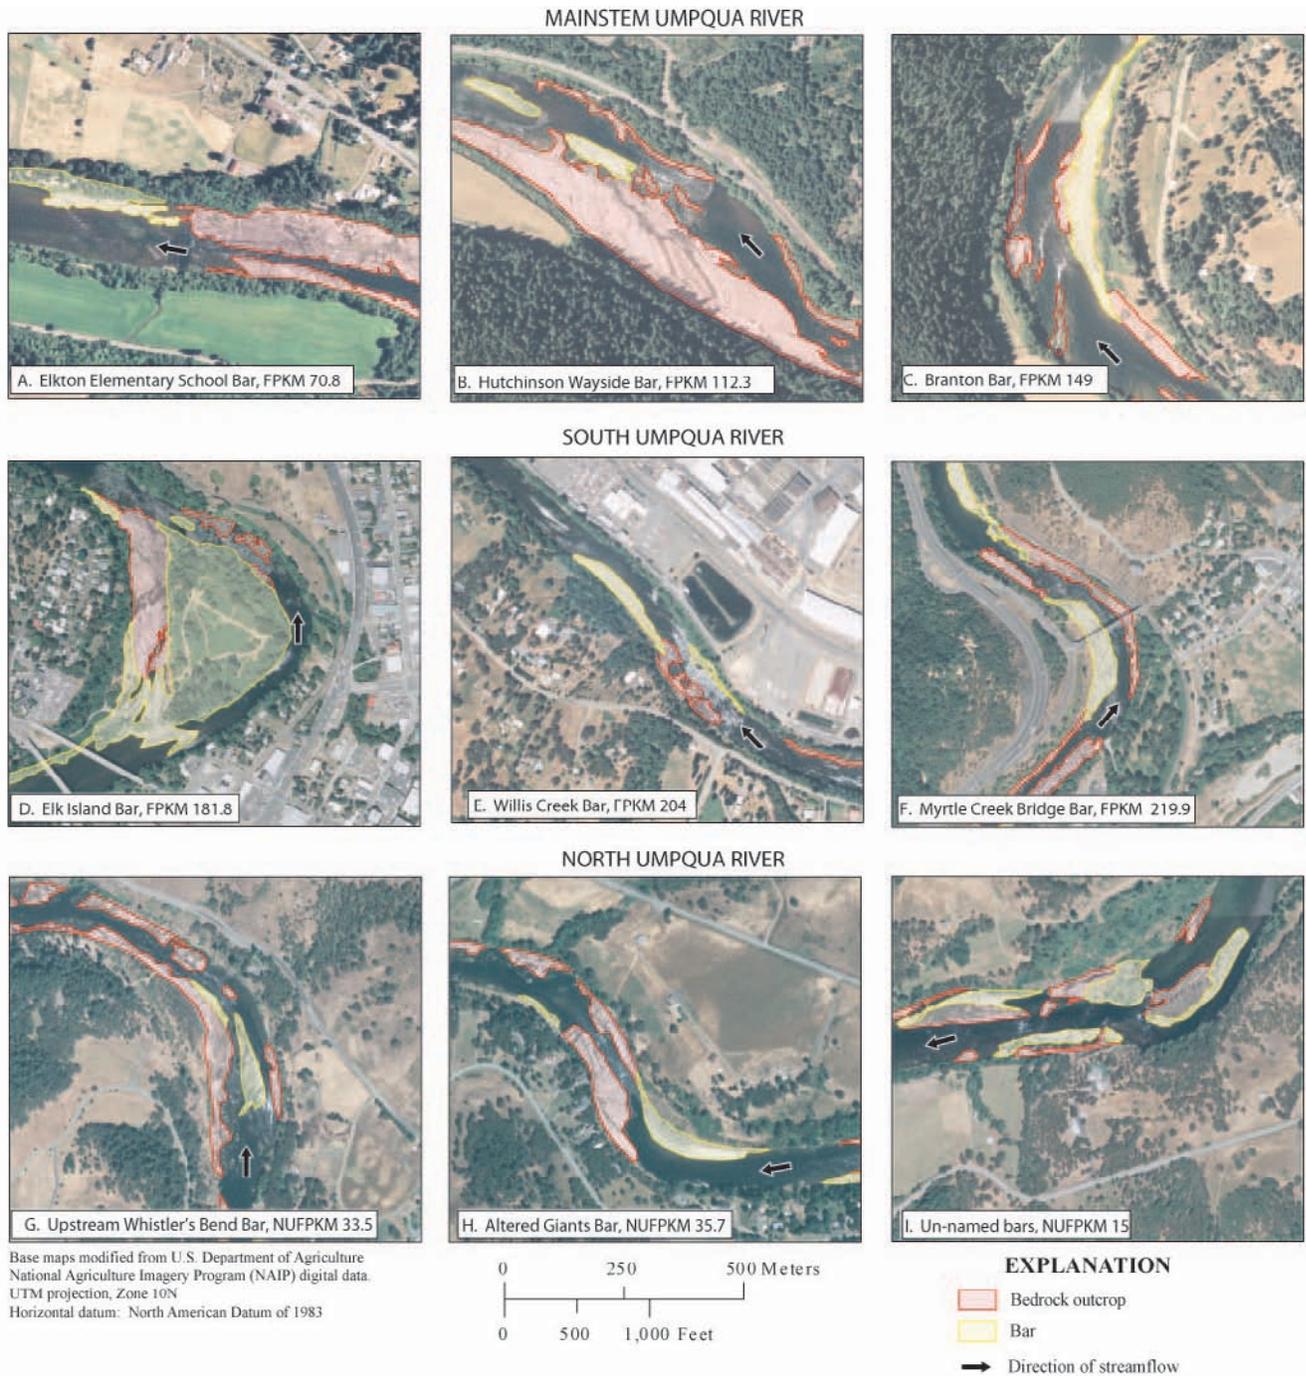
Figure 16. Photographs showing examples of gravel bars in close proximity to bedrock rapids in the Umpqua River, Oregon

local hydraulic conditions established by valley and bedrock morphology rather than broad-scale transport conditions (fig. 16).
