Channel Change and Bed-Material Transport in the Umpqua River Basin, Oregon

Prepared in cooperation with the U.S. Army Corps of Engineers

Open-File Report 2010–1314

U.S. Department of the Interior
U.S. Geological Survey

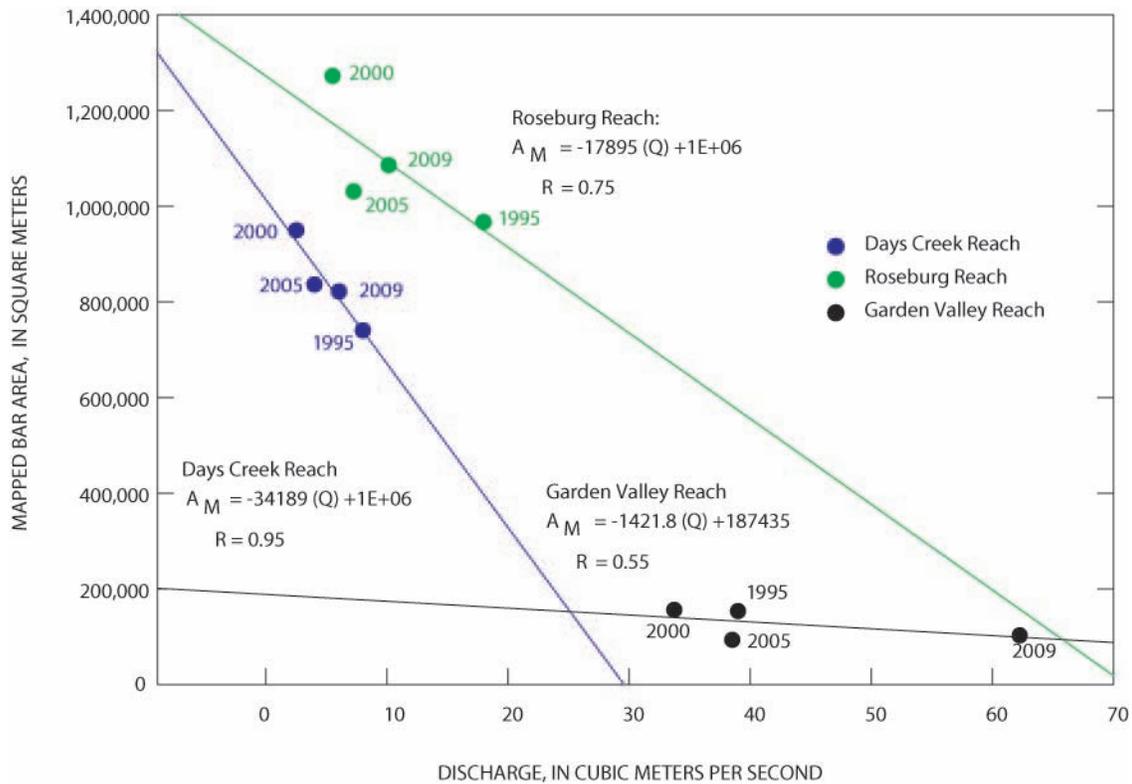
Figure 17. Graph showing relation of bar area to discharge in photographs of the Days Creek, Roseburg, and Garden Valley reaches, of the Umpqua River, Oregon, 1995–2009. Linear regressions between mapped bar area and photograph discharge (the discharge when the photograph was made) were used to normalize bar areas to a common, reach-specific discharge.

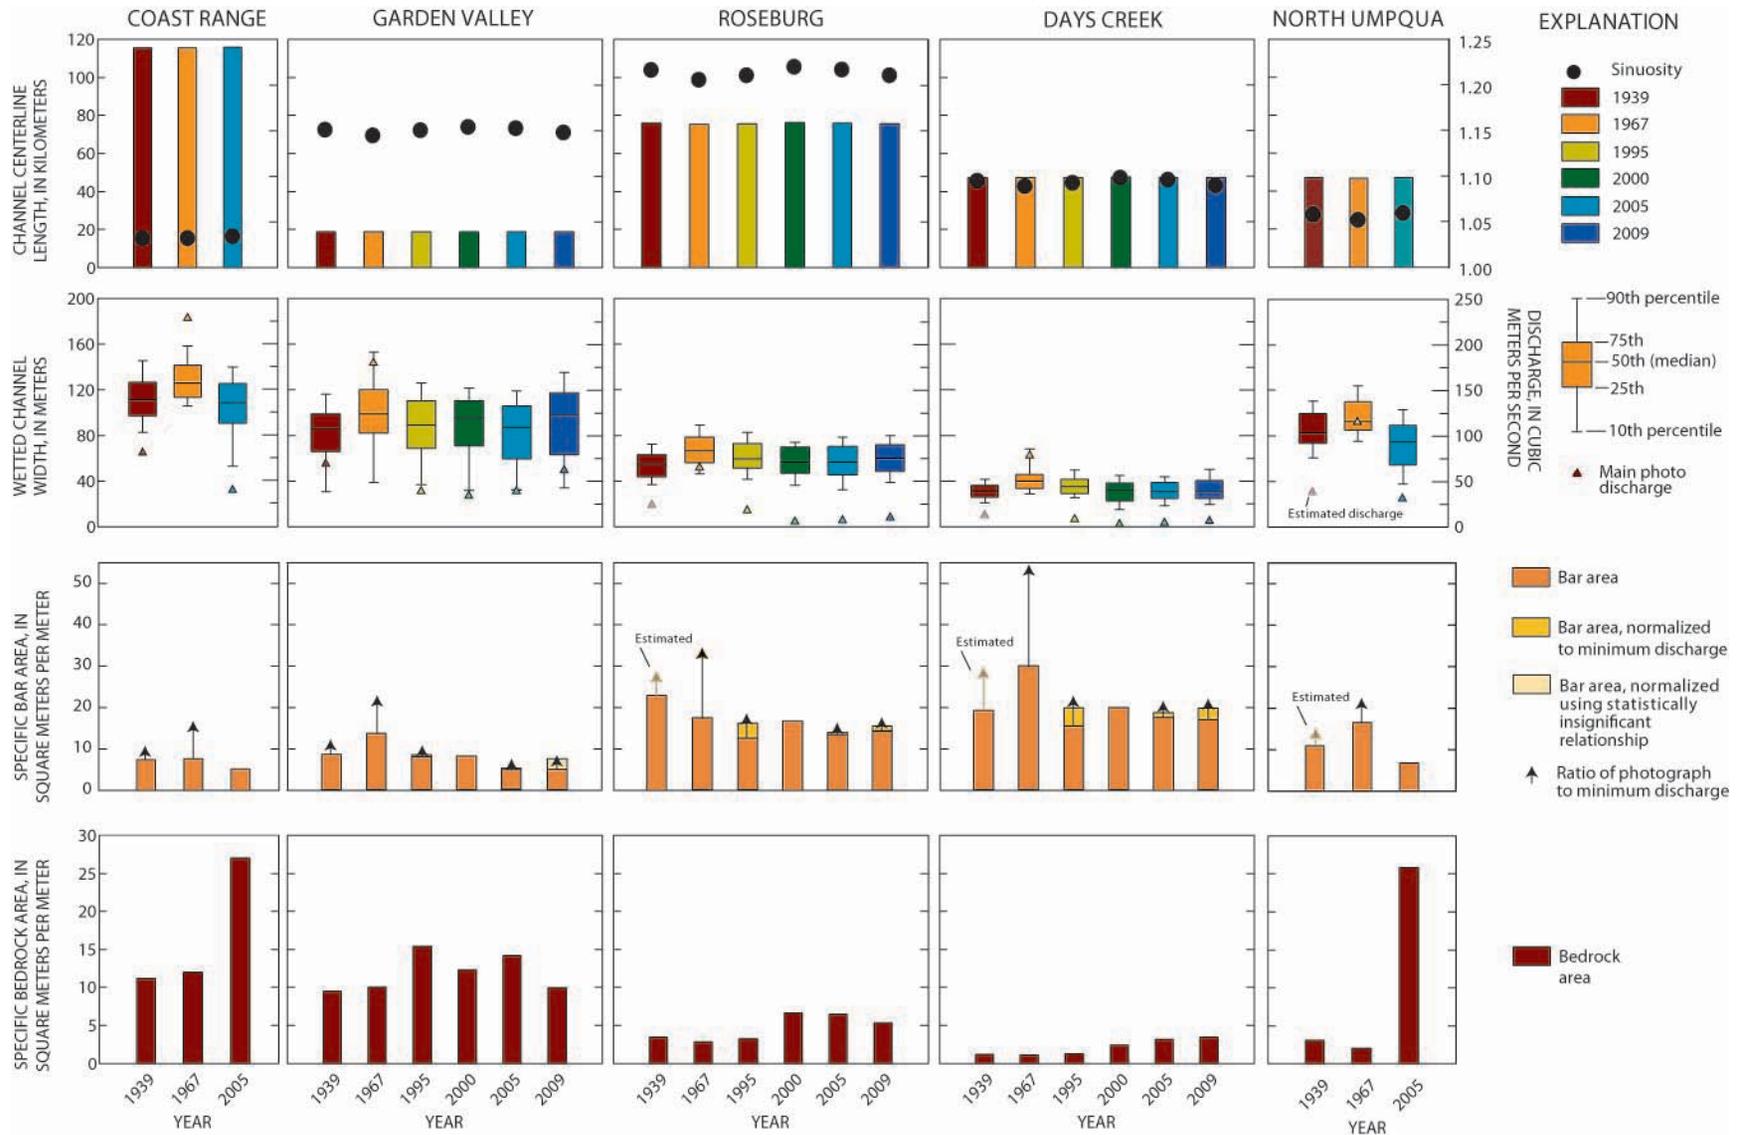
Figure 18. Graphs showing a summary of historical channel change 1939–2009 for fluvial reaches of Umpqua and South Umpqua Rivers, Oregon. The total area of gravel bars and bedrock in each reach was divided by the centerline length from 2005 to determine the specific area of bars and bedrock in each reach. Arrows in bar area plot show ratio of photograph discharge to minimum photograph discharge for each reach and indicate magnitude of bias introduced by variation in photograph discharge.

The most evident temporal changes in active channel conditions for all five fluvial reaches between 1939 and 2005 are the large net reduction in bar area. Between 1939 and 2005, the total bar area decreased 29 percent from 4.22 to 2.87 km² (figs. 18 and 20). But the temporal trend of decreasing bar size has not been monotonic; total bar area above the head of tide increased 11 percent between 1939 and 1967, and aerial photographs from 1967 show substantial deposition along nearly all bars in the study area. This increase in bar area, however, was more than compensated by a 39-percent decrease in bar area between 1967 and 2005 (fig.18).

Channel change on the Coast Range, Garden Valley, and North Umpqua reaches followed similar trends as the Days Creek and Roseburg reaches, but with several distinctions. Despite local areas where bars were stripped to bedrock (such as Mary's Island at FPKM 121.3, fig. 22A), bar area on the Coast Range reach remained similar between 1939 and 1967, whereas bar area increased 51 percent in the North Umpqua reach during the same period (fig. 18). Many of these newly formed 1967 bars were replaced by areas of bedrock by 2005, causing an 11-fold increase in near-channel bedrock between 1967 and 2005 along the North Umpqua reach. Similarly, bedrock area within the Coast Range reach increased 124 percent (figs. 18 and 21). During the same period, bar area decreased 59 percent from 16.5 to 6.7 m²/m on the North Umpqua reach, and 32 percent from 7.58 to 5.13 m²/m on the Coast Range reach (fig. 18). Trends in bar area on the Garden Valley reach most closely follow that of the Days Creek reach, but the overall magnitude of change during each time period is less than for the more gravel-rich South Umpqua reaches (fig. 18). Like other reaches, bar area on the Garden Valley reach was greatest in 1967, increasing 58 percent between 1939 and 1967, but then decreasing 40 percent between 1967 and 1995, primarily as newly formed bars were eroded to bedrock (figs. 18 and 21). Bar area on the Garden Valley reach remained about stable from 1995 to 2000, then decreased another 40 percent from 2000 to 2005 and showed little change from 2005 to 2009 (figs. 18 and 21).

Like other reaches, the North Umpqua River had a substantial net loss of bar area during 1939–2005, especially between 1967 and 2005, when mapped gravel deposits diminished by nearly 60 percent (fig. 18). This decrease, as well as the associated 115 percent increase in exposed bedrock observed on the North Umpqua reach between 1967 and 2005, probably was at least partly because of construction of hydropower dams in 1952–55, which trap bed material sediment from 32 percent of the North Umpqua River basin. Although the difference in discharge at the time of the two sets of photographs may account for some of the difference in bar and bedrock area, inspection of individual bar polygons from 1967 and 2005 shows that 49 percent of the bar area from 1967 for the North Umpqua reach was scoured to bedrock by 2005. Similar transformation of gravel bars to bedrock areas during this time period downstream of the confluence of the North Umpqua and South Umpqua Rivers in the Garden Valley and Coast Range reaches may indicate that diminished sediment supply for the North Umpqua River has decreased bar area in these downstream reaches as well.

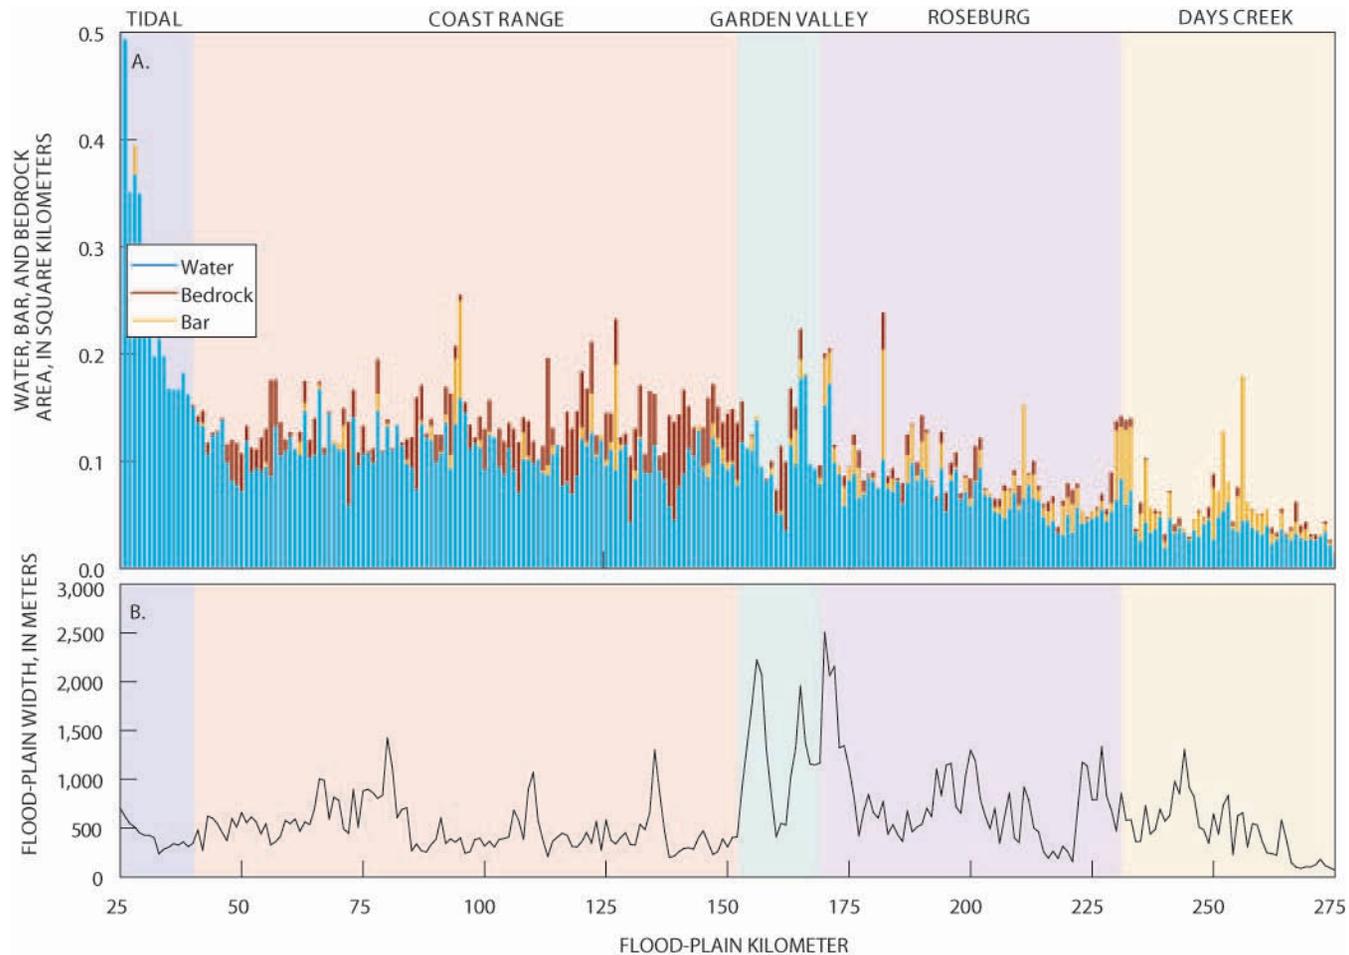
Figure 19. Graphs showing: (A) The fraction of water, bedrock, and gravel bars in each flood-plain kilometer transect in the Umpqua River basin, Oregon, as mapped from 2005 aerial photographs. Downstream of FPKM 25 in the Tidal Reach, channel area increases substantially in the lower Umpqua River estuary. (B) Flood-plain width by flood-plain kilometer.

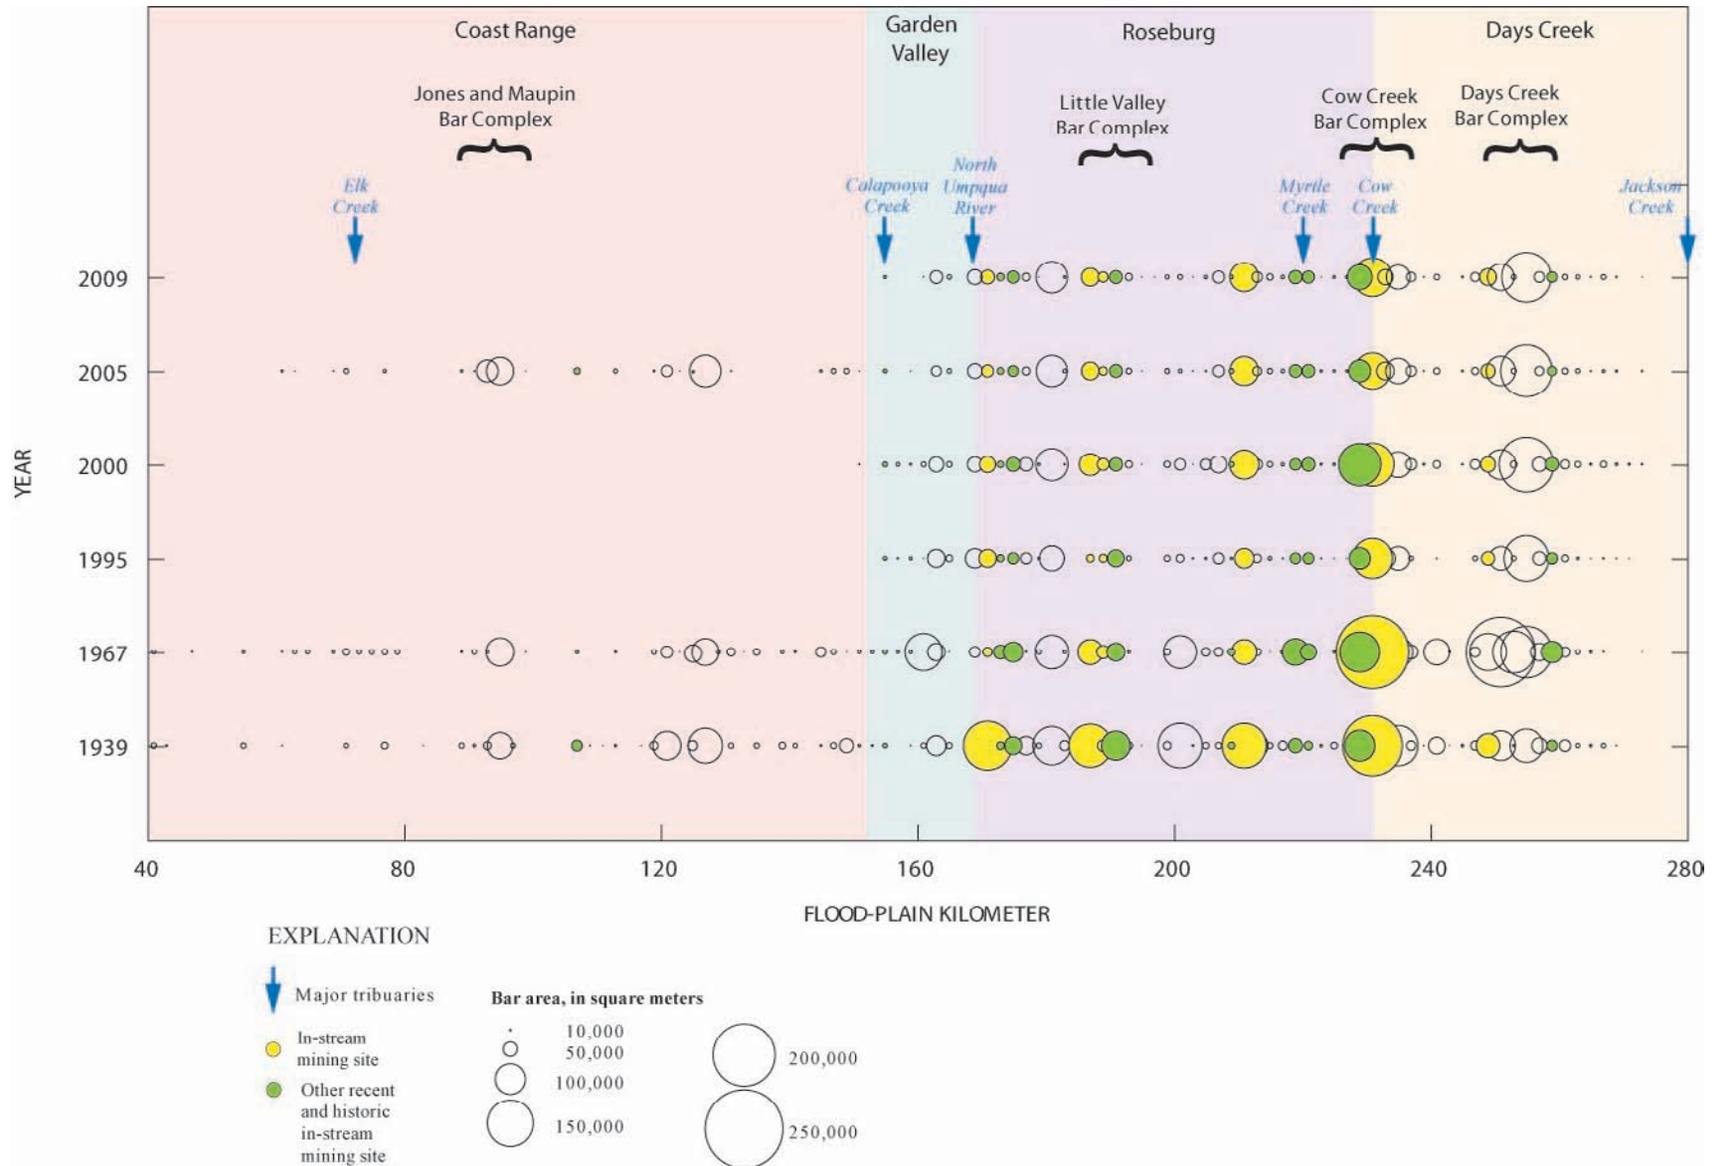
Figure 20. Graph showing the size and location of mapped gravel bars along the South Umpqua and Umpqua Rivers, Oregon, 1939–2005. Each circle represents the total bar area, aggregated every two flood-plain kilometer transects, and does not necessarily correspond to individual bars. Bar complexes are arbitrary names assigned to particularly gravel-rich areas and may include multiple bars.

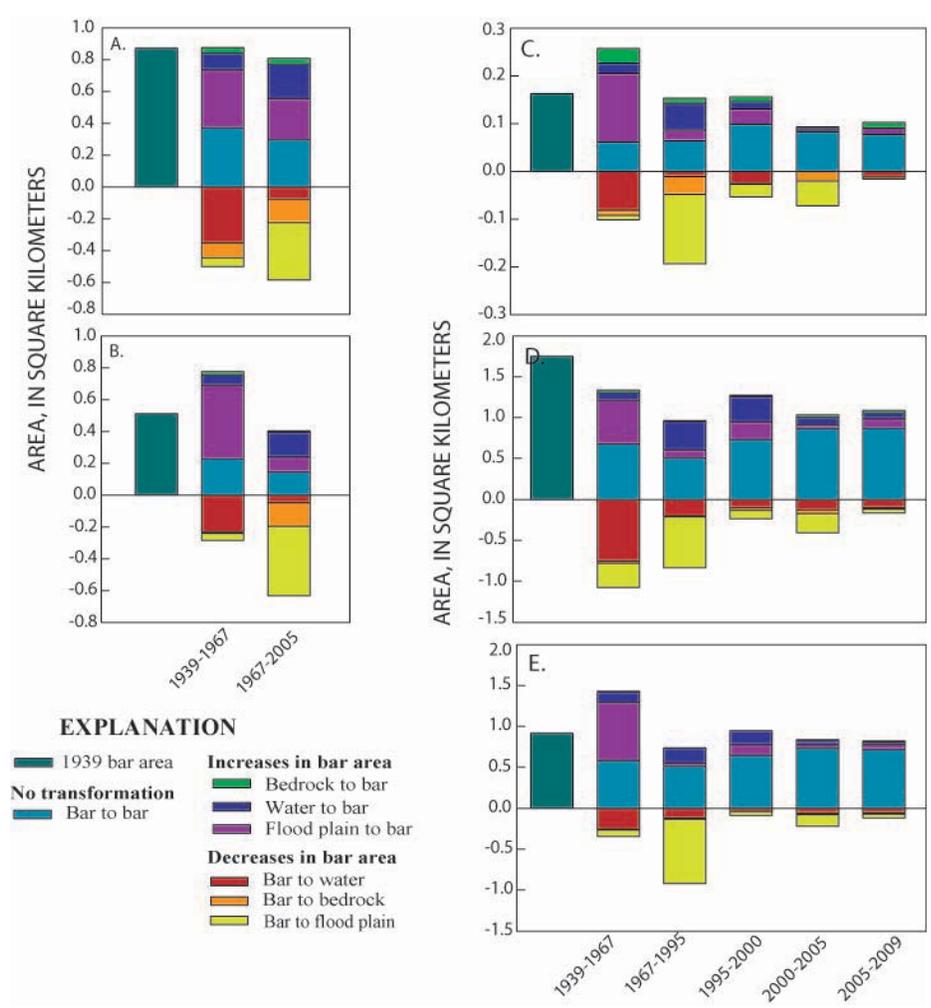
Figure 21. Graphs showing reach-segregated changes in bar area in the Umpqua River basin, Oregon, 1939–2005. Positive balance represents net bar area in each time period separated according to areas that were previously mapped as bars, and newly created bars that were previously mapped as water, flood plain, or bedrock. Negative balances represent total decreases in bar area, separated into areas that became water, bedrock, or flood plain. A. Coast Range, B. North Umpqua, C. Garden Valley, D. Roseburg, E. Days Creek.

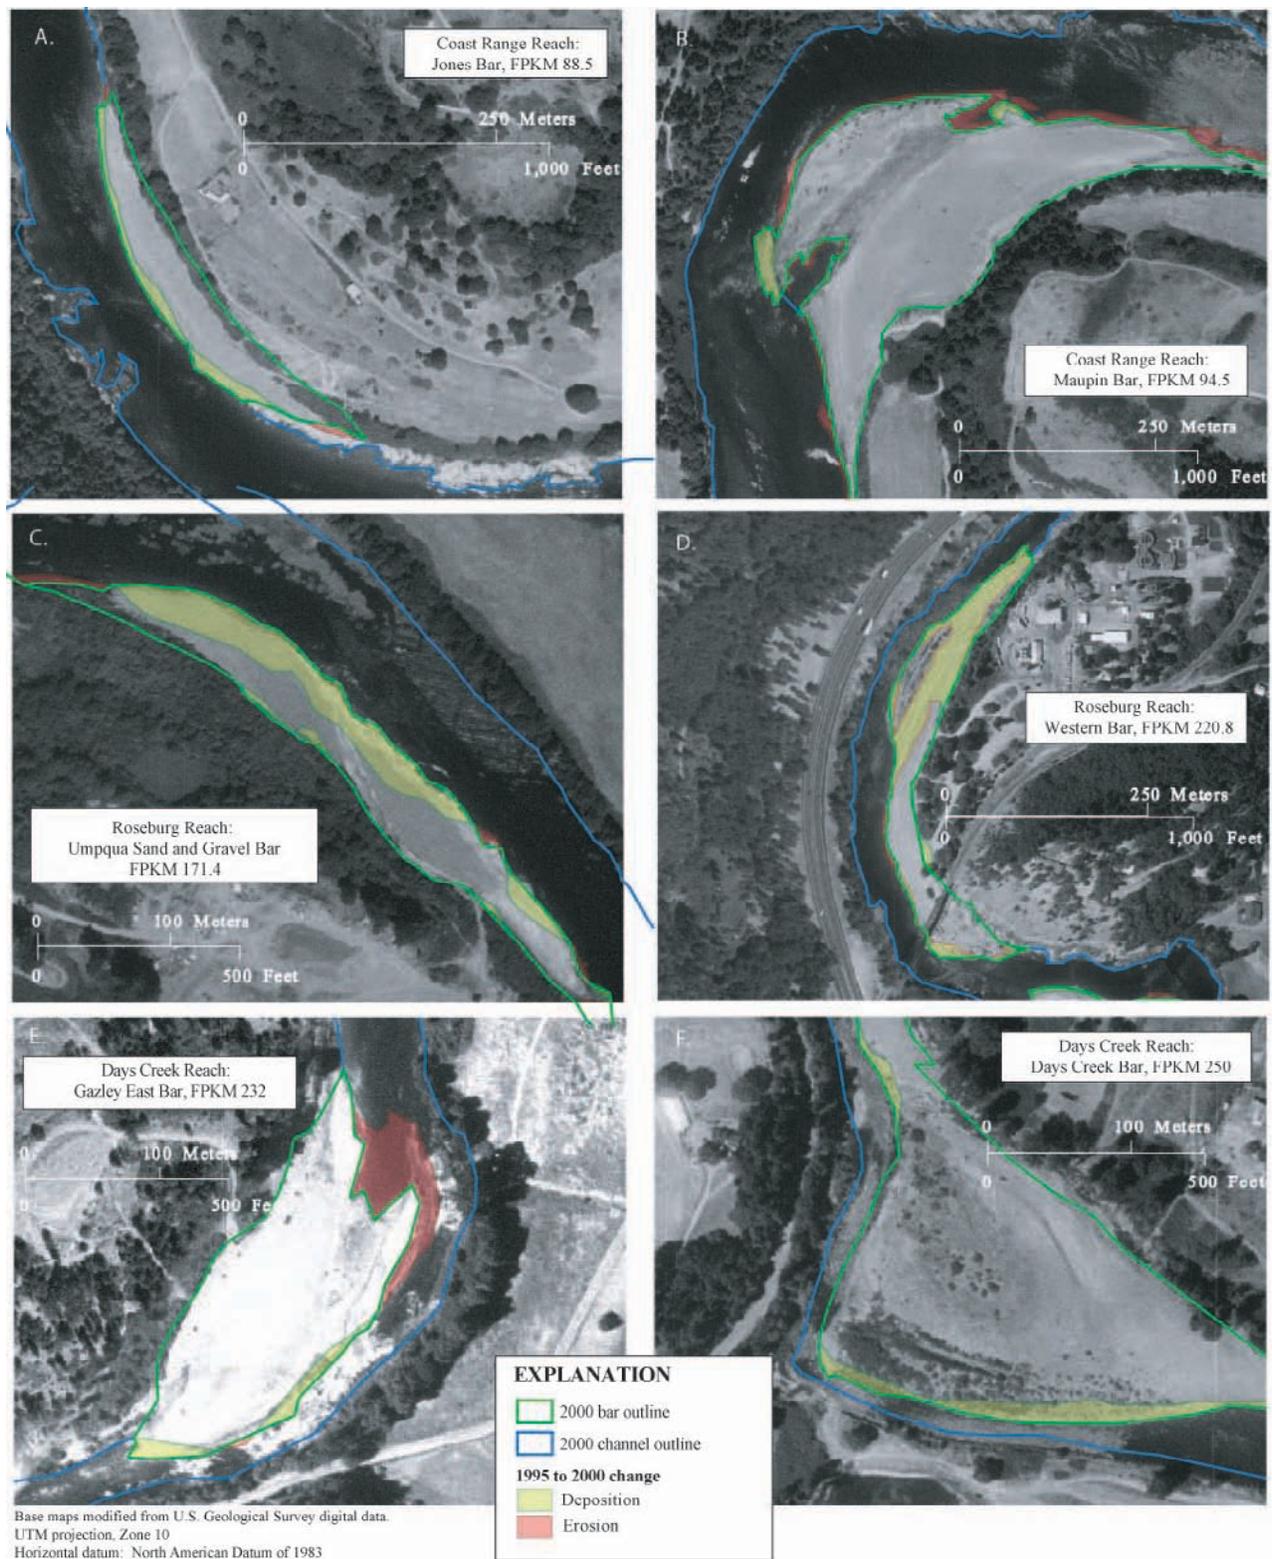
Figure 23. Photographs showing changes in bar morphology between 1995 and 2000 for select sites on the Umpqua River, Oregon. Mapping (1995 and 2000) and aerial photographs (2000) span the December 1996 flood.

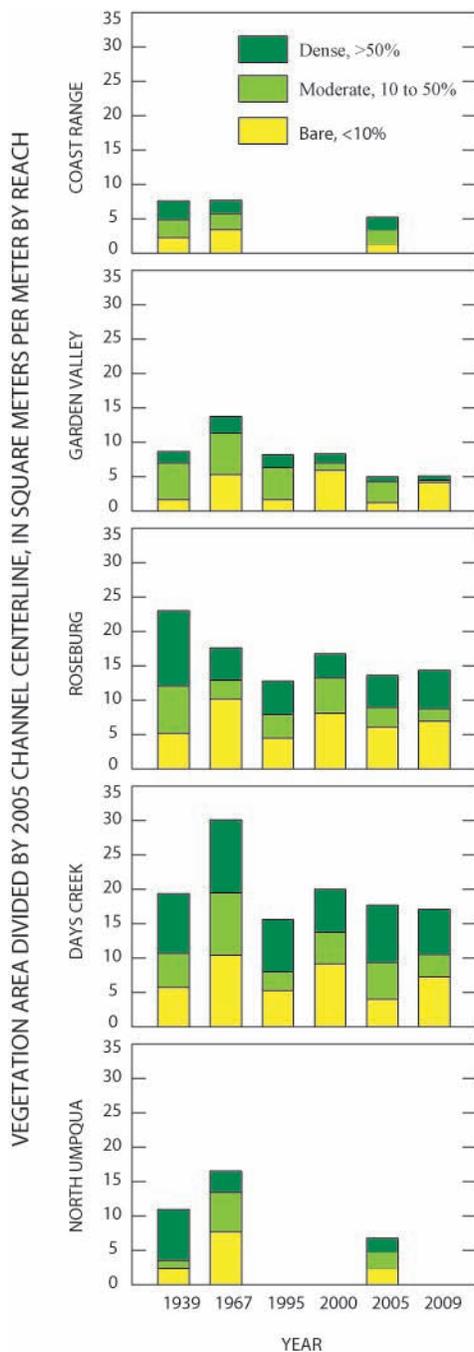
Figure 24. Graphs showing historical changes in vegetation density within the active channel for fluvial reaches of the Umpqua River basin, Oregon, 1939–2009. Coast Range and North Umpqua reaches were mapped only in 1939, 1967, and 2005.

Repeat mapping of vegetation density on gravel bars reveals patterns of disturbance and recovery that primarily were caused by large floods, in particular the large flood of December 1964. Vegetation density maps created for the Days Creek, Roseburg, and Garden Valley reaches from 1995, 2000, 2005, and 2009 show that floods in 1996–97 and 2005 also influenced vegetation density on gravel bars, although these smaller floods had less effect than the December 1964 flood (fig. 24).

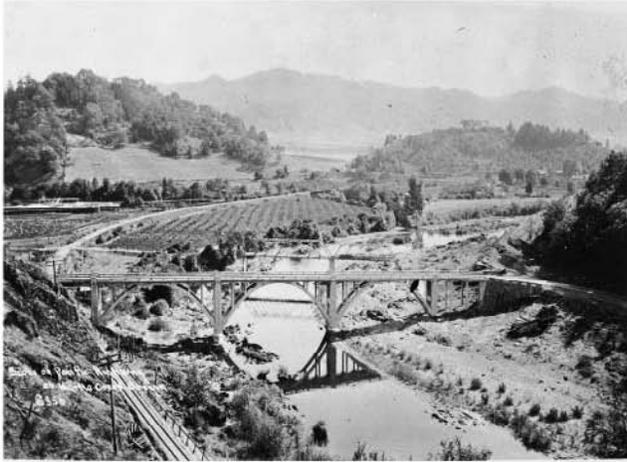
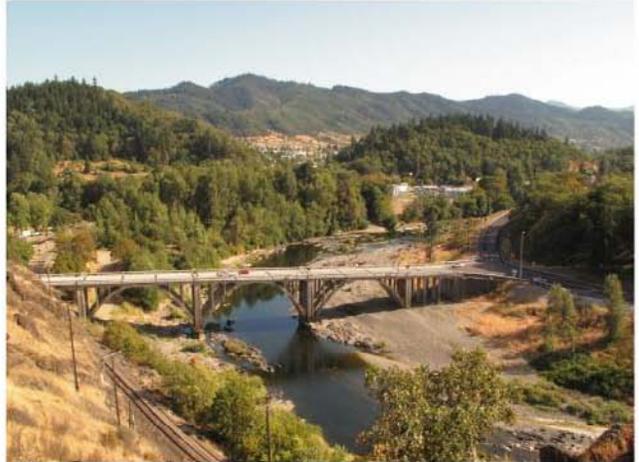
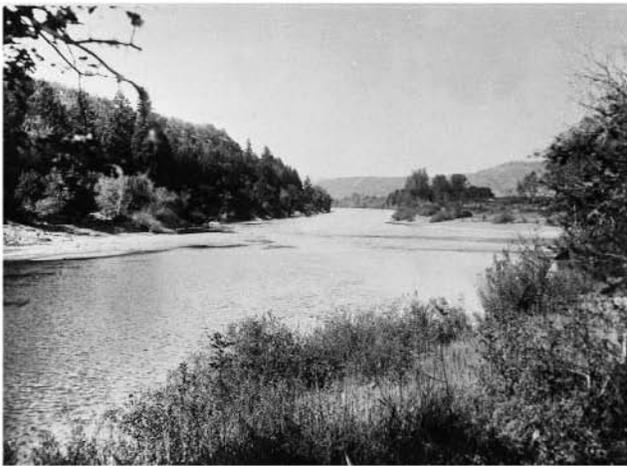
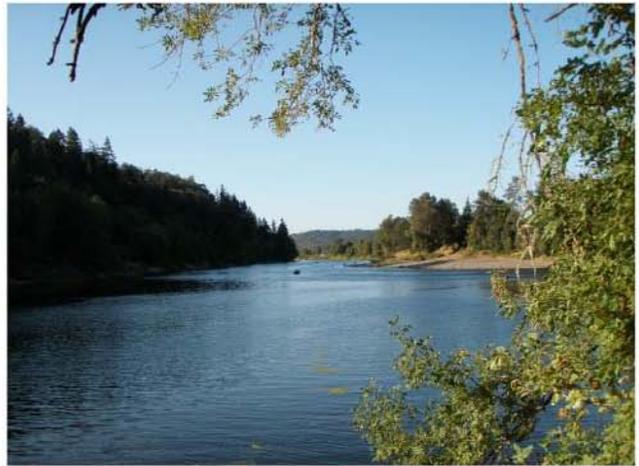
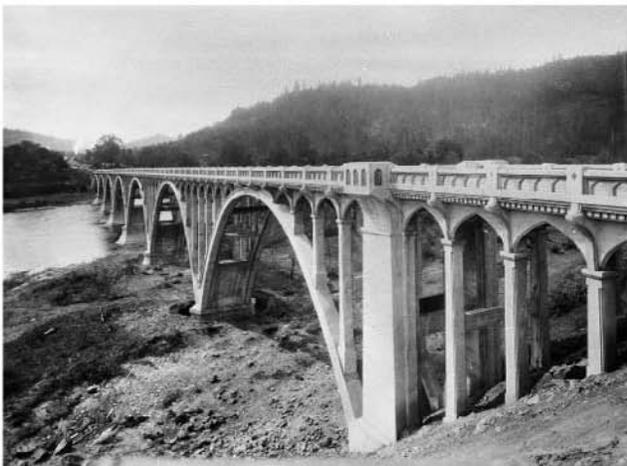
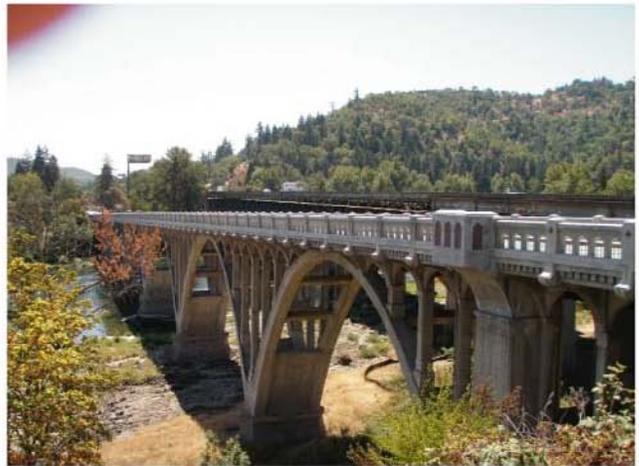
Myrtle Creek Bridge, South Umpqua River, FPKM 219.9,1925 to 2009

Confluence of the South Umpqua and North Umpqua Rivers, near Singleton Park, FPKM 168.4,1925-2009

Booth Bridge, North Umpqua River, NUFPM 10, 1925-2009

Figure 26. Photographs showing historical channel changes in the Umpqua River basin, Oregon, 1920s–2009. Locations of photographs are provided in appendix A.

Repeat land-based photographs of the South Umpqua and North Umpqua Rivers show little variation in channel planform or bar characteristics over the past 70+ years at the three sites (fig. 26). At Myrtle Creek Bridge (FPKM 219.9), the bar along the left bank appears very similar in 1925 and 2009, as both photographs show a thin mantle of gravel overlying bedrock, but with perhaps slightly more gravel evident in the 2009 photograph (fig. 26). The confluence of the North Umpqua and South Umpqua Rivers near Singleton Park (FPKM 168.4) also changed little between 1925 and 2009, as the bar along the right bank of the mainstem Umpqua River has similar, size, shape, and texture in both photographs (fig. 26). Likewise, the photographs from 1925 and 2009 at Booth Bridge on the North Umpqua River show negligible change in bed-material characteristics, as both photographs show thin patches of gravel overlying channel-adjacent bedrock (fig. 26).

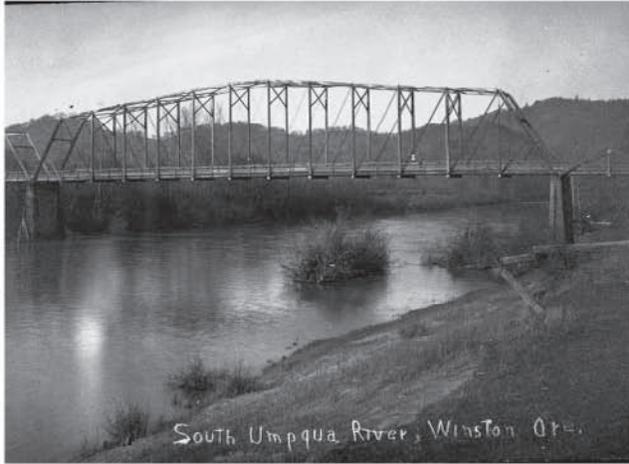
A. Winston Bridge, South Umpqua River, FPKM 195, 1929–2009

B. Rice Creek covered bridge, South Umpqua River, FPKM 204.5, early 1900s–2009

C. Whistler's Bend, North Umpqua River, NUFPM 33, early 1900s–2009

Figure 27. Photographs showing historical changes in riparian vegetation in the Umpqua River basin, Oregon, 1920s–2009. Locations of photographs are provided in appendix A..

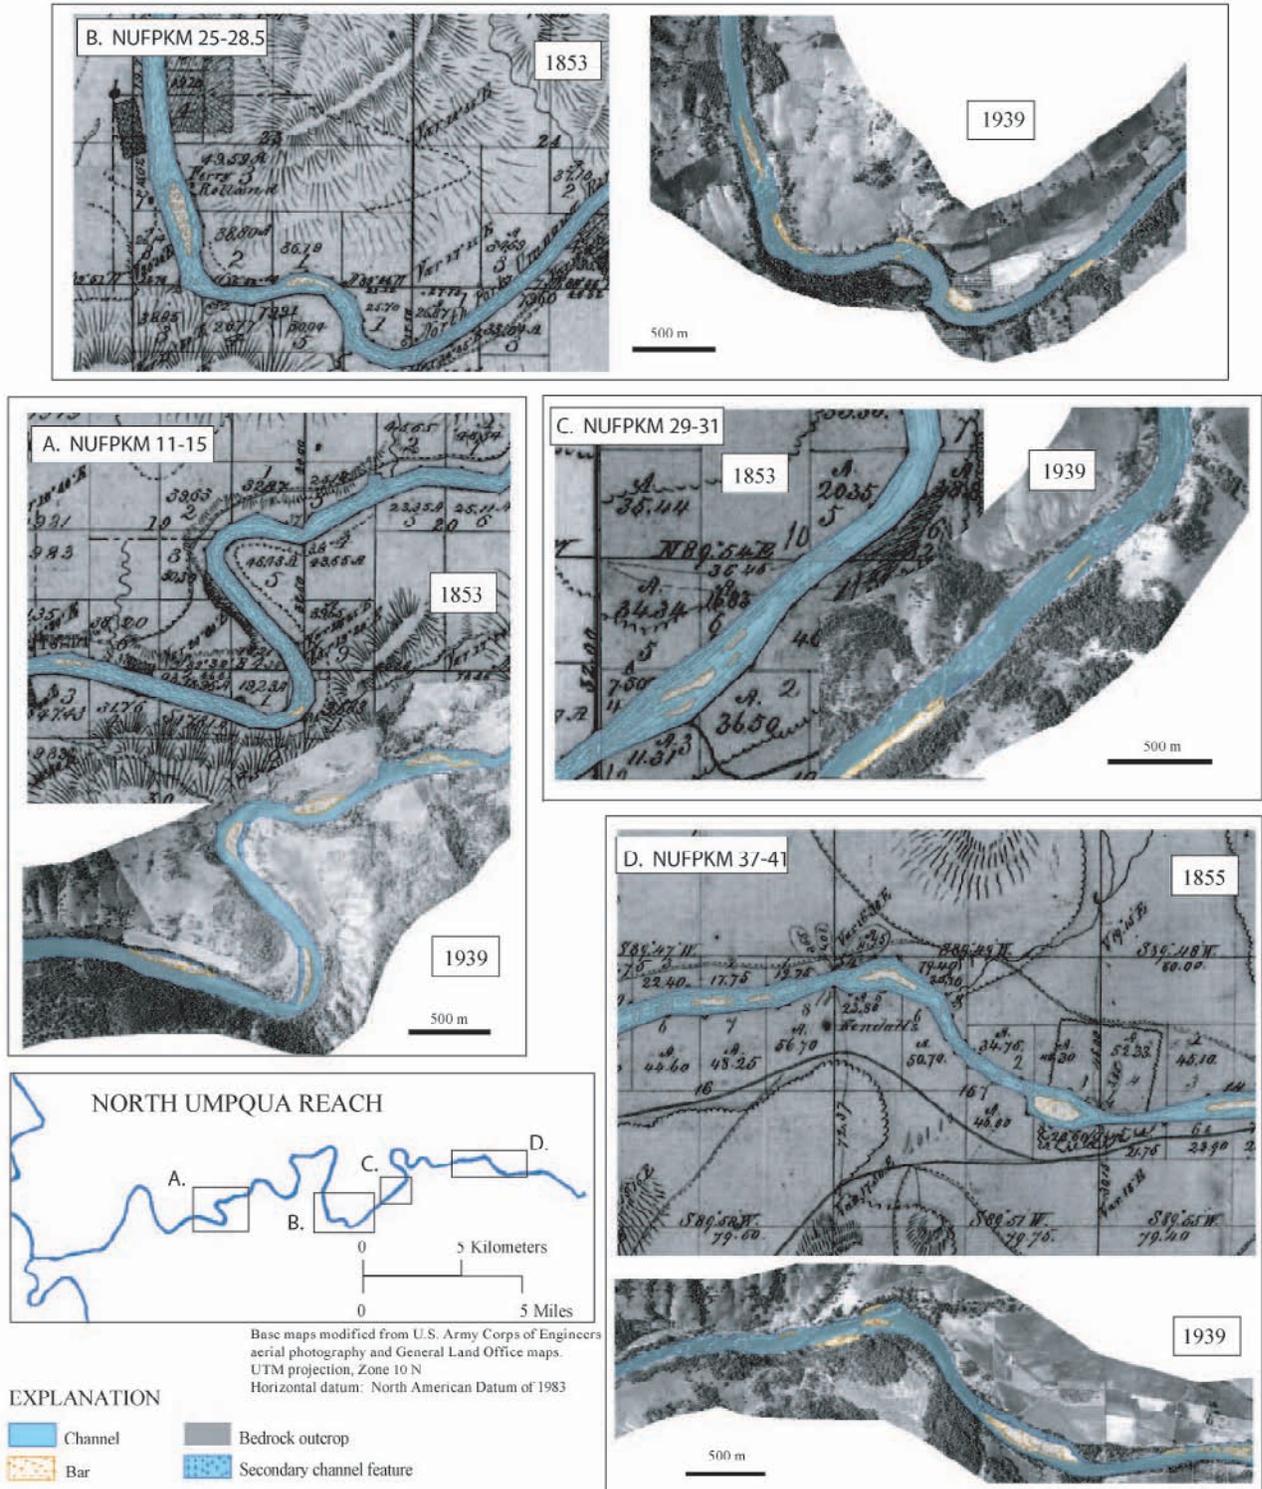
Figure 28. Maps showing comparison of channel position at select sites along the North Umpqua Reach as depicted in General Land Office surveys from 1853 to 1855 and channel maps based on aerial photographs from 1939.

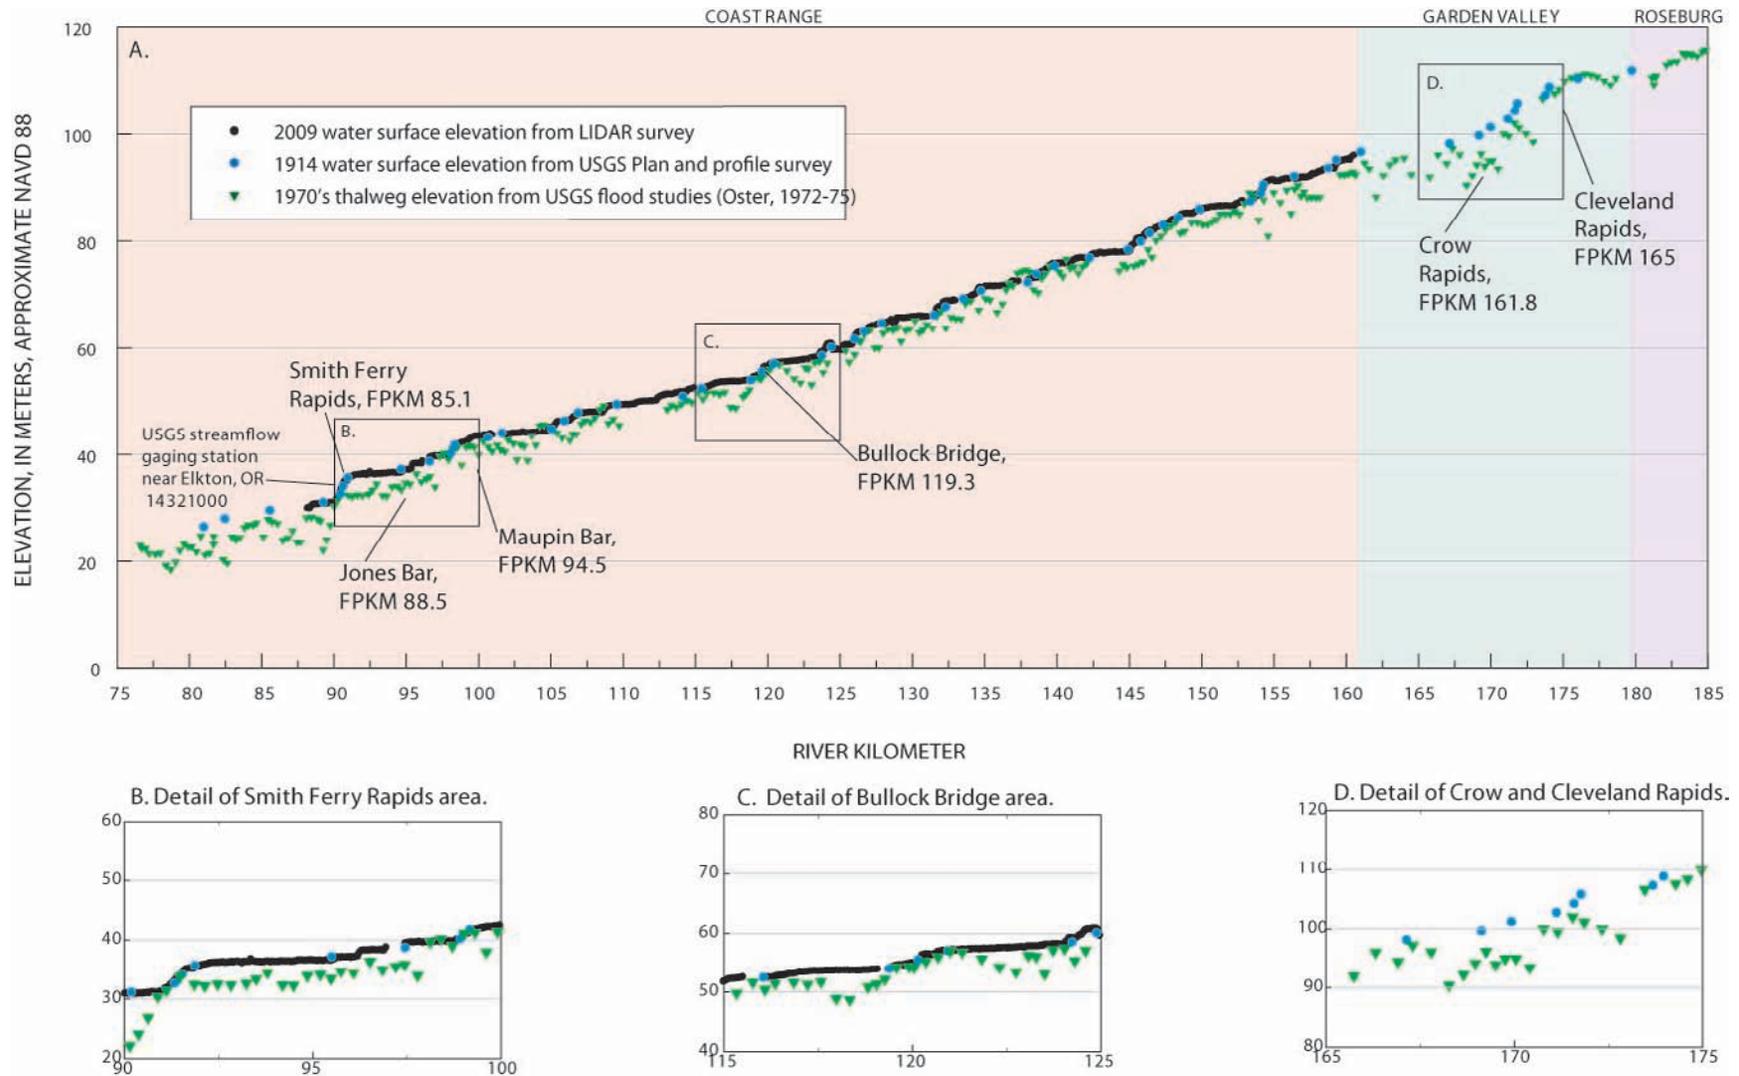
Figure 29. Diagram showing repeat longitudinal profiles of the mainstem Umpqua River between Elkton and confluence of North and South Umpqua rivers, Oregon, 1914–2009. Refer to table 7 for sources of survey data.

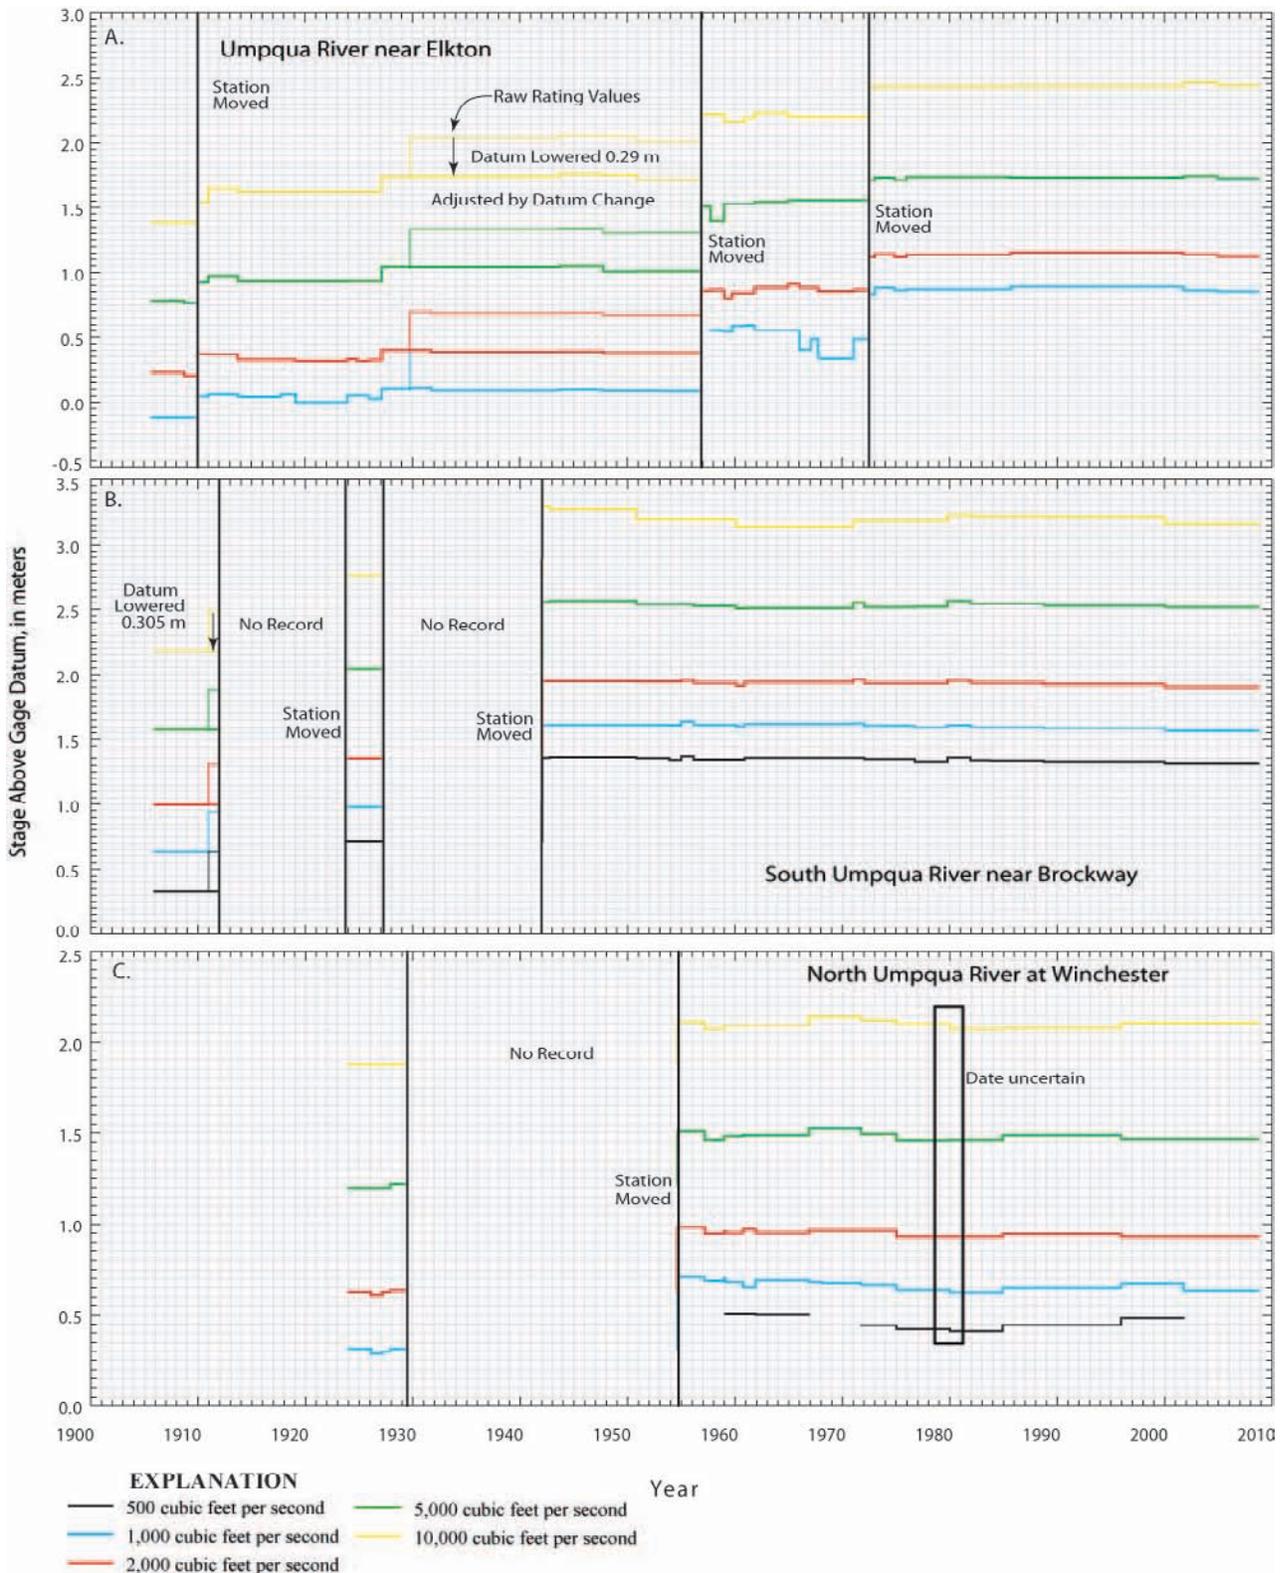
Figure 30. Graphs showing stage–discharge rating-curve elevations for specific discharges for long-term mainstem streamflow gages in the Umpqua River basin, Oregon. Source data is from station records housed at Oregon Water Science Center, U.S. Geological Survey, Portland, Oregon.

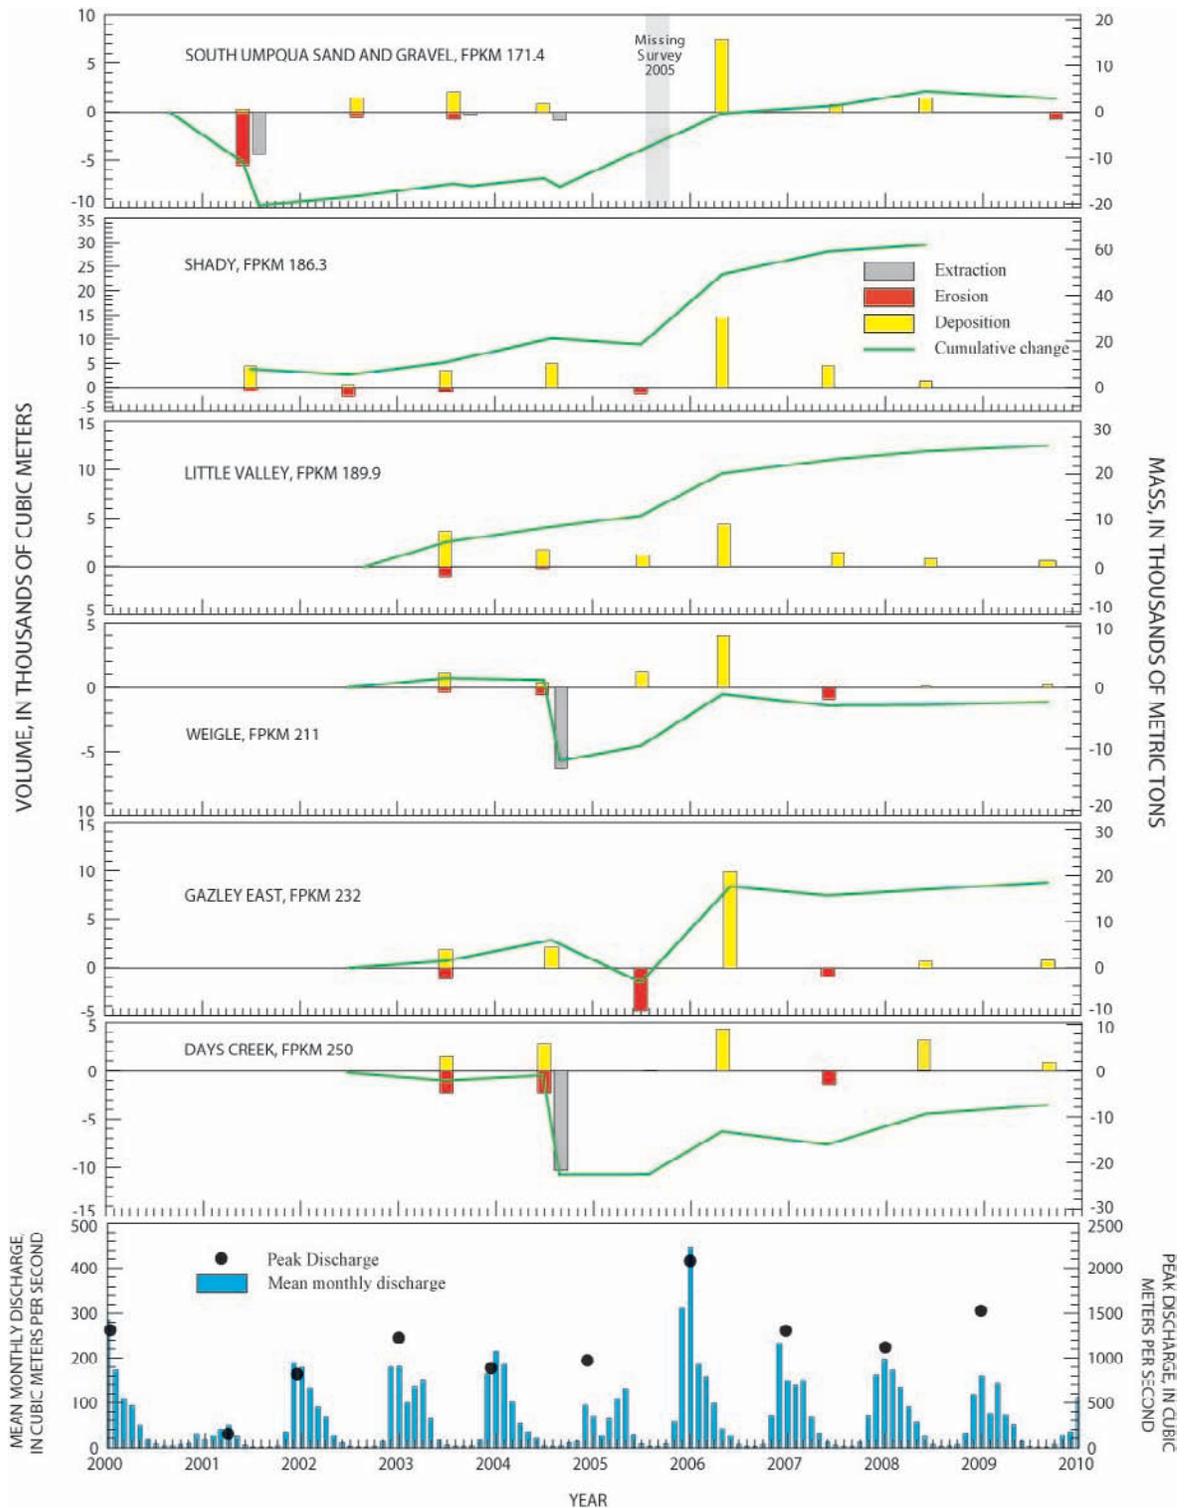
Figure 31. Graphs showing gravel bar volume changes during 2001–2009 at instream gravel mining sites along the South Umpqua River, Oregon. Refer to table 8 for data sources and values underlying this figure. For sites with missing surveys, cumulative totals assume no net change for period of missing data. Mean monthly and annual (water year) peak flows from USGS data for streamflow-gaging station on South Umpqua River near Brockway (station ID 14312000).

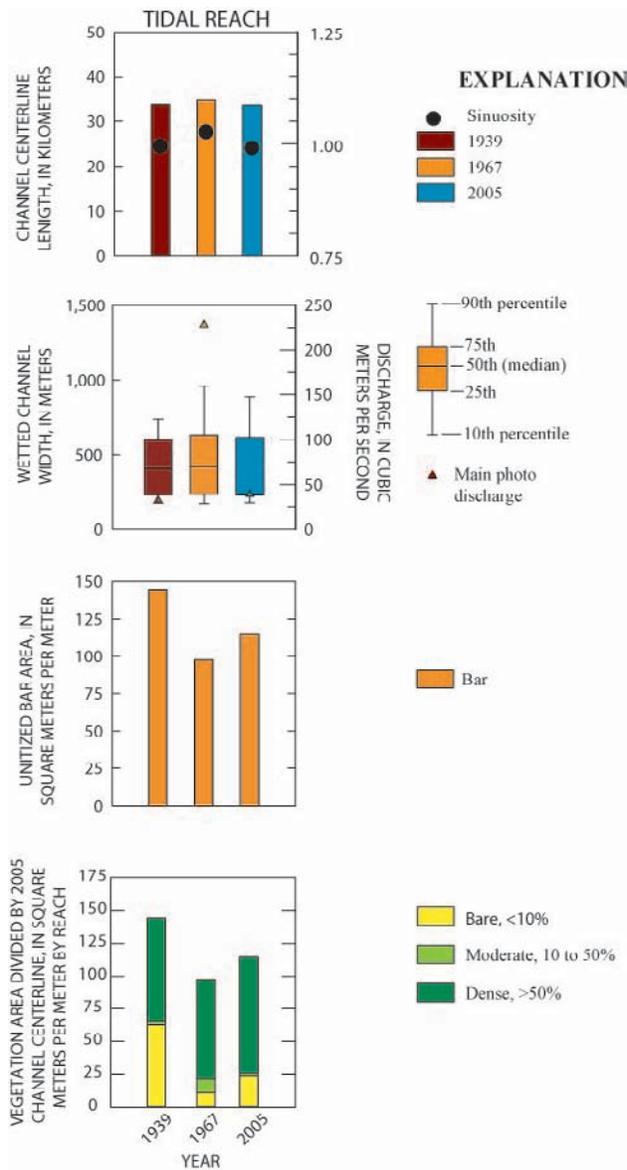
Figure 32. Graphs showing channel planform changes during 1939–2005 between FPKM 7 and 40 for the Tidal reach of the Umpqua River, Oregon.
