Channel Change and Bed-Material Transport in the Umpqua River Basin, Oregon

Prepared in cooperation with the U.S. Army Corps of Engineers

Open-File Report 2010–1314

U.S. Department of the Interior
U.S. Geological Survey

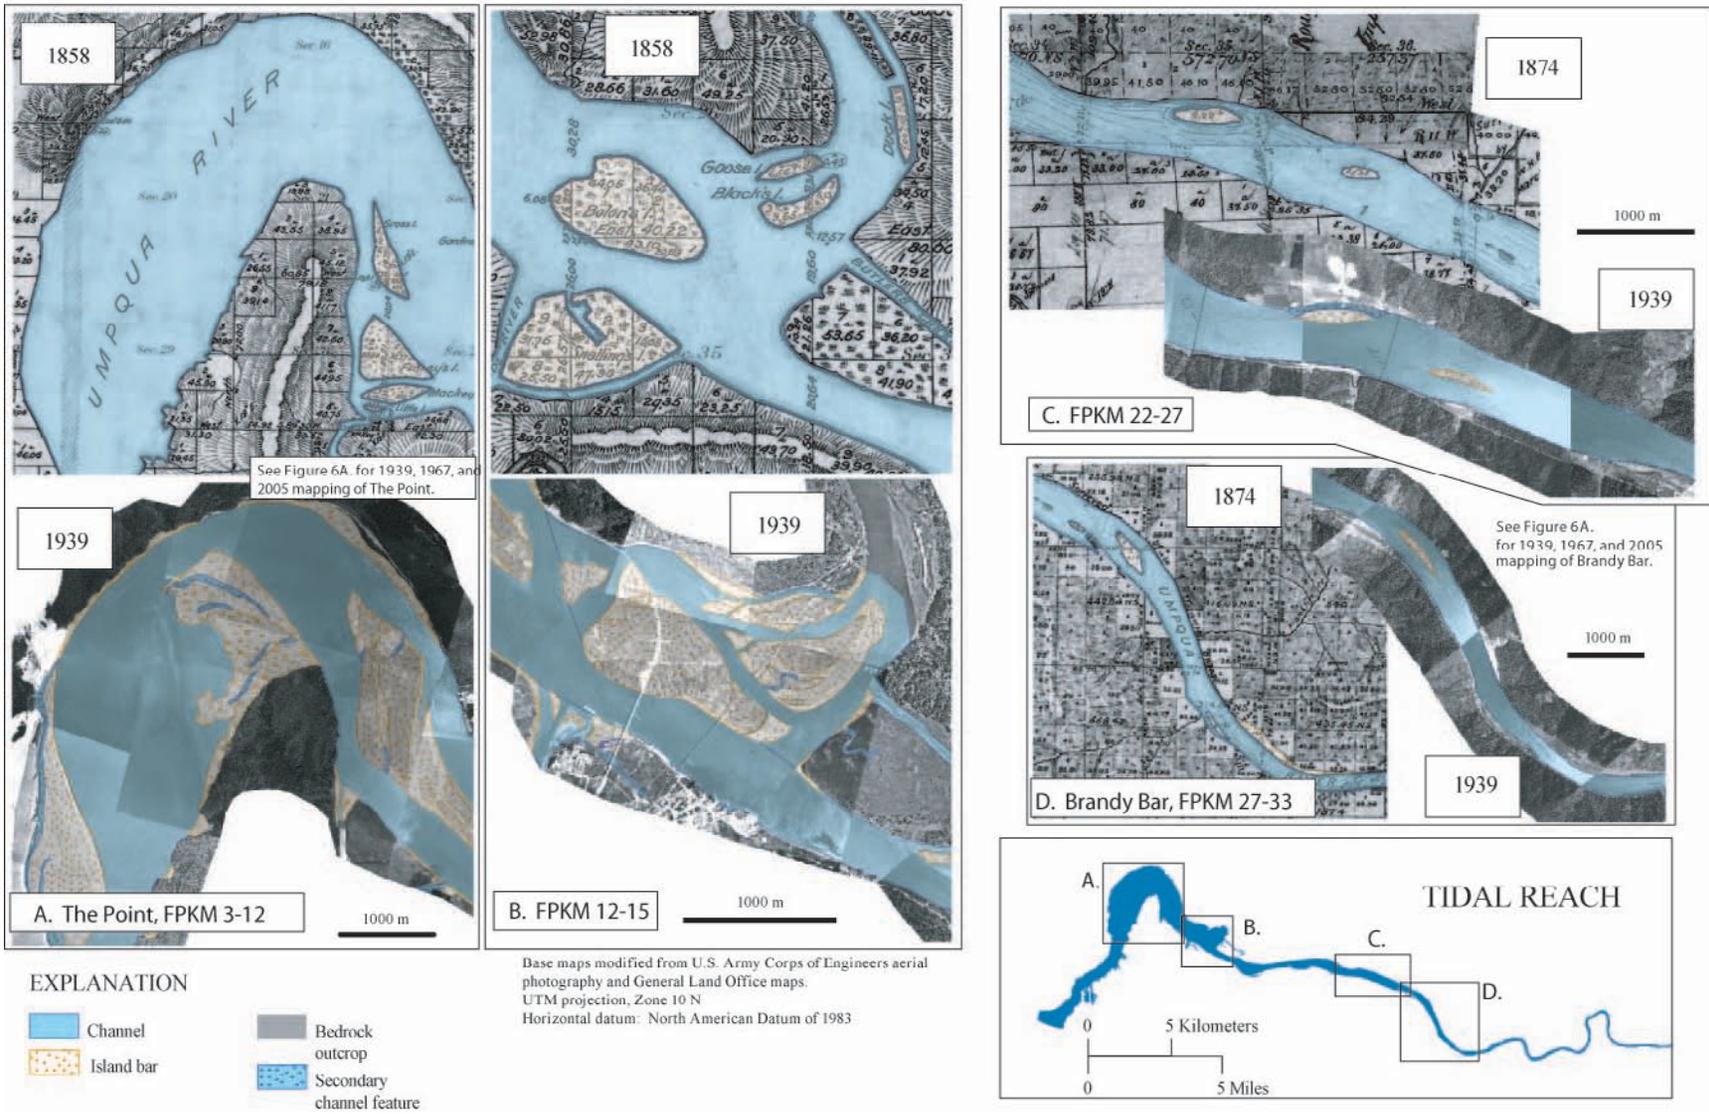
Figure 33. Maps showing comparison of channel planform for the Tidal reach of the Umpqua River, Oregon, as depicted in 1857–74 General Land Office Surveys, with aerial photographs from 1939. Refer to figure 6 for a more detailed map of Tidal reach planform and historical changes.

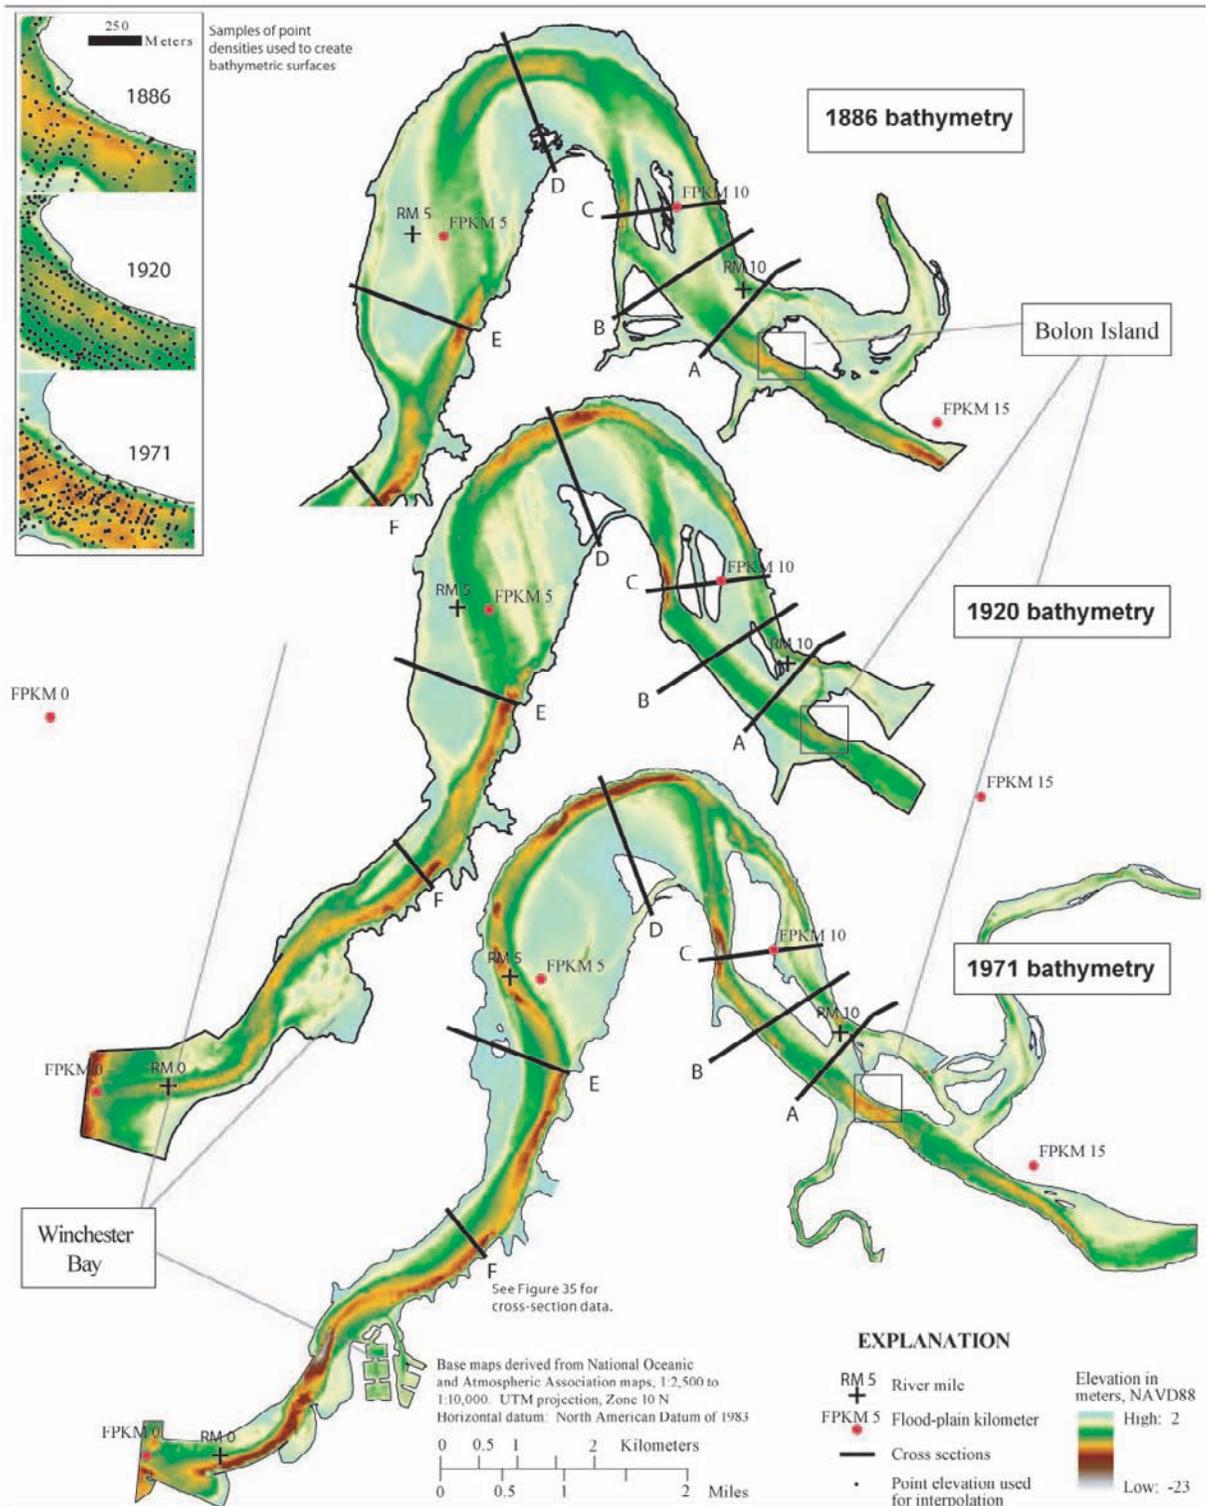
Figure 34. Maps showing bathymetric changes to the Tidal reach of the Umpqua River, Oregon, as detected in historical navigation surveys from 1886, 1921, and 1970. Refer to table 7 for information on survey sources.

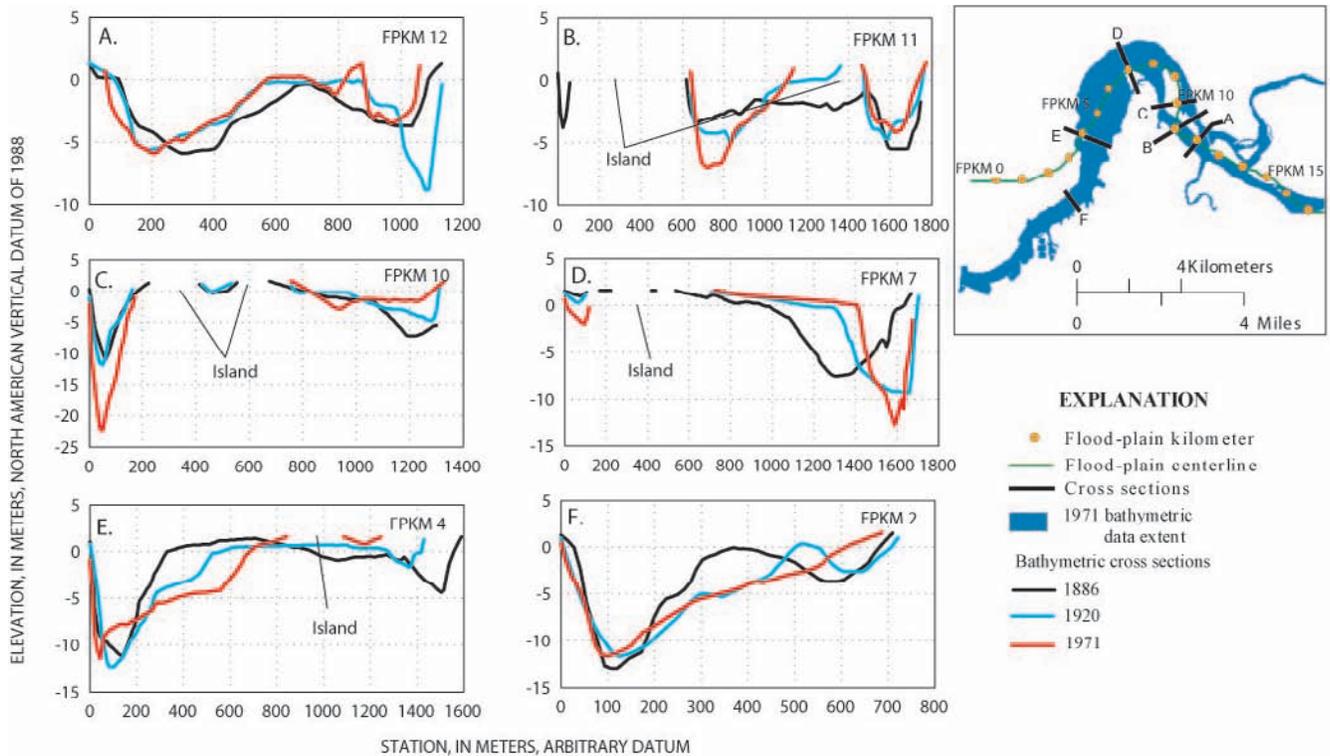
Figure 35. Graphs showing cross sections from navigational surveys dating to 1886, 1920, and 1971. Cross sections were extracted from bathymetric surfaces created from historical surveys that were rectified and digitized in this study. Cross section locations are shown in figure 34.

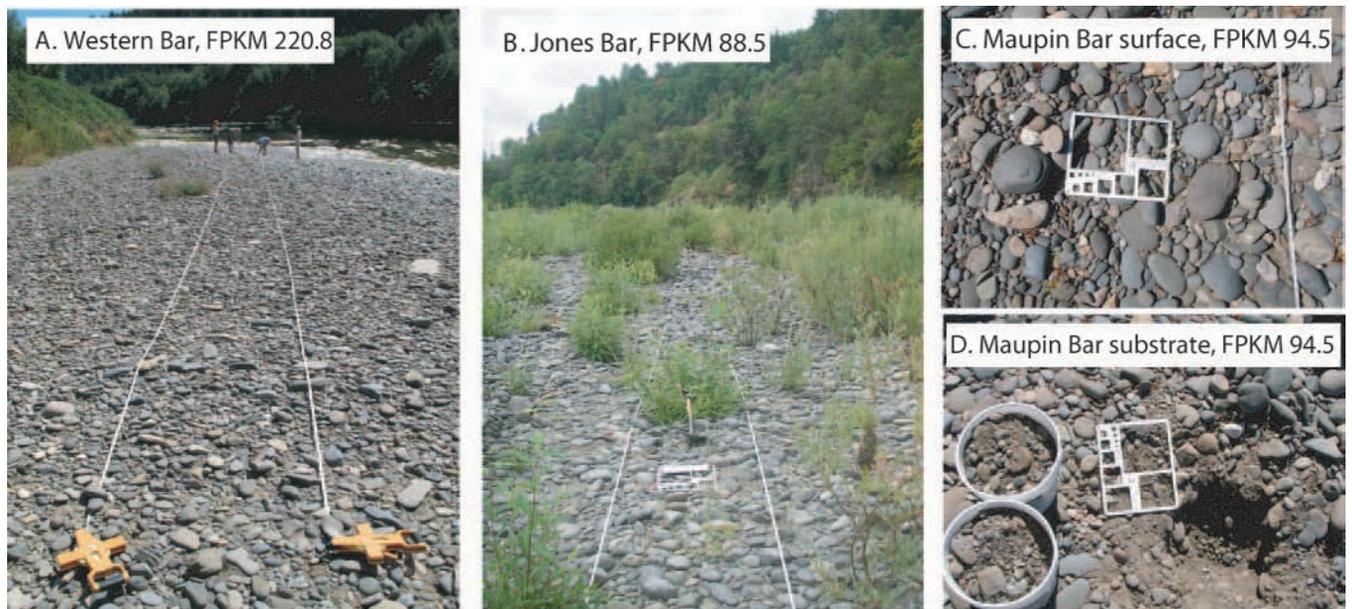
Figure 36. Photographs showing examples of bed material sampling sites in the Umpqua River basin, Oregon.

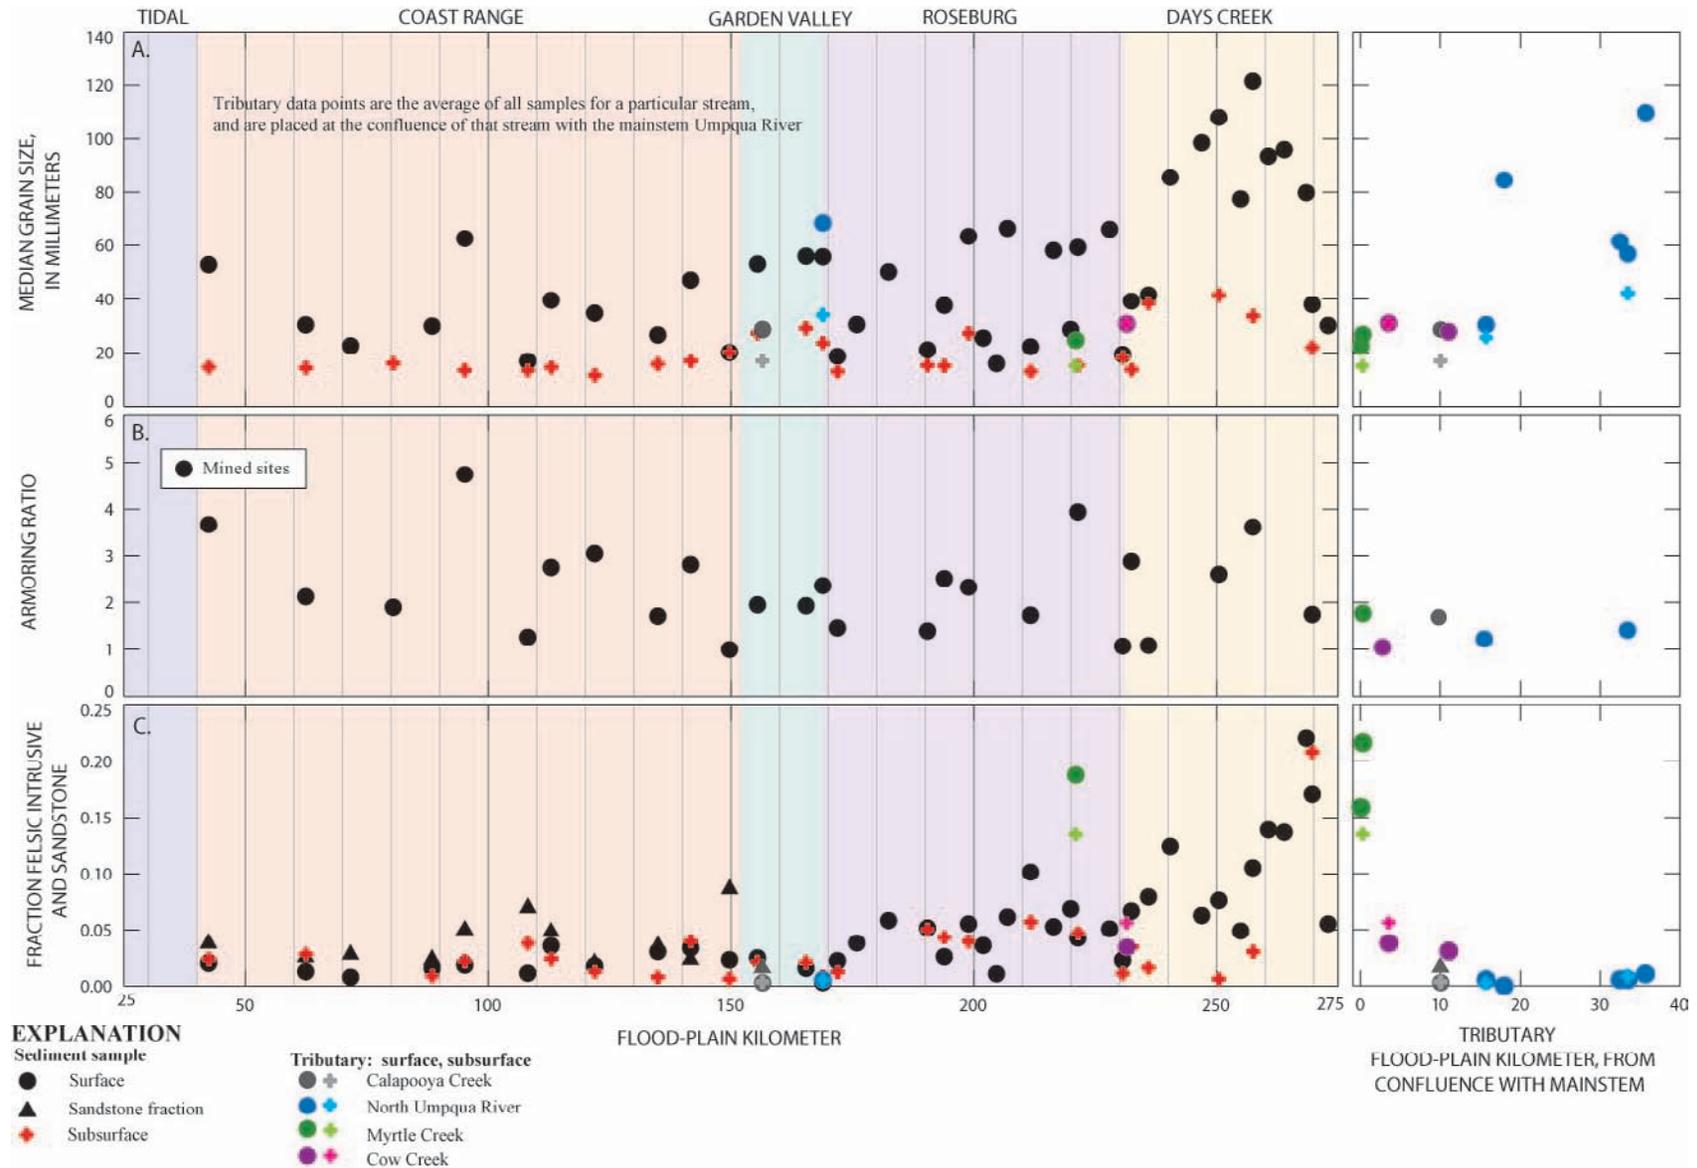
Figure 37. Graphs showing bed-material grain size, armoring ratios, and lithology for bed material sampling sites in the Umpqua River basin, Oregon. A. Median grain size of bar surface and substrate. B. Armoring ratio at each site computed as ratio of median grain size from the bed material surface and substrate. C. Percentage of felsic intrusive clasts. Refer to table 9 and appendix C for particle size and lithology values.

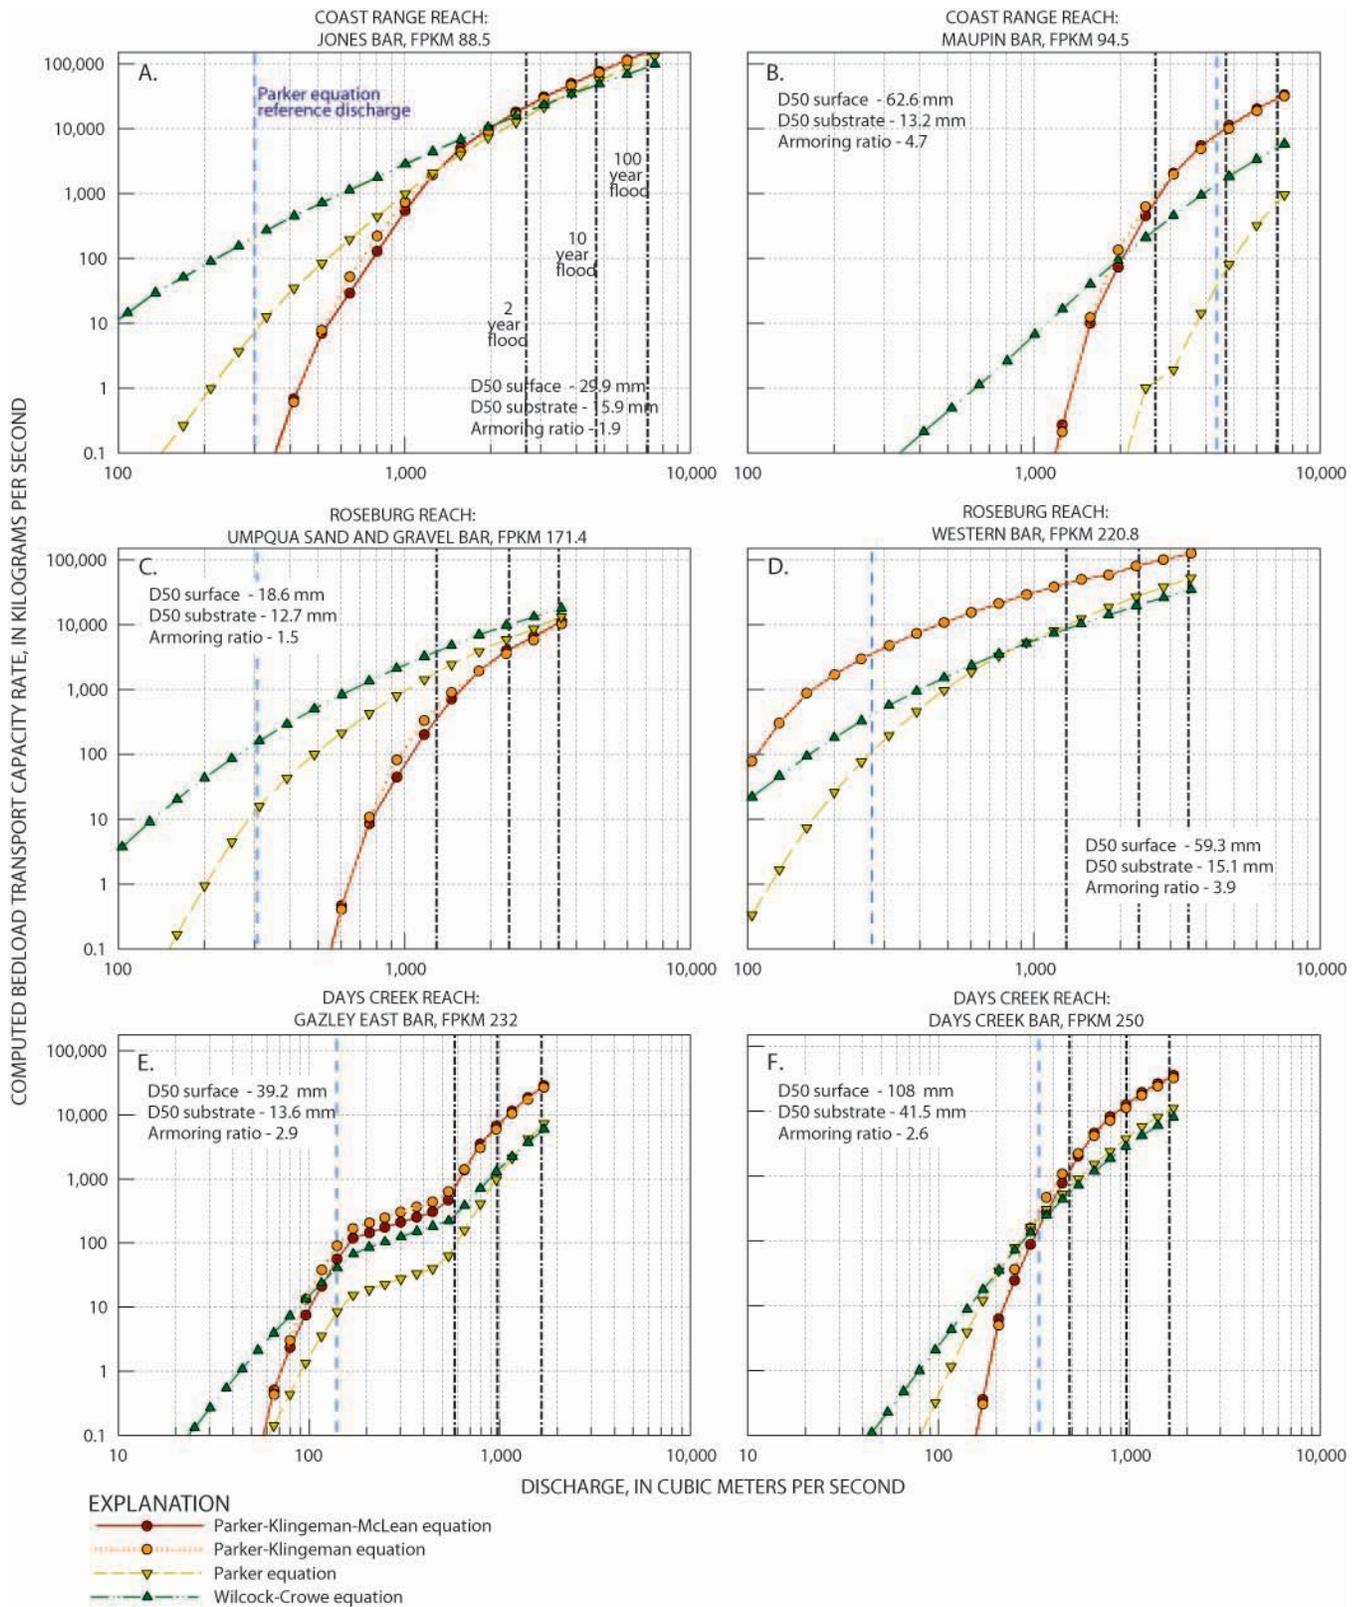
Figure 38. Graphs showing computed bedload transport rating curves for select sites in the Umpqua River basin, Oregon.

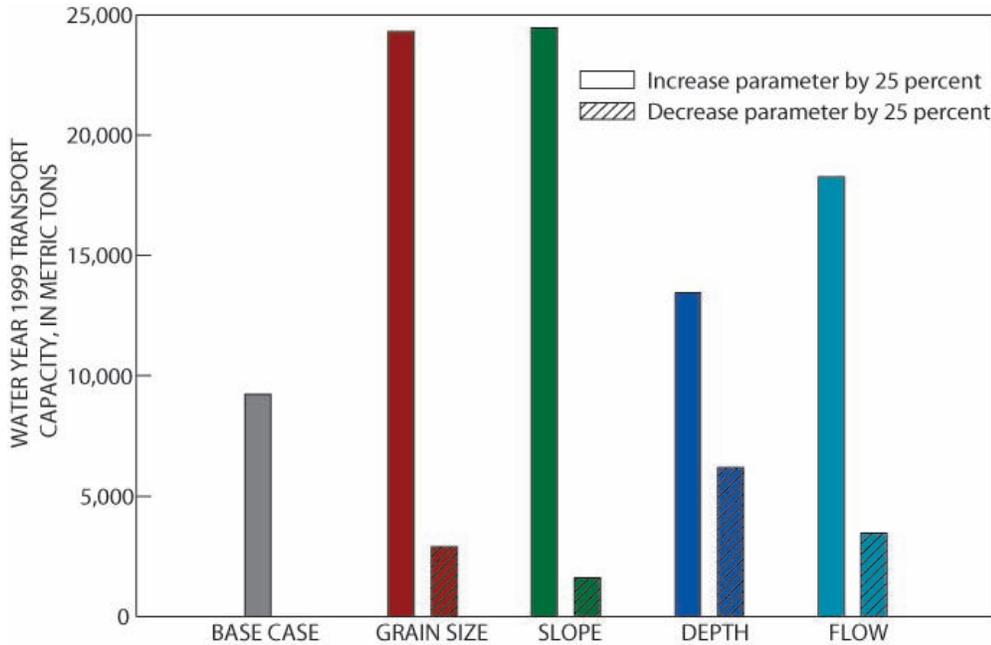
Figure 39. Graph showing effect of grain size, slope, water depth, and discharge on annual bedload transport capacity. Sensitivity trials conducted for Umpqua Sand and Gravel Bar (FPKM 171.4) for water year 1999 used the Parker (1990a,b) equation.

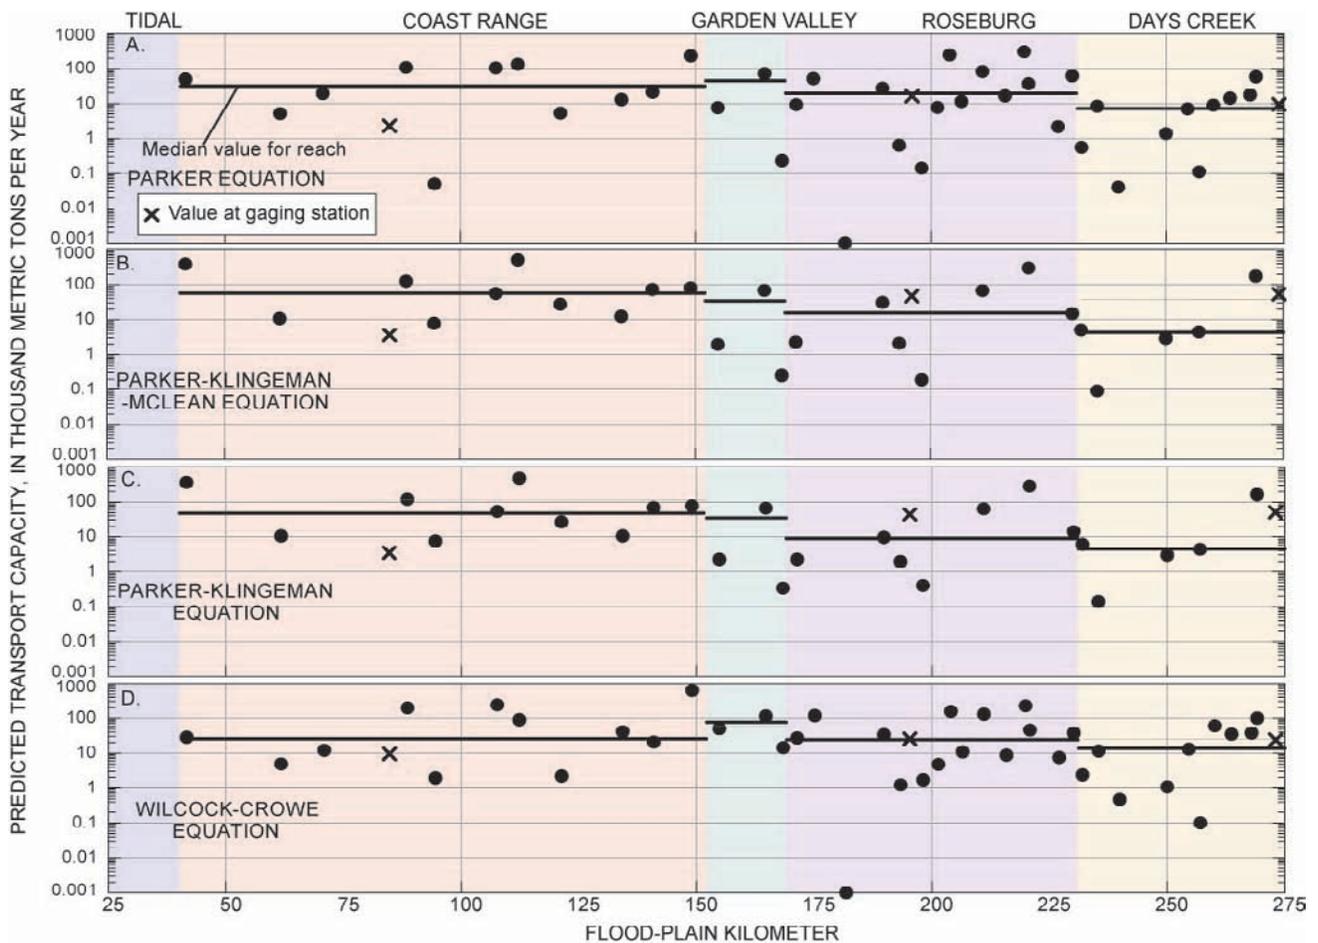
Figure 40. Longitudinal variation in calculated transport capacity for bed material sampling sites on Umpqua and South Umpqua Rivers, Oregon. Data points represent site specific annual transport, as calculated for 1951–2008, whereas horizontal lines represent median values for each reach. See table 9 for transport capacity values, grain size, and slope data for each sampling site.

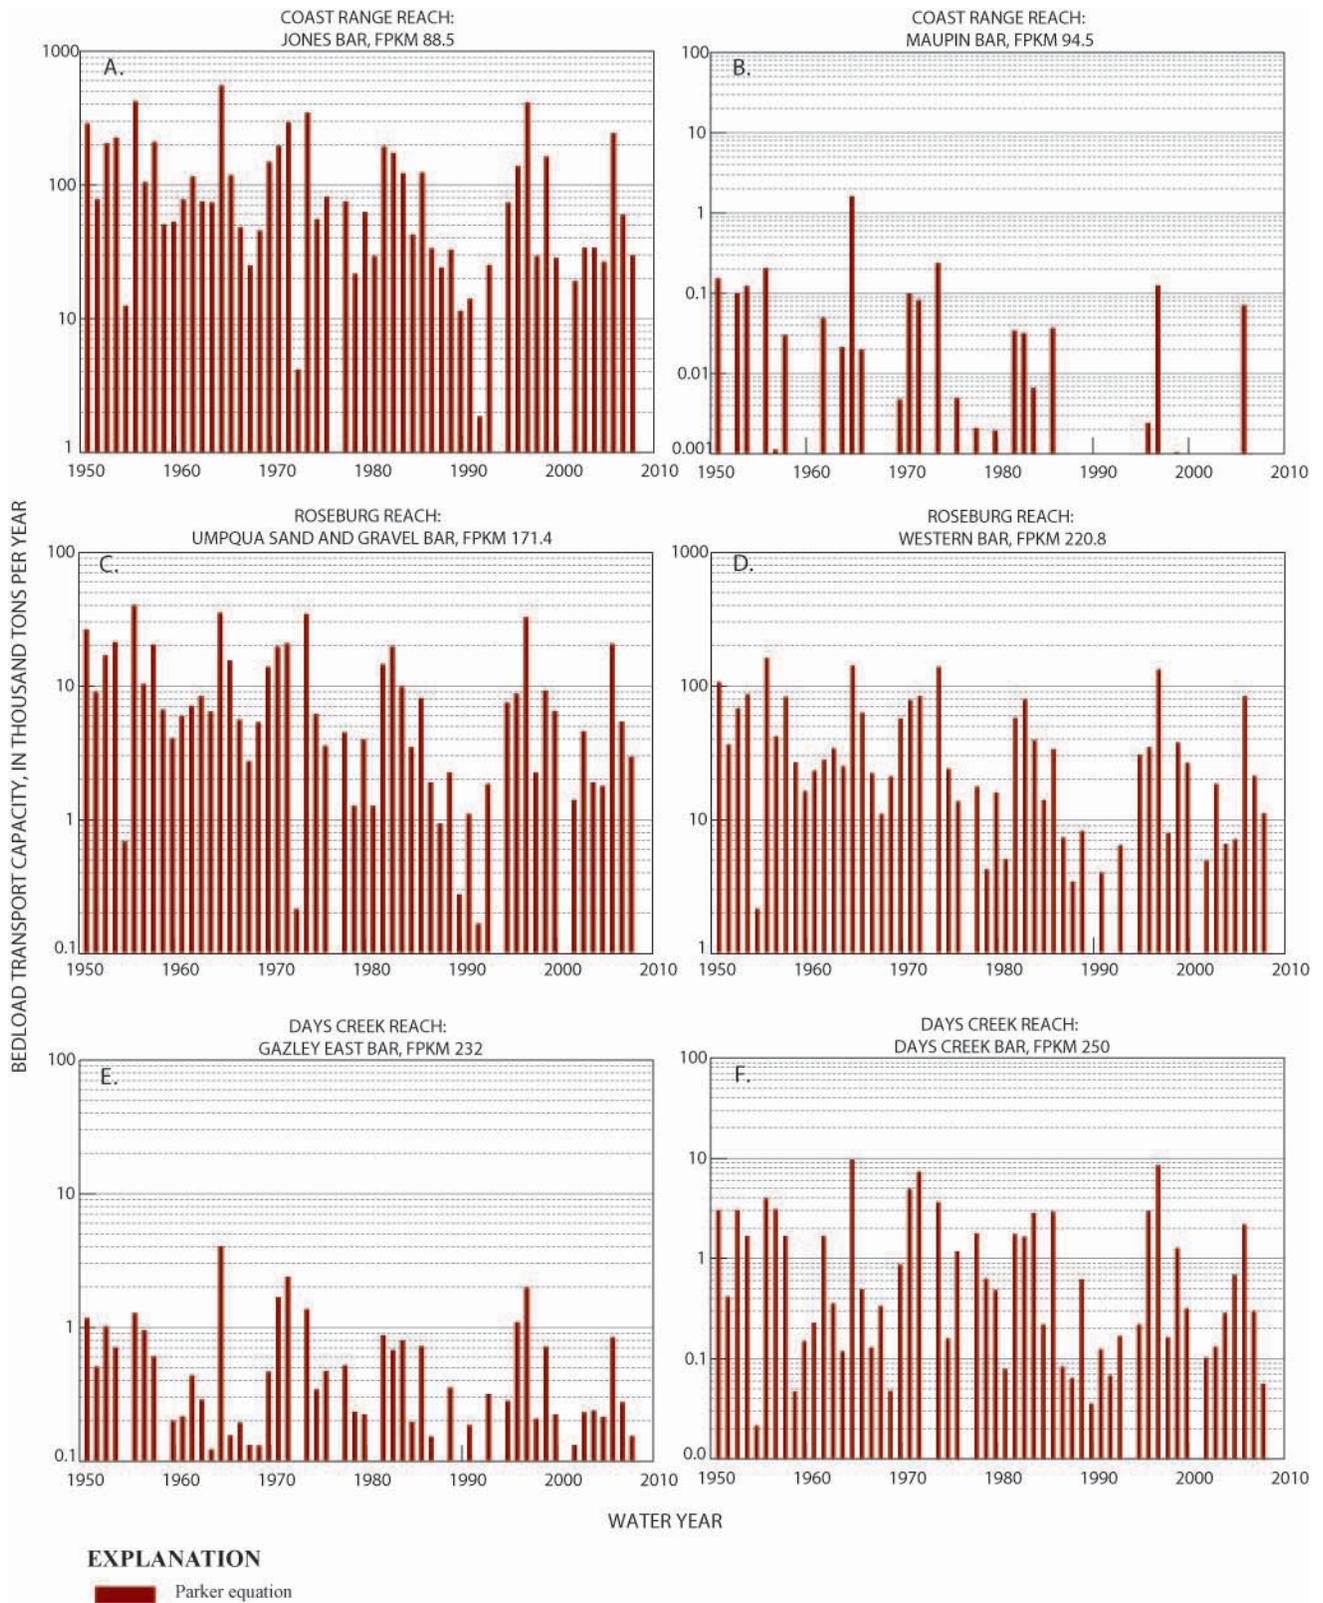
Figure 41. Graphs showing annual computed transport capacity for water years 1951–2008 for selected sites in the Umpqua River basin, Oregon.

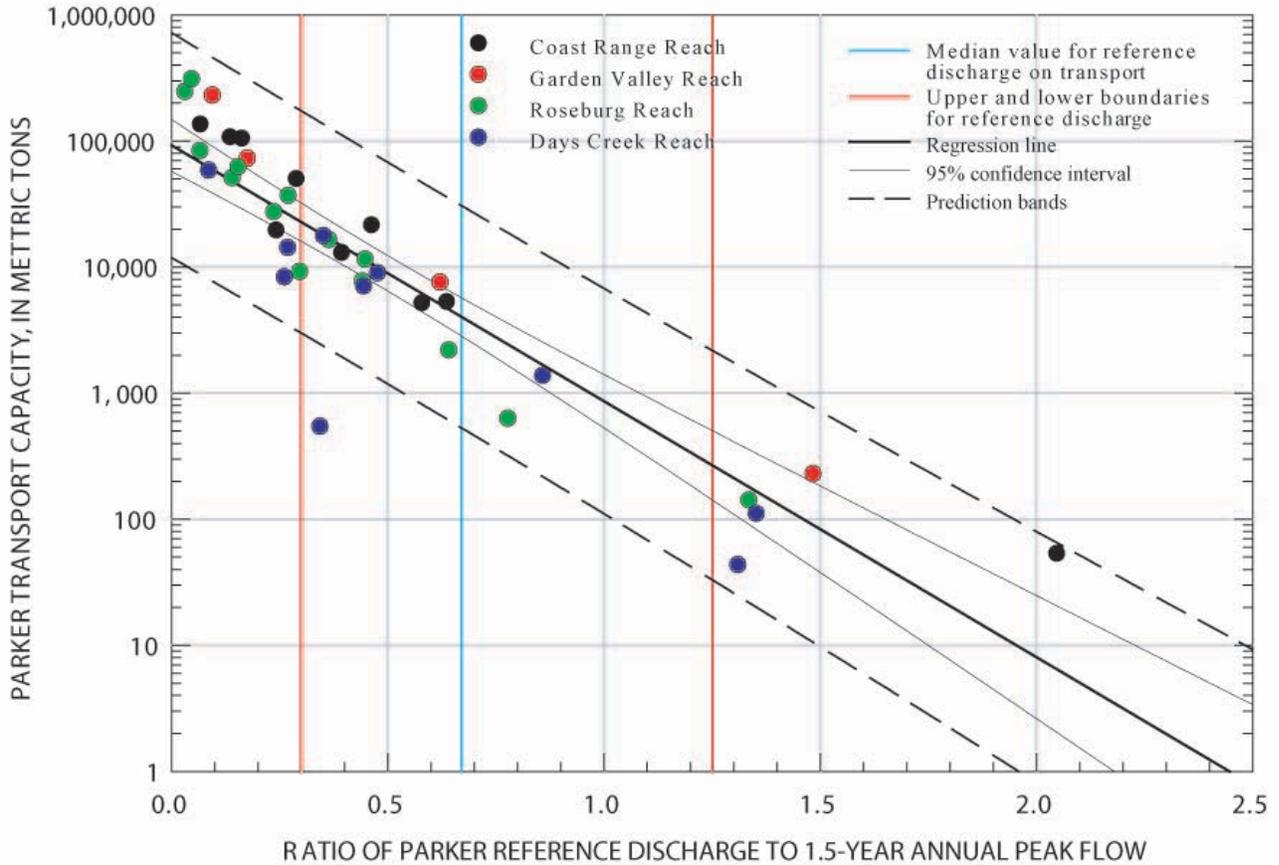
Figure 42. Graph showing relation of reference discharge to mean annual transport capacity in the Umpqua River basin, as computed using the Parker equation.

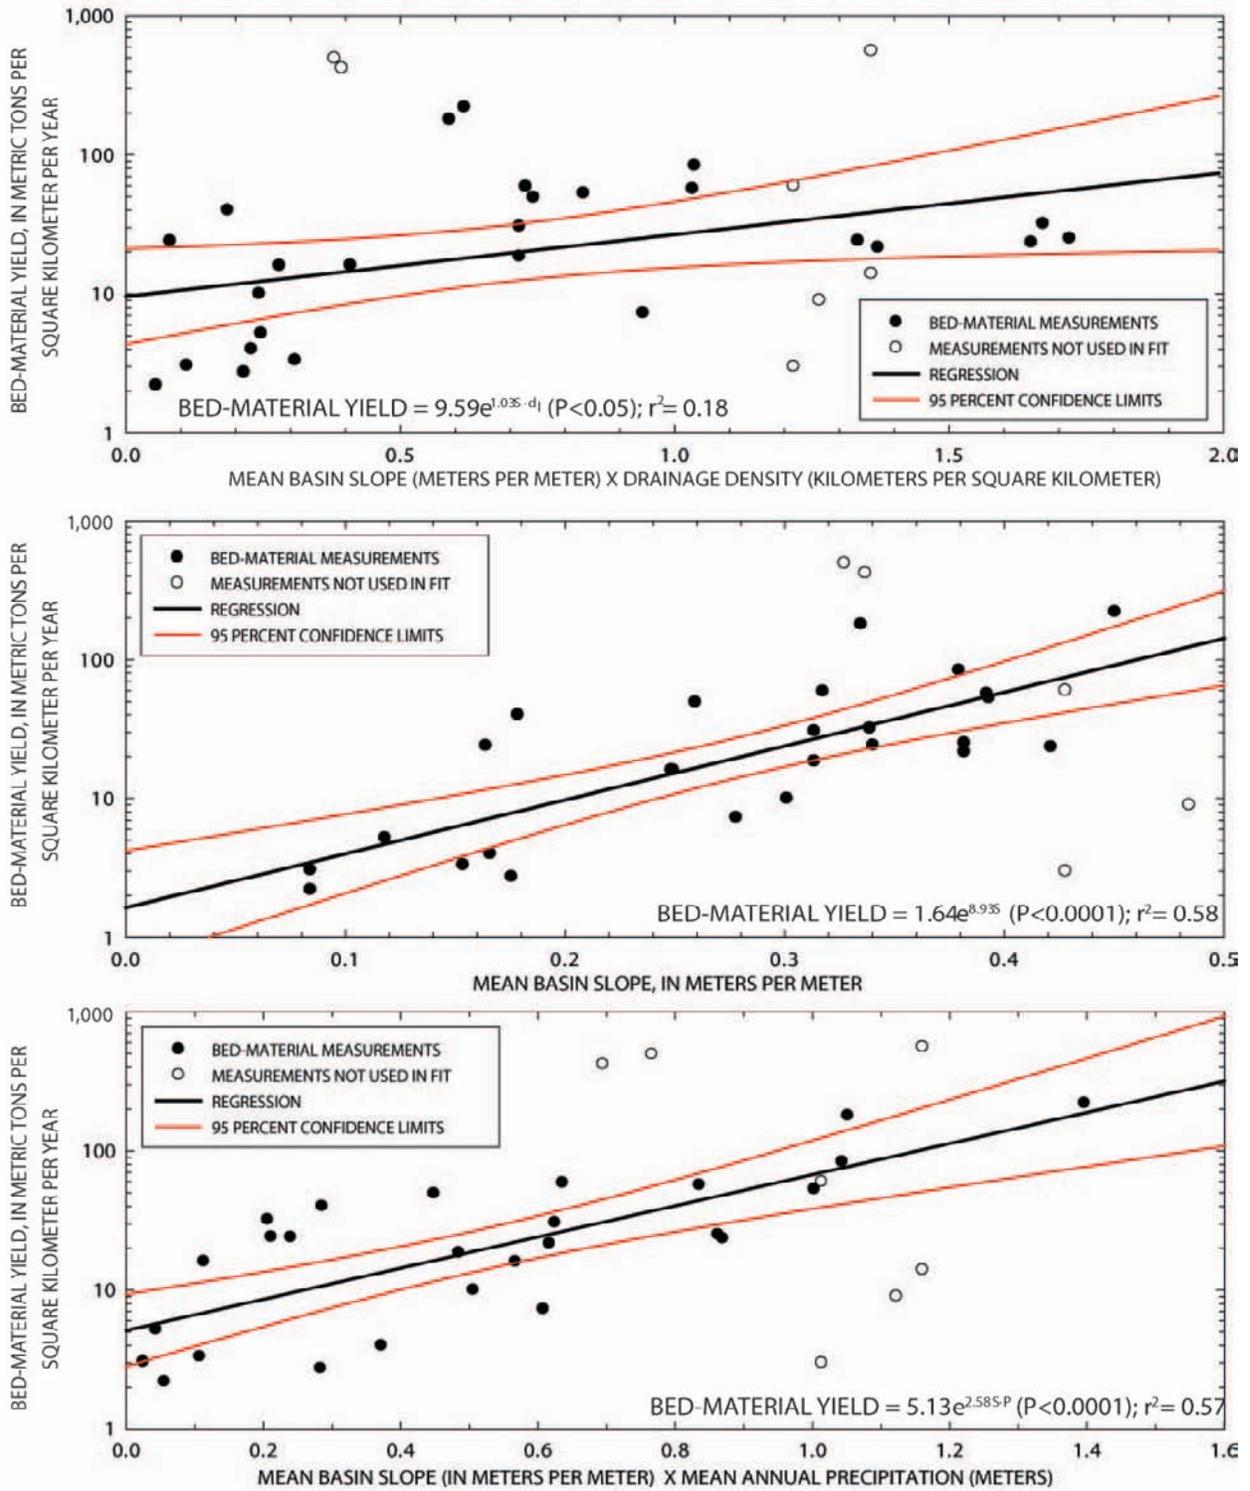
Figure 43. Graphs showing regional sediment yield regressions, as calculated for 26 basins in Oregon and northern California.

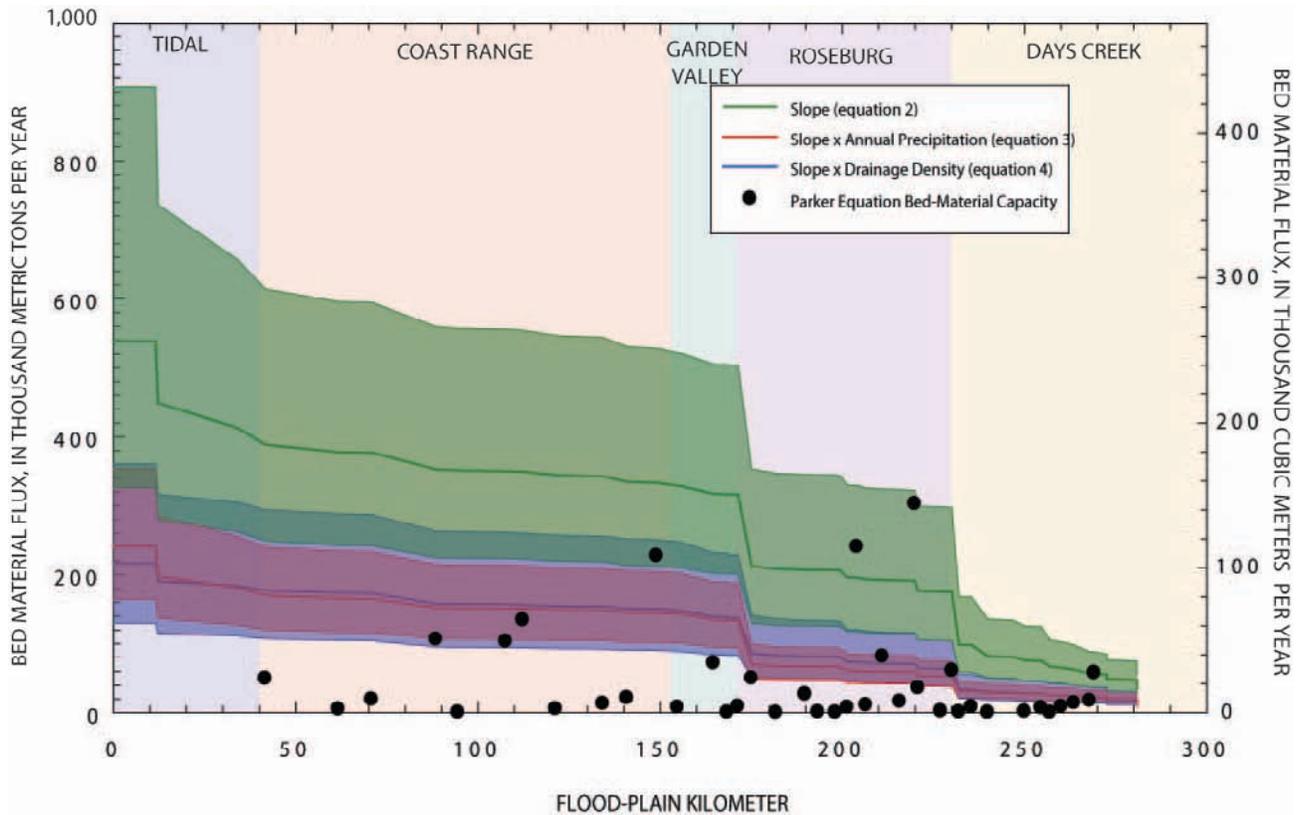
Figure 44. Graphs showing predicted bed-material yield for South Umpqua and Umpqua Rivers, Oregon. Total yield was calculated by regressions between bed material flux and different predictor variables (regressions shown in figure 43). Shown here is the predicted yield and range of yields predicted by the 95 percent confidence limits for each regression.

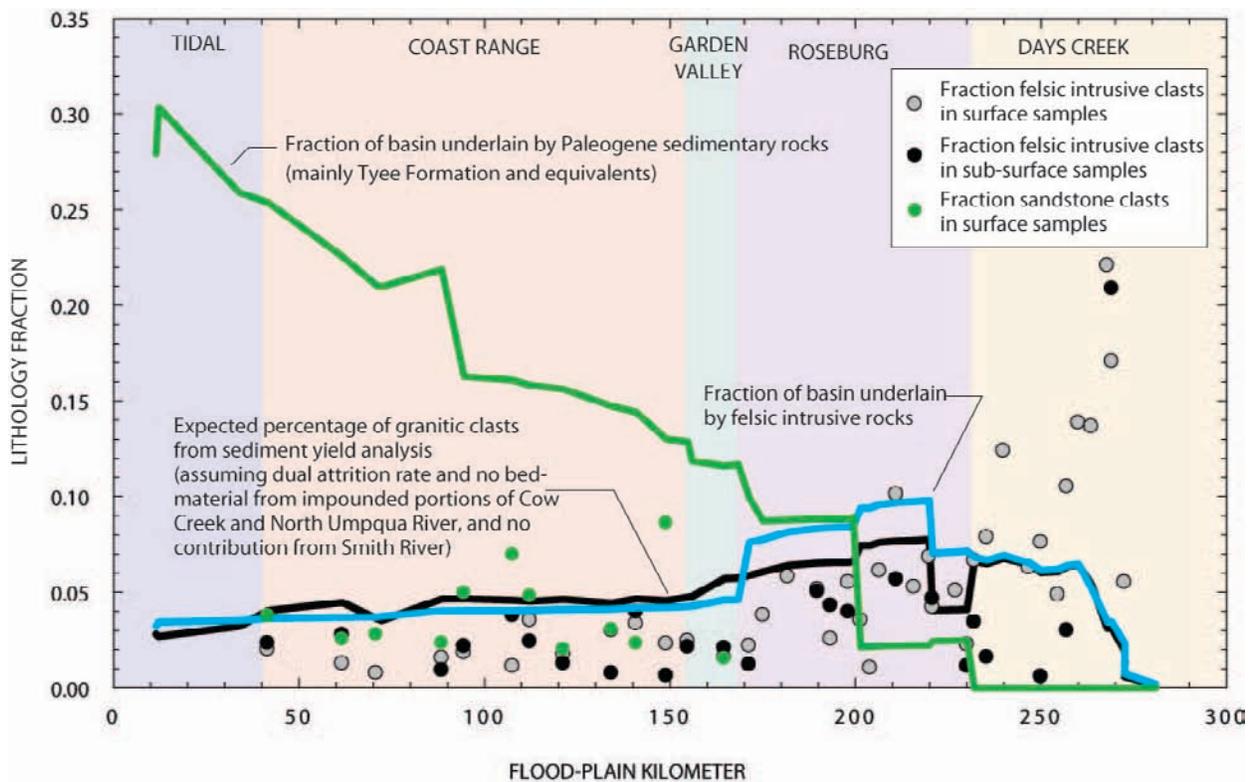
Figure 45. Graph showing comparison between longitudinal distribution of clast lithologies in bed-material sampling sites, fraction of contributing area underlain by these lithologies, and expected lithologies based on sediment yield analysis. See table 9 and appendix C for lithology values at sampling sites.

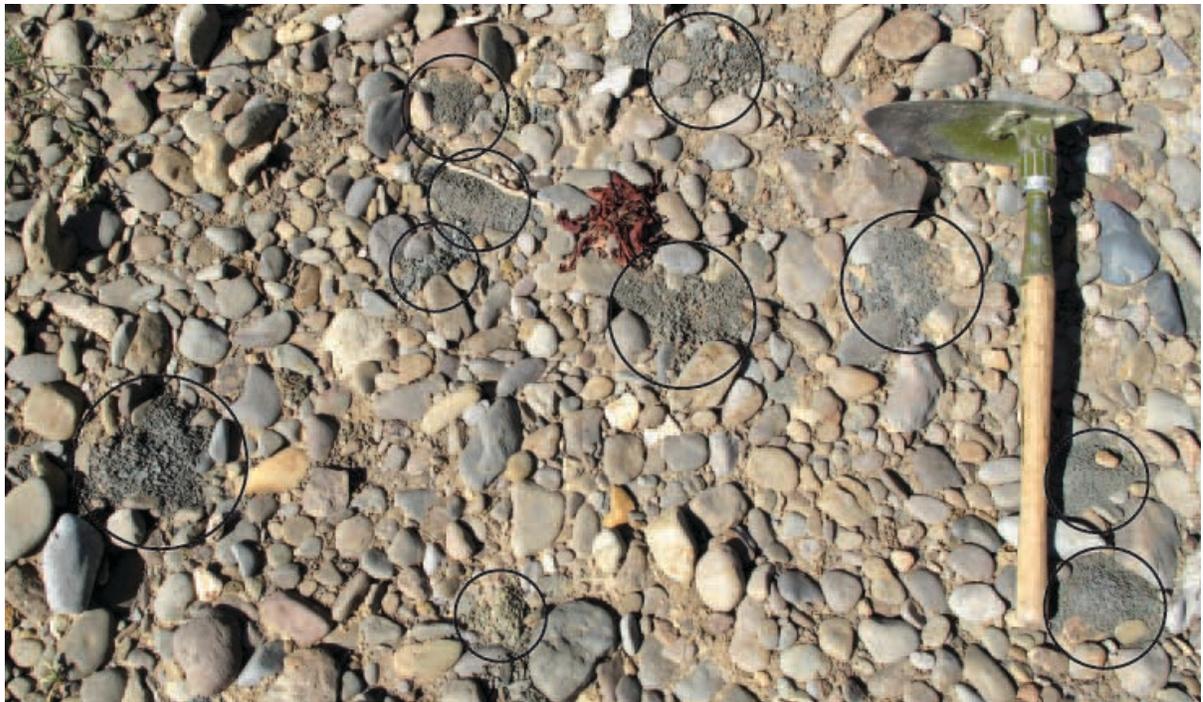
Figure 46. Photograph showing examples of disintegrating sandstone clasts derived from Tye Formation in the Oregon Coast Range.

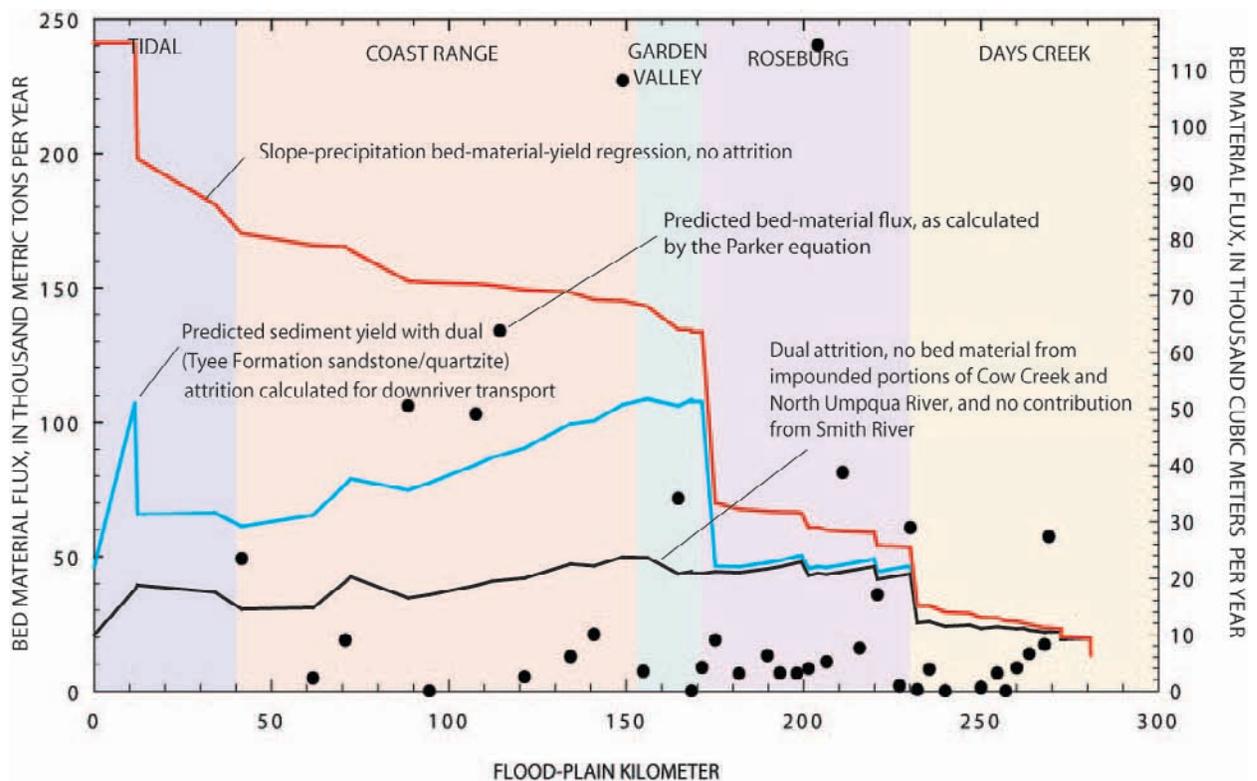
Figure 47. Diagram showing predicted bed-material yield in the Umpqua River basin, Oregon, under different scenarios of attrition and tributary contribution.
