Prepared in cooperation with the
U.S. Department of Homeland Security
Federal Emergency Management Agency

Elevation of the March–April 2010 Flood High Water in Selected River Reaches in Central and Eastern Massachusetts

Open-File Report 2010–1315

By Phillip J. Zarriello and Gardner C. Bent

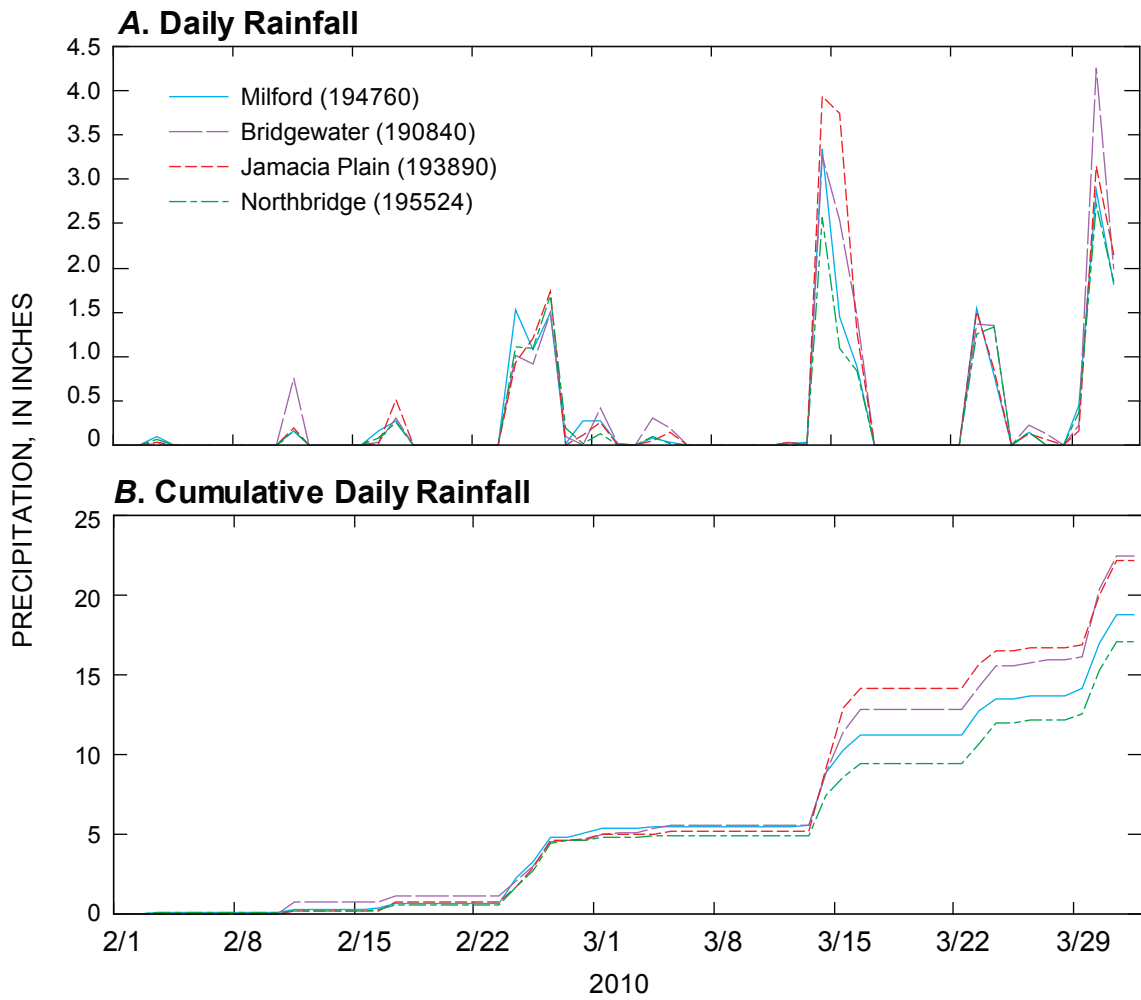
Figure 3. Daily rainfall (A) hyetographs and (B) cumulative totals during February and March 2010 at four National Weather Service (NWS) stations in central and eastern Massachusetts. Number in parenthesis is the NWS station shown in figure 2.

Rainfall hyetographs and cumulative rainfall (fig. 3A and 3B) for four selected National Weather Service (NWS) daily record stations (190840, 193890, 194760, and 195524; fig. 2) exemplify the pattern of excessive moisture in eastern Massachusetts. Prior to the March high water, a late February storm dropped nearly 5 inches of rain over the region, saturating soils, filling available storage, and elevating streamflows. Thus, conditions were primed for the first large runoff response following the 4 to 9 inches of rain that fell between March 13th and 15th. From late February through mid-March total precipitation ranged from about 9 to 15 inches in the study area, resulting in the maximum peak stages and flows at streamgages in the region that set new record peaks at

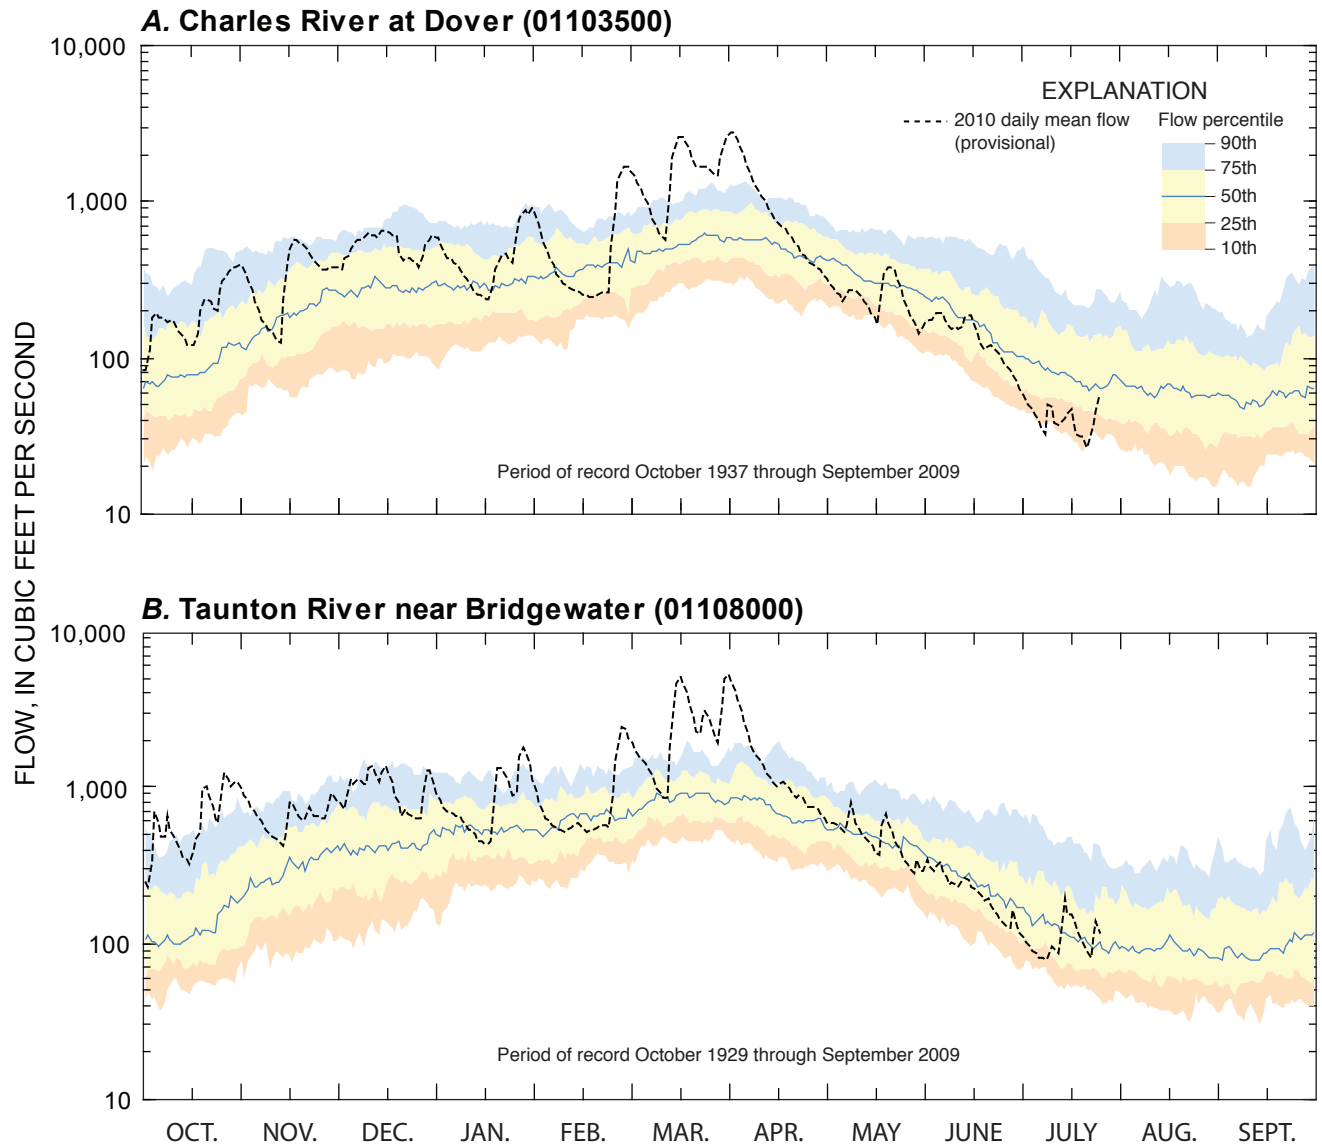
Figure 4. Period-of-record daily mean flow percentiles and 2010 daily mean flow at (A) Charles River at Dover (01103500) and (B) Taunton River near Bridgewater (01108000), Massachusetts. Location shown in figure 1.

Flow conditions in the region prior the March floods are illustrated by the daily mean flow for the 2010 water year in relation to the 10th-, 25th-, 50th-, 75th-, and 90th-percentile flows for a given day, calculated from the period-of-record daily mean flows at Charles River at Dover (01103500) and Taunton River near Bridgewater (01108000) (fig. 4A and 4B, respectively). Note that these streamgages were established in 1938 and 1930, respectively. Prior to the late February rainfall, flows were below the median (50th percentile) but quickly rose well above the 90th percentile following the late February rainfall. Flows that exceeded the 90th percentile occurred only 10 percent of the time at this time of year, which is the normal seasonal high-flow period. Flows receded to about the median range in early March, then rose sharply following the mid-March storm to set a new peak flow for water year 2010. Flows continued to stay above the 90th percentile into late March because of saturated conditions and additional rainfall. Another large rainfall event at the end of March caused a rise in streamflow that slightly exceeded the peak flow in mid-March at the Charles River at Dover (01103500) and Taunton River near Bridgewater (01108000) streamgages. Again, note that at 24 of the 37 streamgages in table 1, the mid-March peak flows exceeded the late March–early April peak flows.

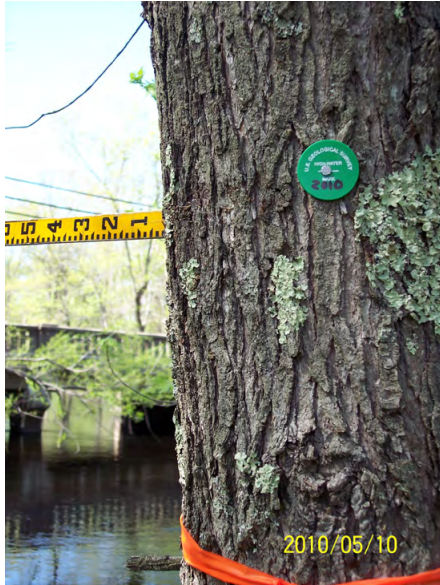
Ipswich River (IpsSR)

Figure 5. Examples of high-water mark debris lines on trees and structures found following the March–April 2010 floods in central and eastern Massachusetts. Value in parentheses refers to the Site_ID in Appendix I, table 1-1.

stranded at the highest water elevation. The best HWMs are small seeds or floating debris that adhere to smooth surfaces or lodge in tree bark that forms a distinct water line. Stain lines on buildings, fences, and other structures also provide excellent marks. HWMs are best identified immediately following the peak stage as time and weather (wind and rain) fade the evidence of the peak water line. Additionally, care was taken to identify HWMs farthest from the main channel as possible where velocities are generally small and pileup or drawdown's common in fast moving waters are best avoided. The general methods used to identify and document HWMs are described by Benson and Dalrymple (1967).
