Field Reconnaissance Report of Landslides Triggered by the January 12, 2010, Haiti Earthquake

By Randall W. Jibson and Edwin L. Harp

Open-File Report 2011–1023

U.S. Department of the Interior
U.S. Geological Survey

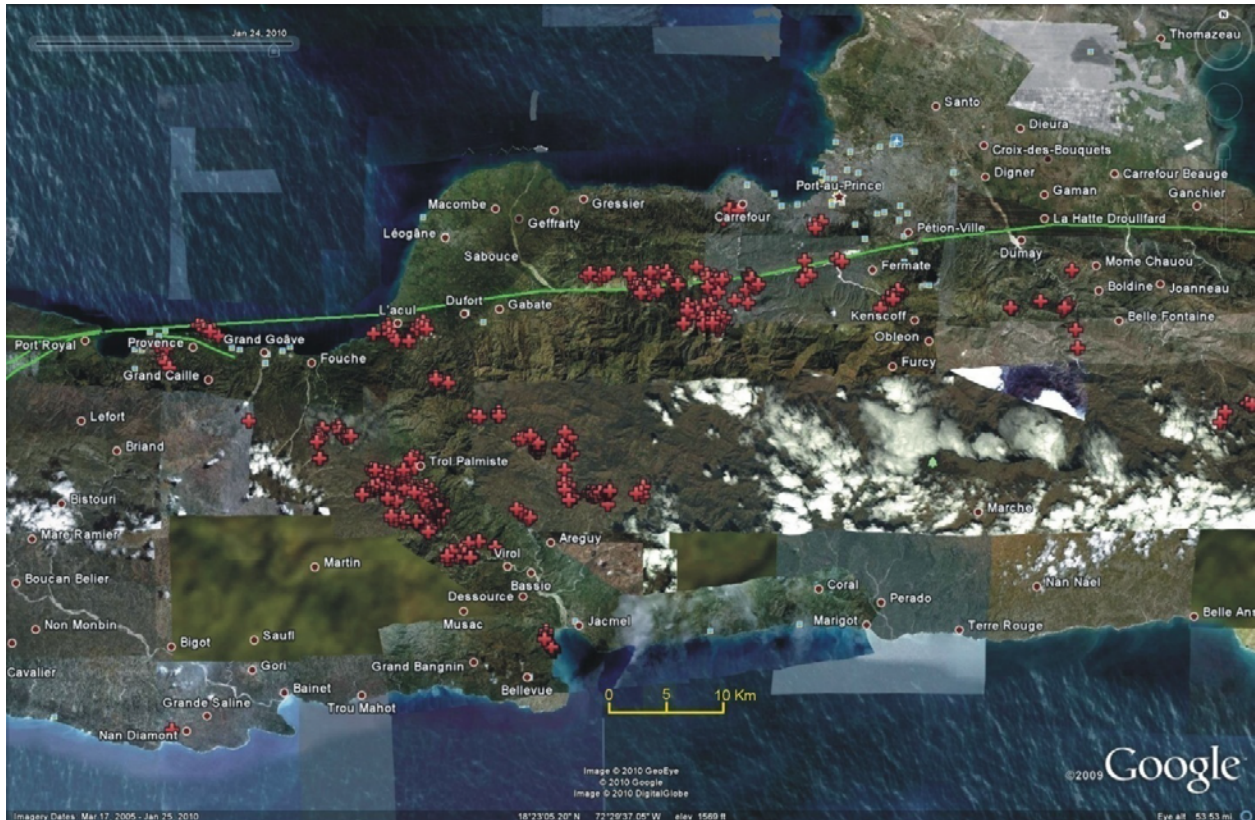
Figure 1. Preliminary map of locations of landslides triggered by the January 12, 2010, Haiti earthquake as observed from imagery in Google Earth. Red crosses denote landslide locations; Enriquillo-Plantain Garden fault shown in green; small labeled red circles are towns and cities; blue squares are photograph locations in Google Earth. This map is not complete and shows only some of the triggered landslides; more thorough mapping is continuing. (Note the misspelling on this image of the town named Nan Diamant in the southwestern corner of the view.) Base image is copyrighted by Google, Inc., GeoEye, and DigitalGlobe, all 2010.

Imagery acquired soon after the earthquake by Google Earth has 60-centimeter (cm) resolution; using this imagery we produced a preliminary map of the point locations of landslides triggered in areas around the Enriquillo-Plantain Garden fault zone (fig. 1). More detailed mapping of landslides as polygons is partially completed and is continuing. Based on mapping completed to date, several observations can be made regarding the number and distribution of landslides triggered by the earthquake:

- The area affected by landslides extends about 60 kilometers (km) east and west from the earthquake epicenter and across the entire north-south extent of the peninsula west of Port-au-Prince (fig. 1). Studies of earthquake-triggered landslides around the world indicate that the maximum distance limit for slides from a M 7.0 earthquake is about 200 km (Keefer, 1984); thus, this earthquake appears to have produced shaking well below the maximum of similar historical earthquakes worldwide, as indicated by triggered landslides.

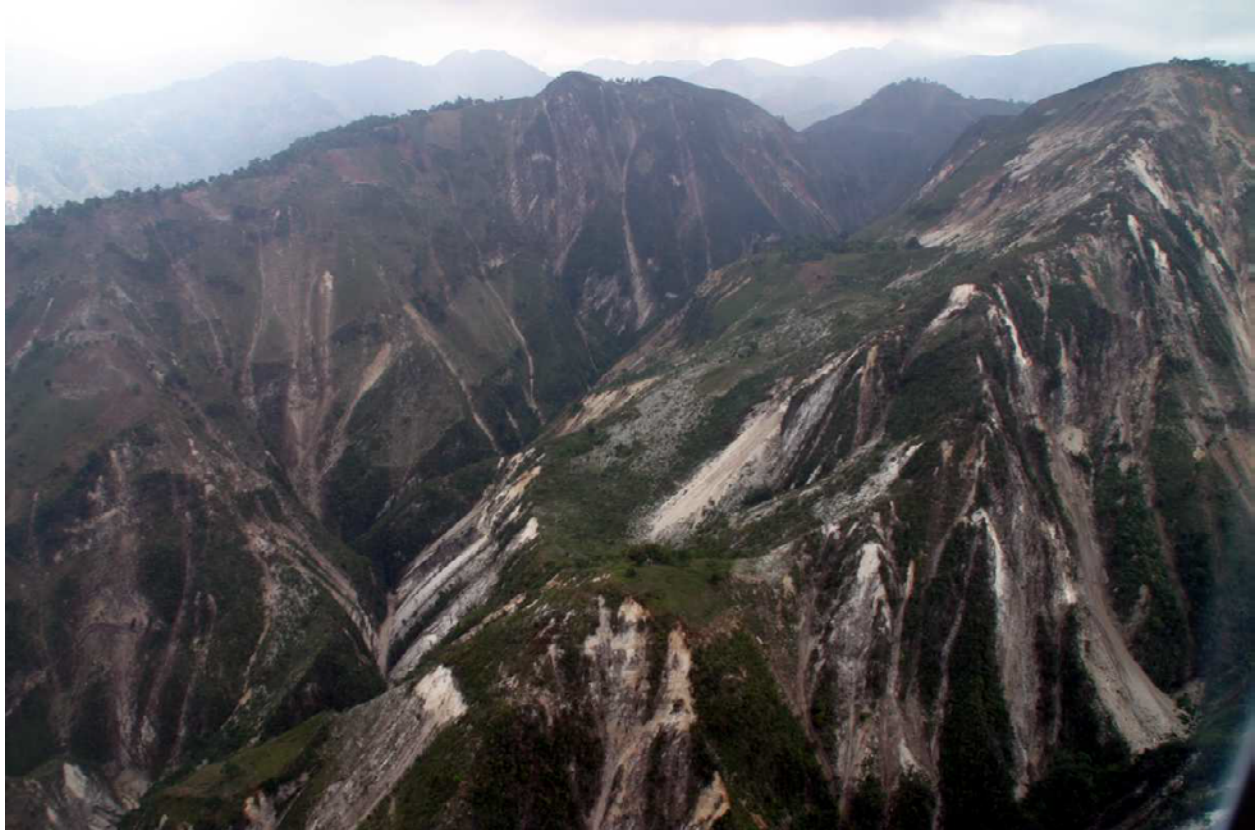
Figure 2. Dense concentration of landslides in limestone near the Enriquillo-Plantain Garden fault zone about 10 kilometers south-southwest of Carrefour.

- Landslide densities were greatest in deeply weathered, sheared, fractured, and (or) altered limestone (fig. 2). That material tends to disaggregate as downslope movement begins, and disrupted rock fragments form most of the landslide deposits. Weathered basalt slopes produced far fewer landslides; those slopes are less steep, more rounded, and, apparently, less susceptible to landsliding (fig. 3).

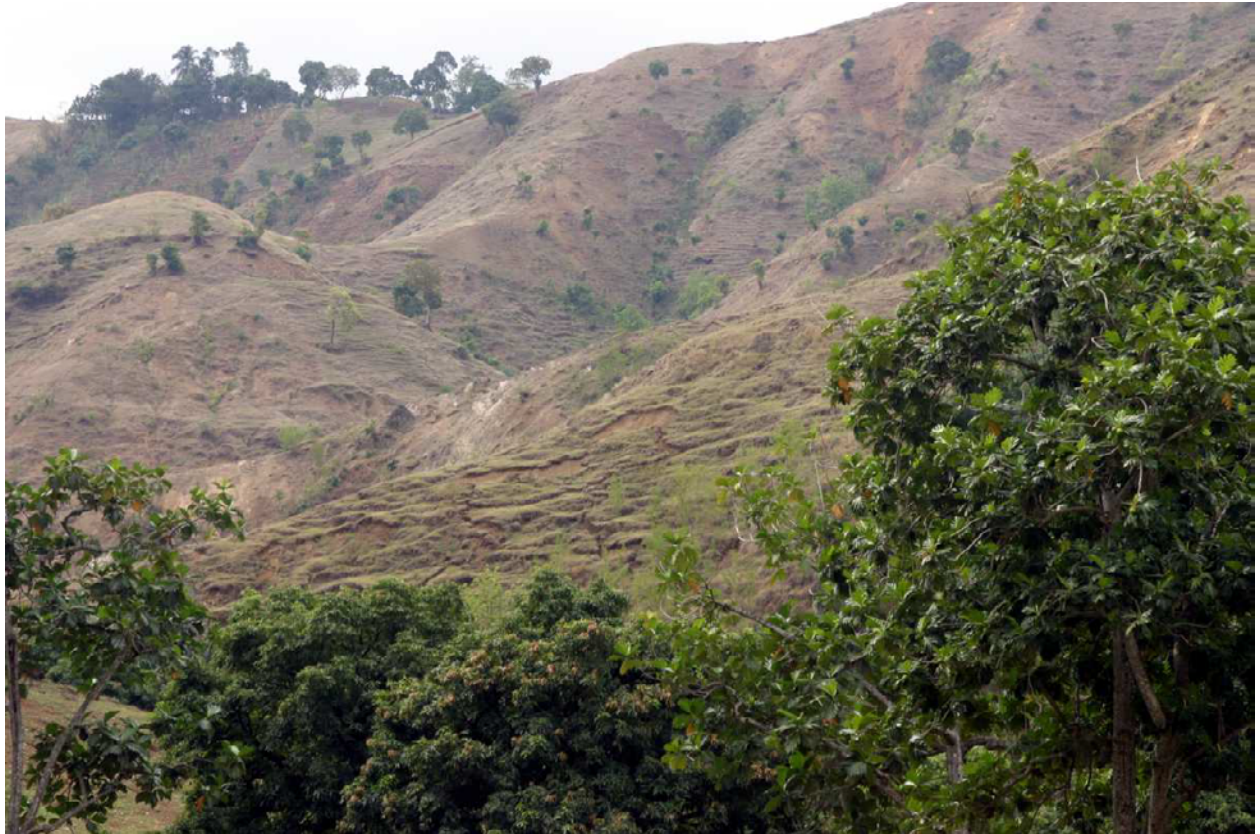
Figure 3. Landslide cracks in weathered basalt 12.7 kilometers southwest of Carrefour. Note the soft, rounded topography of the basalt.

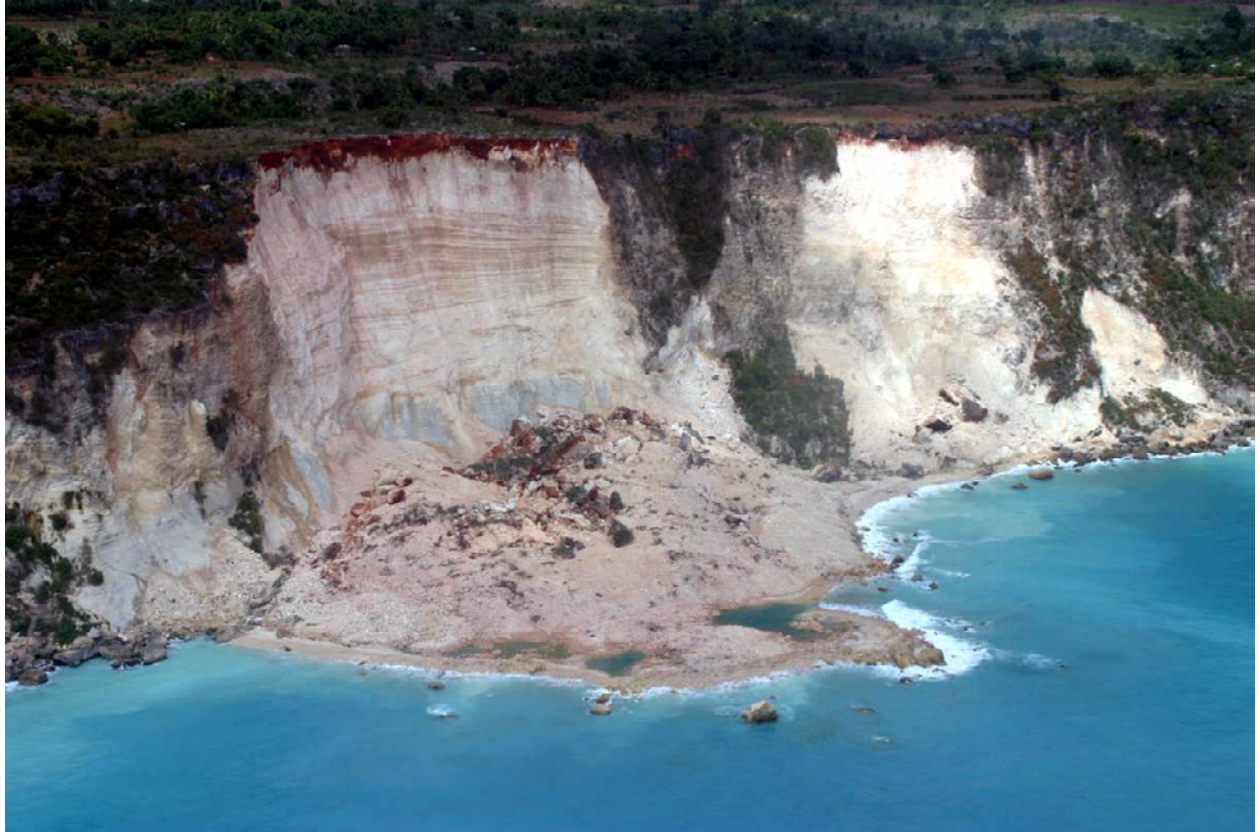
Figure 4. Earthquake-triggered landslide on southern coast of Haiti near village of Nan Diamant.

Landslide is about 135 meters wide and has an estimated volume of 300,000 cubic meters.

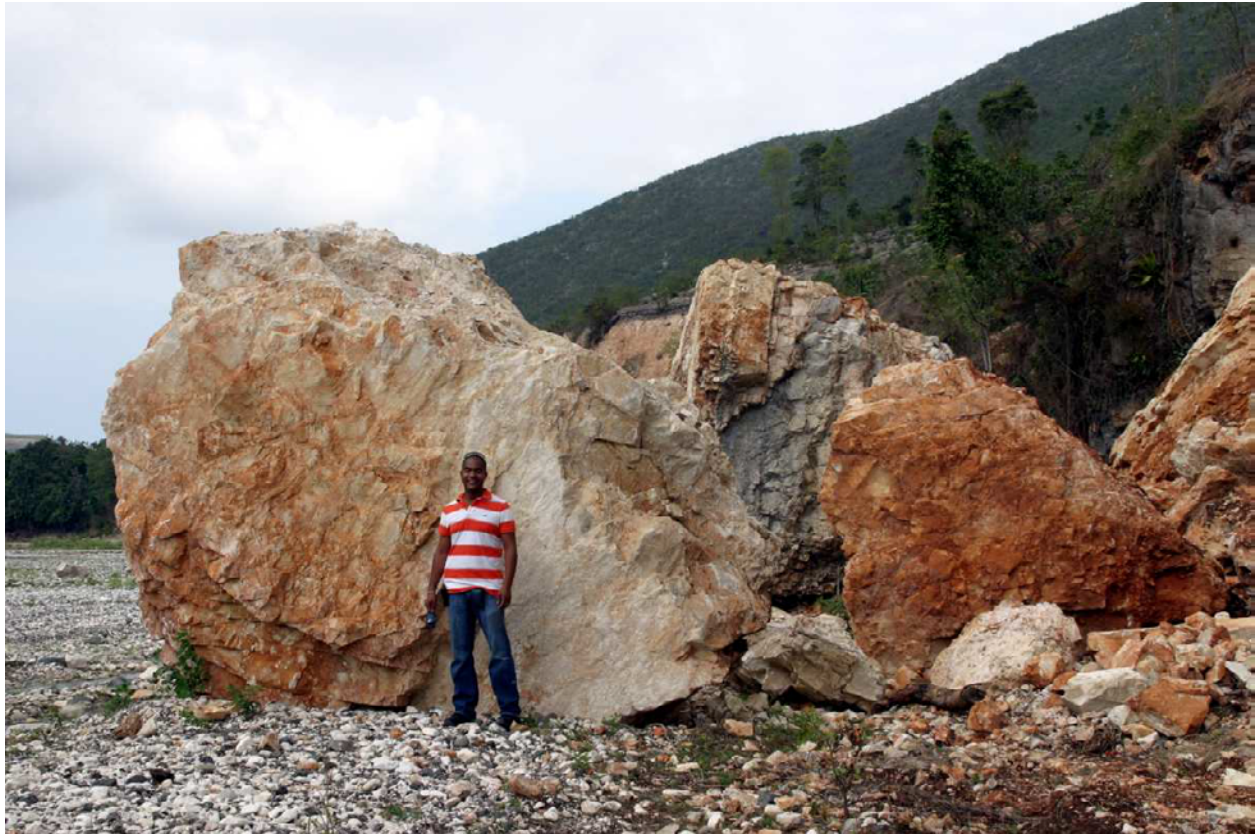
Figure 5. Boulders of intact limestone that fell and rolled during the earthquake from cliffs along the Enriquillo-Plantain Garden fault zone.

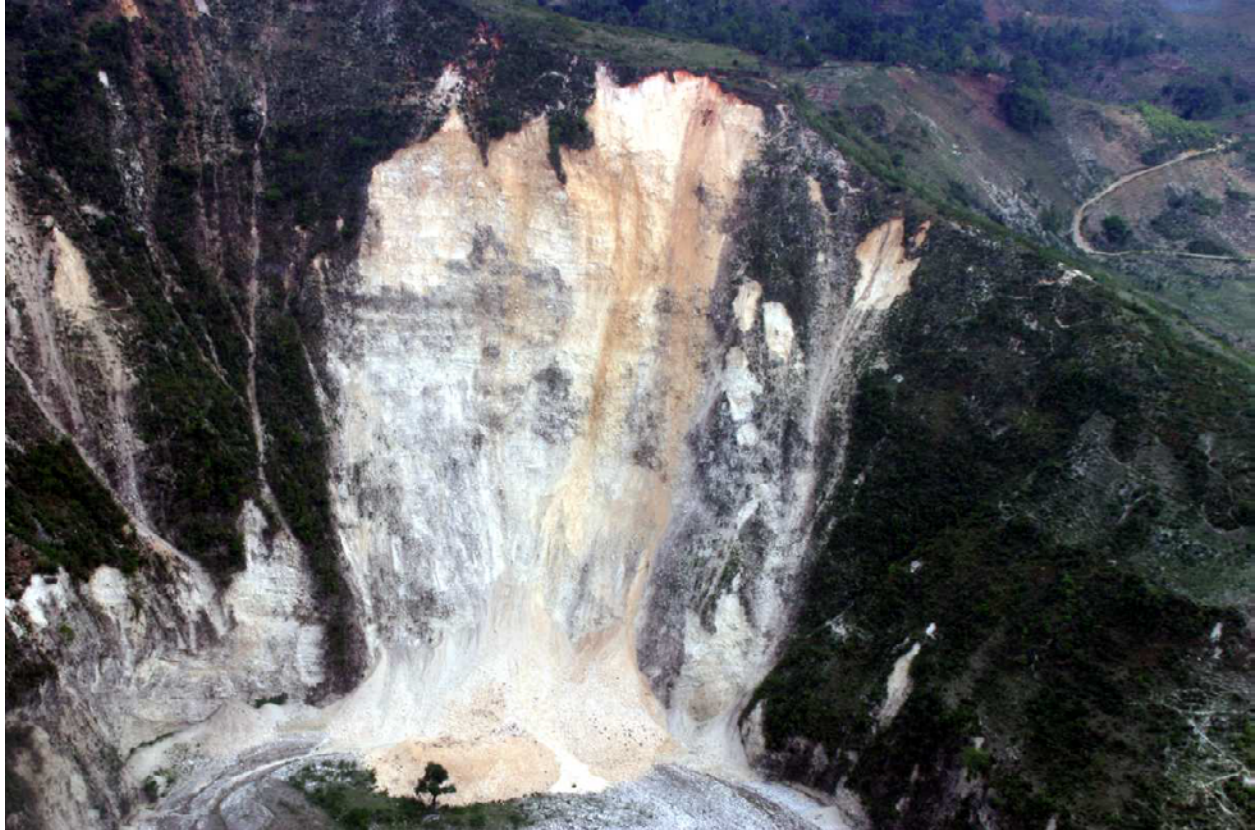
Figure 6. Rock fall that deposited disaggregated limestone fragments in river valley. The landslide is about 200 meters wide and is 5.4 kilometers southwest of Carrefour.

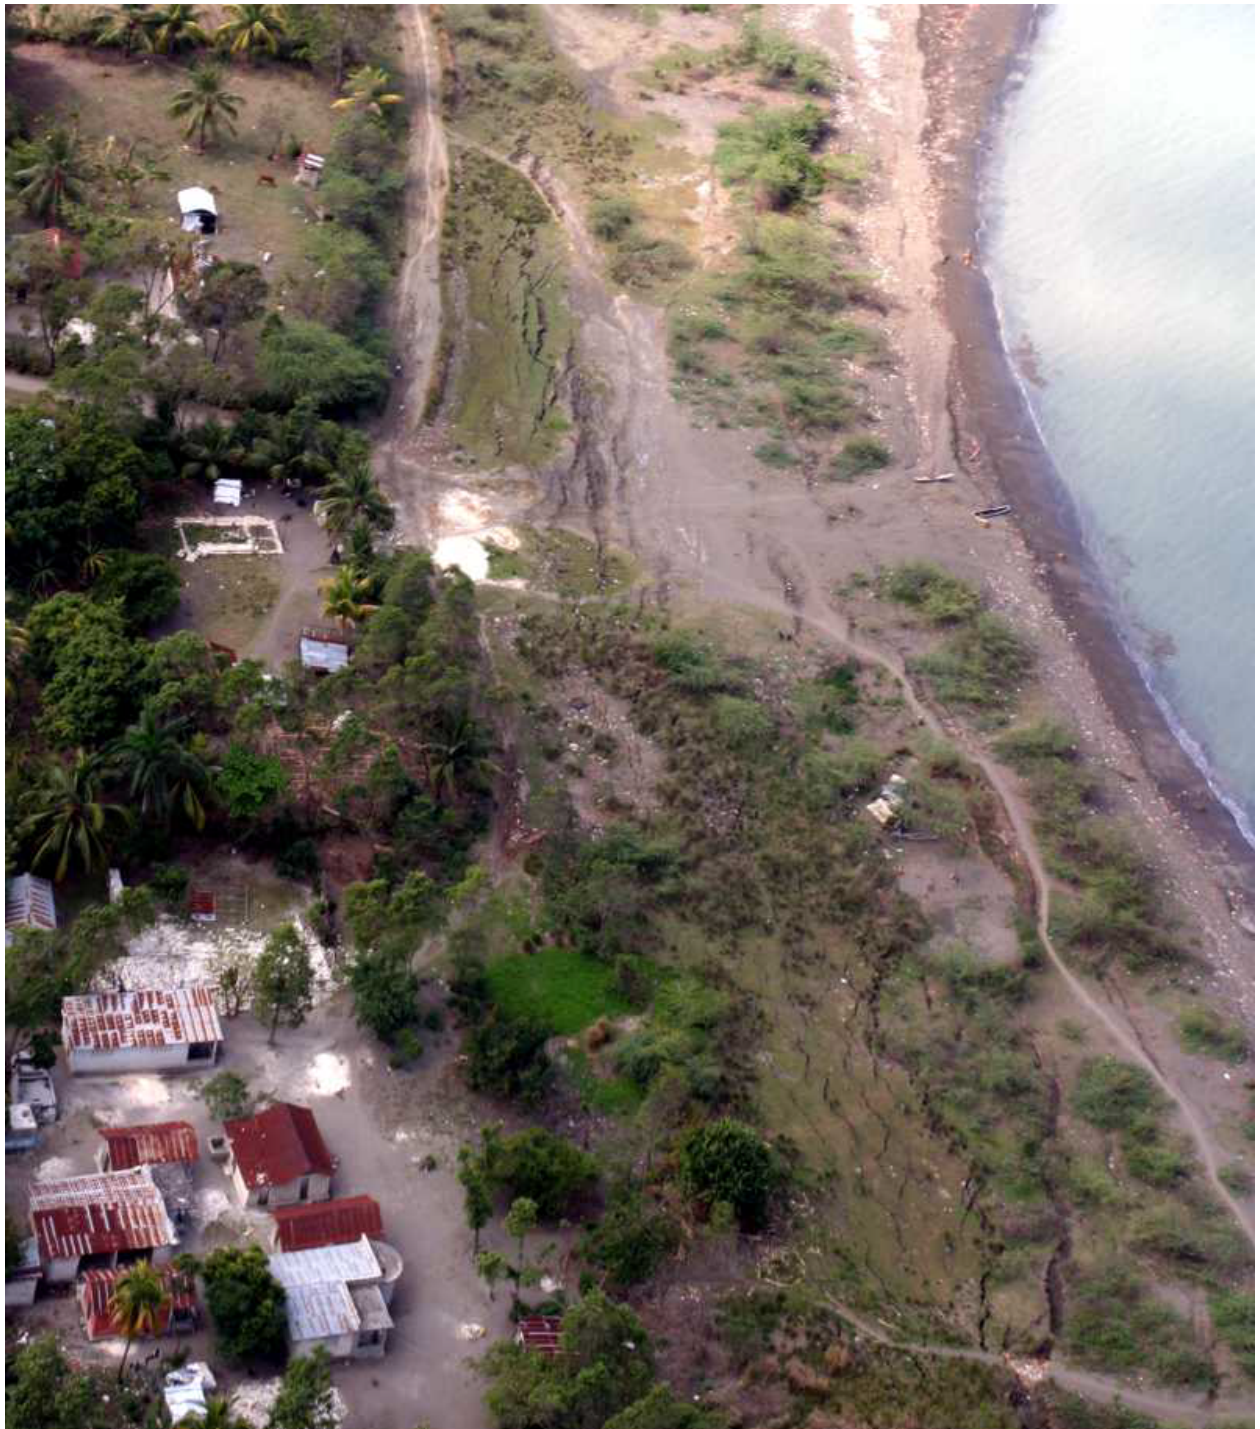
Figure 7. Lateral-spread cracks along coast west of Port-au-Prince near Léogâne.

Most of the landslides triggered by the earthquake were disrupted rock falls and rock slides in the limestone and weathered basalt that predominate in the region surrounding the Enriquillo-Plantain Garden fault (landslide terminology after Varnes, 1978). These landslides consist of partially or completely disrupted masses of rock that form on the steep slopes of deeply incised river valleys and coastal bluffs (fig. 4). Where the rock mass is harder and well-cemented, large blocks fell, slid, and (or) rolled down the slopes (fig. 5). In weaker rock, the material locally crumbled into smaller pieces and slid or flowed to the base of the slope (fig. 6). The predominance of disrupted rock falls and rock slides is consistent with observations from other earthquakes around the world (Keefer, 1984, 2002). Lateral spreads (horizontal movement of blocks of soil on nearly level ground) occurred at some port facilities in Port-au-Prince and along coastal areas to the west (fig. 7).

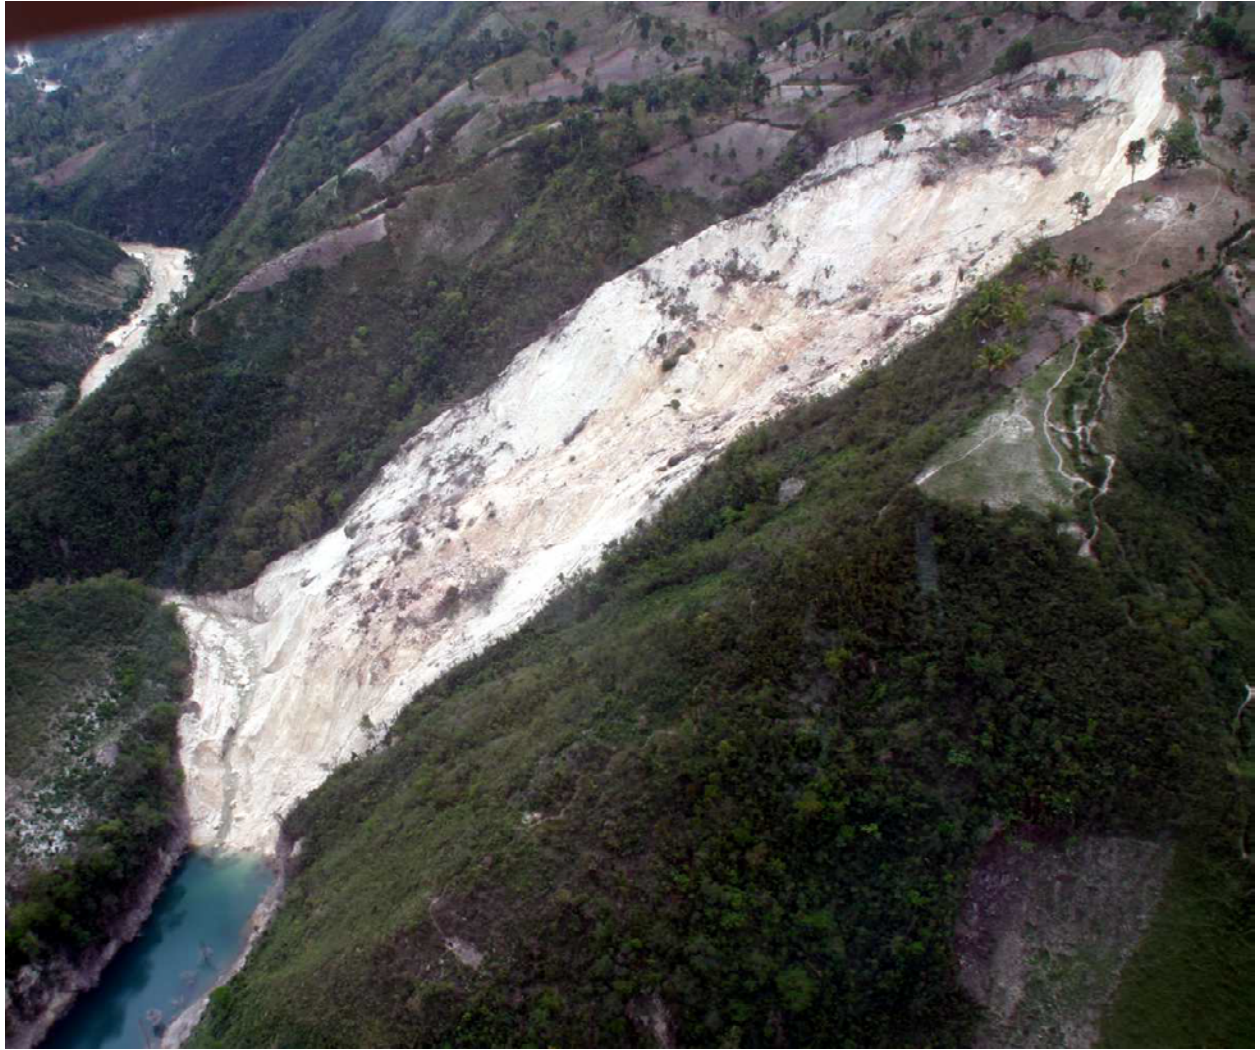
Figure 8. Landslide dam 15 kilometers northwest of Jacmel. The dam has breached, and the small amount of water impounded upstream should pose no future hazard. The landslide is about 150 meters wide.

Many of the landslides blocked stream drainages and impounded lakes. The larger landslide dams had already been breached, and streams were flowing through them in a stable state, at the time of our visit (fig. 8). Water downstream from these breached dams was running clear at the time of our investigation, which indicated that little or no upstream erosion was occurring. Some small lakes are still impounded in tributary valleys, and those likely will breach during future rainy seasons (fig. 9). Volumes of such lakes are not large enough to be of concern for downstream populations. During future rainy seasons, already-breached dams will be downcut slightly more but should not pose a significant hazard. The landslide dam blocking the Grand Goave River, 5 km south of Grand Goave, has breached and drained; no lake remains.

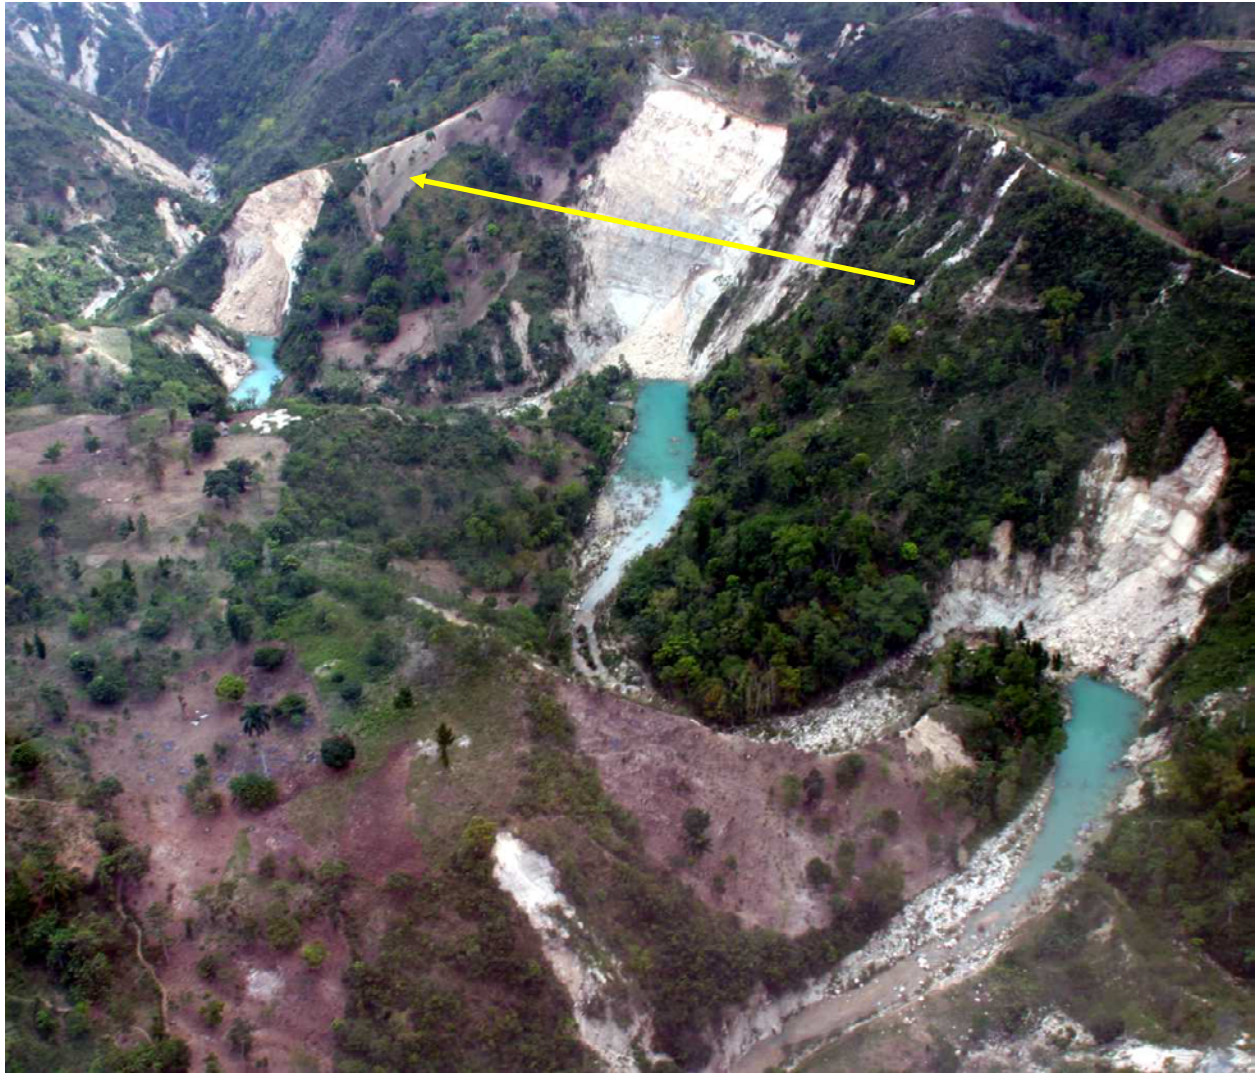
Figure 9. Small lakes impounded by landslide dams along a 600-meter length of stream northwest of Jacmel. Yellow arrow shows general downstream direction.

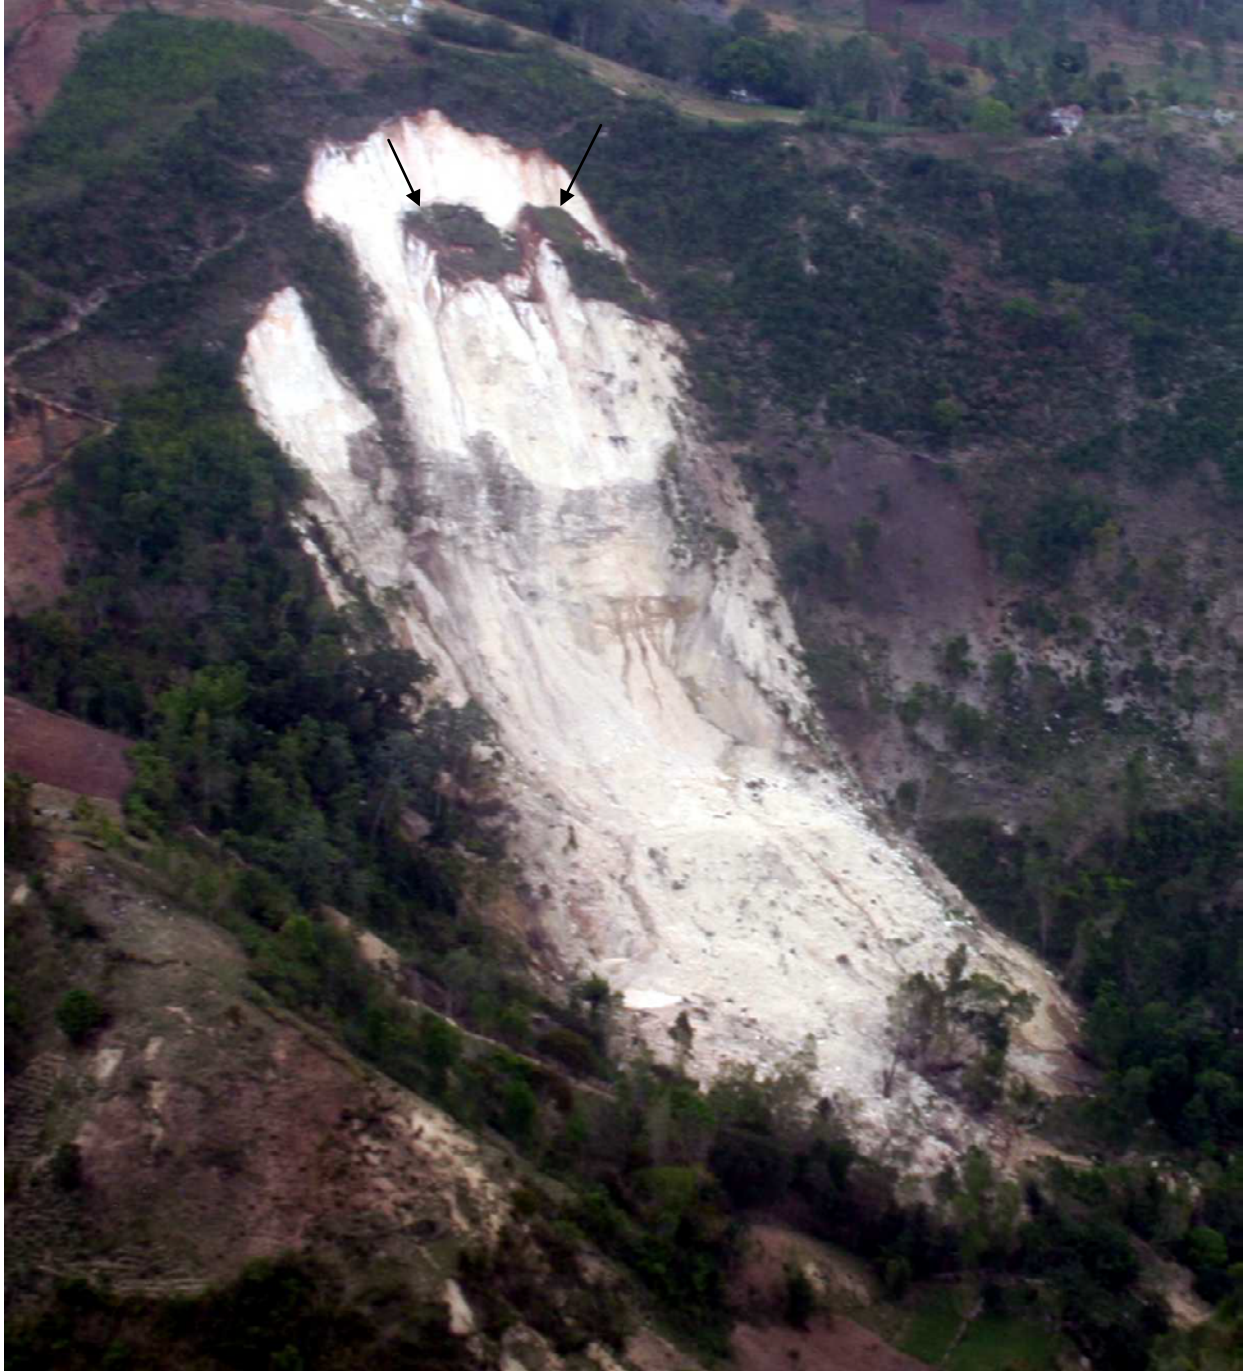
Figure 10. Detached landslide blocks (arrows) about 15 km northwest of Jacmel that could move further in future earthquakes or rain storms.

- The earthquake shaking created many partially detached landslide masses. These are blocks of rock that moved but did not slide all the way to the bottom of the slope (fig. 10). Such blocks can be precarious, and renewed movement could occur in future earthquakes or during rainy periods. Renewed movement could damage areas downslope and could, in some places, form new landslide dams.
- Many landslides that initiated at the tops of slopes have related cracks behind the main scarp (fig. 11). These cracks indicate a potential for more landsliding—either during future earthquakes or rainy periods—which could enlarge the initial slide.

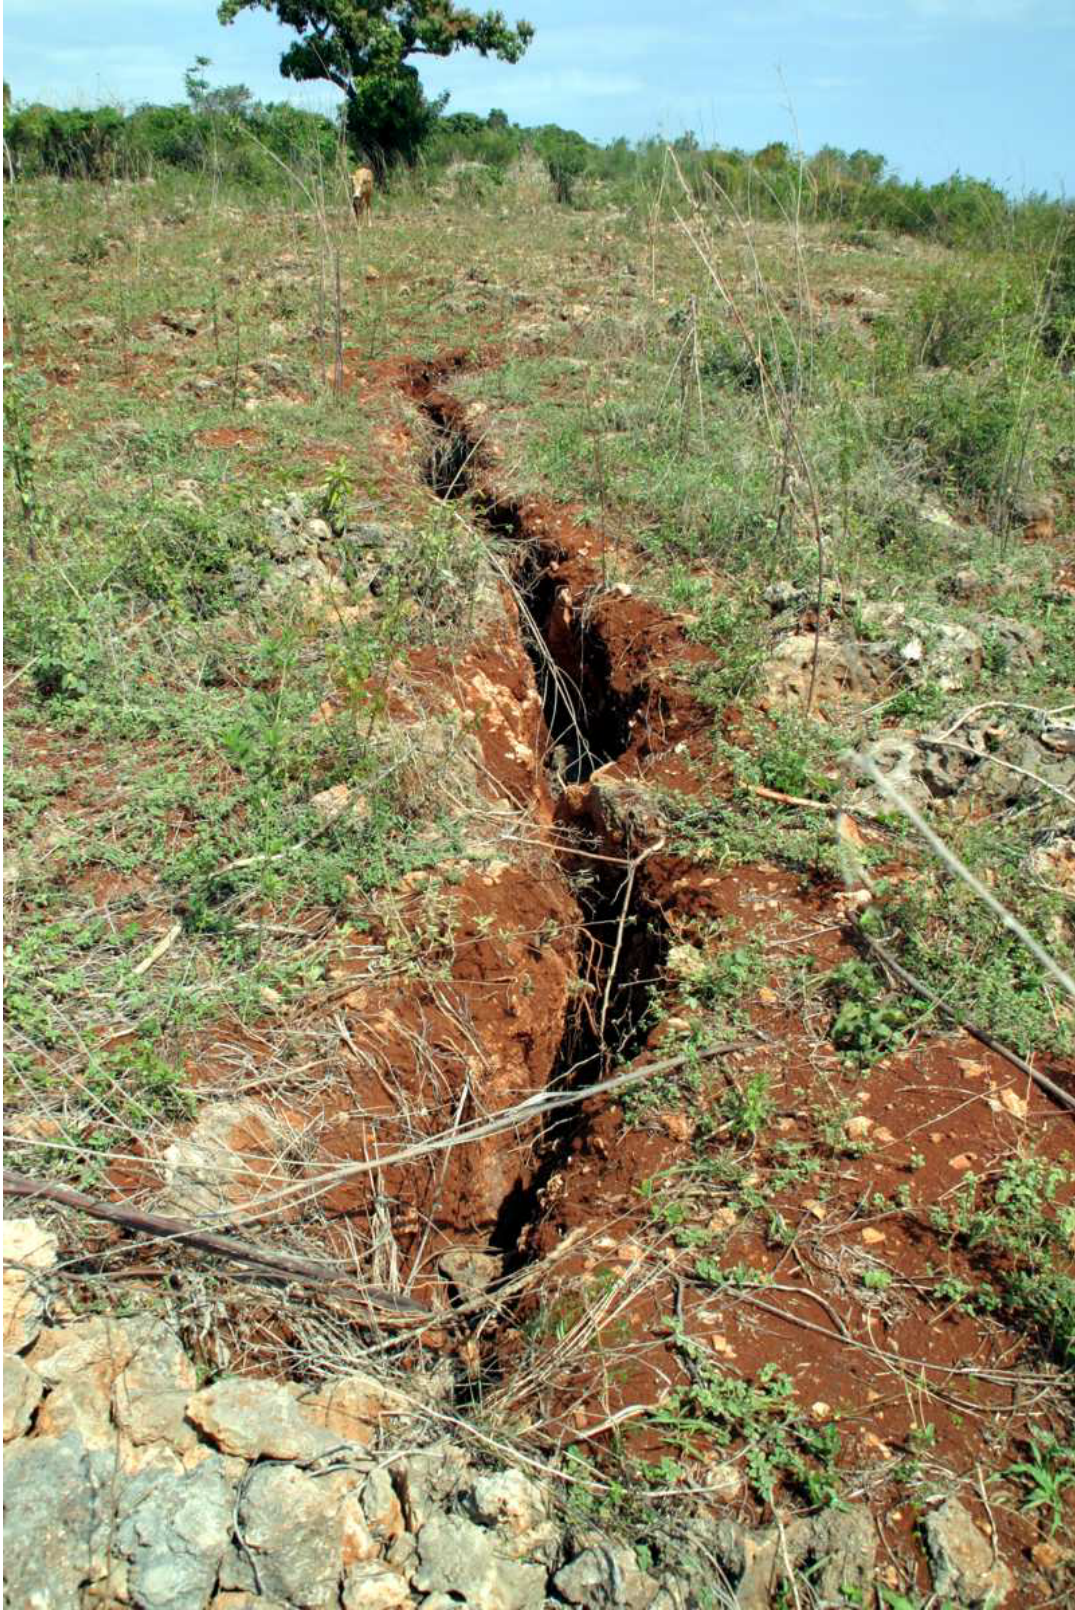
Figure 11. Extensional cracks behind the main scarp of the coastal landslide shown in figure 4.

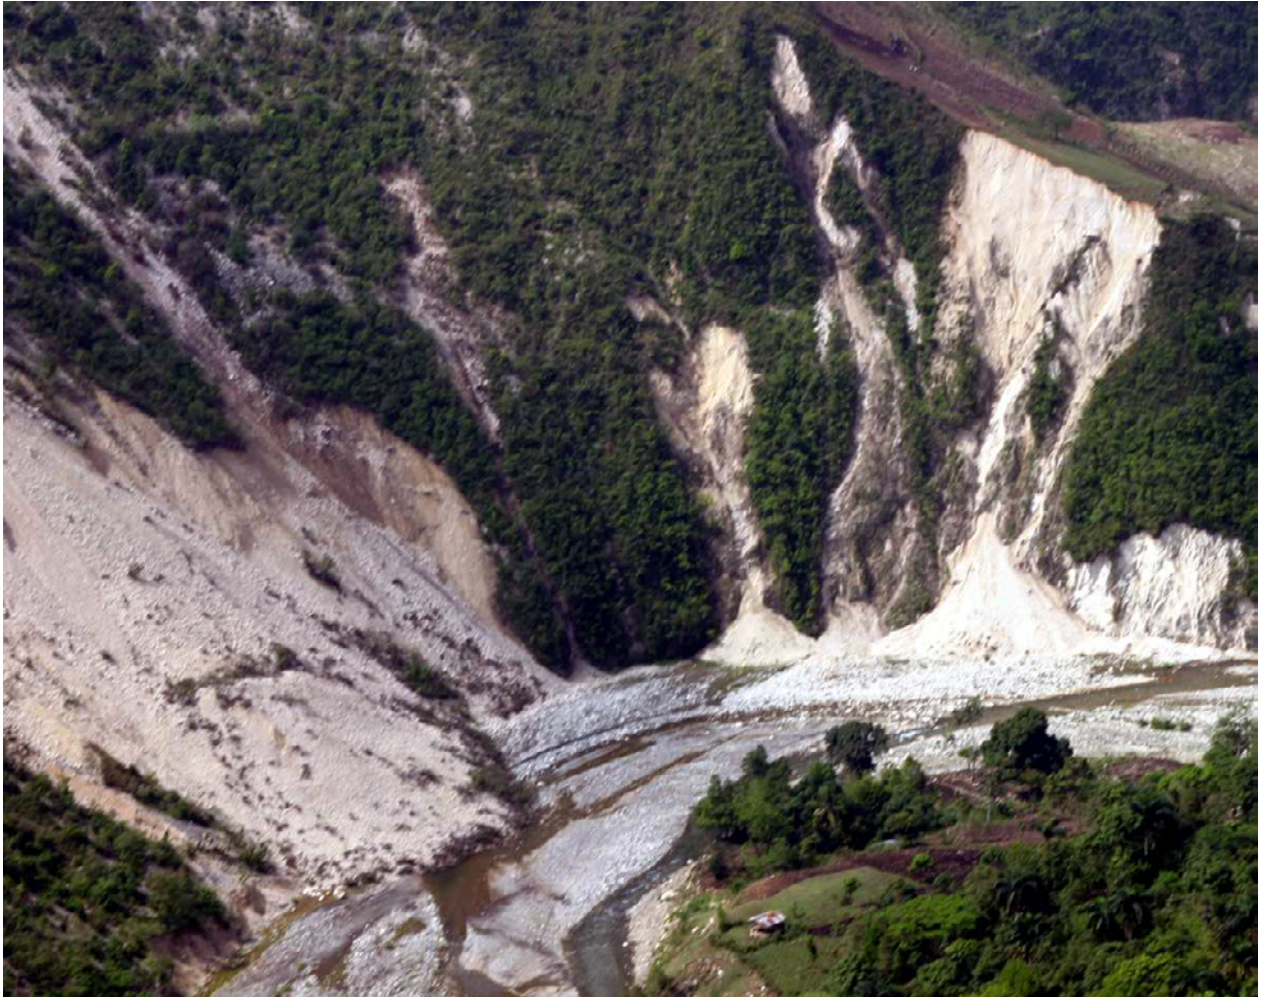
Figure 12. Landslides that deposited sediment to a river valley along the Enriquillo-Plantain Garden fault zone about 6 kilometers south-southwest of Carrefour.

- Earthquake-triggered landslides have moved large amounts of loose sediment into stream drainages (fig. 12); additional material has been detached from slopes but has not slid all the way to the valley bottoms. During future rainy seasons this sediment associated with earthquake-triggered landslides will move into river systems and create significant increases in downstream sedimentation. The magnitude of this effect cannot be quantified with currently available data.
