Map of Debris Flows Caused by Rainfall During 1996 in Parts of the Reedsport and Deer Head Point Quadrangles, Douglas County, Southern Coast Range, Oregon

By Jeffrey A. Coe, John A. Michael, and Marianela Mercado Burgos

Pamphlet accompanies map
Open-File Report 2011-1150

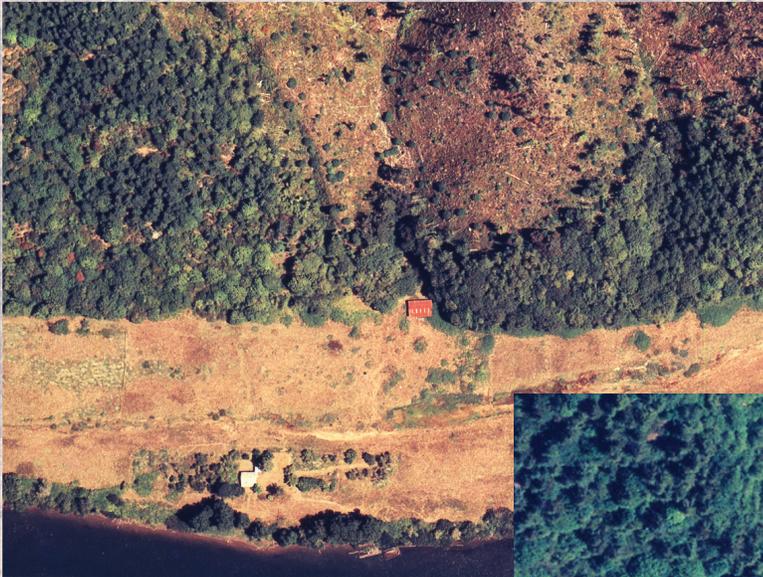
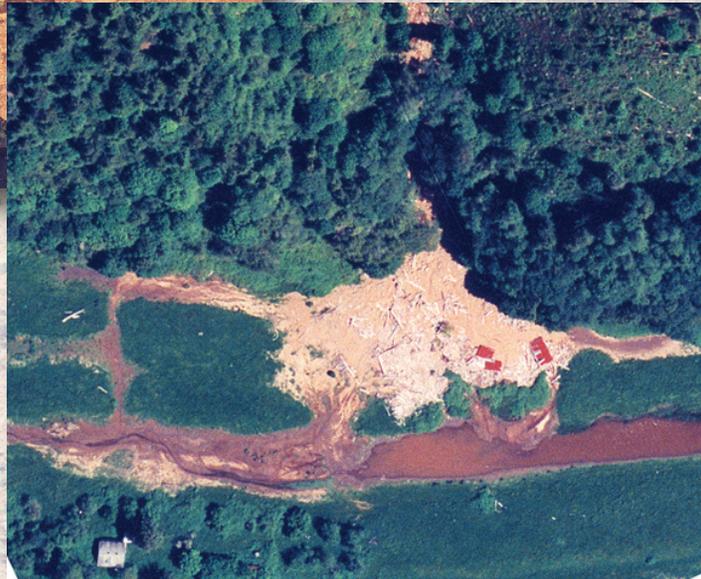
Cover: Aerial photographs of a debris fan taken before and after a debris flow in the map area. Photograph on the left was taken on July 29, 1992. Photograph on the right was taken May 17, 1997. The horizontal distance between the two buildings is about 200 m. The debris fan is located along the right edge of the map, just north of the Umpqua River. Photographs by the U.S. Bureau of Land Management.

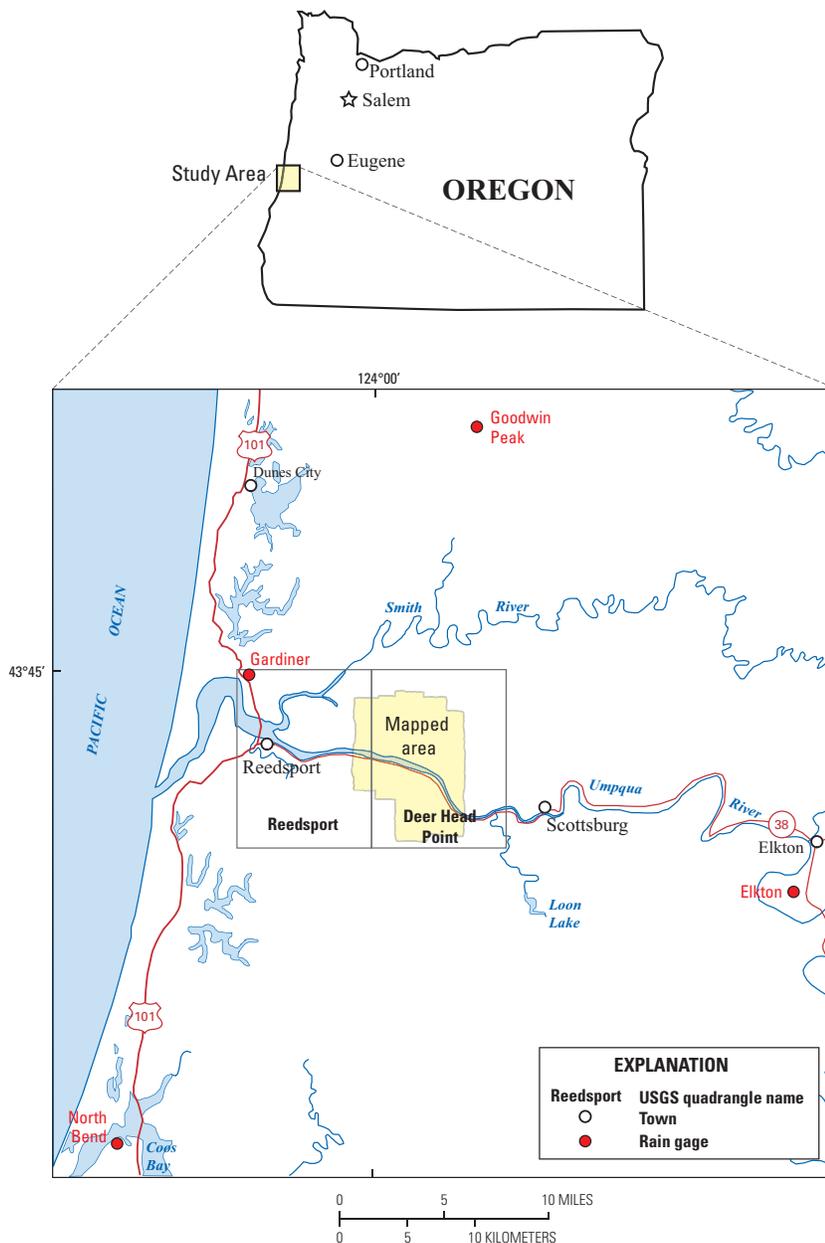
Figure 1. Index map showing the location of the map area with respect to the Reedsport and Deer Head Point 1:24,000-scale USGS topographic quadrangles.

Our work expands on this previous work by providing detailed debris-flow mapping in a 94.4 square kilometer (km^2) area along Highway 38 between Reedsport and Scottsburg (fig. 1 and map). Our mapping identifies debris-flow source areas, areas of predominantly erosion, transport or mixed erosion and deposition, and areas of deposition. We used newly available (2009), high resolution (0.91 m cells (3 ft.)), airborne Light Detection And Ranging (LiDAR) data from the Oregon Department of Geology and Mineral Industries (DOGAMI) as the topographic base for our mapping.

Four rain gages were operating in the vicinity of the study area in 1996 (figs. 1 and 2). Three gages, Gardiner, North Bend, and Elkton, were located at National Weather Service (NWS) Cooperative Network stations, and the fourth, Goodwin Peak, was at a U.S. Forest Service Remote Automatic Weather Station (RAWS). The Gardiner and North Bend stations were along the Pacific coast at elevations of 9 m and 2 m, respectively. The Goodwin Peak gage was within the Coast Range at an elevation of 557 m. The Elkton gage was on the eastern (leeward) flank of the Coast Range at an elevation of 37 m.

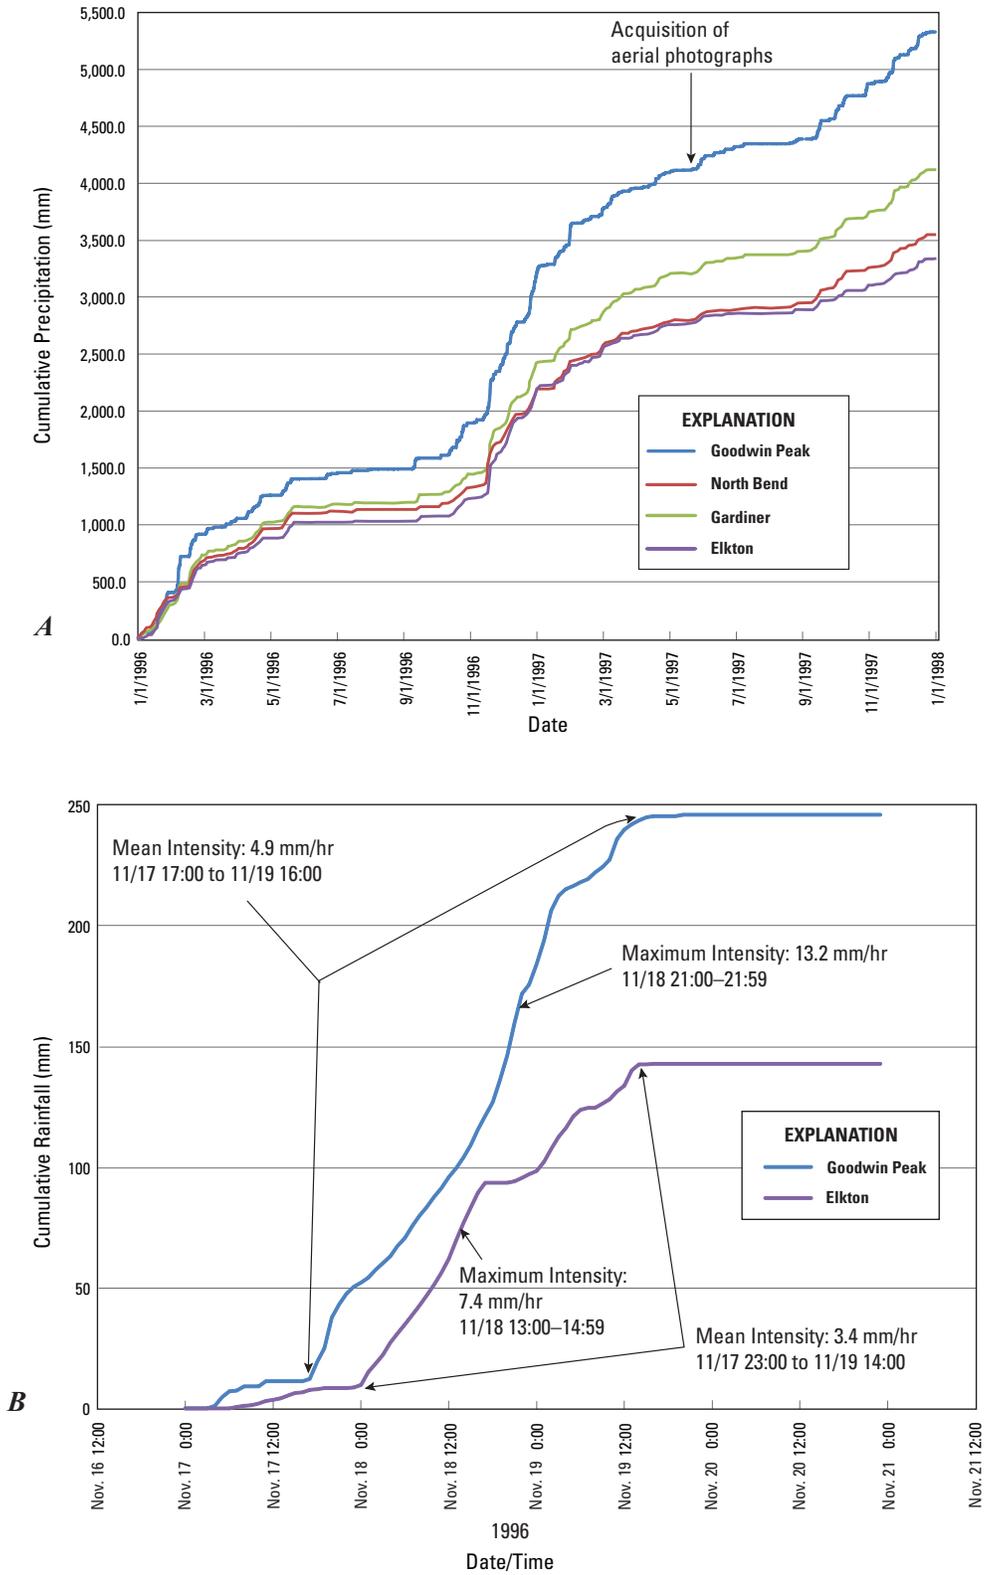
Figure 2. Diagram showing **A**, cumulative precipitation during 1996 and 1997, and **B**, cumulative hourly rainfall during the November 17–19 rainstorm. See figure 1 for rain gage locations.

Cumulative rainfall in 1996 was greatest at Goodwin Peak (3,232 mm, fig. 2A) and lowest at Elkton (2,163 mm). Cumulative rainfall at Gardiner and North Bend was 2,418 mm and 2,182 mm, respectively. Seasonal antecedent rainfall from the beginning of the fall/winter wet season on October 1, 1996, to the start of the November 17–19 storm was 441 mm, 232 mm, 256 mm, and 201 mm at Goodwin Peak, Gardiner, North Bend, and Elkton, respectively. With the exception of Elkton rainfall, all of these rainfall values exceed the antecedent rainfall threshold of 203 mm defined by Wiley (2000) as necessary for debris-flow occurrence in Oregon.

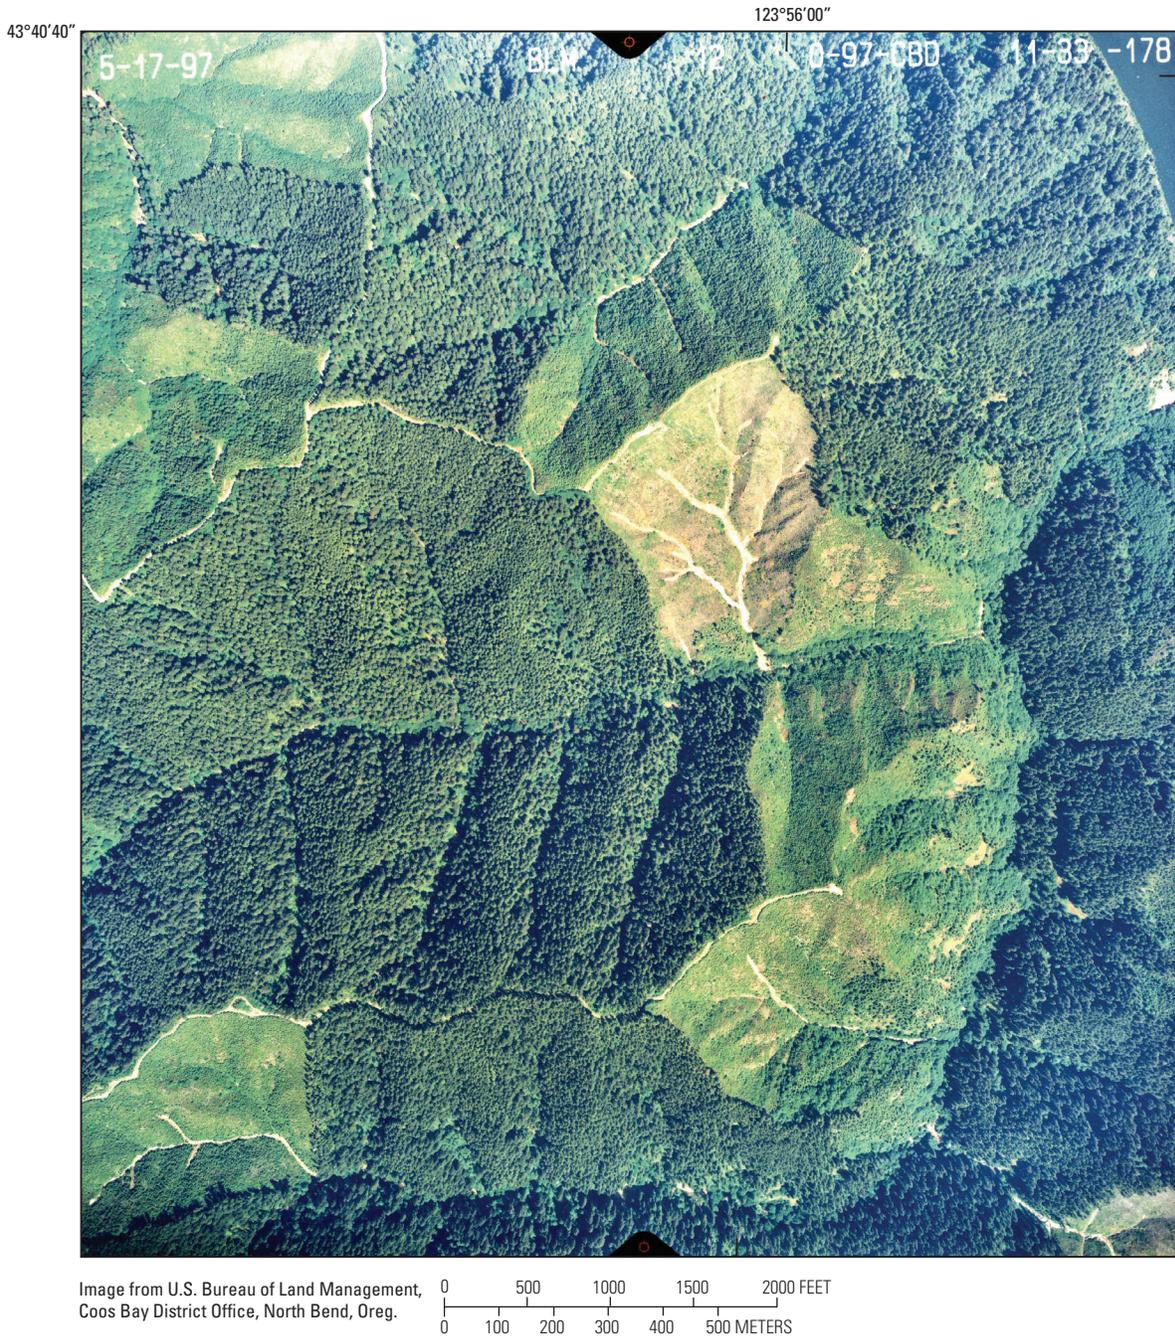
Figure 3. Example of a 1:12,000-scale aerial photograph used for mapping. Area covered by the photograph is shown on map.
