Block D Geophysics: Core of the Hunton Anticline

PANEL 2 Epikarst

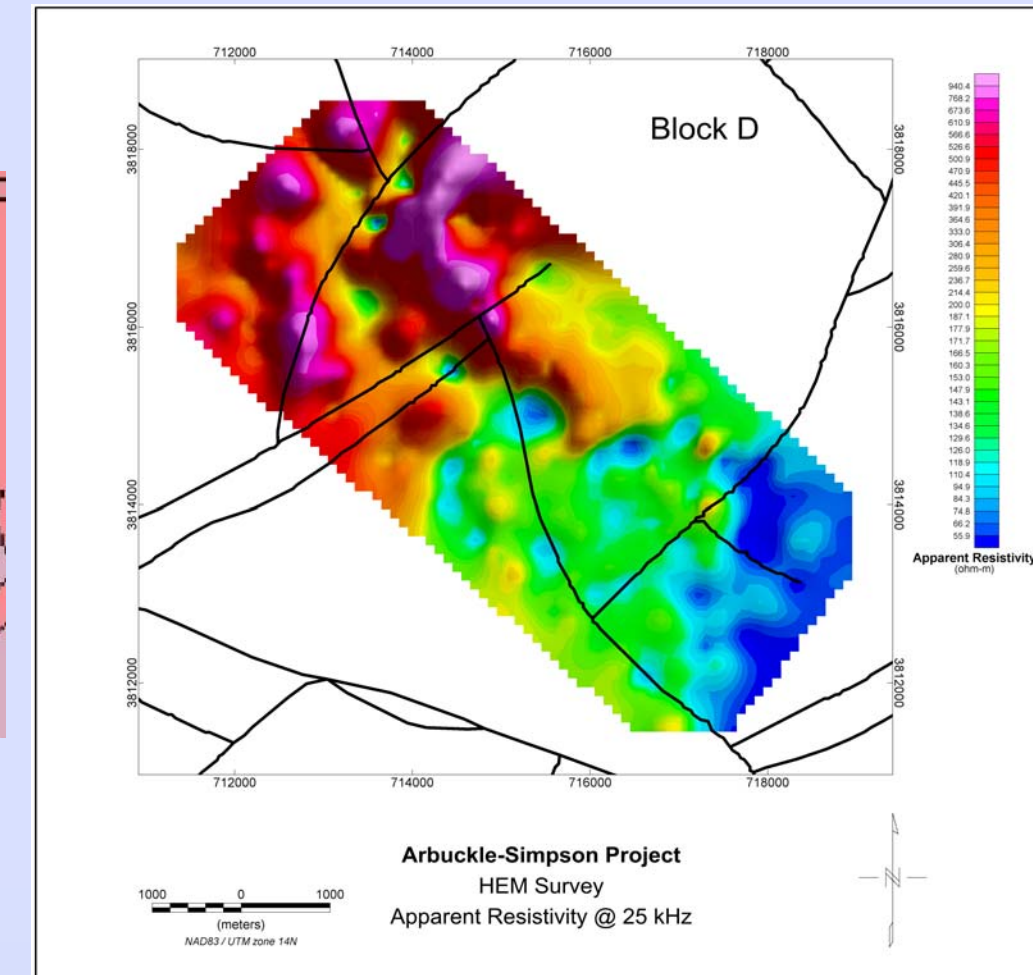
Area D encompasses the Spears Ranch study area, where two deep wells were drilled in the central part of the Hunton anticline. Except for a broad trend from northwest to southeast mirroring the geology, apparent resistivity maps of this area do not reveal much lateral variation in rock electrical properties due to fault structures.

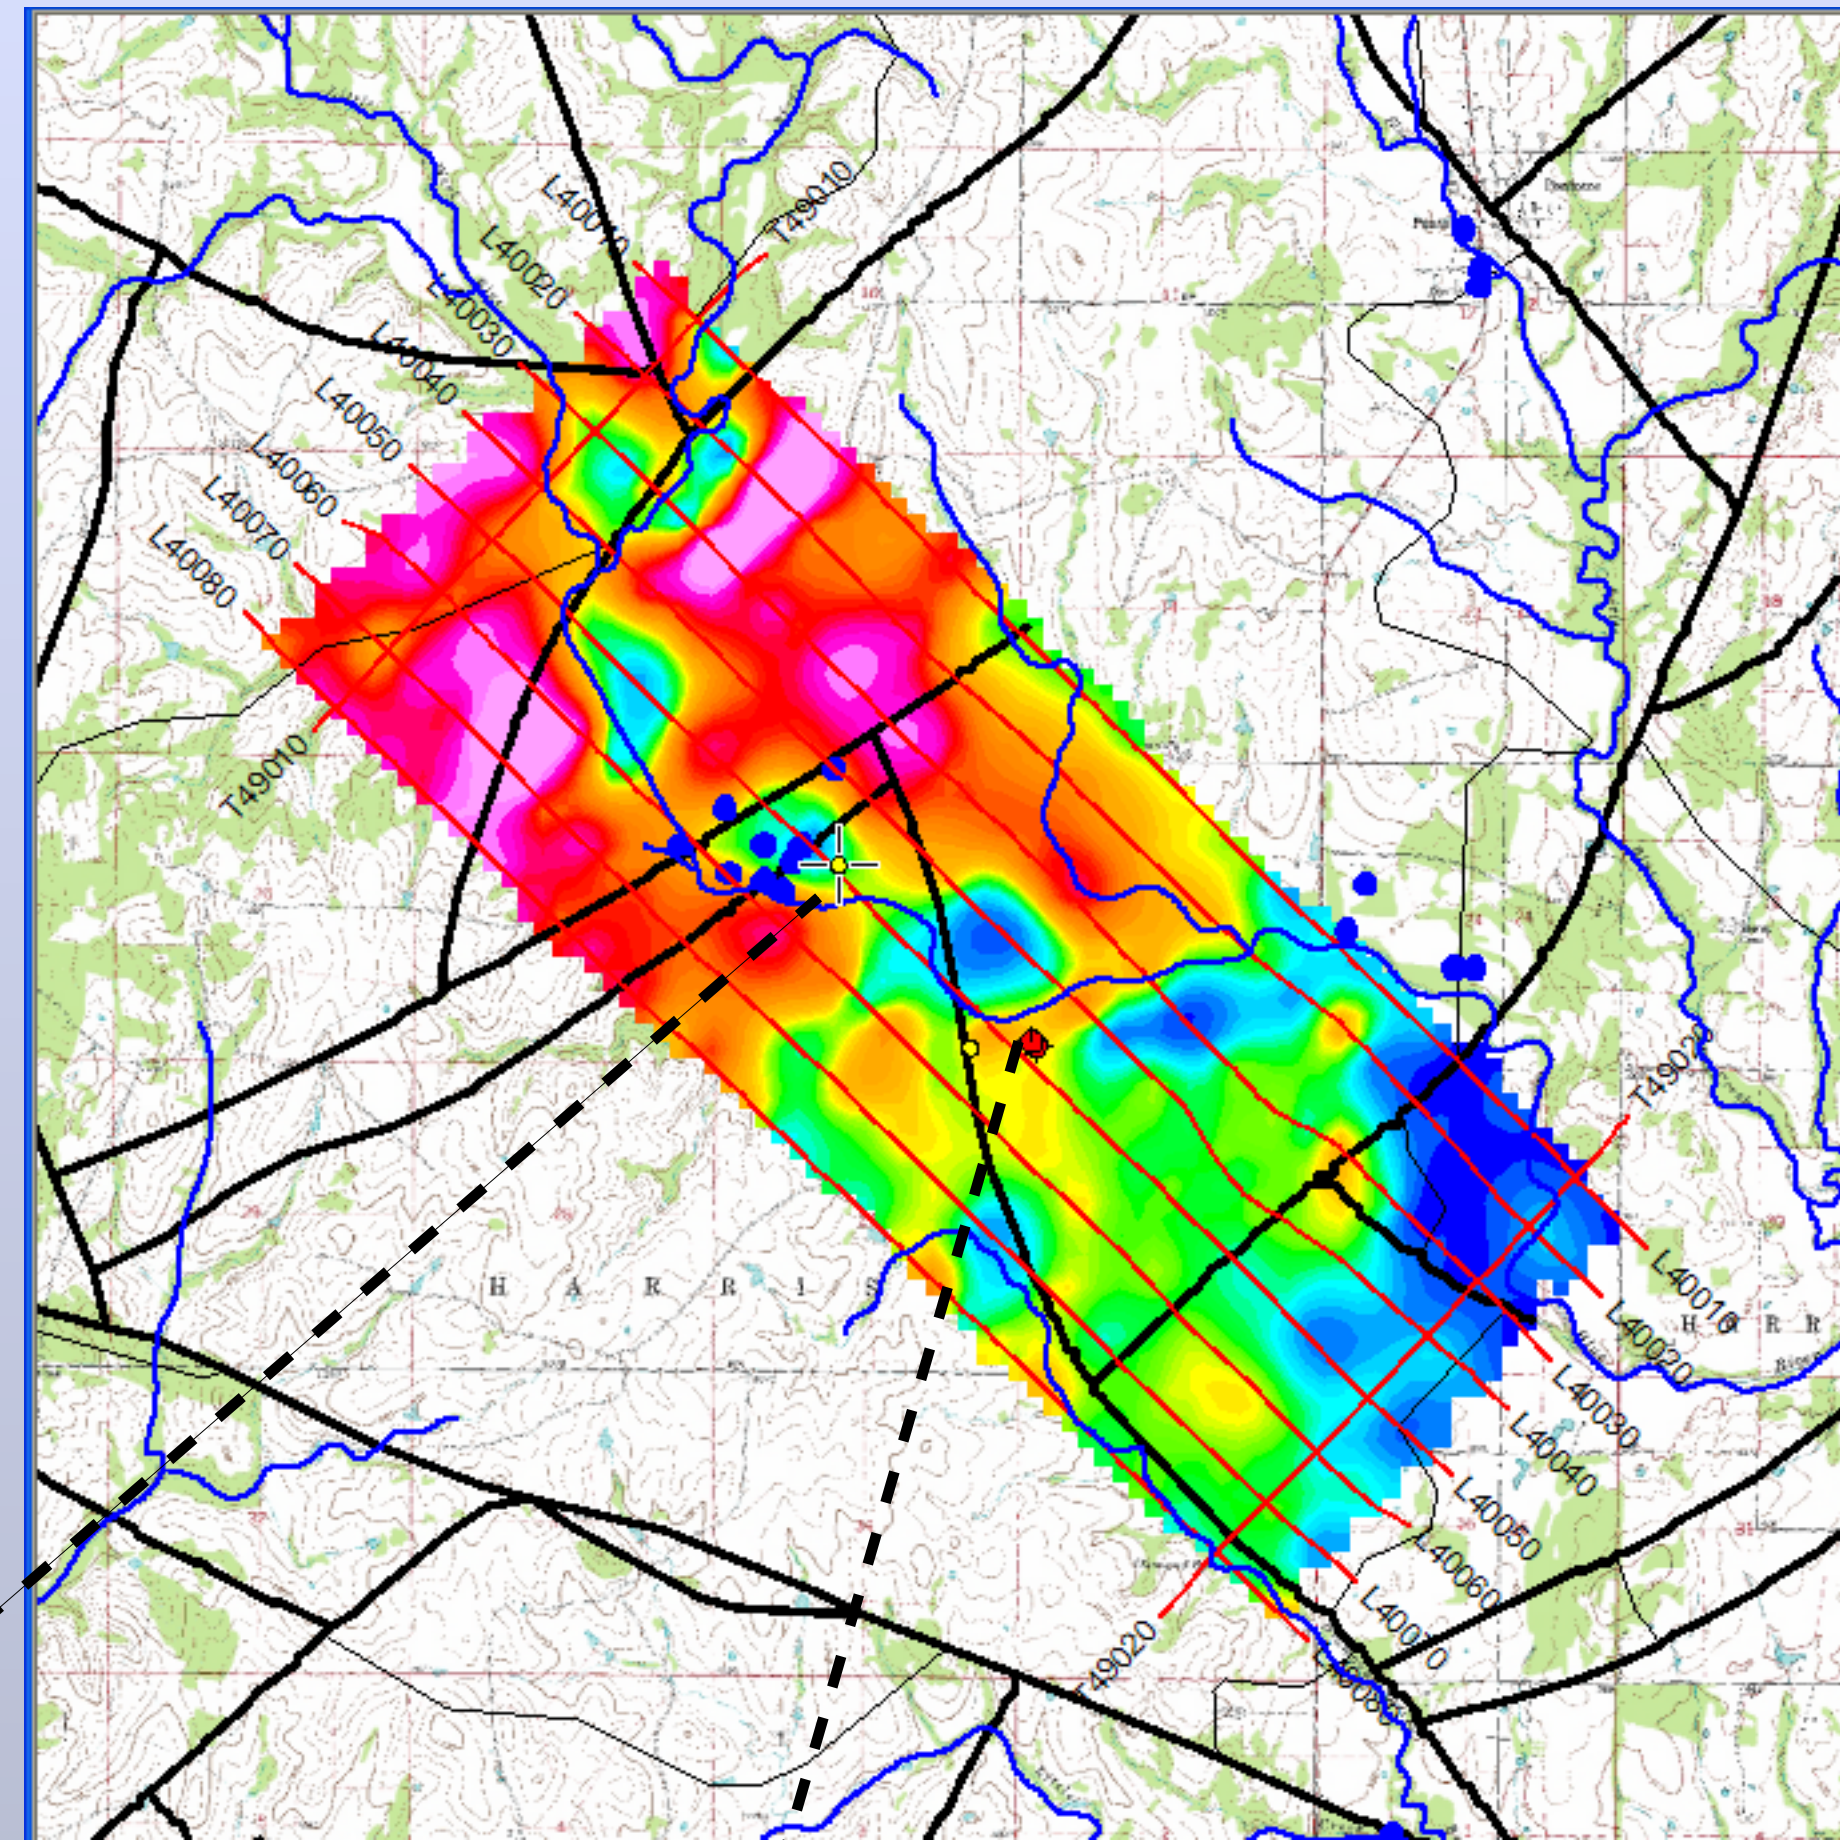
Recent electrical resistivity imaging (ERI) surveys in the Spears Ranch study area (Sample, 2008) mapped the epikarst as a low resistivity surface layer above competent limestone. The dashed line in the resistivity sections indicates the depth to refusal of a Geoprobe penetrometer. The thickness of epikarst at one location is about 15 m (50 ft) and about 6 m (20 ft) at the other. Faults not visible in the apparent resistivity maps are clearly detected as discontinuities in the HEM inversions, as well as in the ERI inversions. Likewise, epikarst is evident as a relatively thin, conductive veneer overlying the more resistive bedrock.
