Data Report for the Geologic and Scenic Quality Evaluation of Selected Sand and Gravel Sites on the Wind River Indian Reservation, Wyoming

Open-File Report 2011-1302

By William H. Langer, Bradley S. Van Gosen, Belinda Arbogast, and David A. Lindsey

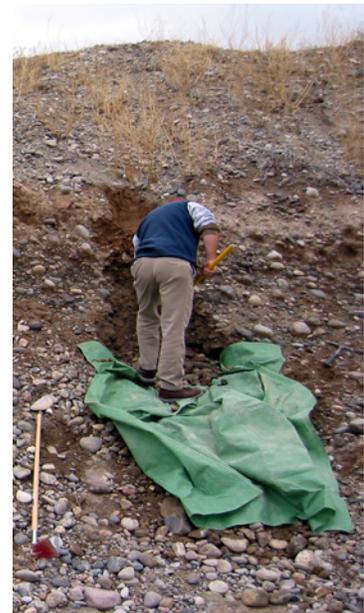
Figure 4. Geologist taking sample from pit face using a technique referred to as vertical trenching.

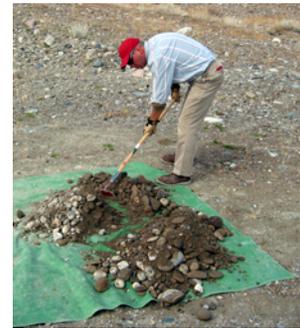
Figure 5. Geologist dividing a large bulk sample using a technique referred to as “cone and quartering.”

As part of this study, samples were collected in the field (fig. 5) and were taken to Inberg-Miller Engineers, Riverton, Wyo., where they were subjected to three engineering tests (in addition to determining particle size distribution): the Los Angeles Abrasion test, the Sodium Sulfate Soundness test, and tests to determine specific gravity and absorption. The tests generally yielded satisfactory results and are reported in Appendixes 1 and 2.

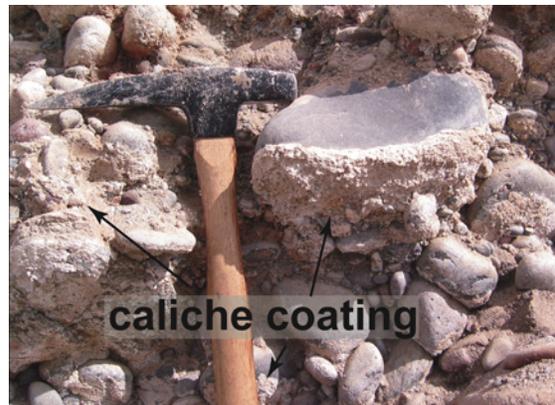
Maximum carbonate stage refers to the degree of coating or cementation of particles by CaCO_3 (caliche) in gravel (Birkeland, 1999). Calcium carbonate (CaCO_3) at stages III and IV may cement gravel into large blocks or layers, thus complicating the excavation and processing of aggregate.

Caliche coatings may be detrimental to the strength of concrete if the bond of the cement paste to the coating is greater than the bond of the coating to the aggregate. However, caliche may not affect the aggregate/matrix bond if it is strongly cemented to the gravel, or if it is broken from the surface of the aggregate during crushing and processing. The presence of caliche may increase the amount of fines in the final product due to attrition during processing.

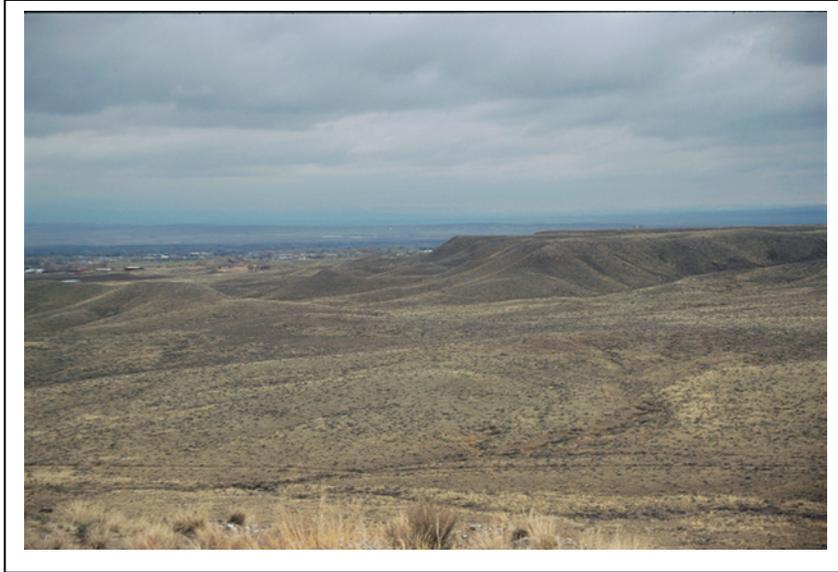
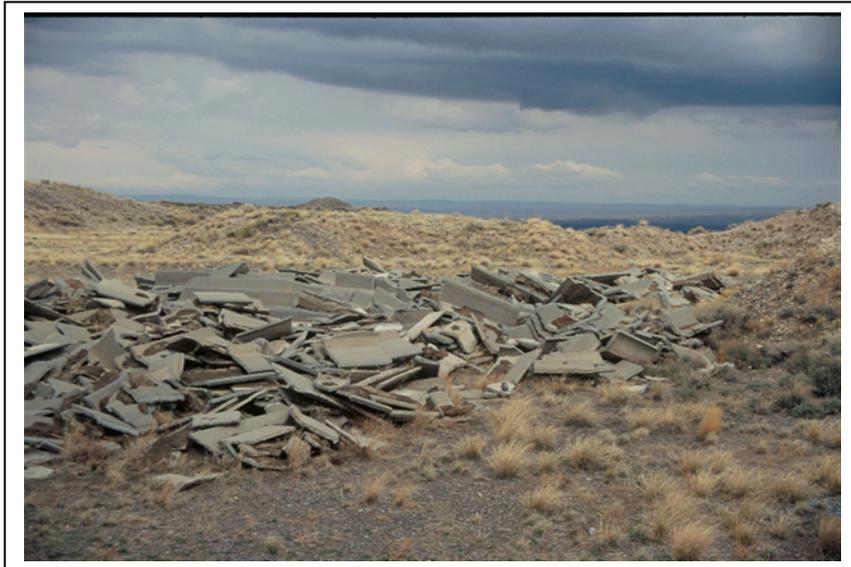
Upper, Large tracts of grassland and stream terraces are visible in this southeast-oriented view from the Airport site. *Lower*, Photo from within site showing concrete drainage slabs from canal work are saved for recycling. Sand and gravel spoils surround the pit area.

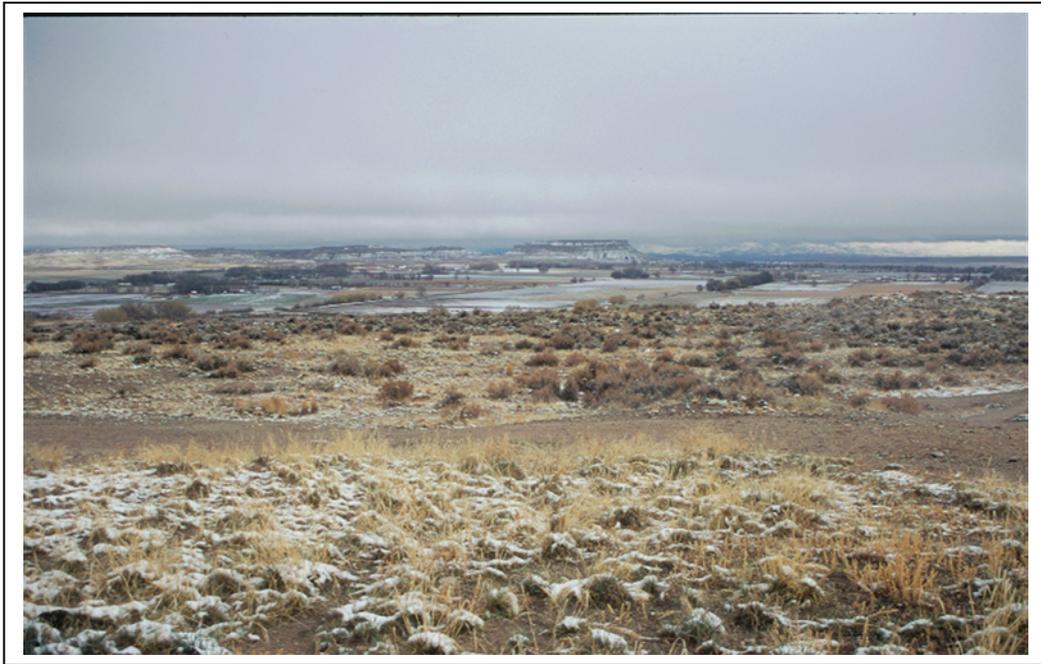
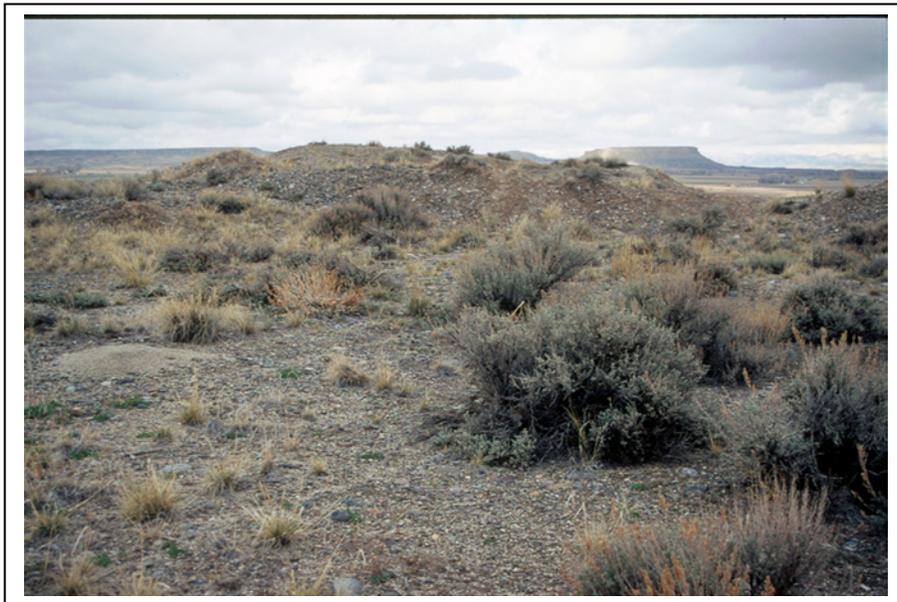
Upper, View north from eastern site at Burma Hill. Paradise Valley, riparian, and irrigated land cover are visible in the middle ground. *Lower*, View from western site at Burma Hill. Spoil piles and sand and gravel are visible on site.

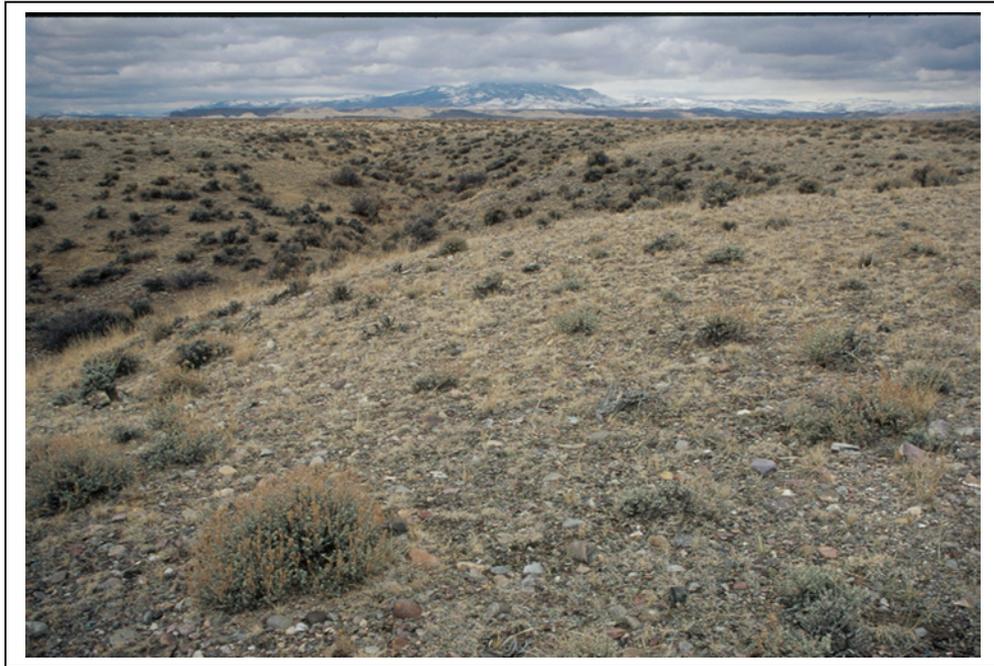
Upper, View north from terrace tread, from Crowheart Butte #1 site. *Lower*, The Wind River Formation is exposed in this view west. The Wind River Mountains are in the background.

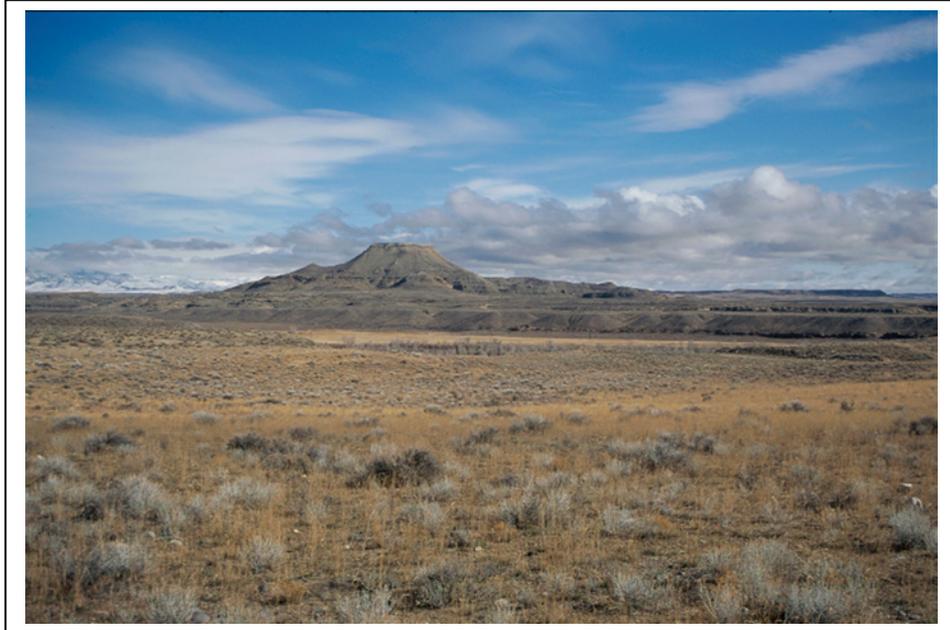
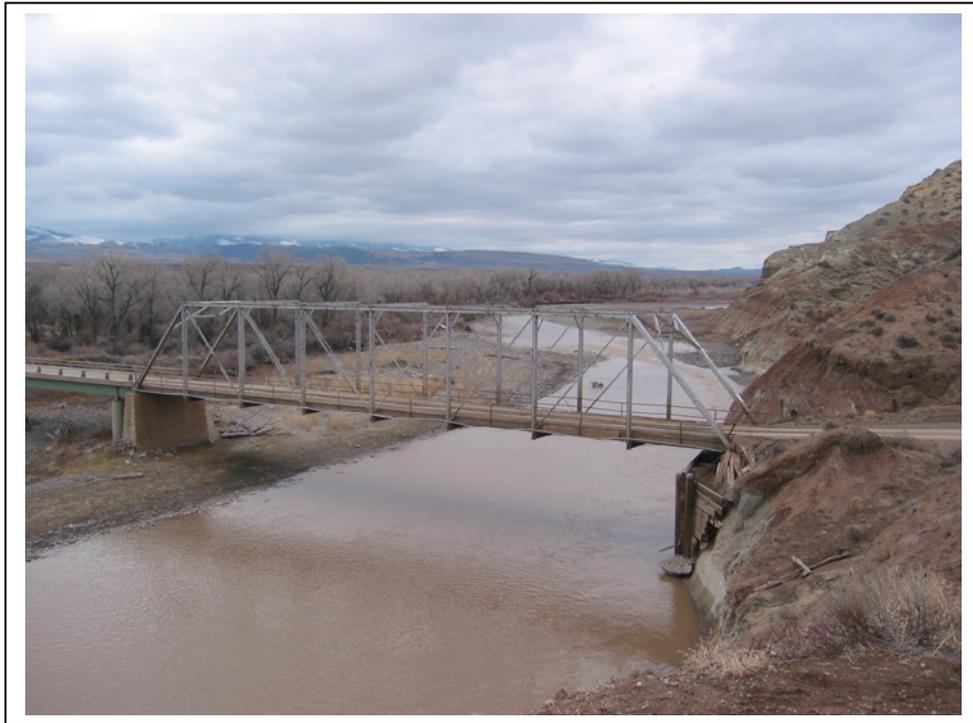
Upper, Crowheart Butte, a monolithic table-top mesa, is near the Wind River and is a dominant feature of this landscape. *Lower*, Vehicular traffic crosses the Wind River via a simple truss bridge and continues on Lenore Bridge Road to the Crowheart Butte #1 site. Note the condition of the bridge abutment on the right side of the river.

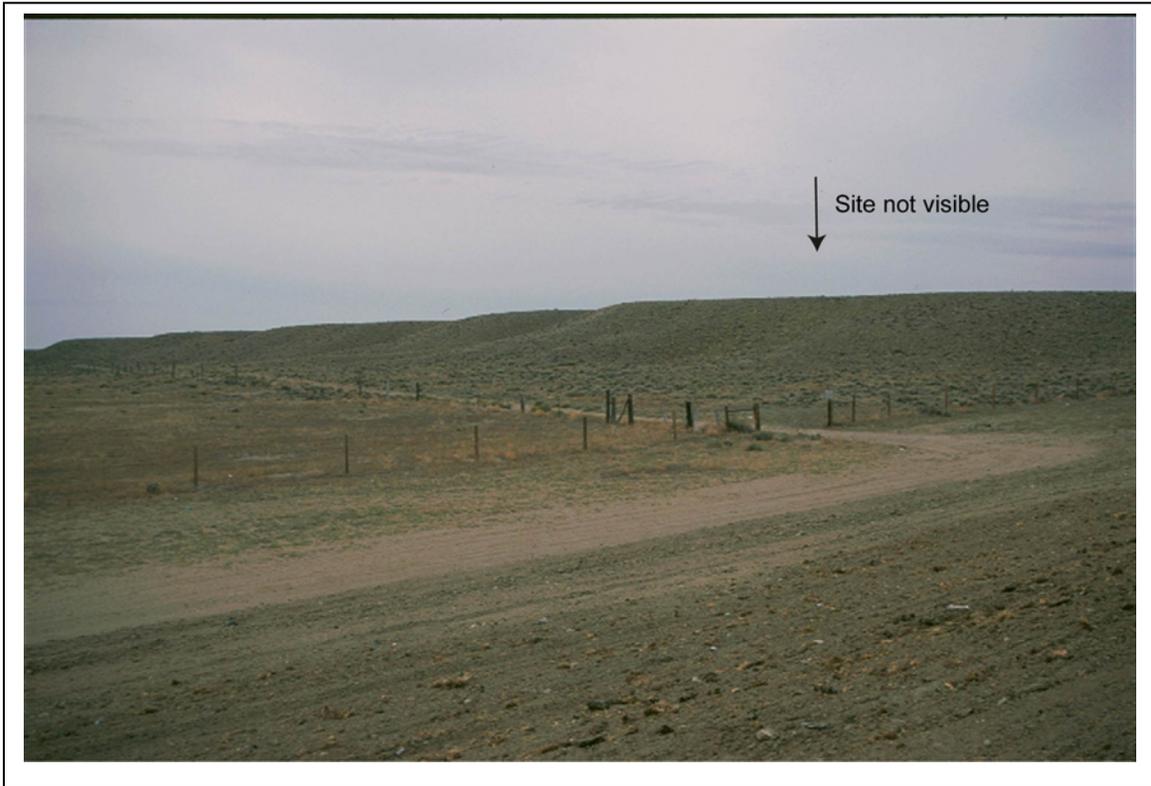
This view is from U.S. Hwy 26, looking south, towards the terraces and the E. Boysen Causeway site. The terrace slopes are plainly visible and block viewing of background objects. The site is not visible from the road despite being located on the terrace top. The vegetation and landform lack visual variety and therefore typically are considered less visually appealing.

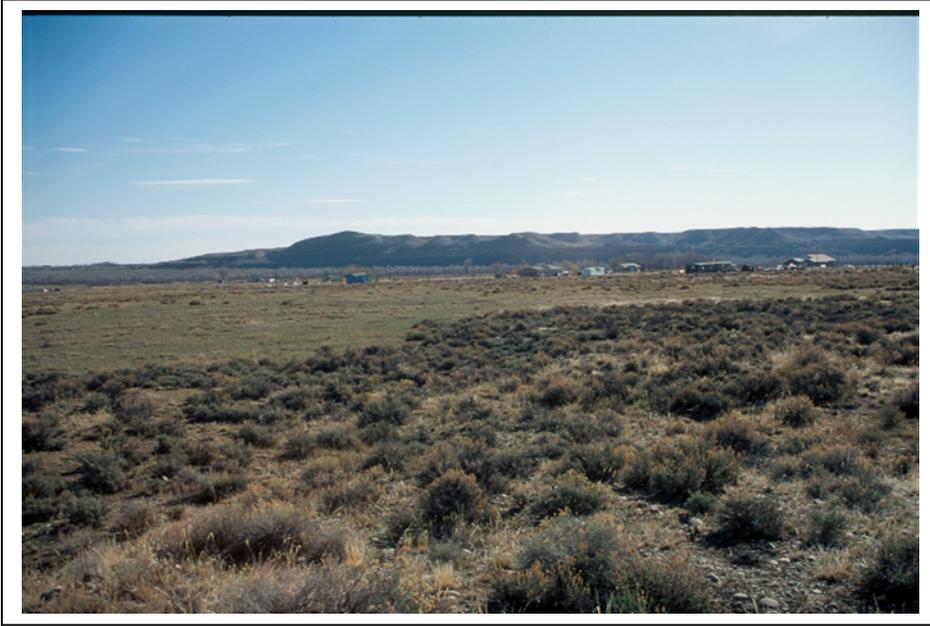
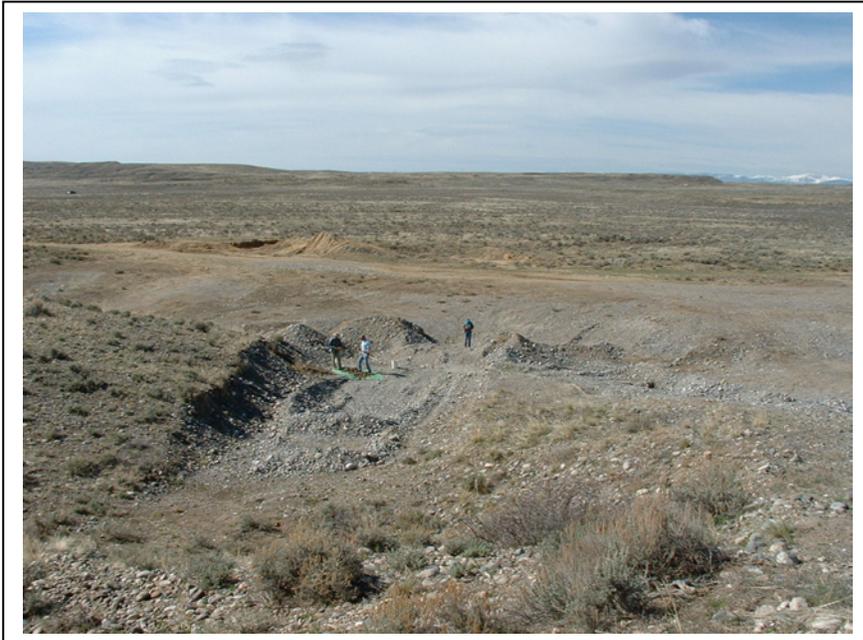
Upper, View east from the Johnstown site across Johnstown Valley and Edmo Buttes. Residences are in close proximity to the site. *Left*, Southern view of the sand and gravel pit on the Johnstown site. The sand piles are visible from Hwy 132, not the gravel pit itself, due to the contrast in color, profile, and orientation. Lower photograph courtesy Floyd Phillips.

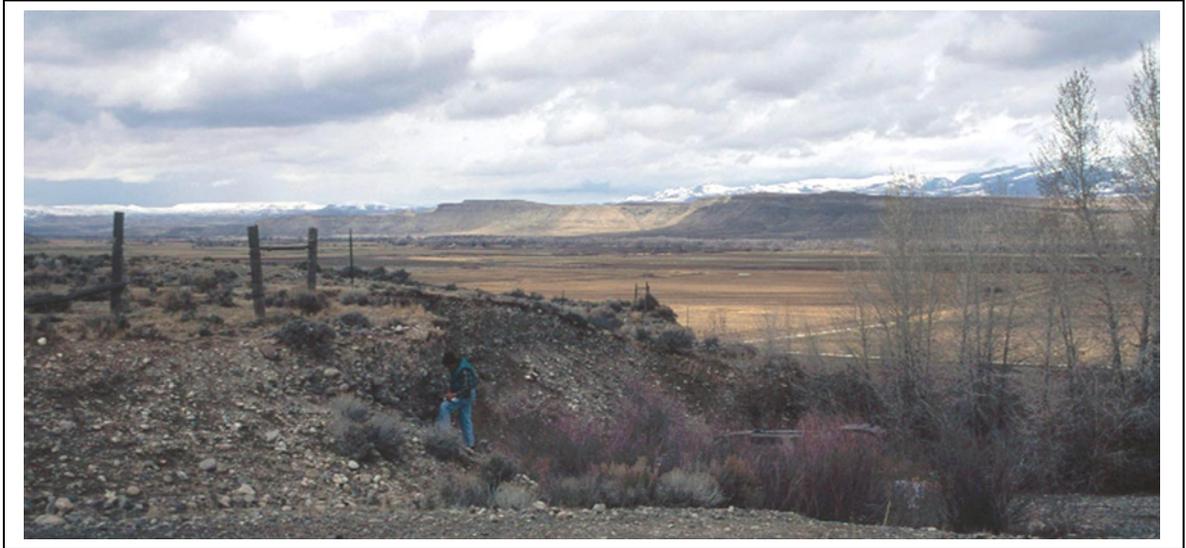
Upper, View northwest from terrace tread with exposed terrace face in foreground. Urbigket Road, riparian, and irrigated land cover occupy the middle ground. Owl Creek Mountains are to the right. *Lower left*, View east of north-facing terrace riser viewed from the road. Crowheart Butte is in the distance. *Lower right*, Overgrazed land cover on terrace tread, view northeast.

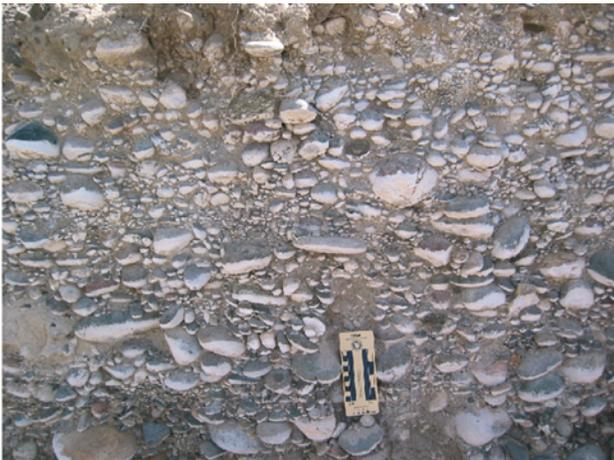
White caliche deposits on underside of dark-colored rocks. Red box in column shows location of photograph.

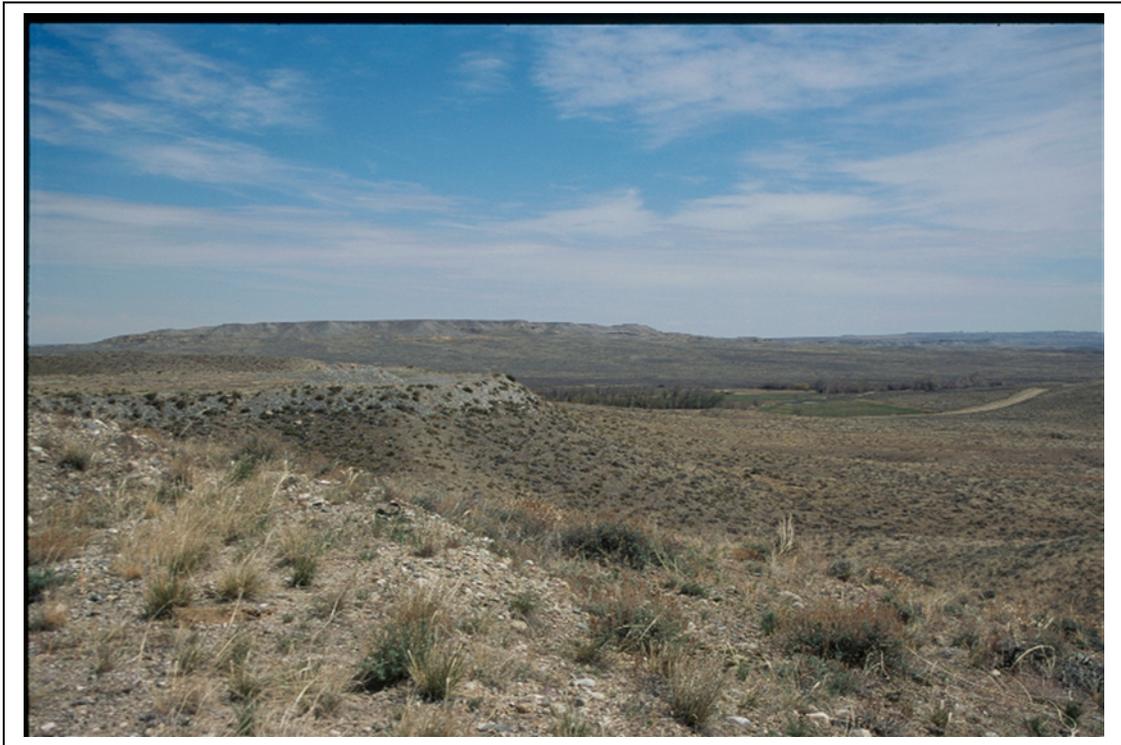
Upper, View east of an adjacent sand and gravel pit from the Kinnear site, River Road, riparian land cover in the middle ground, and Big Ridge in the back ground. *Lower left*, Typical grass. *Lower right*, Sulfur flower, possibly *Eriogonum flavum*.

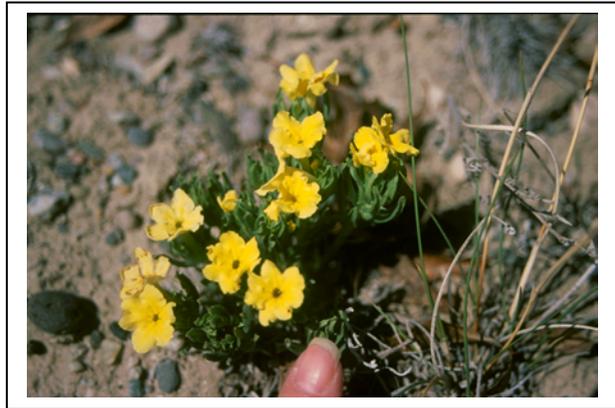
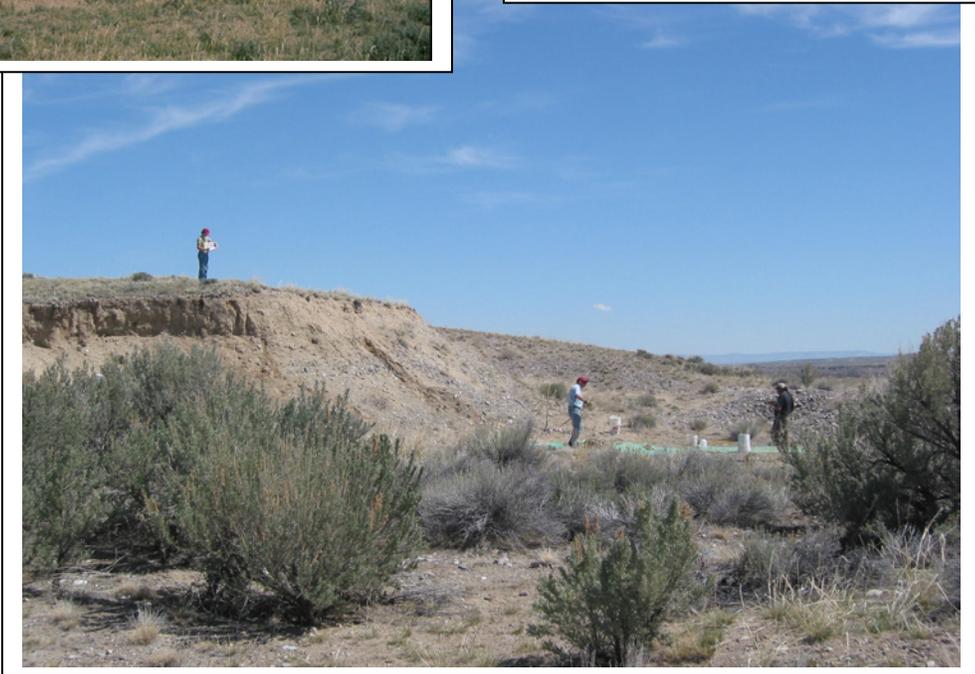
Left, View north of gravel tip and rocky outcrops east of the Le Clair site. Upper, Possibly a paccoon or stoneseed, *Lithospermum* spp. Below, Field work being conducted on exposed sand and gravel terrace on site, view east.

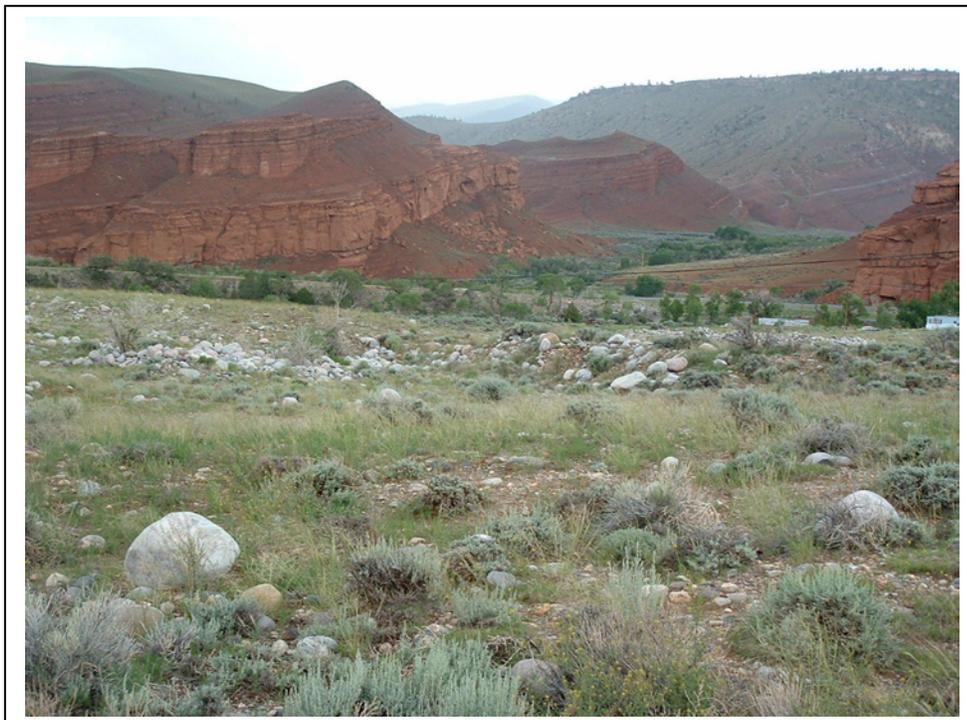
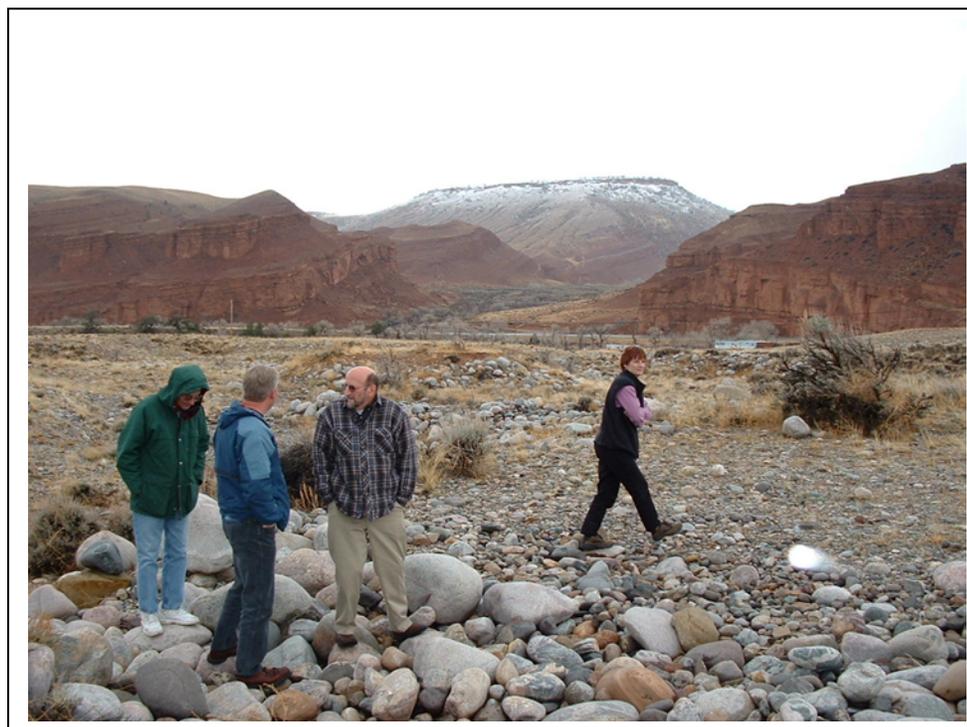
The two photographs above were taken from approximately the same location but at different times of the year. They illustrate how much greener the habitat is in August than April. The deciduous vegetation along U.S. Hwy 26/287 camouflages the site from vehicular observers more in the summer than the rest of the year. (Both photographs courtesy of Floyd Phillips.)

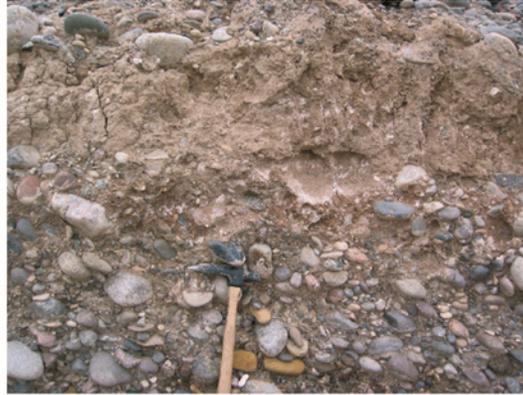
Red box in column shows location of photograph

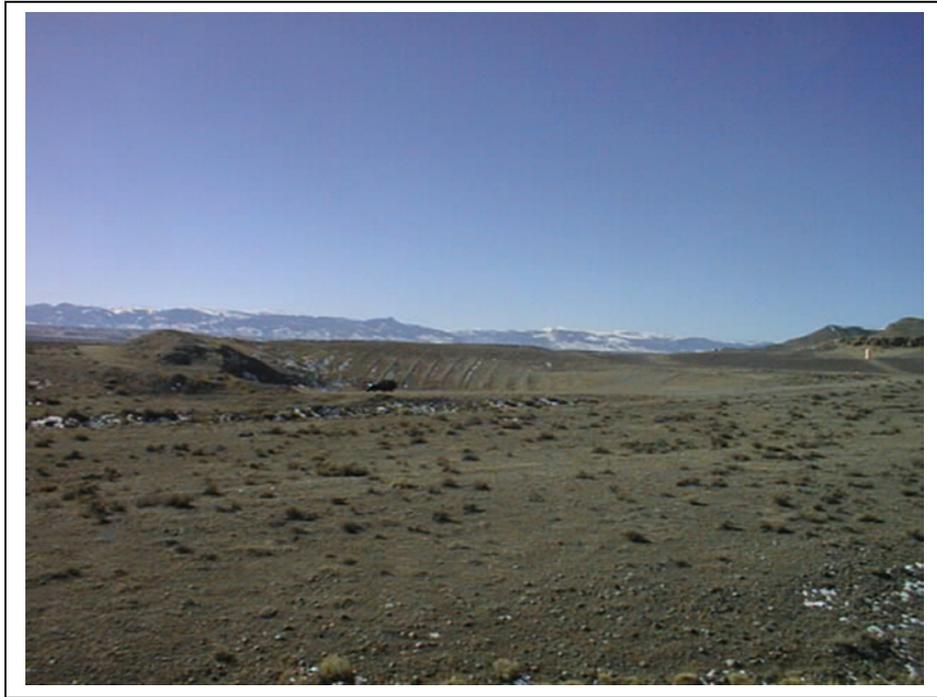
Upper, Photograph of Sheer pit site in February, 2002. Photograph courtesy of Floyd Phillips. The pit forms a convex landform. The scene is not markedly different in 2005. *Left*, Typical vegetation is sparse and uneven.

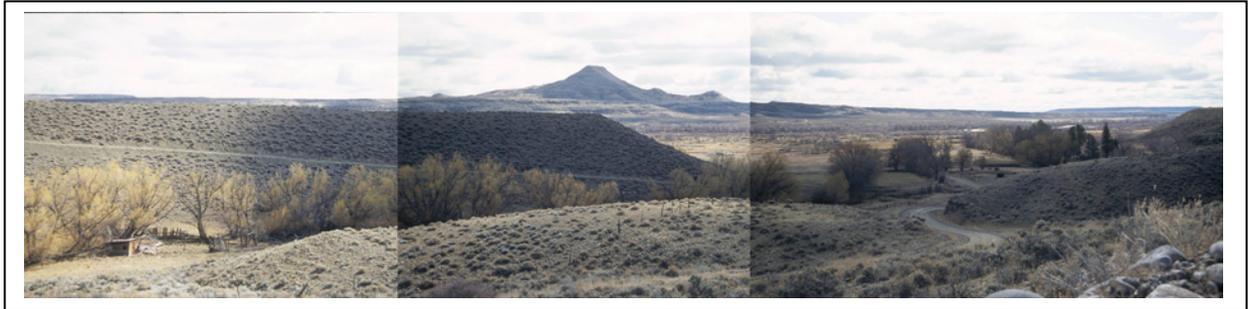
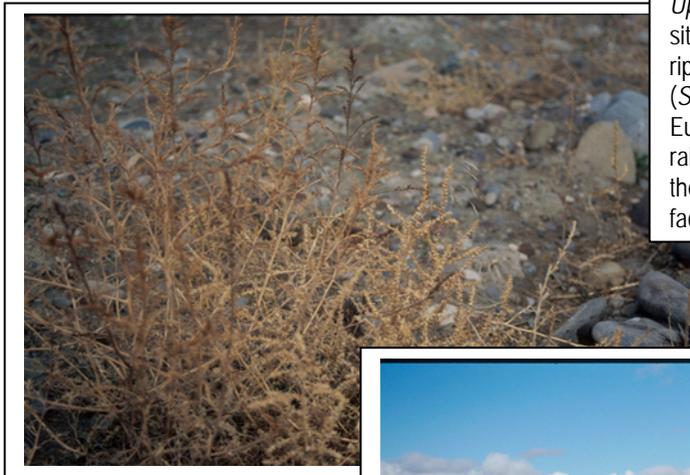
Upper, Panoramic view northeast from the Willow Creek site. Crowheart Butte and the drainage areas, supporting riparian habitat, are the visual focus. Left, Tumbleweed (*Salsola kali*) is an introduced noxious weed from Eurasia. Lower, Western view from above pit. Rubber rabbitbrush or sand sagebrush has established around the pit perimeter. Sample collection at the exposed pit face is underway by USGS staff.

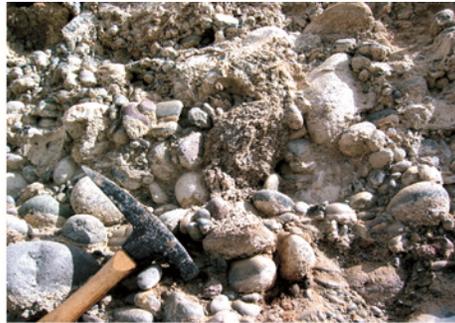
Winkleman Dome #1

Red box in column shows location of photo.

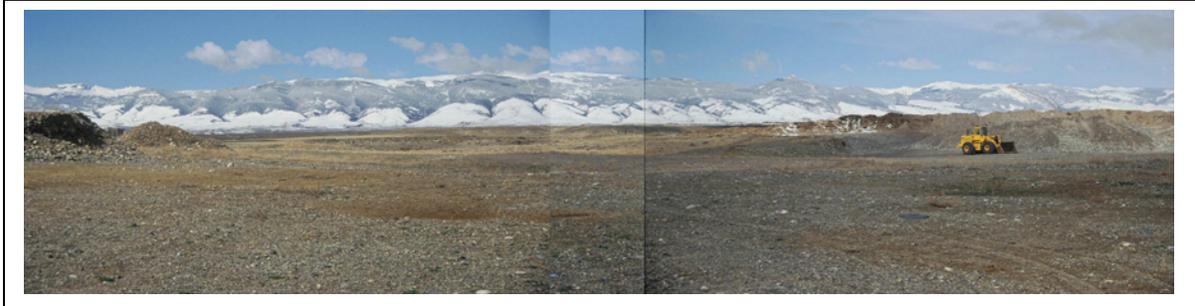
Upper, the Winkelman Dome #1 site has little sense of boundary except for the Wind River Mountains to the west. The photograph was taken with a 50 mm lens in order to represent the cone of vision and depth of field an observer would experience on site. The photographs were joined together in Adobe Photoshop. *Lower*, Typical mixed grass vegetation and terrace slopes in the area.

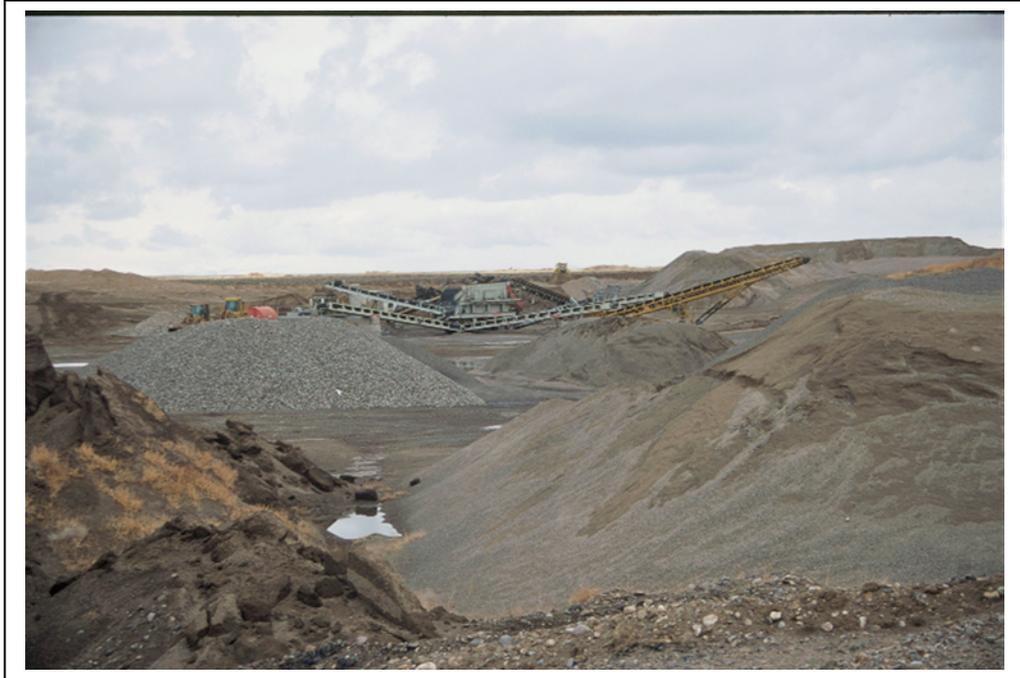
Upper, The Winkleman Dome 2 site includes a Shoshone Tribal processing plant. Stock piles and equipment are evident in this northeast view. *Lower*, The view southwest is of the typical Wyoming big sagebrush land cover. Photograph was taken from above the pit on the terrace tread. The Wind River Mountains are in the background.

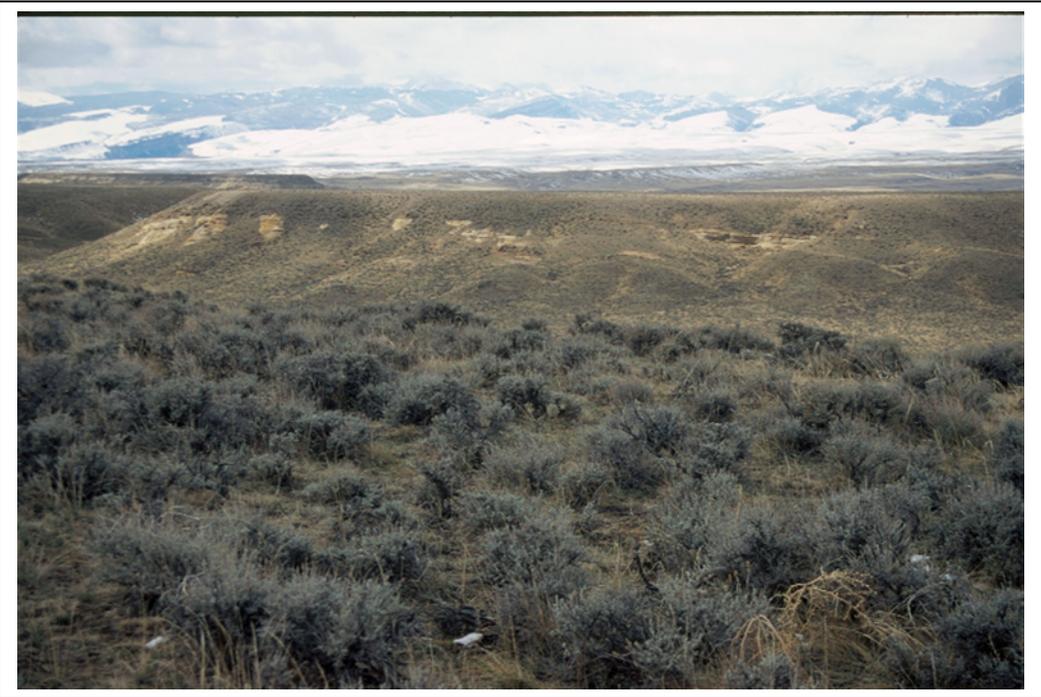
View east. The Winkelman Dome 2 site is adjacent to the Winkelman Dome oil field. Roads, storage tanks, and an oil derrick are noticeable cultural modifications, even during an early spring snowstorm.

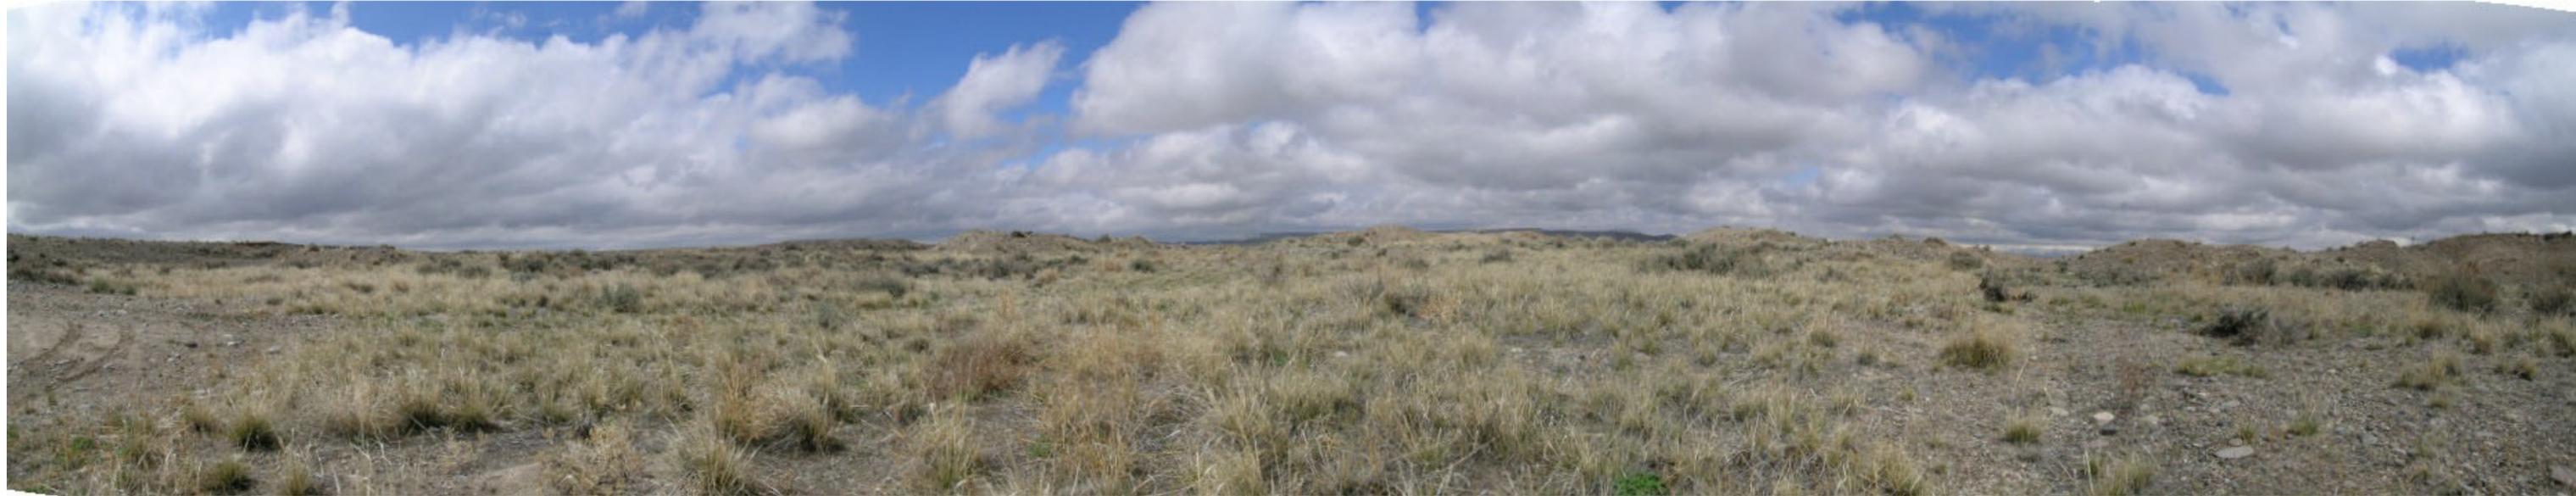
Plate Number 1

General Description: The snow has melted and the sky is overcast with grey clouds, windy. The surface dries quickly. The panoramic, relatively flat, grassy terrain is dotted with small spoil heaps.

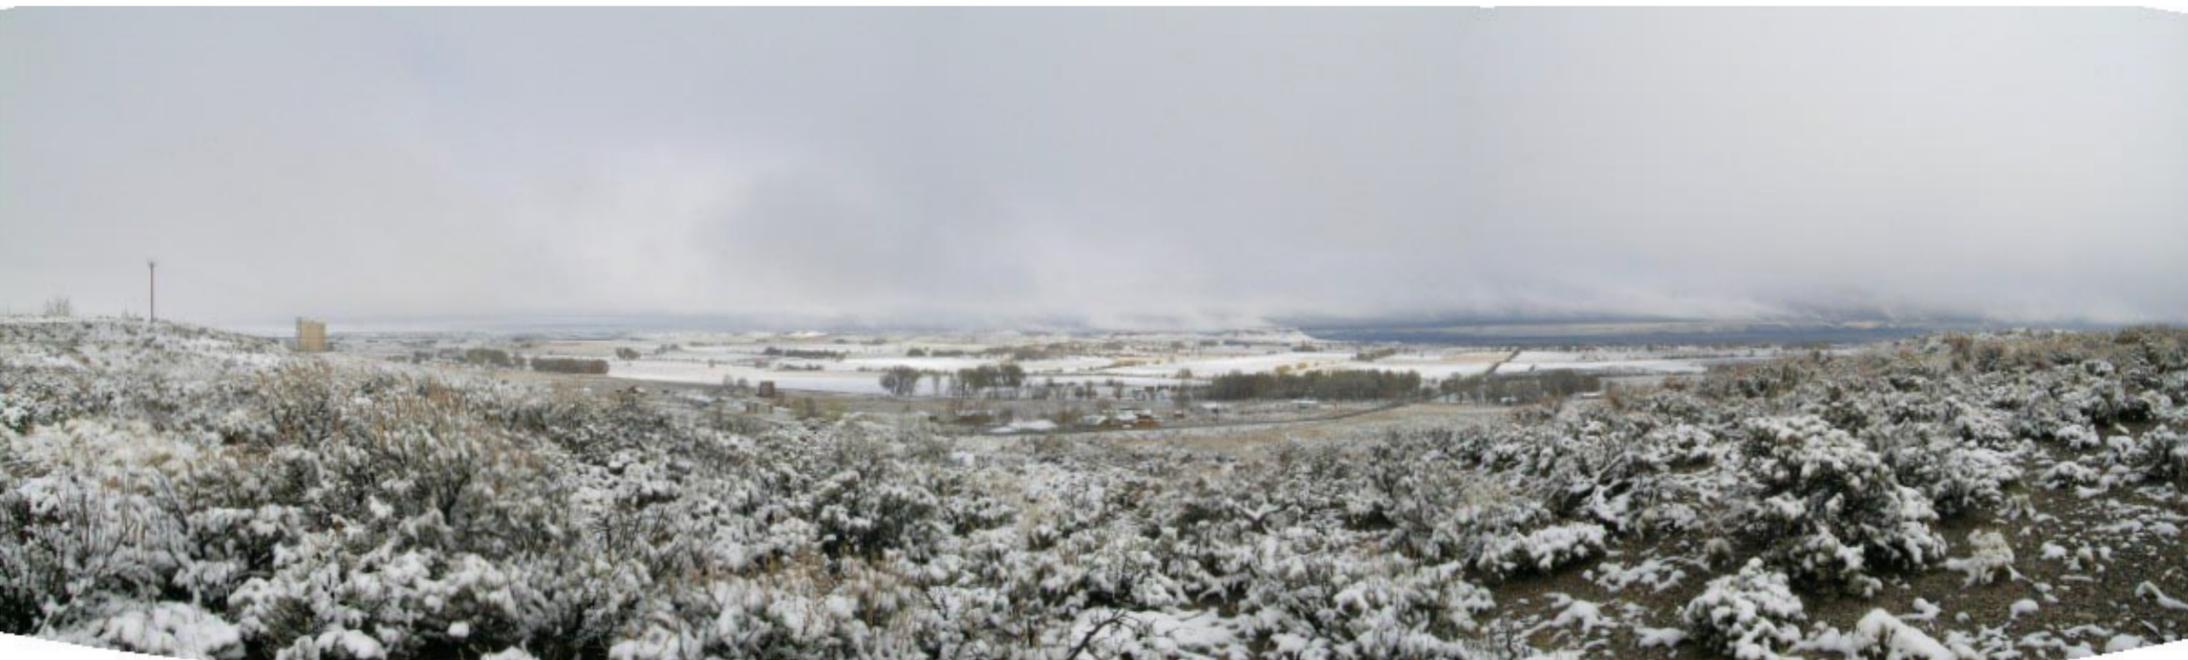
Plate Number 2

General Description: Despite snow on the ground, contours are still visible. The falling snow gives a textured look and low cloud cover limits distant views. The feature landscape is dominated by Paradise Valley, Sand Gulch, and Lost Wells Butte in the middle ground. The area shows transitional-mixed land use; agricultural, industrial (oil), and residential. The foreground vegetation appears to be big sagebrush and mixed grasses.

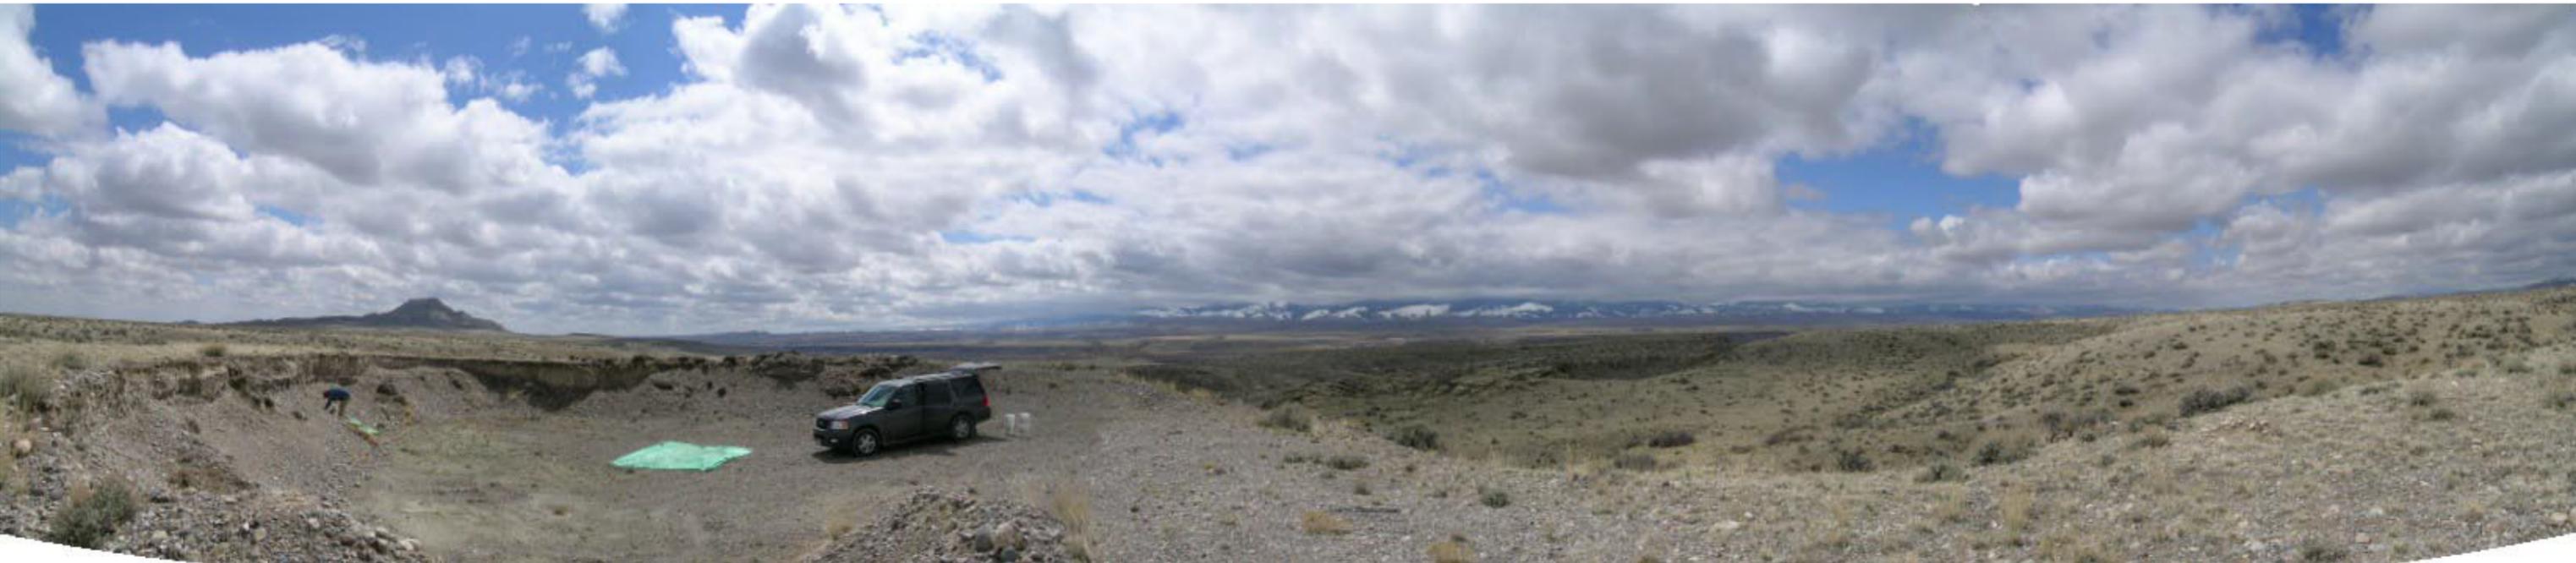
Plate Number 3

General Description: Clearing sky illuminates a feature landscape dominated by Crowheart Butte, a historical landmark, on the left. The gently rolling hills give way to a vista of surrounding mountains. Terraces scarps and sandstone outcrops are noticeable. The vegetation is sparse sagebrush and grasses.

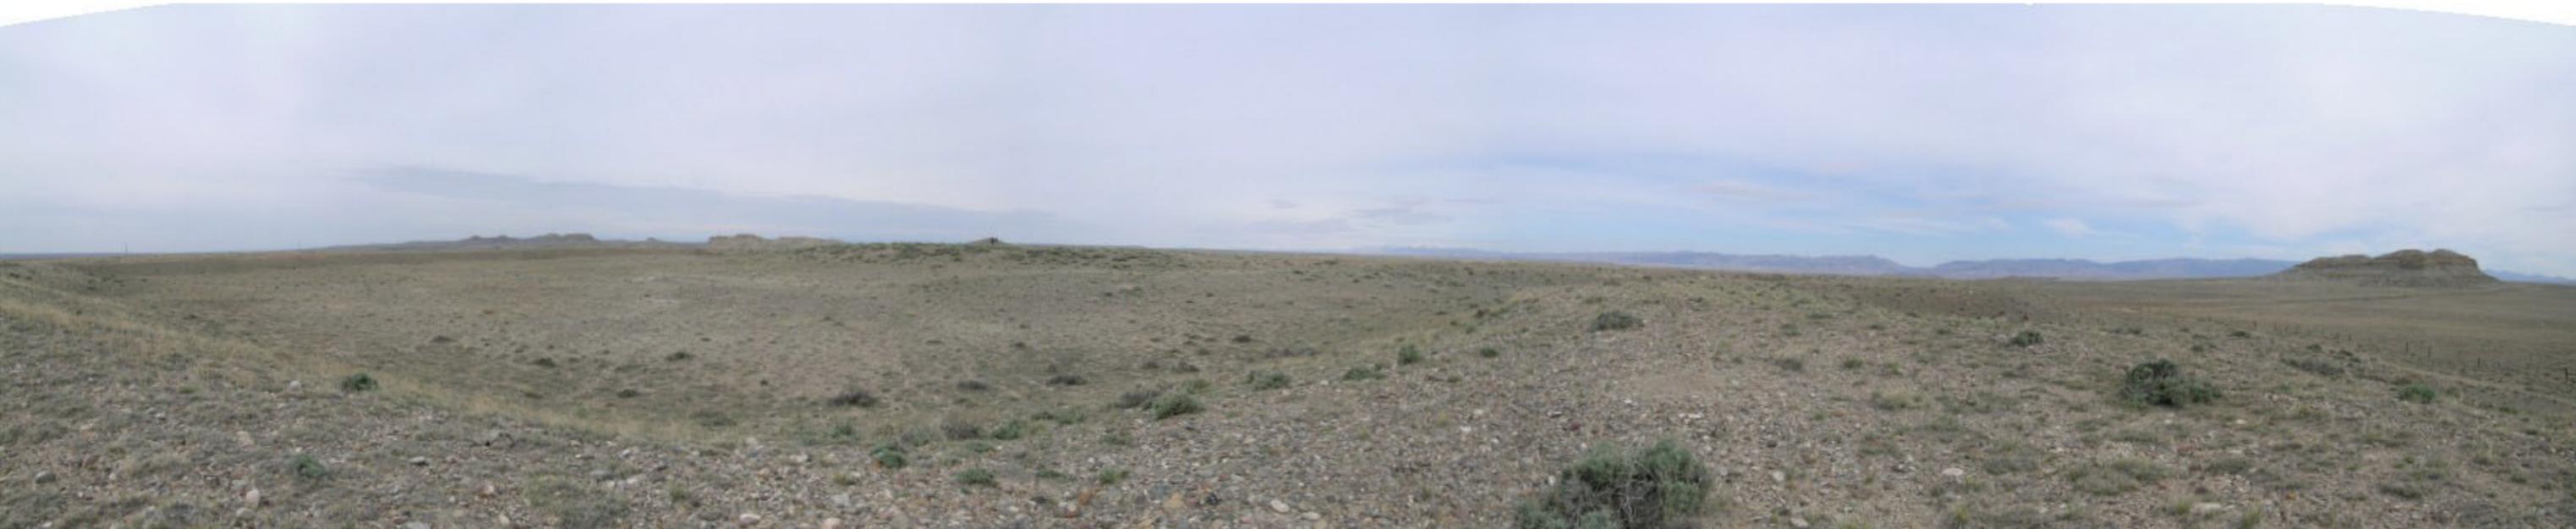
Plate Number 4

General Description: A panoramic landscape type with little vertical relief except for adjacent terraces and foothills. Water Tank Hill (on right) adds to the scarcity of landform variety. The flat area is characterized by short grasses and sparse short brush. Example of sand and gravel pit reclamation by the Wyoming Department of Transportation.
