Data Report for the Geologic and Scenic Quality Evaluation of Selected Sand and Gravel Sites on the Wind River Indian Reservation, Wyoming

Open-File Report 2011-1302

By William H. Langer, Bradley S. Van Gosen, Belinda Arbogast, and David A. Lindsey

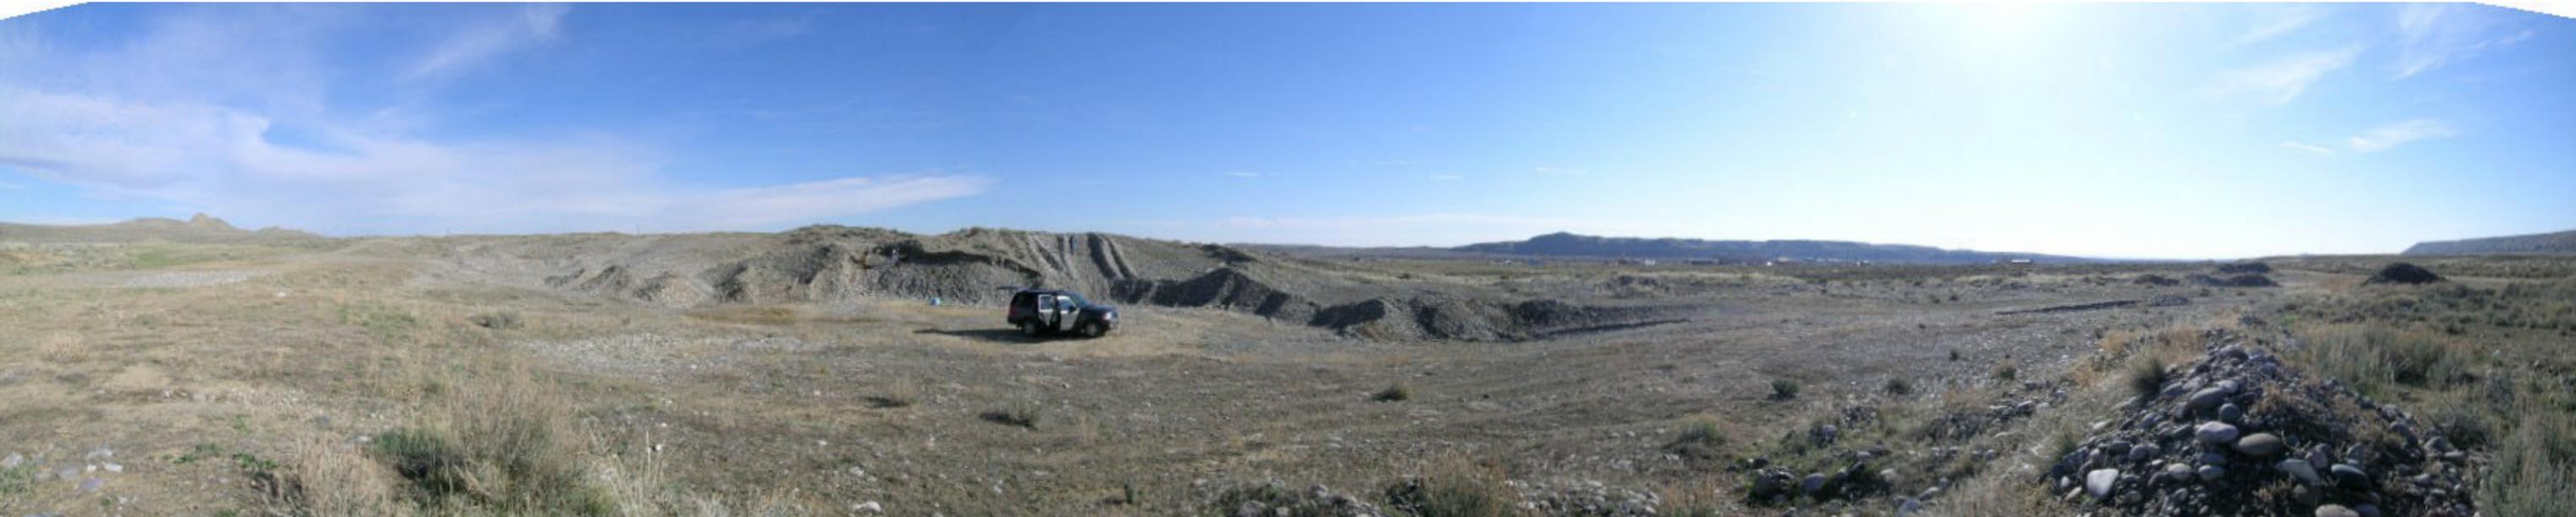
Plate Number 5

General Description Clear skies and a trace of clouds allow the panoramic landscape to be appreciated. The relatively flat terrain of Johnstown Valley and adjacent terraces appear to blend together. The only vertical relief is the distant buttes. Even the small sand and gravel heaps are visible from the main highway. Homes are less than ½ mile away.

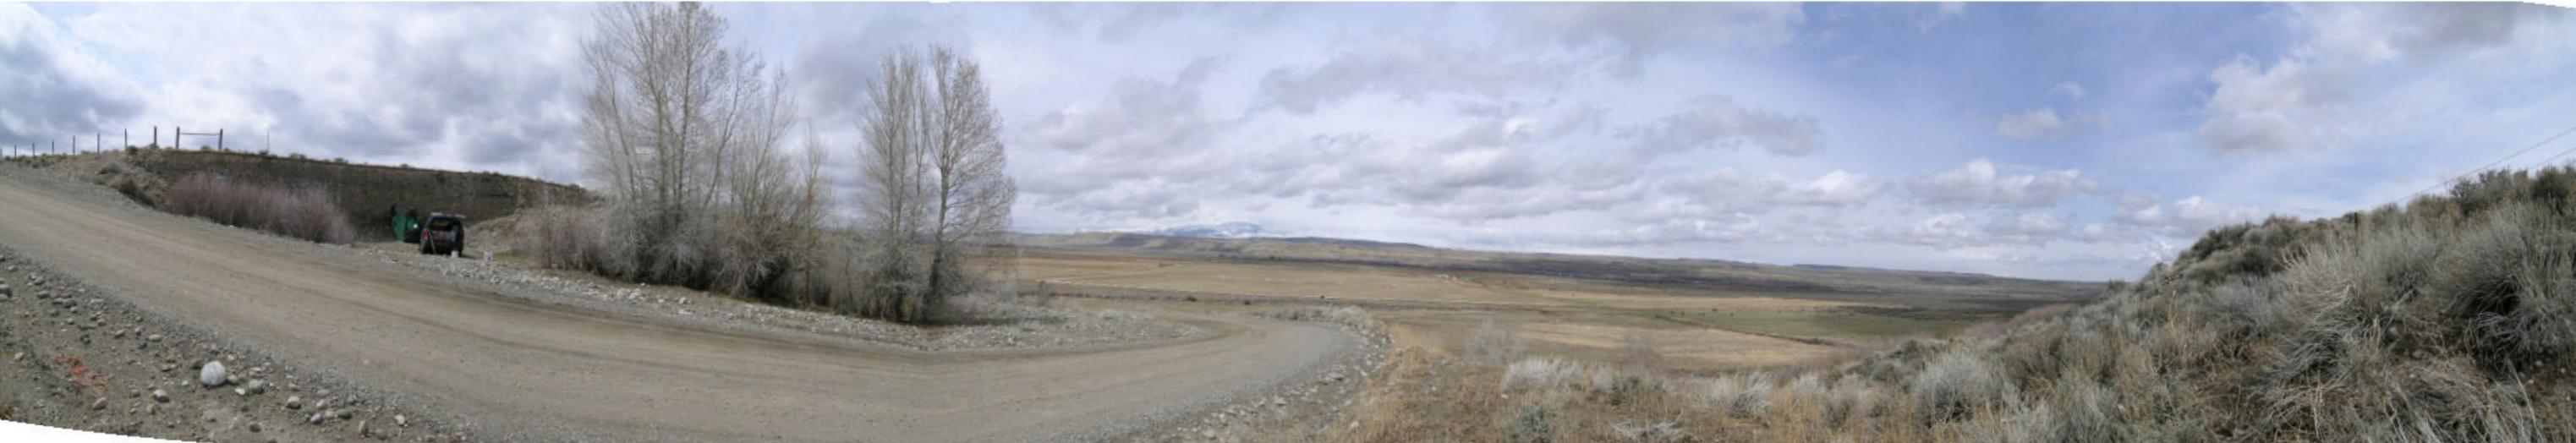
Plate Number 6

General Description The terraces are separated by the Wind River Valley. The panoramic landscape type allows distant views of the Owl Creek Mountains. Shrubs dominate the north facing terrace slopes; cottonwoods and willows occur in drainage areas. Urbigket Road crosses the landscape.

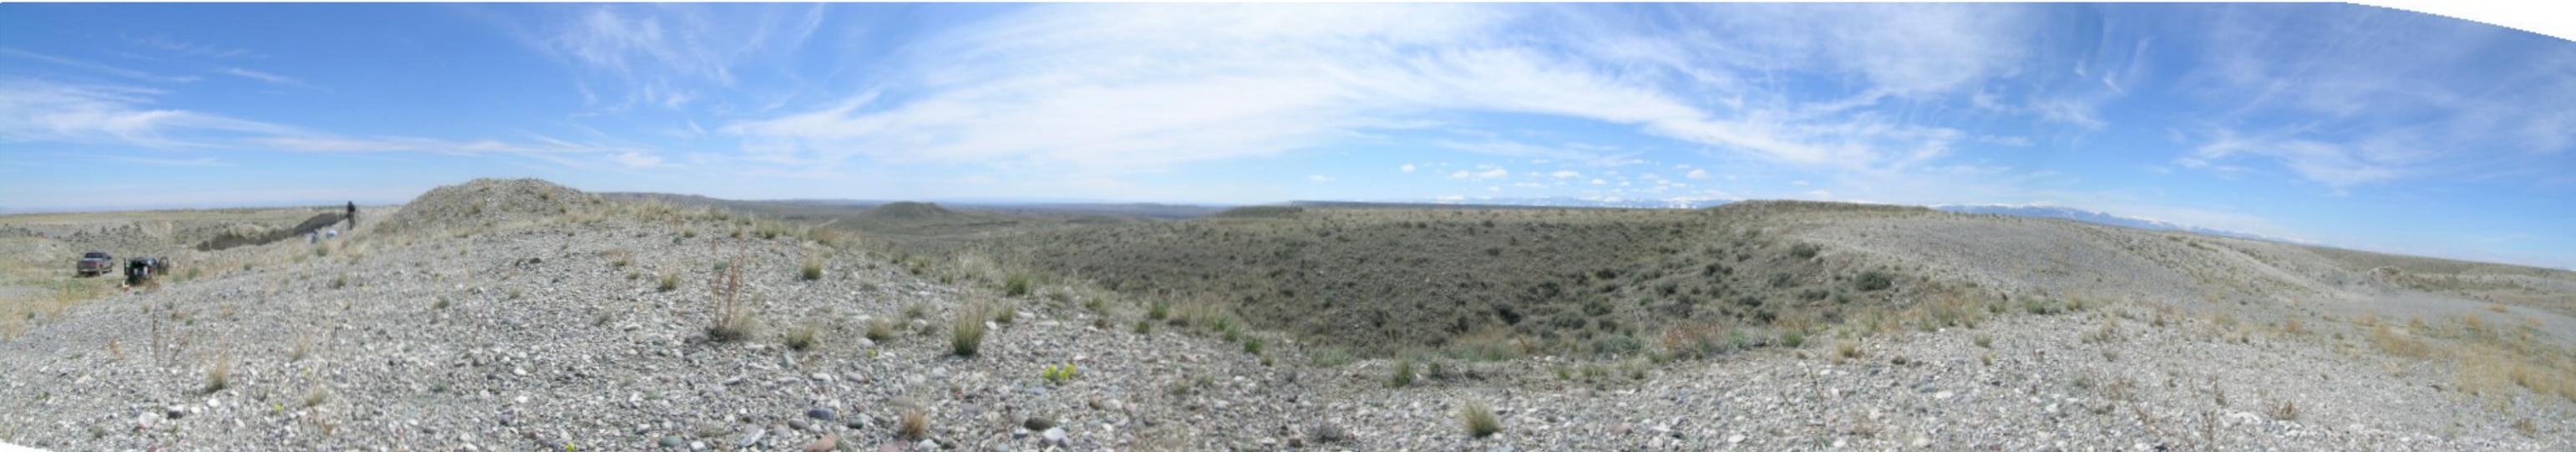
Plate Number 7

General Description: The gently sloping panoramic landscape has little variety in topography. Three sand and gravel pits are visible from the terrace tread. Spotted clumps of vegetation are unevenly distributed.

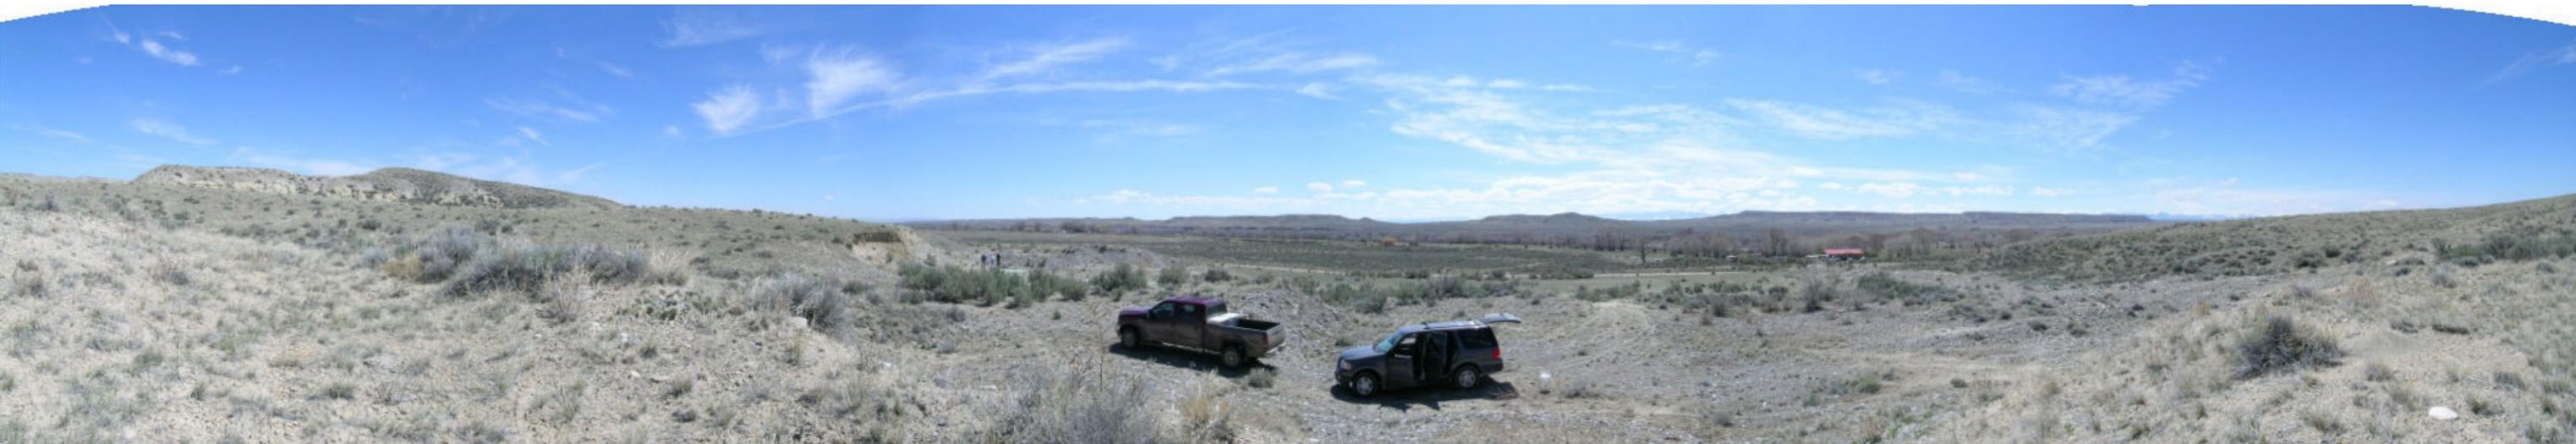
Plate Number 8

General Description: The foreground and middle ground do not substantially block views in this panoramic type landscape. A large patch mosaic is formed by mounds of sagebrush, pricklypear cactus, cottonwoods, and grazing lands. Exposed sandstone and the Wind River provide contrast in the landform.

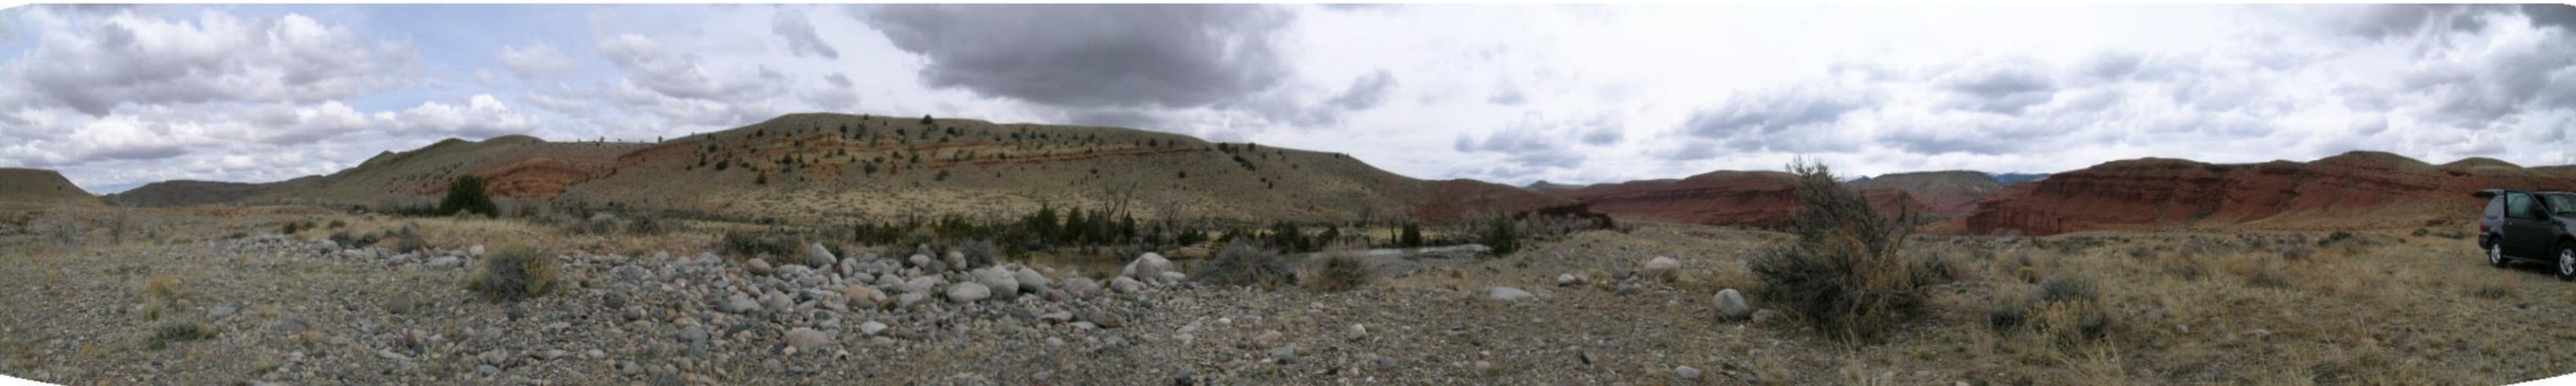
Plate Number 9

General Description: The narrow Wind River Valley floor and exposed bluffs form an enclosed landscape. Picturesque pines and junipers are scattered across the area in small groups. Strands of cottonwood-willow mark the major drainage. Large grey river rocks provide a color contrast to the exposed red-orange terrace slopes.

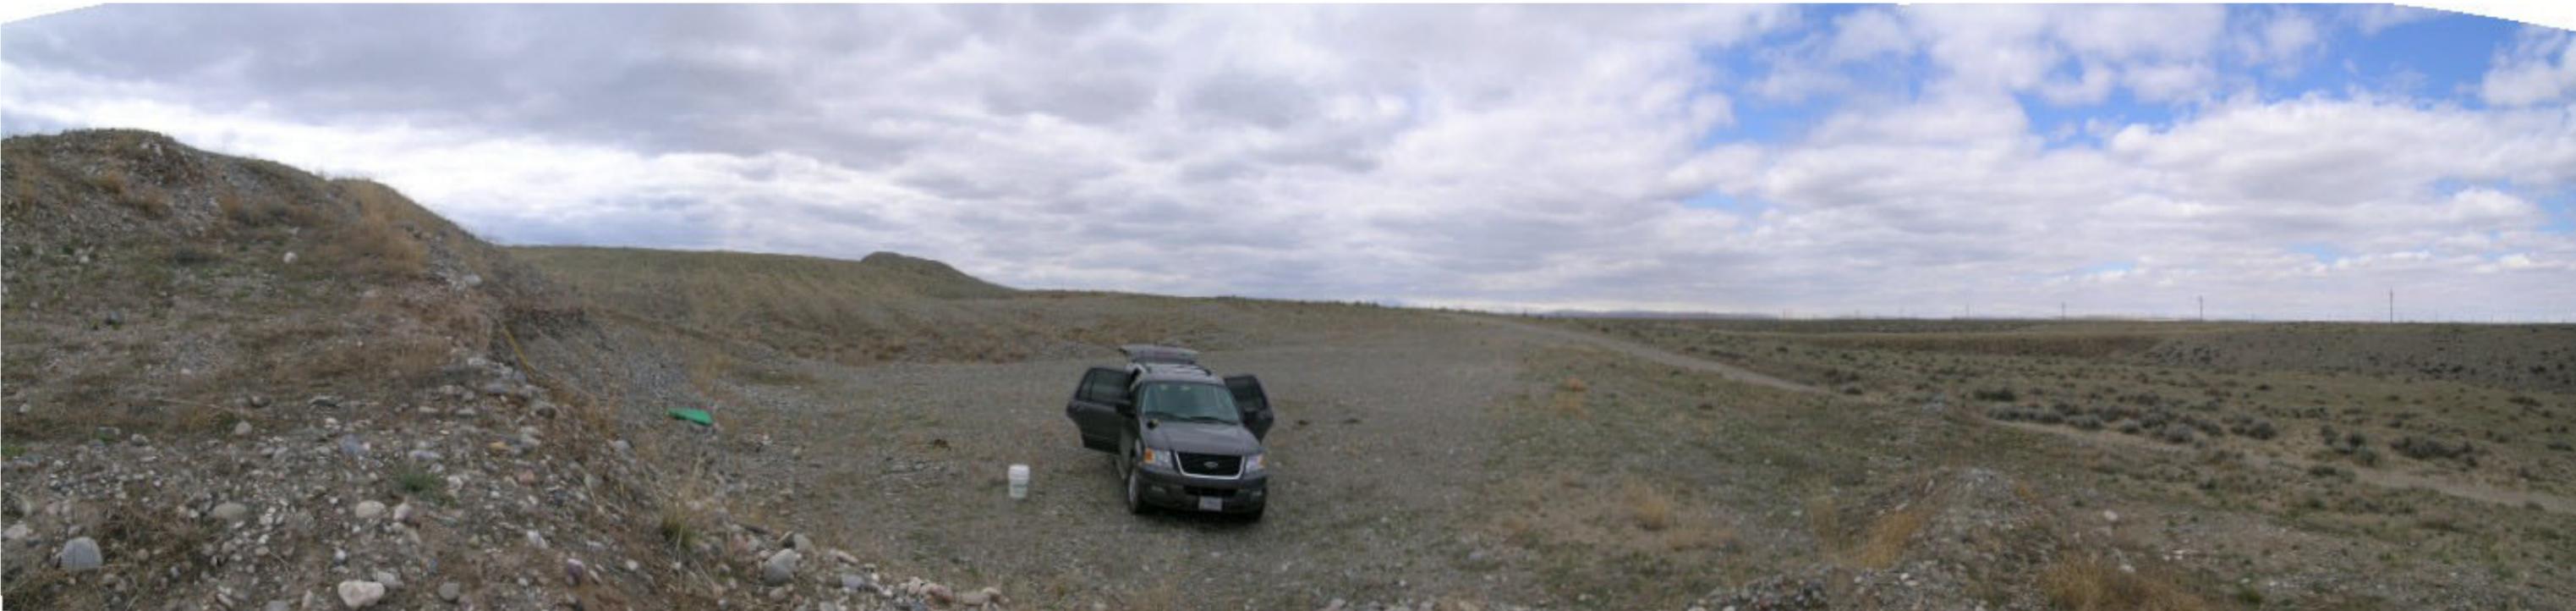
Plate Number 10

General Description The isolated panoramic landscape has industrial development nearby. Typical vegetation is sparse and uneven.

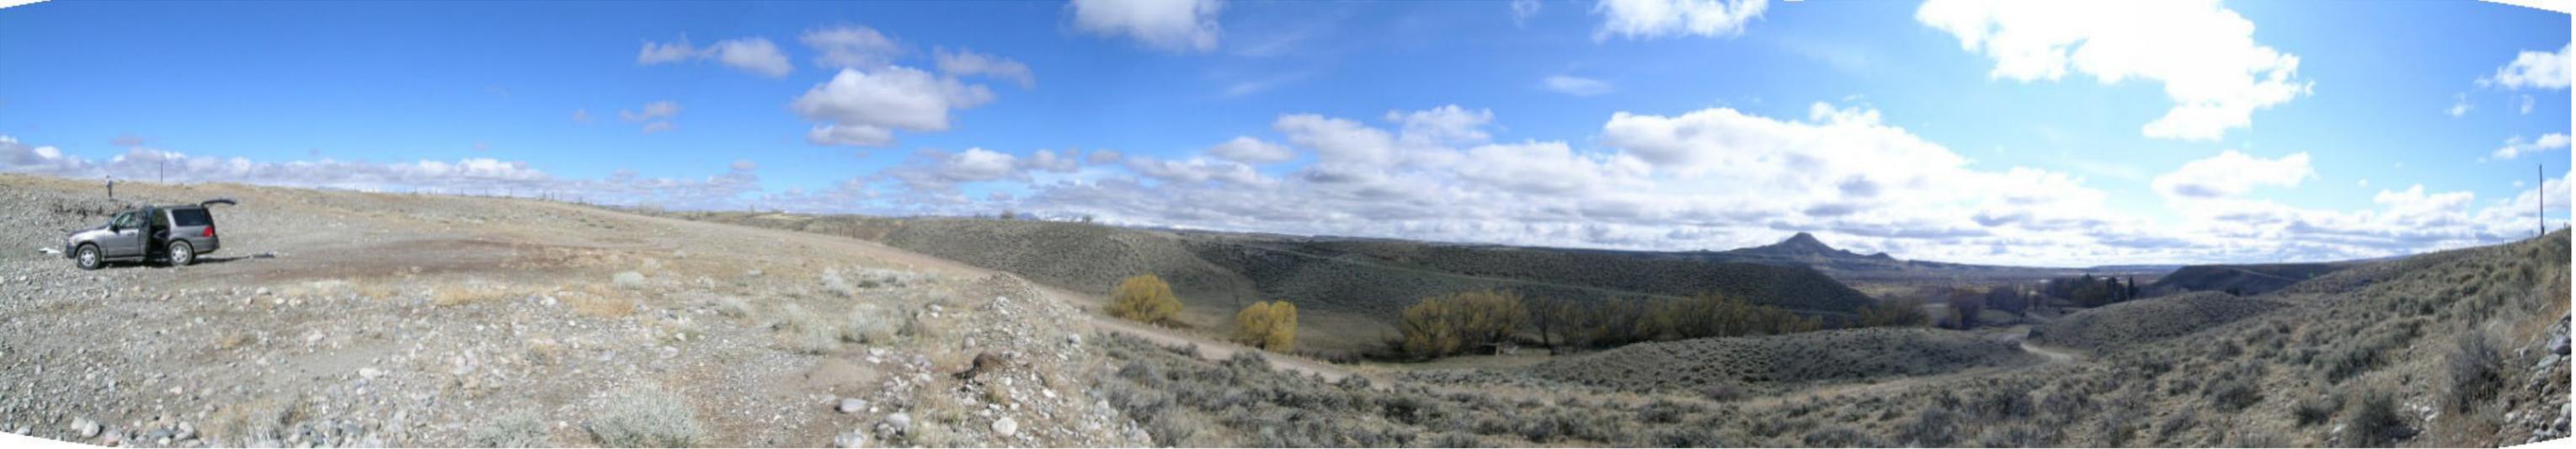
Plate Number 11

General Description The eye is led along a horizontal curve to distant Crowheat Butte and the Wind River Valley in this focal landscape. Farming, ranching, and wildlife habitat make up the pastoral setting.

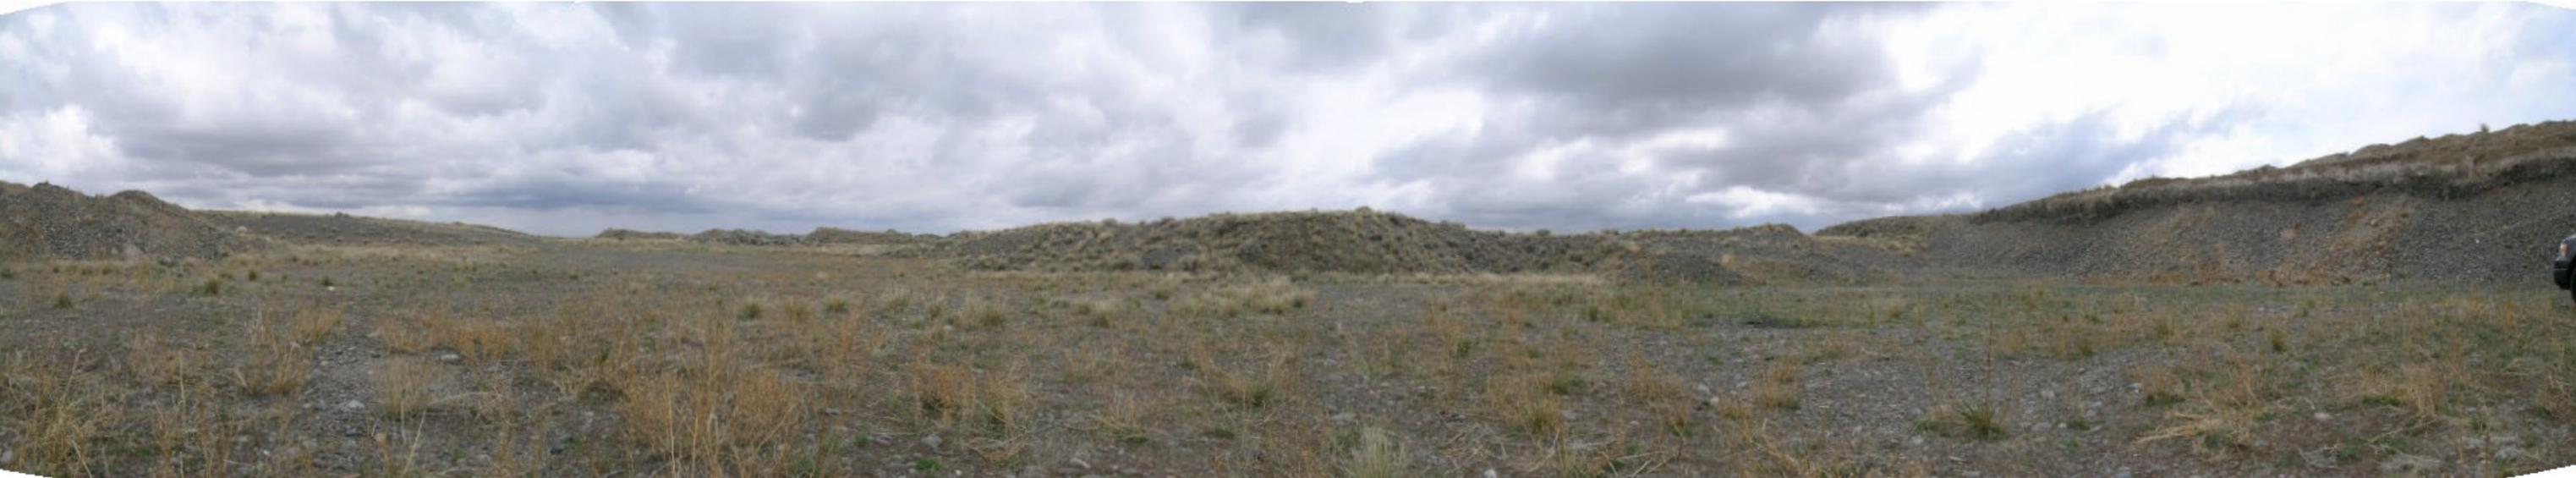
Plate Number 12

General Description Atmospheric conditions mute the impact of the Wind River Mountains forming a dramatic backdrop. The Shoshoni Tribe is actively processing sand and gravel on site and there is oil development to the east (out of observer's view from this vantage point). Stock piles and overburden are in the foreground. The surrounding area is dominated by sagebrush and grasses.
