Preliminary Assessment of Channel Stability and Bed-Material Transport in the Coquille River Basin, Southwestern Oregon

Prepared in cooperation with the U.S. Army Corps of Engineers and the Oregon Department of State Lands

Open-File Report 2012-1064

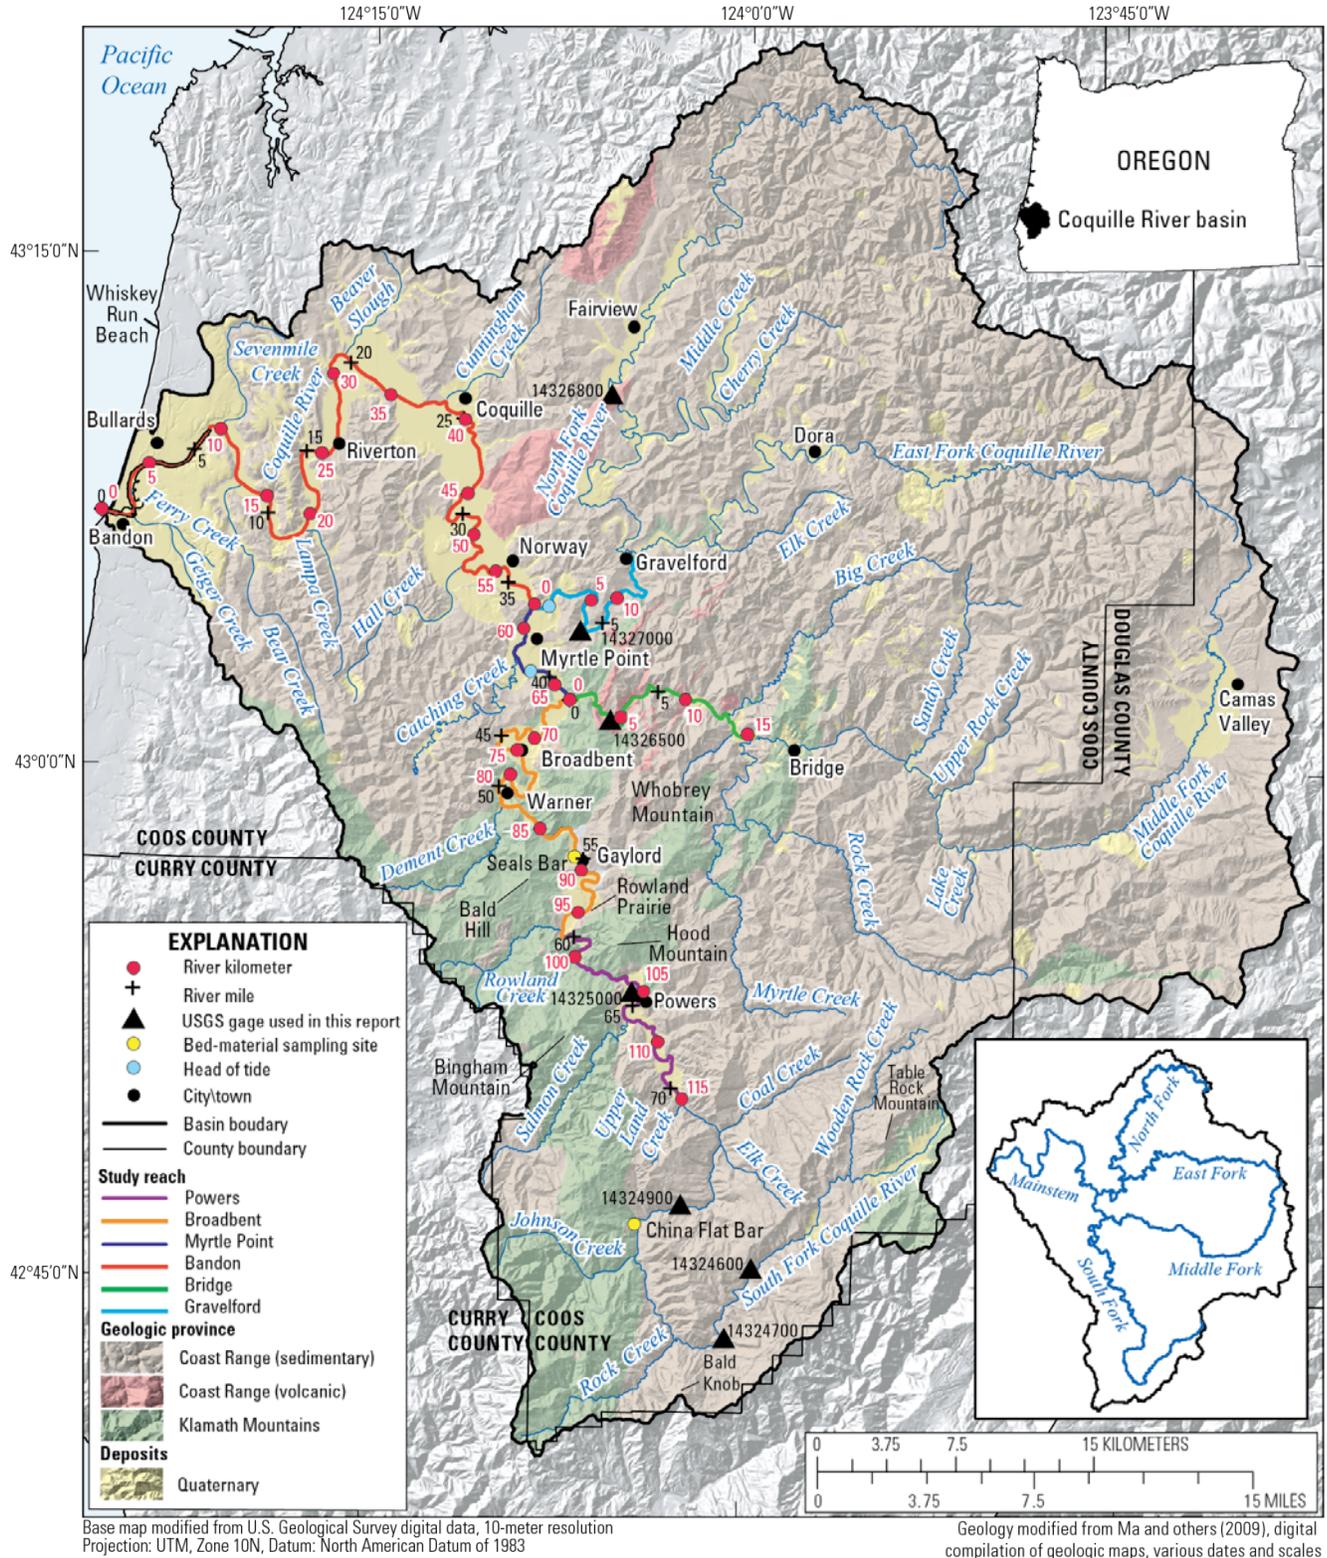
Figure 1. Map displaying the stream network, basin and county boundaries, geologic provinces, study reaches, linear reference systems, and streamflow gage used in this study of the Coquille River basin, southwestern Oregon.

For the purposes of this assessment, the overall geography, geomorphology, and land-use history of the Coquille River basin led to delineation of a focused study area, including (1) the South Fork Coquille River from RKM 115.4 near its confluence with Upper Land Creek to RKM 58.5 at its confluence with the North Fork Coquille River, (2) the mainstem Coquille River from RKM 58.5 at the confluence of the South and North Forks of the Coquille River to its mouth, (3) the Middle Fork Coquille River from RKM 15.4 to its confluence with the South Fork Coquille River, and (4) the North Fork Coquille River from RKM 14.6 to its confluence with the South Fork Coquille River (fig. 1). These mainstem and tributary corridors contain most of the alluvial deposits within the basin and have had the most active and historical instream gravel mining. This study area, encompassing 145.4 km of river channel in total, was further subdivided into six reaches based on topography and hydrology (figs. 1 and 3A–C; tables 2 and 3).

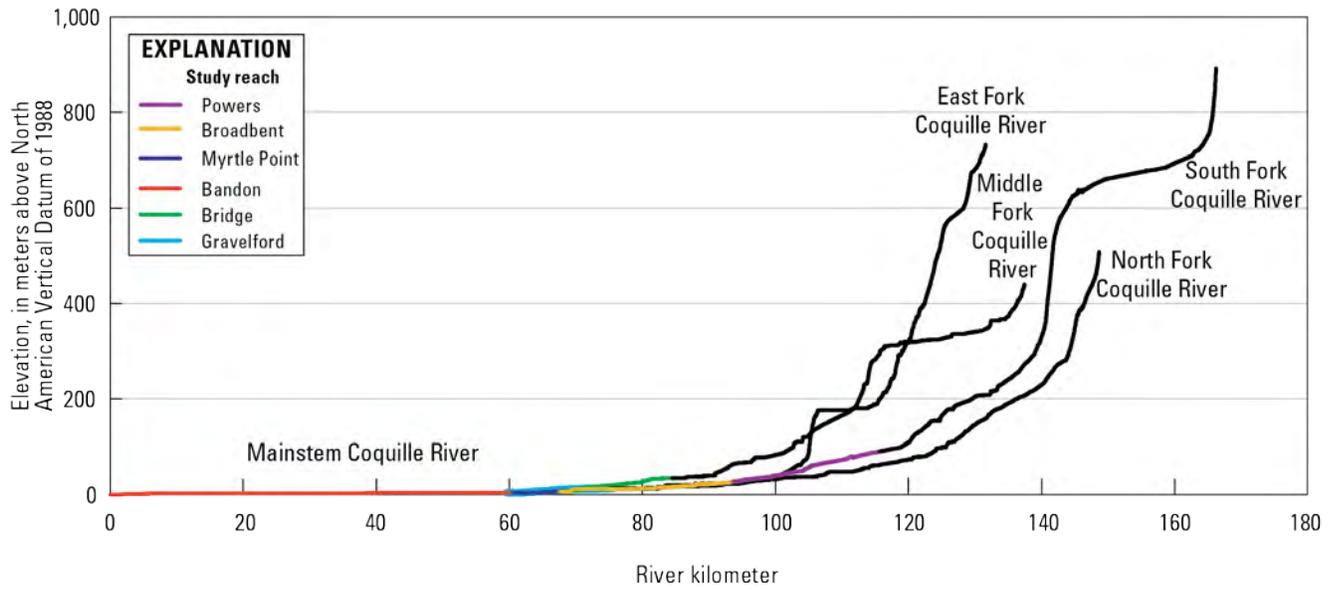
Figure 2. Graph showing the longitudinal profile of the Coquille River basin, southwestern Oregon, as determined from the U.S. Geological Survey 10-m Digital Elevation Model (DEM).

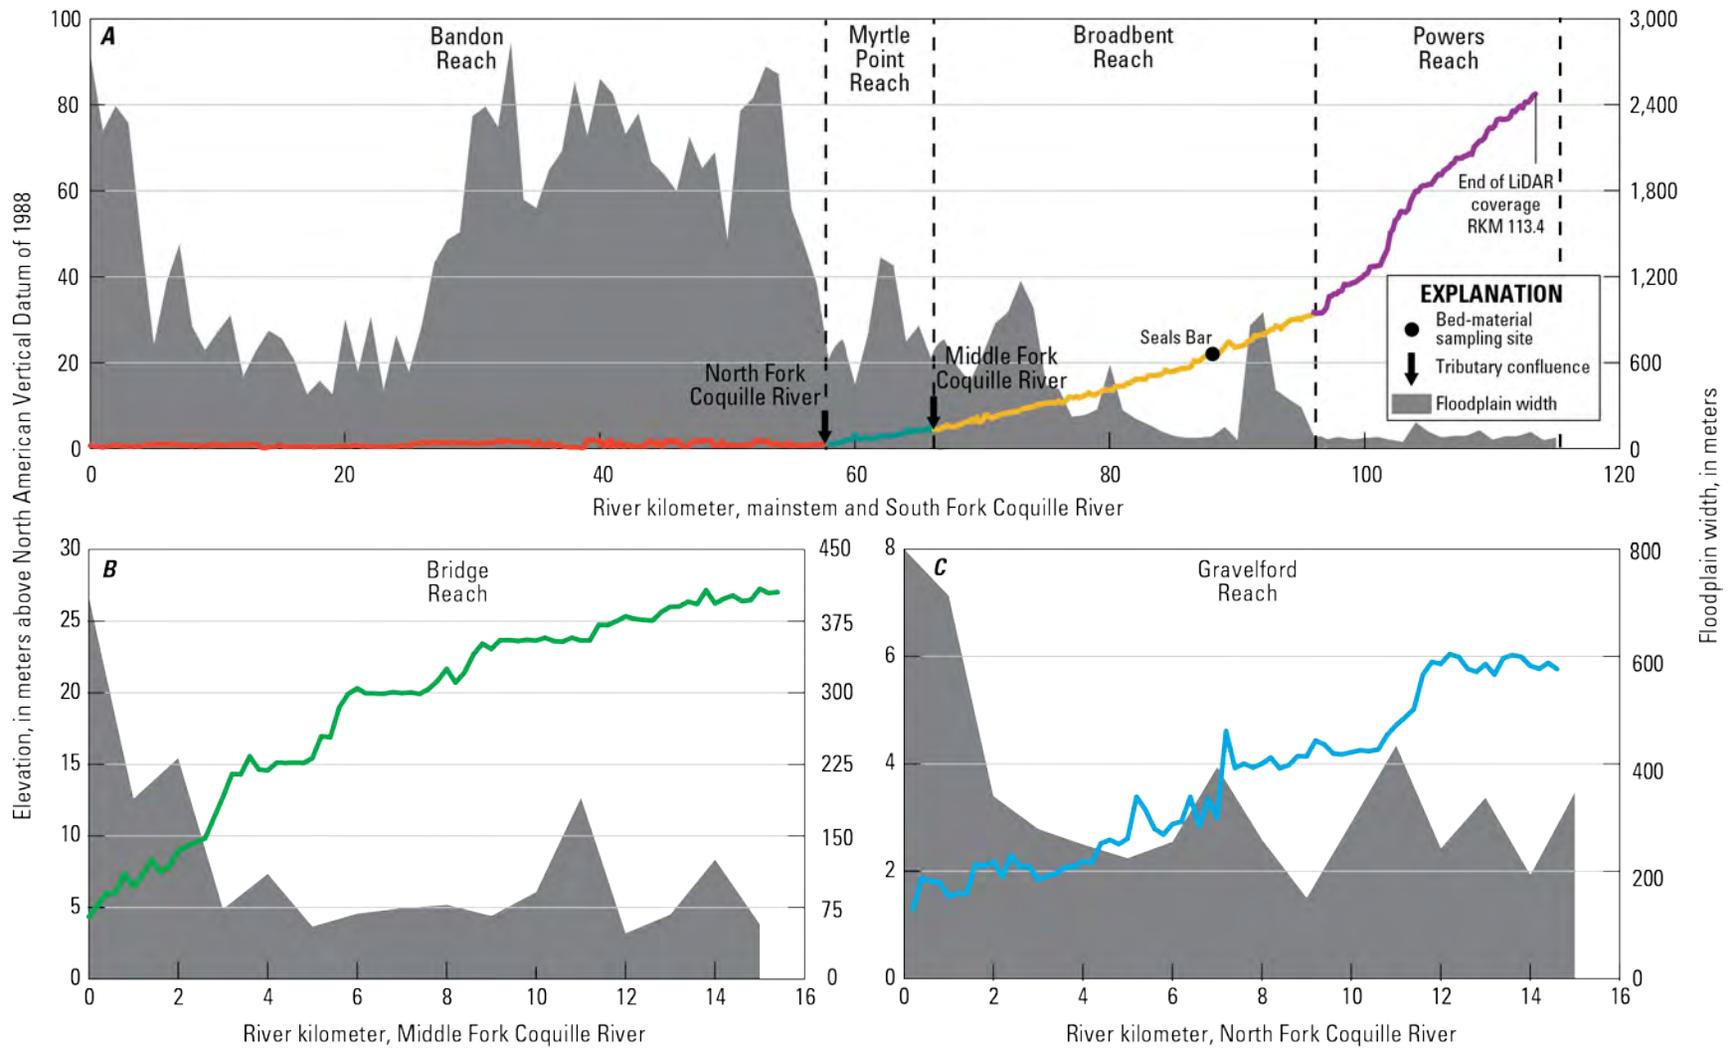
Figure 3. Graphs showing longitudinal profiles and floodplain widths for the (A) Powers, Broadbent, Myrtle Point, and Bandon Reaches on the mainstem and South Fork Coquille River, (B) Bridge Reach on the Middle Fork Coquille River, and (C) Gravelford Reach on the North Fork Coquille River, southwestern Oregon. Elevations were derived from the 1-m Light Detection And Ranging (LiDAR) topographic survey and floodplain widths were derived from LiDAR, soils and geology maps, and aerial photographs.

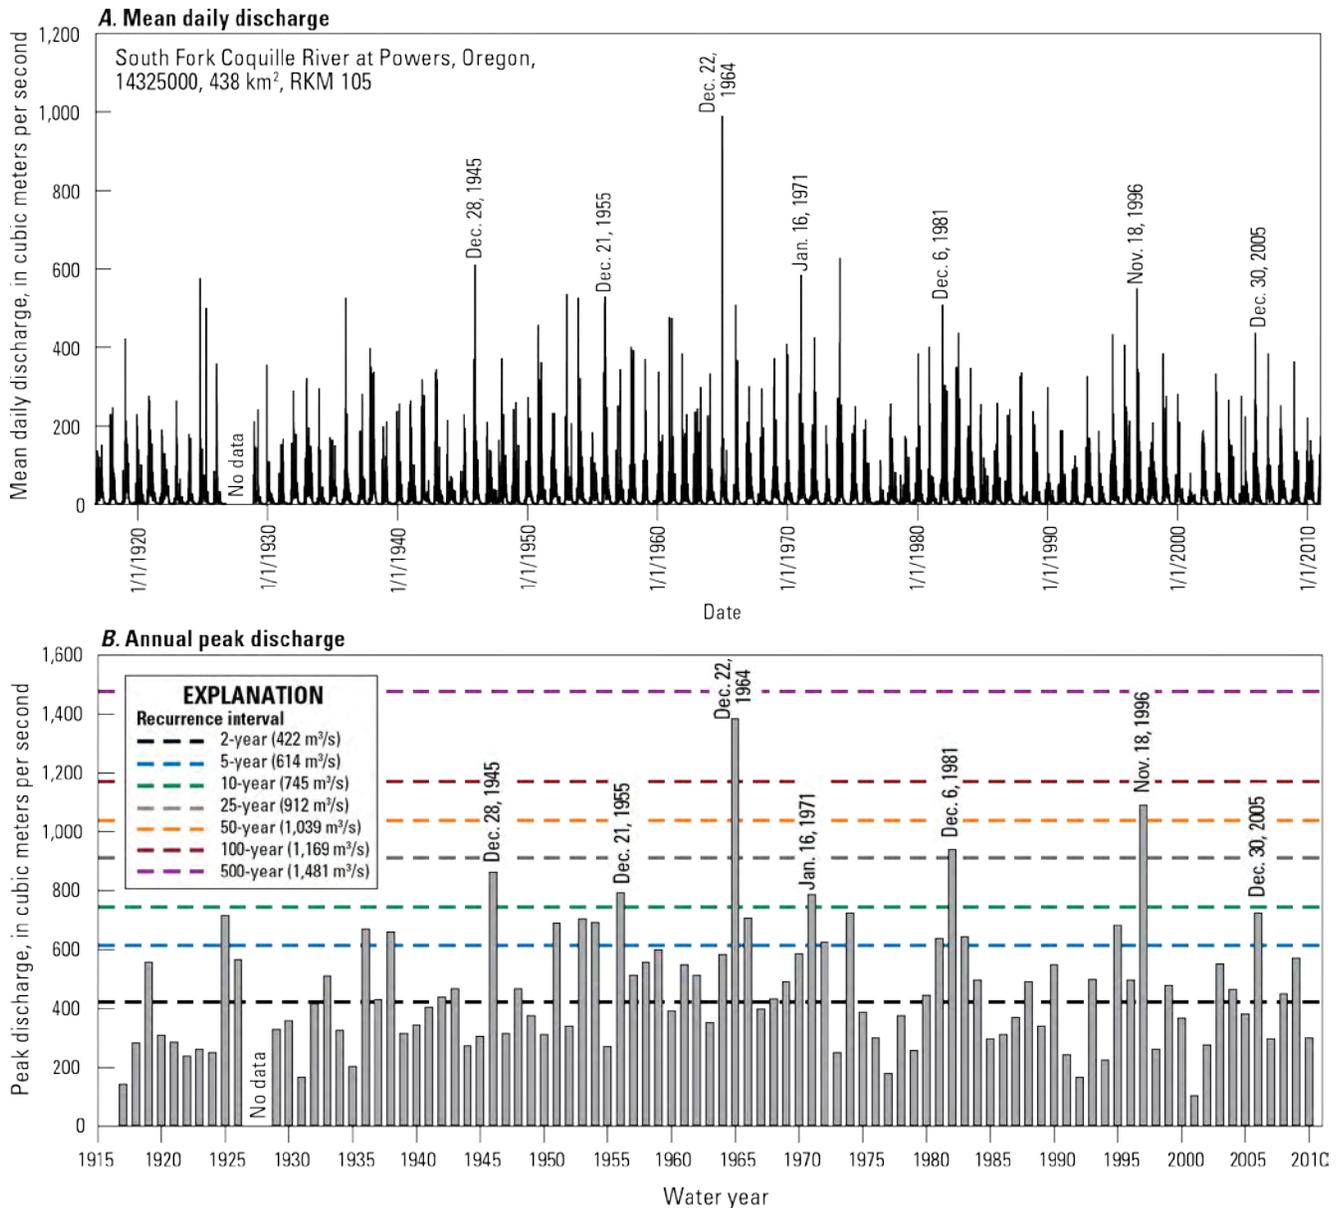
Figure 4. Graphs showing (A) mean daily discharge and (B) annual peak discharge for the U.S. Geological Survey streamflow-gaging station at Powers (14325000) on the South Fork Coquille River, southwestern Oregon. Flow recurrence intervals from Cooper (2005).

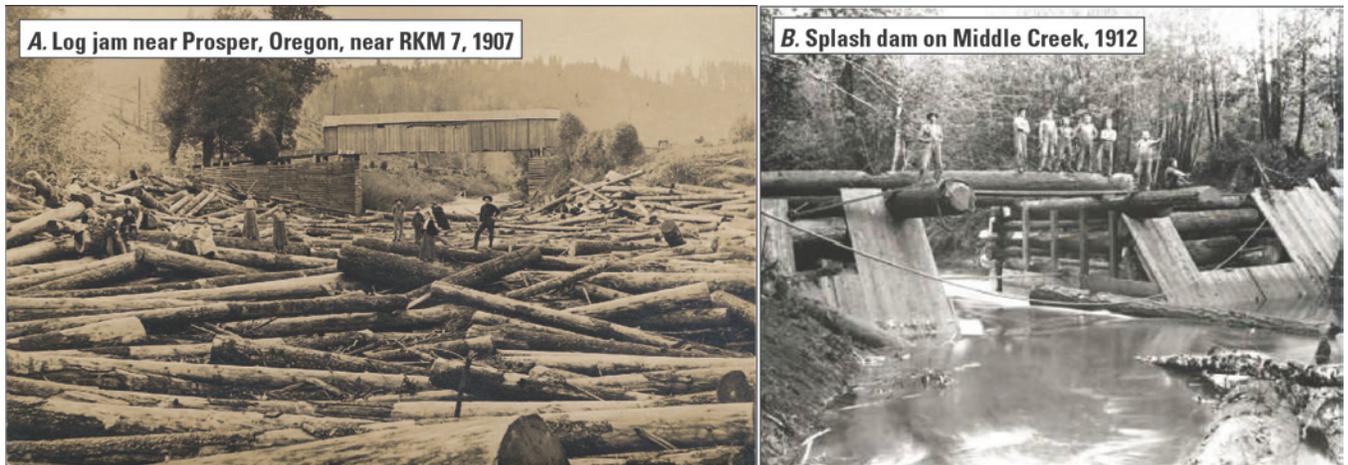
Figure 5. Historical photographs showing: (A) a 200-m-long jam of about 5,400 logs near Prosper, Oregon (near river kilometer 7) in 1907, and (B) splash damming on Middle Creek, a tributary to the North Fork Coquille River, in 1912. (A) and (B) used by permission of Roxann Gess Smith of Salem, Oregon, and Stephen Beckham of Portland, Oregon, respectively.

The tributaries and rivers of the Coquille River basin served as transportation routes (fig. 5A) connecting the upland logging areas with the lowland mills. Initially, channels were cleared of wood and boulders and logs were then floated downstream on the South Fork Coquille River below Powers, mainstem Coquille River, North Fork Coquille River, Middle Fork Coquille River, and numerous tributaries (Benner, 1991; Miller, 2010). The South Fork Coquille River was used for these log drives until about 1914 (Farnell,

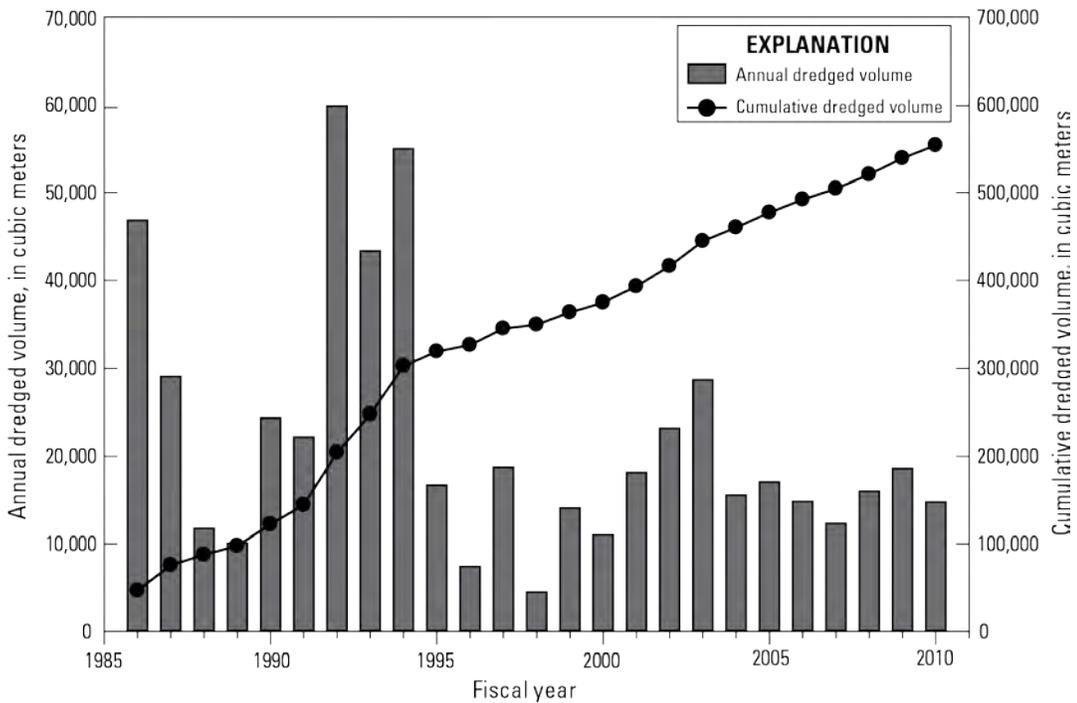
Figure 6. Graph showing reported annual and cumulative volumes of sediment removed from 1986 to 2010 near the mouth of the Coquille River, southwestern Oregon. Data from Judy Linton and Katharine Groth (U.S. Army Corps of Engineers, written commun., 2011) and U.S. Army Corps of Engineers (2010). Fiscal year refers to the Federal fiscal year of October 1 to September 30.

ties and dredged since 1880 (Willingham, 1983). Historical and ongoing dredging has focused on maintaining a stable channel elevation between the jetties and along the lower 2 km of the main-stem Coquille River. Between 1986 and 2010, more than 533,000 m³ of sediment (primarily sand) was removed from the lower 2 km of the Coquille River, averaging nearly 22,150 m³ per year (fig. 6).

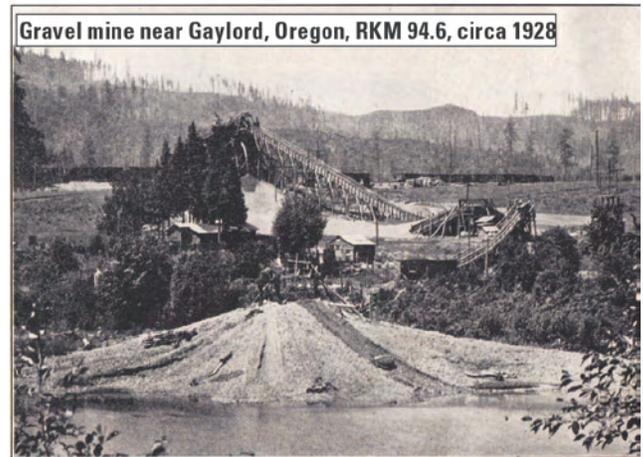
Figure 7. Historical photograph from a Coos Bay Times (1928) article showing the McGeorge Gravel Company's mining site on the South Fork Coquille River near Gaylord, Oregon. Dolores Knight of the Coos Bay Public Library provided this copy of the photograph.

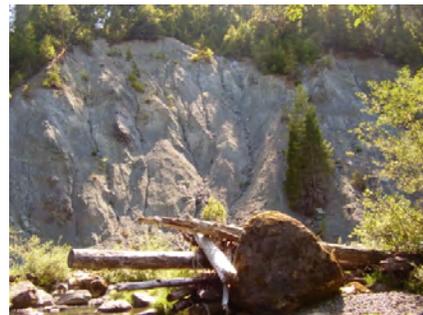
Landslide on the South Fork Coquille River upstream of China Flat Bar

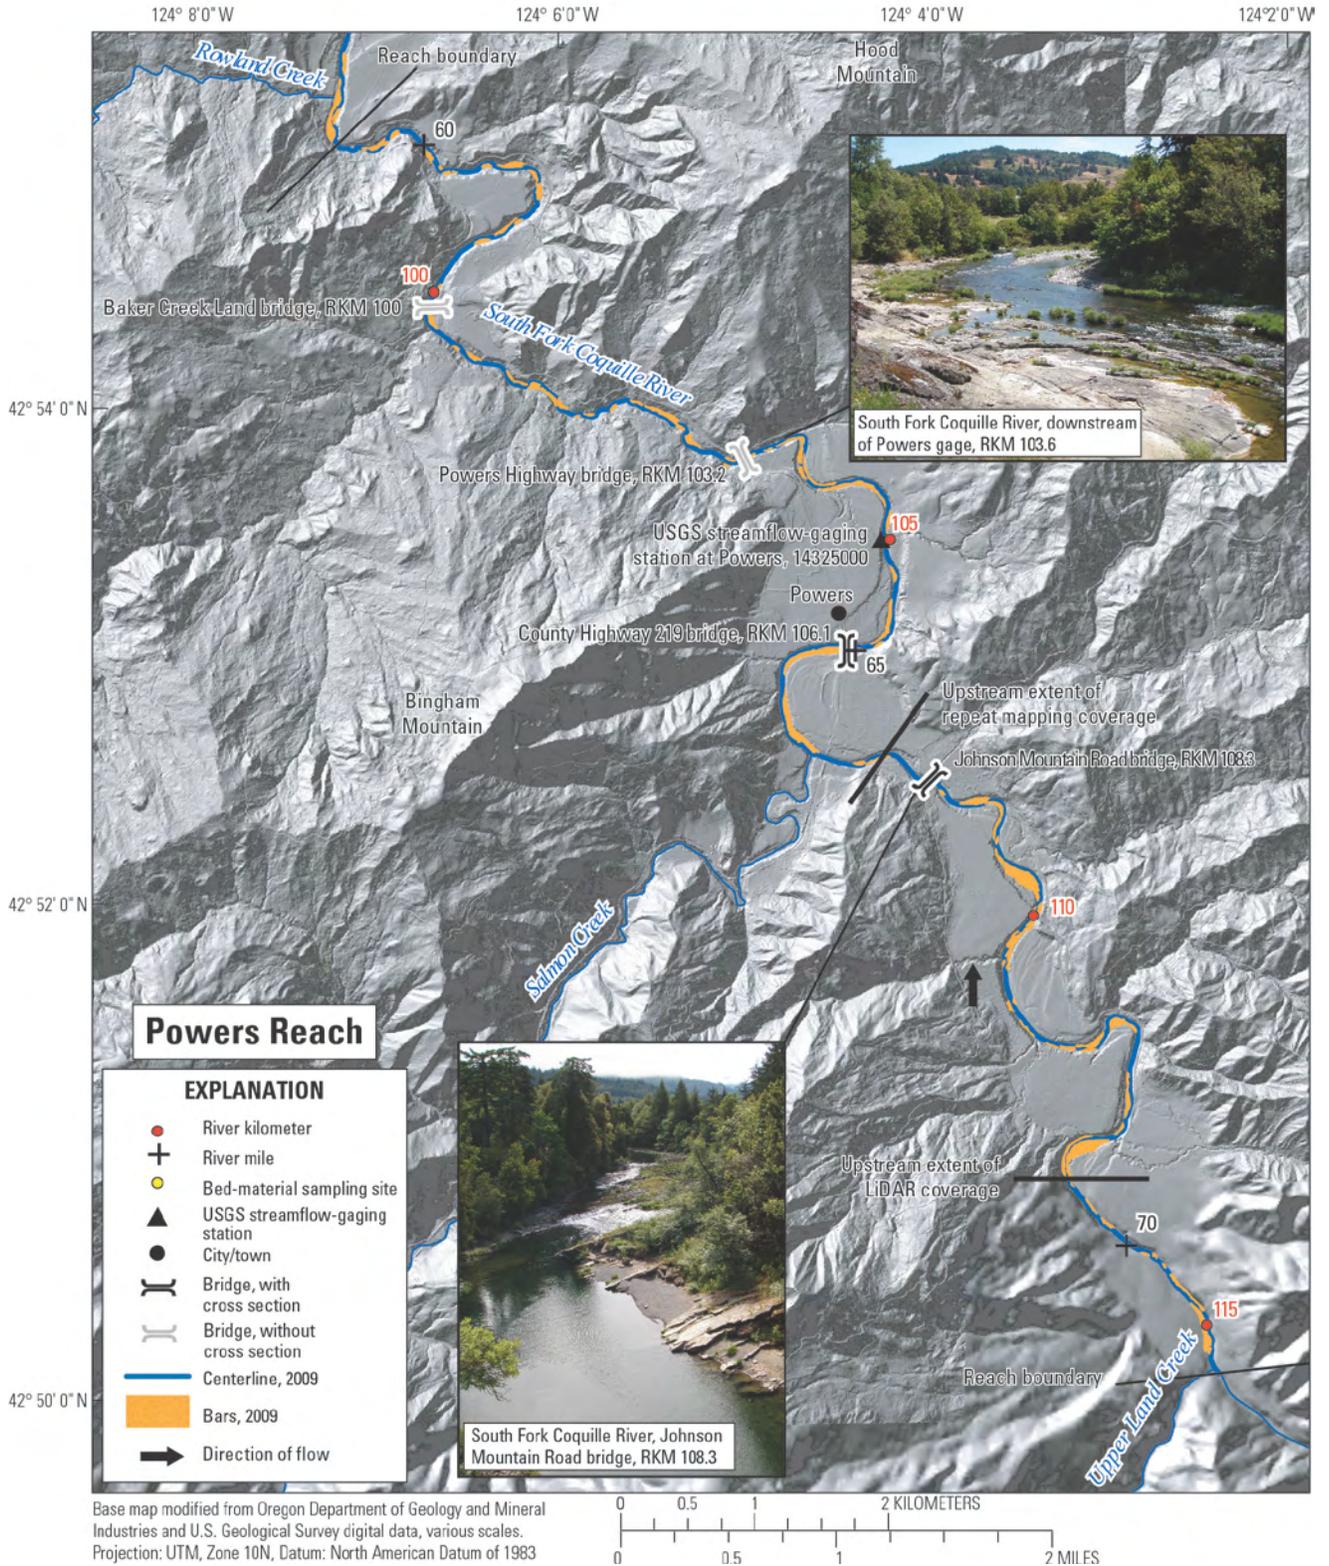
Figure 8. Map showing key locations and bars and channel centerline delineated from 2009 orthophotographs and field reconnaissance photographs for the Powers Reach on the South Fork Coquille River, southwestern Oregon.

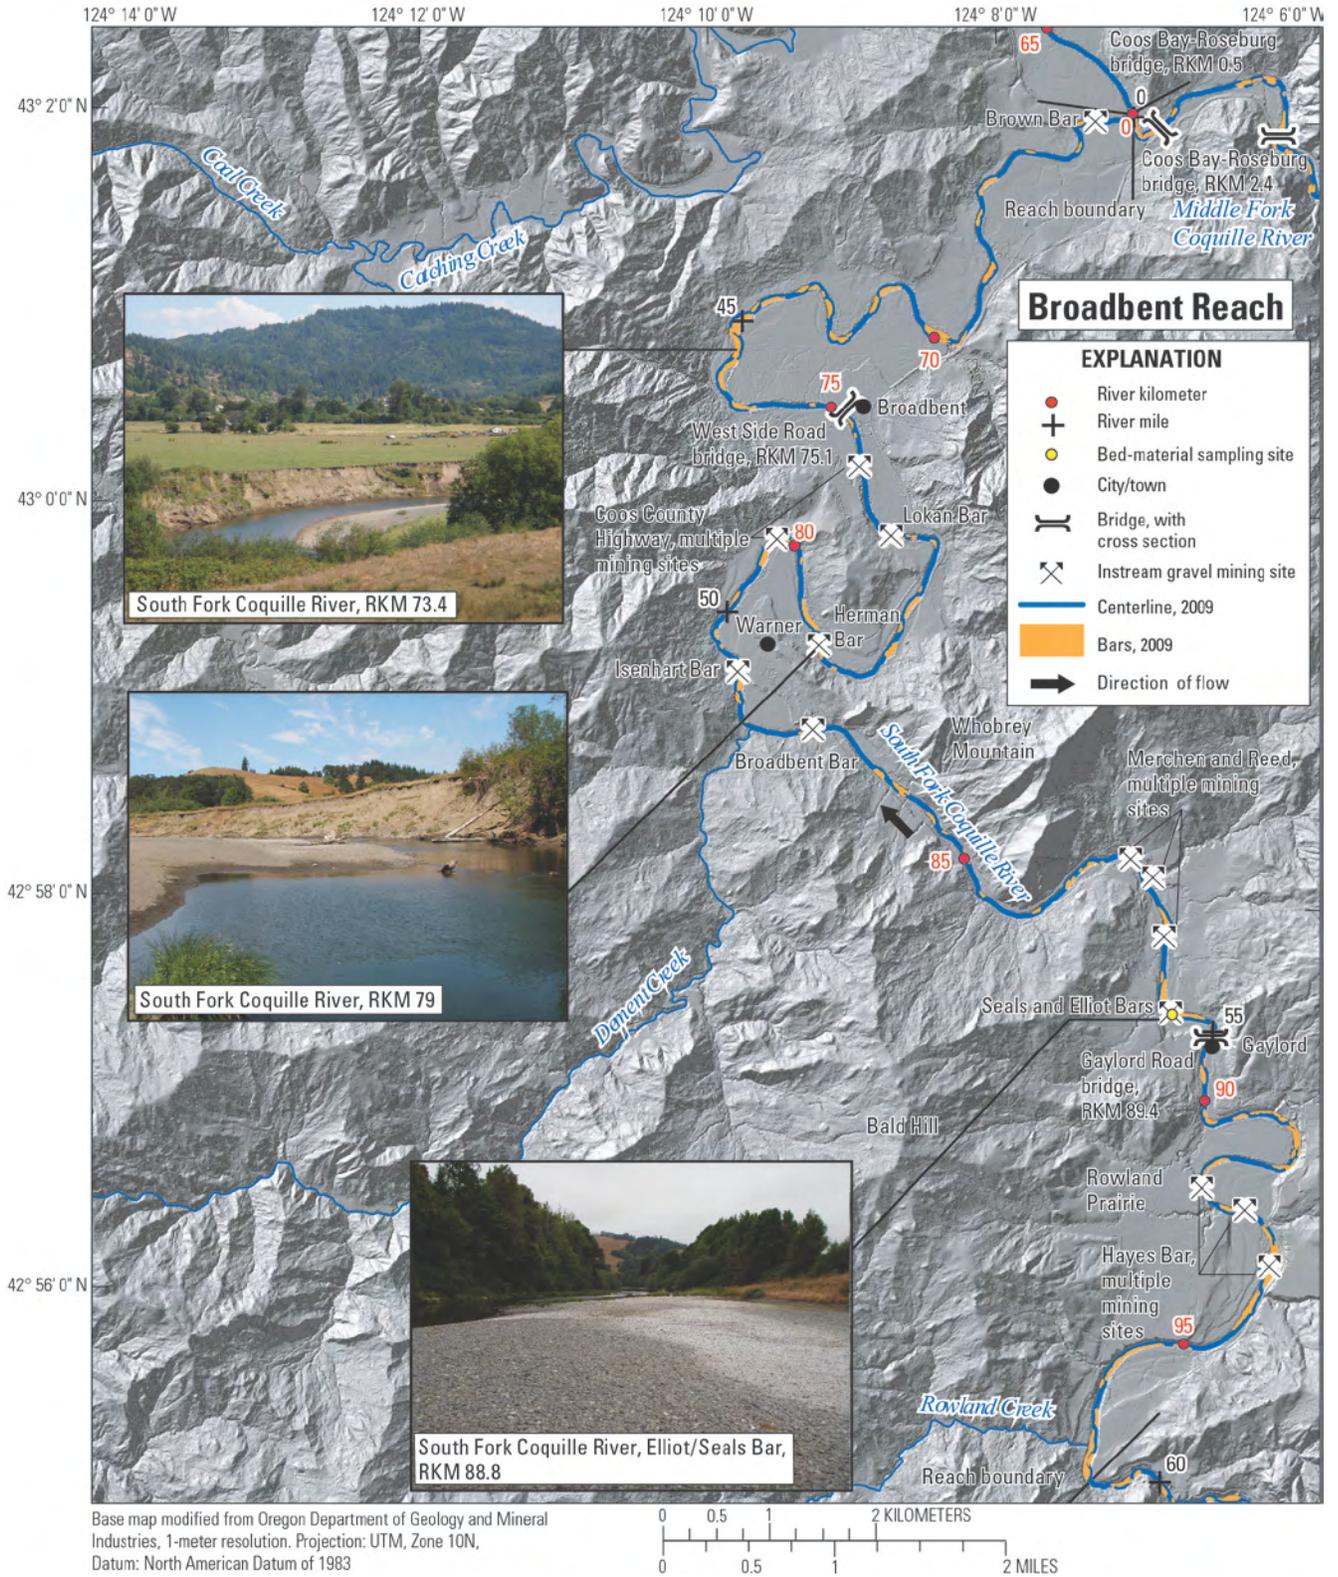
Figure 9. Map showing key locations and bars and channel centerline delineated from 2009 orthophotographs and field reconnaissance photographs for the Broadbent Reach on the South Fork Coquille River, southwestern Oregon.

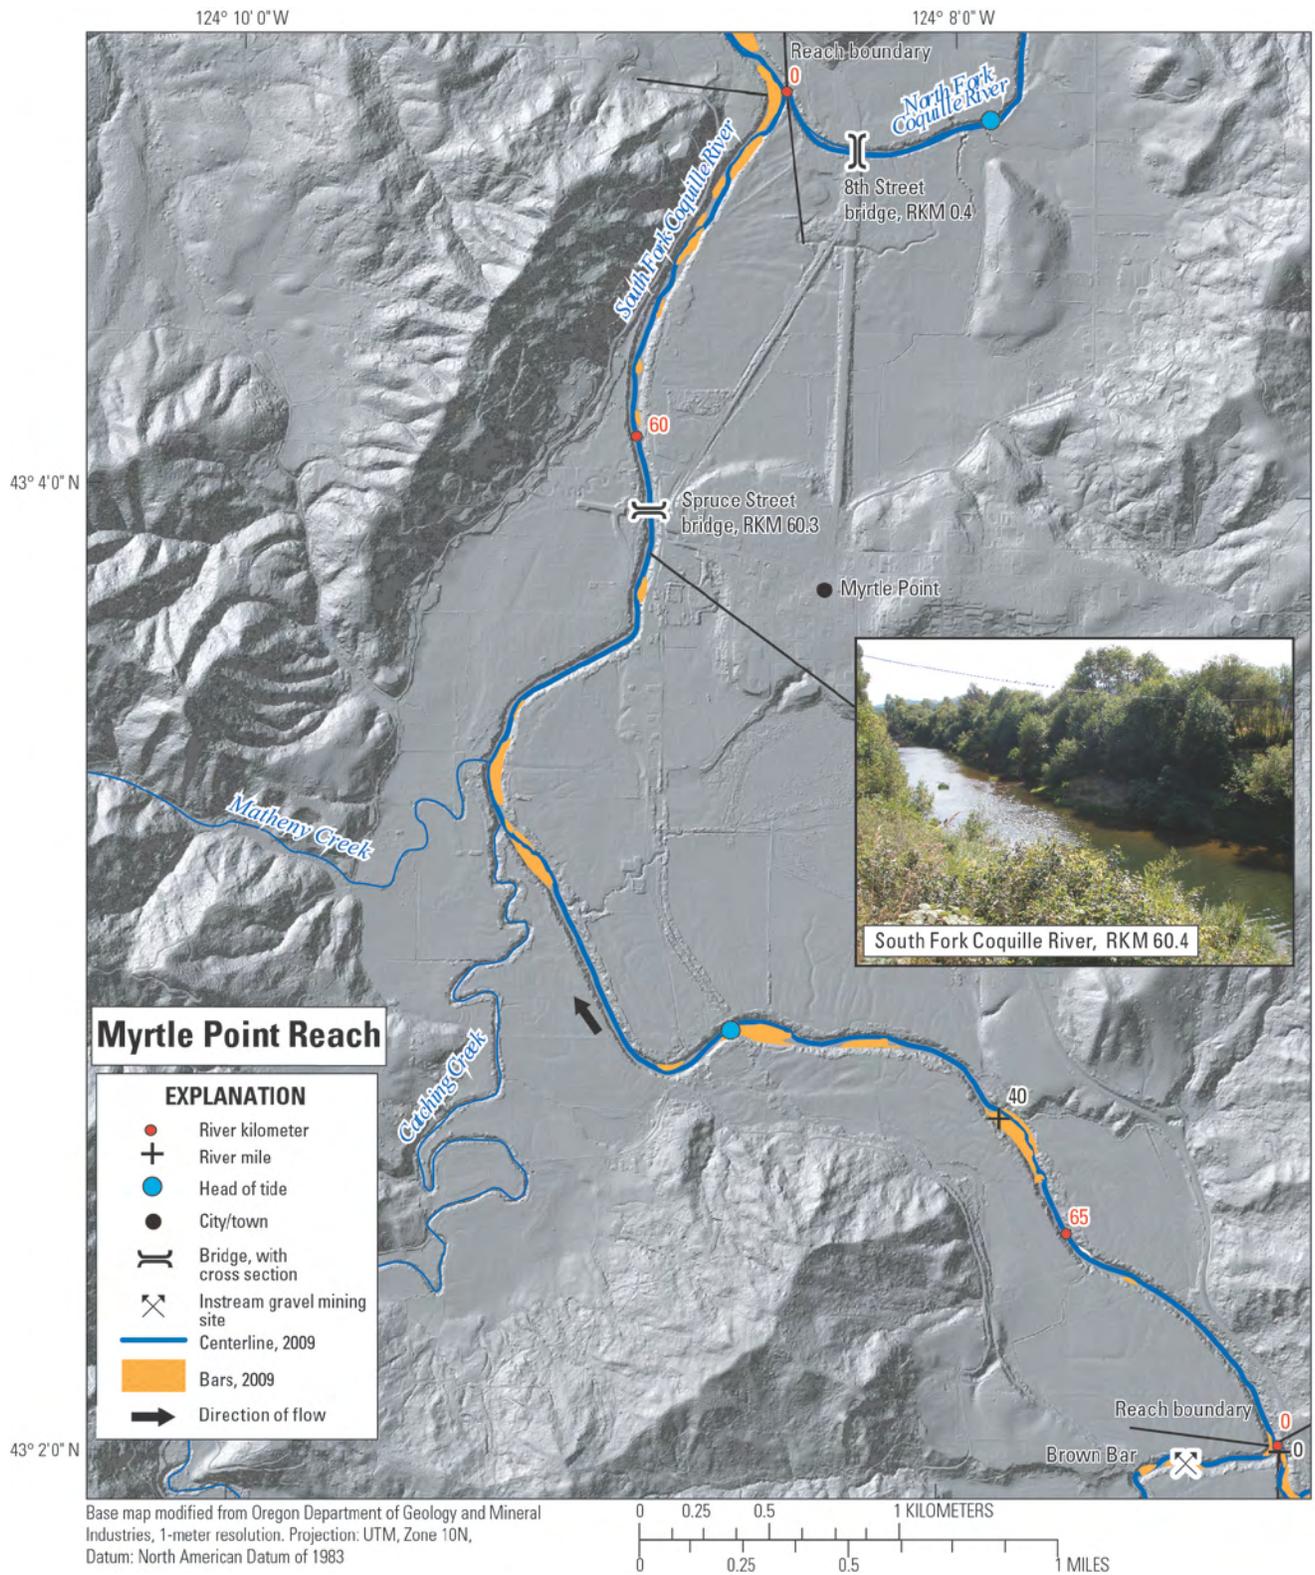
Figure 10. Map showing key locations and bars and channel centerline delineated from 2009 orthophotographs and a field reconnaissance photograph for the Myrtle Point Reach on the South Fork Coquille River, southwestern Oregon.

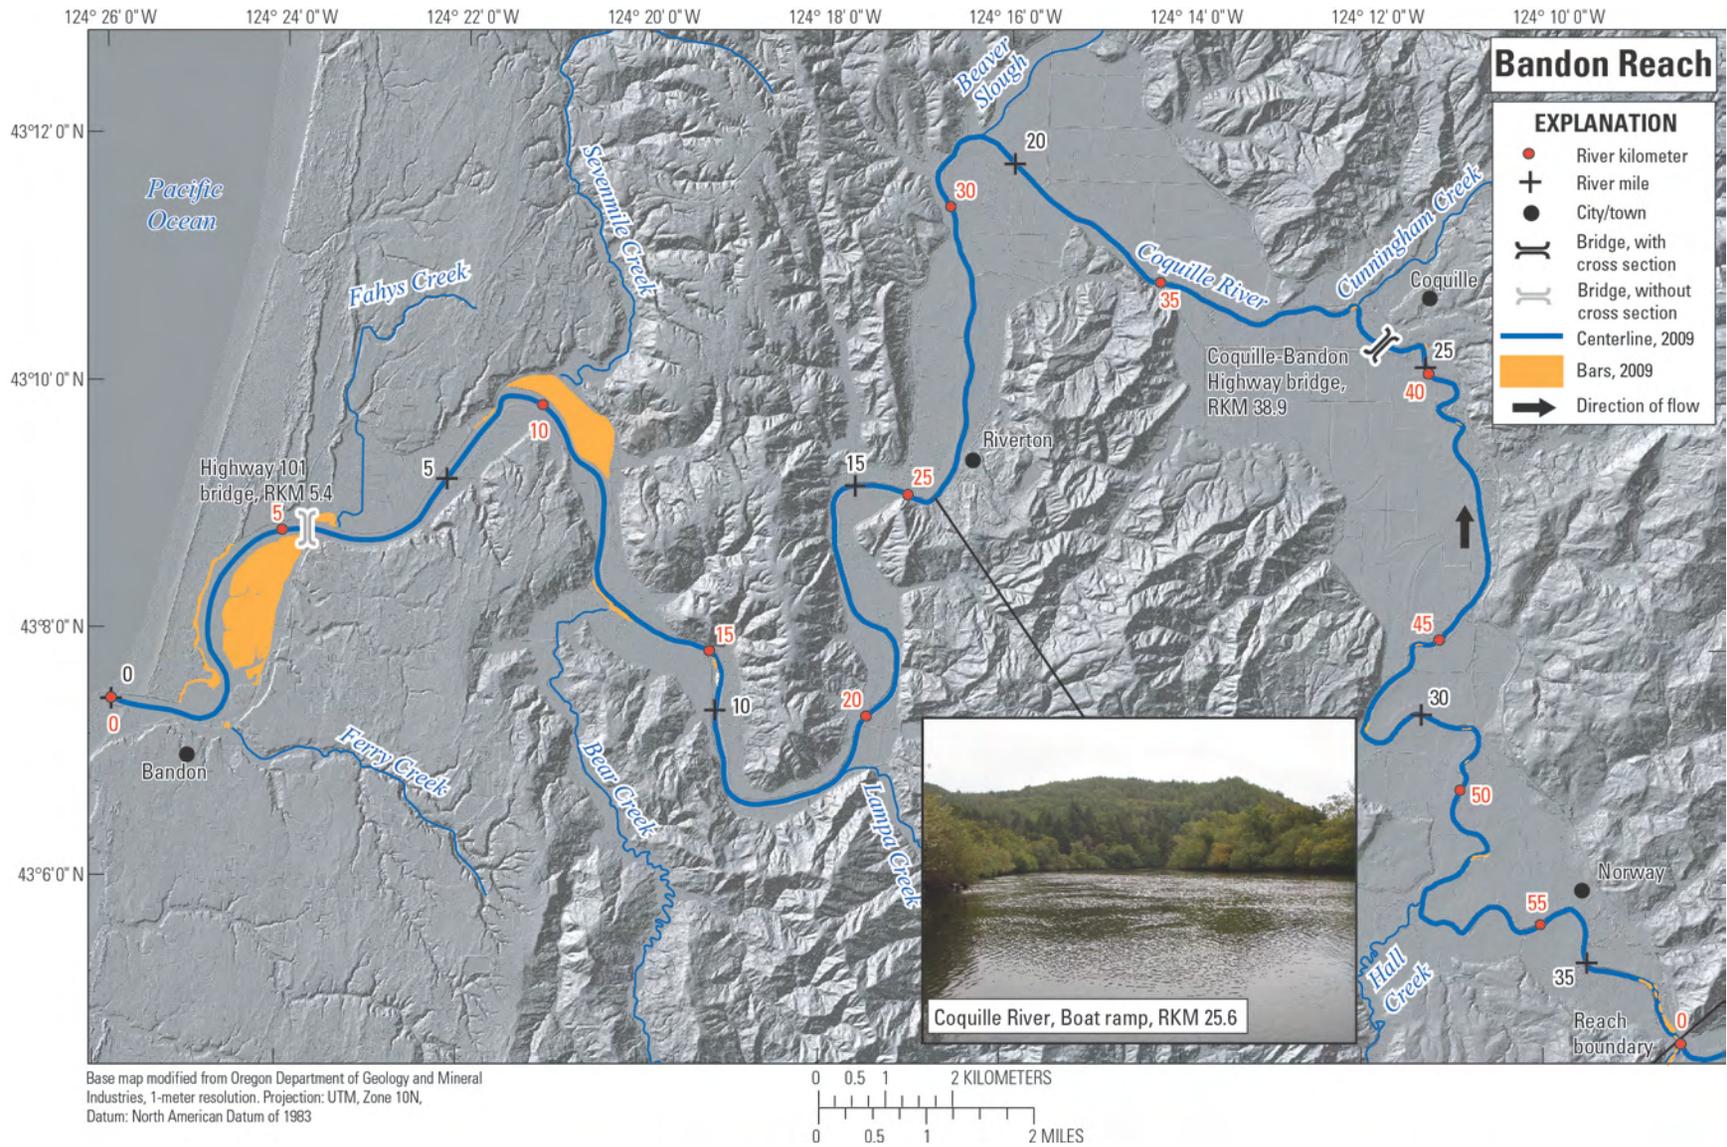
Figure 11. Map showing key locations and bars and channel centerline delineated from 2009 orthophotographs and a field reconnaissance photograph for the Bandon Reach on the mainstem Coquille River, southwestern Oregon.

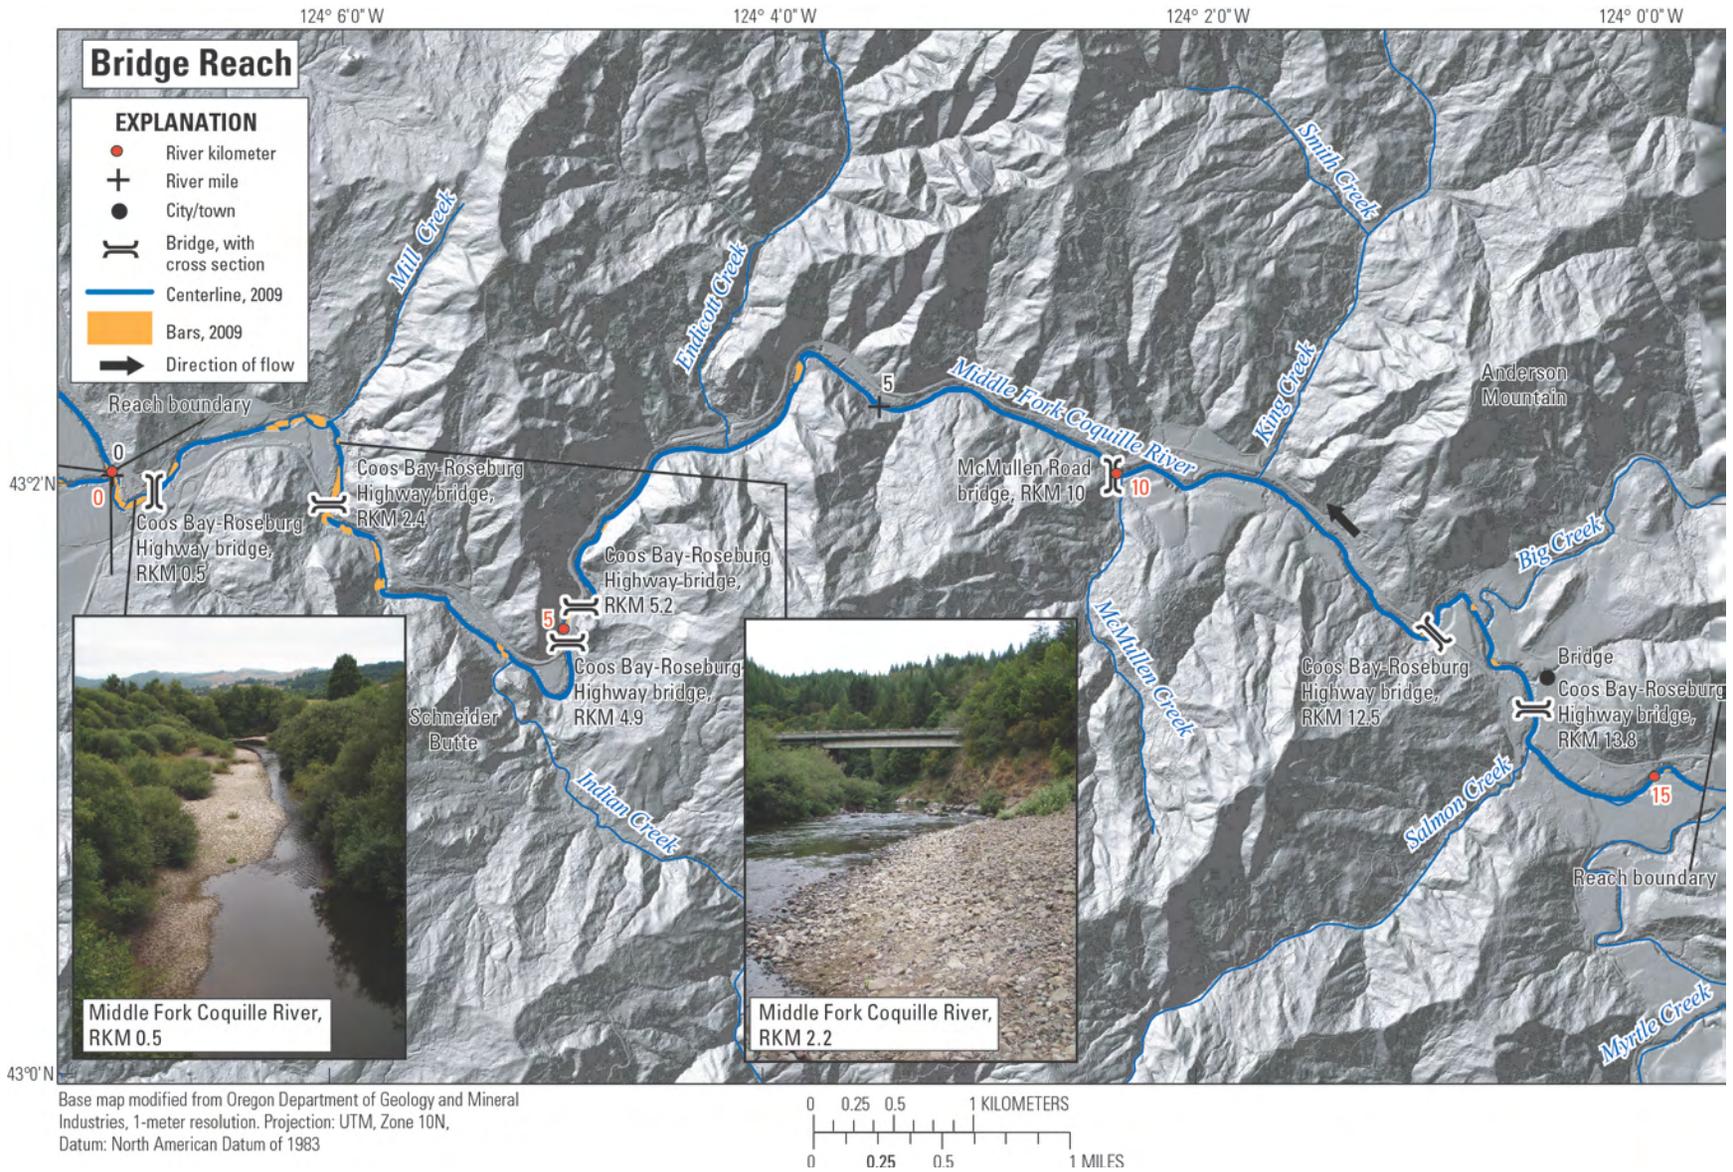
Figure 12. Map showing key locations and bars and channel centerline delineated from 2009 orthophotographs and field reconnaissance photographs for the Bridge Reach on the Middle Fork Coquille River, southwestern Oregon.

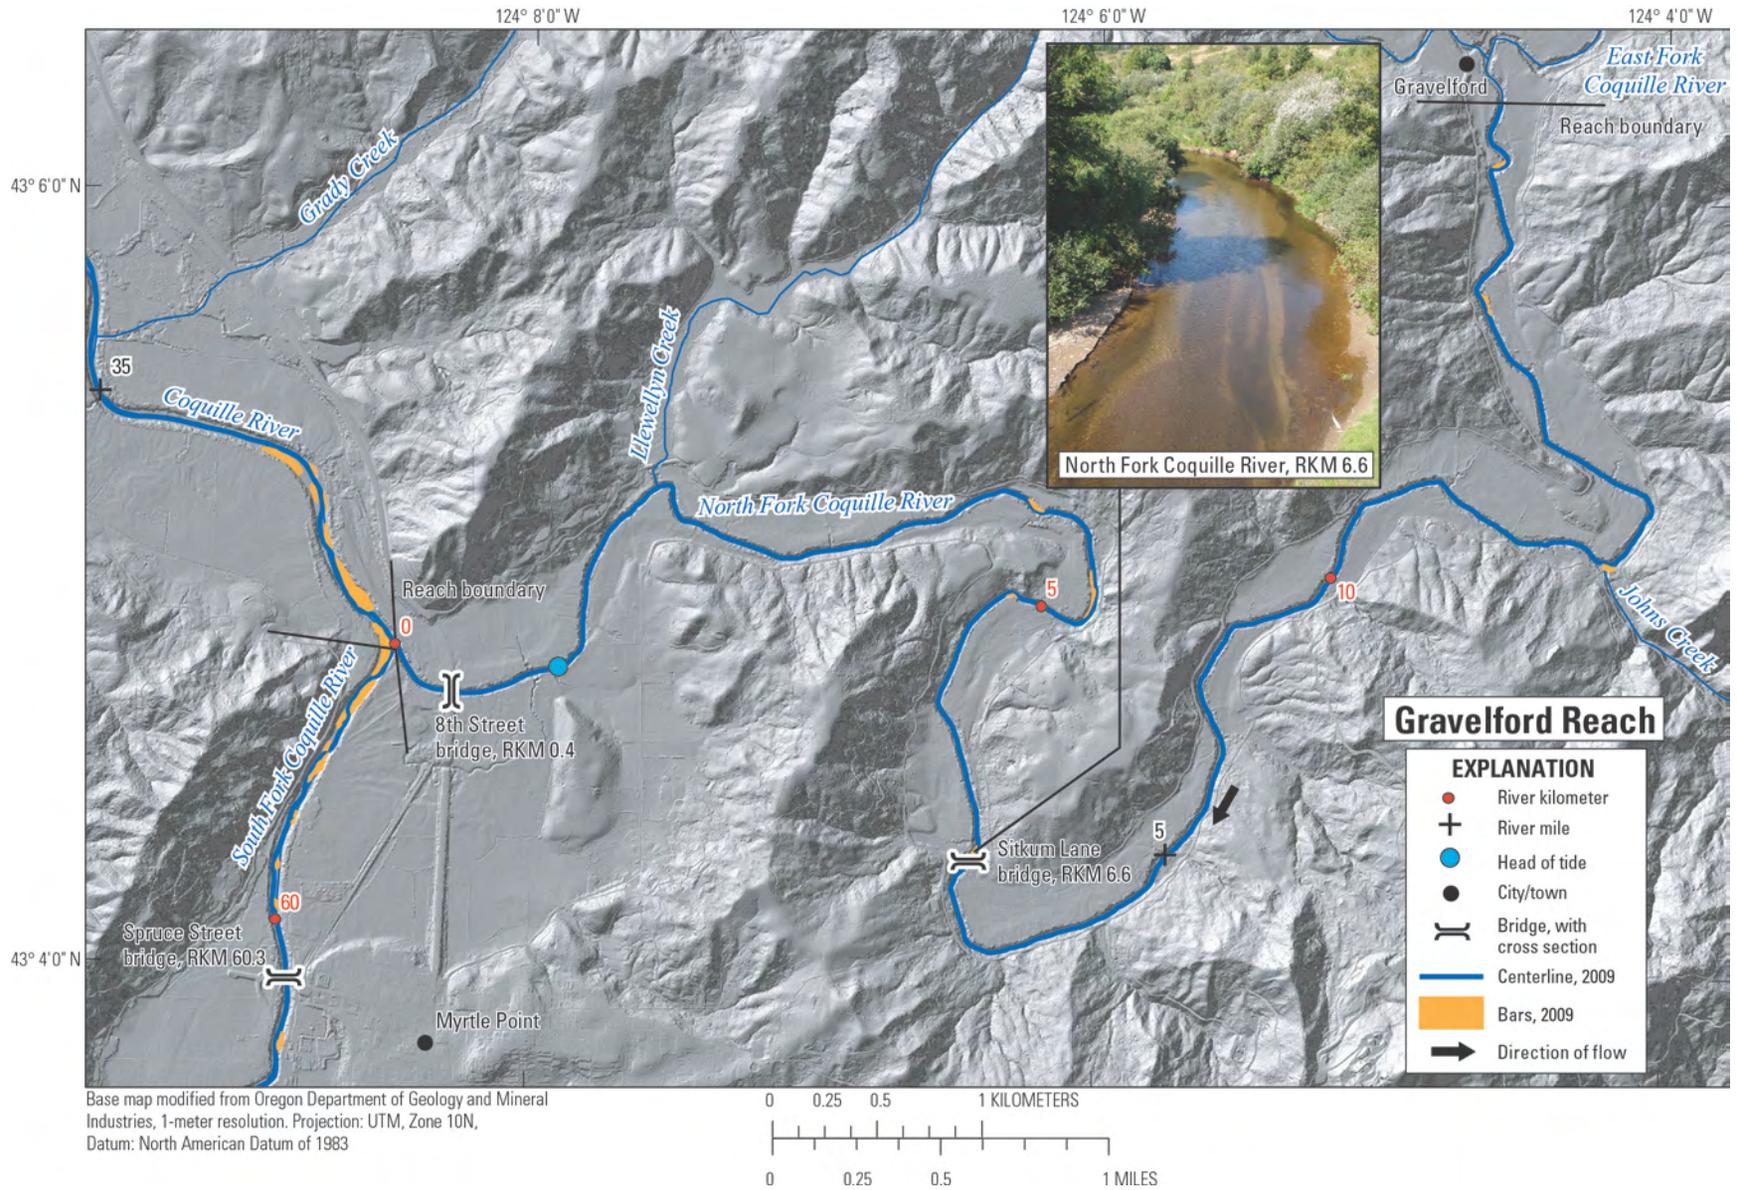
Figure 13. Map showing key locations and bars and channel centerline delineated from 2009 orthophotographs and a field reconnaissance photograph for the Gravelford Reach on the North Fork Coquille River, southwestern Oregon.
