Preliminary Assessment of Channel Stability and Bed-Material Transport in the Coquille River Basin, Southwestern Oregon

Prepared in cooperation with the U.S. Army Corps of Engineers and the Oregon Department of State Lands

Open-File Report 2012-1064

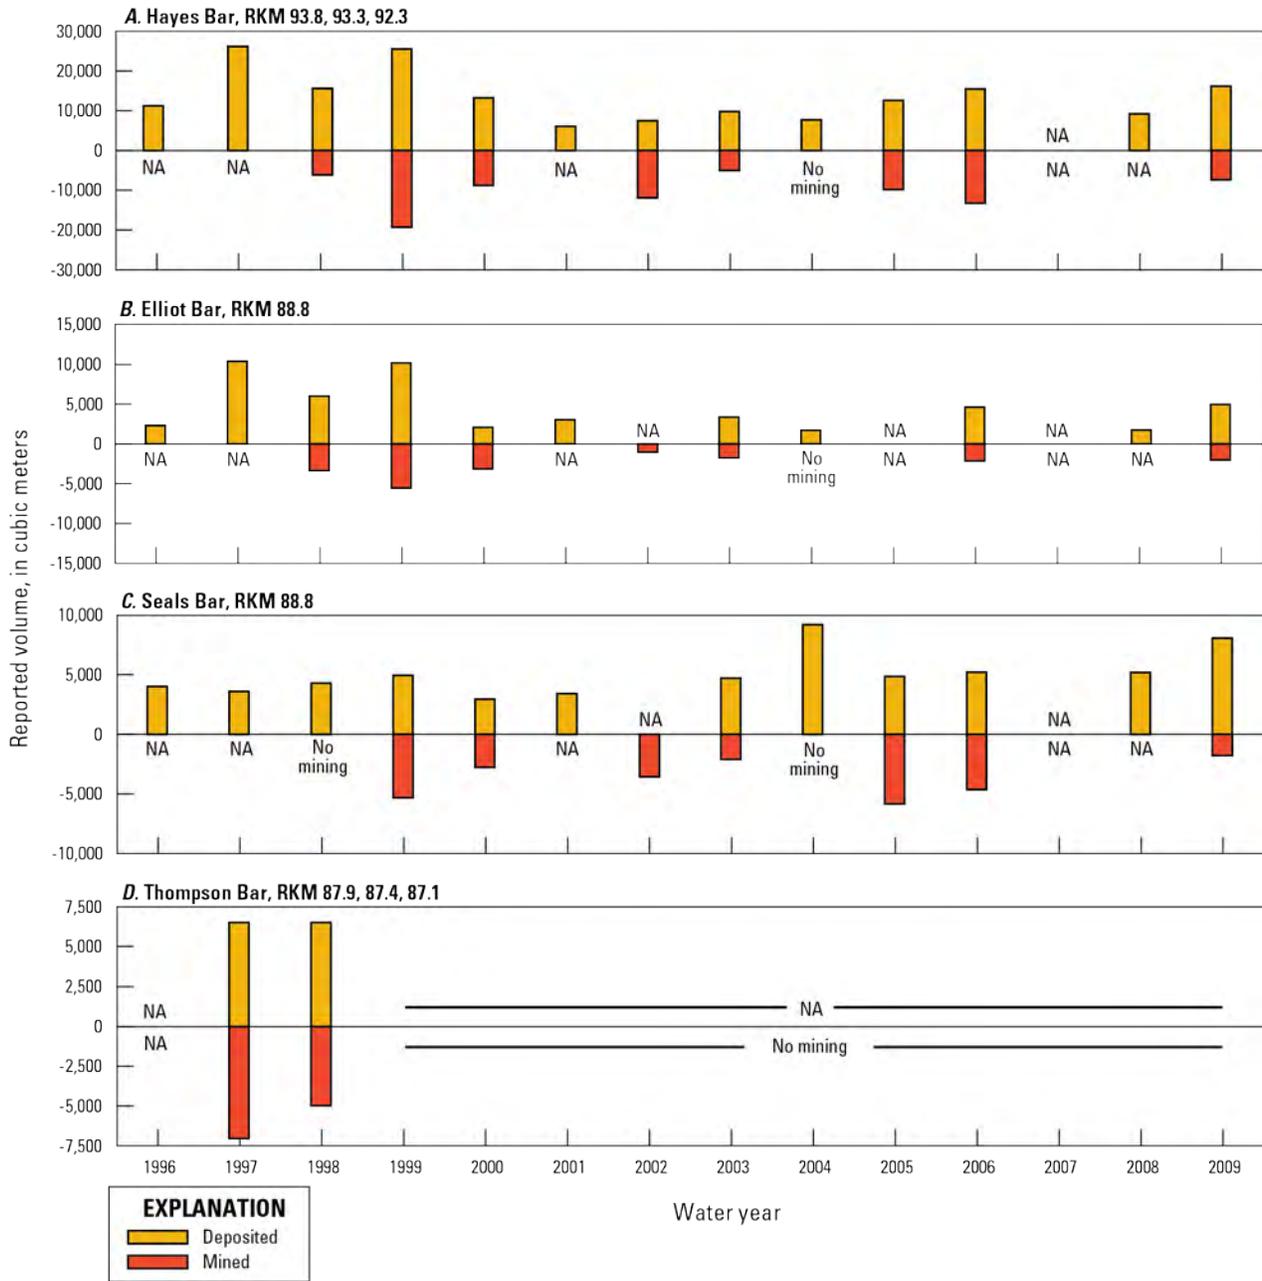
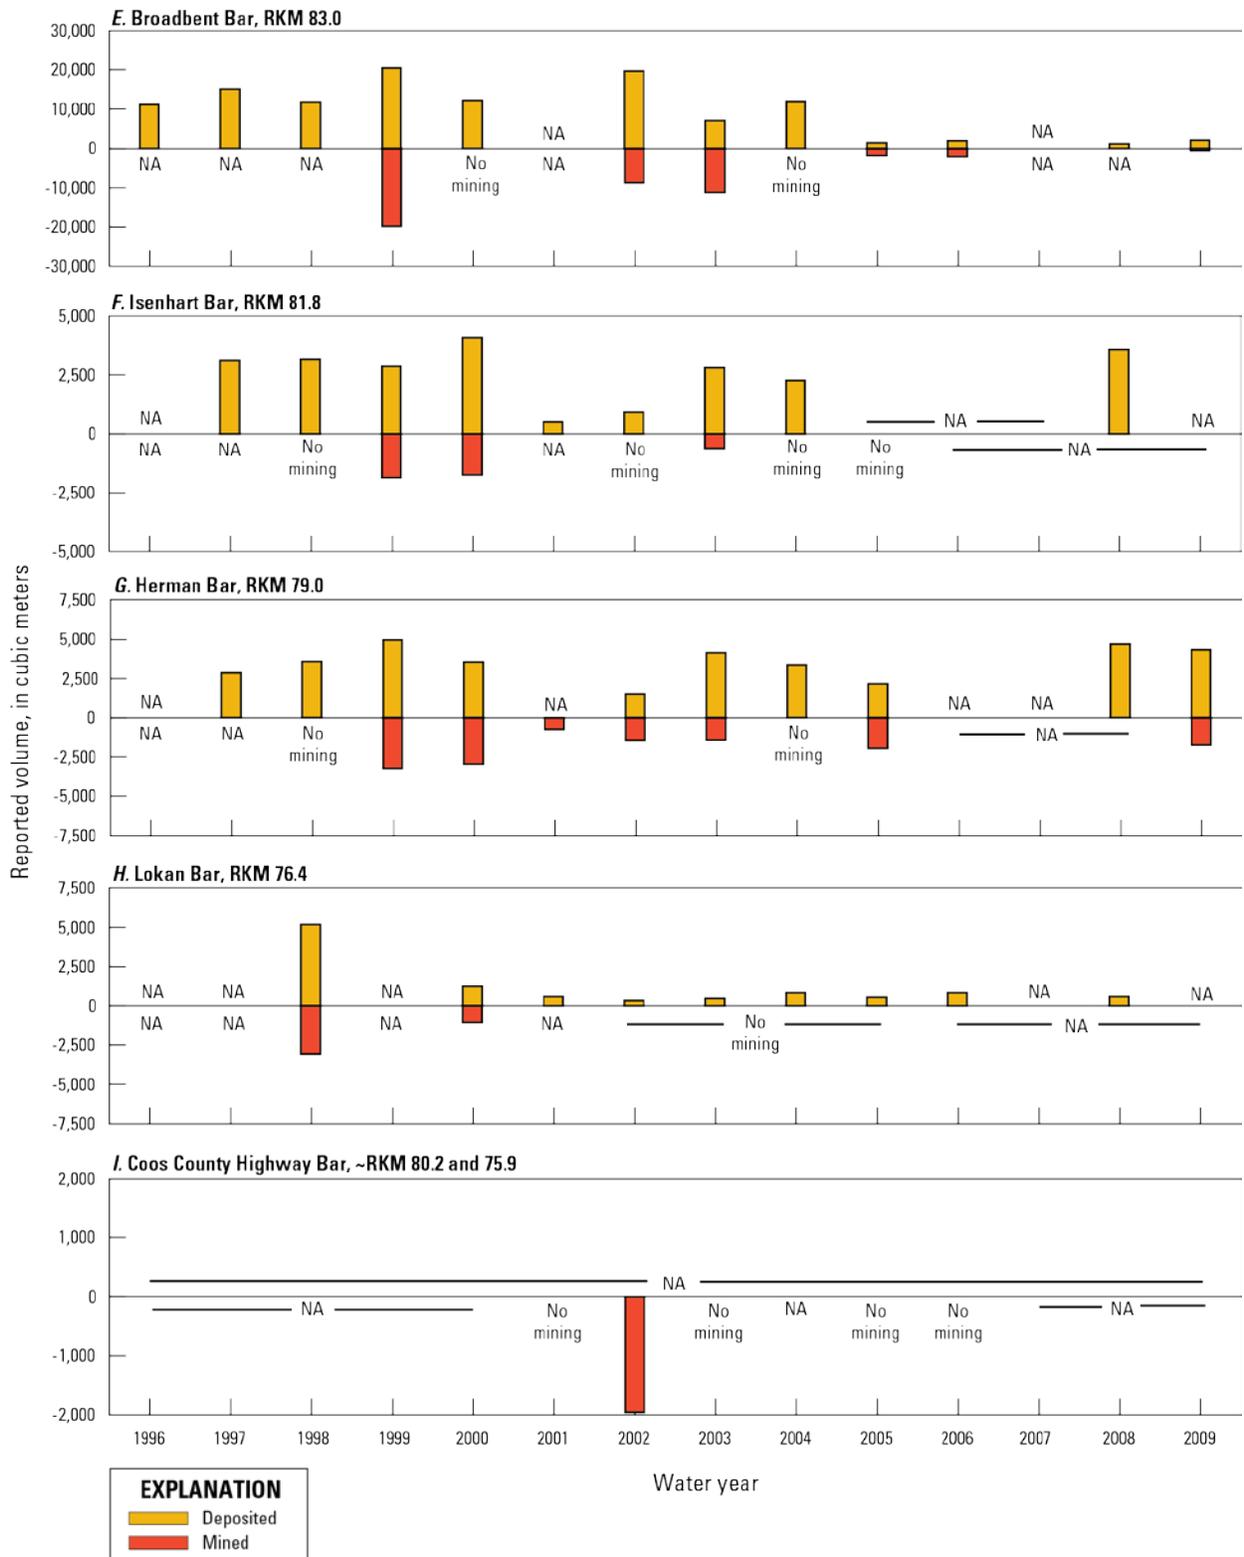
Figure 14. Graphs showing reported estimates of deposited and mined gravel (in cubic meters) from 1996 to 2009 for instream mining sites along the South Fork Coquille River, southwestern Oregon. Data compiled from permit files housed at Oregon Department of State Lands (accessed June 2011).

Figure 14 (continued). Graphs showing reported estimates of deposited and mined gravel (in cubic meters) from 1996 to 2009 for instream mining sites along the South Fork Coquille River, southwestern Oregon. Data compiled from permit files housed at Oregon Department of State Lands (accessed June 2011).

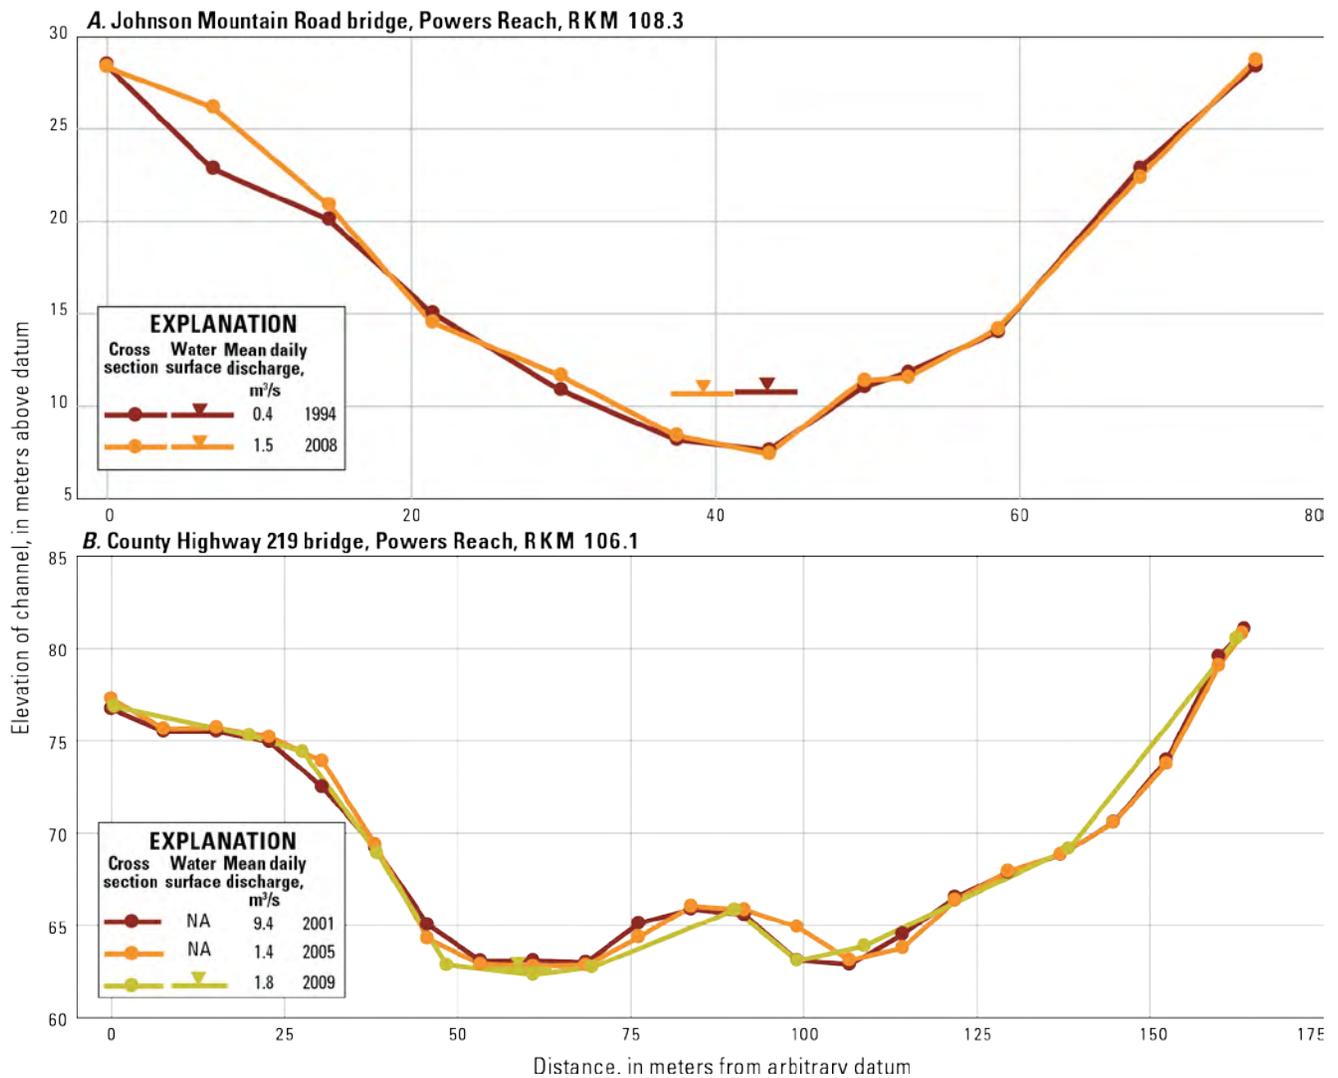
Figure 15. Diagrams showing channel cross sections surveyed at RKM 108.3 and 106.1 in the Powers Reach on the South Fork Coquille River, southwestern Oregon. Data provided by the Oregon Department of Transportation (written commun., 2010). Mean daily discharge record is from the U.S. Geological Survey streamflow-gaging station at Powers, Oregon (14325000) on the South Fork Coquille River for each survey date.

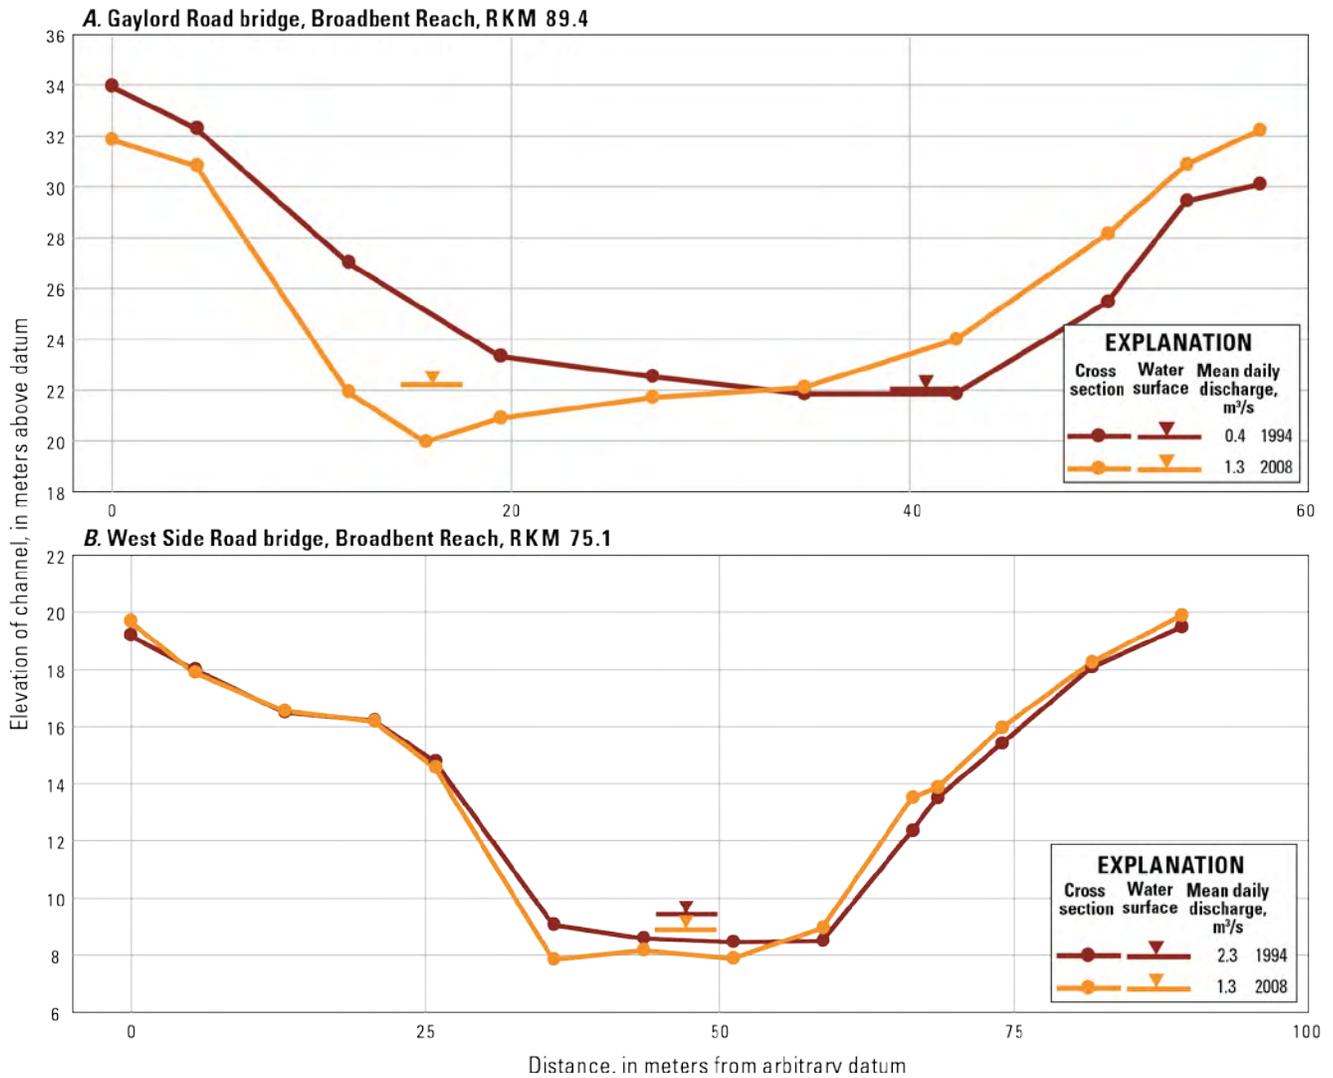
Figure 16. Diagrams showing channel cross sections surveyed at RKM 89.4 and 74.1 in the Broadbent Reach on the South Fork Coquille River, southwestern Oregon. Data provided by the Oregon Department of Transportation (written commun., 2010). Mean daily discharge record is from the U.S. Geological Survey streamflow-gaging station at Powers, Oregon (14325000) on the South Fork Coquille River for each survey date.

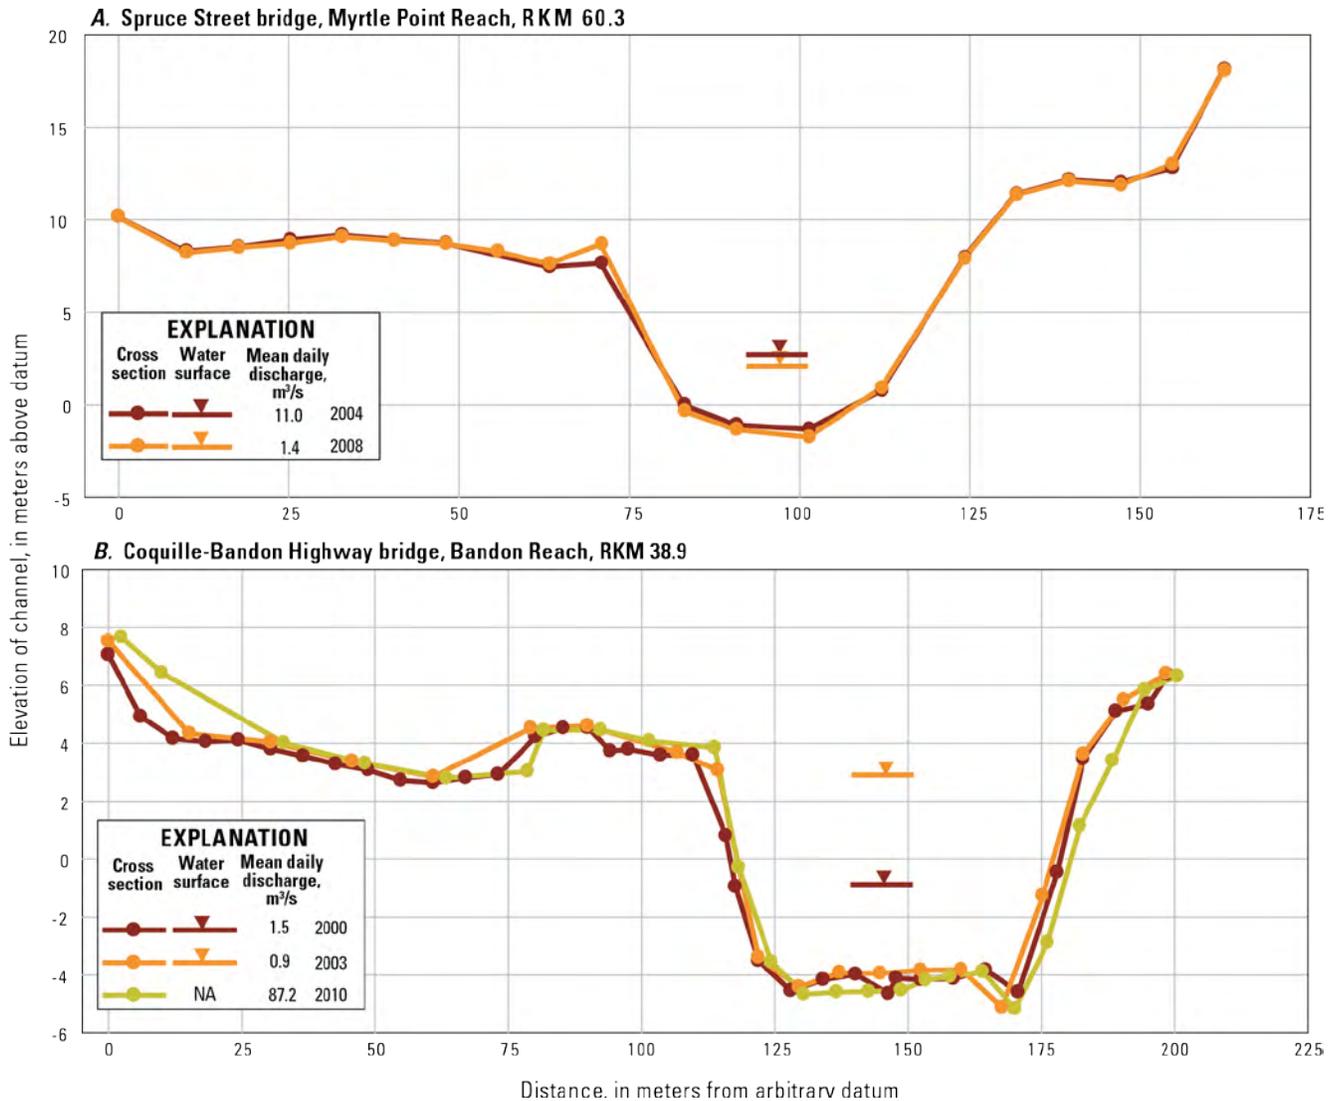
Figure 17. Diagrams showing channel cross sections surveyed at RKM 60.3 in the Myrtle Point Reach of the South Fork Coquille River and RKM 38.9 in the Bandon Reach on the Coquille River, southwestern Oregon. Data provided by the Oregon Department of Transportation (written commun., 2010). Mean daily discharge record is from the U.S. Geological Survey streamflow-gaging station at Powers, Oregon (14325000) on the South Fork Coquille River for each survey date.

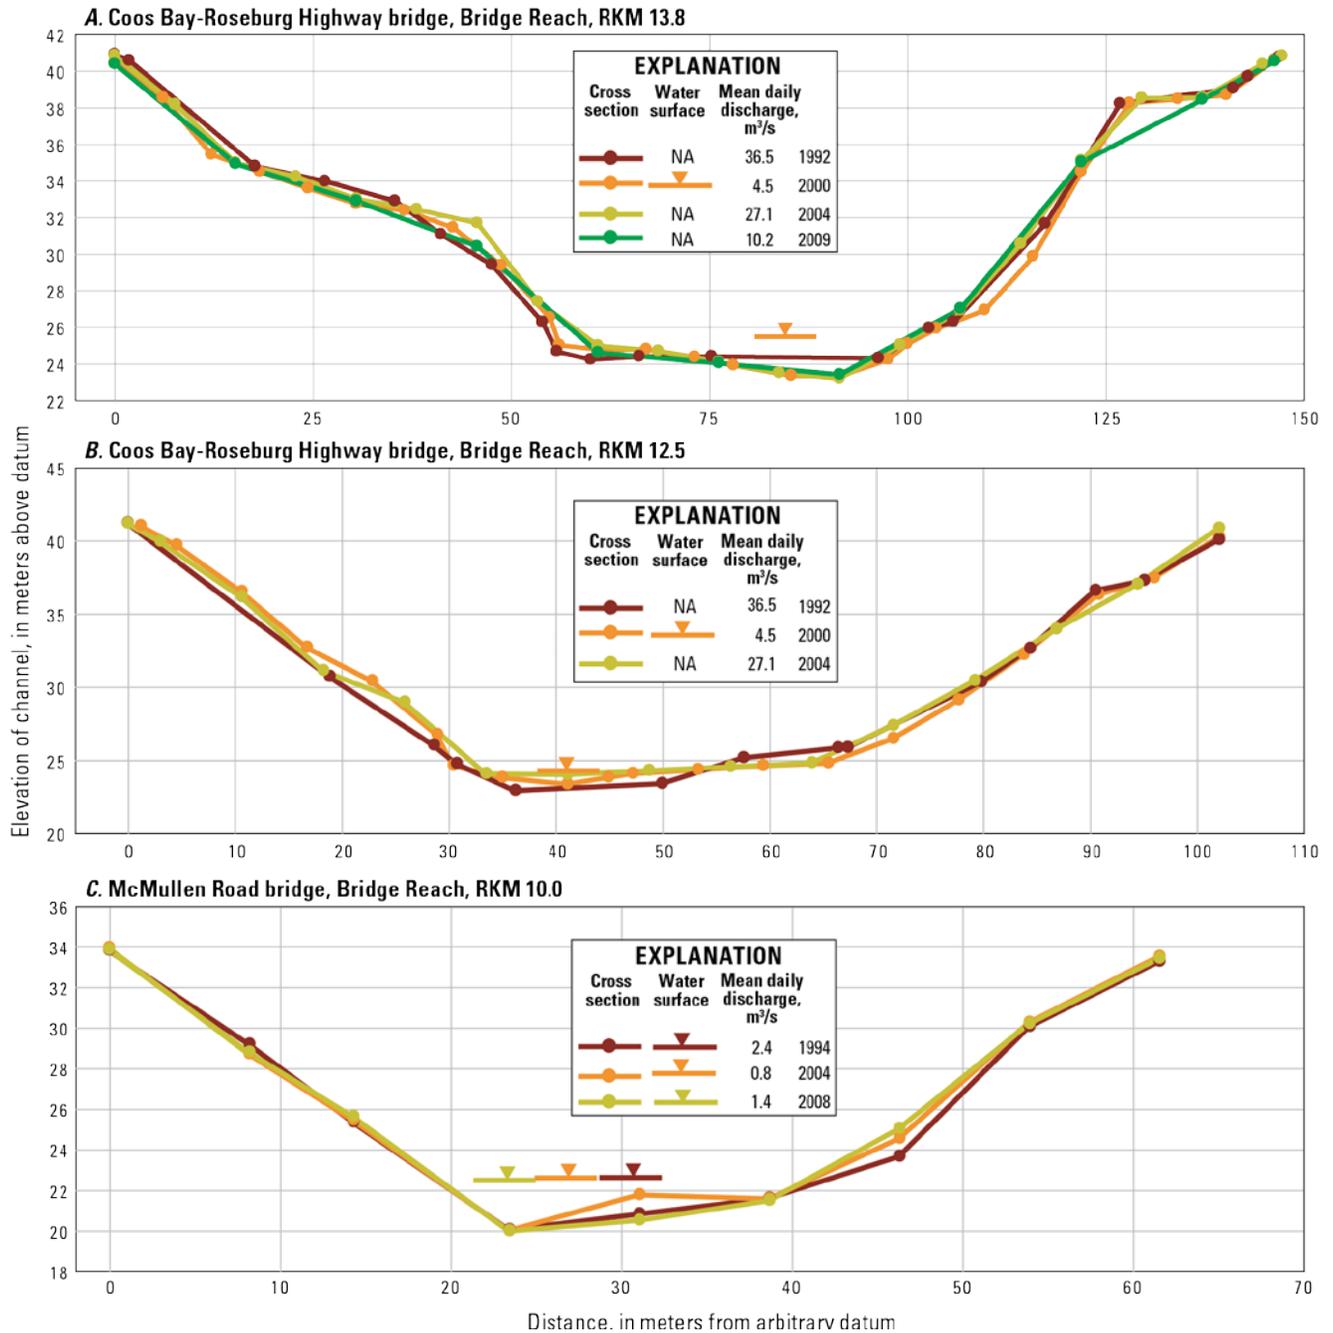
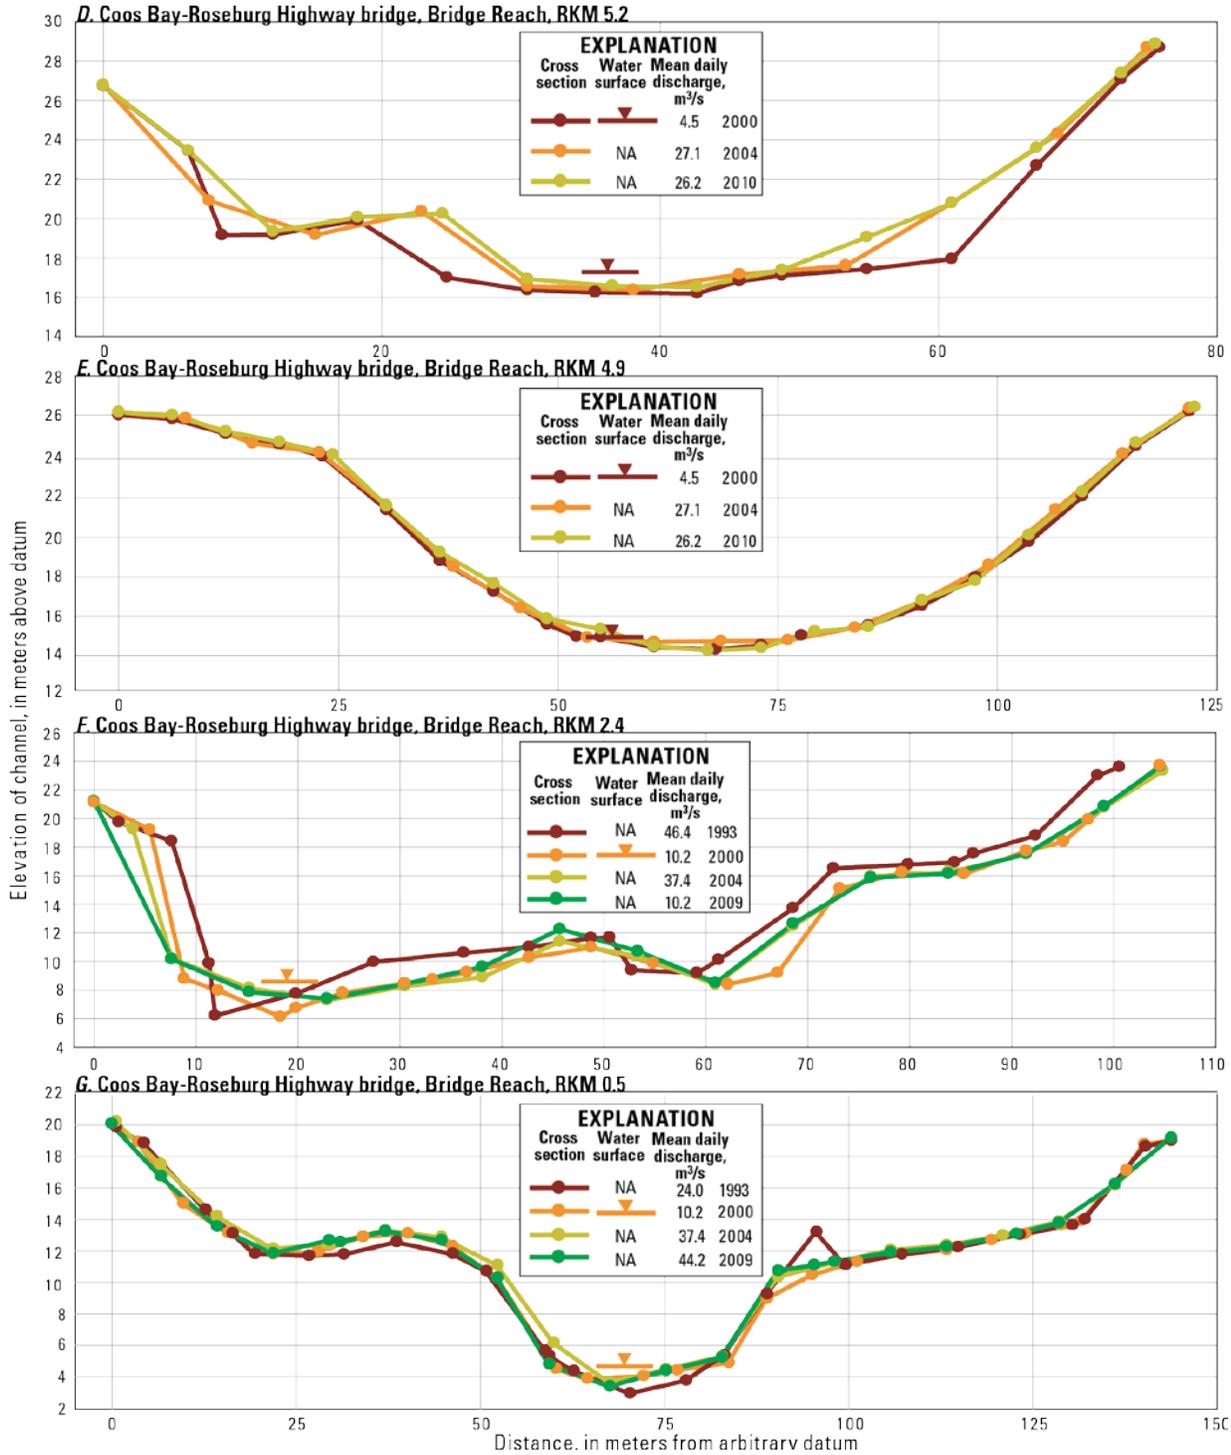
Figure 18. Diagrams showing channel cross sections surveyed at RKM 13.8, 12.5, 10.0, 5.2, 4.9, 2.4, and 0.5 in the Bridge Reach on the Middle Fork Coquille River, southwestern Oregon. Data provided by the Oregon Department of Transportation (written commun., 2010). Mean daily discharge record for each survey date is from the U.S. Geological Survey streamflow-gaging station at Powers, Oregon (14325000) on the South Fork Coquille River because the Middle Fork Coquille River gage near Myrtle Point (14326500) was no longer operational.

Figure 18 (continued). Diagrams showing channel cross sections surveyed at RKM 13.8, 12.5, 10.0, 5.2, 4.9, 2.4, and 0.5 in the Bridge Reach on the Middle Fork Coquille River, southwestern Oregon. Data provided by the Oregon Department of Transportation (written commun., 2010). Mean daily discharge record for each survey date is from the U.S. Geological Survey streamflow-gaging station at Powers, Oregon (14325000) on the South Fork Coquille River because the Middle Fork Coquille River gage near Myrtle Point (14326500) was no longer operational.

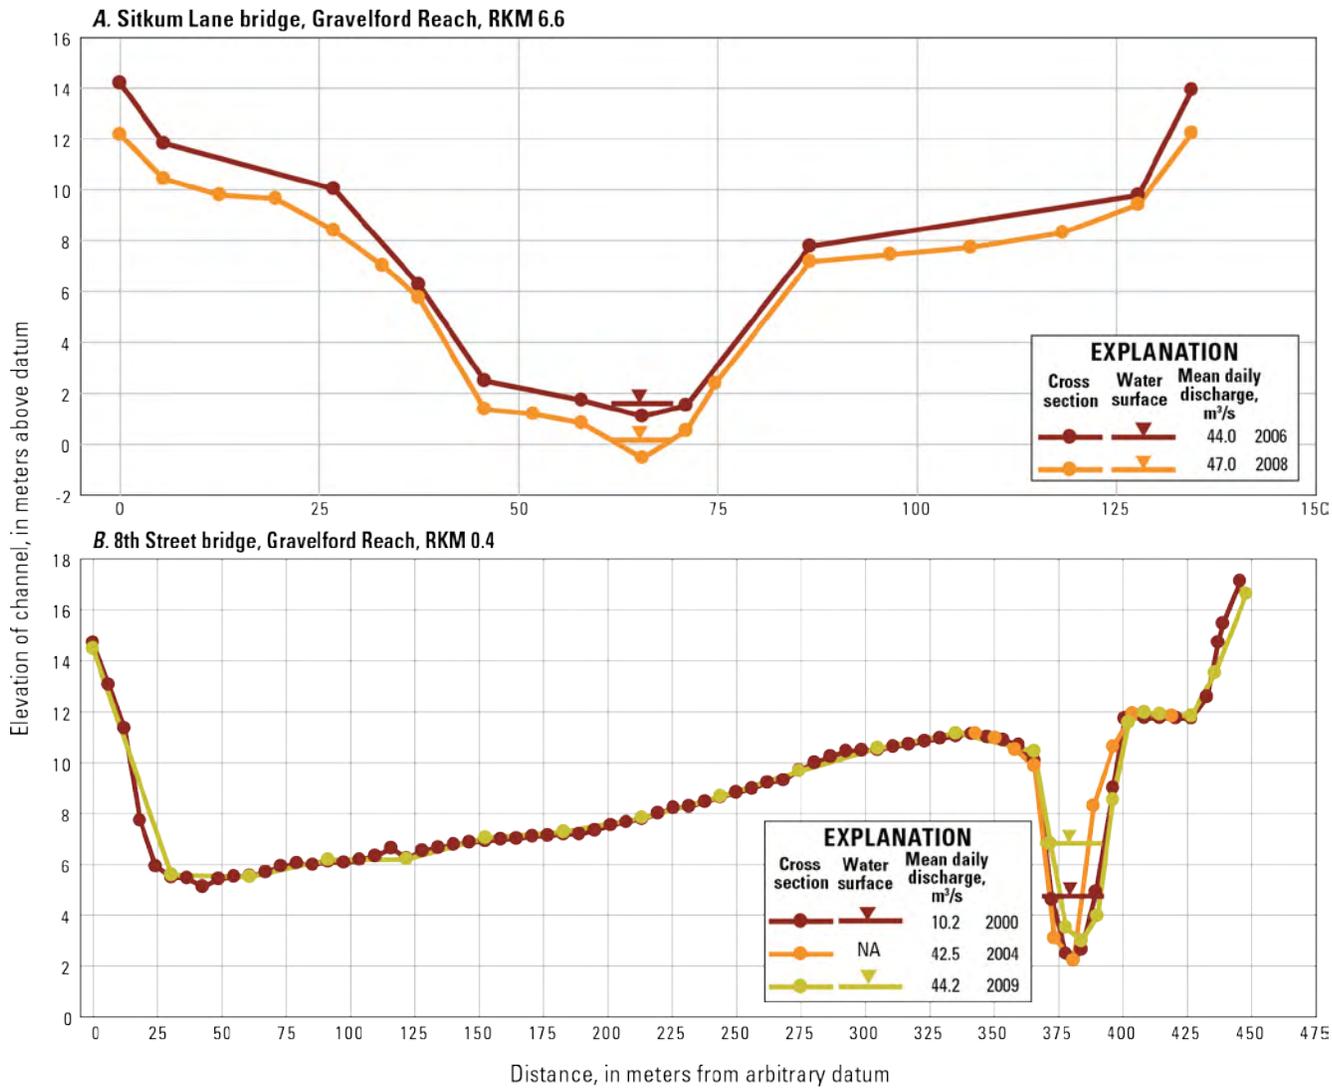
Figure 19. Diagrams showing channel cross sections surveyed at RKM 6.6 and 0.4 in the Gravelford Reach on the North Fork Coquille River, southwestern Oregon. Data provided by the Oregon Department of Transportation (written commun., 2010). Mean daily discharge record for each survey date is from the U.S. Geological Survey streamflow-gaging station at Powers, Oregon (14325000) on the South Fork Coquille River because the North Fork Coquille River gage near Myrtle Point (14327000) was no longer operational.

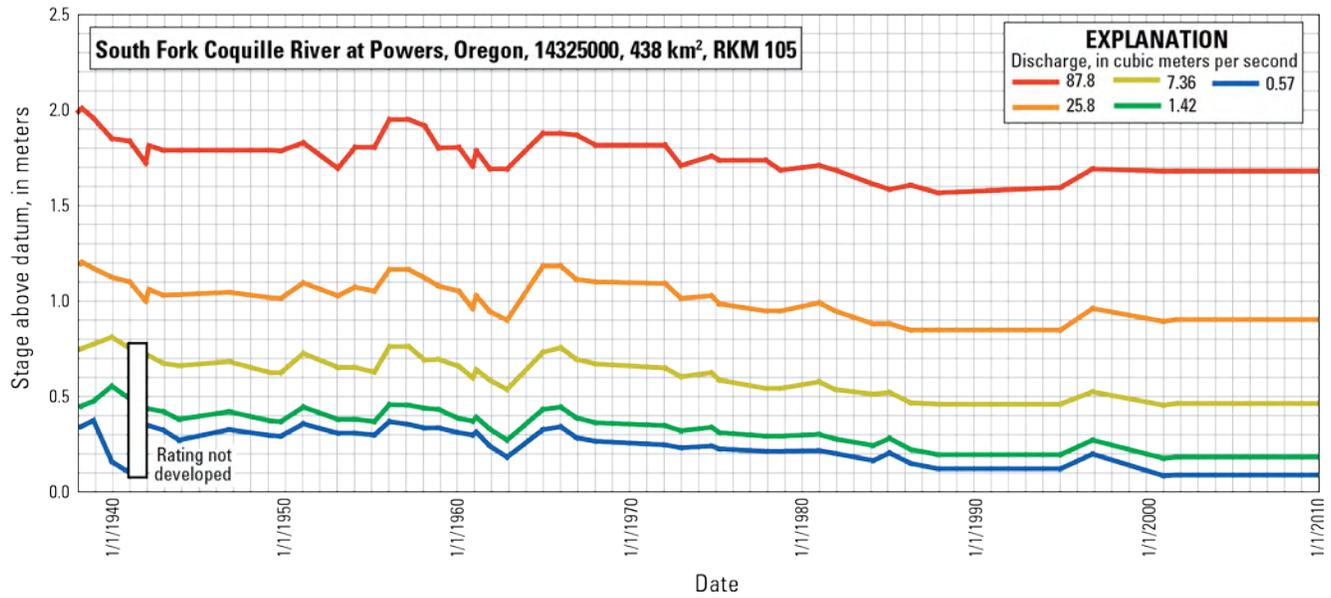
Figure 20. Graph showing the stage-discharge rating curve for specific discharges for the U.S. Geological Survey streamflow-gaging station at Powers (14325000) on the South Fork Coquille River, southwestern Oregon. The source data are station records housed at the Oregon Water Science Center, U.S. Geological Survey, Portland, Oregon.

Over the period of record, the overall declining stage trend has been interrupted by short periods of rising stage during three periods (1955–1956, 1963–1965, and 1995–1997; fig. 20). These episodes coincide with the floods exceeding a 10-year return period on December 21, 1955, December 22, 1964, and November 18, 1996 (fig. 4B), and perhaps indicate bed-material transport and channel aggradation associated with these relatively large floods. Future review and analysis of station notes, historical cableway surveys, and individual discharge measurements could provide additional information on trends in channel geometry and bed-material at this station.

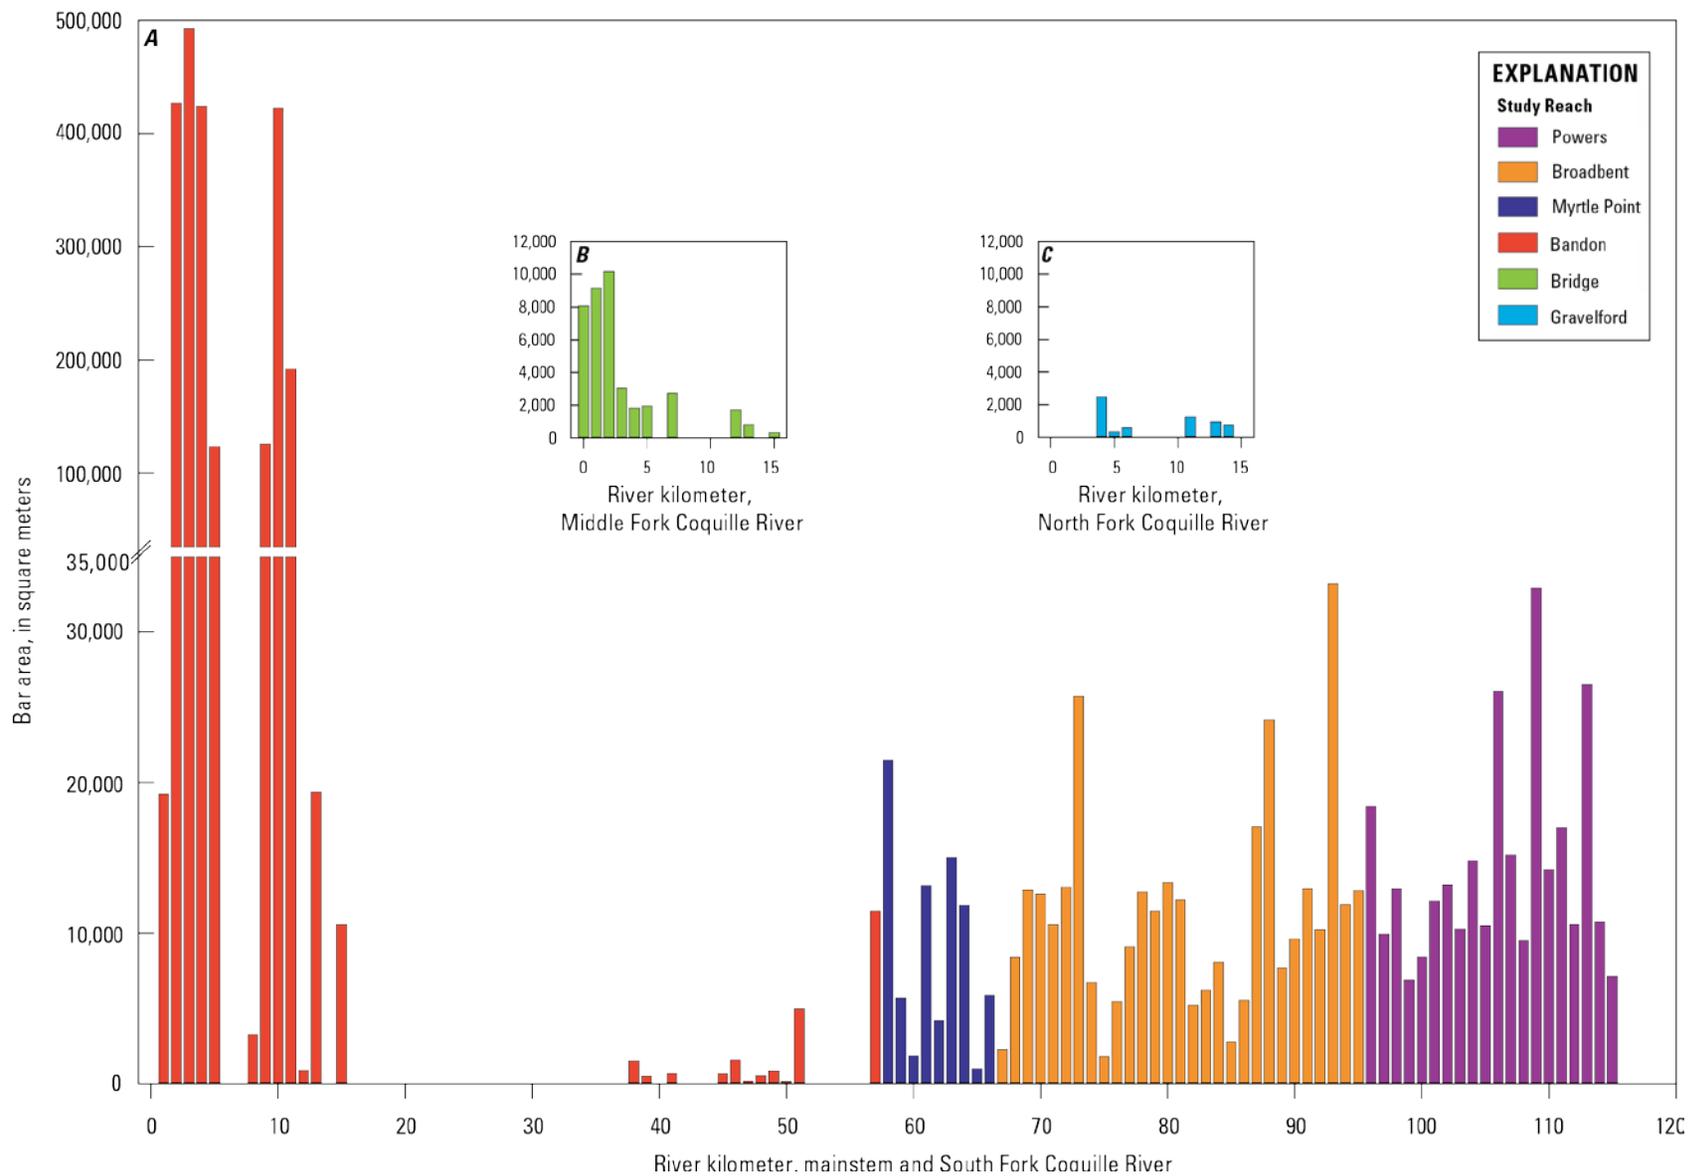
Figure 21. Graphs showing bar area by river kilometer as delineated from orthophotographs taken in 2009 for study reaches on the (A) South Fork and mainstem Coquille River, (B) Middle Fork Coquille River, and (C) North Fork Coquille River, southwestern Oregon. The upstream extent of the Powers Reach is RKM 115.4.

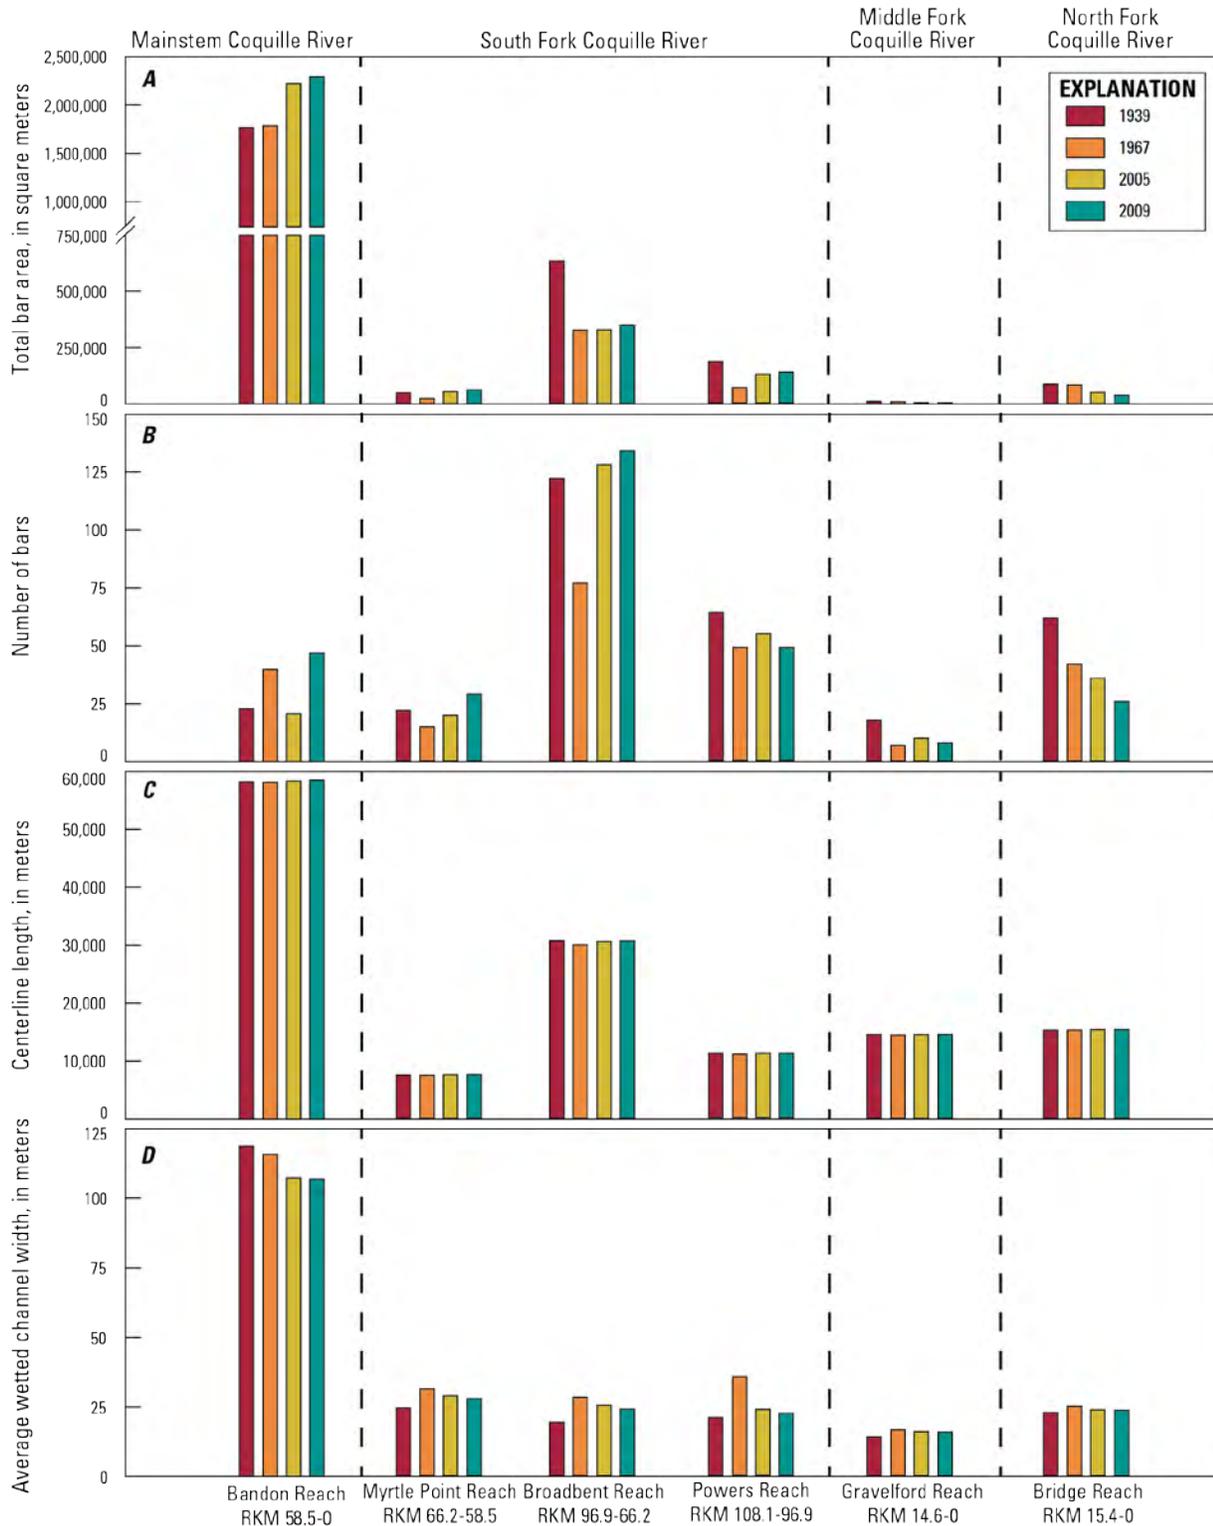
Figure 22. Graphs showing the results for (A) total bar area, (B) bar number, (C) channel centerline length, and (D) average wetted channel width as delineated from photographs taken in 1939, 1967, 2005, and 2009 for the study areas on the mainstem and North and Middle Forks of the Coquille River and South Fork Coquille River to RKM 108.1.

Mapped wetted channel width is sensitive to the streamflow and tide levels at the time the photographs were taken. Nevertheless, from 1939 to 2009, the average wetted width of the channel increased in all reaches except the Bandon Reach (fig. 22D; table 13). In fluvial reaches, the net increases in average wetted width ranged from 1 m in the Powers and Bridge Reaches to 5 m in the Broadbent Reach. Because discharge was similar during the collection of the 1939 and 2009 photographs (table 10), these changes in average wetted width in the fluvial reaches may indicate actual channel widening, possibly in association with the loss of bar area. A more detailed delineation of the active channel width (instead of wetted channel width, which can be influenced by small streamflow or tide differences) may help better quantify possible changes in channel width for the fluvial study reaches and its relation to the extent and number of bars.

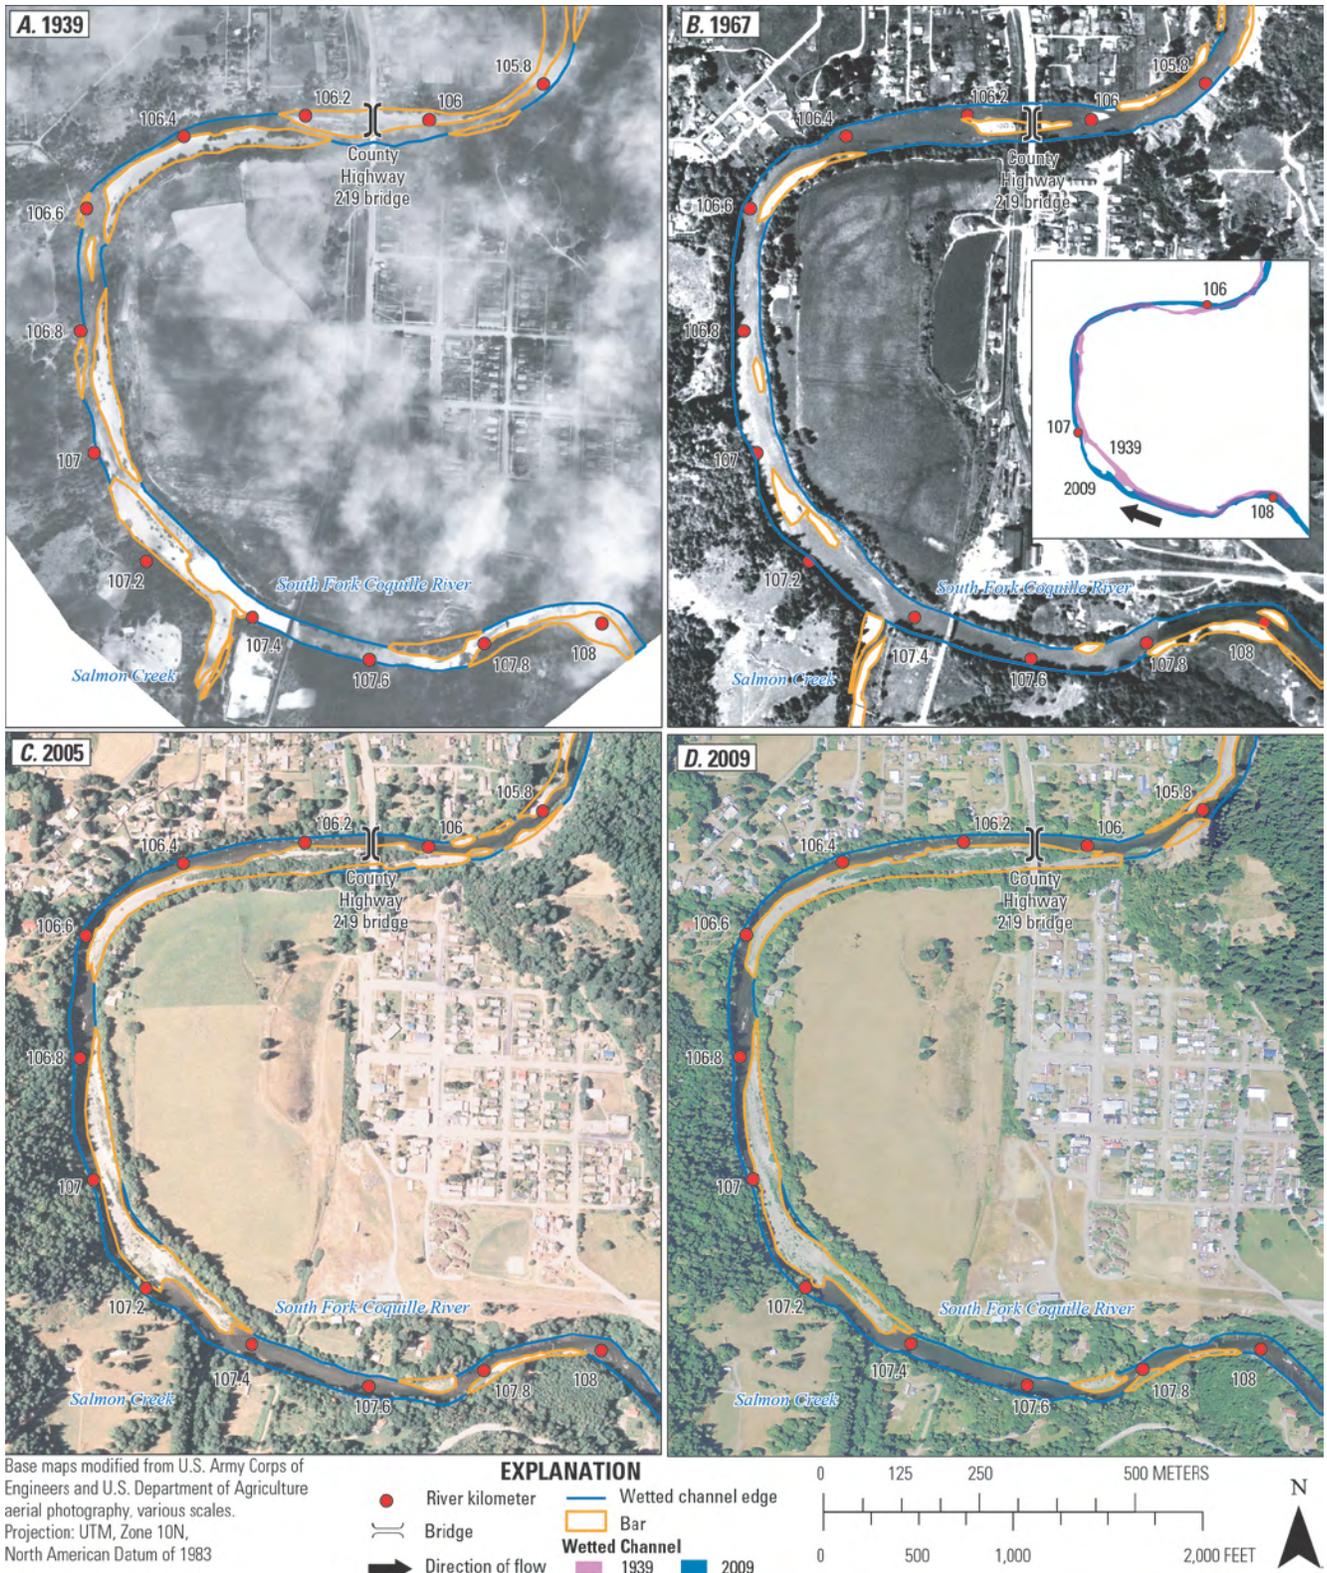
Figure 23. Images showing repeat bar and channel delineations, lateral channel shifting, and vegetation establishment on bars in a section of the Powers Reach on the South Fork Coquille River, southwestern Oregon.

Lateral channel movement, bar geometry changes, and vegetation establishment on bar surfaces were evident in the repeat delineation of bar and channel features near instream gravel mining sites on the South Fork Coquille River. For
