Preliminary Assessment of Channel Stability and Bed-Material Transport in the Coquille River Basin, Southwestern Oregon

Prepared in cooperation with the U.S. Army Corps of Engineers and the Oregon Department of State Lands

Open-File Report 2012-1064

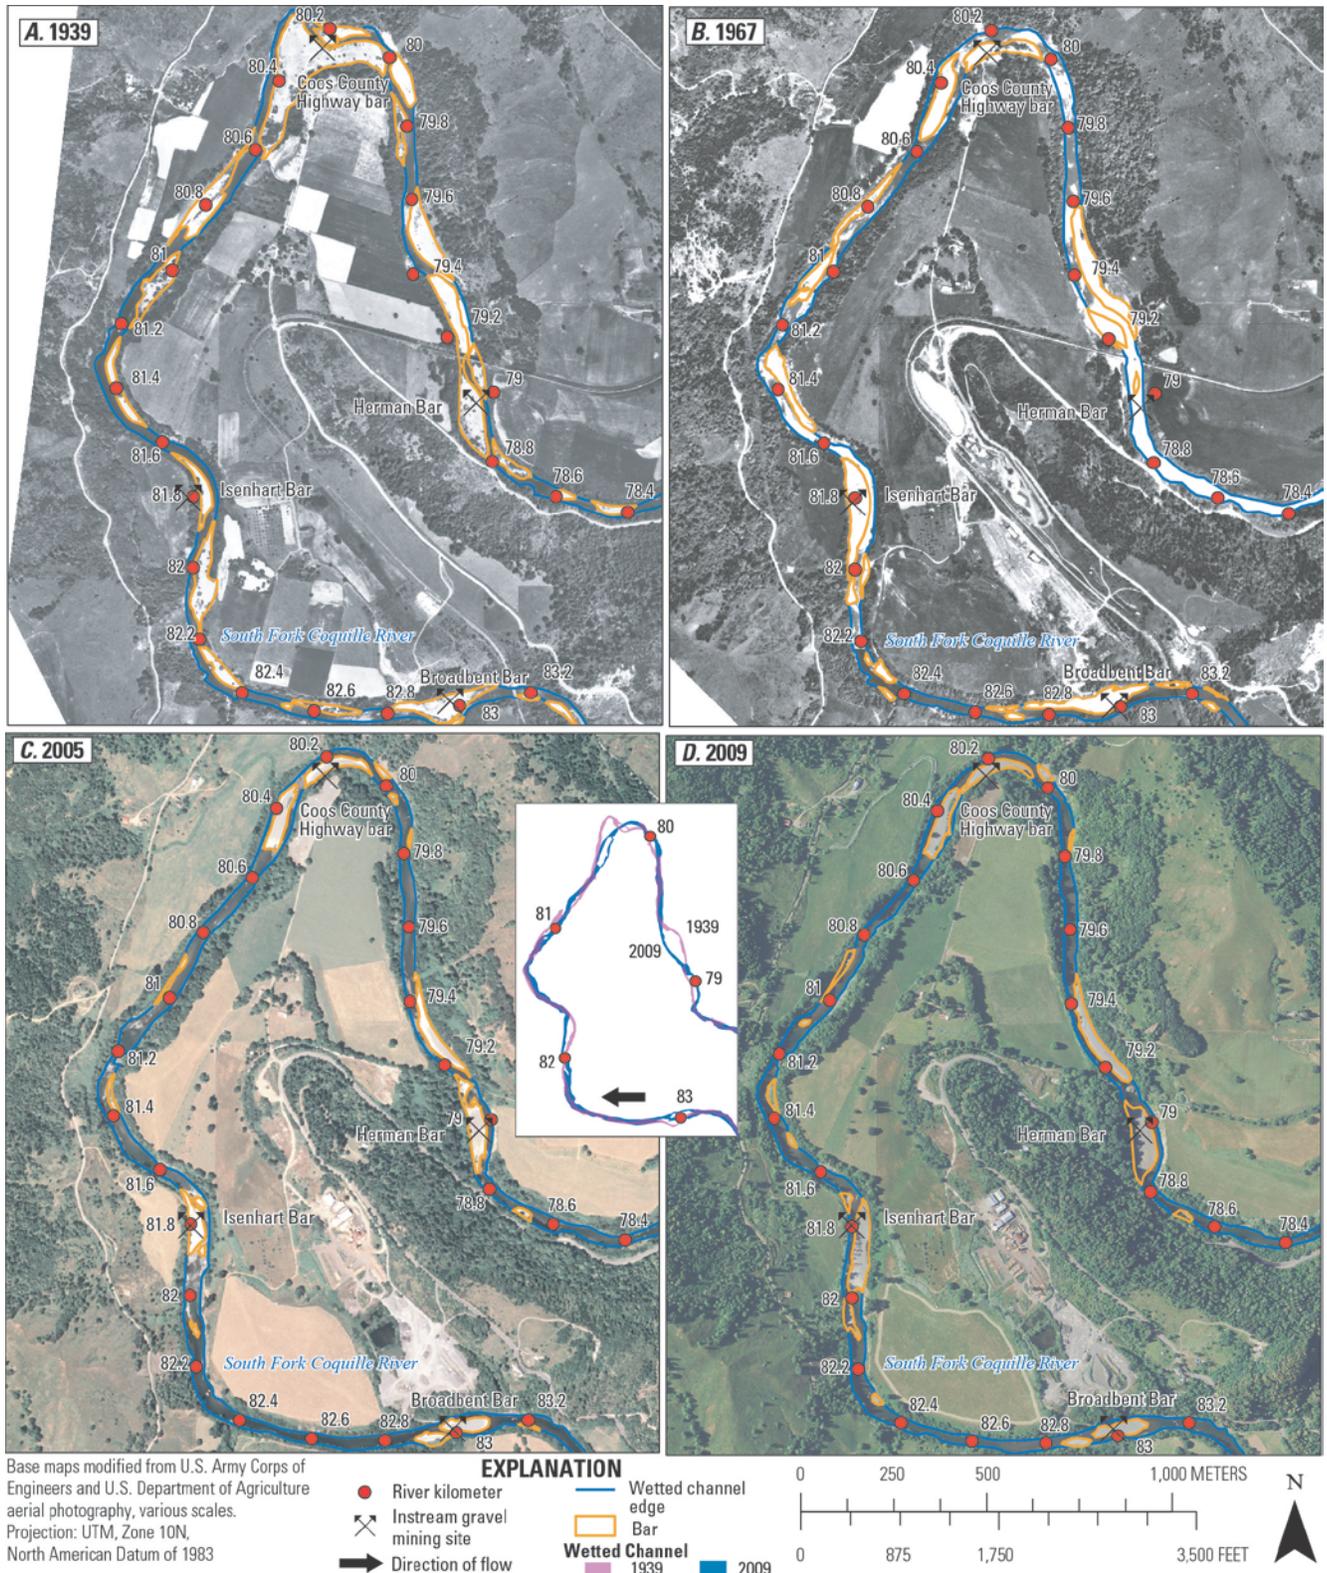
Figure 24. Images showing repeat bar and channel delineations, lateral channel movement, bank erosion, and other channel changes in the Broadbent Reach on the South Fork Coquille River near Warner, Oregon.

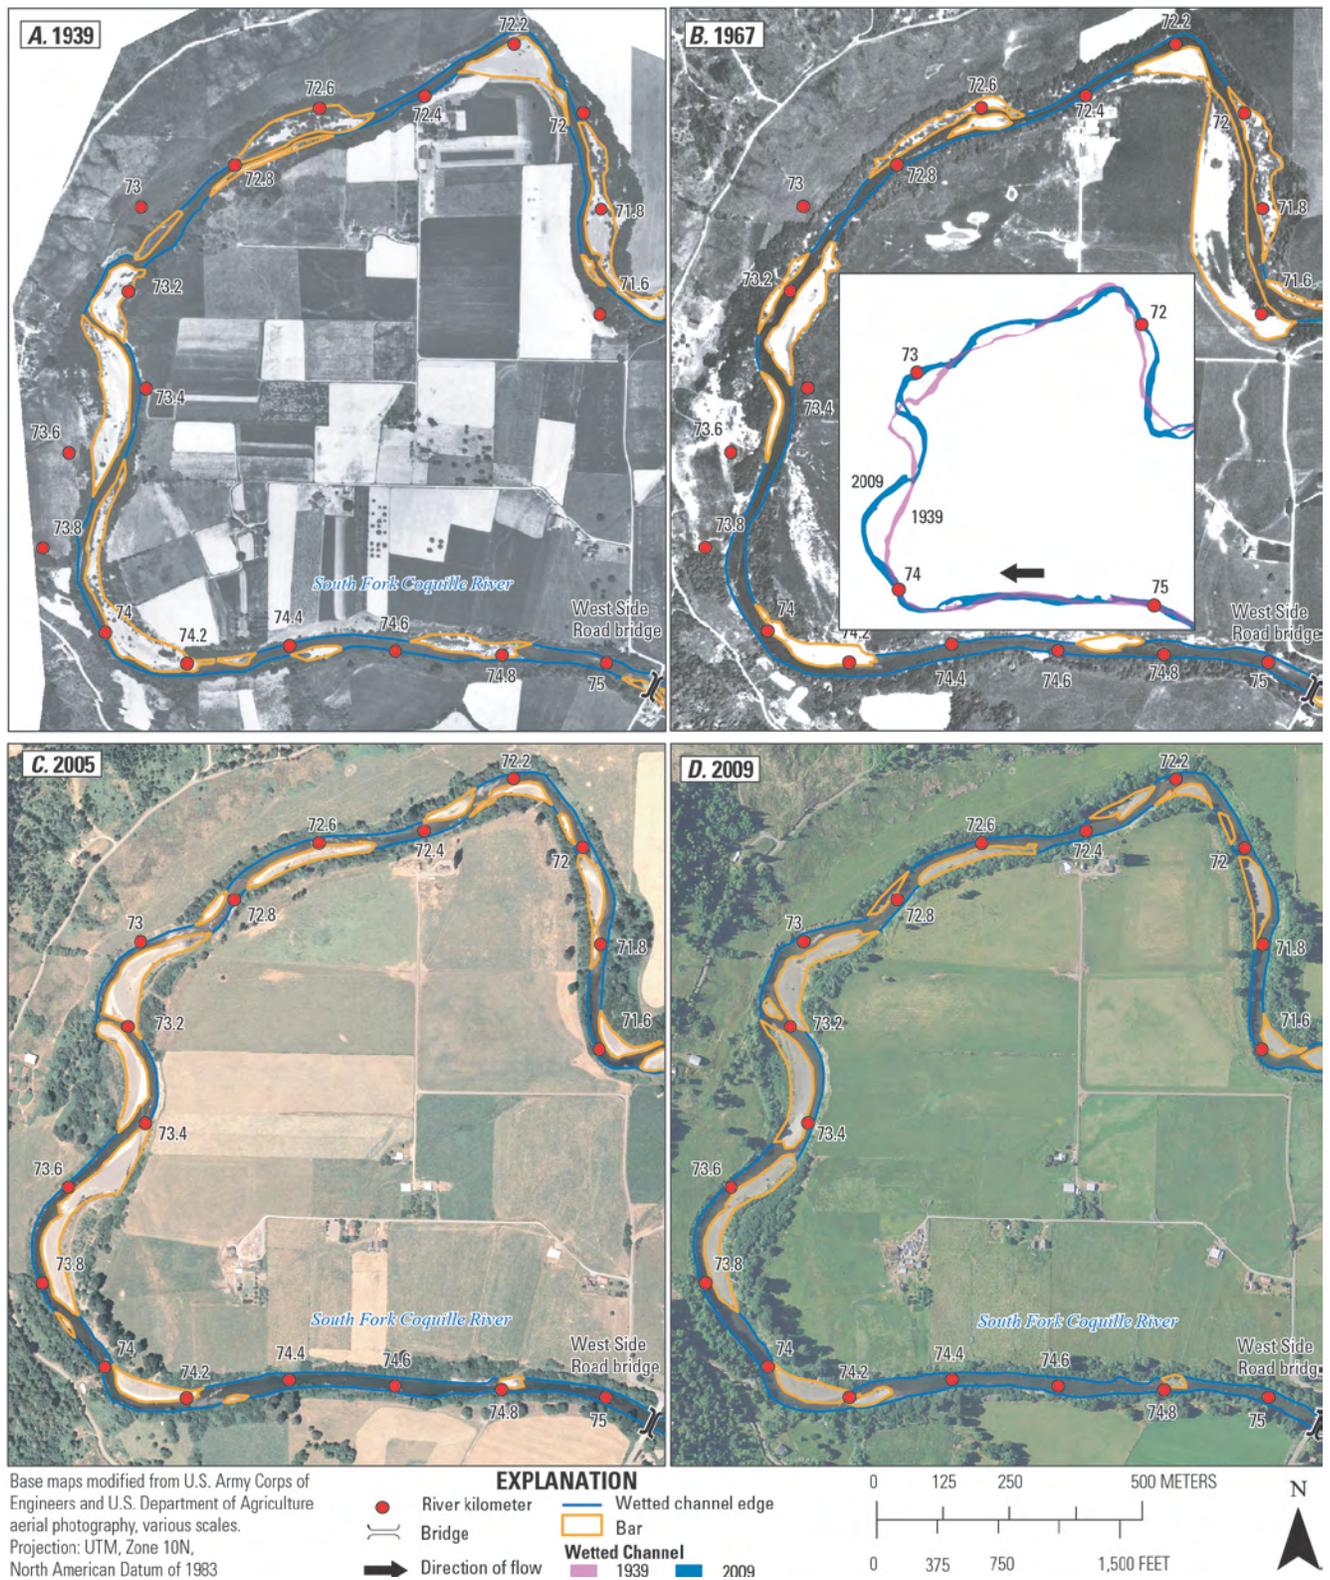
Figure 25. Images showing repeat bar and channel delineations, lateral channel movement, bank erosion, and other channel changes in the Broadbent Reach on the South Fork Coquille River near Broadbent, Oregon.

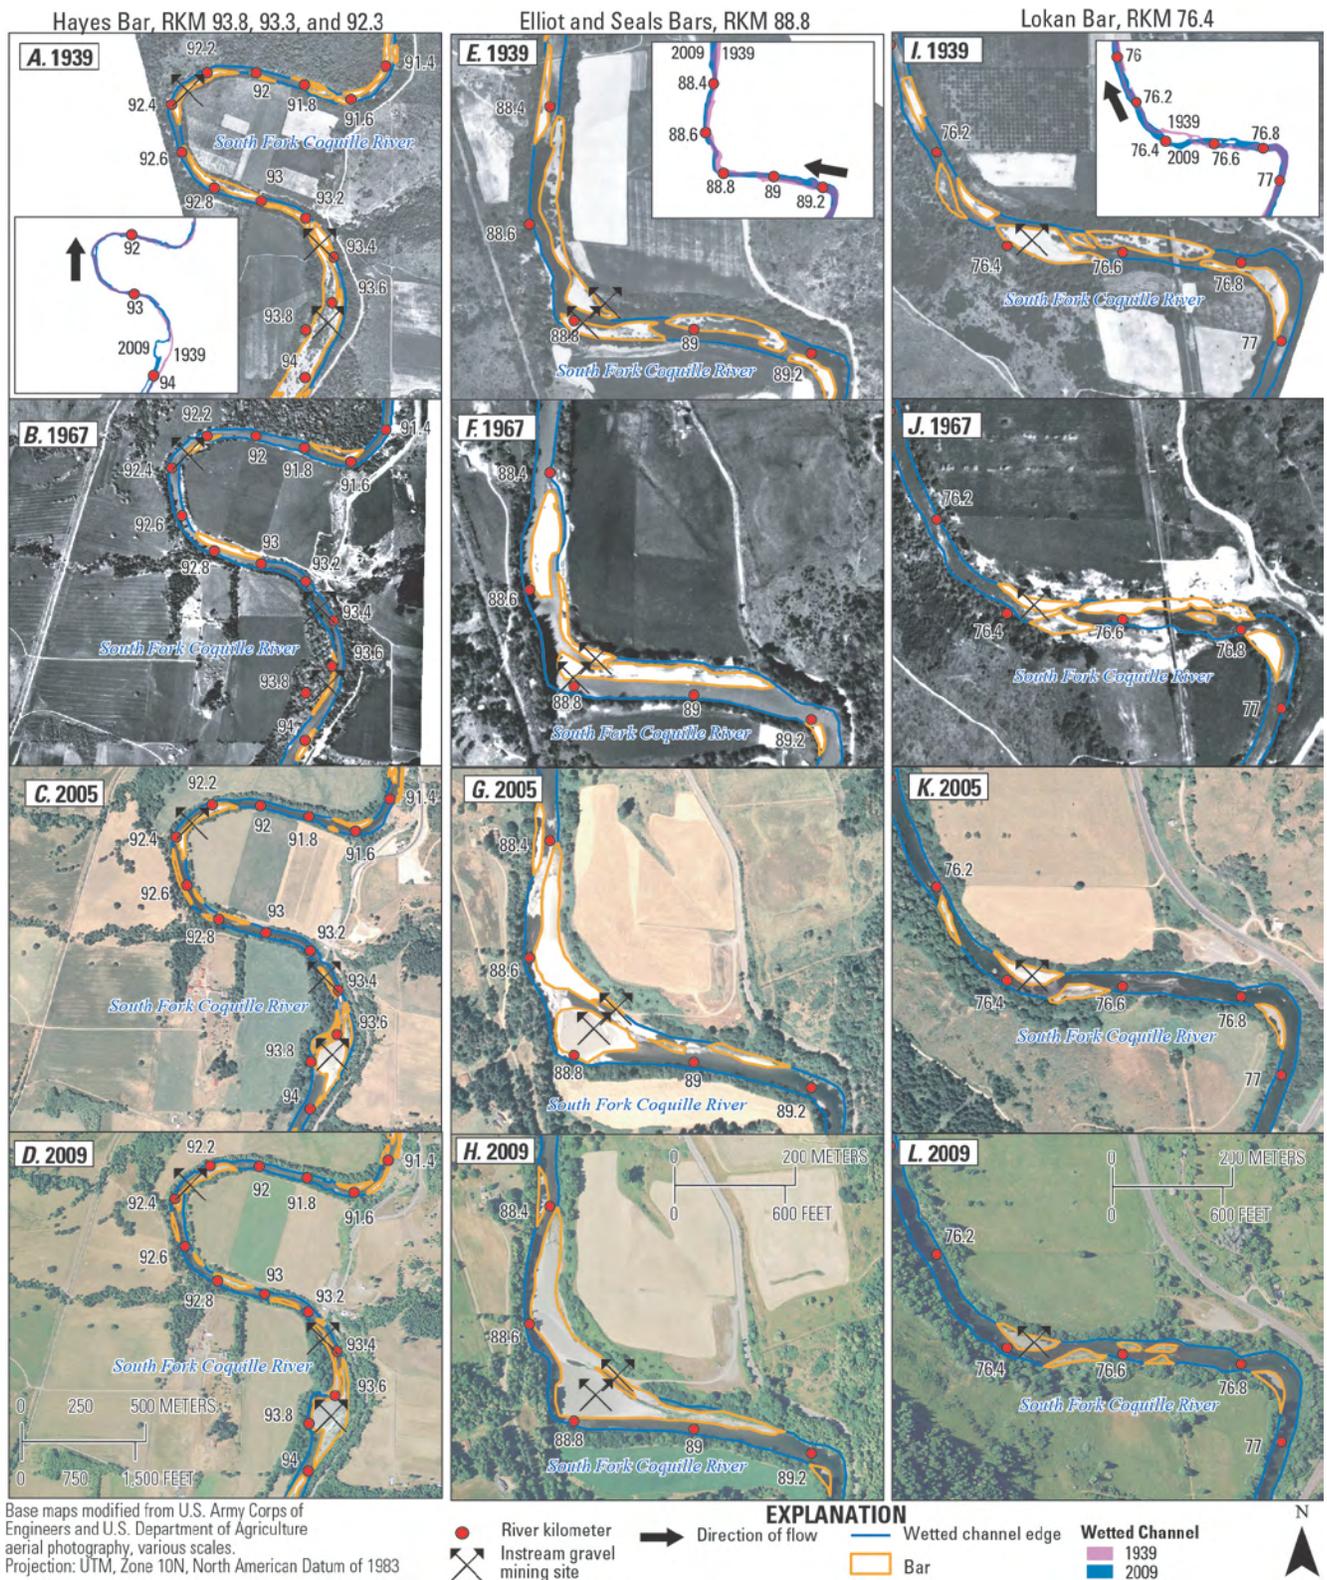
Figure 26. Images showing repeat bar and channel delineations for Hayes, Elliot/Seals, and Lokan Bars in the Broadbent Reach on the South Fork Coquille River, southwestern Oregon.

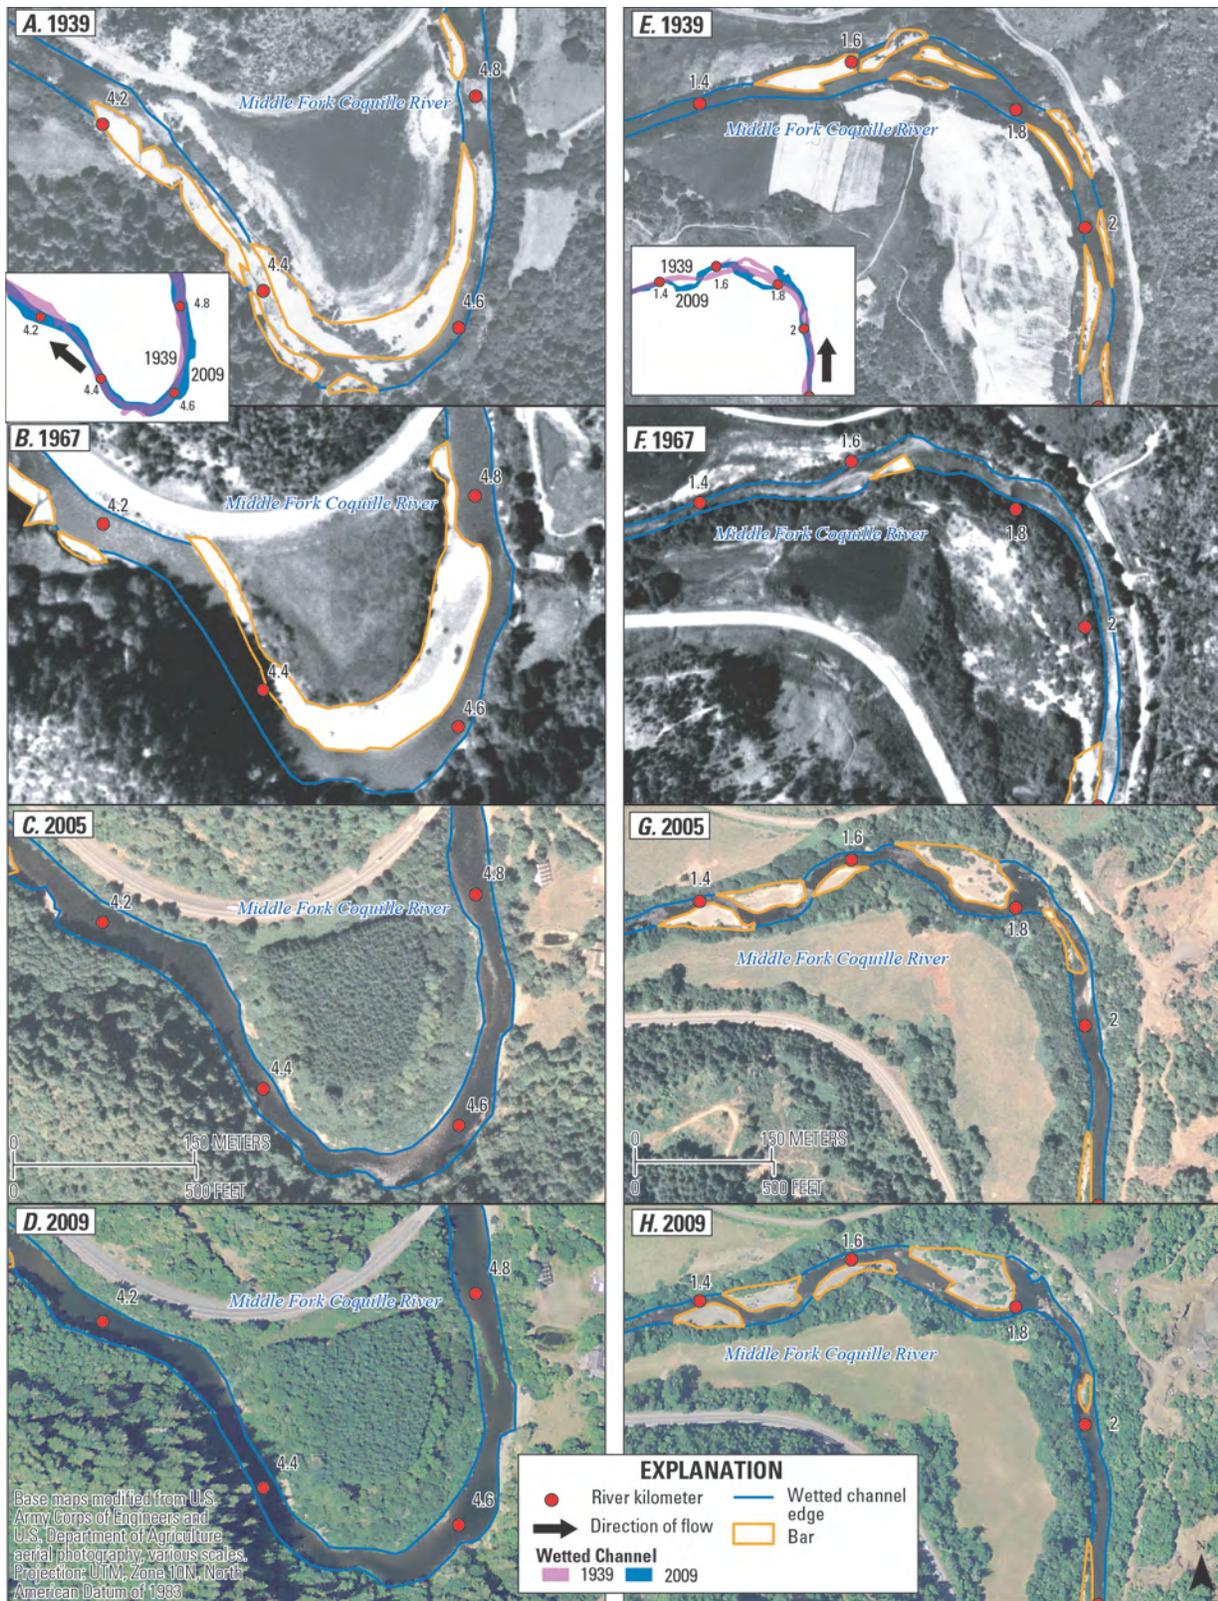
Figure 27. Images showing repeat bar and channel delineations, vegetation establishment, and lateral channel movement in the Bridge Reach on the Middle Fork Coquille River, southwestern Oregon.

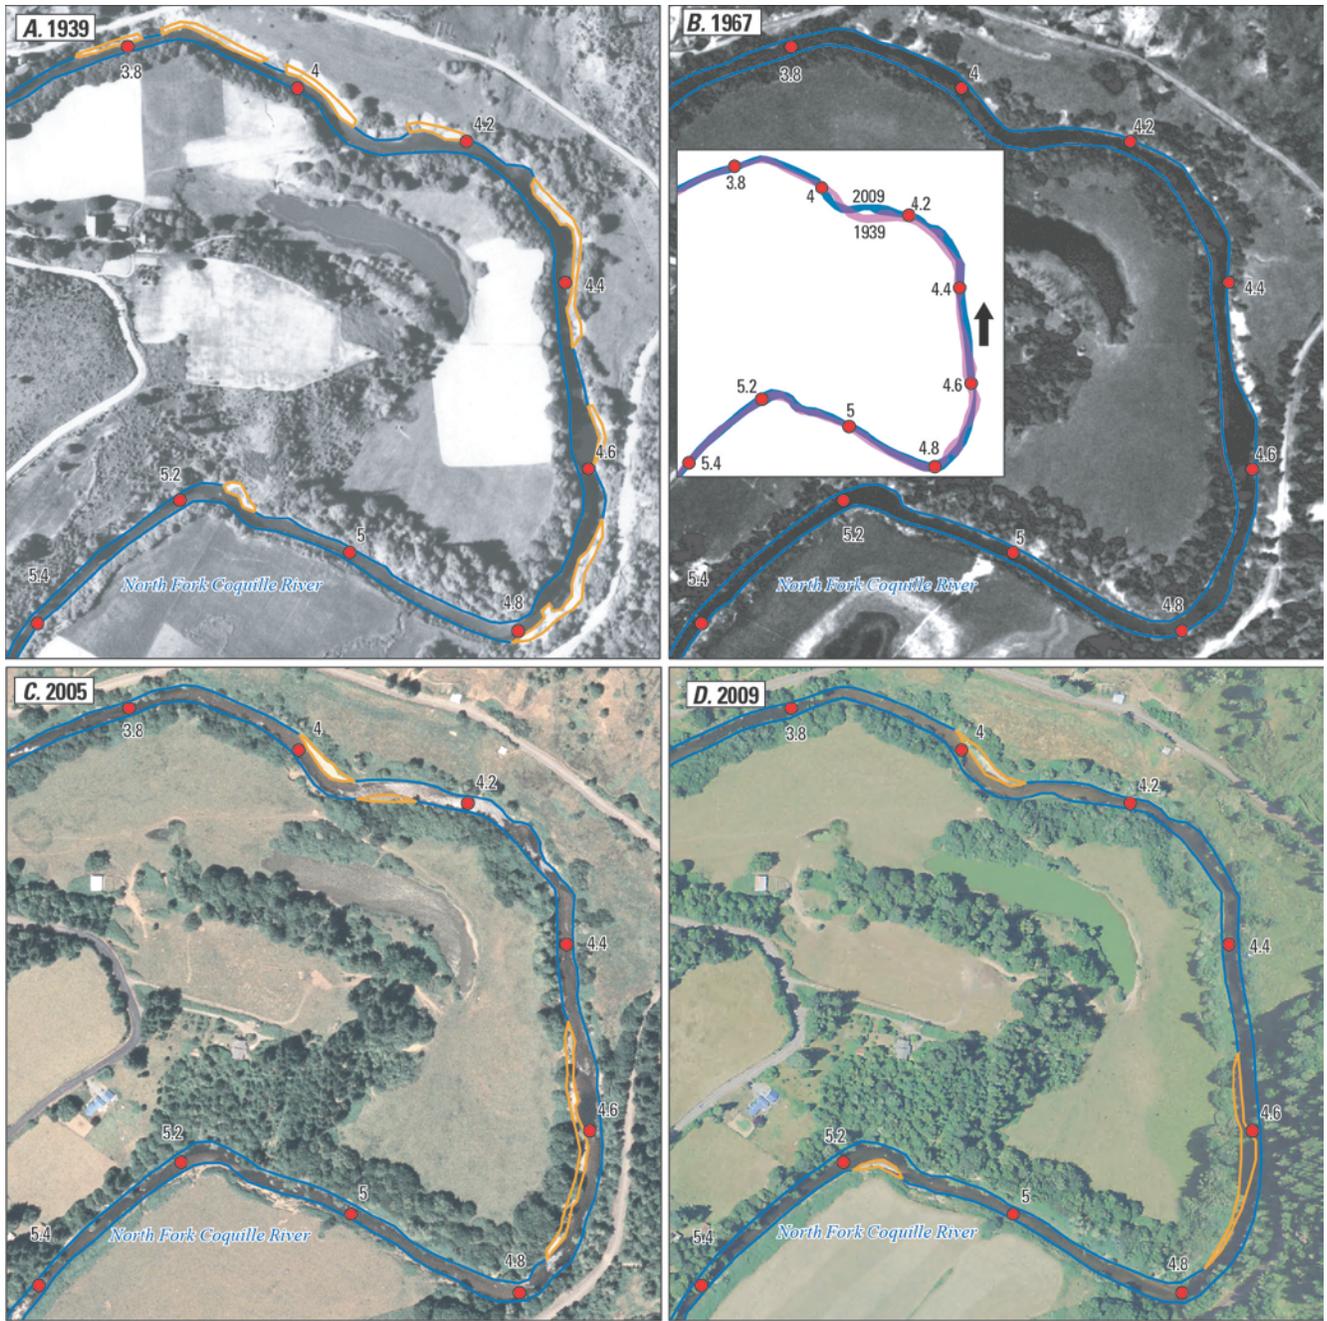
Figure 28. Images showing repeat bar and channel delineations and vegetation establishment in the Gravelford Reach on the North Fork Coquille River, southwestern Oregon.

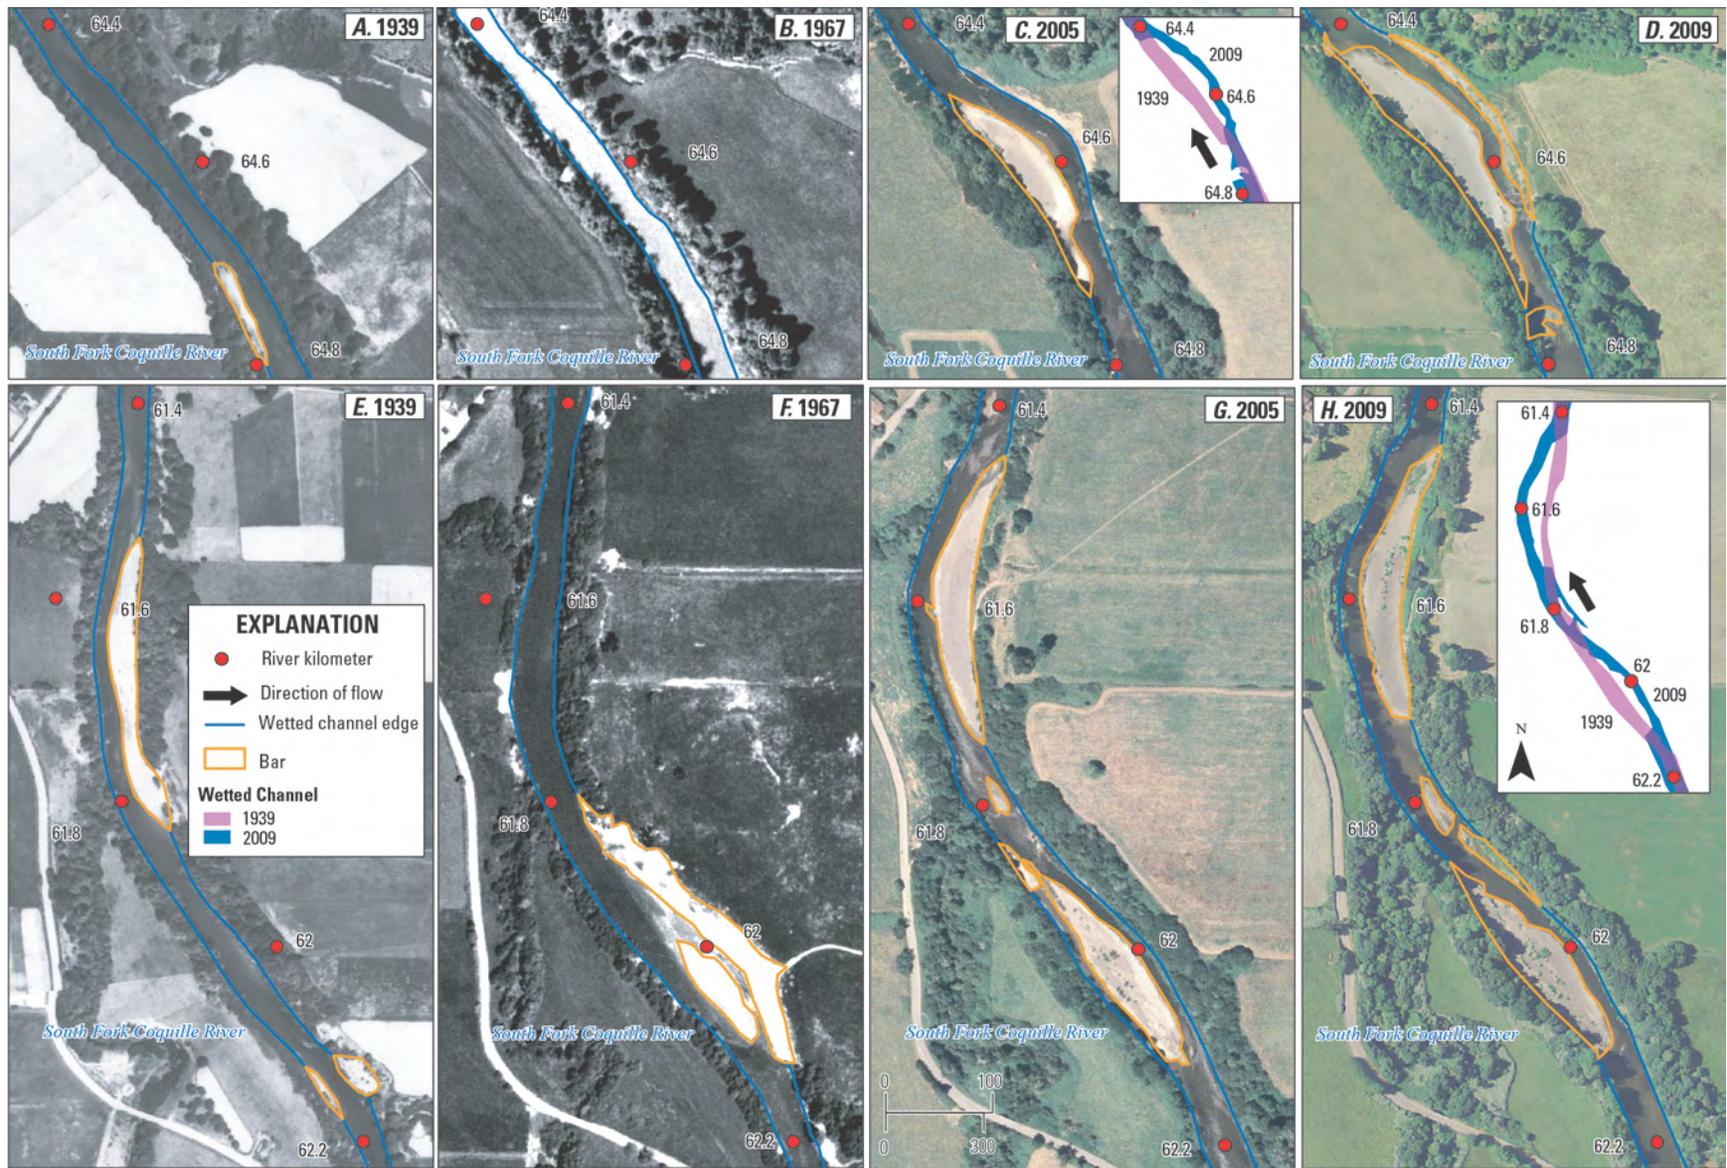
Figure 29. Images showing repeat bar and channel delineations and lateral channel movement in the Myrtle Point Reach on the South Fork Coquille River, southwestern Oregon.

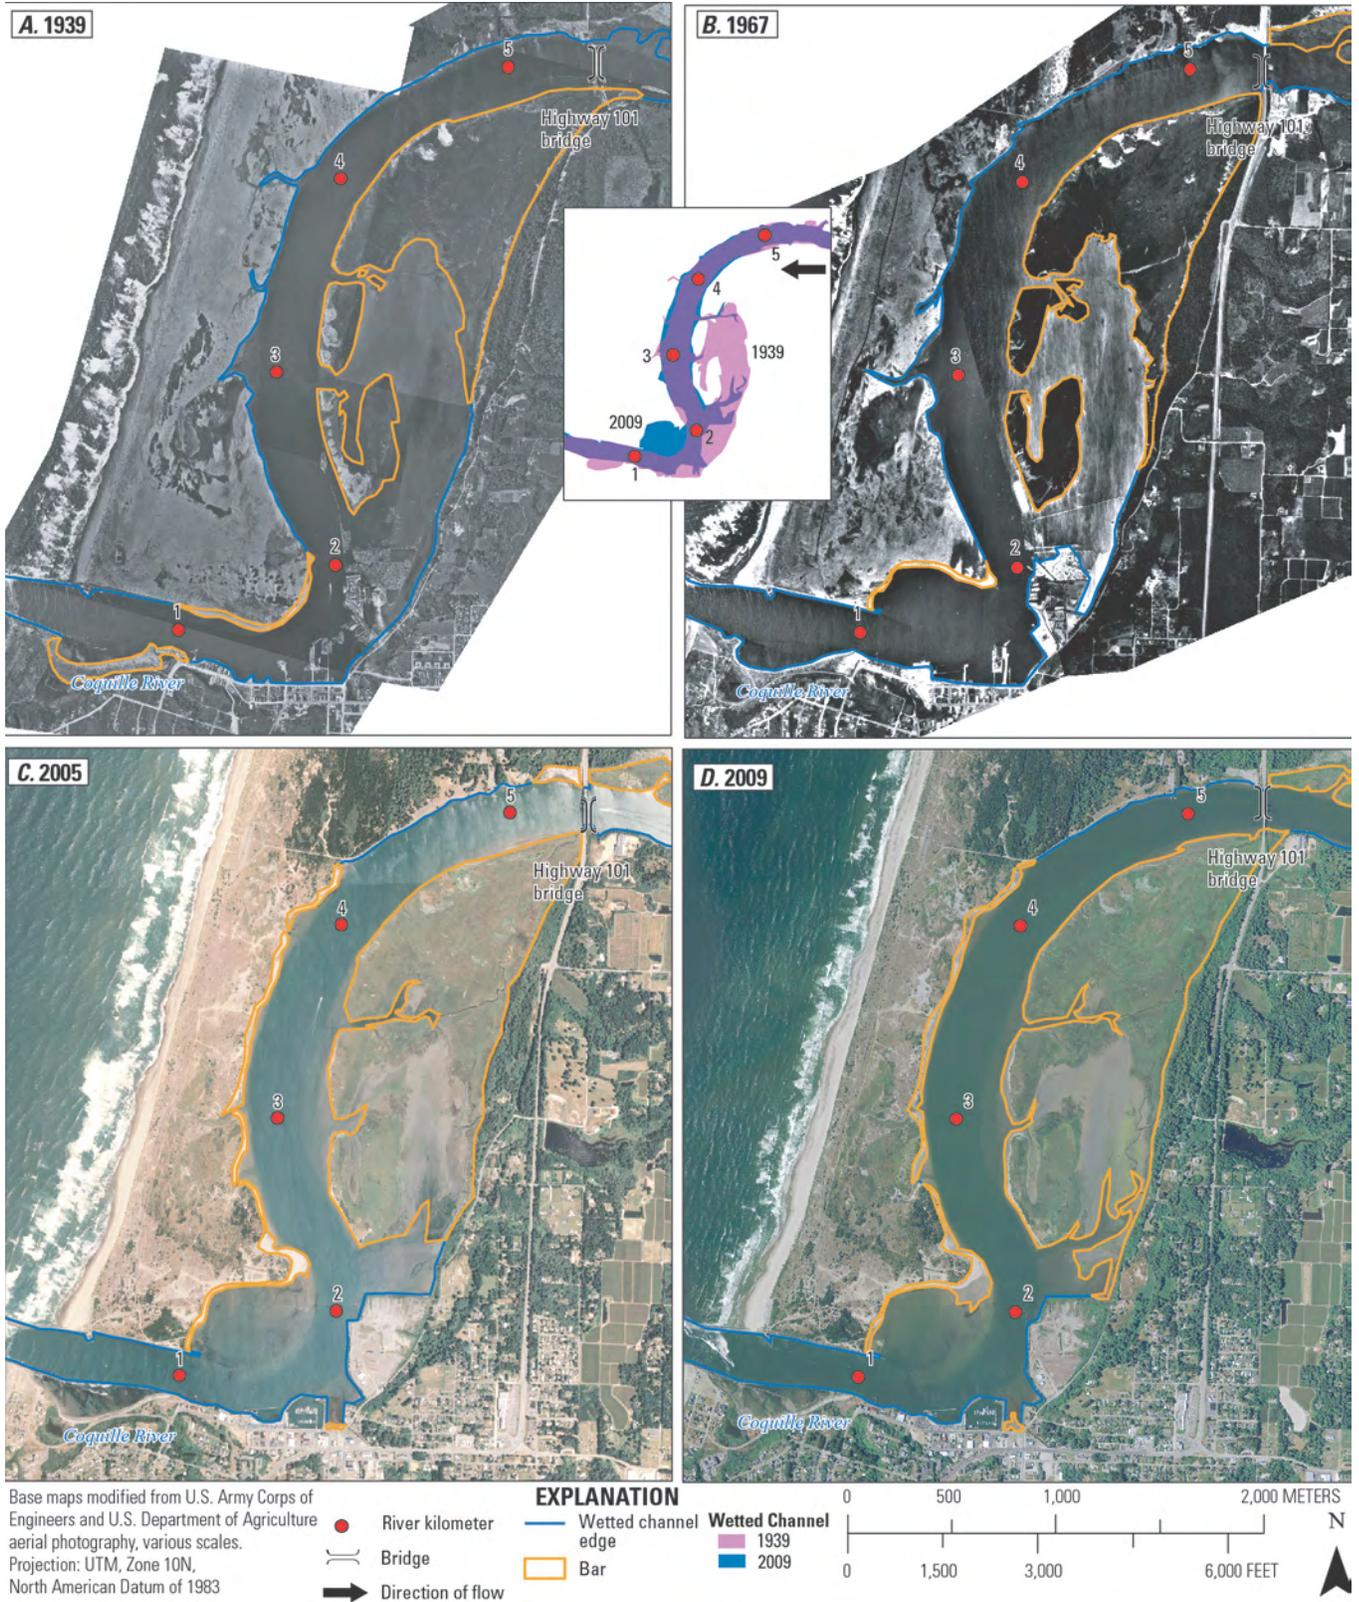
Figure 30. Images showing repeat bar and channel delineation in Bandon Reach near the mouth of the Coquille River, southwestern Oregon.

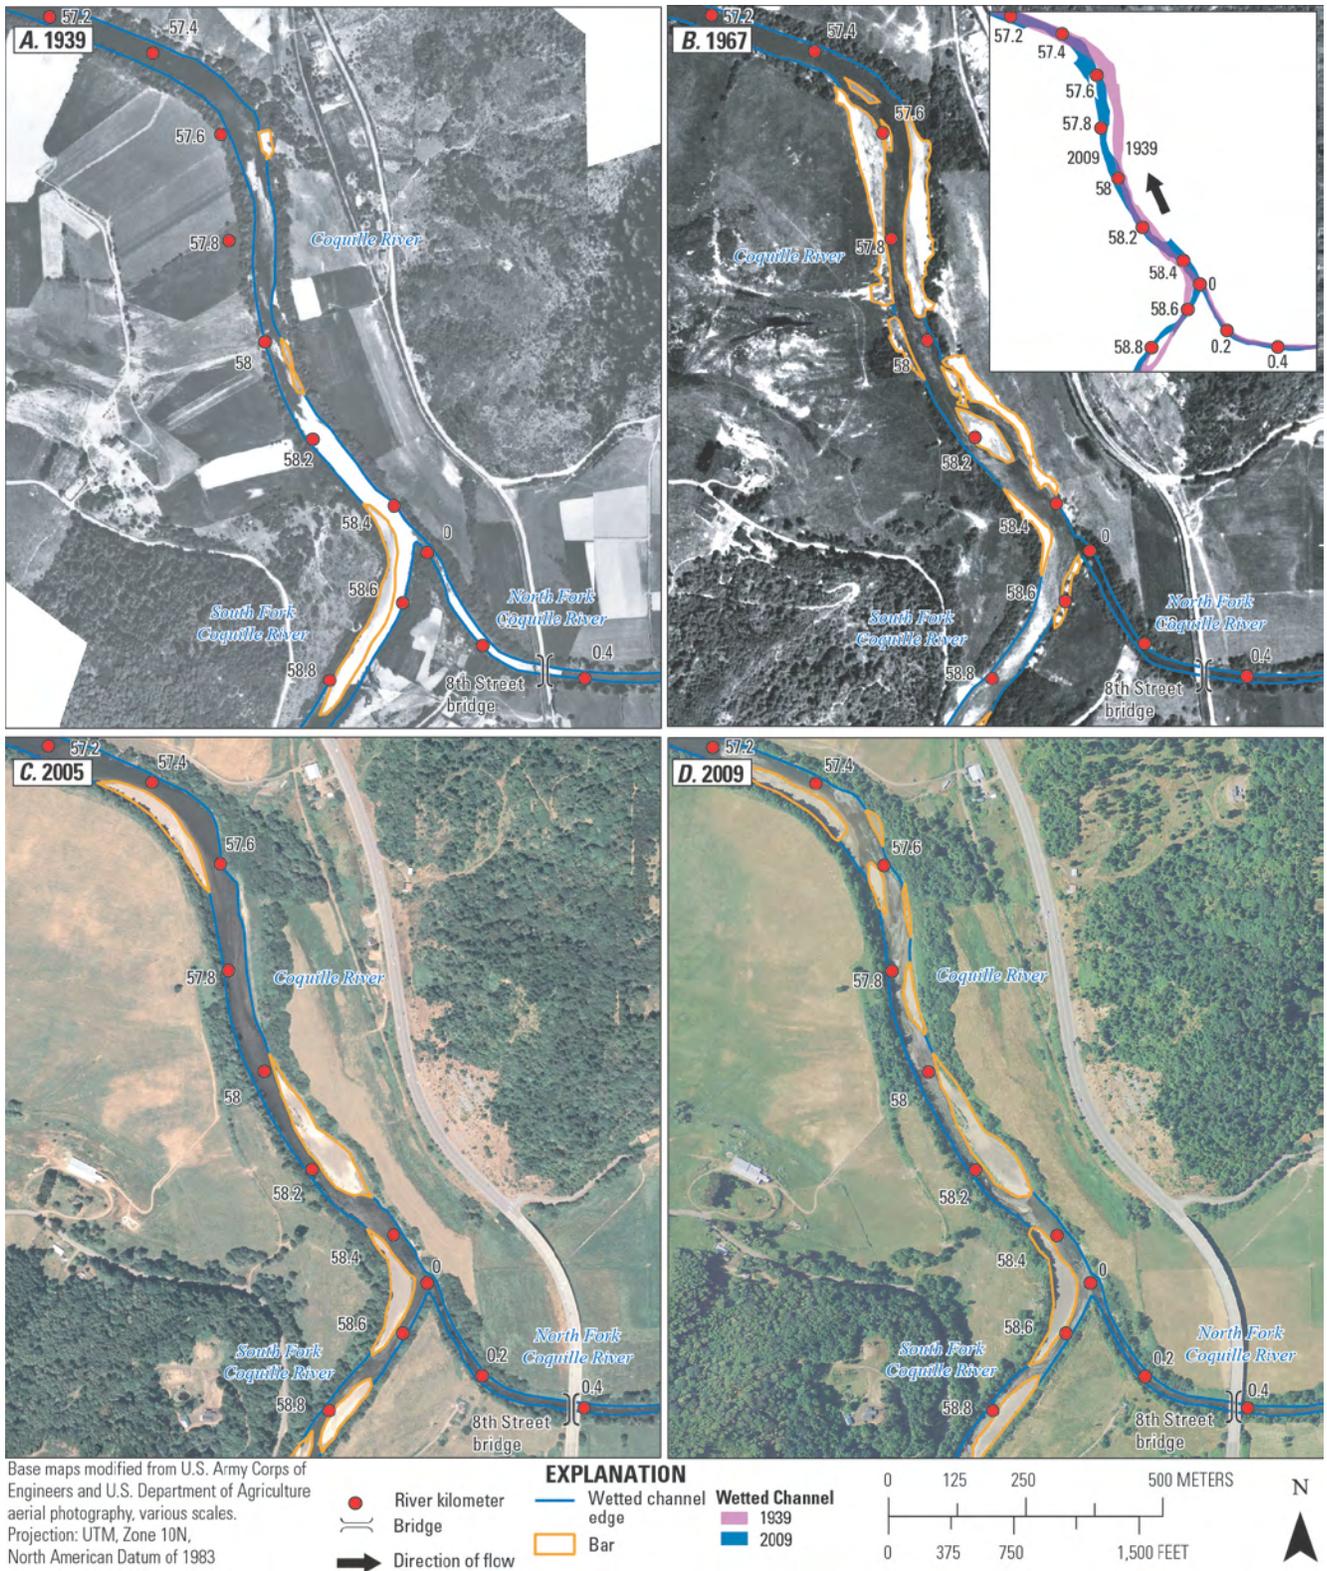
Figure 31. Images showing repeat bar and channel delineations and lateral channel movement in a section of the Bandon Reach on the Coquille River, southwestern Oregon.
