| DESCRIPTIVE REPORT | |
| Registry Number: | H12023 |
| General Locality: | Block Island Sound |
| Sub-locality: | Point Judith to Green Hill Point |

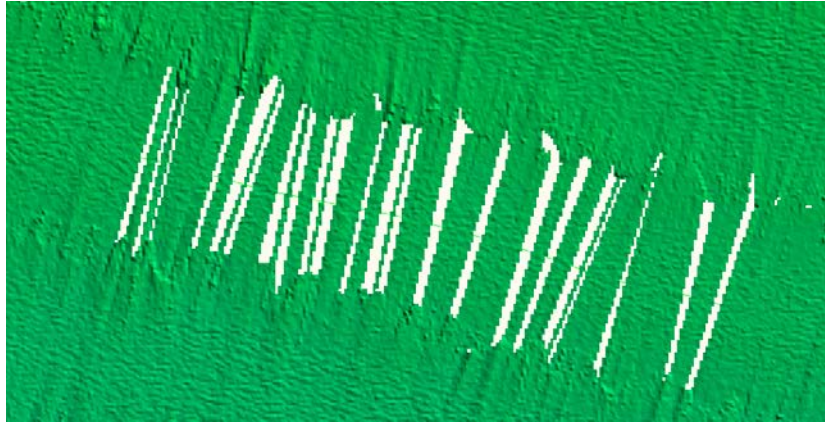
On DNs 243, 267 and 268, the Reson 7125 computer on Launch 3102 had an intermittent timing error. The error can be observed throughout the data as a wave in the surface. This generally does not exceed 40 cm in the grid. Where it exceeded this, the swaths were rejected, leaving gaps in the data (Figure 5). See correspondence in Appendix V.

Figure 5: Data gaps from rejected data where heave artifacts exceeded 40cm.

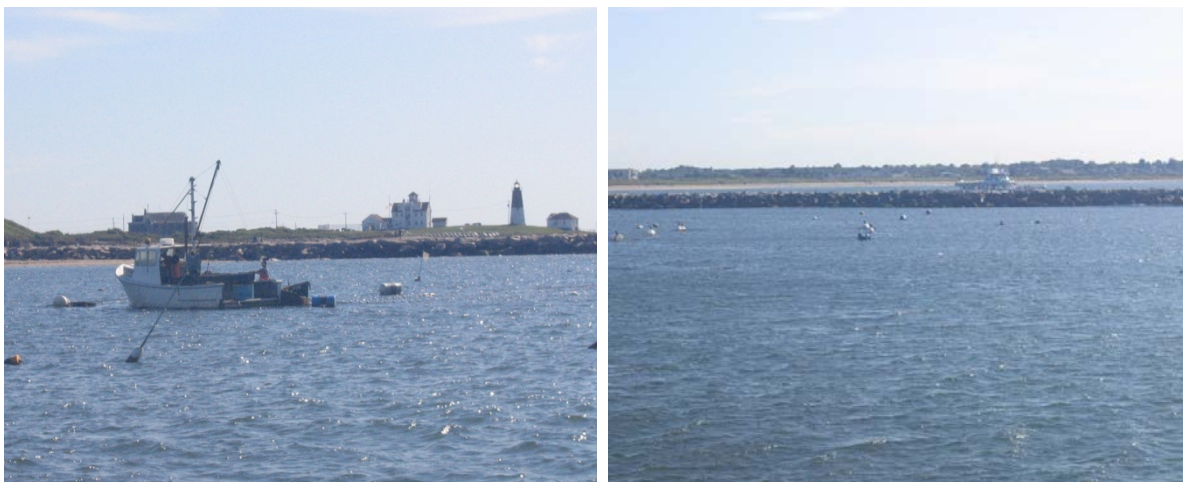
**Figure 10: Fish traps photos.**

There are 3 fish traps found by ortho-imagery. The fish traps at West Wall and East Wall were verified visually and positioned by launch 3102. The Brickwater Village Trap was not in place at the time, but its intended position was verified by Captain Tom Hoxsie of the *North Star*. The three traps are intermittent as they get serviced and replaced at the same location. Below is the *North Star* servicing the trap and a view of a typical layout of a fish trap (Figure 10). There are barrels anchored to the bottom supporting the trap gear. See Appendix II and V.
