Rio Grande Headwaters

West Alder Creek

Site ID: 1

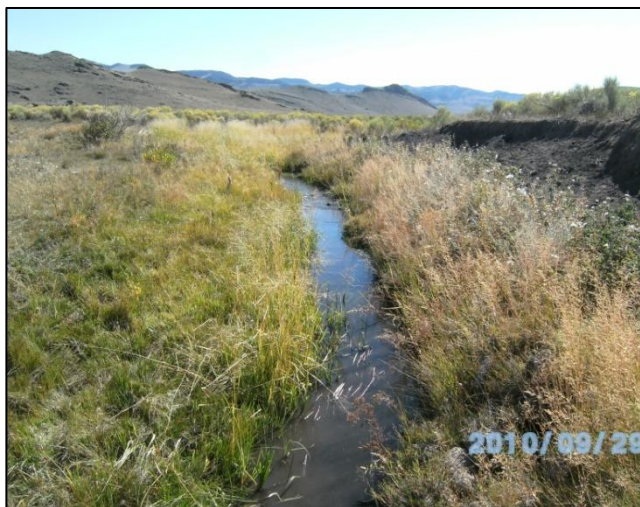
Figure 1. Lower monitoring site on Jack's Creek.

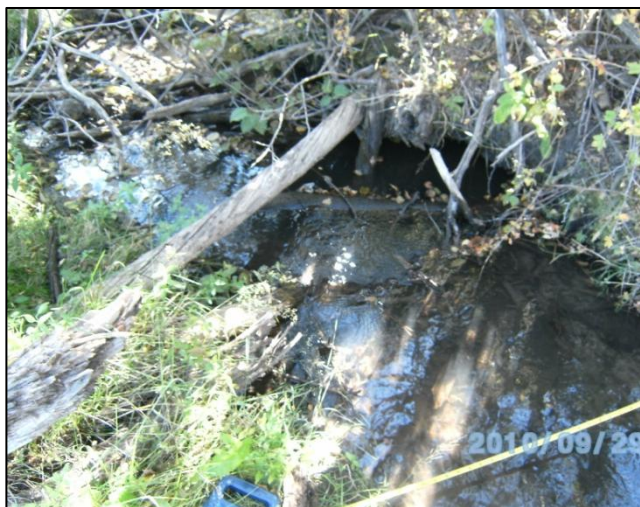
Figure 1. Upper monitoring site on Jack's Creek.

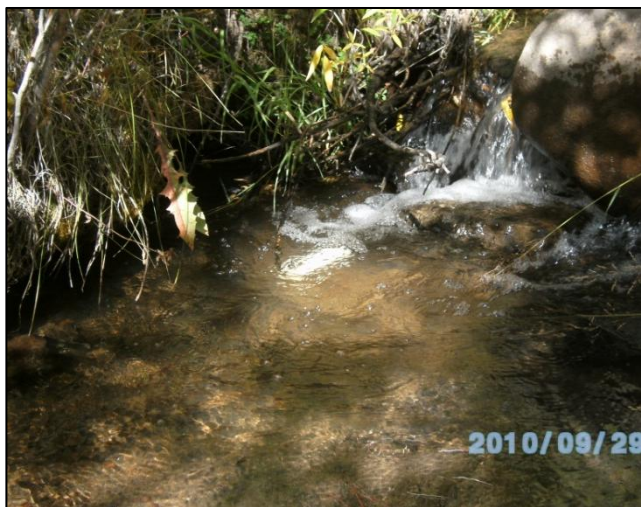
Figure 1. Monitoring site on Cross Creek.

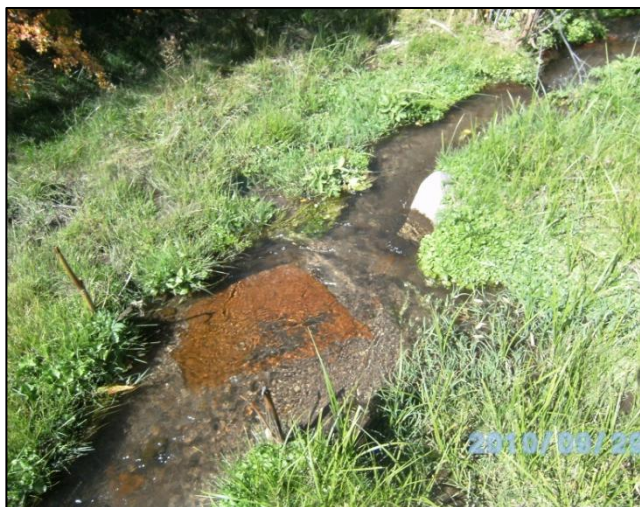
Figure 1. Monitoring site on Big Spring Creek.

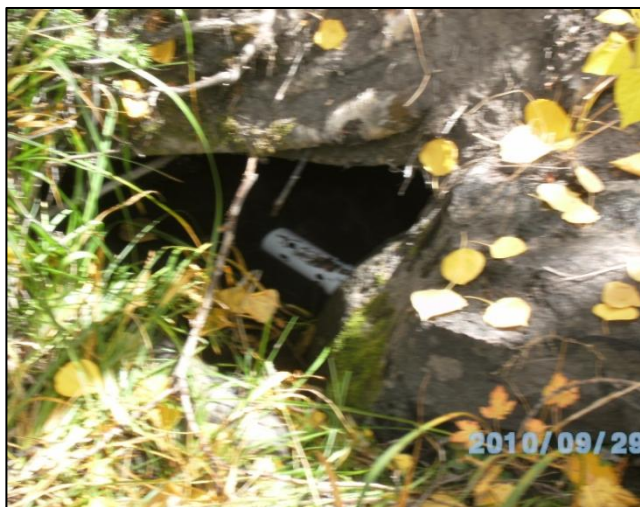
Figure 1. Monitoring site on East Pass Creek.

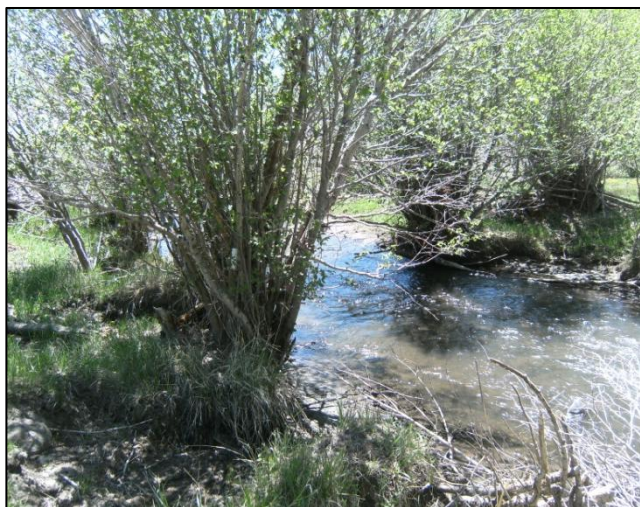
Figure 1. Monitoring site on Carnero Creek.

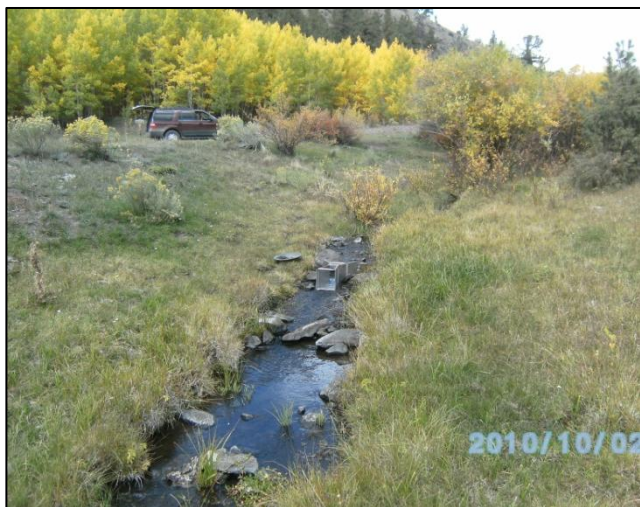
Figure 1. Monitoring site on North Fork Carnero Creek.

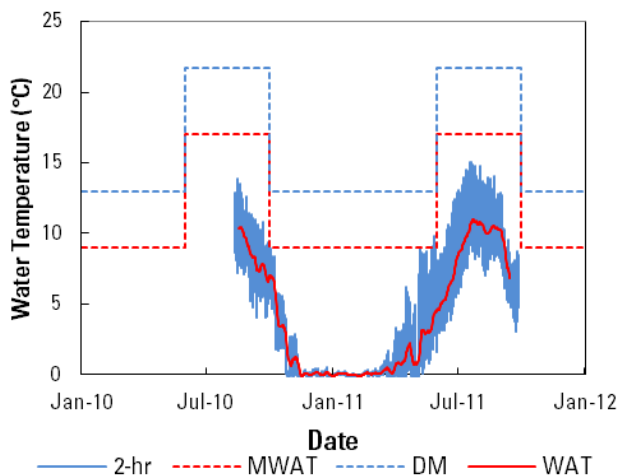
Figure 3. Two hour running mean (blue line) and weekly average water temperature (red line) at upper monitoring site on upper Medano Creek. Dashed lines represent Colorado Tier 1 Cold Water Criteria.

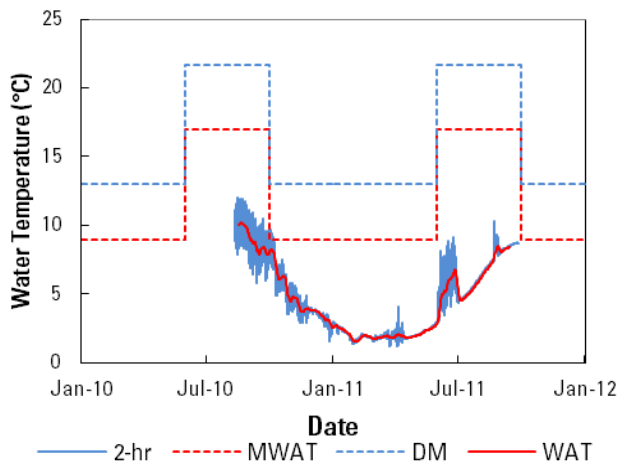
Figure 3. Two hour running mean (blue line) and weekly average water temperature (red line) at upper monitoring site on Little Medano Creek. Dashed lines represent Colorado Tier 1 Cold Water Criteria.
