# **Three-Dimensional Imaging, Change Detection, and Stability Assessment during the Centerline Trench Levee Seepage Experiment Using Terrestrial Light Detection and Ranging Technology, Twitchell Island, California, 2012**

Open-File Report 2014–1092

U.S. Department of the Interior  
U.S. Geological Survey

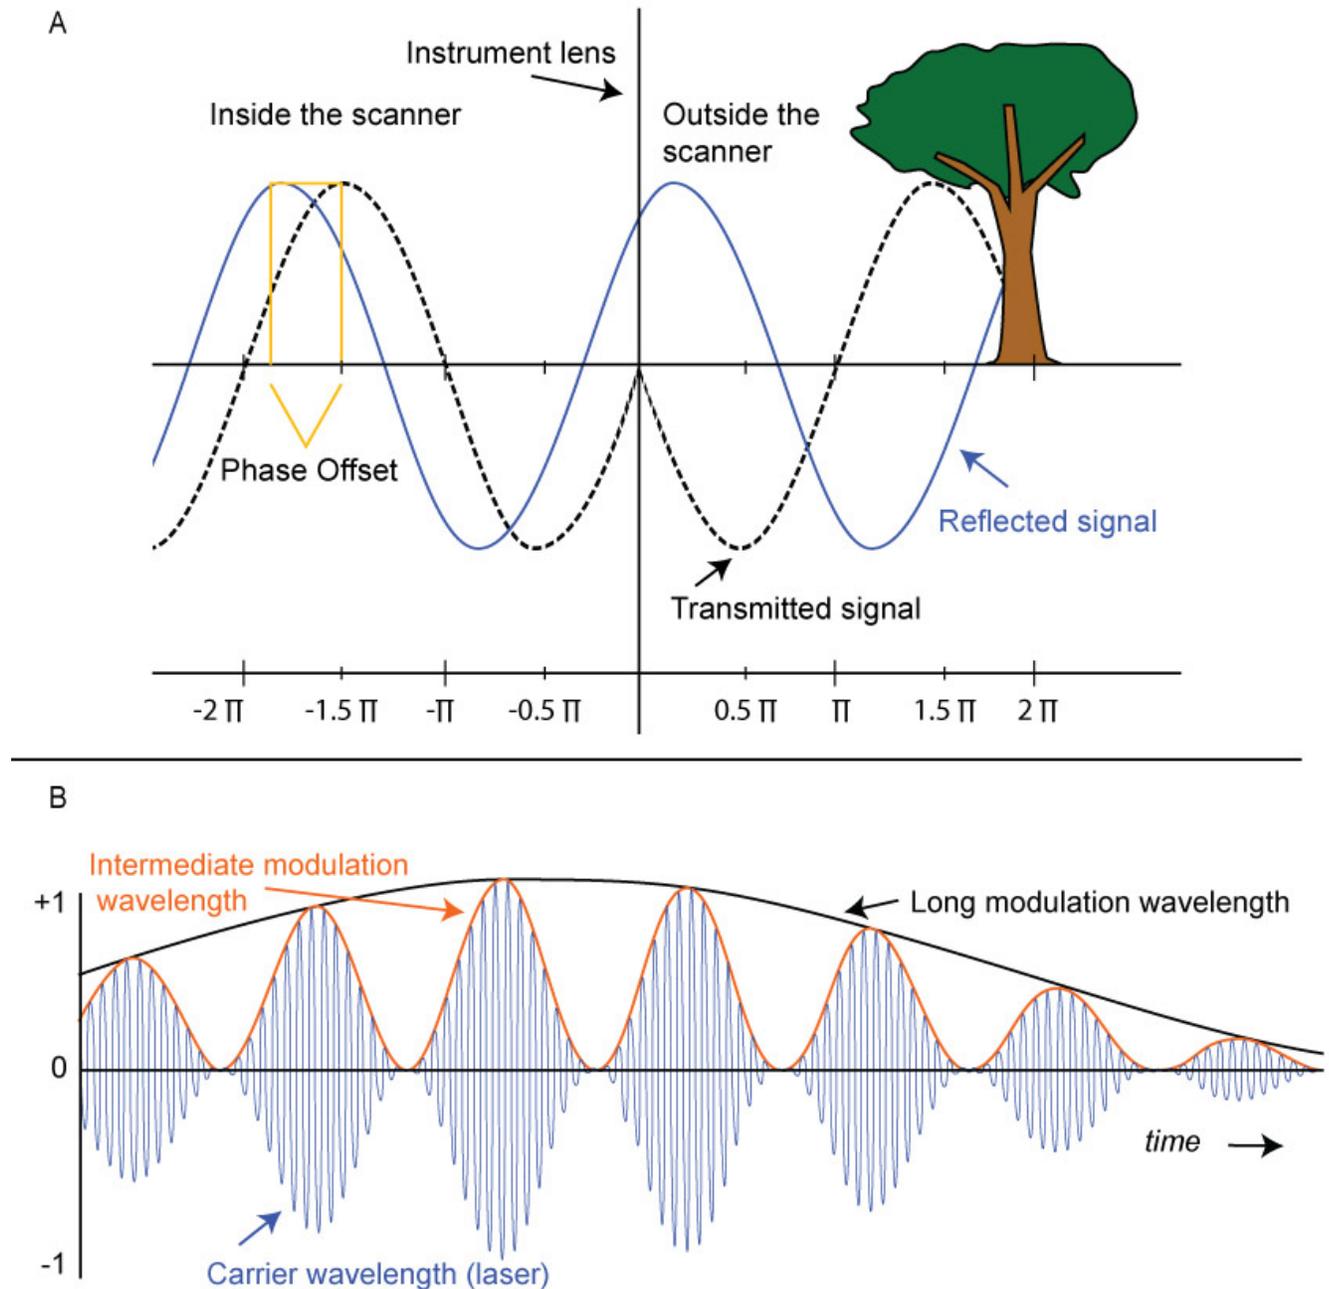
**Figure 2.** Schematic diagram showing phase shift and phase modulation. (A) The transmitted signal (black, dashed sine wave) reflects off a target (tree) and returns to the scanner (blue sine wave). Inside the scanner, the reflected signal is matched with the waveform of the transmitted signal to measure the phase offset. Modified from FARO Technologies, Inc., 2012a. (B) The carrier wavelength (shortest wavelength in blue) is modulated from both an intermediate wavelength (orange) and a long modulation wavelength (black). Modified from Pfeifer and Briesse (2008).

The FARO T-Lidar system is a phase-shift based laser scanner that, in ideal conditions, can collect accurate, less than or equal to 1.1 mm uncertainty 3D point cloud data to a distance out to 153.49 m (120 m to a 90 percent reflective target; most natural targets are reflective at 20–30 m during midday sun). The phase-shift approach uses a laser that emits a continuous sinusoidal laser beam that travels from the instrument, reflects off the target, and travels back to the scanner (FARO Technologies, Inc., 2012a). The phase shift is the difference in the peaks between the “emitted laser” beam and the peaks of the “returned laser” beam (fig. 2A; Pfeifer and Briese, 2008). The distance the pulse travel is calculated by the following equation:

The phase-shift approach cannot resolve distances that exceed maximum modulation frequency because this approach can only resolve the phase shift for one full sinusoidal wave cycle. Any phase return that exceeds this distance would theoretically be mapped into the first phase interval; firmware filters remove any *n*-modulation frequency returns to provide a clean dataset devoid of this ambiguity. Modern phase-shift scanners improve the accuracy of the distance measurement by using more than one modulation wavelength, where the amplitude of the carrier wave is modulated to form two longer wavelengths (fig. 2B). This bootstrapping approach uses the longest modulation wavelength to determine a coarse distance and uses the intermediate wavelength to improve the distances measured to a point that there is no ambiguity on the shortest carrier wavelength and the highest accuracies can be obtained.

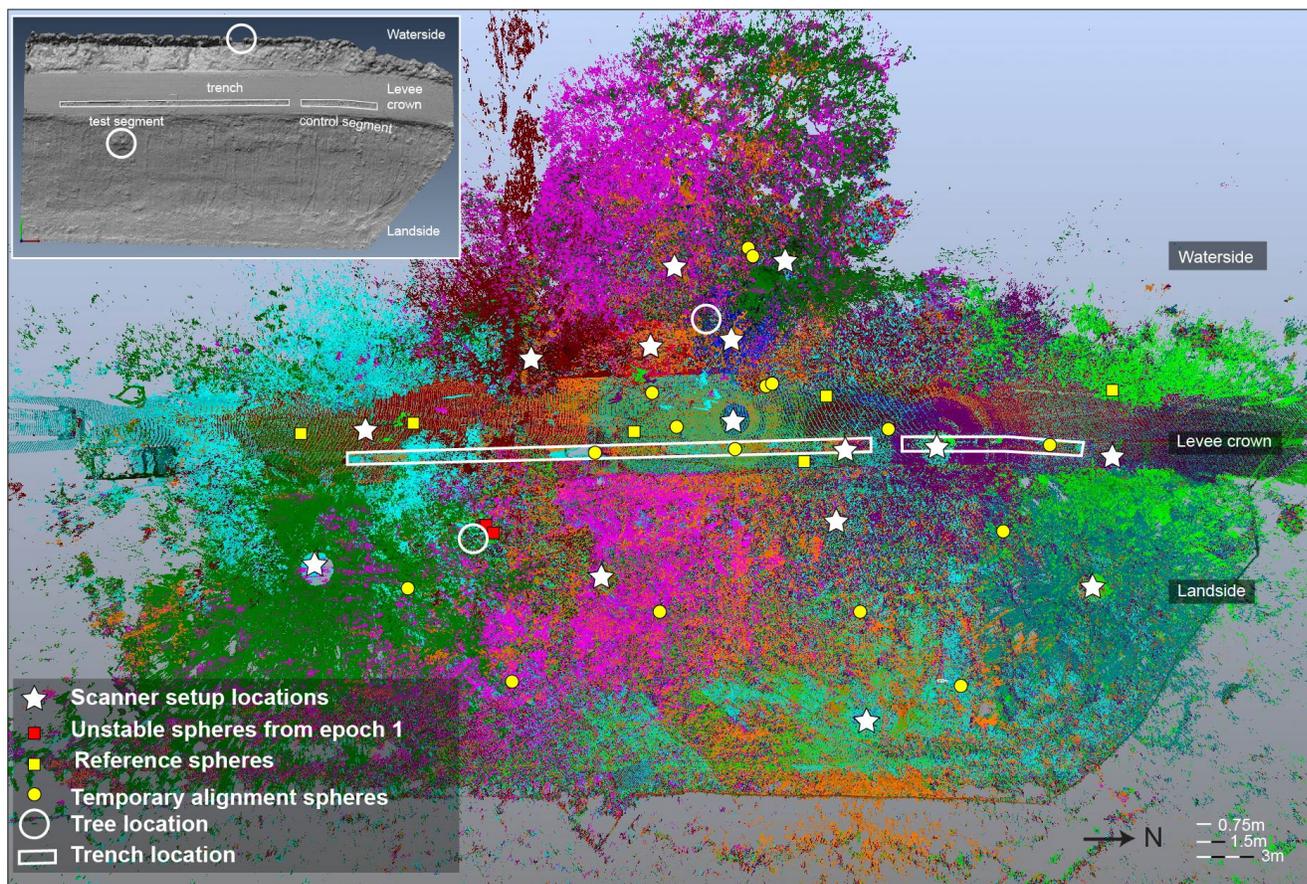
**Figure 3.** Example of terrestrial light detection and ranging point cloud map of the imaged levee (epoch 3) with scanner setup locations, reference frame sphere locations, and temporary alignment sphere locations. Each scan is shown as a different color with the scanner location shown as a star, with data (color points) extending radially outward from the star where data is not collected directly beneath the instrument. The inset in the upper left corner shows a gridded 2-centimeter shaded-relief, bare-earth digital elevation model of the levee surface with the trench location outlined in white. The map shows the two unstable reference spheres (red squares) and the other reference spheres that were used during the surveys (yellow squares). Additionally, the temporary alignment spheres (yellow circles) that only applied to the final survey are shown as distributed throughout the seepage test area. The trench location is outlined in white, with the smaller control segment to the north (right) and the longer test segment to the south (left). The white circles represent the locations of the two trees discussed in the report. Twitchell Island, California, 2012. (m, meter.)

The same alignment-sphere sizes were placed on the reference target locations for each of the subsequent surveys to ensure a good alignment from one time period to the next. The remainder of the FARO spheres were treated as temporary alignment spheres (TAS) to increase the density of alignment spheres in adjacent scans during the same survey. When the scanner position exceeded approximately 25 m from a TAS, the sphere was relocated to a position where it could be easily seen in the next few scan locations. Moving the TAS positions provided a more balanced distribution of the spheres throughout the scan area to improve the 3D alignment (fig. 3).

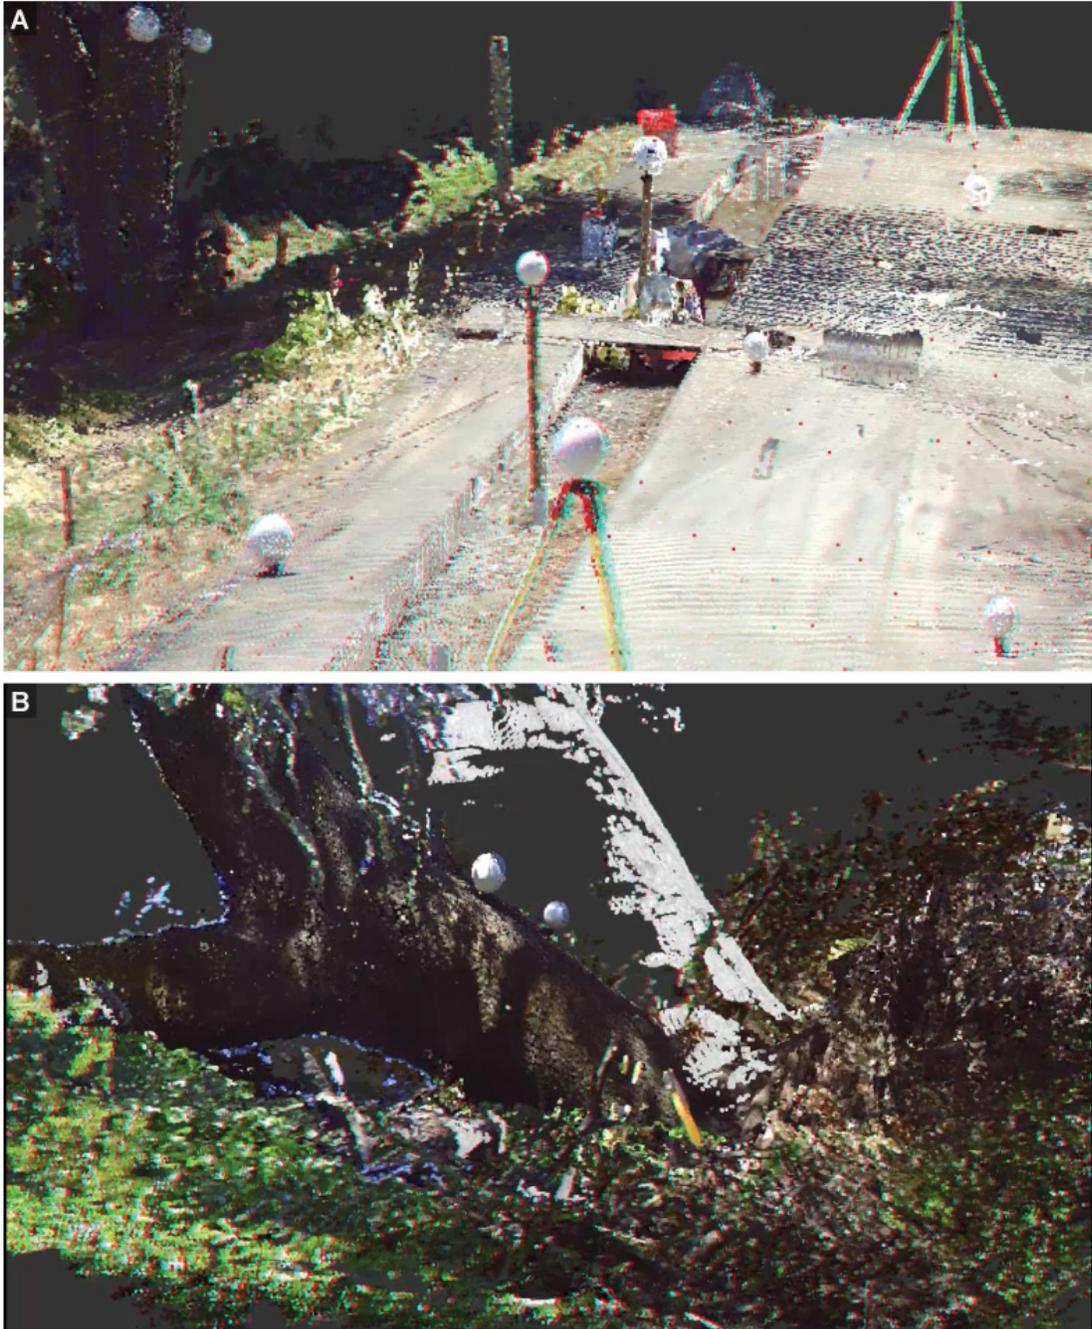
**Figure 4.** Three-dimensional anaglyph visualization of the point cloud data of (A) the levee crown, alignment spheres, and seepage trench image; and (B) the tilted waterside tree with white points showing the initial position of the tree and the colorized point cloud showing the data collected at the end of the project. Twitchell Island, California, 2012. Use red/blue anaglyph glasses for best viewing of the figure.

We used the 3D virtual reality software developed by the University of California Davis KeckCAVES LidarViewer (Kreylos and others, 2008) to scrutinize all of the scan alignments—internally within a given survey and among each of the surveys when aligned together. The LidarViewer software visualization package allowed us to assess the alignment quality of each of the scans and sets of scans by color coding each scan and using active-sync 3D stereo glasses to view the data in true 3D so that centimeter misalignments could be identified and corrected. LidarViewer also allowed us to visualize the point cloud data and directly measure the motion/feature offsets between each epoch. Two examples of LidarViewer images are provided in figure 4 and show: (1) a colorized 3D point cloud image of the trench with alignment spheres, and (2) the toppled tree on the water side where the initial baseline data are in white and the final survey is colorized; the figure can be viewed with red/blue 3D anaglyph glasses to visualize the point cloud in 3D (fig. 4).

Midway through the seepage test, the large tree located on the waterside of the levee toppled over into the water behind the levee (fig. 4B) and generated a series of cracks on the levee bank. Fresh fractures/cracks formed on the paved levee crown in the hours and days after the tree toppled. Our analysis determined that the trunk of the tree rotated towards and into the water by 20.67 degrees with a minor levee parallel motion in the rotation (fig. 5). The rotation was calculated by fitting a best-fit cylinder primitive (primitive—a mathematic geometric feature, such as points, vectors, polylines, planes and cylinders) to each of the tree trunks along a corresponding straight section of the tree in each epoch. The cylinders were then extended to determine their intersection, thereby determining the 3D rotation vertex location (angle vertex on fig. 5). The rotation magnitude was determined by measuring the angular relationship of the centerline vectors within each of the cylinder primitives using the cylinder vector intersection as the tree rotational vertex.

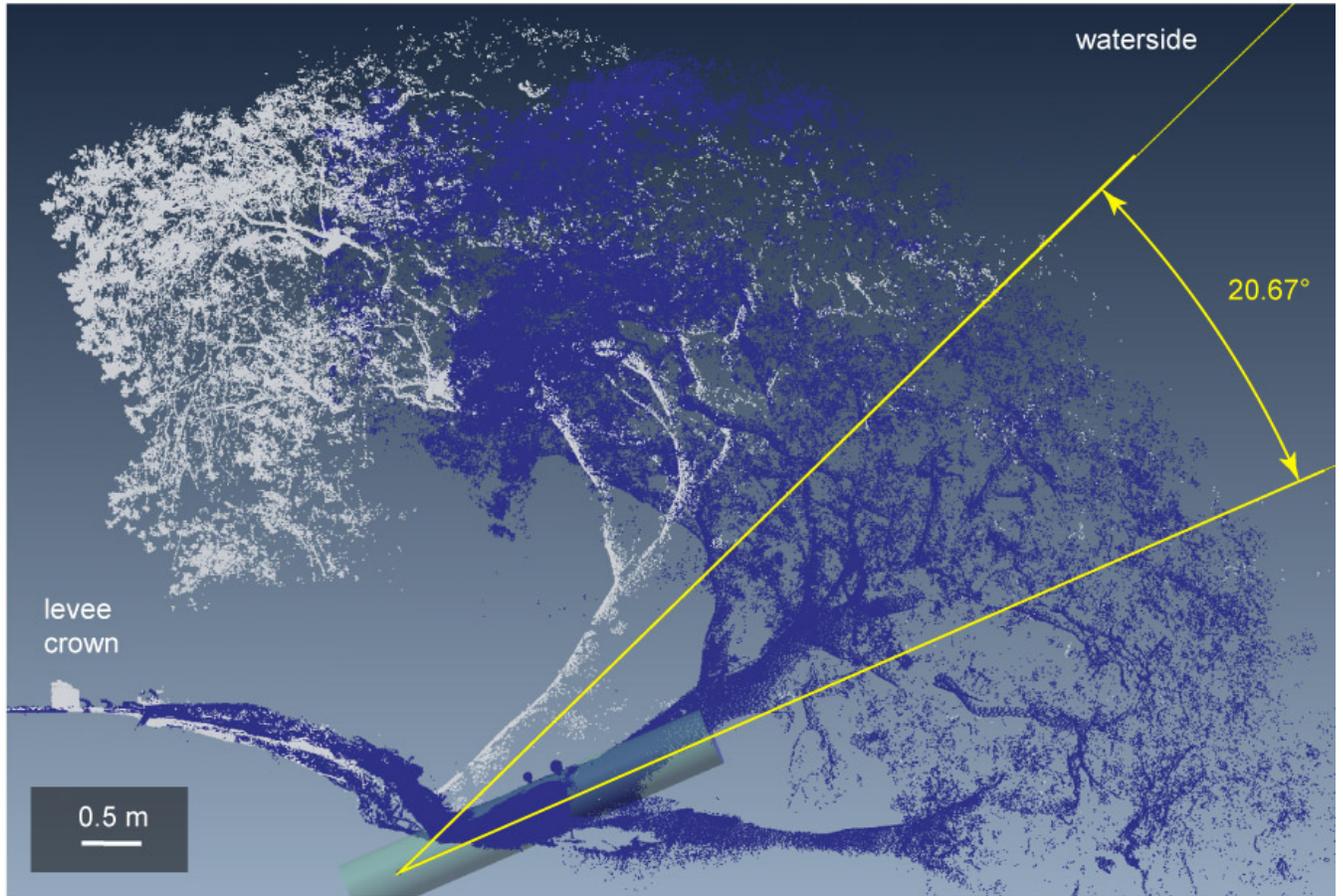
**Figure 5.** Point-cloud imagery shows 20.67 degrees of rotation of the waterside tree from the pre-seepage test scan on April 4, 2012, (white) and the final survey on June 6, 2012, (blue) with the best-fit cylinder for the June dataset. Twitchell Island, California, 2012.

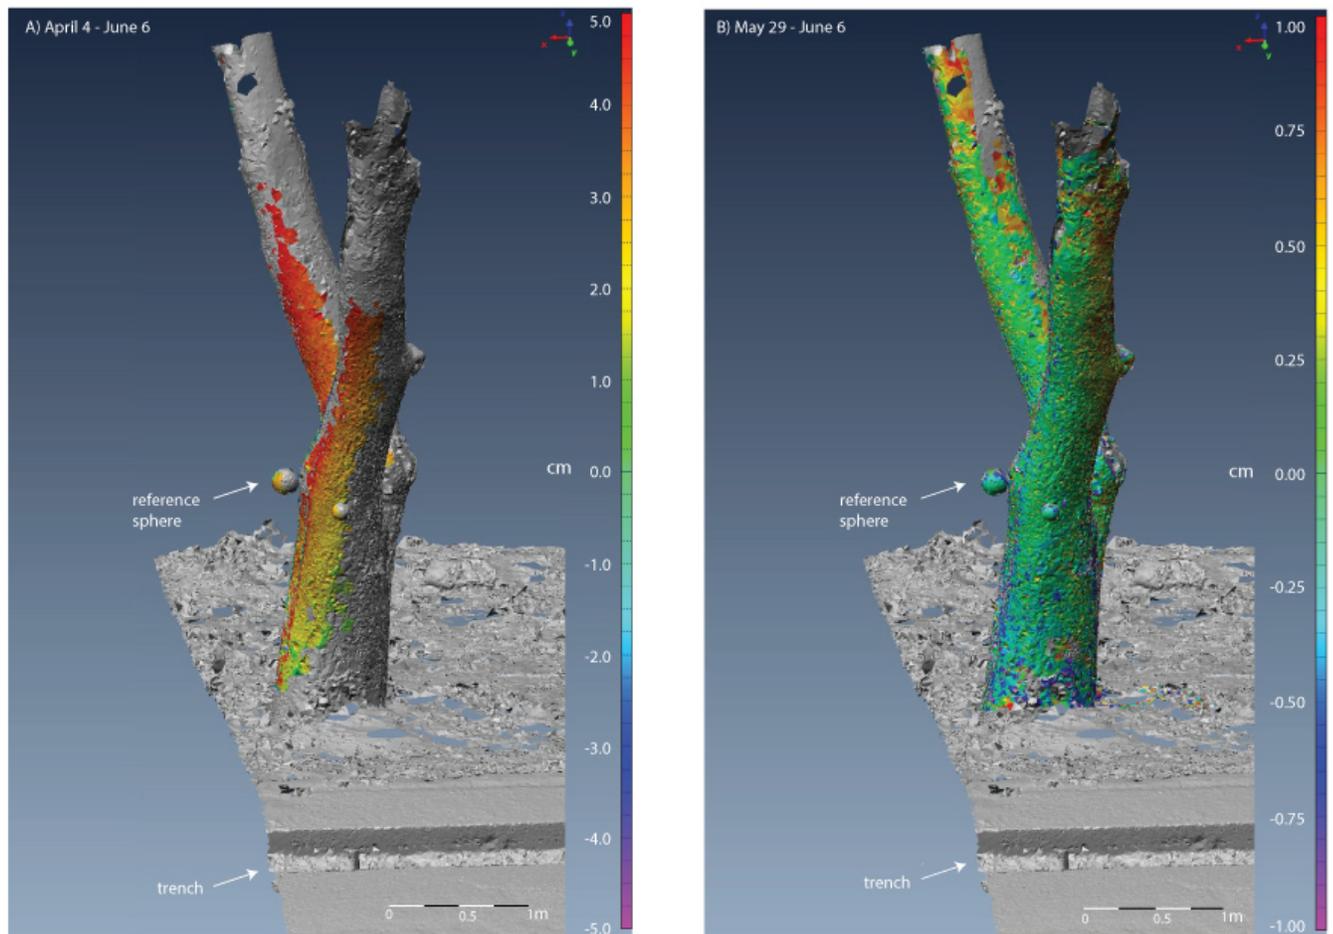
**Figure 6.** Difference map showing displacement pattern on the landside tree between (A) April 4–June 6, 2012, and (B) May 29–June 6, 2012, Twitchell Island, California. Note that the color scales are not the same in both images. The scale is larger in (B) to show smaller displacement along the y-axis (perpendicular to the levee) that occurred between the second and final survey. Twitchell Island, California, 2012.

Assessing the stability of the landslide tree was important because our initial reference frame was anchored to the tree and had two alignment spheres attached which were scanned in every survey. Therefore, any motion (rotation) of the tree automatically resulted in misalignments with subsequent surveys. Once we recognized that the landslide tree had shifted the reference frame, we removed these spheres from the alignment process so we could track positional changes along the tree trunk. Between April 4 and June 6, 2012 (the first and final survey), we determined that the tree rotated towards the landslide about 5 cm at a tree height of 2 m (fig. 6A) and can be seen as increased displacement in the tree position from the ground upward. Between May 29 and June 6, 2012, (second and final surveys) there was about 1 cm of motion; therefore, the majority of the tree motion took place between April 4 and May 29—the first and second survey (fig. 6). The UCB string extensometer placed on the landside tree after the waterside tree toppled showed just less than 1 cm of landward motion, which is in good agreement with our measurement between our second and final surveys.

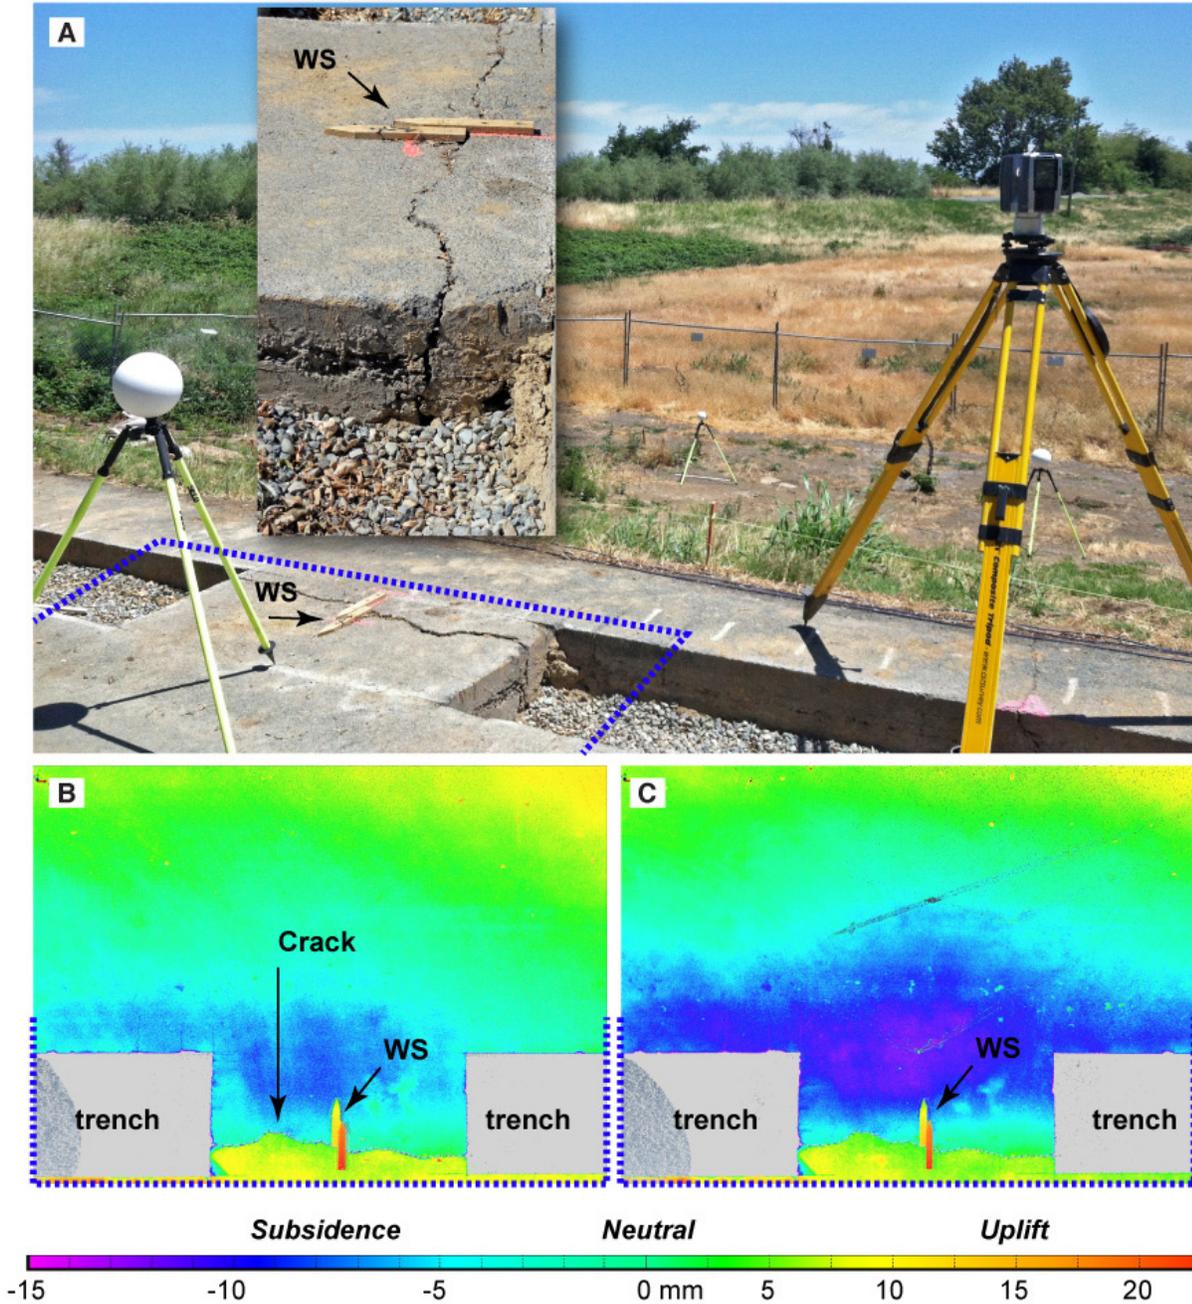
**Figure 7.** Photograph of (A) the laser scanner imaging a prominent crack in a connecting wall at the northern end of the primary seepage trench and elevational difference maps across the crack from (B) April 9–May 29, 2012, and (C) April 9–June 6, 2012, Twitchell Island, California. The view of (B) and (C) is looking from the landside of the levee with the wood stakes (WS) in the lower center and the trench floor in gray; the location of (B) and (C) is represented as the blue dashed line in (A) and on the corresponding parts of (B) and (C) The photograph does not span the full area represented in [B] and [C]. The inset shows a close view of the crack as viewed from near the scanner location. Note that the scale is non-linear; it was optimized to show the wood stakes and the localized subsidence. Twitchell Island, California, 2012. (Photographs [A] and inset both taken June 6, 2012, by Sandra Bond and Gerald Bawden, respectively.)

The waterside tree failure produced noticeable cracks in the paved levee crown, including a crack that formed on the northern lateral wall of the trench with approximately 1 cm of observable differential motion with the waterside subsidence (fig. 7) measured at the break between the control trench and the test trench. The levee crown is a very lightly traveled abandoned asphalt road surface that spans the width of the levee. We produced a difference map of the crown showing the location and extent of the subsided region (fig. 8) by comparing the first epoch to a mesh of the last epoch along the z-axis. We located three regions on the levee crown that showed vertical motion (Labeled X, Y, and Z on fig. 8A–B). The northernmost region (area X) associated with the crack caused by the subsidence is approximately 1.3 m wide and 15.8 m long with a maximum subsidence of 2.1 cm (fig. 8B–C). The central region (area Y) is a semicircular feature, 3.4 m wide and 11.2 m long with the maximum subsidence magnitude of 6.25 cm located near the waterside of the trench. The southernmost subsidence feature (area Z) parallels the waterside trench and is 1.4 m wide and 8.2 m long with a maximum subsidence of 3.5 cm. It must be noted that because our initial survey occurred before the trench was excavated, we cannot resolve the exact timing of the subsidence; specifically, whether these features are associated with the trench construction, the seepage test, or the waterside tree fall. A high frequency T-Lidar scanning approach would have been required to constrain the temporal and spatial variability of the levee throughout the full seepage test experiment. We noted that there is an area of uplift about 1.5 cm located on the waterside of the levee between the Y and Z shown on the figure 8B–C. This feature was recognized months after the experiment had concluded, therefore it was not possible to verify, in the field, the observations and explore possible deformation sources. Another area of apparent uplift is the red levee parallel feature near X on figure 8B–C was determined to be straw wattles used during the seepage test that were not in the initial baseline survey.

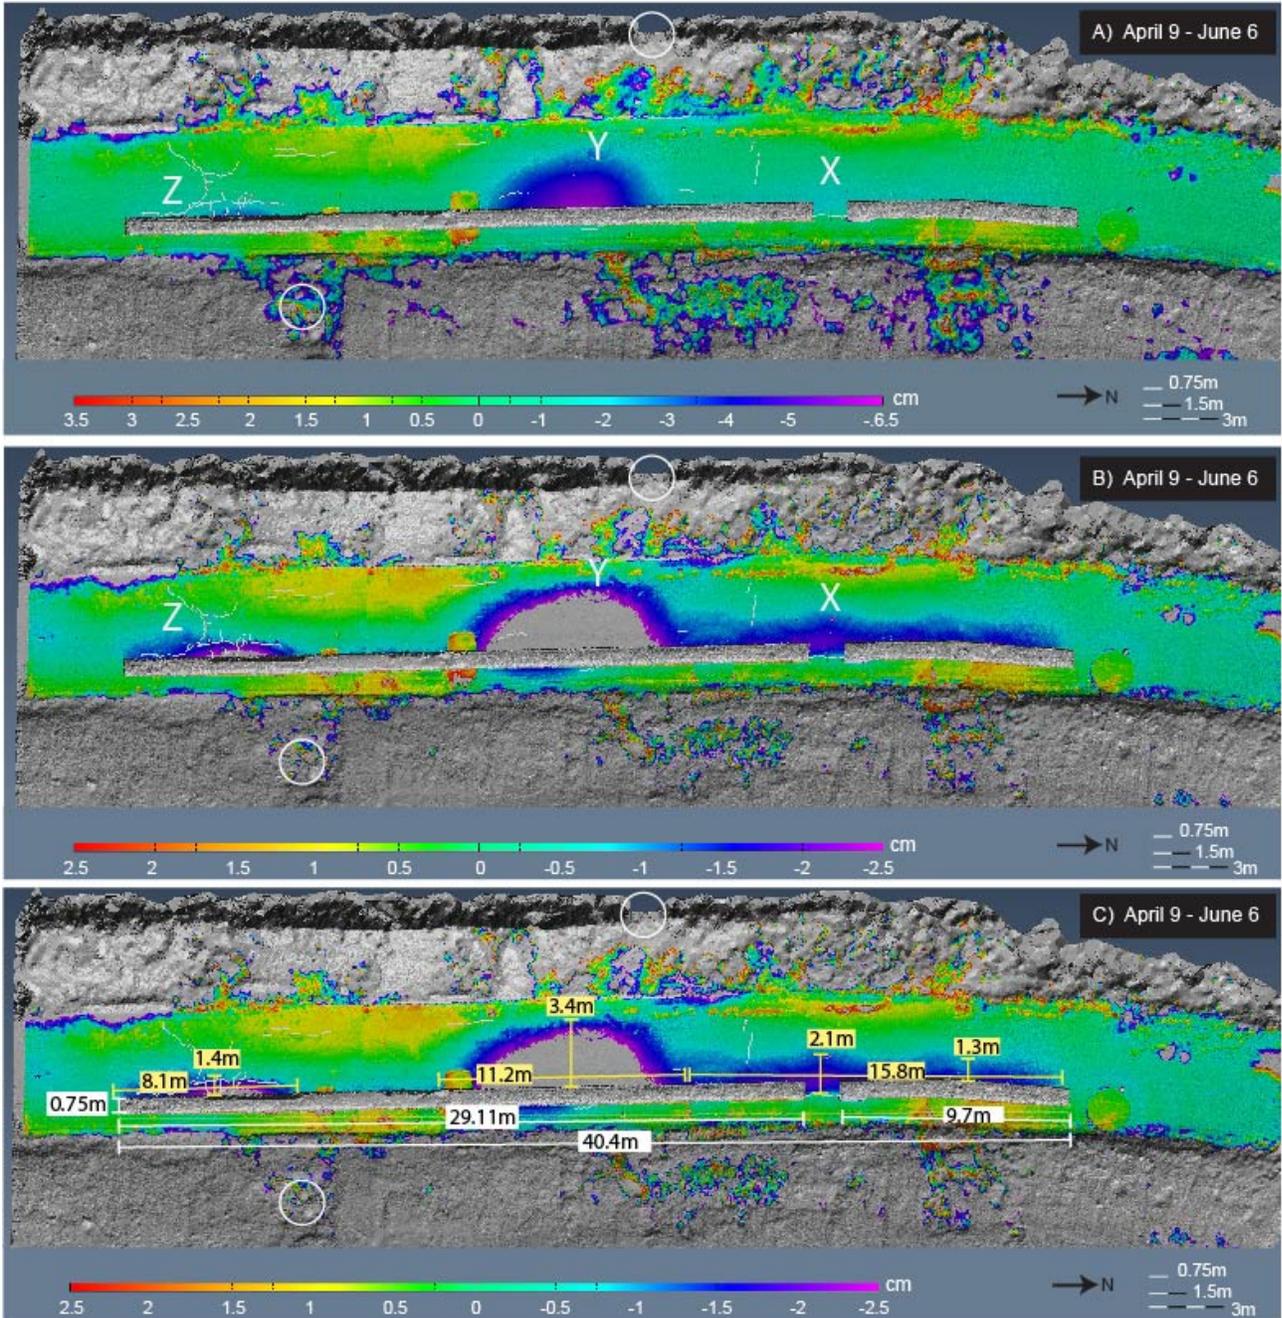
**Figure 8.** Colorized vertical change map focusing on the levee crown, Twitchell Island, California, between April 9 and June 6, 2012. Colors show the magnitude of elevational change between the two time periods in centimeters (cm). Areas of gray either have insufficient data between the two time periods or the magnitude of the motion exceeds the scale range for the figure. (A) Optimized to show the full range of motion on the levee crown and (B) Optimized to show small-scale elevational changes on the levee crown between 2.5 and -2.5 cm, where the gray areas on the levee crown that are colorized in (A) exceed the scale range. X, Y, and Z are subsidence areas discussed in the report and the white lines are mapped small scale fractures/cracks. (C) Shows the physical measurements of the trench (white) and the extent of the subsidence features on the paved levee crown (yellow), the elevational changes are shown the same as in (B). Twitchell Island, California, 2012. (m, meter.)

We created a digital map of the major fractures in the asphalt-covered levee crown by evaluating subtle linear geomorphic expression of the cracks in the T-Lidar elevation data and by using the 3D RGB color component of the T-Lidar data to effectively map the cracks with assistance of the photographs (fig. 11). Relative elevational difference associated with the center of the crack, having a slightly lower height than the surrounding sides, creates a geomorphic quasi-linear feature that can be identified by differencing the point cloud data height and a best-fit plane that was fit through the surrounding point cloud data along the crack (fig. 11D). Areas along the fracture that had a lower relative elevation were identified and mapped using Polyworks Inspect module (InnovMetric Software, Inc., 2013). Additionally, many of the cracks were visible in the colorized point cloud data because they are slightly darker than the surrounding points, which allowed us to identify and map the cracks. A crack map of the levee crown shows that most of the major cracks were observed along the levee crown and on the immediate side of the levee near the fallen tree (fig. 8).

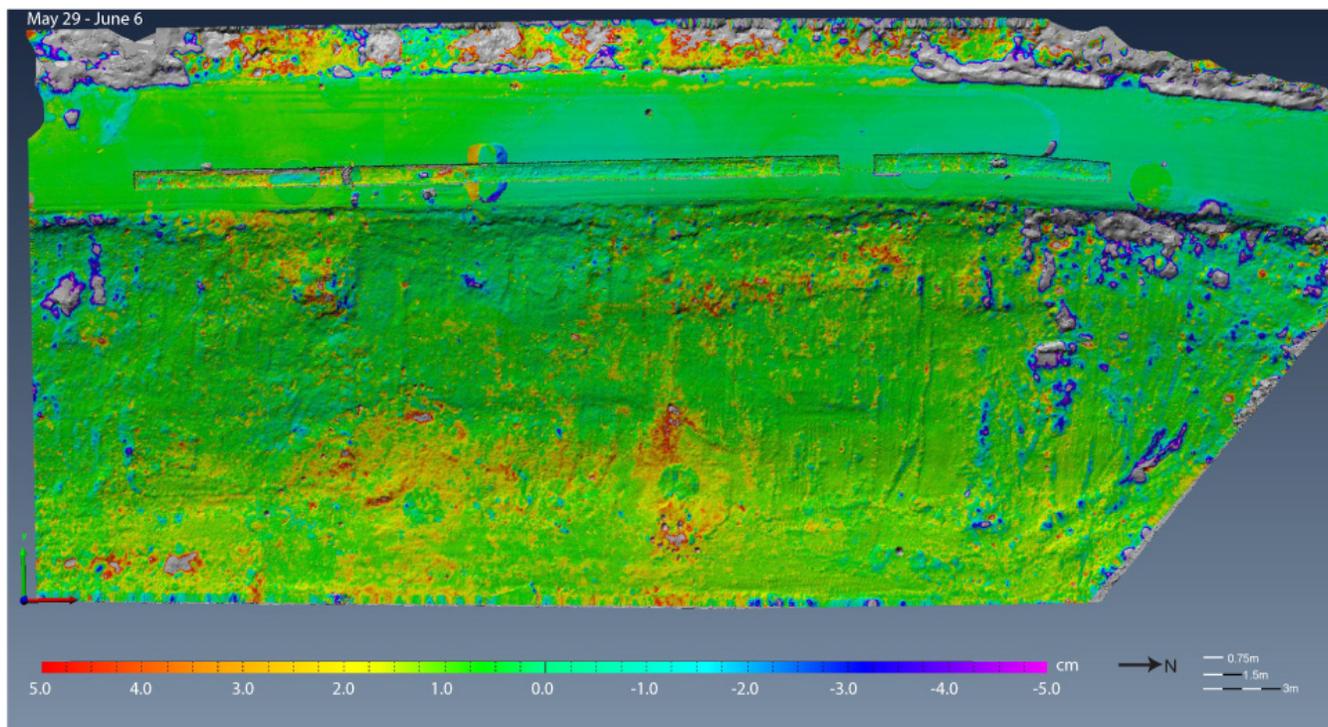
**Figure 9.** Difference map showing  $\pm 5.0$  centimeters (cm) of vertical change on the levee flank and crown, Twitchell Island, California, between May 29 and June 6, 2012. Red shows an increase in surface elevation between the two time periods where blue shows a decrease in elevation. The base map is a 5-cm bare-earth digital elevation model of the levee flank. Twitchell Island, California, 2012.

We created bare-earth models of the landside levee flank for each epoch to assess if there was detectable motion, especially in areas where there were water seeps. The landside levee flank was not cleared of vegetation (mostly grasses) during our first survey; as a consequence, the laser scanner was not able to fully penetrate the dense vegetation and image the land surface so we could measure surface elevation changes associated with the seepage test. Therefore, we could only get a measurement for changes between the second and final surveys, because much of the vegetation had been removed by that time. We used the TerraScan™ software to identify the remaining vegetation in the point cloud data on the landside of the levee, remove it from the dataset (Terrasolid Ltd., 2013), and create a gridded 5-cm bare-earth (25 cm<sup>2</sup> grid size) DEM of the levee crown and landside levee flank. We then differenced the DEMs along the z-axis for each of the epochs to resolve possible vertical motion along the levee flanks (fig. 9). We found no vertical motion that exceeded 5 cm between May 29 and June 6, 2012, on the landside levee flank. There are some localized areas of -2 cm vertical change (blue; fig. 9) that are likely associated with vegetation changes on the levee. The east-west feature spanning the trench in the middle of the trench that shifts from 3 to -3 cm (orange/blue; fig. 9) is a piece of plywood that was moved sometime during the week between surveys. The band of yellow/red (3–5 cm; fig. 9) on the waterside of the levee crown is associated with debris that was swept to the side of the levee.

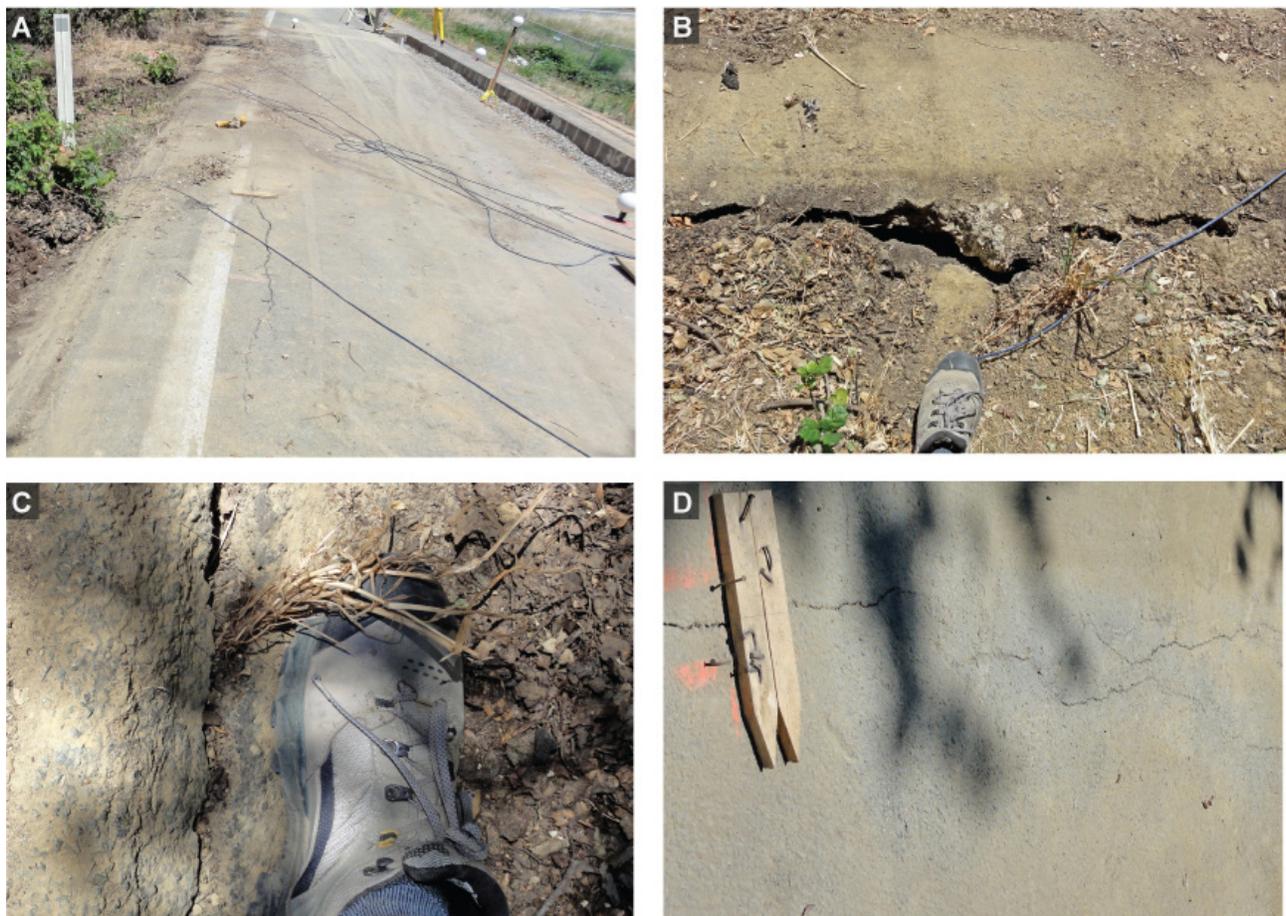
**Figure 10.** Photographs showing cracks on the levee crown, Twitchell Island, California, 2012. (A) An active crack located on the water side of the levee – note the debris on the levee surface; (B) an active crack on the water side of the levee where a few centimeters of motion was observed and (C) vegetation (now dead) was growing from the crack showing that the crack predated the seepage test but was reactivated during the test; and (D) an active crack on the levee crown where wood stakes were attached to either side of the crack to measure additional crack motion. Twitchell Island, California, 2012. (Photographs taken by Gerald Bawden, June 6, 2012).

There were two sets of fractures on the levee: a set that predated the seepage test and a new set of fractures that formed during the test, most notably following the tree failure. The pretest asphalt had many cracks that were consistent with an aging surface. However, new cracks developed in the road surface after the tree toppled. Since the concept of mapping the fractures was only discussed during the final hours of the last day of T-Lidar data collection, and fracture mapping was not a component of the project scope, we neither optimized the T-Lidar survey to uniquely map all of the cracks nor assigned a formation age to each of the cracks to fully relate the cracking to the seepage test. However, we were still able to identify and map small cracks and fractures that appeared on the levee in our data. Some of the active cracks associated with the seepage test were apparently old cracks that were reactivated during the seepage test (fig. 10), as evident from dead and dried vegetation predating the test. We only mapped the most observable cracks on the levee surface with T-Lidar

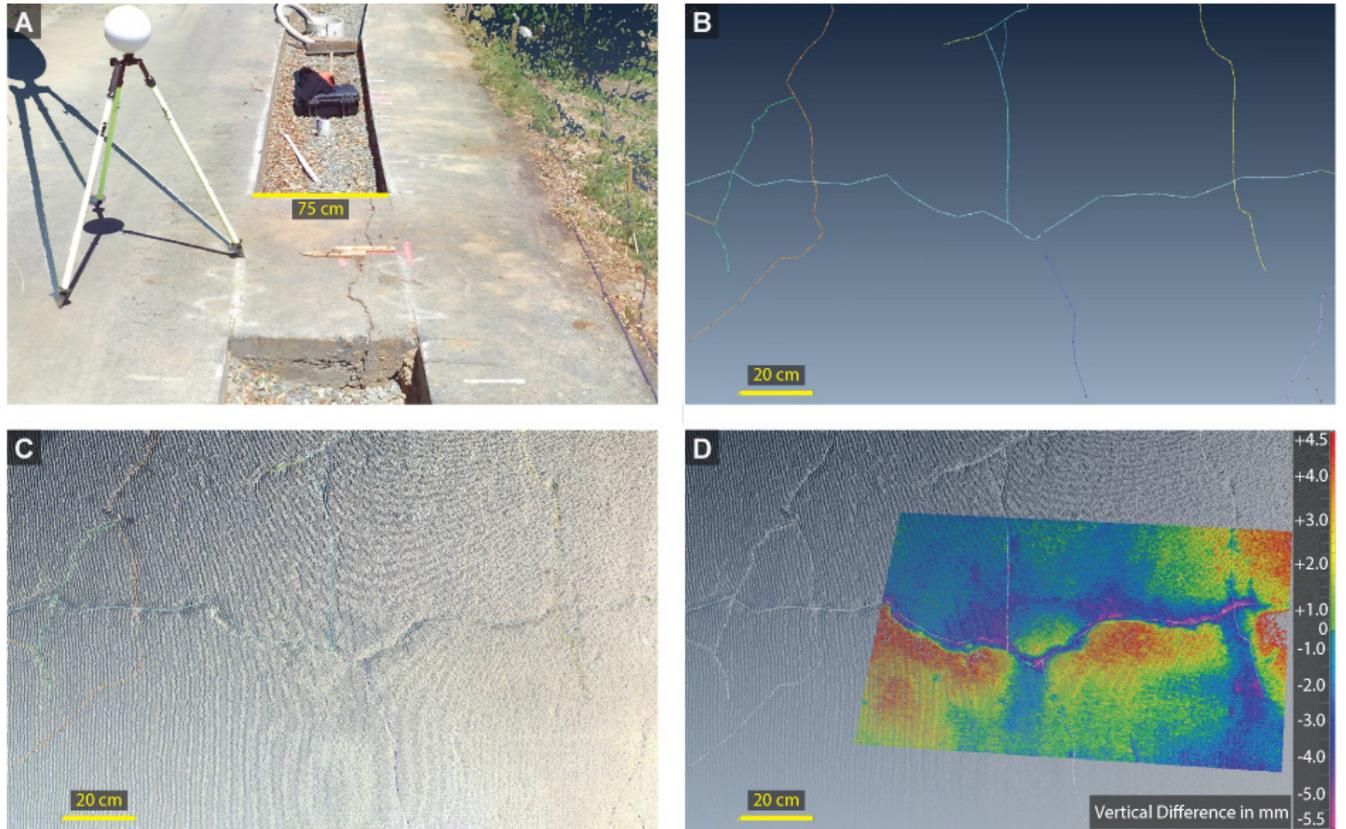
**Figure 11.** Terrestrial light detection and ranging (T-Lidar) analysis of cracks on the levee crown, Twitchell Island, California, 2012. (A) Shows a photo-quality colorized point cloud image from a single scan of the newly formed fracture connecting the two section of the levee seepage test where dark blue areas in the image are datagaps that are caused by object in the scanner field of view casting shadows (datagaps are in the upper right and behind the alignment sphere and a solar shadow is below the alignment sphere in the center of the image). This scan came from the T-Lidar setup shown in figure 7. (B) Shows mapped cracks on the levee surface from (C) the point cloud data and from (D) an elevation difference plot of the same area, where colored height differences from an averaged best-fit plane can easily identify the local height minimum (cool colors) from nearby high topography. The vertical difference scale in (D) is in millimeters (mm). Twitchell Island, California, 2012.

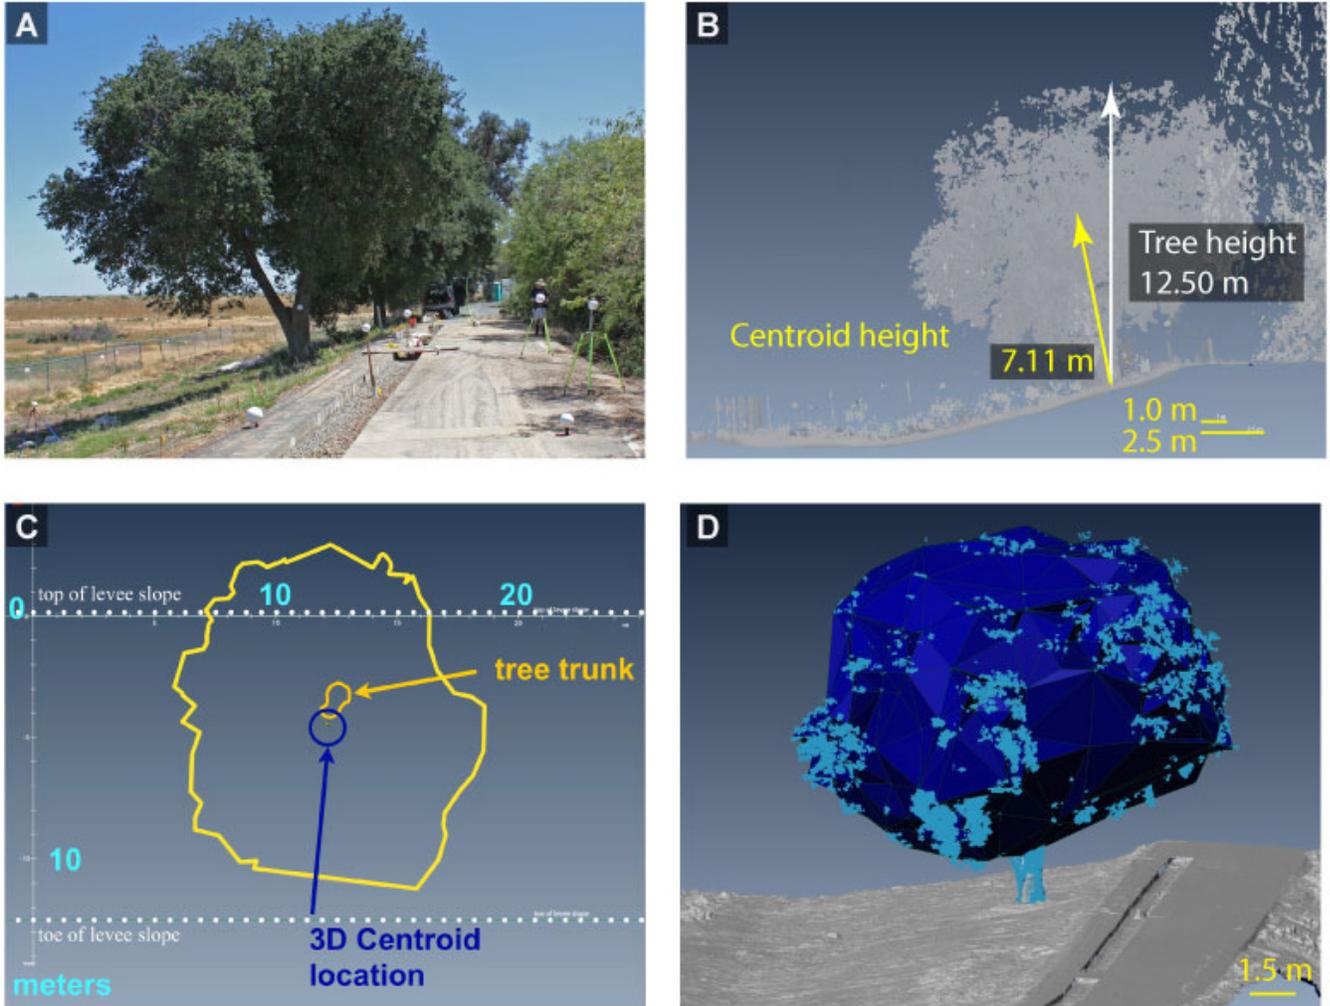
**Figure 12.** Characterization of the landside tree, Twitchell Island, California, 2012. (A) Photograph of the landside tree. (B) The tree height (white) and centroid height (yellow) calculated from the point cloud data and related to the tree position on the levee flank. (C) Map view of the locations of the tree trunk, canopy extent, and centroid. (D) The mesh (dark blue surface) with point cloud data (cyan) on a 2-centimeter bare-earth digital elevation model (gray) of the levee. Twitchell Island, California, 2012. (m, meter; photograph taken by Sandra Bond, June 6, 2012.)

We used the T-Lidar imagery from the final survey to characterize the landside tree height, its cross sectional area parallel and perpendicular to the levee, and its canopy volume centroid. These biomorphic parameters were requested by the UCB team to be used in their analysis and computer modeling, which included assessing the wind footprint (cross-sectional area) of the landside tree on the levee. The landside tree height (12.50 m) was directly measured from the point cloud data (fig. 12) using the highest points at the top of the tree. The base of the tree was determined by defining the center of the tree trunk in the point cloud data where it intersects with a best-fit plane of the levee surface immediately surrounding the tree trunk. The tree centroid and cross-sectional area were calculated by creating a mesh from the outermost points in the scanned canopy (fig. 12) using Polyworks Inspect and IM Edit modules (InnovMetric Software Inc., 2013)—a methodology that has the appearance of digitally wrapping the tree with shrink-wrap that allows a few low data density branches to extend through the digital surface (fig. 13).

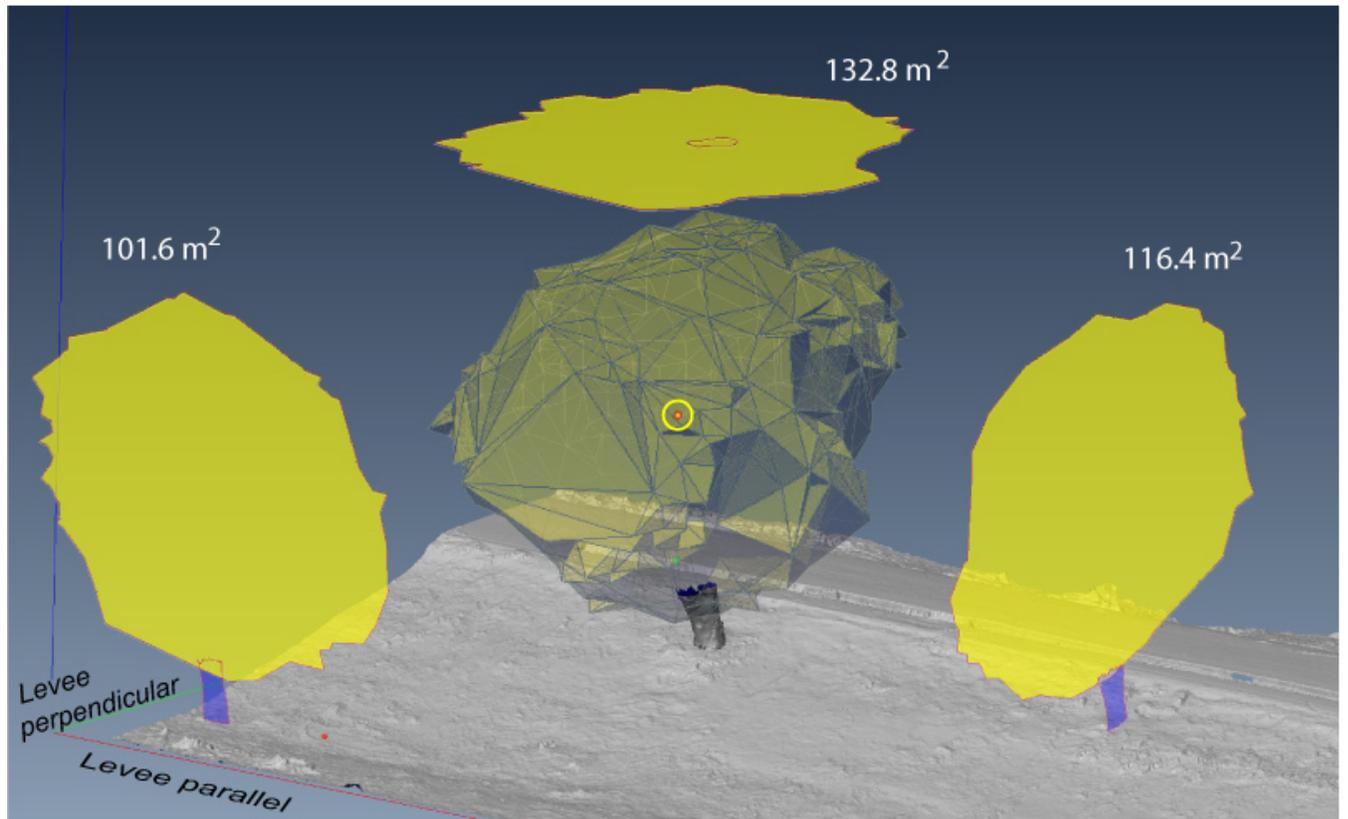
**Figure 13.** Levee parallel, perpendicular, and map view cross-sectional areas (solid yellow) derived from the terrestrial light detection and ranging point cloud canopy mesh (transparent yellow with blue wireframe of the mesh) of the landside tree, proximal to the seepage trench, Twitchell Island, California, 2012. The tree trunk cross-section is in transparent blue. The yellow circle at the center of the mesh is the three-dimensional centroid location and the levee is shown as a 2-centimeter bare-earth topographic model (gray). Twitchell Island, California, 2012. ( $\text{m}^2$ , square meter).

The levee parallel, perpendicular, and planar cross sections were determined by projecting the mesh derived from the canopy point cloud onto axis-parallel planes that are orthogonal to the levee (fig. 13). The levee parallel, perpendicular, and map view cross-sectional areas measured 101.6, 116.4, and 132.8 m<sup>2</sup>, respectively. Our mesh approach simplifies the overall shape of the tree canopy, which is effective for calculating the tree centroid (fig. 13). However, this approach does not measure 3D branch volume or diameter and, therefore, is insufficient to calculate the above-ground center of gravity for the tree. A T-Lidar survey targeting the tree's center of gravity would be needed to fully characterize the 3D canopy structure with a point cloud density sufficient to calculate the 3D distribution of the tree's above-ground biomass.
