Gully Monitoring at Two Locations in Grand Canyon National Park, Arizona, 1996–2010, with Emphasis on Documenting Effects of the March 2008 High-Flow Experiment

Open-File Report 2014–1211

By Nathan D. Schott, Joseph E. Hazel, Jr., Helen C. Fairley, Matt Kaplinski, and Roderic A. Parnell

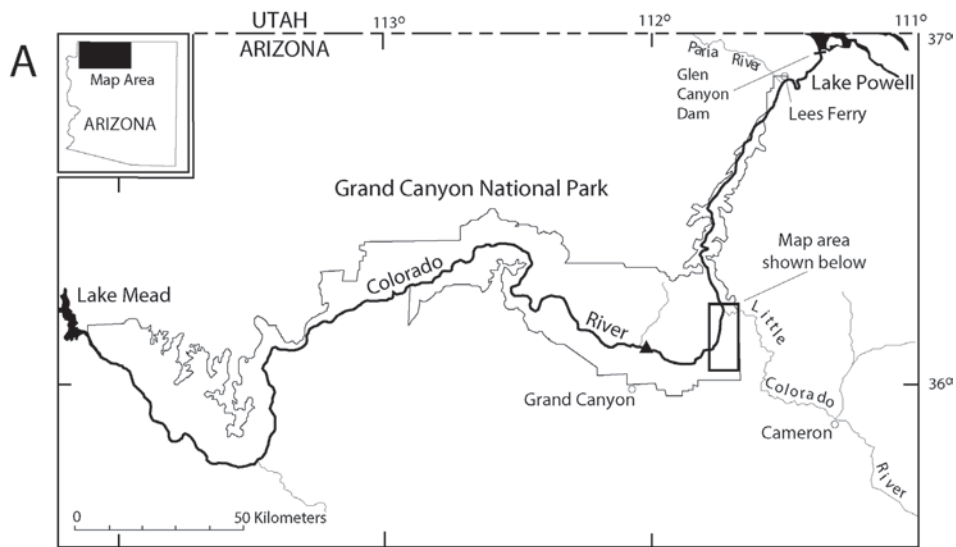
Figure 1. Map showing (A) general location of study area within the Grand Canyon National Park, Arizona and (B) the two specific study areas in the eastern Grand Canyon National Park, Arizona.

The three gullies discussed in this report occur within two study areas—the Palisades Site and the Furnace Flats Site (fig. 1). The Palisades Site includes two gullies which are referred to as the Palisades South Gully and the Palisades North Gully, respectively. Collectively, these two gullies comprise the Palisades Gully Network. The third gully is located in the Furnace Flats Site and is simply referred to as the Furnace Flats Gully.

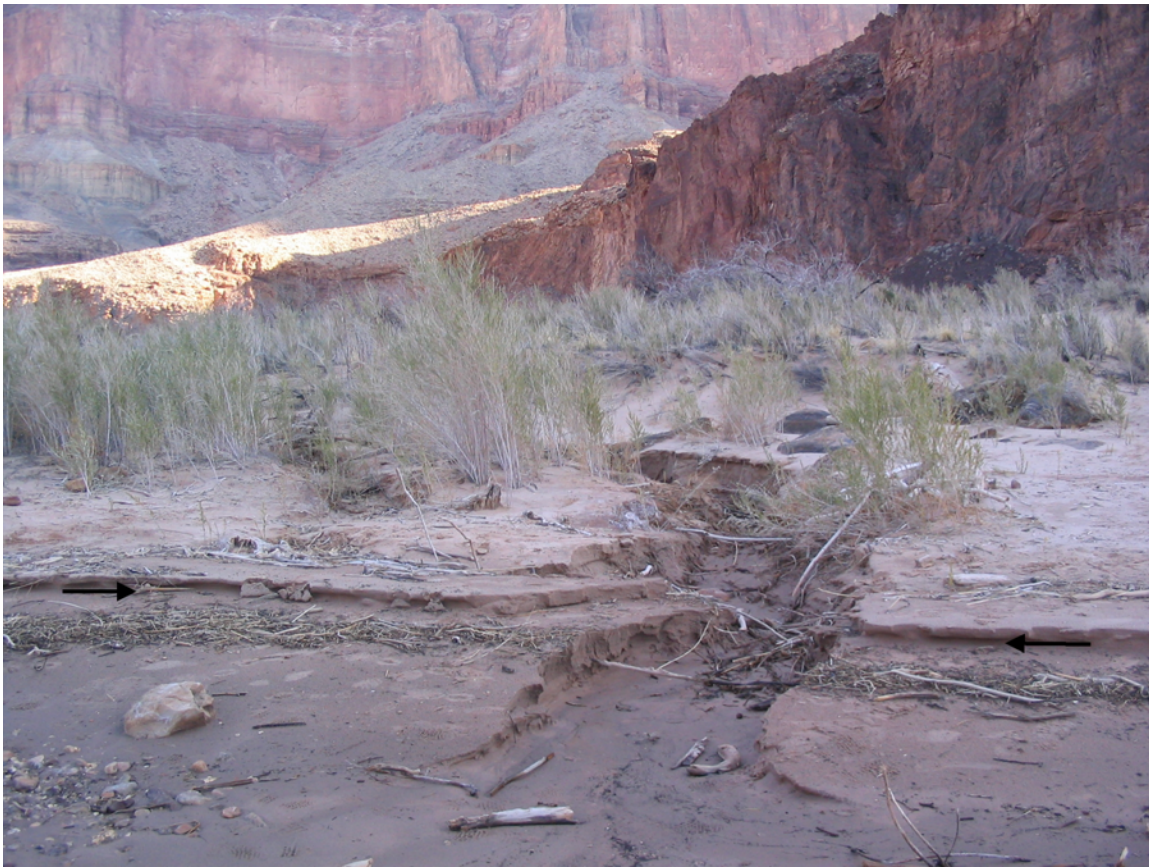
Figure 2. Photograph showing mouth of the Palisades South gully, Grand Canyon National Park, Arizona, February 9, 2008. View is to the northwest. Black arrows indicate a typical base flow of the Colorado River in the post-dam era of 351 cubic meters per second. Photograph by J. Hazel, Northern Arizona University.

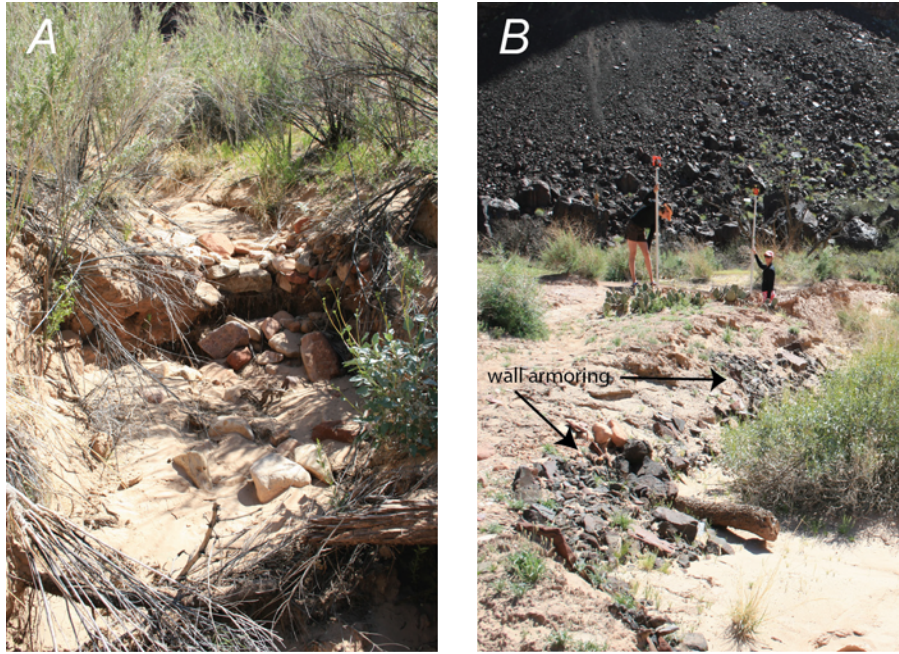
Figure 4. Photographs showing examples of erosion control structures constructed to reduce gully erosion at the Palisades South gully. (A) A rock check dam; (B) Wall armoring. View for both photographs is to the east. Photographs by J. Hazel, Northern Arizona University, April 1, 2008.

The larger of the two gullies is the downstream, southernmost gully. This gully is more than 300 m in length and is approximately 1.5 m deep near the confluence with the Colorado River. Using the convention established by Pederson and others (2003), this gully is referred to as the Palisades South gully. The upstream gully, herein referred to as the Palisades North gully, is slightly more than 100 m in length and less than 0.75 m deep at its deepest point. Erosion-control structures, including rock and brush check-dams, rock armoring and other bank stabilization efforts, are present in both of these gullies (fig. 4).

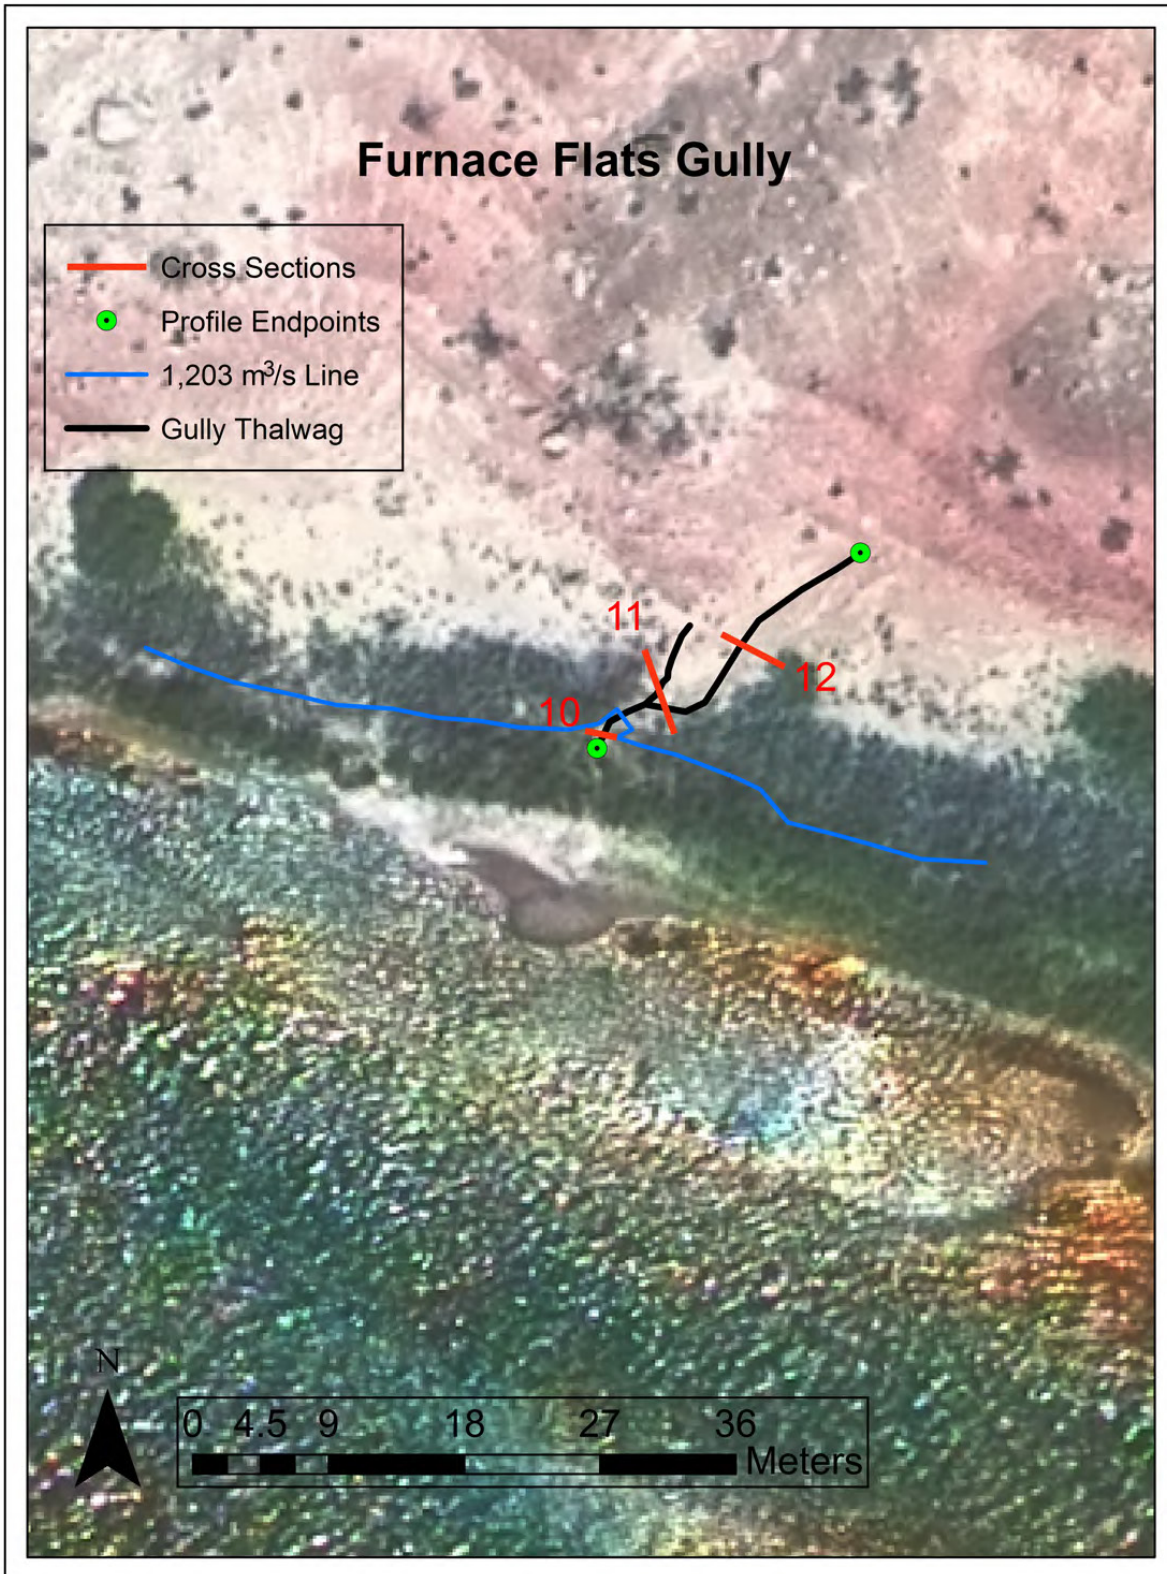
Figure 5. Aerial photograph showing Furnace Flats gully, Grand Canyon National Park, May 2002. The 1,203 m³/s line is the high water mark of the 2008 high-flow experiment. The Colorado River flows from east to west.

The third gully studied in this paper is located on river right at river mile 71.9 (fig. 5). Yeatts (1996) examined this site because it was an actively eroding gully, located in proximity to but not within known cultural sites. Although there are several gullies in this area, we report only on the gully called Furnace Flats #1 by Yeatts (1996, 1998) and Hazel and others (2000), herein referred to as the Furnace Flats gully. This gully is approximately 35 m long, 1 m wide, and 0.5 m deep, and has not been altered by ECS stabilization efforts.

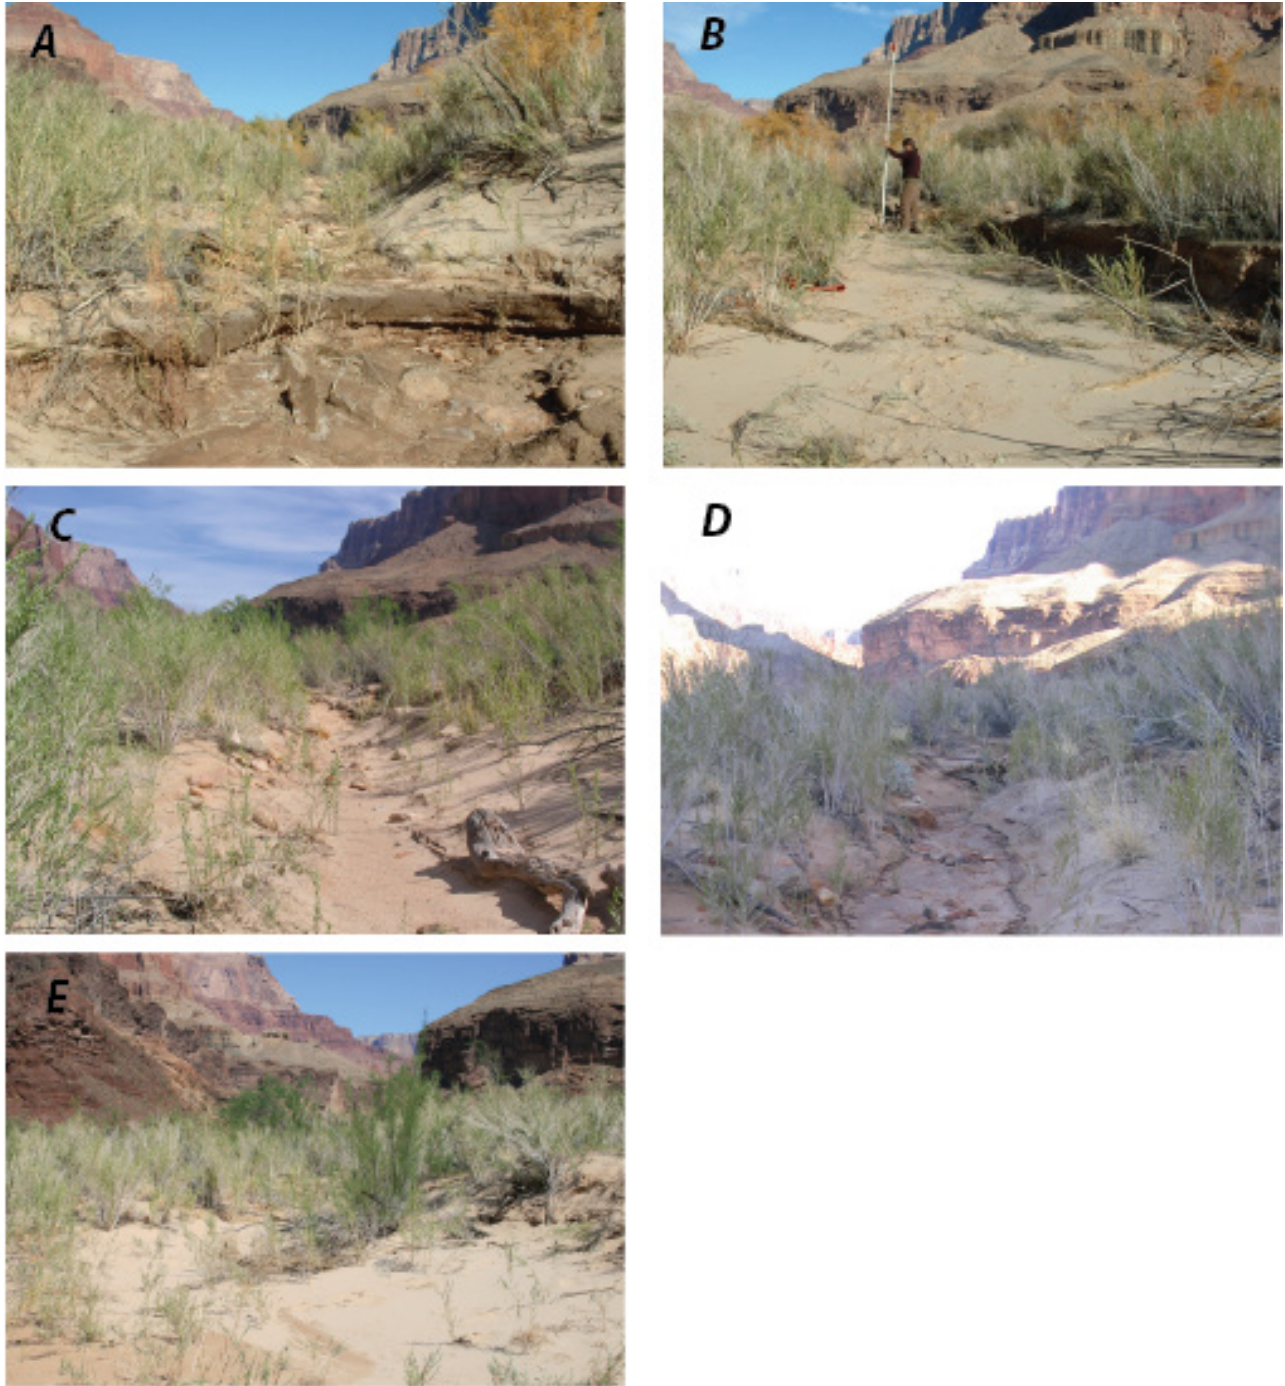
Figure 6. Selected repeat photographs showing the Palisades South gully as viewed looking northeast from the terminus near the Colorado River. (A) The gully area mouth as it appeared on November 20, 2004; (B) deposition in the gully bottom on December 10, 2004, as a result of the 2004 high-flow experiment; (C) gully mouth area as it appeared on April 19, 2007; (D) evidence of recent surface flow in the gully bottom (photograph taken on February 9, 2008); (E) deposition in the gully bottom on April 4, 2008, as a result of the 2008 high-flow experiment. Photographs 6A and 6B by A. East; U.S. Geological Survey; photographs 6C-6E by J. Hazel, Northern Arizona University.

The 2008 HFE resulted in 12 m³ of deposition and 11 m³ of erosion resulting in net deposition of 1 m³ of sediment in the predefined mouth area of the Palisades South gully during the 2008 HFE (volume boundary shown in fig. 3). Net deposition from the 2008 HFE was less than the 10 m³ of deposition attributed to the 2004 HFE, but greater than the 1 m³ of erosion measured after the 1996 HFE (table 2). Surface elevations within the mouth of the Palisades South gully increased by as much as 0.6 m (figs. 6E, 7B, and 8C)

In addition to depositing sediment in the mouth of the Palisades South gully, the 2008 HFE significantly reshaped and widened the mouth area (figs. 6 and 7). Cross sections located in the upper elevations of the Palisades South gully mouth indicate gully widening of 0.5–1 m within the gully mouth (figs. 8A and 8B).

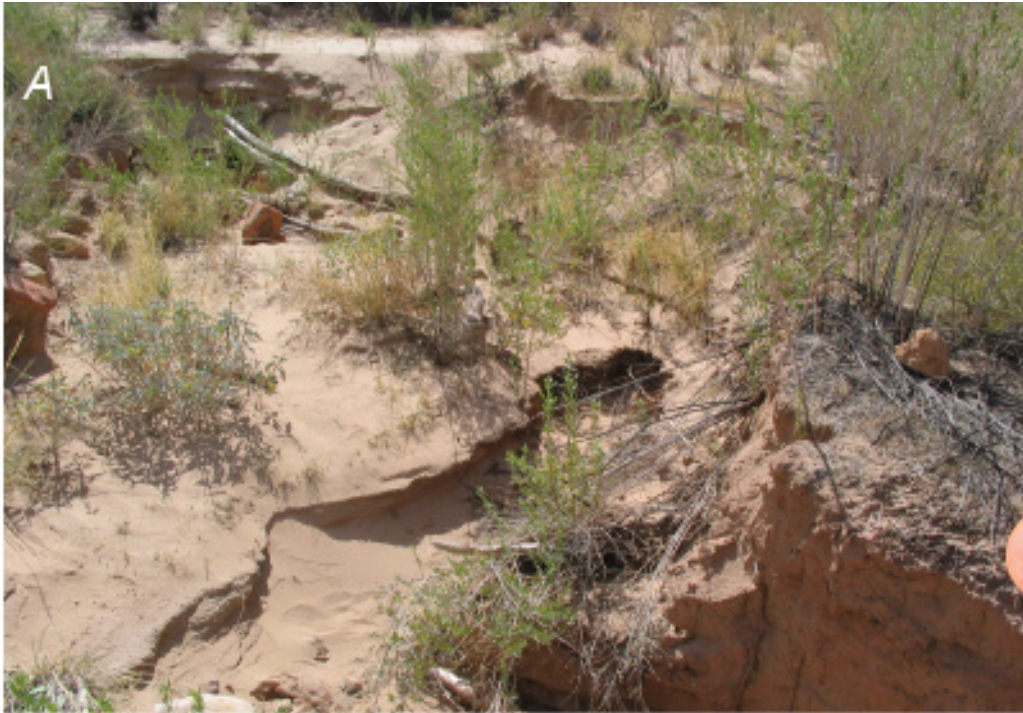
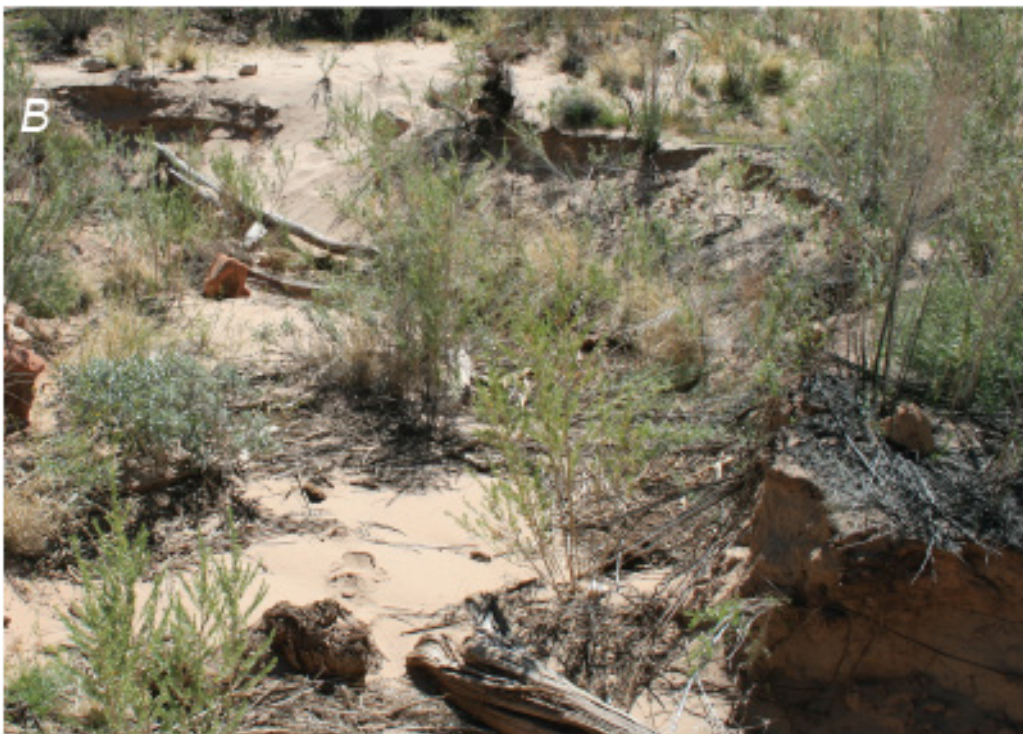
Figure 7. Repeat photographs showing Palisades South gully upper mouth area from (A) April 19, 2007, 11 months prior to the 2008 high-flow experiment and (B) April 4, 2008, just after the 2008 high-flow experiment. View is to the east. Effects of the 2008 high-flow experiment, including infilling of the gully thalweg and gully widening along the southern wall, can be observed. Photographs by J. Hazel, Northern Arizona University.

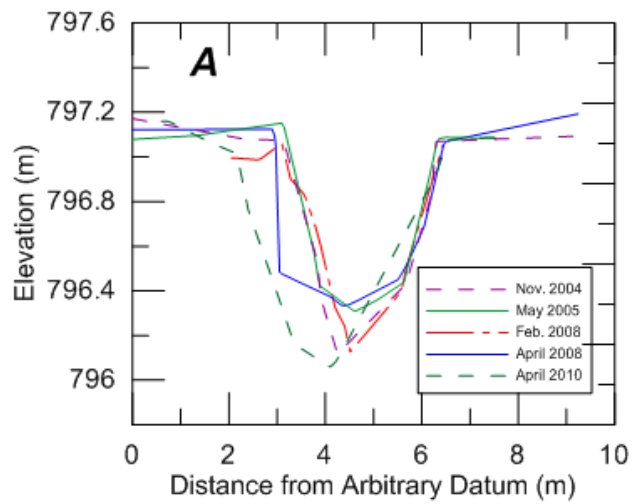
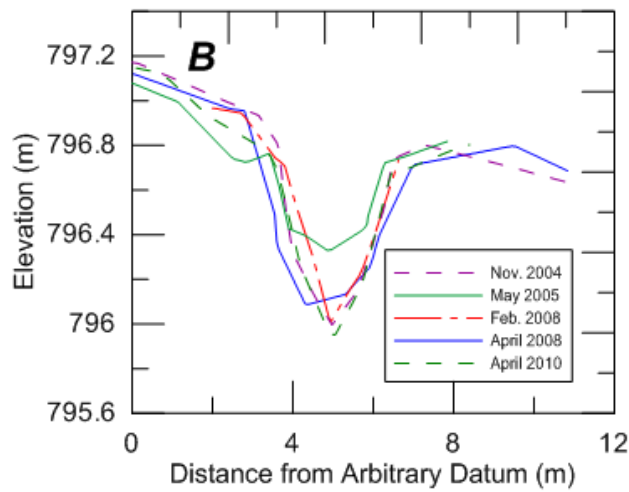
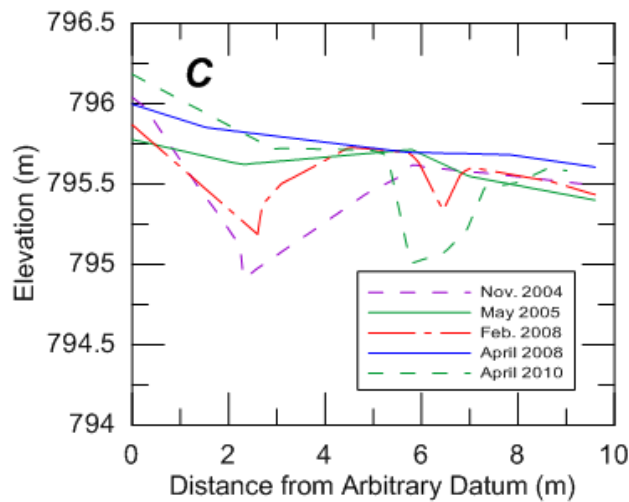
Figure 8. Cross sections across the mouth of the Palisades South gully, Grand Canyon National Park, Arizona. (A) Cross section 1; (B) cross section 2; and (C) cross section 3. All cross section locations are shown in figure 3 and are viewed in a down-gully direction.

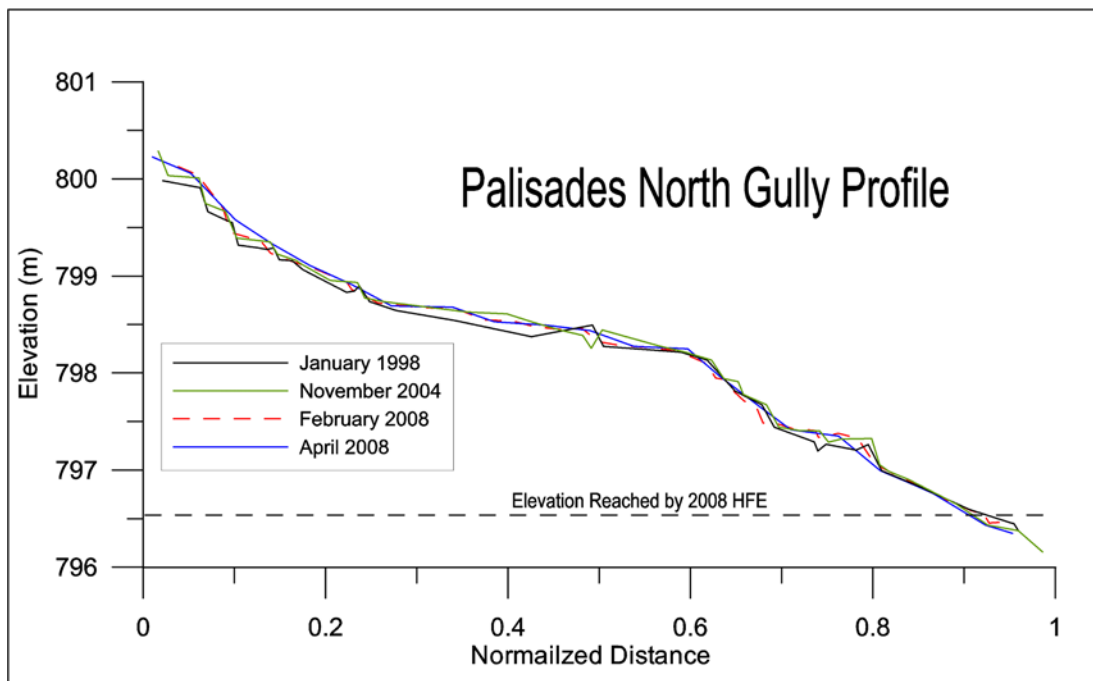
Figure 9. Normalized profile of the Palisades North gully, Grand Canyon National Park, Arizona, 1998–2010. Profile endpoints are shown in figure 3. Profile length between endpoints is approximately 86 meters.

Because the Palisades North gully did not contain a discernible mouth area with measurable walls, only the thalweg profile was collected. Analysis of the Palisades North gully thalweg profile indicates no significant change between February and April 2008 (fig. 9). This result is consistent with the findings in Hazel and others' (2008a) report, which documented that the Palisades North gully was largely unaffected by both the 1996 and 2004 HFEs.

Long-term thalweg evolution of the Palisades North gully is shown in figure 9. This gully has remained relatively unchanged during 12 years of monitoring. Check dam installation and maintenance may explain the lack of detectable change at this gully, but the lack of detectable change also may be attributable to the variable survey coverage and different point densities between surveys.

The Palisades North gully remained relatively stable between January 1998 and April 2008. We attribute the differences in the gully thalweg profiles shown in figure 9 to the variance caused by the different spacing of the ground points used to generate the profile, and the fact that not all surveyors collected thalweg profile data at exactly the same locations along the thalweg. Both brush and rock check dams were constructed at the Palisades North gully in 1995 and have been maintained or rebuilt in February 1997, February 1998, April 2000, October 2000, March 2003, March 2004, and March 2005 (Dierker and Leap, 2006), and perhaps at other times not yet reported. We believe that installation and maintenance of ECS, including check dams and wall armoring, could be partially responsible for stabilizing this gully. Slumping of the gully wall (shown in fig. 14F) and redistribution of this material to the thalweg also may play a role in the stability of the Palisades North gully profile.

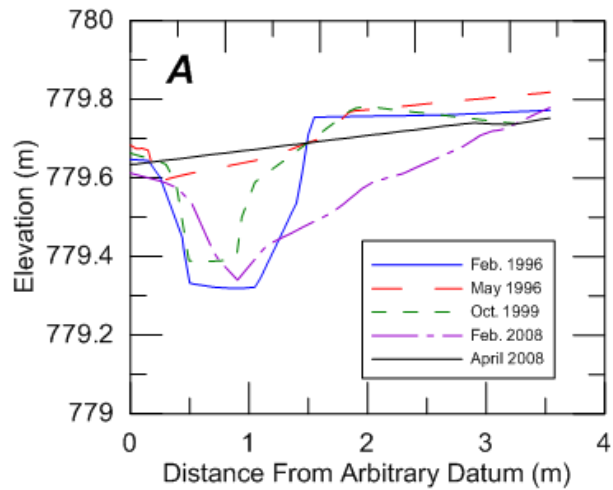
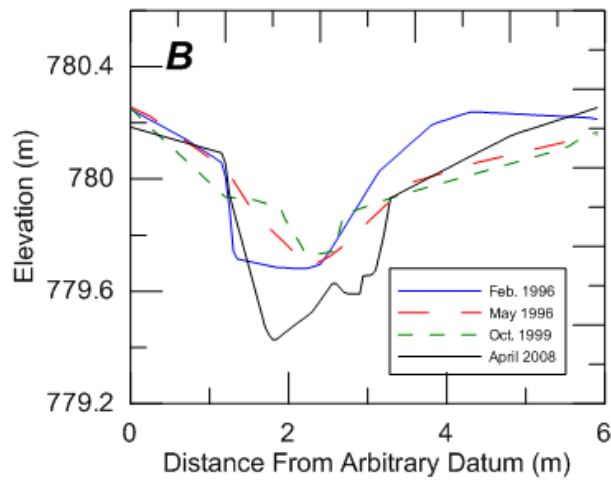
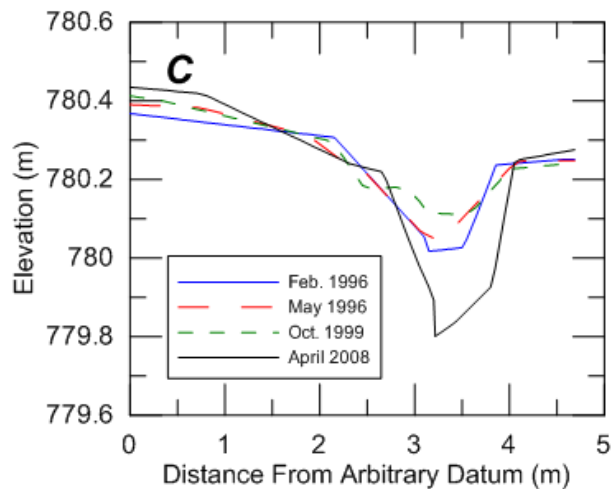
Figure 10. Cross sections at the Furnace Flats gully, Grand Canyon National Park, Arizona. (A) Cross section 10; (B) cross section 11; and (C) cross section 12. All cross section locations are shown in figure 5, and are viewed in a down-gully direction.

In contrast to the changes at the Palisades gullies, the cross sections at the Furnace Flats gully show progressive incision and gully widening between 1996 and 2008 (fig. 10). These cross sections were established by Hazel and others (2000). Cross section 10, located on a flood-deposited sandbar, has been discussed above. Cross section 11 shows the formation of a tributary to the main gully between October 1999 and April 2008 (fig. 10B). More than 0.5 m of gully widening is evident at cross section 12 (fig. 10C). Between 1996 and 2008, there was as much as 0.3 m of thalweg incision above the elevation inundated during HFEs (figs. 10B and 10C).

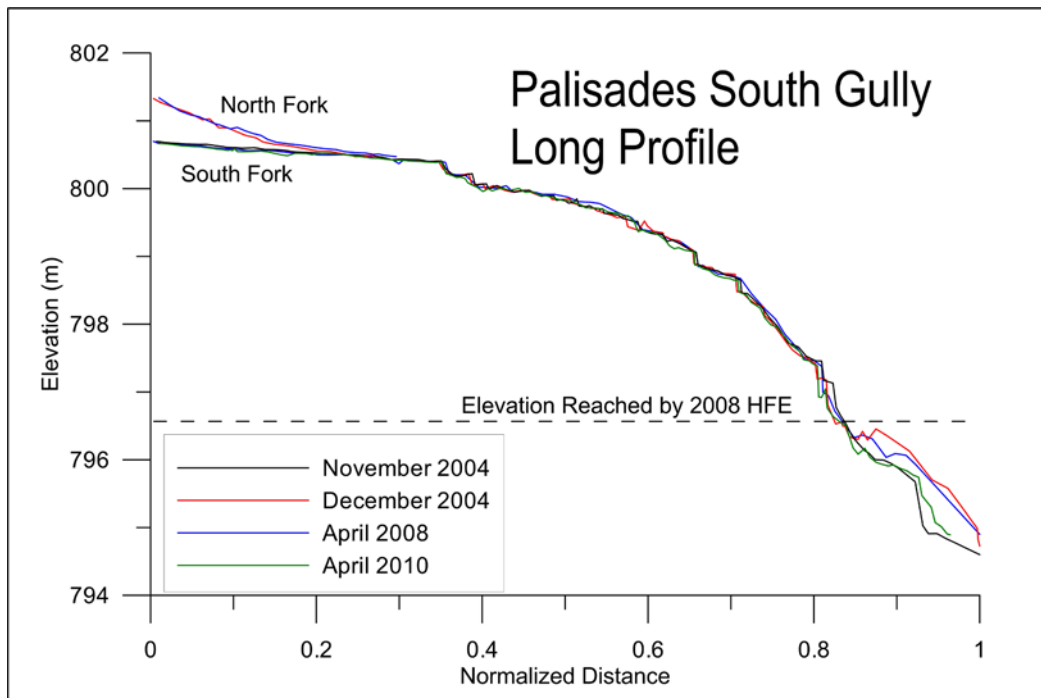
Figure 11. Normalized long profile of the Palisades South gully, Grand Canyon National Park, Arizona, 2004–2010. Gully long profile endpoints are shown in figure 3. Profile length between endpoints is approximately 308 meters.

Gully thalweg evolution between 2004 and 2010 of the entire ~308 m length of Palisades South gully, including the two main tributaries, is shown in figure 11. The 2004 thalweg profiles were collected at an average spacing of 1 point per 2.8 meters (pt/m), whereas the 2008 thalweg profile has a coarser spacing of 1 pt/3.6 m. The April 2010 thalweg data were collected at the highest density, with an average spacing of 1 pt/2.2 m. At elevations above those reached by the 2004 HFE, no discernible change can be detected between the February 2004 and April 2010 surveys of the gully thalweg. The variance in thalweg profiles is likely attributable to differences in point spacing between the surveys. Interpretation is further complicated by evidence of gully widening over this same time period (described in the next section, “Channel Widening”), as well as continued ECS maintenance by National Park Service personnel in March 2005 (Dierker and Leap, 2006), and possibly at other times not reported.

The uppermost elevations of the Palisades South gully show relatively little change between 2004 and 2010 (fig. 11). Although slight thalweg aggradation is evident between 2004 and 2008, explaining the aggradation in the upper reaches is complicated by point spacing issues and installation and maintenance of ECS in March 2005 (Dierker and Leap, 2006). Evidence of gully-wall slumping in the higher elevations of the Palisades South gully (fig. 15) may explain the slight increase in gully thalweg elevation between 2004 and 2008. Although gully widening is a natural process in the Grand Canyon, some have suggested that it might be exacerbated by anthropogenic influences during monitoring efforts (see Collins and others, 2008), installation and maintenance (or lack thereof) of ECS (Pederson and others, 2006), and excavation of at-risk cultural sites (Collins and others, 2012). Although identifying the causes of gully widening, anthropogenic or not, is beyond the scope of this study, we conclude that the gully thalweg did slightly aggrade at the higher elevations of the Palisades South gully between 2004 and 2008. We attribute this aggradation to both widening of the gully (and deposition of this gully side-wall material in the thalweg), and infilling behind recently installed or maintained ECS. By April 2010, all evidence of thalweg aggradation had disappeared, and the thalweg profile very closely resembled the profile observed in November and December 2004. Gully-wall slumping and anthropogenic influences likely mitigated any thalweg incision that might have occurred between 2004 and 2010 in the uppermost reaches of the Palisades South gully.

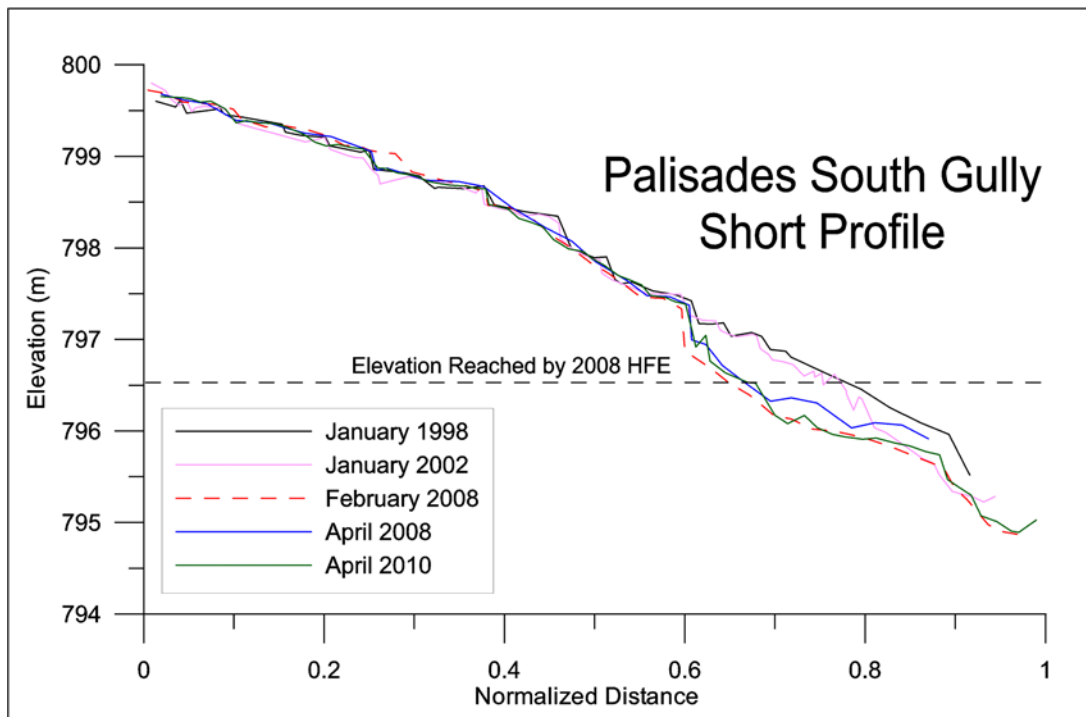
Figure 12. Normalized short profile of the Palisades South gully, Grand Canyon National Park, Arizona, 1998–2010. Gully short profile endpoints are shown in figure 3. Profile length between endpoints is approximately 135 meters.

Prior to 2004, detailed topographic surveys were focused on the lowest ~150 m of the Palisades South gully. Gully evolution between January 1998 and April 2010 of the lowest ~135 m of the Palisades South gully is shown in figure 12. Comparison of the surveys shows as much as 0.8 m of thalweg incision between 1998 and 2010 between 797.5 m (stage elevation of ~2,020 m³/s) and the Colorado River at base flow. Most of the erosion evident below an elevation of 797.5 m is attributed to knickpoint retreat resulting from an unusual weather system that produced widespread rain and tributary debris flows to the Colorado River in the vicinity of the Palisades gully network on September 7, 2002 (Hazel and others, 2008a). Above this elevation, no significant change was detected over the same time period.

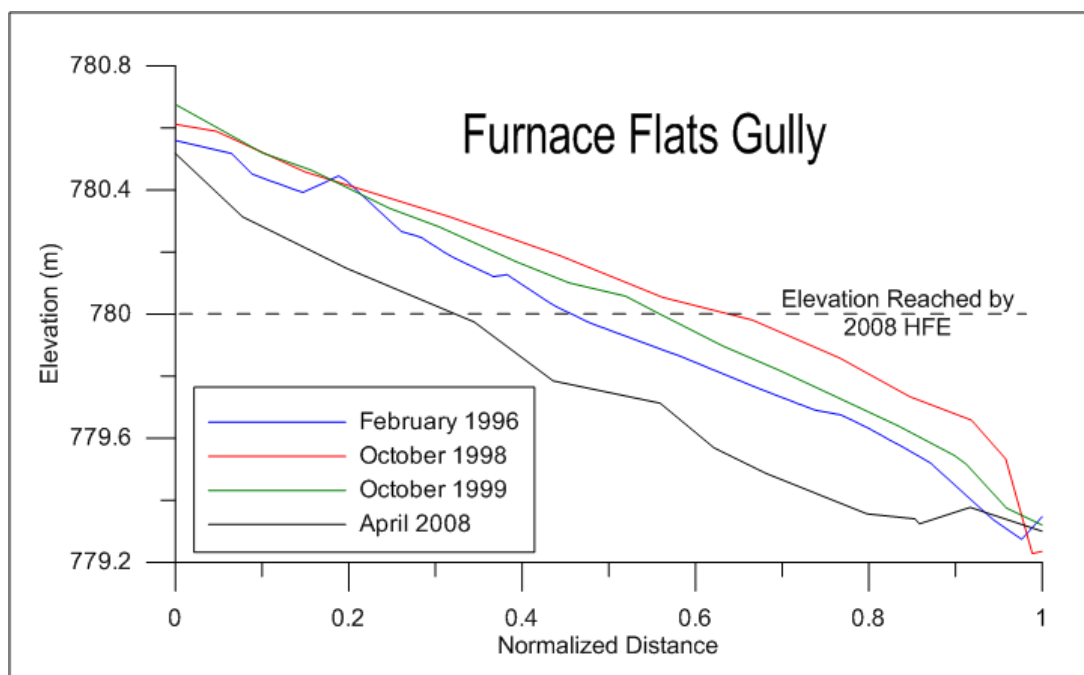
Figure 13. Normalized profile of the Furnace Flats gully, Grand Canyon National Park, Arizona, 1996–2008. Gully profile endpoints are shown in figure 5. Profile length between endpoints is approximately 23 meters.

The evolution of the Furnace Flats gully thalweg (fig. 13) is markedly different than that of the Palisades North gully. The Furnace Flats gully thalweg aggraded between February 1996 and October 1998. Aggradation may be attributed to sediment deposition in the gully mouth during the 1996 HFE, aeolian deposition, or gully-wall collapse. Some, but not all, of this aggradation was eroded between October 1998 and October 1999. The long-term evolution of the Furnace Flats gully is characterized by substantial erosion, as evidenced by more than 0.2 m of incision across the entire thalweg profile between October 1999 and April 2008. Average point spacing for the Furnace Flats thalweg surveys ranged from 1 pt/1.3 m to 1 pt/1.8 m between the different surveys. The Furnace Flats gully has received no erosion mitigation actions, is rarely visited by recreationists, and is perhaps a better reflection of natural gully evolution in the Grand Canyon.

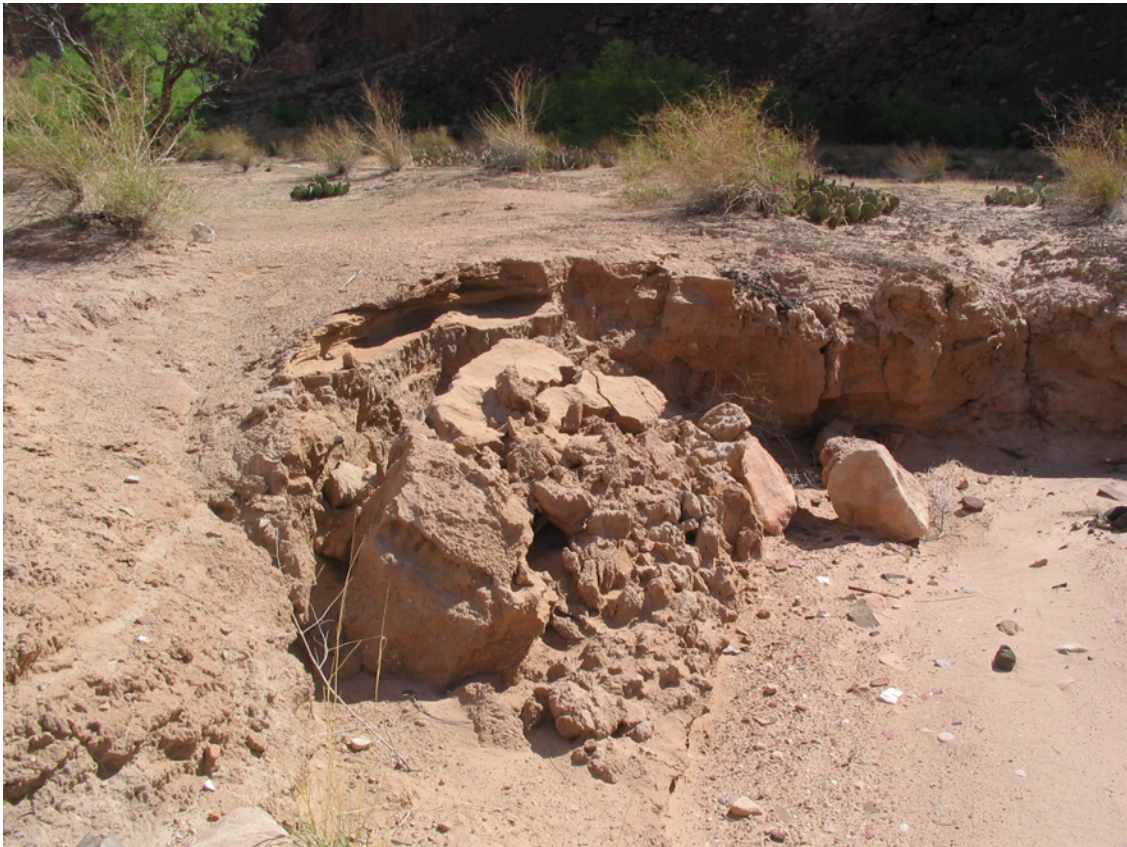
Figure 15. Photograph showing an example of gully-wall slumping at the Palisades South gully, Grand Canyon National Park, Arizona. Photograph taken by J. Hazel, Northern Arizona University, April 19, 2007.
