## Use of Satellite Images to Determine Surface-Water Cover During the Flood Event of September 13, 2013, in Lyons and Western Longmont, Colorado

By  
Christopher J. Cole,<sup>1</sup> Beverly A. Friesen,<sup>1</sup> Earl M. Wilson,<sup>1</sup> Stanley R. Wilds,<sup>2</sup> and Suzanne M. Noble<sup>2</sup>  
2015

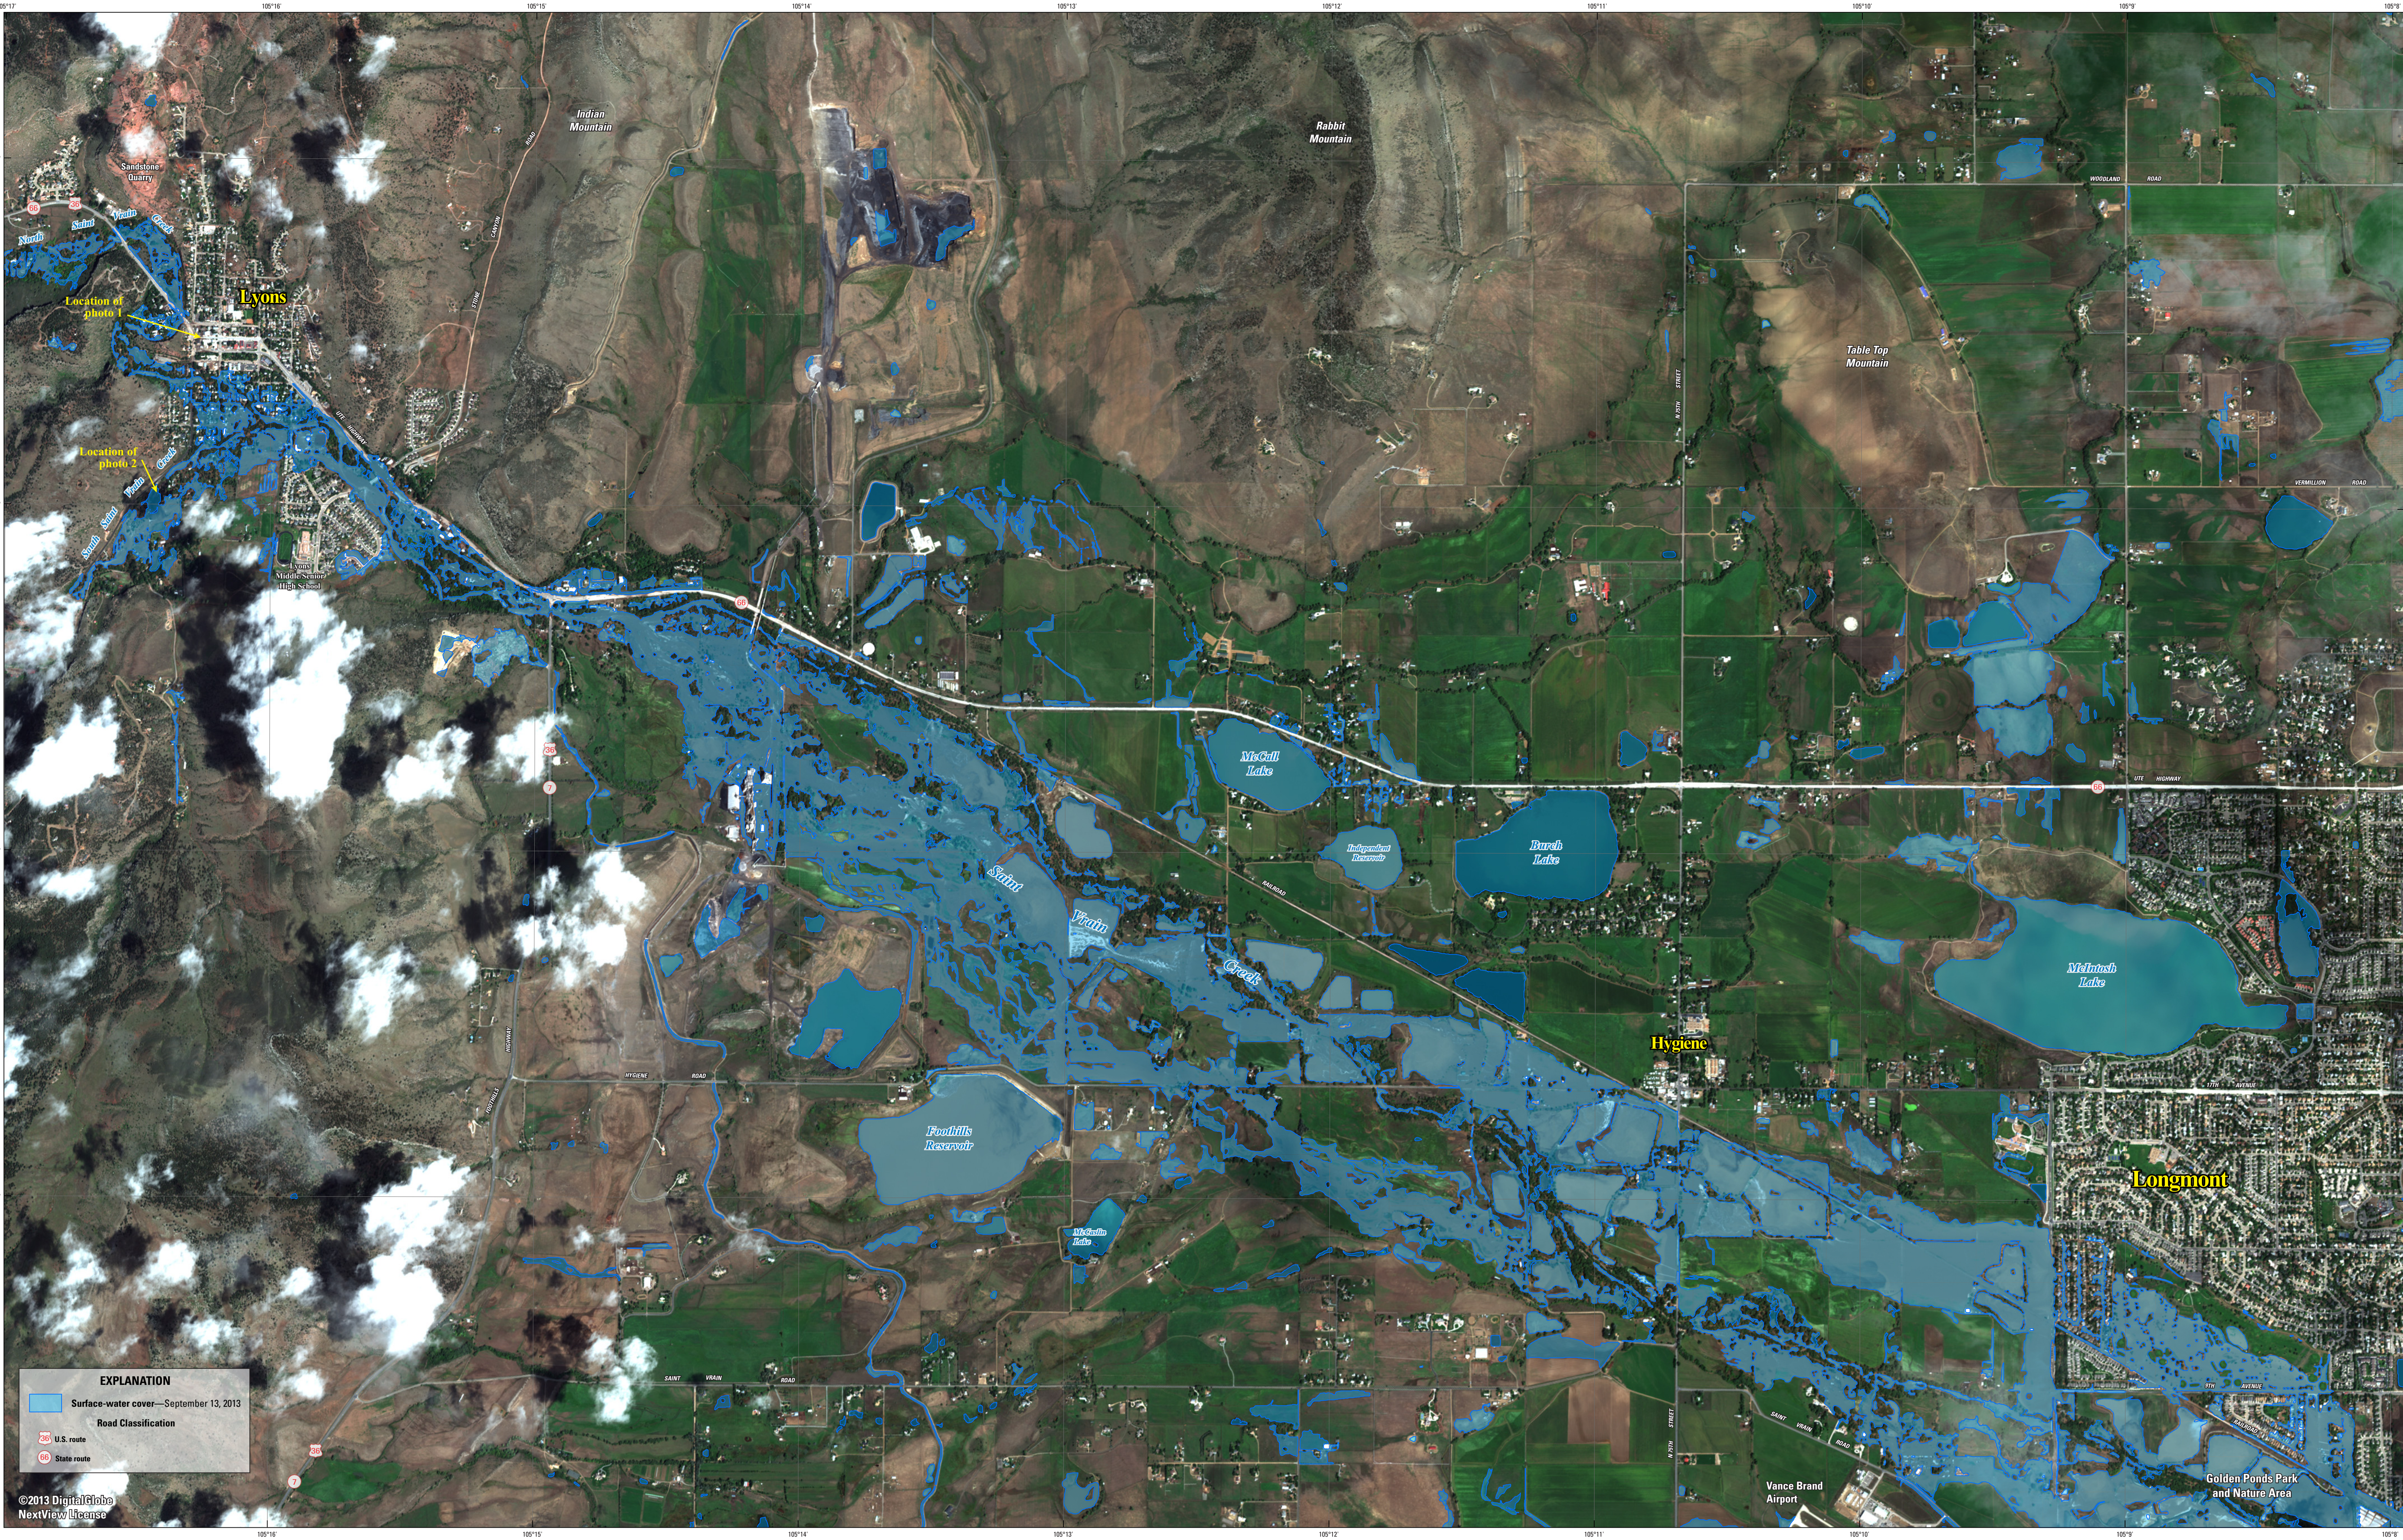
Image base mosaics produced from DigitalGlobe WorldView-2 data, accessed Sept. 13, 2013. Water and place names derived from 1:100,000-scale U.S. Geological Survey National Map digital data, accessed in 2014 at <http://viewer.nationalmap.gov/viewer/>. This dataset has been orthorectified and pan-sharpened to enhance mapping accuracy and spatial resolution. Multispectral red (band 3), green (band 2), and blue (band 1) image composite shown.

The U.S. Geological Survey (USGS) developed a 1:15,000-scale geospatial product to identify surface-water cover to support local, State, and Federal disaster response coordination efforts in Colorado. This product, presented here as a map, depicted the water-surface cover that resulted from the flooding that occurred from Lyons to western Longmont on September 13, 2013.

The data displayed on this map were created to support flood-response efforts, specifically for use in determining damage assessment and informing mitigation decisions. Water cover was derived from multispectral imagery at a spatial resolution of 3 m. The data were orthorectified and pan-sharpened to produce a multispectral image. Three spectral indices (NDVI, NDWI, and NDTI) were computed from the processed imagery. The extent of the surface-water cover was determined and converted to a vector format. The processed data were then placed onto a base image. All processed imagery and derived products were uploaded to the USGS Hazards Data Distribution System (HDDS) website (<http://hddsexplorer.usgs.gov/qginfo/hdds/>) for distribution to those responding to the flood event. These data were intended to provide a timely representation of post-flood ground conditions to aid in flood-response efforts by decisionmakers and the general public, and could also be used to support future water-science studies, such as historical inundation trends.

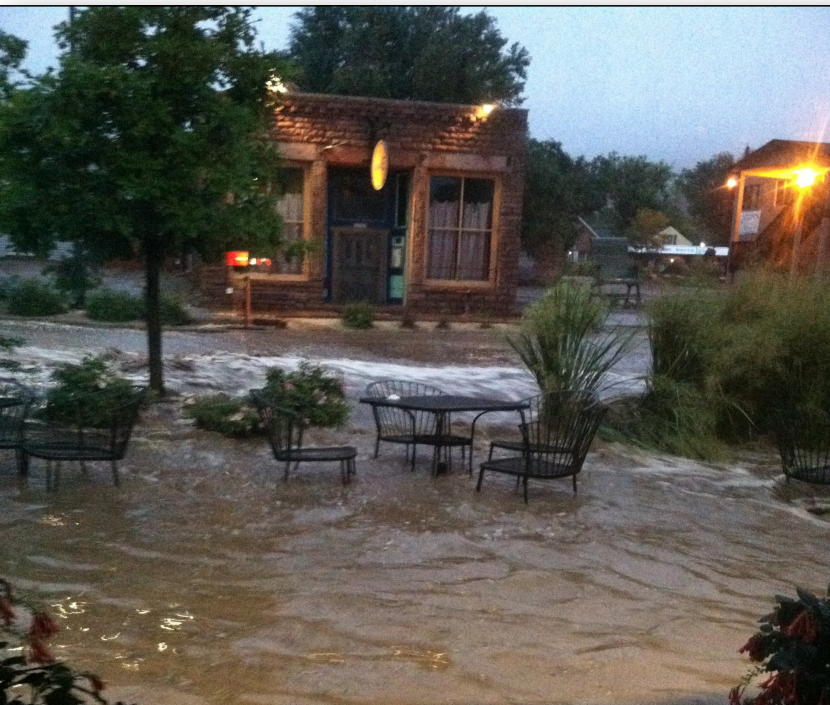
Photo 1. Main Street in downtown Lyons is inundated during the September 13, 2013, flood event. Photograph by Lauren Simms. Used with permission.

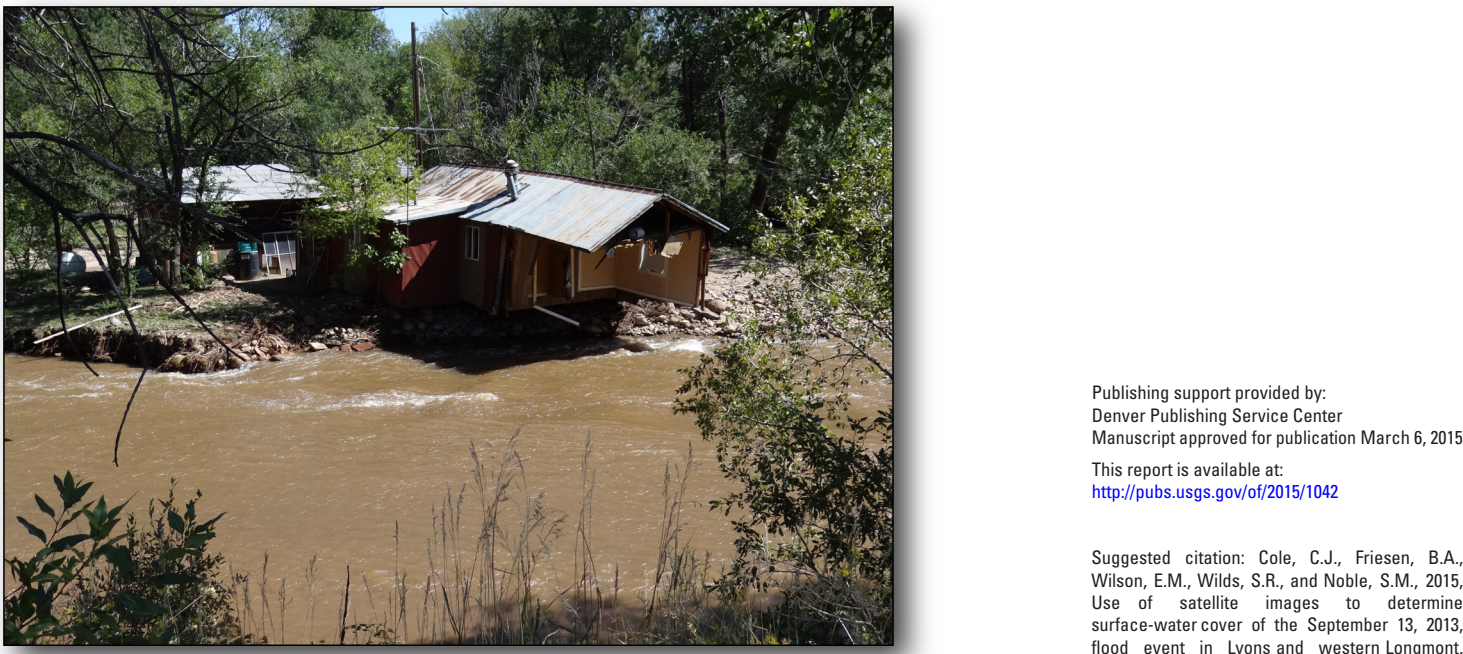
Photo 2. Flooded house on the South Saint Vrain Creek, southwest of Lyons, Colorado, September 13, 2013. Photograph by Bill Benzel (USGS).
