Storm Tide Monitoring During the Blizzard of January 26–28, 2015, in Eastern Massachusetts

Open-File Report 2015–1081

By Andrew J. Massey and Richard J. Verdi

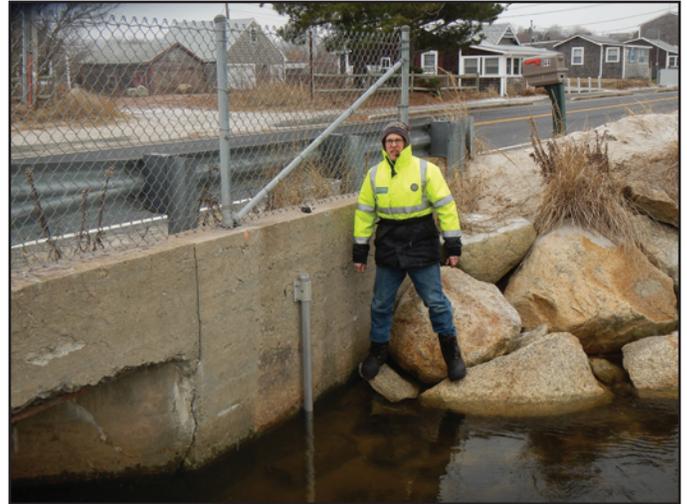
Figure 2. U.S. Geological Survey scientist Andrew Massey deploying a storm surge sensor in a presurveyed mounting bracket before the onset of the blizzard of January 26–28, 2015. Photograph by David S. Armstrong, U.S. Geological Survey.

Sensors were deployed at selected monitoring locations established and surveyed in 2014 as part of the SWaTH Network. These monitoring locations had been outfitted with presurveyed mounting brackets specifically designed for rapid storm surge sensor deployments (fig. 2). The brackets were surveyed to the North American Vertical Datum of 1988 (NAVD 88) using survey-grade Global Navigation Satellite System (GNSS) equipment following USGS protocols (Rydland and Densmore, 2012). Prior to deployment for this storm, each sensor was installed in a protective aluminum housing, then the housings were affixed to the brackets to hold the storm surge sensors securely in place. The housing pipes range in length from 4 to 12 ft to hold the storm surge sensors about 1 ft above land surface and below sea level. The housings are perforated to allow water movement. The storm surge sensors and accompanying barometric pressure sensors were set to record at 30-second intervals. Manual water-level measurements were recorded at the time of deployment to calibrate the water level data to the NAVD 88.

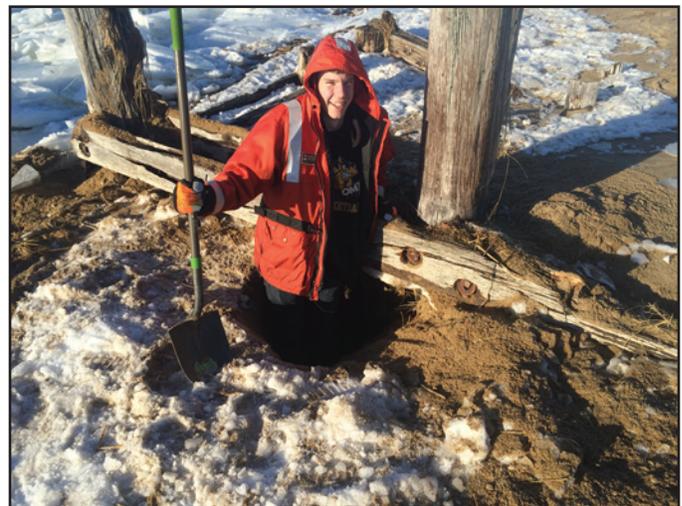
Figure 6. U.S. Geological Survey scientist Christopher Bruet excavating a storm surge sensor after sand was deposited by the blizzard of January 26–28, 2015, on Plum Island at Newburyport, Massachusetts. Photograph by Josh Combs, U.S. Geological Survey.

In recent years, movement of sand has changed the beach front significantly at the northern end of Plum Island. The Plum Island storm surge sensor, which is at the mouth of the Merrimack River at the northern end of Plum Island near the Massachusetts Division of Marine Fisheries pier in Newburyport, was buried by approximately 3 ft of sand deposited during the Blizzard of January 2015. A large hole was dug in the sand to access the bracket and unlock the storm surge sensor housing during retrieval of the equipment (fig. 6). Evidence of sand deposition over time is shown in figure 7. The photograph in figure 7A, captured in October 2012 before the landfall of Hurricane Sandy, shows the end of the pier to be exposed by

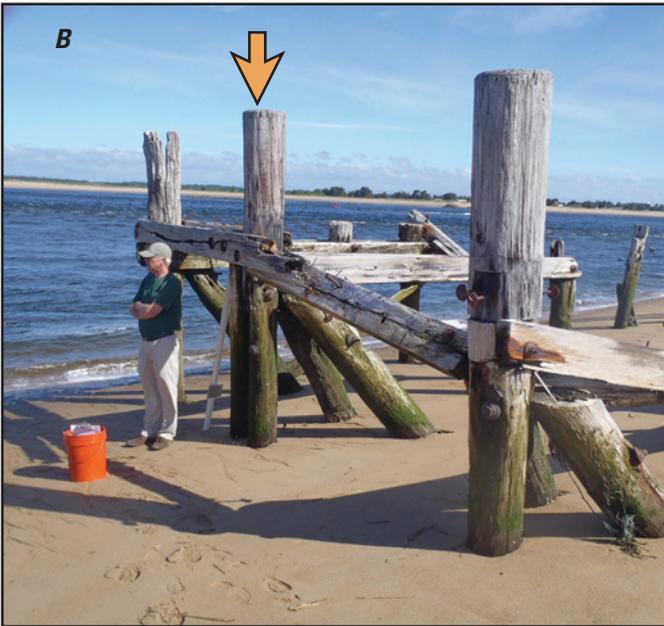
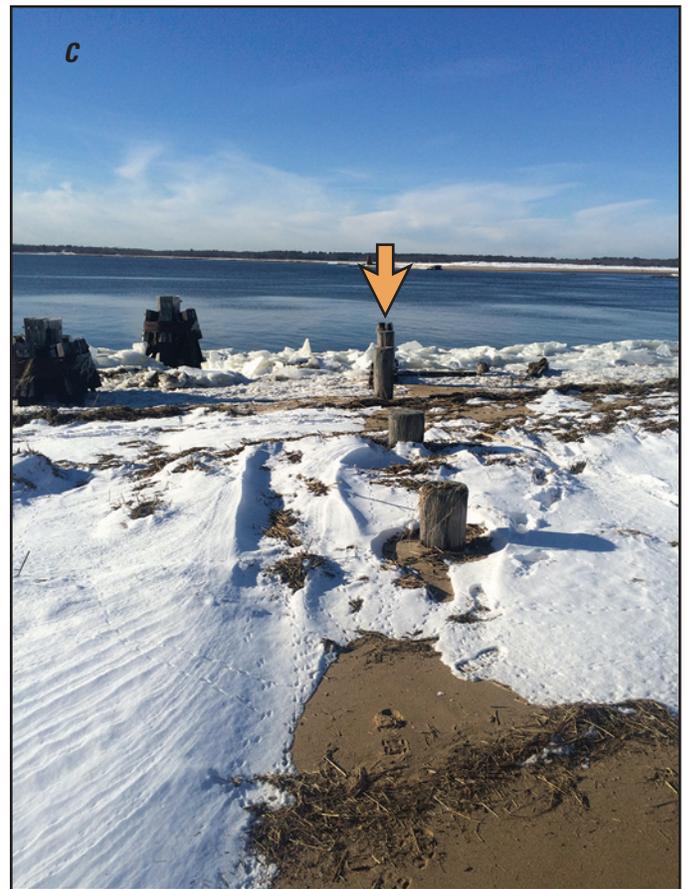
Figure 7. Evidence of sand deposition on Plum Island at Newburyport, Massachusetts, from 2012 to 2015. Photographs were taken *A*, on October 26, 2012, before Hurricane Sandy, *B*, during bracket installation on June 19, 2014, and *C*, during sensor retrieval on January 29, 2015, after the blizzard of January 26–28, 2015. Photographs by the U.S. Geological Survey.

12 ft or more. The photograph in figure 7B, taken in June 2014 when the USGS installed a mounting bracket on the same wooden piling, shows several feet of sand deposition. The photograph in figure 7C shows that the piles were nearly buried as a result of the Blizzard of January 2015. Overall, more than 10 ft of sand has accreted at this site since October 2012.

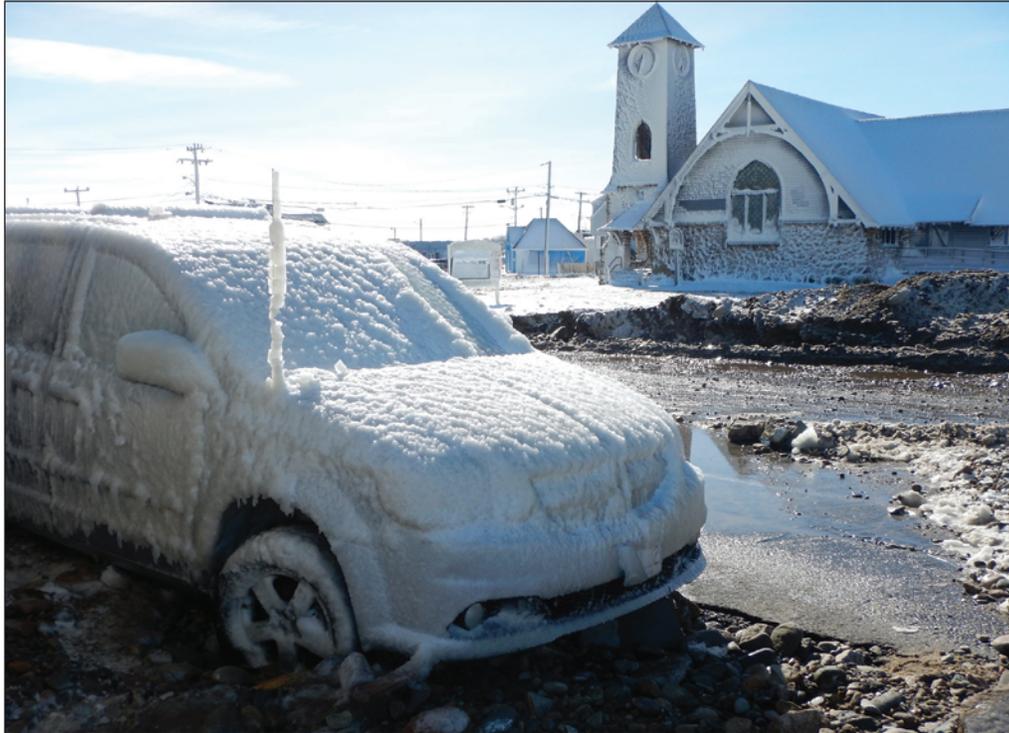
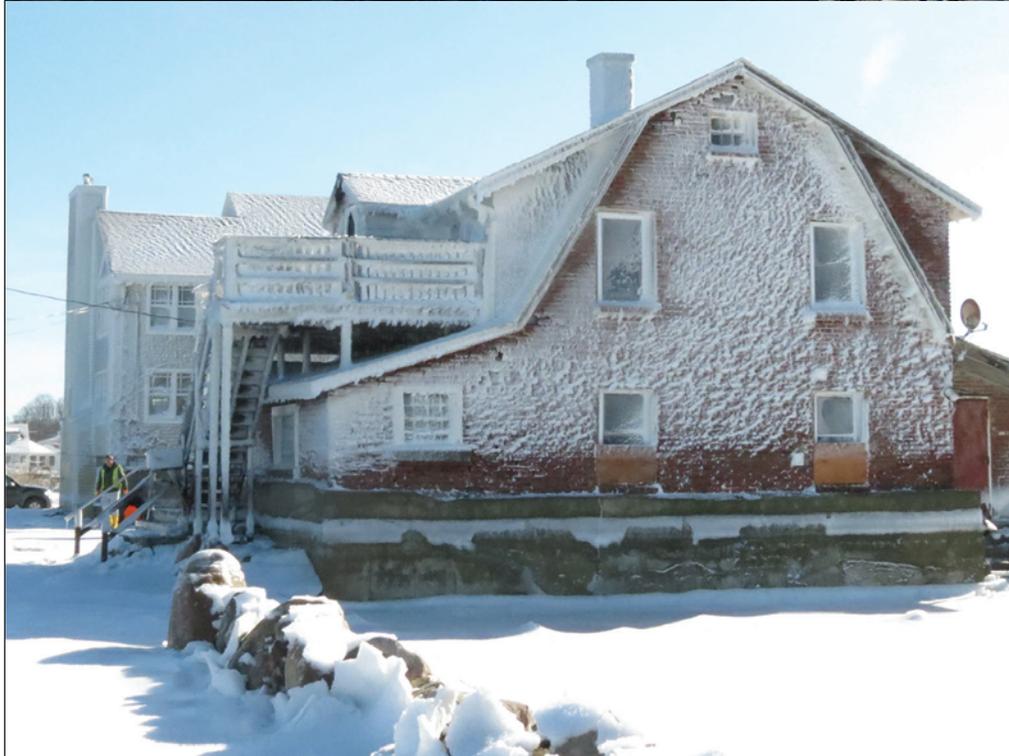
Figure 8. Examples of damage to infrastructure and property on the southern shore of Massachusetts as a result of flooding, strong wind, overwash, and icing during the blizzard of January 26–28, 2015. Examples shown are in the towns of *A*, Marshfield and *B*, Scituate, where frozen splashover and high water marks of the storm tide height remained on structures for days after the storm. Photographs by the U.S. Geological Survey.

winds, splashover, and icing. Sections of seawall in Scituate and Marshfield were damaged and breached by the storm, exacerbating local flooding of roads, homes, and businesses. Ocean sediment and beach material were also deposited overland by the storm surge (fig. 8). About 30,000 households were without power during and immediately after the storm. On Nantucket Island, about 12,800 households were without power for up to 3 days after the onset of the storm.
