Assessment of Existing and Potential Landslide Hazards Resulting from the April 25, 2015 Gorkha, Nepal Earthquake Sequence

Open-File Report 2015–1142
Version 1.1, August 2015

By Brian D. Collins and Randall W. Jibson

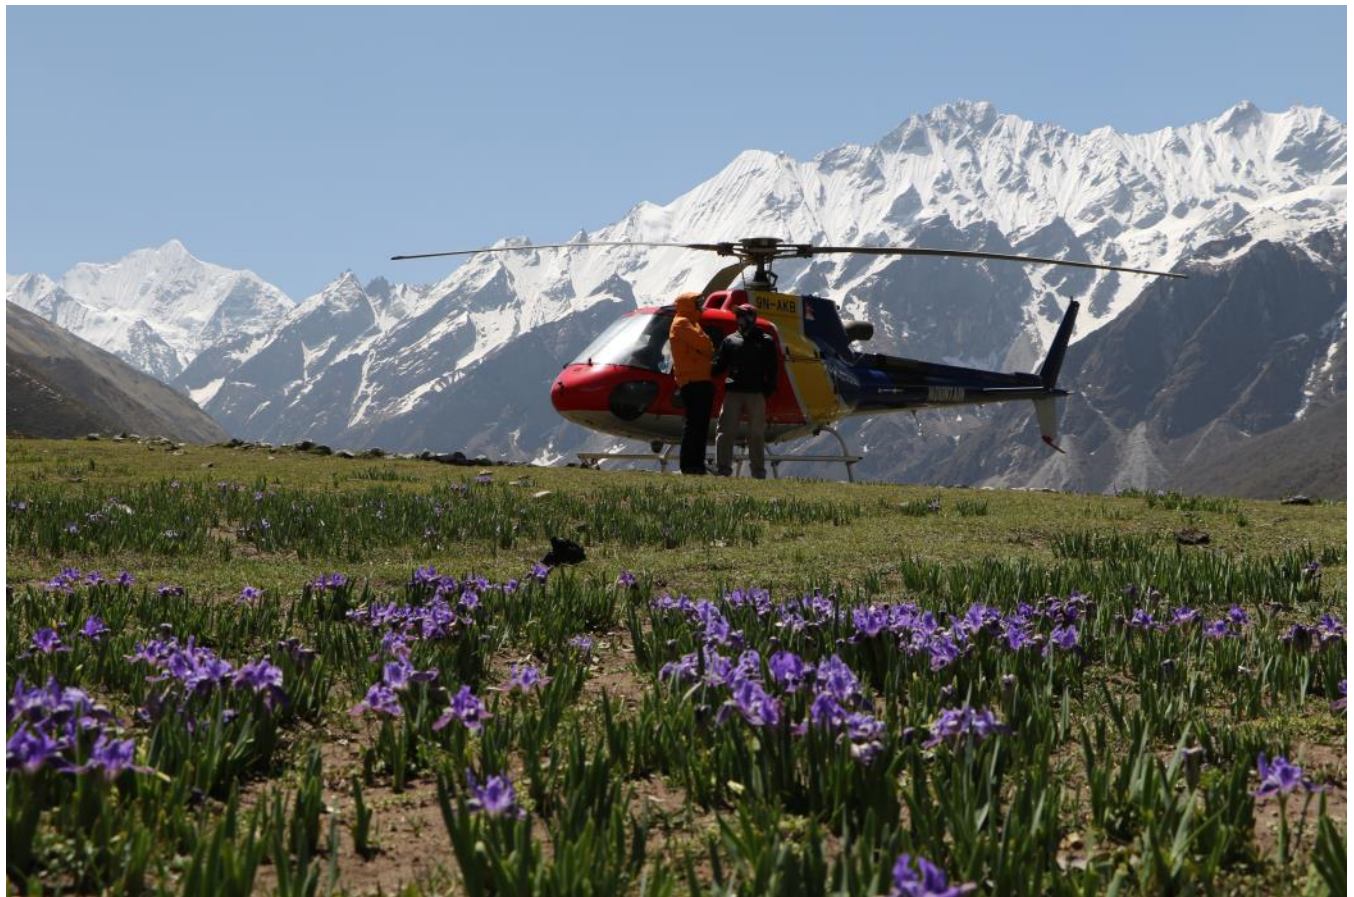
Figure 5. Photograph showing high-performance, high-altitude helicopter required to reach remote, and in some cases, high-altitude areas where earthquake shaking triggered thousands of landslides.

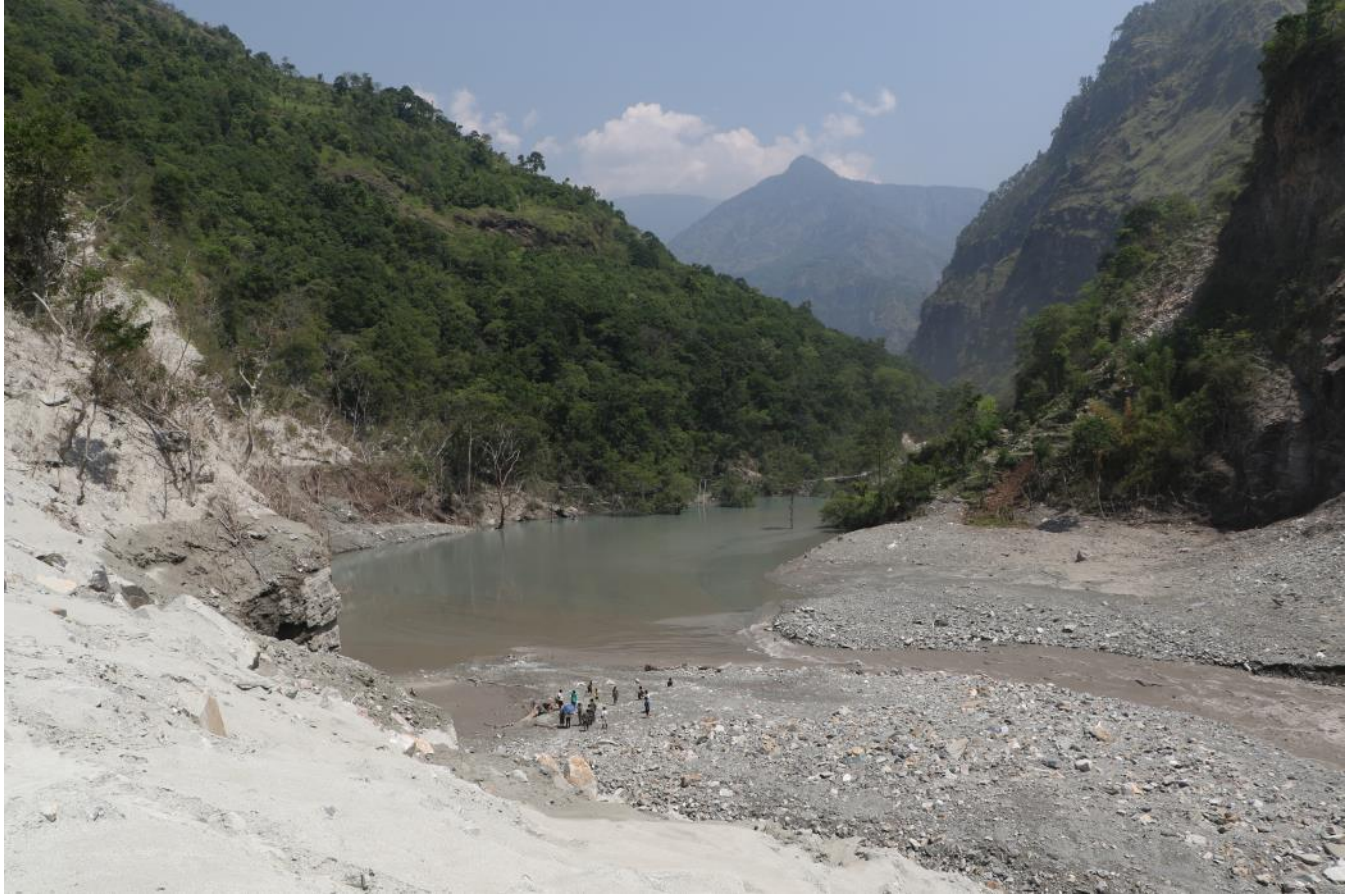
Figure 13. Photograph showing existing lake impoundment formed by May 24, 2015 rock slide at Baisari village. The lake blocks road access to all villages to the north.

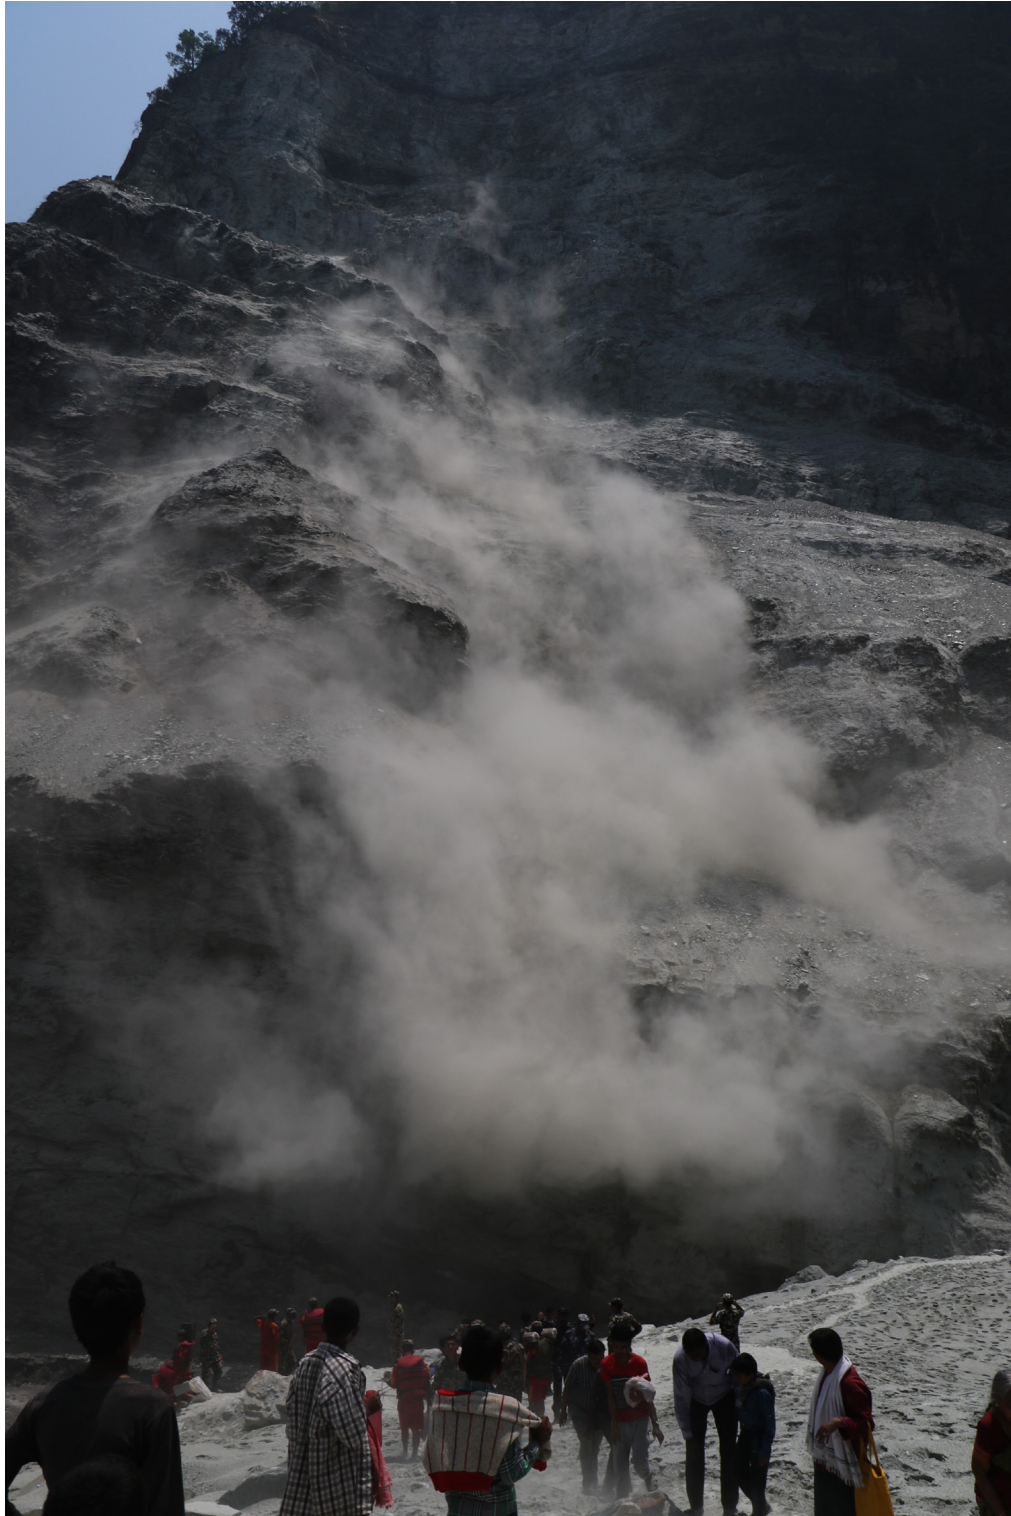
Figure 14. Photograph showing rock fall from landslide scarp (as expressed by dust cloud) five days after the failure, indicates continuing hazard in the Baisari area.

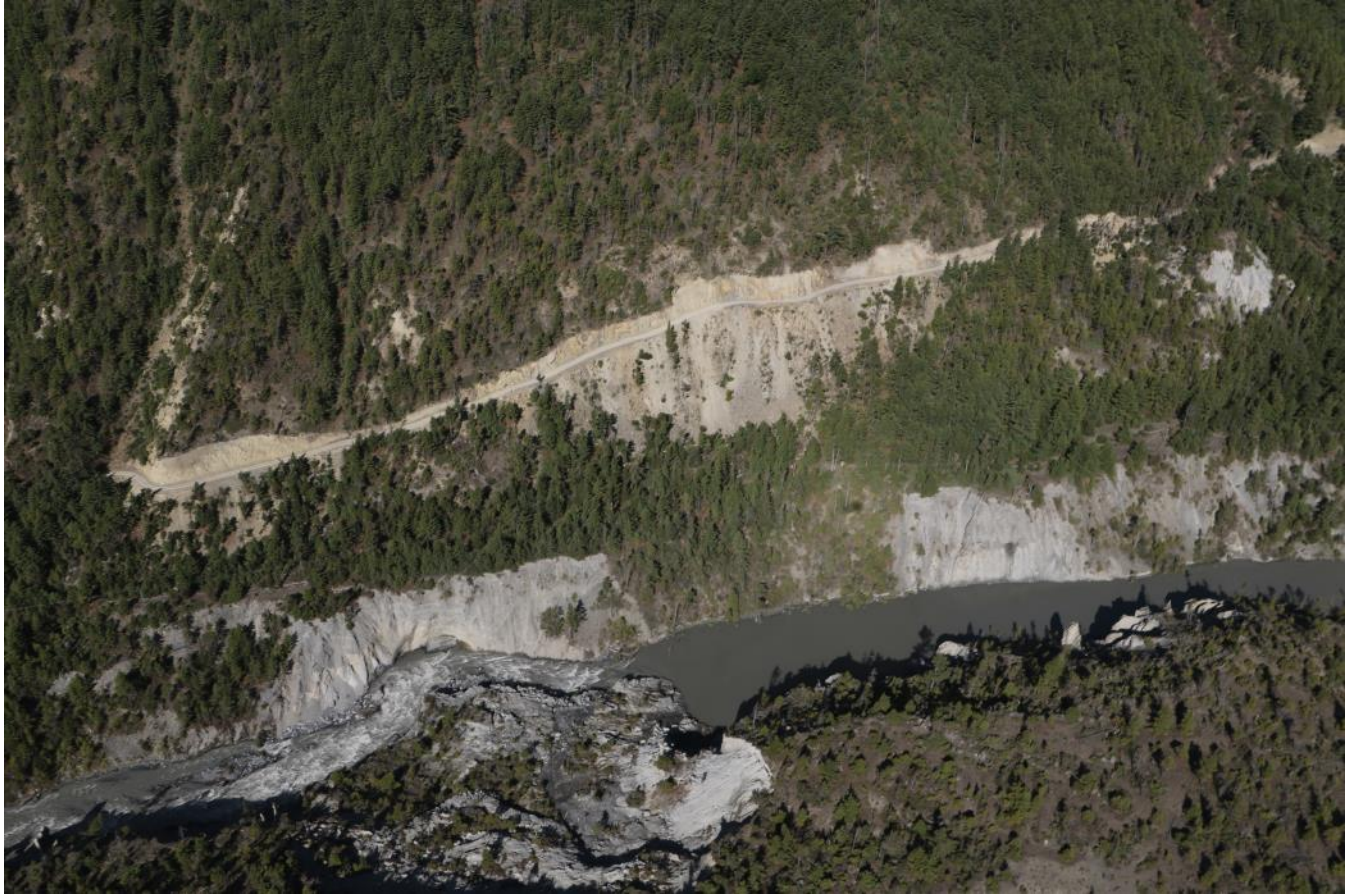
Our estimates of landslide volumes range from 30,000 to 100,000 m³. At the Pisang 1 landslide, partial blockage of the river currently (May 30, 2015) formed a 50-m-long slackwater lake upstream of the constriction. At Pisang 2 (fig. 15), an approximately 350-m-long lake had formed with surface elevation that we estimate from drowned trees to be about 3 m above pre-slide river levels. This landslide is reported to have completely blocked the flow of the river and formed a longer lake that subsequently breached when water spilled over the top of the landslide dam. The river course is now against the south side of the river channel and continues to erode the landslide toe. The Humde 1 landslide (fig. 16A) also likely fully blocked the river's flow. It currently backs up water for approximately 100 m with an estimated river-surface elevation increase of 1 m. Similarly, the Humde 2 landslide (fig. 16B) backs up water for about 200 m with an estimated river-surface elevation increase of 1 m above pre-slide river elevations and also likely temporarily blocked the river's flow.

Figure 15. Aerial image of the Pisang 2 earth slide along the Marsyangdi River upstream from Pisang village. As of May 30, 2015, this landslide constricted the river with a 350-m-long slackwater lake upstream of the landslide deposit. Maximum width of impoundment in image is approximately 50 m.

Based on several existing constrictions in the river from these landslides, we judge the hazard level of these landslides to be moderate and expect that additional landslide deformation will occur from fluvial erosion at the toe of the landslide. If deposits remobilize as flows, they could impound the river again. If the volume of a river-blocking deposit is small, it could be quickly overtopped and eroded away similar to what occurred in the days and weeks following the earthquake. However, if a larger deposit forms, this could impound significant volumes of water, and given the fine grain size of the deposit material, rapid and catastrophic breaching could occur.

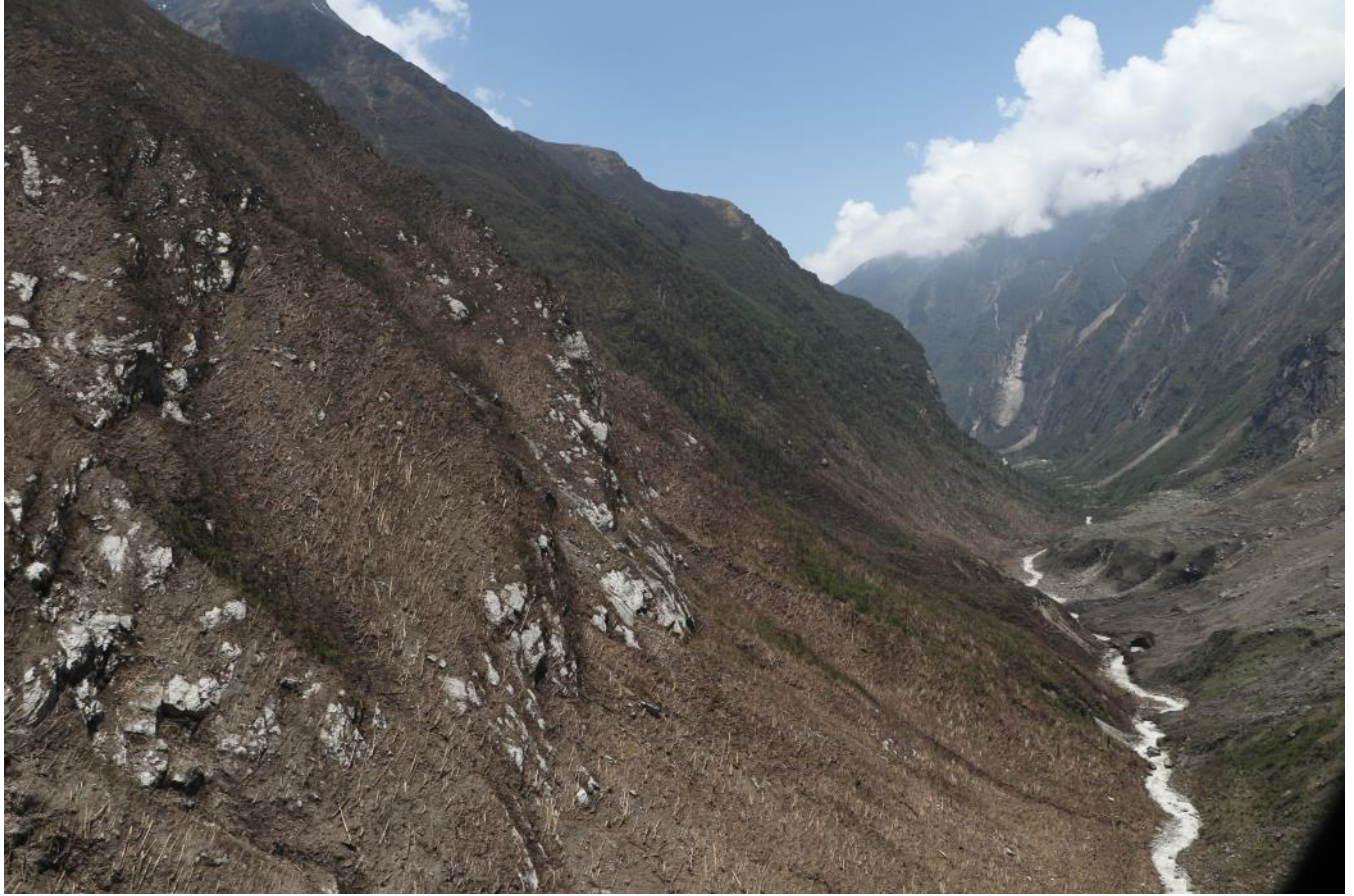
Figure 20. Photograph showing blown down trees caused by rapid emplacement of the Langtang debris avalanche deposit and resulting radial air blast. The air blast flattened all parts of the village not originally buried by debris and caused blowdown of trees in all directions for a distance of approximately 1 km. View is down-valley to the west and shows approximately 1,000 m of vertical relief between river and foreground mountain.

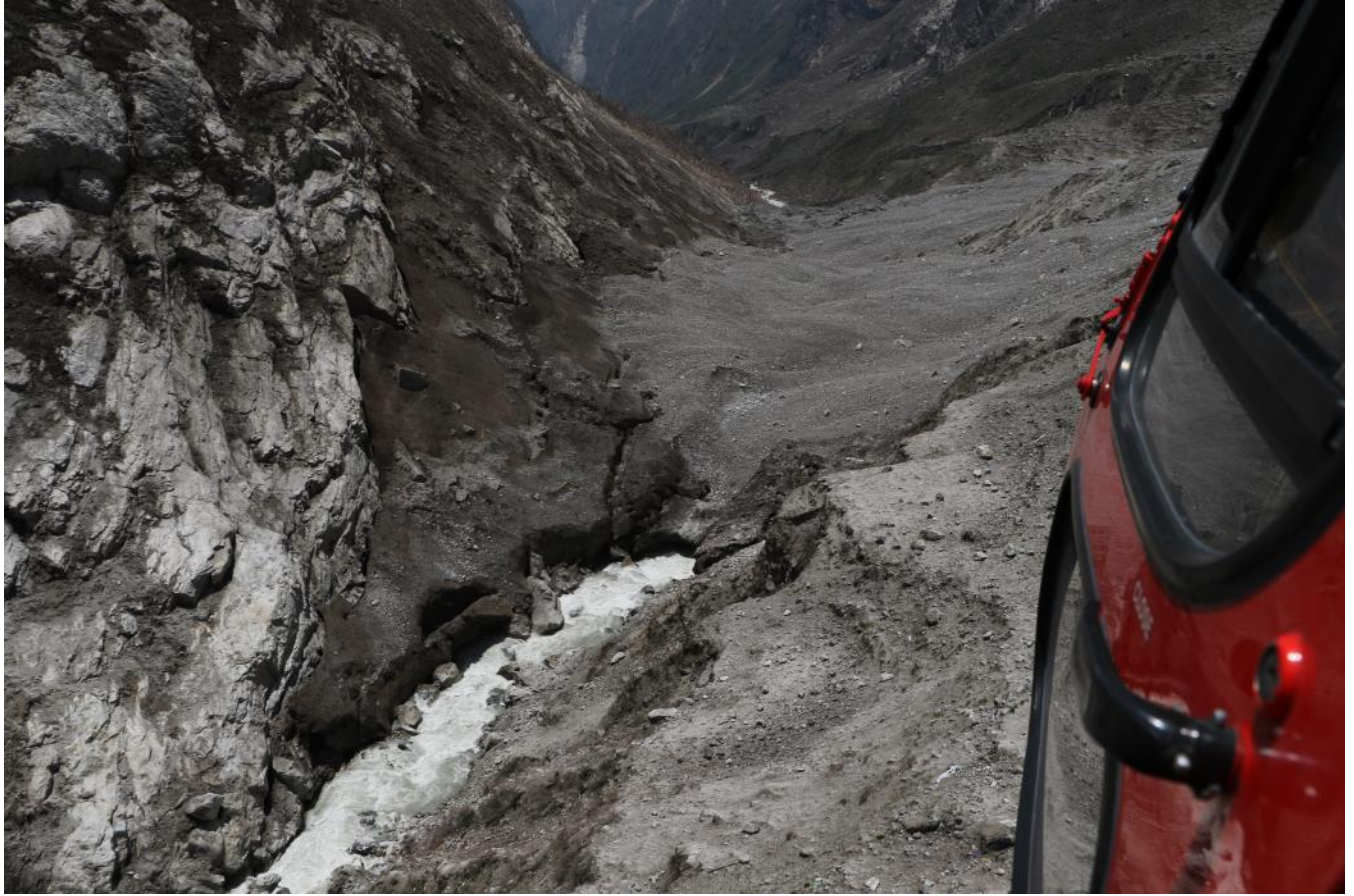
Figure 21. Photograph showing the Langtang debris avalanche deposit temporarily blocking the flow of the Langtang River, which subsequently formed a tunnel through the ice in which the river was flowing through in May 2015. River in foreground is approximately 10 m wide. Tunnel through ice and debris is approximately 650 m long.

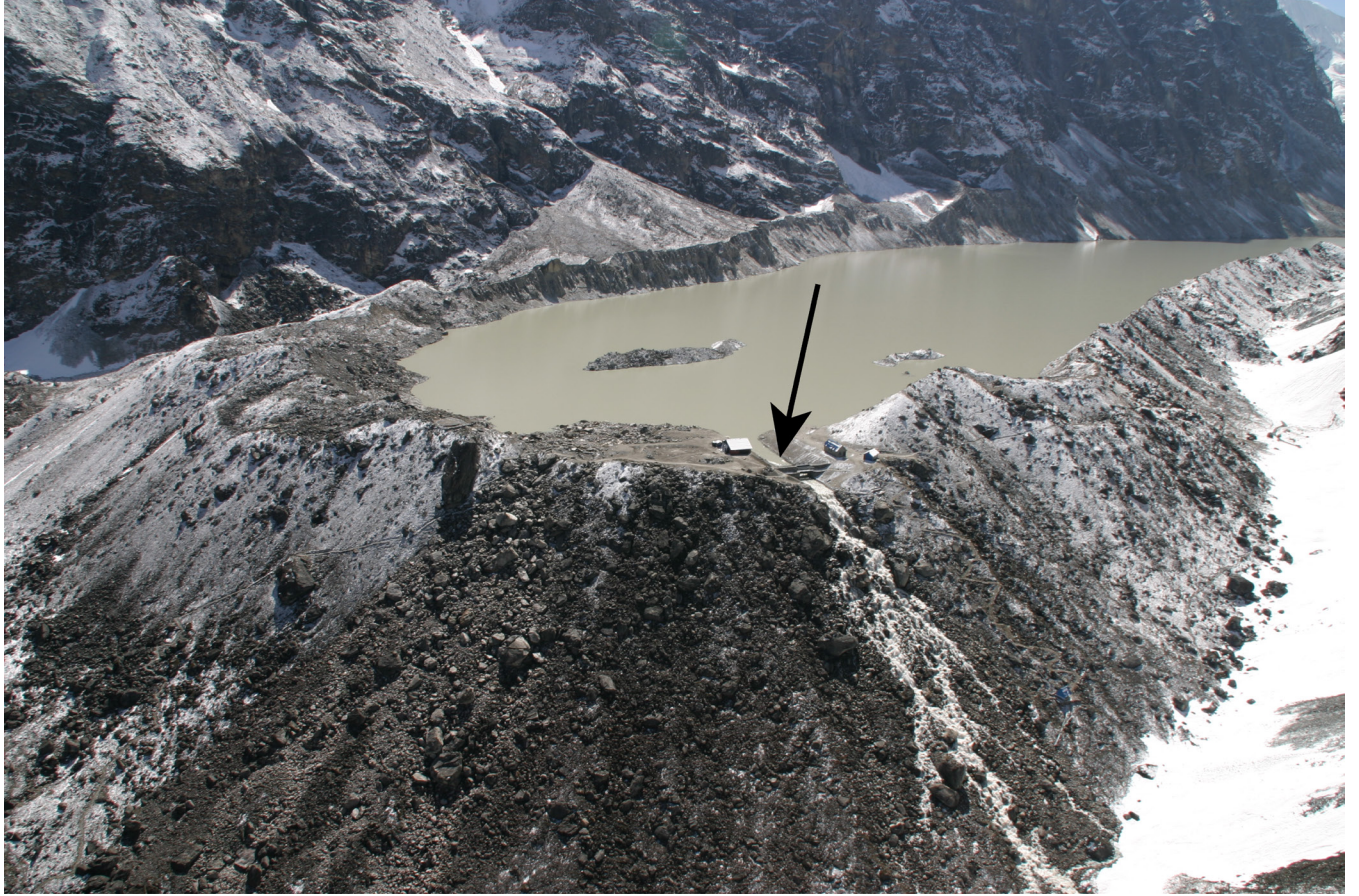
Figure 22. Photograph showing eastward view of the terminal moraine forming Tsho Rolpa glacial lake. The engineering outlet works (fig. 23) are indicated by an arrow.

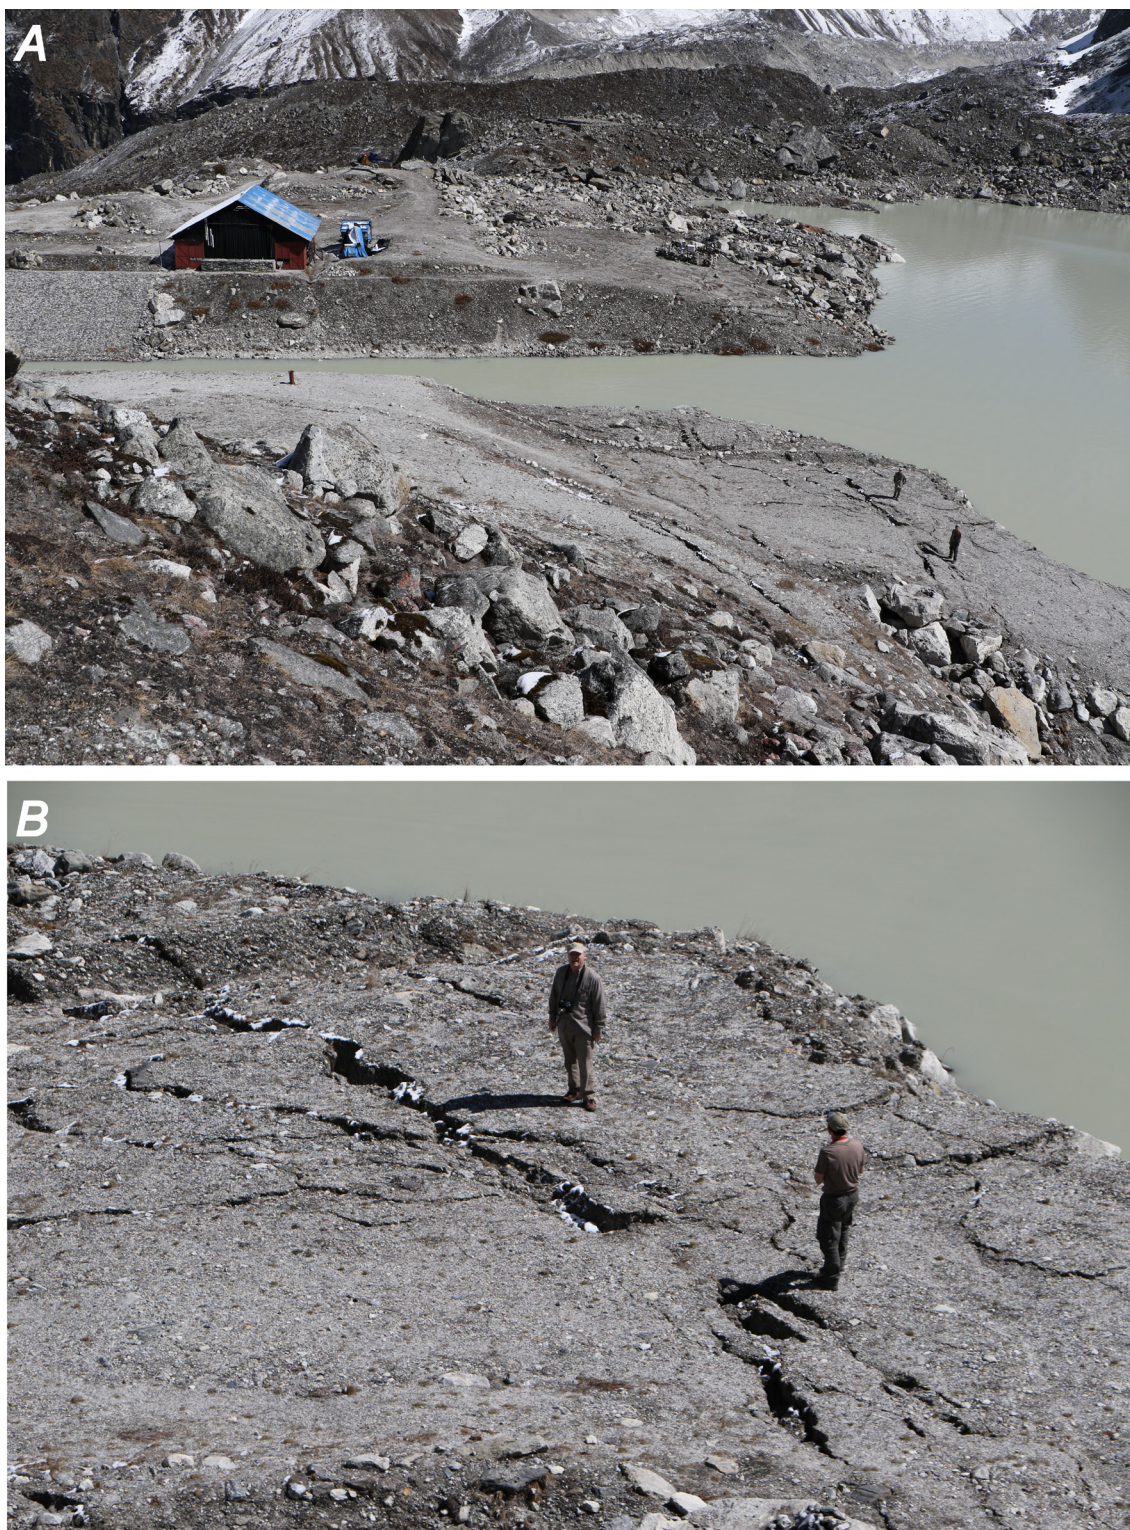
Figure 24. Photographs showing lateral spreading at the inlet to the Tsho Rolpa engineered drainage channel (A, B). Approximately 1.0–1.5 m of horizontal displacement (toward the lake) and 0.5 m of downward displacement on the eastern side of the channel did not appear to compromise the stability of the moraine dam or engineered outlet.
