Preliminary Peak Stage and Streamflow Data at Selected USGS Streamgaging Stations for the South Carolina Flood of October 2015

Open-File Report 2015–1201
Version 1.1, November 2015

By Toby D. Feaster, John M. Shelton, and Jeanne C. Robbins

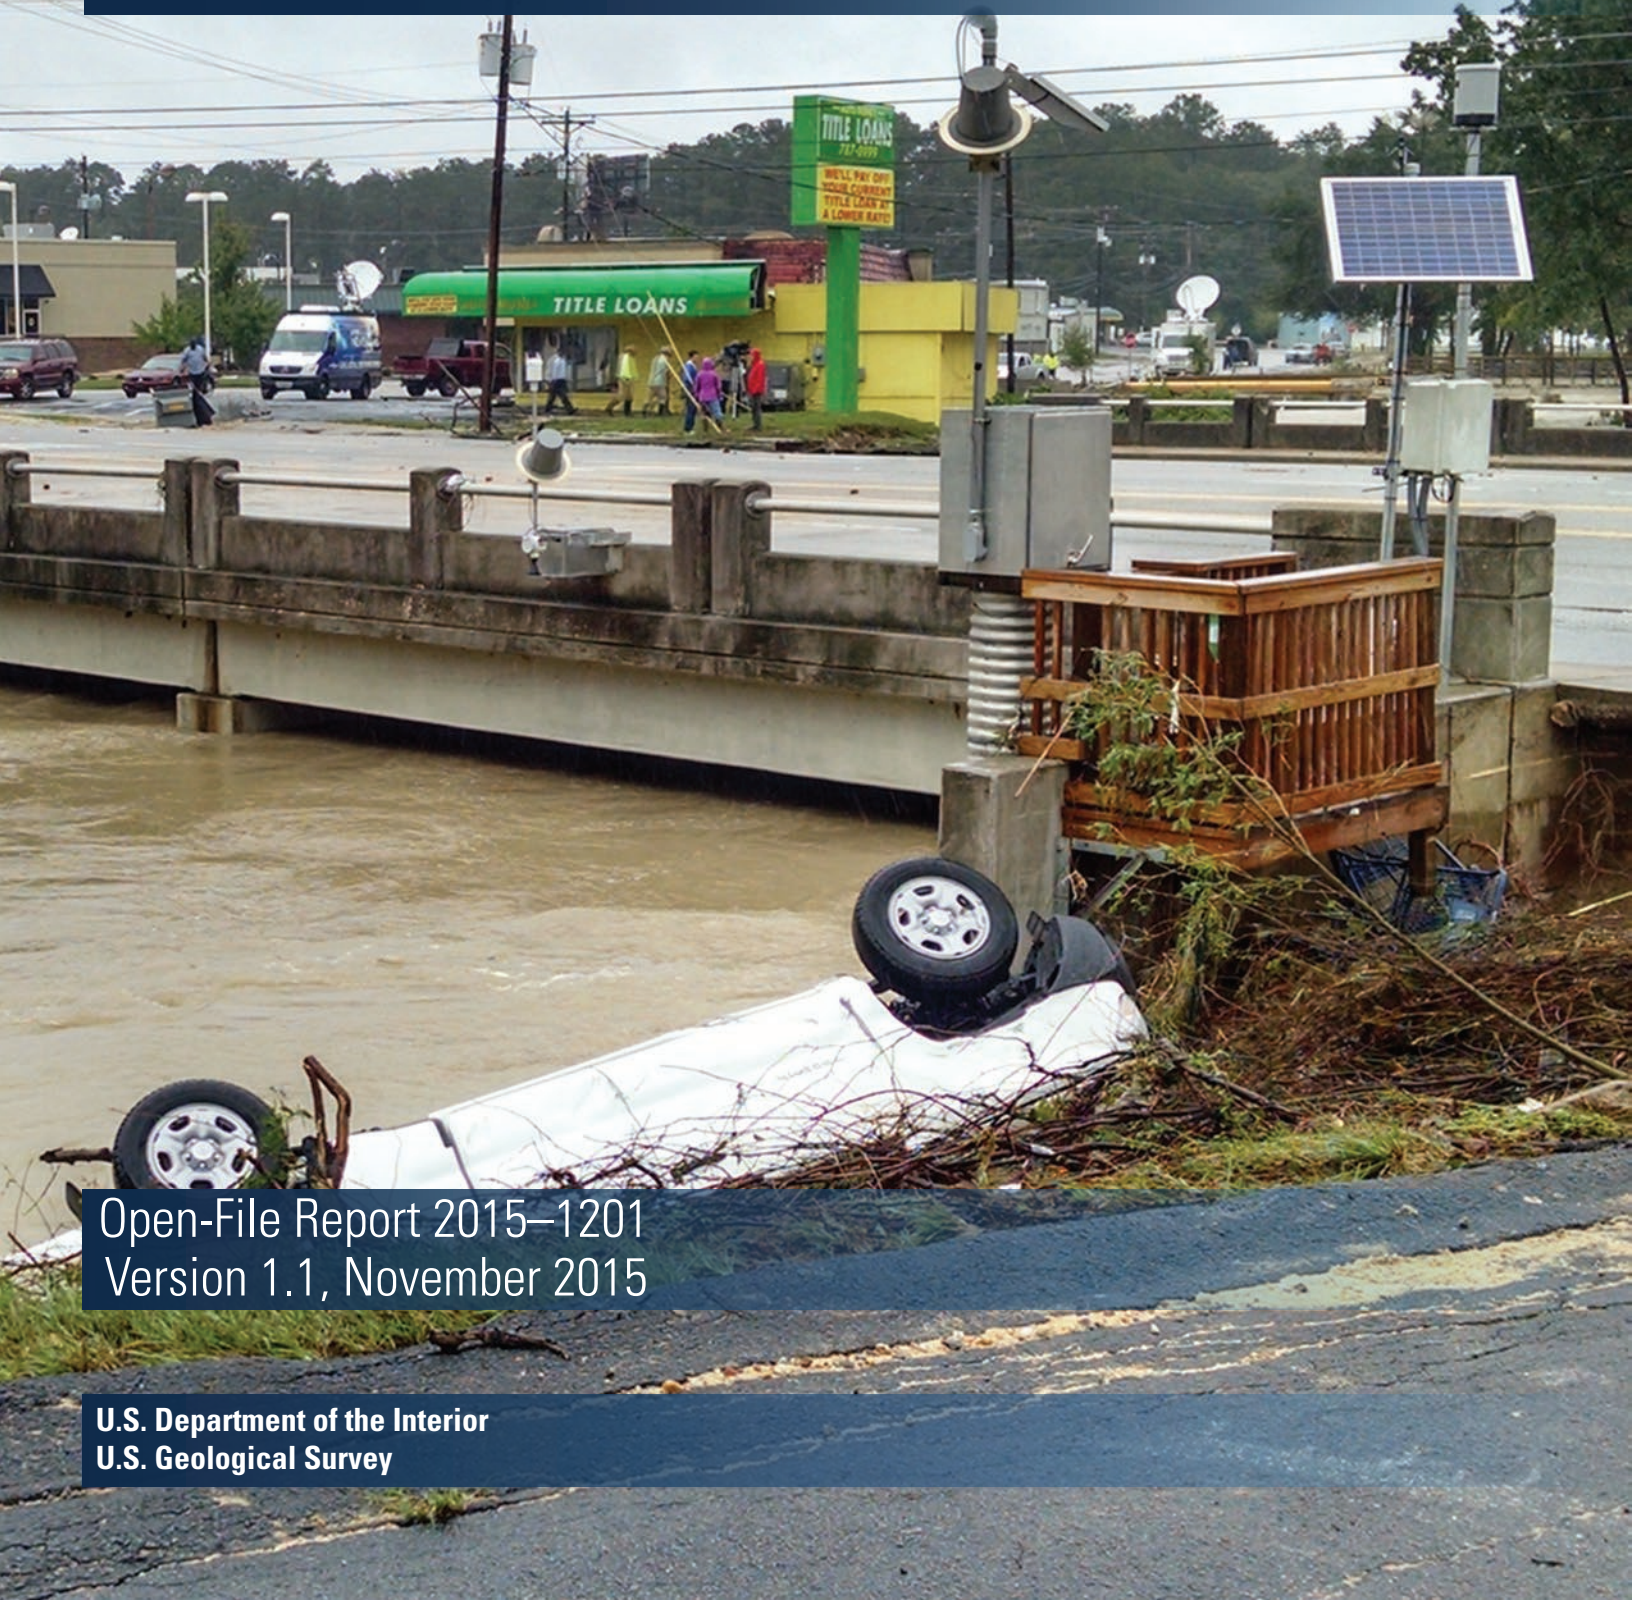
Cover: Left bank looking upstream toward U.S. Geological Survey station 02169570, Gills Creek at Columbia, S.C. Streamgaging station is located on the downstream side of the bridge on U.S. Highways 378 and 76 (Devine St.).

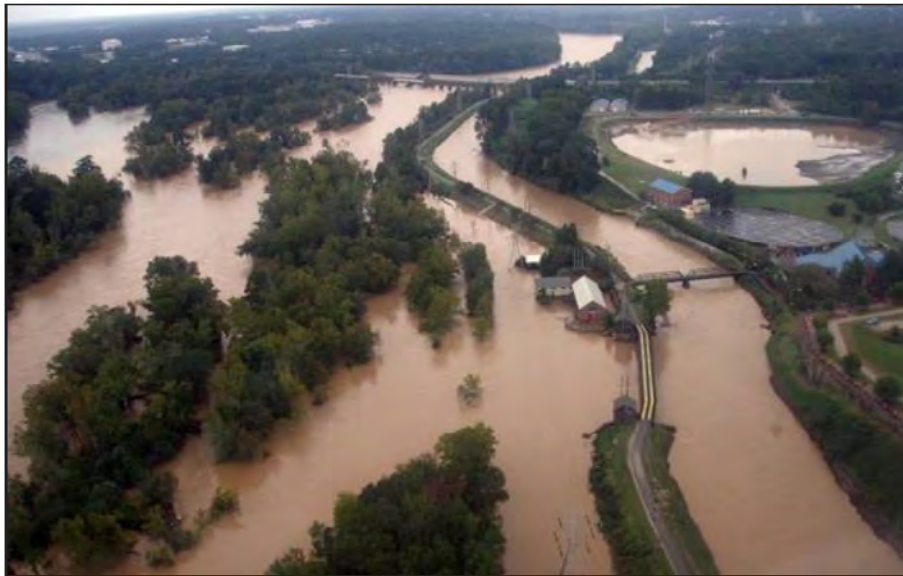
Figure 2. Aerial photograph of flooding in Columbia, South Carolina, at the confluence of the Broad and Saluda Rivers, looking upstream. (Photograph by the South Carolina Army National Guard, October 5, 2015)

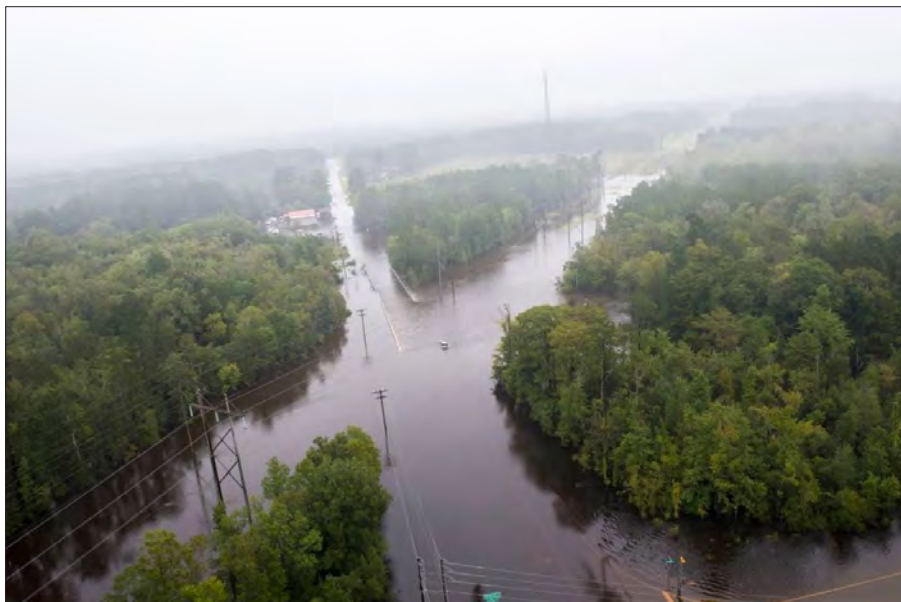
Figure 3. Aerial photograph of flooding in Charleston, South Carolina, and surrounding areas, October 5, 2015. (Photograph by Petty Officer 1st Class Stephen Lehmann, U.S. Coast Guard)

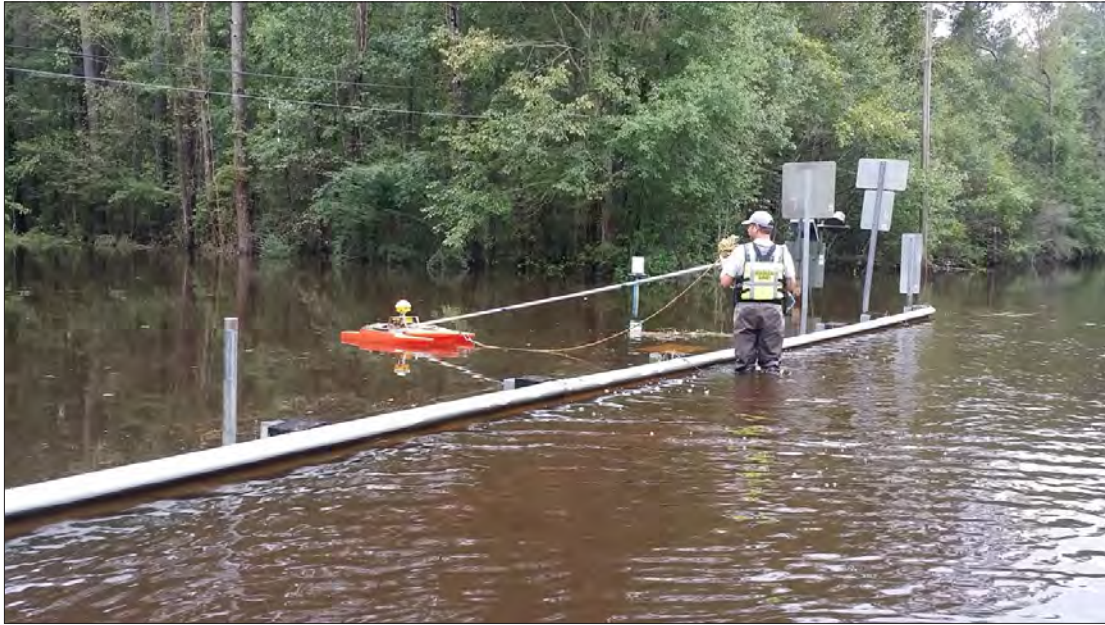
Figure 7. U.S. Geological Survey personnel making a streamflow measurement at station 02110701, Crabtree Swamp at Conway, South Carolina, using an acoustic Doppler current profiler.

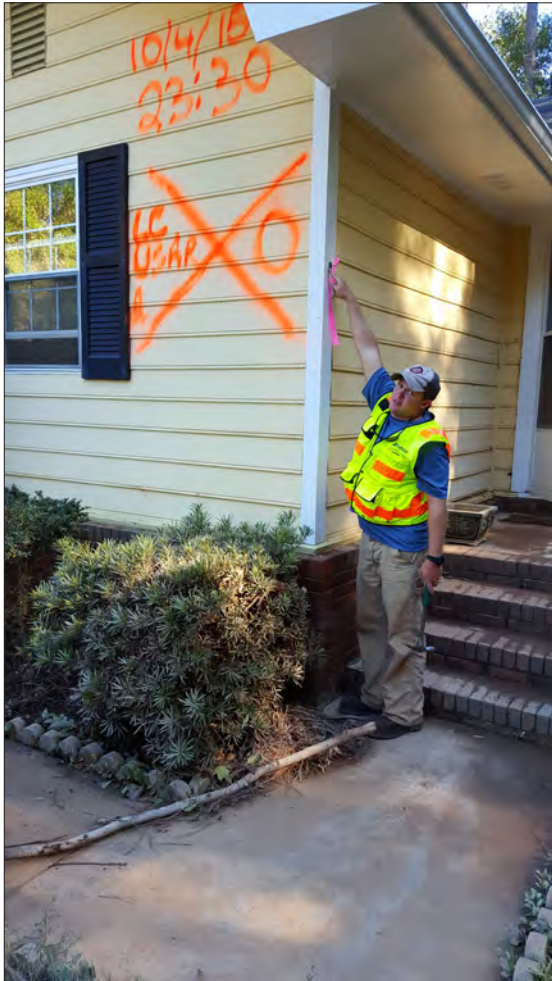
Figure 9. U.S. Geological Survey field crews conducting surveys of high-water marks to document the depth of flood waters in Lexington County, South Carolina, for the October 2015 flood.

field survey. Roughness is subjectively determined on the basis of bed material, cross-section irregularities, depth of flow, vegetation, and channel alignment. The USGS assigns uncertainty/accuracy estimates to each indirect measurement on the basis of the hydraulic and geometry conditions found at each field site (Benson and Dalrymple, 1967; Dalrymple and others, 1967; Hulsing, 1967; Matthai, 1967; Bodhaine, 1968). In other cases, high-water marks are documented for the purpose of recording the depth of the flood waters (fig. 9).
