# Field Survey of Earthquake Effects from the Magnitude 4.0 Southern Maine Earthquake of October 16, 2012

Open-File Report 2016–1071

U.S. Department of the Interior  
U.S. Geological Survey

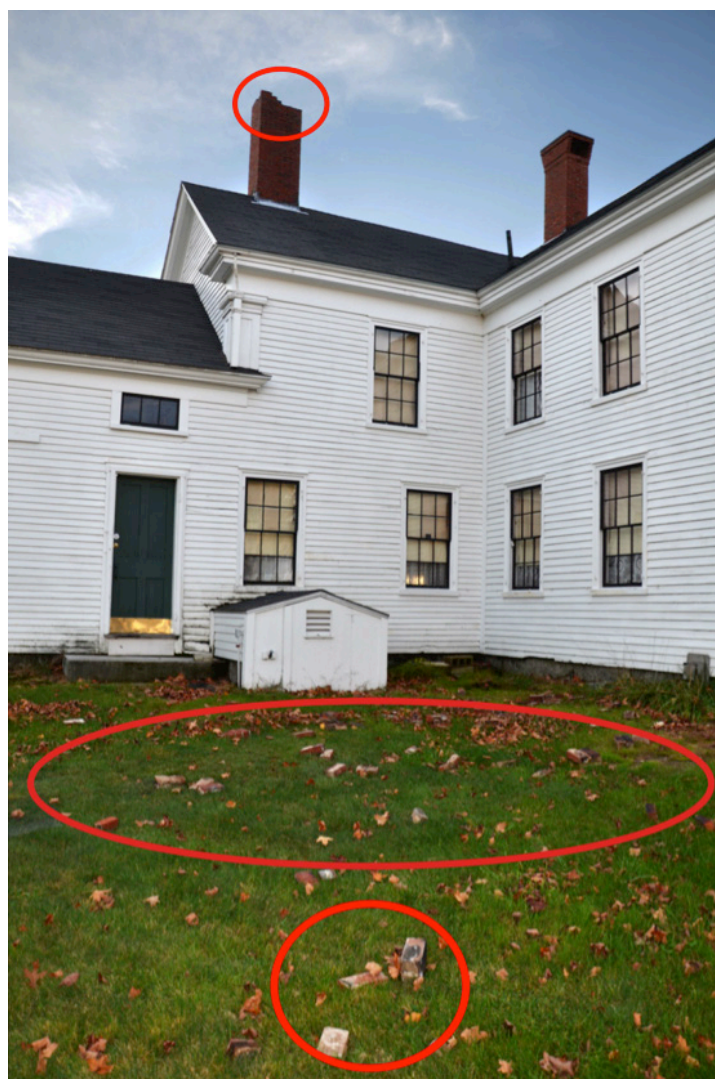
**Cover**—Damaged chimney and brick debris at the Taylor-Frey-Leavitt House Museum in East Waterboro, Maine, caused by the October 16, 2012, magnitude 4.0 southern Maine earthquake.

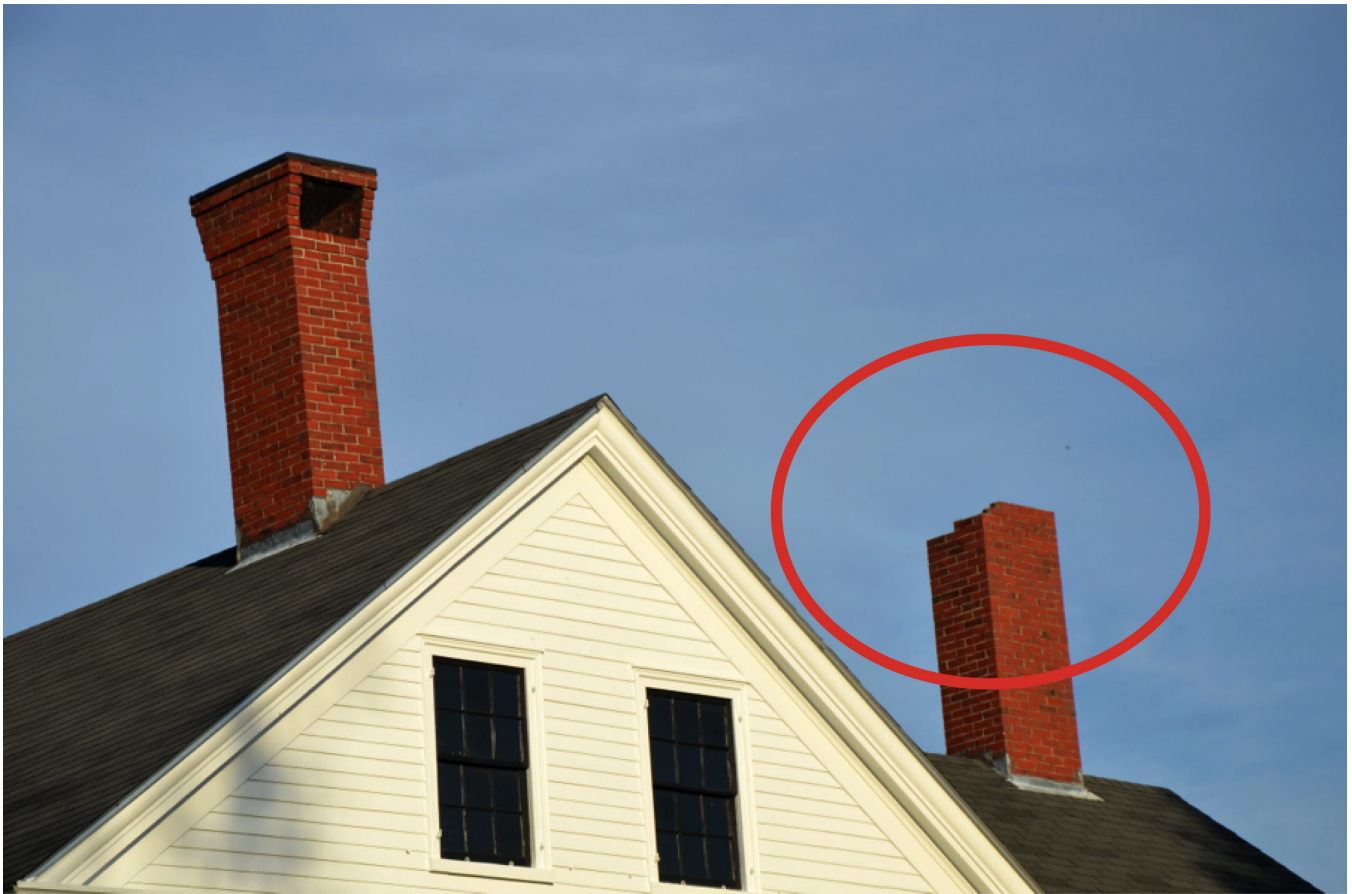
The earthquake damaged four buildings near the epicenter (figs. 1–3). The most severe damage that we observed was the partial failure (topping) of a brick chimney of the Taylor-Frey-Leavitt House Museum in East Waterboro (fig. 5; interview k, table 2), ~6 km west of the epicenter. Of three identical brick chimneys on the building, only one was damaged. The debris on one side of the building are shown in figure 6; the damage to the roof where the bricks hit it as they fell is difficult to see in the photograph, but was clearly evident from the ground below the building.

**Figure 5.** Damaged (red circle) and undamaged chimneys on the Taylor-Frey-Leavitt House Museum in East Waterboro, Maine, caused by the October 16, 2012, southern Maine earthquake.

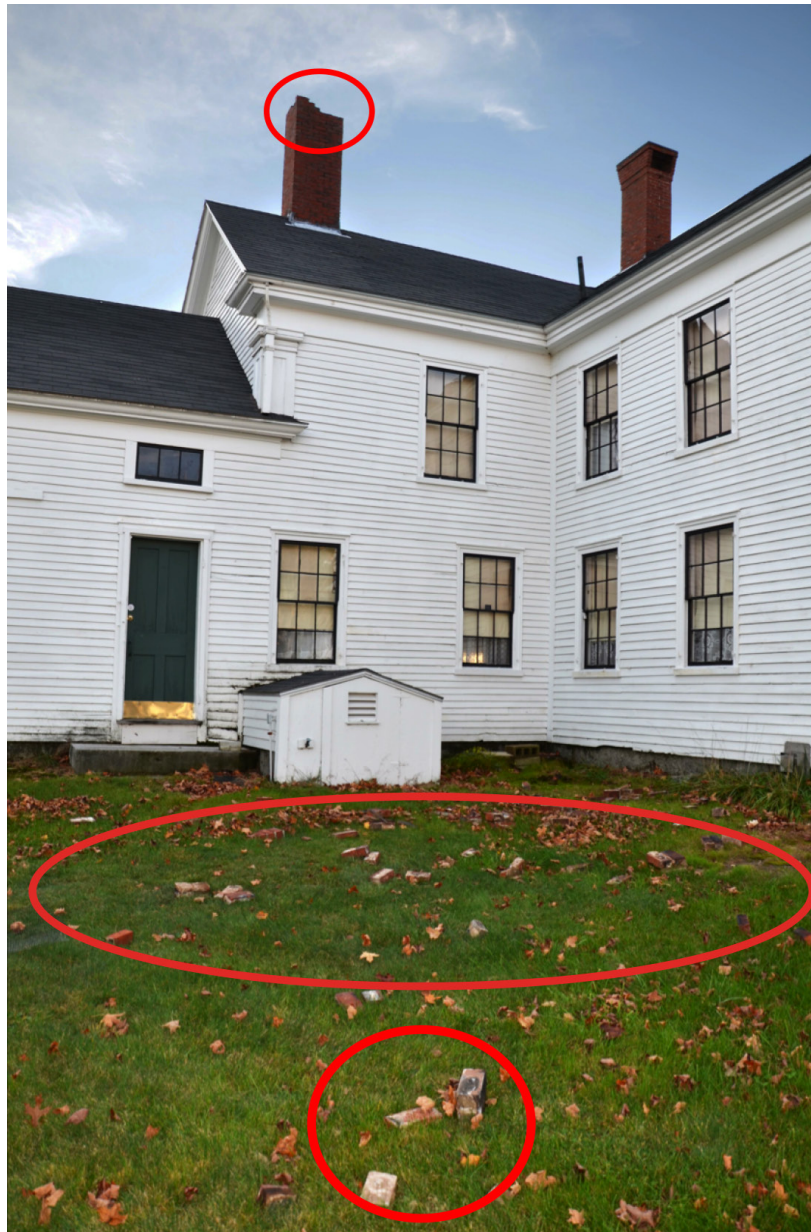
**Figure 6.** Damaged chimney and brick debris at the Taylor-Frey-Leavitt House Museum in East Waterboro, Maine, caused by the October 16, 2012, southern Maine earthquake.
