Environmental and Eelgrass Response to Dike Removal: Nisqually River Delta (2010–14)

Open-File Report 2016–1169

U.S. Department of the Interior
U.S. Geological Survey

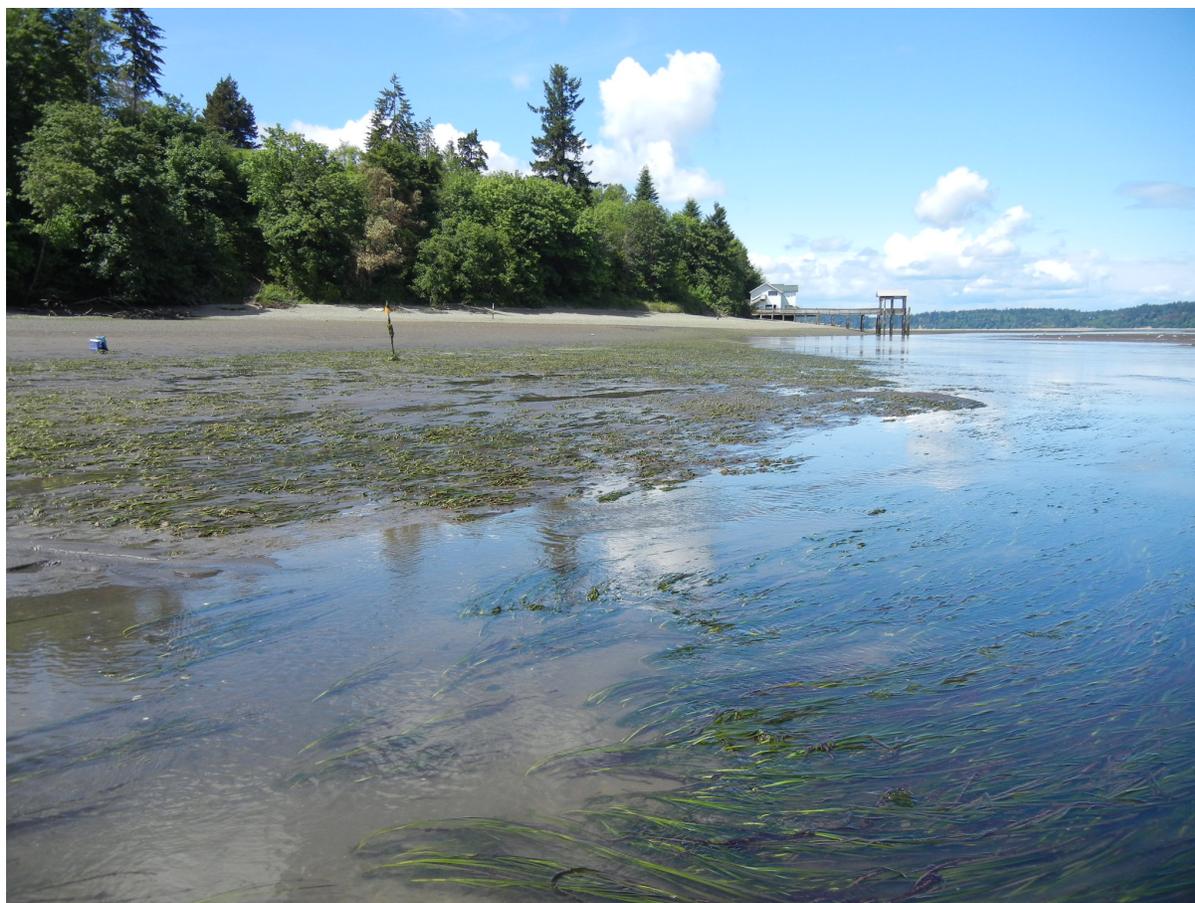
Cover. Photo of an environmental sensor measuring turbidity and temperature in an eelgrass bed near a restored tidal channel in the Nisqually River Delta, Puget Sound, Washington. Photo by Renee Takesue, U.S. Geological Survey.

Water column turbidity was measured at the top of the eelgrass canopy using self-logging optical backscatter sensors (SLOBS) with added temperature and pressure sensors (Aquatech). The top of the eelgrass canopy was approximately 90 cm above the sediment surface. The sensors recorded in burst mode, taking readings once a second (1 hertz [Hz]) for 120 second-long bursts every 15 minutes. During the initial year of study, sensors were deployed for 12 days from May 17, 2010, to May 29, 2010, with automated wipers to prevent particles from settling on the sensor windows and interfering with backscatter readings. In subsequent years, SLOBS were deployed for 4–5 days without wipers because particle build-up was not significant over the shorter period. Surface sediment (0–2 cm) was collected in replicate below the SLOBS for lab calibrations to convert optical backscatter (volts) into sediment concentration (milligrams per liter [mg/L]). Data was processed using Matlab software.

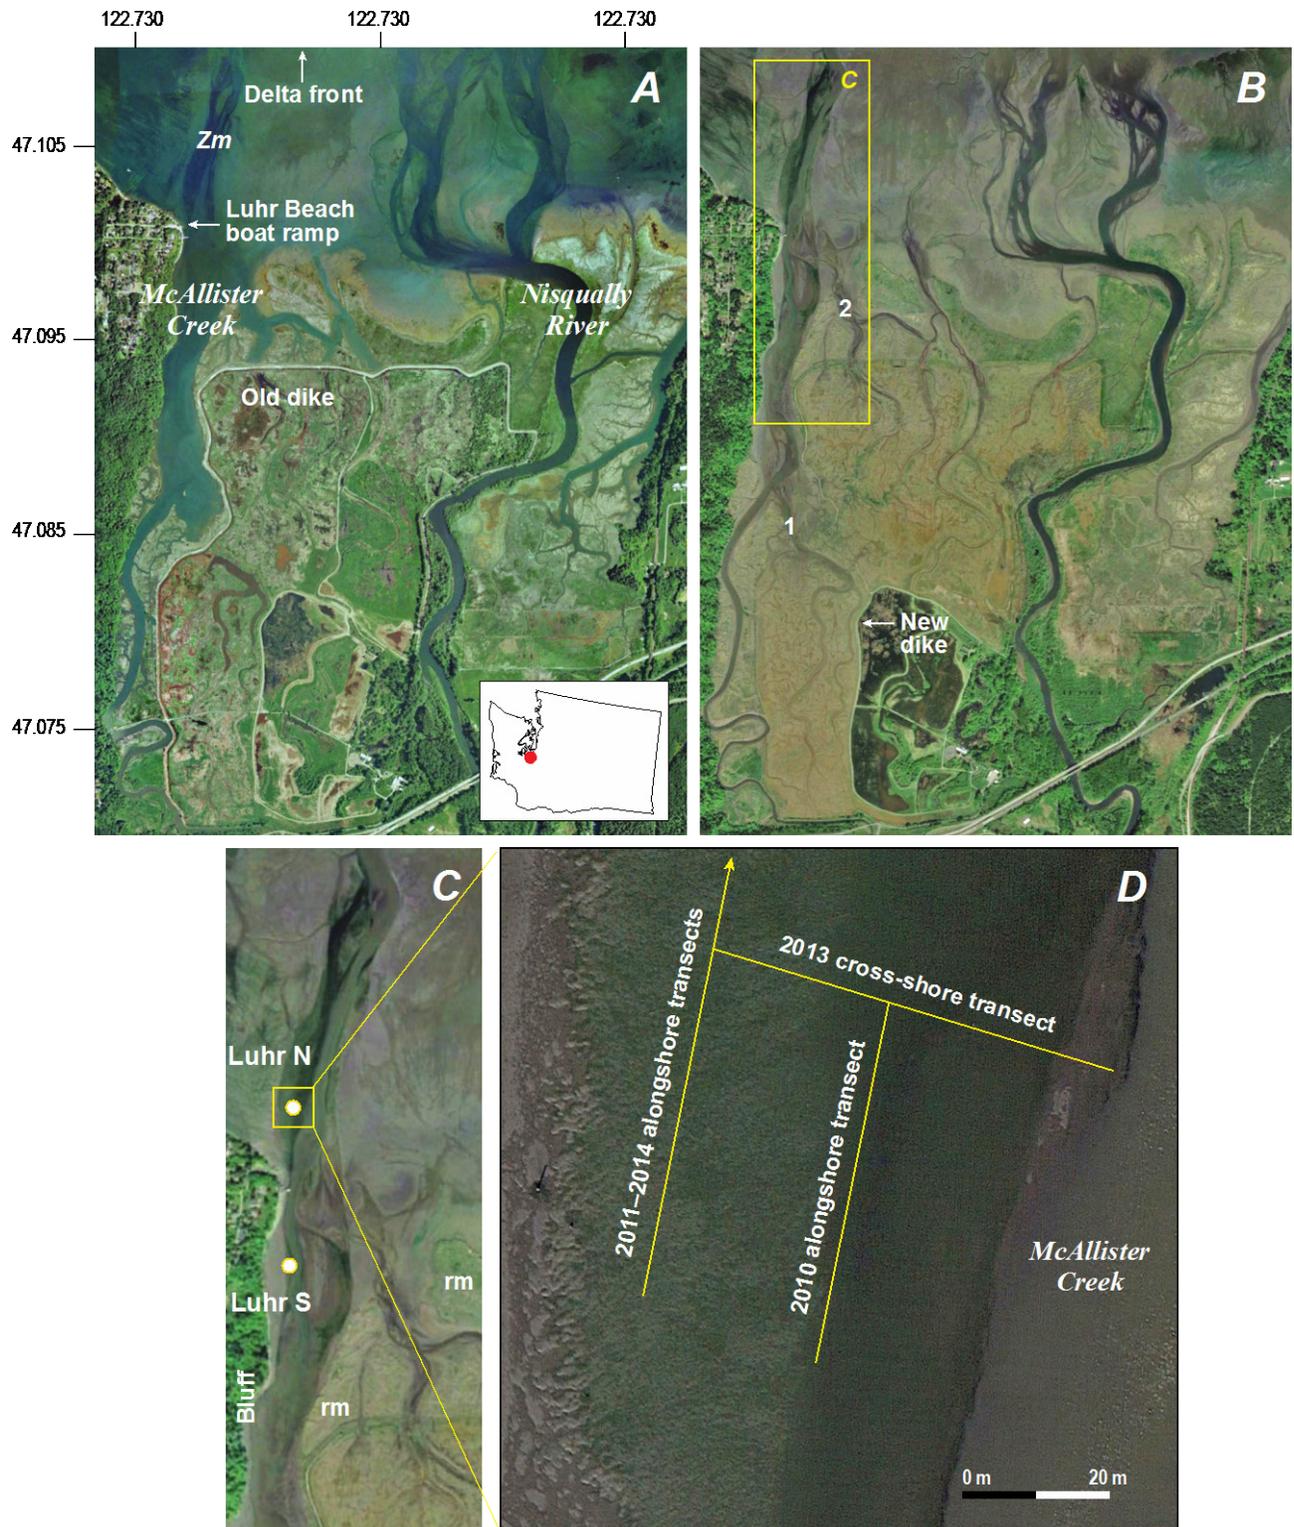
Figure 1. Satellite images of the Nisqually River Delta, Washington (Google Earth). *A*, The delta in mid-2009 with the old dike; *Zm* is the 8-ha *Zostera marina* bed. *B*, The delta in mid-2015 with the new dike; 1 and 2 are restored tidal channels that drain to McAllister Creek. *C*, Locations of monitoring sites at Luhr N and Luhr S; *rm* are remnant marsh platforms. *D*, Approximate locations of eelgrass transect by year.

McAllister Creek is a spring-fed creek on the west side of the Nisqually River Delta into which restored tidal channels drain (fig. 1B). Monitoring was conducted at two sites on the west bank of McAllister Creek, 200 meters (m) north and 300 m south of the Luhr Beach boat ramp, designated Luhr N and Luhr S (fig. 1C). North (seaward) of the boat ramp, McAllister Creek crosses intertidal mud flats and flows to the delta front, and a continuous 8-ha eelgrass meadow extends along its west bank (fig. 1A). South (landward) of the boat ramp, the channel of McAllister Creek is confined between a bluff to the west and marsh platforms to the east (fig. 1C). Eelgrass occurs in discrete beds and patches in the landward portion of McAllister Creek. The eelgrass bed monitored at Luhr S was 0.3 ha in area.

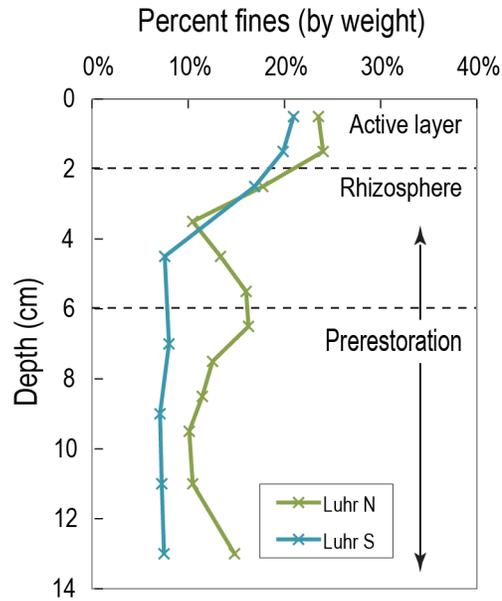
Figure 2. Graph showing variation with depth of the sediment fine fraction (percent fines) in sediment cores collected in May 2010 at Luhr N and Luhr S. Dashed lines show the approximate depths (in centimeters) of the active surface layer, rhizosphere, and prerestoration intervals.

Surface sediment was not collected at the monitoring sites prior to dike removal, so prerestoration sediment grain-size distributions were determined from records in sediment cores. Rooted, mature eelgrass plants (>1 year old, see section on eelgrass rhizomes) were present when cores were collected in May 2010. Therefore, sediment in and below the root zone, or rhizosphere, was in place for at least 1 year, meaning it was deposited before dike removal. Below the rhizosphere (>6 centimeters [cm]), sediment texture varied between 10 to 16 percent fines at Luhr N and averaged 7 percent fines at Luhr S (fig. 2). In the rhizosphere (2–6 cm), sediment texture became finer toward the surface at Luhr S (fig. 2) and was variable at Luhr N. Prerestoration sediments in the rhizosphere and deeper at Luhr N and S had a coarser texture than that of the active surface layer (0 to 2 cm). The overall sediment texture was finer at Luhr N than at Luhr S (fig. 2).

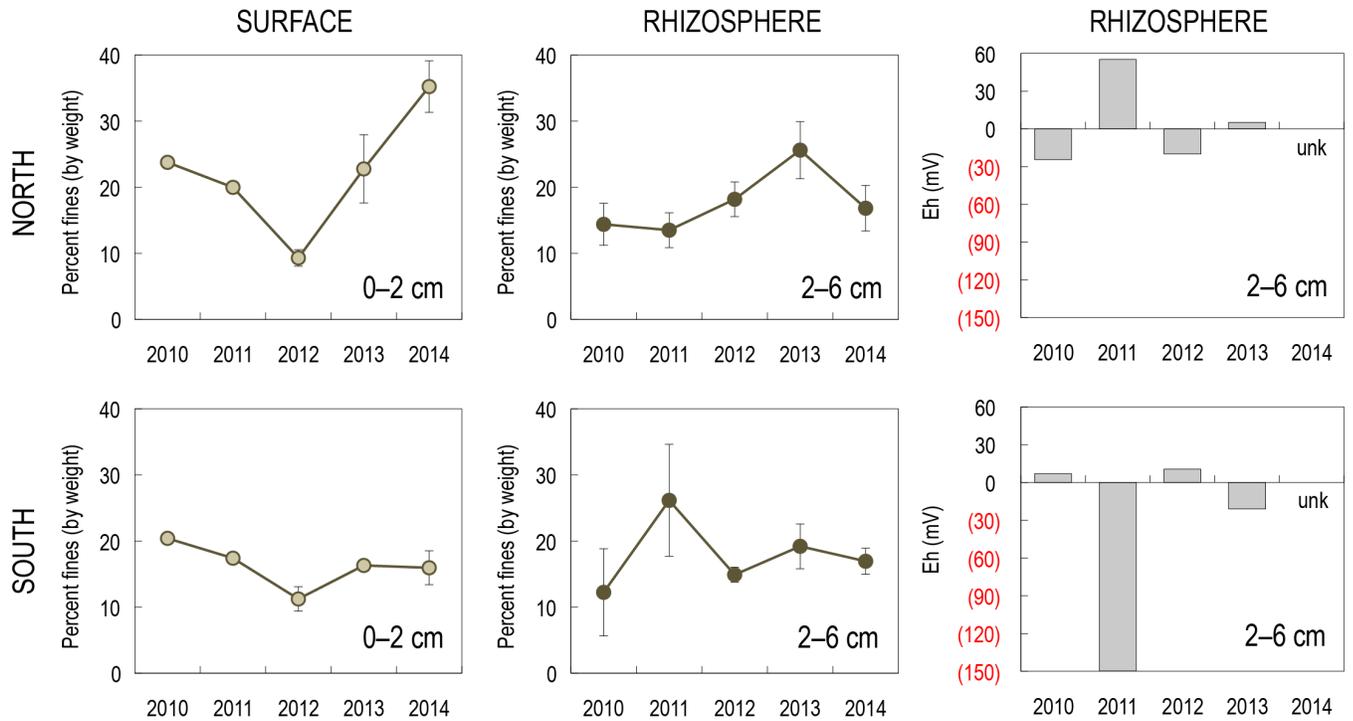
Figure 3. Graphs showing year-to-year changes in the sediment fine fraction (percent fines) in the active surface layer (left column) and rhizosphere (middle column) and sediment pore water redox values, also known as Eh, in the rhizosphere (right column). Top row, Luhr N; bottom row, Luhr S. Values are averages over the specified sediment intervals. Red numbers in parentheses indicate negative values. Error bars show $\pm 1 \sigma$. [cm, centimeters; unk, value unknown; mV, millivolts.]

Year-to-year changes of sediment properties of the active surface layer (0–2 cm) were compared to gain insight about temporal changes following dike removal. Surface sediment texture at both sites coarsened between 2010 and 2012, then became finer in 2013 (fig. 3, left column). From 2010 to 2013, year-to-year changes in surface sediment grain-size distributions varied in the same direction, either coarser or finer, at both sites. This pattern diverged in 2014 when surface sediment at Luhr N became considerably finer, while that at Luhr S changed little. Surface sediment at Luhr N had a higher proportion of fines than at Luhr S in all years except 2012, when the two were similar. Over the 5-year period, the mean percentage of fine sediment in the active surface layer was higher at Luhr N and lower at Luhr S compared to May 2010 (fig. 3, left column). In all years, surface sediment was well oxygenated (redox potential, also known as Eh, was 0 to 200 millivolts [mV], not shown), light brown in color, and had no detectable H₂S (not shown).

Year-to-year changes of sediment properties of the rhizosphere (2–6 cm) were compared to gain insight about temporal changes following dike removal. Prior to 2014, sediment pore water in the rhizosphere of the Luhr N eelgrass meadow was oxygenated to slightly reducing ($Eh > -30$ mV; fig. 3, right column) and had no measurable H_2S (not shown). The Luhr S rhizosphere was also oxygenated, or slightly reducing, except in 2011, when pore waters were moderately reducing ($Eh = -150$ mV; $H_2S = 2.2$ parts per million [ppm], or 63 micromolar [μM]), which was consistent with a large fraction of fine sediment in the substrate (26 percent fines). In 2014, a new Eh electrode was used, and it measured a five times larger range of Eh values in pore water (whose H_2S content was three times lower in 2014 than in 2010–13) compared to the previous electrode, suggesting it had a different sensitivity to Eh. Multipoint calibrations of the two electrodes, which would be needed to cross-calibrate the sensitivities of the electrodes, were not performed at the time of the study, therefore it is not known whether Eh values measured in 2014 were comparable to those from previous years. The 2014 Eh data will not be discussed further.

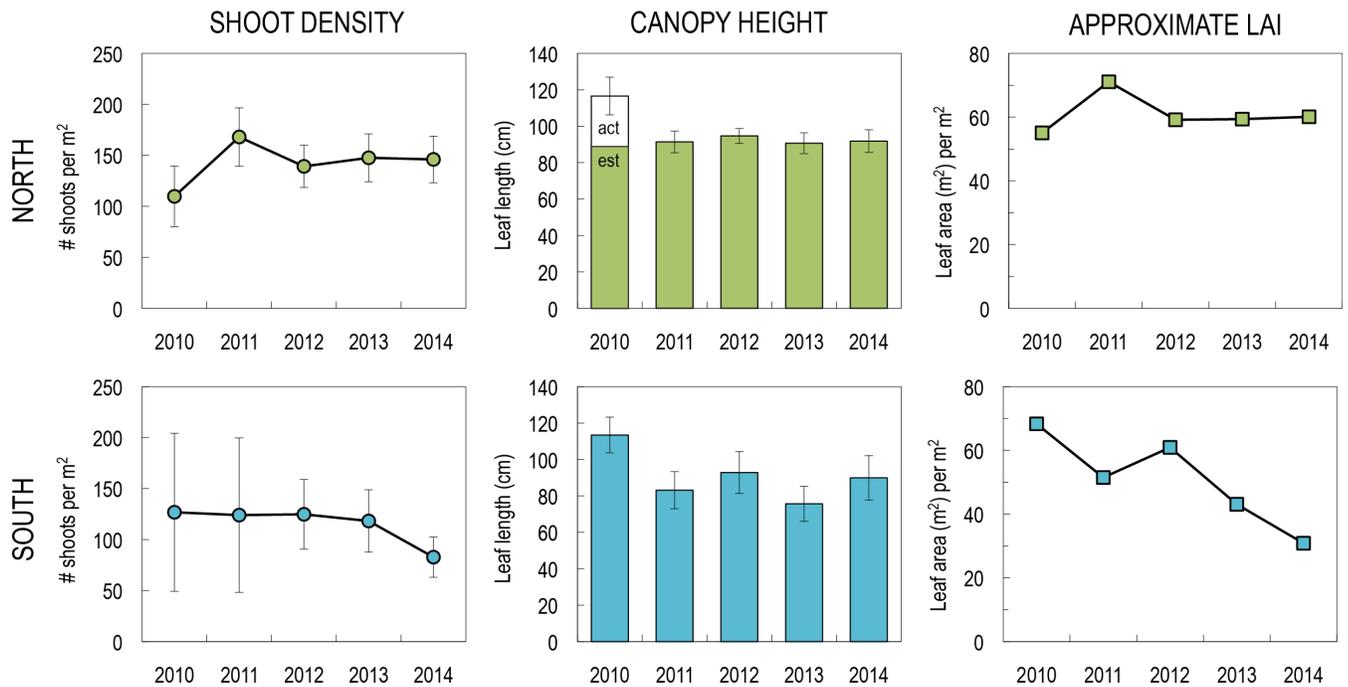
Figure 4. Graphs showing year-to-year changes in mean shoot density, canopy height (leaf length), and the approximate leaf area index (LAI) at Luhr N (top row) and Luhr S (bottom row). Error bars show the ± 95 percent confidence interval (CI); $n=10$ except for Luhr N in 2012 ($n=11$) and Luhr S in 2013 ($n=9$). [#, number; m^2 , square meter; cm, centimeter; act, actual value; est, estimated value.]

Between May 2010 and 2014, mean eelgrass shoot densities at Luhr N increased from 110 to 146 shoots per m^2 , but this change was not statistically different at the 95 percent confidence level (fig. 4). The mean increase did not appear to be related to the lower tidal depth at which the shoots were

counted in 2010 because shoot densities were no different at this depth than at the depth of the 2011–14 shoot counts (appendix 3). Canopy heights of eelgrass measured in May 2010 were not directly comparable to those in subsequent years because there was a tidal depth dependent variation of leaf length (appendix 3). Measurements in the cross-shore direction showed that eelgrass canopy heights were up to 24 percent higher at the tidal depth of the 2010 measurements than at the tidal depth of the 2011–14 measurements. If the mean canopy height measured in 2010, 117 ± 10 cm (95 percent confidence interval [CI], $n=10$), were reduced by 24 percent to 89 cm to allow comparison with 2011–14 data, then there did not appear to be any change in mean canopy heights at the 95 percent confidence level between 2010 and 2014 at Luhr N (fig. 4). Mean leaf widths did not change from 2010 to 2014 (not shown), and as a result, there was a very small but not statistically significant increase in available eelgrass leaf area from 55 to 60 m^2 of leaf per m^2 of seabed at Luhr N (fig. 4).

At Luhr S, there was a 20 percent decrease in mean canopy height and a 35 percent decrease in mean shoot density between 2010 and 2014 (fig. 4). This resulted in a large decrease in eelgrass leaf area between 2010 and 2014. The large 95 percent CIs of mean shoot densities at Luhr S reflected the presence of bare or sparsely vegetated patches in the eelgrass bed. The narrowing of CIs over 5 years (fig. 4) reflects infilling of bare or sparsely vegetated patches, resulting in more uniform shoot densities across the bed.

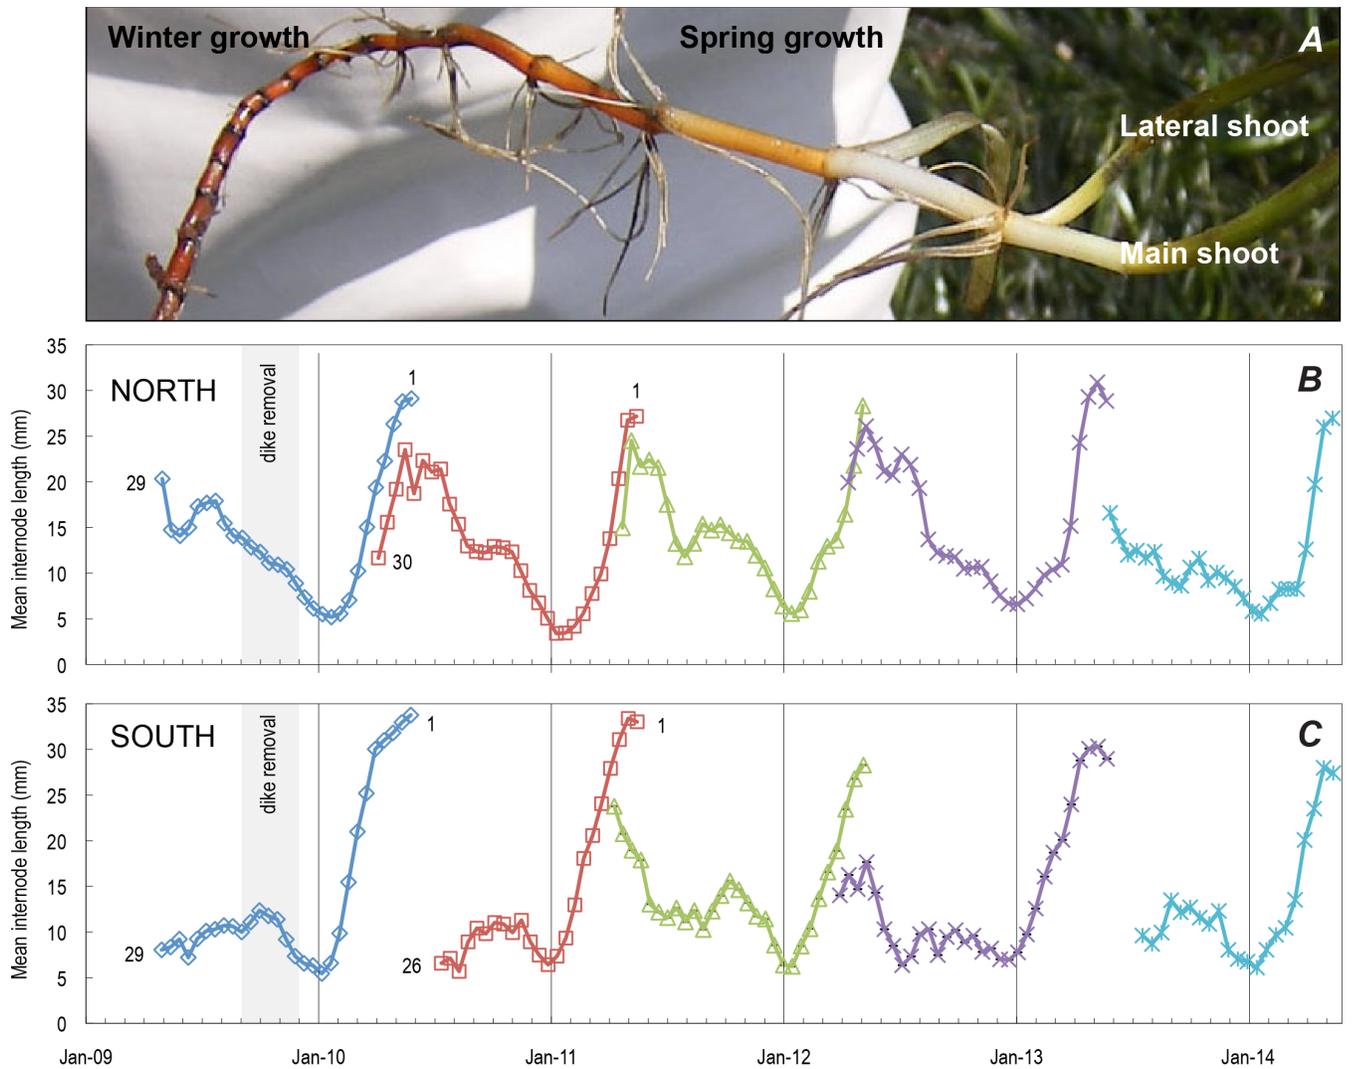
Figure 5. Eelgrass rhizomes from Luhr Beach. A, Photograph of eelgrass rhizome with segmented growth; B, mean rhizome internode lengths (in millimeters) of plants collected annually at Luhr N; and C, mean rhizome internode lengths (in millimeters) of plants collected annually at Luhr S. Colors vary with the year that rhizomes were collected. Numbers, shown for rhizomes collected in May 2010 (blue) and May 2011 (red), indicate the internode number starting with the most recently formed internode. For internodes 1–11, $n=10$ except for Luhr N in 2012 ($n=11$) and Luhr S in 2013 ($n=9$). For internodes 12 and higher, $2 \leq n \leq 10$. The shaded region shows the period when dike removal occurred.

Z. marina rhizomes are multisegmented and laterally branching (fig. 5A). The beginning and end of a rhizome segment is marked by a node that forms when a new leaf emerges (Phillips, 1984). The distance between two rhizome nodes is referred to as the internode length. Nodes and leaves of *Z. marina* form approximately every 14 days in temperate latitudes (Phillips, 1984; Lee and others, 2006), and the internode length can vary with the season (Phillips, 1972). In winter, when irradiance and the length of the photoperiod decreased, rhizome internode lengths of Nisqually eelgrass were short (December/January minima, fig. 5B, C). In spring, when light was more plentiful, internode lengths increased and peaked in May of each year (fig. 5B, C).

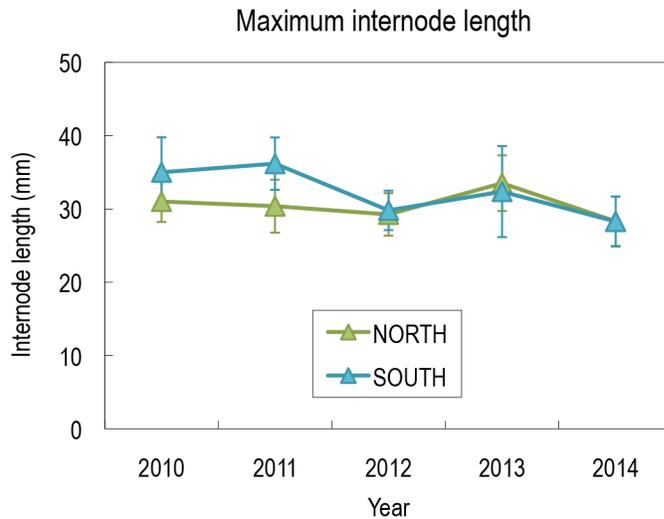
Figure 6. Graph showing year-to-year changes in the mean maximum rhizome internode lengths (in millimeters [mm]) at Luhr N and Luhr S. Error bars show ± 95 percent confidence interval (CI); $n=10$ except for Luhr N in 2012 ($n=11$), Luhr S in 2013 ($n=9$).

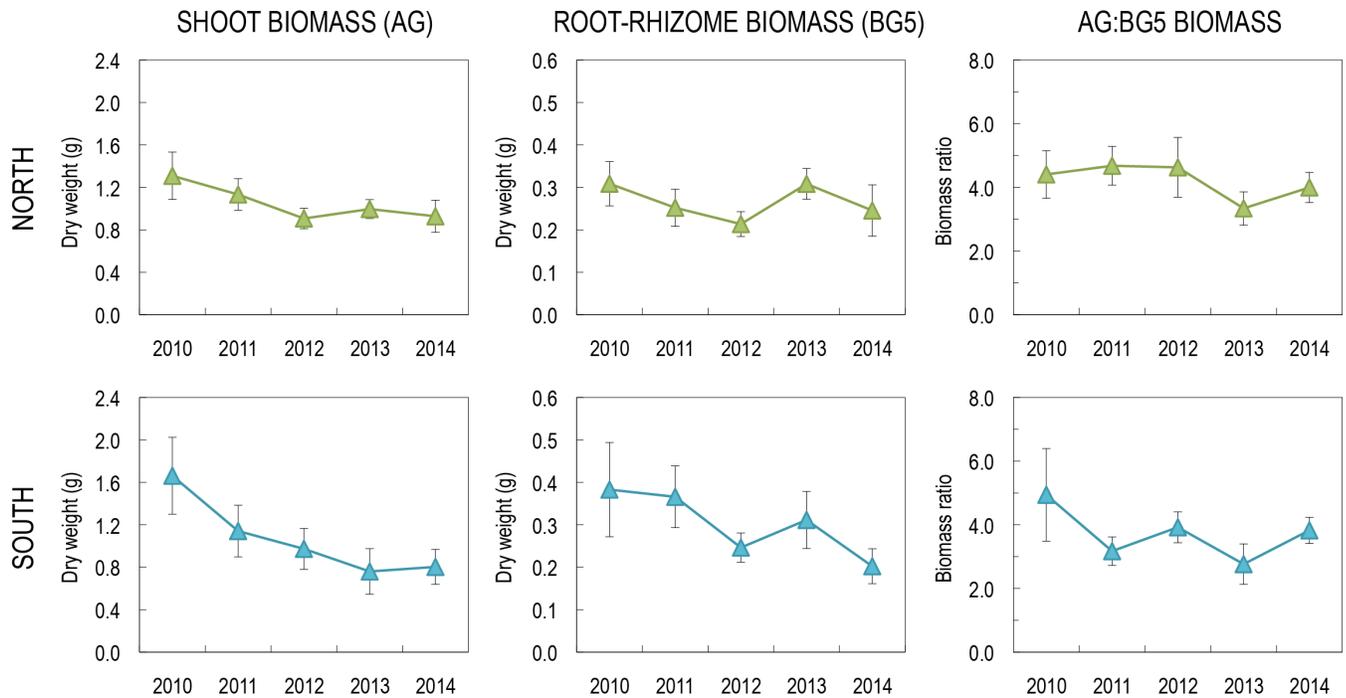
Figure 7. Graphs showing year-to-year changes in mean dry biomass (in grams [g]) of shoots (AG), roots plus five rhizomes (BG5), and the AG:BG5 ratio at Luhr N (top row) and Luhr S (bottom row). Error bars show the ± 95 percent confidence interval (CI); $n=10$ except for Luhr N in 2012 ($n=11$), Luhr S in 2013 ($n=9$).

Mean biomass of eelgrass shoots (AG) and roots plus five rhizome internodes (BG5) at Luhr N both initially decreased for 3 years following dike removal, and these decreases were proportionate, resulting in little change in the AG:BG5 ratio from 2010 to 2012 (fig. 7). Mean AG biomass at Luhr N did not change in 2013 and 2014, while BG5 biomass increased, resulting in lower mean AG:BG5 ratios in 2013 and 2014 (fig. 7). At Luhr S, mean AG biomass decreased for 4 years following dike removal, while overall mean BG5 biomass decreased over 5 years, with the exception of a one-time increase in 2013 (fig. 7). Compared to May 2010, the mean AG:BG5 ratio of Luhr S eelgrass was 21 to 44 percent lower in the subsequent 4 years, but this difference fell within the 95 percent CI of the 2010 mean because of the large variability that year. Mean AG:BG5 ratios were much greater than the critical value of 2:1 for *Z. marina* (Hemminga, 1998) in all years at both sites. When AG:BG ratios are less than 2:1, the respiratory carbon demand of the plant can exceed the photosynthetic carbon production, resulting in a carbon deficit that can negatively impact plant growth (Hemminga, 1998).

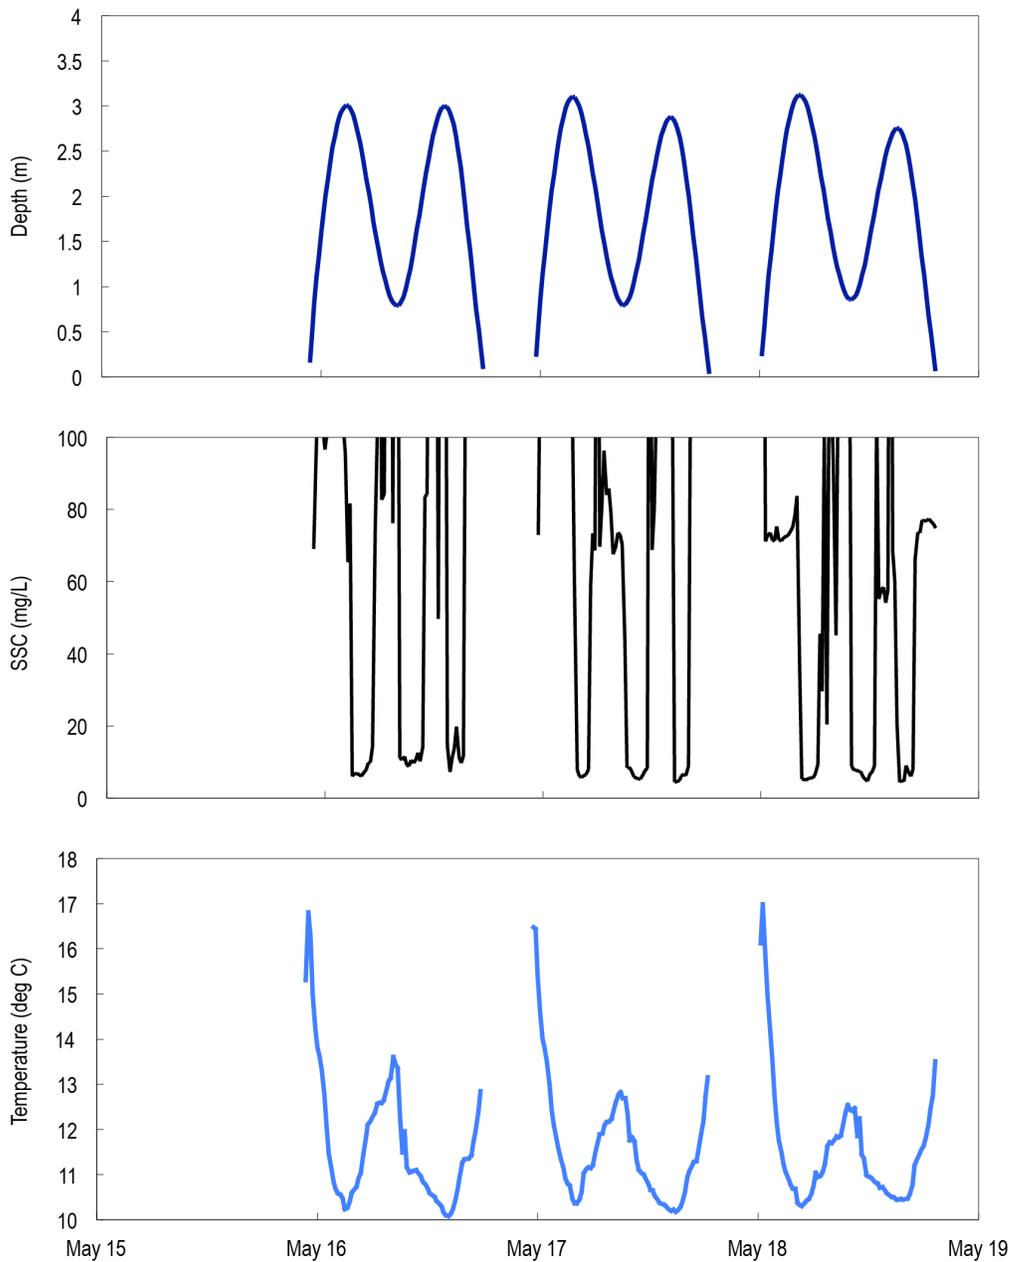
Appendix 2. Example of Sensor Data

Graphs show time series of water depth (top), 2-minute averages of suspended sediment concentration (SSC, middle), and 2-minute averages of water temperature (bottom) at Luhr N during May 2014. The high and variable SSC values likely reflect biofouling by macroalgae.

When the turbidity sensors (SLOBS) were recovered after deployment, they were found to be fouled by drifting macroalgae (*Ulva* species) that interfered with backscatter measurements and produced erroneously high readings at one or both sites during each deployment (see appendix 2). In 2011–14, macroalgae was manually removed from the SLOBS during each morning or early afternoon low tide of the 4–5 day deployment to allow an accurate backscatter measurement on the following flood tide. It may be possible to estimate minimum turbidity levels over the Luhr N and Luhr S eelgrass beds; however, high, rather than low, turbidity levels would be more likely to impact eelgrass growth.

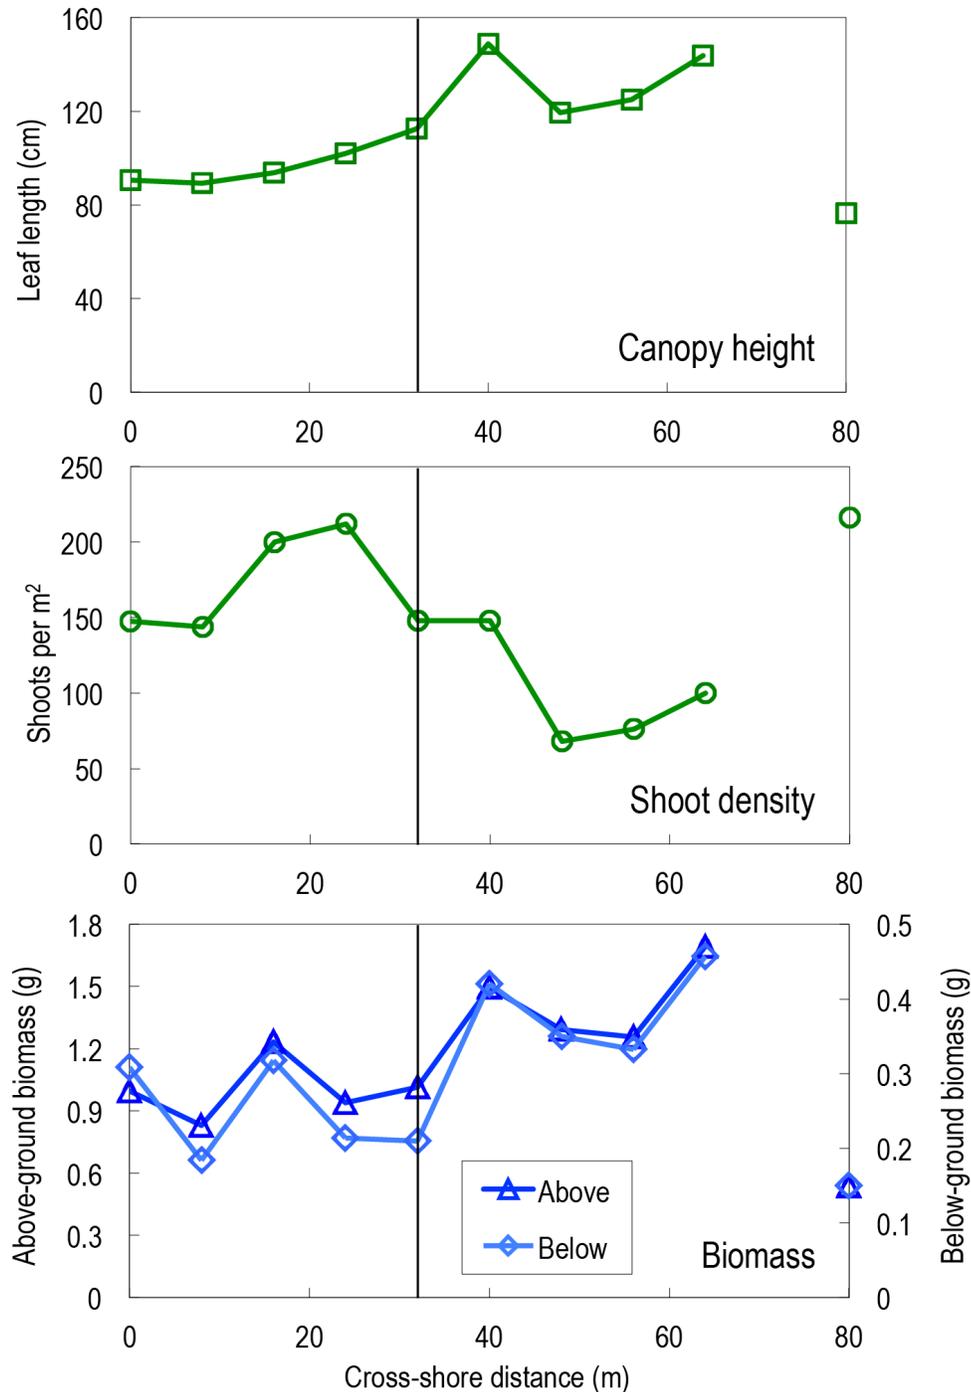
Appendix 3. Cross-Shore *Z. marina* Characteristics

Graphs show eelgrass characteristics along a cross-shore depth transect at Luhr N in May 2013 (fig. 1D). Data points represent single measurements (n=1). Vertical lines show where the 2010 alongshore transect intersected the cross-shore transect (fig. 1D). The cross-shore transect started (0 m mark) on the 2011–14 alongshore transect line and extended 80 m across-shore (fig. 1D).
