Geophysical Logging and Thermal Imaging Near the Hemphill Road TCE National Priorities List Superfund Site Near Gastonia, North Carolina

Open-File Report 2017-1017

By Dominick J. Antolino and Melinda J. Chapman

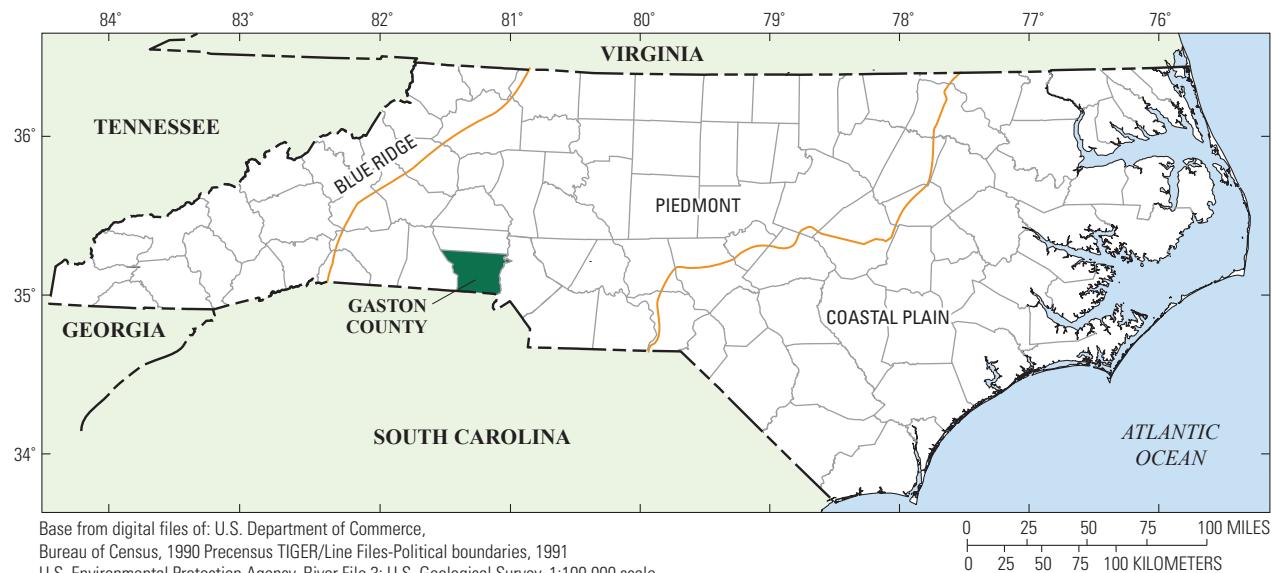
Figure 1. Physiographic provinces in North Carolina, and the Hemphill Road TCE National Priorities List Superfund site and associated local geologic units, Gaston County, North Carolina.

The purpose of this report is to present geophysical logging, geological mapping, and thermal imaging data collected near the Hemphill Road TCE NPL Superfund site near Gastonia, N.C. (fig. 1). Borehole geophysical logs and surface geological mapping methods were used to characterize subsurface and surface features in the fractured bedrock and overlying regolith near the Hemphill Road TCE NPL Superfund Site. Geologic mapping was

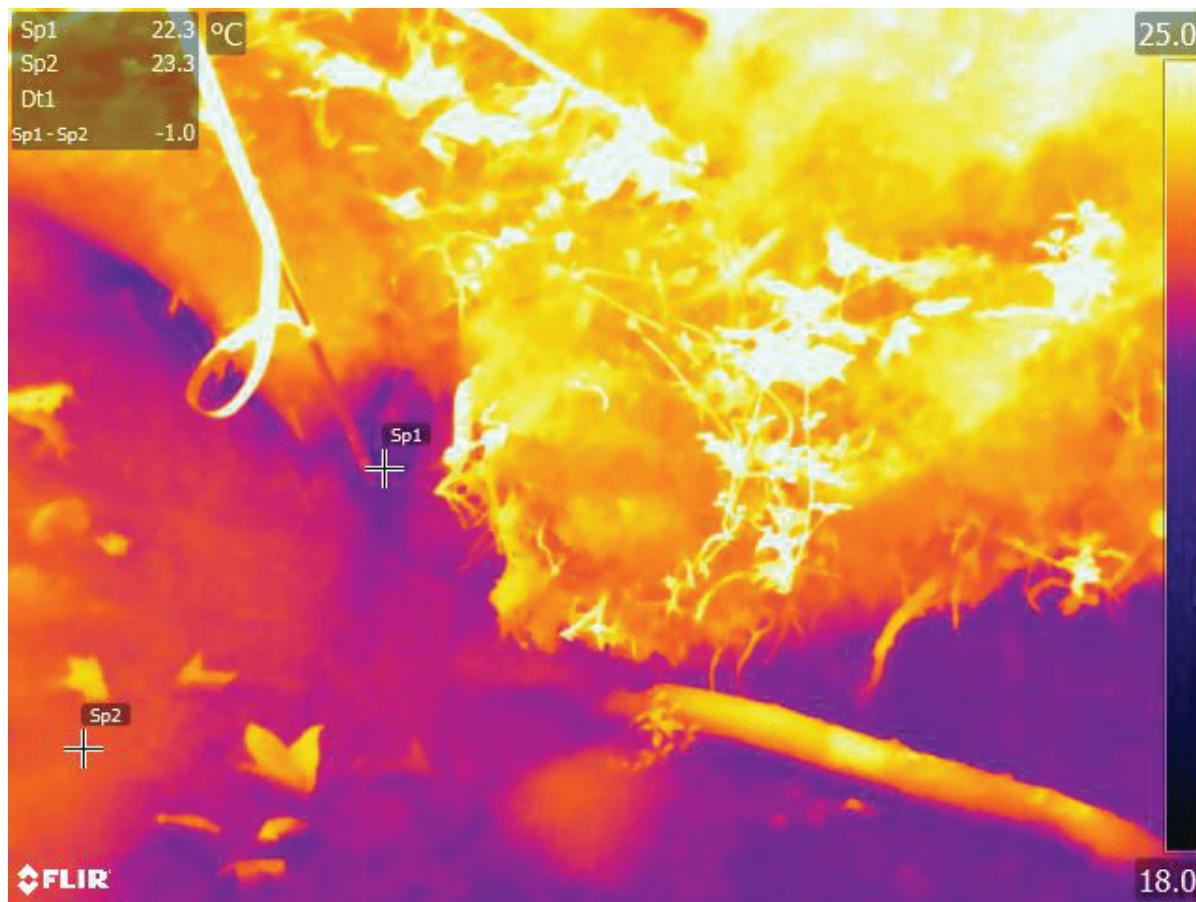
Figure 3-6. Infrared images captured by FLIR camera at site FS-06 to measure stream surface and bank seepage temperature differences in August/September 2014 near the Hemphill Road TCE National Priorities List Superfund site, Gastonia, Gaston County, North Carolina FS-01 to measure stream surface and bank seepage temperature differences in August/September 2014 near the Hemphill Road TCE National Priorities List Superfund site, Gastonia, Gaston County, North Carolina.

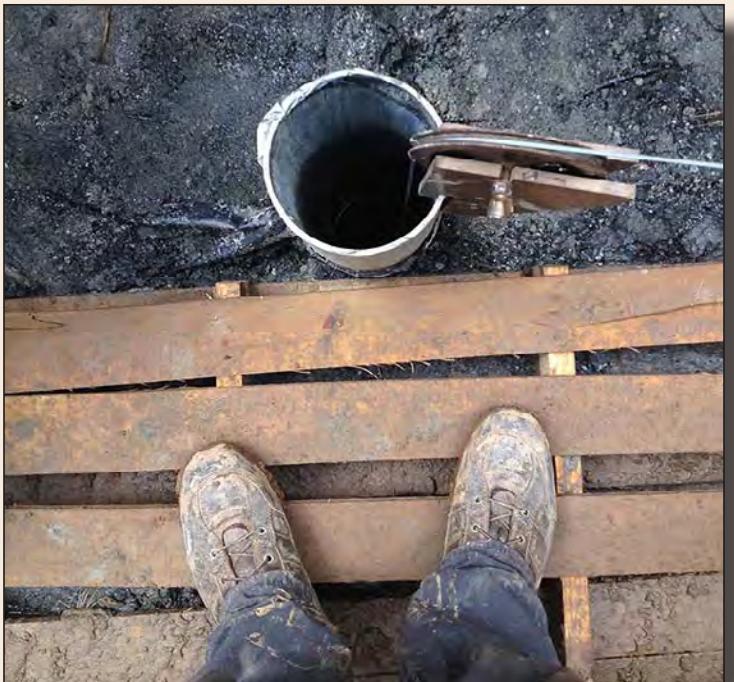
Back cover. Photograph showing deployment of borehole geophysical logging tool in well GS-293 near Gastonia, North Carolina (September 2014). Photograph by Dominick Antolino, USGS.
