# Summary of Oceanographic and Water-Quality Measurements in Chincoteague Bay, Maryland and Virginia, 2014–15

Open-File Report 2017–1032

U.S. Department of the Interior  
U.S. Geological Survey

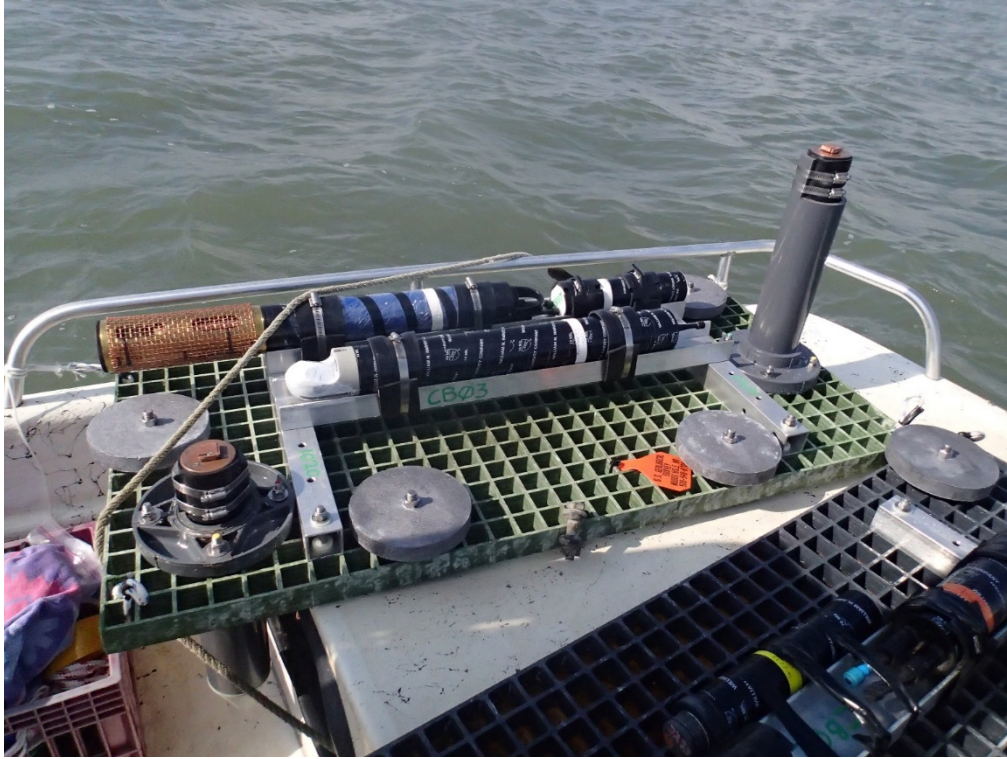
**Figure 4.** Photograph showing shallow water irradiance platform ready for initial deployment at mooring 1020 (CB03) on August 13, 2014. Instruments: ECO-PARSB light sensors (mounted vertically), Aquadopp high-resolution pulse coherent acoustic Doppler current profiler (center), EXO2 multi-parameter sonde (copper mesh guard), and D|wave pressure logger (mounted opposite to EXO2).

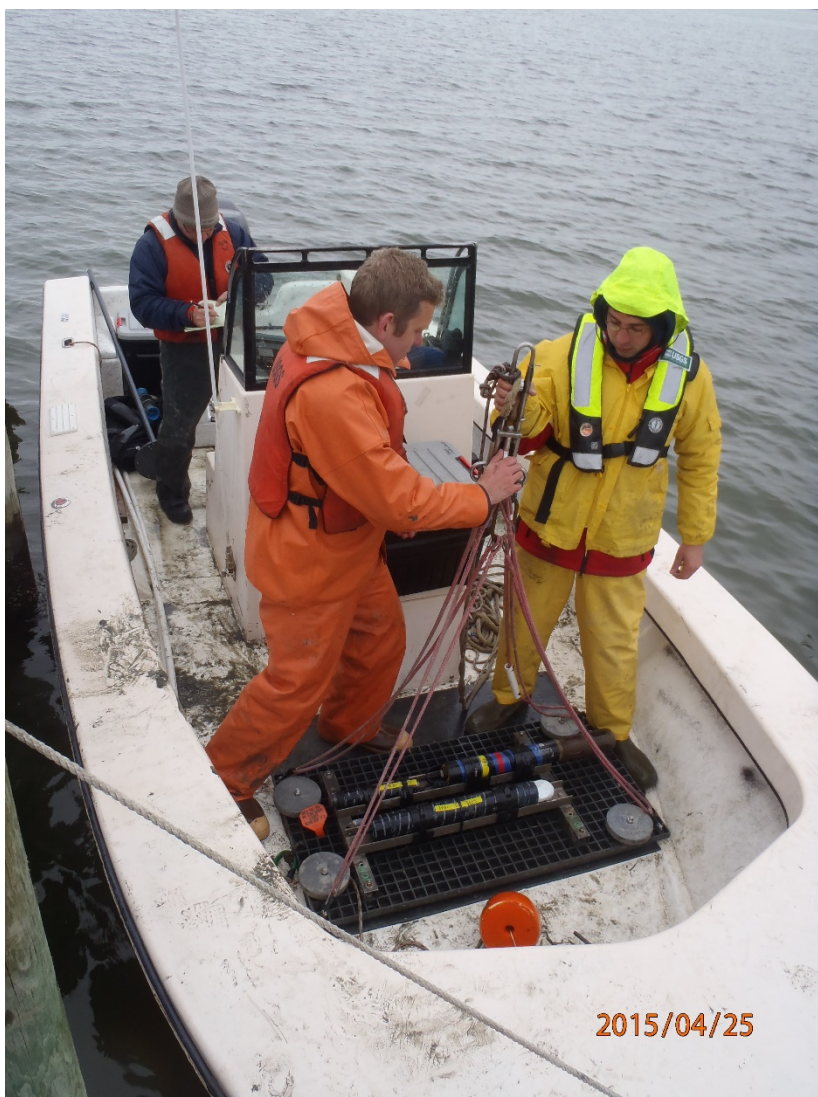
**Figure 5.** Photograph showing U.S. Geological Survey personnel preparing release bridle on bottom platform for deployment at mooring 1019 (CB02) on April 25, 2015.

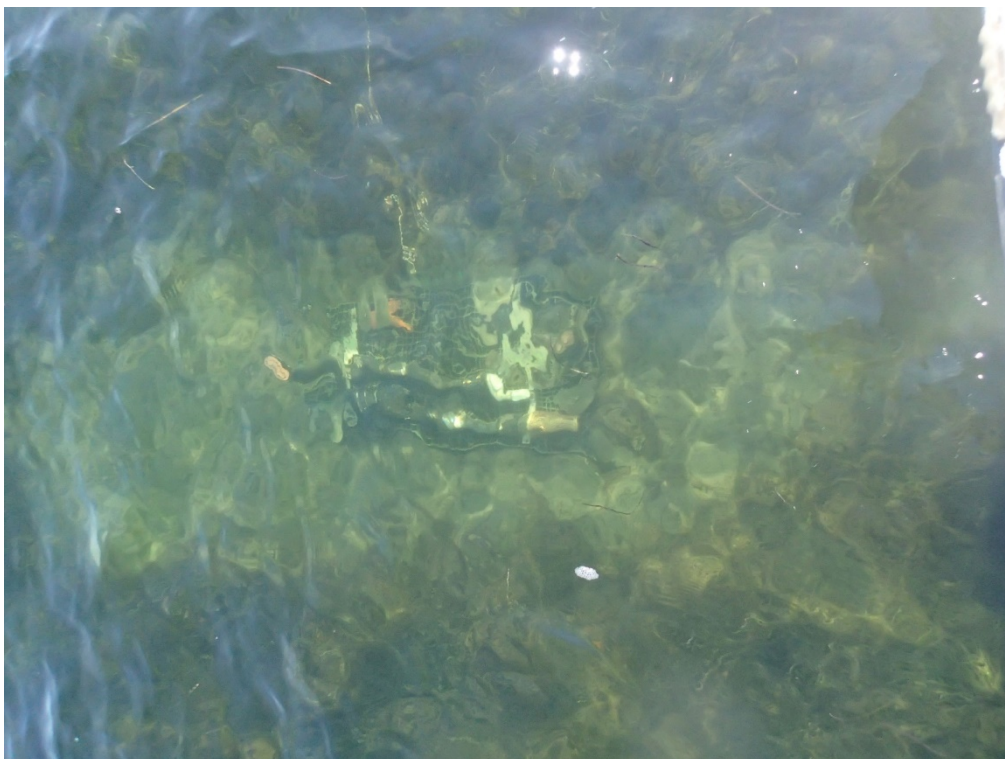
**Figure 6.** Photograph showing shallow water irradiance platform deployed in bare patch of a dense seagrass bed at mooring 1020 (CB03) on August 13, 2014. Water depth at the time of deployment was approximately 1.5 meters.

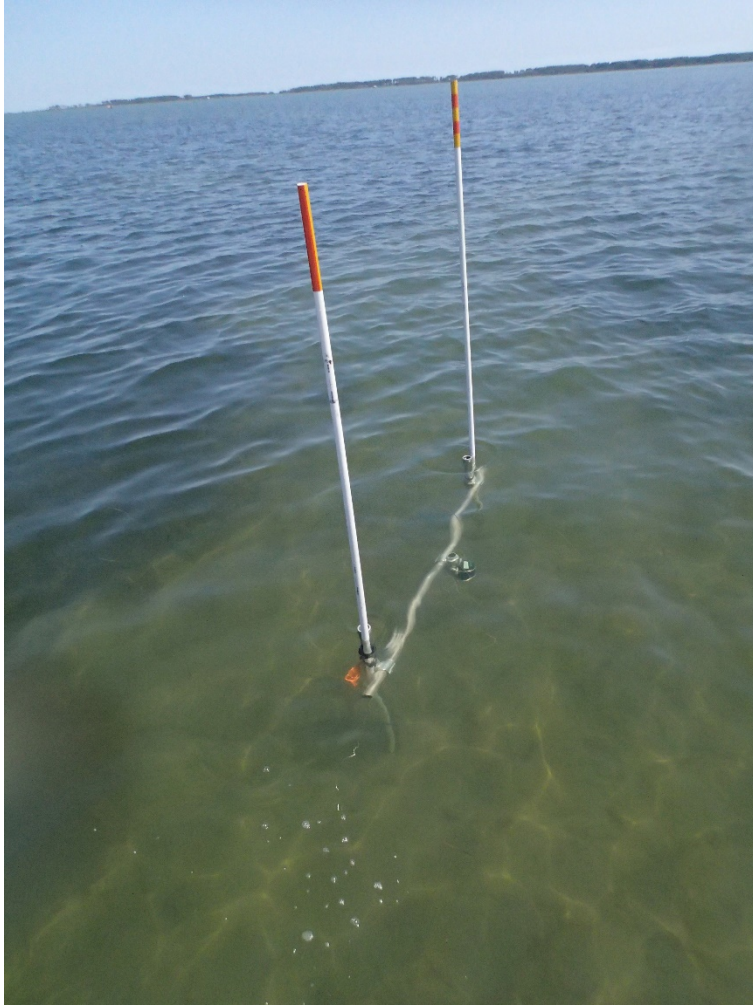
**Figure 8.** Photograph showing deployment of installed seabed altimeter at mooring 1021 (CB04) on August 15, 2014. An Echologger AA400 altimeter is mounted in the center of the aluminum H-frame cross bar with the transducer pointing straight down toward the seabed, which is nominally 0.50 meter below the altimeter transducer.

instruments were securely mounted to an aluminum H-Frame (fig. 8), nominally 0.5 meter above the seabed. The manufacturer uses a fixed speed of sound of 1,500 meters per second (m/s) to calculate distance to the seabed.

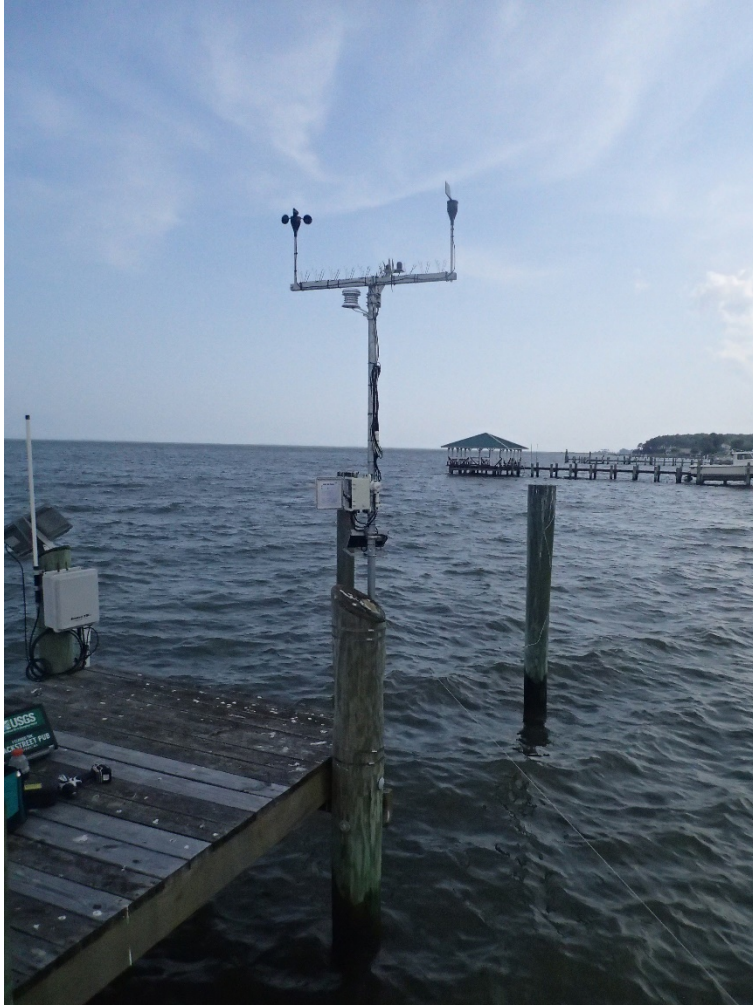
**Figure 9.** Photograph showing Onset Hobo U30 weather station on private dock at Public Landing, Maryland, mooring 1031 (CBWS), just after installation on August 16, 2014. The weather station measured wind speed and direction, air temperature, relative humidity, barometric pressure, photosynthetically active radiation, and shortwave irradiance.

An Onset Hobo U30 weather station (fig. 9) provided local meteorological conditions during the study period (see previous bulleted list for measured parameters). The Hobo U30 is equipped with a solar panel and rechargeable battery such that changing batteries is not routinely required at servicing turnarounds between deployment segments. For additional information on all instruments used, please consult the manufacturers' Web sites.

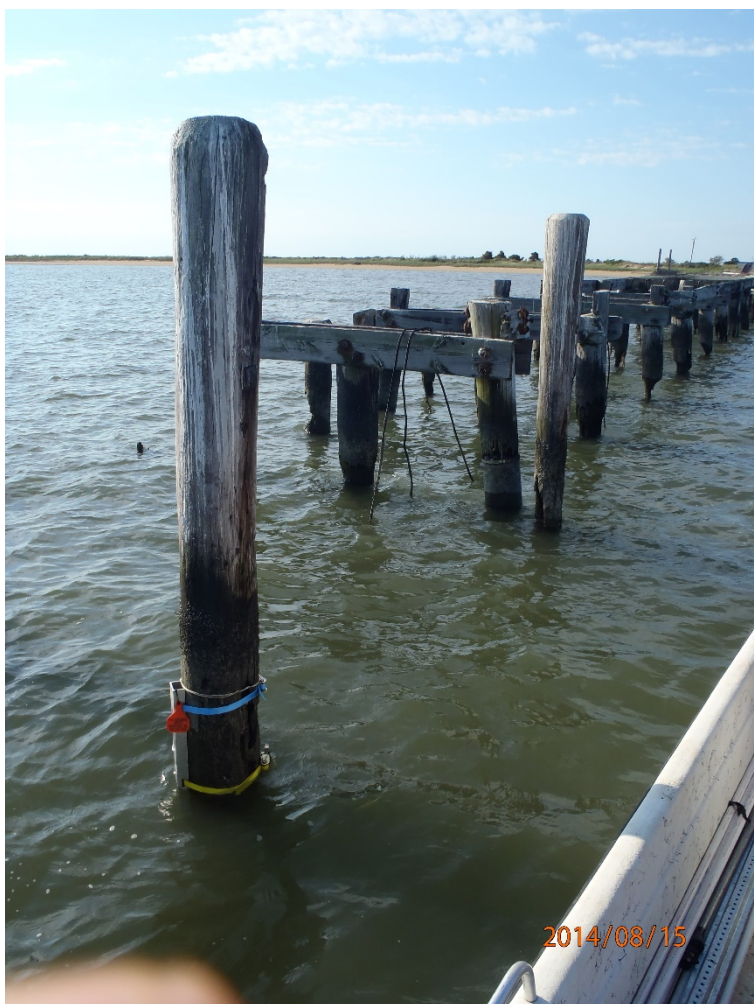
**Figure 10.** Photograph showing Mooring 1018 (CB01) mounted to an old Coast Guard station piling at Toms Cove near Chincoteague Inlet on August 15, 2014. A YSI 6600 multiparameter water-quality sonde is mounted to the aluminum channel, about 0.5 meter below the water level at time of the photograph.

Toms Cove (figs. 1 and 2) is as an area of special interest because of its location within the Chincoteague National Wildlife Refuge and is prone to overwash from the ocean during strong storms. Mooring 1018 (CB01) was located on a defunct Coast Guard station pier piling (fig. 10) in a small embayment east of Chincoteague Inlet at the end of Assateague Island on the Virginia coast. A YSI 6600 sonde was deployed at the Toms Cove site for the August 2014 to January 2015 period (A and B), but because of instrument failure the sonde had to be abandoned for the remainder of the study.

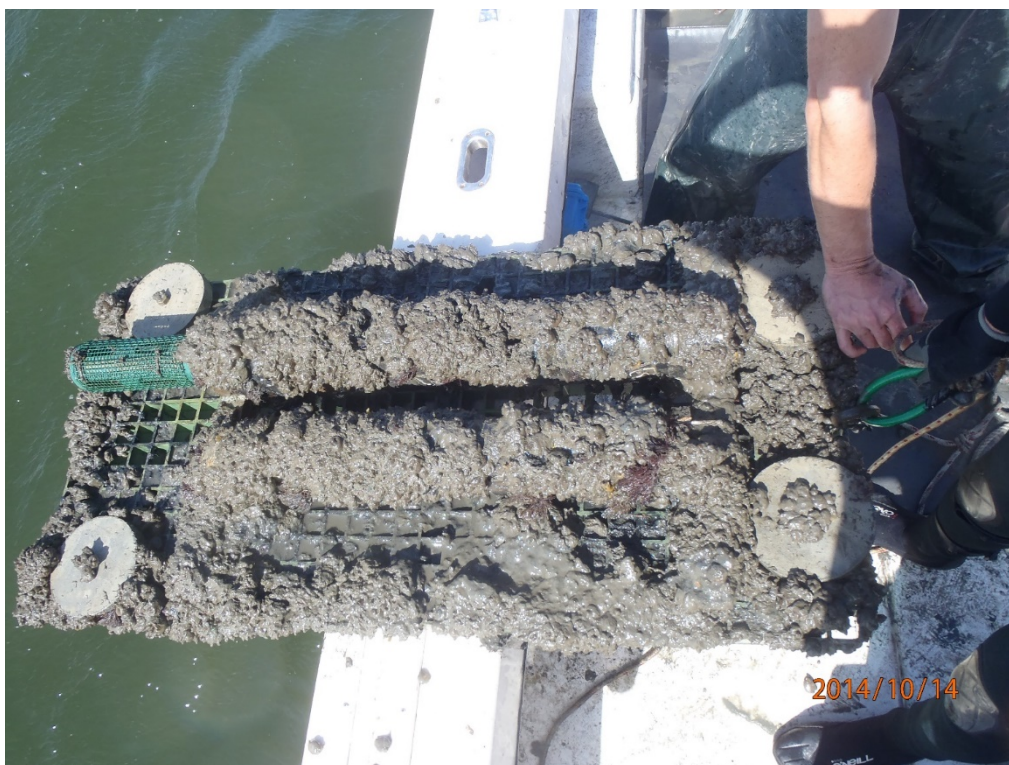
**Figure 11.** Photograph showing heavy biological and sediment fouling that occurred on a platform recovered at mooring 1029 (CB11) in Newport Bay on October 14, 2014. Copper mesh and guard kept the EXO2 sonde sampling chamber relatively clean. Despite the heavy fouling, the Aquadopp acoustic Doppler current profiler collected usable data for the entire deployment. The EXO2 sonde stopped working 11 days before recovery because of a power issue; however, it collected usable data until that time.

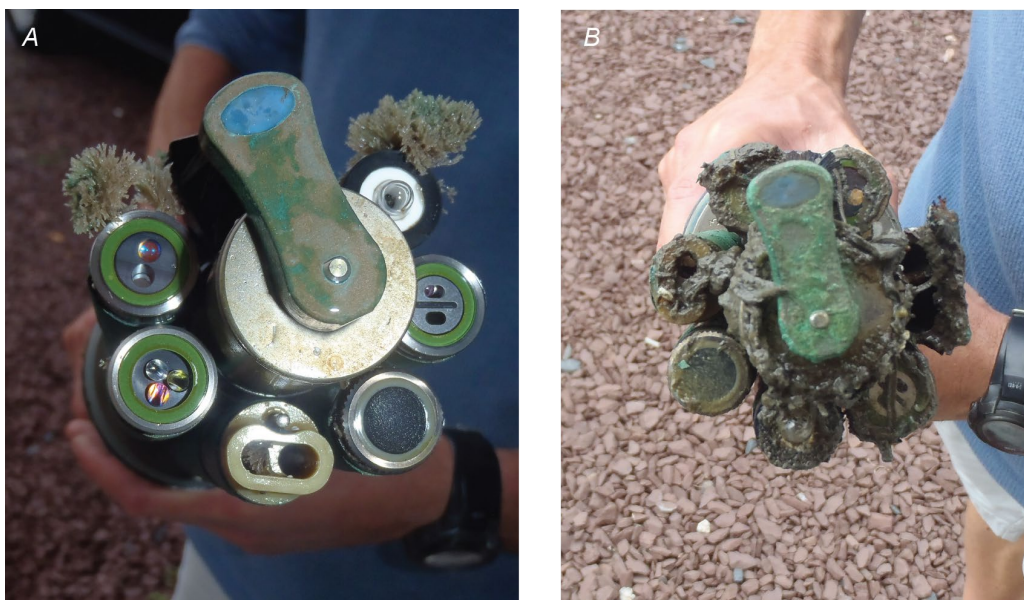
**Figure 12.** Photographs showing a comparison of fouling on EXO2 sensors from moorings *A*, 1028 and *B*, 1029 upon recovery in October 2014 during the first turnaround of the deployed instruments. Sensor faces are clean on the sensors from mooring 1028 (CB10) with the exception of some fouling on the conductivity cell (third sensor counterclockwise from left, approximately 6 o'clock) where the wiper was not effective. All sensors are heavily fouled from the EXO2 sonde at 1029 (CB11), where the sonde ran out of battery power 11 days prior to recovery, causing the wiper to no longer function.

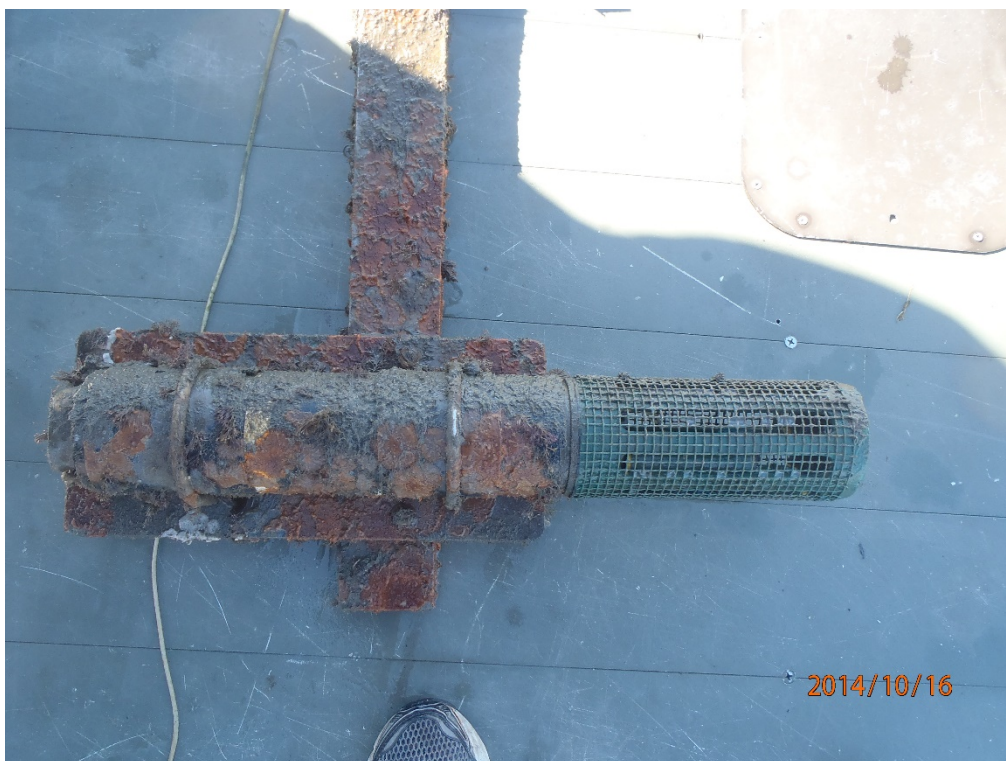
**Figure 14.** Photograph showing YSI 6600 sonde from mooring 1018 (CB01) just after recovery in October 2014. Some moderate biological fouling was present on the instrument body and mount, but the sampling chamber with copper mesh and copper-taped guard were clean.

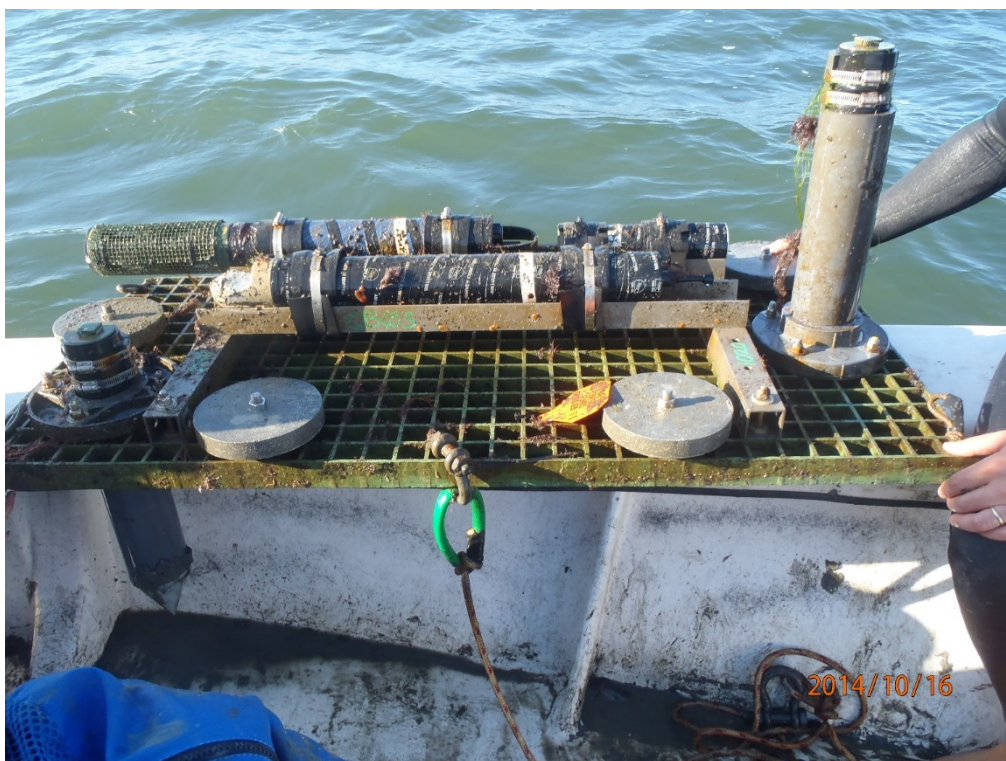
**Figure 15.** Photograph showing shallow water irradiance platform at mooring 1020 (CB03), a shoal site with dense seagrass coverage, just after recovery on October 16, 2014. Only light fouling was observed on this deployment; some seagrass is attached to the upper photosynthetically active radiation sensor.

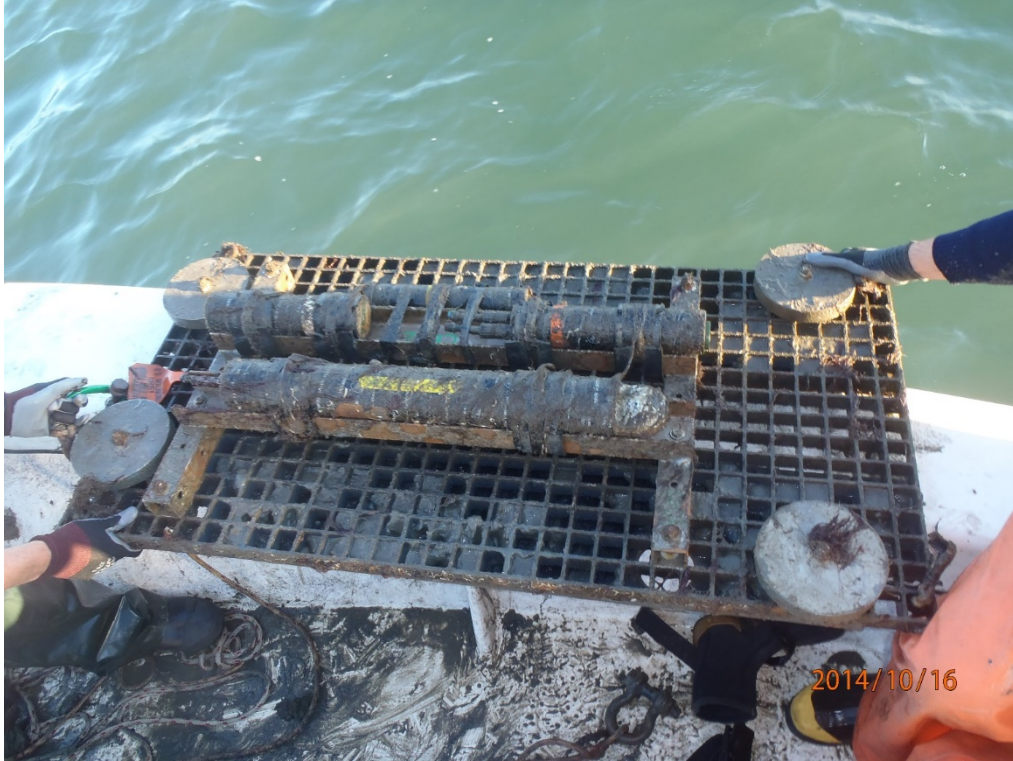
**Figure 16.** Photograph showing bottom platform at 1019 (CB02) upon recovery on October 16, 2014. Moderate sediment fouling was observed during this deployment.

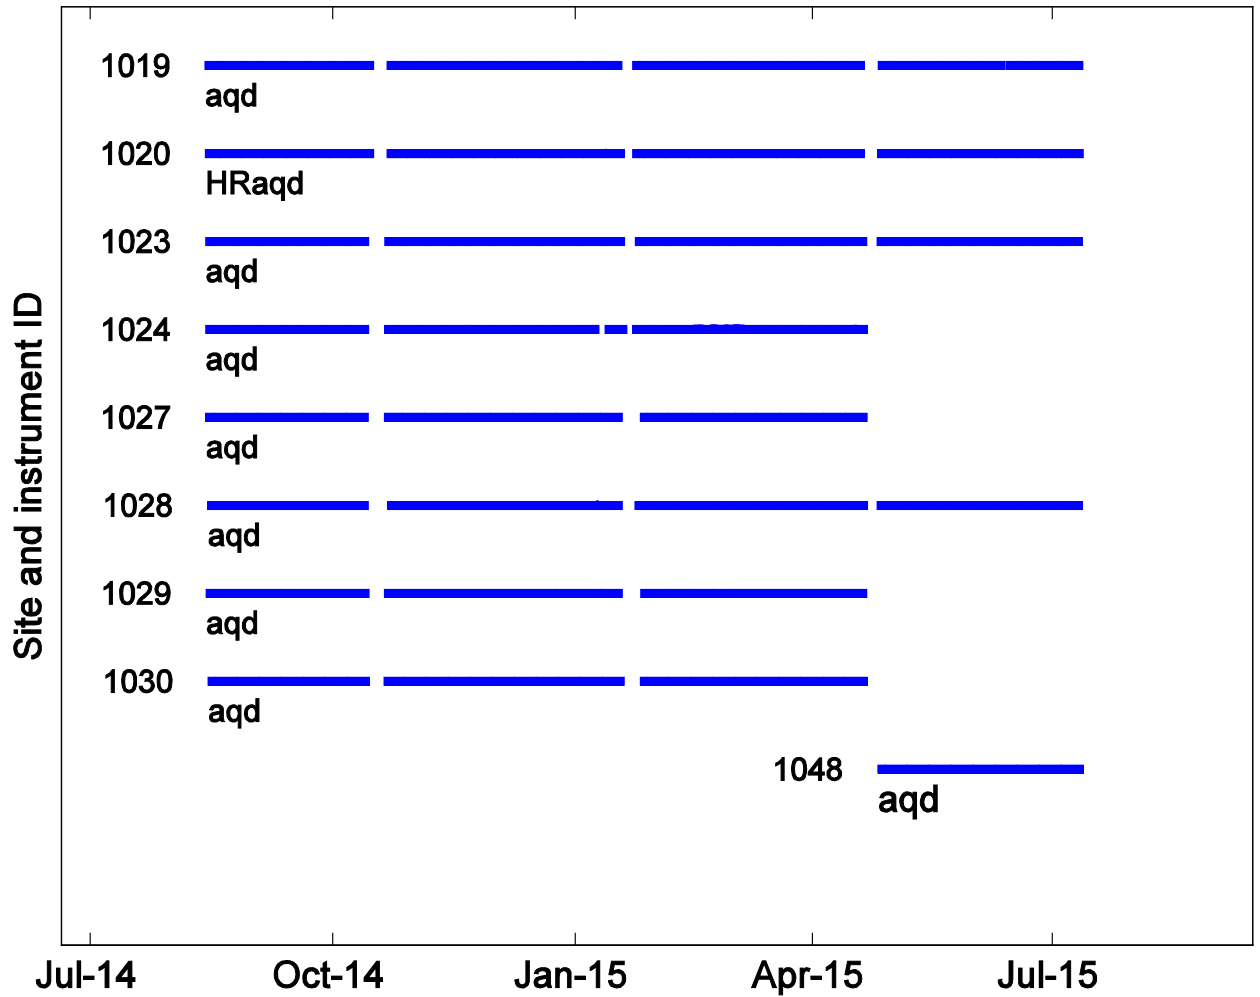
**Figure 17.** Chart showing the availability of current velocity data for Chincoteague Bay, Maryland and Virginia, for the Estuarine Physical Response to Storms study from August 2014 to July 2015. aqd, Nortek Aquadopp; HRaqd, Nortek Aquadopp high resolution; ID, identification number.

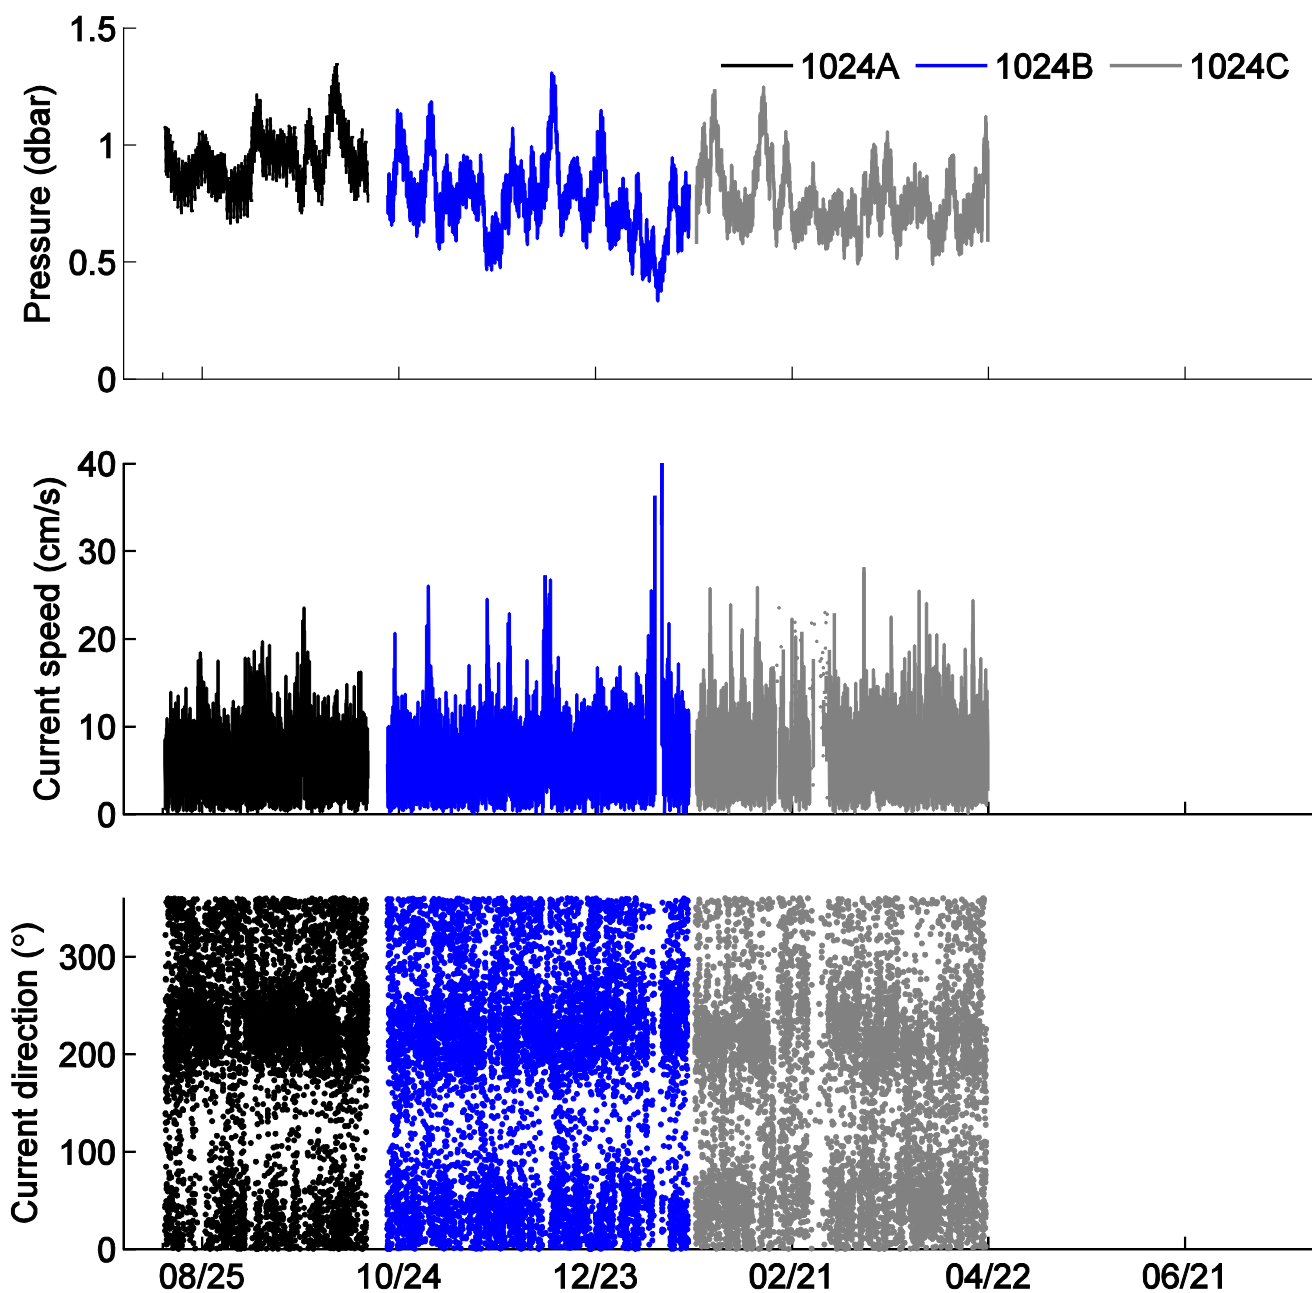
Figure 21. Graphs showing pressure (atmospherically corrected), current speed, and current direction (traveling towards convention) from 2-megahertz Aquadopp acoustic Doppler current profiler, bin 2, at mooring 1024 (CB07) from August 13, 2014, to April 21, 2015. dbar, decibar; cm/s, centimeter per second; °, degree true.

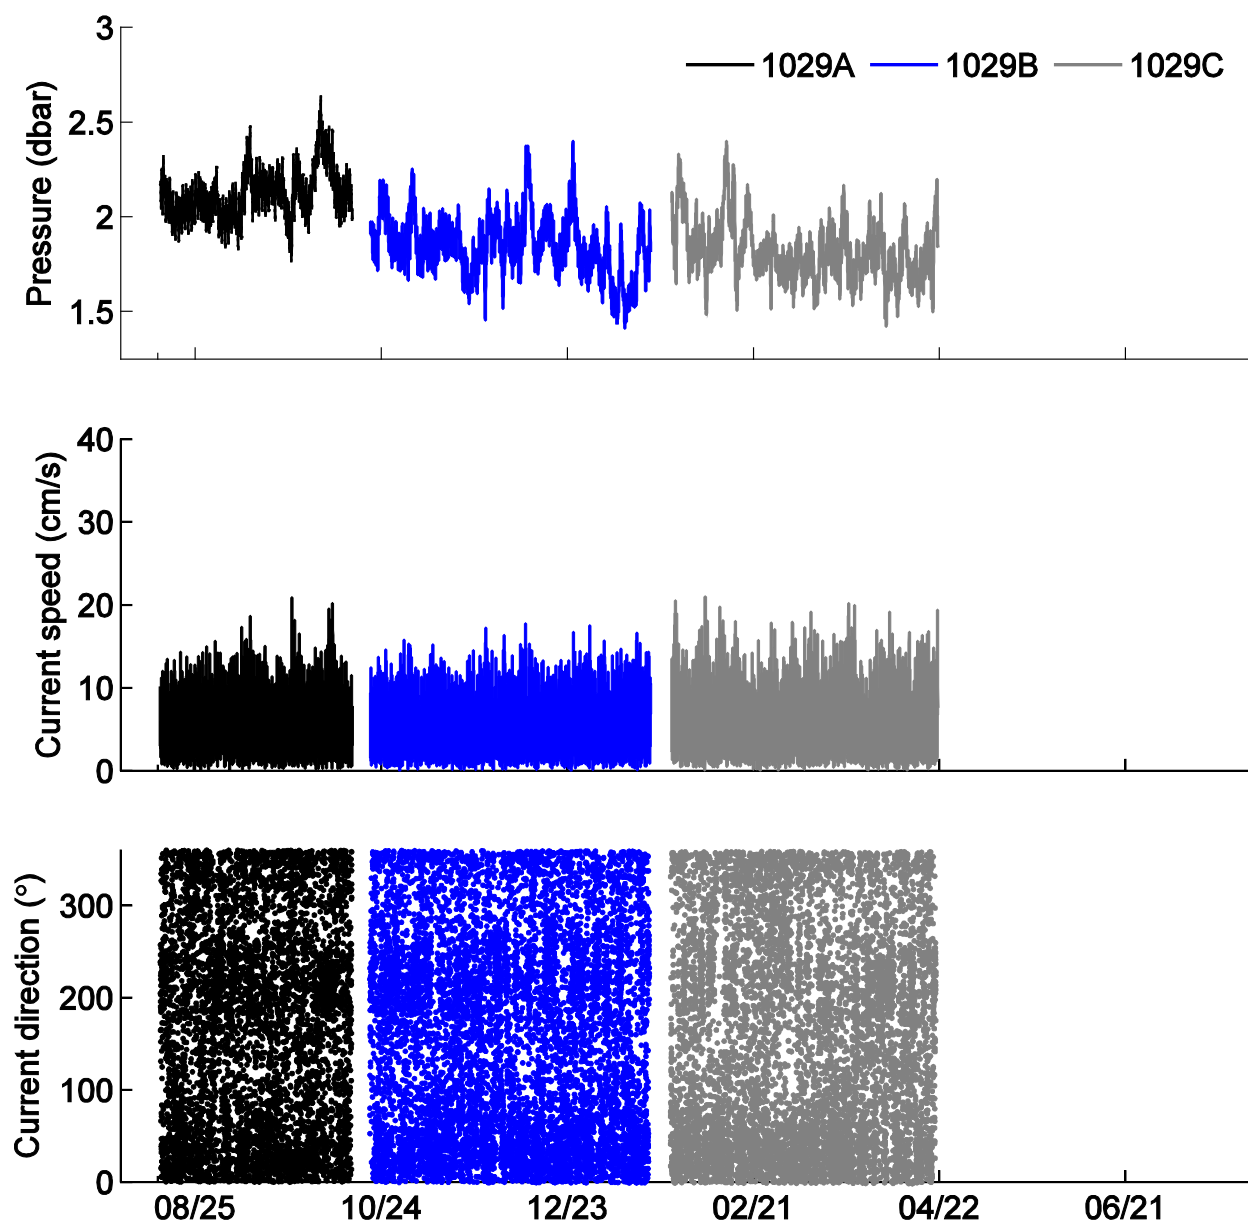
**Figure 24.** Graphs showing pressure (atmospherically corrected), current speed, and current direction (traveling towards convention) from 2-megahertz Aquadopp acoustic Doppler current profiler, bin 2, at mooring 1029 (CB11) from August 13, 2014, to April 21, 2015. dbar, decibar; cm/s, centimeter per second; °, degree true.

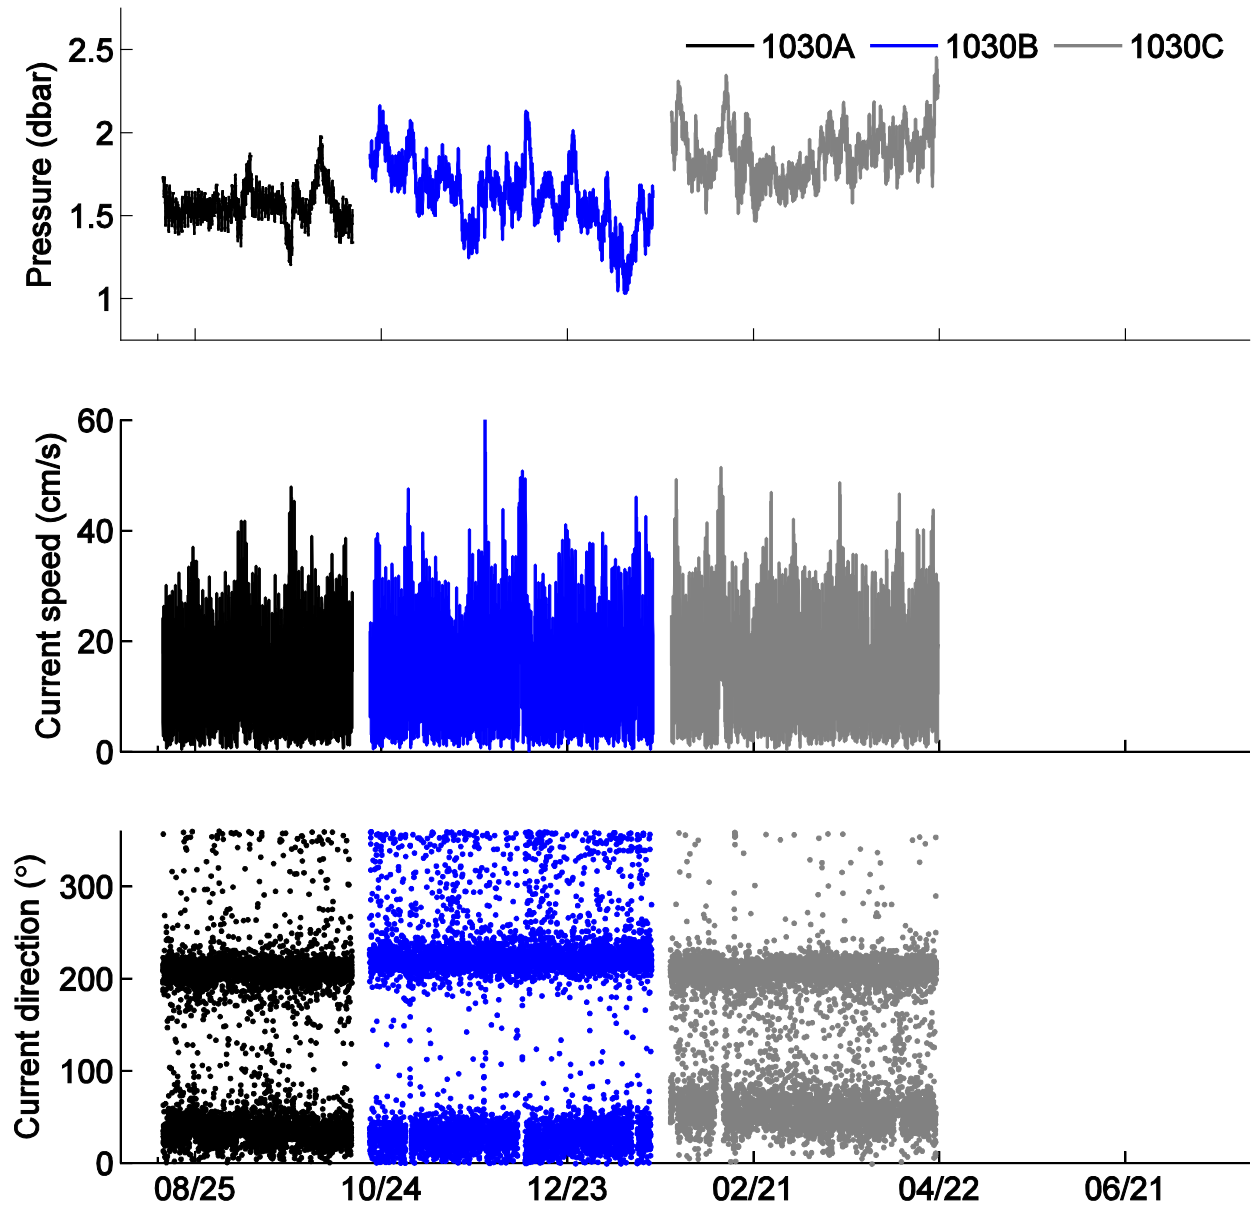
Figure 25. Graphs showing pressure (atmospherically corrected), current speed, and current direction (traveling towards convention) from 2-megahertz Aquadopp acoustic Doppler current profiler, bin 2, at mooring 1030 (CB12) from August 14, 2014, to April 21, 2015. dbar, decibar; cm/s, centimeter per second; °, degree true.

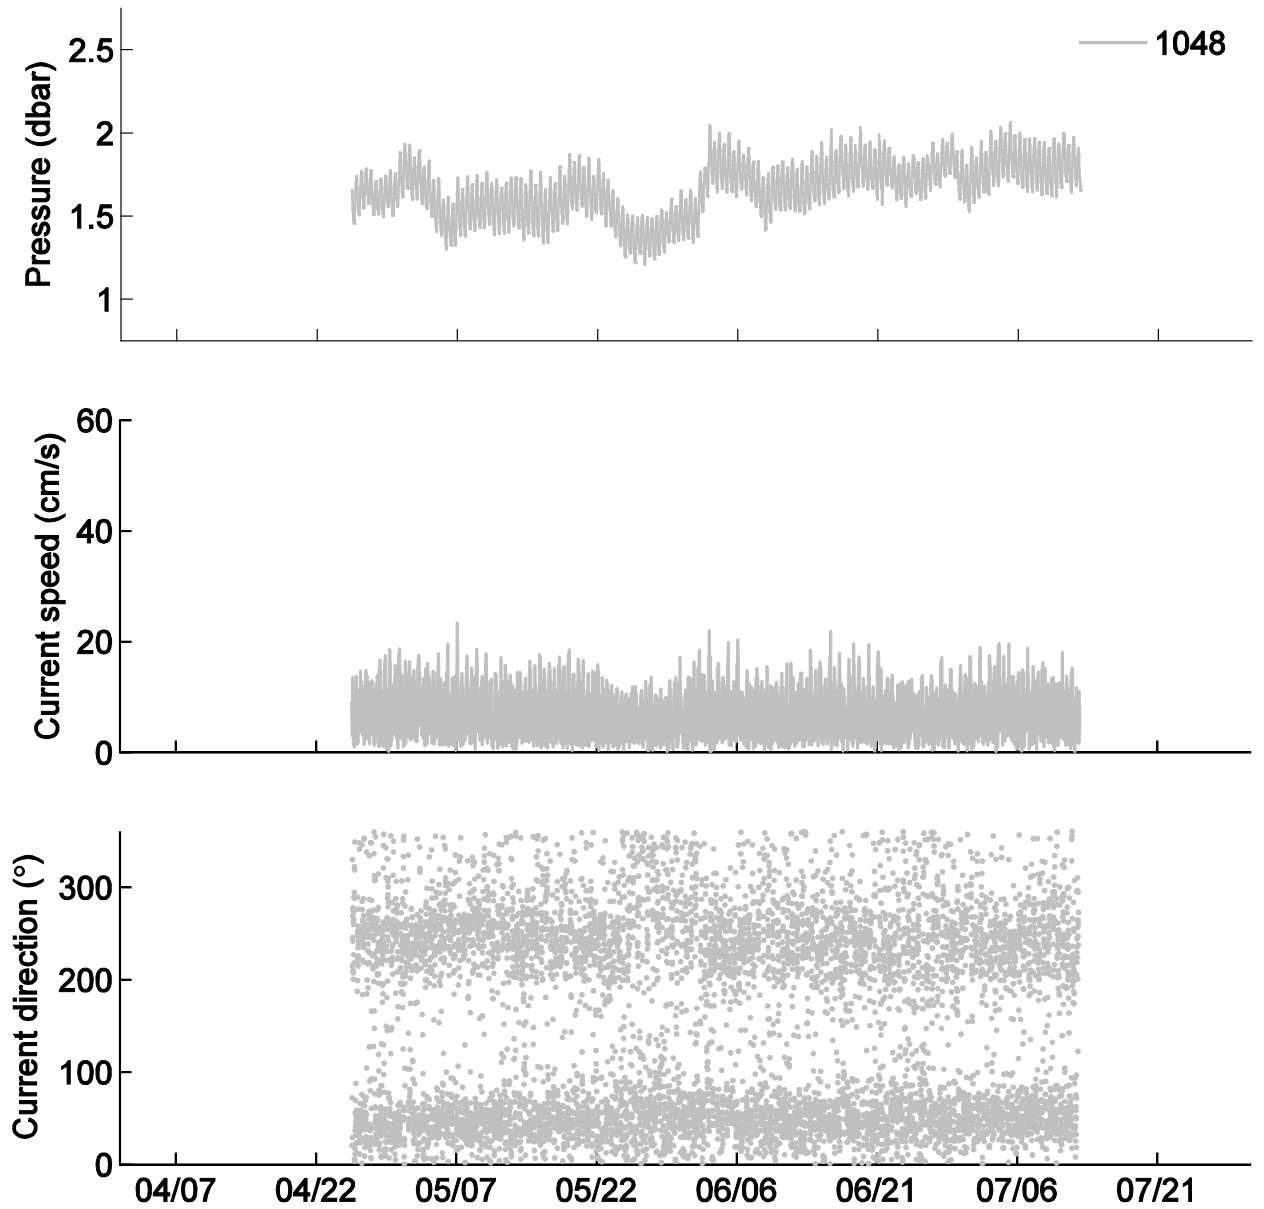
**Figure 26.** Graphs showing pressure (atmospherically corrected), current speed, and current direction (traveling towards convention) from 2-megahertz Aquadopd acoustic Doppler current profiler, bin 2, at mooring 1048 (V1) from April 25 to July 12, 2015. dbar, decibar; cm/s, centimeter per second; °, degree true.

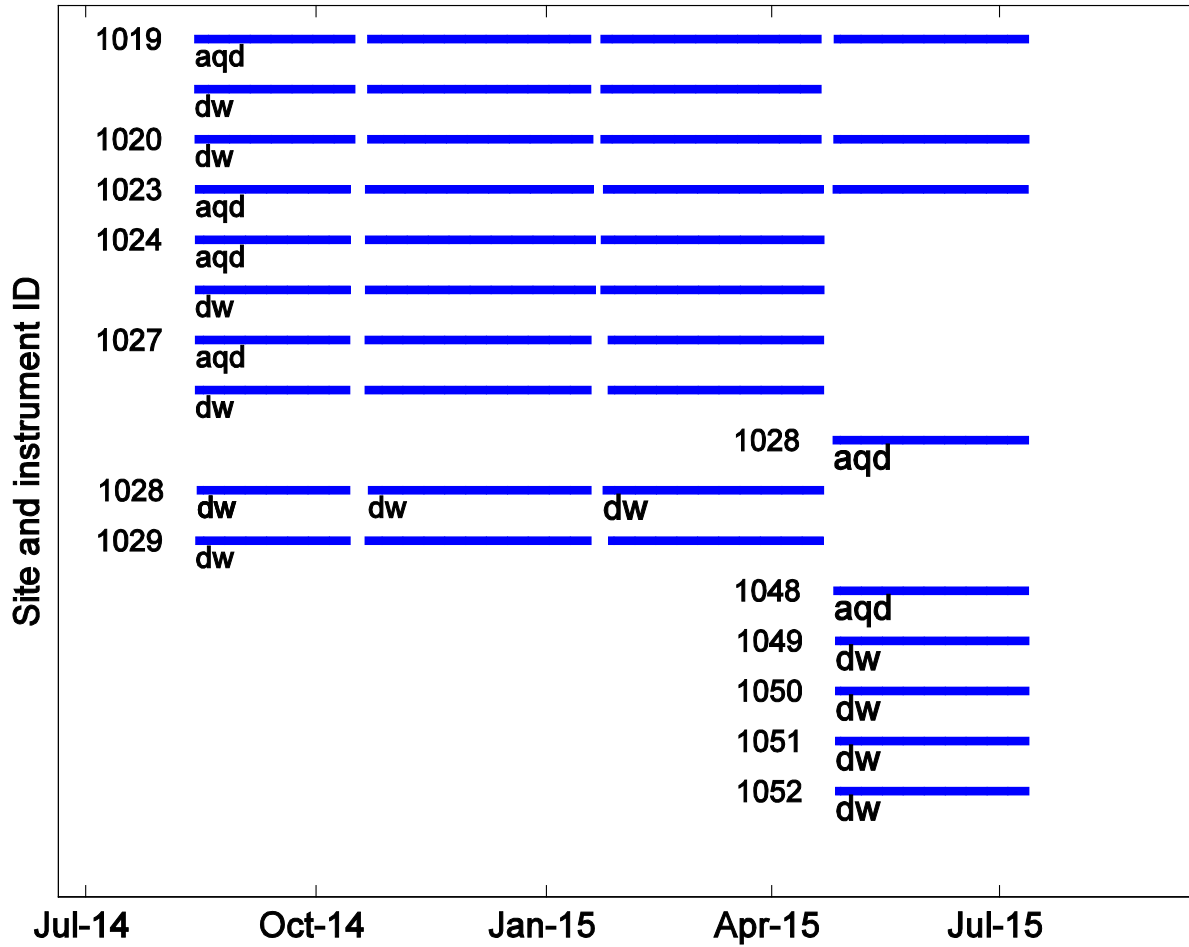
Figure 27. Chart showing the availability of wave data for Chincoteague Bay, Maryland and Virginia, for the estuarine physical response study from August 2014 to July 2015. aqd, Nortek Aquadopp; dw, RBR D|wave; ID, identification number.

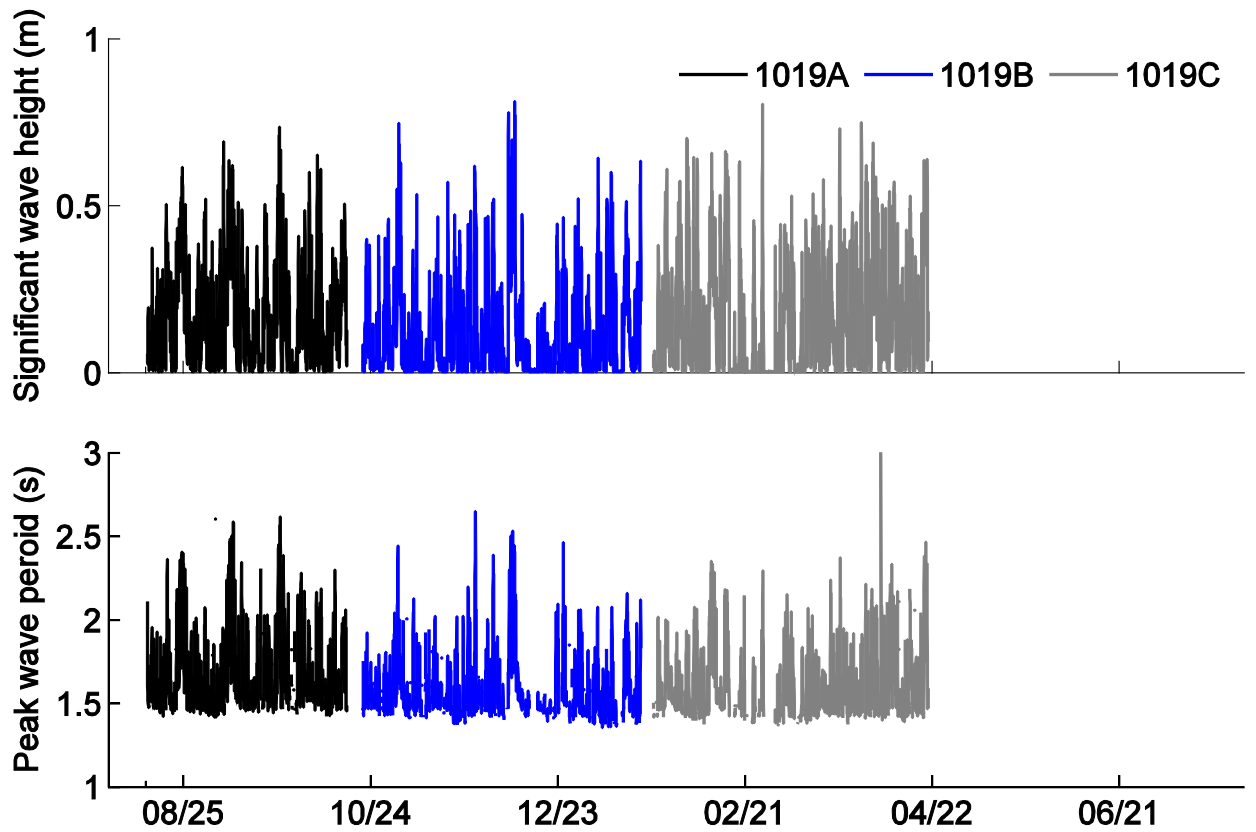
Figure 29. Graphs showing significant wave height and peak wave period from D|wave pressure logger wave burst data at mooring 1019 (CB02) from August 13, 2014, to April 20, 2015. m, meter; s, second.

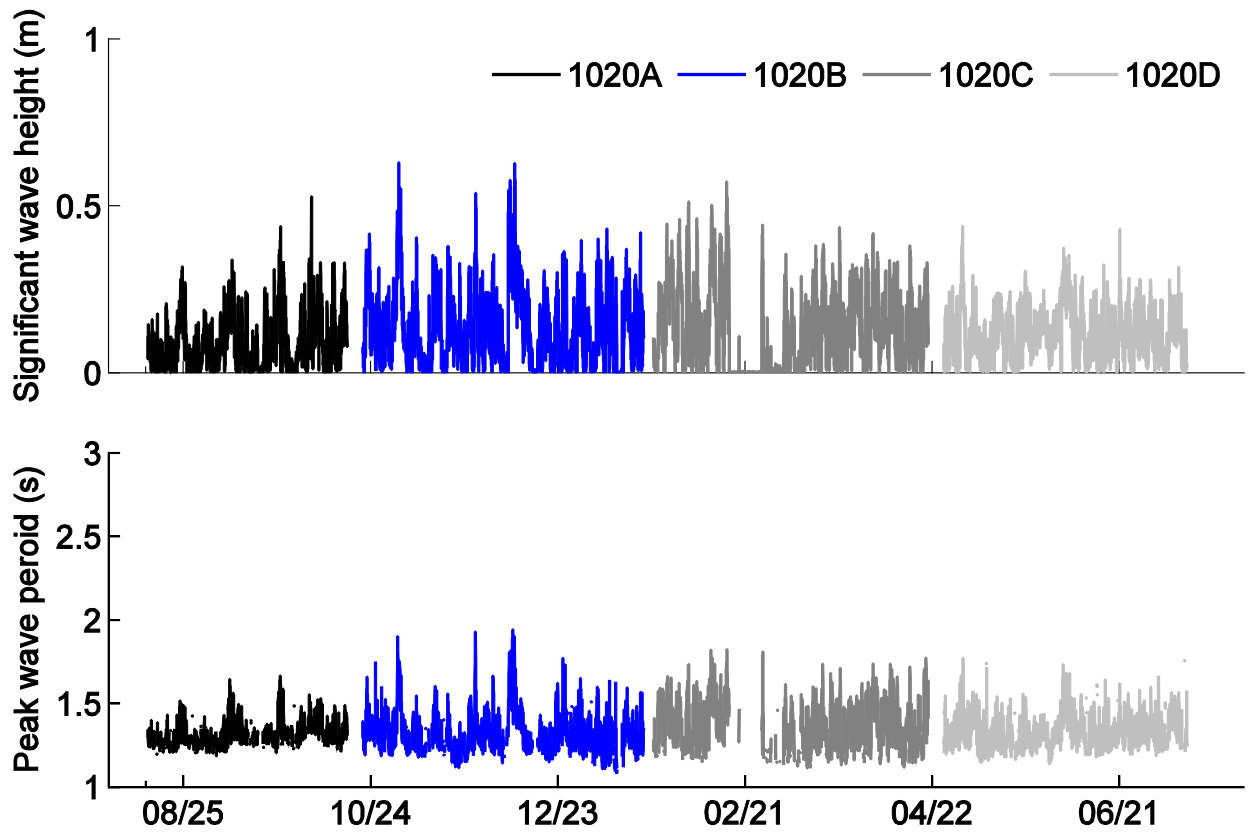
Figure 30. Graphs showing significant wave height and peak wave period from D|wave pressure logger wave burst data at mooring 1020 (CB03) from August 13, 2014, to July 12, 2015. m, meter; s, second.

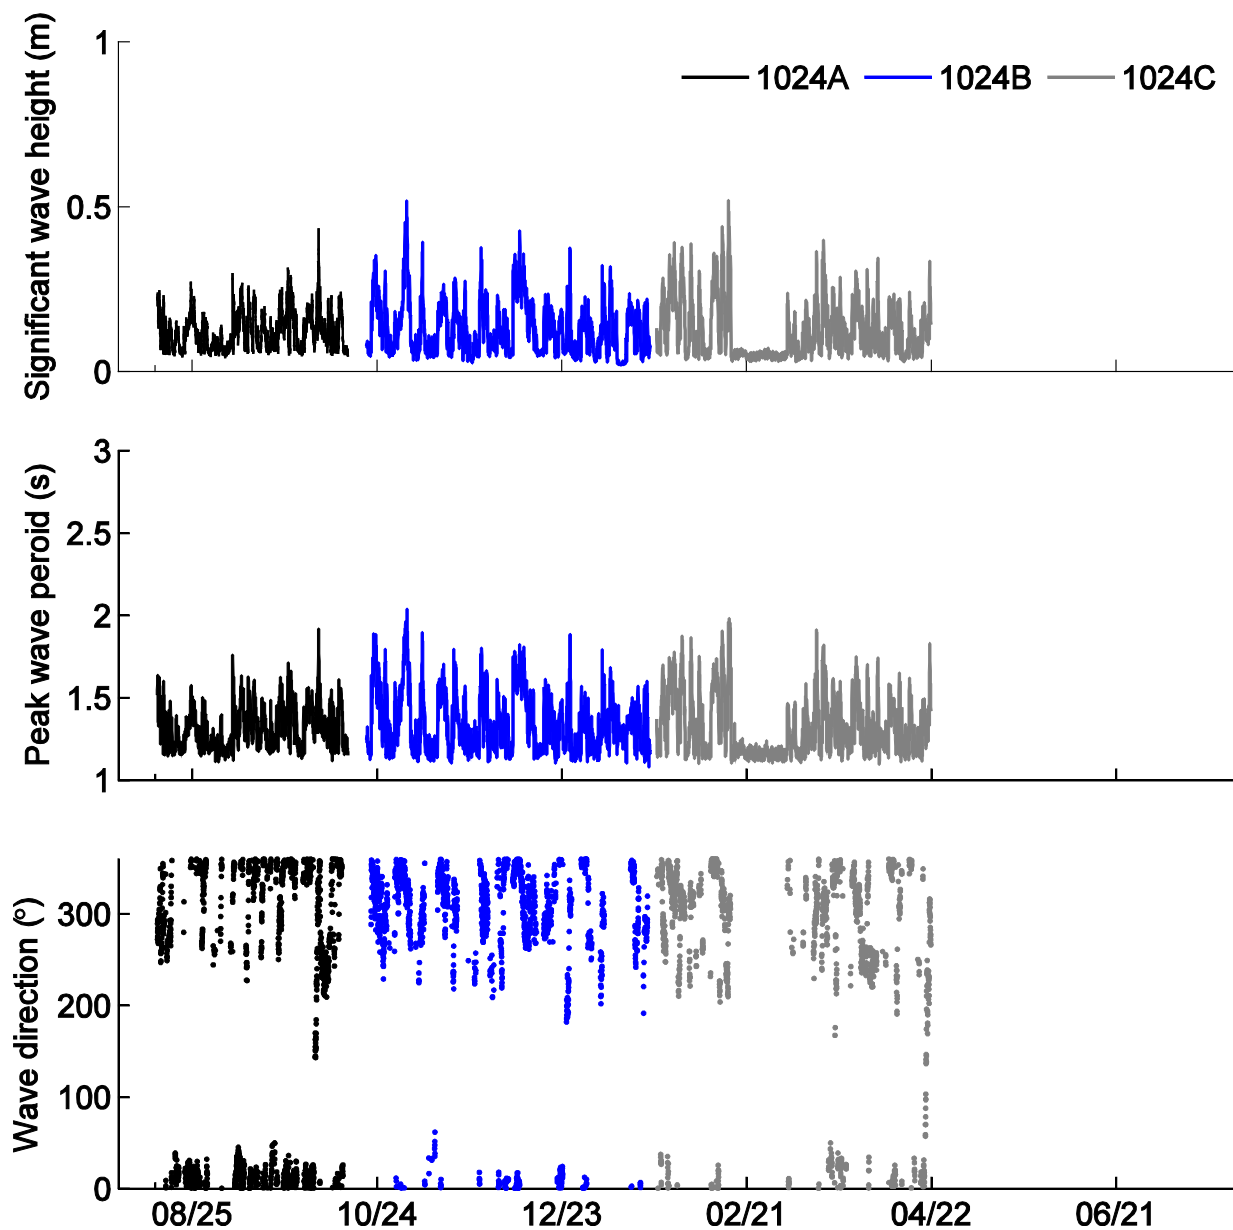
**Figure 32.** Graphs showing significant wave height, peak wave period, and mean wave direction (traveling from convention) from 2-megahertz Aquadopp acoustic Doppler current profiler wave burst data at mooring 1024 (CB07) from August 13, 2014, to April 21, 2015. Wave directions are shown for significant wave heights greater than or equal to 0.10 meter. m, meter; s, second; °, degree true.
