# Summary of Oceanographic and Water-Quality Measurements in Chincoteague Bay, Maryland and Virginia, 2014–15

Open-File Report 2017–1032

U.S. Department of the Interior  
U.S. Geological Survey

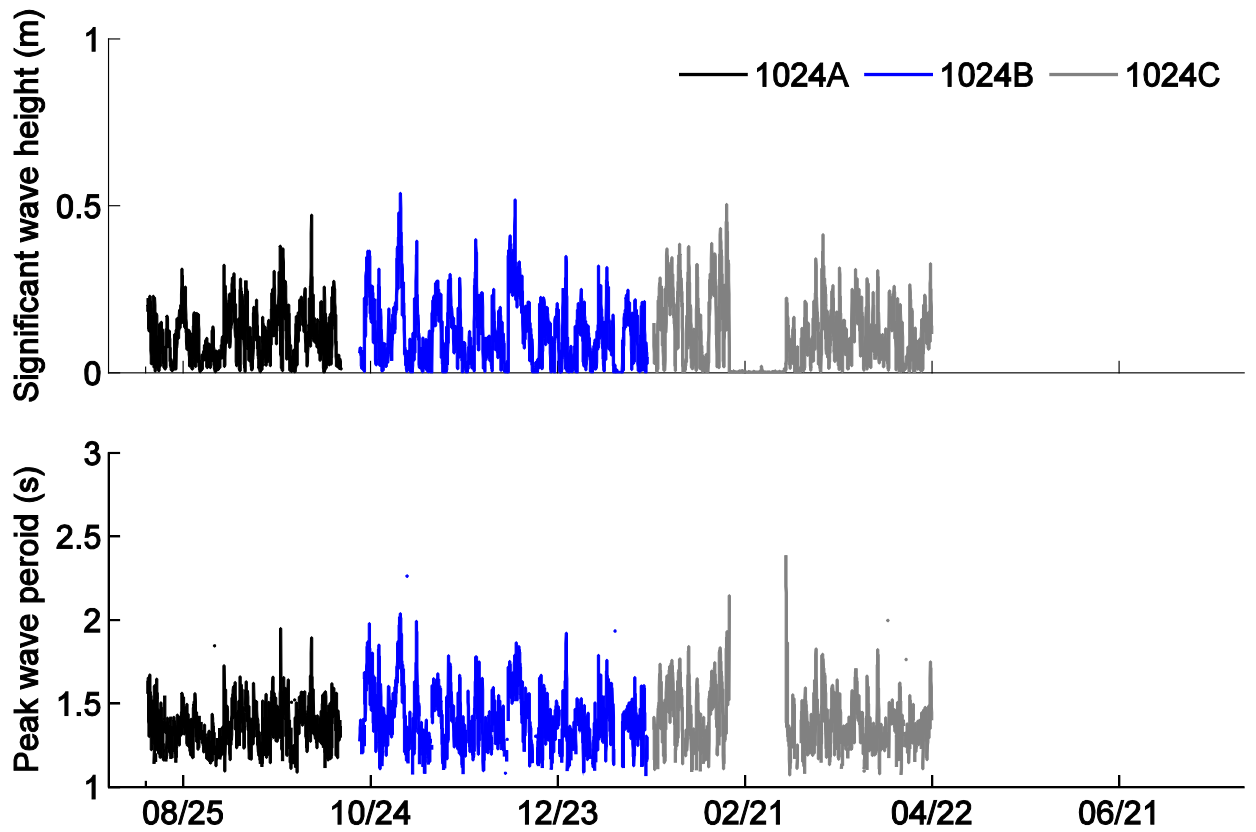
Figure 33. Graphs showing significant wave height and peak wave period from D|wave pressure logger wave burst data at mooring 1024 (CB07) from August 13, 2014, to April 21, 2015. m, meter; s, second.

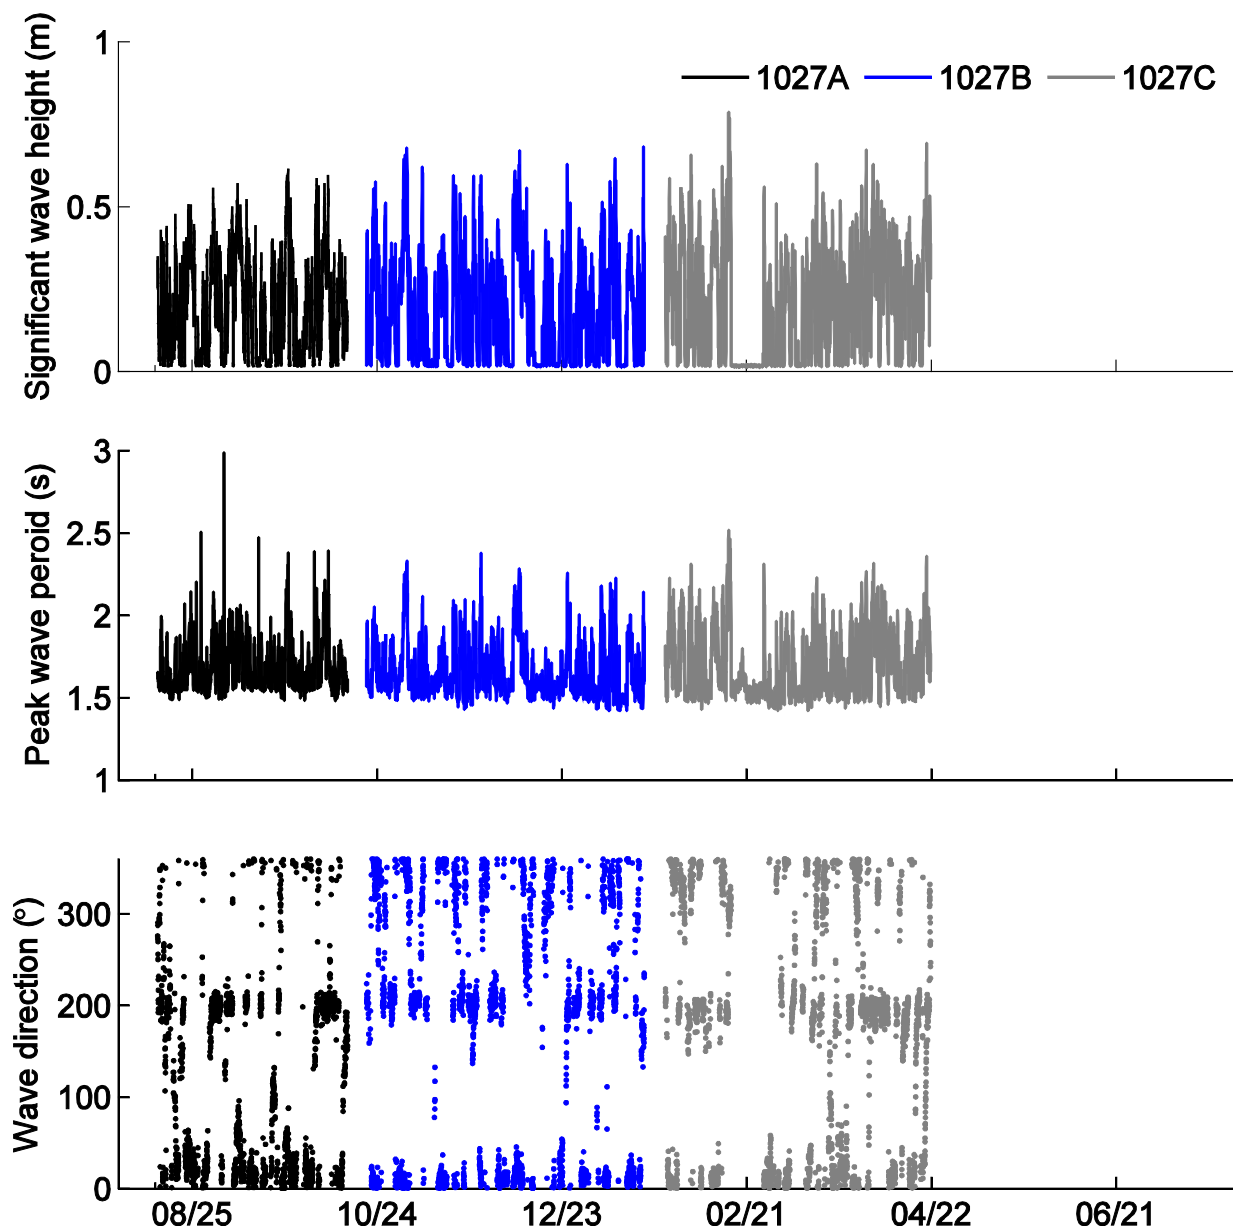
Figure 34. Graphs showing significant wave height, peak wave period, and mean wave direction (traveling from convention) from 1-megahertz Aquadopp acoustic Doppler current profiler wave burst data at mooring 1027 (CB09) from August 13, 2014, to April 21, 2015. Wave directions are shown for significant wave heights greater than or equal to 0.10 meter. m, meter; s, second; °, degree true.

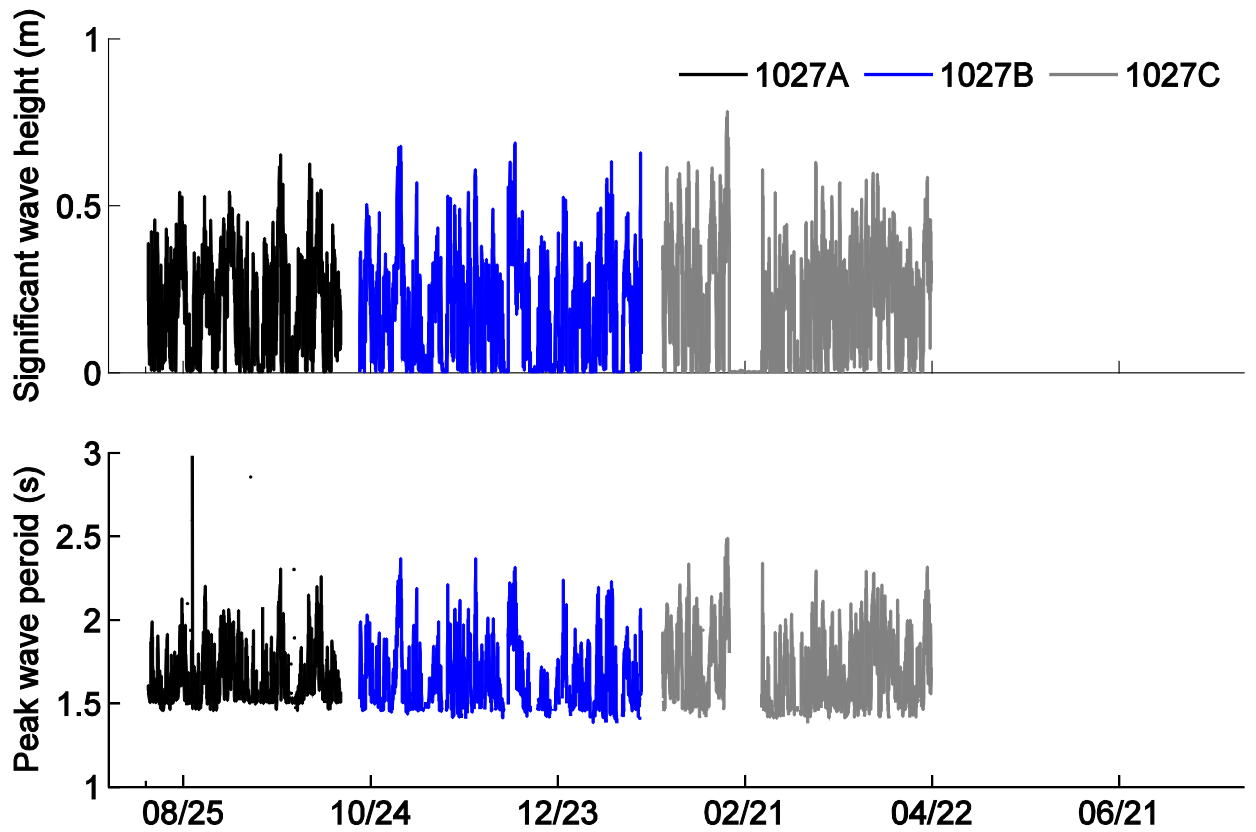
Figure 35. Graphs showing significant wave height and peak wave period from D|wave pressure logger wave burst data at mooring 1027 (CB09) from August 13, 2014, to April 21, 2015. m, meter; s, second.

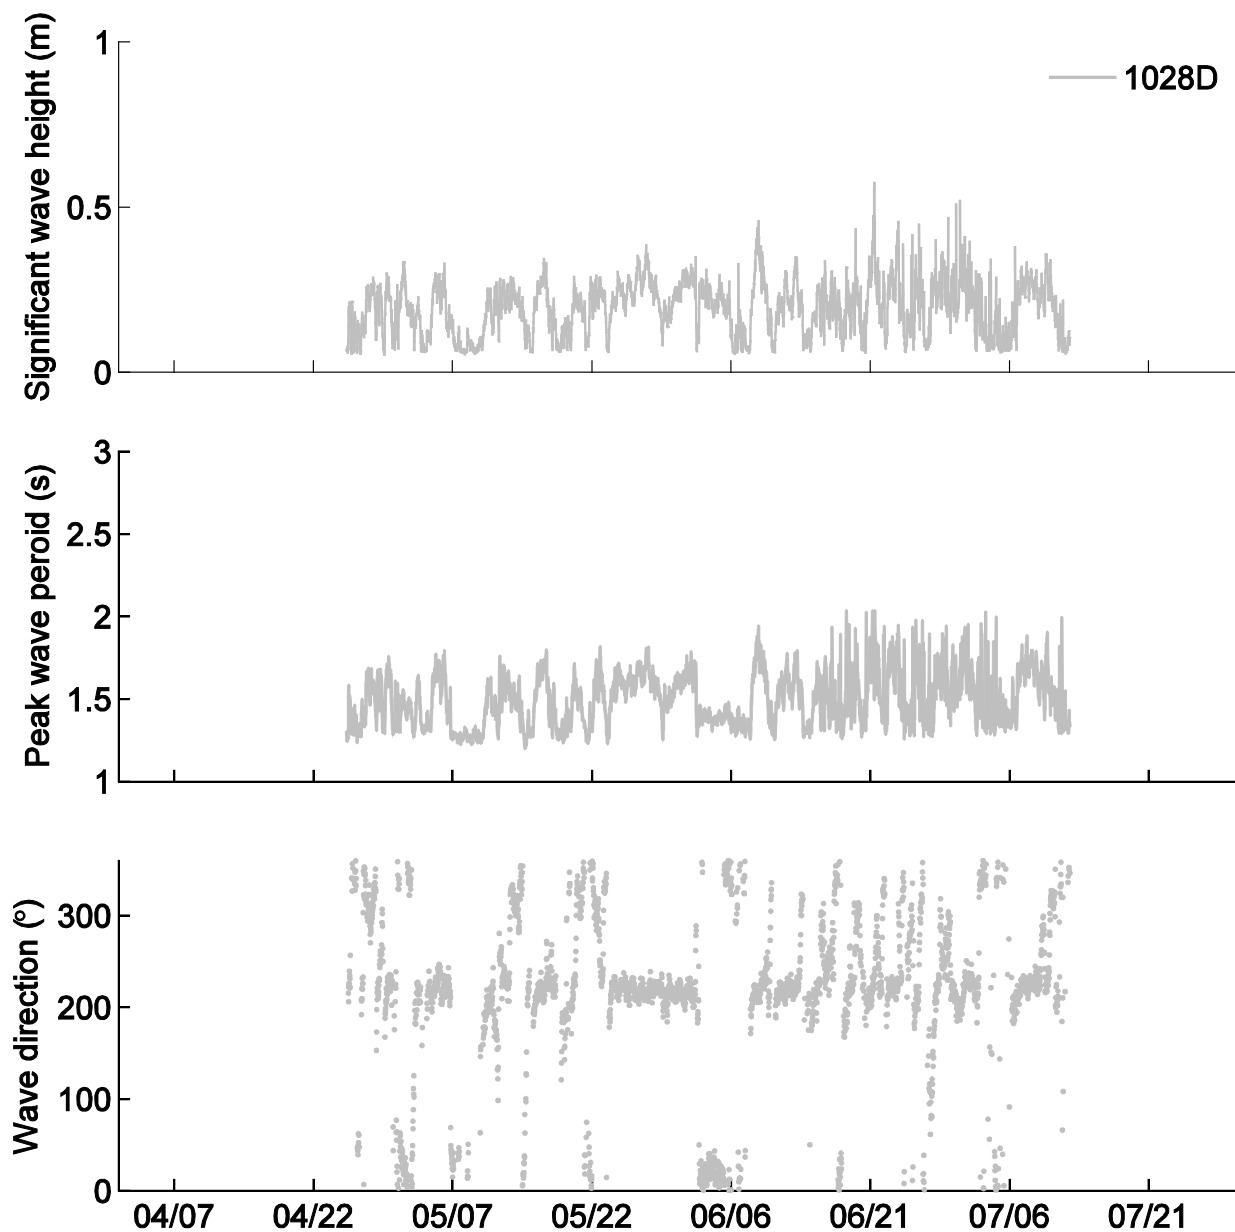
**Figure 36.** Graphs showing significant wave height, peak wave period, and mean wave direction (traveling from convention) from 2-megahertz Aquadopp acoustic Doppler current profiler wave burst data at mooring 1028 (CB10) from April 25 to July 12, 2015. Wave directions are shown for significant wave heights greater than or equal to 0.10 meter. m, meter; s, second; °, degree true.

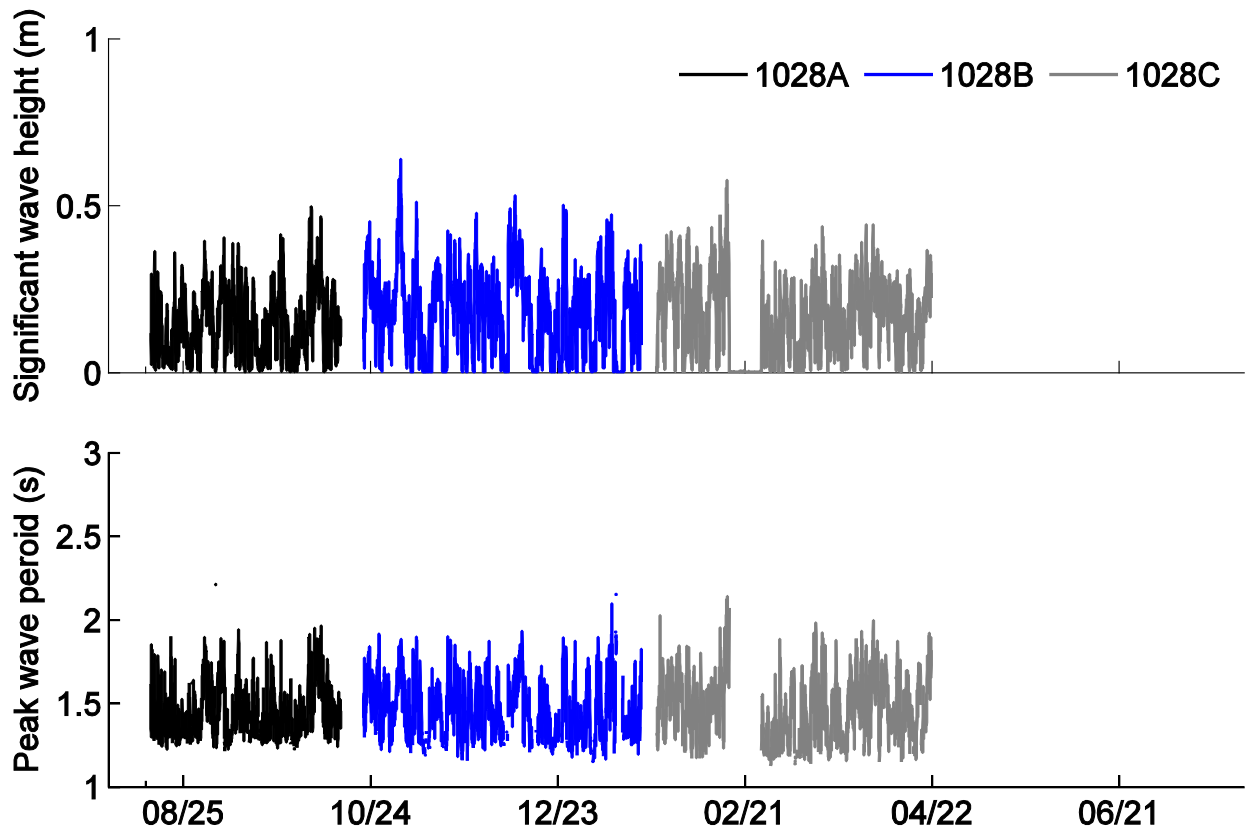
Figure 37. Graphs showing significant wave height and peak wave period from D|wave pressure logger wave burst data at mooring 1028 (CB10) from August 14, 2014, to April 21, 2015. m, meter; s, second.

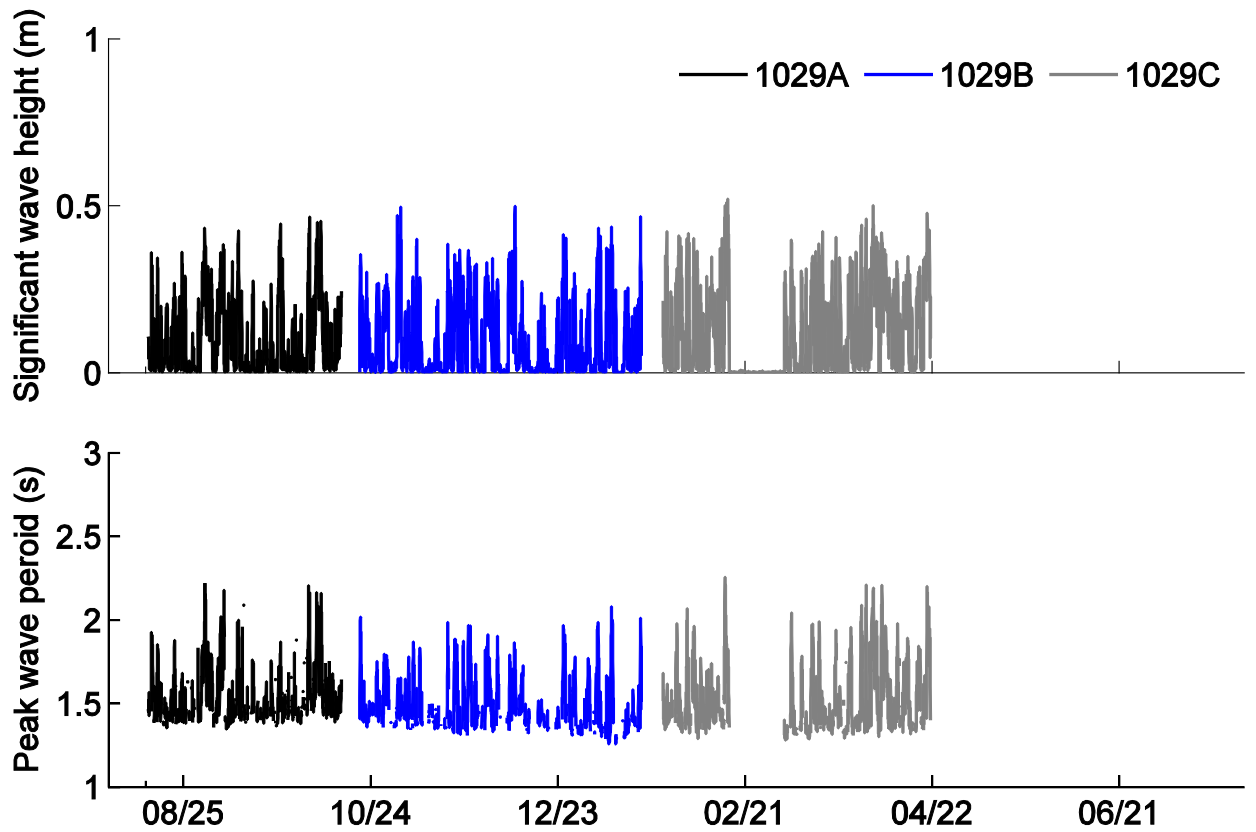
Figure 38. Graphs showing significant wave height and peak wave period from D|wave pressure logger wave burst data at mooring 1029 (CB11) from August 13, 2014, to April 21, 2015. m, meter; s, second.

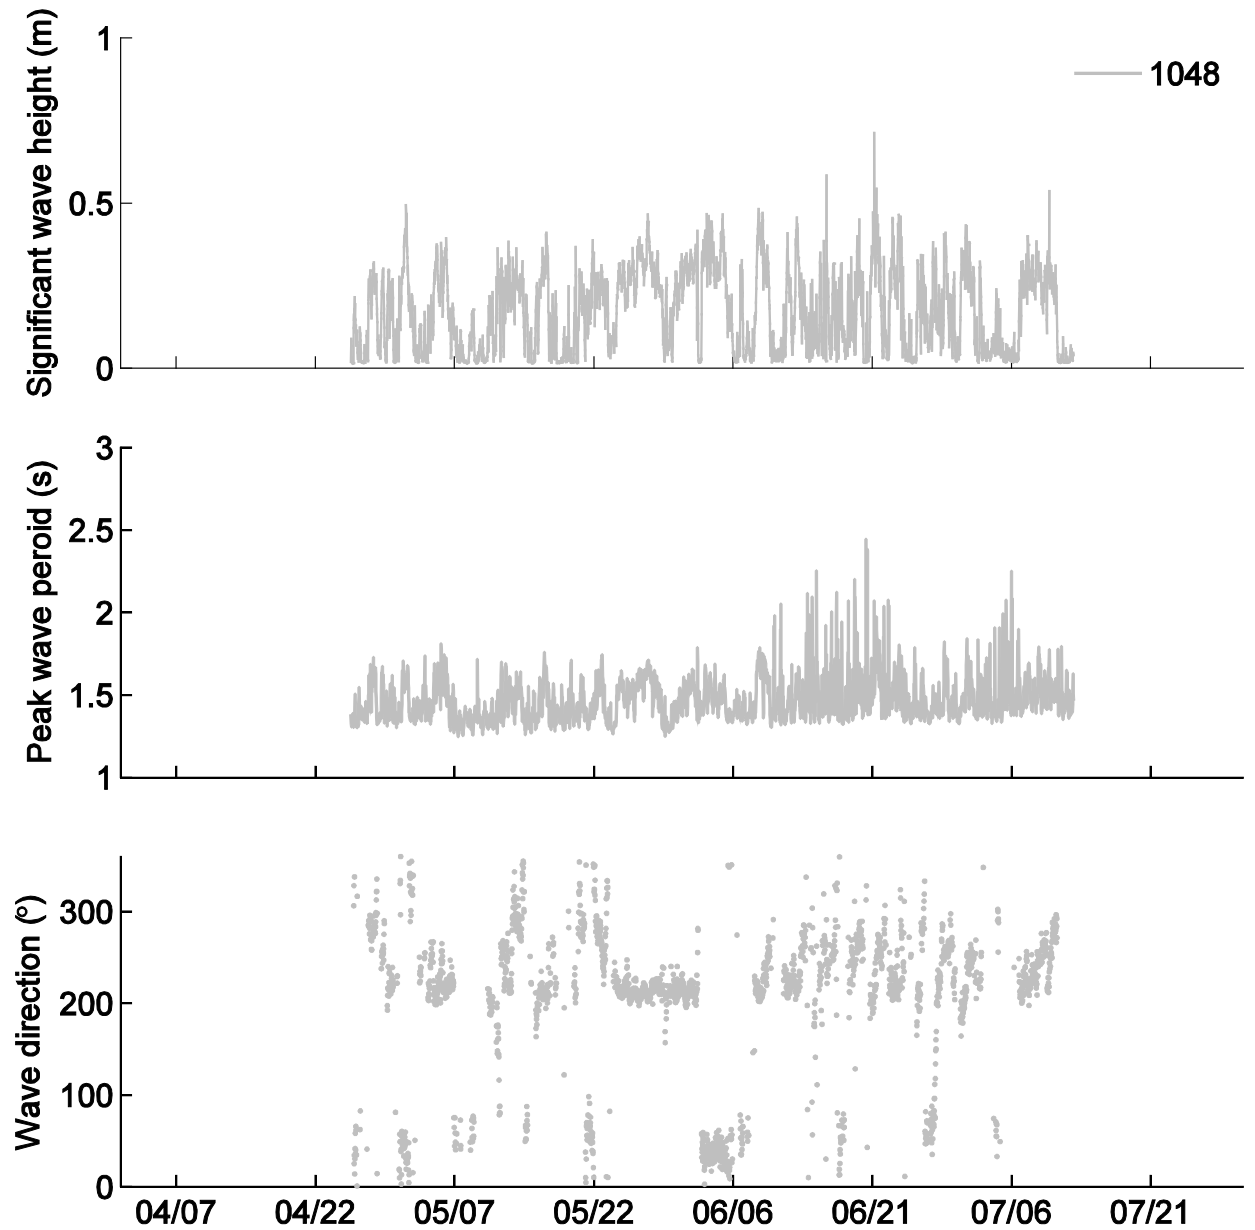
**Figure 39.** Graphs showing significant wave height, peak wave period, and mean wave direction (traveling from convention) from 2-megahertz Aquadopp acoustic Doppler current profiler wave burst data at mooring 1048 (V1) from April 25 to July 12, 2015. Wave directions are shown for significant wave heights greater than or equal to 0.10 meter. m, meter; s, second; °, degree true.

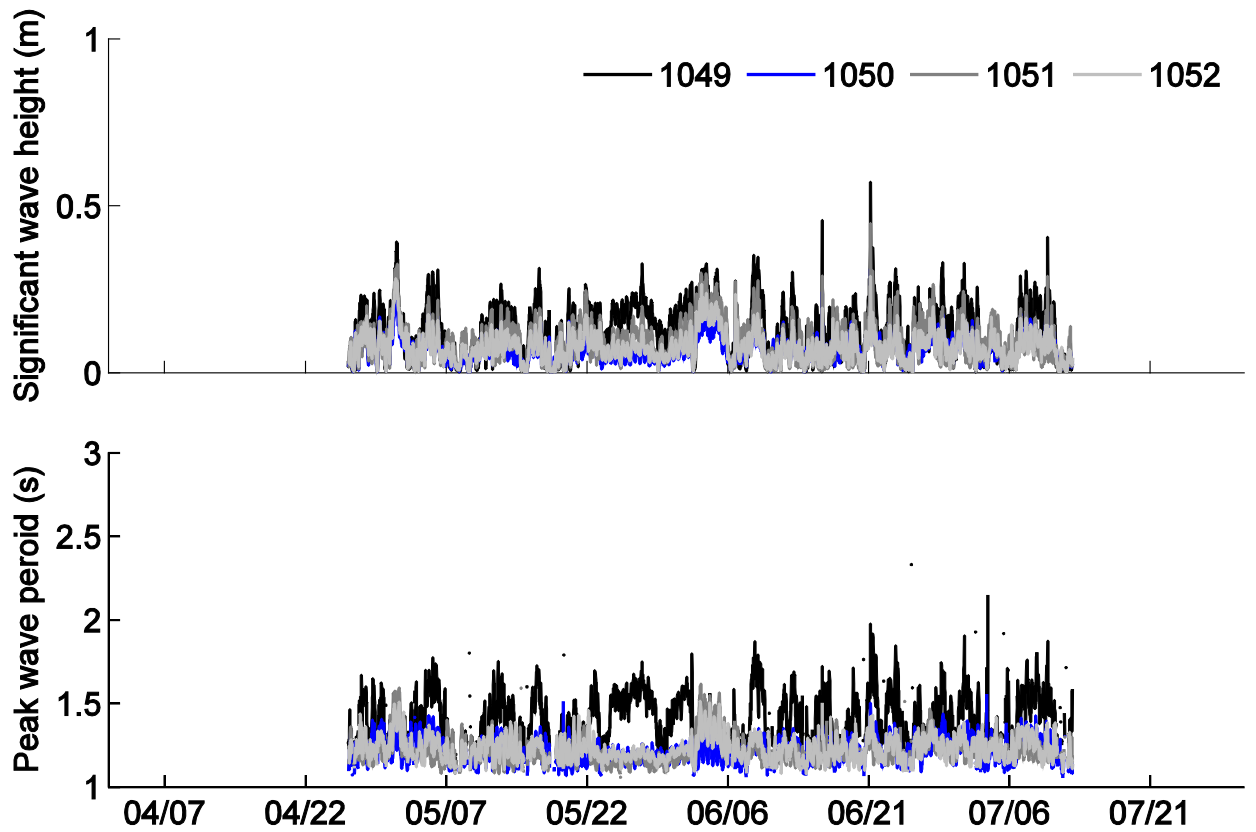
**Figure 40.** Graphs showing significant wave height and peak wave period from wave burst data collected with D|wave pressure loggers at moorings 1049–1052 (V2–V5) from April 26 to July 12, 2015. m, meter; s, second.

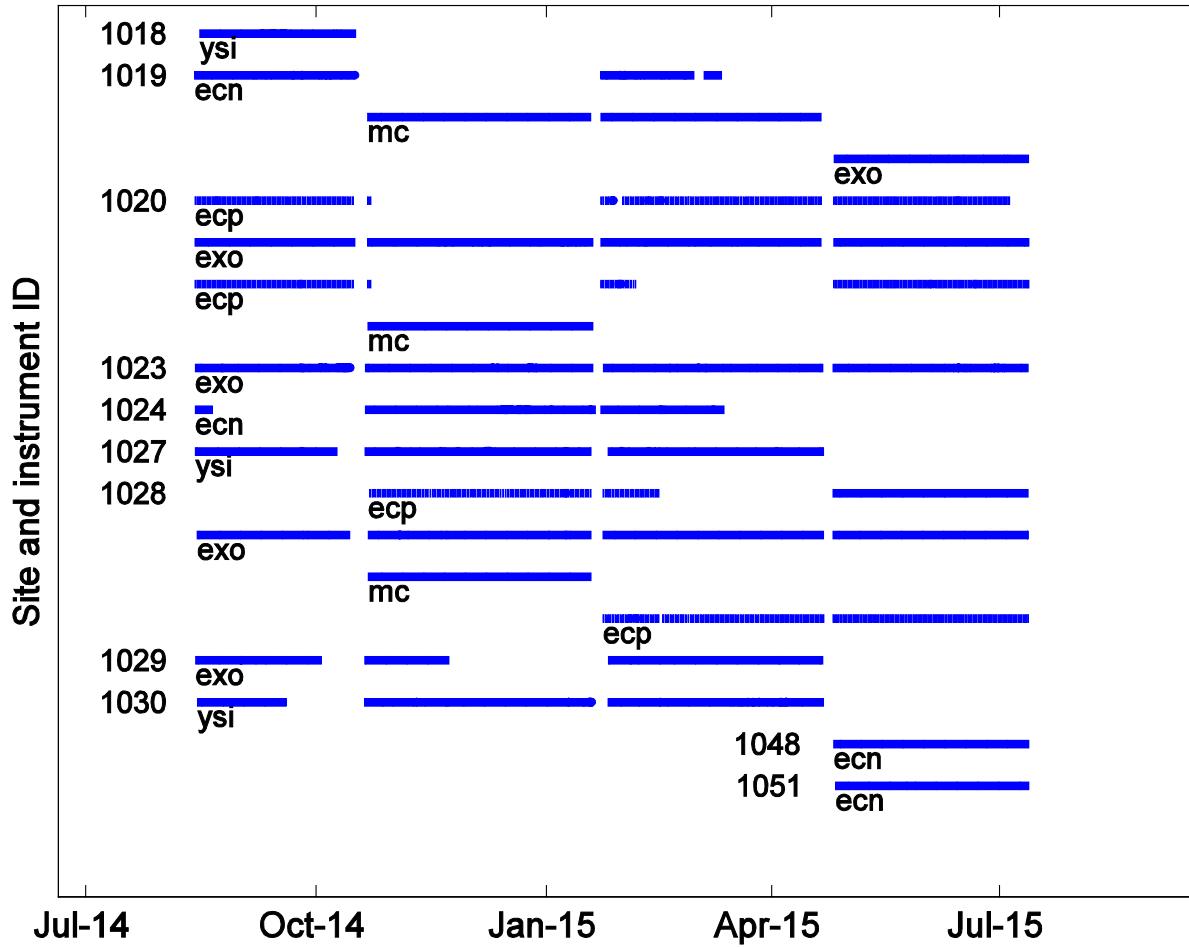
**Figure 41.** Chart showing the availability of water-quality data for Chincoteague Bay, Maryland and Virginia, for the Estuarine Physical Response to Storms study from August 2014 to July 2015. ysi, YSI 6600 sonde; ecn, WET Labs ECO-NTUSB; ecp, WET Labs ECO-PARSB; exo, YSI EXO2 sonde; mc, Sea-Bird SBE 37-SM MicroCAT; ID, identification number.

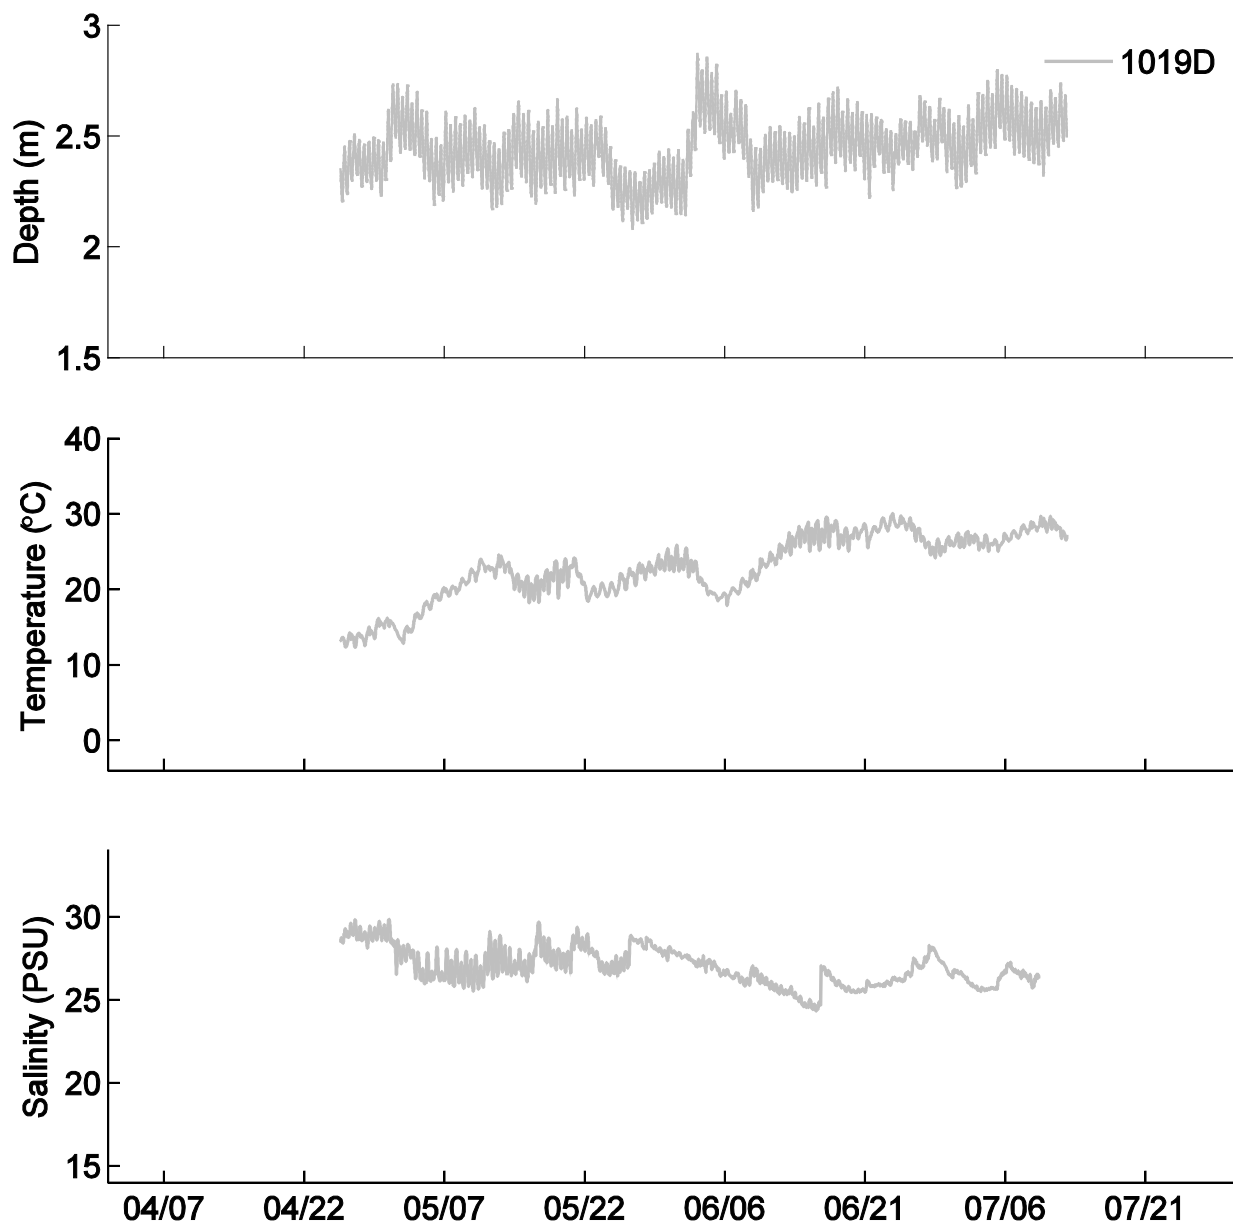
**Figure 42.** Graphs showing sensor depth, water temperature, and salinity from YSI EXO2 multiparameter sonde data at mooring 1019 (CB02) from April 25 to July 12, 2015. m, meter; °C, degree Celsius; PSU, practical salinity unit.

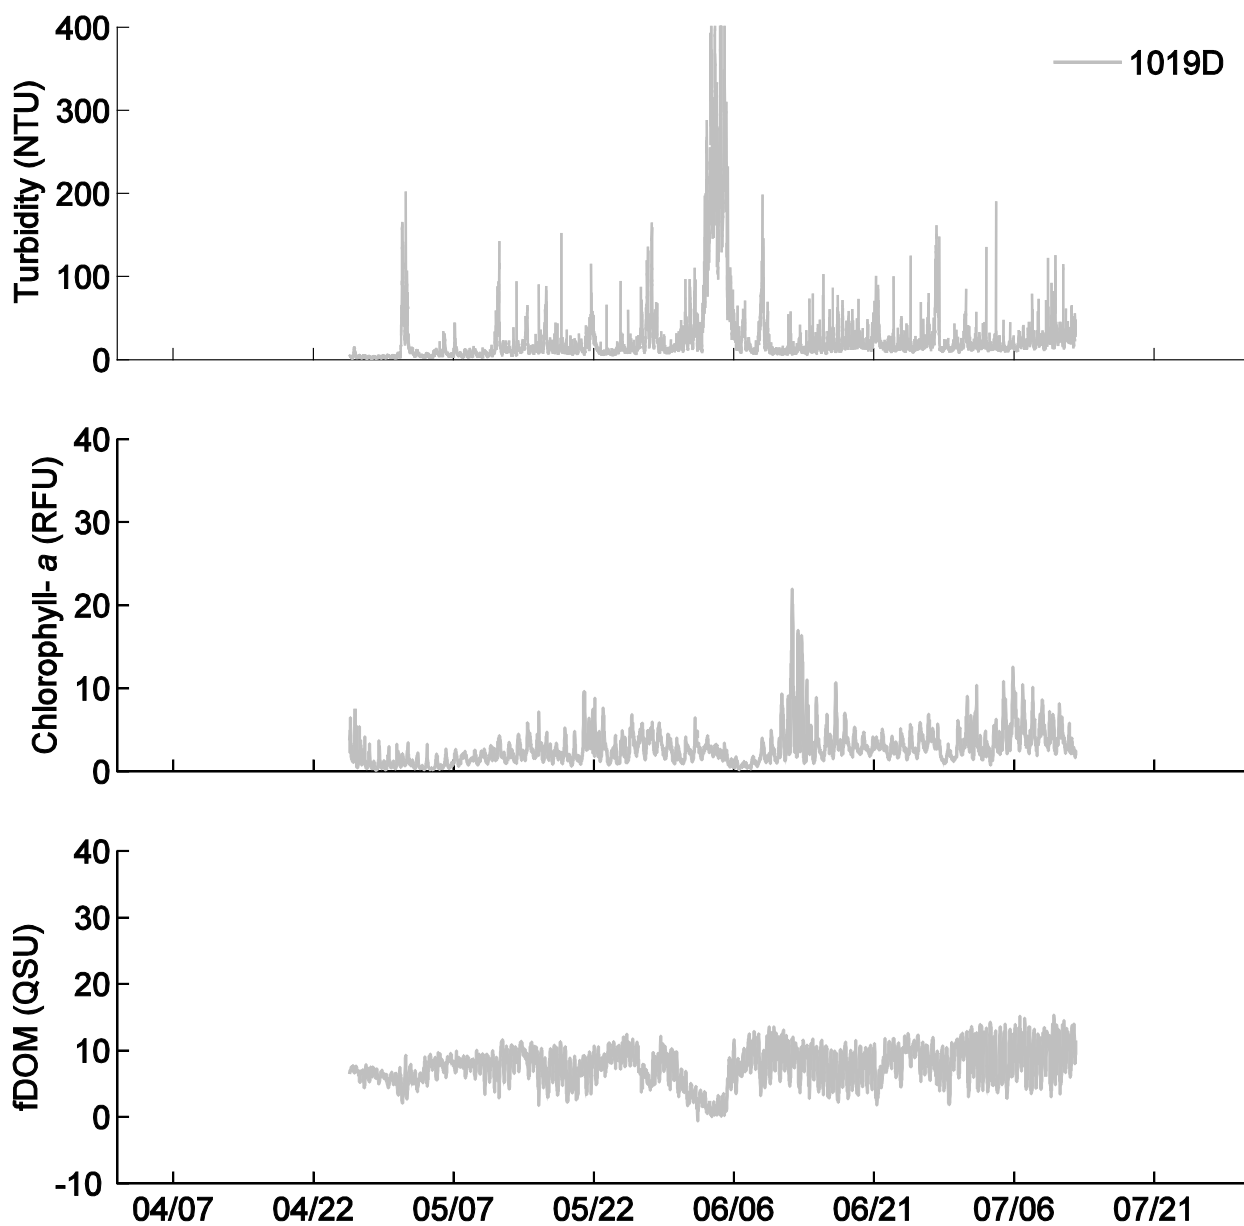
**Figure 43.** Graphs showing turbidity, chlorophyll-*a*, and fluorescent dissolved organic matter (fDOM) from YSI EXO2 multiparameter sonde data at mooring 1019 (CB02) from April 25 to July 12, 2015. NTU, nephelometric turbidity unit; RFU, relative fluorescence unit; QSU, quinine sulfate unit.

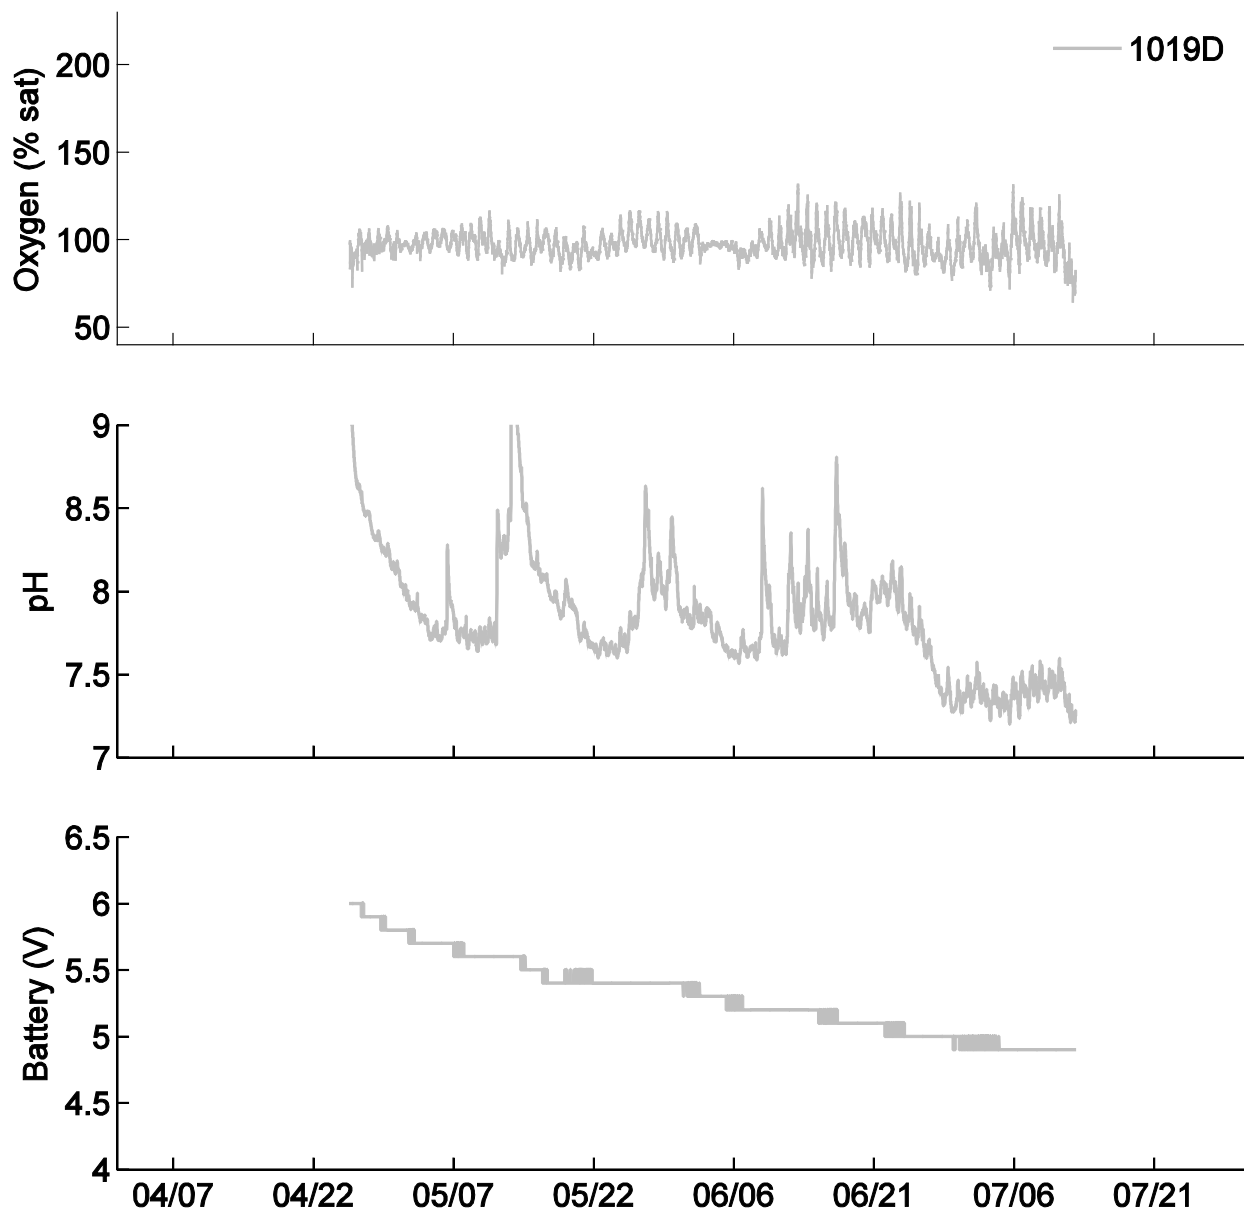
Figure 44. Graphs showing oxygen saturation, pH, and battery power from YSI EXO2 multiparameter sonde data at mooring 1019 (CB02) from April 25 to July 12, 2015. % sat, percent saturation; pH, pH unit; V, volt.

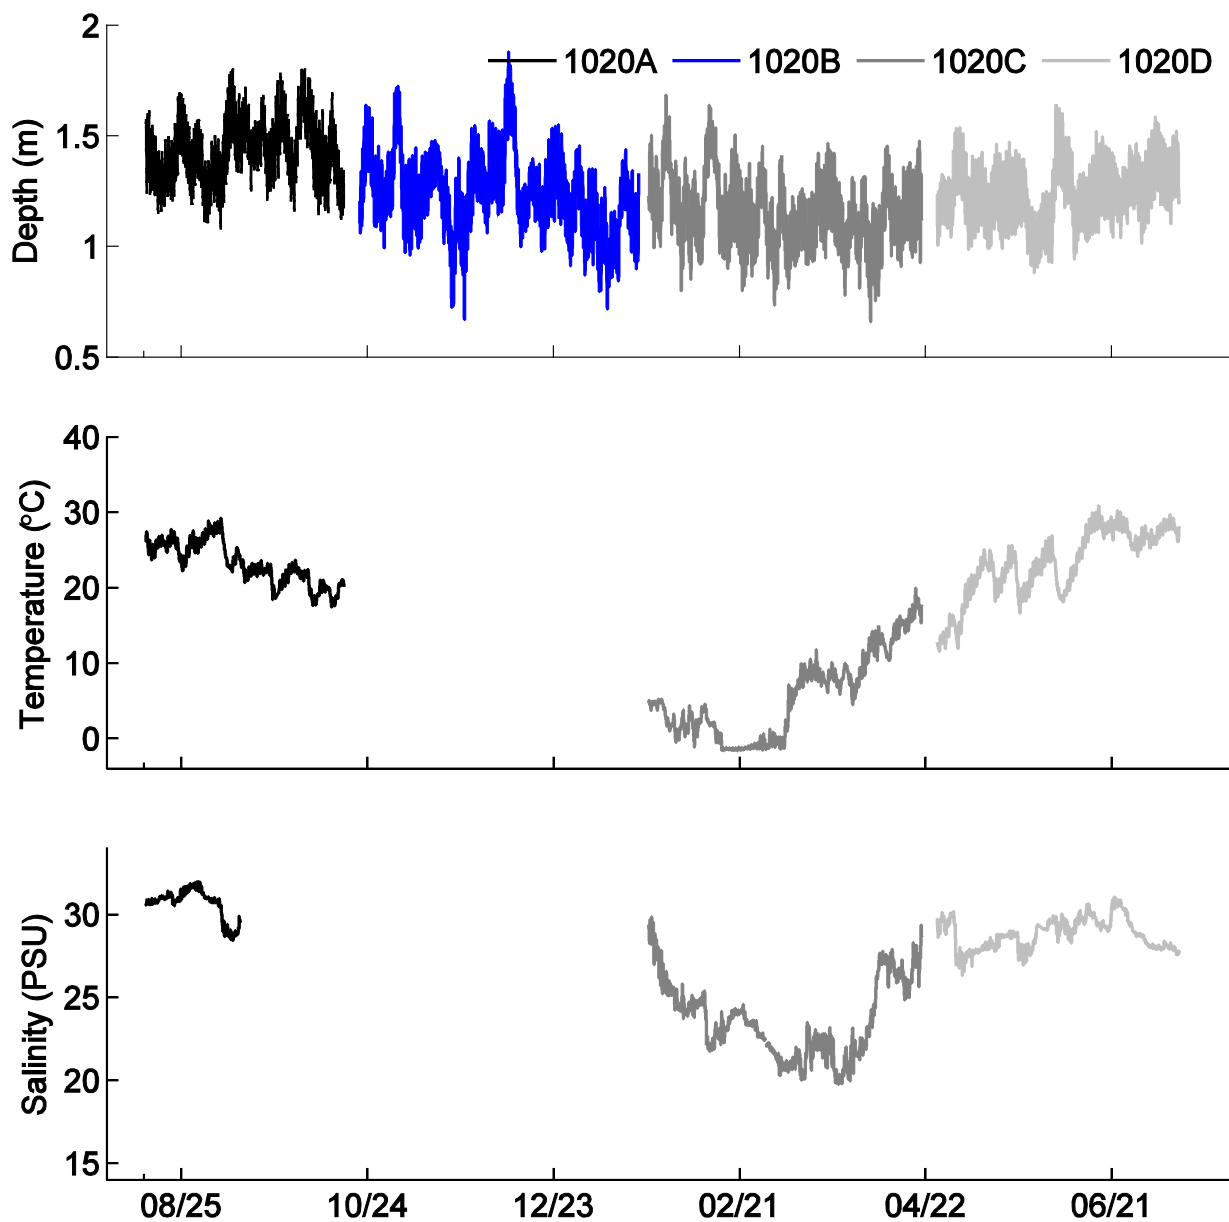
**Figure 45.** Graphs showing sensor depth, water temperature, and salinity from YSI EXO2 multiparameter sonde data at mooring 1020 (CB03) from August 13, 2014, to July 12, 2015. m, meter; °C, degree Celsius; PSU, practical salinity unit.

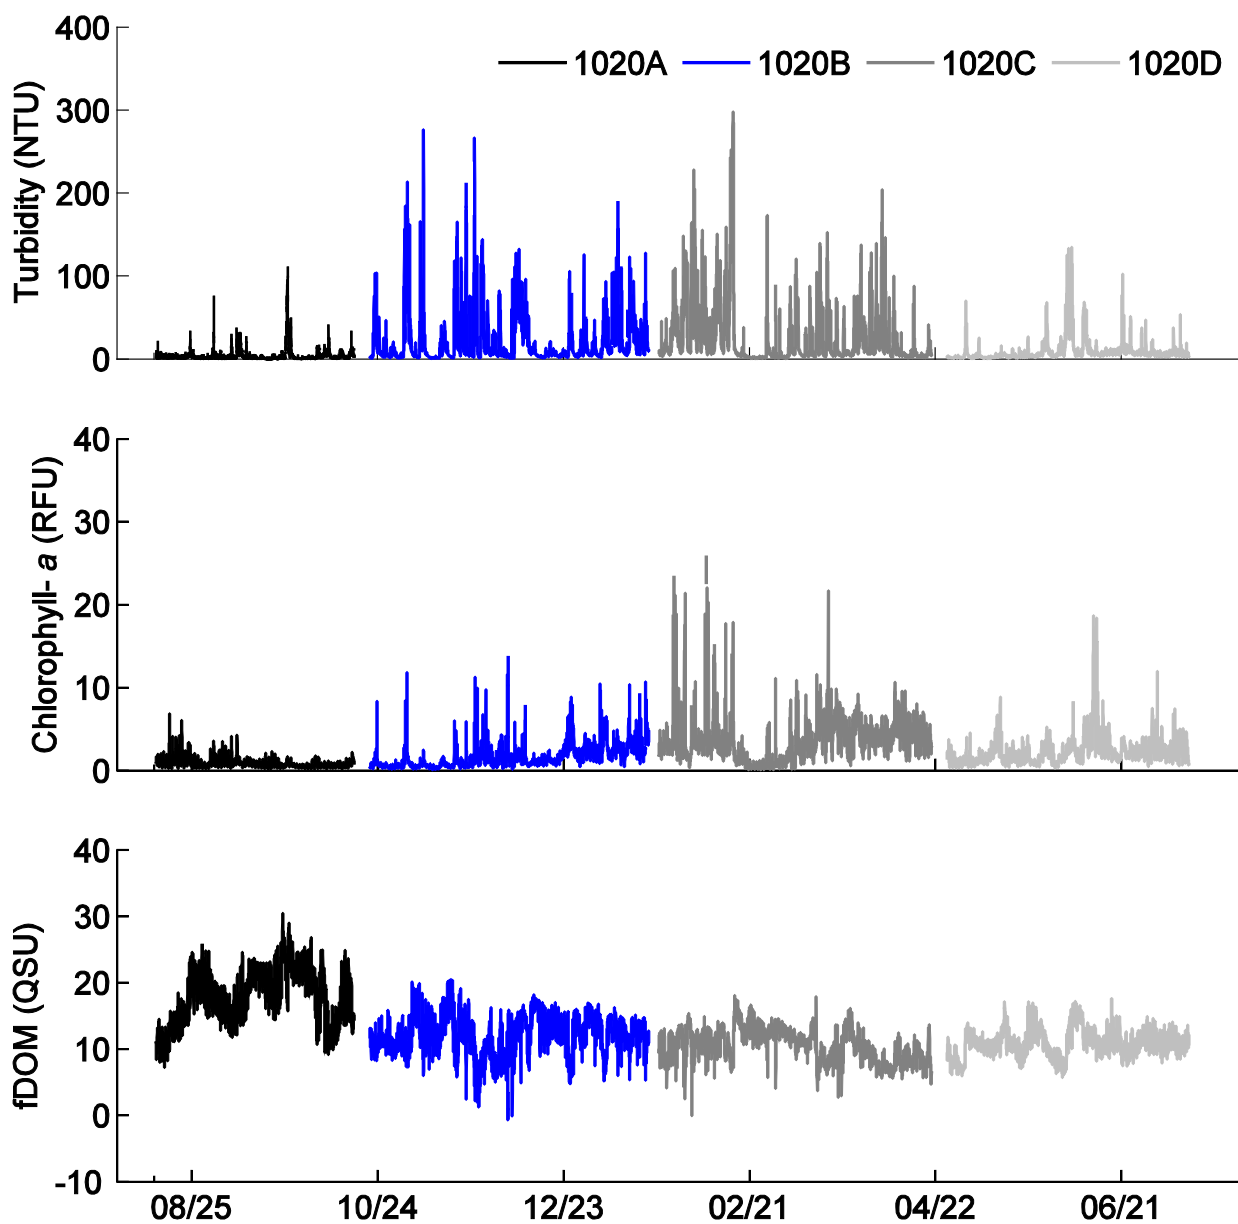
**Figure 46.** Graphs showing turbidity, chlorophyll-*a*, and fluorescent dissolved organic matter (fDOM) from YSI EXO2 multiparameter sonde data at mooring 1020 (CB03) from August 13, 2014, to July 12, 2015. NTU, nephelometric turbidity unit; RFU, relative fluorescence unit; QSU, quinine sulfate unit.

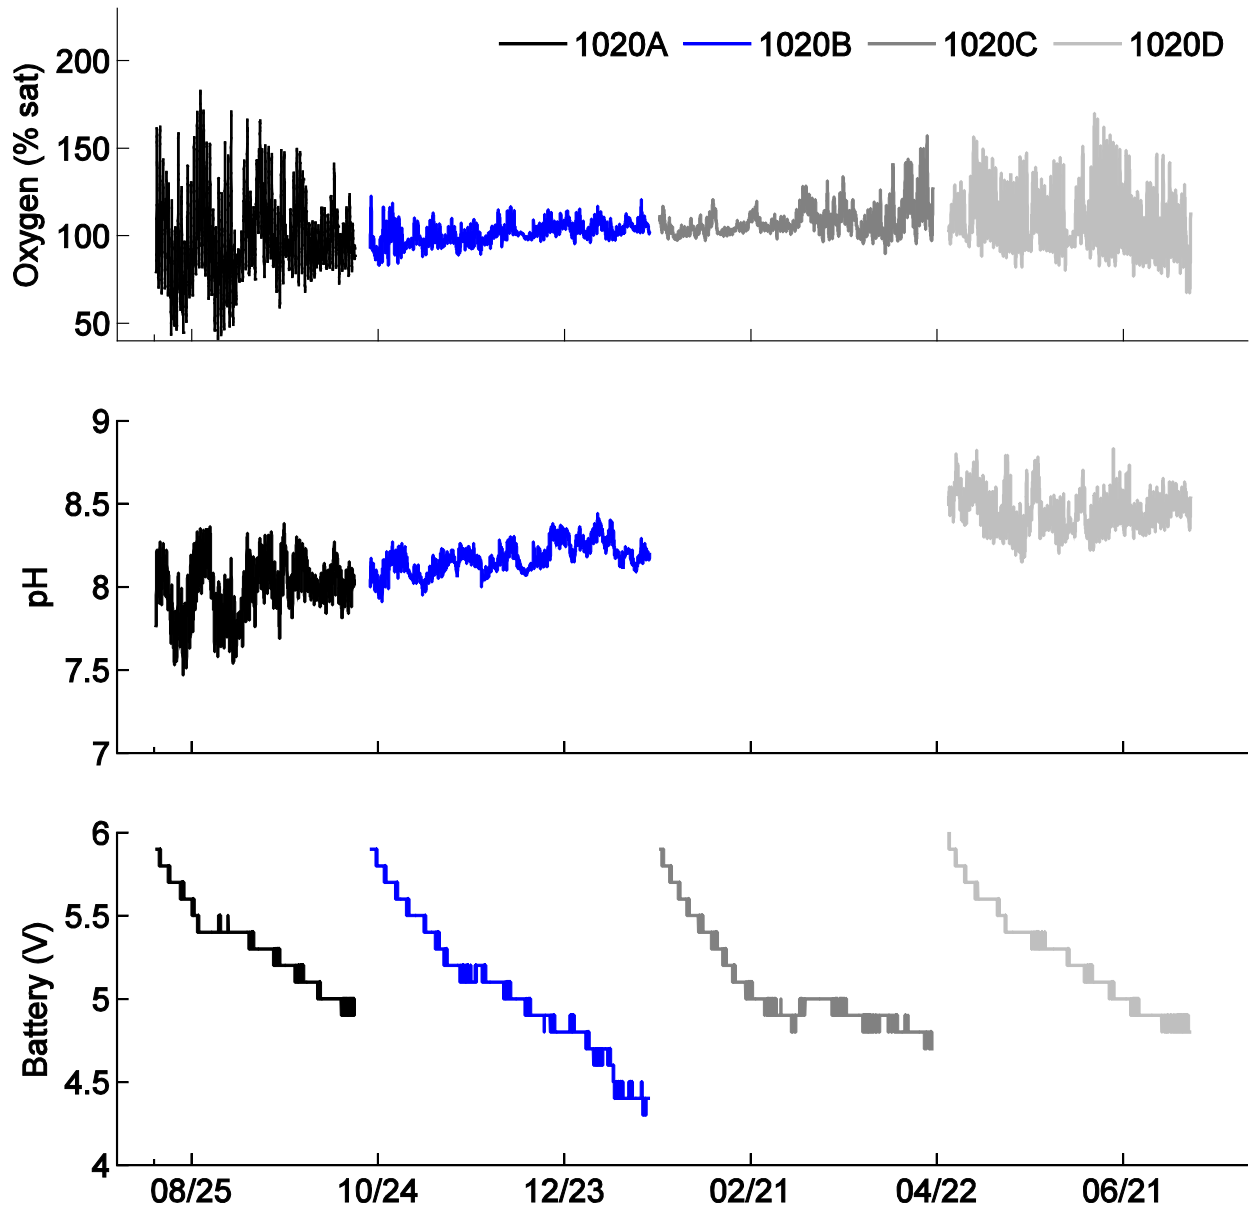
Figure 47. Graphs showing oxygen saturation, pH, and battery power from YSI EXO2 multiparameter sonde data at mooring 1020 (CB03) from August 13, 2014, to July 12, 2015. % sat, percent saturation; pH, pH unit; V, volt.

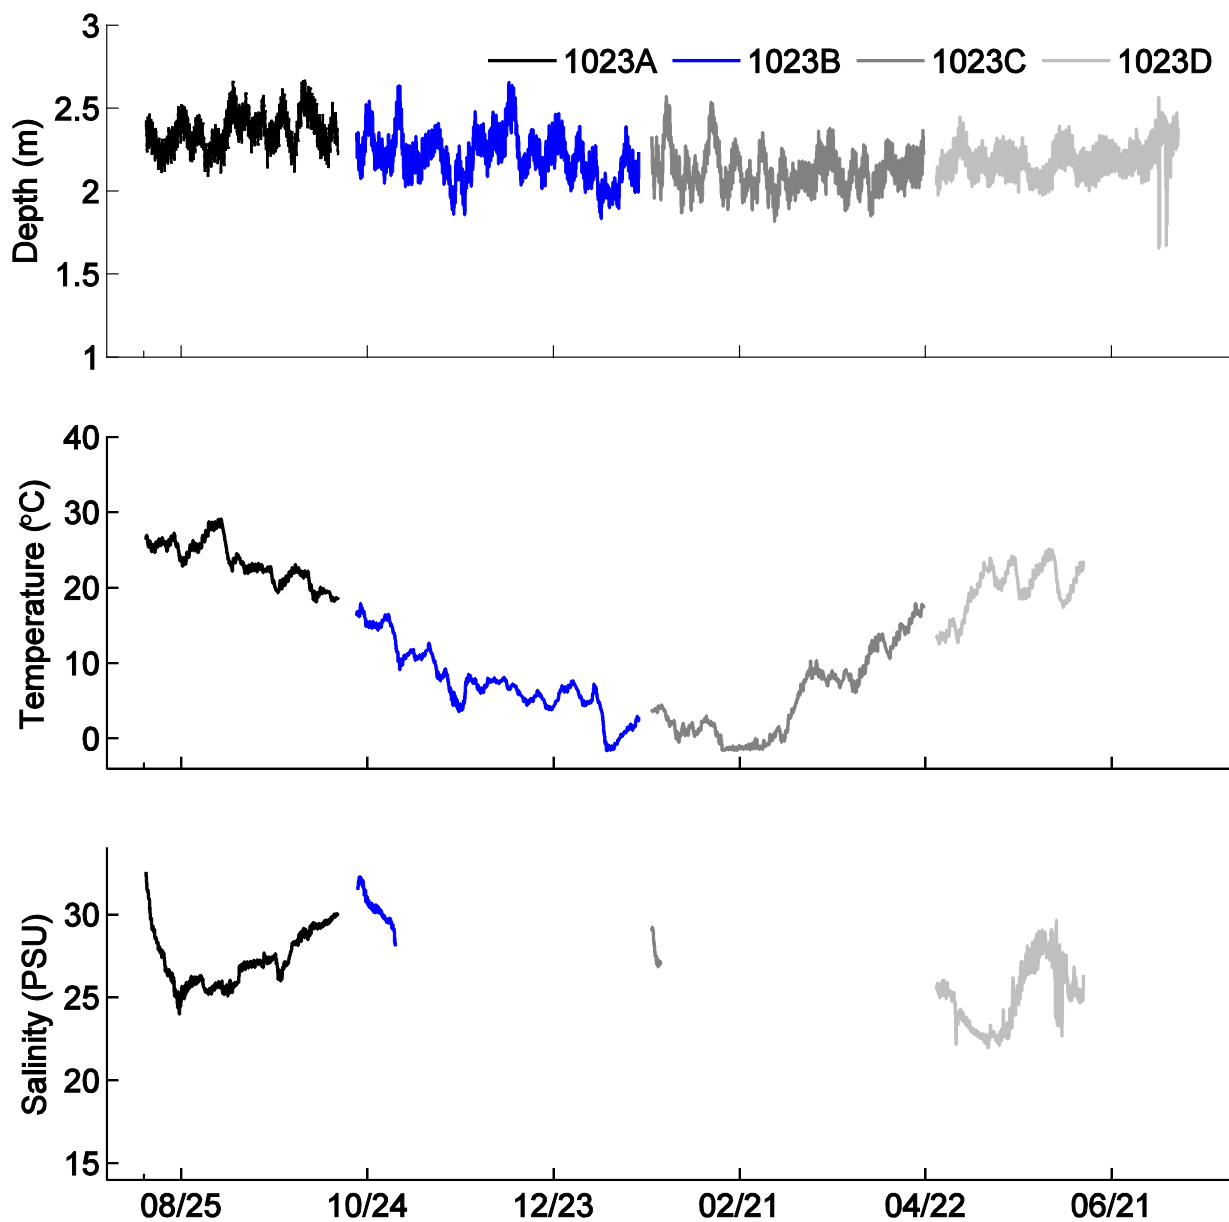
**Figure 48.** Graphs showing sensor depth, water temperature, and salinity from YSI EXO2 multiparameter sonde data at mooring 1023 (CB06) from August 13, 2014, to July 12, 2015. m, meter; °C, degree Celsius; PSU, practical salinity unit.
