# Summary of Oceanographic and Water-Quality Measurements in Chincoteague Bay, Maryland and Virginia, 2014–15

Open-File Report 2017–1032

U.S. Department of the Interior  
U.S. Geological Survey

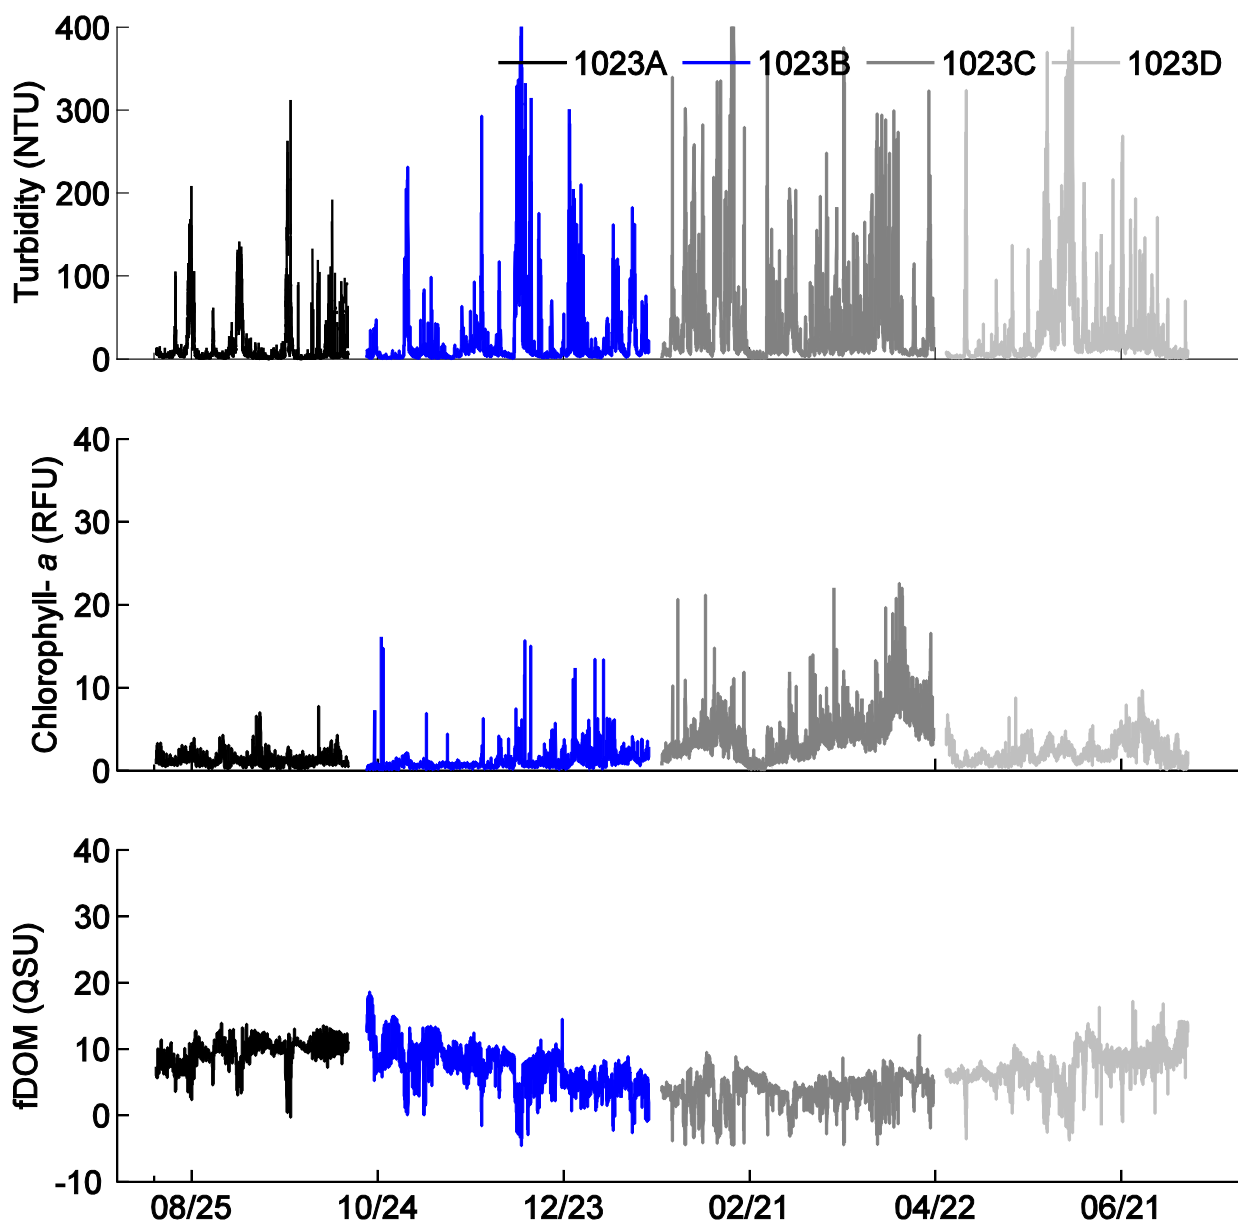
Figure 49. Graphs showing turbidity, chlorophyll-*a*, and fluorescent dissolved organic matter (fDOM) from YSI EXO2 multiparameter sonde data at mooring 1023 (CB06) from August 13, 2014, to July 12, 2015. NTU, nephelometric turbidity unit; RFU, relative fluorescence unit; QSU, quinine sulfate unit.

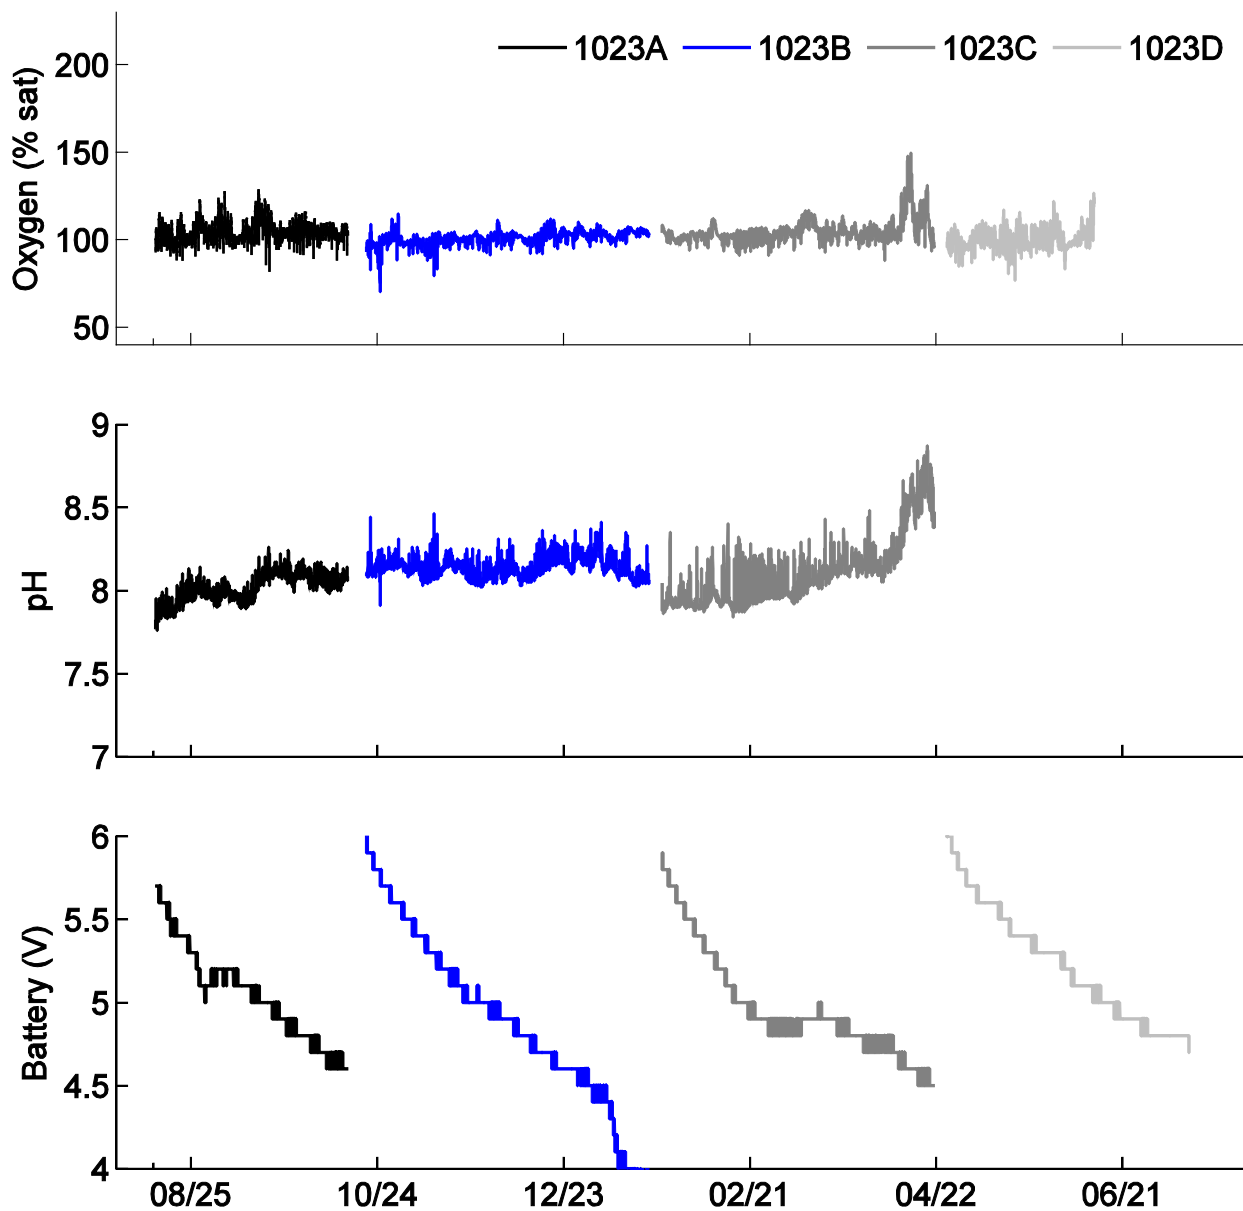
**Figure 50.** Graphs showing oxygen saturation, pH, and battery power from YSI EXO2 multiparameter sonde data at mooring 1023 (CB06) from August 13, 2014, to July 12, 2015. % sat, percent saturation; pH, pH unit; V, volt.

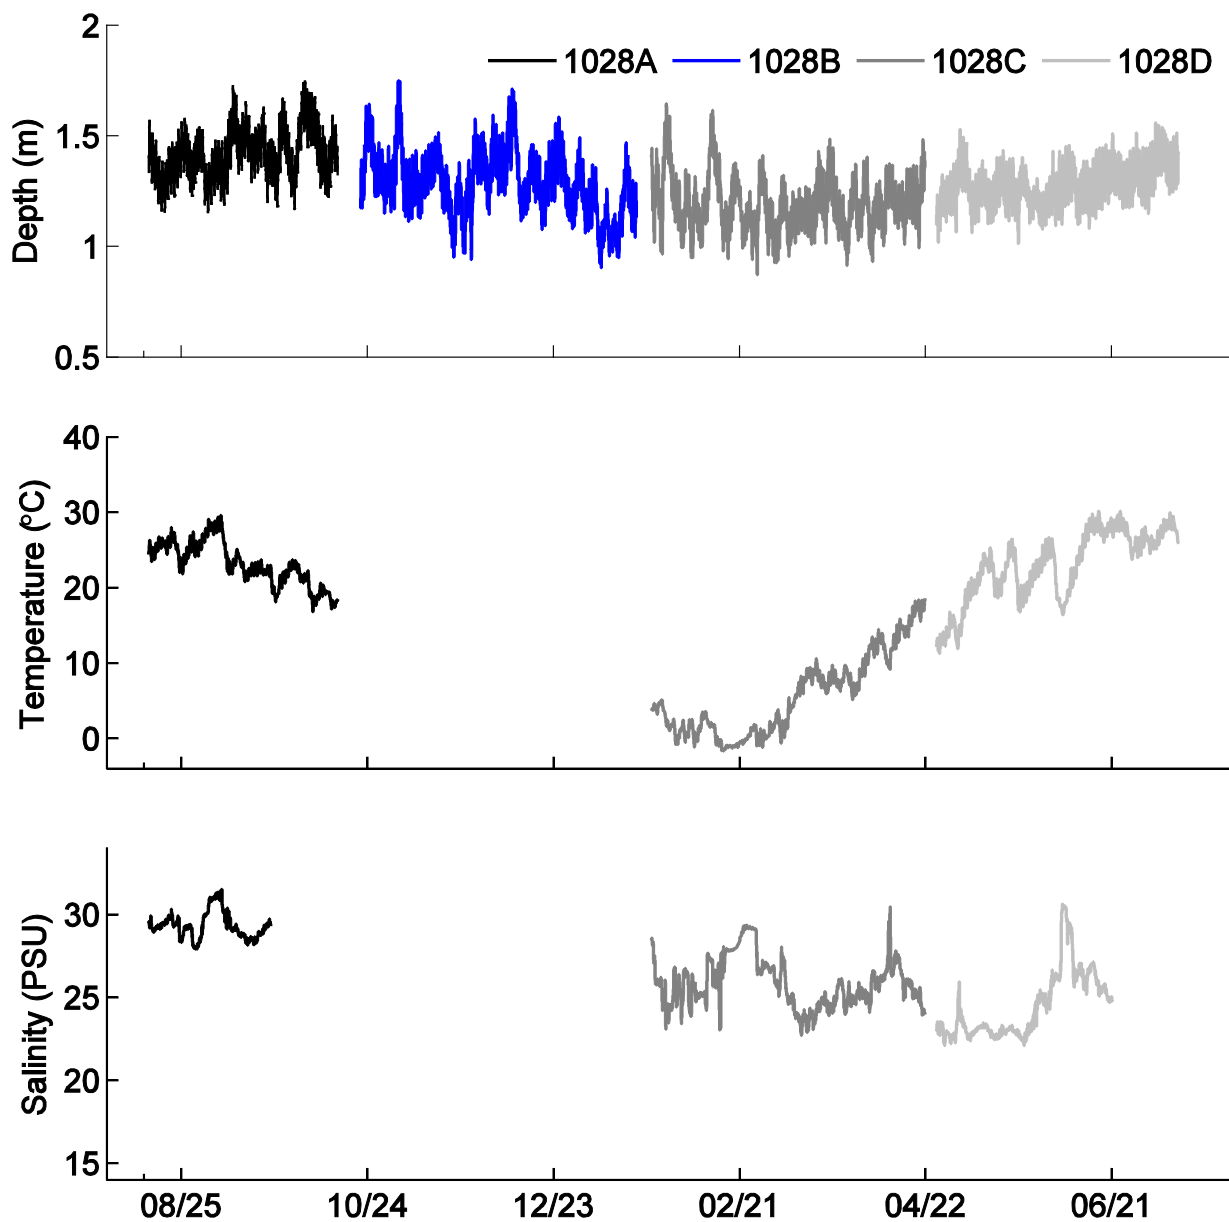
**Figure 51.** Graphs showing sensor depth, water temperature, and salinity from YSI EXO2 multiparameter sonde data at mooring 1028 (CB10) from August 14, 2014, to July 12, 2015. m, meter; °C, degree Celsius; PSU, practical salinity unit.

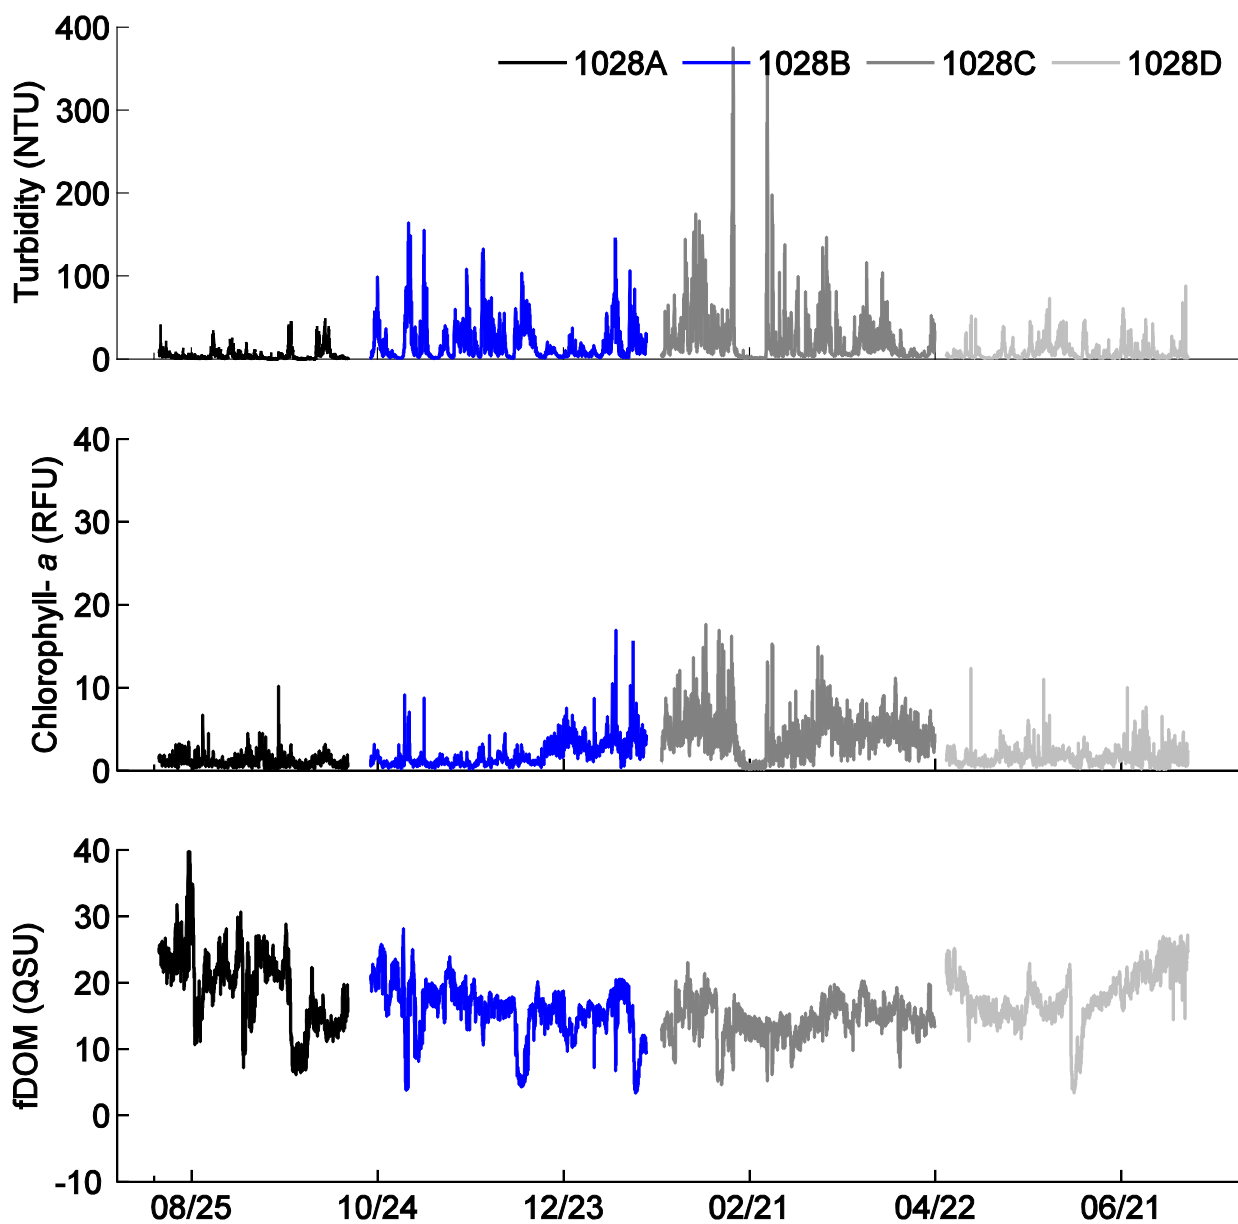
Figure 52. Graphs showing turbidity, chlorophyll-*a*, and fluorescent dissolved organic matter (fDOM) from YSI EXO2 multiparameter sonde data at mooring 1028 (CB10) from August 14, 2014, to July 12, 2015. NTU, nephelometric turbidity unit; RFU, relative fluorescence unit; QSU, quinine sulfate unit.

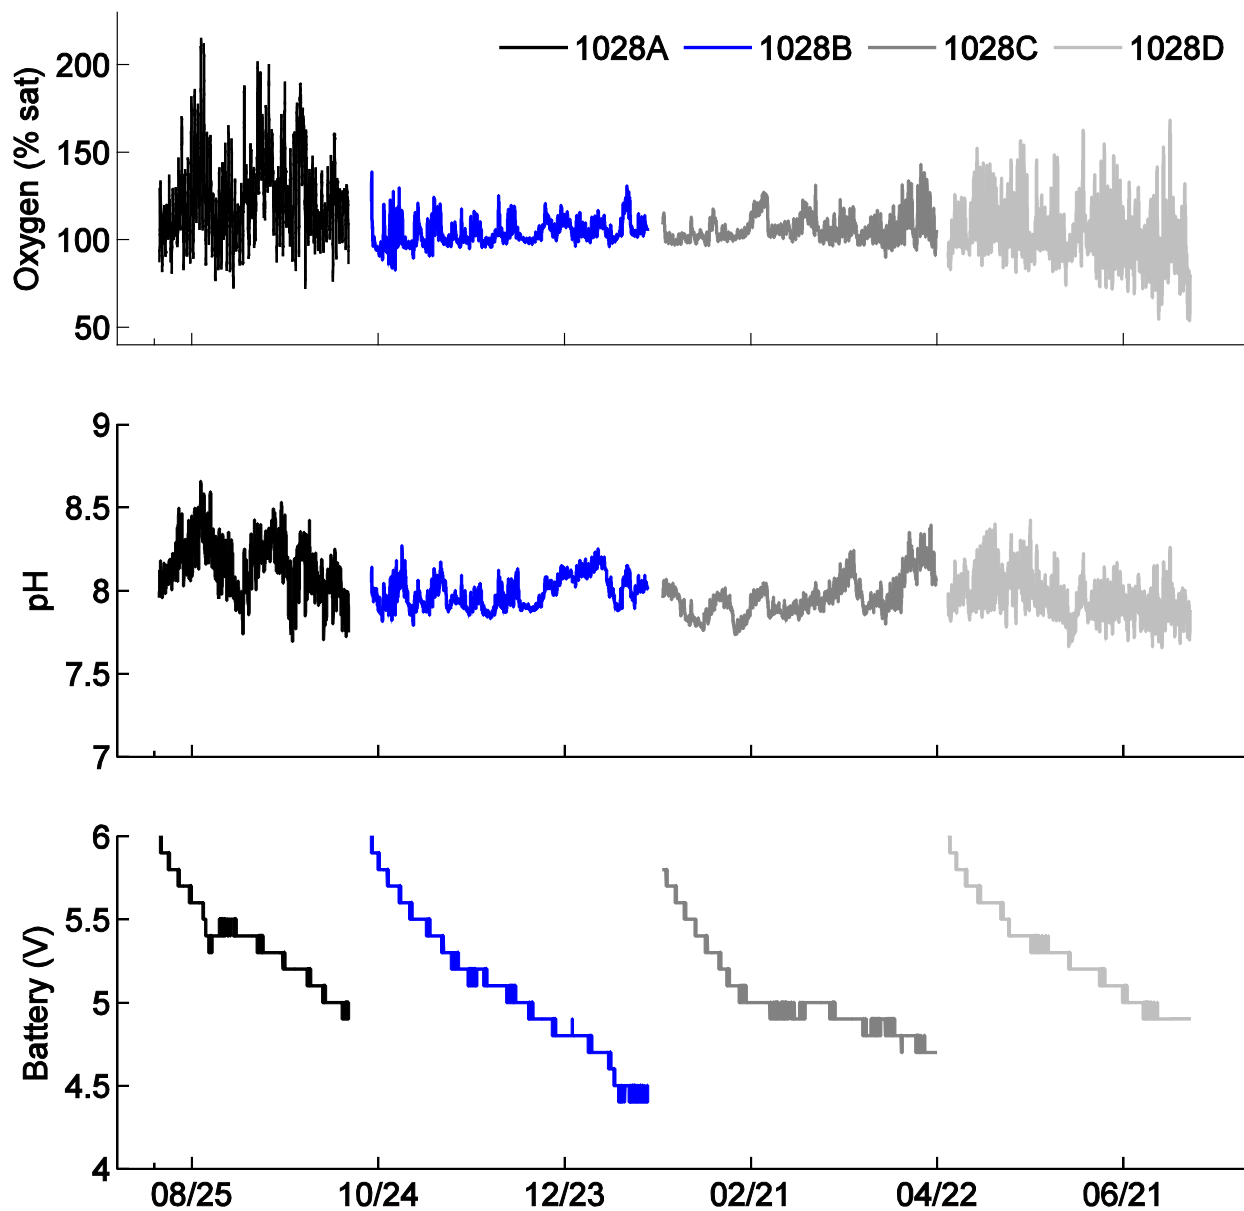
**Figure 53.** Graphs showing oxygen saturation, pH, and battery power from YSI EXO2 multiparameter sonde data at mooring 1028 (CB10) from August 14, 2014, to July 12, 2015. % sat, percent saturation; pH, pH unit; V, volt.

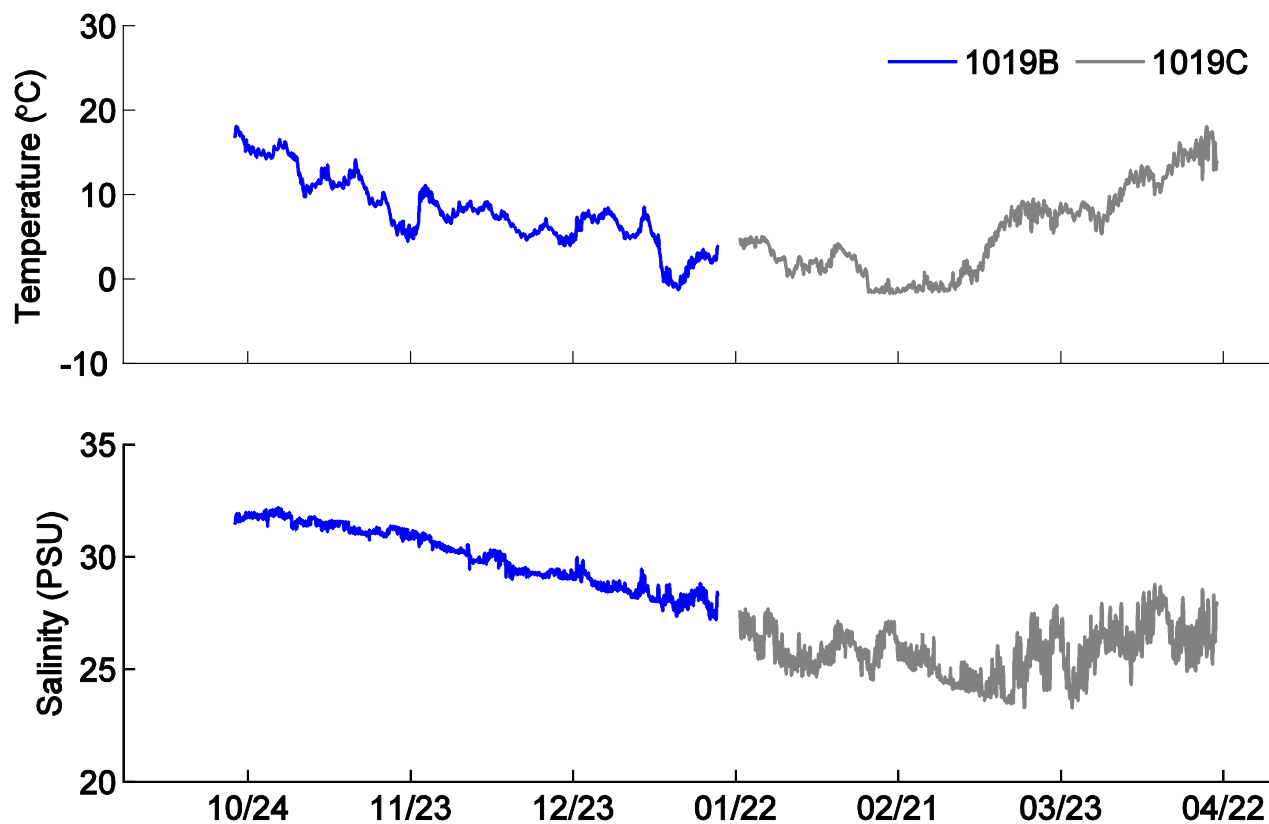
**Figure 63.** Graphs showing water temperature and salinity from Sea-Bird SBE 37–SM MicroCAT at mooring 1019 (CB02) from October 21, 2014, to April 20, 2015. °C, degree Celsius; PSU, practical salinity unit.

Sea-Bird SBE 37–SM MicroCAT instruments, measuring CT, were used for deployments 1019 (B and C), 1020B, and 1028B to provide temperature and salinity data where either a CT sensor on an EXO2 sonde had failed or the measurement was missing and deemed important. Figures 63–65 show the time series of water temperature and salinity from the MicroCAT deployments. These MicroCAT data can be compiled with the EXO2 data at these three sites for a more complete record of salinity and temperature.

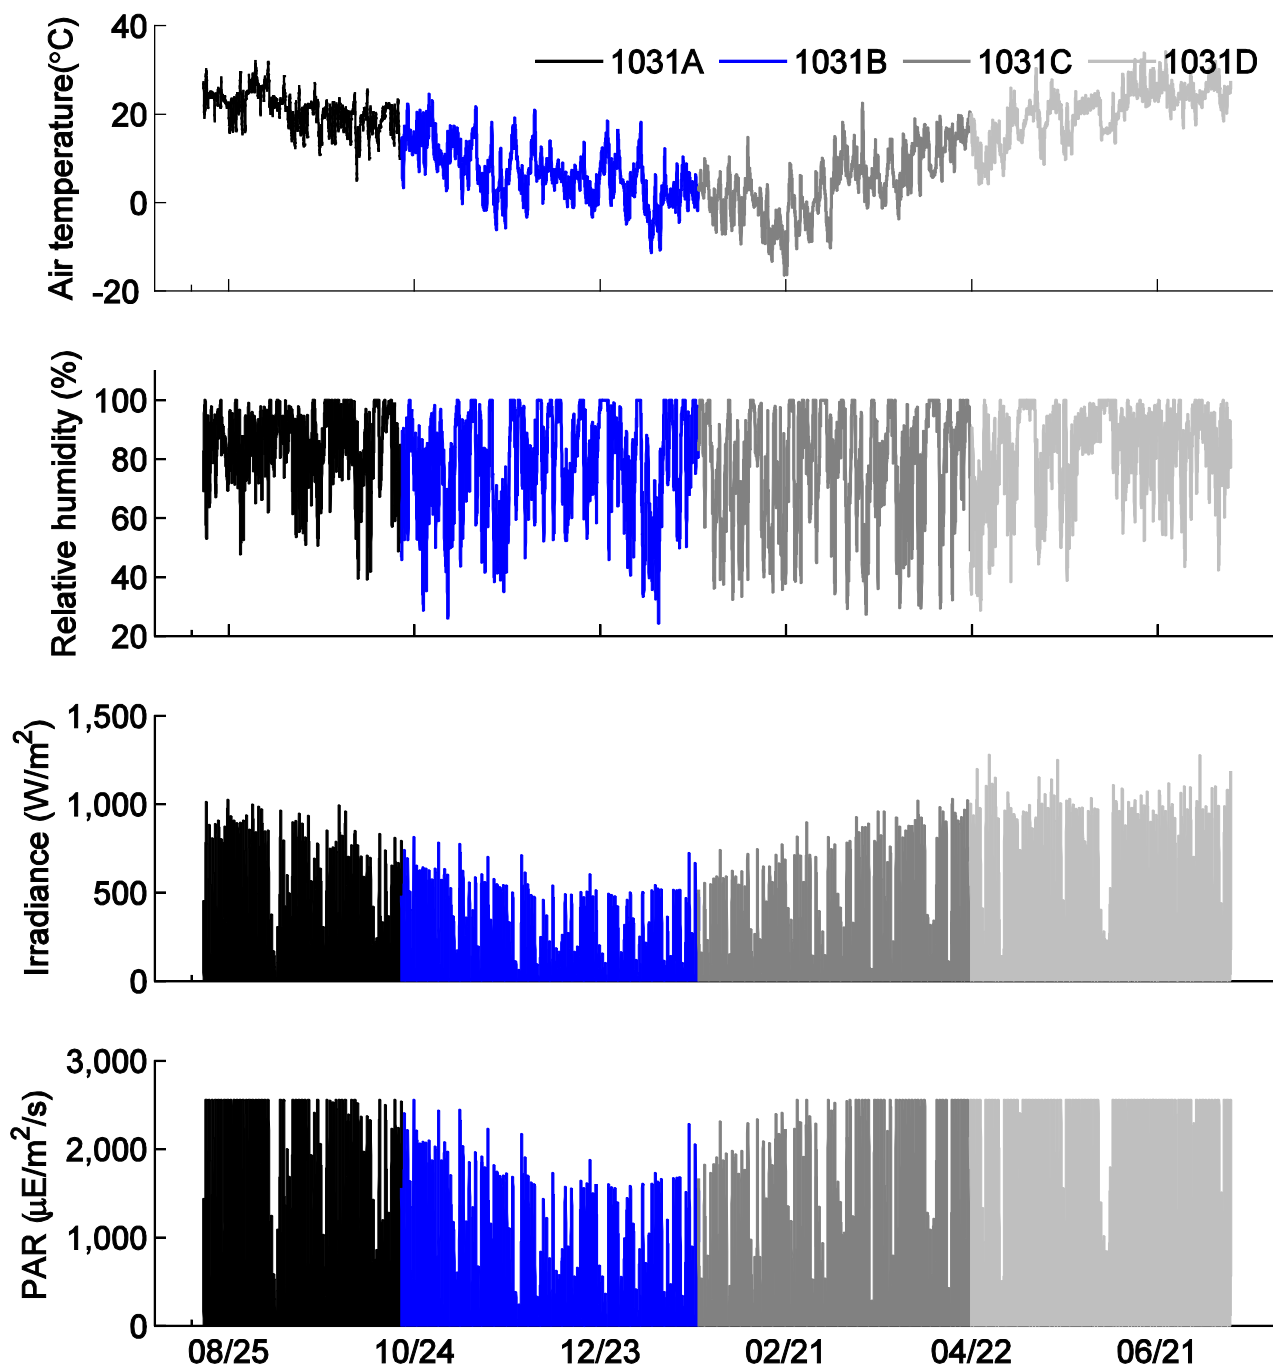
**Figure 74.** Graphs showing air temperature, relative humidity, solar irradiance, and photosynthetically active radiation (PAR) data from Onset Hobo U30 weather station at mooring 1031 (CBWS) from August 16, 2014, to July 14, 2015. °C, degree Celsius; %, percent; W/m<sup>2</sup>, watt per square meter; μE/m<sup>2</sup>/s, microeinstein per square meter per second.

The Onset Hobo U30 weather station, deployed on a private dock on the western side of Chincoteague Bay at Public Landing, Maryland (mooring 1031), provided a nearly complete, usable data record for the continuous period from August 16, 2014, to July 14, 2015 (fig. 70). Parameters measured were barometric pressure, wind speed and direction, air temperature, relative humidity, shortwave solar radiation (irradiance), and incident PAR (figs. 73 and 74). The ability to recharge its battery using a solar panel and the incremental offloading ability via a universal serial bus (USB) shuttle allowed the U30 to collect data without interruption, although the processed data were sectioned according to when the incremental download took place during each site visit for congruence with the other deployments. The maximum reading of the wind direction sensor is 355.2 degrees, and because a resolution of 1.4 degrees was used, this created a gap in measureable wind directions between 355 and 360 degrees (magnetic). Raw wind direction data were recorded in reference to magnetic north and then rotated to true direction in the postprocessing step(s). Barometric pressure data from 1031 were used to correct subsurface pressure data from other instruments used in this study. Wind speed and gust records from mooring 1031 show the presence of several moderate wind/storm events during the study. It should be noted that because of the weather station’s proximity to land with structures and wooded areas, it probably underrepresented the wind conditions in the open waters of Chincoteague Bay, especially when the wind was blowing offshore at the site (clockwise from south-southwest to north-northeast).
