# Decadal Changes in Channel Morphology of a Freely Meandering River—Powder River, Montana, 1975–2016

Open-File Report 2018–1012

U.S. Department of the Interior  
U.S. Geological Survey

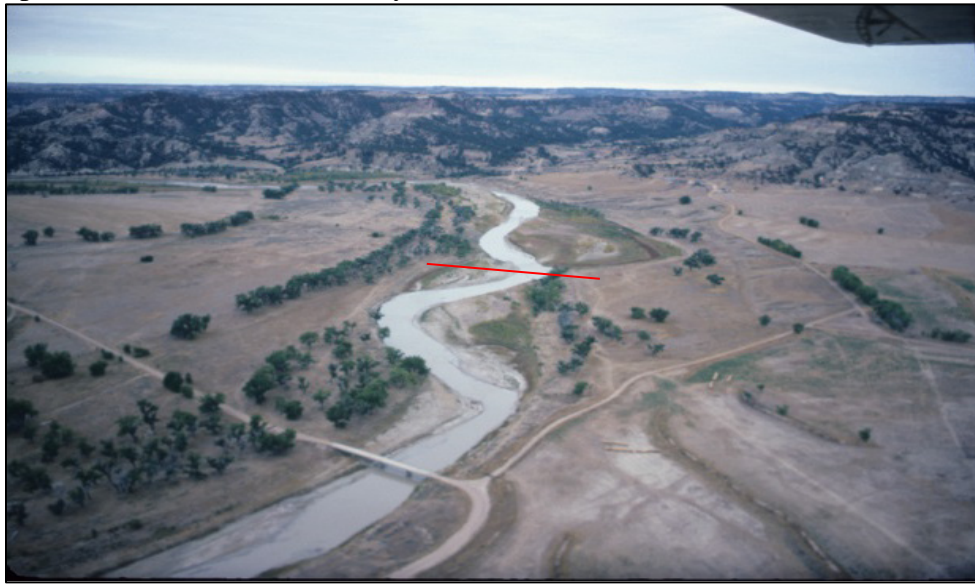
**Figure 4.** Aerial view of cross section PR113. The view is nearly due west, looking up the Powder River from just below the Moorhead Bridge. The approximate location of cross section PR113 is shown by the red line. Photograph was taken on September 22, 1989.

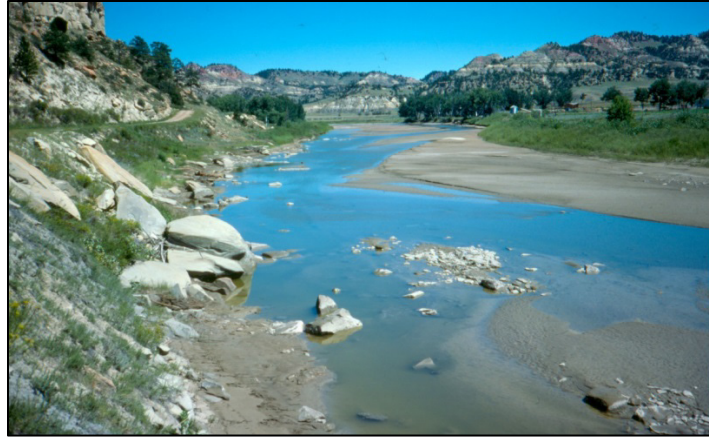
**Figure 11.** Downriver view of cross section PR116 taken on July 21, 1977. This was the site of the streamgaging station in 1977 and 1978 and shows the bedrock control of this exceptionally stable reach of Powder River.

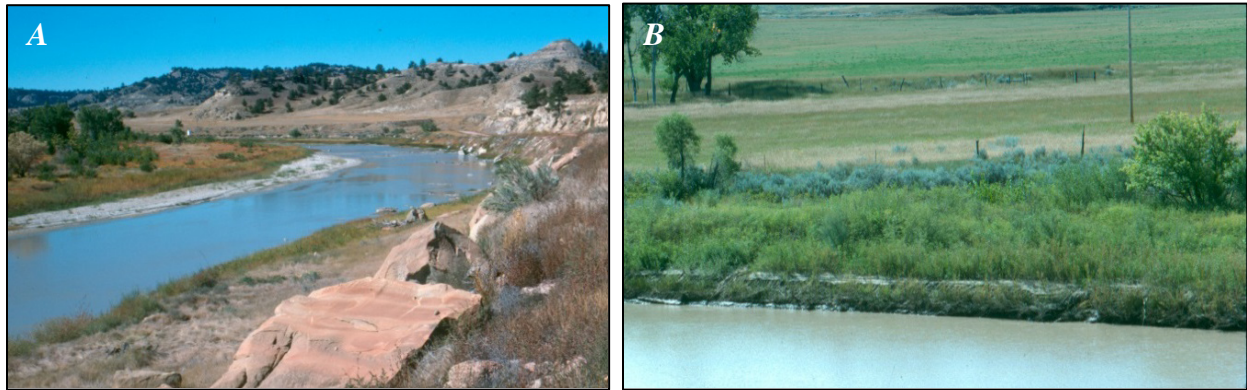
**Figure 13.** Views of cross section PR116 in 1989 and 1993. *A*, Photograph was taken on September 19, 1989 from the left bank looking upriver (camera man is standing on the line of section PR116). The white cylindrical structure on the left bank upriver, left of the center of the photograph, is the interim gage house for Powder River at Moorhead, Montana. Current gage house is now at Moorhead Bridge (fig. 4), about 1.8 kilometers upriver from the interim gage house. *B*, Newly deposited sand bench along the right bank just downriver from PR116. Flow is from right to left. Photograph was taken on August 25, 1993.

During the two decades following the flood of 1978, annual resurveys showed how the active river bed varied between net deposition one year and net erosion the next, at rates of only a few decimeters of vertical change, either up or down, from year to year. During the same two decades, the left terrace bank was eroded back at an average rate of 0.1 meter per year (m/yr), but the sediment was deposited as narrow benches (about 8 m wide) along each bank (fig. 13).

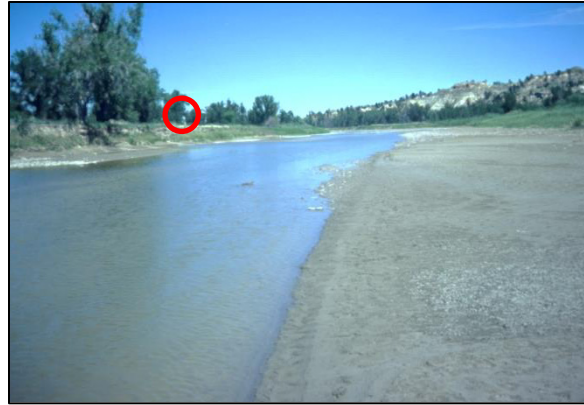
**Figure 15.** View downriver of cross section PR120 before the 1978 flood. Photograph was taken on July 21, 1977, with E. Meade (about 1.6 meters tall) standing on the line of section (inside the red circle).

Section PR120 crosses a gently curving reach of Powder River, about 0.3 km downriver of the mouth of Thompson Creek (fig. 1). The left bank of Powder River is developed on a Moorcroft-level terrace (Leopold and Miller, 1954) that covers most of the area locally known as “Reynolds Battlefield” (Moody and Meade, 2008; Vaughn, 1961; Hedren, 2016, p. 145–182) (fig. 15).

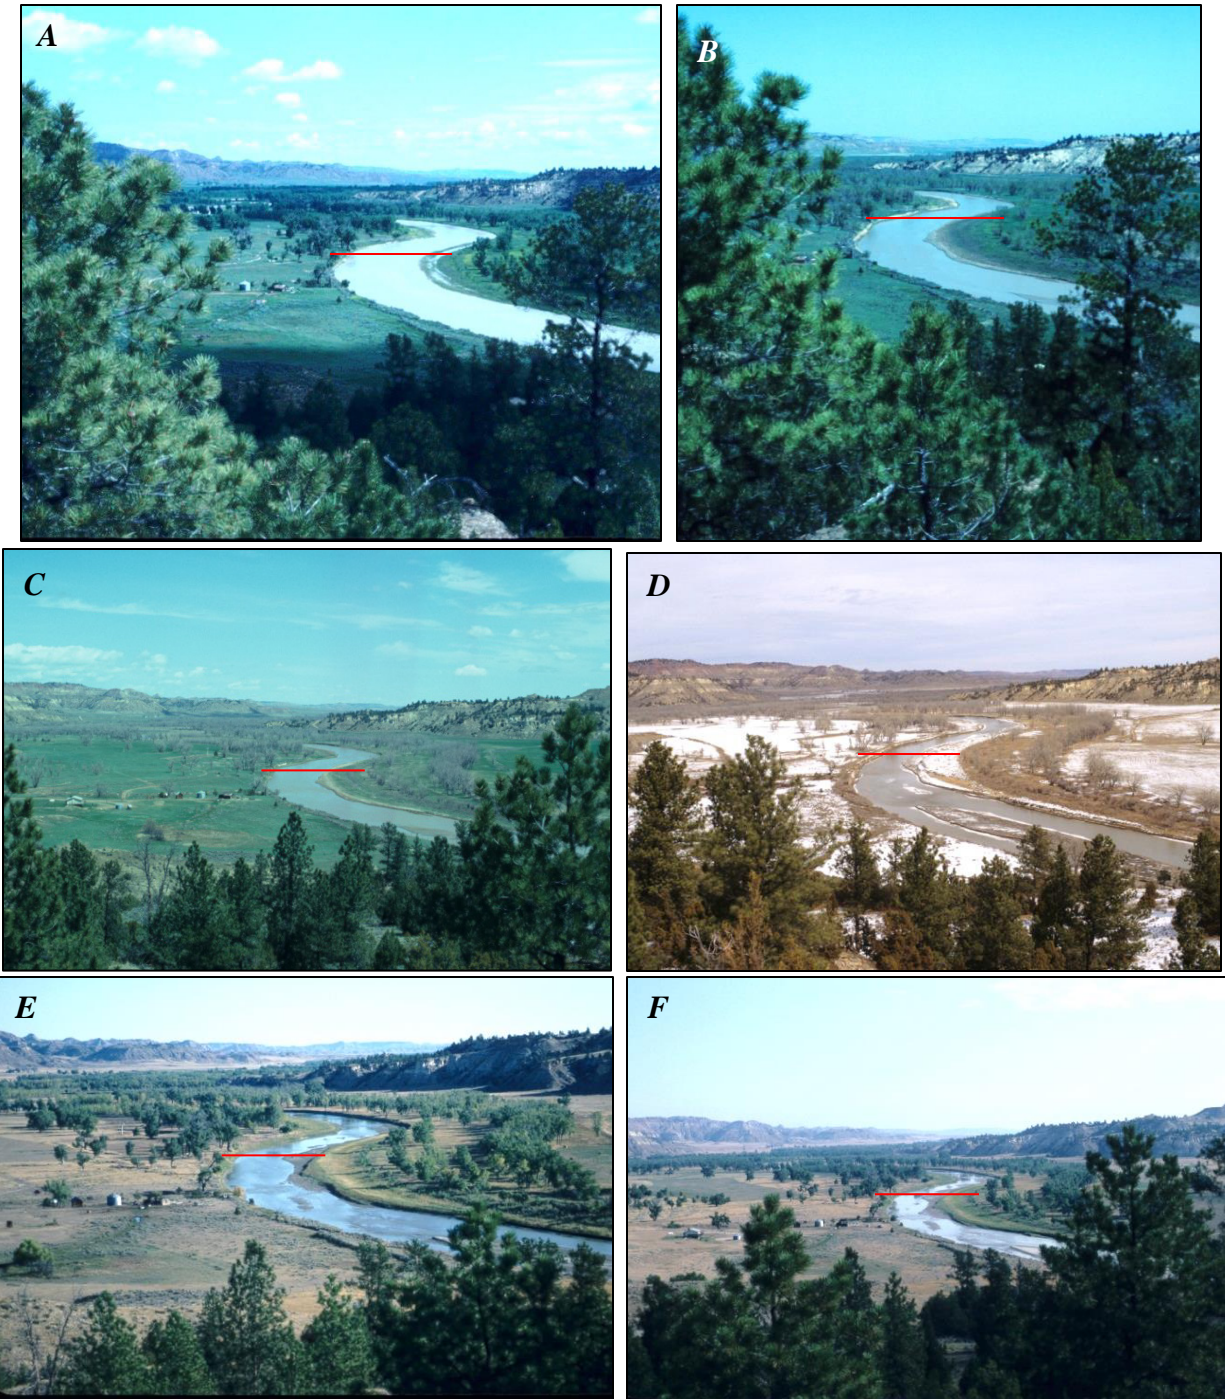
**Figure 18.** Views of cross section PR120 at different discharges. Red lines indicate the approximate line of section. *A*, Discharge is 170 cubic meters per second ( $\text{m}^3/\text{s}$ ) on June 9, 1993. Note the water in the trough between the new inset flood plain and the old bank (Lightning-level terrace) above and below the section. *B*, Discharge is 34  $\text{m}^3/\text{s}$  on May 13, 1993. *C*, Discharge is 17  $\text{m}^3/\text{s}$  on May 9, 1994. *D*, Discharge is 3.1  $\text{m}^3/\text{s}$  on March 10, 1995. *E*, Discharge is about 1.5  $\text{m}^3/\text{s}$  on September 24, 1994. *F*, Discharge is 0.23  $\text{m}^3/\text{s}$  on August 23, 1994.

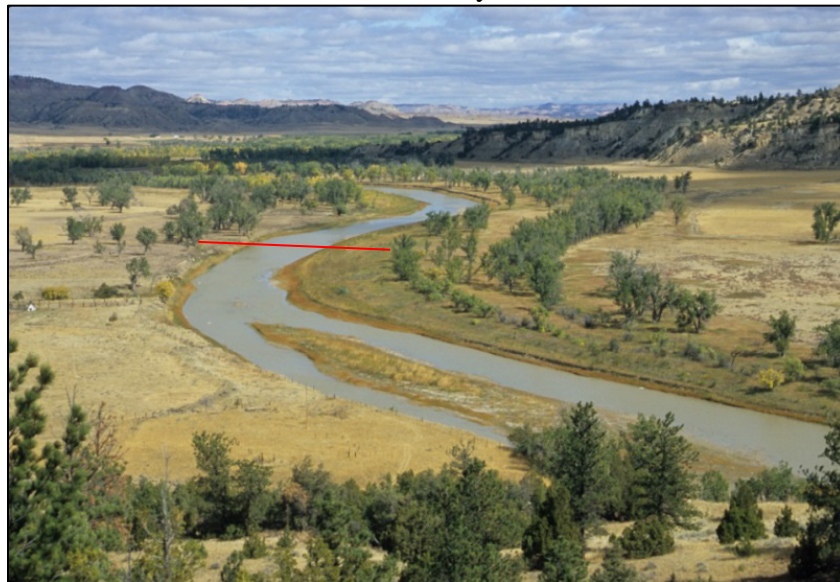
**Figure 20.** Downriver view of cross section PR120 was taken on September 27, 2006.

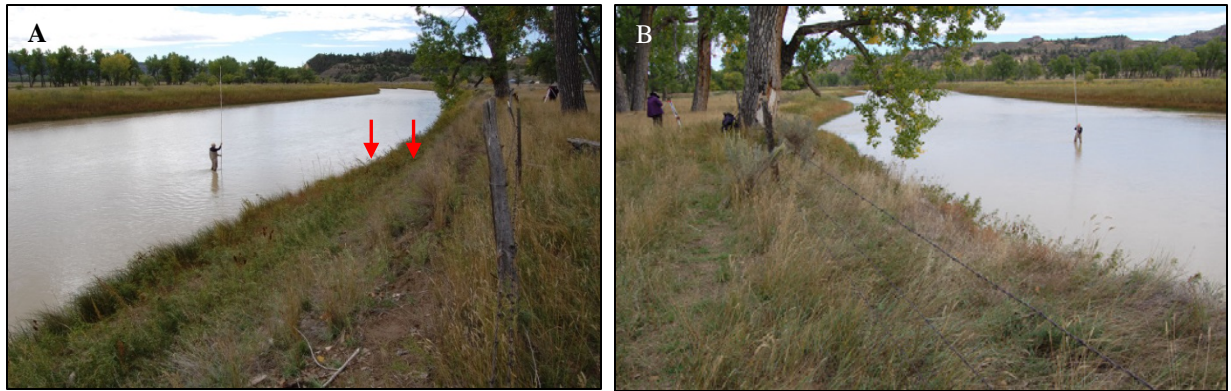
**Figure 21.** Upriver and downriver views of cross section PR120 on September 28, 2013. A, View is upriver. A narrow bench (approximately 2 meters [m] wide) below the top of the left bank is shown by the red arrows (also see fig. 41). J. Moody (1.9 m tall) is standing on the line of section in Powder River. The edge of the 2-m high flood plain along the right bank is now at about station 50, whereas in 2001 it was about at station 58. B, View is downriver and J. Moody (1.9 m tall) is standing on the line of section in Powder River.

During the last decade (judging from surveys done in 2001, and 2012 through 2015) the width of the low-water channel has decreased. The right-side flood plain has expanded leftward by another 6 m as a bench, and an additional bench (approximately 2 m wide) has been built along the base of the cut bank (Page and Nanson, 1982; fig. 41) further decreasing the width of the low-water channel at section PR120 (figs. 20 and 21). The low-water channel width in 2016 was less, by some 10–15 m, than it was in 1977, the year before the flood of 1978.

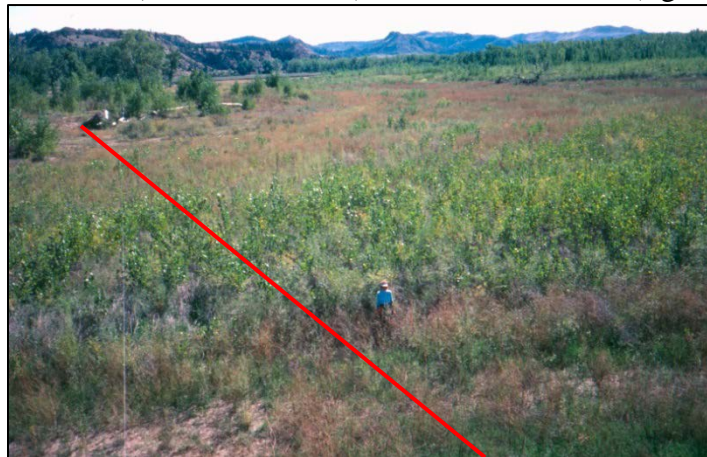
**Figure 26.** New vegetation growing in the cutoff at cross section PR122 on September 17, 1982. The taller vegetation is a band of cottonwood trees about 4 years old. S. Stewart (about 1.7 meters [m] tall) is 6 m upriver from station 30. Red line shows the approximate line of section.

The meander bend that includes section PR122 was cut off at its neck by the flood of 1978 (figs. 11 and 12 of Meade and Moody, 2013). But before the neck of the bend was breached, the flowing flood waters had already eroded the bend crest, removing a 7-m width of deltaic fan material from the left bank at section PR122, and adding a thickness of 0.5–1.0 m of new sand across a 40-m width (stations 20 to 60) of the river channel (fig. 26).

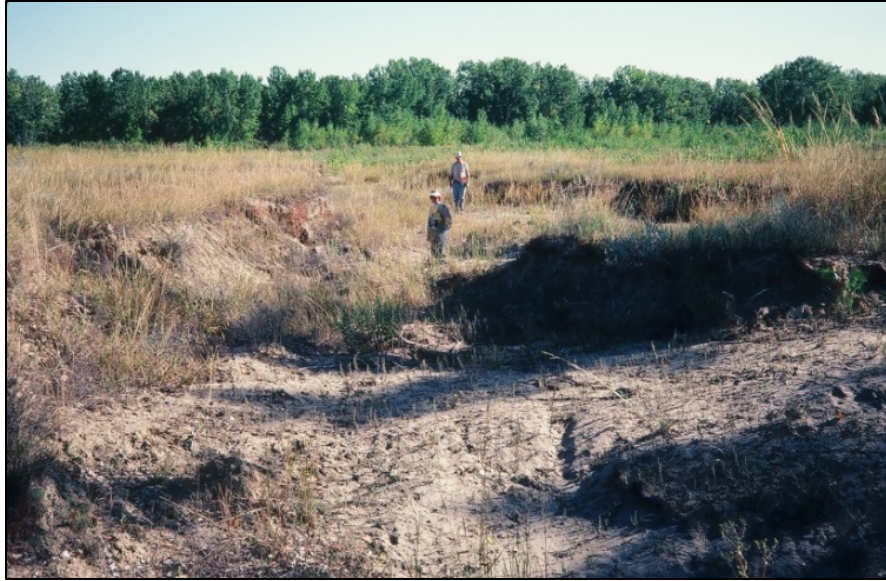
**Figure 30.** Headcut at cross section PR122A on September 21, 1982. View is down valley through the headcut that crosses section PR122A near station -35. S. Stewart (about 1.7 meters [m] tall), in the middle ground, is standing on the line of section and M. Karlinger (about 1.8 m tall) is standing downriver of the section.

As the flood of 1978 flowed across the neck of the bend, several gullies formed on the downstream bank of the meander neck (fig. 30) and began cutting their way headward across the neck. One of these eventually succeeded in breaching the neck and in diverting the main flow of the flood waters (fig. 8 of Gay and others, 1998; figs. 11 and 12 of Meade and Moody, 2013). Because the cutoff was completed late in the flood, the width of the new channel remained fairly narrow—45 m on the line of section (fig. 31).

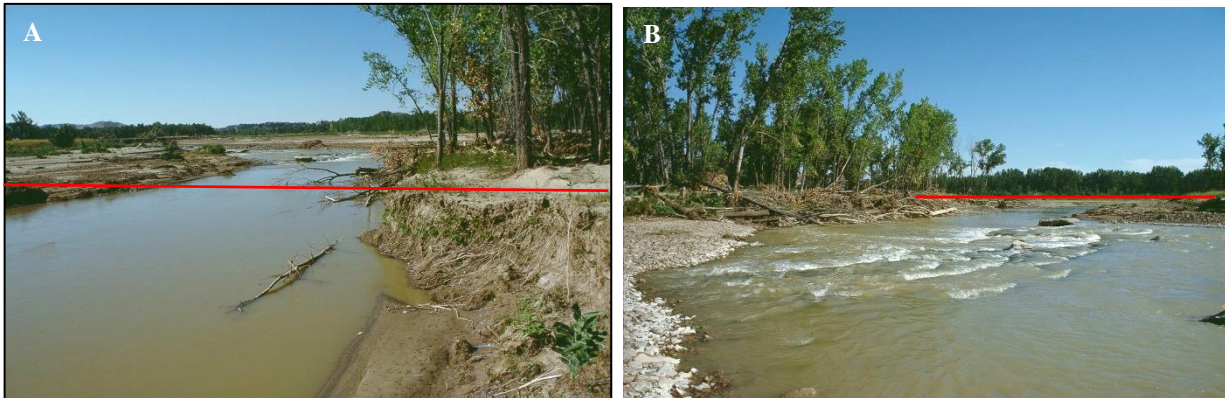
**Figure 31.** Views through the cutoff at cross section PR122A on September 4, 1978. Red lines show the approximate location of cross section PR122A. *A*, View is upriver through the cutoff showing the bedrock rapids in the new channel formed during the flood of 1978. *B*, View is downriver of the bedrock (coal) rapids.

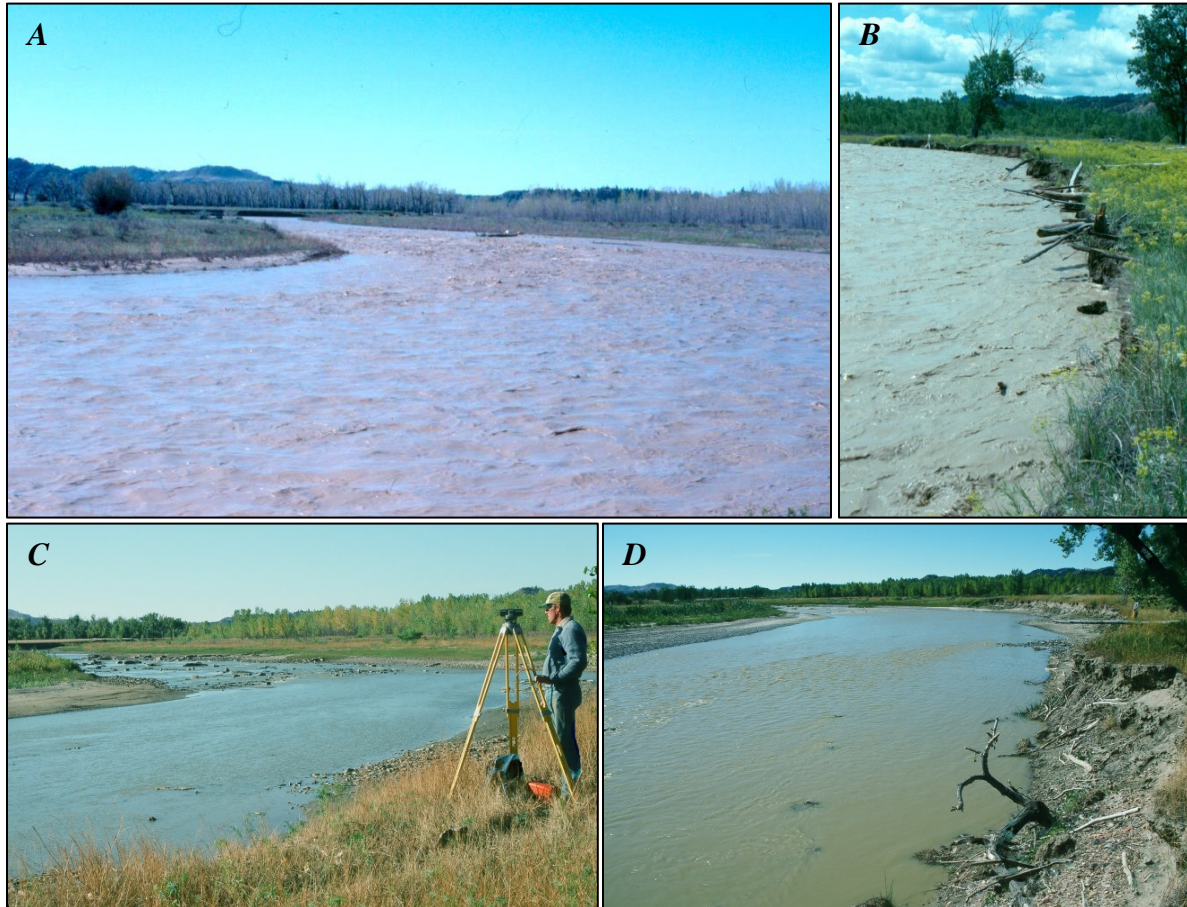
**Figure 33.** Upriver views of the location of cross section PR122A. *A*, Photograph was taken on May 10, 1993, about 30 meters (m) upriver from the location of cross section PR122A to show the bedrock rapids at higher flow (daily mean discharge was 76.2 cubic meters per second [ $\text{m}^3/\text{s}$ ] at Moorhead Bridge upriver) than in figure 32. *B*, Photograph was taken on June 9, 1993. Tripod was on the line of section, water level was 1008.9 m above sea level (NGVD 29), and the daily mean discharge at the Moorhead Bridge was 157  $\text{m}^3/\text{s}$ . *C*, Photograph was taken on September 25, 1994. J. Moody and tripod are near the line of section. Right edge of water is at station 45.5 and top of berm is at about station 65. *D*, Photograph was taken on September 26, 1995, and J. Moody is on the line of section.

Between 1979 and 1985 the bank-to-bank width of cross section PR122A increased from 45 to 62 m without much consistent deposition of sediment. In 1985 and again in 1987, layers of sand (0.1–0.6 m thick) were deposited between stations 43 and 76 (fig. 33); and then in 1989, an ice break-up flood deposited additional sand and gravel between stations 50 and 75, and this became the foundation of the point bar (Moody and Meade, 2014). More sediment was added to the point bar in 1990, 1993, and 1995, while the channel continued to widen to 90 m (double its initial postflood width) by 1999 (fig. 33).

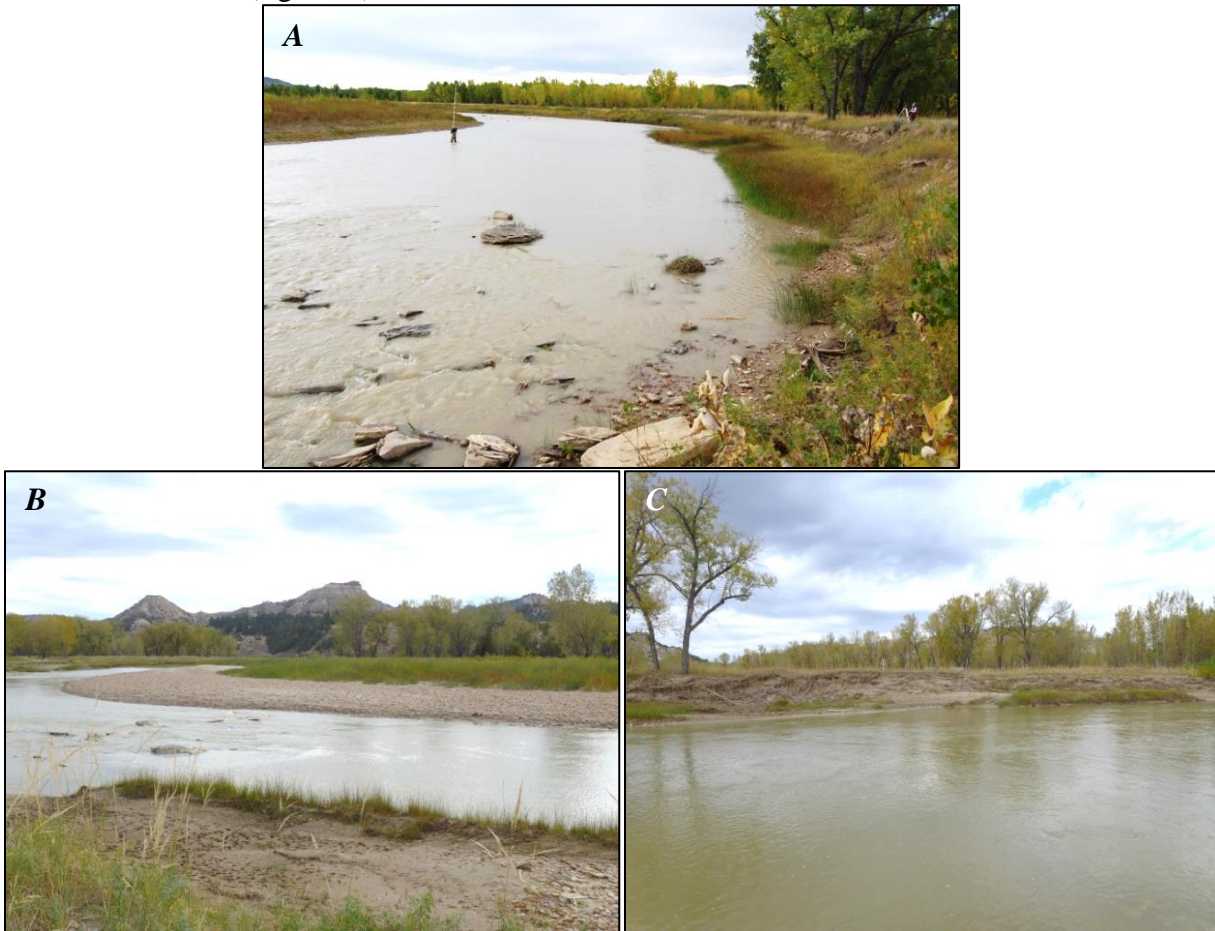
**Figure 34.** Views of cross section PR122A in 2013 and 2015. *A*, Photograph was taken on September 29, 2013, looking upriver. J. Moody with the leveling rod is on the line of section near station 15, which is where the edge of the left bank stood in 1984. In 1979, the edge of the left bank stood at station 31, which is now the approximate right edge of water in the photograph indicating nearly 50 meters of lateral bank erosion during 1979–2013. *B*, Photograph was taken on September 28, 2015, looking downriver from the left bank near the line of section. A substantial amount of gravel was deposited by the snowmelt floods in 2015 riverward of the point bar along the right bank. *C*, Photograph was taken on September 28, 2015, looking along the line of section toward the left bank (tripod is on the line of section).

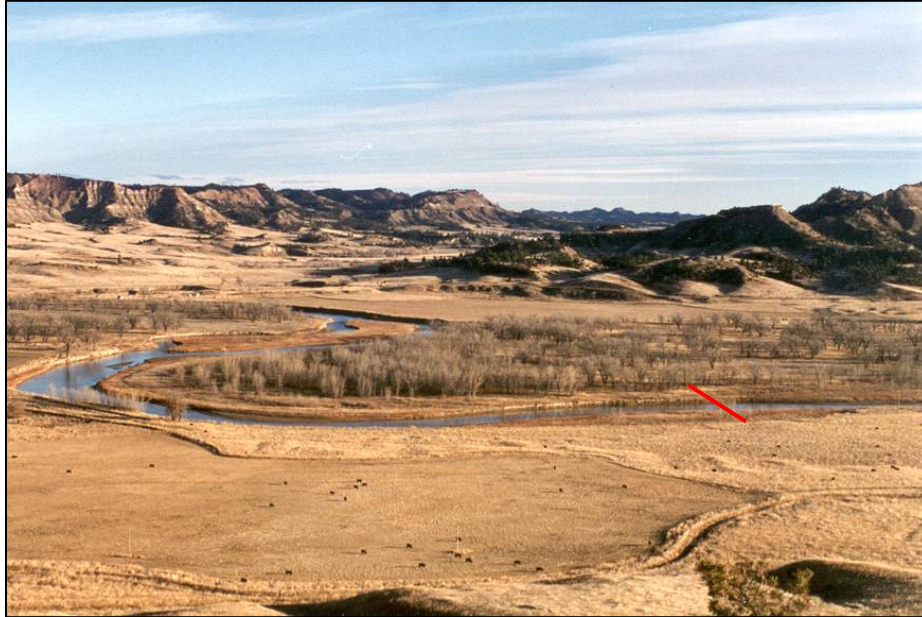
**Figure 36.** Elevated view of cross section PR125 in May 1996. View is eastward across Powder River valley, and Powder River is flowing from right to left in the channel in the foreground. Approximate location of PR125 is shown by the red line. The surface with grazing cattle is the top of the Moorcroft-level terrace.

Cross section PR125 is about 1.5 km down Powder River valley from the point where the channel of Flood Creek enters the left side of the valley (fig. 1). The section is near the crossover point of a large bend in Powder River (fig. 36). The left bank of the channel is formed by the flood plain surface developed after the flood of 1978 (Moody and others, 1999), which steps upward onto a piece of the Moorcroft-level terrace. The right bank is a Lightning-Moorcroft-level terrace (Moody and Meade, 2008).

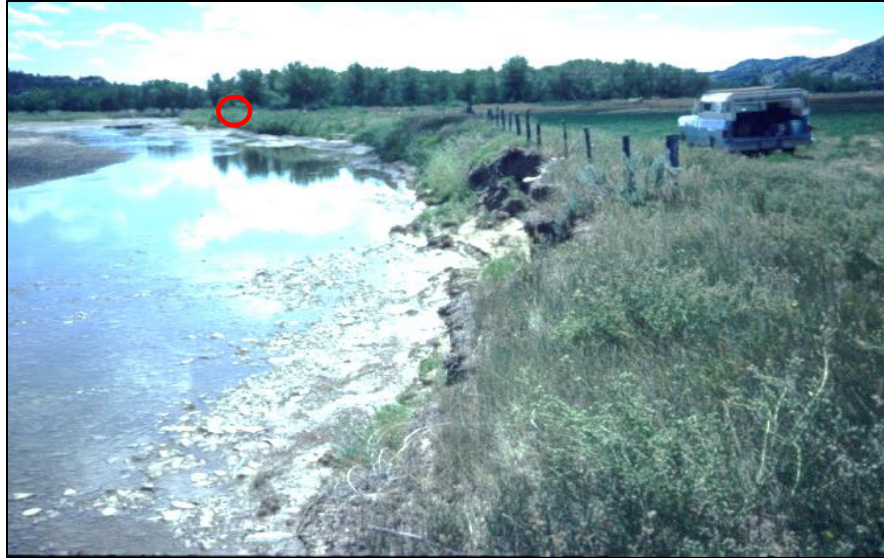
**Figure 37.** Upstream view of cross section PR125 on July 22, 1977. The cut bank is on the left side, and E. Meade (about 1.6 meters tall) is standing on the section in the red circle.

The flood of 1978 produced one massive change in section PR125: a shift in the lateral arrangement of the channel from cut bank on the left side and point bar on the right (fig. 37) to cut bank on the right and pointbar on the leftside. The thalweg of the river channel here shifted, during 2 weeks of flood flows in May 1978, some 70 m toward the right bank. This lateral shift seems to have been produced by the downriver transport of a large gravel bar (some 40 m wide and about 1 m in thickness; figs. 14 and 15 of Meade and Moody, 2013) toward the left bank. Bank erosion during the flood of 1978 amounted only to 3 m of cutback of the right bank. The combination of large (70 m) thalweg shift and small (3 m) cut bank erosion was probably a result of section PR125 being near the inflection point (or, more likely, in the inflection zone) between the downriver limb of one meander bend and the upriver limb of the next meander bend downstream.

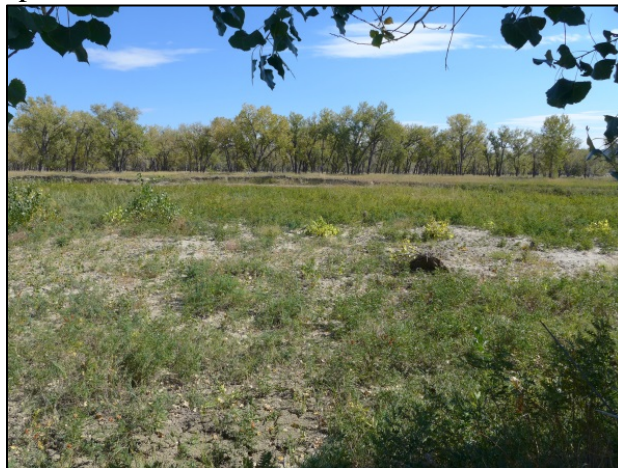
**Figure 40.** Photograph of the newly deposited sediment in 2015 on the inset flood plain at cross section PR125. Photograph was taken on September 27, 2015, and shows sediment deposited during the snowmelt floods in May 2015. Most of the sediment is in the form of lee dunes deposited downstream from clumps of vegetation. The view (looking toward the right bank, which is at about station 104) encompasses the inset flood plain starting at about station 12 in the foreground.

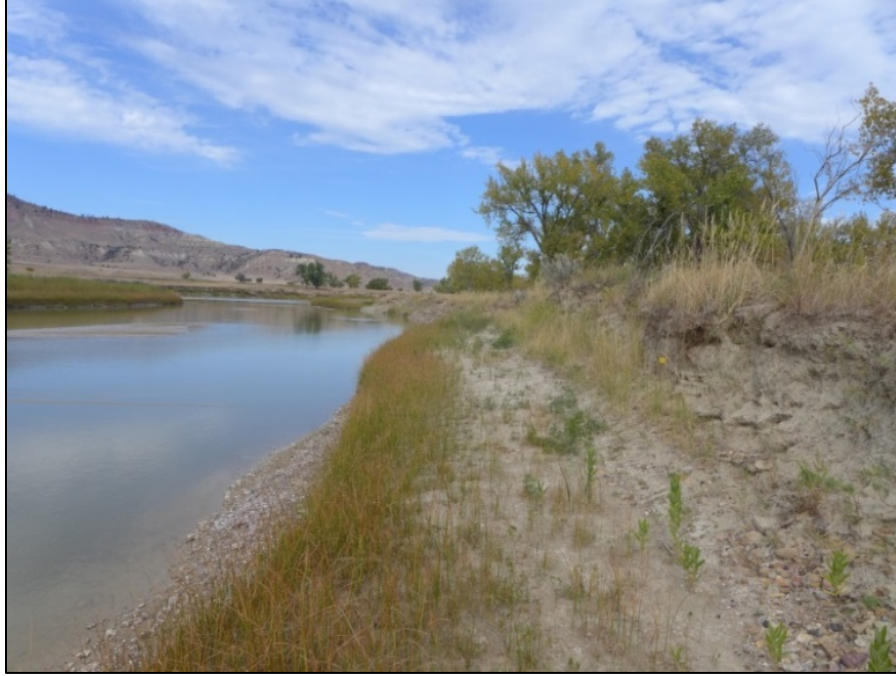
**Figure 41.** Photograph of a developing bench along the right bank of cross section PR125. The view is downriver and was taken on September 27, 2015. It shows the most recent (2015) sediment deposit that forms the top of the bench at the base of the right bank. The bench is about 2 meters wide. Green sedges have red tops at this time of year and usually colonize the banks starting at the level of the bed-full discharge (12 cubic meters per second; Moody and others, 1999).

A small bench (Page and Nanson, 1982) was first noted at the base of the right bank in our survey of 2011 (fig. 41). Because we did not survey section PR125 between 2001 and 2011, we can only surmise that the bench may have begun to form as early as 2008 or 2006. This bench has continued to accrete and is now (2015) about 2 m wide. The riverward edge is vegetated by sedges (fig. 41).

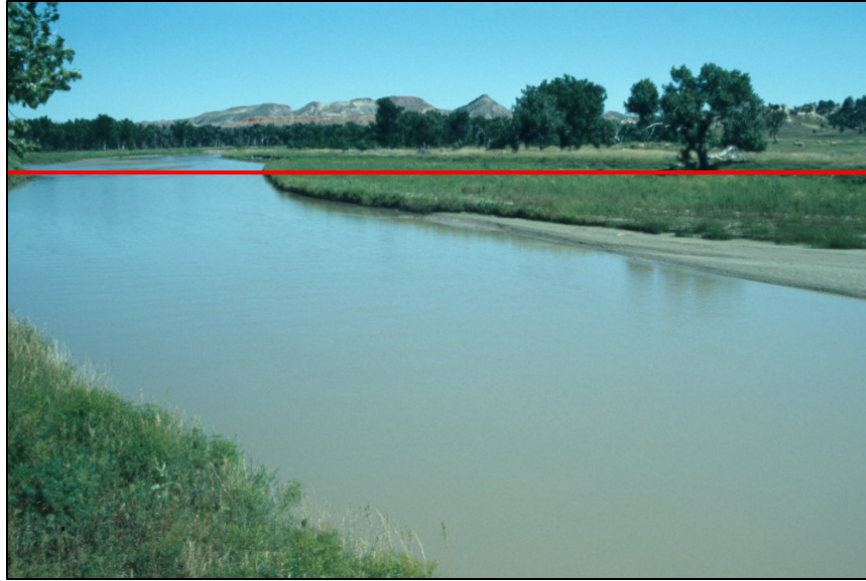
**Figure 52.** Downriver view of cross section PR136 on August 27, 1993. A secondary channel exists between the tree on the right bank just downriver from the line of section (shown by the red line drawn at the elevation of the top of the island) and the vegetated island seen in the upper center of the photograph.

This island was mainly new flood plain that was raised again in 1993 (fig. 52) along both edges as levees increased in height by 0.1–0.2 m. During the annual snowmelt flood of 1995 sediment was deposited and raised the entire island an additional 0.2–0.4 m (Moody and others, 1999). Some sediment deposition was the result of local ice jams leaving blocks of ice on the flood plain and sediment filling in around the blocks (fig. 53A).

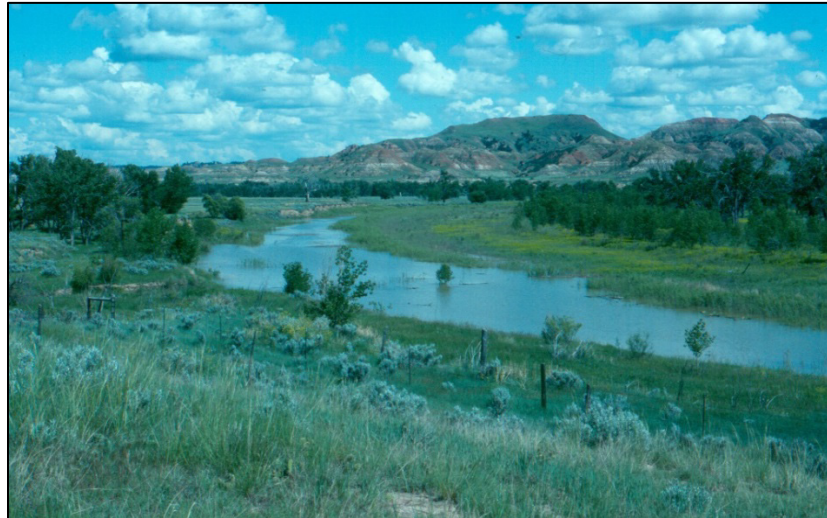
**Figure 59.** Downriver view of the oxbow lake near cross section PR141 on June 9, 1993. Photograph was taken northeastward from the same bluff-top locality as the southeastward-looking photos in figures 57–59. The view is 0.5–1.0 kilometer downriver from cross section PR141, which is not visible. The channel of Bloom Creek enters the abandoned Powder River channel in the group of cottonwood trees at the left edge of the photograph. Water filled and connected the oxbow lake to the main channel during high flow in 1993.

Little geomorphic change has been recorded in the large oxbow channel of Powder River that was cut off here by the flood of 1978. Repeated upriver-looking photographs (taken from a point about 300 m downriver from section PR141 in the abandoned channel) show little change over the years (fig. 58). Some annual floods have refilled the channel and presumably deposited some fine suspended sediment (fig. 59).

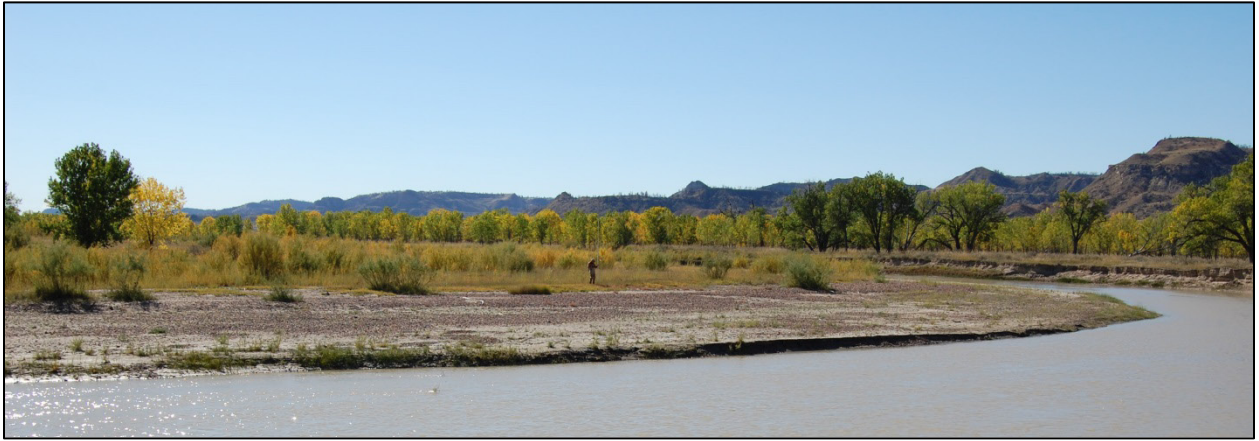
**Figure 63.** Upriver view of the point bar at cross section PR141A on October 1, 2013. This point bar has formed since the flood of 1978. J. Moody (about 1.9 meters tall) is standing on the line of section at station 20, which was the location of the left-side cut bank in 1979 and is now the location of the third scroll bar. The second scroll bar is centered at about station 38, and the first scroll bar is at station 80 where the cottonwood tree with yellow leaves is growing (left side of photograph).

Early large changes at cross section PR141A were erosion of about 14 m of the left bank recorded in 1984, and the erosion of the right bank in 1986. Between 1987 and 1995 there were a series of overbank deposits on top of the right bank landward of station 80 (fig. 63). Evidence of the first scroll bar in section PR141A is in the cross-channel profile surveyed in 1992 between stations 70 and 90. Successive higher deposition after 1992 built up the first scroll bar, which consisted of mostly very fine sand and silt. Sometime during these depositional and erosional events, a cottonwood tree sprouted and grew on the crest (near station 80) of this scroll bar

The foundation of the second scroll bar was laid down in 1994 between stations 26 and 46 (fig. 63). In 1995, an approximately 14-m width of old Lightning-level terrace was eroded from the left bank (39.6 m<sup>3</sup> per meter of bank), which was nearly balanced by 10.5 m<sup>3</sup> per meter of new flood plain deposition and 26.9 m<sup>3</sup> per meter of new point-bar deposition between stations 18 and 48 (Moody and others, 2002; fig. 3 of Moody and Meade, 2014). The scroll bar may have formed by the process of rapid channel expansion and subsequent deposition of sediment near a separation zone along the opposite bank (a process described by Nanson, 1980). The scroll bar was further increased in height by sediment deposition in 1996.

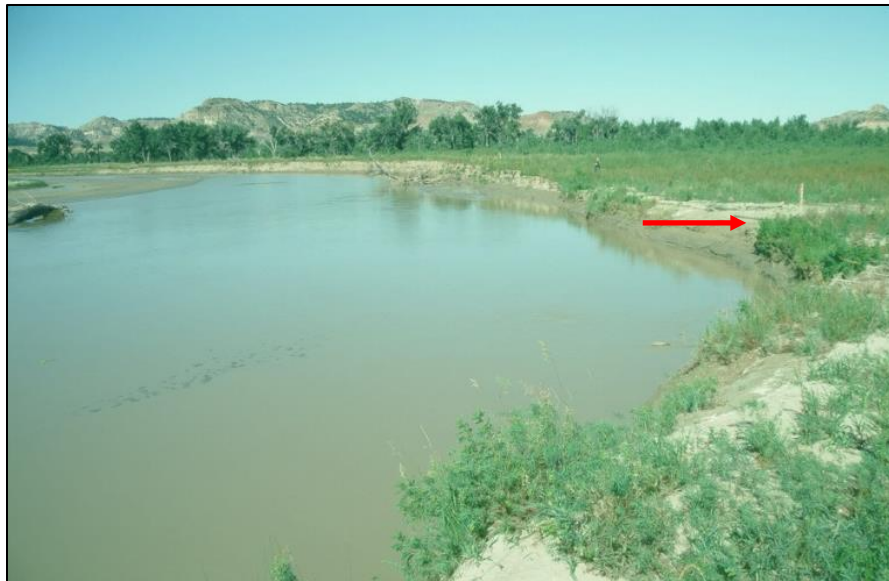
**Figure 64.** Upriver view of the left bank at cross section PR141A on August 28, 1993. The yellow tripod is a few meters upriver from the line of section. The new mouth of Bloom Creek is indicated by the red arrow.

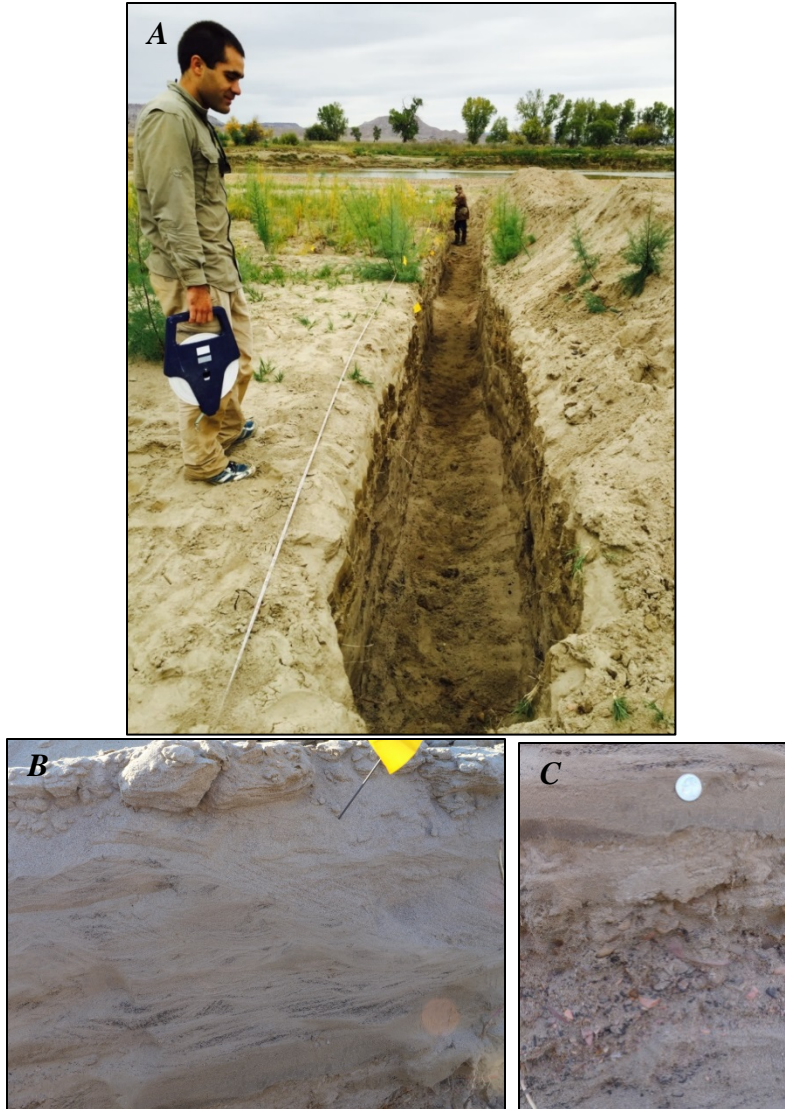
**Figure 68.** Photographs of a trench dug at cross section PR141A on October 3, 2015. Trench was dug along a cross-channel line 2 meters (m) downriver from the line of section for PR141A. *A*, View is from the right bank towards the left bank. *A*. Torres (about 1.7 m tall) is standing at about station 36, and J. Held (about 1.7 m tall) is standing in the distance near station 20. *B* and *C*, These two close-up photographs indicate some of the sedimentary structures and the range of particle sizes. Diameter of the wire holding the yellow flag in *B* is about 2 mm, and the coin in *C* is a quarter.

In 2015, an exploratory trench was dug by hand across part of the point bar on the right bank. It was 2 m downriver from cross section PR141A and between stations 18 and 40 (fig. 68). This trench cut through sediments forming the third scroll bar at about station 20 and through a channel (between the second and third scroll bar), which was partially filled by sediment deposited in 2011 ( $178 \text{ m}^3/\text{s}$ , June 1, 2011). Accretionary surfaces in this short trench were fragmented rather than being continuous (Torres, 2016). In 2016, a second, longer trench was dug using a backhoe between station 0 and 80. Comparison of the accretionary bodies indicates the some corresponded to chronostratigraphic units defined by the annual resurveys of the cross section, whereas others represented the accretion from several floods within 1 year or from several years (Warwick and others, 2016).

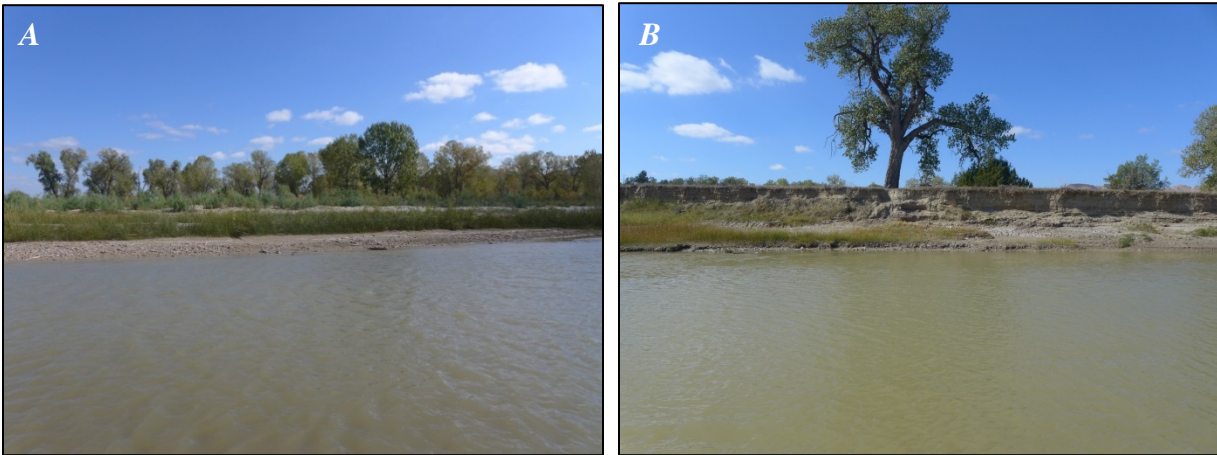
**Figure 70.** Views of cross section PR141.7 on September 29, 2015. *A*, View is of the left bank where ice floes deposited sediment in 1994. Flow is from left to right. *B*, View of the right bank. Flow is from right to left. Cross section PR141.7 ends about 1.0 meter upriver from the large cottonwood tree on the right bank.

This cross section was resurveyed annually from 1993 to 1998, and then after a 14-year hiatus, in 2012, and again in 2015 and 2016 (fig. 70). Estimates of the flood-plain elevations in 1993 were made in 1994 by digging holes at 16 locations between stations 0.0 and 48.5 until evidence was found for the 1993 flood plain surface.

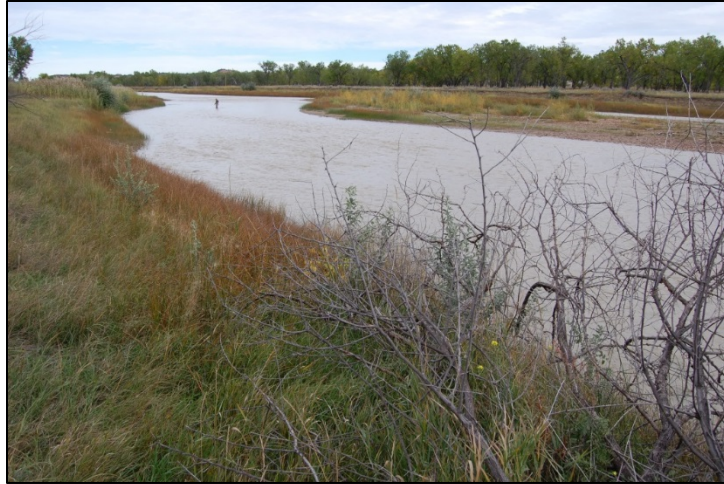
**Figure 73.** Downriver view of cross section PR147 on September 29, 2013. J. Moody (about 1.9 meters tall) is in the river standing on the line of section. A mid-channel island with a secondary channel to the right is in the upper right of the photo.

The other notable feature of cross section PR147 is a mid-channel sandbar that developed on the downslope of a gravel-bedded riffle whose crest intersected the section between stations 32 and 40, as it extended from the right bank of the river approximately 150 m upriver from the section to the left bank of the river approximately 30 m downriver from the section. After the 1995 flood, this sandbar began to emerge when about 0.2 m of new sediment was left on top between stations 57 and 79, and by 1996 it was populated with cottonwood seedlings growing in an additional 0.5 m of sediment between stations 62 and 72. This was probably the foundation on which a larger island evolved in the middle of the channel between 1998 and 2013, and had increased in elevation by about 0.7 m during this period.

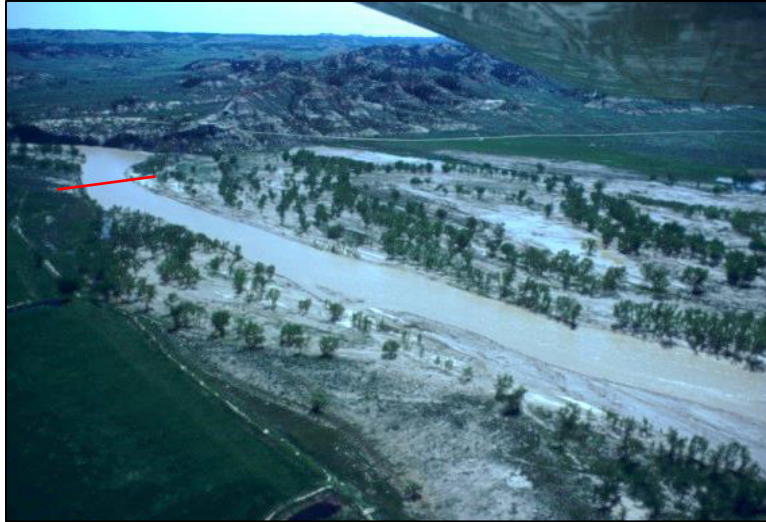
**Figure 77.** Aerial view of cross section PR151 on May 25, 1978. View is downriver and was taken during the waning stages of the flood of 1978. The red line is the approximate line of section. White areas show the extent of sand newly deposited by the flood on flood plain and terraces. Photograph taken by B. Ringen.

The flood of 1978 eroded the right bank of the small island causing it to lower in elevation by about 0.3 m (figure 16 of Meade and Moody, 2013). Additionally, substantial overbank sediment was deposited as lee dunes (Moody and Meade, 2008) downriver from cottonwood trees on the right bank (fig. 77). Between 1979 and 1984 the secondary channel separating the remnant of the small island from the left bank was filled in and a new flood plain surface was formed (Moody and others, 1999). This new surface accreted upwards by about 0.1 m in 1987, by another 0.1–0.2 m in 1993, and by still another 0.2–0.3 m in 1995.

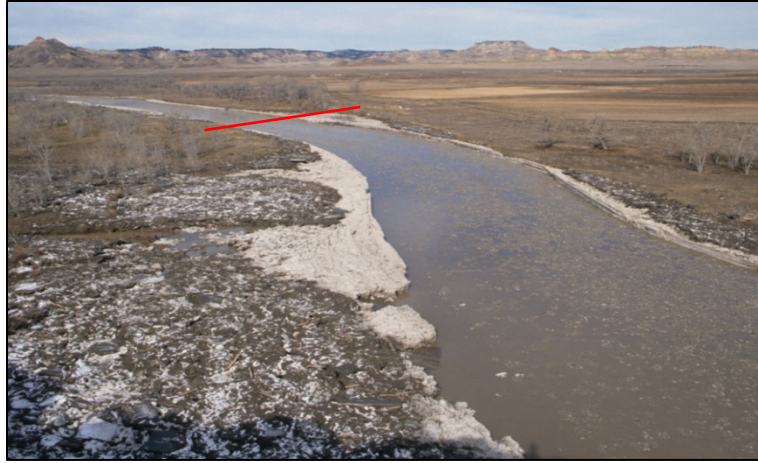
**Figure 79.** Photograph of ice deposited on the flood plains downriver from cross section PR151. Upriver view was taken on March 11, 1995. The red line indicates the approximate line of section.

Ice-jam floods in February and March often deposit fine and coarse sediment on the flood plain and low terraces (figs. 78 and 79). Ice-flood deposits are localized and not necessarily along the entire river. Other Powder River cross sections that had ice-flood deposits were PR141A and PR120.

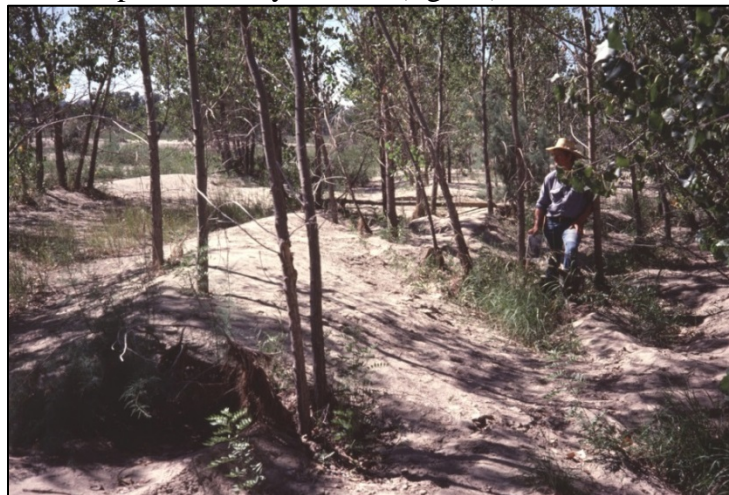
**Figure 83.** Lee dunes on the left bank of cross section PR156 on September 1, 1978. View is downriver showing lee dunes deposited downriver from trees or clumps of cottonwood trees. J. Moody is approximately 1.9 meters tall.

During the flood of 1978, the river channel was widened substantially by the lateral removal of approximately 10 m width of flood plain from the left bank, and approximately 20 m width of a 2-m-high Lightning terrace (Leopold and Miller, 1954; Moody and Meade, 2008) (including the shade tree) from the right bank (fig. 5 of Meade and Moody, 2013). During the flood of 1978, one characteristic depositional form on the flood plains and some Lightning-level terraces (Moody and Meade, 2008) were lee dunes downriver from shrubs, trees, or clumps of trees. These dunes were composed mostly of sand (fig. 83).

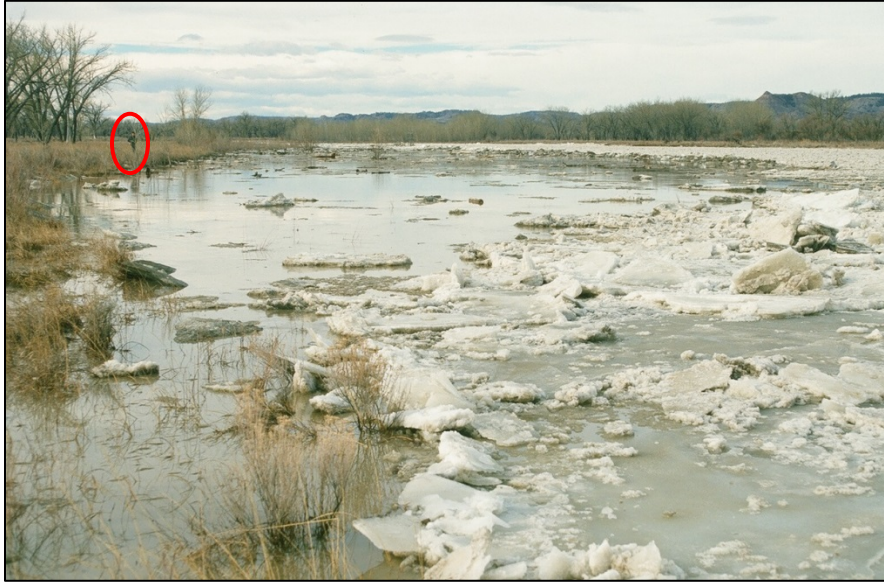
**Figure 84.** Upriver view of ice flowing across cross section PR156 on March 11, 1995. View is approximately 30–40 meters (m) downriver from section PR156. Ice breakup is moving onto the new inset flood plain (Moody and others, 1999). J. Moody (about 1.9 m tall inside red oval) stands about 10 m upriver from section PR156A.

During the years 1979–98, most of section PR156 remained mainly stable (which was to be expected of a large riffle), alternately gaining or losing a few decimeters of sand in the above-the-riffle waters near the left bank. Under the right bank, meanwhile, there gradually developed, between stations 97 and 111, a new flood plain which had reached a thickness of about a meter by the time of our last survey in 1998. As at several other cross sections, sedimentation at PR156 has been affected by ice break-up floods (fig. 84).

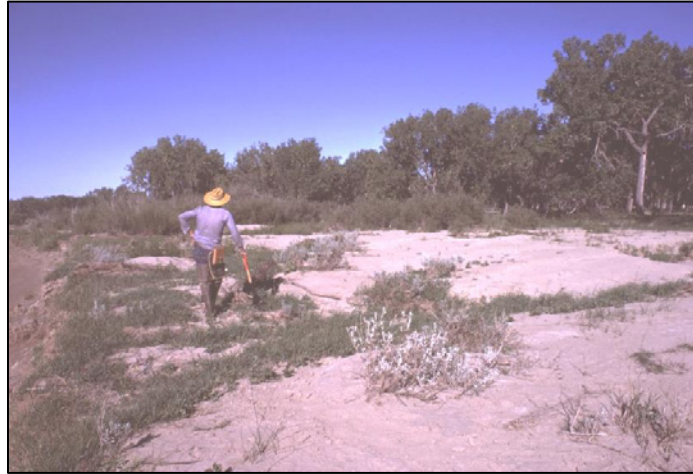
**Figure 86.** Photograph of the right-bank flood plain of cross section PR156A on August 4, 1978. View is downriver showing sand deposits left by the flood of 1978. J. Moody is about 1.9 meters tall. Mature cottonwood trees (*Populus sargentii*) are on a Moorcroft-level terrace.

The flood of 1978 left sand on a wide surface sloping riverward away from the base of a Moorcroft-level terrace on the right bank (fig. 86). This surface relatively quickly aggraded between 1980 and 1982, leaving a distinct quasi-level, approximately 40-m wide flood plain surface. Between 1982 and 1984, the lowest areas of this flood plain surface aggraded 0.1–0.2 m. Beginning in 1986, the right-side flood plain expanded primarily along the riverward edge as a levee, mostly between stations 60 and 65 (fig. 87), vertically adding 0.10–0.40 m of new sand in 1987, another 0.10–0.40 m in 1993, and yet another 0.10–0.25 m in 1995.

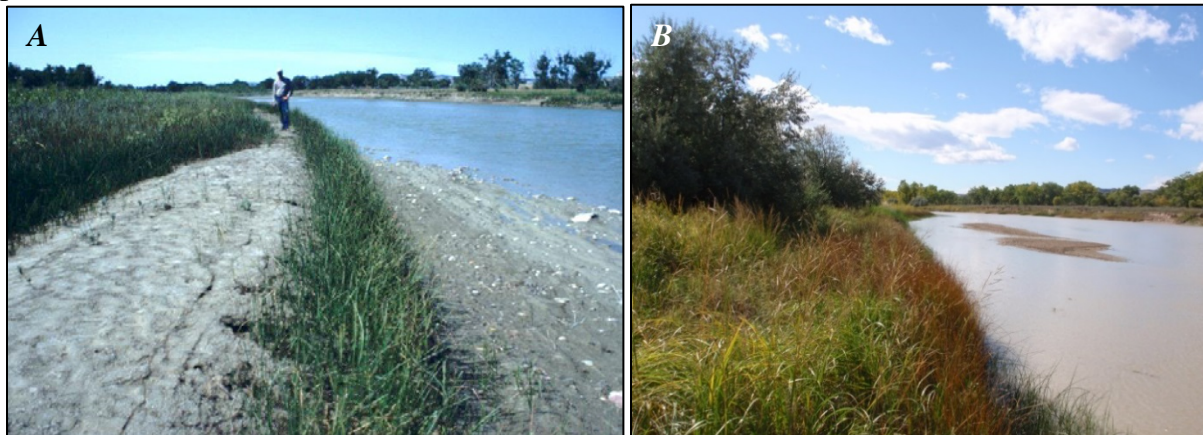
**Figure 87.** Comparison of the right bank of cross section PR156A in 1986 and 2013. A, Upriver view of the right bank taken on August 20, 1986. J. Moody (about 1.9 meters [m] tall) is standing on the line of section at station 63 (elevation 970.35 m above sea level) on top of newly (1986) deposited berm of sand, 0.3–0.4 m thick. B, September 30, 2013. Similar upriver view as in A taken on September 30, 2013, but elevation of station 63 is now 971.28 m above sea level, and Russian olive trees have colonized the right bank flood plain.

During the flood of 2008 (329 m<sup>3</sup>/s, May 27), another 0.10–0.15 m of sediment was deposited across the new flood plain, and additional sediment was deposited on a bench (Page and Nanson, 1982) at the base of the outer bank of the flood plain (figs. 87A, 89, and 90) that had developed since 1999 (also see PR120, PR125, PR136, and PR151 narratives).
