# Decadal Changes in Channel Morphology of a Freely Meandering River—Powder River, Montana, 1975–2016

Open-File Report 2018–1012

U.S. Department of the Interior  
U.S. Geological Survey

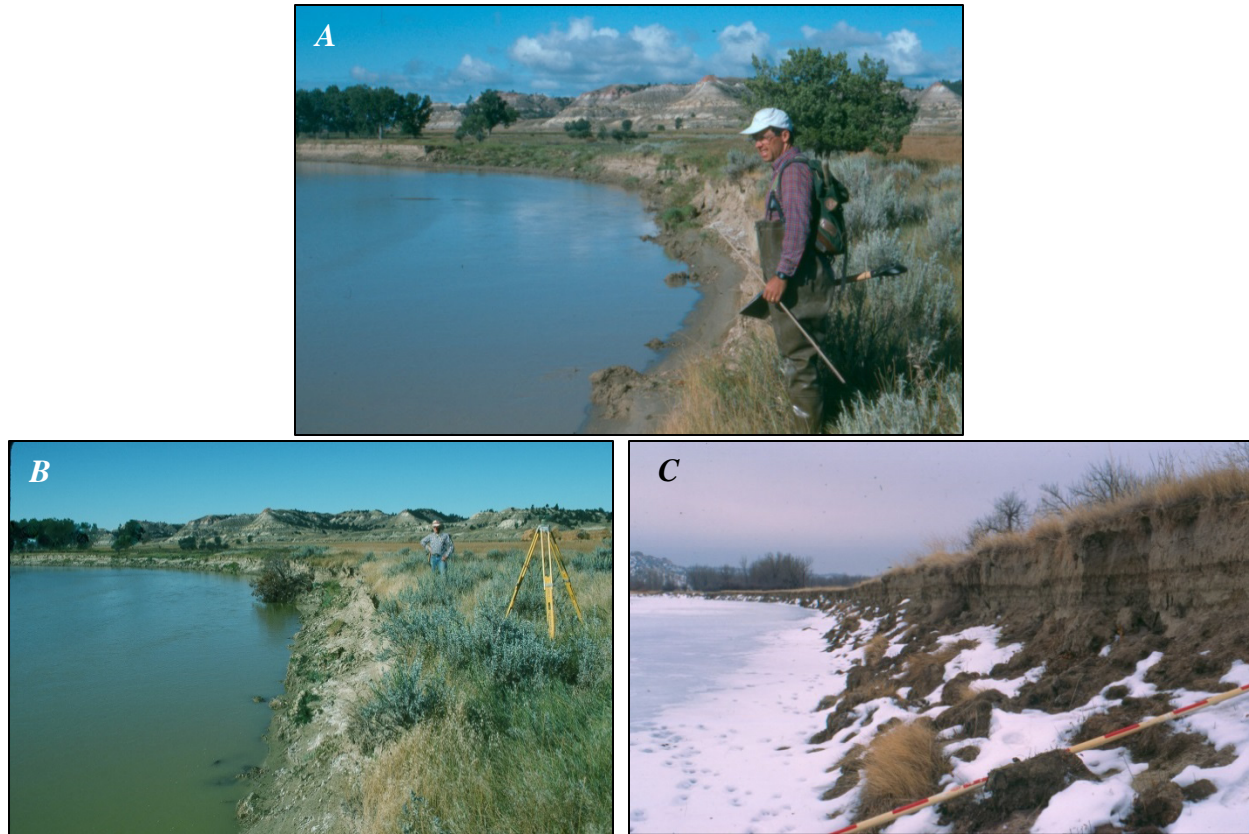
**Figure 93.** Comparison of upriver views of the left bank of cross section PR163 in 1993, 1995, and 1996. *A*, Photograph was taken on August 30, 1993. J. Pizzuto (about 1.8 meters [m] tall) is standing on the line of section. The tree behind him is the same tree near the edge of the left bank in figure 92*B*. *B*, Photograph was taken on September 25, 1995. J. Moody (about 1.9 m tall) is standing on the line of section. *C*. Photograph was taken on January 14, 1996. Red and white survey rod is lying on the line of section. Bank erosion often results in slump blocks and is enhanced by melting snow and perhaps by the freeze-thaw process at this bend that faces approximately southeast.

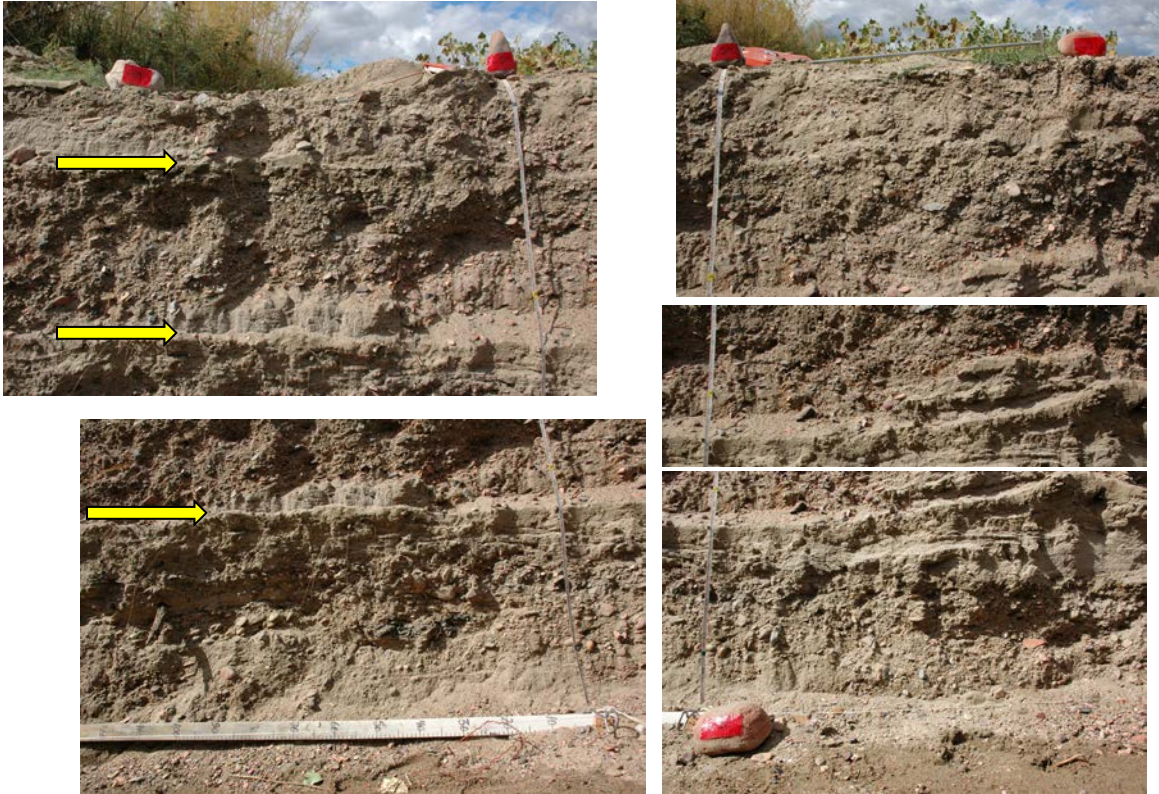
**Figure 102.** Photographs of the deposits at station -22.0 of section PR163 on September 9, 2016. The vertical distance from top of trench to the white meter stick is approximately 1.2 meters. The triangular rock with red tape is at station -22, and the two other rocks with red tape are at station -21.0 (to the left) and -23.0 (to the right), giving a field of view of 2 meters. The photographs overlap each other but have not been superimposed because they are not georectified. The sediment between the two yellow arrows in the upper left photograph is assumed to represent deposition from the flood of 2008.

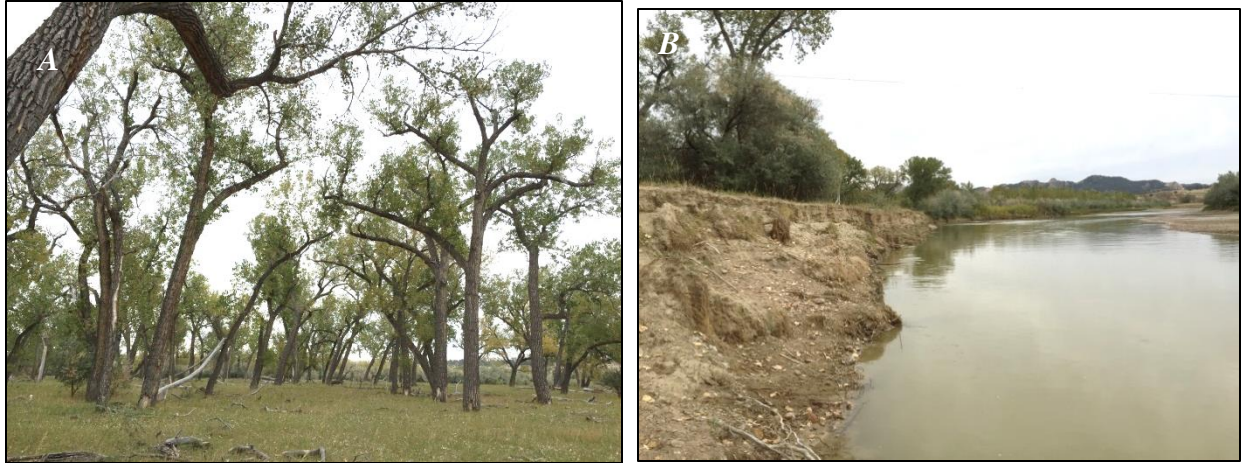
**Figure 108.** Views of the vegetation and right bank of cross section PR167 on October 1, 2015.  
**A,** Photograph taken by Deborah Martin of the typical size of mature cottonwood trees (*Populus sargentii*) that are growing on a Lightning-level terrace along the right bank, which was at station 132 in 2015.  
**B,** Upriver view along the right bank standing on the line of section. Top of the right bank (Lightning-level terrace) was at station 132 with an elevation of 959.8 meters (m) above the National Geodetic Vertical Datum of 1929 (NGVD 29) in 2015. Water level elevation was 957.3 m above NGVD 29. Optical stimulated luminescence (OSL) sediment cores were collected 7.4 m downriver from station 132.

This cross section was virtually unchanged by the snowmelt floods in 2015 (May 28, 2015; 280 m<sup>3</sup>/s; 6 June 6, 2015; 283 m<sup>3</sup>/s). About 1 m of the right bank was eroded, and only about 0.2 m of sediment was deposited on the left-bank point-bar levee between stations 57 and 64. Minimal sediment (less than 0.05 m) was deposited among the Russian olive and tamarisk trees in the thicket on the left bank flood plain. Sediment cores were collected for dating the 2.5-m Lightning-level terrace on the right bank by OSL from three locations (0.5, 1.0, and 1.7 m below the top of the right bank) in a vertical profile (fig. 108).

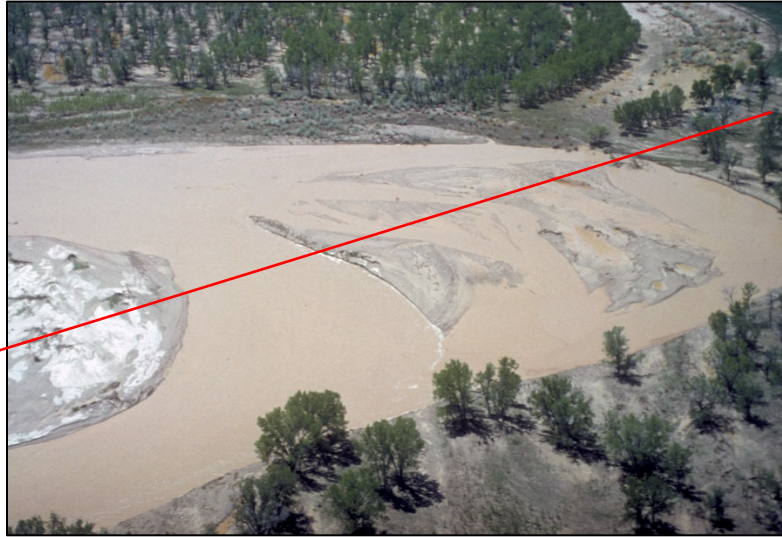
**Figure 110.** Aerial view of cross section PR175 on May 25, 1978. This view upriver towards the southwest was taken by B. Ringen about 1 week after peak flow during the flood of 1978. Red line shows approximate line of section at bank-full elevation. The left cut bank of the preflood (1977) channel shows on the upper right section of the photograph. The channel newly formed by the flood of 1978 is shown flowing between the emerging sandbar in the left center of the photograph and the nearly submerged sandbars in the right center of the photograph.

The cut bank was on the left bank, but during the 1978 flood the river first eroded 7 m into this cut bank, then cut across the inside of the point bar, perhaps starting in an old chute channel between stations 133 and 143 (fig. 110), and left a new cut bank at station 178. Probably during the waning stages of the 1978 flood, the river filled in the old channel leaving an average of about 1 m of newly deposited sand spread across more than 100 m (see fig. 7 of Meade and Moody, 2013).

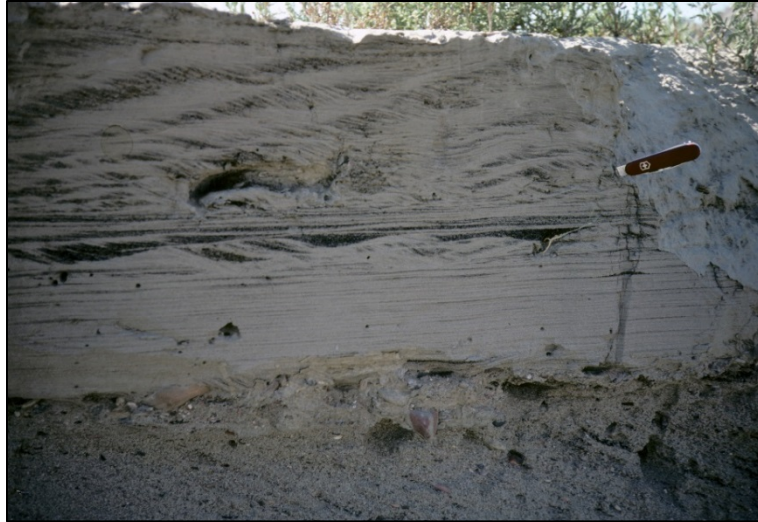
**Figure 111.** Photograph of sand deposited during the flood of 1978 at cross section PR175. This deposit is on the left bank about 23 m downriver from station 176. Photograph was taken on August 11, 1979.

The second story was vegetation succession. The top of the locally 2-m-thick layer of new sand deposited by the flood of 1978 (fig. 111) provided an ideal surface for the germination of cottonwoods whose growth could be monitored during each succeeding cross-sectional survey of PR175.

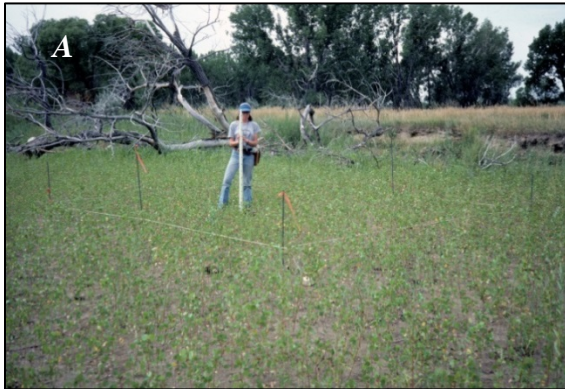
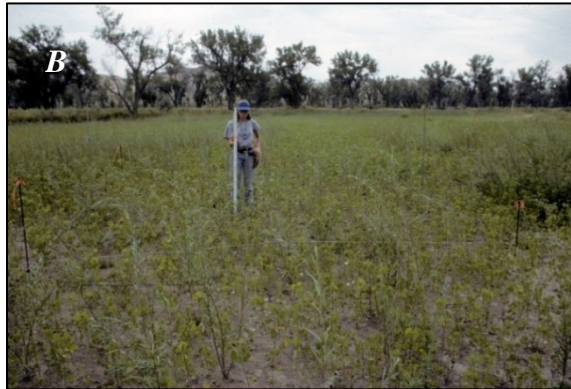
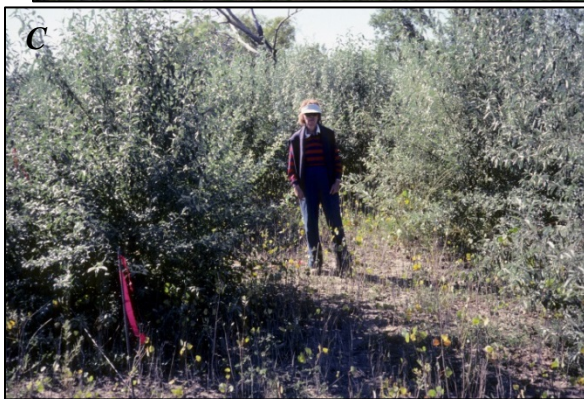
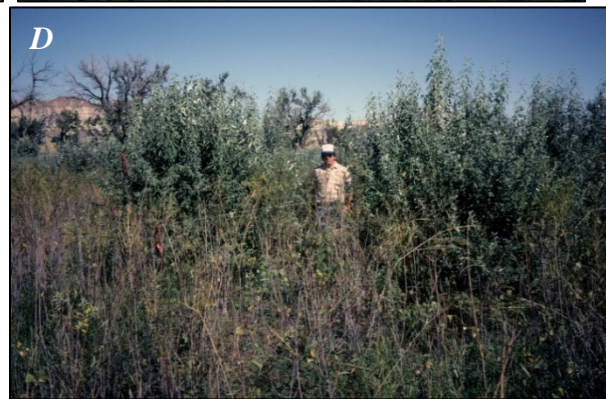
**Figure 112.** Series of photographs showing the changes in vegetation at cross section PR175 after the flood of 1978. *A*, August 20, 1979. View showing the vegetation from station 17 to 22. View is to the southwest and obliquely upstream. H. Martinson is about 1.6 meters (m) tall. *B*, August 20, 1979. View showing the vegetation from station 34 to 39. View is towards the north and downstream. H. Martinson is about 1.6 m tall. *C*, September 19, 1982. View showing the vegetation from station 17 to 22. View is to the southwest and obliquely upstream. S. Stewart is about 1.7 m tall. *D*, September 19, 1982. View showing the vegetation from station 34 to 39. View is towards the north and downstream. M. Karlinger is about 1.8 m tall.

Plots were established in 1979 and measurements of were made of the heights and densities of seedlings of willows and cottonwoods (fig. 112). These measurements were repeated in 1980, but by 1982 Russian olives had germinated and were already crowding out the native vegetation. The native vegetation study was abandoned.

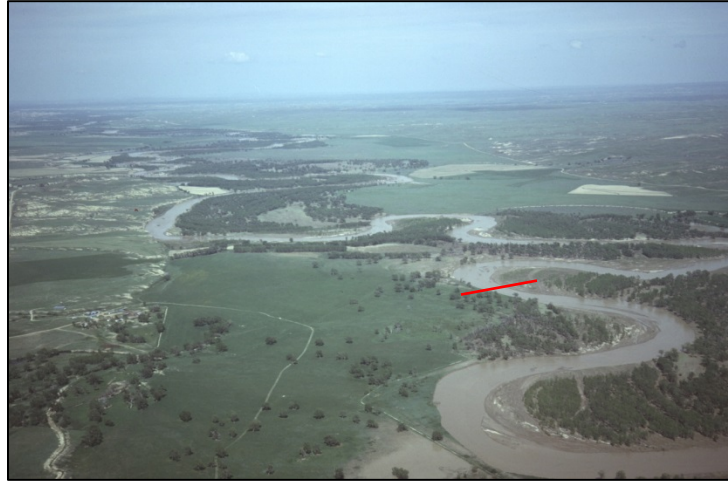
**Figure 114.** Aerial view of cross section PR180 on May 25, 1978. This downriver view was taken about 1 week after peak flow during the 1978 flood by B. Ringen. Red line shows approximate line of section at bank-full elevation.

The cross-sectional shape of PR180 is typical of curved river reaches worldwide in that a prominent and active cut bank in a 3-m high Moorcroft-level terrace (Leopold and Miller, 1954; Moody and Meade, 2008) on one side (left, in this instance) faces a gently sloping point bar on the other side (figs. 114 and 115).

Likely owing to its location at the time near the planimetric crossover point between two meanders (fig. 114), the cross section at PR180 was changed relatively little during the flood of 1978. There was less than 2 m of lateral cut bank erosion, and a thickness of 0.2–0.8 m of new sediment was deposited atop some 30-m width of the right-side flood plain. See the upper panel of figure 18 of the report by Meade and Moody (2013), and compare the magnitudes of the flood-induced changes with those shown for other active cross sections in figures 17 and 19 of the same report.

The changes to cross section PR180 since 1978 reflect the multidecadal passage of a planimetric meander crest through the cross section. The erosion at cross section PR180 took place on the left bank (fig. 119), and the leftward-eroding meander bend was downriver of the 1978 section (fig. 114), thus this planimetric meander crest appears to have migrated upvalley.

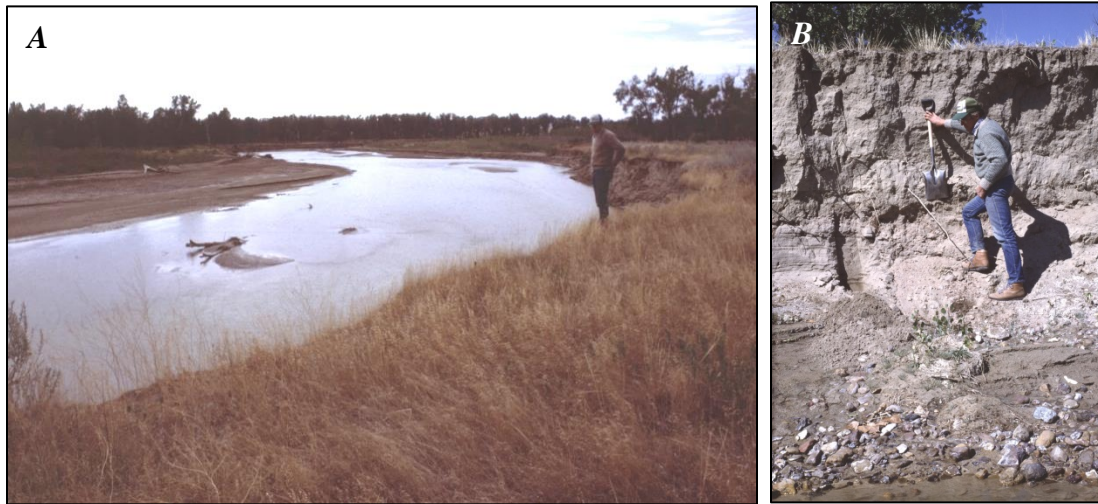
**Figure 116.** Views of cross section PR180 on August, 21, 1986. *A*, Upriver view shows J. Moody (about 1.9 meters [m] tall) standing at station -5.0. *B*, View is of the left bank (Moorcroft-level terrace) about 5 m upriver from the cross section. Shovel tip is at the contact where older overbank sediment (not from the flood of 1978) overlies even-older point-bar sediment.

of meters to the left. From 1978 through 1997, the left-side cut bank (fig. 116) retreated 49 m, with the greatest annual increments during 1984 (5.4 m), 1986 (6.0 m), 1987 (4.9 m) 1991 (8.6 m), 1993 (4.5 m), 1995 (4.3 m), 1996 (2.9 m), and 1997 (2.8 m).

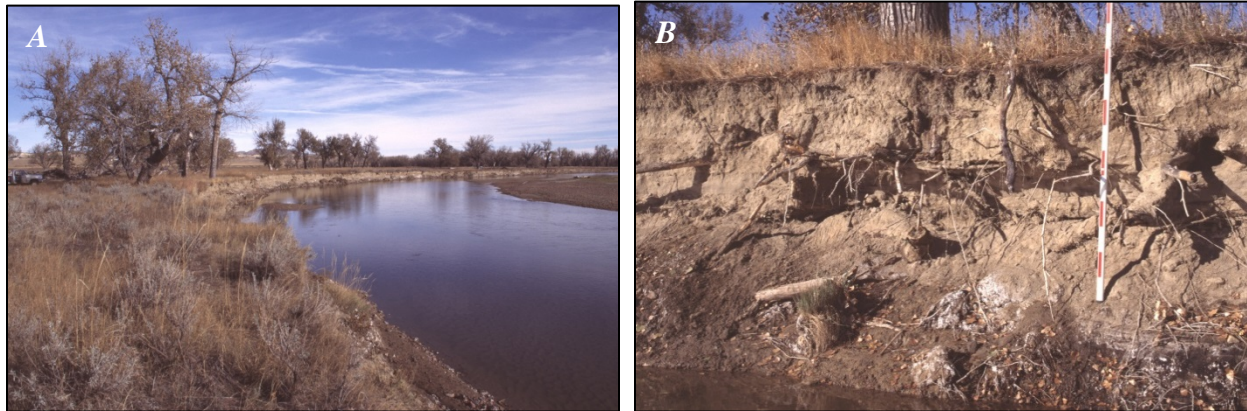
**Figure 118.** Views of cross section PR180 on October 22, 1996. A, View is downriver and the line of section passes just upstream from the two prominent trees near the left bank. Same two trees can be seen in photographs on September 18, 1994, and September 30, 1995 (fig. 117). Left bank has eroded about 3 meters (m) since September 1995. Tripod is not on the line of section. B, Survey rod is at station -38.0, and each rod division is 0.2 m. Top of left bank (Moorcroft-level terrace, elevation 949.8 m above the National Geodetic Vertical Datum of 1929) is 2.7 m above the water level and 3.3 m above the thalweg adjacent to the left bank.

Channel changes at cross section PR180 have slowed considerably since 1997. During 1997–2014, the left-side cut bank retreated only 5.2 m—a 17-year total quantity of bank erosion that was exceeded during the individual years 1984, 1986, and 1991 (fig. 118). Cumulative new

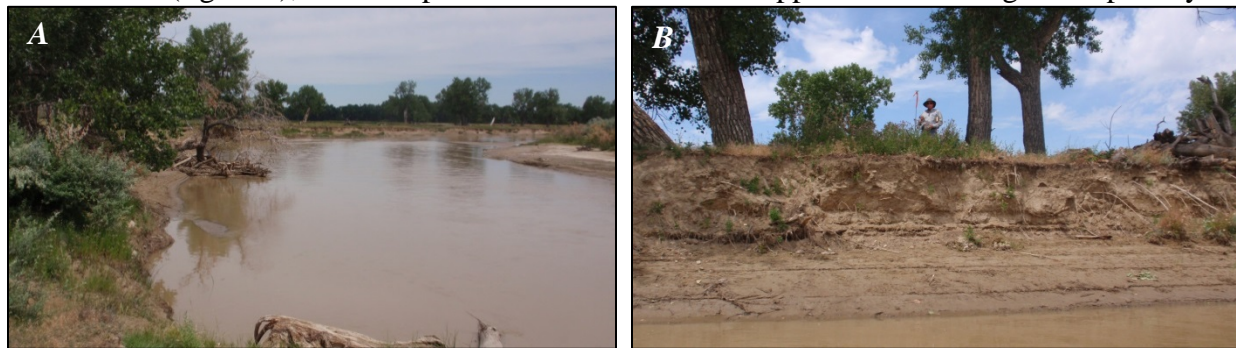
**Figure 119.** Views of cross section PR180 on July 15, 2014. A, Downriver view is along the left bank showing the active eroding bank downriver from cross section PR180. The point bar can be seen on the right edge of the photograph. B, A range pole is to R. Meade's right (about 1.8 meters tall) on the line of section on the left bank.

High water during the two snowmelt floods in 2015 was not bank full. The two peak discharges on May 28, 2015 ( $280 \text{ m}^3/\text{s}$ ) and June 6, 2015 ( $283 \text{ m}^3/\text{s}$ ) were estimated to be about 0.8 m below the top of the left bank (fig. 119B and 120A), but floodwaters flowing over the right bank deposited a layer of sand, which was about 0.5 m thick closest to the channel (station 28.0) and tapered in thickness away from the channel to about 0.1 m at station 72.0, where a thicket of Russian olives and tamarisk begins. There was virtually no deposition within the thicket even though there was evidence of floodwaters in the thicket. The point bar at PR180 has had sufficient deposition over the years that it is now elevated and is transitioning into a flood plain.

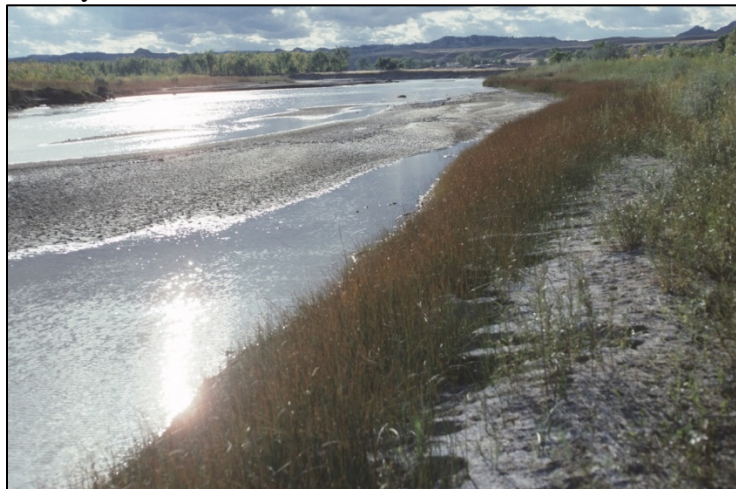
**Figure 129.** Upriver view of cross section PR191 along the left bank on September 30, 1995. Red-colored sedge (*Scirpus* spp., Moody and others, 1999) indicates the approximate elevation of bed-full flow (about 12 cubic meters per second).

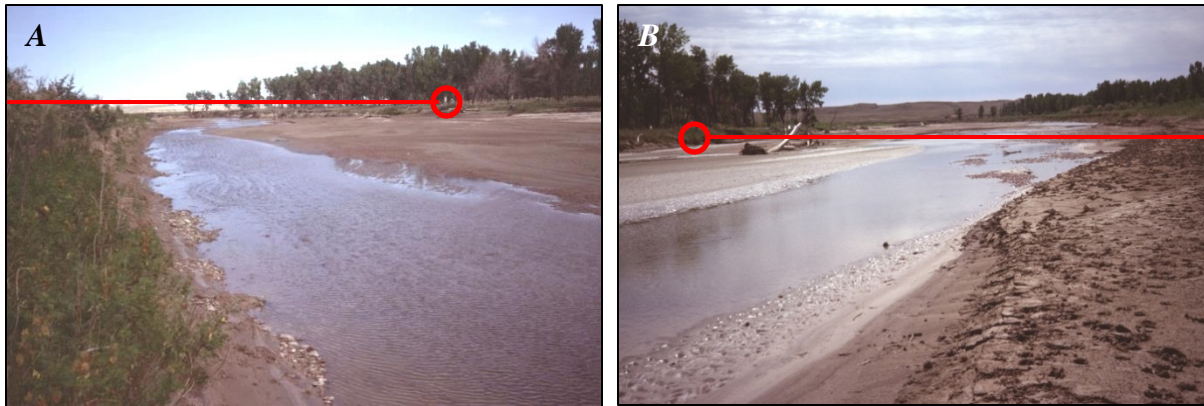
**Figure 133.** Views of cross section PR194 on July 19, 1977. *A*, View is upriver, and E. Meade (about 1.6 meters tall) is standing on the line of section inside the red circle, and the red line shows the approximate line of section at bank-full elevation. *B*, View is downriver, E. Meade is standing on the line of section inside the red circle, and the red line shows approximate line of section at bank-full elevation.

Cross section PR194 was established in 1977 at the inflection point (crossover) on the downriver limb of an actively changing meander bend of Powder River (figs. 132 and 133). Resurveys were done during the years 1978–80, 1982, 1984–98, 2014, 2015, and 2016 (see Moody and Meade 2017, PR194\_SciBase2.xlsx for survey data).

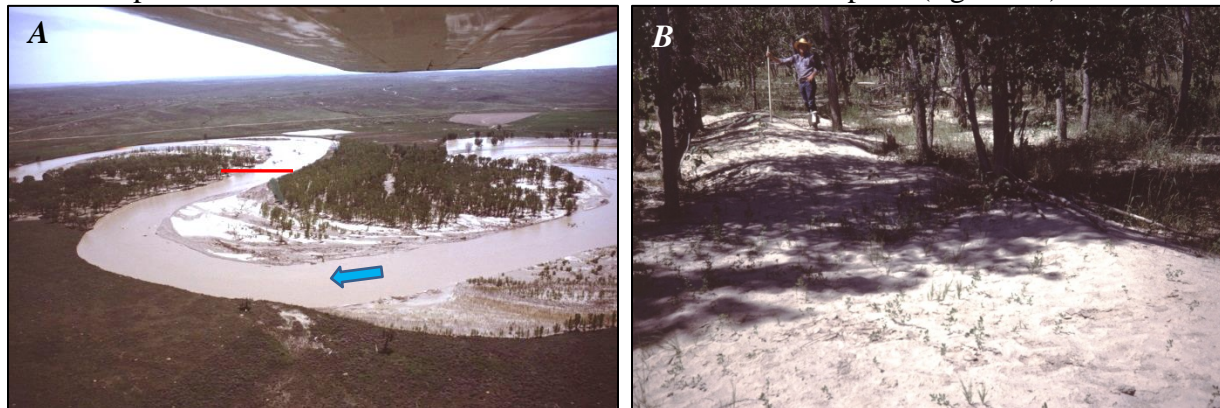
**Figure 134.** Views of cross section PR194 in 1978. *A*, Aerial view (downriver is to the left) was taken on May 25, 1978, by B. Ringen about one week after the peak of the flood of 1978. Blue arrow indicates flow direction, and red line indicates the approximate location of the line of section at bank-full elevation. *B*, View is upvalley taken on August 8, 1978. J. Moody (about 1.9 meters [m] tall) is standing on a new lee dune left after the flood of 1978 on the right-bank flood plain about 30–40 m back from the river bank.

Because of its location near the crossover (inflection point) of the downstream limb of a meander (fig. 134A), section PR194 has shown little significant erosional or depositional change during the last three and a half decades. Little change was recorded here after the flood of 1978 (see the “bottom-line” panels in figures 5 and 6 of the report by Meade and Moody, 2013) other than the deposition of lee dunes downriver from trees on the flood plain (fig. 134B).

The narrow neck of the large meander bend (fig. 134) makes it susceptible to being cut off. Water from the 1993 snowmelt flood (June 9, 1993, 157 m<sup>3</sup>/s) crossed the neck (fig. 135A), enlarged gullies on the downriver part of the neck, and caused bank erosion (fig. 135B).

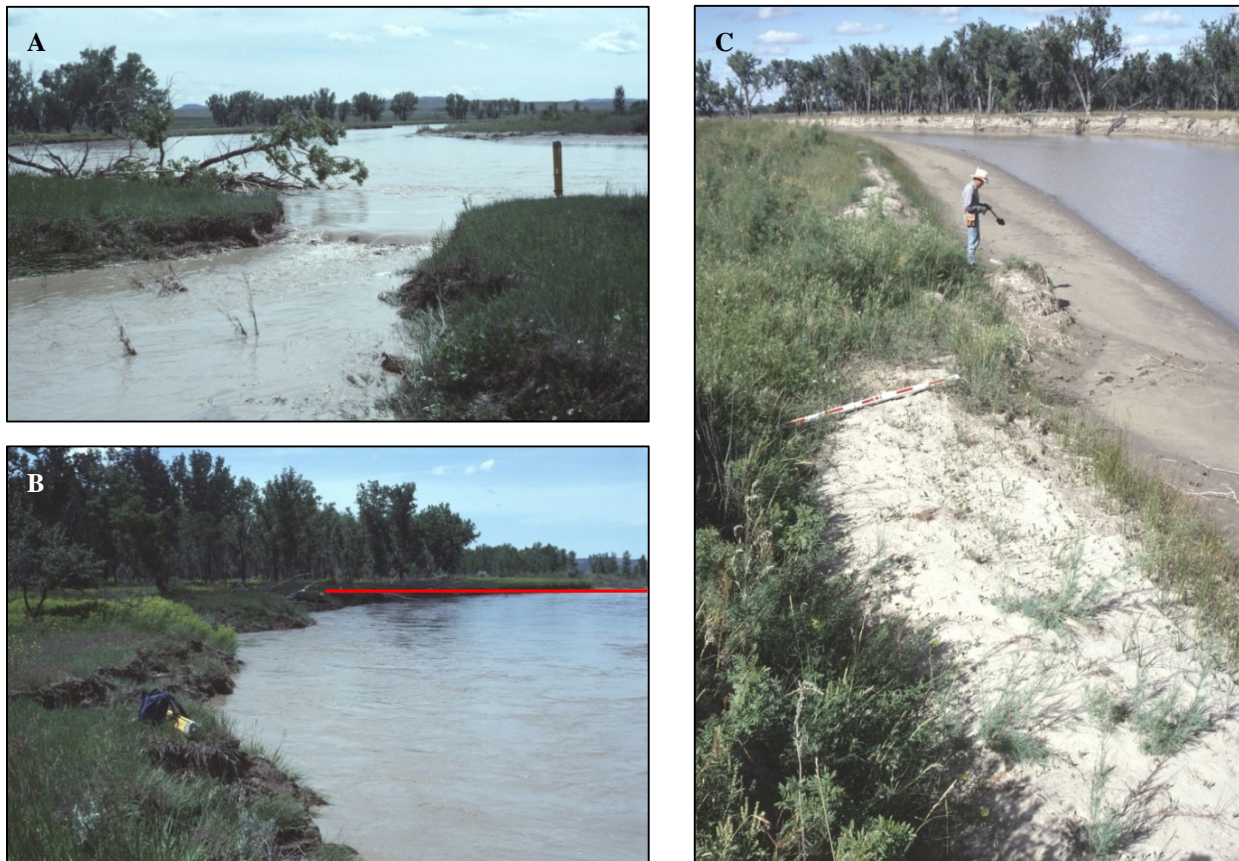
**Figure 135.** Views of the high-water effects at cross section PR194 on June 10, 1993. *A*, View is upriver and was taken at 1630 hours. Water is leaving the main channel at a point some 1,100 meters (m) upriver from cross section PR194 and flowing across the narrow neck (see fig. 132). Secondary channel opening at the bank is about 4.7 m wide and sill depth is approximately 0.10 m. Water level in the main channel is about 0.4–0.6 m below the top of the bank. Water flowed across the narrow neck and back into Powder River below PR194. *B*, View is upriver and was taken at 1300 hours. Bank failure downstream from PR194 (red line indicates approximate location of PR194 at bank-full elevation). The indentations in the bank indicate the location of gully mouths. *C*, Upriver view taken on September 2, 1993, shows new sand that was deposited during high water. Survey rod lies approximately on the line of section. J. Moody (about 1.9 m tall) is standing at the elevation of the bank-full flow (12.5 cubic meters per second).

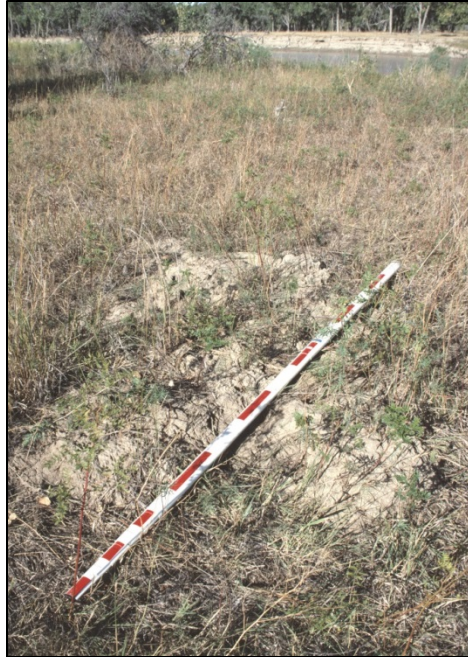
**Figure 136.** Photograph of a pod of ice-rafted sand and gravel at cross section PR194 on September 20, 1994. View is upriver. Ice-rafted sand and gravel pile was left on the Lightning-level terrace (Leopold and Miller, 1954; Moody and Meade, 2008) by the high water in February and March of 1994. Base (farther end) of survey rod is at station 103. Longest red and white markers on the rod are 0.2 meter long.

Some ice-rafted sediments were deposited on the right-bank flood plain by the high flows that followed ice breakups in February and March 1994 (fig. 136). On June 10, 1994, water was observed flowing across the neck of the meander bend and causing substantial bank erosion about 500 m downriver of section PR194.

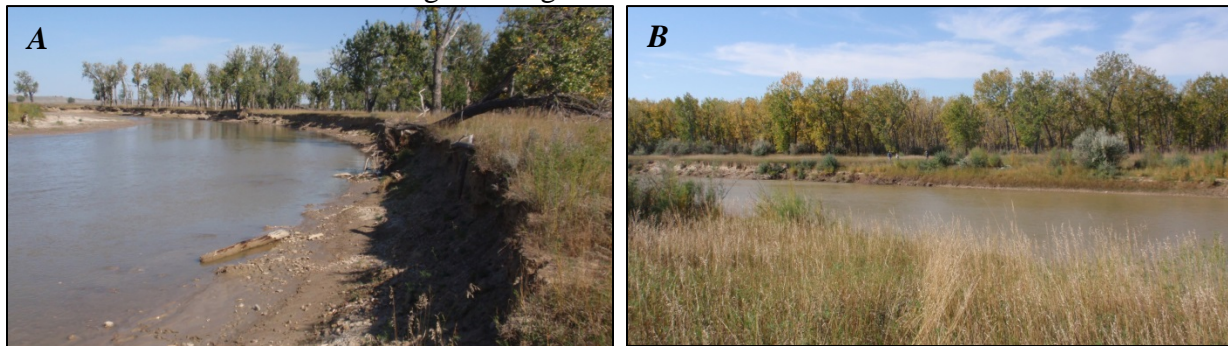
**Figure 137.** Views of cross section PR194 on September 27, 2014. *A*, View is upriver (taken standing on the line of section) and shows the eroded left bank. *B*, View of the right bank looking downriver.

The small inset flood plain that had been built since 1982 was partially eroded (about 5 m) between 1998 and 2014 (fig. 137). Erosion along the left bank upriver since 1977 has changed substantially the orientation of cross section PR194, which now appears rotated relative to the river channel and is no longer orthogonal to the direction of flow.

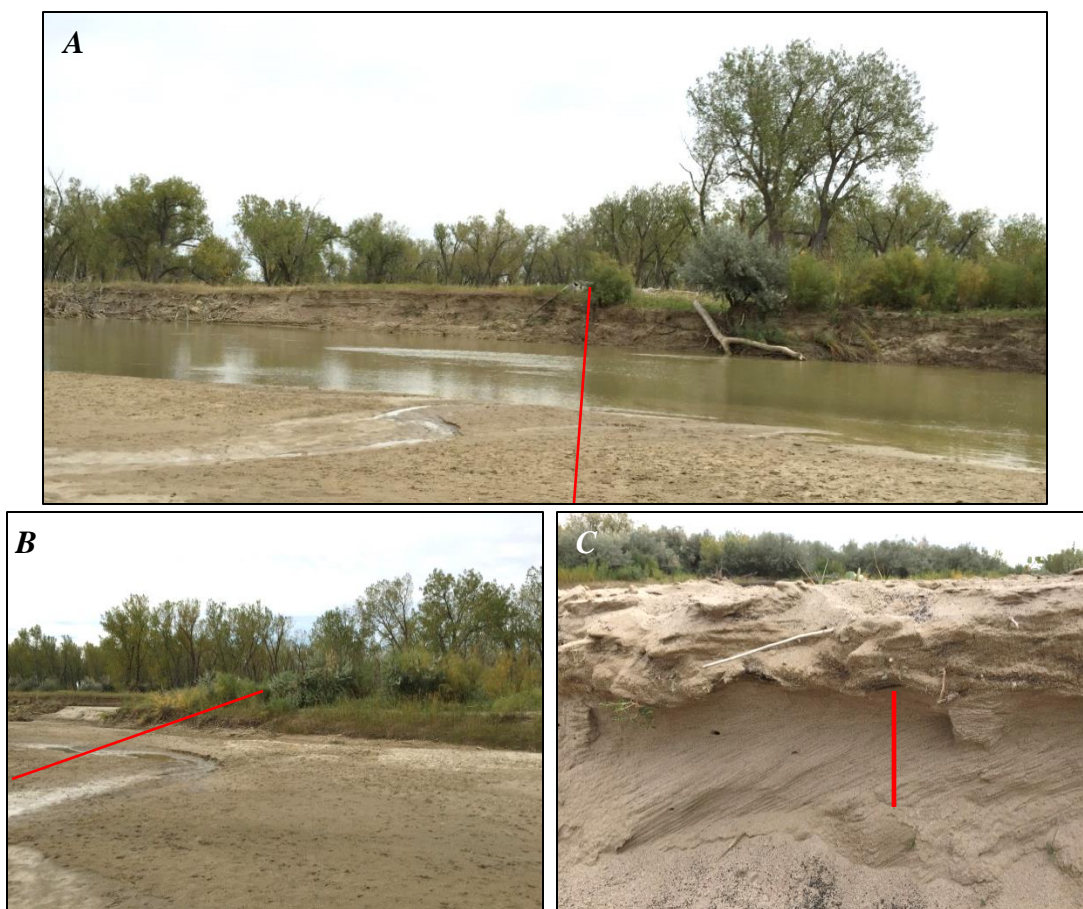
**Figure 138.** Views of cross section PR194 on October 1, 2015. *A*, View is of the left bank and the line of section is shown by the red line. *B*, View is of the right bank with the approximate line of section shown by the red line. *C*, Close-up view of the sediment deposition in the mouth of the gully at the left of the photo on the left. The vertical red line is about 0.1 meter tall.

The snowmelt floods in 2015 (May 28, 2015, 280 m<sup>3</sup>/s; June 6, 2015, 283 m<sup>3</sup>/s) continued to erode the left bank and completely removed the inset flood plain (fig. 138A). There was a net lateral erosion of 13 m of the left bank, but no erosion of the right bank or deposition on the right bank flood plain, which is a Lightning-level terrace. However, sediment was deposited in the mouth of a gully downriver from PR194 (fig. 138C).

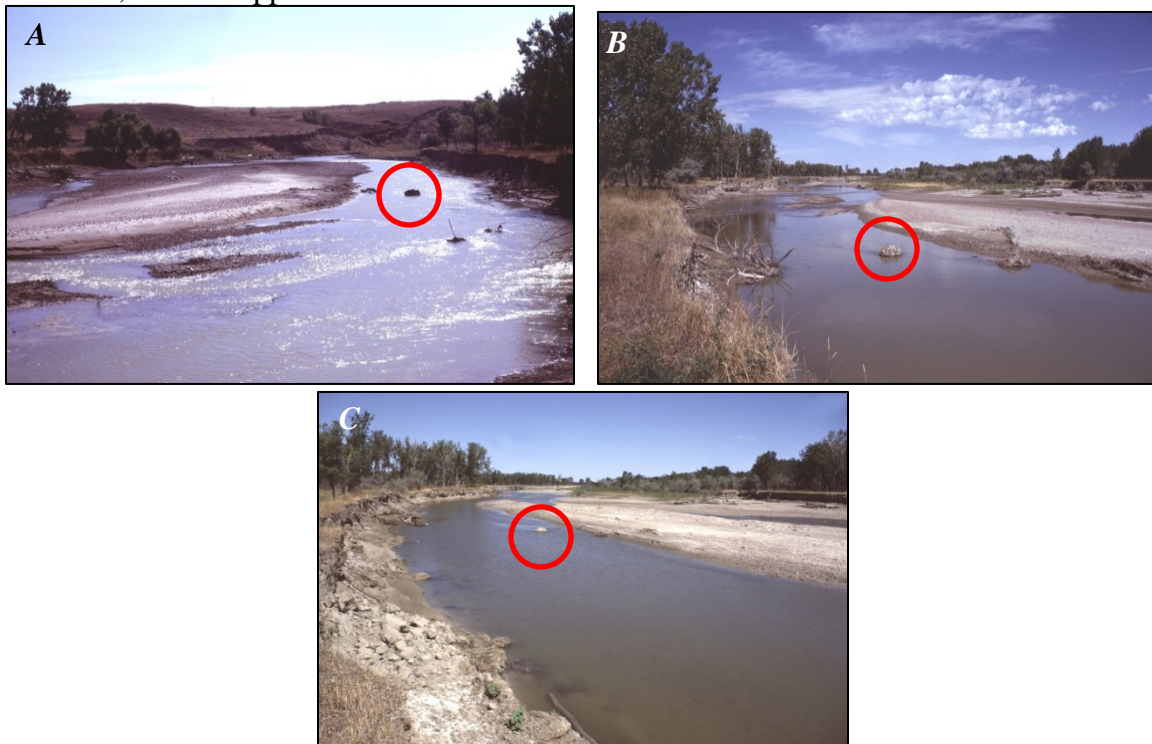
**Figure 147.** Views of cross section PR206 in 1984 and 1986. Concrete deadman is inside the red circle between stations 4–5. *A*, Upriver view was taken on September 16, 1984. *B*, Downriver view was taken on September 16, 1984. The left bank (Moorcroft-level terrace) has been eroded back, since our first survey of 1977, about 24 m–15 m of which was eroded since the survey of 1982. *C*, Downriver view was taken on August 22, 1986.

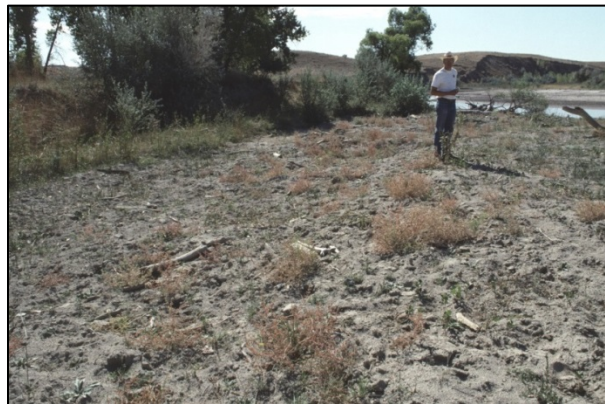
**Figure 149.** View of cross section PR206 on September 19, 1994. View is upriver. J. Moody (about 1.9 meters [m] tall) is standing on a thin layer (0.1 m or less) of sediment deposited by ice-breakup flood between stations 50 and 60 on top of the existing inset flood plain (Moody and others, 1999) along the right bank that is about 2 m above the channel thalweg.

others, 1999) developed on each side of the channel, and by 1995 these were about 2 m above the thalweg (figs. 148 and 149).

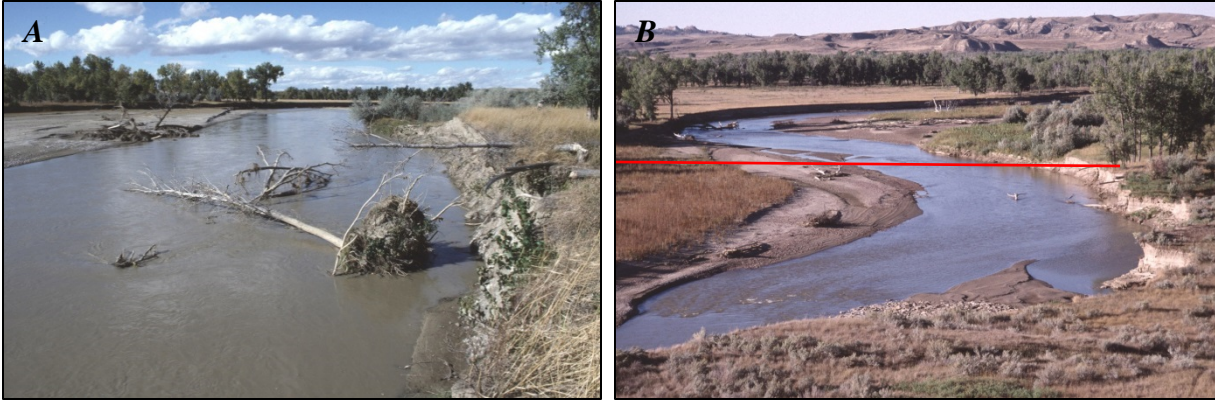
**Figure 150.** Views of cross section PR206 in 1995 and 1997. *A*, Downriver view taken on October 1, 1995. J. Moody (about 1.9 meters tall) and the tripod are on the line of section at the upper right edge of the photograph. *B*, Downriver view taken on September 23, 1997. The red line indicates the approximate line of section at bank-full elevation across the developing point bar and onto the Moorcroft-level terrace along the right bank. The prominent curvature of the bank downriver from the red line developed during the previous two decades since 1977, at which time this was a mostly straight reach of river.

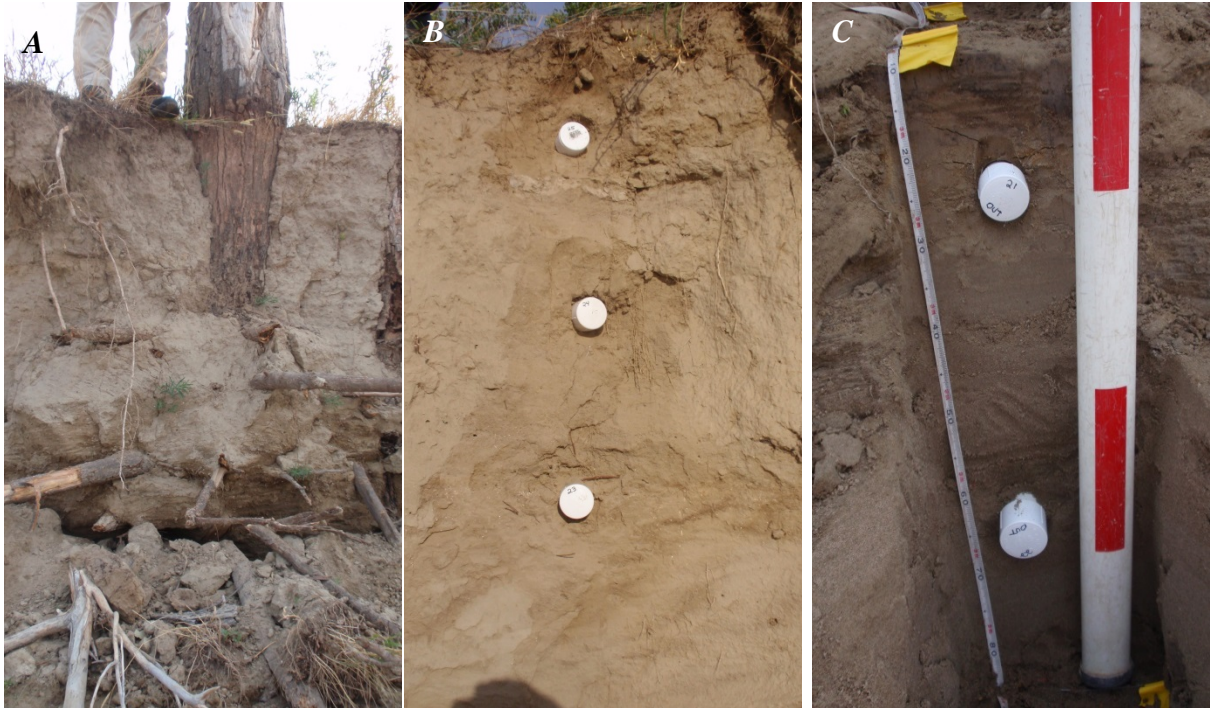
**Figure 152.** Location of sediment cores collected from the right bank of cross section PR206 for optical stimulated luminescence dating. *A*, Exposed tree root, next to *B*. Elba's feet, is on the tread of the Moorcroft-level terrace forming the edge of the river bank (see fig. 151*D*). *B*, Cores collected on October 1, 2014 are 0.2, 0.5, and 0.9 meter (m) below the terrace tread (see fig. 152*C* at right). *C*, Cores collected on July 19, 2014 are 2.2 and 2.6 m below the terrace tread. Red bars on survey rod are 0.2 m long.

Six sediment cores for dating by OSL were collected from the Moorcroft-level terrace (Leopold and Miller, 1954; Moody and Meade, 2008) forming the right bank. Three were collected on July 19, 2014, three were collected on October 1, 2014 (fig. 152), and together these six cores formed a vertical profile about 3 m downriver from PR206 (between B. Elba and the cottonwood tree at the edge of the bank in fig. 151D).
