Automated Remote Cameras for Monitoring Alluvial Sandbars on the Colorado River in Grand Canyon, Arizona

By Paul E. Grams, Robert B. Tusso, and Daniel Buscombe

Open-File Report 2018-1019

U.S. Department of the Interior
U.S. Geological Survey

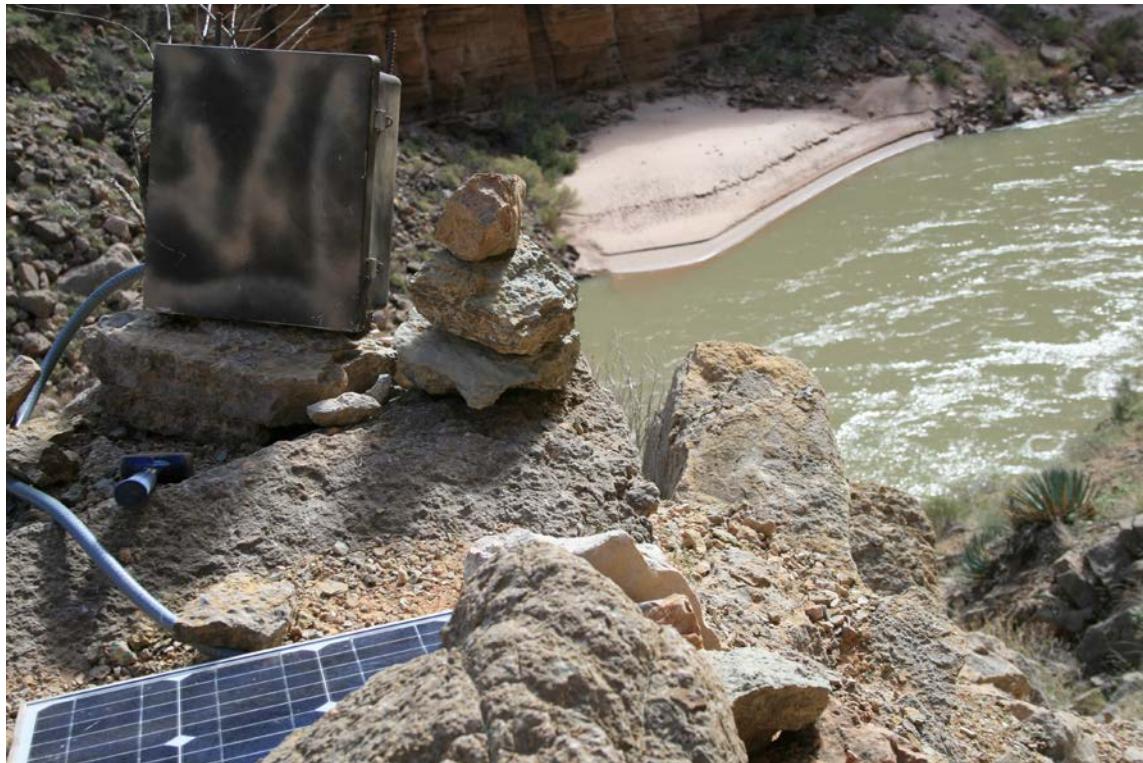
Cover image: Photograph of sandbar that is photographed daily by remote digital camera (in foreground) along the Colorado River in Grand Canyon National Park, Arizona.

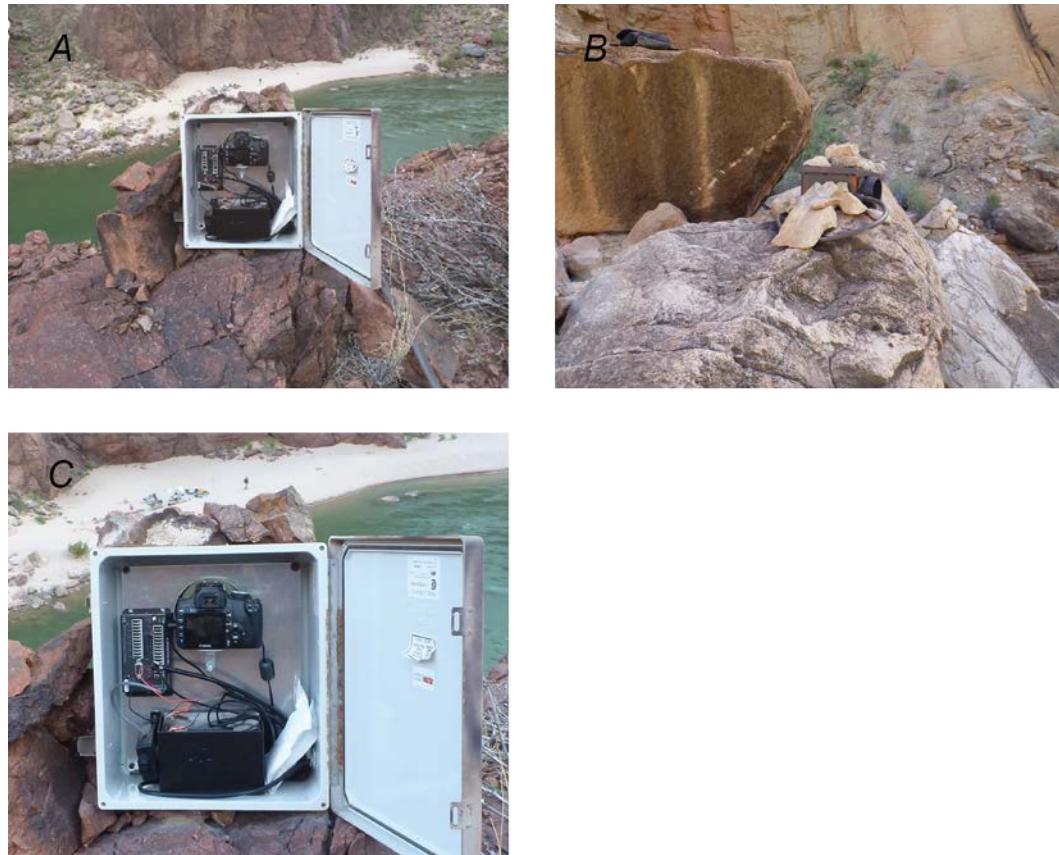
Figure 3. Photographs of remote-camera systems used along the Colorado River in Grand Canyon National Park, Arizona—*A*, vertically mounted; *B*, horizontally-mounted; and *C*, close-up view of system components.

All monitoring sites currently instrumented with remote cameras use a system based on the automated camera system described by Bogle and others (2013). This system consists of a digital SLR camera, programmable controller, voltage-regulation switch, and 12-volt rechargeable battery all in a weatherproof enclosure and an external solar panel. All systems use a camera in the Canon EOS Digital Rebel™ series (table 2), which have the ability to be configured for: (1) direct current (DC) power input and (2) a wired remote shutter trigger. These cameras also have a mechanical power switch that can be left in the on position so that the camera can be turned on and off by controlling the DC power supply. All cameras are equipped with the Canon EF-S 18-55 millimeter auto-focusing zoom lens. A Campbell Scientific CR-200 series data logger is programmed to (1) supply and cut power to the camera at specified intervals and (2) trigger the camera shutter within

the period the power is on. The voltage-regulation switch is used to manually turn the camera on for servicing. Power is supplied with a 12 amp-hour, 12-volt sealed lead-acid battery that is charged by a 20-watt solar panel. System wiring diagrams and specifications for the voltage-regulation switch are in Bogle and others (2013). The system components are installed in a 34×30×16 centimeter (cm) enclosure in two different configurations (fig. 3). The vertically oriented configuration was originally designed for mounting on a pole or other constructed mounting system (Bogle and others, 2013). The horizontal configuration is generally better suited for mounting directly on bedrock or boulders (fig. 3).

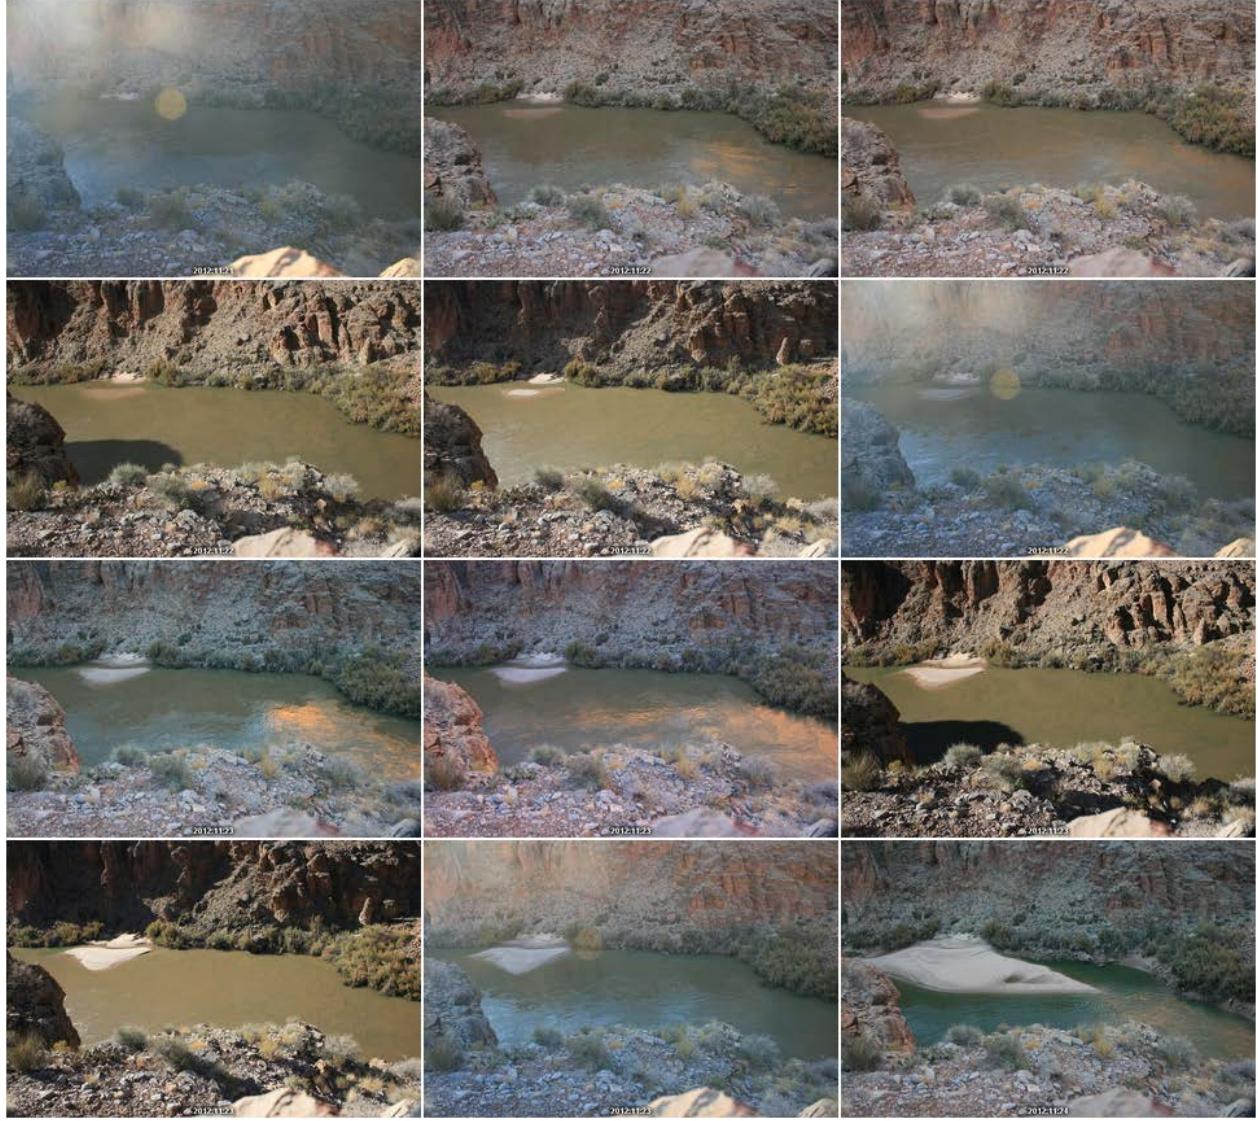
Figure 10. Time series of oblique imagery from a sandbar monitoring site (RC0307R) along the Colorado River in Grand Canyon National Park, Arizona, taken during the November 2012 controlled flood release from Glen Canyon Dam. Time increases from left to right and from top to bottom.

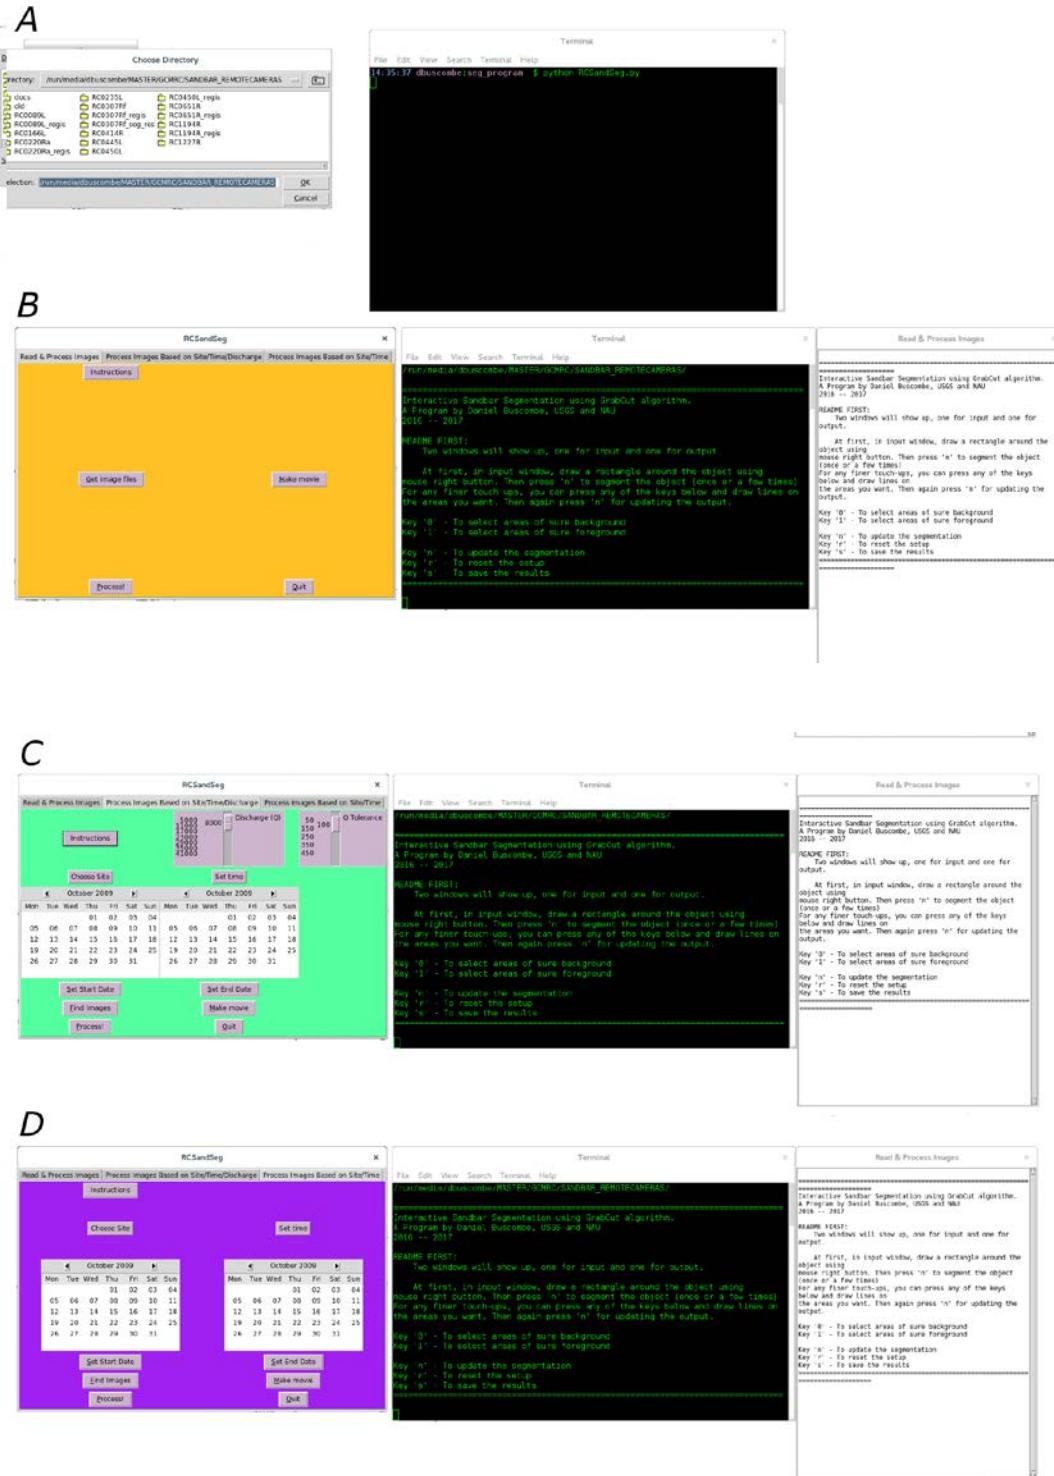
Figure 11. Screenshots from the RCSandSeg program (Buscombe, 2017) used to process remote-camera images for sandbar monitoring along the Colorado River in Grand Canyon National Park, Arizona. *A*, The user launches the program and selects a working directory, subdirectories contain images per camera site; *B*, the gold tab of the program allows the user to select and process arbitrary collections of images; *C*, the green tab of the program allows the user to select and process imagery based on site, date range, discharge level, and time of day; and *D*, the purple tab of the program allows the user to select and process imagery based on site, date range, and time of day.

RCSandSeg (Buscombe, 2017) is a Python program with a graphical user interface (GUI) that enables a user to interactively segment a sandbar from an image (a registered image still in an image reference frame, unrectified) or series of images. The user selects a set of images, and interactively segments them, one by one. The results from each image are saved in a binary Python format (a so-called pickled object), one file per image. There are three tabs in the program, each with slightly different functionality (fig. 11). The first (gold) tab allows the user to select multiple arbitrary files, make a movie of them (which greatly facilitates the visual detection of sandbar changes over time), and (or) process them. The act of processing in this case refers to the interactive segmentation that is explained below. The second (green) tab allows the user to find images from the database, based on site or camera deployment, date range, time of day (including the ideal time for a given site, predetermined based on average lighting conditions at a particular site), and discharge level (fig. 12). The discharge at a particular site is then estimated using empirical relations developed for each site based on the average lag time between the discharge at the nearest upstream gage. These relations were constructed by running the Wiele and Griffin (1998) unsteady flow model over the full range of flows for each of the five Colorado River gages upstream from the study sites. The predicted hydrograph at the cross section closest to each site was then cross correlated with the hydrograph of the nearest upstream gage (fig. 13). The program will find images within a user-specified tolerance of the desired discharge level at the nearest gage (the default is ± 100 ft³/s). Again, once the images are found based on the user's criteria, the user can process and make a movie of these images (the movie this time will include a plot of the discharge curve for the selected date range). The third (purple) tab allows the user to find images from the database, based on site/deployment, date range, and time of day (including the ideal time for a given site). In other words, it does the same as the green tab, except the specification of discharge.

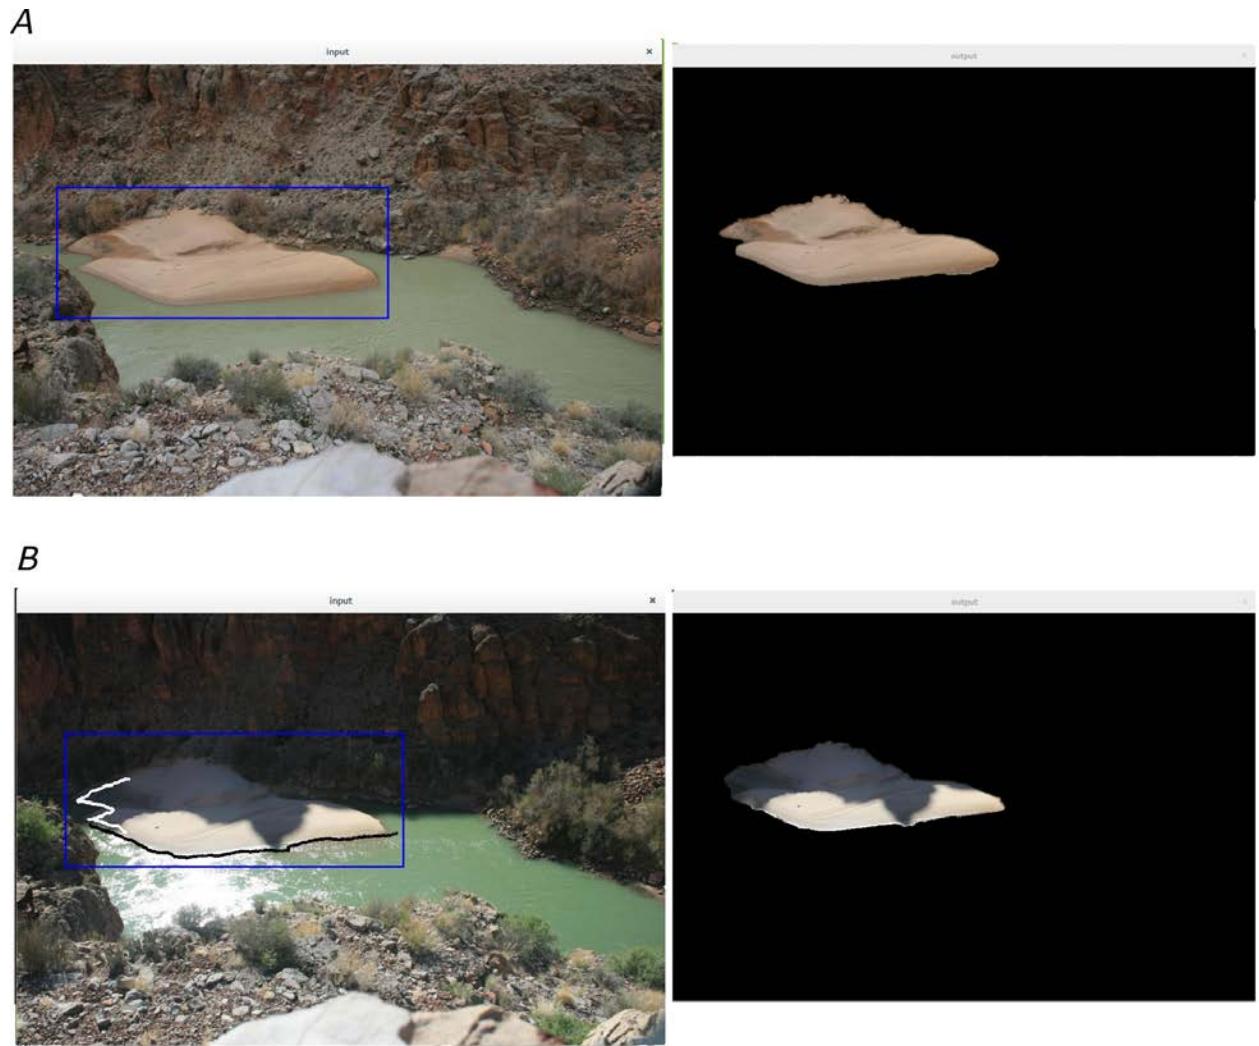
Figure 14. Example interactive segmentation in the RCSandSeg program (Buscombe, 2017) used to process remote-camera images for sandbar monitoring along the Colorado River in Grand Canyon National Park, Arizona. *A*, The user draws a blue bounding box around an image (left), and the resulting segmentation (right) is perfect; *B*, the user draws a bounding box around the bar in this image with strong shadows, and annotates foreground (white) and background (black) with the mouse (left). The resulting segmentation is on the right.

The program is used in the following way. A window appears containing the image. The user draws a box around the sandbar by dragging the mouse over the image, then presses the "n" key on the keyboard. The program makes an initial estimate of the sandbar location within the box and displays this within a second window (fig. 14). When the user presses "n" again, the program updates its estimate. After a few presses of the "n" key, the estimate of the sandbar location no longer changes. At that point, the user can accept the sandbar segmentation by visually comparing the segmentation with the input image and making a subjective decision about whether or not it is of acceptable accuracy. Sometimes, no additional input is necessary (fig. 14A). Then, the program saves the result (the coordinates, in the image reference frame, of the sandbar boundary) and moves on to the next image. If the segmentation is unsatisfactory, the user gives the program new information that allows it to improve its estimate. This is done by specifying what is foreground (sandbar) or background in the image, by drawing on the image with the mouse. Foreground marking is carried out by pressing the "1" key and then drawing on the image where there is sandbar the program has missed. Background marking is carried out by pressing the "0" key, then drawing on the image where there is no sandbar. The program refines its estimate of the sandbar location based on this new information (fig. 14B).
