# **Geomorphic Survey of North Fork Eagle Creek, New Mexico, 2017**

Open-File Report 2018–1187

By Alexander P. Graziano

Prepared in cooperation with the Village of Ruidoso, New Mexico

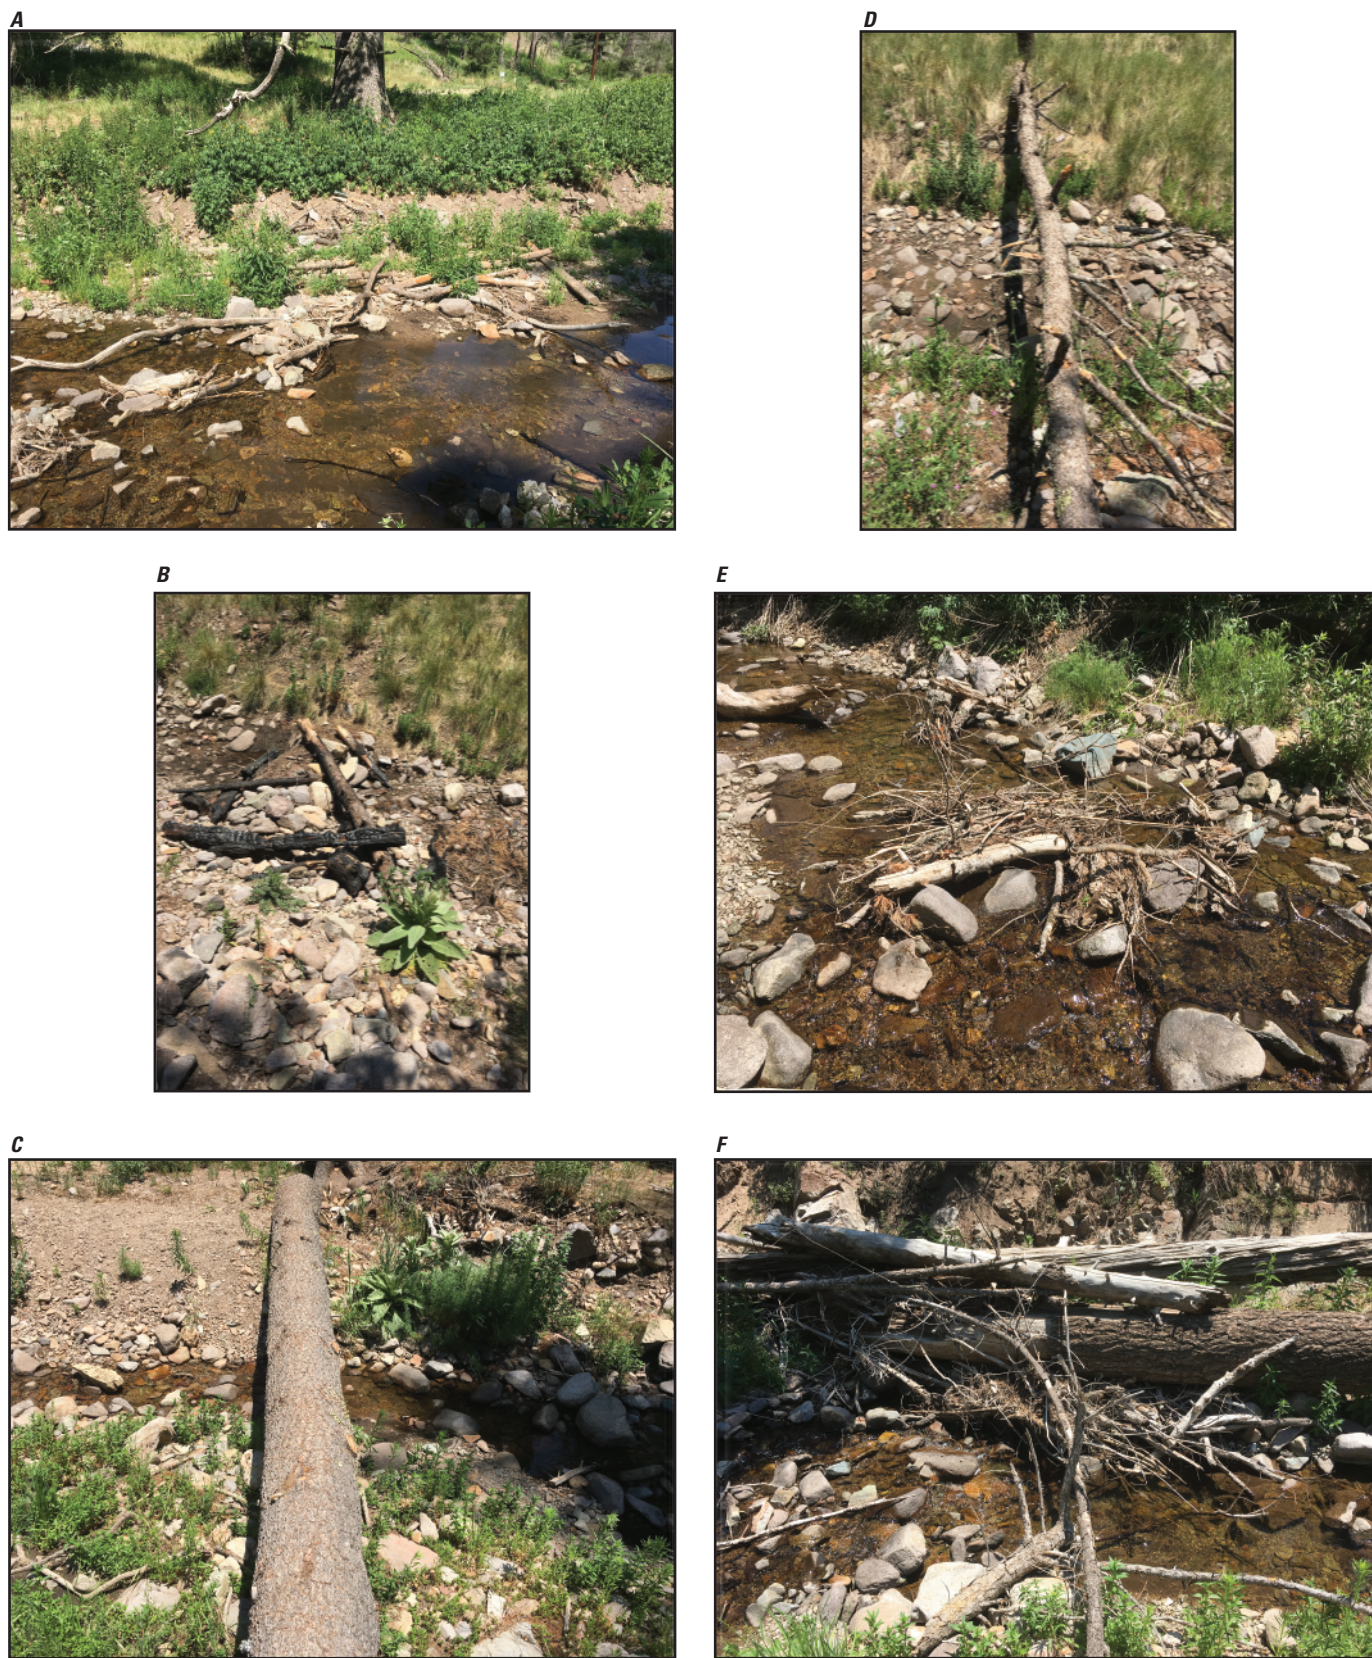
**Figure 10.** Examples of woody debris accumulations found in North Fork Eagle Creek, south-central New Mexico, 2017 (photographs by S. Green, U.S. Geological Survey). Locations of examples are shown in figure 9. *A*, Debris deposit. *B*, Debris deposit. *C*, Potential debris jam. *D*, Potential debris jam. *E*, Active debris jam. *F*, Active debris jam.

charred wood (charred wood or burn-marked wood was also present in at least seven other woody debris accumulations). Figure 10*C*, which depicts the site of a potential debris jam, shows a large log that appears to have been cleanly cut and left in its location. The tree in figure 10*D*, which also depicts a potential debris jam, is assumed to have fallen across the channel naturally. Figures 10*E* and 10*F*, both depicting active debris jams, show the range in the size of the woody debris seen in active debris jams. Woody debris accumulation photographs indicated that, with one or two possible exceptions (including the woody debris accumulation depicted in fig. 10*F*), the woody debris present in North Fork Eagle Creek at the time of the survey likely had negligible effects on channel dimensions. Further, they did not appear to prevent any bed materials larger than sand from being transported downstream.

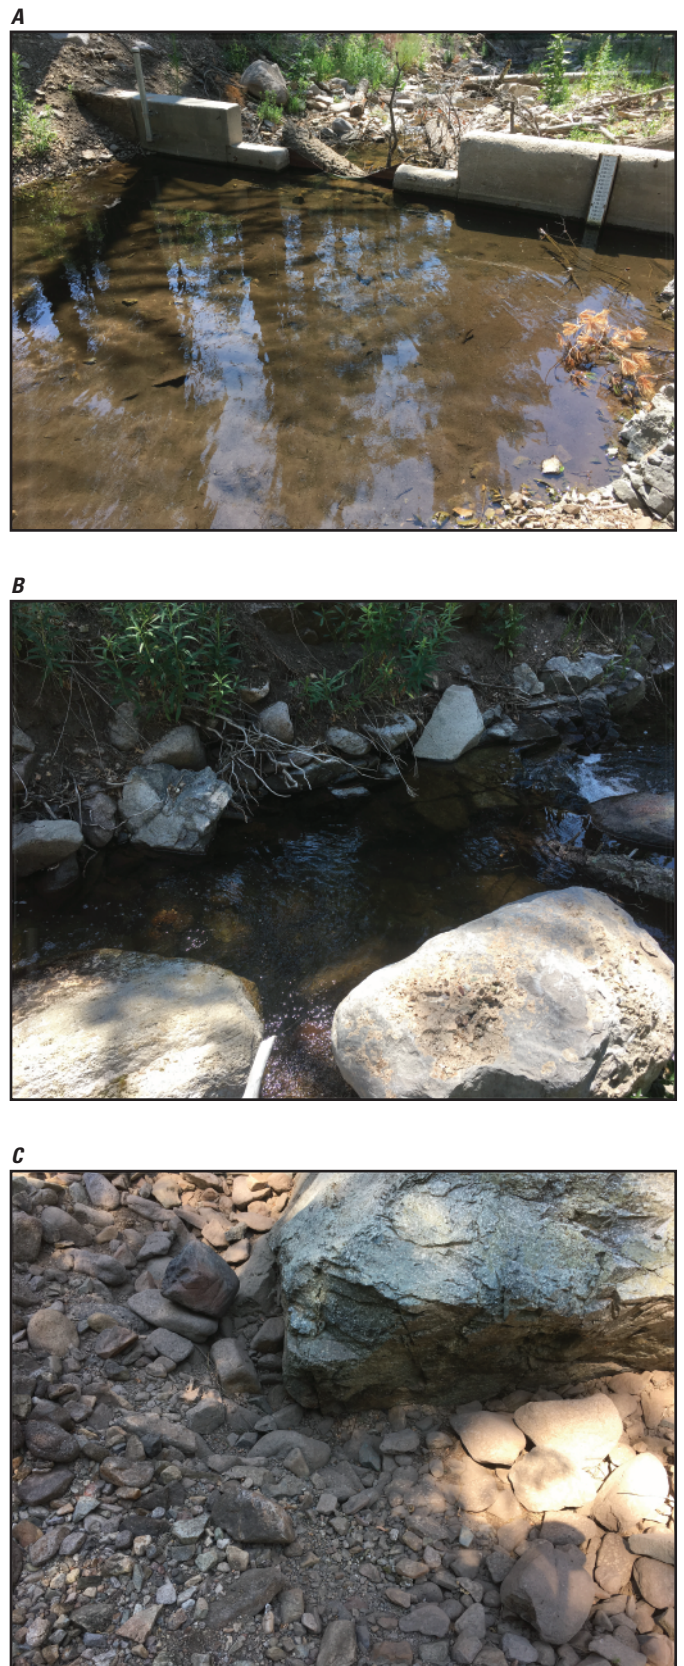
**Figure 11.** Examples of pools found in North Fork Eagle Creek, south-central New Mexico, 2017 (photographs by S. Green, U.S. Geological Survey). Locations of examples are shown in figure 9. *A*, Artificial weir of the North Fork Eagle Creek near Alto, New Mexico, streamflow-gaging station (U.S. Geological Survey site 08387550) and the pool that has formed upstream from it. *B*, Naturally occurring pool, which is representative of most of the pools that were found in the study reach. *C*, Dry area of the study reach that would likely form a pool during periods of continuous flow in the study reach.

the artificial weir of the North Fork gaging station and the pool that has formed upstream from it. It can be noted from the photograph that, because of the presence of the weir, fine sediment (which was not typically covering the streambed over much of the reach) has settled in the pool. Figure 11B depicts a naturally occurring pool, which is representative of most of the pools that were found in the study reach. However, figure 11B also depicts the only pool that was colocated with woody debris. Notably, the woody debris present in the photograph did not appear to cause the pool to form. Figure 11C depicts a dry area of the study reach that would likely form a pool during periods of continuous flow in the study reach. Photographs were taken of all but three of the pools, and of the photographed pools, all but one (fig. 11C) had water. Because large sections of the reach were dry, it is likely that pool identification was biased towards areas where water was present. Therefore, some pools present in the reach at the time of the survey may not have been identified. To mitigate this source of potential bias in the future, measurements of “residual depth” are planned for future surveys. Measurements of “residual depth” can be used to both classify pools and better define what qualifies as a pool in a dry section of the reach.
