Bridge Scour Countermeasure Assessments at Select Bridges in the United States, 2016–18

Open-File Report 2019–1008

By Taylor J. Dudunake, Richard J. Huizinga, and Ryan L. Fosness

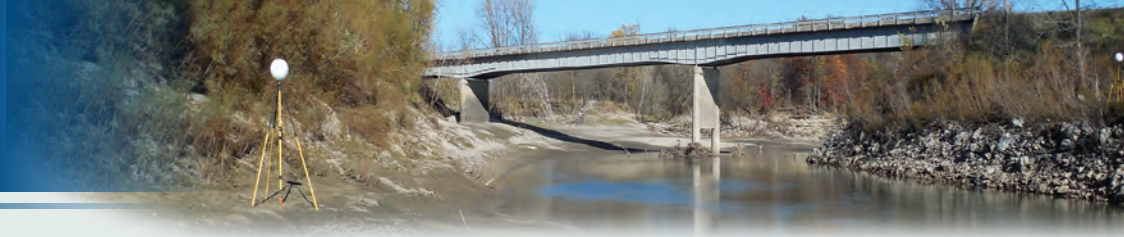
Banner:

T-LiDAR survey being conducted during the November 2015 site visit at the Grand River near McFall, Missouri (site ID 011). Photograph by Richard Huizinga.

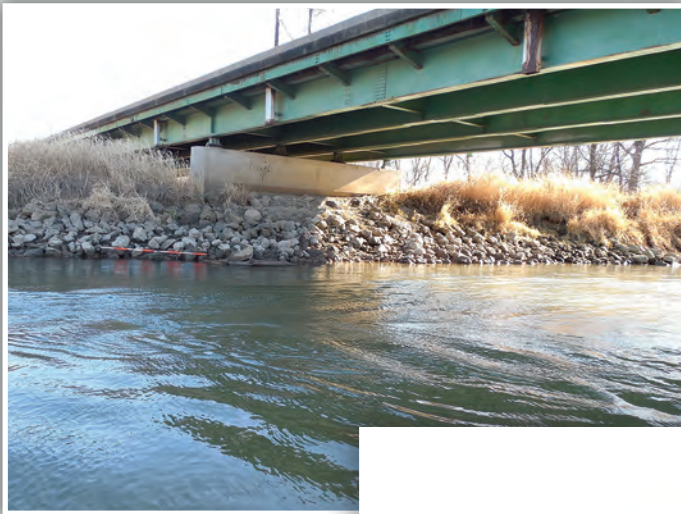
Top left:

Conducting Wolman pebble count on riprap on left bank at the Wapsipinicon River near Wheatland, Iowa (site ID 031). Photograph by Richard Huizinga.

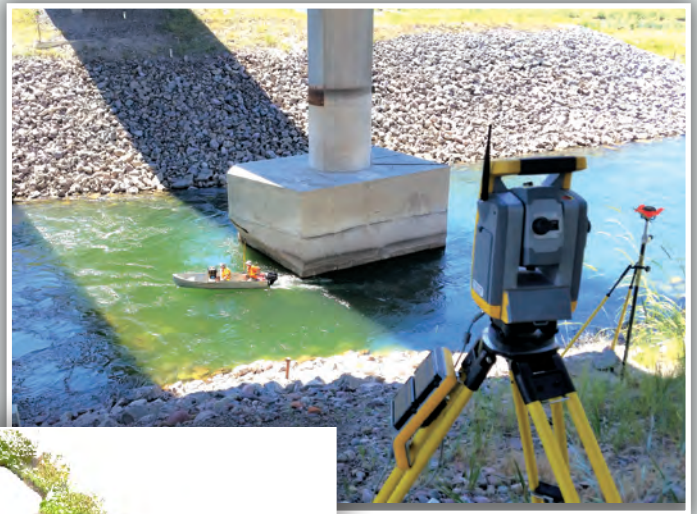
Top right:

Photograph showing singlebeam bathymetric survey being conducted during the June 2016 site visit using Trimble S6 total station scanner at the Blackfoot River near Bonner, Montana (site ID 016). Photograph by Taylor Dudunake.
