Appendix 8. Tabulated Observations and Photographs of Surface Faulting and Ground Deformation Produced by the M_w 6.0 South Napa Earthquake of August 24, 2014—Trace G

Trace G

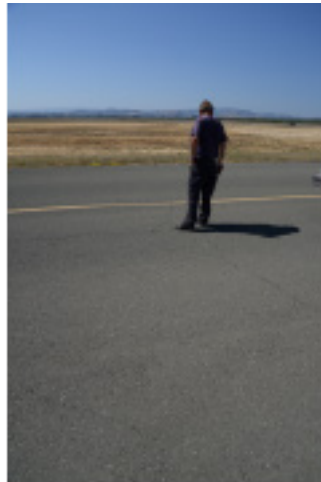
Station ID: 853**Observer: Hudnut/Dawsom**

Fracture in pavement at airstrip.

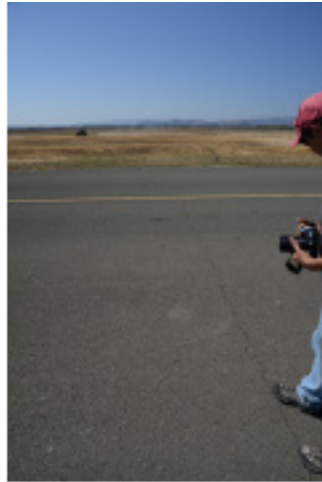
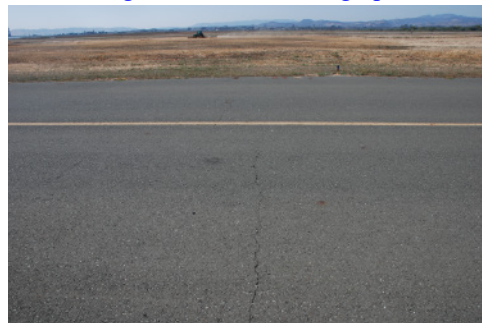
Station ID: 854 **Observer: Hudnut/Dawson**

Fracture in pavement at airstrip.

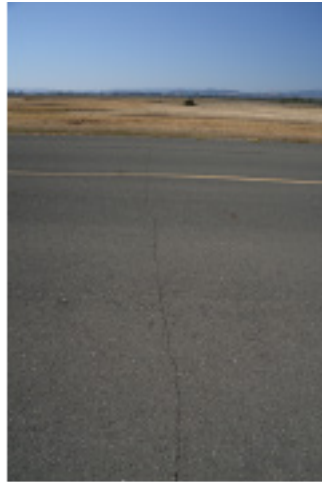
Station ID: 855			Observer: Hudnut/Dawson	
------------------------	--	--	--------------------------------	--

Description
Fracture across yellow line at airport strip.

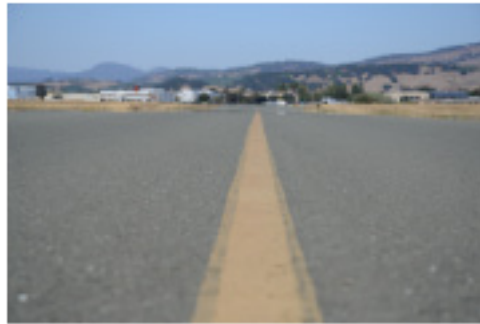
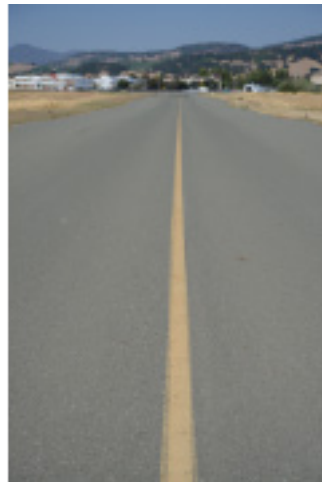
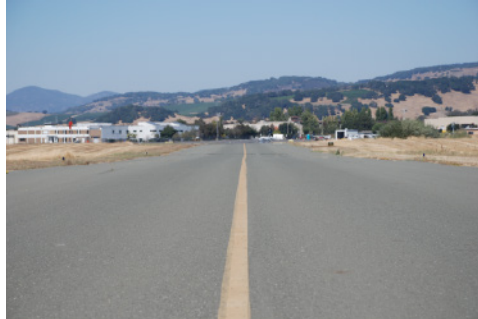
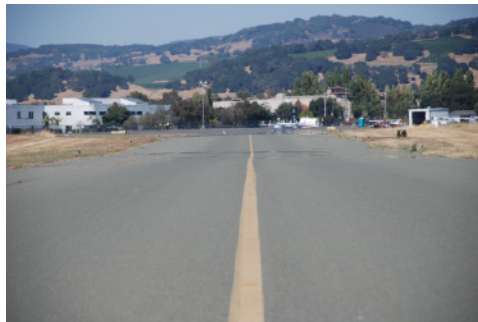
Station ID: 856	Observer: Hudnut/Dawson			
------------------------	--------------------------------	--	--	--

Description
Slight bend in yellow line along airstrip.

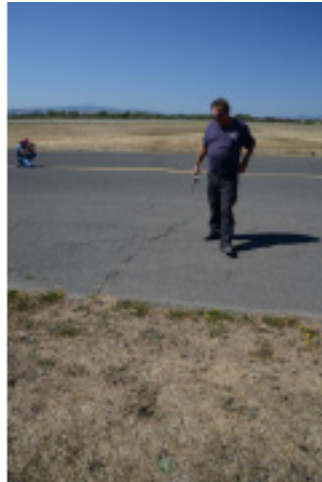
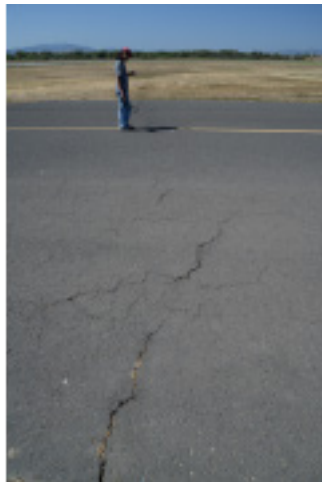
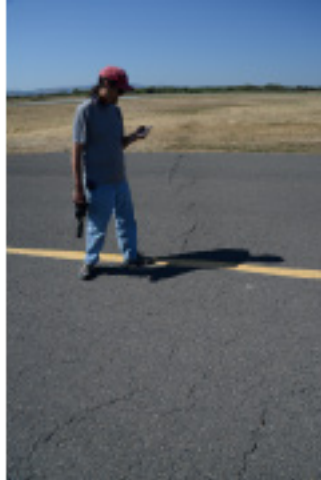
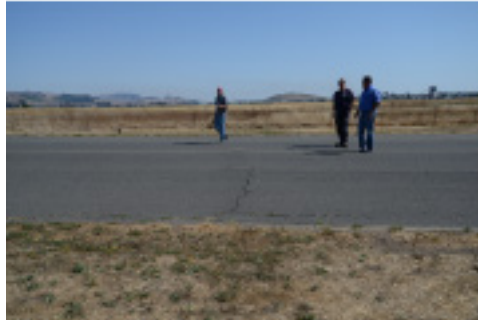
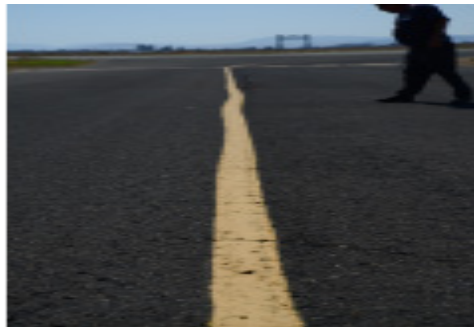
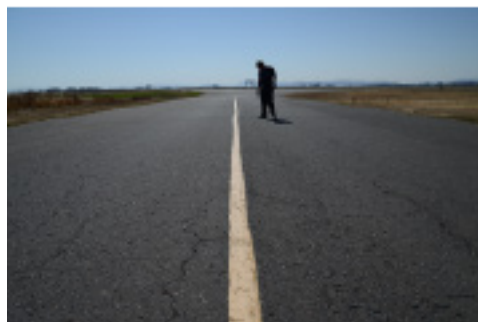
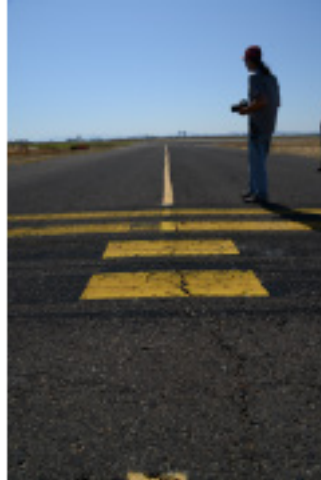
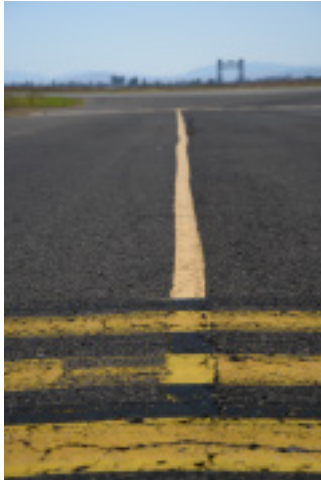
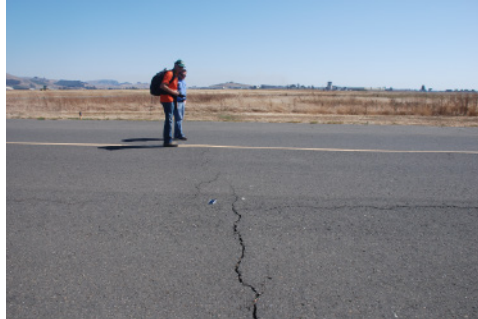
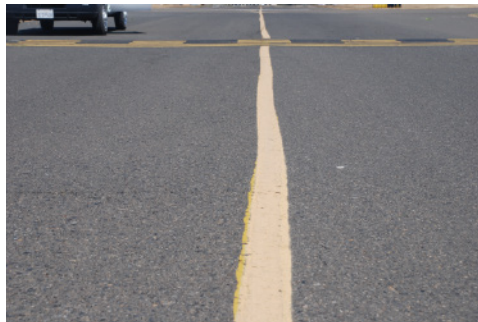
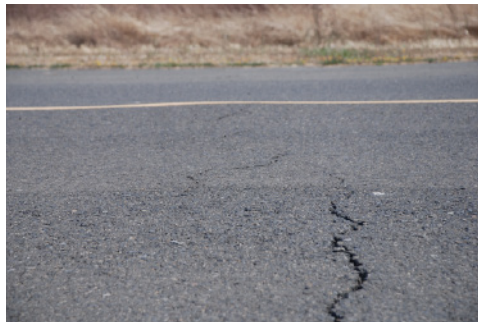
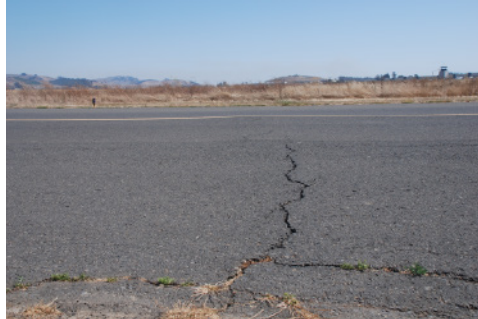
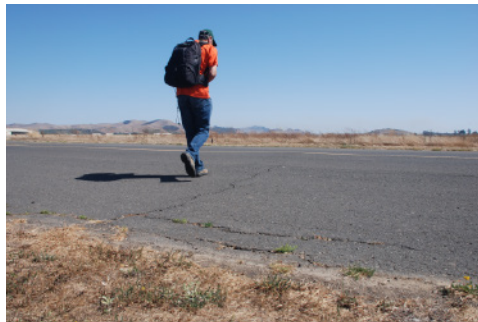
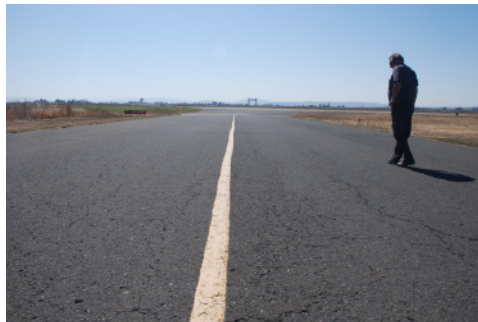
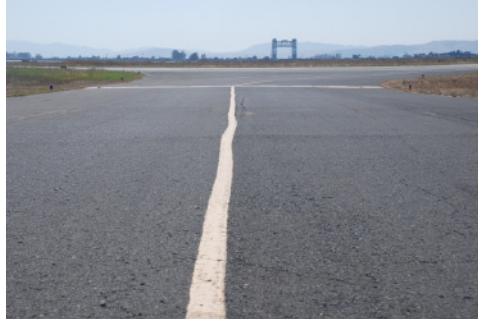
Station ID: 857	Observer: Hudnut/Dawson			
------------------------	--------------------------------	--	--	--

Description
Fractures across entire airstrip through this point.

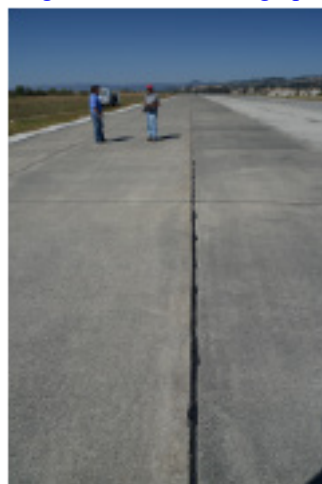
Station ID: 859	Observer: Hudnut/Dawson			
------------------------	--------------------------------	--	--	--

Description
Expansion in pavement? Along fault trace.

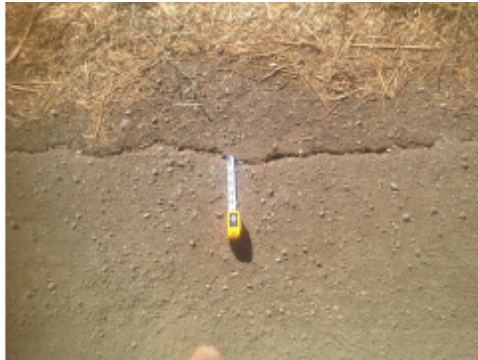
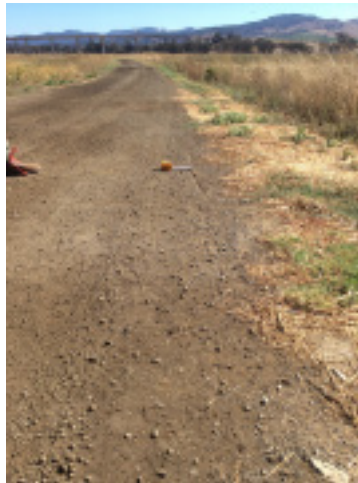
Station ID: 860		Observer: Hitchcock/Lutz		
Observation Date	Latitude	Longitude	Offset Feature	Inferred Origin
2014:09:16	38.23829	122.29417	Soil	Uncertain
Description				
Fissures along southeast edge of road. Likely fresh based on absence of infilling or vegetation growth.				
Photographer	Camera Coordinates		Photograph Date	
Hitchcock/Lutz			2014:09:16 13:53:56
