# Appendix 11. Tabulated Observations and Photographs of Ground Deformation Produced by the $M_w$ 6.0 South Napa Earthquake of August 24, 2014—Ridge-Top Fractures

The following pages contain maps and tables of descriptions, slip measurements, and photographs of ground deformation features obtained in the field at observation stations located in regions H and K. Station locations are shown as circles in figures 11.1 and 11.2 and labeled by the Station ID number. To aid in locating a specific observation station, IDs increase numerically from south to north. Where multiple observations occur at the exact same locality, IDs are shown as a range (for example 200–202 identifies stations 200, 201, and 202 all at the same location). Where stations are too closely spaced to be individually labeled in the figures, a single label is used for a group of stations, with the IDs or groups of IDs listed in a vertical column and the label leader pointing to the approximate midpoint of the group of closely spaced stations. Mappable fault rupture and surface deformation features are symbolized on the included maps as described in appendix 1.

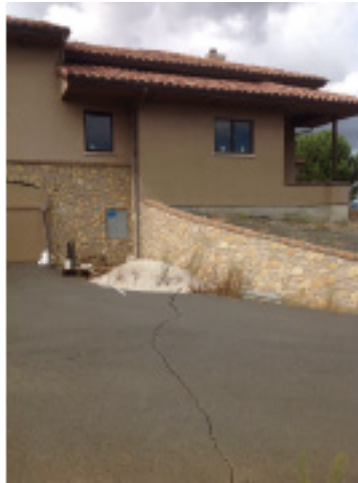
High Resolution Photograph

<b>Station ID: 862</b>				<b>Observer: Ponti</b>
<b>Observation Date</b>	<b>Latitude</b>	<b>Longitude</b>	<b>Offset Feature</b>	<b>Inferred Origin</b>
2014:09:18	38.33120	122.35071	Soil	Uncertain
<b>Photographer</b>	<b>Camera Coordinates</b>		<b>Photograph Date</b>	
Ponti	38.33125	122.35067	2014:09:18 14:32:33

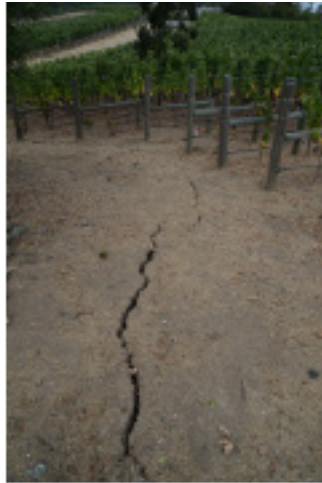
<b>Station ID: 891</b>				<b>Observer: Ponti</b>		
<b>Observation Date</b>	<b>Latitude</b>	<b>Longitude</b>	<b>Offset Feature</b>	<b>Inferred Origin</b>		
2014:09:17	38.33255	122.35196	Soil	Uncertain		
<b>Description</b>						
Vector length=4.5 cm. Vector plunge=5 deg. Vector azimuth=72 deg. Local fracture azimuth=317 deg.						
<b>Fault Azimuth</b>	<b>Strike Slip</b>	<b>Strike-slip Sense</b>	<b>Extension</b>	<b>Compression</b>	<b>Vertical</b>	<b>Upthrown Side</b>
317	1.9	RL	4.1		0.4	W

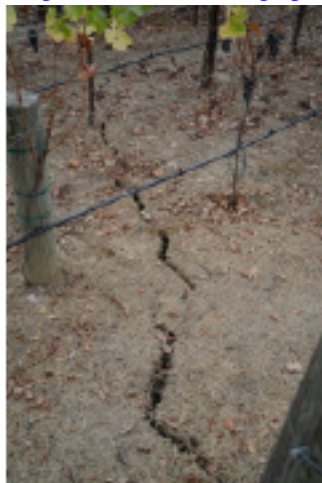
<b>Station ID: 894</b>				<b>Observer: Ponti</b>
<b>Observation Date</b>	<b>Latitude</b>	<b>Longitude</b>	<b>Offset Feature</b>	<b>Inferred Origin</b>
2014:09:18	38.33260	122.35310	Soil	Uncertain
<b>Description</b>				
Possible cracking, although difficult to tell because of matted grass over the surface. Unclear if this trend continues to where a crack is observed several tens of meters to the southeast.

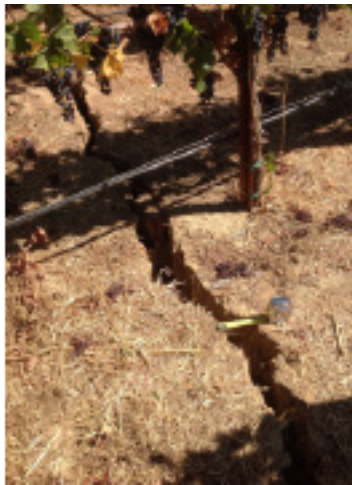
<b>Station ID: 913</b>				<b>Observer: Ponti</b>
<b>Observation Date</b>	<b>Latitude</b>	<b>Longitude</b>	<b>Offset Feature</b>	<b>Inferred Origin</b>
2014:09:17	38.33274	122.35258	Soil	Uncertain
<b>Description</b>				
Tension crack; intermittent along mapped trend. Discontinuous and hard to see; mostly only shows up adjacent to the vineyard posts.

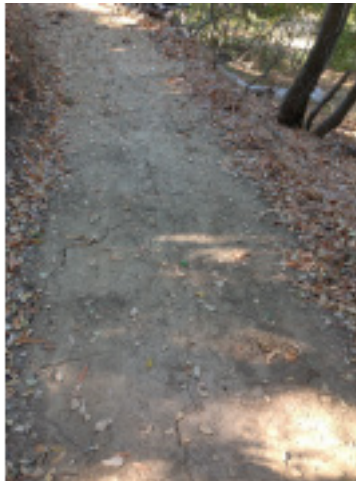
<b>Station ID: 936</b>				<b>Observer: Ponti</b>
<b>Observation Date</b>	<b>Latitude</b>	<b>Longitude</b>	<b>Offset Feature</b>	<b>Inferred Origin</b>
2014:09:17	38.33320	122.35282	Soil	Uncertain
<b>Description</b>				
Tension crack; intermittent along mapped trend. Small cracks.

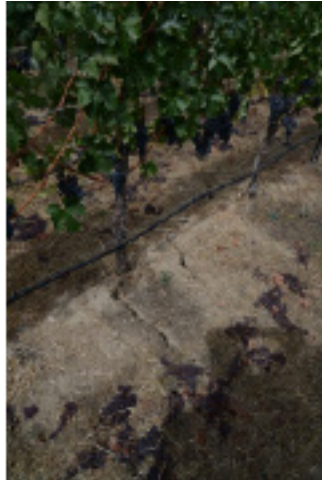
<b>Station ID: 940</b>				<b>Observer: Hudnut</b>
<b>Observation Date</b>	<b>Latitude</b>	<b>Longitude</b>	<b>Offset Feature</b>	<b>Inferred Origin</b>
2014:08:29	38.33331	122.35260	Soil	Uncertain
<b>Photographer</b>	<b>Camera Coordinates</b>		<b>Photograph Date</b>	
Hudnut	38.33330	122.35258	2014:08:29 13:03:56

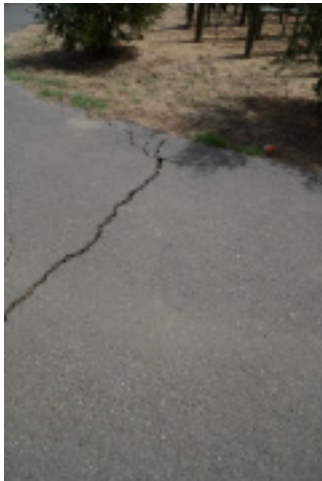
<b>Station ID: 942</b>					<b>Observer: Ponti</b>
<b>Observation Date</b>	<b>Latitude</b>	<b>Longitude</b>	<b>Offset Feature</b>	<b>Inferred Origin</b>	
2014:09:17	38.33334	122.35281	Pavement	Uncertain	
<b>Description</b>					
Tension crack; continuous along mapped trend. Crack in pavement.

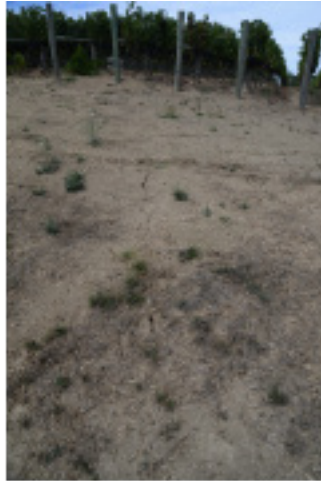
<b>Station ID: 943</b>					<b>Observer: Hudnut</b>
<b>Observation Date</b>	<b>Latitude</b>	<b>Longitude</b>	<b>Offset Feature</b>	<b>Inferred Origin</b>	
2014:08:29	38.33336	122.35346	Soil	Uncertain	
<b>Photographer</b>	<b>Camera Coordinates</b>		<b>Photograph Date</b>		
Hudnut	38.33332	122.35342	2014:08:29 14:07:16

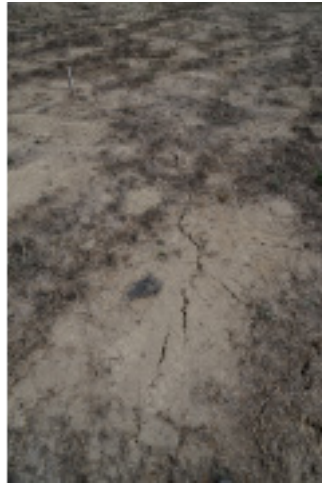
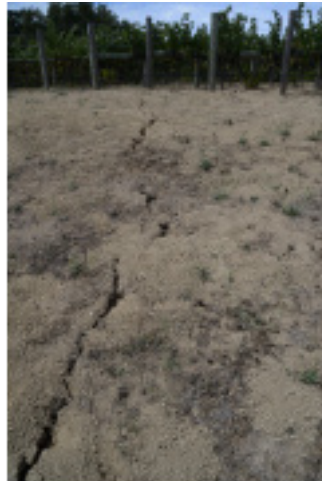
<b>Station ID: 944</b>				<b>Observer: Hudnut</b>
<b>Observation Date</b>	<b>Latitude</b>	<b>Longitude</b>	<b>Offset Feature</b>	<b>Inferred Origin</b>
2014:08:29	38.33337	122.35402	Soil	Uncertain
<b>Photographer</b>	<b>Camera Coordinates</b>		<b>Photograph Date</b>	
Hudnut	38.33339	122.35405	2014:08:29 14:04:13

<b>Photographer</b>	<b>Camera Coordinates</b>		<b>Photograph Date</b>
Hudnut	38.33340	122.35406	2014:08:29 14:04:17

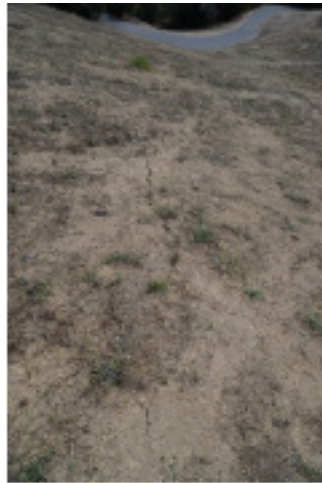
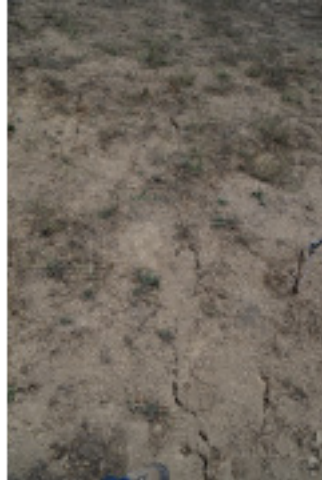
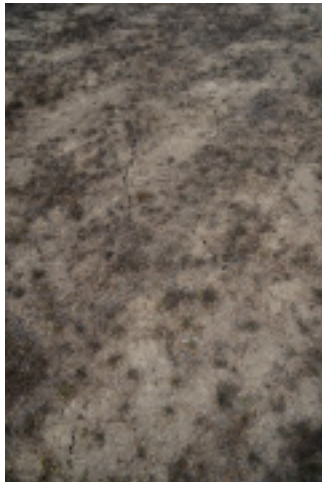
<b>Station ID: 946</b>					<b>Observer: Hudnut</b>
<b>Observation Date</b>	<b>Latitude</b>	<b>Longitude</b>	<b>Offset Feature</b>	<b>Inferred Origin</b>	
2014:08:29	38.33339	122.35393	Soil	Uncertain	
<b>Photographer</b>	<b>Camera Coordinates</b>		<b>Photograph Date</b>		
Hudnut	38.33335	122.35387	2014:08:29 14:03:53

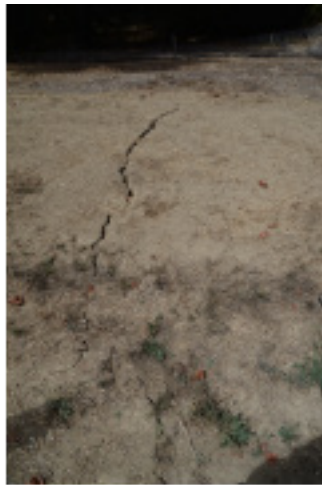
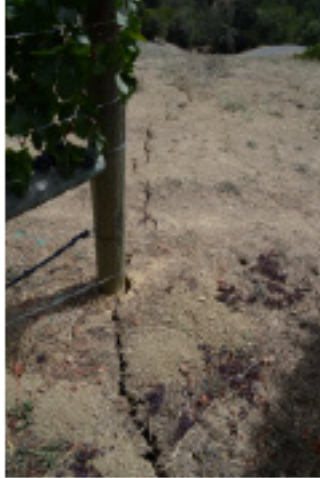
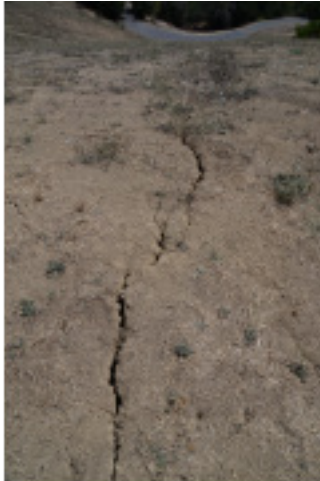
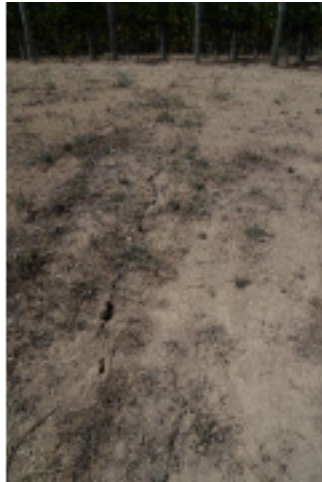
<b>Station ID: 948</b>				<b>Observer: Hudnut</b>	
<b>Observation Date</b>	<b>Latitude</b>	<b>Longitude</b>	<b>Offset Feature</b>	<b>Inferred Origin</b>	
2014:08:29	38.33339	122.35421	Soil	Uncertain	
<b>Photographer</b>	<b>Camera Coordinates</b>		<b>Photograph Date</b>		
Hudnut	38.33353	122.35430	2014:08:29	13:52:20

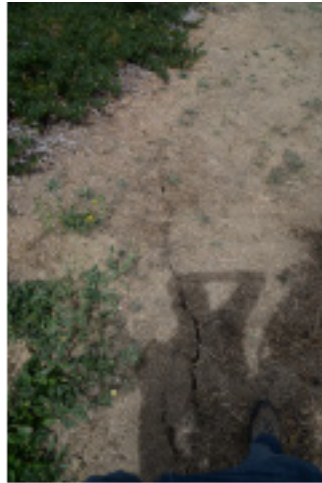
<b>Station ID: 950</b>				<b>Observer: Hudnut</b>
<b>Observation Date</b>	<b>Latitude</b>	<b>Longitude</b>	<b>Offset Feature</b>	<b>Inferred Origin</b>
2014:08:29	38.33341	122.35265	Soil	Uncertain
<b>Photographer</b>	<b>Camera Coordinates</b>		<b>Photograph Date</b>	
Hudnut	38.33340	122.35264	2014:08:29 13:05:06

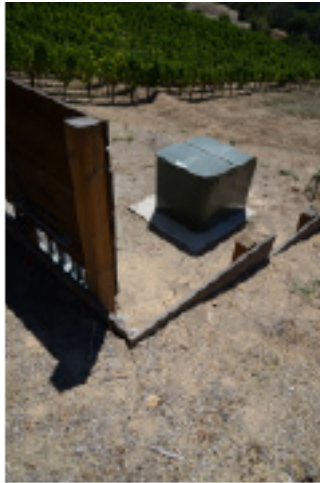
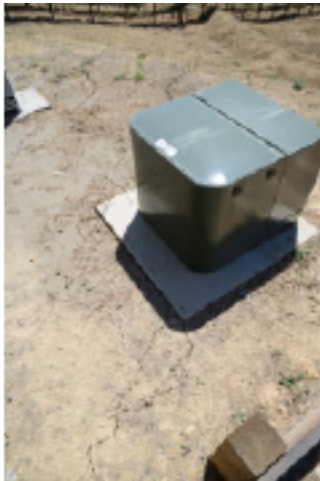
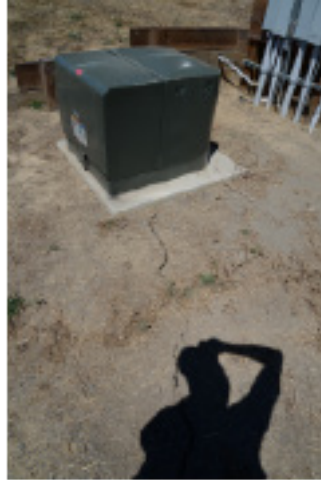
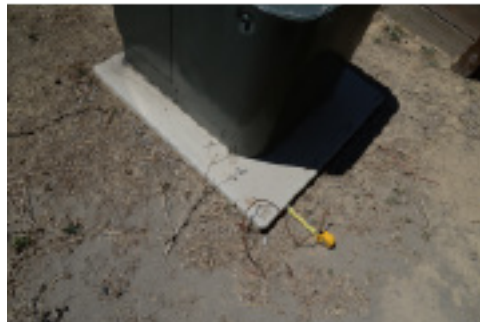
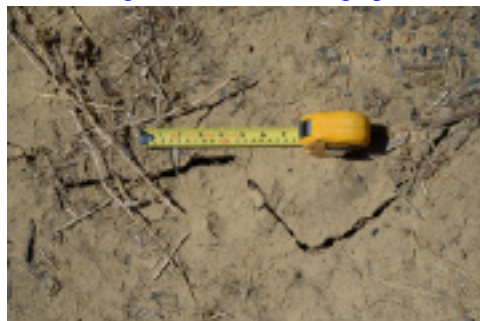
<b>Station ID: 953</b>				<b>Observer: Hudnut</b>
<b>Observation Date</b>	<b>Latitude</b>	<b>Longitude</b>	<b>Offset Feature</b>	<b>Inferred Origin</b>
2014:08:31	38.33343	122.35309	Soil	Uncertain
<b>Photographer</b>	<b>Camera Coordinates</b>		<b>Photograph Date</b>	
Hudnut	38.33348	122.35312	2014:08:31 13:03:49

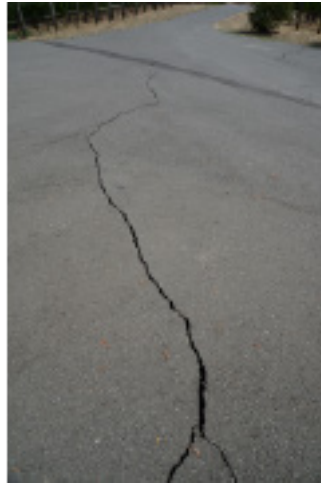
<b>Station ID: 956</b>				<b>Observer: Ponti</b>
<b>Observation Date</b>	<b>Latitude</b>	<b>Longitude</b>	<b>Offset Feature</b>	<b>Inferred Origin</b>
2014:09:17	38.33343	122.35285	Soil	Uncertain
<b>Description</b>				
Tension crack; continuous along mapped trend. Observed in pavement.

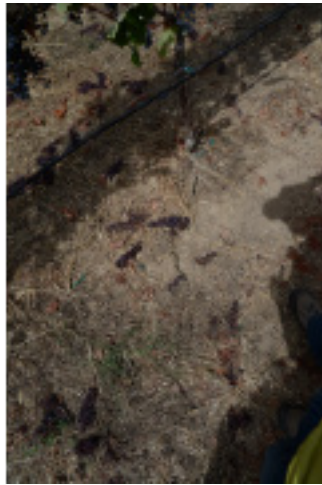
<b>Station ID: 959</b>					<b>Observer: Hudnut</b>
<b>Observation Date</b>	<b>Latitude</b>	<b>Longitude</b>	<b>Offset Feature</b>	<b>Inferred Origin</b>	
2014:08:29	38.33346	122.35261	Soil	Uncertain	
<b>Photographer</b>	<b>Camera Coordinates</b>		<b>Photograph Date</b>		
Hudnut	38.33345	122.35259	2014:08:29 13:04:29

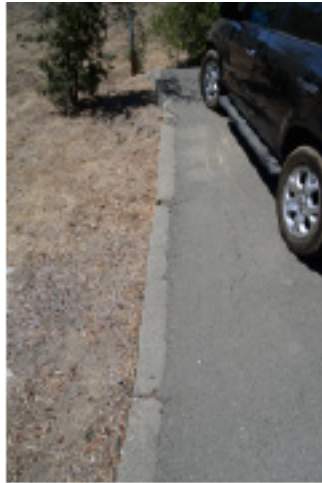
<b>Station ID: 960</b>				<b>Observer: Hudnut</b>
<b>Observation Date</b>	<b>Latitude</b>	<b>Longitude</b>	<b>Offset Feature</b>	<b>Inferred Origin</b>
2014:08:31	38.33348	122.35312	Soil	Uncertain
<b>Photographer</b>	<b>Camera Coordinates</b>		<b>Photograph Date</b>	
Hudnut	38.33350	122.35311	2014:08:31 13:03:42

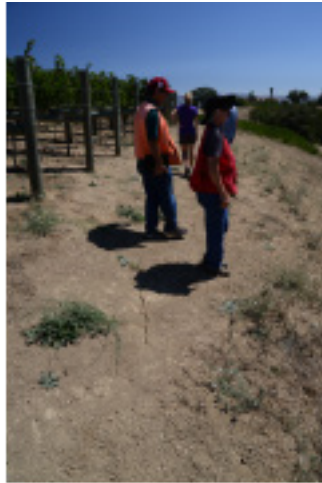
<b>Station ID: 962</b>				<b>Observer: Hudnut</b>
<b>Observation Date</b>	<b>Latitude</b>	<b>Longitude</b>	<b>Offset Feature</b>	<b>Inferred Origin</b>
2014:08:31	38.33349	122.35385	Soil	Uncertain
<b>Photographer</b>	<b>Camera Coordinates</b>		<b>Photograph Date</b>	
Hudnut	38.33348	122.35384	2014:08:31 12:58:19

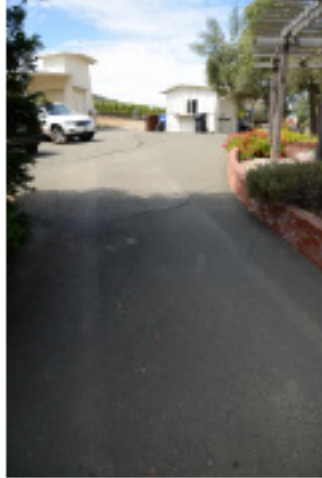
<b>Station ID: 964</b>				<b>Observer: Ponti</b>
<b>Observation Date</b>	<b>Latitude</b>	<b>Longitude</b>	<b>Offset Feature</b>	<b>Inferred Origin</b>
2014:09:17	38.33349	122.35305	Pavement	Uncertain
<b>Description</b>				
Tension crack; continuous along mapped trend. Observed in pavement.

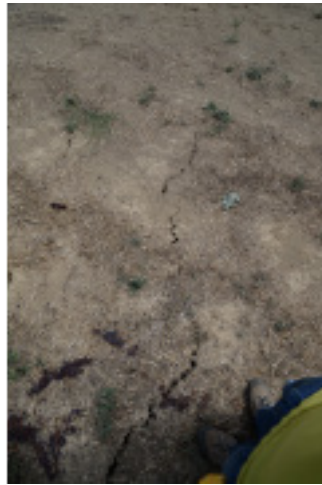
<b>Station ID: 965</b>				<b>Observer: Hudnut</b>
<b>Observation Date</b>	<b>Latitude</b>	<b>Longitude</b>	<b>Offset Feature</b>	<b>Inferred Origin</b>
2014:08:29	38.33349	122.35408	Soil	Uncertain
<b>Photographer</b>	<b>Camera Coordinates</b>		<b>Photograph Date</b>	
Hudnut	38.33347	122.35408	2014:08:29 14:04:28

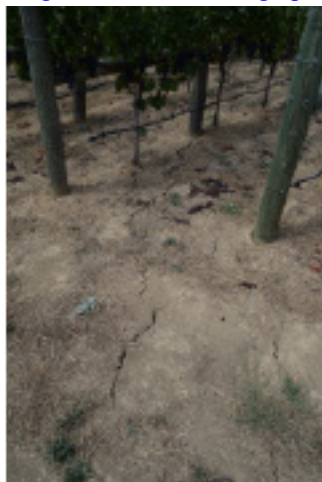
<b>Station ID: 966</b>				<b>Observer: Ponti</b>
<b>Observation Date</b>	<b>Latitude</b>	<b>Longitude</b>	<b>Offset Feature</b>	<b>Inferred Origin</b>
2014:09:18	38.33349	122.35408	Soil	Uncertain
<b>Description</b>				
Tension crack; continuous along mapped trend. Short zone of cracks extending out of the open field; on UAVSAR lineament.

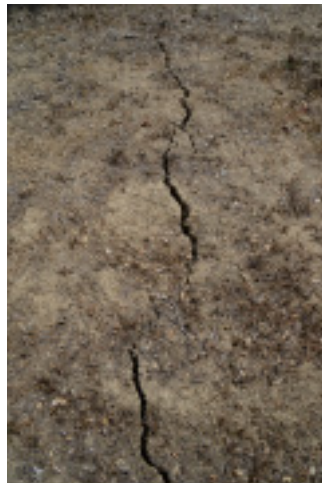
<b>Station ID: 970</b>					<b>Observer: Hudnut</b>
<b>Observation Date</b>	<b>Latitude</b>	<b>Longitude</b>	<b>Offset Feature</b>	<b>Inferred Origin</b>	
2014:08:29	38.33354	122.35437	Soil	Uncertain	
<b>Photographer</b>	<b>Camera Coordinates</b>		<b>Photograph Date</b>		
Hudnut	38.33366	122.35435	2014:08:29 13:51:09

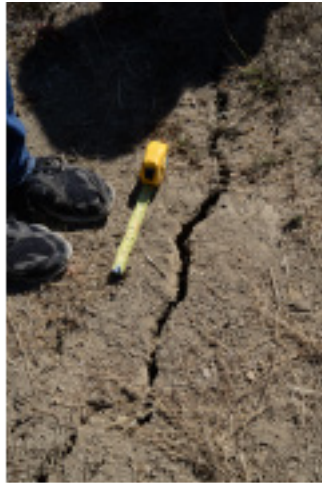
<b>Station ID: 971</b>				<b>Observer: Hudnut</b>
<b>Observation Date</b>	<b>Latitude</b>	<b>Longitude</b>	<b>Offset Feature</b>	<b>Inferred Origin</b>
2014:08:31	38.33354	122.35437	Soil	Uncertain
<b>Photographer</b>	<b>Camera Coordinates</b>		<b>Photograph Date</b>	
Hudnut	38.33350	122.35441	2014:08:31 12:45:16

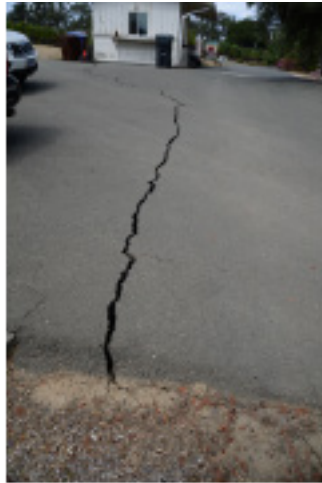
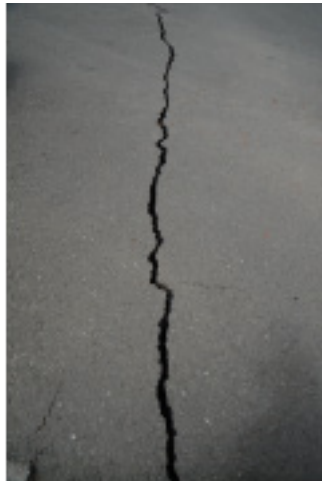
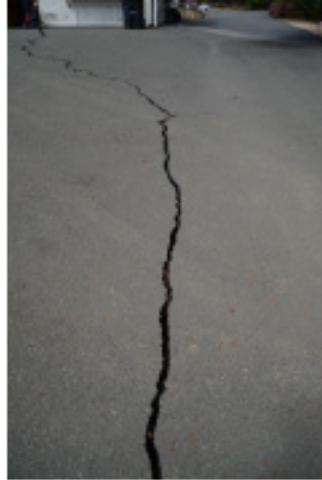
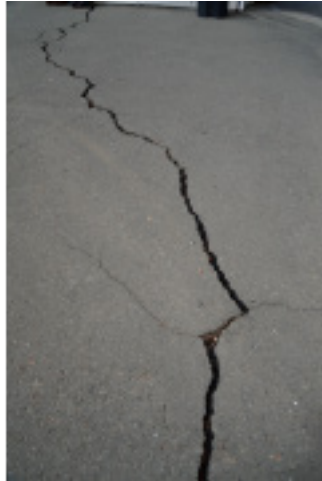
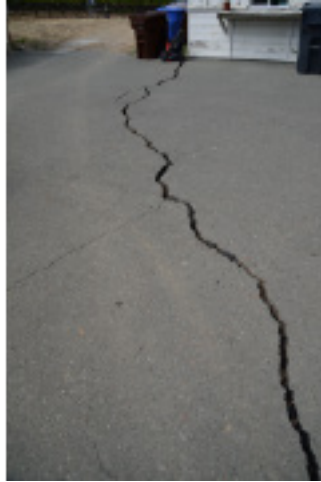
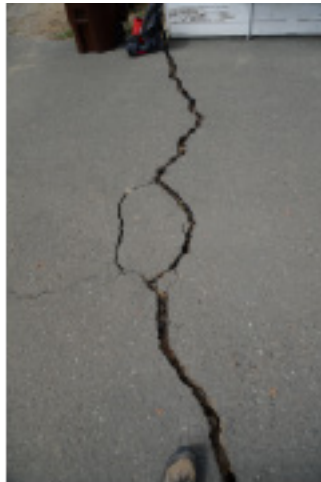
<b>Station ID: 972</b>				<b>Observer: Hudnut</b>
<b>Observation Date</b>	<b>Latitude</b>	<b>Longitude</b>	<b>Offset Feature</b>	<b>Inferred Origin</b>
2014:08:29	38.33355	122.35314	Pavement	Uncertain
<b>Photographer</b>	<b>Camera Coordinates</b>		<b>Photograph Date</b>	
Hudnut	38.33347	122.35308	2014:08:29 14:15:17

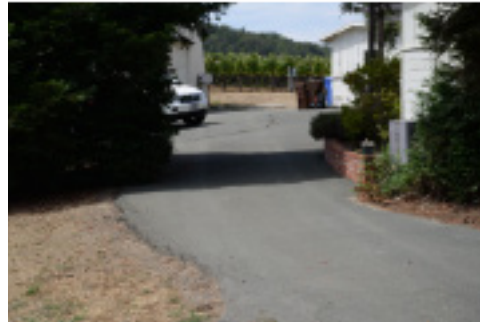
<b>Station ID: 973</b>				<b>Observer: Ponti</b>
<b>Observation Date</b>	<b>Latitude</b>	<b>Longitude</b>	<b>Offset Feature</b>	<b>Inferred Origin</b>
2014:09:17	38.33355	122.35314	Pavement	Uncertain
<b>Description</b>				
Tension crack; continuous along mapped trend. Prominent, in pavement.

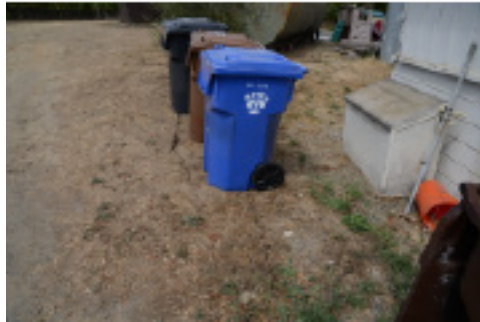
<b>Station ID: 974</b>				<b>Observer: Hudnut</b>
<b>Observation Date</b>	<b>Latitude</b>	<b>Longitude</b>	<b>Offset Feature</b>	<b>Inferred Origin</b>
2014:08:29	38.33364	122.35322	Soil	Uncertain
<b>Photographer</b>	<b>Camera Coordinates</b>		<b>Photograph Date</b>	
Hudnut	38.33360	122.35320	2014:08:29 14:15:39

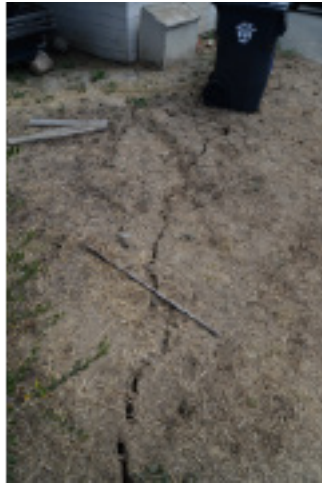
<b>Station ID: 975</b>				<b>Observer: Hudnut</b>
<b>Observation Date</b>	<b>Latitude</b>	<b>Longitude</b>	<b>Offset Feature</b>	<b>Inferred Origin</b>
2014:08:29	38.33368	122.35321	Soil	Uncertain
<b>Photographer</b>	<b>Camera Coordinates</b>		<b>Photograph Date</b>	
Hudnut	38.33365	122.35320	2014:08:29 14:13:31

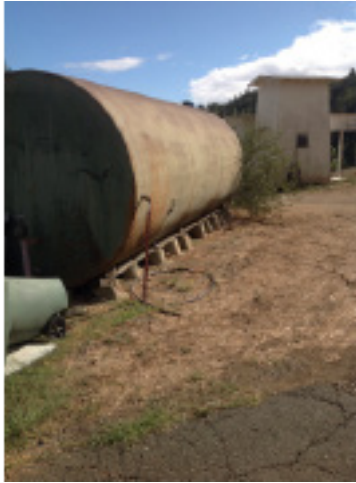
[High Resolution Photograph](#)

<b>Station ID: 976</b>				<b>Observer: Ponti</b>
<b>Observation Date</b>	<b>Latitude</b>	<b>Longitude</b>	<b>Offset Feature</b>	<b>Inferred Origin</b>
2014:09:18	38.33373	122.35320	Curb/Sidewalk	Uncertain
<b>Description</b>				
Tank foundation piers pitch to the east, likely as a result of shaking. However, there are some ground cracks extending through the south west end of the tank.				
<b>Photographer</b>	<b>Camera Coordinates</b>		<b>Photograph Date</b>	
Ponti	38.33372	122.35314	2014:09:18 15:51:04

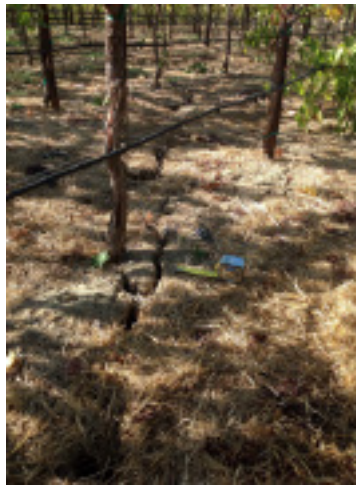
[High Resolution Photograph](#)

<b>Station ID: 977</b>				<b>Observer: Ponti</b>		
<b>Observation Date</b>	<b>Latitude</b>	<b>Longitude</b>	<b>Offset Feature</b>	<b>Inferred Origin</b>		
2014:09:18	38.33373	122.35369	Soil	Uncertain		
<b>Description</b>						
Photo view is to the northwest. Vector length=3; Vector azimuth=237; Vector plunge=0; Fracture azimuth=327. Fault zone azimuth=327.						
<b>Fault Azimuth</b>	<b>Strike Slip</b>	<b>Strike-slip Sense</b>	<b>Extension</b>	<b>Compression</b>	<b>Vertical</b>	<b>Upthrown Side</b>
327	0		3			
<b>Photographer</b>	<b>Camera Coordinates</b>			<b>Photograph Date</b>		
Ponti	38.33371	122.35368		2014:09:18 16:37:26

View is to the northwest.

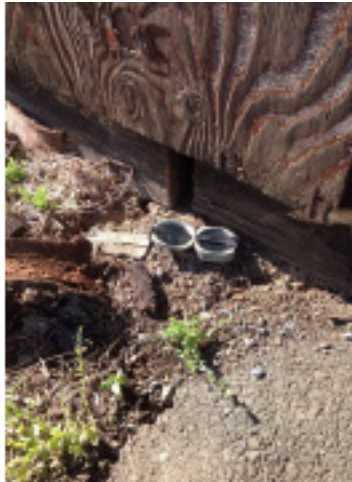
[High Resolution Photograph](#)

<b>Station ID: 979</b>				<b>Observer: Ponti</b>		
<b>Observation Date</b>	<b>Latitude</b>	<b>Longitude</b>	<b>Offset Feature</b>	<b>Inferred Origin</b>		
2014:09:18	38.33379	122.35325	Foundation	Uncertain		
<b>Description</b>						
Apparent separation of wooden foundation. Unclear if the entire separation occurred in the earthquake or if it may have been enhanced. The crack going through the foundation has about 2 cm of separation, whereas the foundation has about 4 cm. Vector length=4; Vector azimuth=50; Vector plunge=0; Fracture azimuth=330.						
<b>Fault Azimuth</b>	<b>Strike Slip</b>	<b>Strike-slip Sense</b>	<b>Extension</b>	<b>Compression</b>	<b>Vertical</b>	<b>Upthrown Side</b>
330	0.7	LL	3.9			
<b>Photographer</b>	<b>Camera Coordinates</b>		<b>Photograph Date</b>			
Ponti	38.33381	122.35326	2014:09:18 15:48:34

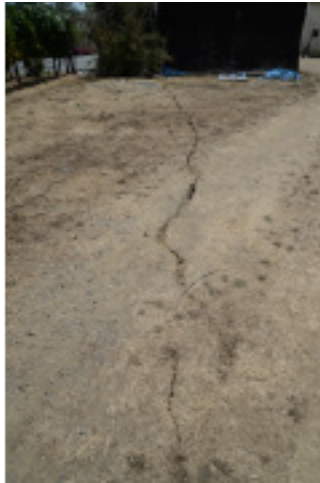
<b>Station ID: 984</b>					<b>Observer: Ponti</b>
<b>Observation Date</b>	<b>Latitude</b>	<b>Longitude</b>	<b>Offset Feature</b>	<b>Inferred Origin</b>	
2014:09:18	38.33392	122.35377	Soil	Uncertain	
<b>Description</b>					
Intermittent fractures here. This might be on a throughgoing trend but nothing is continuous.

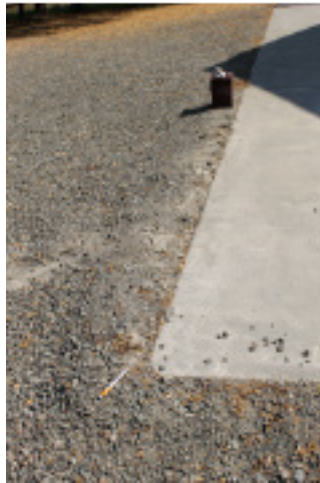
[High Resolution Photograph](#)

<b>Station ID: 990</b>		<b>Observer: Pickering/Crewdson</b>		
<b>Observation Date</b>	<b>Latitude</b>	<b>Longitude</b>	<b>Offset Feature</b>	<b>Inferred Origin</b>
2014:09:09	38.33410	122.35703	Soil	Uncertain
<b>Description</b>				
Compressional feature in garden gravel.				
<b>Photographer</b>	<b>Camera Coordinates</b>		<b>Photograph Date</b>	
Pickering/Crewdson			2014:09:09 14:16:08

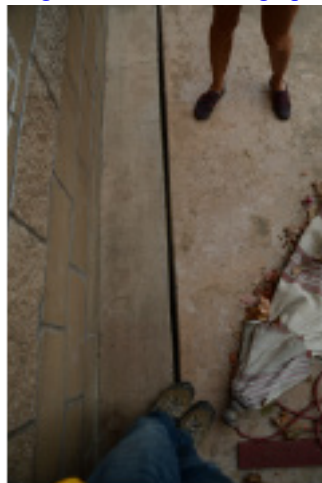
<b>Station ID: 1006</b>				<b>Observer: Ponti</b>
<b>Observation Date</b>	<b>Latitude</b>	<b>Longitude</b>	<b>Offset Feature</b>	<b>Inferred Origin</b>
2014:09:22	38.33434	122.35349	Soil	Uncertain
<b>Description</b>				
Tension crack; intermittent along mapped trend. Discontinuous, meandering cracks appear to line up with the more continuous cracking adjacent to the water tank to the south.

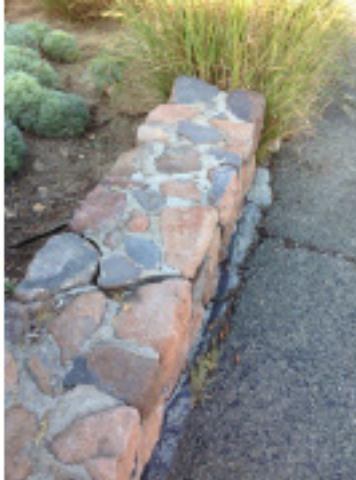
[High Resolution Photograph](#)

<b>Station ID: 1014</b>				<b>Observer: Ponti</b>
<b>Observation Date</b>	<b>Latitude</b>	<b>Longitude</b>	<b>Offset Feature</b>	<b>Inferred Origin</b>
2014:09:22	38.33460	122.35469	Pavement	Uncertain
<b>Description</b>				
Tension crack; continuous along mapped trend. In pavement and retaining wall. No obvious lateral displacement.				
<b>Photographer</b>	<b>Camera Coordinates</b>		<b>Photograph Date</b>	
Ponti	38.33463	122.35468	2014:09:22 17:05:07

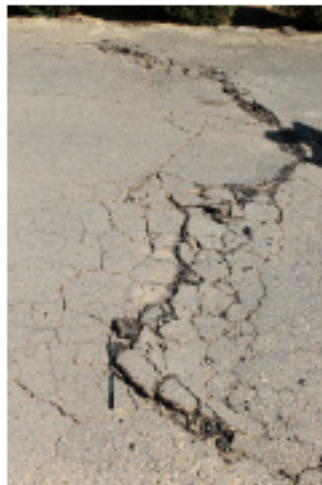
<b>Station ID: 1018</b>		<b>Observer: Pickering/Crewdson</b>		
<b>Observation Date</b>	<b>Latitude</b>	<b>Longitude</b>	<b>Offset Feature</b>	<b>Inferred Origin</b>
2014:09:09	38.33508	122.35910	Pavement	Uncertain
<b>Description</b>				
Compressional fracture in driveway.

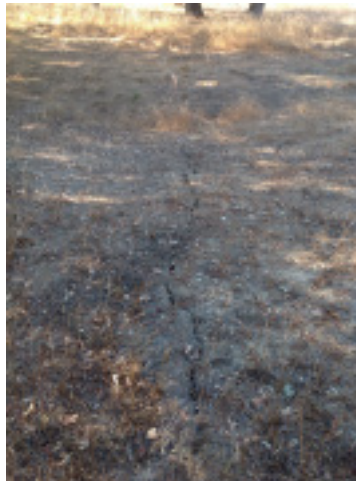
<b>Station ID: 1023</b>				<b>Observer: Ponti</b>
<b>Observation Date</b>	<b>Latitude</b>	<b>Longitude</b>	<b>Offset Feature</b>	<b>Inferred Origin</b>
2014:09:22	38.33528	122.35561	Soil	Uncertain
<b>Description</b>				
Tension crack; continuous along mapped trend. Prominent.

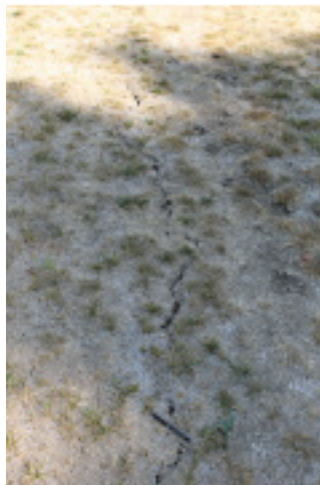
<b>Station ID: 1025</b>				<b>Observer: Ponti</b>
<b>Observation Date</b>	<b>Latitude</b>	<b>Longitude</b>	<b>Offset Feature</b>	<b>Inferred Origin</b>
2014:09:22	38.33533	122.35602	Soil	Uncertain
<b>Description</b>				
Tension crack; continuous along mapped trend. Prominent crack across trail, but cannot observe fractures in the tall grass to the north. No obvious lateral displacement.

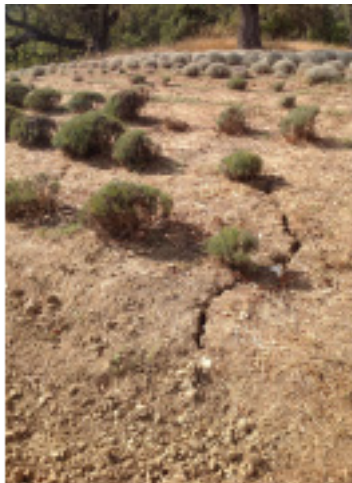
<b>Station ID: 1031</b>				<b>Observer: Ponti</b>	
Observation Date	Latitude	Longitude	Offset Feature	Inferred Origin	
2014:09:22	38.33574	122.35655	Soil	Uncertain	
Description					
Subparallel set of tensions cracks approximately 3 m across through lavender field. Photo to the northwest.					
Photographer	Camera Coordinates		Photograph Date		
Ponti	38.33574	122.35654	2014:09:22 16:25:05

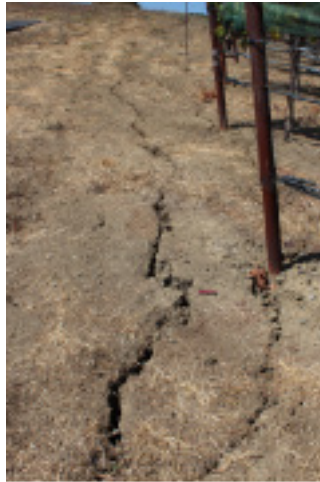
<b>Station ID: 1184</b>		<b>Observer: Zaccone</b>		
<b>Observation Date</b>	<b>Latitude</b>	<b>Longitude</b>	<b>Offset Feature</b>	<b>Inferred Origin</b>
2014:09:04	38.33521	122.34817	Soil	Uncertain
<b>Description</b>				
Dry Creek Road.				
<b>Photographer</b>	<b>Camera Coordinates</b>		<b>Photograph Date</b>	
Zaccone			2014:09:04 13:37:43
