Prepared in cooperation with the Village of Ruidoso, New Mexico

# **Geomorphic Survey of North Fork Eagle Creek, New Mexico, 2018**

Open-File Report 2020–1121

By Alexander P. Graziano

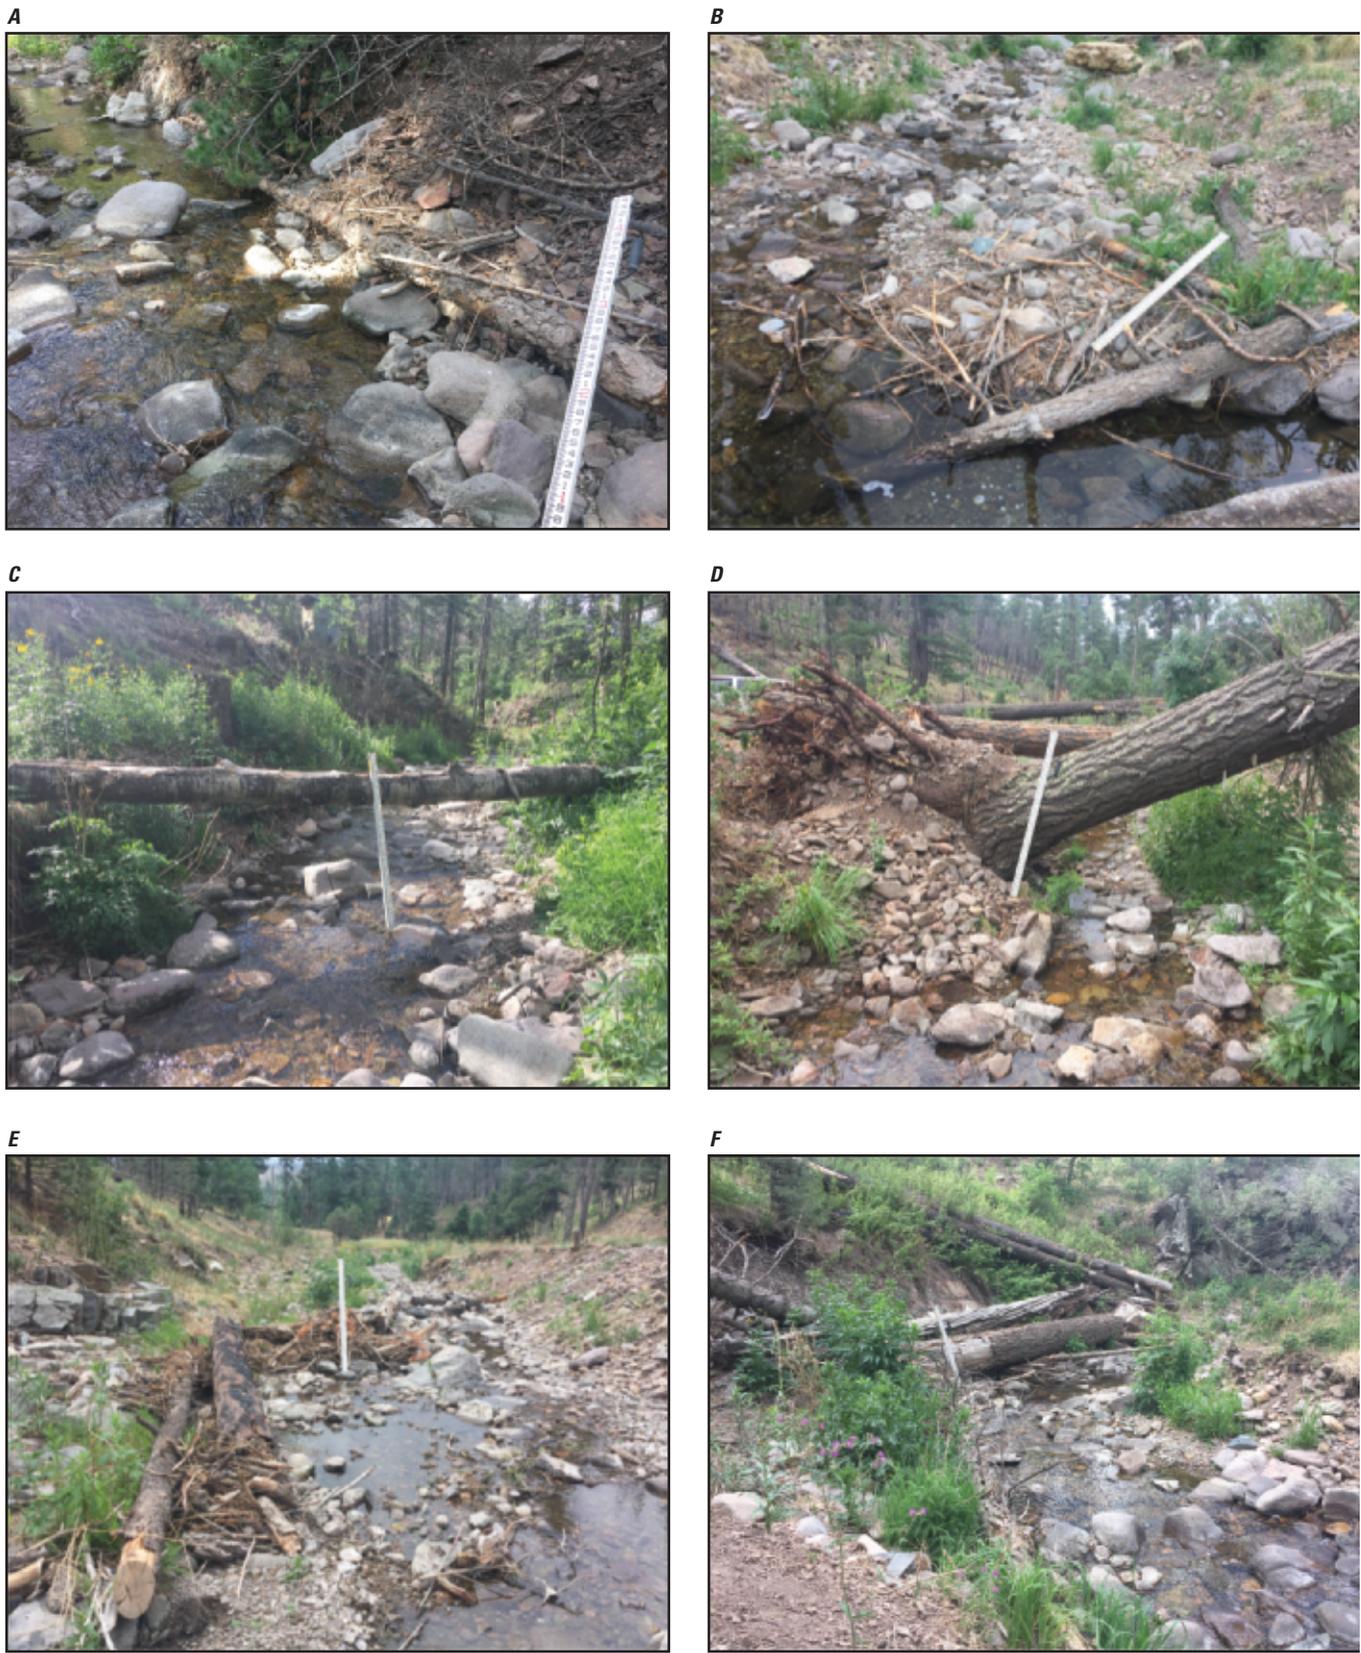
Example photographs of different woody debris accumulations identified during the 2018 survey are presented in figure 9, and the locations of the examples are shown in figure 8. Figure 9A depicts a type of debris deposit that was commonly seen during the 2018 survey, that being a debris deposit made up of woody debris loosely scattered on the side of the channel rather than in the middle. The debris deposit shown in figure 9A was not identified during the 2017 survey; however, because this debris deposit was almost entirely on the right side of the channel, it is possible that it was present in the channel during the 2017 survey and therefore was categorized as one of the 25 debris deposits that may have been overlooked in 2017. Notably, during the 2017 and 2018 surveys, in many locations along the study reach, deposits of LWD were observed on the channel banks or in the floodplain, but these woody debris accumulations were not photographed, cataloged, or surveyed.

Figure 9B depicts a type of debris deposit less commonly seen during the 2018 survey, that being a debris deposit that both included many pieces of woody debris and spanned most of the channel. The debris deposit depicted in figure 9B was found about 5 ft downstream from the third road crossing (located between cross sections 5 and 6) where no bridge is present and North Fork Eagle Creek crosses over the road. It

appeared that what had caused woody debris to accumulate in this location was a combination of effects from the sheer drop in the channel of about 5 ft at the downstream side of the road crossing and the gravel bar located about 5 ft downstream from the drop. The debris deposit depicted in figure 9B was 1 of the 11 debris deposits that were presumed to have newly formed between the 2017 and 2018 surveys because it was not observed in 2017, and due to its size and extent, it was not likely to have been overlooked during the 2017 survey.

Figure 9C depicts a common type of potential debris jam, that being a potential debris jam formed by LWD suspended over the channel that may not have been deposited by streamflow (for example, it could have fallen across the channel) but would likely require wood-mobilizing streamflows to become an active debris jam. Notably, wood-mobilizing streamflows may also be capable of removing the LWD in figure 9C from its location. However, the LWD in figure 9C was also identified during the 2017 survey and was one of the four woody debris accumulations that were classified as potential debris jams in both 2017 and 2018. Additionally, there were high, wood-mobilizing streamflows that occurred between the 2017 and 2018 surveys, and they did not cause notable change to the LWD in figure 9C.

**Figure 9.** Examples of woody debris accumulations identified in North Fork Eagle Creek, south-central New Mexico, 2018. All photographs were taken facing downstream. For scale, a survey rod that is 4.46 feet in length (with graduation at feet, tenths of feet, and hundredths of feet) was included in each photograph. Locations of examples are shown in [figure 8](#). *A*, Debris deposit. *B*, Debris deposit. *C*, Potential debris jam. *D*, Potential debris jam. *E*, Active debris jam. *F*, Active debris jam.

Figure 9D depicts a unique potential debris jam that was one of the seven potential debris jams that was presumed to have newly formed between 2017 and 2018. This potential debris jam was unique in that it was the only potential debris jam that appeared to have contributed to relatively substantial geomorphic change in the channel, specifically, where the tree uprooted on the left bank, the left bank collapsed, and the channel became constricted. It was also unique because it can be said with certainty that it was not woody debris that was mobilized and deposited by streamflow. Further, because the tree was large (between 2 and 3 ft in diameter) and it appeared to be firmly anchored by its root structure, it is likely that it will remain in place unless there is a substantial increase in streamflow or it is removed by artificial means. Therefore, it is likely well suited to become the key member in an active debris jam and to continue to be a driver of geomorphic change in the location where it was found during the 2018 survey.

Figure 9F depicts what appeared to be the largest (by volume) active debris jam found in the study reach in 2018. It is located about 5–10 ft downstream from cross section 4 on the outer edge of a 90-plus degree bend in the channel. The active debris jam depicted in figure 9F was one of the eight active debris jams that was present during both the 2017 and 2018 surveys, and a photograph of it from the 2017 survey was used as an example of an active debris jam in Graziano

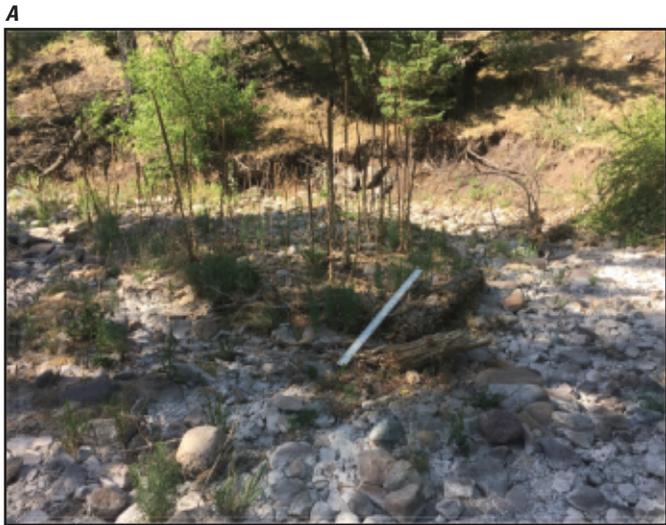
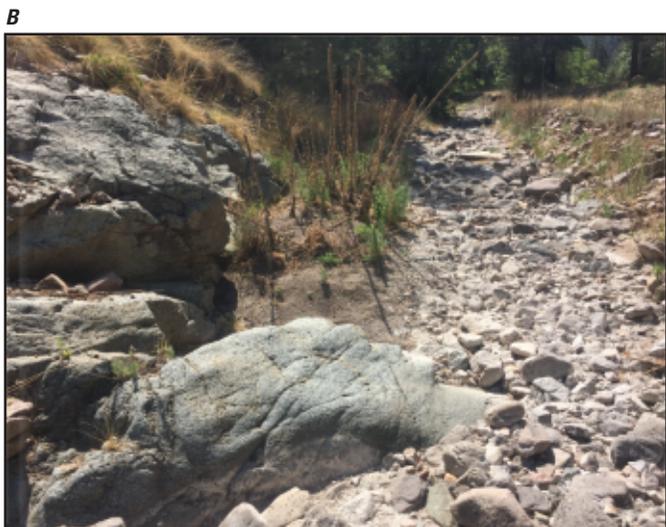
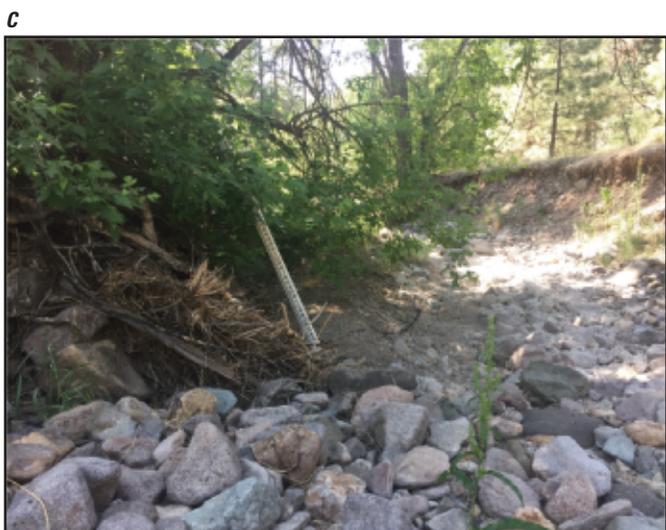
Example photographs presented in figure 11 depict various characteristics of channel bifurcations and fine-sediment accumulations identified in the study reach during the 2018 survey (locations of the examples are shown in fig. 8). Figure 11A depicts a channel bifurcation that was about 40 ft long (channelwise) and had a debris deposit in it at the point where it forked. Woody debris accumulations were found at all four of the channel bifurcations identified in the study reach. Figure 11B depicts a fine-sediment accumulation that was directly downstream from exposed bedrock that likely influenced its formation. The plants present in this fine-sediment accumulation may have been providing some stability to the accumulation. Figure 11C depicts a fine-sediment accumulation that was directly downstream from an active debris jam that likely influenced its formation. Because the formation of this fine-sediment accumulation was likely influenced by a relatively temporary feature (that is, a woody debris accumulation instead of a boulder or exposed bedrock) and plants were not observed to be growing in the accumulation, this fine-sediment accumulation may not have been as stable or as old as the fine-sediment accumulation depicted in figure 11B. Of the seven fine-sediment accumulations identified during the 2018 survey, the formation of four appeared to have been influenced by active debris jams, and the formation of the other three appeared to have been influenced by bedrock or boulders. However, only the fine-sediment accumulation depicted in figure 11B had plants growing in it.

**Figure 11.** Examples of channel bifurcations and fine-sediment accumulations found in North Fork Eagle Creek, south-central New Mexico, 2018. All photographs were taken facing downstream. For scale, a survey rod that is 4.46 feet in length (with graduation at feet, tenths of feet, and hundredths of feet) was included in two of the photographs. Locations of examples are shown in figure 8. *A*, Channel bifurcation, which was about 40 feet long and has a debris deposit at the point where it forks. *B*, Fine-sediment accumulation, which was directly downstream from exposed bedrock. *C*, Fine-sediment accumulation, which was directly downstream from an active debris jam.
