**Sediment Mobility and River Corridor Assessment for a  
140-Kilometer Segment of the Main-Stem Klamath River  
Below Iron Gate Dam, California**

Open-File Report 2020–1141

By Jennifer Curtis, Travis Poitras, Sandra Bond, and Kristin Byrd

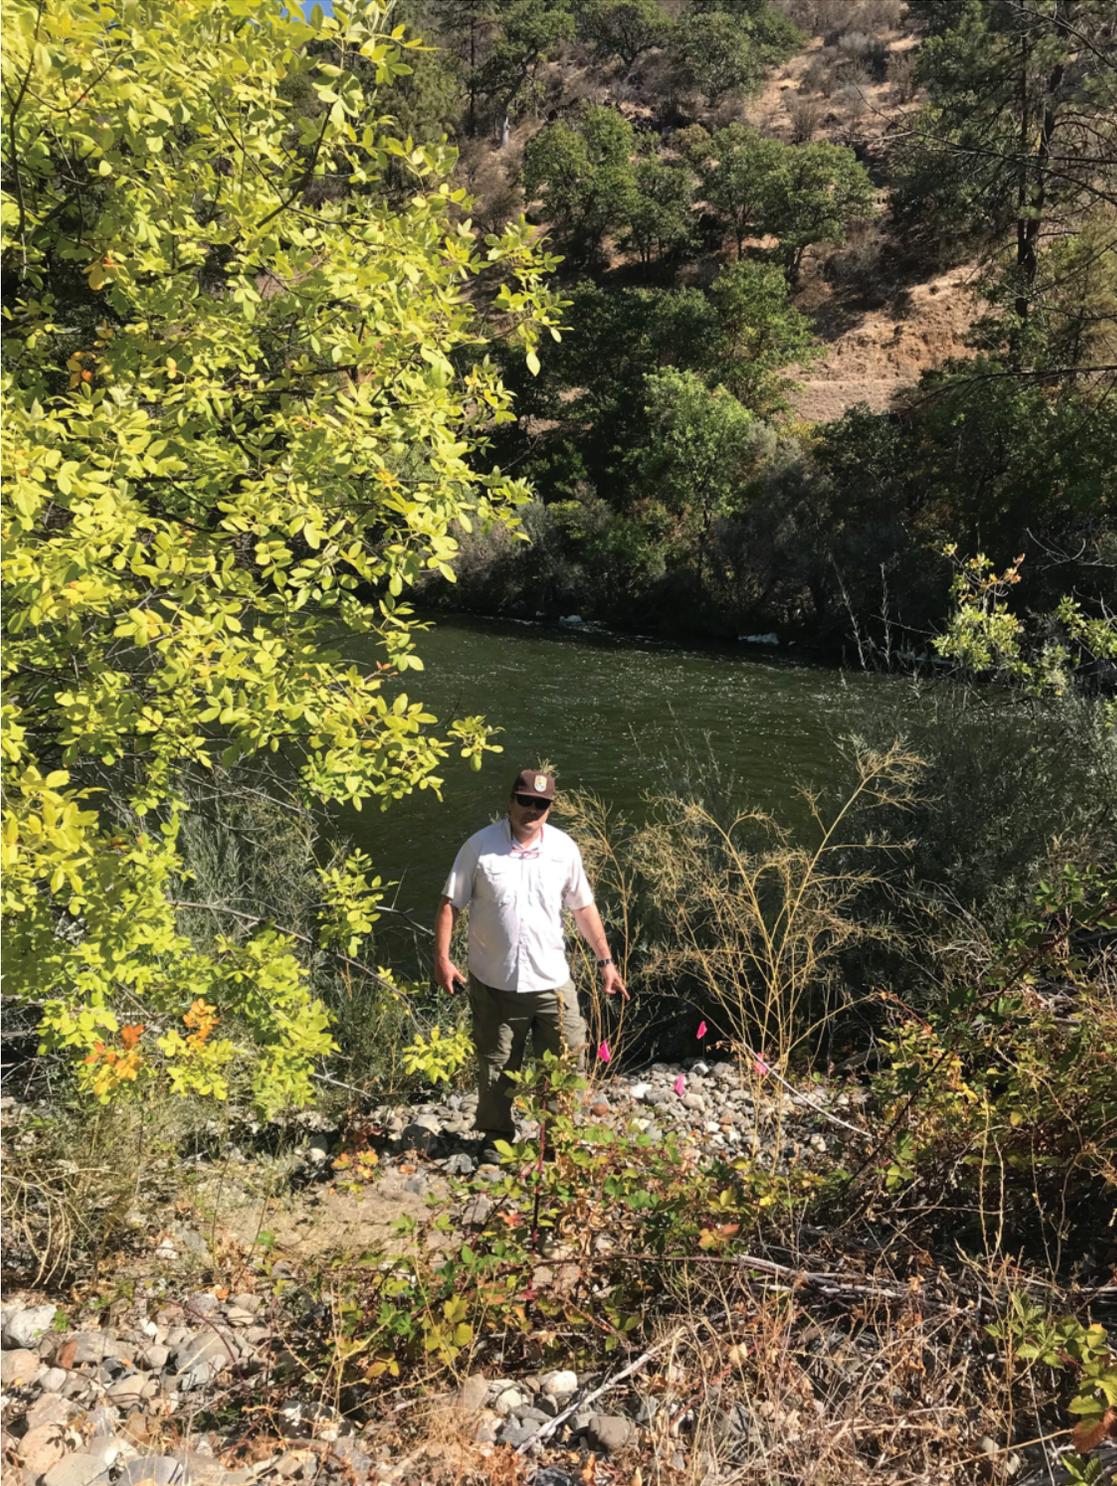
**Figure 10.** U.S. Fish and Wildlife employee and a substrate grain-size plot (KCC\_Veg1), showing evidence active bedload transport along a densely vegetated channel margin, collected in September 2018 at Klamath Community Center (KCC), located 53 kilometers downstream from Iron Gate Dam along the main-stem Klamath River, California. (See [fig. 9](#) and [table 8](#) for grain size distributions and [fig. 4](#) for site location). Photograph taken by Jennifer Curtis, U.S. Geological Survey.
